Alaska Department of Transportation and Public Facilities Central Region

NHS STORM DRAIN INSPECTION CONDITION REPORT PROJECT NO. 0A31055 / Z591280000

Dimond Boulevard from Jewel Lake Road to Old Seward Highway
Muldoon Road from Boundary Avenue to Northern Lights Boulevard
Debarr Road from Bragaw Street to Muldoon Road
Downtown: 5th and 6th Avenue from Gambell Street to Orca Street and
Ingra Street from 6th Avenue to 9th Avenue

May 20th, 2019

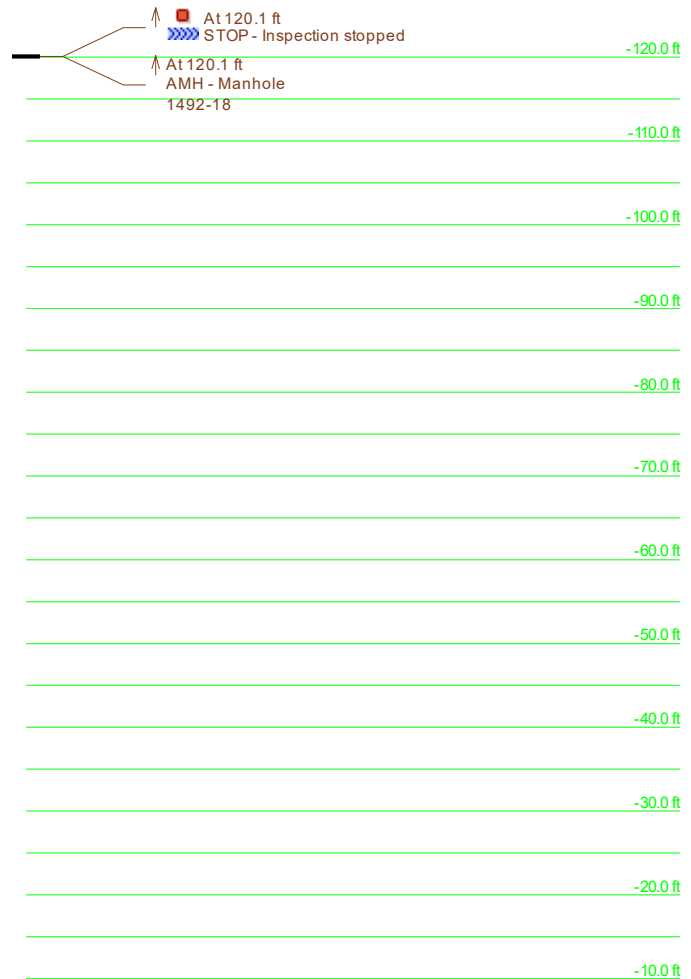
Notes: 1492-18 to 1492-17

- 30-in. CMP
- 120 LF
- Corrosion w/minor material loss along flow line.
- Two pin holes: Sta. 0+04 @ 3:00 position & Sta. 0+56 @ 5:00 position.
- All joints have leaks with mineral buildup.
- Flow: Minimal
- Grade score of: 2

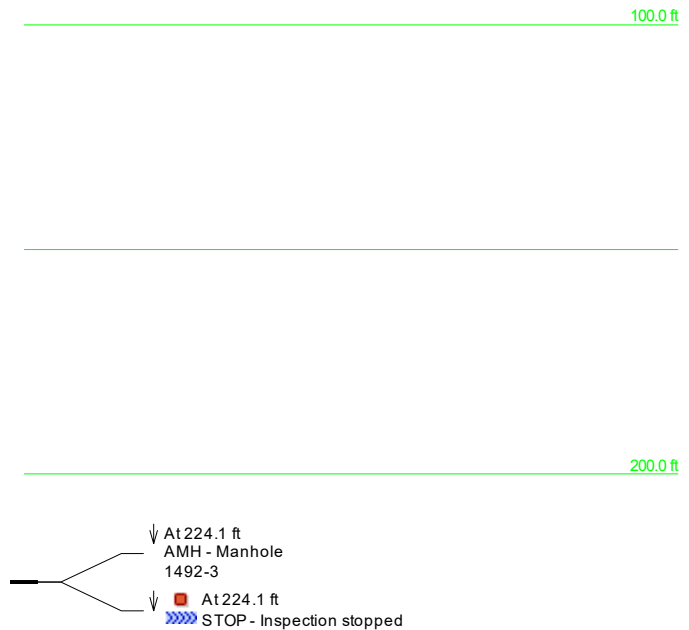
Notes: 1492-17A to 1492-3

- 30-in. CMP
- 224 LF
- 8% ovality from Sta. 1+10 to 1+60.
- Corrosion w/minor material loss
- 2 to 3 joints have leaks with mineral buildup.
- Flow: Minimal
- Grade score of: 3

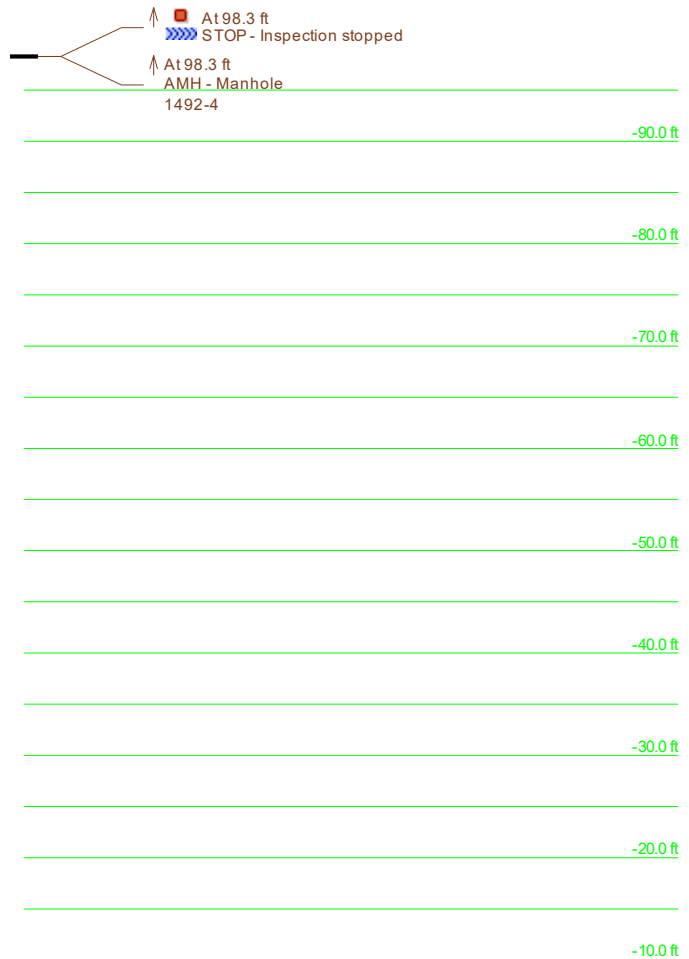
Notes: 1492-4 to 1492-3

- 18-in. CMP
- 98 LF
- Discoloration & some corrosion in the invert.
- Flow: Minimal
- Grade score of: 1

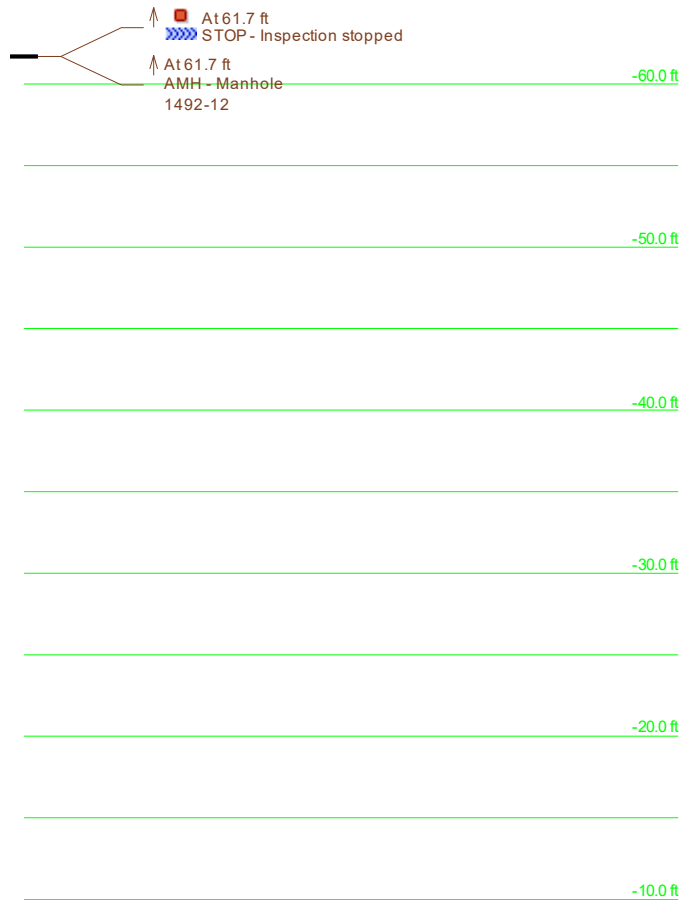
Notes: 1492-12 to 1492-5

- 18-in. CMP
- 62 LF
- Discoloration & some corrosion with metal loss in the invert.
- Flow: Minimal
- Grade score of: 2

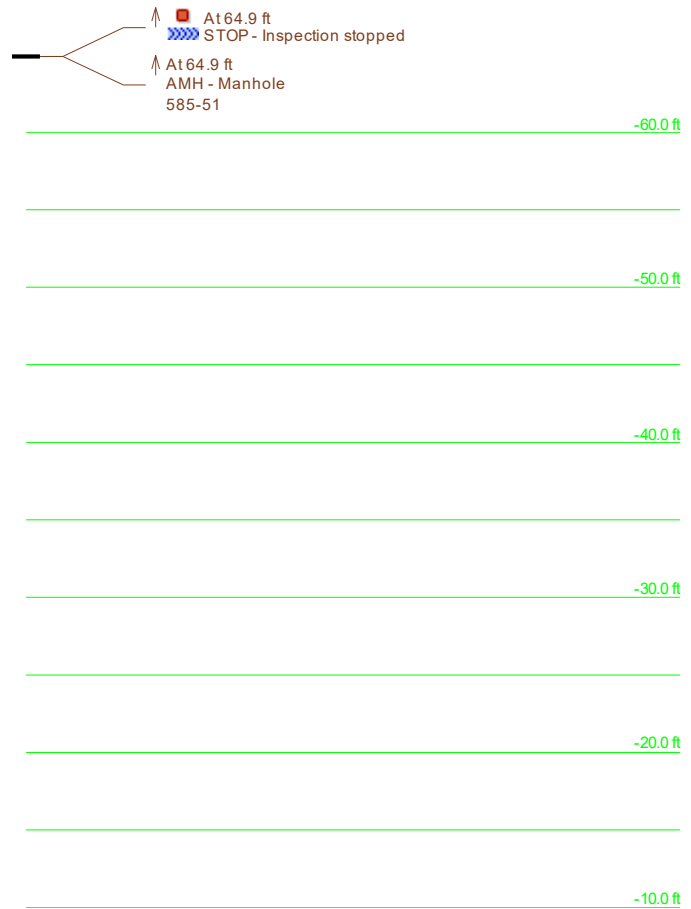
Notes: 585-51 to 585-50

- 18-in. CMP
- 65 LF
- Corrosion w/some metal loss from 5:00 to 7:00 position, for the length of the pipe.
- Pipe cleaned before CCTV
- Flow: Minimal
- Grade score of: 2

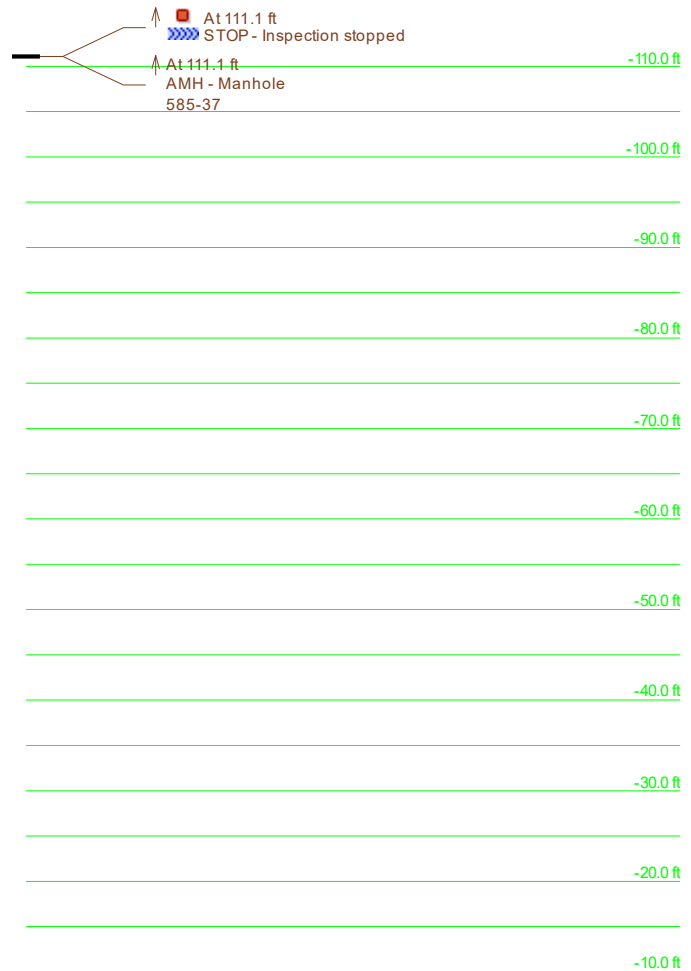
Notes: 585-37 to 585-36

- 18-in. CMP
- 111 LF
- Corrosion w/metal loss & holes, 3:00 to 9:00 position for the length of the pipe.
- Joints w/some corrosion, leaks & mineral build-up.
- Between 585-37 to 585-36:
 - # Approx. 6" high point from Sta. 0+42 to 0+52.
 - # Reverse grade from Sta.0+52 to Sta.0+62.
- Flow: 1" to 6"
- Grade score of: 3

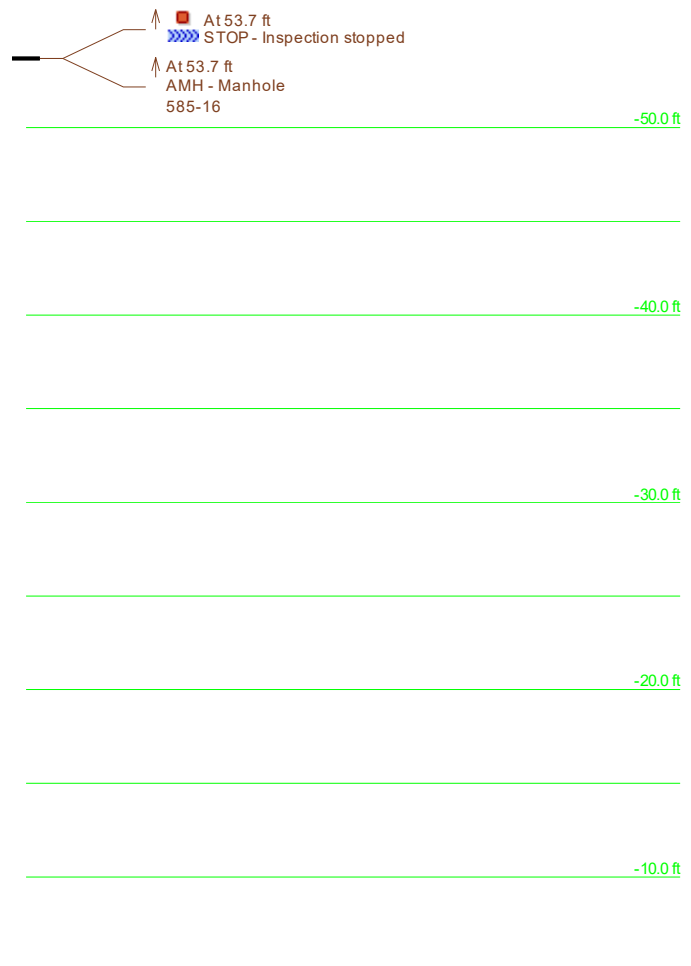
Notes: 585-16 to 585-15

- 24-in. CMP
- 54 LF
- Corrosion w/some metal loss, 5:00 to 7:00 position, for the length of the pipe.
- Joint w/some corrosion, leaks & mineral build-up, Sta. 0+33.
- Vertical grade breaks at:
 - # Sta.0+04
 - # Sta.0+11
 - # Sta.0+16
 - # Sta.0+32
- Flow: 1" to 2"
- Grade score of: 1

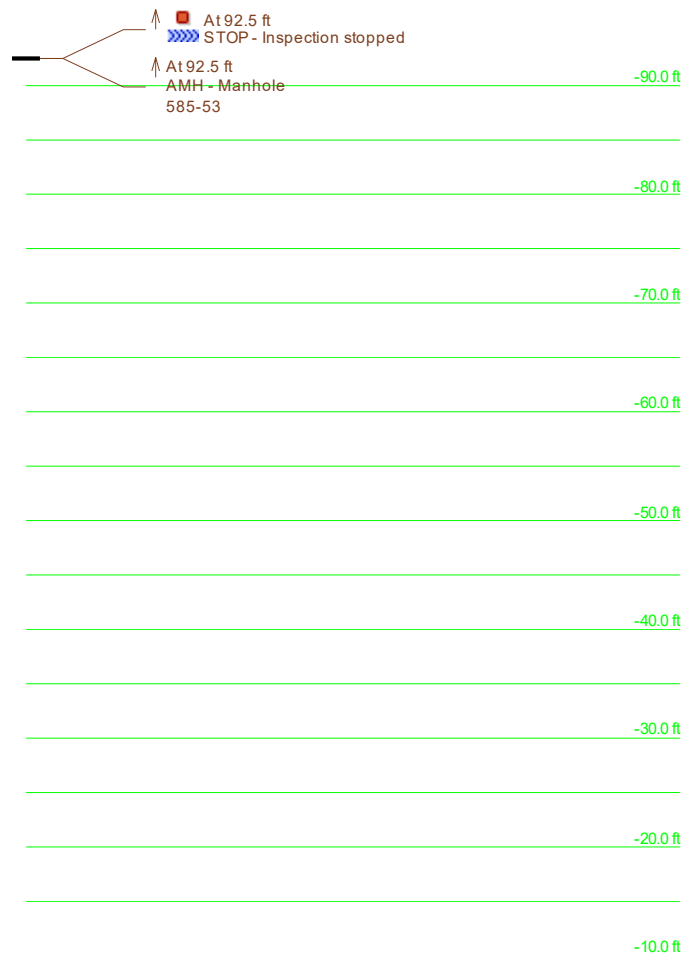
Notes: 585-53 to 585-15

- 18-in. CMP
- 93 LF
- Corrosion w/some metal loss, in invert intermittently for the length of the pipe.
- 3-1" deformations, 12:00 position, Sta. 0+32.
- Flow: Minimal
- Grade score of: 2

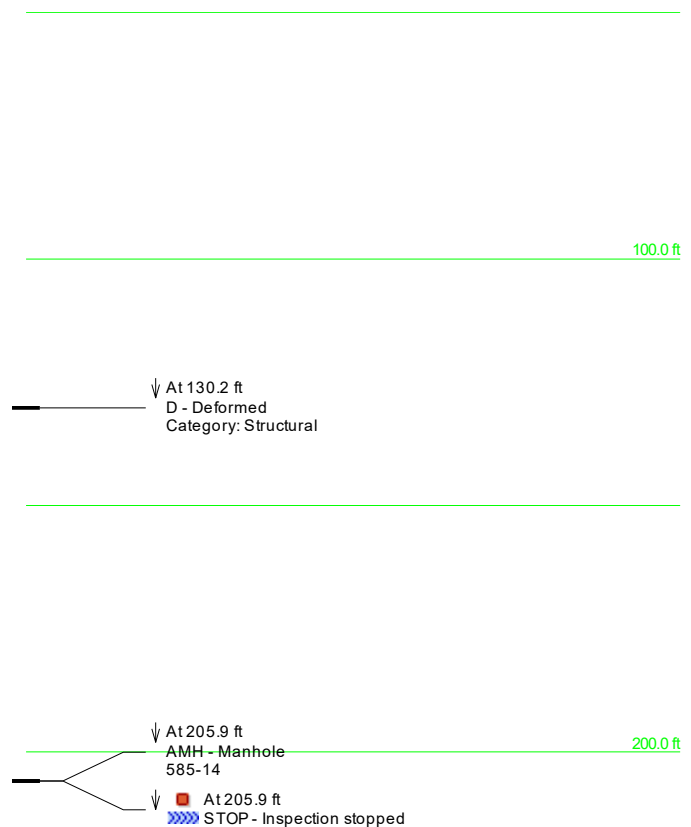
Notes: 585-15 to 585-14

- 24-in. CMP
- 206 LF
- Corrosion w/some metal loss, 5:00 to 7:00 position, for the length of the pipe.
- Multiple joints w/some corrosion, leaks & mineral build-up.
- Deformation at the 5:00 position, 5% flow reduction, Sta. 1+30.
- Flow: 1"
- Grade score of: 2

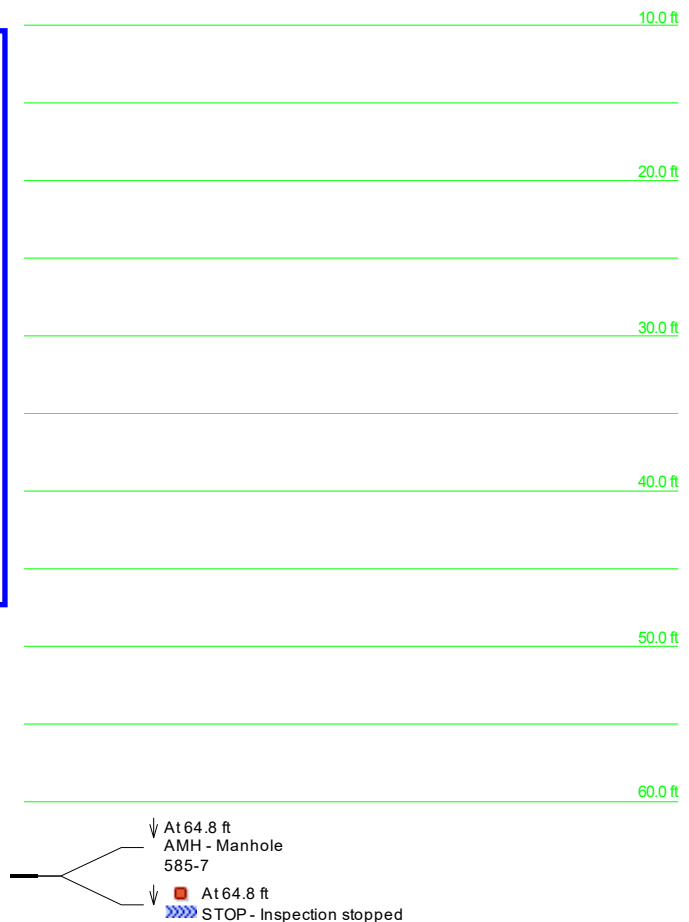
Notes: 585-11 to 585-7

- 18-in. CMP
- 65 LF
- Bottom of pipe 5:00 to 7:00 covered w/water & debris. Condition of invert unknown.
- Some corrosion with minor metal loss at 5:00 & 7:00 along length of the pipe.
- Flow: Minimal
- Grade score of: 2

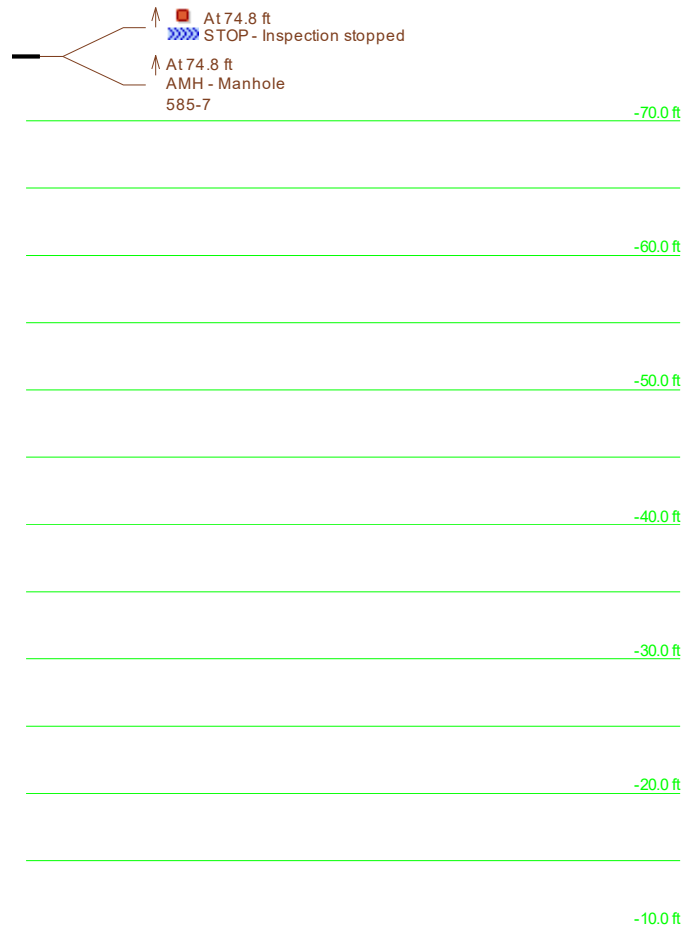
Notes: 585-7 to 585-6

- 18-in. CMP
- 75 LF
- Some corrosion with minor metal loss at 5:00 & 7:00 position along length of the pipe.
- Flow: Minimal
- Grade score of: 2

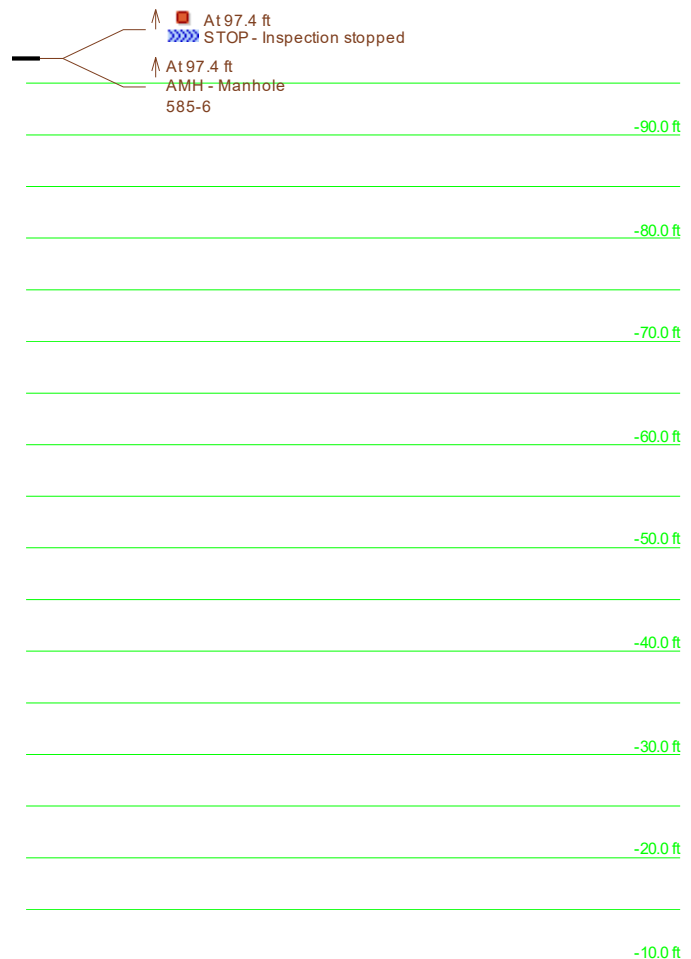
Notes: 585-6 to 585-5

- 18-in. CMP
- 97 LF
- Sta. 0+00 to 0+30 water depth 4" to 2". Sta. 0+30 to 0+97 water depth 2" to 1".
- Some corrosion with minor metal loss at 5:00 & 7:00 along length of the pipe.
- Flow: 1" to 4"
- Grade score of: 2

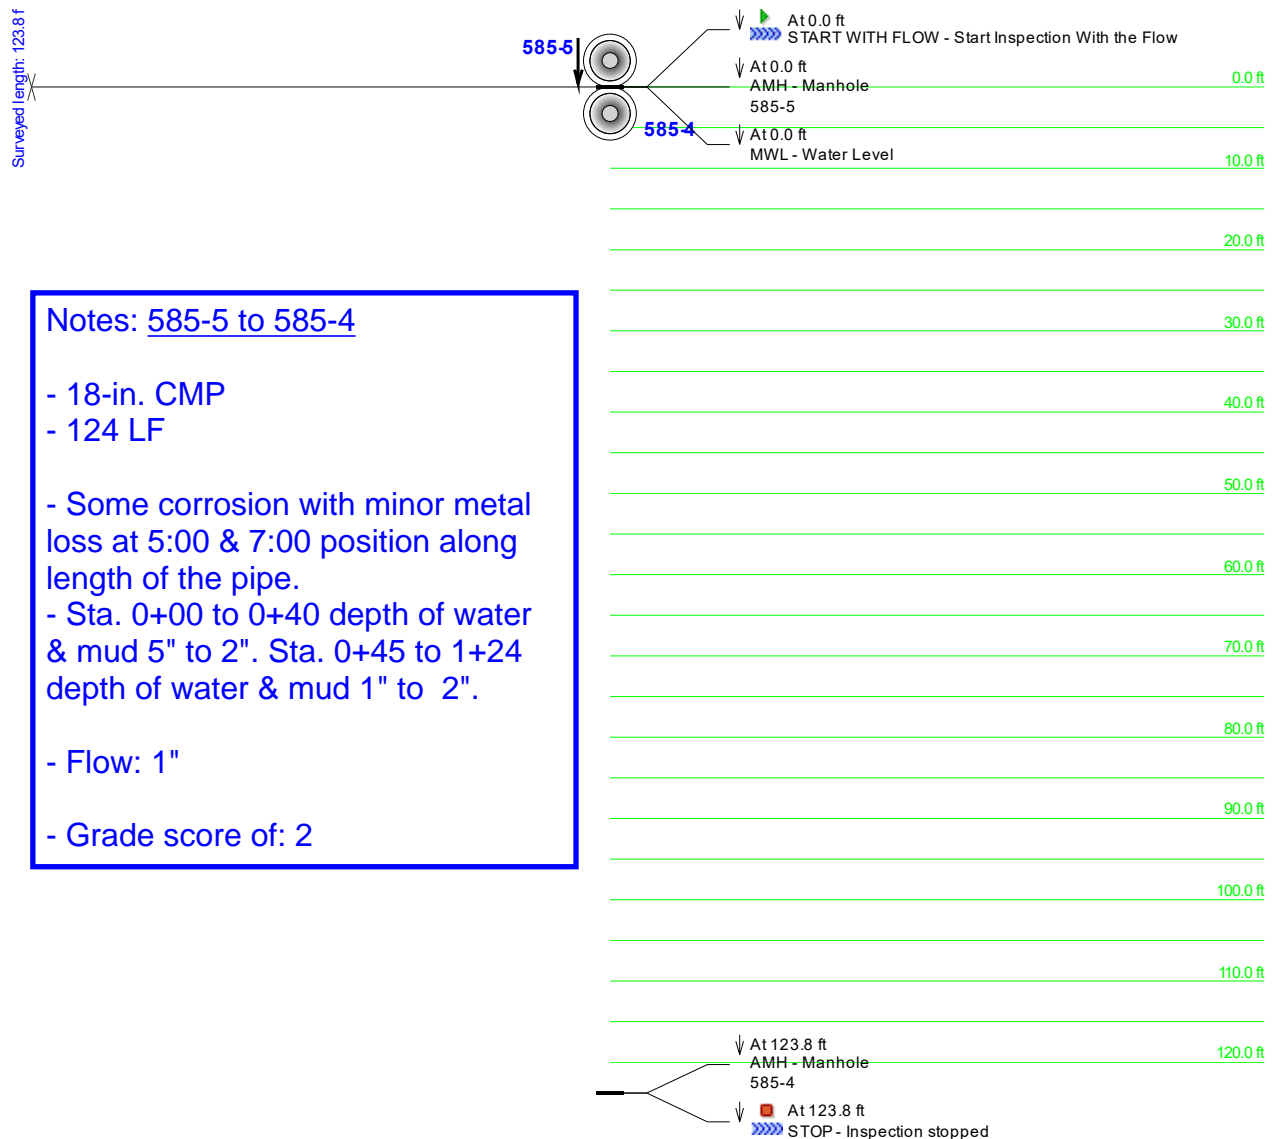
Notes: 585-5 to 585-4

- 18-in. CMP
- 124 LF
- Some corrosion with minor metal loss at 5:00 & 7:00 position along length of the pipe.
- Sta. 0+00 to 0+40 depth of water & mud 5" to 2". Sta. 0+45 to 1+24 depth of water & mud 1" to 2".
- Flow: 1"
- Grade score of: 2

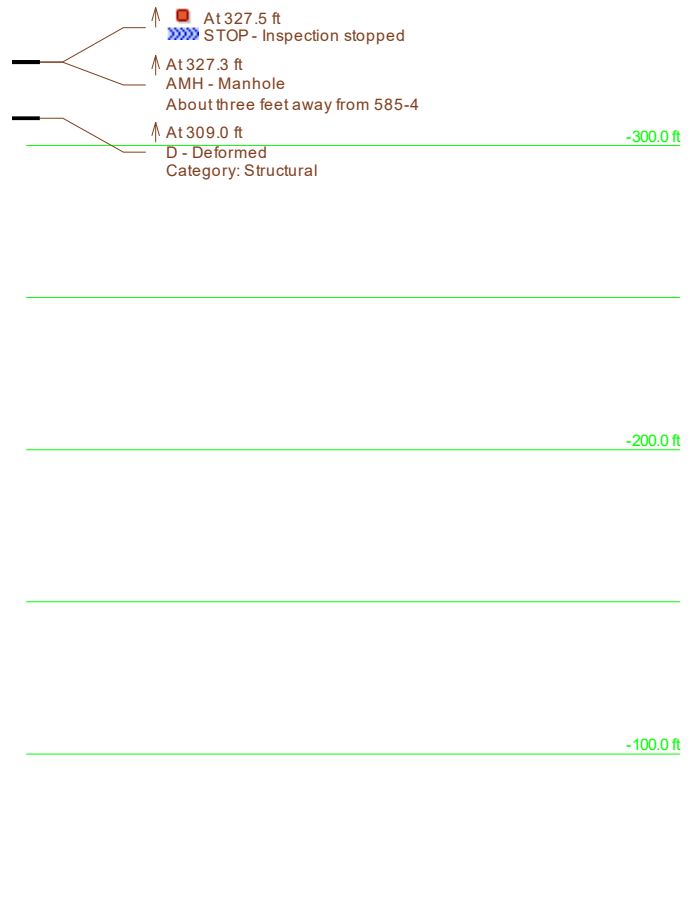
Notes: 585-4 to 585-3

- 30-in. CMP
- 328 LF
- Corrosion w/some material loss 5:00 position, for the length of the pipe. This corrosion is w/in 6" of 2 thaw cable.
- Deformation 12:00 position Sta.1+10 & 3+08.
- Slight joint off set Sta.3+18.
- Flow: 1"
- Grade score of: 2

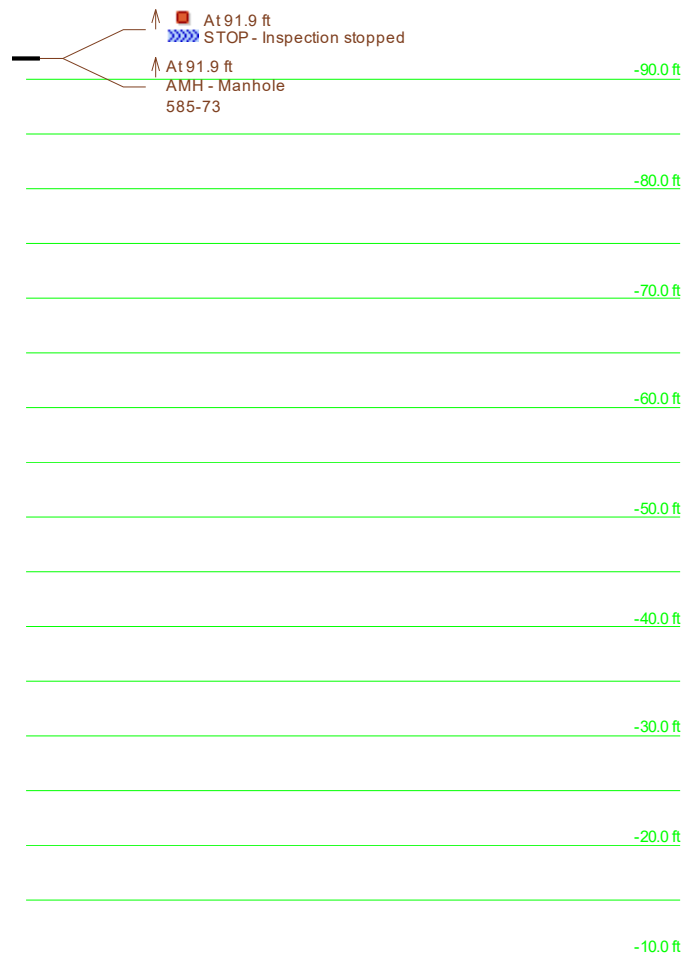
Notes: 585-73 to 585-72

- 18-in. CMP
- 92 LF
- Minor surface corrosion in invert for the length of the pipe.
- Flow: Minimal
- Grade score of: 1

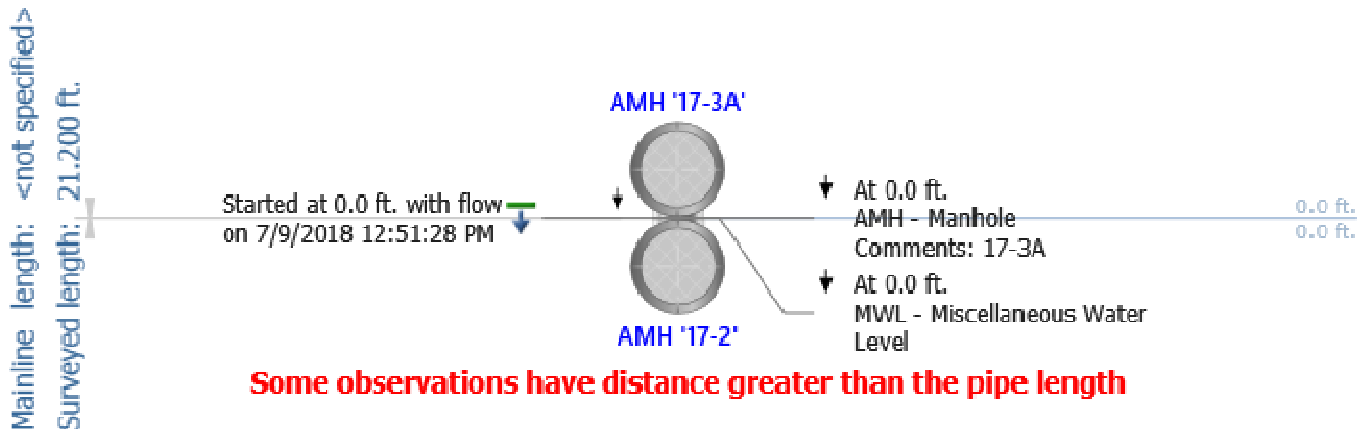
Notes: 17-3 to 17-2

- 24-inch CMP
- 21 LF
- Varying debris
- Possible surface corrosion in invert, unable to see invert completely due to debris
- CMP outfall structure at end of inspection
- No major defects observed
- Flow: 1"
- Grade score of: 1

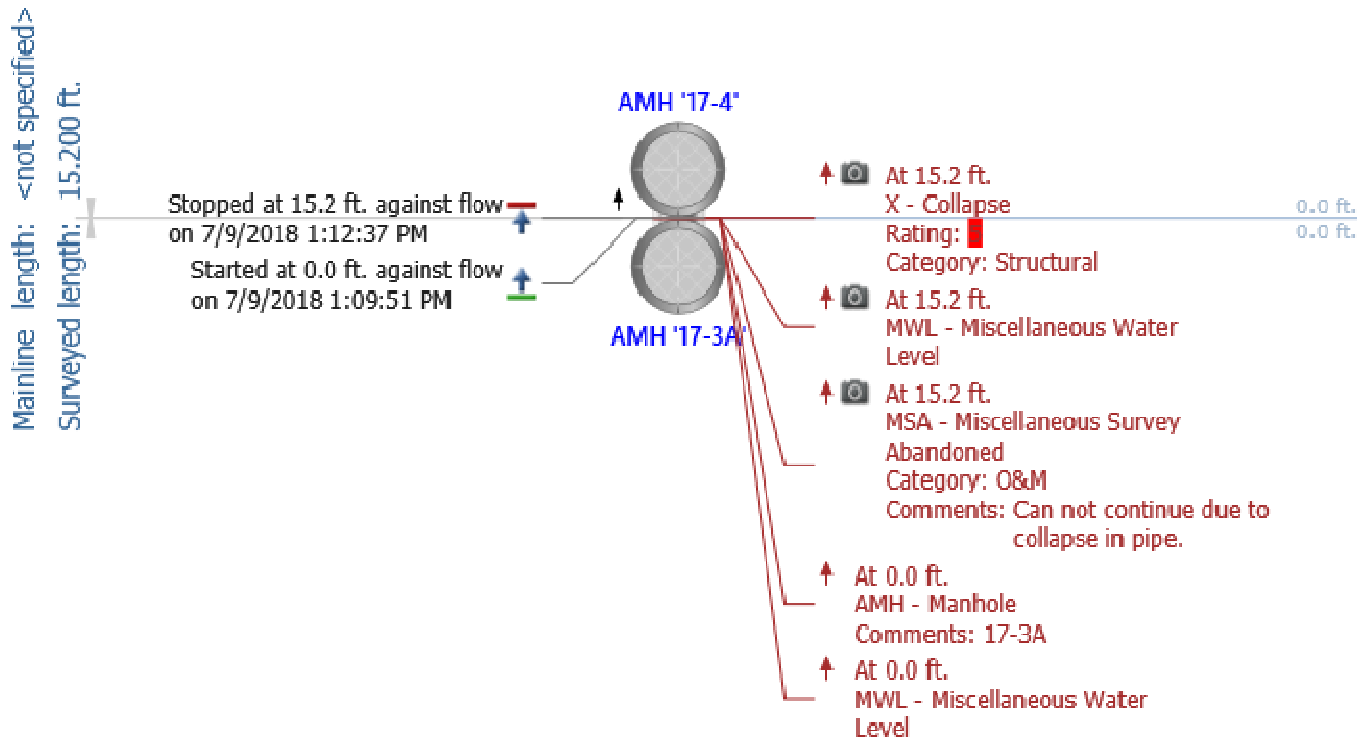
Notes: 17-4 to 17-3

- 18-inch CMP
- 98 LF
- 0-1" debris,
- Pipe crush at 15 LF, 15" in 12" position, camera unable to pass
- Flow: None
- Grade score of: 4

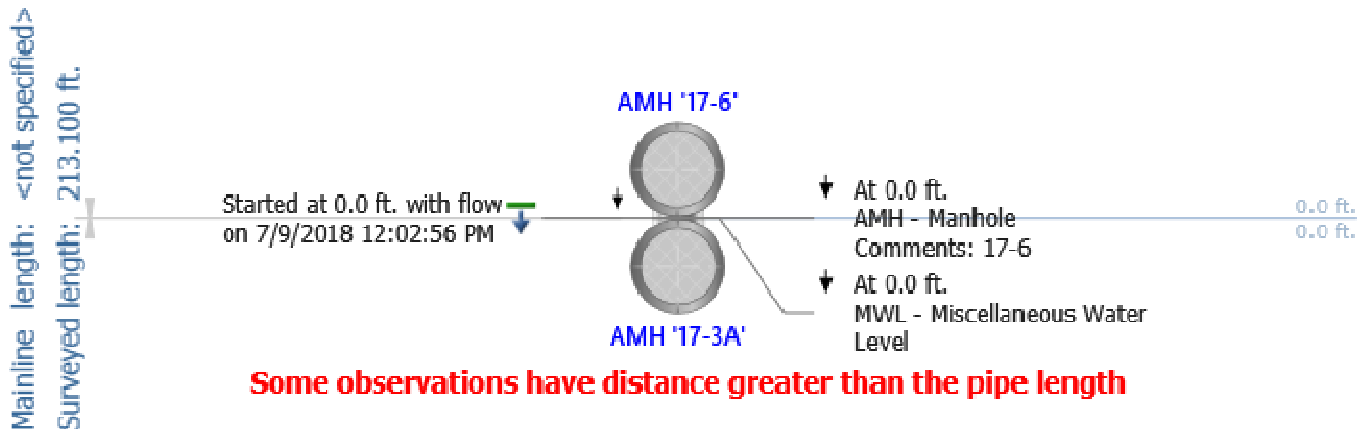
Notes: 17-6 to 17-3

- 24-inch CMP
- 213 LF
- Possible surface discoloration/corrosion in invert, degree of severity unknown
- 1" deformation 1:00 position, 27 LF
- 1" deformation 12:00 position, 41 LF
- 1" deformation 3:00 position, 163 LF
- 4-6" deformation 11:00 position, 204 LF
- Flow: 1"
- Grade score of: **2**

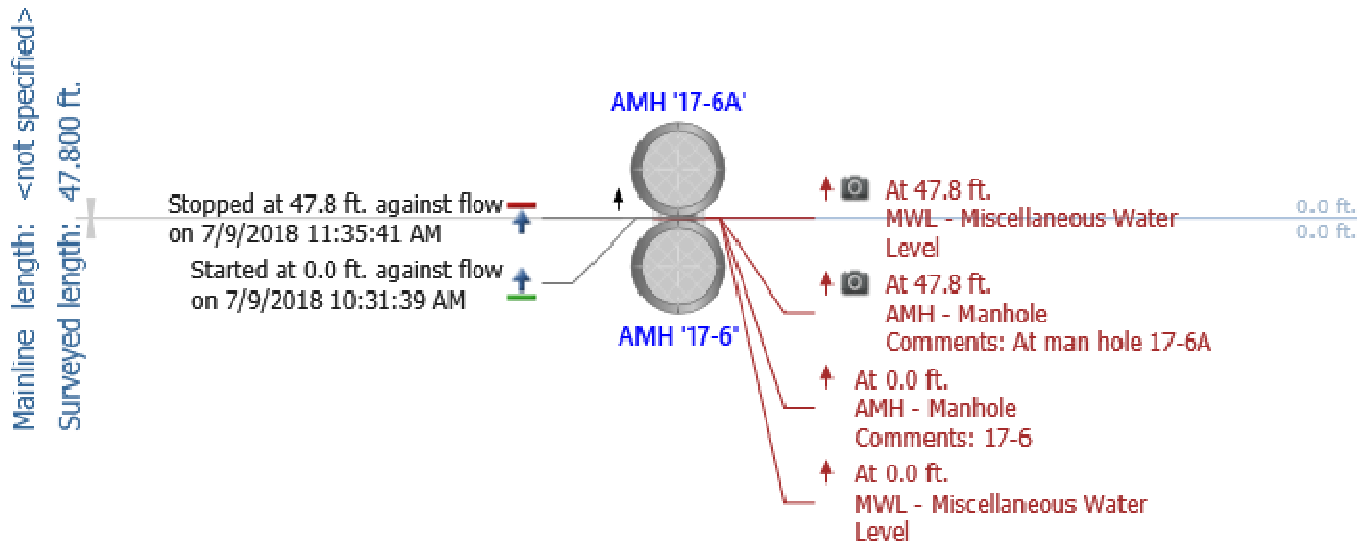
Notes: 17-6A to 17-6

- 24-inch CMP
- 48 LF
- Possible minor surface corrosion in invert
- No debris buildup or major defects
- Flow: 1"
- Grade score of: 1

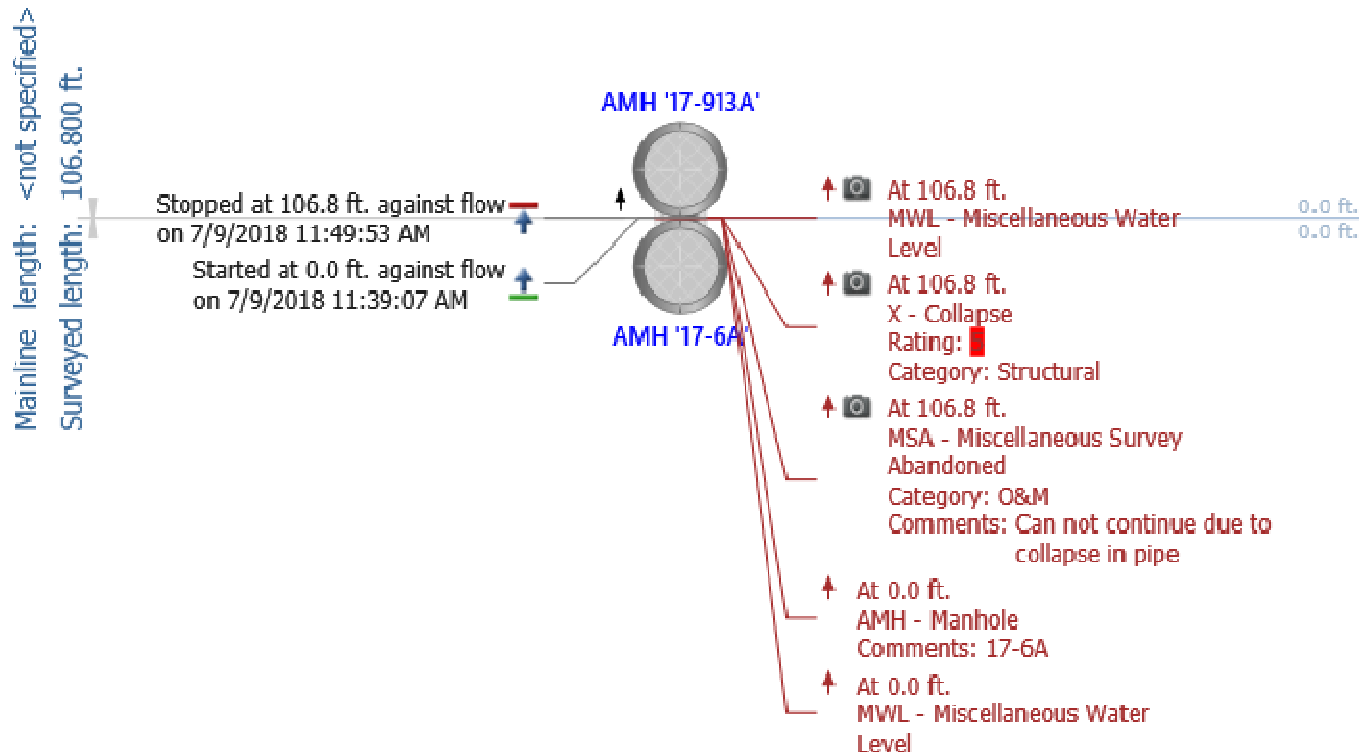
Notes: 17-8 to 17-6A

- 24-inch CMP
- 267 LF
- Possible minor surface corrosion in invert
- Potential belly at approximate 35 LF
- Mineralization at joint at 66 LF, 86 LF, 106 LF
- 12" deformation in 12:00 position at 105 LF continues for approximately 5-10', camera unable to pass,
- Flow: 1"
- Grade score of: 4

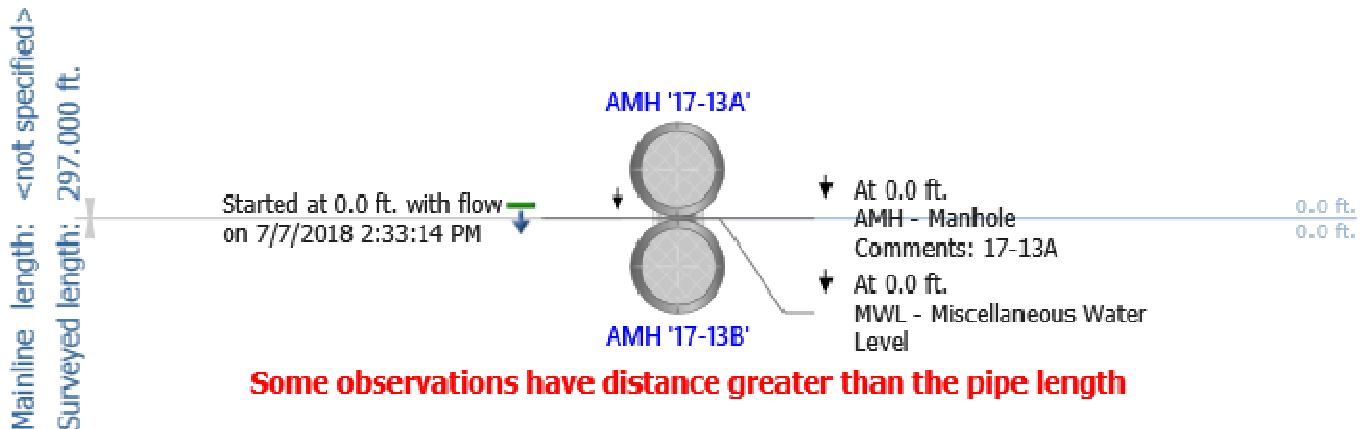
Notes: 17-13A to 17-8

- 24-inch CMP
- 297 LF
- Discoloration and evidence of corrosion in invert
- 1-2" deformation in 1:00 position, 14 LF
- Evidence of infiltration with mineralization, 9:00 position 25 LF
- Corrosion at joint at 190 LF
- No major structural defects observed
- Flow: 1"
- Grade score of: **2**

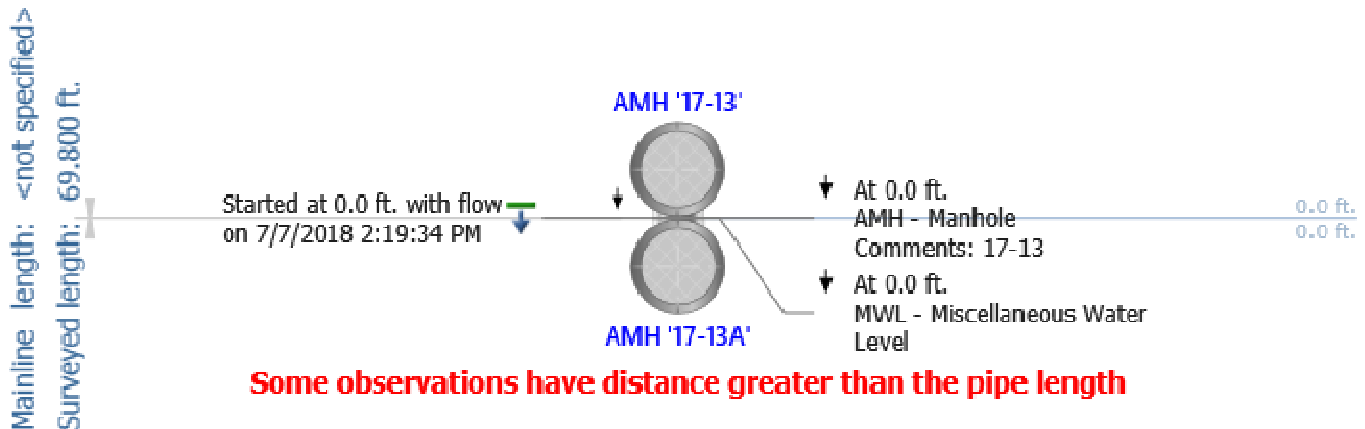
Notes: 17-13 to 17-13A

- 24-inch CMP
- 70 LF
- Discoloration in bottom of pipe
- Minimal debris
- 2-3" deformation of pipe end protruding in downstream manhole 10:00 position
- Evidence of minor surface corrosion in invert
- No major defects observed
- Flow: Minimal
- Grade score of: 1

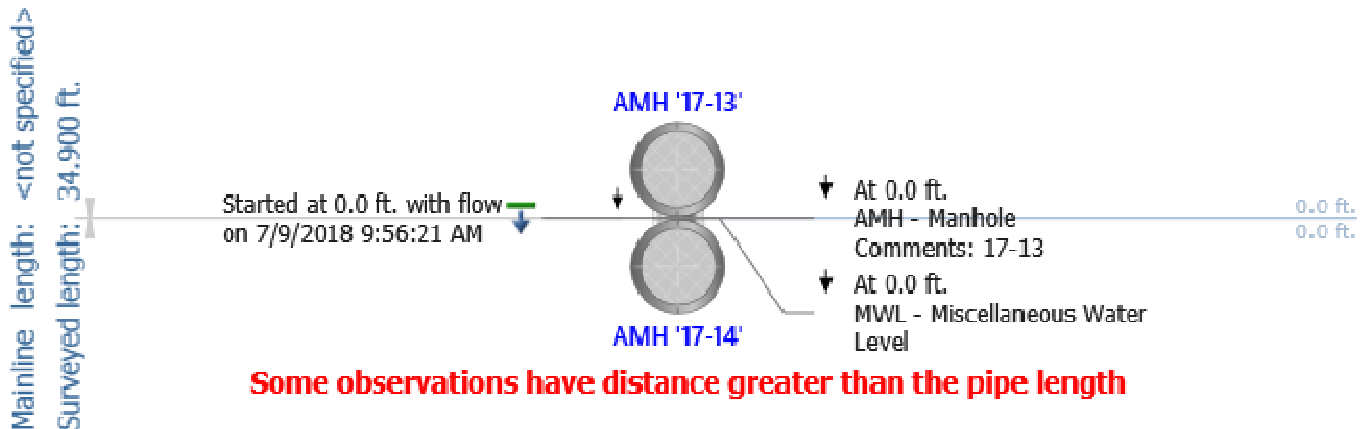
Notes: 17-14 to 17-13

- 12-inch CMP
- 69 LF
- 0-1" of debris in pipe, increases to half full at conclusion of survey
- Discoloration in bottom of pipe, evidence of corrosion in invert, mostly obscured by debris
- Minor corrosion at joint at 26 LF
- Possible belly in pipe at 35 LF
- Flow: 0-1"
- Grade score of: **2**

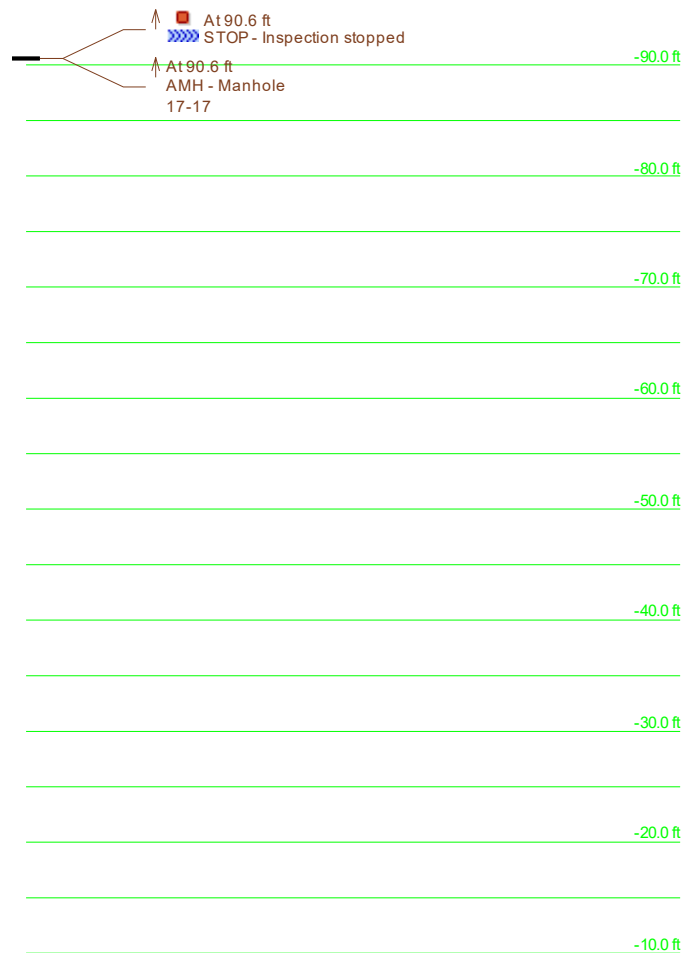
Notes: 17-17 to 17-17A

- 18-in. CMP
- 91 LF
- 1-2" of debris in pipe
- Visible corrosion in 5:00 position from 0.5 LF to 16.0 LF
- Possible belly in pipe at 21 LF
- Surface corrosion visible in 5:00 and 7:00 positions at 21 LF to 31 LF
- Surface corrosion visible in invert when not covered in debris
- Surface corrosion in 7:00 position at 57 LF to 68 LF
- 1-2" deformation in 1:00 position at 86 LF
- Non-standard upstream end treatment, cut to fit beneath slab in upstream manhole
- Flow: Minimal
- Grade score of: 3

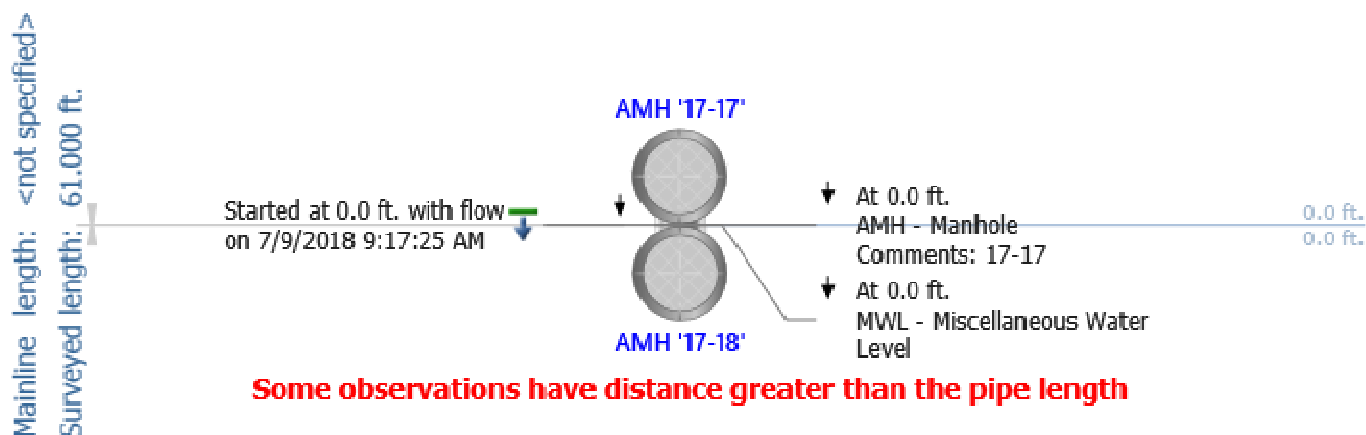
Notes: 17-18 to 17-17

- 15-inch CMP
- 61 LF
- 0-1" debris in pipe
- 10% cross sectional area loss at downstream end of pipe
- Evidence of corrosion in invert
- 1" deformation in 11:00 position, end of inspection at upstream end of pipe
- Flow: Minimal
- Grade score of: **2**

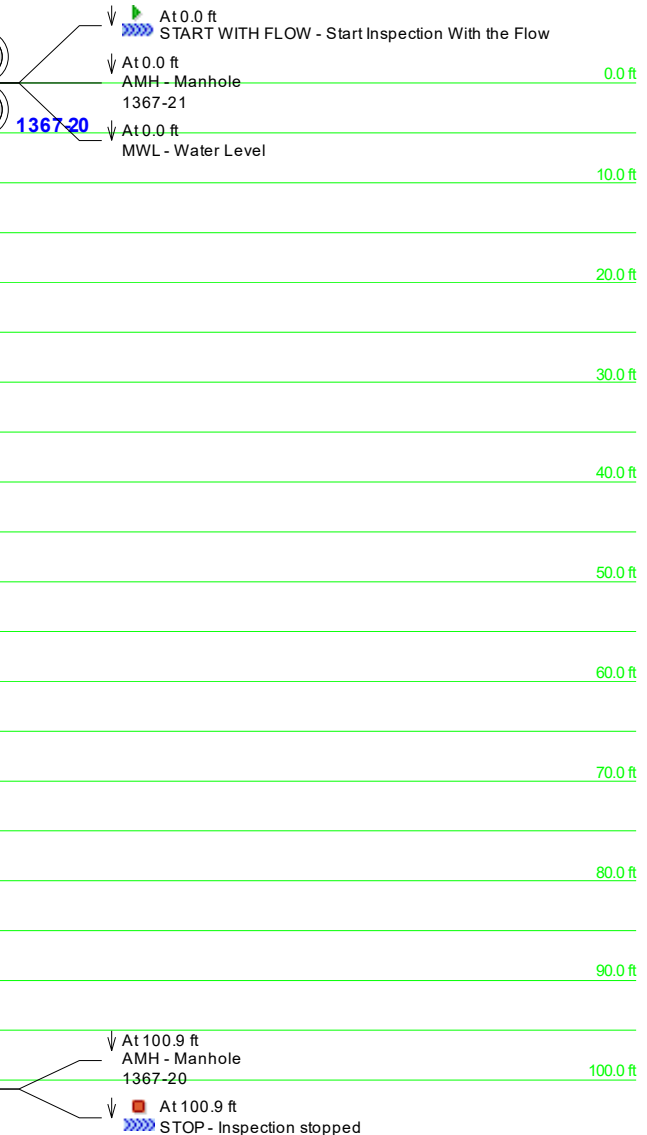
Notes: 1367-21 to 1367-20

- 12-in. CMP
- 101 LF
- Various debris depths 0-2" throughout pipe
- Surface corrosion in 3:00 and 9:00 position, visible metal loss 0-10 LF
- Surface discoloration in 9:00 position 10-25 LF
- Potential sag made apparent by debris buildup at 56 LF
- Offset joint appx. 1 in. at 64 LF
- Potential sag made apparent by debris buildup at 76 LF
- Physically inspected invert, metal appeared sound
- Flow: None
- Grade score of: 3

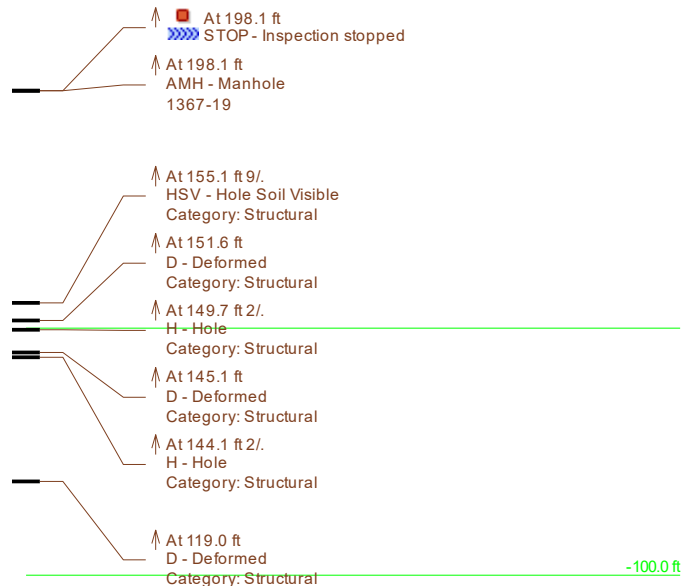
Notes: 1367-19 to 1367-16

- 18-in. CMP
- 198 LF
- 2-3" of debris, pipe cleaned 8-4-17
- Evidence of joint infiltration at 107 LF
- 1-2" deformation in 1:00 to 2:00 position
- Damage/hole from installation repair, screws showing, 2:00 position at 144 LF
- 0-1" deformation 10:00 position at 145 LF
- 6" Hole from installation repair, screws showing in 2:00 position at 149 LF
- 1-2" deformation 10:00 position at 152 LF
- 1-2" deformation 9:00 position at 155 LF
- Evidence of joint infiltration at 175 LF and 195 LF
- Visible surface discoloration in 5:00 position 195 LF
- Flow: None
- Grade score of: 3

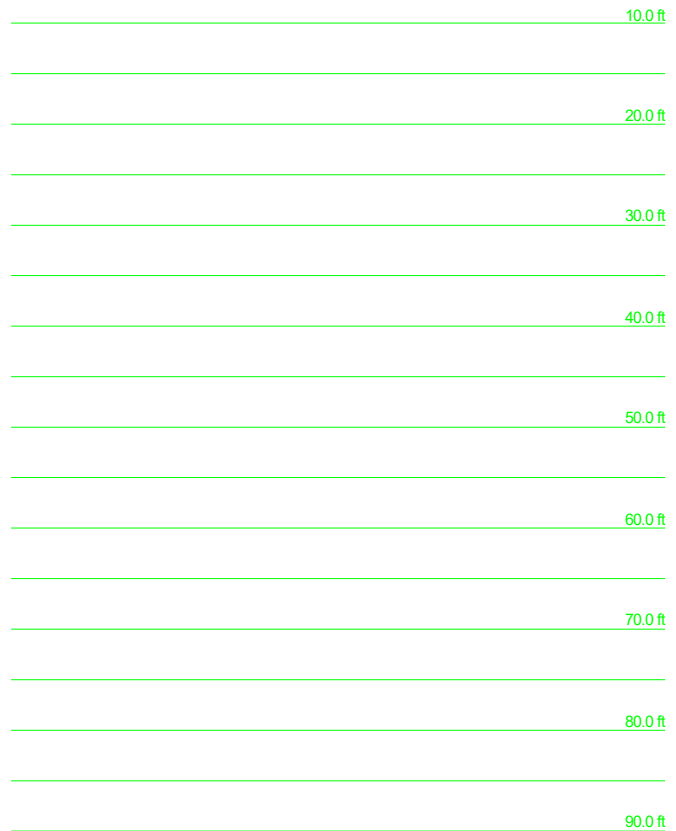
Notes: 1367-25 to 1367-24

- 18-in. CMP
- 100 LF
- Discoloration/corrosion 4:00-5:00 and 7:00-8:00 position 0.0 LF to 21 LF
- Minimal debris 31 LF to 43 LF, 75 LF to 85 LF
- Flow: None
- Grade score of: 1

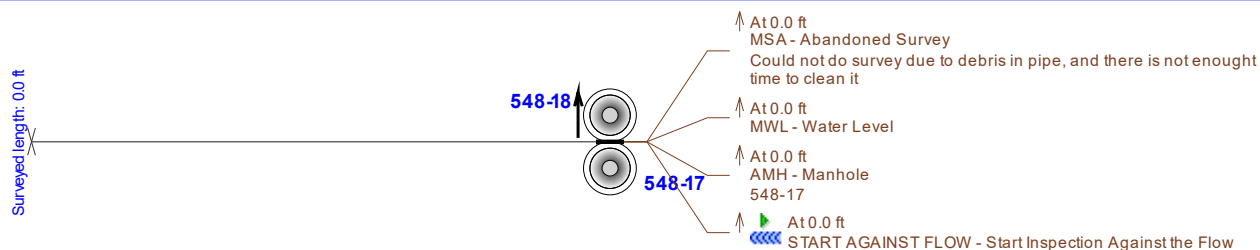
Notes: 548-18 to 548-17

- 18-in. CMP
- 0 LF, GIS 42 LF
- Debris in pipe, camera could not move.
- Used zoom lens on camera for inspection.
- Invert covered w/debris
- Some minor corrosion on pipe sides.
- Flow: Minimal
- Grade score of: 2

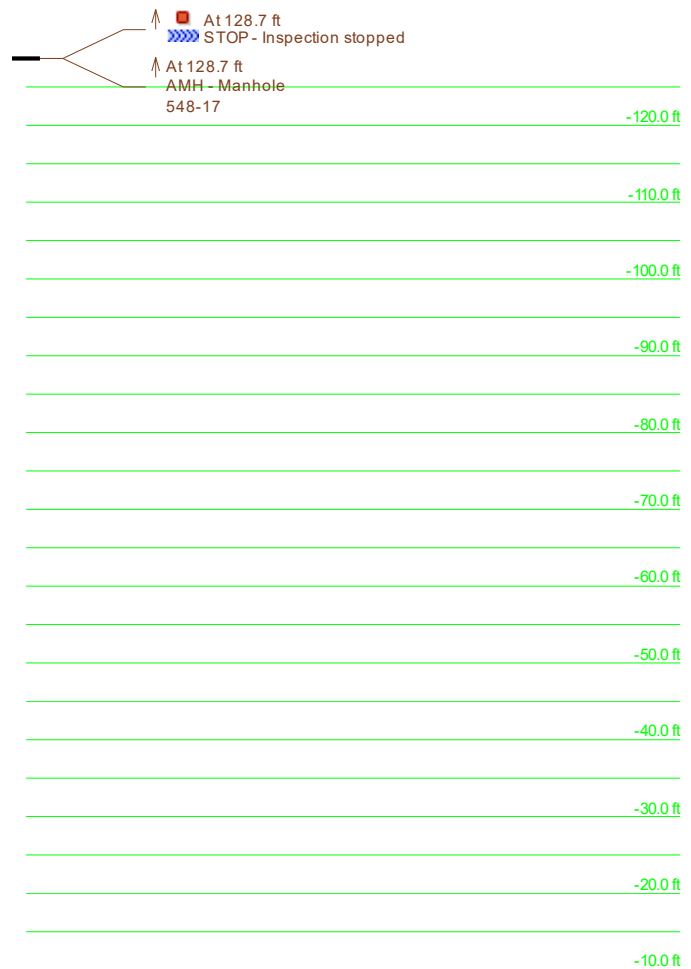
Notes: 548-17 to 548-15

- 18-in. CMP
- 129 LF
- Pipe cleaned before inspection.
- Sta. 0+00 to 0+40 depth of water & mud 9" to 2". Sta. 0+40 to 1+29 depth of water 1" to 2".
- Some corrosion w/pitting in invert along length of the pipe.
- Flow: 1"
- Grade score of: 2

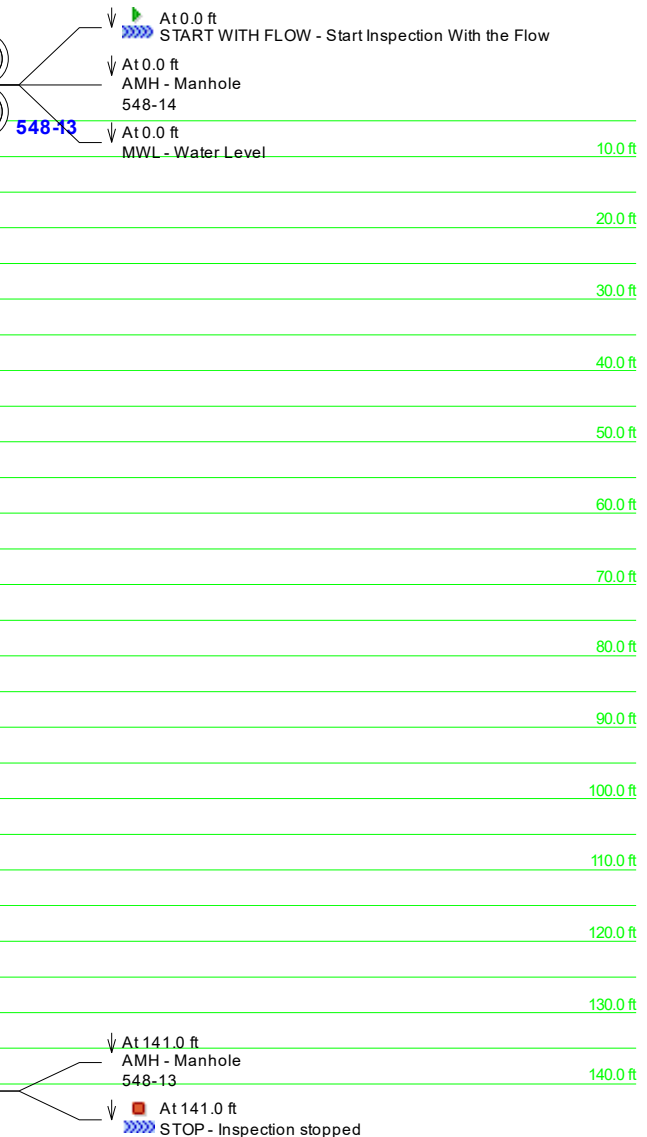
Notes: 548-14 to 548-13

- 30-in. CMP
- 141 LF
- Corrosion w/pitting & metal loss, 5:00 & 7:00 position along length of the pipe.
- Invert may have unseen fractures covered by debris & water.
- Flow: 1"
- Grade score of: 3
