Alaska Department of Transportation and Public Facilities Central Region

NHS STORM DRAIN INSPECTION CONDITION REPORT PROJECT NO. 0A31055 / Z591280000

Dimond Boulevard from Jewel Lake Road to Old Seward Highway
Muldoon Road from Boundary Avenue to Northern Lights Boulevard
Debarr Road from Bragaw Street to Muldoon Road
Downtown: 5th and 6th Avenue from Gambell Street to Orca Street and
Ingra Street from 6th Avenue to 9th Avenue

May 20th, 2019

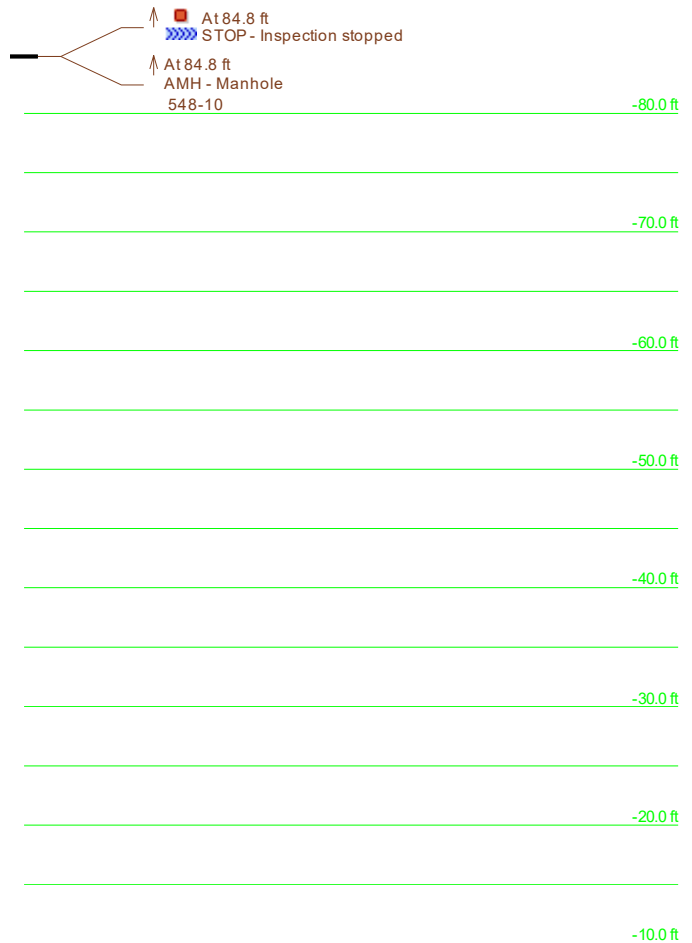
Notes: 548-10 to 548-9

- 18-in. CMP
- 85 LF
- Minor corrosion, 5:00 & 7:00 position along length of the pipe.
- Flow: Minimal
- Grade score of: 1

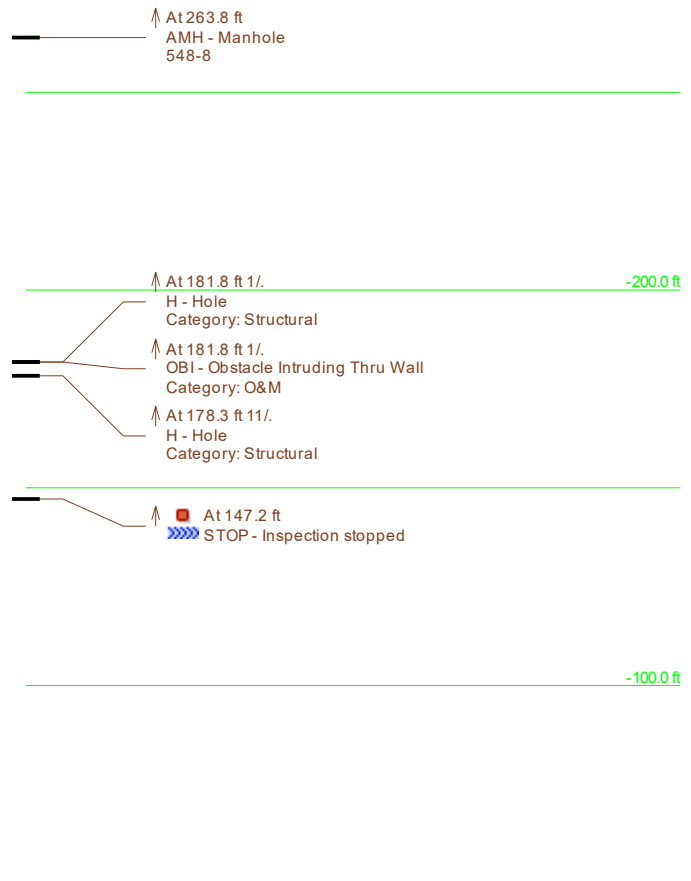
Notes: 548-8 to 548-9

- 48-in. CMP
- 264 LF
- Corrosion w/pitting & metal loss, 5:00 & 7:00 position along length of the pipe.
- Invert may have fractures covered by debris & water.
- 2" Dia. holes 12:00, Sta.1+70.
- Two 2" Dia. cable utility holes, 11:00 & 2:00 position, Sta. 1+78 & Sta. 1+81.
- Obstruction intruding through wall, Sta. 1+81.
- 2" fracture, 5:00 position, Sta. 2+62.
- 10% Max. Ovality issue, Sta.1+37 to 1+81.
- Flow: 2" to 4"
- Grade score of: 3

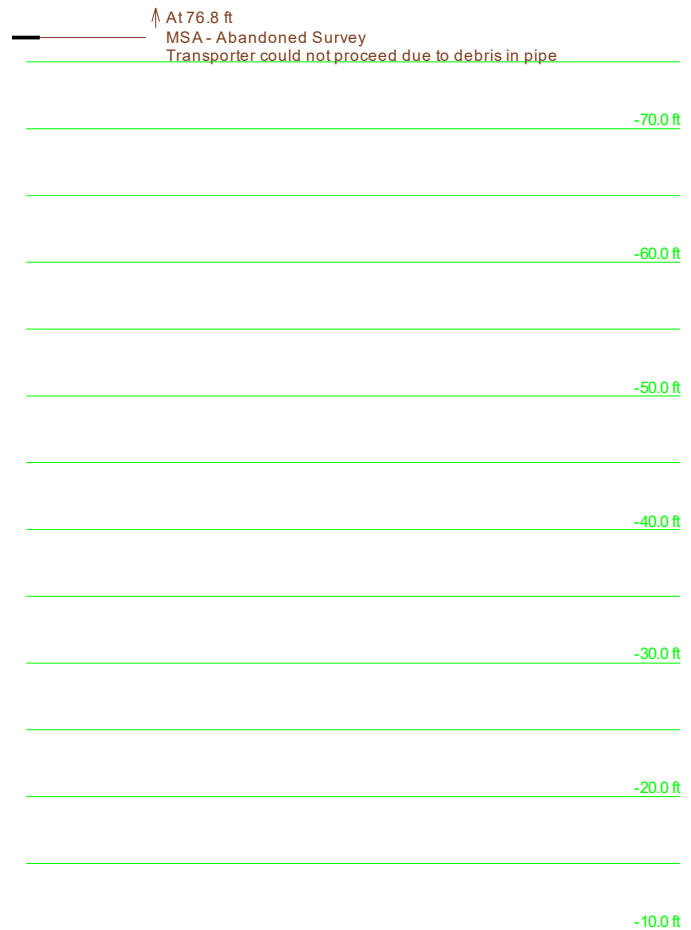
Notes: 548-11 to 548-8

- 18-in. CMP
- 77 LF, GIS 95 LF
- Corrosion w/pitting & possible metal loss, 5:00 & 7:00 position, intermittently along pipe.
- Flow: Minimal
- Grade score of: 2

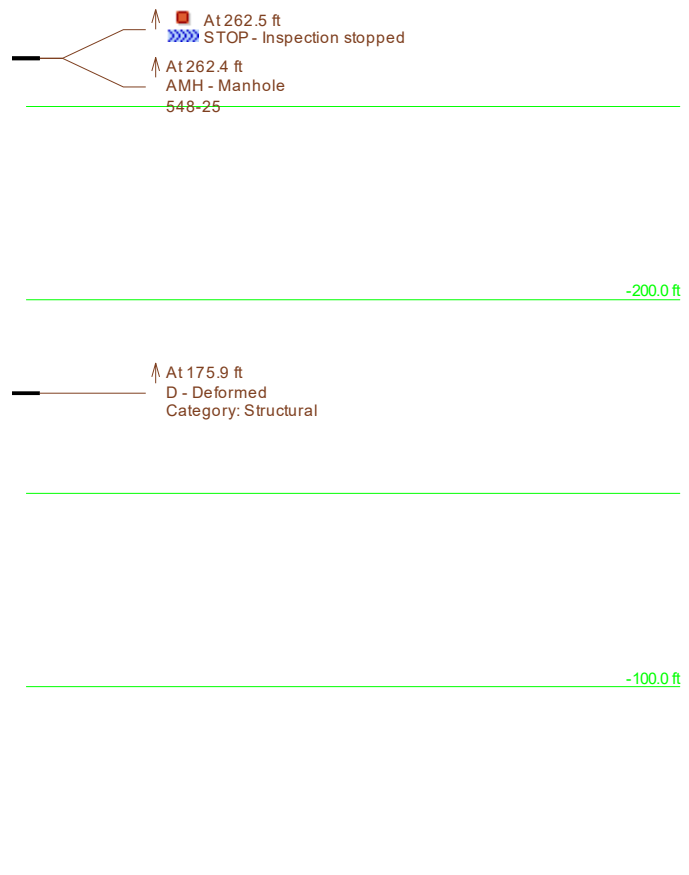
Notes: 548-25 to 548-23

- 36-in. CMP
- 263 LF
- Corrosion w/pitting & metal loss, 5:00 & 7:00 position along length pipe.
- Deformation 9:00 position, Sta. 1+76, no pipe flow reduction.
- Possible corrosion fractures at 5:00, Sta. 0+58 to 0+66 & 7:00, Sta. 1+18.
- Confirm before lining.
- Flow: 2"
- Grade score of: 3

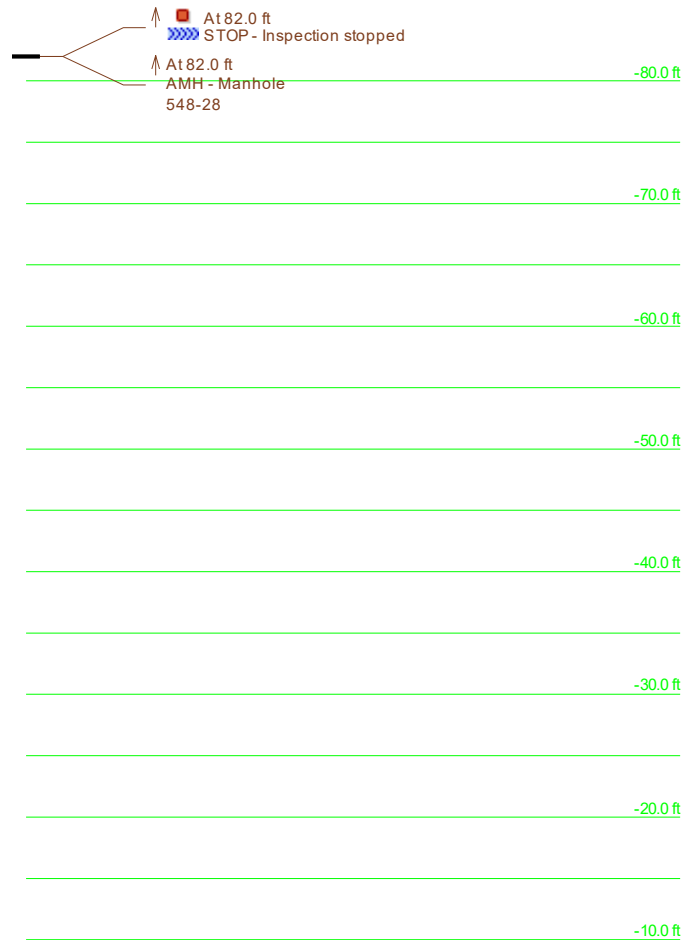
Notes: 548-28 to 548-27

- 36-in. CMP
- 82 LF
- Evidence of discoloration/corrosion in invert
- Pipe appears to be in good condition with no major visible defects, verify invert condition to determine if there is metal loss
- Flow: 1-2"
- Grade score of: 2

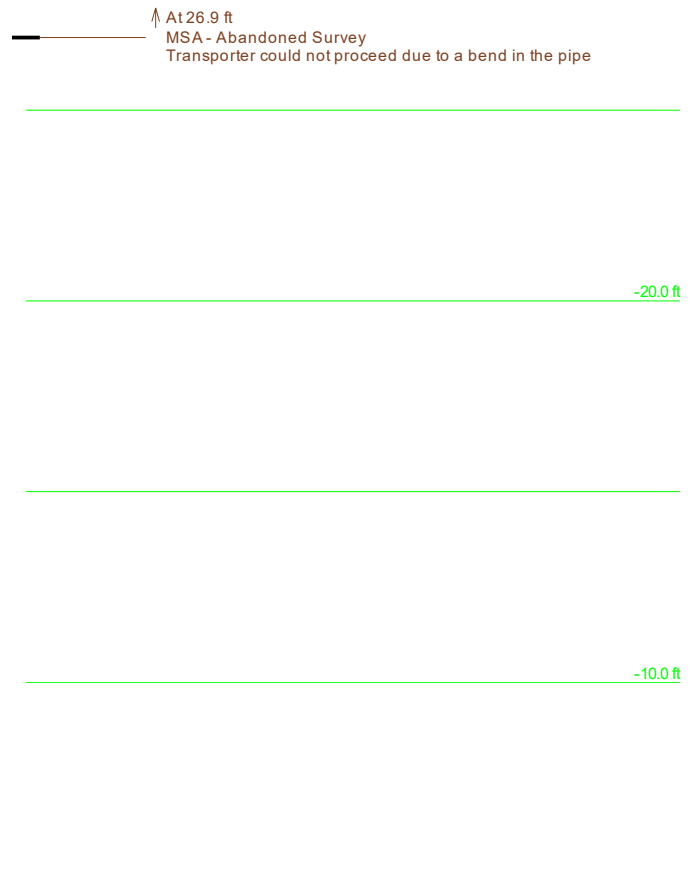
Notes: 548-29 to 548-28

- 18-in. CMP
- 98 LF
- Pipe cleaned in order to perform inspection, 2-3 inches of residual debris in 7:00 position
- Deformation at joint at 26 LF in 12:00 position, camera could not pass
- Zoomed to end, no major defects visible
- Evaluate causes for debris buildup in pipe
- Flow: None
- Grade score of: 1

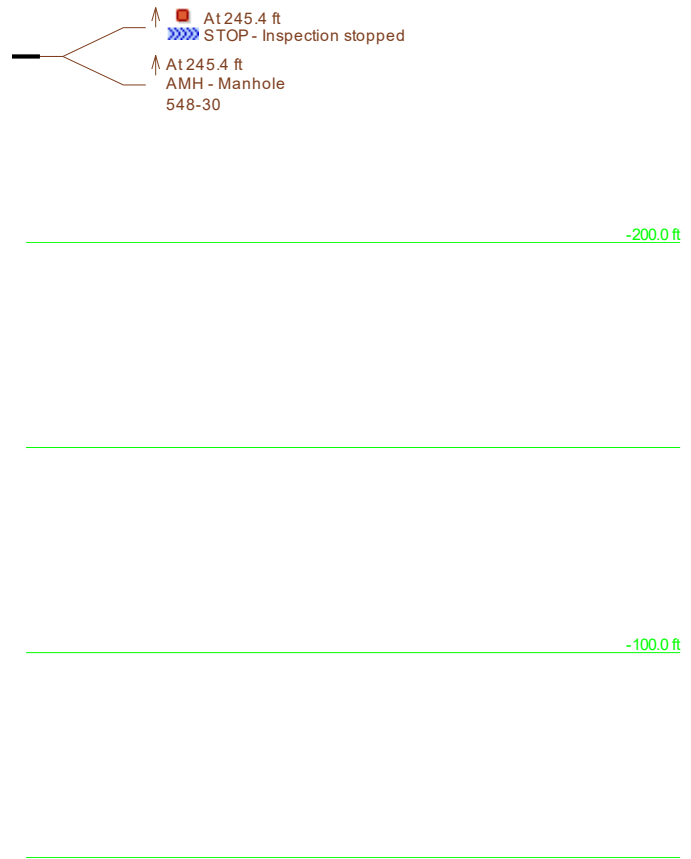
Notes: 548-30 to 548-28

- 36-in. CMP
- 245 LF
- Evidence of discoloration/corrosion in invert 5:00 to 7:00 position
- Possible pin hole in 9:00 position at 18 LF
- Piece of spigot appears to be folded inward at joint at 53 LF
- Evidence of corrosion in 5:00 position at 76 LF
- Root infiltration at joint at 83 LF
- Visible soil in 12:00 position at joint at 144 LF
- Evidence of infiltration at joint at 173 LF
- Verify invert condition to determine if there is metal loss
- Flow: 1-2"
- Grade score of: 3

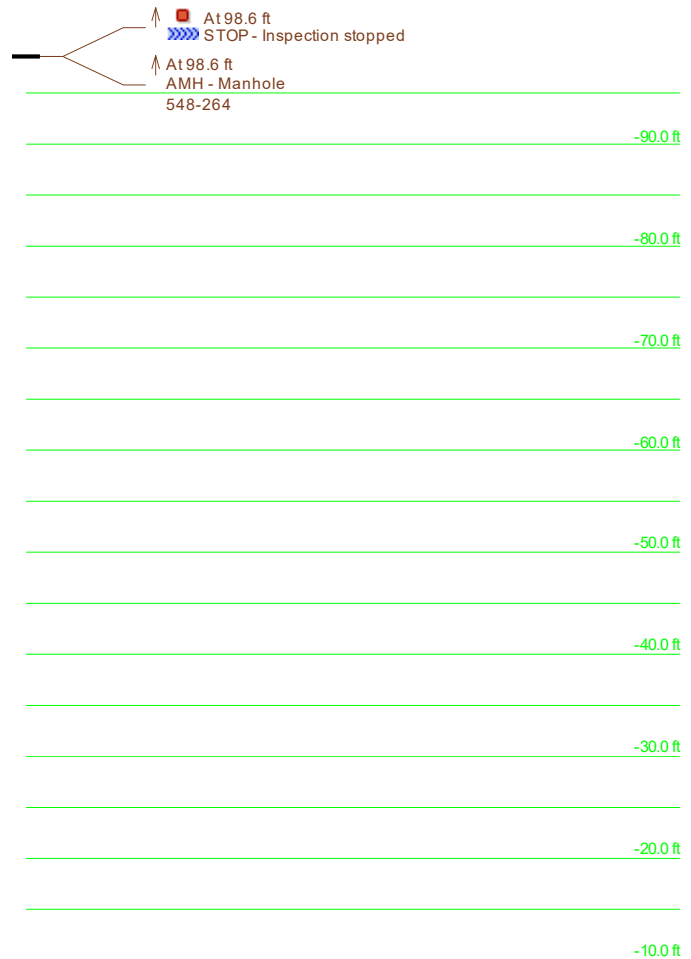
Notes: 548-264 to 548-30

- 18-in. CMP
- 99 LF
- 0-3" debris in pipe throughout pipe
- Visible discoloration in invert at 11 LF
- Discoloration/Corrosion in 3:00 and 6:00 position from 74 LF to 93 LF, increases from discoloration to metal loss
- Flow: None
- Grade score of: 3

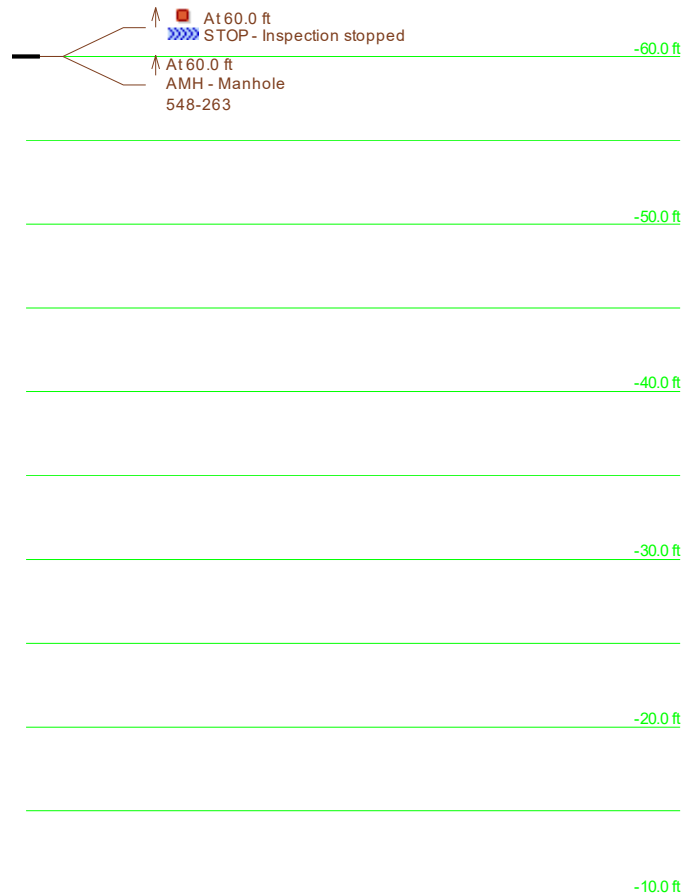
Notes: 548-263 to 548-31

- 18-in. CMP
- 60 LF
- Minimal debris in pipe
- Visible discoloration in invert
- Corrosion in 3:00 and 6:00 position from 45 LF to 56 LF
- 2-3" of debris last 8 LF of pipe
- Flow: None
- Grade score of: 3

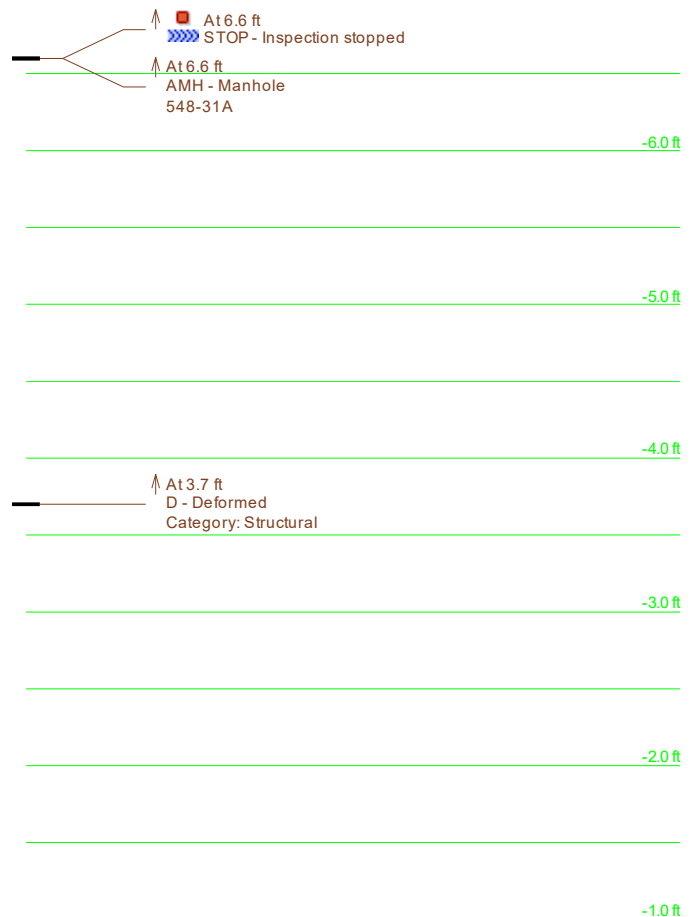
Notes: 548-31A to 548-31

- 18-in. CMP
- 7 LF
- 0-1" deformation in 9:00 position at 0.0 LF
- 1-2" deformation in 12:00 position at 4 LF
- Inspection ends at possible connection to parking lot drainage structure
- Flow: None
- Grade score of: 2

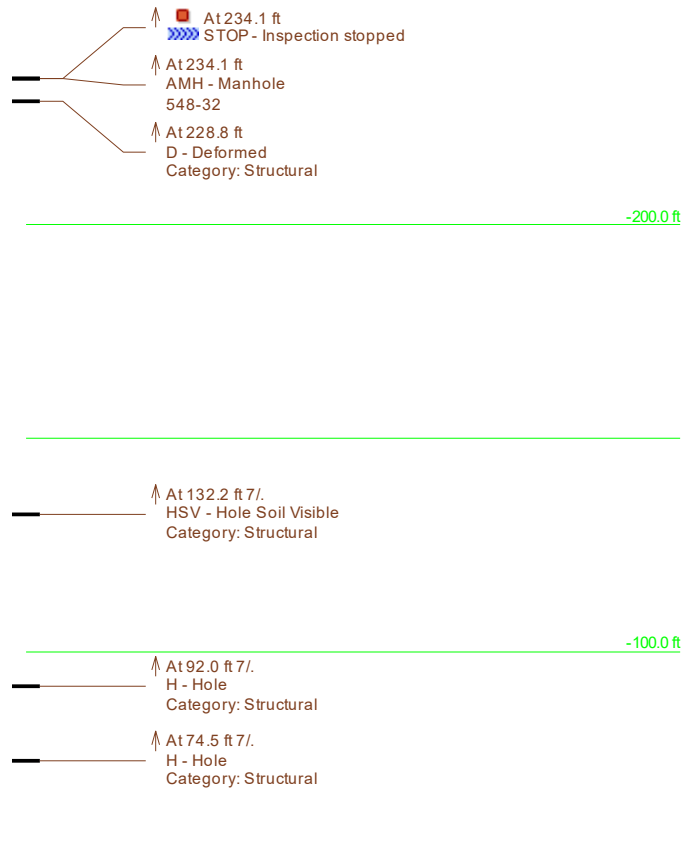
Notes: 548-32 to 548-31

- 36-in. CMP
- 234 LF
- Evidence of discoloration/corrosion in invert 5:00 to 7:00 position
- 0-1" deformation in 12:00 position at 46 LF
- Pipe deformation at joint at 73 LF, approximately 5-10% loss of cross sectional area
- Hole in pipe in 7:00 position at 74 LF, approximately 3 feet long, soil visible
- Hole in pipe in 7:00 position at 92 LF, 1-2 ft. long
- Hole in pipe, 7:00 position at 132 LF, soil visible, 2-3' long
- Pipe deformation in 12:00 position at 228 LF, approximately 10-20% loss of cross sectional area
- Flow: 1-2"
- Grade score of: 4

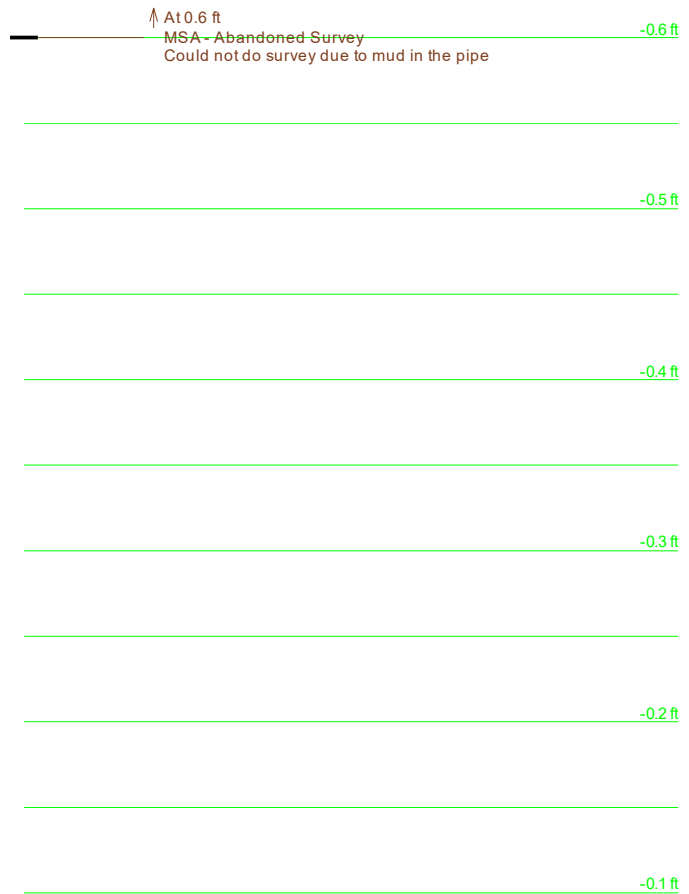
Notes: 548-253 to 548-32

- 12-in. CMP
- 235 LF
- 1-2" of debris, too much debris to complete inspection
- Flow: None
- Grade score of: N/A

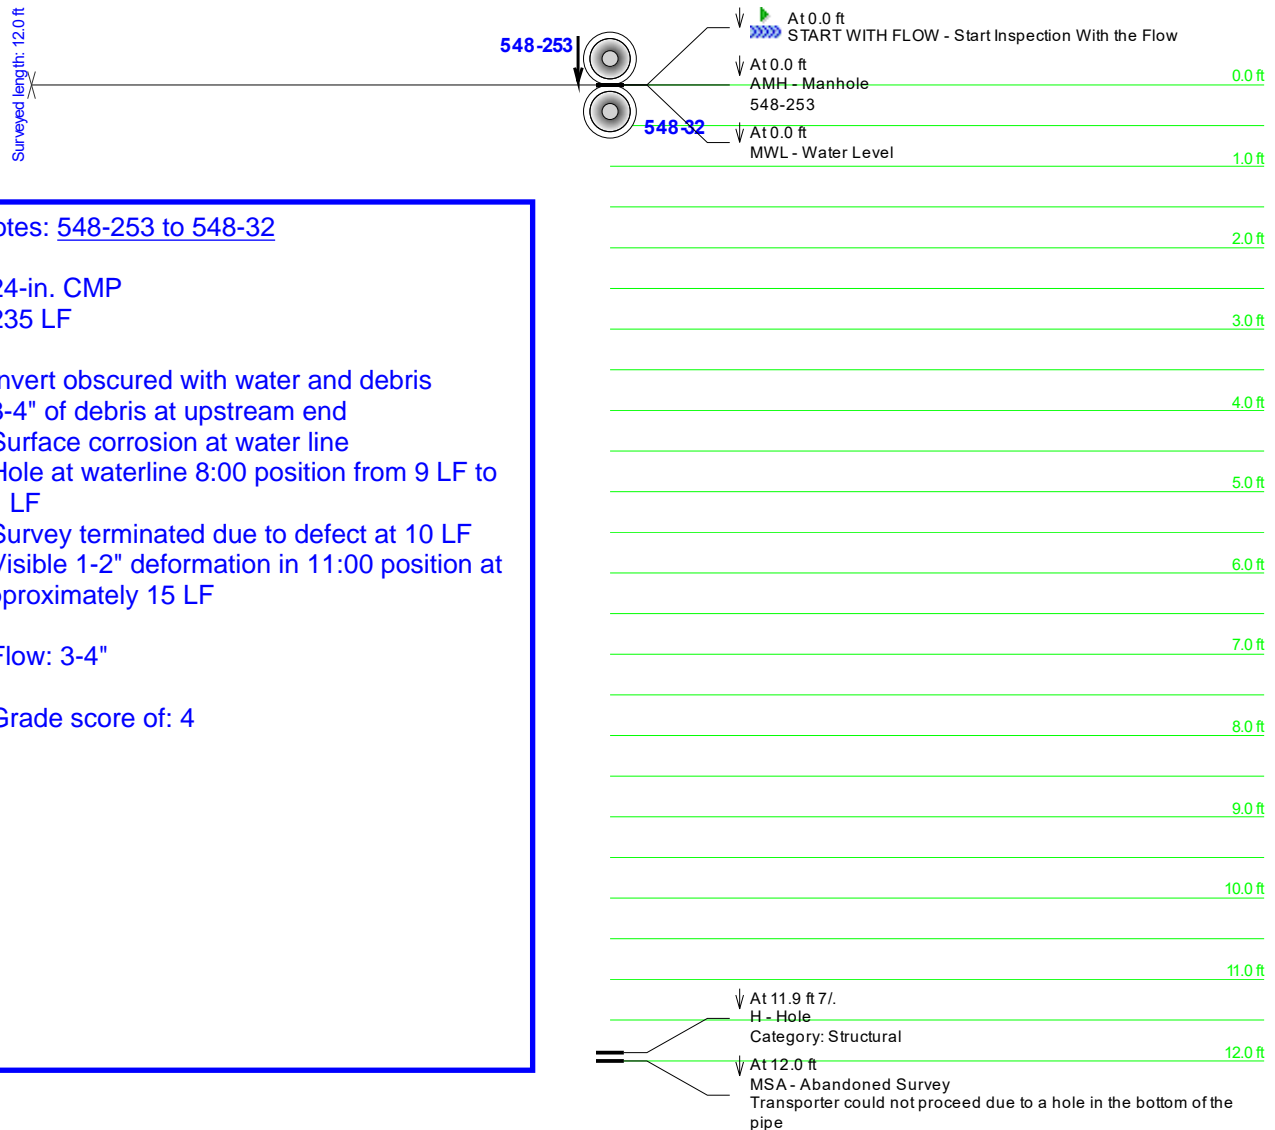
Notes: [548-253 to 548-32](#)

- 24-in. CMP
- 235 LF
- Invert obscured with water and debris
- 3-4" of debris at upstream end
- Surface corrosion at water line
- Hole at waterline 8:00 position from 9 LF to 11 LF
- Survey terminated due to defect at 10 LF
- Visible 1-2" deformation in 11:00 position at approximately 15 LF
- Flow: 3-4"
- Grade score of: 4

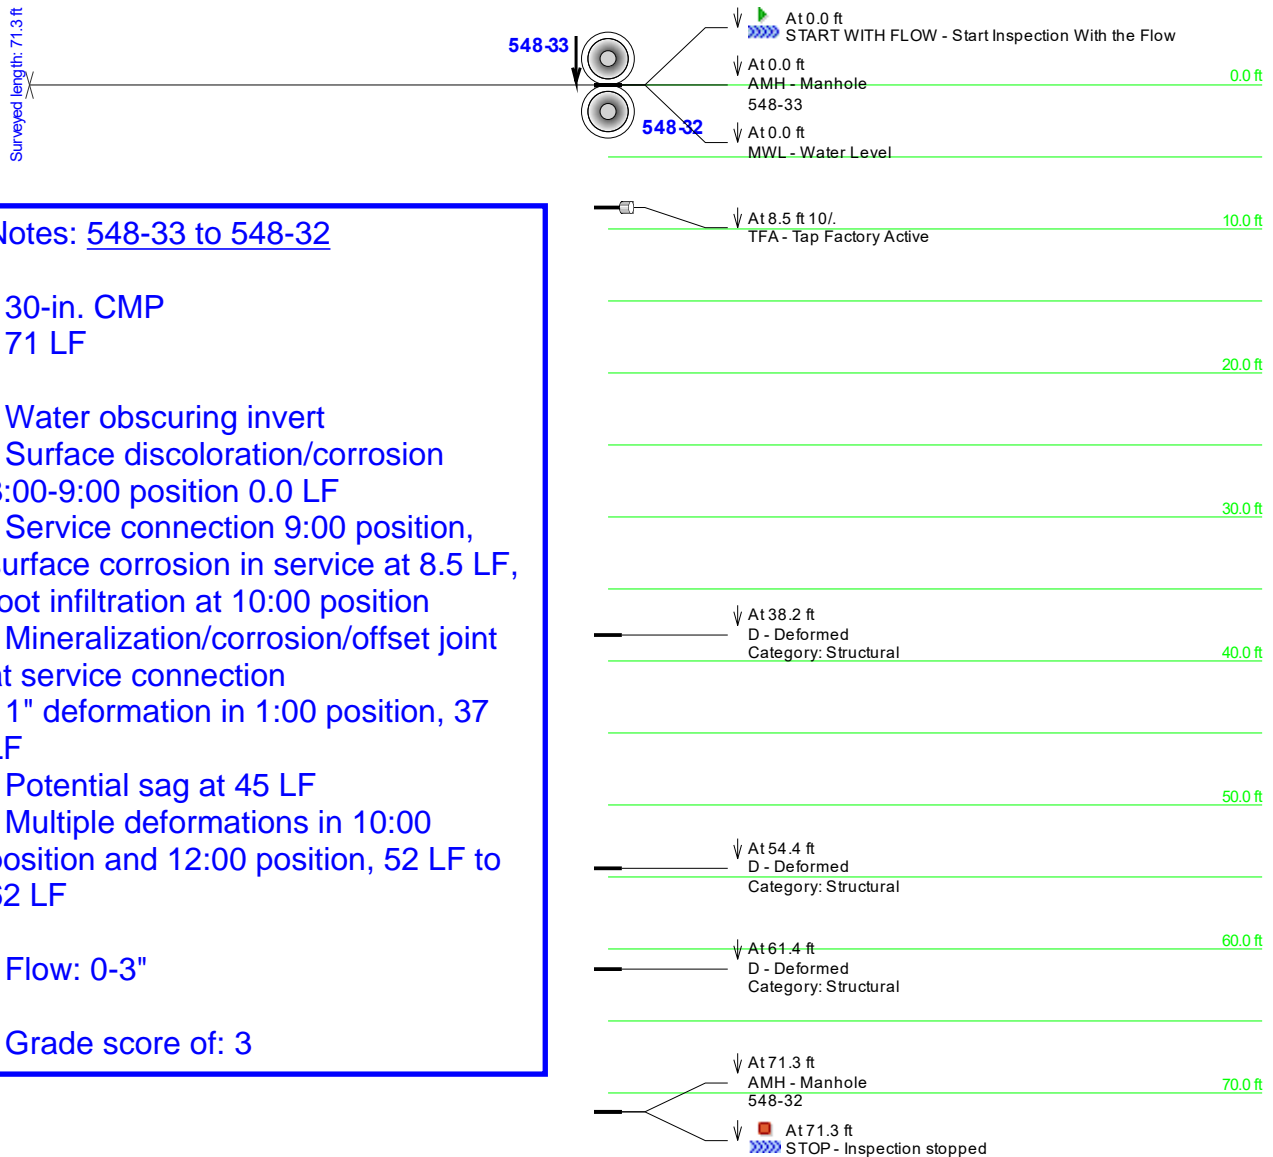
Notes: 548-33 to 548-32

- 30-in. CMP
- 71 LF
- Water obscuring invert
- Surface discoloration/corrosion
3:00-9:00 position 0.0 LF
- Service connection 9:00 position,
surface corrosion in service at 8.5 LF,
root infiltration at 10:00 position
- Mineralization/corrosion/offset joint
at service connection
- 1" deformation in 1:00 position, 37
LF
- Potential sag at 45 LF
- Multiple deformations in 10:00
position and 12:00 position, 52 LF to
62 LF
- Flow: 0-3"
- Grade score of: 3

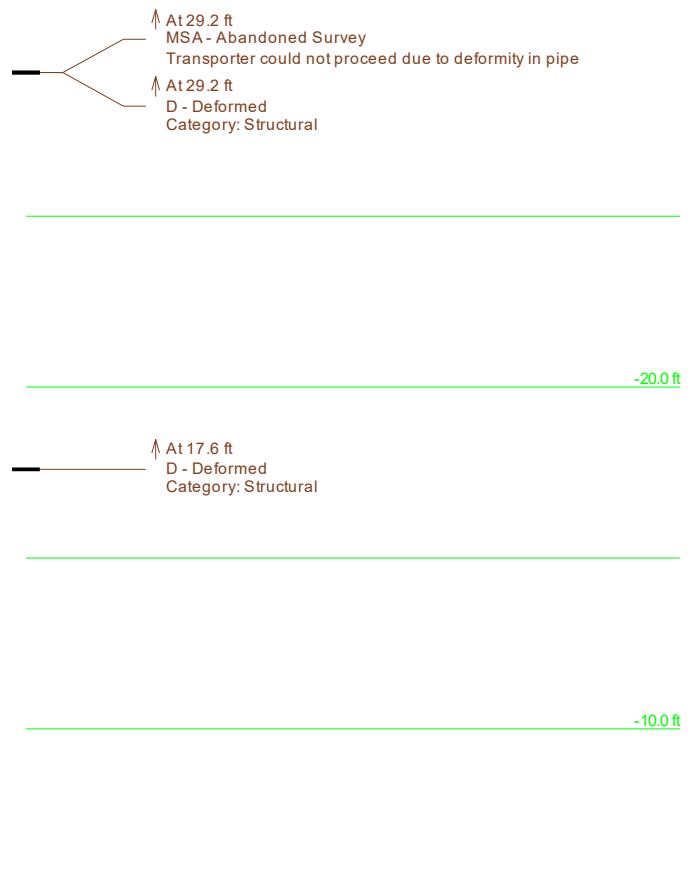
Notes: 548-257 to 548-256

- 18-in. CMP
- 29 LF, GIS 100 LF
- Minor corrosion w/some metal loss.
- Deformation of pipe at 1:00 position, Sta. 0+18, 10% loss of flow.
- Deformation of pipe at 10:00 position, Sta. 0+29, 10% loss of flow.
- Camera could not pass deformation at Sta. 0+29.
- Flow: Minimal
- Grade score of: 3

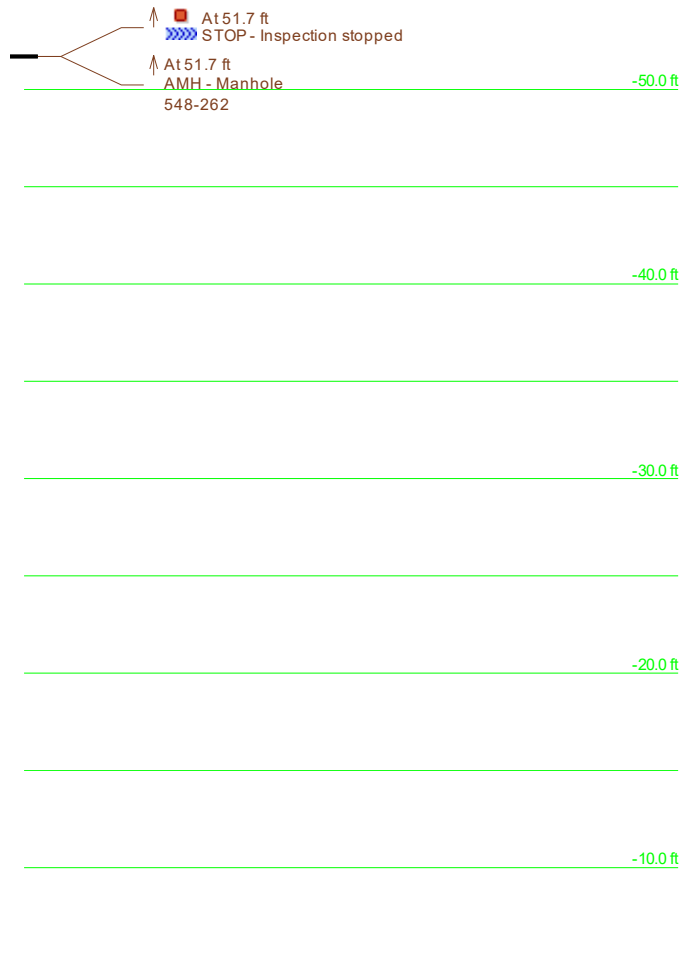
Notes: [548-262 to 548-258A](#)

- 18-in. CMP
- 52 LF
- 27 LF, 0-1" debris buildup
- No defects observed
- Flow: None
- Grade score of: 1

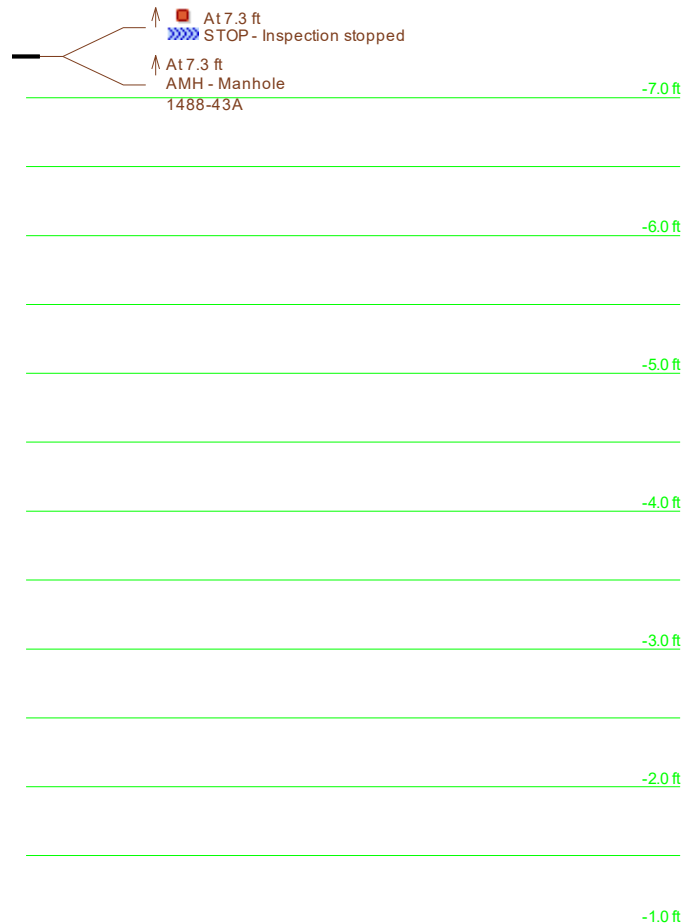
Notes: 1488-43A to1488-43

- 18-in. CMP
- 7 LF
- No corrosion interior pipe.
- Flow: Minimal
- Grade score of: 1

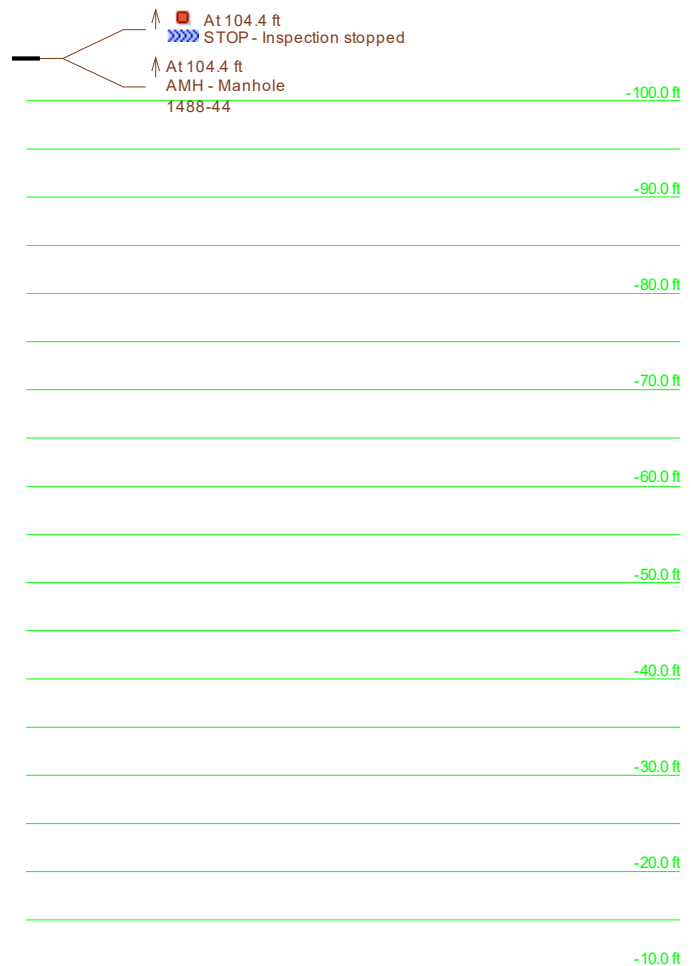
Notes: 1488-44 to 1488-43

- 60-in. CMP
- 104 LF
- Minor corrosion occurs, top of pipe, between 7:00 to 5:00 position for the length of the pipe.
- Pipe is under water between 5:00 to 7:00 position, for the length of the pipe. Condition of the pipe bottom could not be determined.
- Grade score for the pipe is a 2 until the pipe can be drained, cleaned & re-evaluated.
- Flow: 5"
- Grade score of: 2

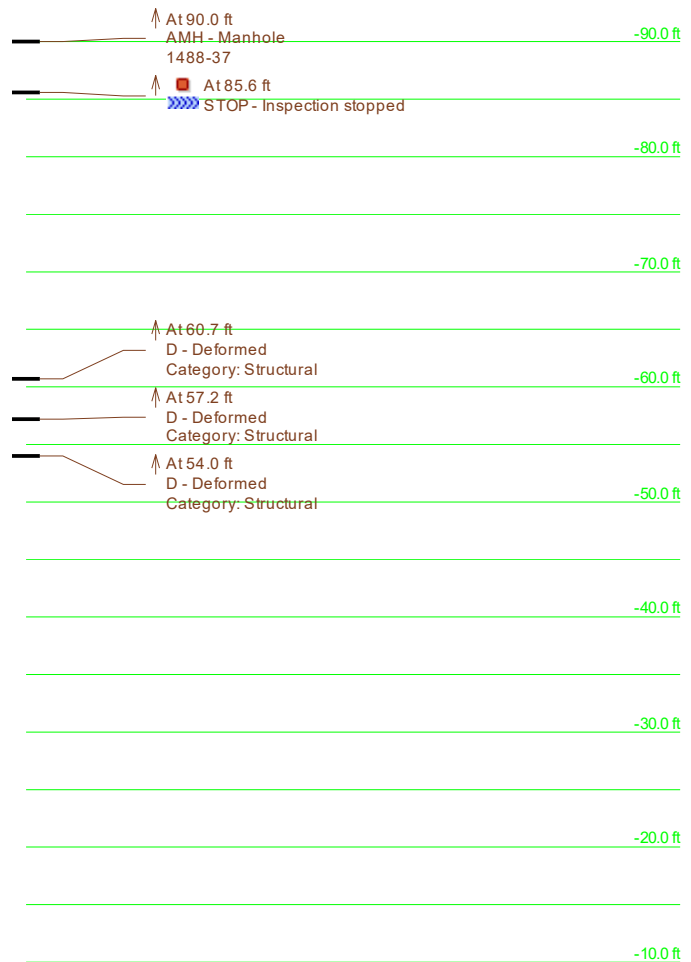
Notes: 1488-37 to 1488-17

- 18-in. CMP
- 90 LF
- Debris increasing in pipe upstream, 0" to approximately 1-2" from 0 LF to 50 LF, debris buildup possible indication of minor grade break
- 1-2" deformations in 10:00/11:00 position at 54 LF, 57 LF, and 61 LF
- Corrosion/Discoloration in 4:00 and 8:00 position from 77 LF to end of pipe, invert obscured with 1-2" debris
- Flow: None
- Grade score of: 1

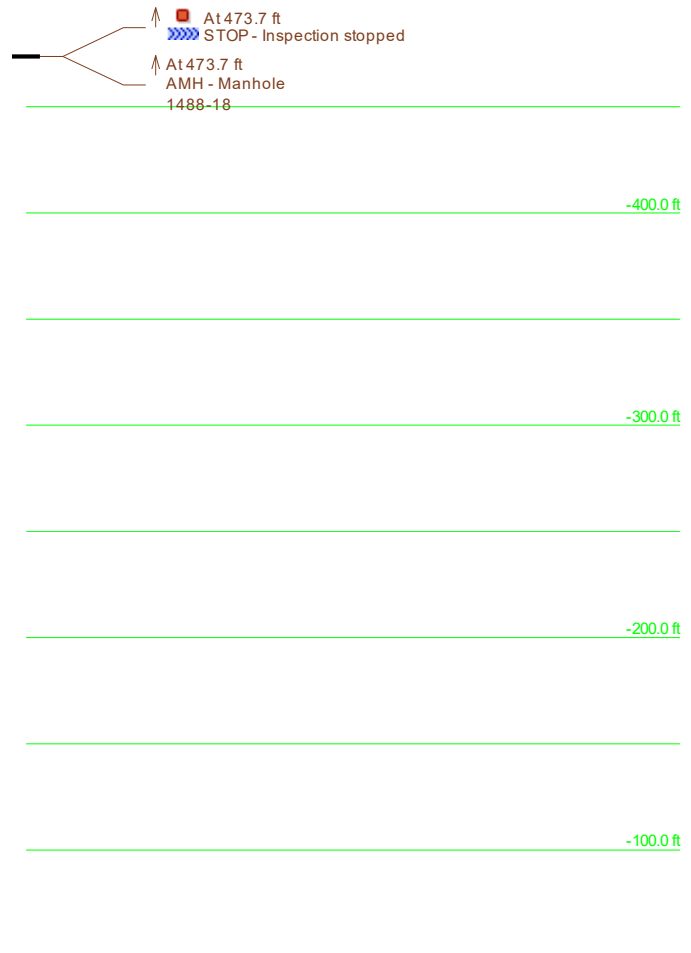
Notes: 1488-18 to 1488-17

- Arch CMP
- 474 LF
- Discoloration/corrosion at bottom 4-6" of CMP arch
- Evidence of minor infiltration/mineralization at joints at 90% of joints
- No major defects observed
- Flow: 2-3"
- Grade score of: 1

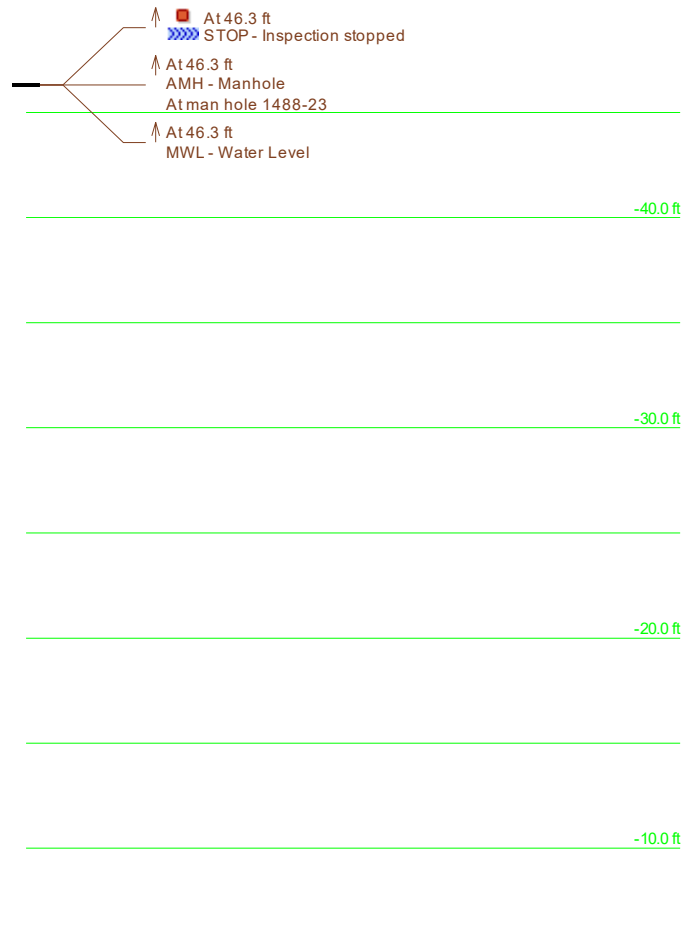
Notes: 1488-23 to 1488-22

- 12-inch CMP, Fin Drain Pipe
- 46 LF
- 1-2" of debris in pipe from beginning of inspection to 7.2 LF
- 1-2" of debris in pipe from 30 LF to end of inspection
- No serious defects observed
- Flow: None
- Grade score of: 1

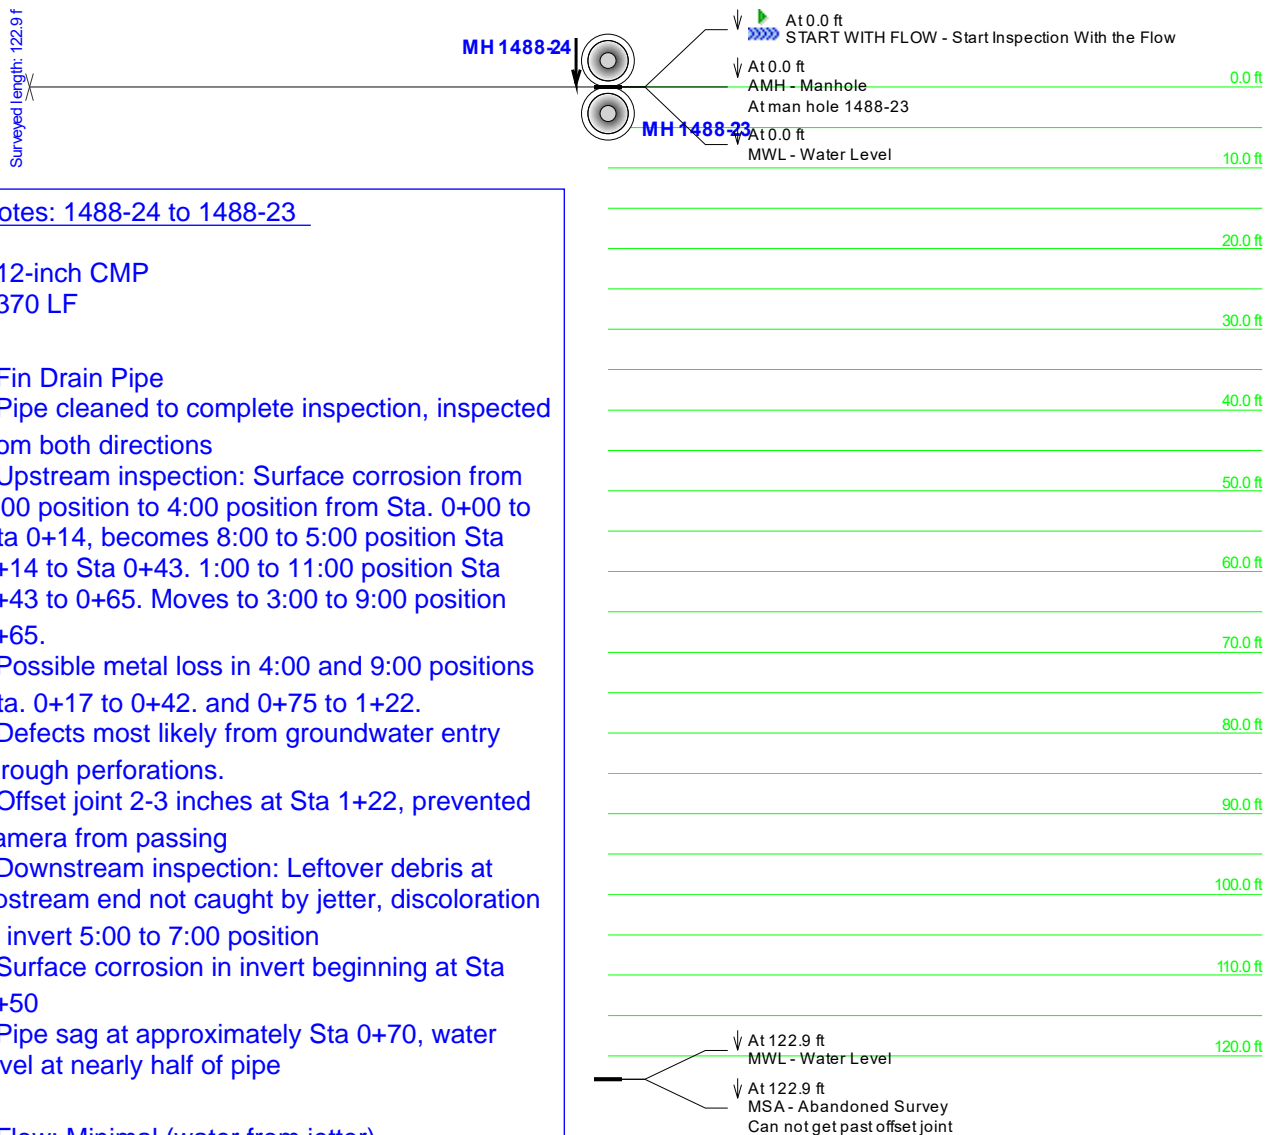
Notes: 1488-24 to 1488-23

- 12-inch CMP
- 370 LF
- Fin Drain Pipe
- Pipe cleaned to complete inspection, inspected from both directions
- Upstream inspection: Surface corrosion from 9:00 position to 4:00 position from Sta. 0+00 to Sta 0+14, becomes 8:00 to 5:00 position Sta 0+14 to Sta 0+43. 1:00 to 11:00 position Sta 0+43 to 0+65. Moves to 3:00 to 9:00 position 0+65.
- Possible metal loss in 4:00 and 9:00 positions Sta. 0+17 to 0+42. and 0+75 to 1+22.
- Defects most likely from groundwater entry through perforations.
- Offset joint 2-3 inches at Sta 1+22, prevented camera from passing
- Downstream inspection: Leftover debris at upstream end not caught by jetter, discoloration in invert 5:00 to 7:00 position
- Surface corrosion in invert beginning at Sta 0+50
- Pipe sag at approximately Sta 0+70, water level at nearly half of pipe
- Flow: Minimal (water from jetter)
- Grade score of: 3

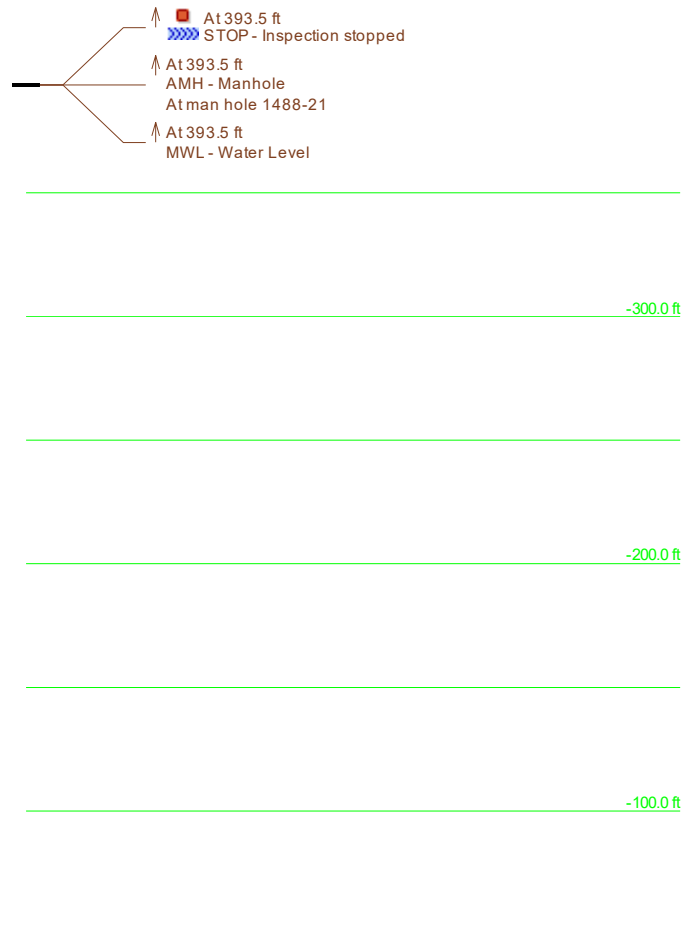
Notes: 1488-21 to 1488-22

- 12-inch CMP, Fin Drain Pipe
- 394 LF
- 59.9 LF to approximately 131 LF, debris buildup begins in bottom half of pipe, invert appears sound
- Discoloration throughout pipe
- Debris/Discoloration at joints
- Debris in invert, discoloration in drainage holes 180 LF to 187 LF
- 341 LF, visible corrosion and discoloration in invert, becomes obscured by debris
- 355 LF, pipe deformation in 11:00 position, approximately 1"
- Corrosion at perforations, 2:00 position from 362 LF to end of survey
- 1" deformation at joint, 5:00 position at 363 LF
- No major structural defects observed
- Flow: None
- Grade score of: 2

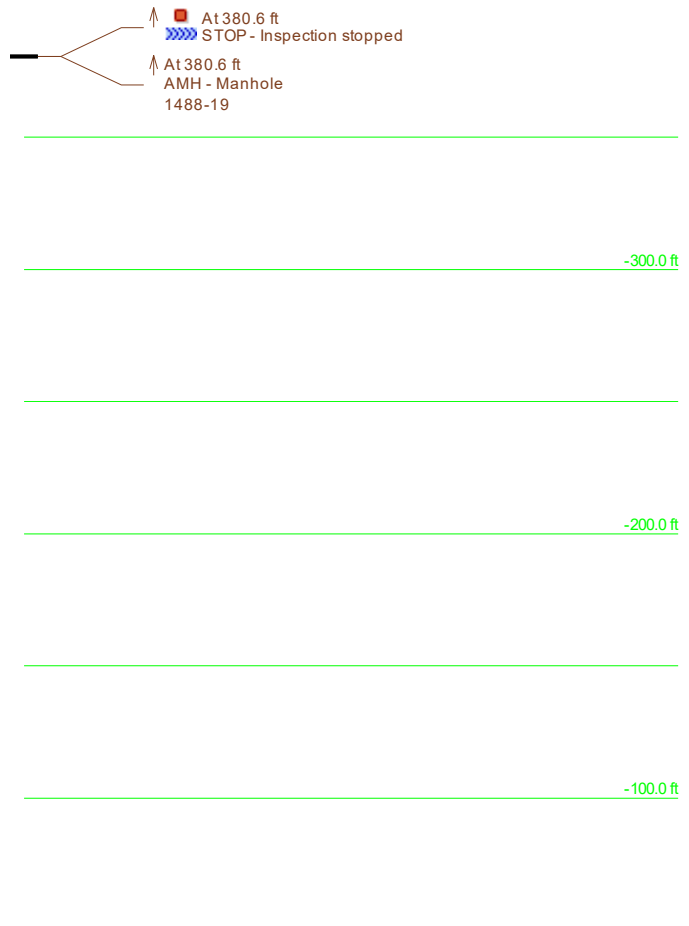
Notes: [1488-19 to 1488-18](#)

- Arch CMP
- 381 LF
- Discoloration/corrosion at bottom 4-6" of CMP arch
- Observed infiltration at joint at 10 LF, mineralization, estimated flow rate 1 GPM
- Evidence of minor infiltration/mineralization at joints at 90% of joints
- No major defects observed
- Flow: 2-3"
- Grade score of: 1

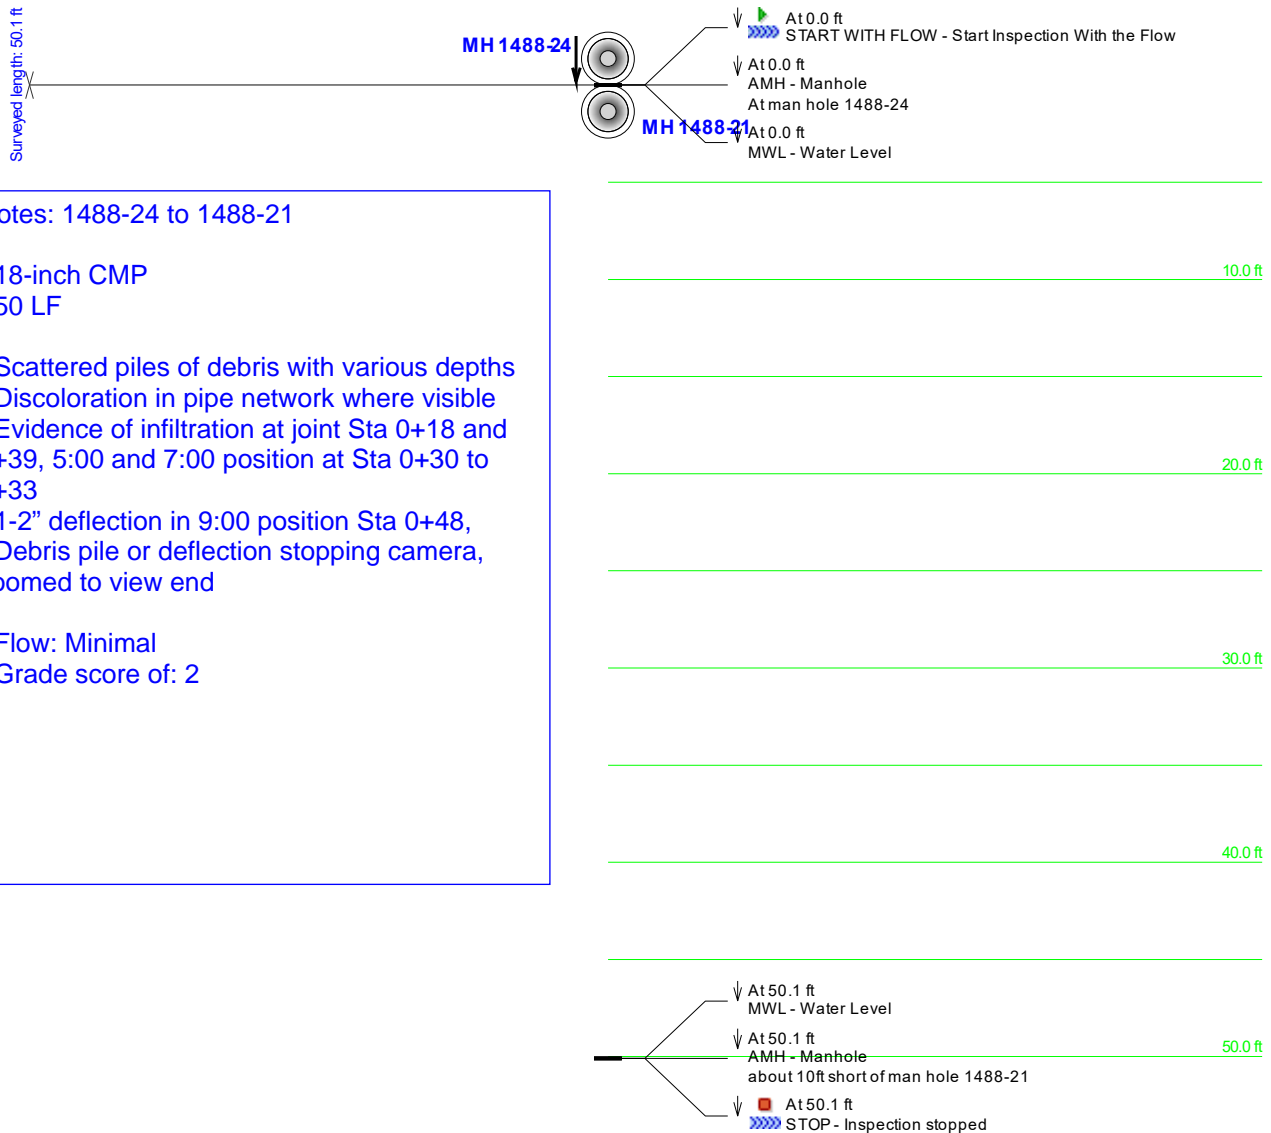
Notes: 1488-24 to 1488-21

- 18-inch CMP
- 50 LF
- Scattered piles of debris with various depths
- Discoloration in pipe network where visible
- Evidence of infiltration at joint Sta 0+18 and 0+39, 5:00 and 7:00 position at Sta 0+30 to 0+33
- 1-2" deflection in 9:00 position Sta 0+48,
- Debris pile or deflection stopping camera, zoomed to view end
- Flow: Minimal
- Grade score of: 2

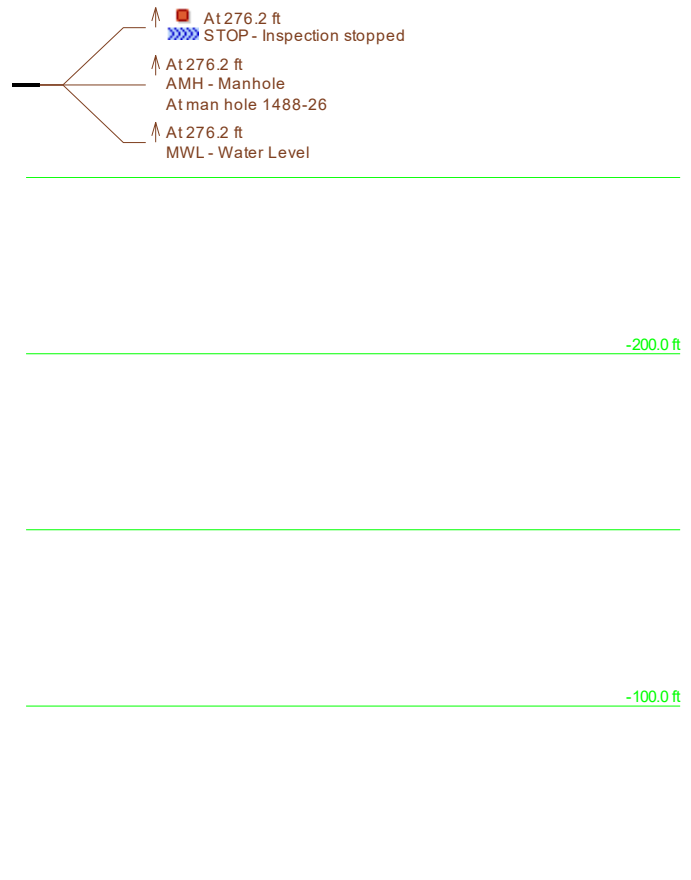
Notes: 1488-26 to 1488-24

- 12-inch CMP
- 276 LF
- Surface corrosion in 9:00 position from Sta 0+00 to approximately 0+20
- Discoloration in invert where debris is thin
- Roots or organic debris at Sta 0+29, 2+21, 2+46
- Minimal debris in pipe, scattered piles
- No major pipe defects observed
- Flow: None
- Grade score of: 2

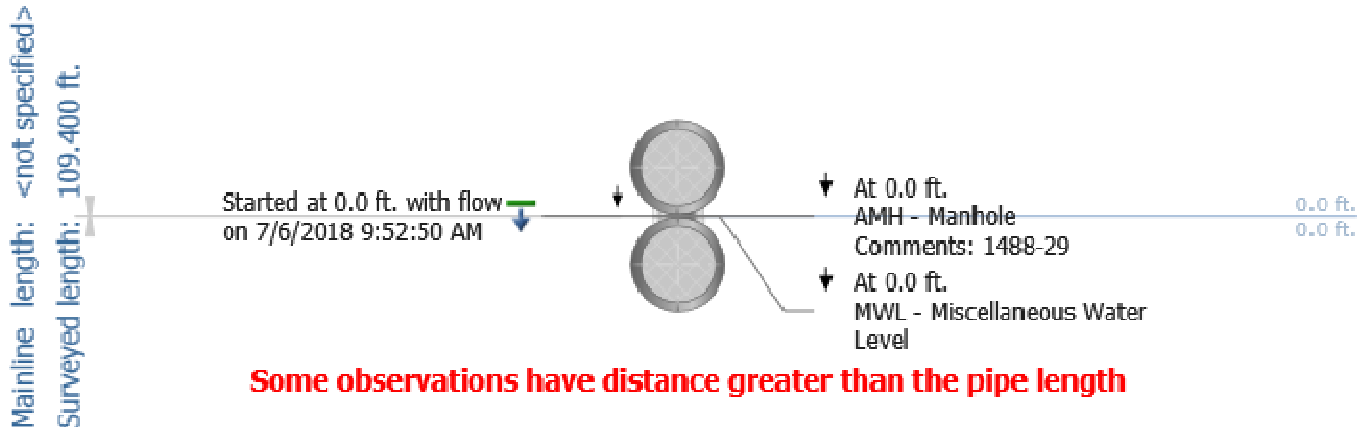
Notes: 1488-29 to 1488-32

- 64-inch CMP
- 109 LF
- Downstream inspection
- Mineral buildup at joint 6 LF, 40 LF, 79 LF
- Physically probed upstream invert, evidence of metal loss in invert, condition likely varies throughout pipe.
- No major structural defects observed
- Flow: 3" to 4"
- Grade score of: **2**
