Alaska Department of Transportation and Public Facilities Central Region

NHS STORM DRAIN INSPECTION CONDITION REPORT PROJECT NO. 0A31055 / Z591280000

Dimond Boulevard from Jewel Lake Road to Old Seward Highway
Muldoon Road from Boundary Avenue to Northern Lights Boulevard
Debarr Road from Bragaw Street to Muldoon Road
Downtown: 5th and 6th Avenue from Gambell Street to Orca Street and
Ingra Street from 6th Avenue to 9th Avenue

May 20th, 2019

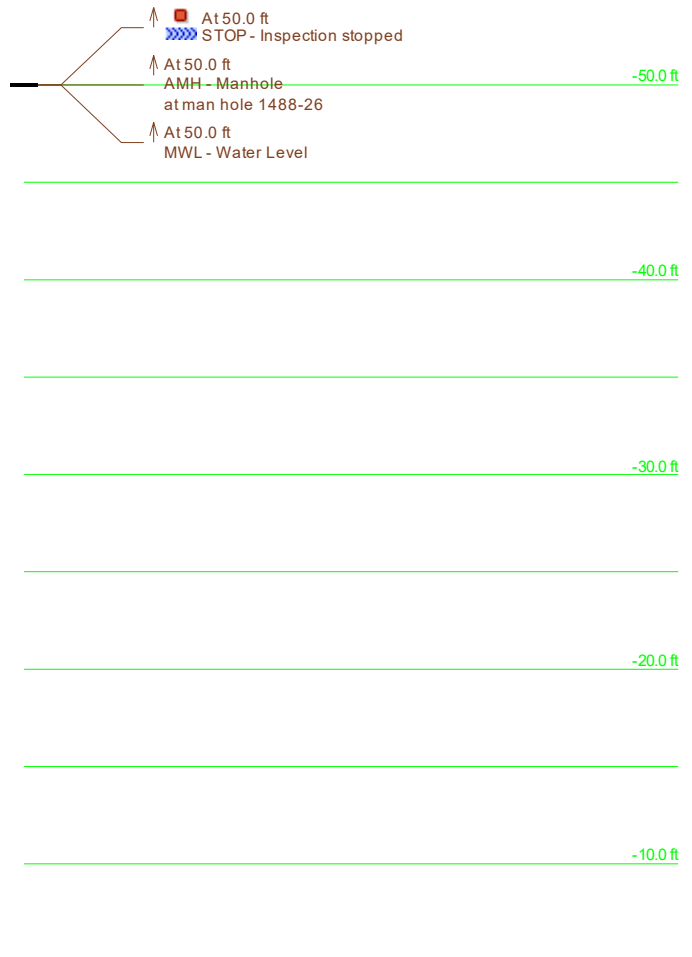
Notes: 1488-26 to 1488-27

- 12-inch CMP
- 50 LF
- Minimal debris in pipe
- No major defects observed
- Flow: None
- Grade score of: 1

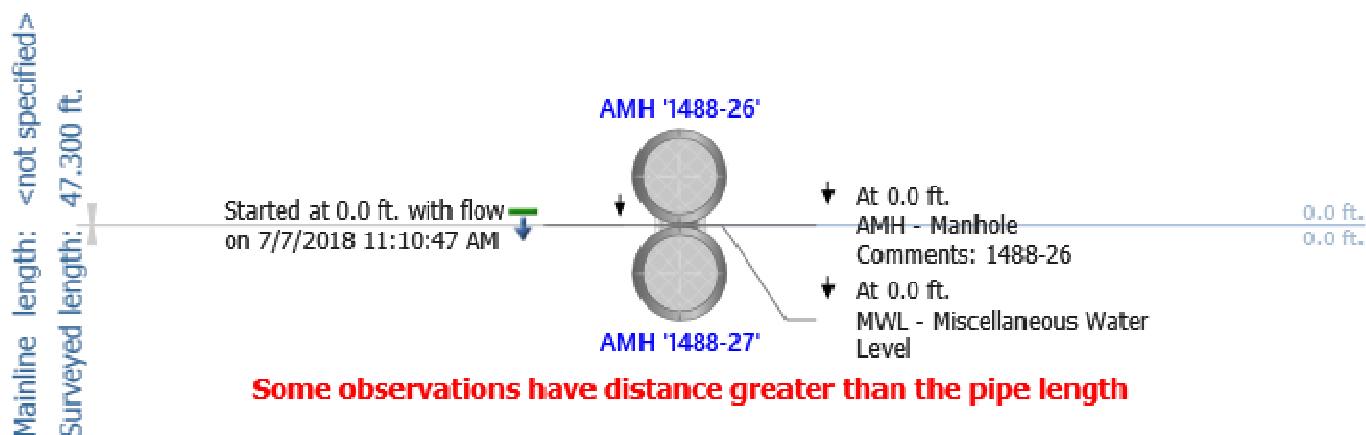
Notes: 1488-26 to 1488-27

- 18-inch CMP
- 47 LF
- 1-2" of debris in pipe
- Surface corrosion visible in invert of downstream end, metal loss in pipe end, pipe requires cleaning to view invert throughout
- Flow: None
- Grade score of: **1**

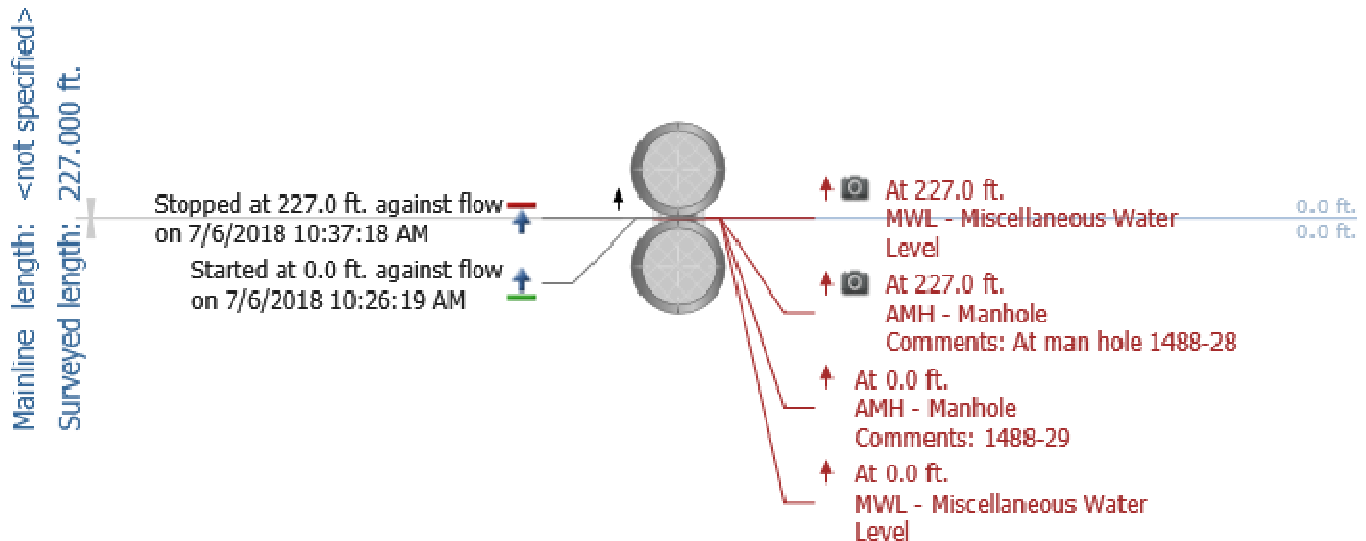
Notes: 1488-28 to 1488-29

- 64-inch CMP
- 227 LF
- Upstream inspection
- Partially crushed pipe end at joint at 15 LF, 1-3" deformation, joint separated from 9:00 position to 3:00 position 1-2"
- Joint deflection, 1-2" in pipe crown at 45 LF, 76 LF, 106 LF, 136 LF, 166 LF
- Mineral buildup at joints
- Physically probed upstream invert, evidence of metal loss in invert, condition likely varies throughout pipe.
- Possible ovality in pipe at approximately 60 LF, camera unable to provide on-center reference point due to pipe size
- Flow: 3" to 4"
- Grade score of: **2**

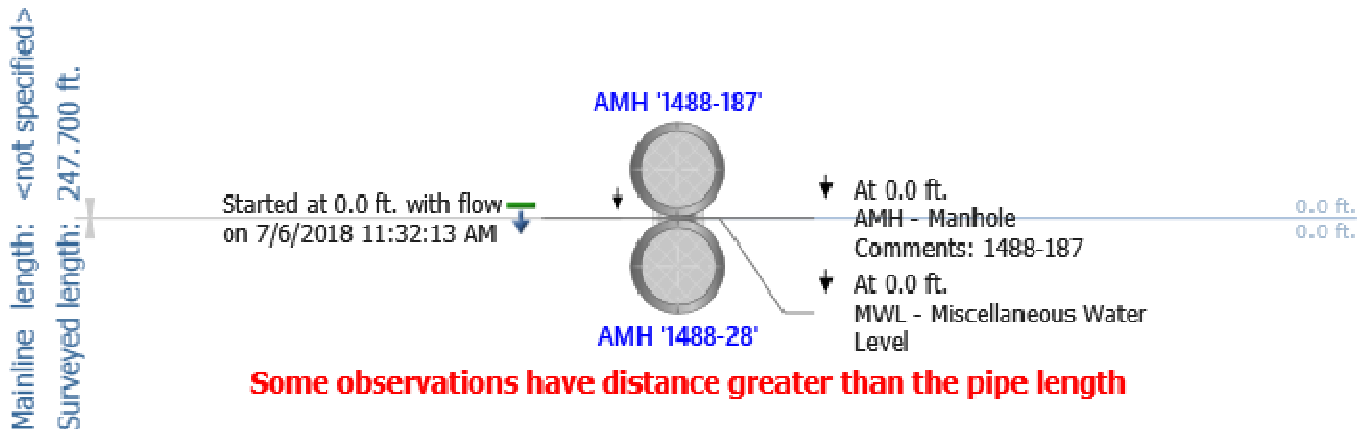
Notes: 1488-187 to 1488-28

- 64-inch CMP
- 248 LF
- Discoloration in invert, evidence of corrosion and metal loss - Mineralization at joint 26 LF
- Corrosion and 1-2" separation at joint 26 LF
- Mineralization and separation at joint at 58 LF, 87 LF, 117 LF, 147 LF, 178 LF
- Mineralization at join 209 LF
- Flow: 2-3"
- Grade score of: **2**

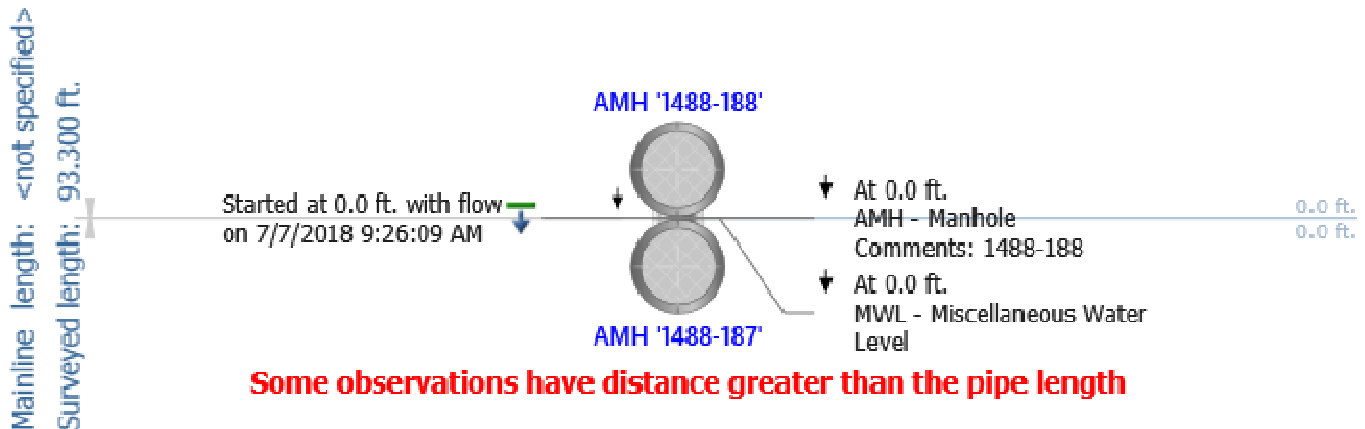
Notes: 1488-188 to 1488-187

- 18-inch CMP
- 93 LF
- 1-2" debris buildup at upstream end
- Minor surface corrosion in invert
- Organic debris at joint at 43 LF
- Debris buildup at 68 LF, possible pipe belly
- 1" pipe deflection in 11:00 position at 69 LF
- Flow: None
- Grade score of: 1

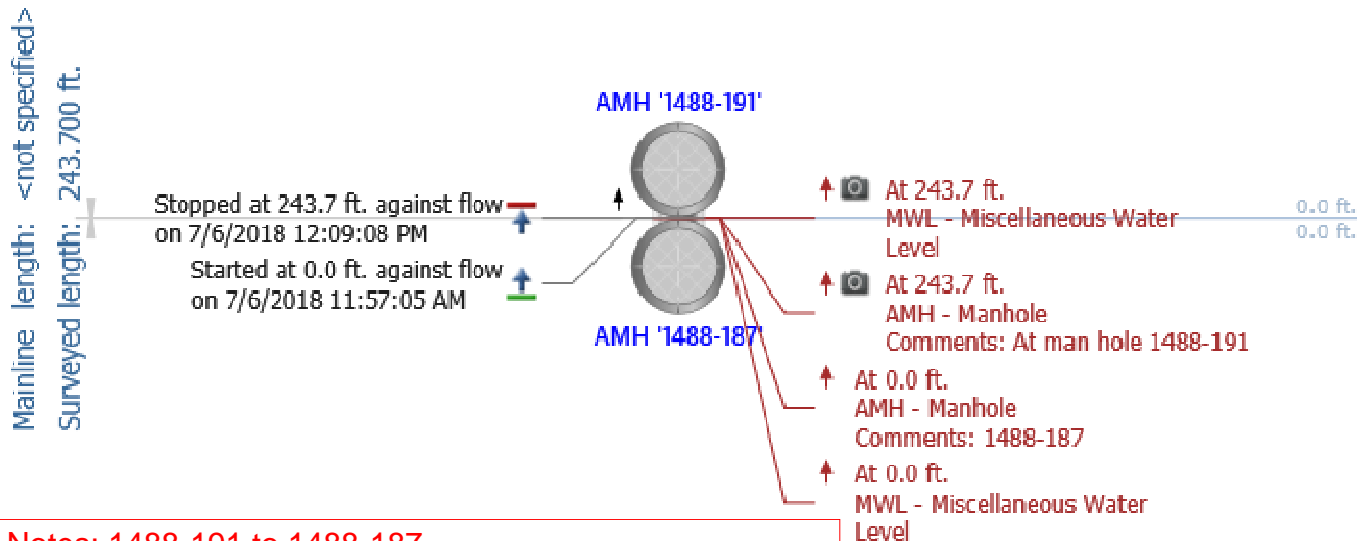
Notes: 1488-191 to 1488-187

- 64-inch CMP
- 244 LF
- Discoloration in bottom of pipe, evidence of corrosion in invert
- Corrosion spots at 8:00 position from 4 LF to 30 LF, some spots appear to have pitting
- Mineralization at joint 32 LF, 63 LF
- Pin holes around joint at 63 LF
- Service connection in 2:00 position at 125 LF, causing corrosion in mainline pipe wall below
- 1-2" deformation in bottom of pipe at joint 152 LF, corrosion pinholes surrounding joint and mineralization
- Mineralization, corrosion, separation at joint at 184 LF
- Debris on thaw line cable at downstream end
- Flow: 2" to 3"
- Grade score of: **3**

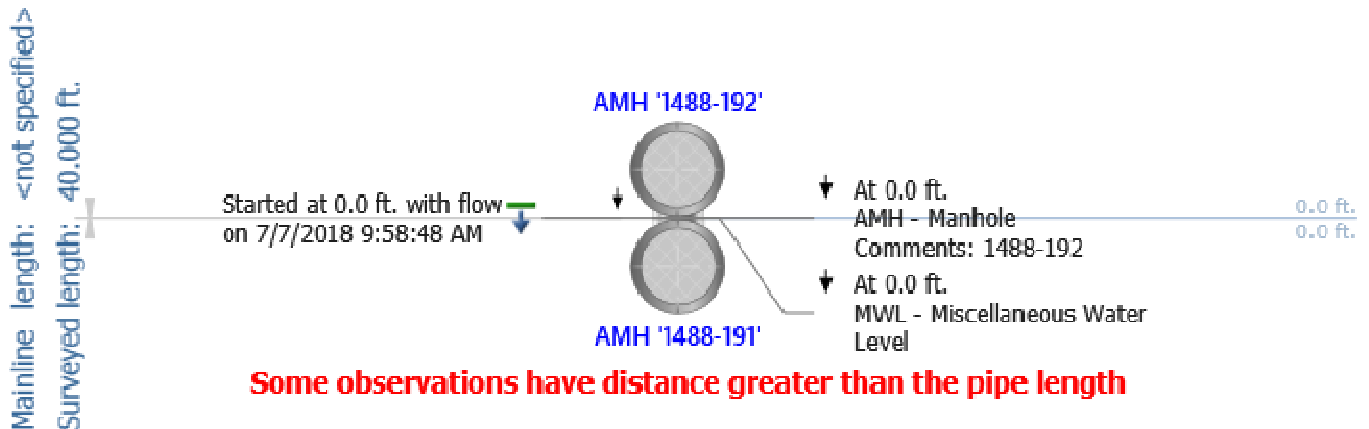
Notes: 1488-192 to 1488-191

- 18-inch CMP
- 107 LF
- 1" of water/debris in invert, unable to determine invert condition, increases downstream, pipe approximately half full of debris at 40 LF
- Clean pipe to complete inspection and verify invert condition
- Flow: Minimal
- Grade score of: **1**

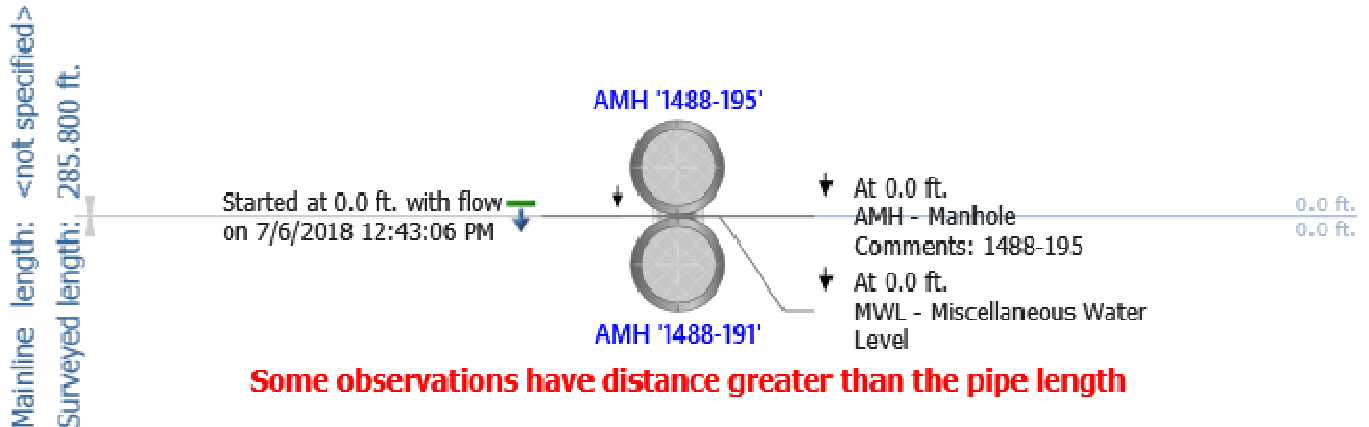
Notes: 1488-195 to 1488-191

- 64-inch CMP
- 286 LF
- Corrosion pinholes and discoloration in 5:00 and 7:00 position throughout pipe
- Mineralization at joint 27 LF, 87 LF, 149 LF, 179 LF, 239 LF, 269 LF
- 3-4" deformation at joint at 58 LF in 1:00 position
- Joints in 64" pipe typically separated
- Invert condition most likely typical of pipes in area, corrosion and metal loss expected
- Flow: 2"-3"
- Grade score of: 3

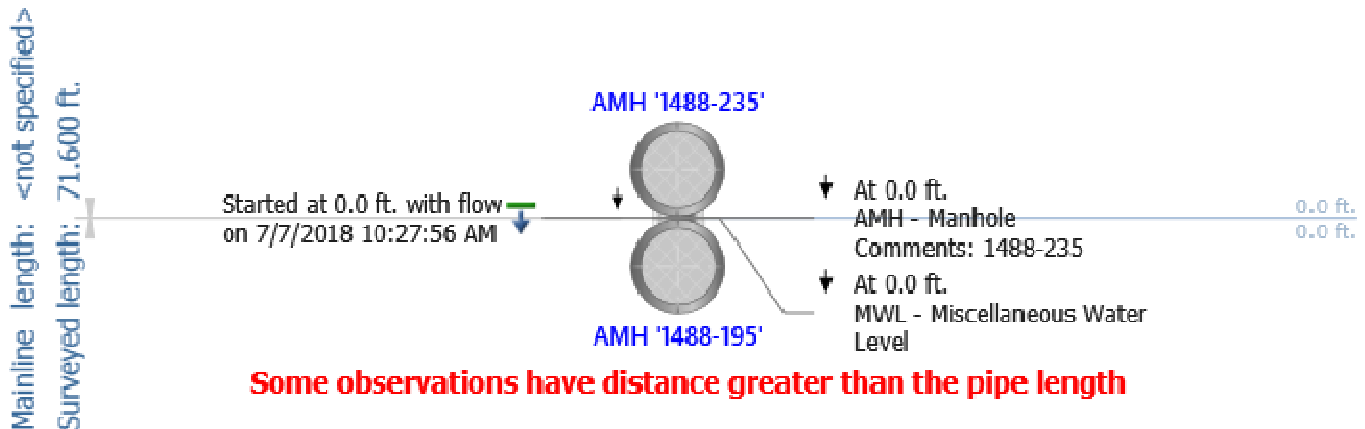
Notes: 1488-235 to 1488-195

- 18-inch CMP
- 129 LF
- Varying levels of debris in pipe, increases to approximately 1/4 pipe toward 30 LF then decreases to 0-1", large pieces of garbage/debris in upstream end, debris increasing from 59 LF to end of survey to approximately half full
- 1-2" deformation in 9:00 position, 20 LF
- 1" deformation in 12:00 position, 28 LF
- 1" deformation in 3:00 position, 47 LF
- Evidence of surface corrosion in invert at 53 LF
- No structural defects observed
- Flow: None
- Grade score of: 1

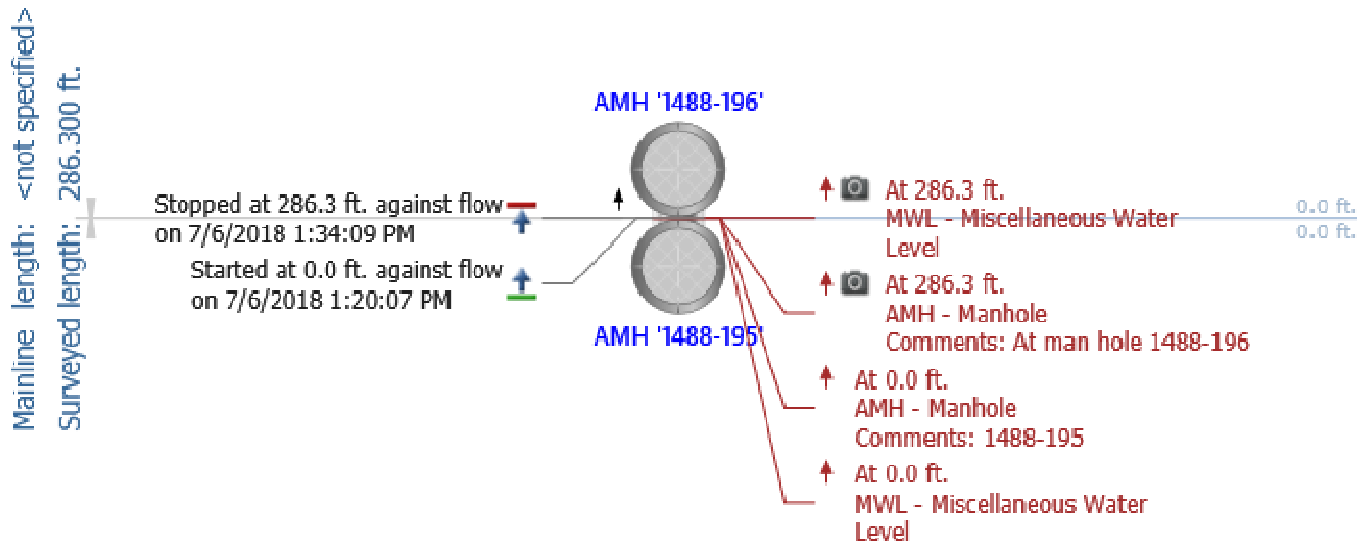
Notes: 1488-196 to 1488-195

- 64-inch CMP
- 286 LF
- Pinholes 4:00 and 8:00 position throughout pipe
- Mineralization at joint 25 LF, corrosion at 55 LF, 76 LF, 140 LF, 161 LF, 181 LF, 200 LF, 211 LF,
- Bent piece of joint showing at 161 LF
- Possible belly at downstream end, does not appear to be limiting flow
- Invert condition most likely typical of pipes in area, corrosion and metal loss expected
- Flow: 2" to 3"
- Grade score of: **3**

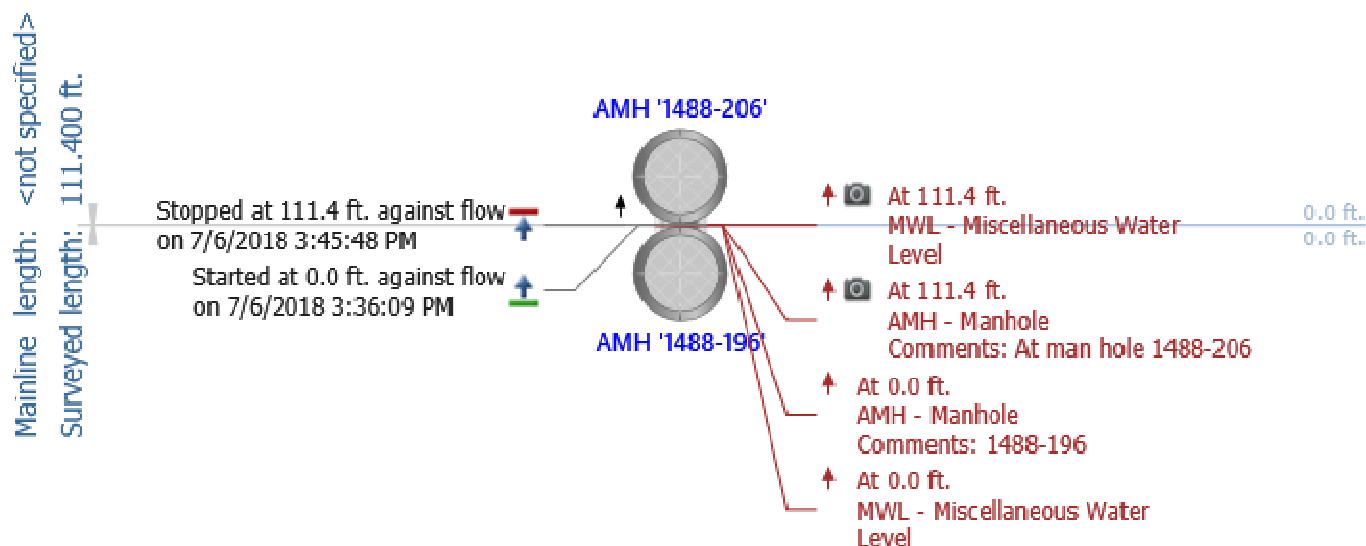
Notes: 1488-206 to 1488-196

- 24-inch CMP
- 111 LF
- Discoloration in pipe bottom, possible corrosion in invert
- Varying debris in invert
- Possible belly in pipe at 30 LF
- Mineralization at joint at 33 LF, 53 LF, 91 LF
- Debris and water increase at 65 LF to end of pipe
- Flow: 1" to 2"
- Grade score of: **2**

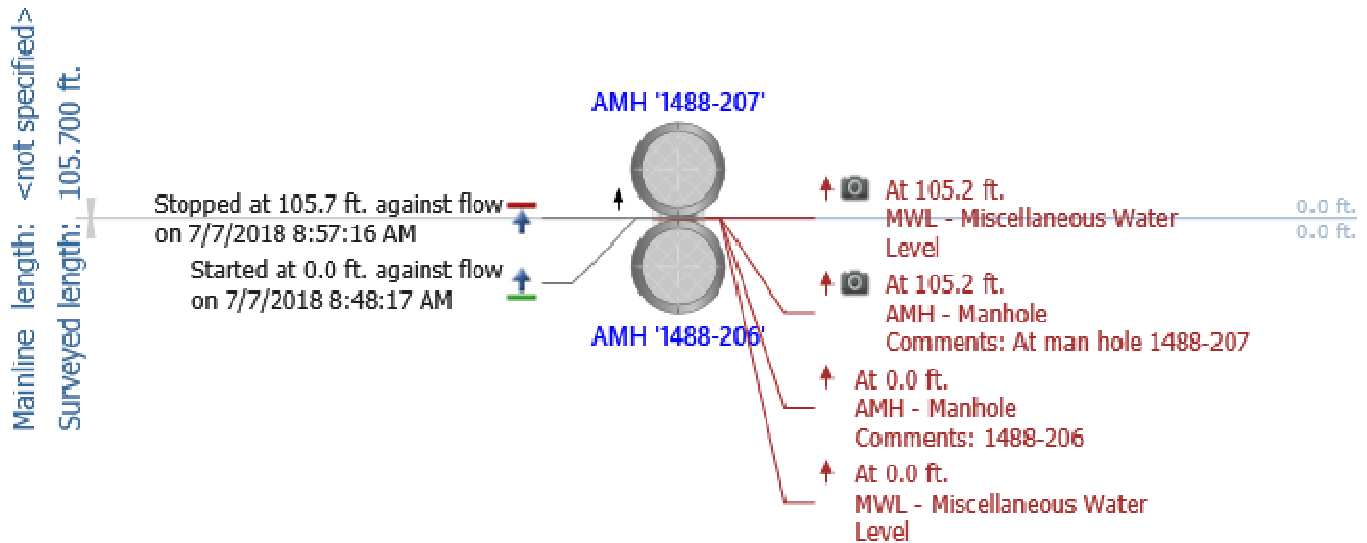
Notes: 1488-207 to 1488-206

- 24-inch CMP
- 105 LF
- 1"-2" of debris
- Discoloration in invert
- Possible belly at downstream end
- Visible infiltration at joint at 19 LF
- Evidence of infiltration at joint at 40 LF, 80 LF
- Flow: 1"-2"
- Grade score of: 2

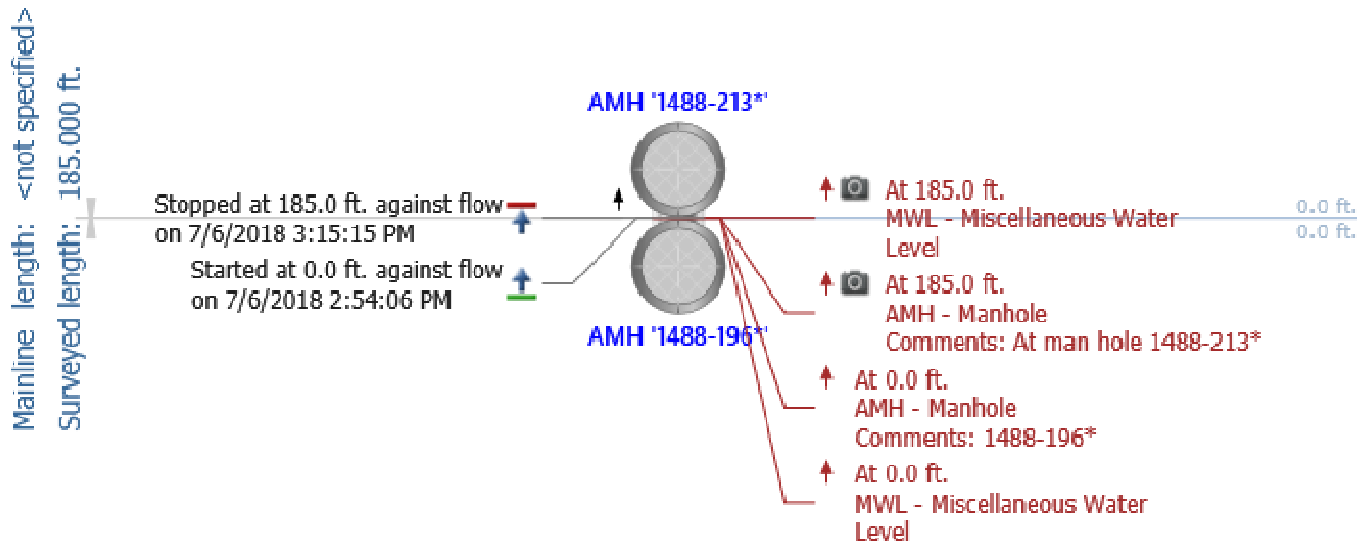
Notes: 1488-213 to 1488-196

- 24-inch CMP
- 185 LF
- Discoloration in bottom of pipe, evidence of corrosion in invert
- Various piles of debris
- Flared piece of joint at 73 LF
- Pipe appears oval at midspan
- Mineralization at joint at 93 LF, 104 LF, 124 LF, 144 LF
- rubber gasket exposed in pipe crown, 165 LF
- Corrosion pitting at 96 LF in 8:00 position
- Infiltration in 5:00 position pinhole 108 LF
- Pinholes w/ infiltration 111 LF 9:00 position
- Possible pipe belly at 124 LF
- Pinhole at 143 LF w/ infiltration in 1:00 position
- Pinholes w/ infiltration at 163 LF in 5:00 position
- Flow: 1" to 2"
- Grade score of: **3**

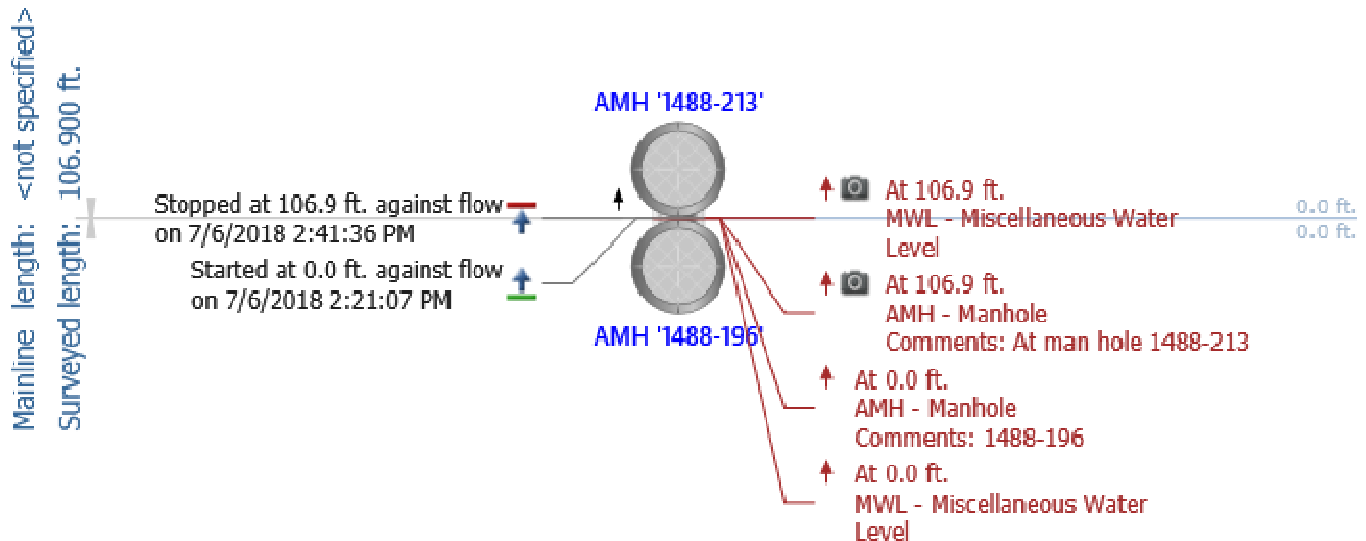
Notes: 1488-213A to 1488-196

- 28-inch CMP
- 107 LF
- Discoloration in bottom of pipe
- 0-1" of debris in invert, discoloration and surface corrosion also in invert
- Mineralization at joint at 19 LF, 33 LF, 48 LF, 53 LF, 73 LF
- Horizontal deflection at 29 LF to the right, to the left at 73 LF, left at 93 LF
- Flow: 1"
- Grade score of: 2

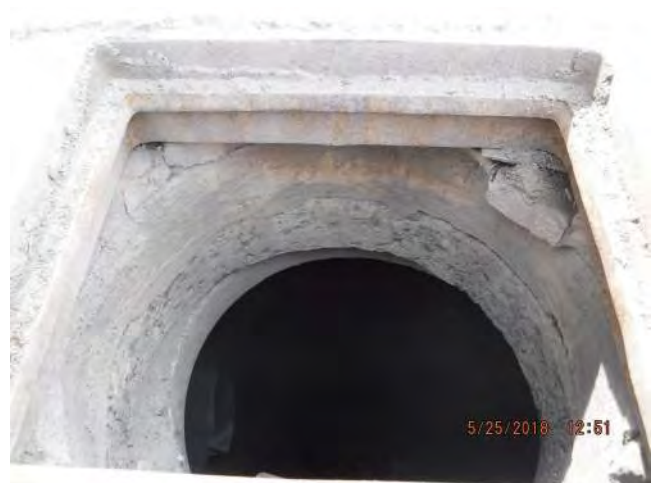
Chimney(s)

Additional Comments: 1st grade ring broken, Aggregate exposed in 2nd Grade Ring

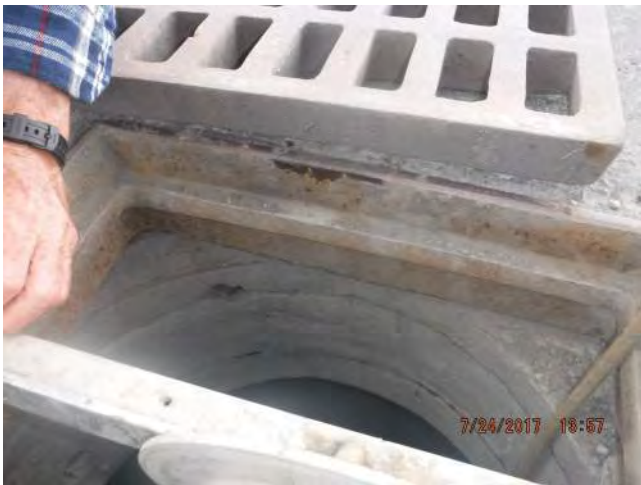
Frame and Chimney

Primary Comments: E 12" LINE, Cracks in Chimney, Effluent connection not visible, Concrete good overall quality

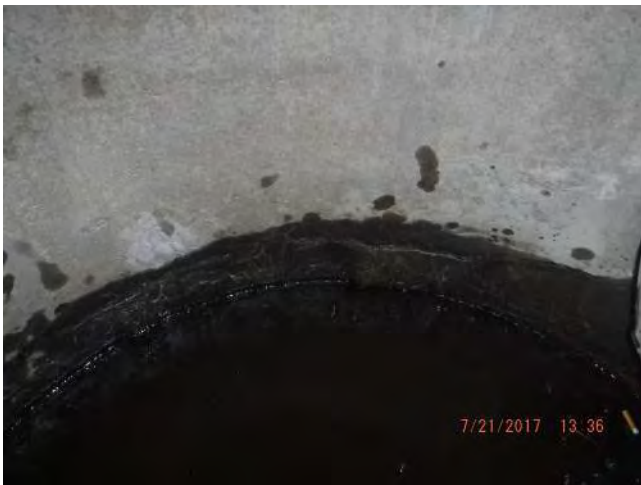
Primary Comments: CRACKED BASE

Circumferential crack in base

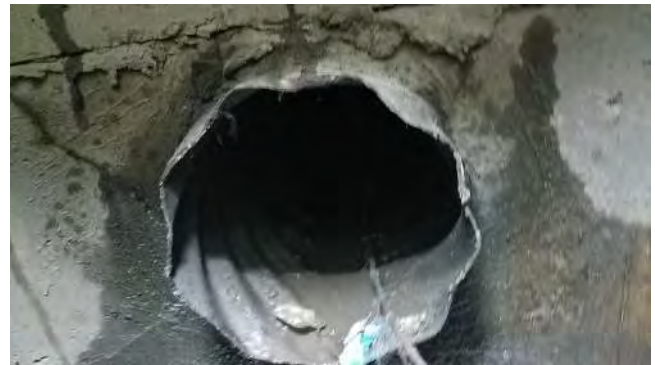
Pipe #2 Connection

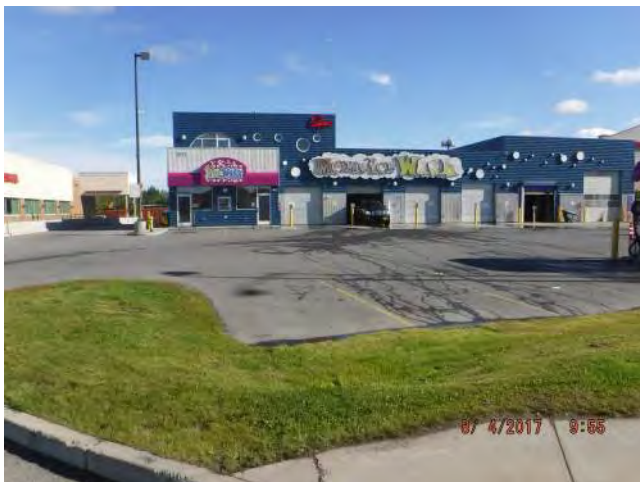
17-17A Facing North

30.8' INSPECTED, TOO MUCH DEBRIS TO COMPLETE 8/4/17 HOLE IN BOTTOM OF UPSTREAM INVERT

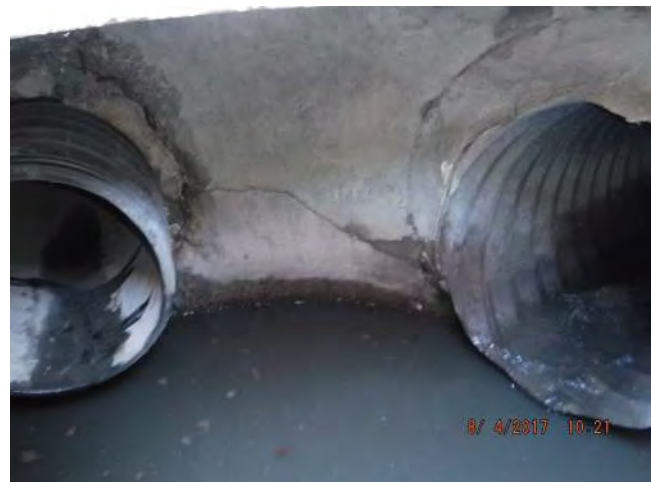
Primary Comments: CRACK IN BASE 12:00 TO 2:00

Crack in Base

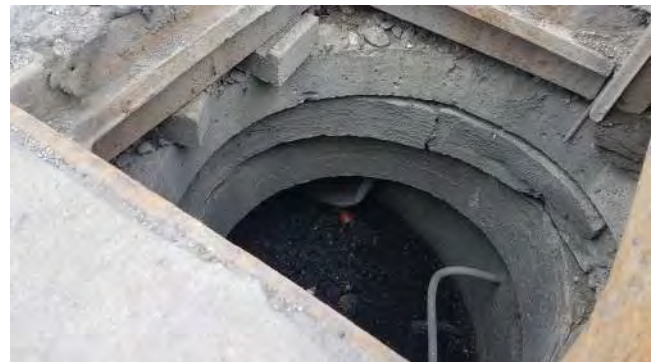
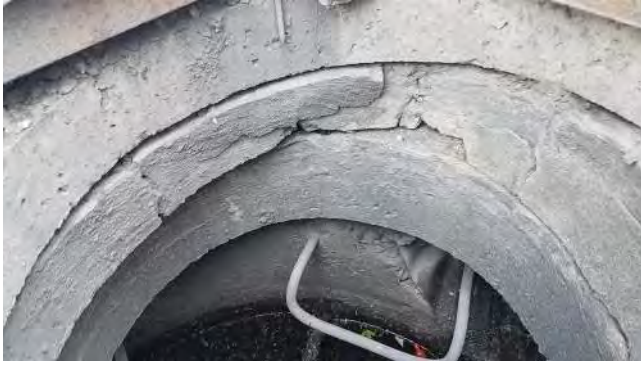
View of Chimney

Primary Comments: CHIMNEY DAMAGE

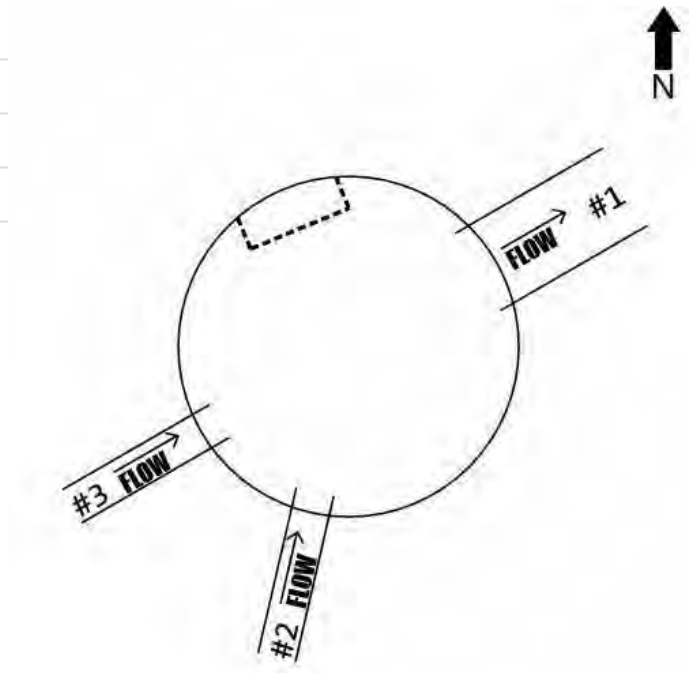
128.7FT CCTV on 7/31/17. complete. pipe was half full of debris and required cleaning to inspect

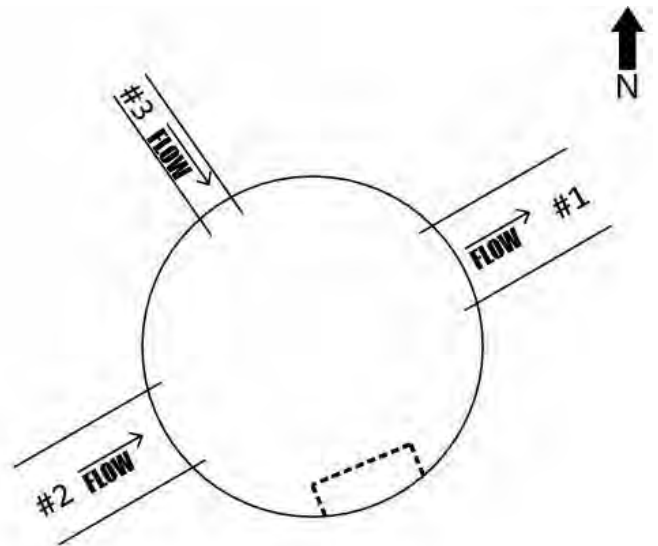
unable to drive camera through. joint deflection with intruding cmp prevented camera 3 ft in from proceeding

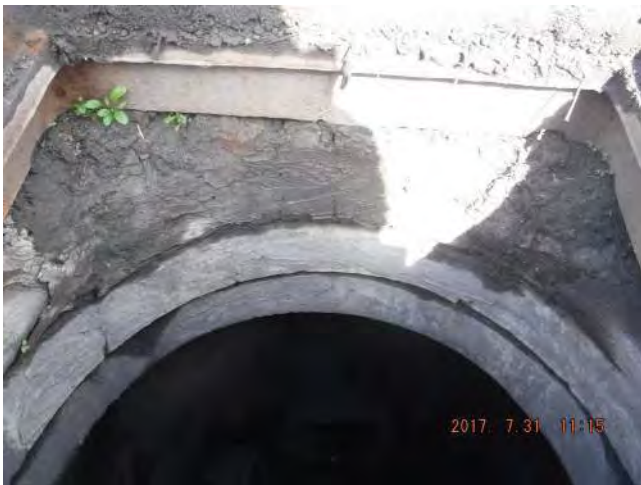
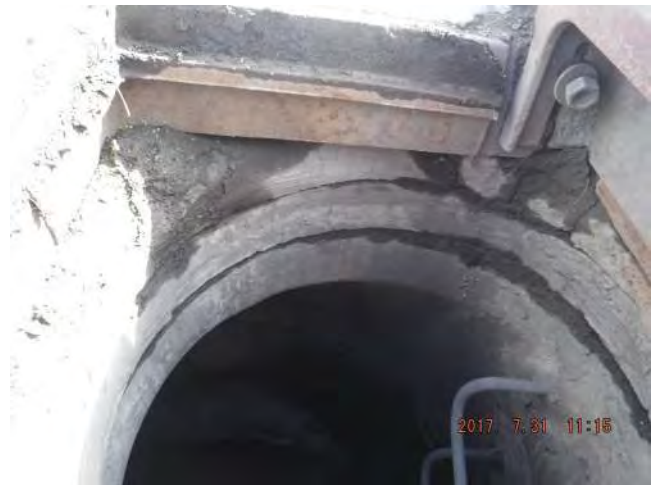
Additional Comments: top grade ring has multiple cracks

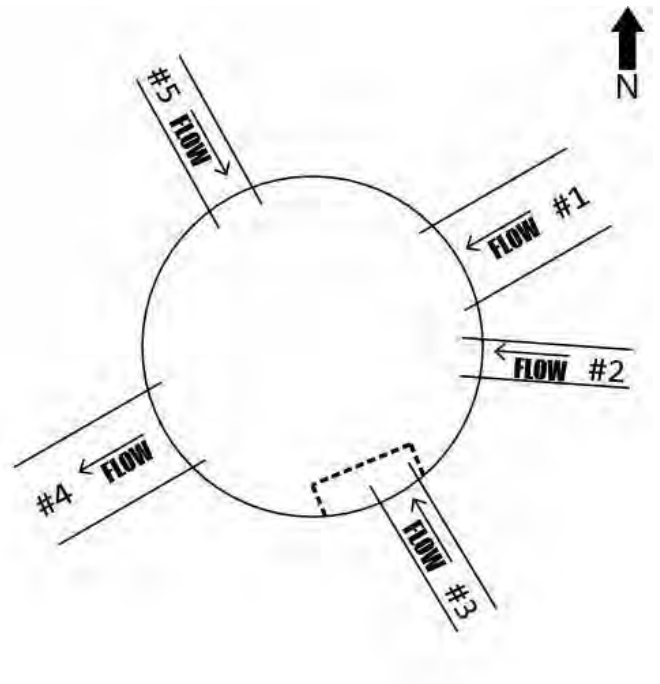
84.8 ft completed 7/31/17. 3to5 inches of debris at upsream structure

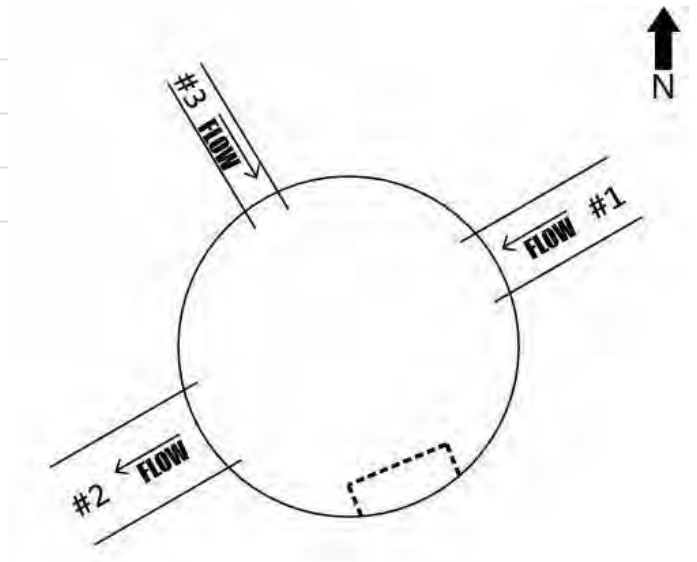
76.8ft inspected. unable to tv last 5feet due to debris

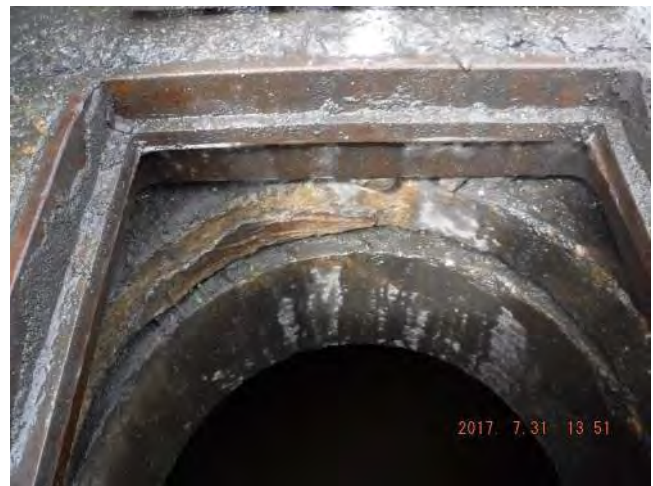
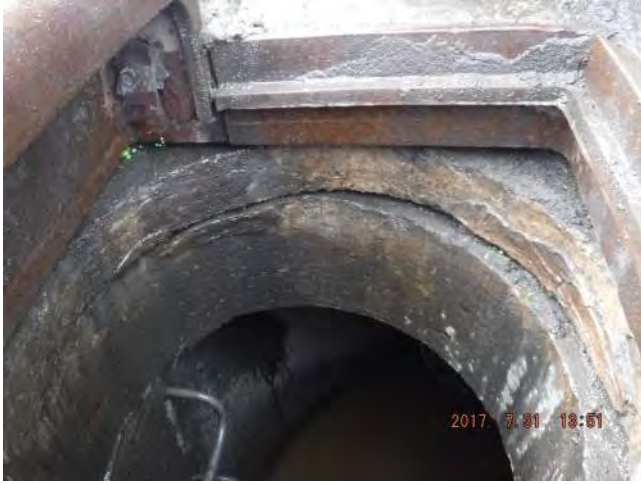
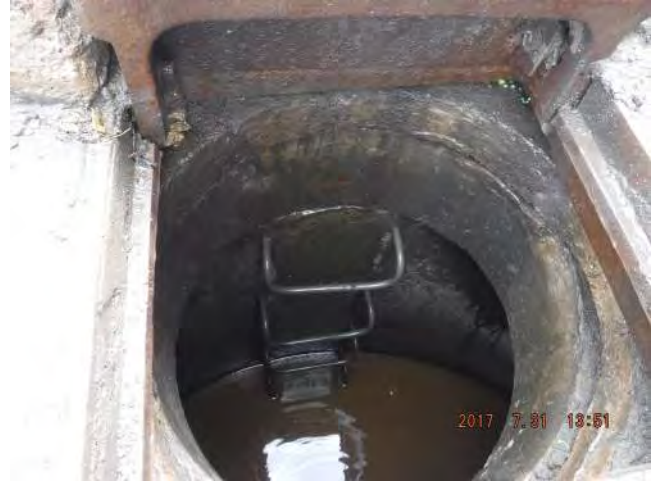
Primary Comments: pipe connections and chimney are missing grout

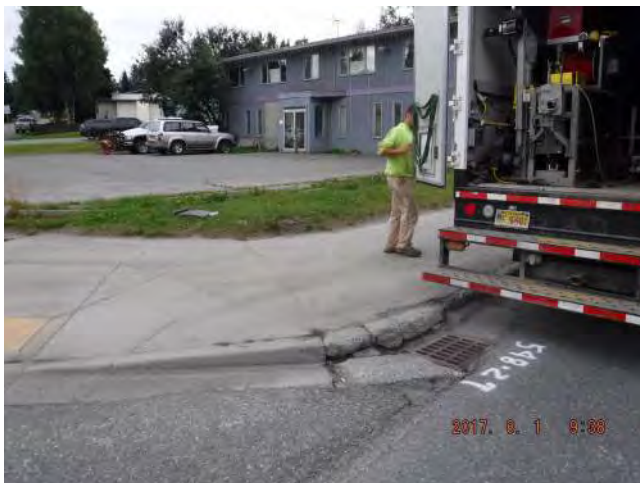
548-27 Facing South

horizontal deflection aat 21 ft. multiple deflections at joints, to the right 150.8 ft completed 7/31/17

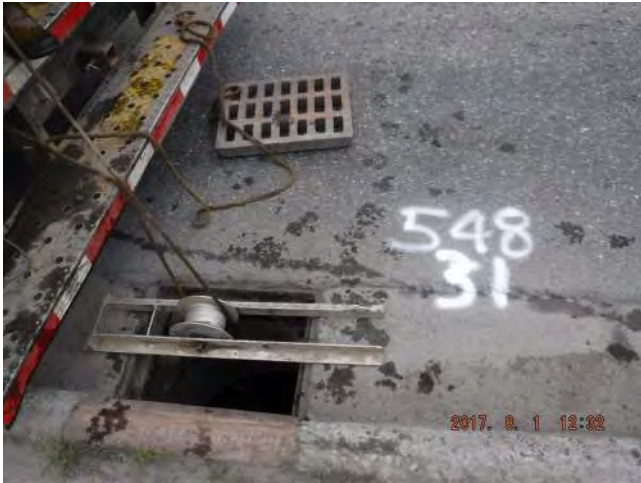
548-31 Facing Northwest

Primary Comments: CIRCUMFERENTIAL CRACK IN BASE AT PIPE connections

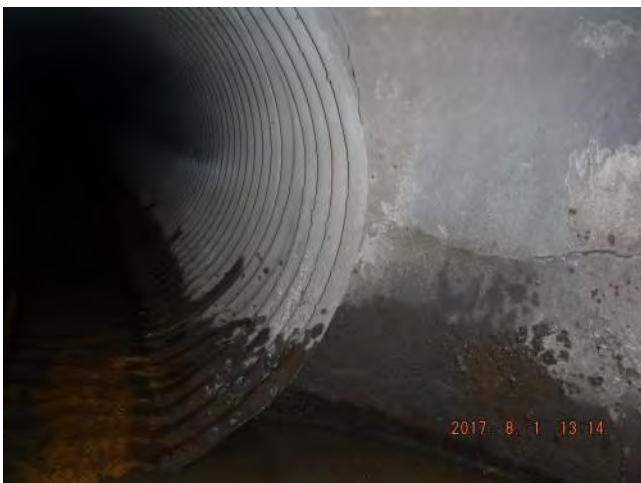
Pipes #6,1, Crack in Base

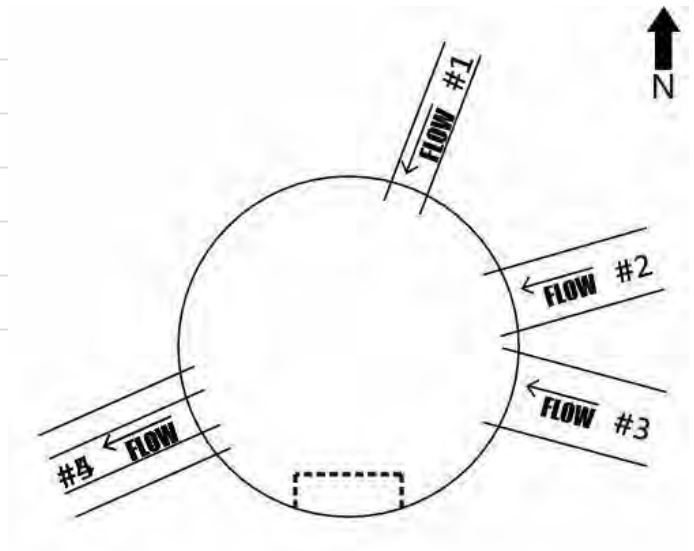
PIPE ID
1	548-253 to 548-32
2	548-253 to 548-32
3	548-33 to 548-32
4	548-32 to 548-31
5	548-32 to 548-31

Primary Comments: circumferential crack in base at pipe connections, offset frame

perforated pipe 164.5 feet upstream on 8/1/17. unable to complete due to debris. set up on upstream manhole and completed downstream 5feet on 8/2/17

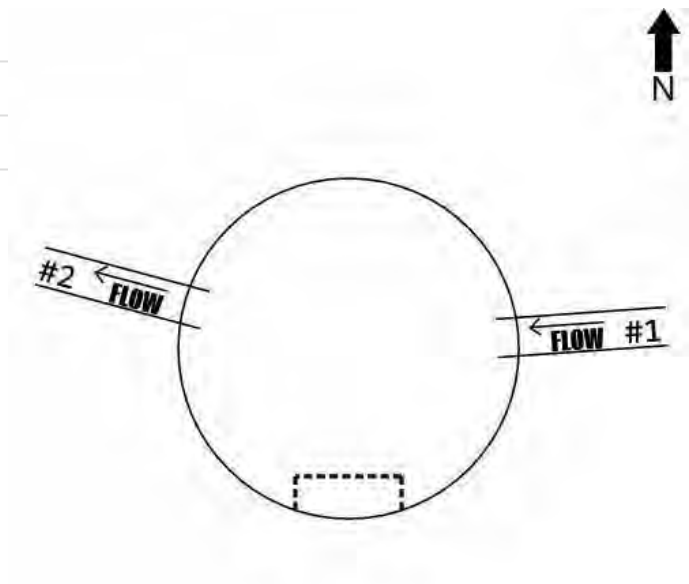
PIPE ID	
1	548-34 to 548-33
2	548-33 to 548-32

multiple deformations. one sag. 71.3 feet completed 8/2/17.

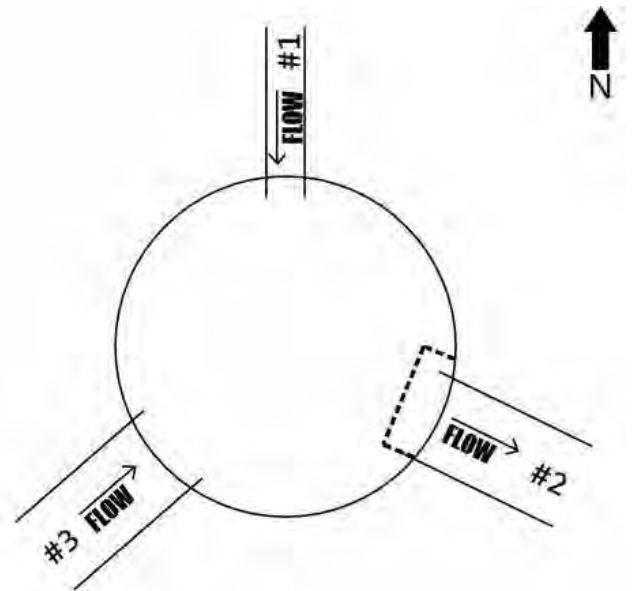
PIPE ID	
1	to 548-256
2	548-256 to 548-255
3	548-257 to 548-256

INSPECTED 29.2' UNTIL BLOCKED BY DEFECT 7/22/17

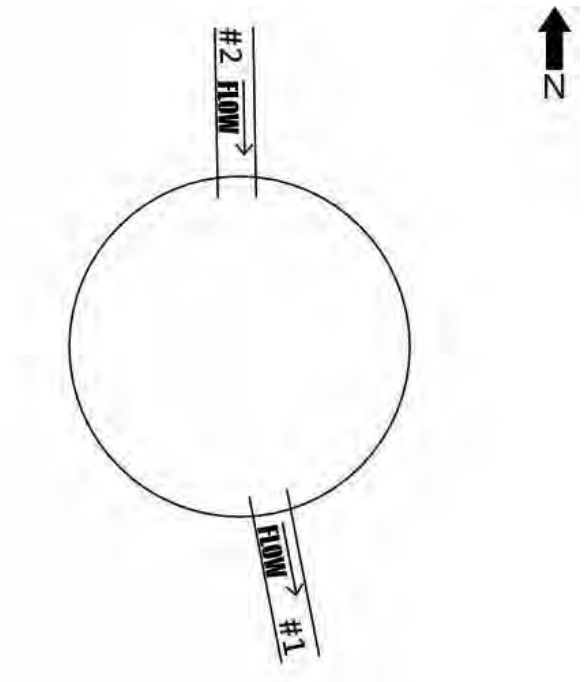
PIPE ID
1	548-254 to 548-253
2	548-255 to 548-254

30.1' INSPECTED BEFORE BLOCKED BY DEFECT 7/22/17

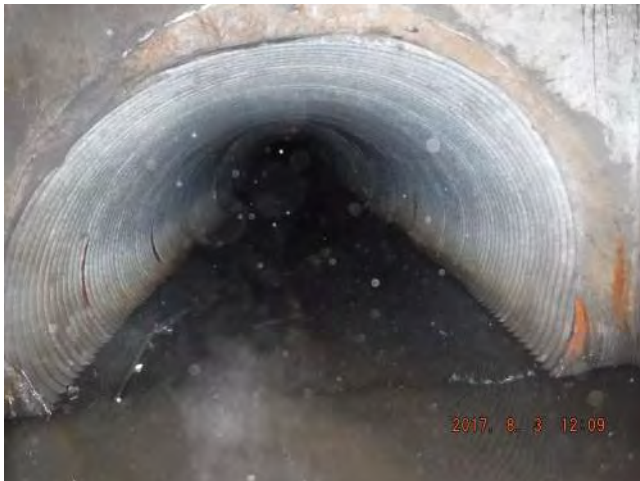
Arched Effluent Pipe

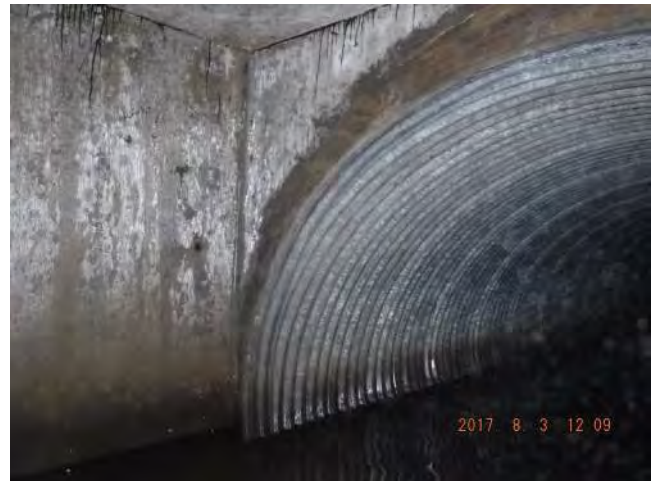
Arched Influent Pipe

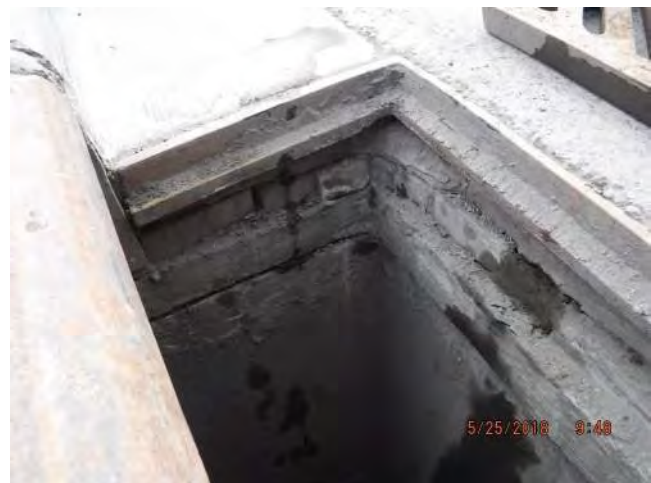
Primary Comments: Mortar cracked on chimneys

Broke Chimney

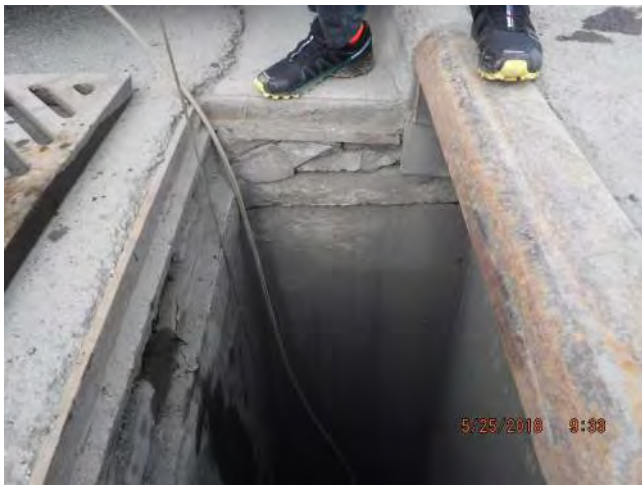
Broke Chimney

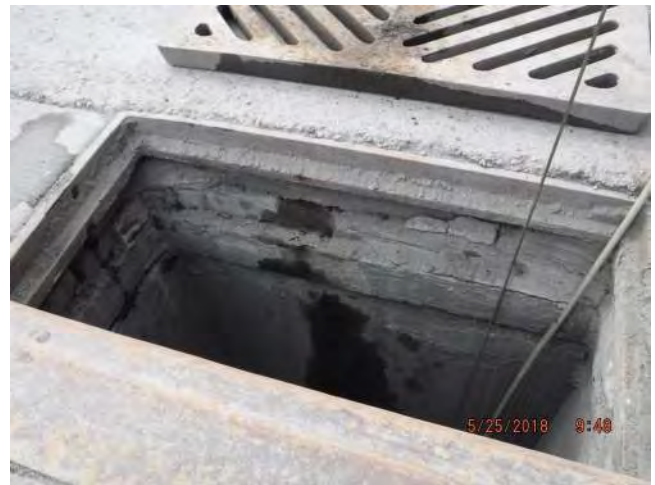
Broke Chimney

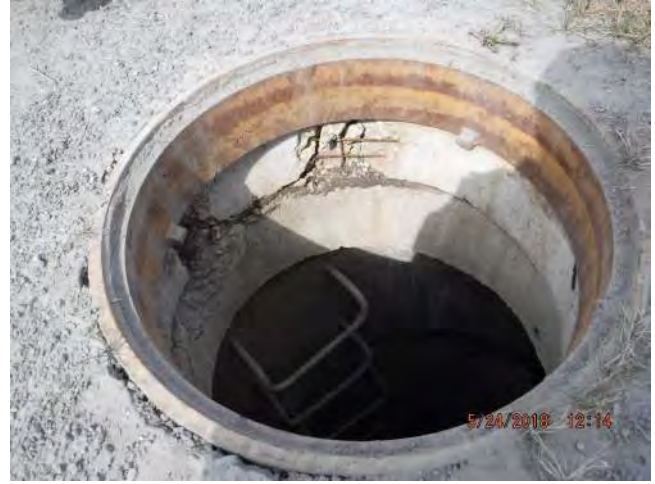
Exposed Rebar in Chimney

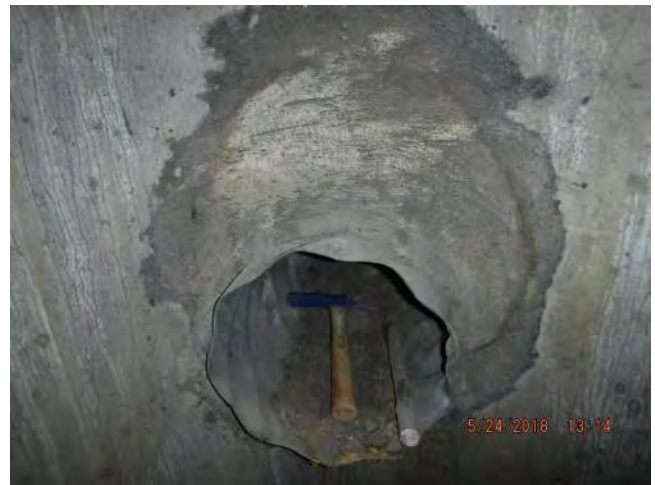
Typical Connection Condition

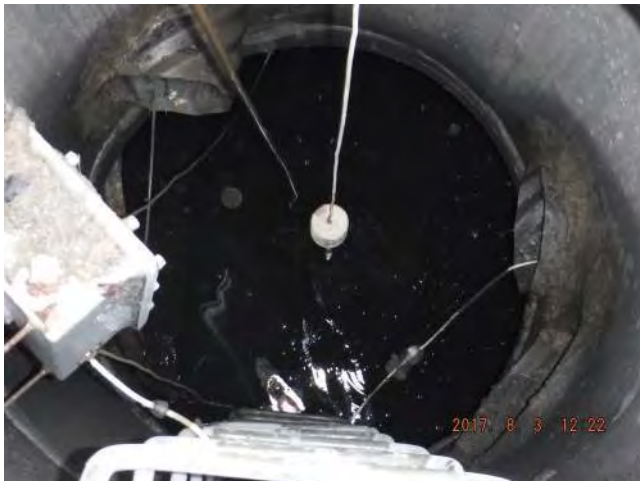
Influent Perforated Pipes

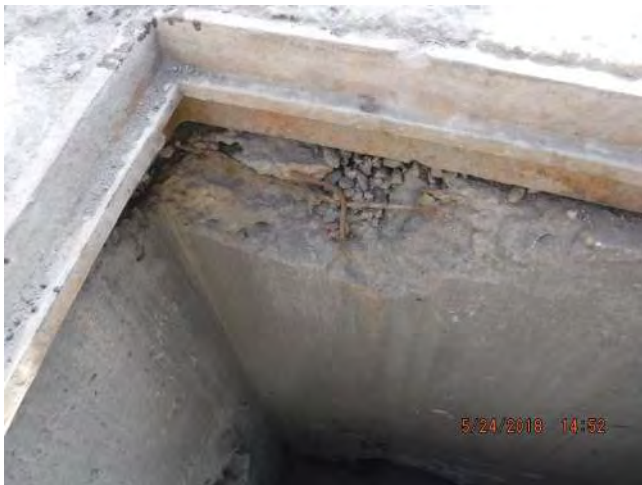
Exposed rebar in manhole wall

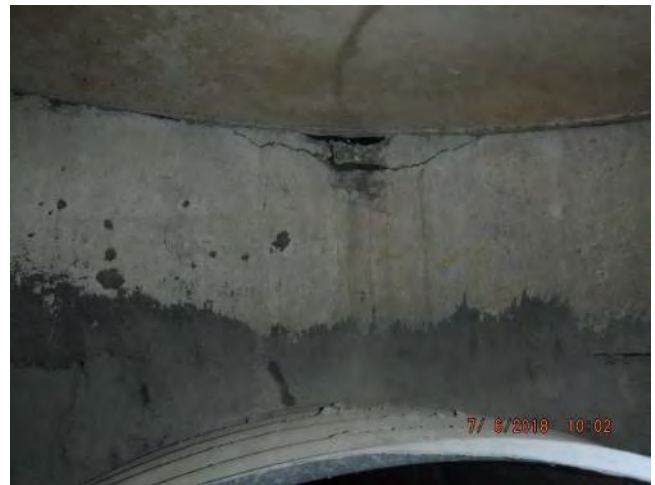
Crack in Barrel

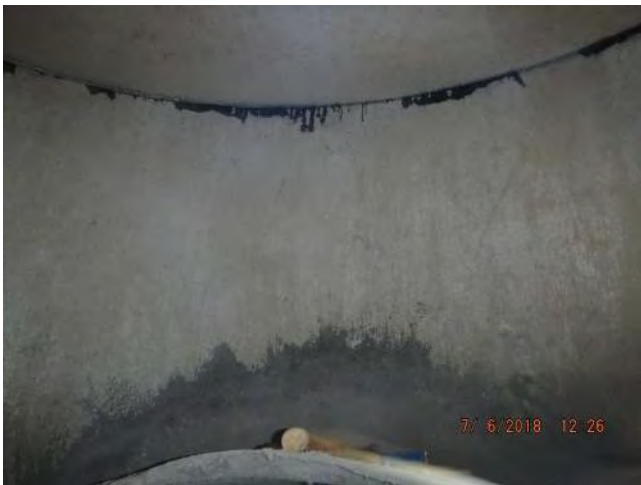
Typical Condition of Concrete
