Alaska Department of Transportation and Public Facilities Central Region

NHS STORM DRAIN INSPECTION CONDITION REPORT PROJECT NO. 0A31055 / Z591280000

Dimond Boulevard from Jewel Lake Road to Old Seward Highway
Muldoon Road from Boundary Avenue to Northern Lights Boulevard
Debarr Road from Bragaw Street to Muldoon Road
Downtown: 5th and 6th Avenue from Gambell Street to Orca Street and
Ingra Street from 6th Avenue to 9th Avenue

May 20th, 2019

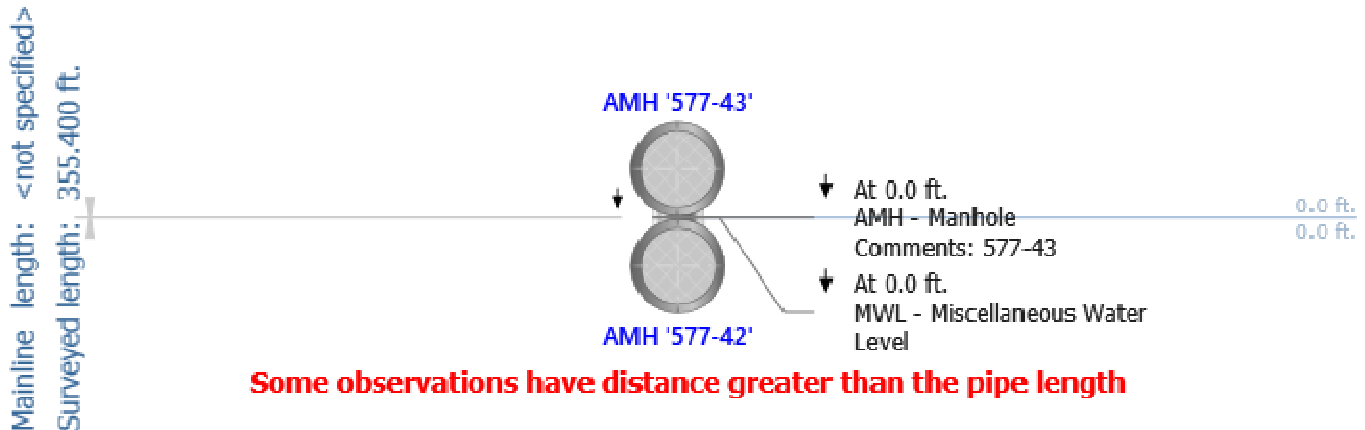
Main Inspection with Pipe-Run Graph

- 30-in. CMP
- 355 LF
- Surface corrosion in bottom half of pipe
- Evidence of infiltration at joints, debris and discoloration/surface corrosion visible
- 3-5" of debris, flow creating channel through debris
- Discoloration in top of pipe
- Unable to view invert due to flow/debris, invert probed, metal loss observed
- Ovality in pipe, difficult to observe due to quality of survey, approximately 5-10% loss of cross sectional area in various sections of the pipe
- Flow: 2-3"
- Grade score of: 4

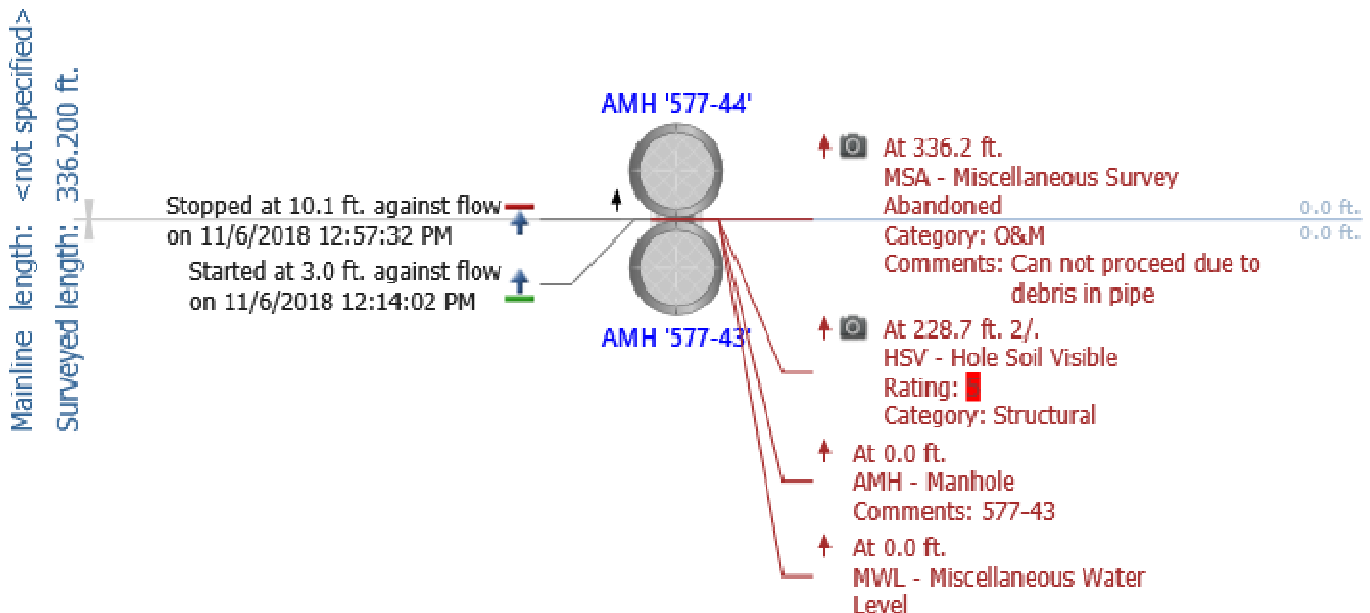
Notes: 577-44 to 577-43

- 30-in. CMP
- 336 LF
- 3-4" of debris, flow creating channel through debris
- Surface corrosion in bottom half of pipe
- Evidence of infiltration at joints, debris and discoloration/surface corrosion visible
- Unable to view invert due to flow/debris, invert probed, metal loss observed
- Discoloration in top of pipe
- Ovality in pipe, difficult to observe due to quality of survey, approximately 5-10% loss of cross sectional area in various sections of the pipe, 3 LF to 100 LF
- Hole, Approximately 6", soil visible, 2:00 position at 228 LF
- 1" deformation, 11:00 and 12:00 position, at 228 LF and 230 LF respectively
- Flow: 2-3"
- Grade score of: 4

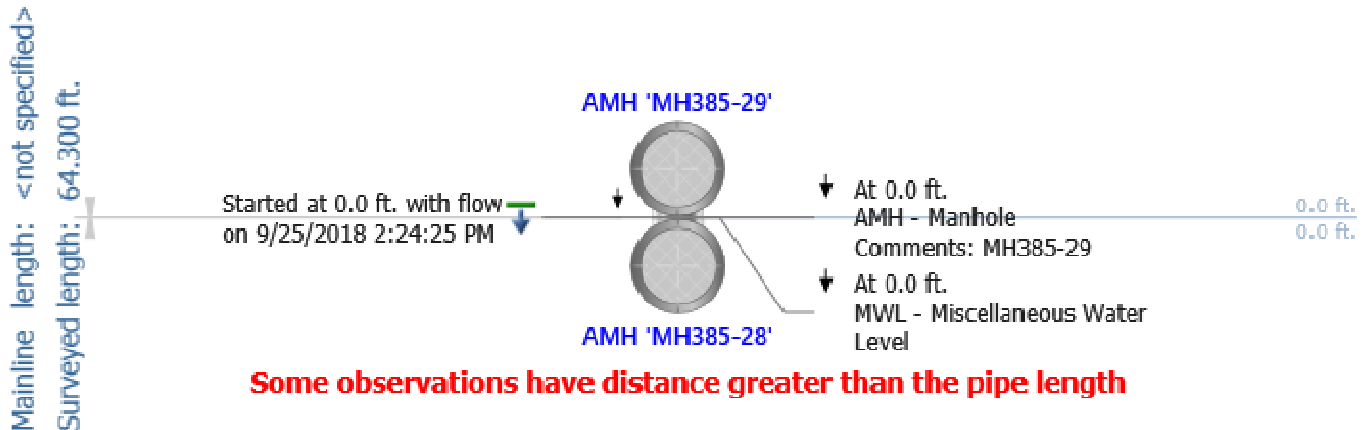
Notes: 385-29 to 385-28

- 18-in. CMP
- 276 LF
- Organic debris (leaves) in pipe
- 0-1" sediment, 3 LF to 64 LF, 2" debris buildup at 12 LF, pipe becomes approximately half full of debris at 64 LF, unable to continue survey
- Surface corrosion visible at 5:00 and 7:00 position throughout pipe
- Corrosion visible in invert when not obscured by debris
- Flow: 0-1"
- Grade score of: 3

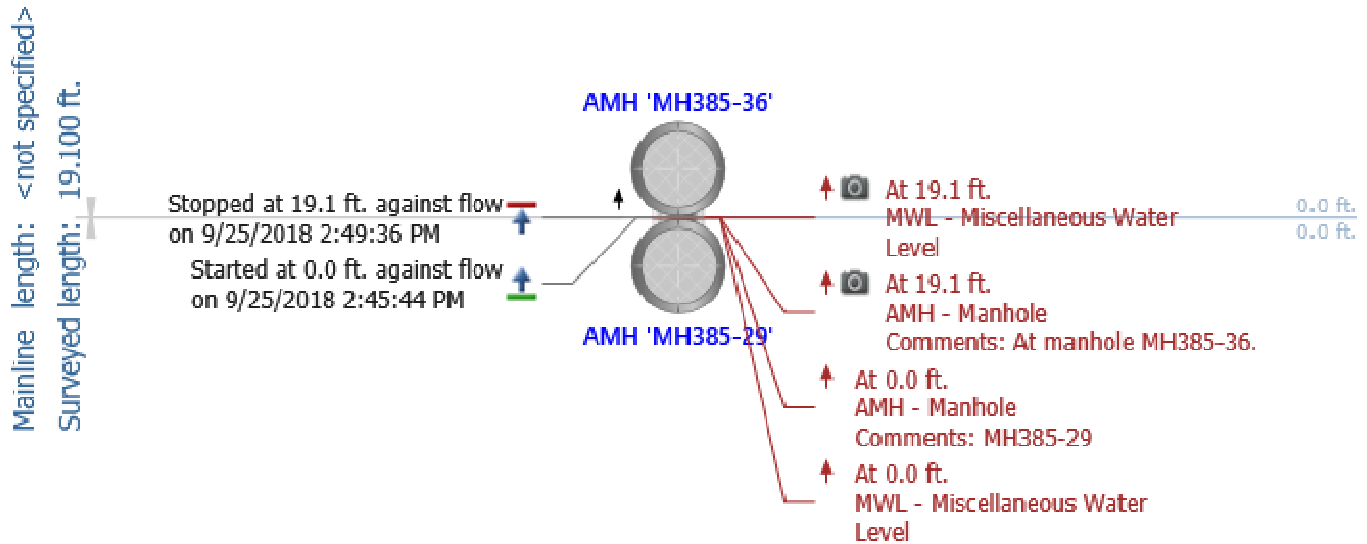
Notes: 385-36 to 385-29

- 18-in. CMP
- 19 LF
- Garbage/debris at downstream end
- Corrosion in invert throughout pipe
- Flow: None
- Grade score of: 2

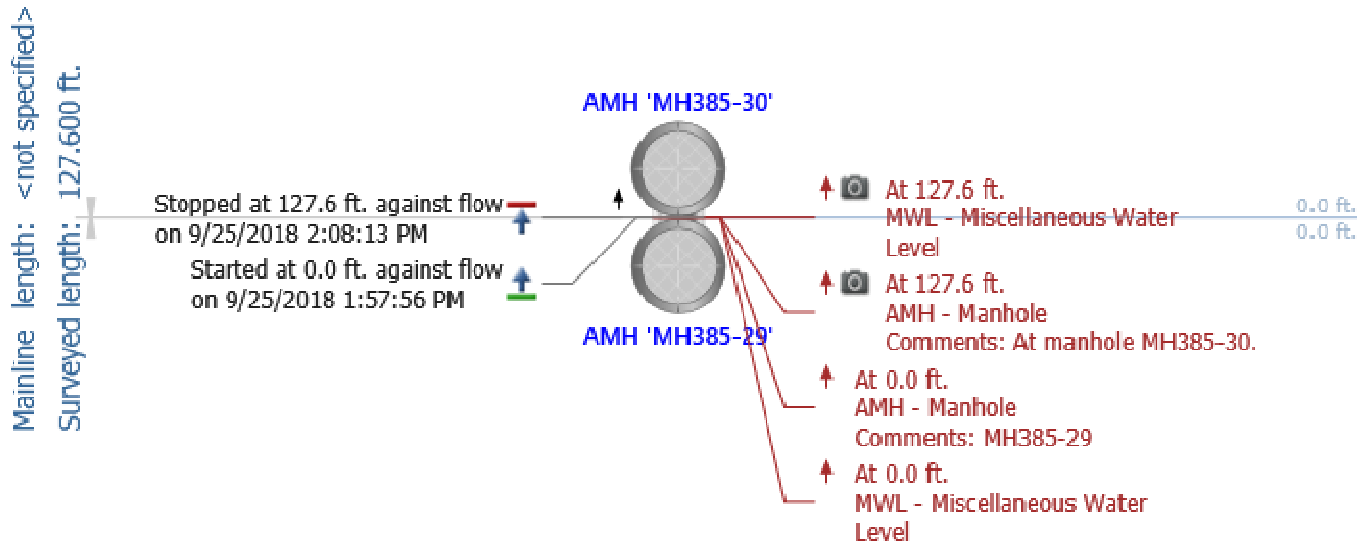
Notes: 385-30 to 385-29

- 18-in. CMP
- 128 LF
- 1-2" of debris in pipe
- Surface corrosion between 5:00 and 7:00 position
- Flow: Minimal
- Grade score of: 2

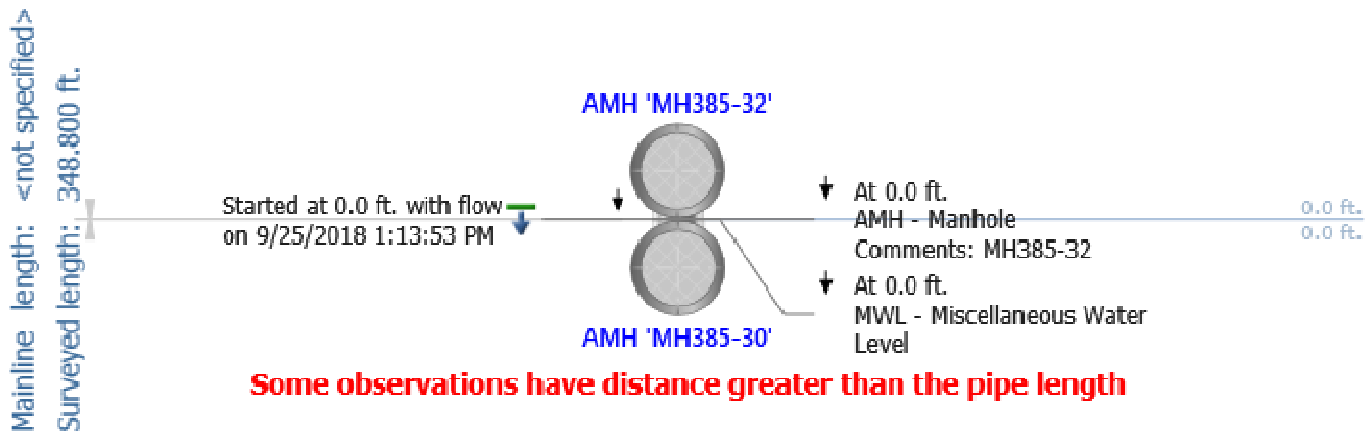
Notes: 385-32 to 385-30

- 18-in. CMP
- 349 LF
- Organic debris (leaves) in pipe
- 0-1" sediment
- Minor surface corrosion at pipe ends at joints
- Surface corrosion visible at 5:00 and 7:00 position throughout pipe
- Corrosion visible in invert when not obscured by debris
- Flow: Minimal
- Grade score of: 2

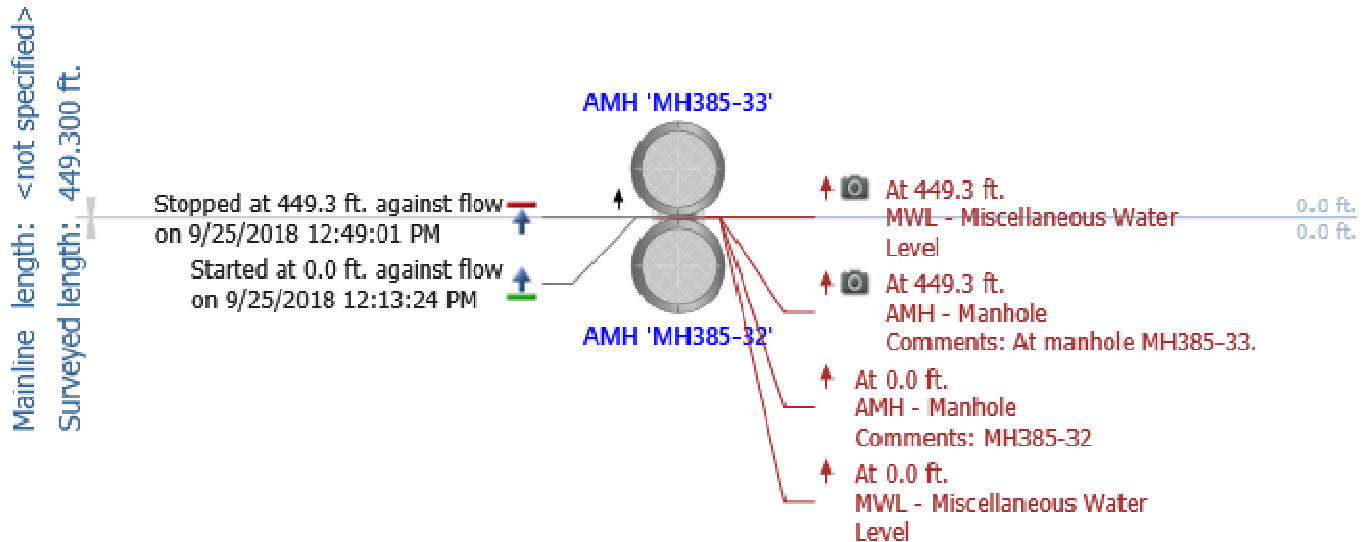
Notes: 385-33 to 385-32

- 18-in. CMP
- 449 LF
- Approximately 2" of debris at downstream end, 6" debris at upstream end
- Surface corrosion between 5:00 and 7:00 position, discoloration between 4:00 and 8:00 position
- Minor surface corrosion at pipe ends at joints
- 0-1" debris in pipe
- Discoloration in top of pipe, 364 LF
- Flow: Minimal
- Grade score of: 2

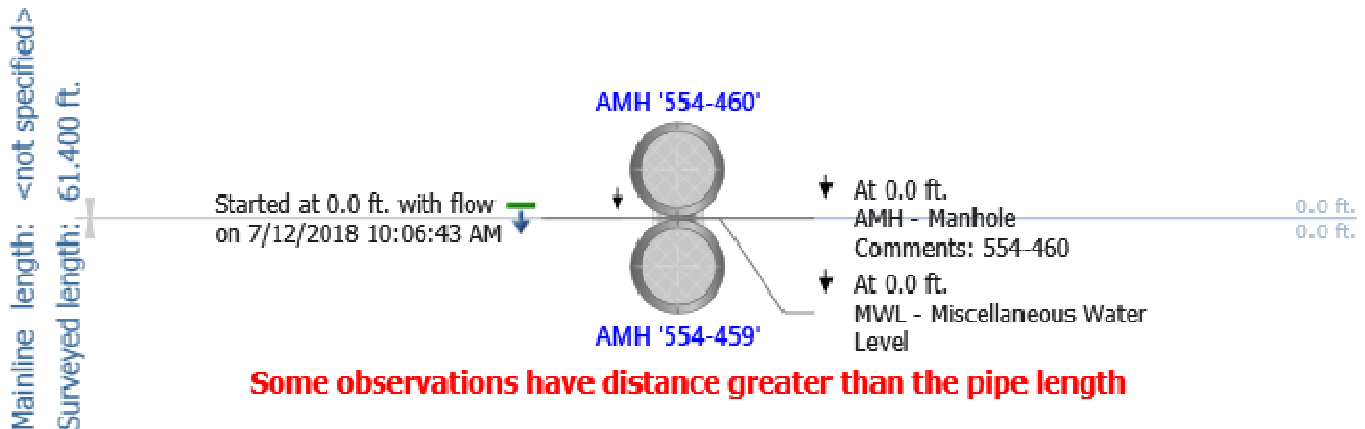
Notes: 554-460 to 554-459

- 12-in. CMP
- 61 LF
- Surface corrosion and discoloration visible in bottom half of pipe, 8 LF
- Surface corrosion at joint, 13 LF
- Corrosion visible in invert at joints
- 1-2" debris in pipe
- Flow: Minimal
- Grade score of: 2

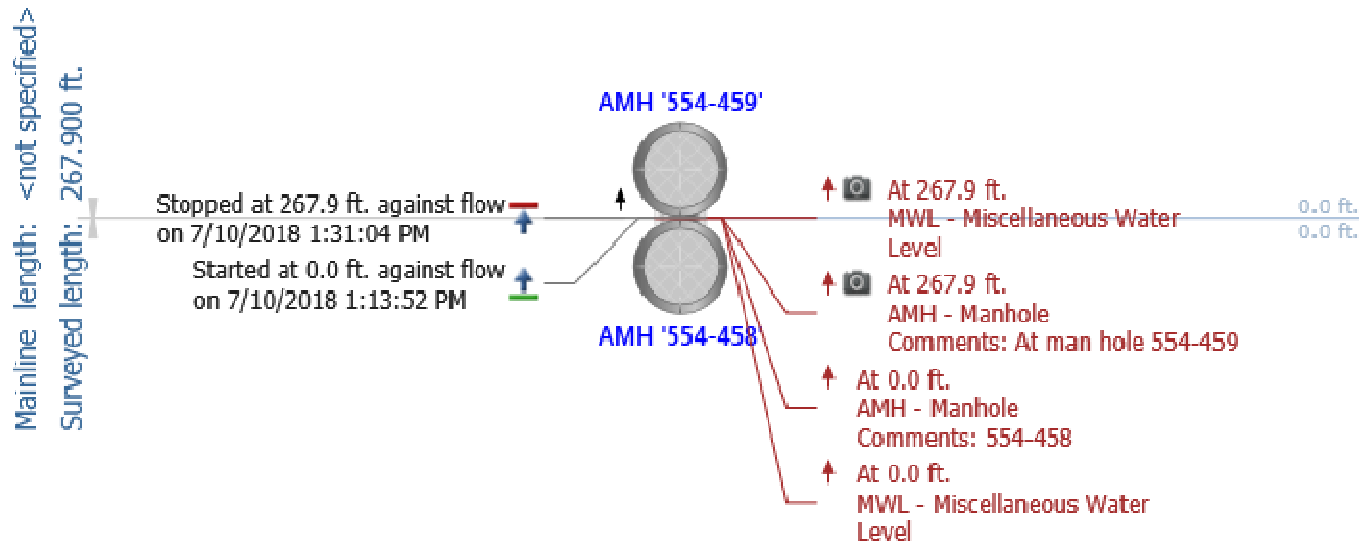
Notes: 554-459 to 554-458

- 18-in. CMP
- 268 LF
- Discoloration in bottom half of pipe throughout pipe
- Minimal debris
- Corrosion in invert, visible at joints
- 1-2" deformation, 11:00 position, 77 LF
- 1" deformation, 11:00 position, 93 LF, 154 LF
- 0-1" debris, varies between 162 LF to end of survey
- Flow: Minimal
- Grade score of: 2

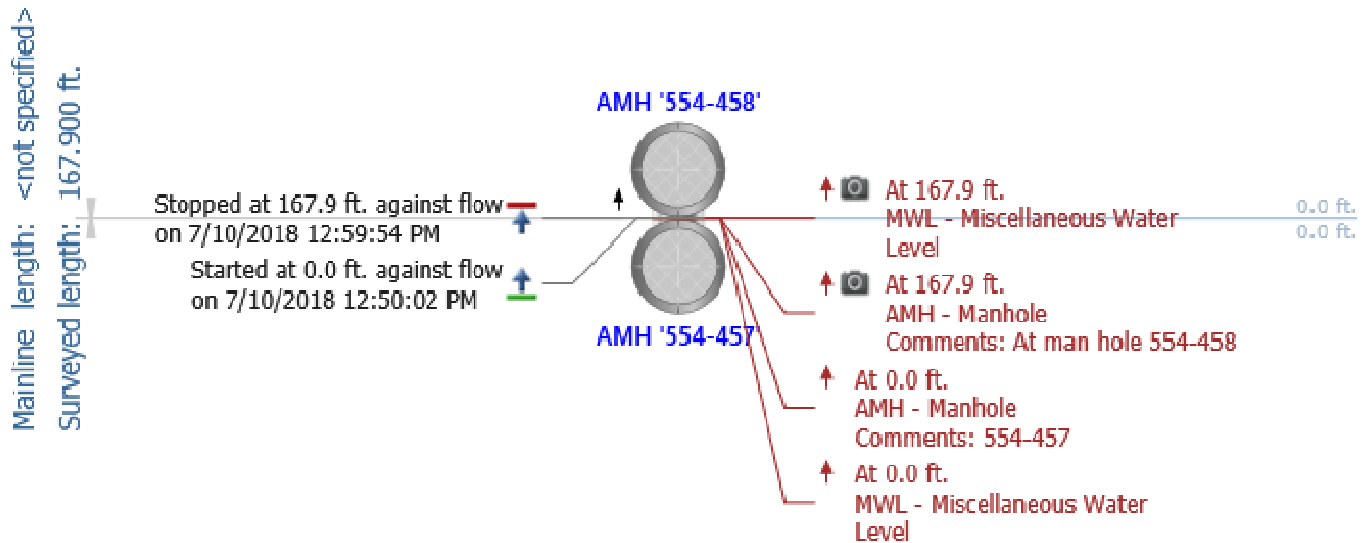
Notes: 554-458 to 554-457

- 18-in. CMP
- 168 LF
- 1-2" of debris downstream end to approximately 20 LF. Debris becomes minimal from 20 LF to end of pipe
- Discoloration in 4:00 and 8:00 position throughout pipe
- Surface corrosion at top of pipe at joint, 20 LF
- Surface corrosion visible in invert at joints (40 LF, 60 LF, 140 LF)
- 1-2" deformation in 12:00 position, approximately 48 LF
- No major structural defects observed
- Flow: Minimal
- Grade score of: 2

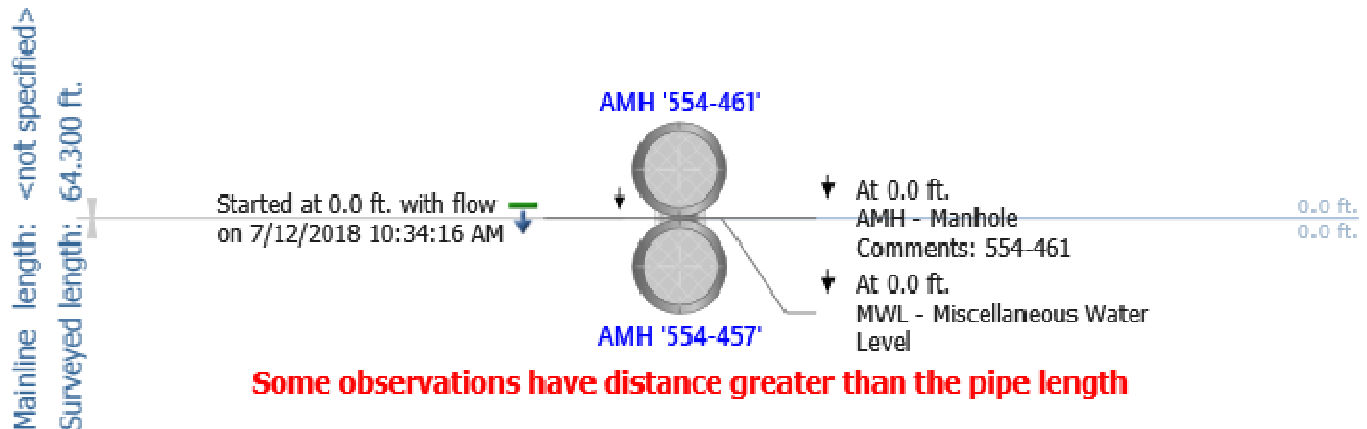
Notes: 554-461 to 554-457

- 12-in. CMP
- 64 LF
- 1-2" of debris
- Surface corrosion visible in 4:00 and 8:00 position, 6 LF to approximately 40 LF, surface corrosion/discoloration at water line
- Surface corrosion at joint (19 LF, 39 LF)
- Invert obscured by debris
- Flow: Minimal
- Grade score of: 2

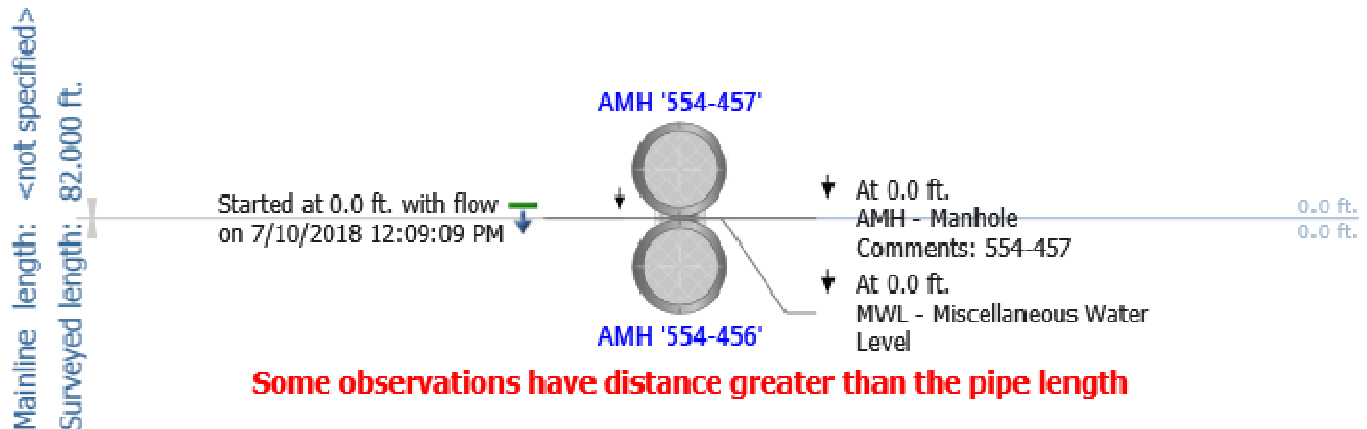
Notes: 554-457 to 554-456

- 18-in. CMP
- 82 LF
- 1-2" of debris in pipe throughout pipe, unable to see invert
- Discoloration in 3:00 and 9:00 position
- Corrosion at joint, 12:00 position (76 LF)
- 1-2" deformation, 12:00 position, downstream end
- No major structural defects observed
- Flow: 1-2"
- Grade score of: 2

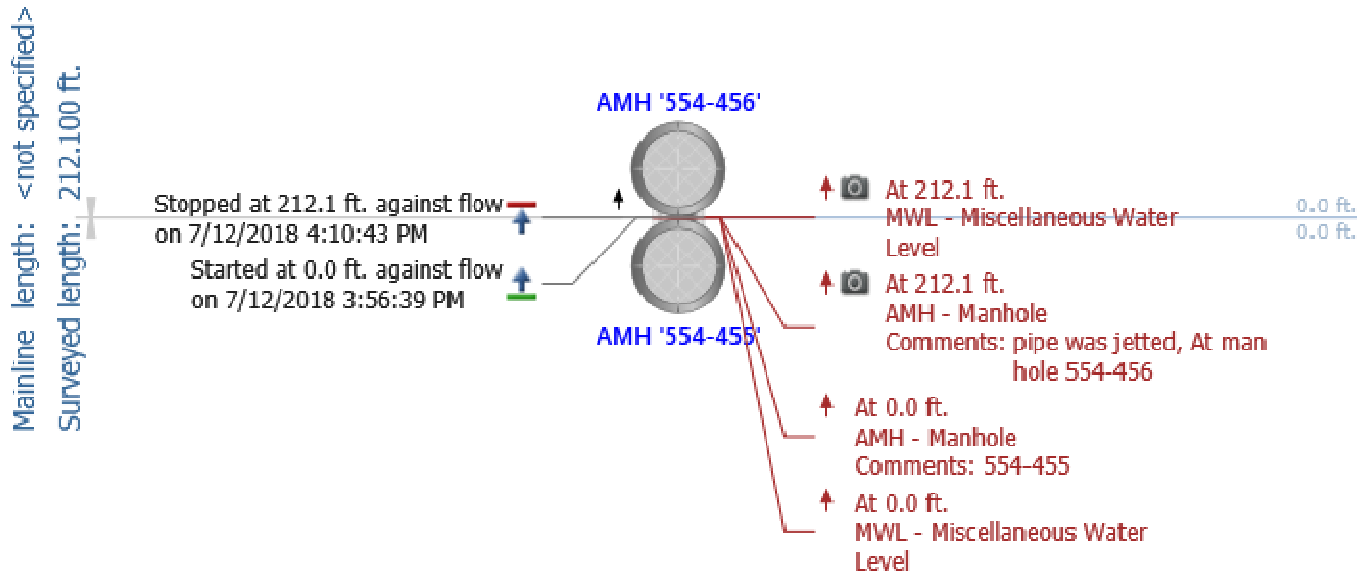
Notes: 554-456 to 554-455

- 18-in. CMP
- 212 LF
- 0-1" deformation, 12:00 position at 13 LF
- Surface discoloration/corrosion visible at joints at water line, discoloration in bottom half of pipe, discoloration/surface corrosion visible in invert (161 LF)
- Corrosion spot, 22 LF in 10:00 position
- 0-1" deformation, 10:00 position, 24 LF
- 1-2" of debris, 30 LF to 90 LF, 0-1" 90 LF to
- Pinhole at 80 LF, 7:00 position
- 0-1" deformation, 11:00 position, 90 LF
- 0-1" deformation, 12:00 position, 115 LF
- Corrosion hole, 118 LF, 1:00 position
- Corrosion hole, 136 LF, 1:00 position
- 2 1" deformations, approximately 190 LF, 11:00 position
- Flow: 0-2"
- Grade score of: 2

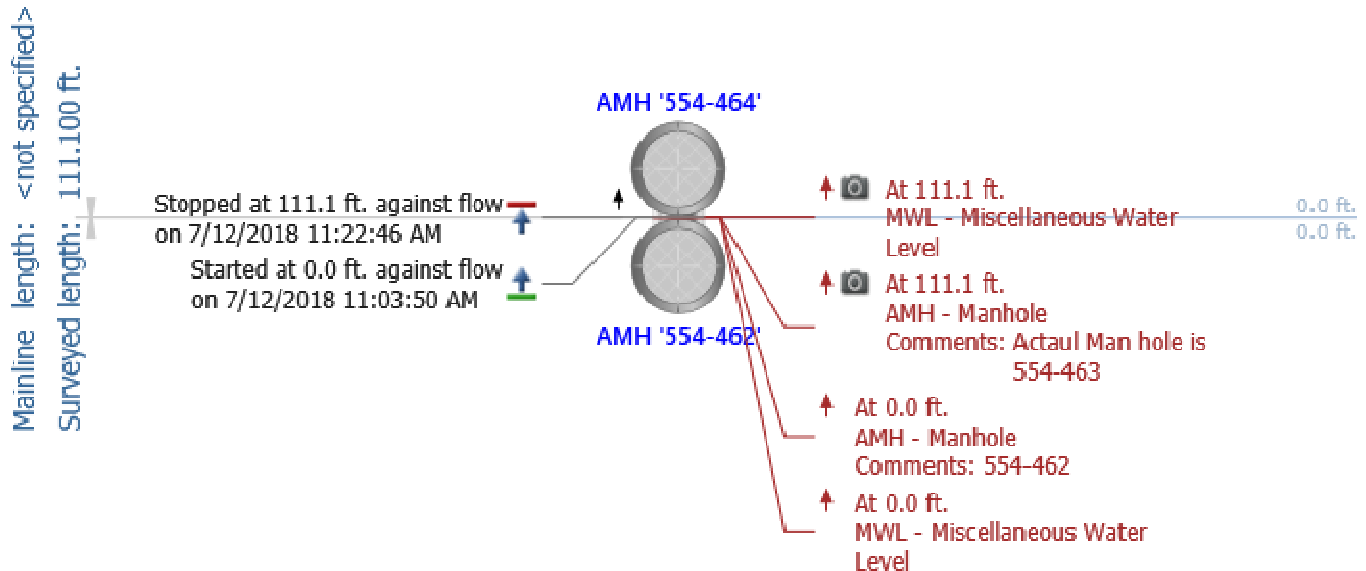
Notes: 554-463 to 554-462

- 12-in. CMP
- 111 LF
- Discoloration throughout pipe
- Surface corrosion visible at flow line, approximately 10 LF
- Debris in top of pipe
- Deformation/ broken pipe at 34 LF, 12:00 position, appears to be repair band
- Corrosion spot, 45 LF, 1:00 position
- Horizontal deflection to left, 60 LF, flow decreases to about 1" after bend
- Horizontal deflection to left, 84 LF
- Surface corrosion visible in invert, 108 LF
- Flow: 1-3"
- Grade score of: 2

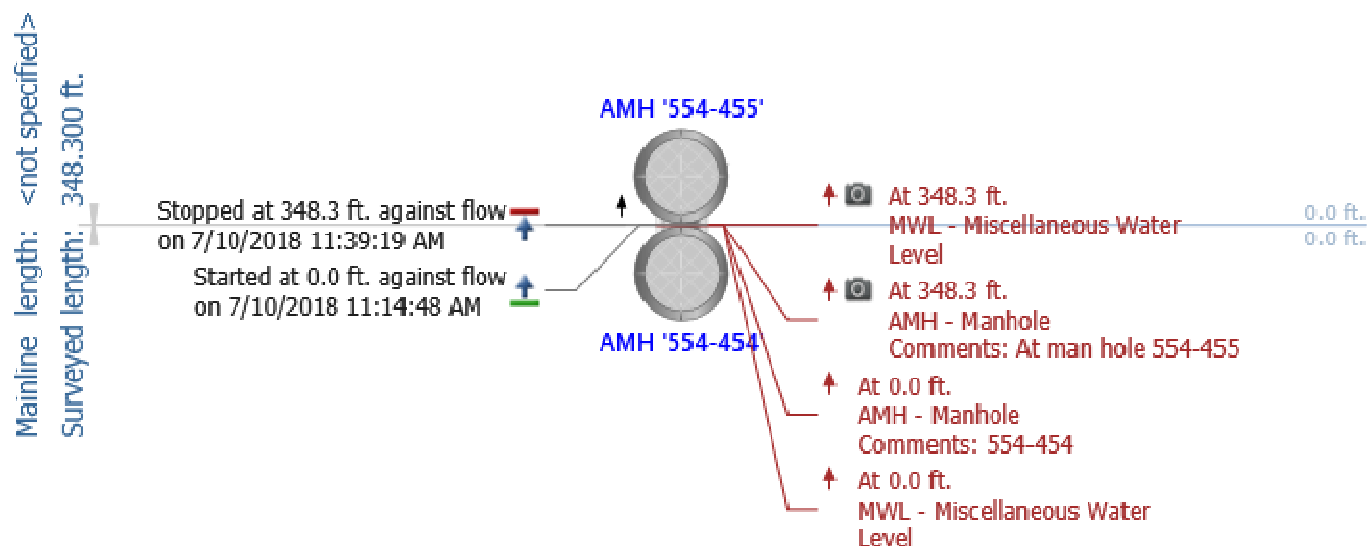
Notes: 554-455 to 554-454

- 18-in. CMP
- 348 LF
- 2-3" of debris throughout pipe, gradually increases upstream
- 0-1" deformation, 1:00 position at 9 LF
- Invert obscured by water and debris throughout pipe, unable to determine invert condition
- Flow increases gradually upstream
- Flow: 2-3"
- Grade score of: 2

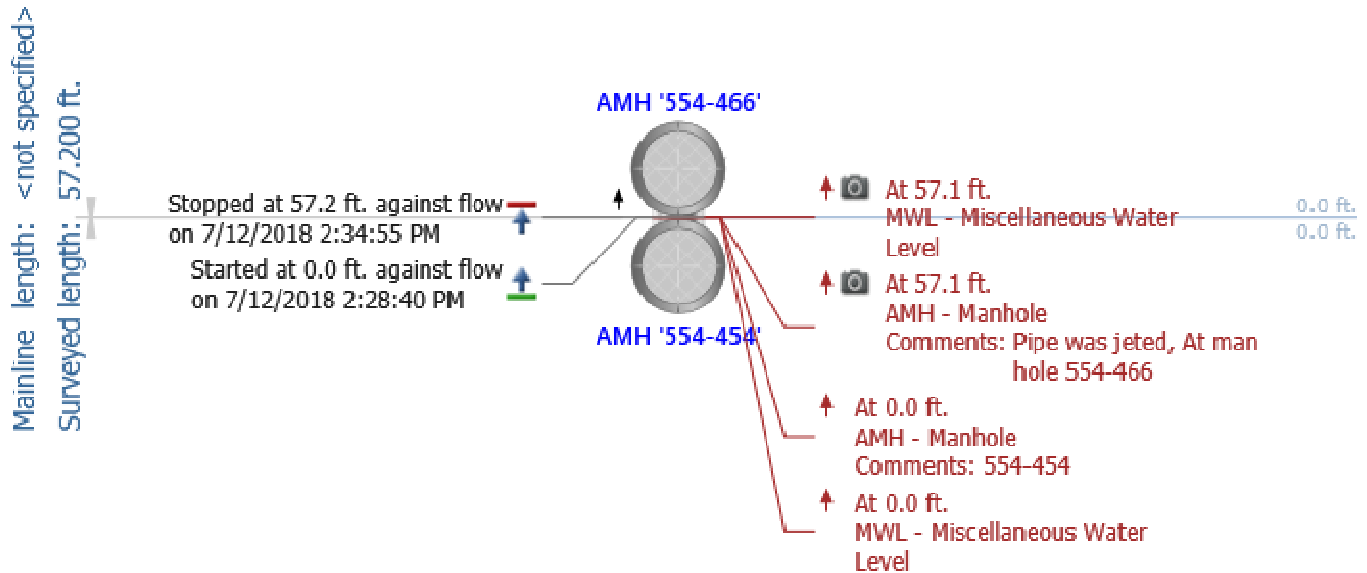
Notes: 554-466 to 554-454

- 12-in. CPEP
- 57 LF
- Pipe cleaned, no debris or flow
- No major structural defects observed
- Flow: None
- Grade score of: 1

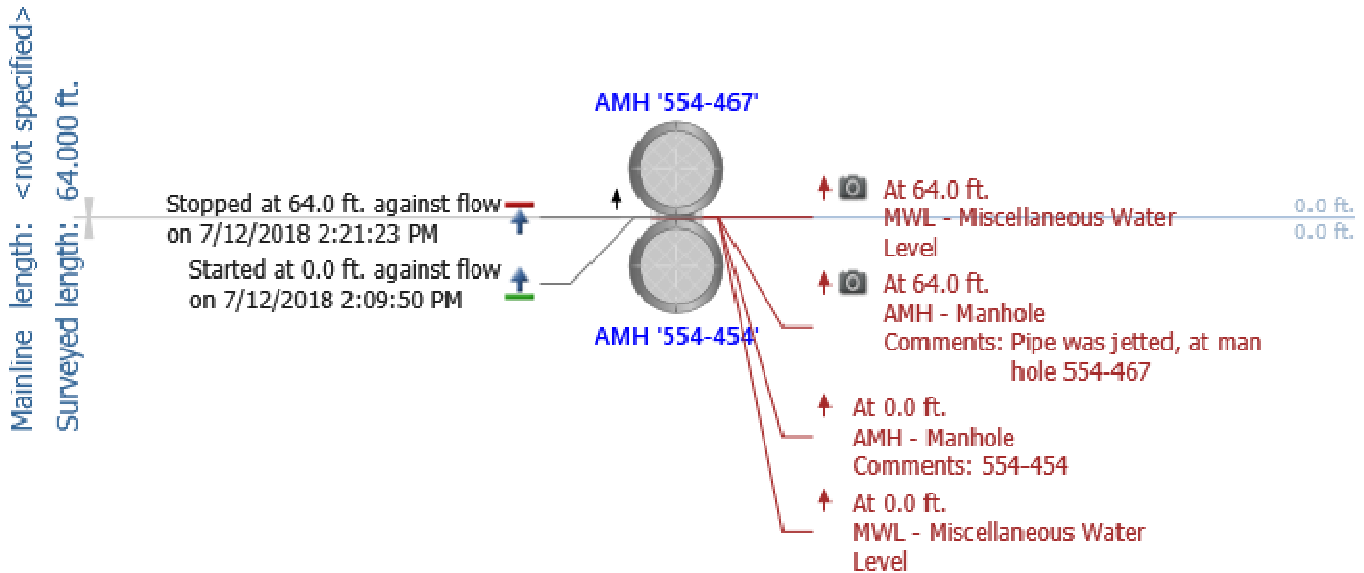
Notes: 554-467 to 554-454

- 12-in. CMP
- 64 LF
- Discoloration in bottom half of pipe
- Surface corrosion in invert, 4:00 and 8:00 position throughout pipe
- Minimal debris in pipe
- Surface corrosion at joints
- Flow: None
- Grade score of: 2

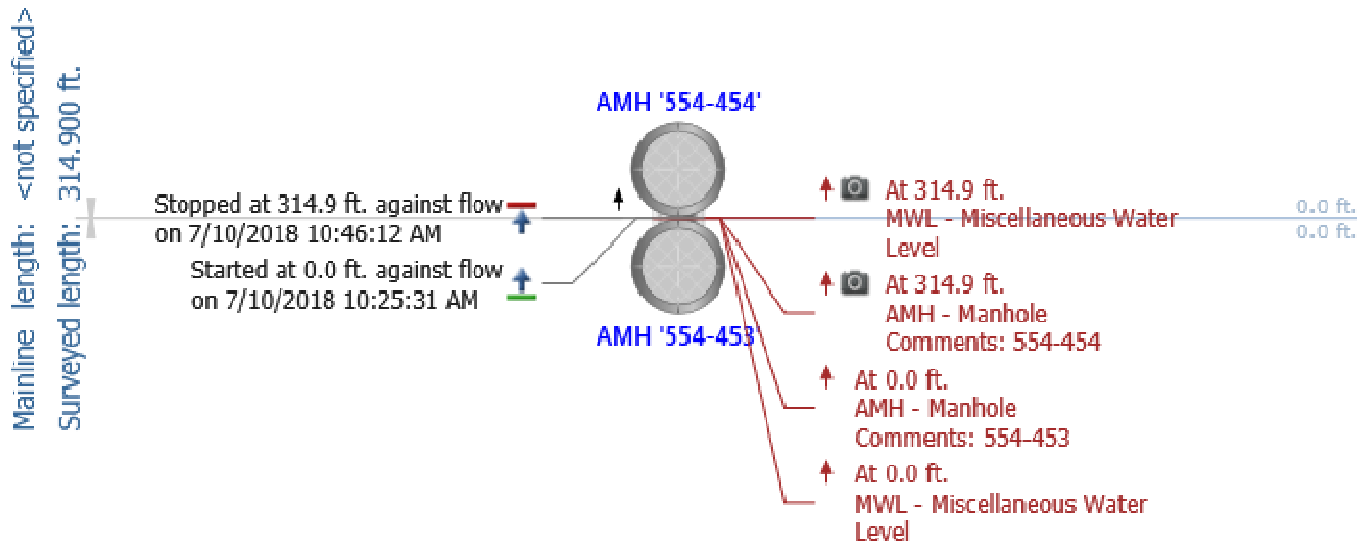
Notes: 554-454 to 554-453

- 18-in. CMP
- 315 LF
- Surface corrosion visible in invert at joints, also visible at water line when invert obscured by debris
- Minimal debris in pipe, less than 1 inch, increases to about 1-2" until 280 LF, returns to 0-1"
- Discoloration in 4:00 and 8:00 position
- Debris in top of pipe
- No major structural defects observed
- Flow: 1-2"
- Grade score of: 2

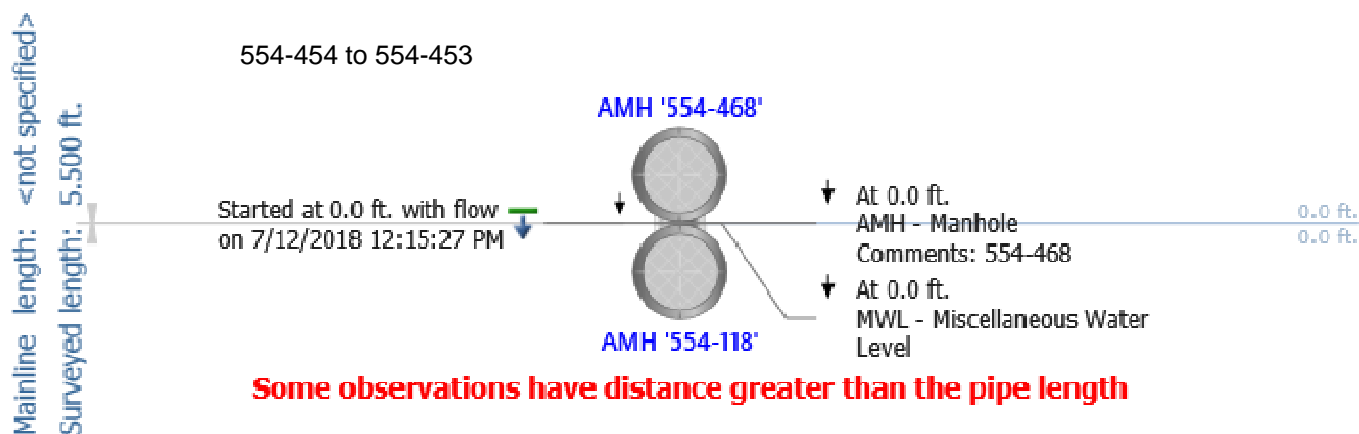
Notes: 554-468 to 554-118

- 12-in. CMP
- 6 LF
- No defects observed
- Flow: None
- Grade score of: 1

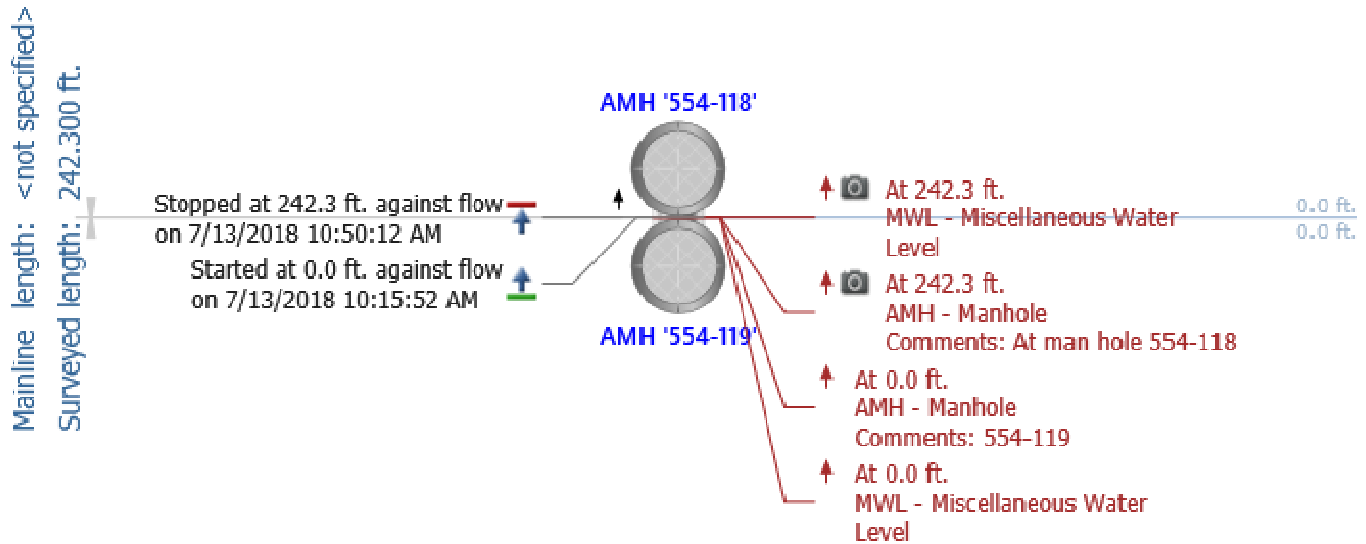
Notes: 554-119 to 554-118

- 36-in. CMP
- 242 LF
- Mild corrosion at flow line, visible at joints
- Debris at joints, debris above flow line assumed to be from infiltration
- Invert obscured by flow, unable to determine condition
- No major structural defects observed
- Flow: 2-3"
- Grade score of: 2

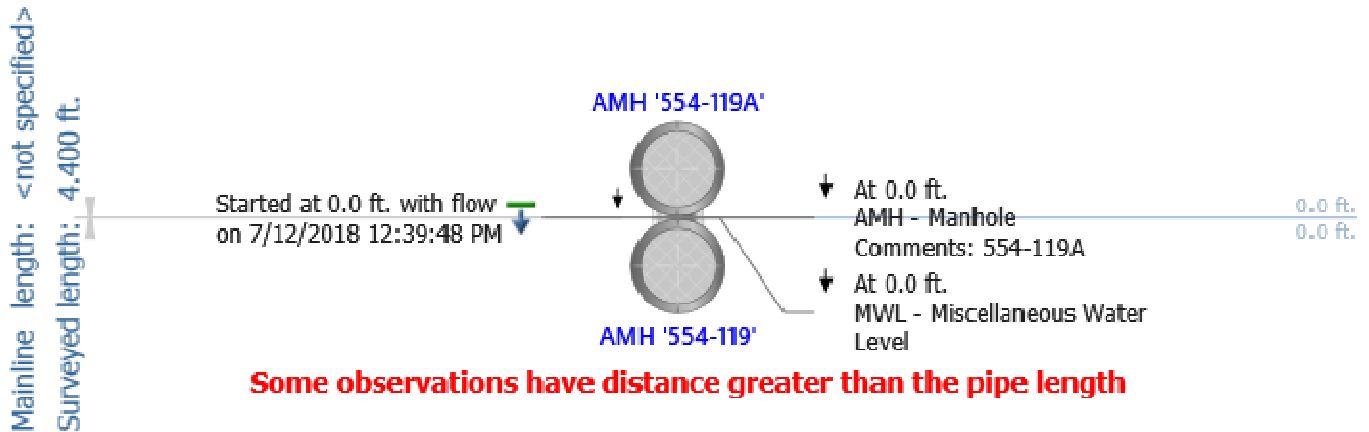
Notes: 554-452 to 554-119

- 12-in. CMP
- 4 LF
- No major defects observed
- Flow: None
- Grade score of: 1

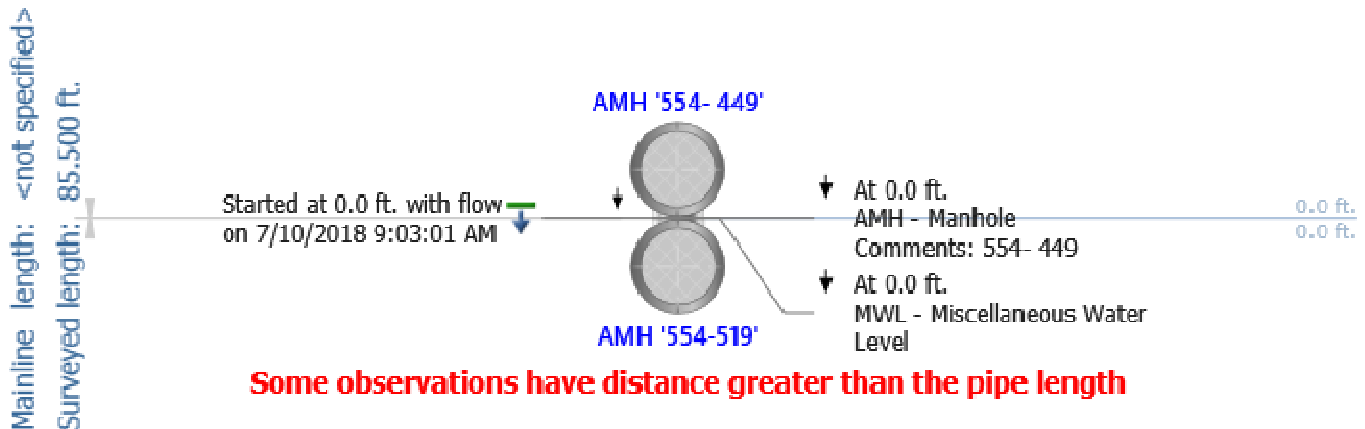
Notes: 554-449 to 554-119

- 24-in. CMP
- 86 LF
- 1-2" of debris, upstream end to 40 LF, 0-1" from 40 LF to end
- Minor surface corrosion at joint (20 LF) in invert at 80 LF and downstream end
- Deformed metal at joint, 20 LF, 11:00 position
- Dirt/debris/discoloration visible in top of pipe
- No major structural defects observed
- Flow: Minimal
- Grade score of: 2

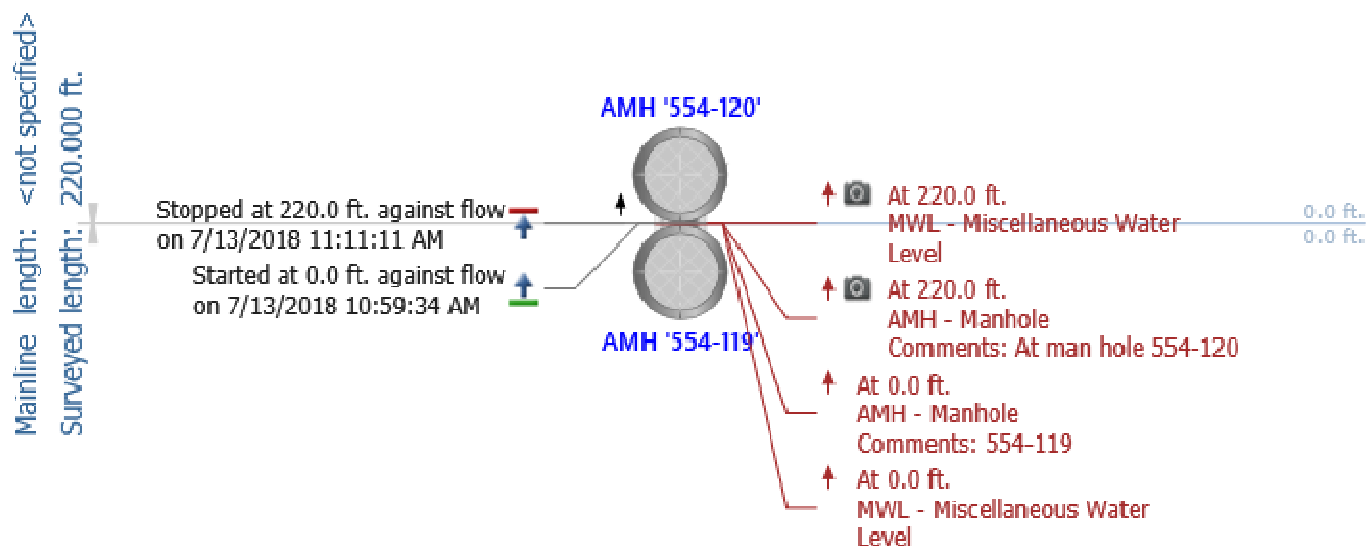
Notes: 554-120 to 554-119

- 36-in. CMP
- 220 LF
- Surface corrosion visible at flow line and invert at joints
- Minimal debris at joints, assuming debris above flow line from infiltration
- No major structural defects, invert condition does not warrant repair at time of inspection
- Flow: 3-4"
- Grade score of: 2

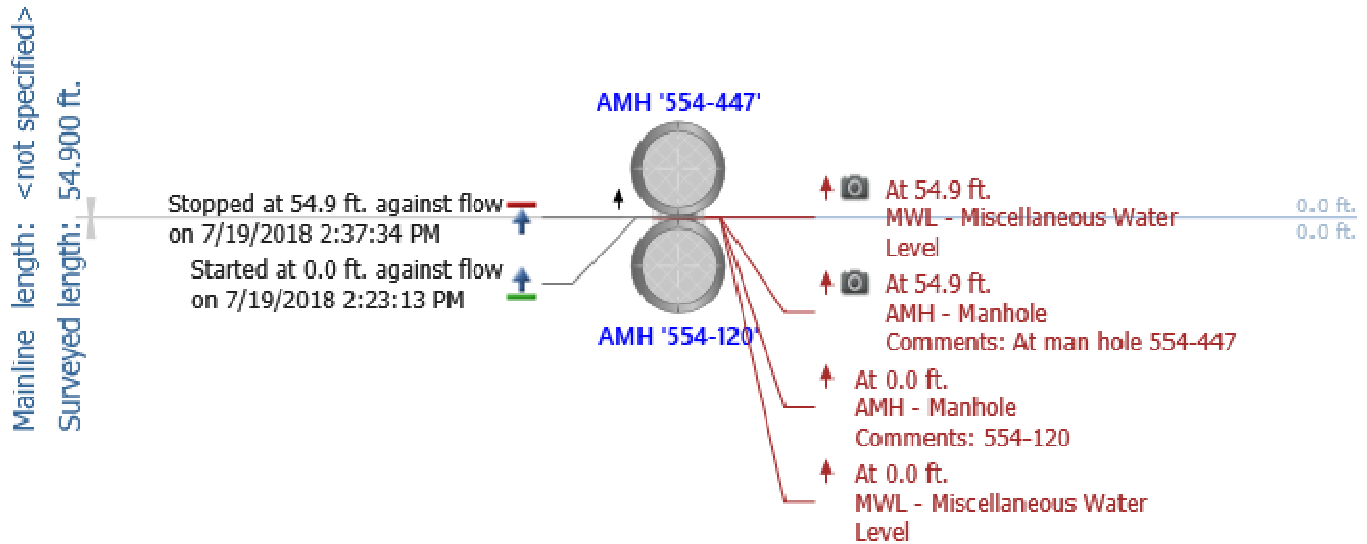
Notes: 554-447 to 554-120

- 12-in. CMP
- 55 LF
- Pipe cleaned to perform inspection
- Discoloration between 4:00 and 8:00 position
- Minor surface corrosion at pipe ends at joints
- Corrosion visible in invert, 3 LF to end of pipe
- Flow: None
- Grade score of: 3

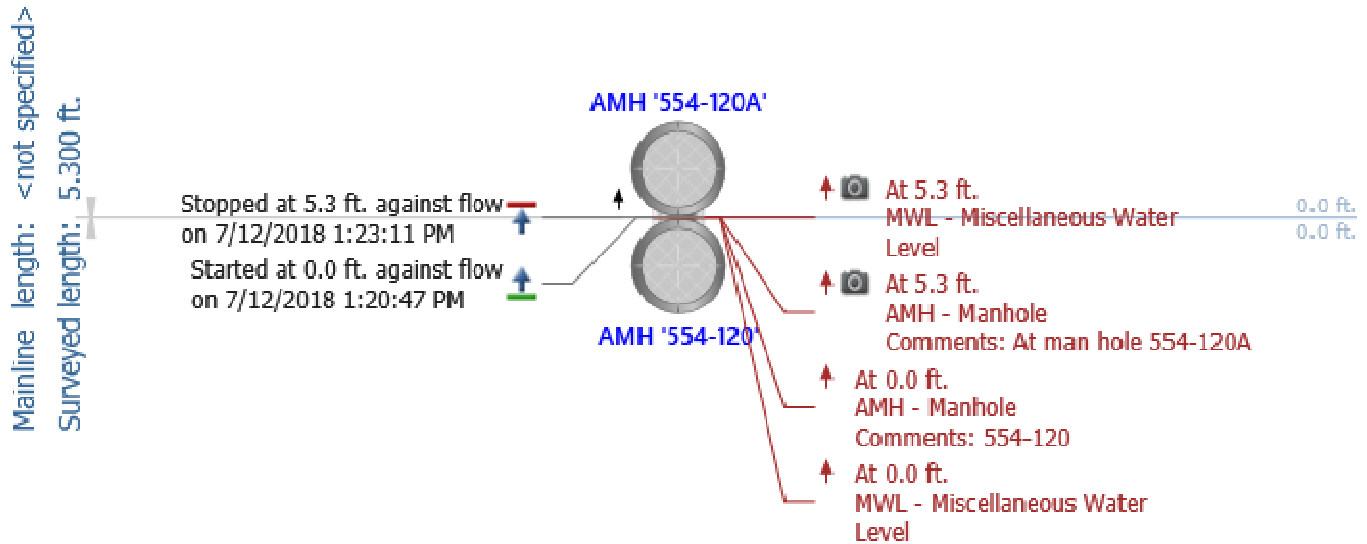
Notes: 554-448 to 554-120

- 12-in. CMP
- 5 LF
- Corrosion at joint
- 3-4" of debris
- Flow: None
- Grade score of: 1

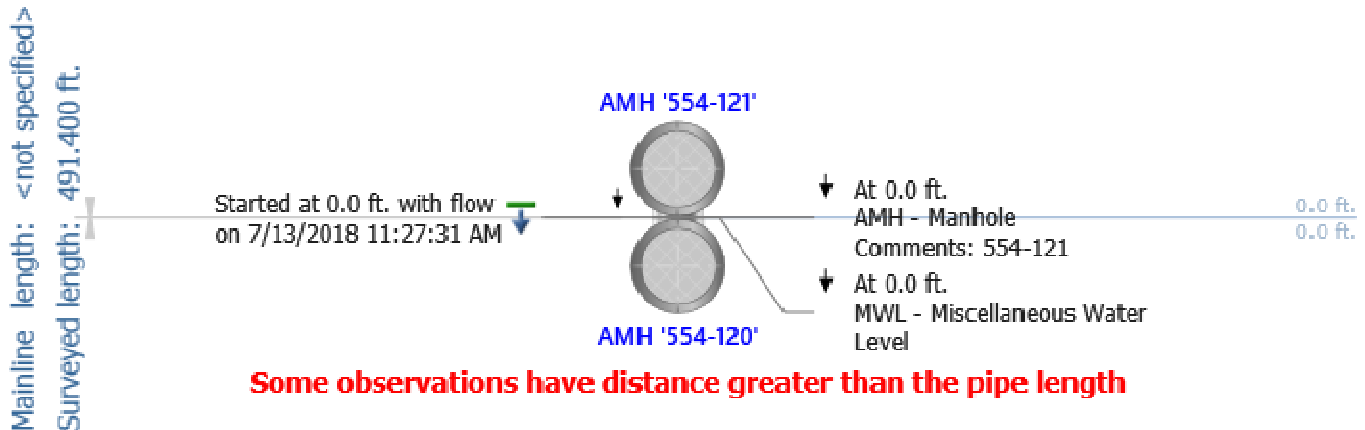
Notes: 554-121 to 554-120

- 36-in. CMP
- 491 LF
- Appears to be corrosion in invert, turbulent flow makes it difficult to observe invert condition
- Discoloration in pipe, 4:00 position to 8:00 position, appears to be surface corrosion at flow line, typical of mainline pipes
- Debris at joints, debris above flow line assumed to be from infiltration
- Joint infiltration, 4:00 position at 330 LF
- Crushed pipe, 9:00 to 12:00 position, 6-8", two holes with soil visible at 386 LF
- Flow: 2-3"
- Grade score of: 3

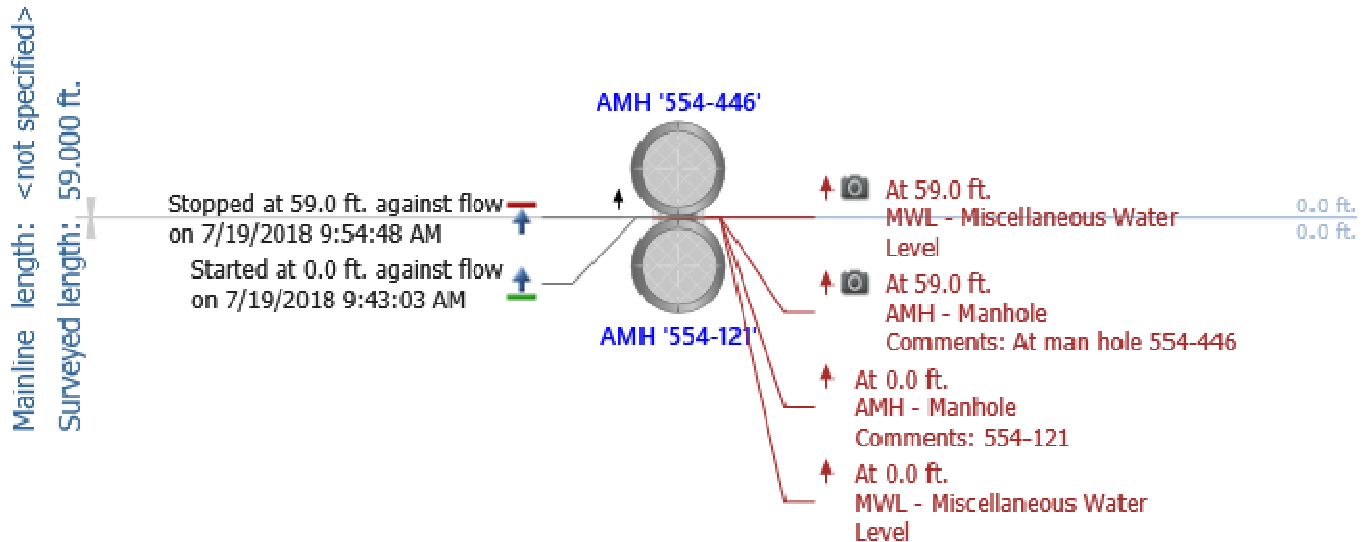
Notes: 554-446 to 554-121

- 12-in. CMP
- 59 LF
- Debris buildup at downstream end, 3-4"
- 1:00-2:00 position, surface corrosion, 6 LF to 16 LF
- Minor surface corrosion visible in invert, 16 LF to
- 2 1-inch holes in pipe, 12:00 position 20 LF, minimal deformation
- Flow: Minimal
- Grade score of: 2

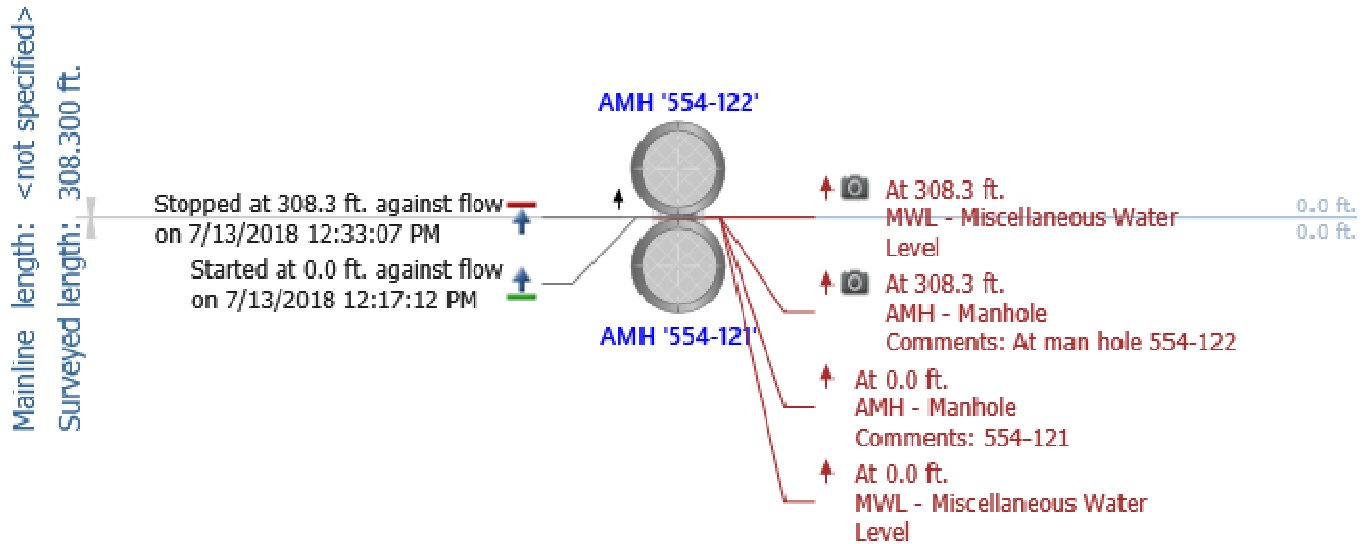
Notes: 554-122 to 554-121

- 36-in. CMP
- 308 LF
- Corrosion visible at flow line at joints
- Corrosion visible in invert at joints
- Minor debris in joints throughout pipe
- No major structural defects, corrosion does not warrant repair at this time
- Flow: 3-4"
- Grade score of: 2

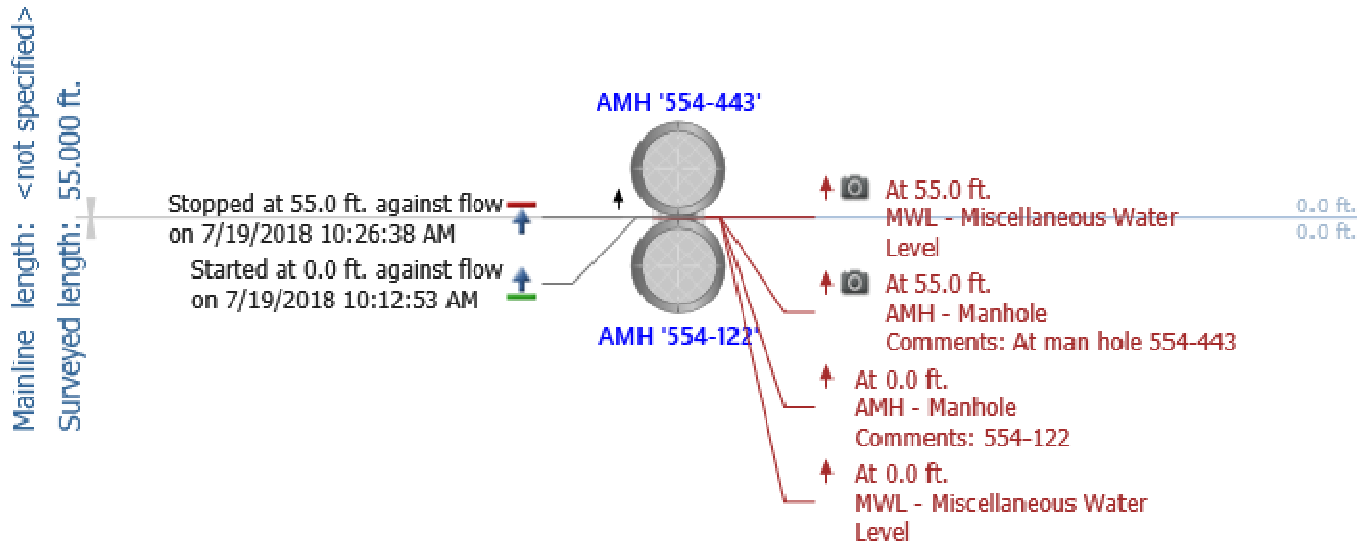
Notes: 554-443 to 554-122

- 12-in. CMP
- 55 LF
- 2-3" debris, 3 LF to 15 LF, possible belly in pipe
- 0-1" debris at joint, 30 LF
- Horizontal bend to left at 6 LF
- 1" deformation, 11:00 position at 15 LF
- Minor surface corrosion visible in invert, 50 LF
- Surface corrosion 3:00 position, 54 LF
- Flow: Minimal
- Grade score of: 2
