Alaska Department of Transportation and Public Facilities Central Region

NHS STORM DRAIN INSPECTION CONDITION REPORT PROJECT NO. 0A31055 / Z591280000

Dimond Boulevard from Jewel Lake Road to Old Seward Highway
Muldoon Road from Boundary Avenue to Northern Lights Boulevard
Debarr Road from Bragaw Street to Muldoon Road
Downtown: 5th and 6th Avenue from Gambell Street to Orca Street and
Ingra Street from 6th Avenue to 9th Avenue

May 20th, 2019

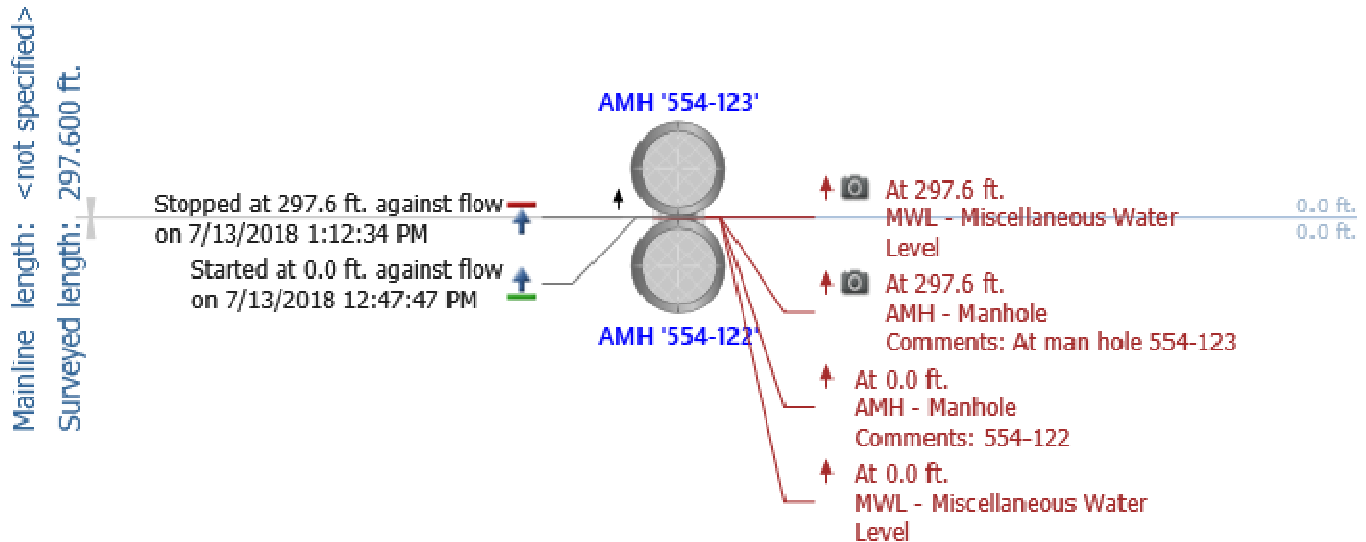
Notes: 554-123 to 554-122

- 36-in. CMP
- 298 LF
- Minor corrosion visible at flow line at joints
- Corrosion visible through flow in invert
- Minor debris at joints, buildup in 12:00 position at 195 LF, 215 LF
- No major structural defects, invert condition does not warrant repair at this time
- Flow: 3-4"
- Grade score of: 2

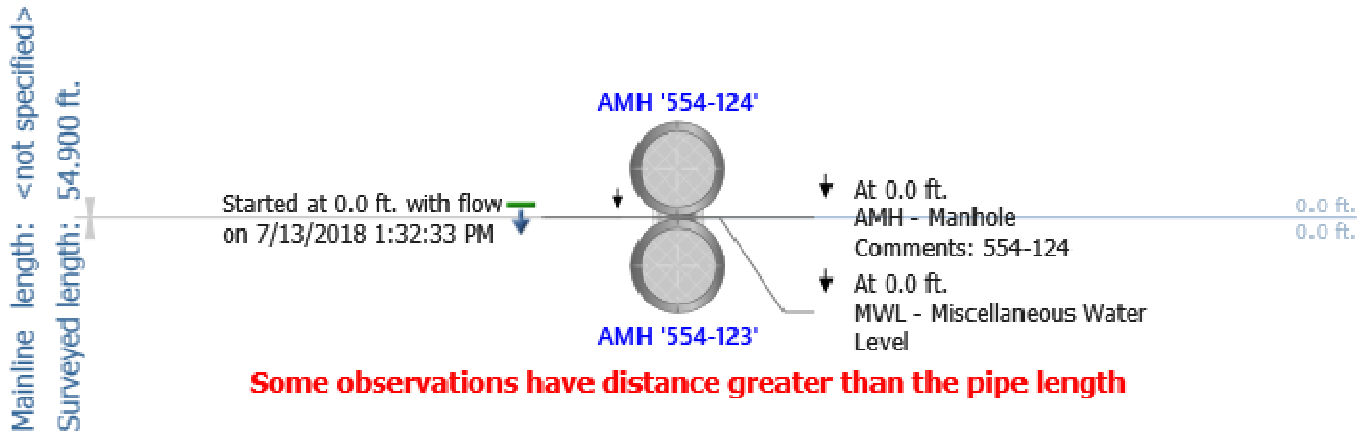
Notes: 554-124 to 554-123

- 36-in. CMP
- 55 LF
- Discoloration, minor surface corrosion visible at flow line
- Turbulent flow, obscures invert
- Debris caught at joints
- No major structural defects
- Flow: 2-3"
- Grade score of: 2

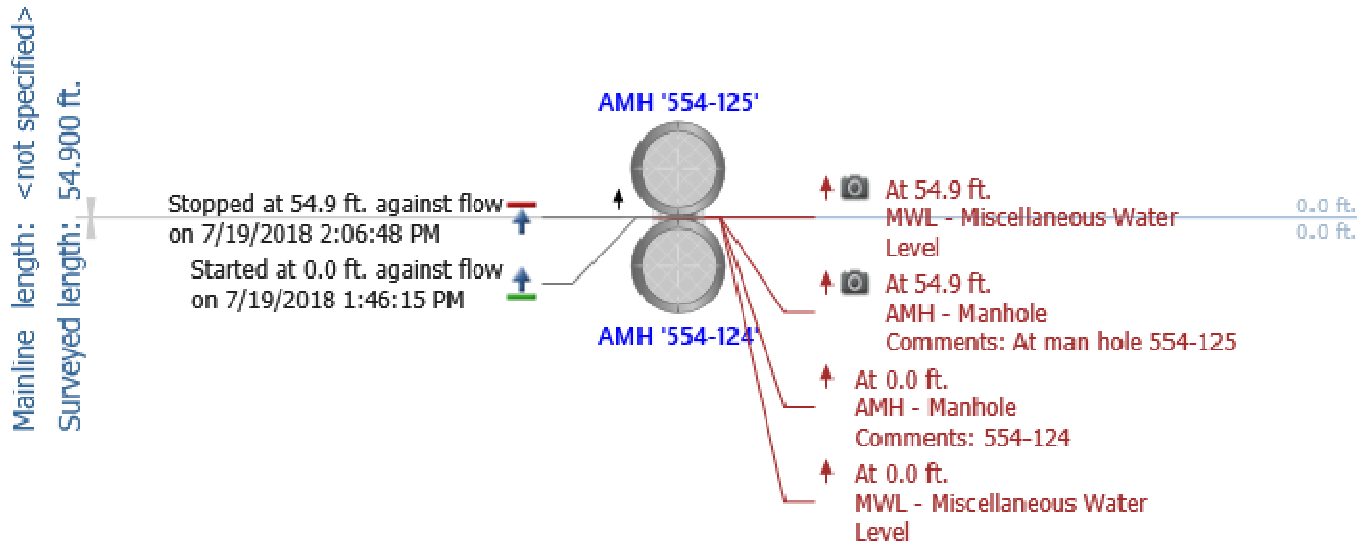
Notes: 554-125 to 554-124

- 12-in. CMP
- 55 LF
- Pipe cleaned
- Minor surface corrosion at pipe ends at joint
- Minimal debris left in invert post cleaning
- Surface corrosion visible in invert between 5:00 and 7:00 position, discoloration in bottom half of pipe
- Small horizontal deflections, pipe alignment is not perfectly linear
- Surface corrosion at spring line at upstream end
- Flow: Minimal
- Grade score of: 2

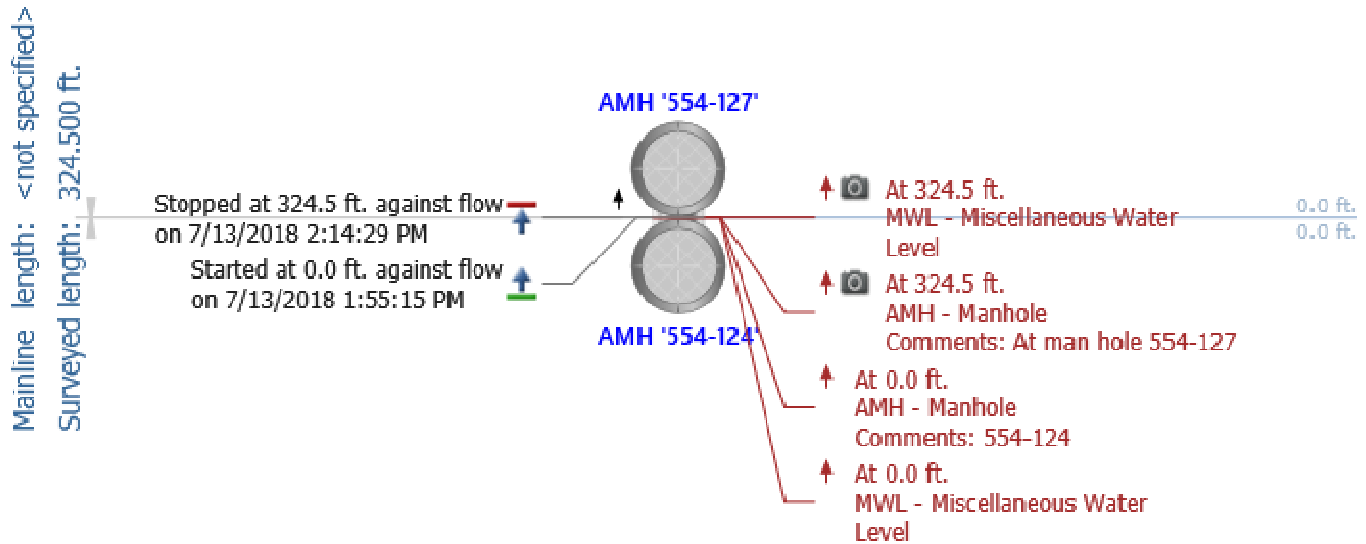
Notes: 554-127 to 554-124

- 36-in. CMP
- 325 LF
- Minor corrosion visible at flow line
- Corrosion in invert visible, obscured by high flow in pipe
- Minor debris caught at joints, likely from infiltration at joints
- Pinhole, 12:00 position at 220 LF
- No major defects observed
- Flow: 3-4"
- Grade score of: 3

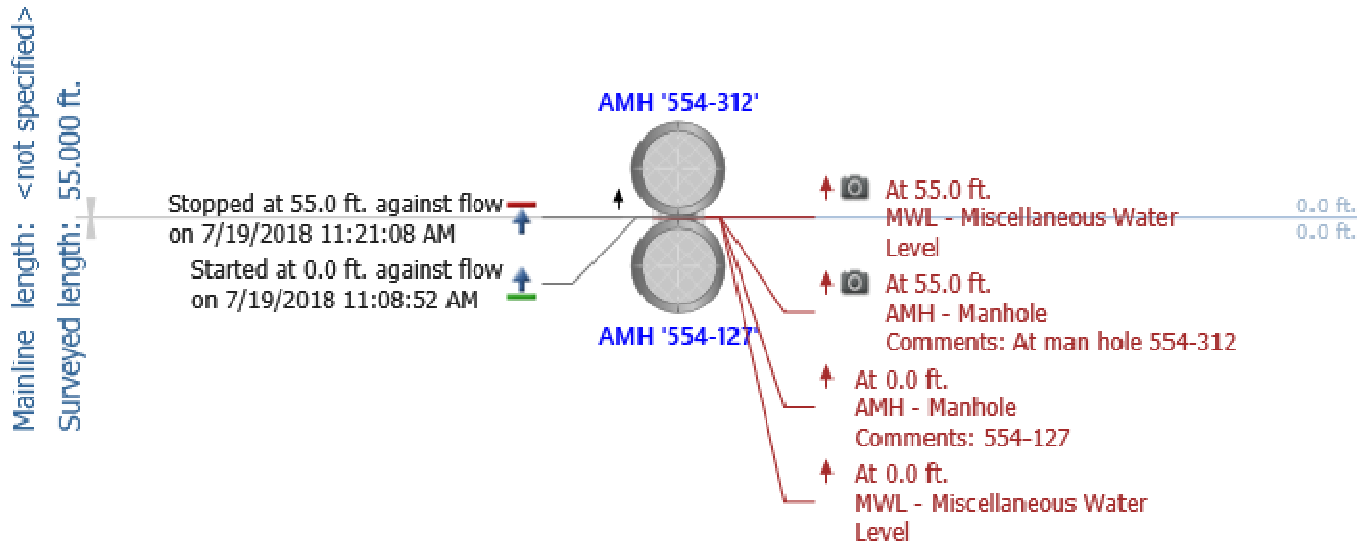
Notes: 554-312 to 554-127

- 12-in. CMP
- 55 LF
- 1-2" debris buildup at downstream end from 3 LF to 15 LF, 0-2" debris 30 LF to 43 LF, 1" debris at upstream end
- Minor surface corrosion at pipe ends at joints
- Minor surface corrosion in invert, visible at joints
- Surface corrosion in 3:00 position 50 LF to 55 LF
- Flow: None
- Grade score of: 2

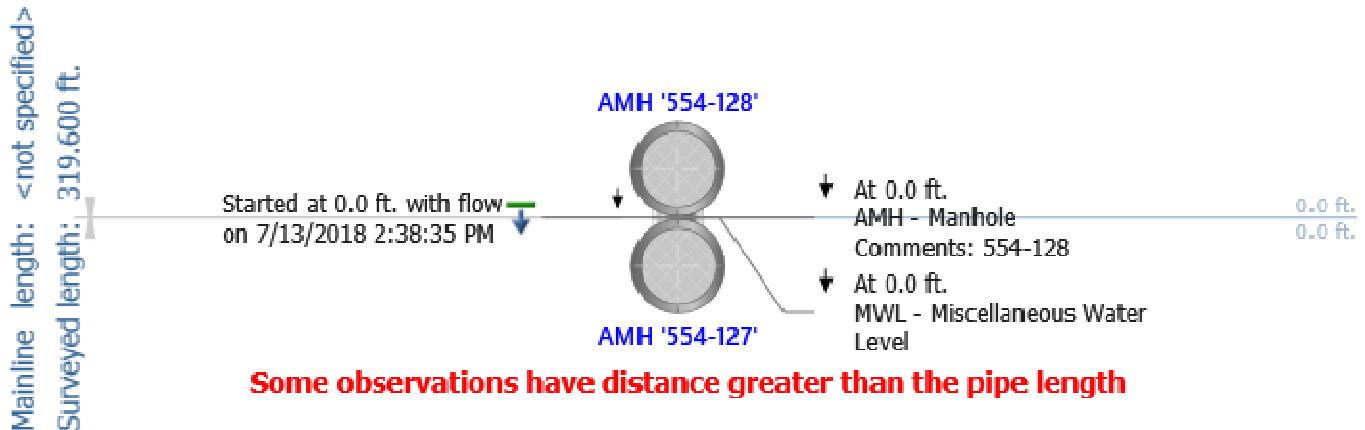
Notes: 554-128 to 554-127

- 36-in. CMP
- 320 LF
- Discoloration, 4:00 position to 8:00 position throughout pipe
- Surface corrosion at top of historical flow line, visible in invert when not obscured by flow, visible pitting
- Minor debris caught at joints, likely from infiltration at joints
- Visible infiltration at joint, 15 LF in 4:00 position, 36 LF in 4:00 and 8:00 position, 56 LF in 4:00 and 8:00 position, 76 LF in 4:00 and 8:00 position, 96 LF in 4:00 and 8:00 position, 137 LF in 4:00 position, 157 LF in 4:00 and 8:00 position, 178 LF in 4:00 and 8:00 position, 198 LF in 4:00 position, 218 LF in 4:00 and 8:00 position, 238 LF in 8:00 position
- No major structural defects
- Flow: 2-3"
- Grade score of: 3

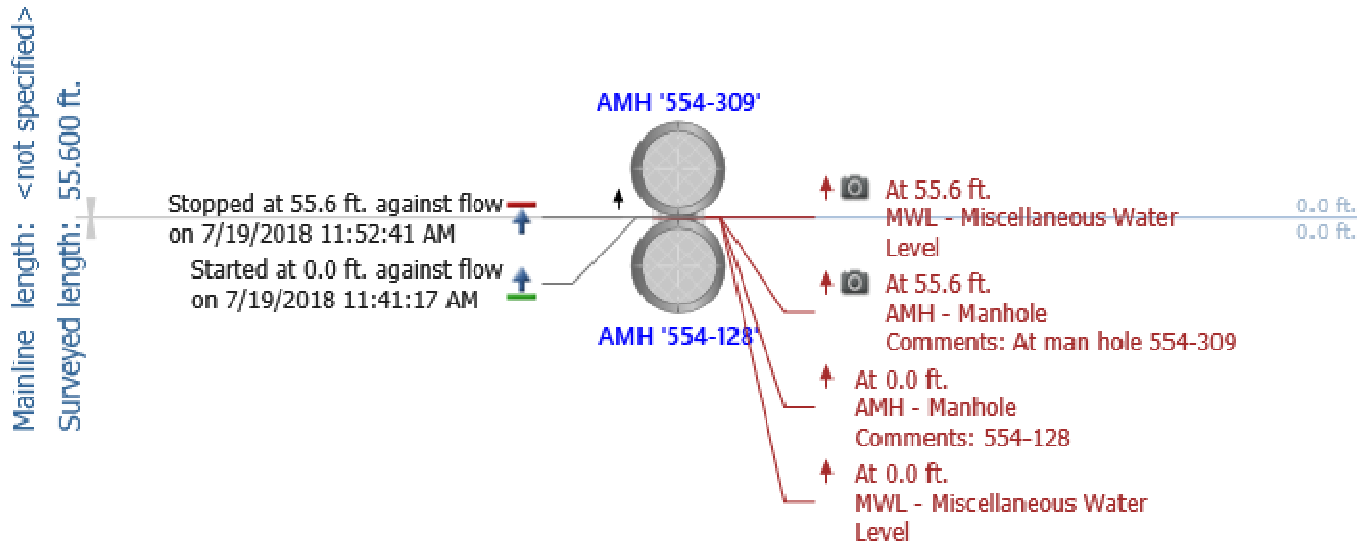
Notes: 554-309 to 554-128

- 12-in. CMP
- 56 LF
- 0-1" debris at joint, 7 LF, 24 LF, 3-4" debris at 35 LF and 42 LF, 4-5" of debris at upstream end various levels of debris throughout pipe
- Surface corrosion in top of pipe, 7 LF to 19 LF
- Surface corrosion in 5:00 and 7:00 position, 43 LF to end of pipe
- Minor surface corrosion at pipe ends at joints
- Surface corrosion, visible in invert at joints
- Flow: None
- Grade score of: 2

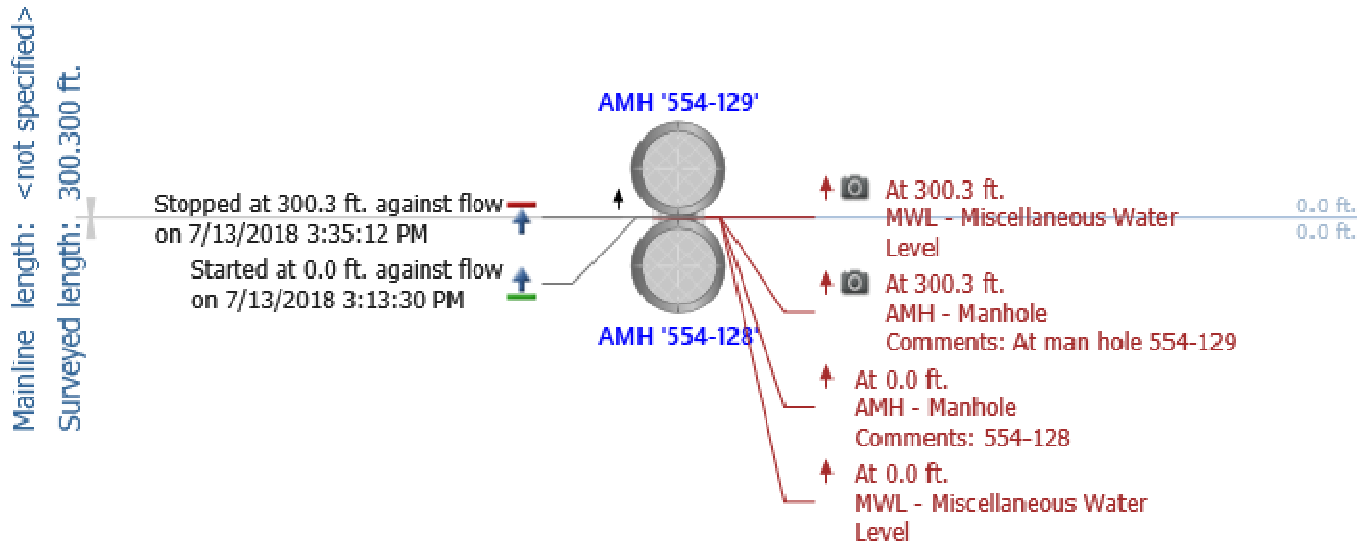
Notes: 554-129 to 554-128

- 36-in. CMP
- 300 LF
- Discoloration and surface corrosion, 4:00 to 8:00 position 3 LF to
- Minor debris caught at joints
- Infiltration at joint, 4:00 position, 80 LF
- Minimal debris in pipe
- Invert partially obscured by debris, probed from manhole, metal loss present
- Flow: 1-2"
- Grade score of: 3

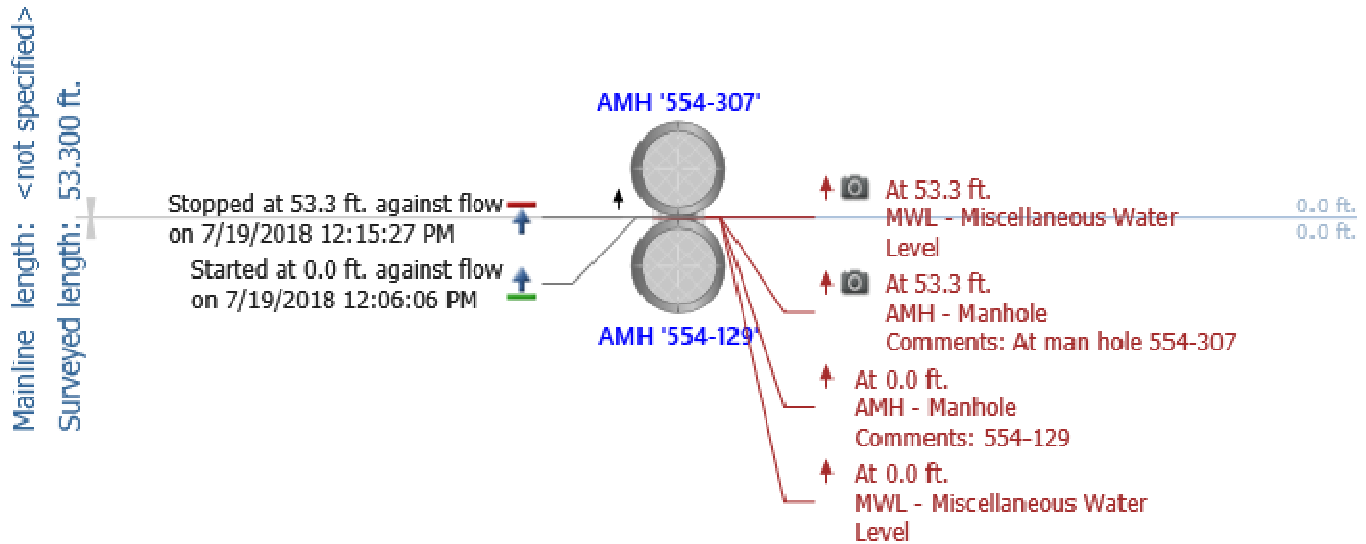
Notes: 554-307 to 554-129

- 12-in. CMP
- 53 LF
- 1" deformation in 9:00 position, 7 LF
- 0-1" debris, 8 LF to 15 LF, 24 LF to 32 LF, 2-3" at 45 LF, pipe half full at upstream end
- Surface corrosion in top of pipe, 18 LF to 20 LF
- Surface corrosion at pipe ends at joints
- Surface corrosion visible in invert, 51 LF
- Flow: None
- Grade score of: 2

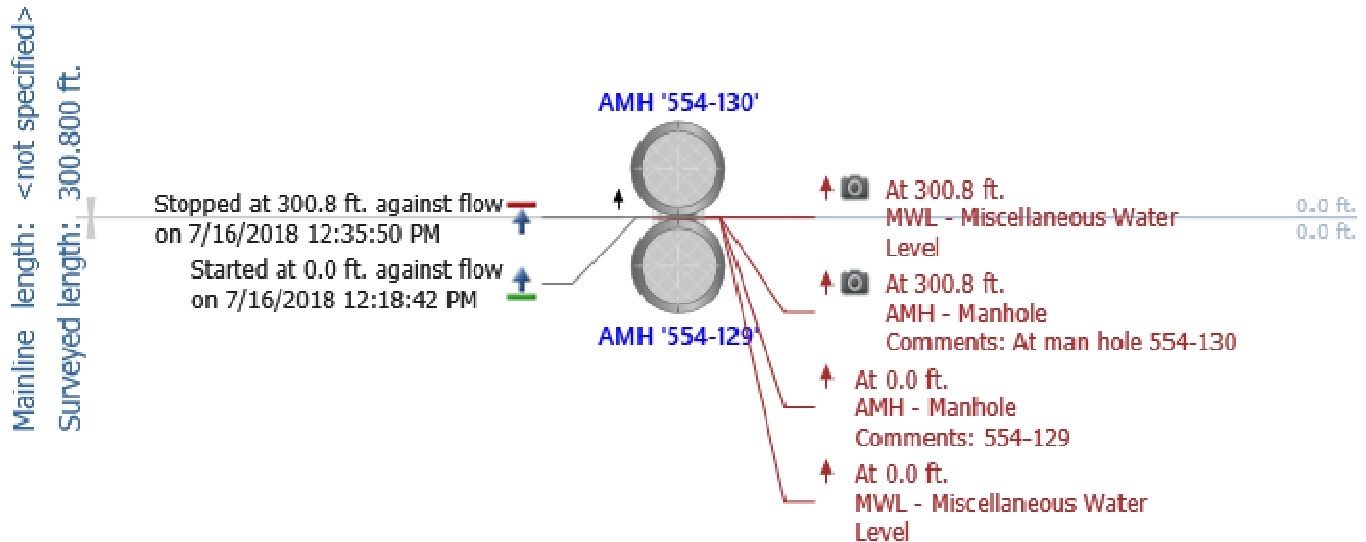
Notes: 554-130 to 554-129

- 36-in. CMP
- 301 LF
- Discoloration from 4:00 to 8:00 position, minor surface corrosion at historic flow line, visible at joints, partially visible in invert but mostly obscured by debris, inverts probed, metal loss observed
- 0-1" of debris in invert
- Debris at joints, debris above flow line assumed to be from infiltration
- Flow: 2-3"
- Grade score of: 3

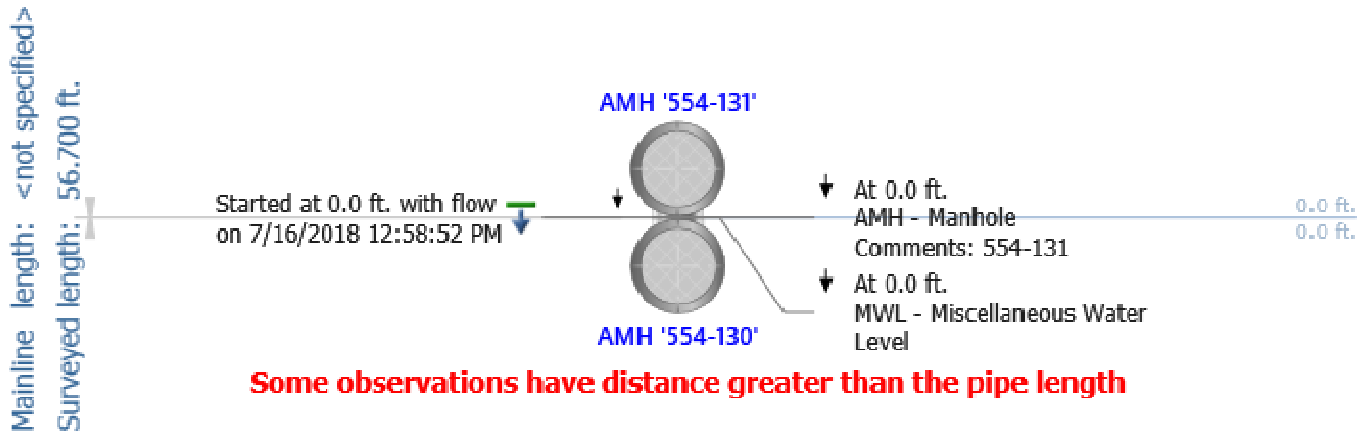
Notes: 554-131 to 554-130

- 24-in. CMP
- 57 LF
- Minimal debris in invert
- Grade steepens at 38 LF
- Minor surface corrosion in invert, visible at joints when not obscured by debris
- No major defects observed
- Flow: 0-1"
- Grade score of: 2

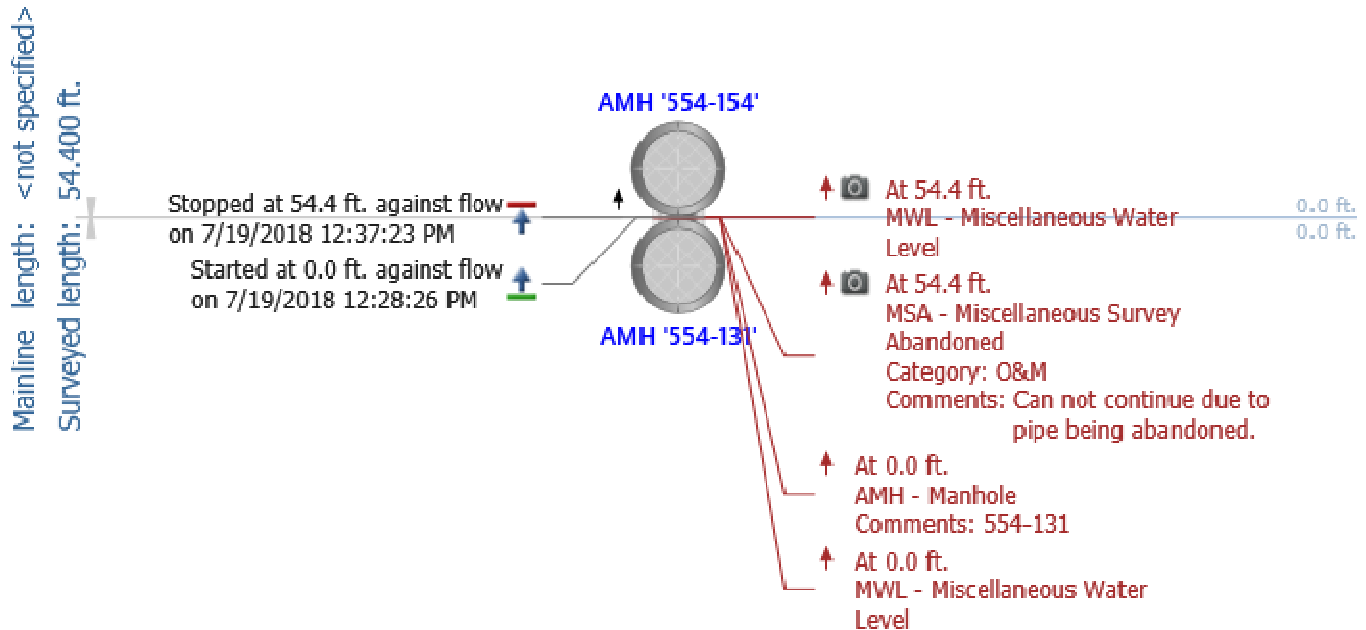
Notes: 554-154 to 554-131

- 12-in. CMP
- 54 LF
- 0-2" debris throughout pipe
- Upstream structure not located above ground
- Corrosion at pipe ends at joints
- Corrosion visible in invert at upstream end
- Upstream end appears to be abandoned with grout, pipe appears to be structurally intact
- Flow: None
- Grade score of: 3

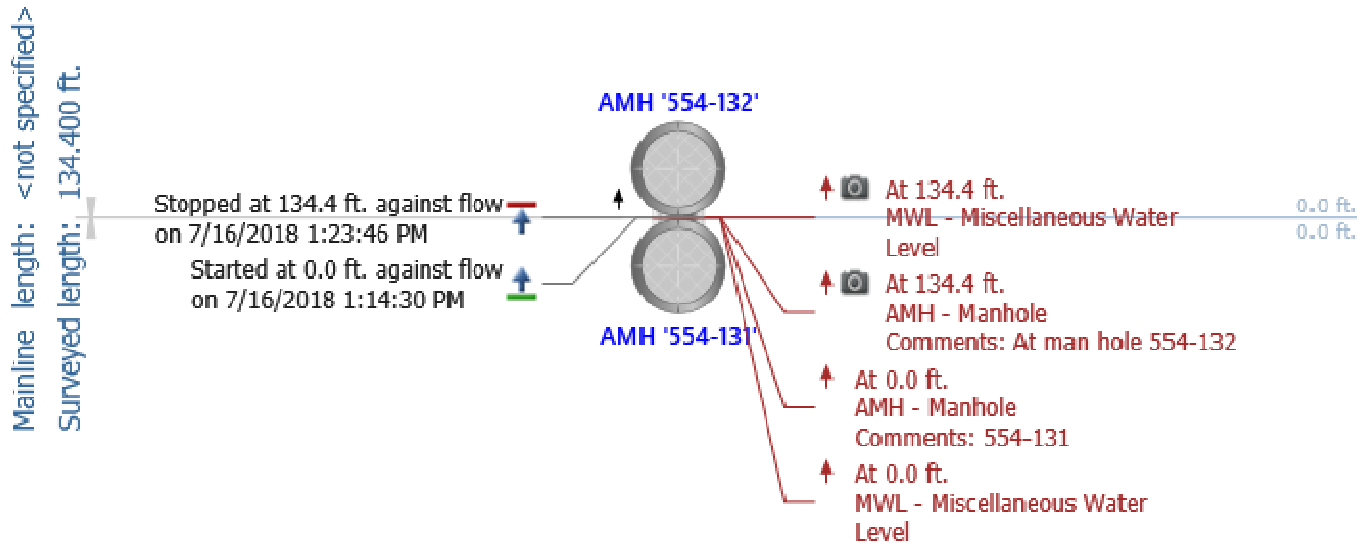
Notes: 554-131A to 554-131

- 24-in. CMP
- 134 LF
- Minimal debris in pipe
- Minor surface corrosion visible in invert when not obscured by debris
- Possible belly in pipe at 101 LF
- No major defects observed
- Flow: 0-1"
- Grade score of: 1

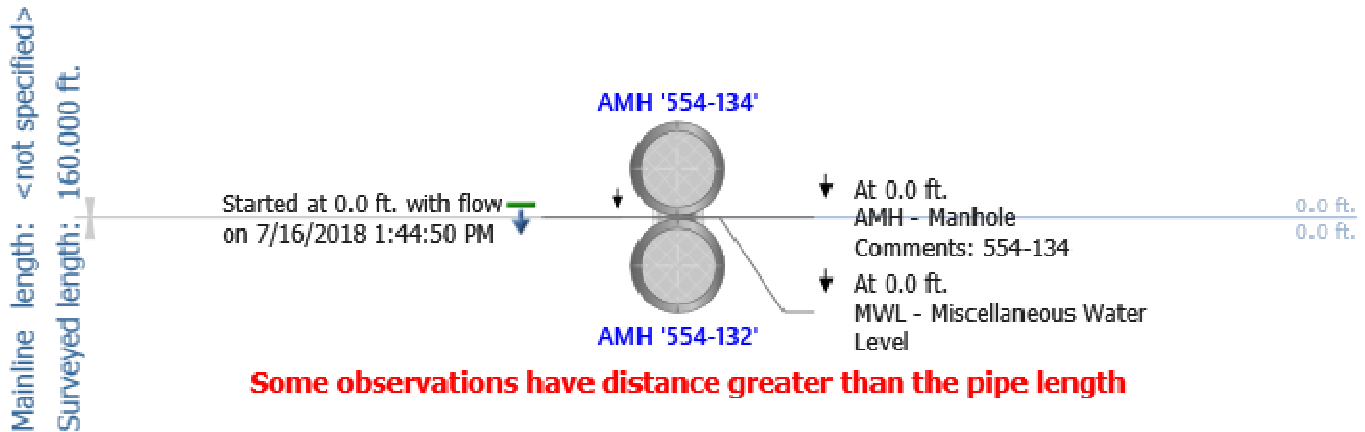
Notes: 554-132 to 554-131A

- 24-in. CMP
- 160 LF
- 1-2" of debris in pipe, 3 LF to approximately 40 LF, 60 LF to approximately 110 LF, 115 LF to end of survey
- Discoloration and surface corrosion visible in invert at joint at 54 LF, 114 LF
- No major structural defects observed
- Flow: Minimal
- Grade score of: 2

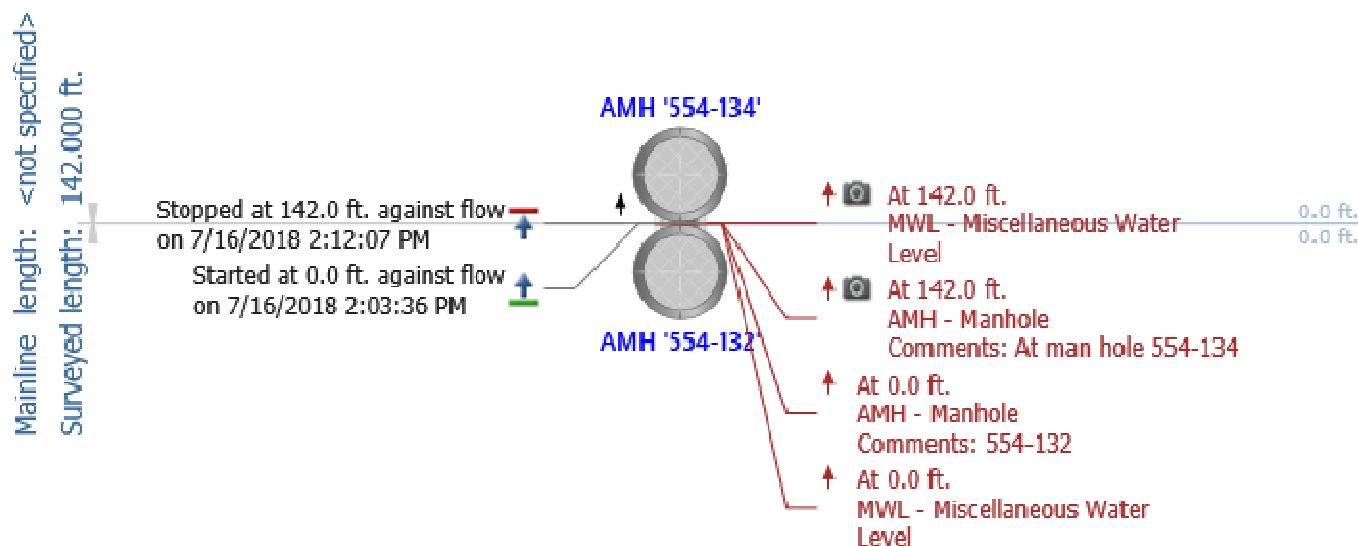
Notes: 554-134 to 554-132

- 24-in. CMP
- 142 LF
- Minimal debris in pipe, increases to 1-2" at approximately 40 LF to 50 LF
- Oval pipe, approximately 6" deformation in 1:00 position, belly in pipe 45 LF
- Surface corrosion/discoloration in invert, visible at joint at 60 LF, 80 LF, 100 LF, 120 LF
- Flow: Minimal
- Grade score of: 3

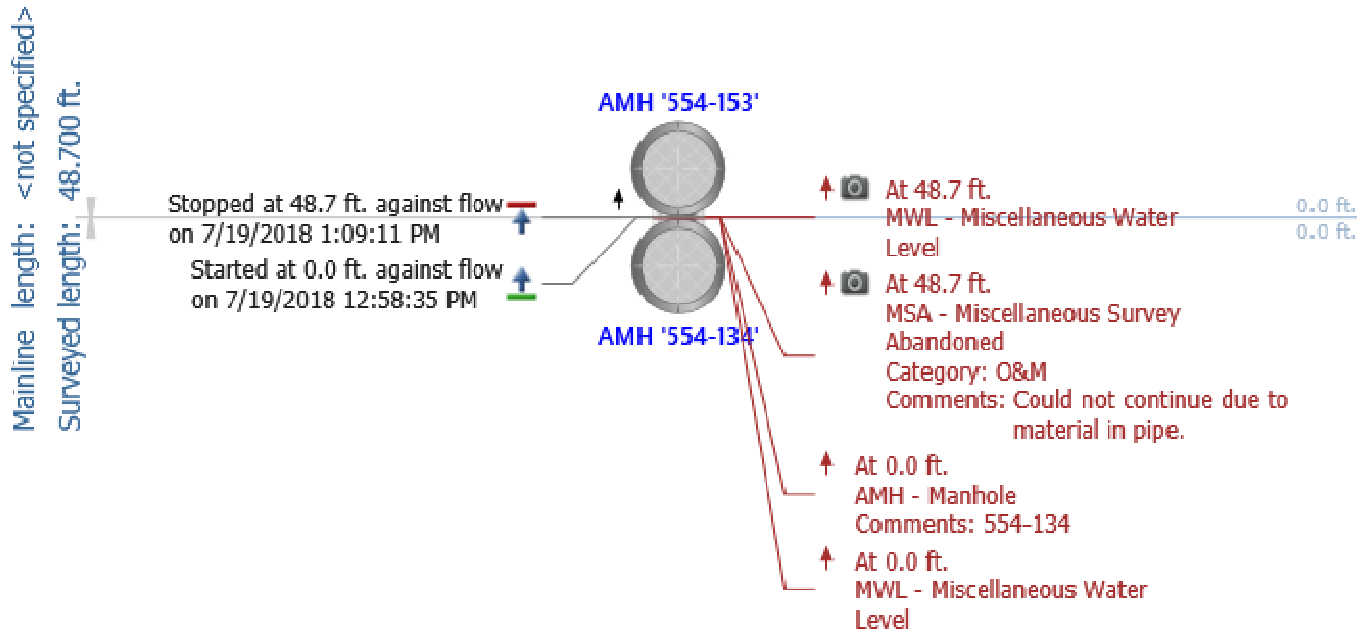
Notes: 554-153 to 554-134

- 12-in. CMP
- 60 LF
- Surface corrosion visible at pipe ends at joints
- 1-2" debris 3 LF to 38 LF, 3-4" 38 LF to end of survey, survey concluded at 48 LF due to debris
- Surface corrosion visible at 4:00 and 8:00 position. 24 LF to end of survey
- Evidence of corrosion in invert, rust color visible in debris, pipe requires cleaning to confirm invert condition
- Flow: None
- Grade score of: 2

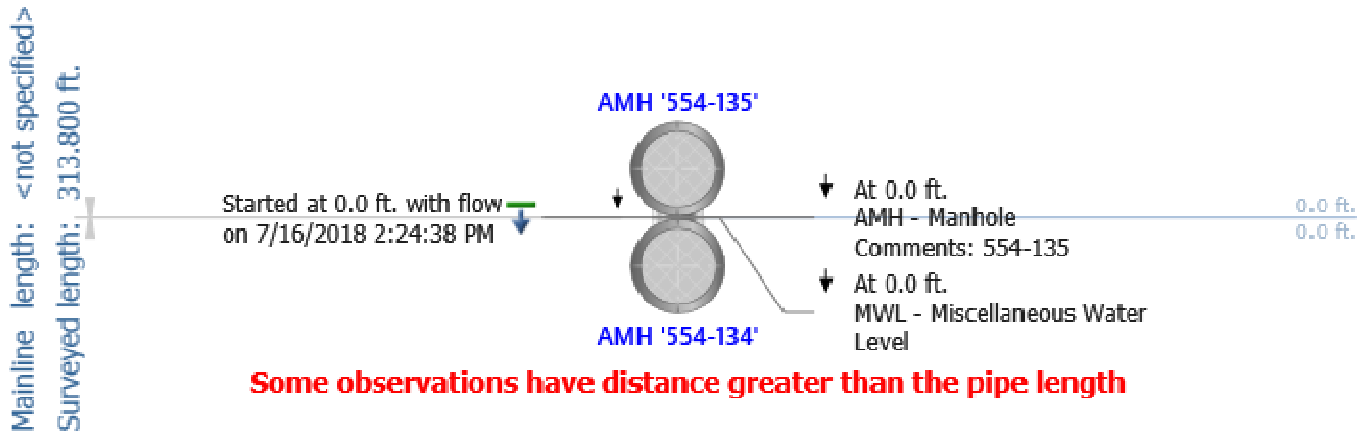
Notes: 554-135 to 554-134

- 24-in. CMP
- 314 LF
- 1-2" debris, 3 LF to 90 LF, 0-1" 90 LF
- Hole in joint soil visible, 1:00 position, 50 LF
- Surface corrosion visible in invert at joint, 131 LF, 191 LF, 252 LF
- Flow: 1-2"
- Grade score of: 2

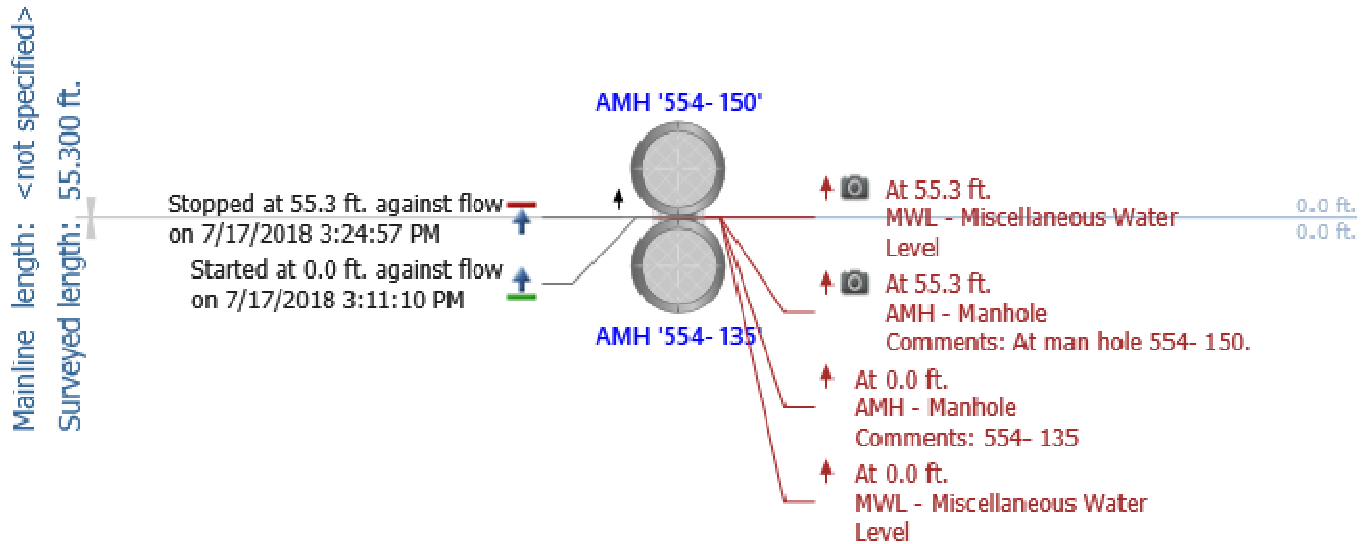
Notes: 554-150 to 554-135

- 12-in. CMP
- 55 LF
- Horizontal bend in pipe, 7 LF
- Pipe ends corroded at joints
- 0-1" of debris in pipe to 45 LF, 1-2" 45 LF to end
- Corrosion in 3:00 and 9:00 position, 35 LF to end
- Flow: Minimal
- Grade score of: 2

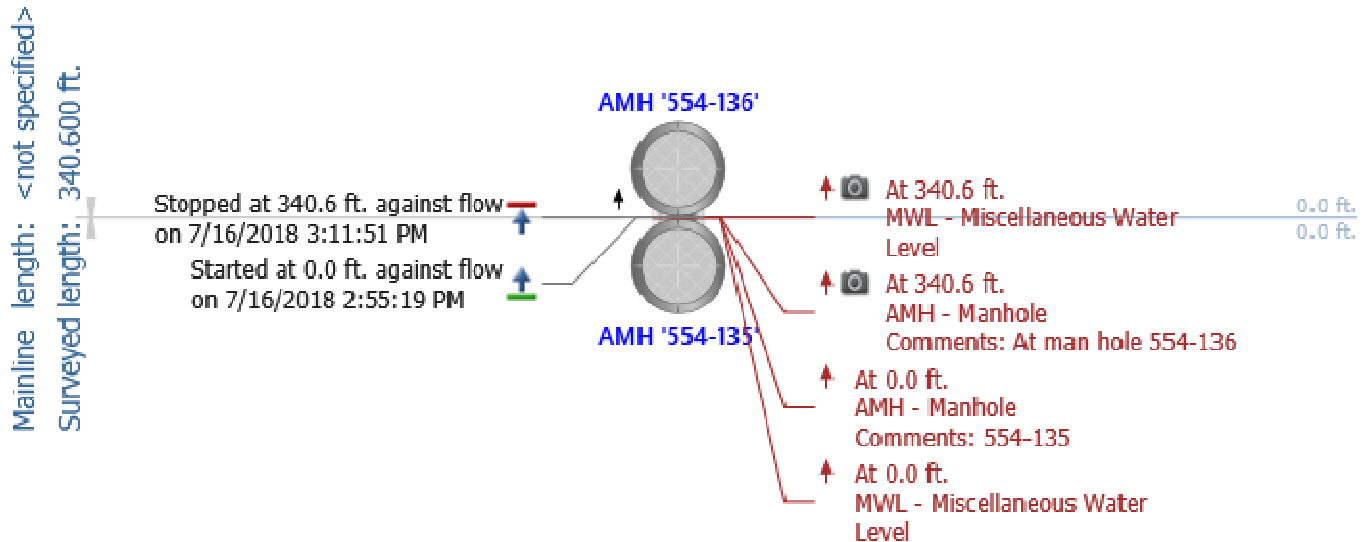
Notes: 554-136 to 554-135

- 24-in. CMP
- 341 LF
- 0-1" debris in invert, except where noted otherwise
- Debris increases from 0-1" to 1-2" from 30 LF to 50 LF, appears to be belly in the pipe
- Debris 1-2" 80 LF to 106 LF possible belly
- Discoloration and minor surface corrosion in invert, visible at joints when not obscured by debris
- 6-8" deformation, 7:00 position at 76 LF
- Flow: Minimal
- Grade score of: 2

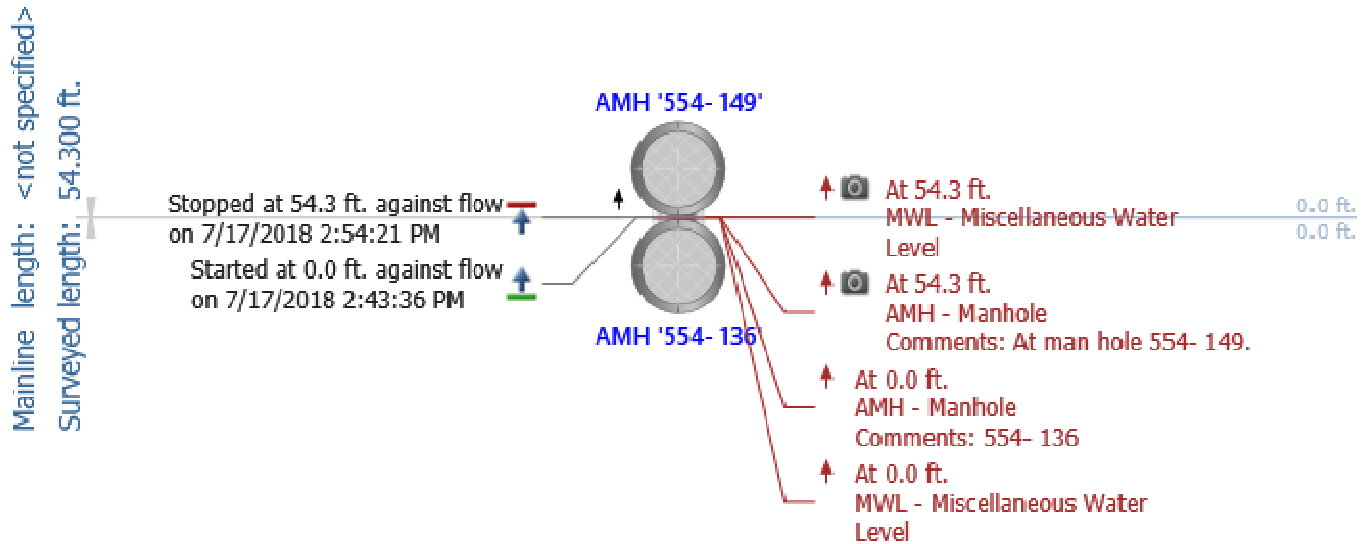
Notes: 554-149 to 554-136

- 12-in. CMP
- 54 LF
- Surface corrosion/discoloration visible in 4:00 and 8:00 position
- Corrosion at pipe ends at joints
- 0-3" debris in pipe
- No major structural defects
- Flow: Minimal
- Grade score of: 2

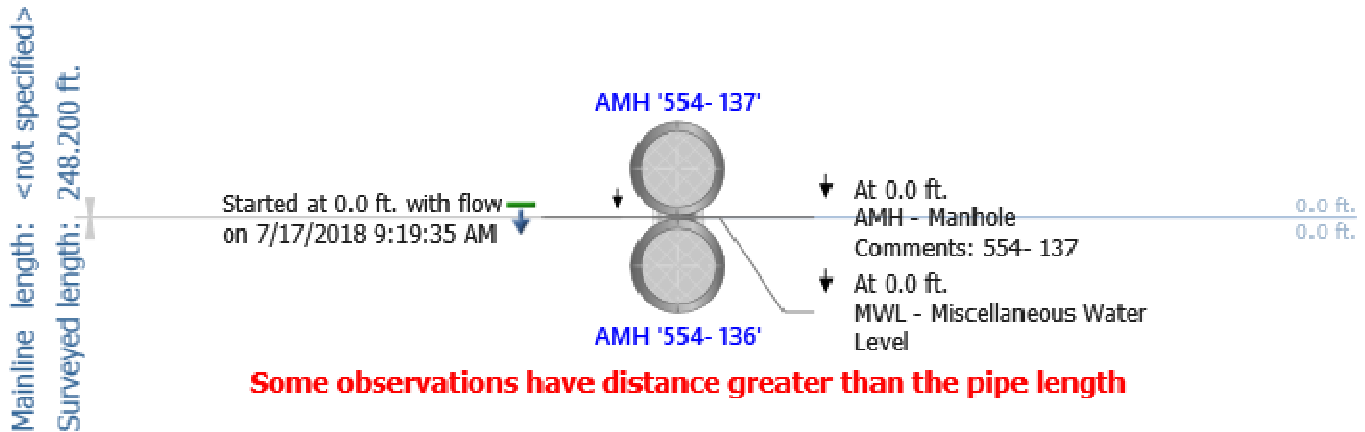
Notes: 554-137 to 554-136

- 24-in. CMP
- 248 LF
- Discoloration between 4:00 and 8:00 position
- Various levels of debris throughout pipe, 0-3"
- Approximately 3" diameter hole in pipe, 48 LF, 10:00 position
- Minor corrosion visible in invert when not obscured by debris
- 1" deformation, 9:00 position at 72 LF
- Corrosion at pipe ends at joints
- Flow: Minimal
- Grade score of: 2

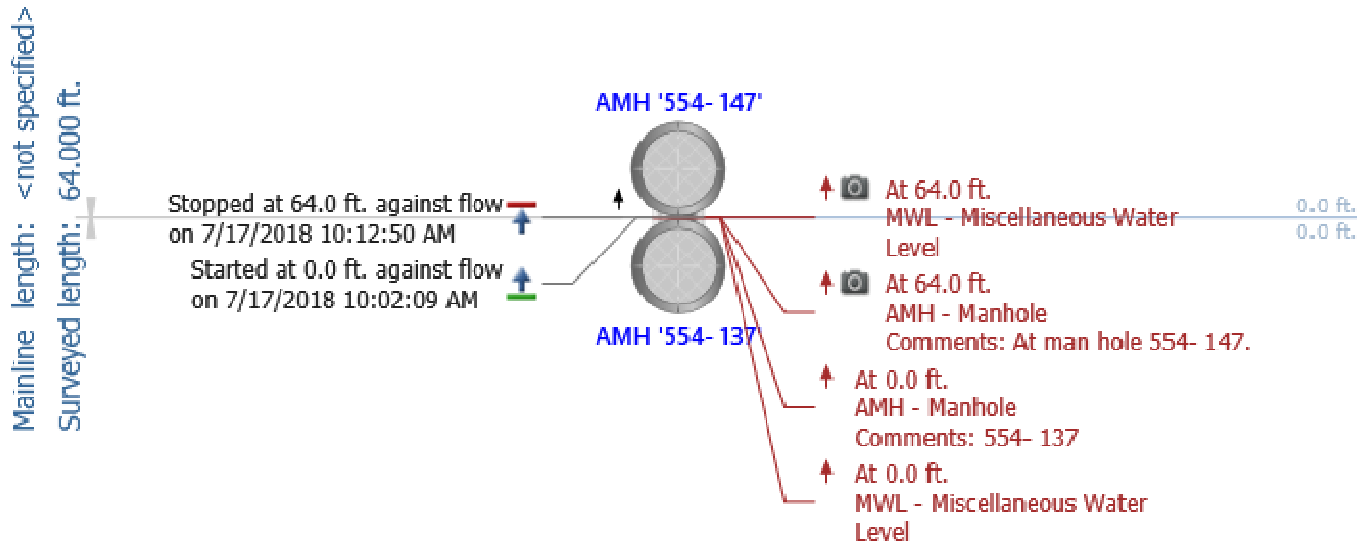
Notes: 554-147 to 554-137

- 18-in. CPEP
- 64 LF
- 1-2" debris buildup in downstream end, 0-1" of debris to approximately 16 LF
- 3-4" of debris in upstream end
- No major defects observed
- Flow: 0-1"
- Grade score of: 1

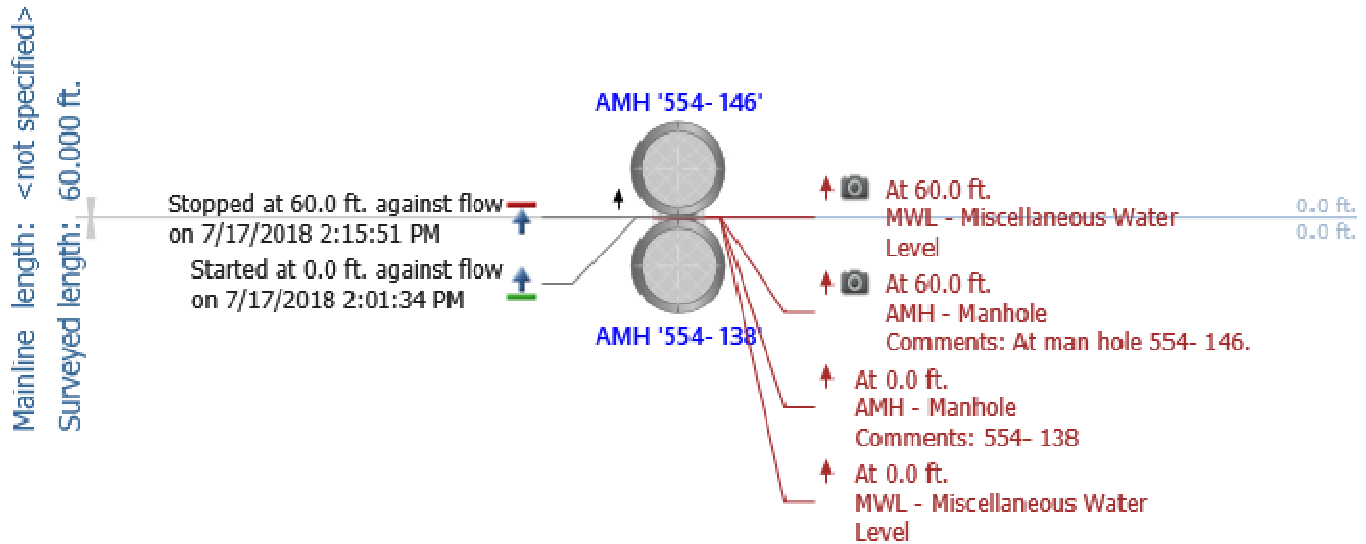
Notes: 554-146 to 554-138

- 12-in. CMP
- 60 LF
- Surface corrosion at pipe ends at joins
- Surface corrosion visible in invert
- 0-1" of debris in invert, increases to approximately 1-2" at 30 LF, half-full at 54 LF
- Surface corrosion at 4:00 and 8:00 position 36 LF to end of pipe
- Flow: Minimal
- Grade score of: 2

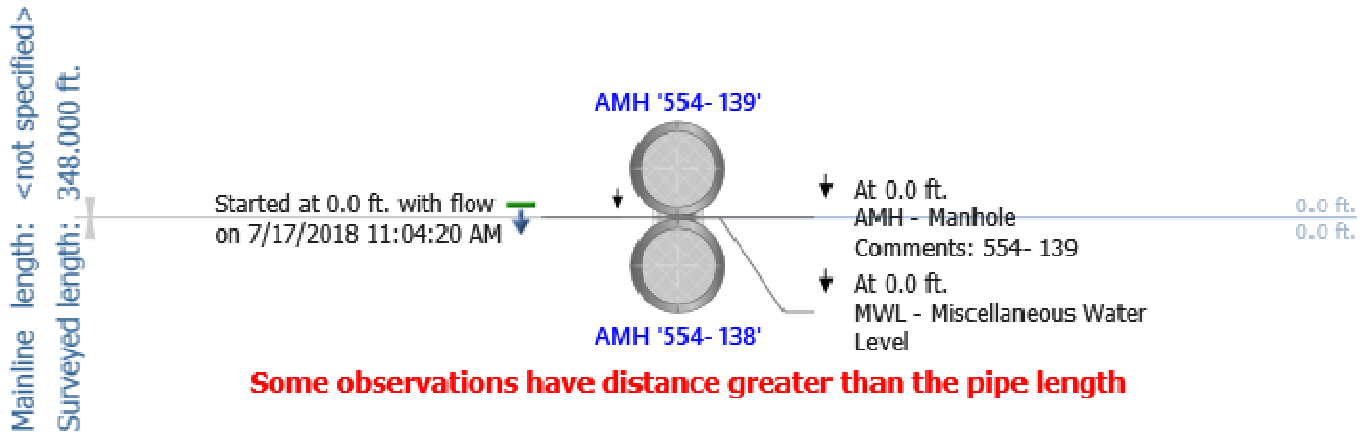
Notes: 554-139 to 554-138

- 24-in. CMP
- 348 LF
- Various levels of debris throughout pipe, approximately 1-3"
- Discoloration in bottom half of pipe
- Minor surface corrosion visible in invert, visible when camera pans at joints where invert not obscured by debris
- No major structural defects
- Flow: 0-1"
- Grade score of: 2

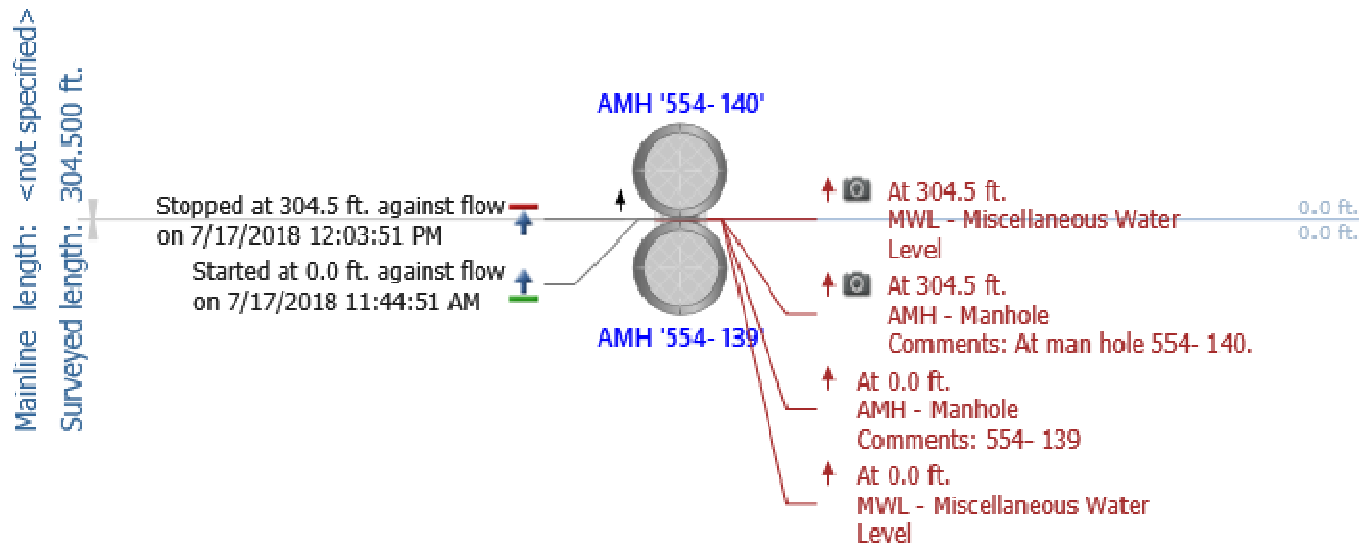
Notes: 554-140 to 554-139

- 24-in. CMP
- 305 LF
- 0-2" debris in pipe throughout pipe
- Discoloration 4:00 position to 8:00 position
- Invert obscured by debris, unable to observe for corrosion
- No major defects observed
- Flow: Minimal
- Grade score of: 1

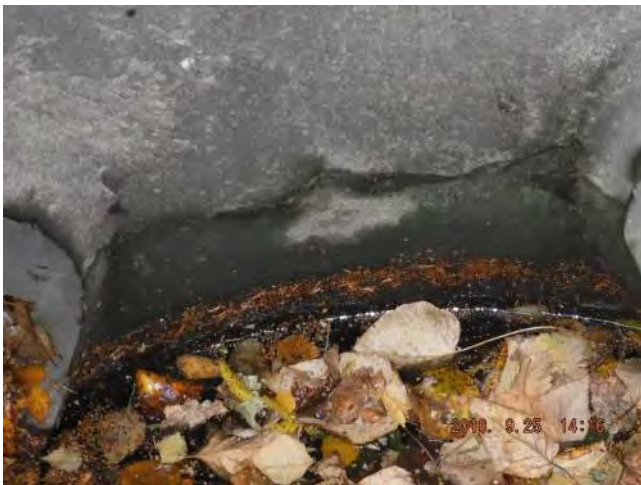
Primary Comments: Crack in base

Crack in base

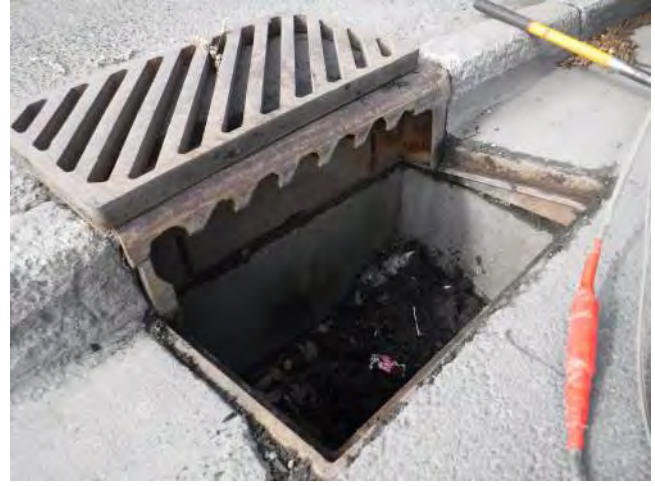
Broken curb inlet

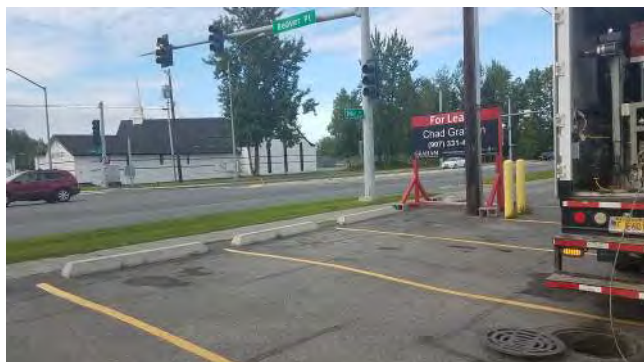
554-450 Facing Southwest

UNABLE TO INSPECT DUE TO DEBRIS CCTV STOPPED AT 20.6 FEET 9/6/18

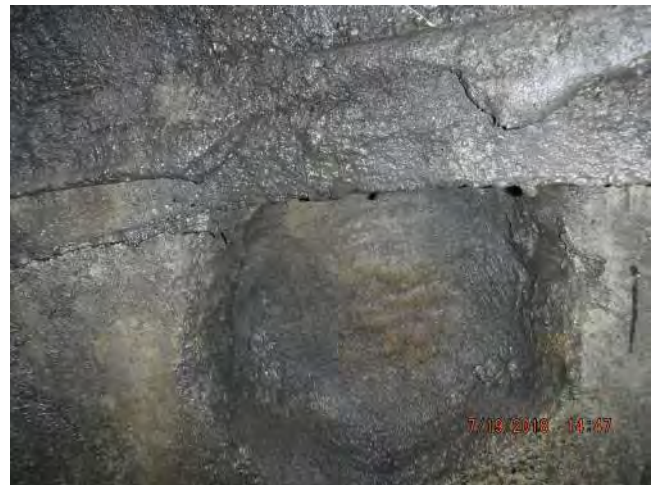
Patchwork done to barrel section

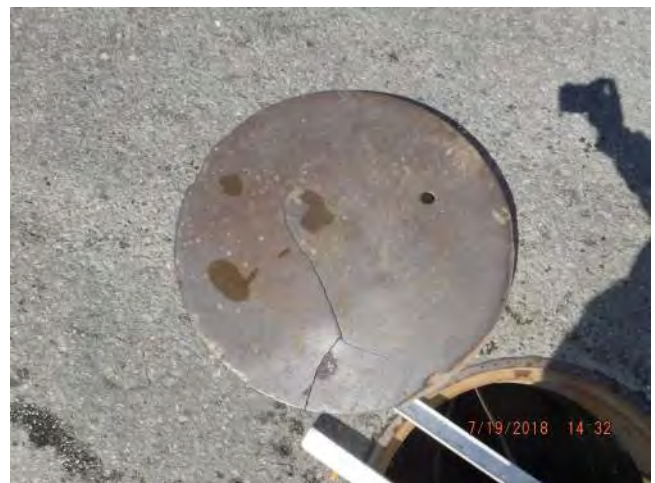
Primary Comments: LID CRACKED

Cracked Lid

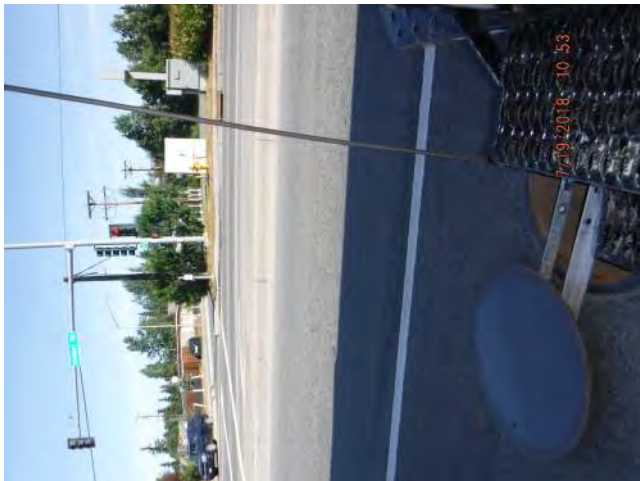
554-124 Facing North

34.6' inspected 7/19/18, pipe full of debris PIPE CLEANED, INSPECTED 54.9' COMPLETE 7/19/18

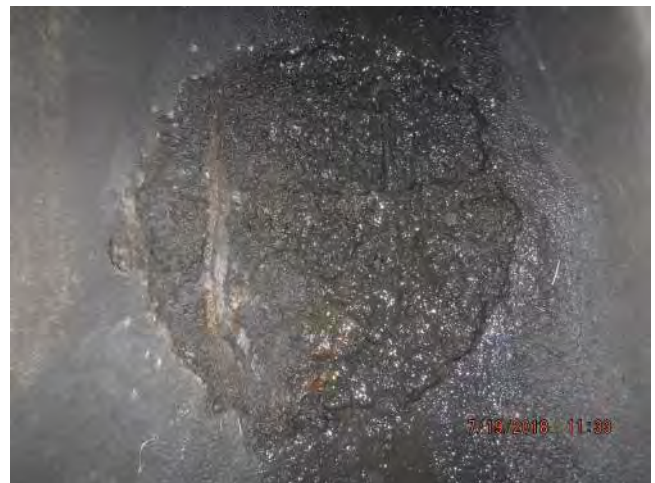
Repair to barrel section

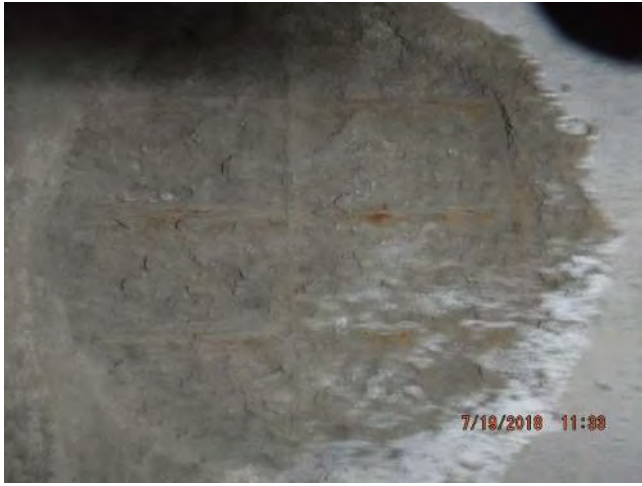
Repair to barrel section

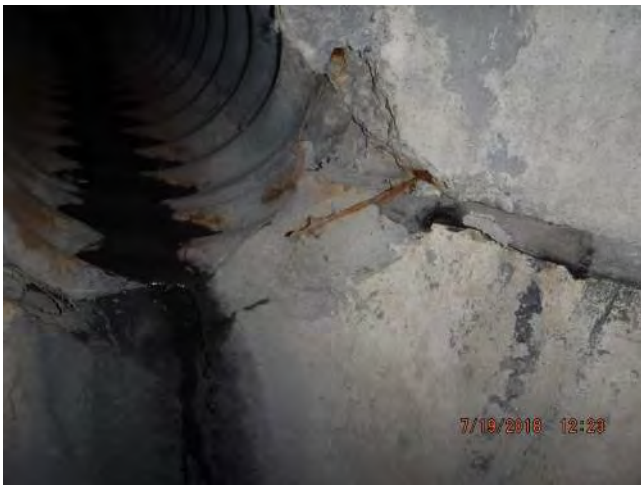
Patch repair to barrel
