Alaska Department of Transportation and Public Facilities Central Region

NHS STORM DRAIN INSPECTION CONDITION REPORT PROJECT NO. 0A31055 / Z591280000

Dimond Boulevard from Jewel Lake Road to Old Seward Highway
Muldoon Road from Boundary Avenue to Northern Lights Boulevard
Debarr Road from Bragaw Street to Muldoon Road
Downtown: 5th and 6th Avenue from Gambell Street to Orca Street and
Ingra Street from 6th Avenue to 9th Avenue

May 20th, 2019

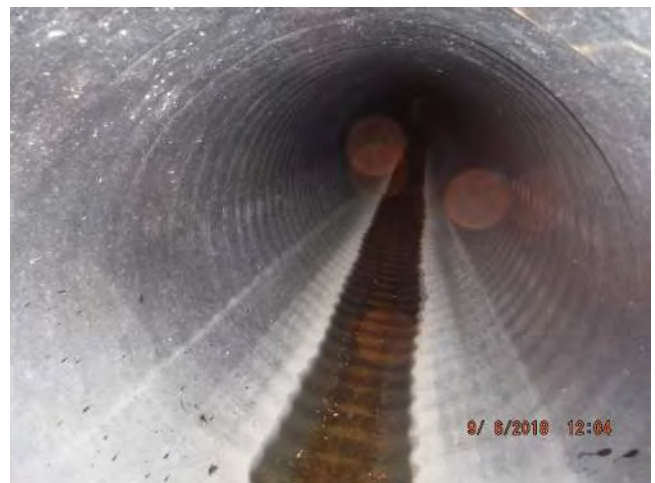
Interior of Pipe #2, CPEP, no defects visible from MH

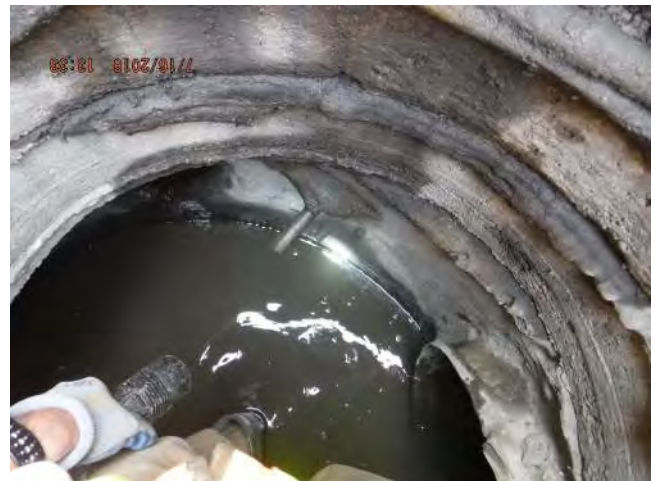
Additional Comments: BROKEN/MISSING RUNGS

Broken Ladder Rung

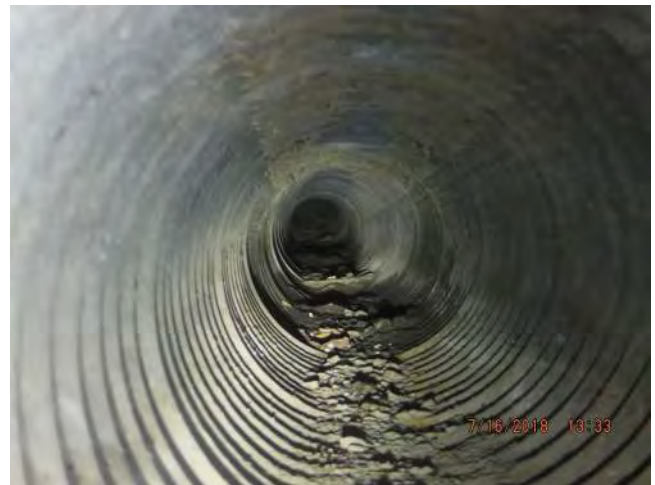
554-154 to 554-131, Upstream end abandoned

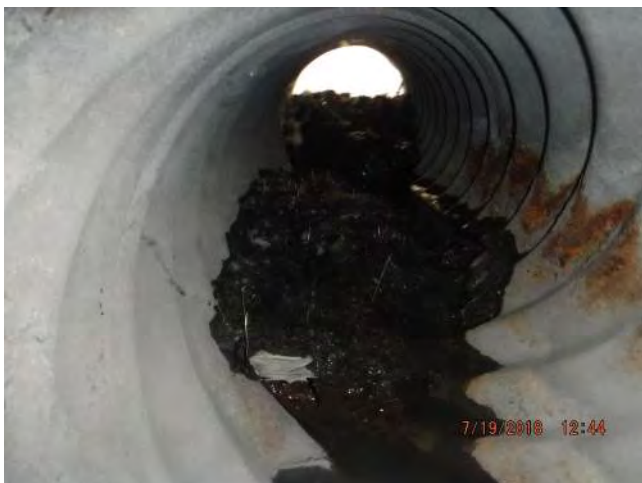
554-155 to 554-131

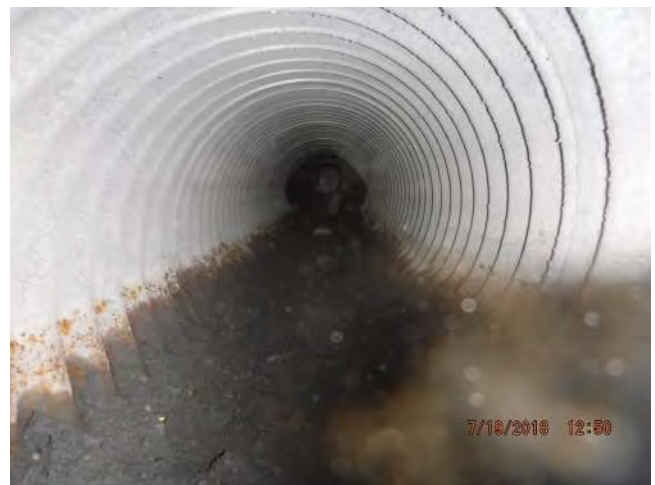
554-133 to 154-132, Pipe appears abandoned

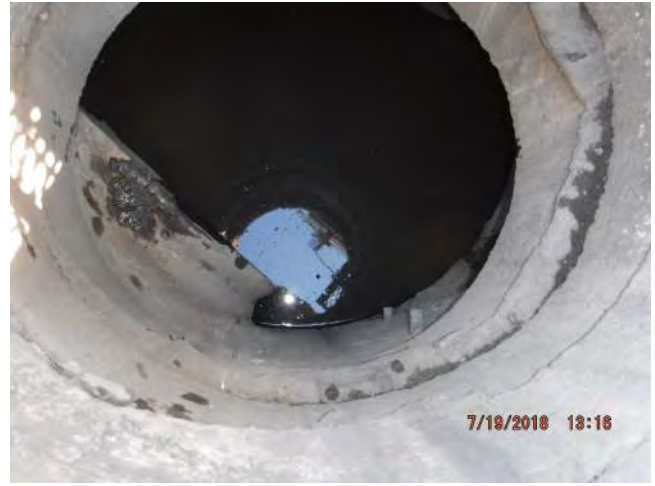
Broken Ladder Rung, North is up

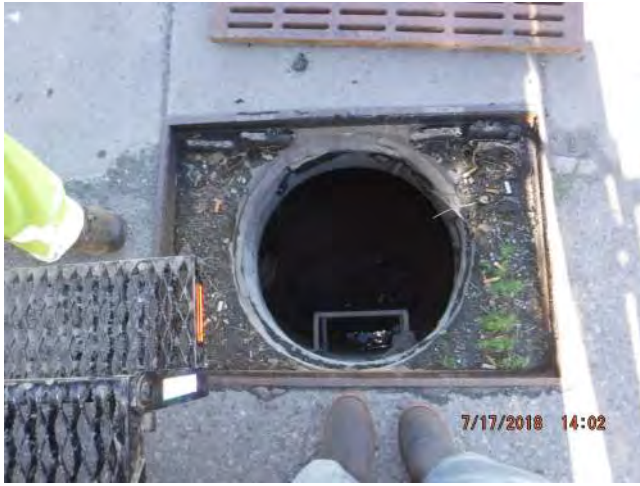
Cover

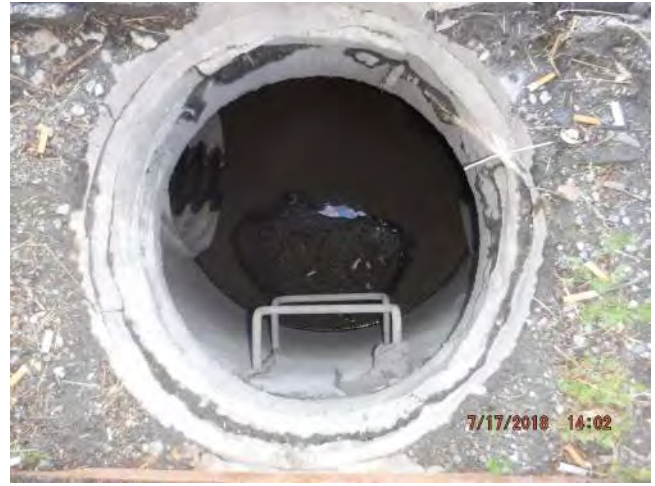
Frame, North is up

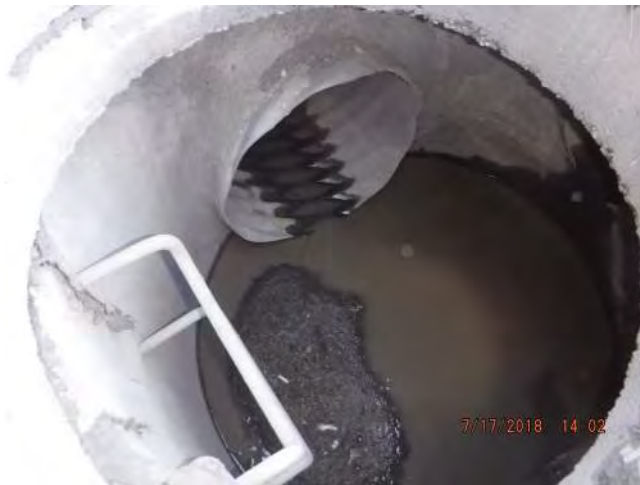
Chimney, North is up

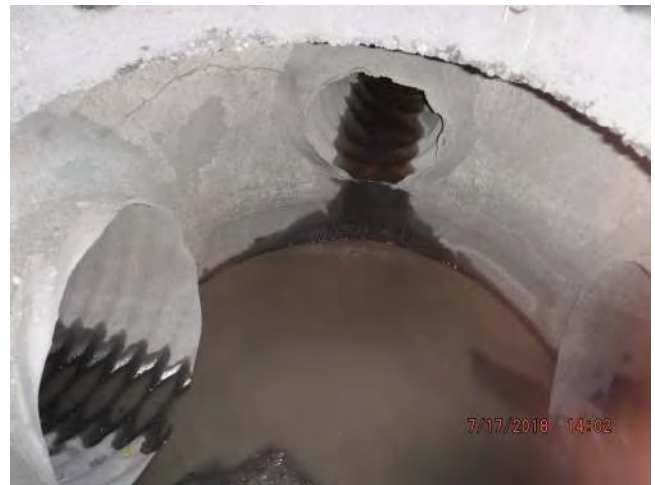
Effluent mainline connection

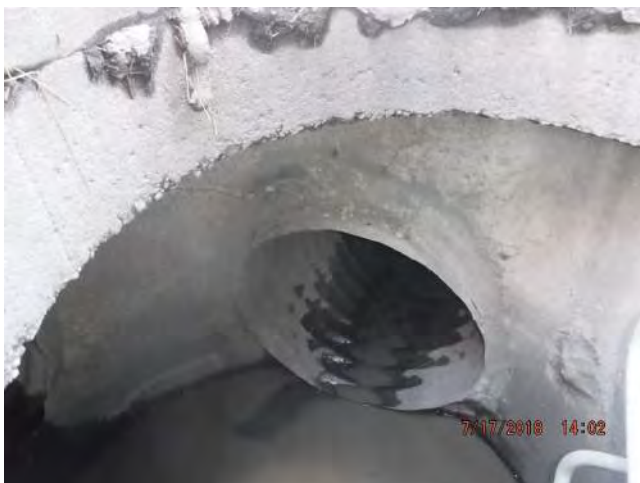
North influent pipe

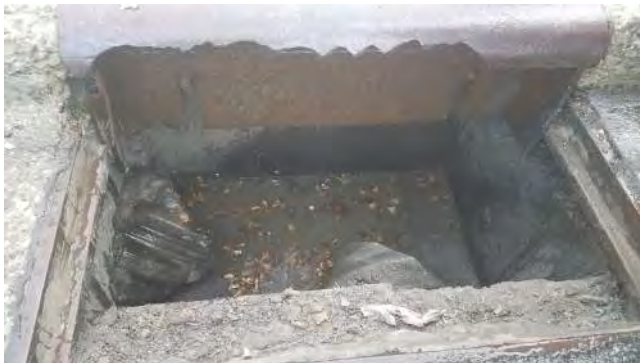
554-144 Facing Northeast

Primary Comments: inspection completed. Pipes extend 1ft into mh. Frame and base cracked

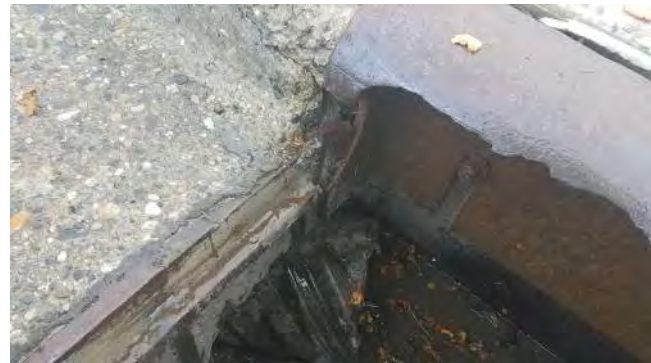
Frame, Broken Curb Inlet

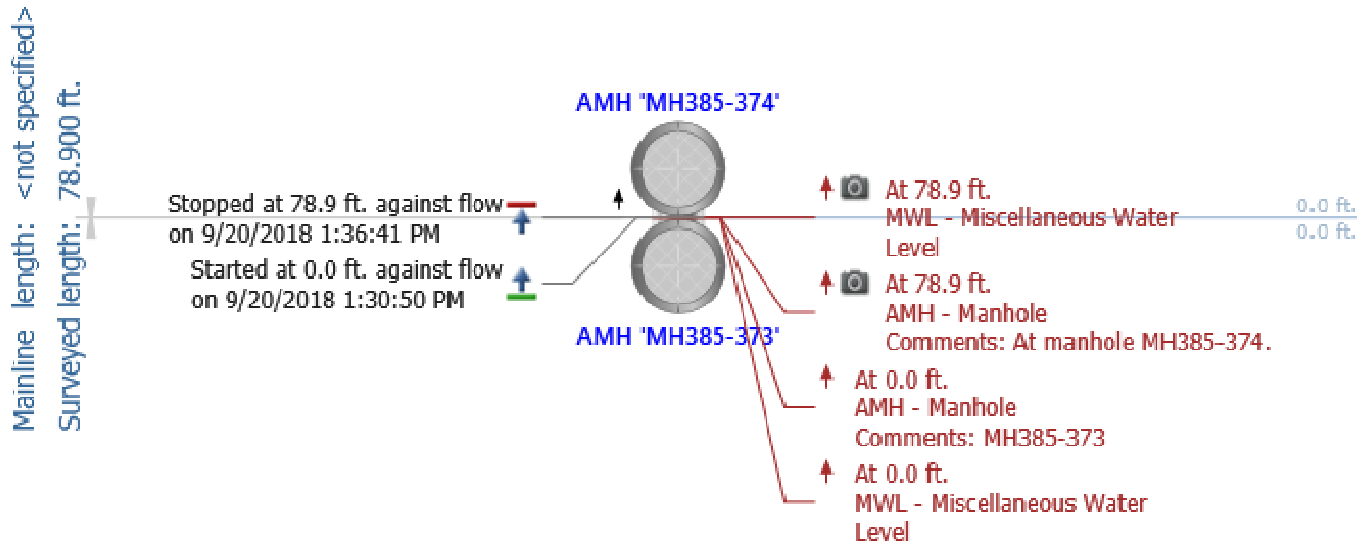
Notes: 385-374 to 385-373

- 12-in. CMP
- 79 LF
- Discoloration, 5:00 to 7:00 position
- 0-2" debris
- Corrosion visible in invert
- Surface corrosion on pipe ends at joints
- Flow: Minimal
- Grade score of: 3

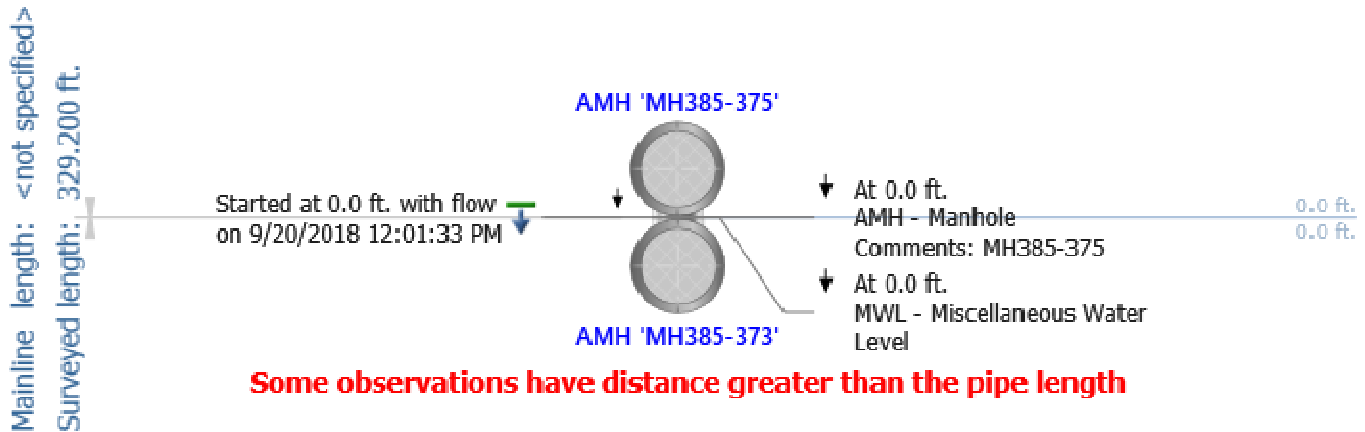
Notes: 385-375 to 385-373

- 24-in. RCP
- 329 LF
- 0-1" debris
- Crack in 11:00 position, 70 LF, 101 LF
- Cracks, 180 LF to approximately 188 LF in 9:00 11:00, and 12:00 position
- Crack in 1:00 position 191 LF to 193 LF
- Circumferential crack, 328 LF
- Flow: 1-2"
- Grade score of: 2

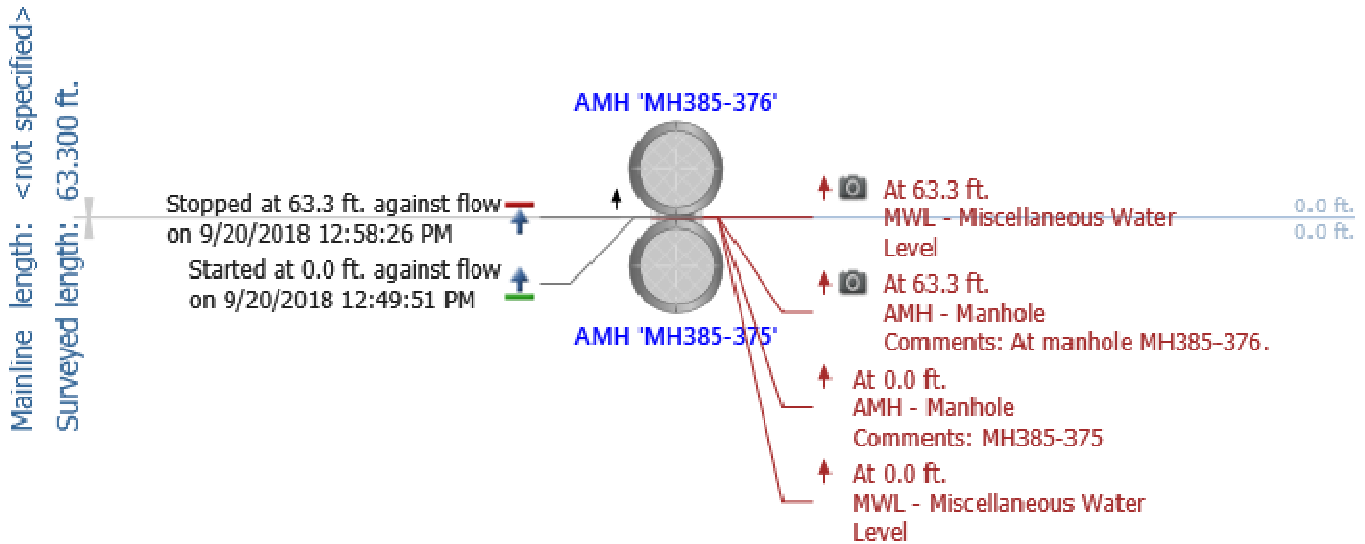
Notes: 385-376 to 385-375

- 12-in. CMP
- 63 LF
- Approximately 1" debris in pipe
- Surface corrosion on pipe ends at joints
- Camera stopped by debris at 63 LF, surface corrosion visible in 3:00 and 9:00 position upstream
- Unable to evaluate condition of invert
- Flow: None
- Grade score of: 2

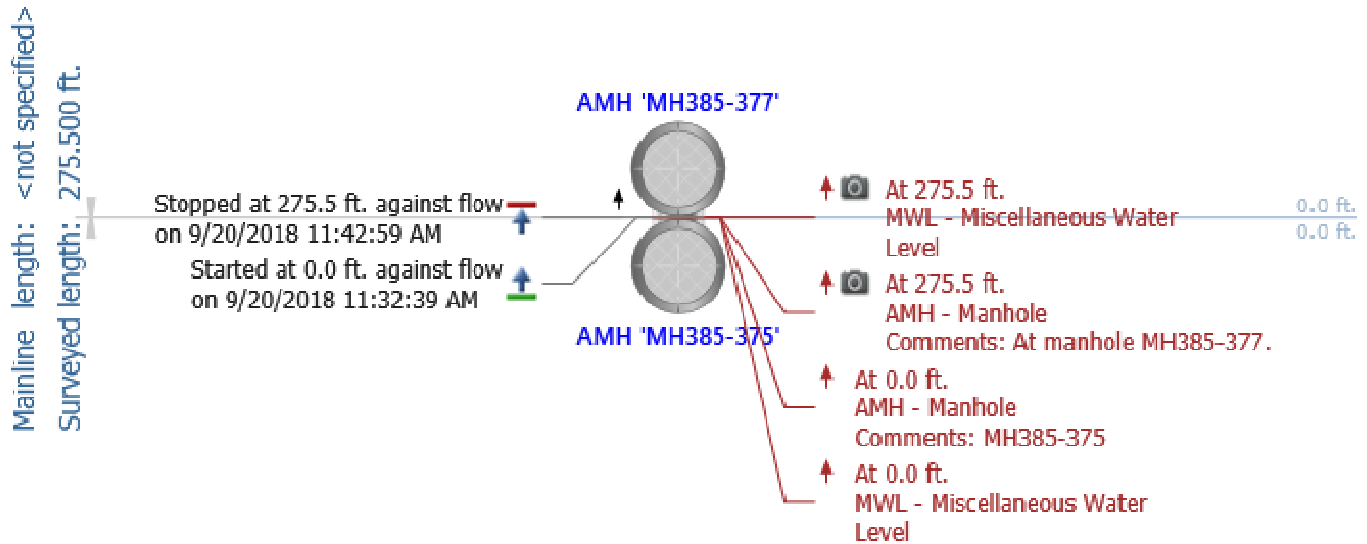
Notes: 385-377 to 385-375

- 24-in. RCP
- 276 LF
- Minimal debris in pipe
- No major defects observed
- Flow: 1-2"
- Grade score of: 1

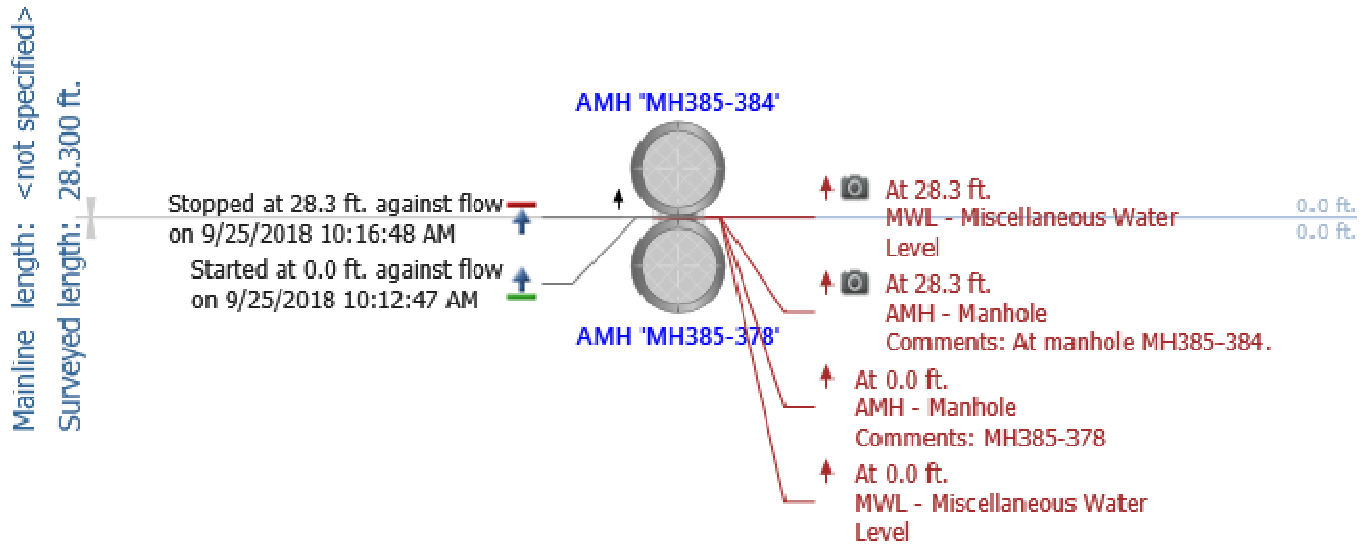
Notes: 385-384 to 385-378

- 12-in. CMP
- 28 LF
- Surface corrosion visible in 4:00 and 8:00 position
- Belly/sag in pipe at approximately 15 LF (midspan), pipe becomes half full with water
- Flow: 1-6"
- Grade score of: 4

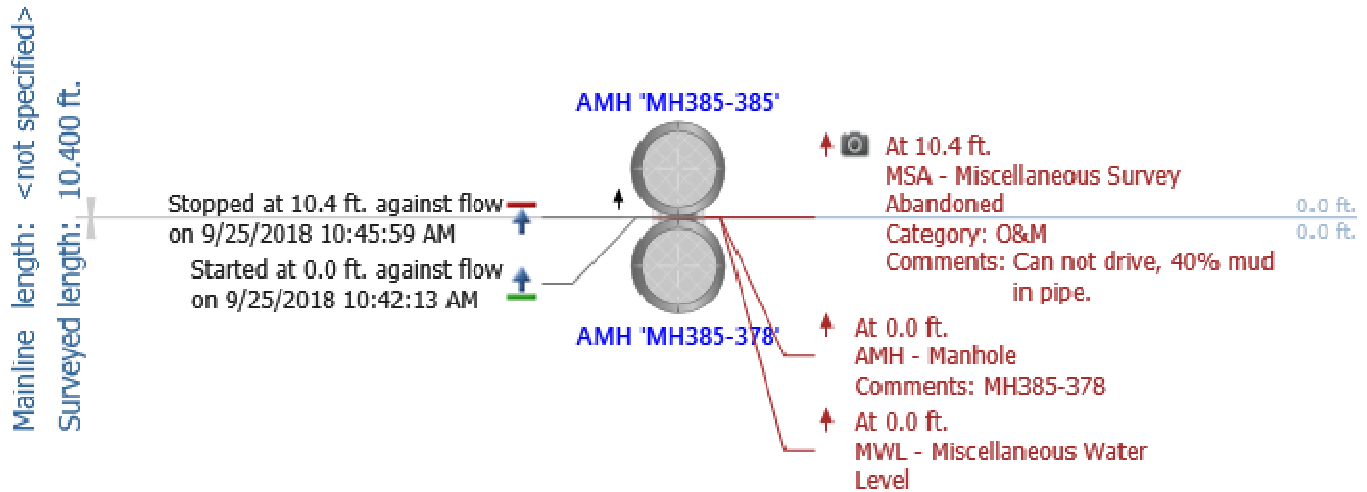
Notes: 385-385 to 385-378

- 12-in. CMP
- 31 LF
- 2-3" debris at downstream end, camera stopped by debris at 10 LF, possible belly in pipe
- Surface corrosion at flow line
- Clean pipe to determine invert condition
- Flow: 2-3"
- Grade score of: 3

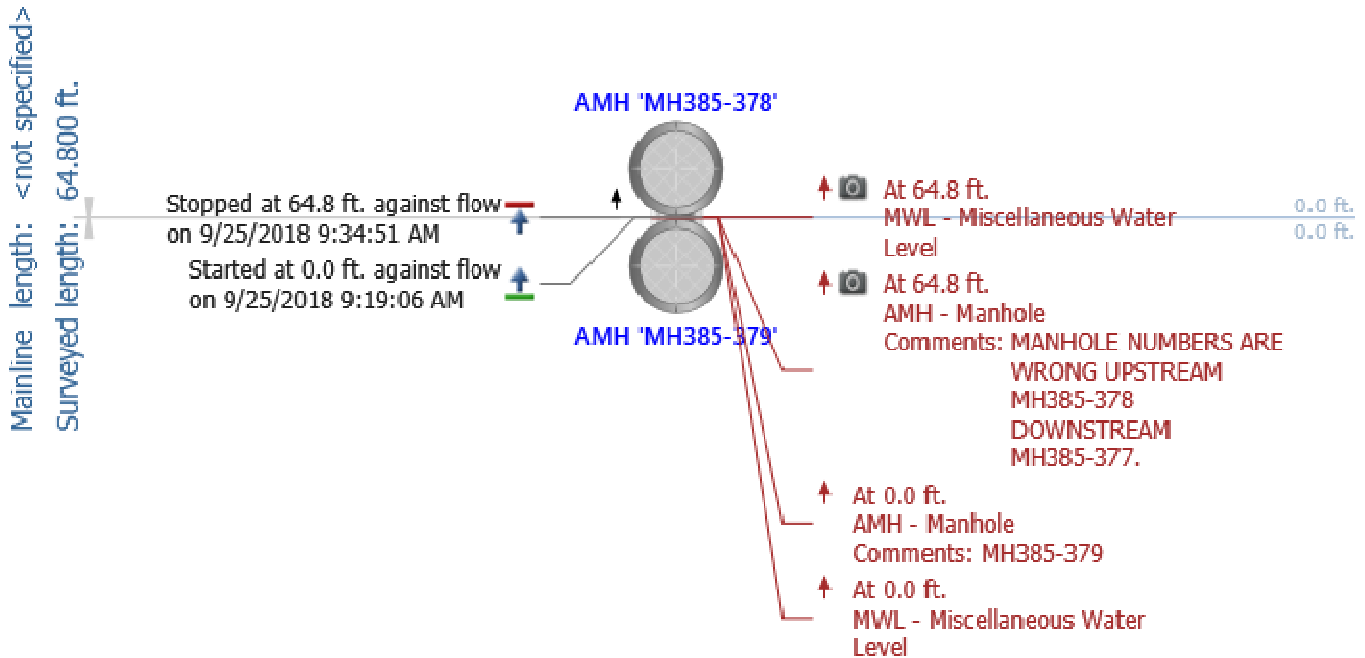
Notes: 385-378 to 385-377

- 18-in. CMP
- 65 LF
- 1-2" of debris, debris pile in downstream end flattened by camera
- Evidence of corrosion in invert, pipe requires cleaning to confirm degree
- Flow: Minimal
- Grade score of: 2

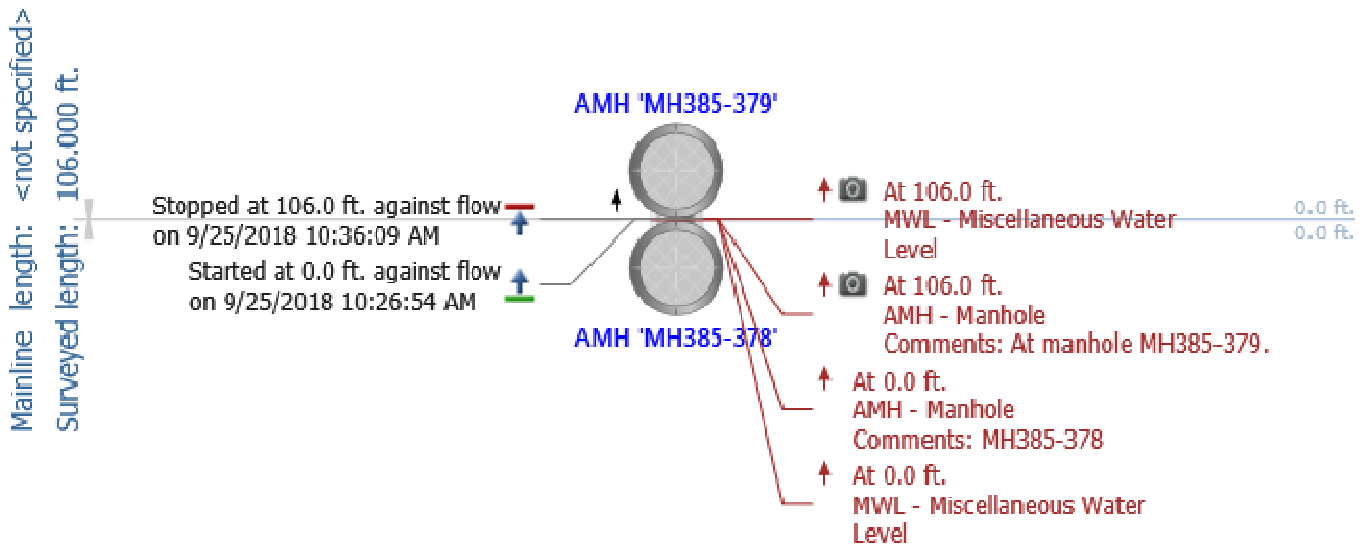
Notes: 385-379 to 385-378

- 12-in. CMP
- 106 LF
- Various levels of debris throughout pipe, 0-3"
- Debris on top of pipe, 36 LF
- Surface corrosion visible in 5:00 and 7:00 position
- Evidence of infiltration at joint 102 LF
- Invert obscured by debris throughout pipe, corrosion visible at upstream end, likely corrosion in invert throughout pipe
- Flow: 0-1"
- Grade score of: 3

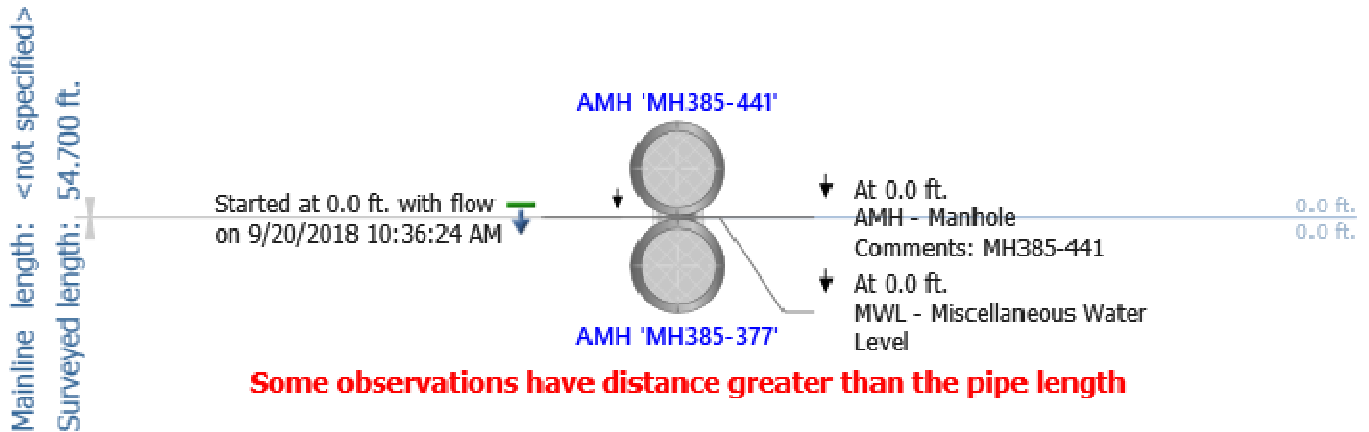
Notes: 385-441 to 385-377

- 18-in. DIP
- 55 LF
- Surface corrosion at pipe ends at joints
- 1-2" debris in pipe
- Corrosion spot, 39 LF in 1:00 position
- Unable to observe invert due to debris
- Flow: Minimal
- Grade score of: 2

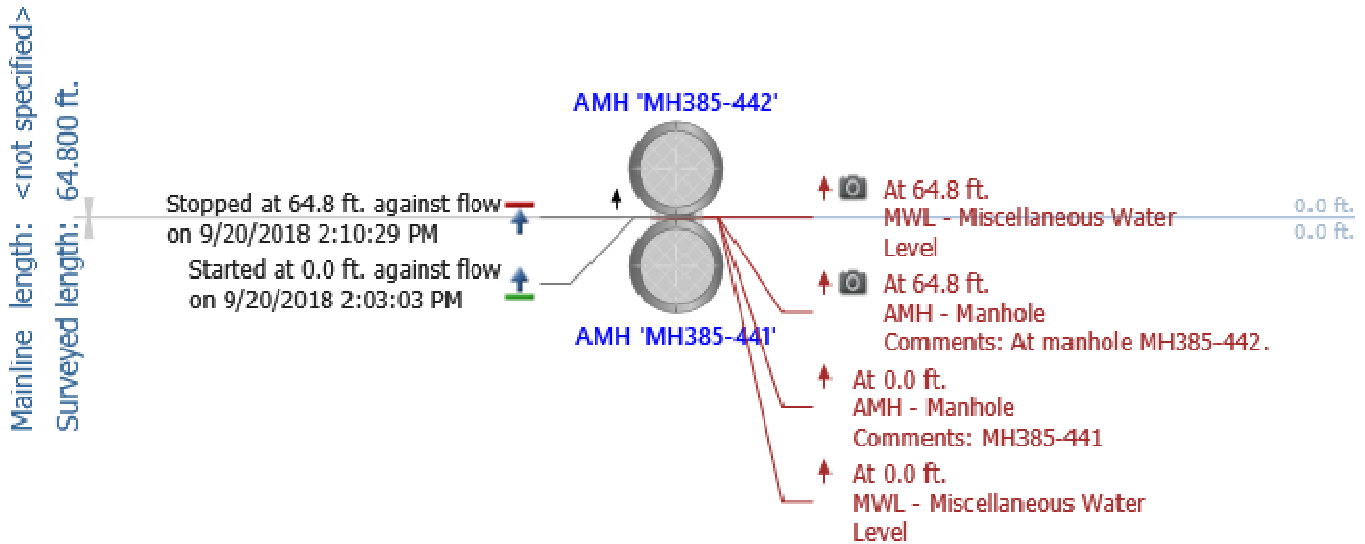
Notes: 385-442 to 385-441

- 12-in. CMP
- 65 LF
- 0-1" of debris, 1-2" at 53 LF
- Surface corrosion spot, 4:00 position at 15 LF, 50 LF
- Surface corrosion visible in invert
- Surface corrosion, 3:00 and 9:00 position 54 LF to 62 LF
- Surface corrosion visible at pipe ends at joints
- Flow: None
- Grade score of: 2

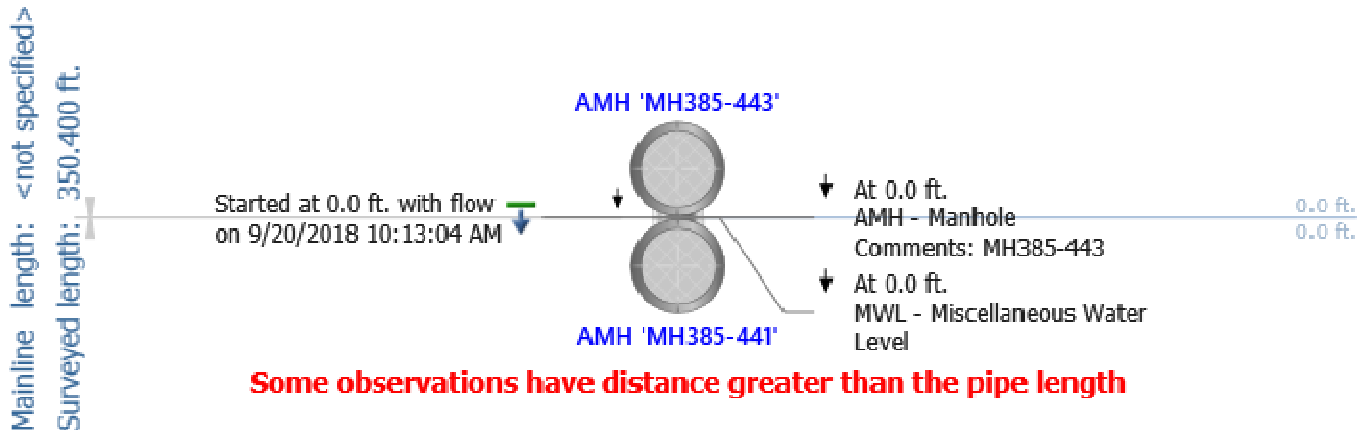
Notes: 385-443 to 385-441

- 18-in. DIP
- 350 LF
- 0-1" debris, 2" debris 285 LF to 297 LF, debris buildup at 297 LF, 0-1" 297 LF to end of pipe
- Evidence of minor surface corrosion in invert, invert probed, metal appeared sound
- Surface corrosion visible at pipe ends at joints
- Flow: 0-1"
- Grade score of: 2

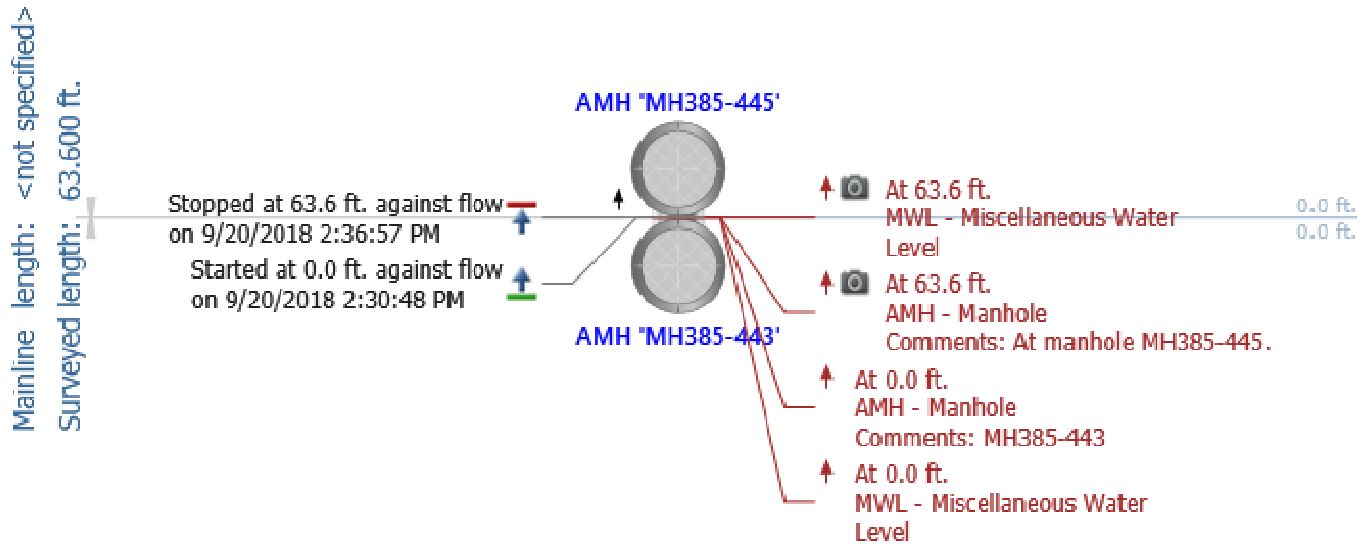
Notes: 385-445 to 385-443

- 12-in. CMP
- 64 LF
- 0-1" debris, 2-3" at upstream end, camera unable to pass at 64 LF
- Surface corrosion visible at pipe end at joint
- Evidence of minor service corrosion visible in invert, invert obscured by debris throughout pipe
- Clean pipe to observe invert
- Flow: None
- Grade score of: 1

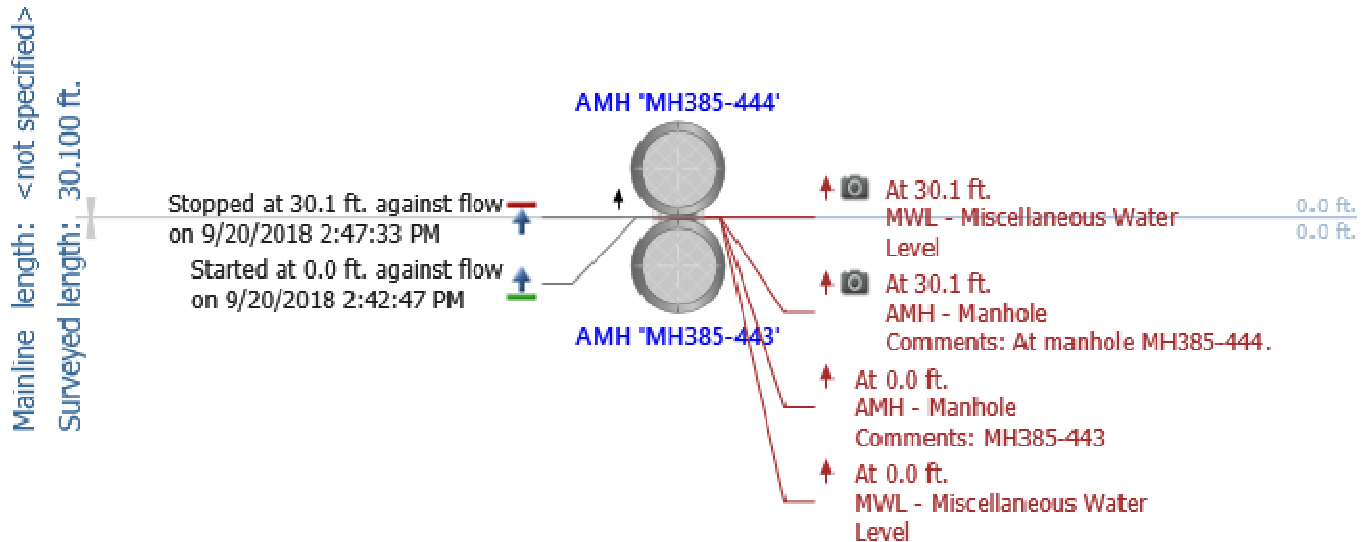
Notes: 385-444 to 385-443

- 12-in. CMP
- 30 LF
- 0-1" debris, 1-2" debris 14 LF, debris buildup approximately 4" at joint 21 LF, 1-2" debris 21 LF to end of pipe
- No major defects observed
- Pipe invert mostly obscured with debris, discoloration visible when debris is minimal
- Flow: Minimal
- Grade score of: 1

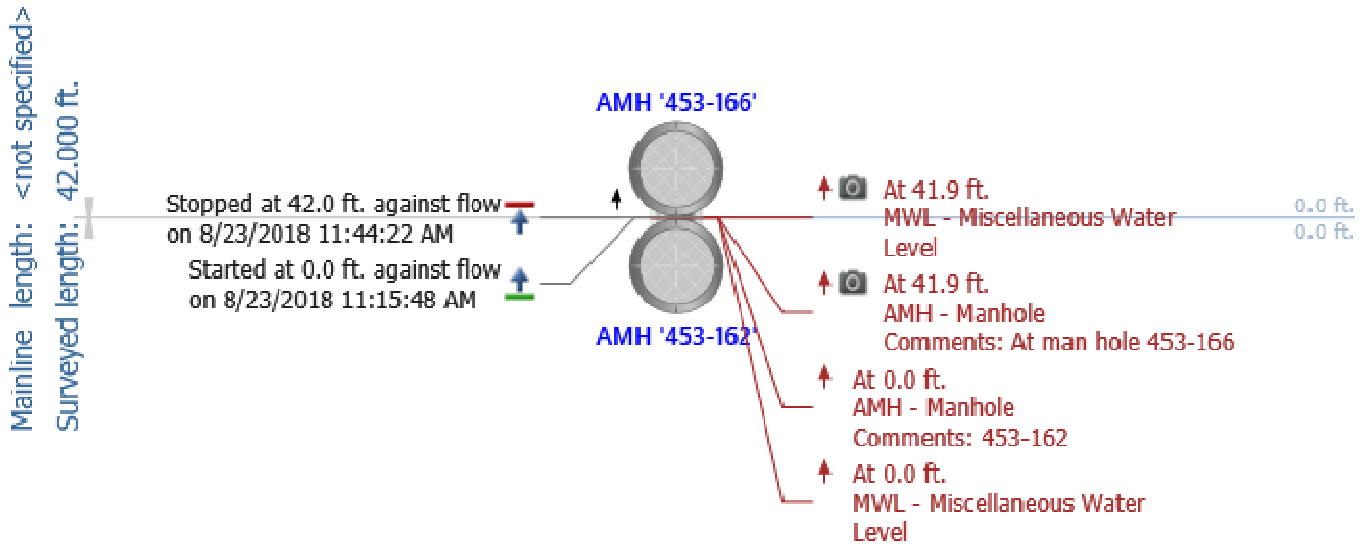
Notes: 453-166 to 453-162

- 12-in. CMP
- 42 LF
- Various debris throughout pipe, 0-2"
- Pipes segments offset at joint, 1-2" in 3:00 to 6:00 position
- Minor surface corrosion at pipe ends at joints
- Surface corrosion, 4:00 and 8:00 position 21 LF to end of pipe
- Downstream invert probe, metal appeared sound
- Flow: 0-1"
- Grade score of: 2

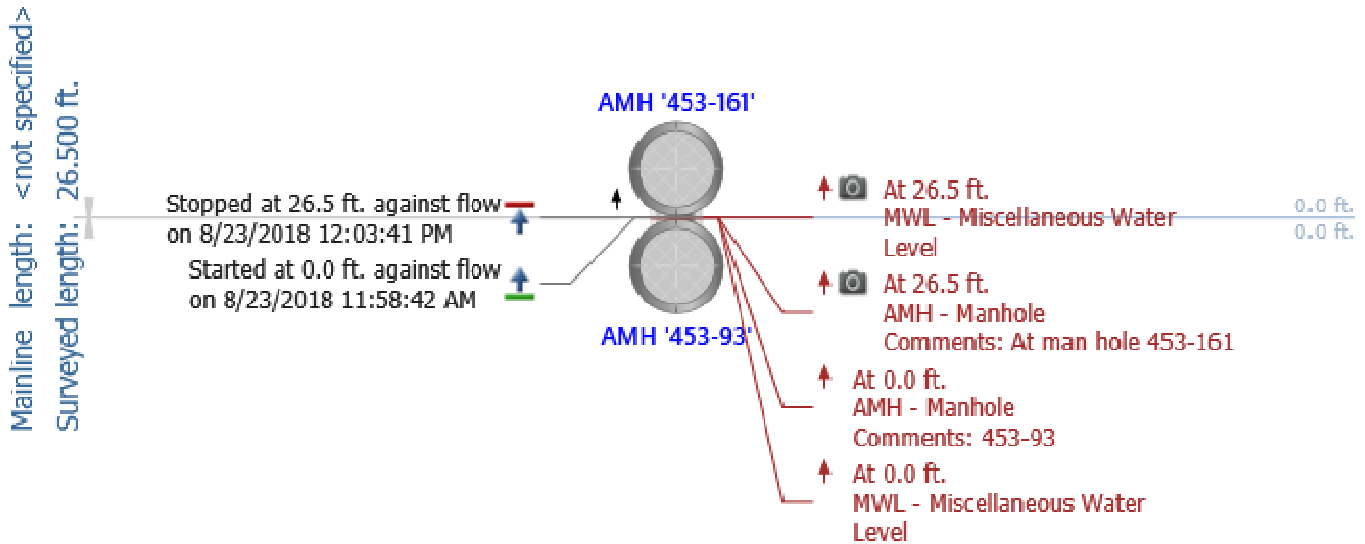
Notes: 453-161 to 453-93

453-161	453-93	West Muldoon Road at E. 3rd Ave.	12	CMP	Yes	8/23/2018	27	34	Upstream	3	0-1"	Surface corrosion, debris, downstream invert probed, surface corrosion observed

- 12-in. CMP
- 27 LF
- Evidence of corrosion in invert
- Downstream invert probed, surface corrosion observed
- Surface corrosion at pipe ends at joints
- Surface corrosion visible in 5:00 to 7:00 position at upstream end
- 2-3" debris buildup at upstream end
- Flow: 0-1"
- Grade score of: 3

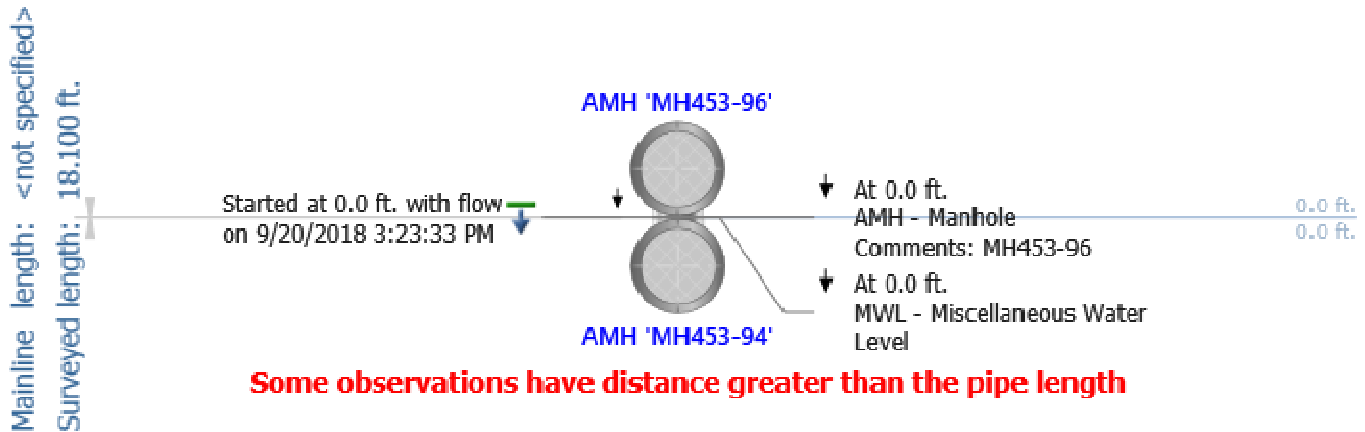
Notes: 453-96 to 453-94

- 12-in. CMP
- 18 LF
- 1-2" debris in pipe
- Invert obscured by debris
- No major defects observed
- Flow: Minimal
- Grade score of: 1

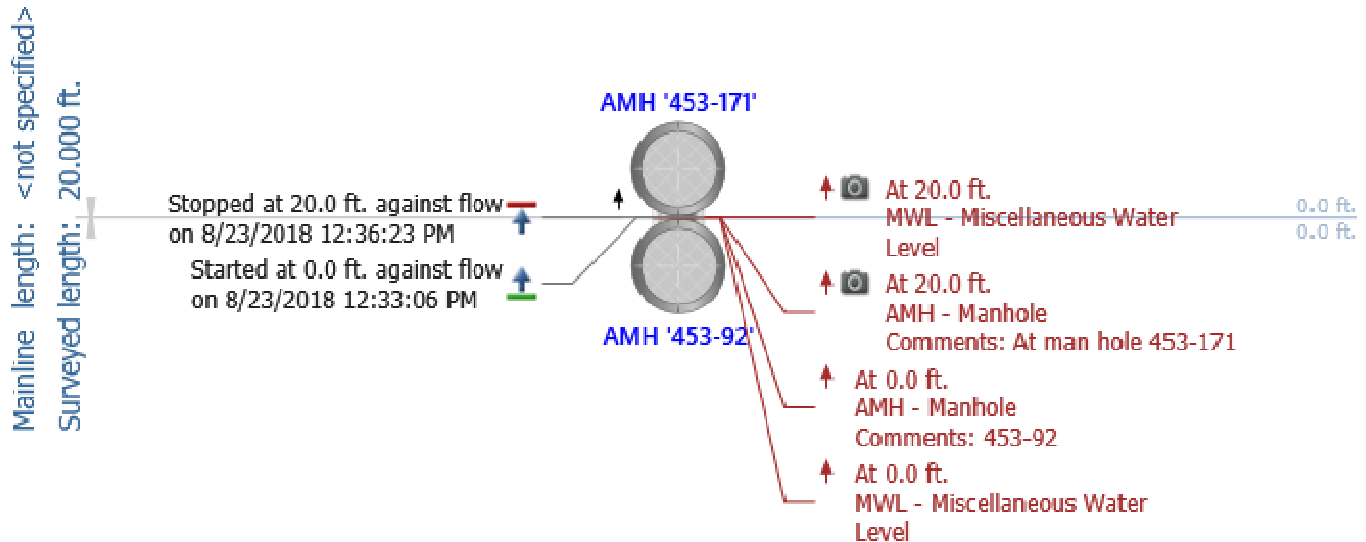
Notes: 453-171 to 453-92

- 12-in. CMP
- 20 LF
- Discoloration in bottom half of pipe
- Surface corrosion at pipe ends at joints
- Surface corrosion in 4:00 position, 13 LF to 17 LF
- Flow in pipe obscures invert, downstream invert probed, metal sound
- Flow: 1-2"
- Grade score of: 2

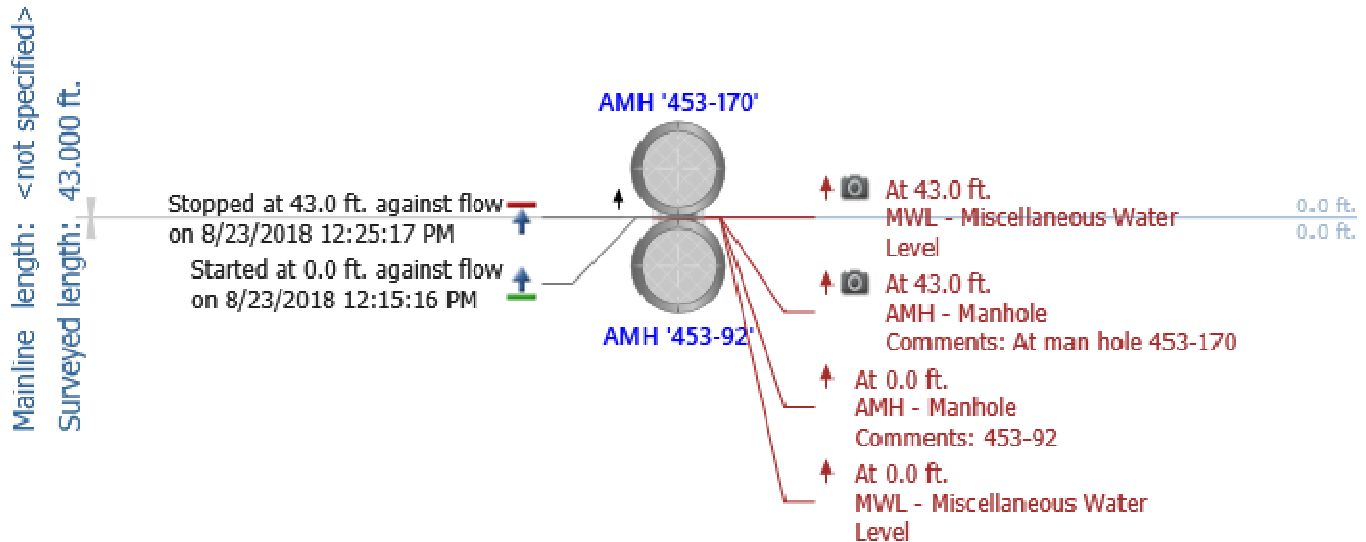
Notes: 453-170 to 453-92

- 12-in. CMP
- 43 LF
- Surface corrosion at pipe ends at joint
- Discoloration and minor surface corrosion in 5:00 and 7:00 position, 3 LF to 30 LF, corrosion in 4:00 and 8:00 30 LF to
- Pinhole at joint, 23 LF in 12:00 position
- Minor debris in pipe, approximately 1" at upstream end
- Invert in downstream end probed, metal appeared sound
- Flow: 0-1"
- Grade score of: 2

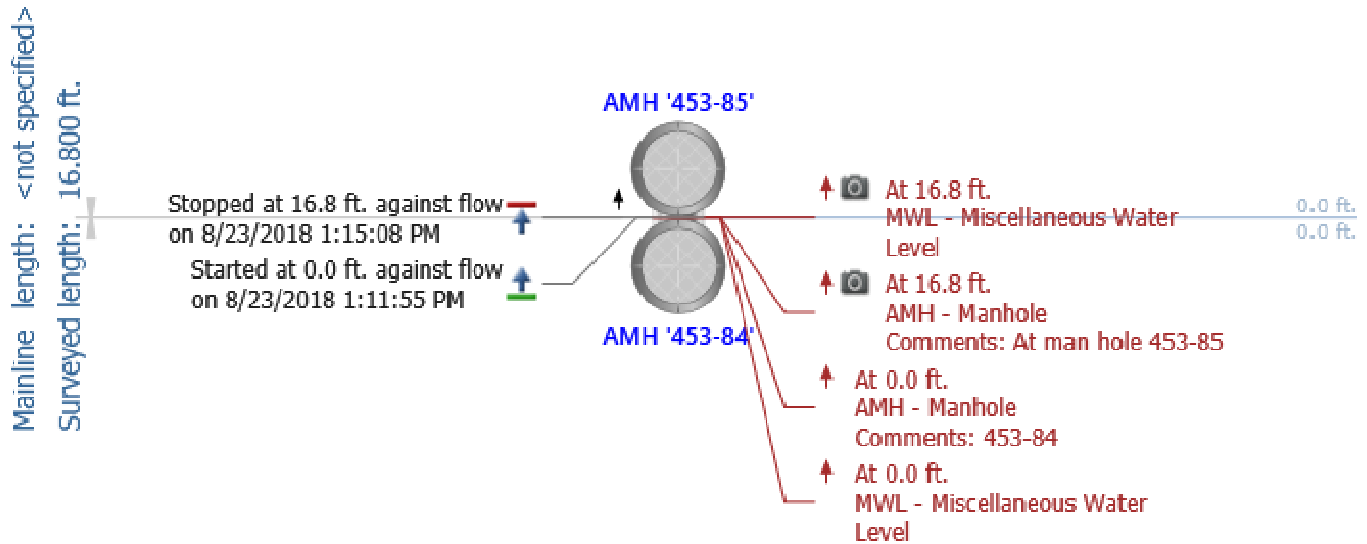
Notes: 453-85 to 453-84

- 12-in. CMP
- 17 LF
- Corrosion and metal loss in bottom half of pipe, holes with soil visible
- Downstream invert probed, metal loss observed
- 1-2" of debris and water in upstream end of pipe
- Flow: Minimal
- Grade score of: 4

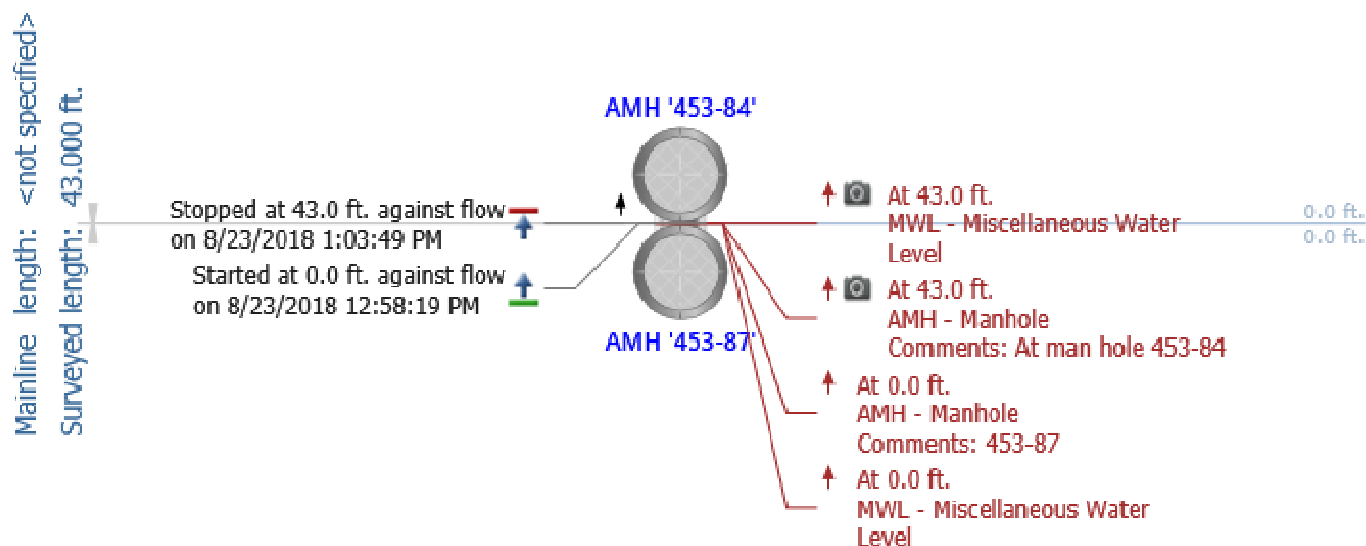
Notes: 453-87 to 453-84

- 12-in. CMP
- 43 LF
- Inspection during rain event
- Surface corrosion at pipe ends at joints
- Flow decreases at 19 LF to between 0" and 1", 1" flow at upstream end
- Minimal debris in invert
- Downstream invert probed, metal appeared soft
- Flow: 0-2"
- Grade score of: 3

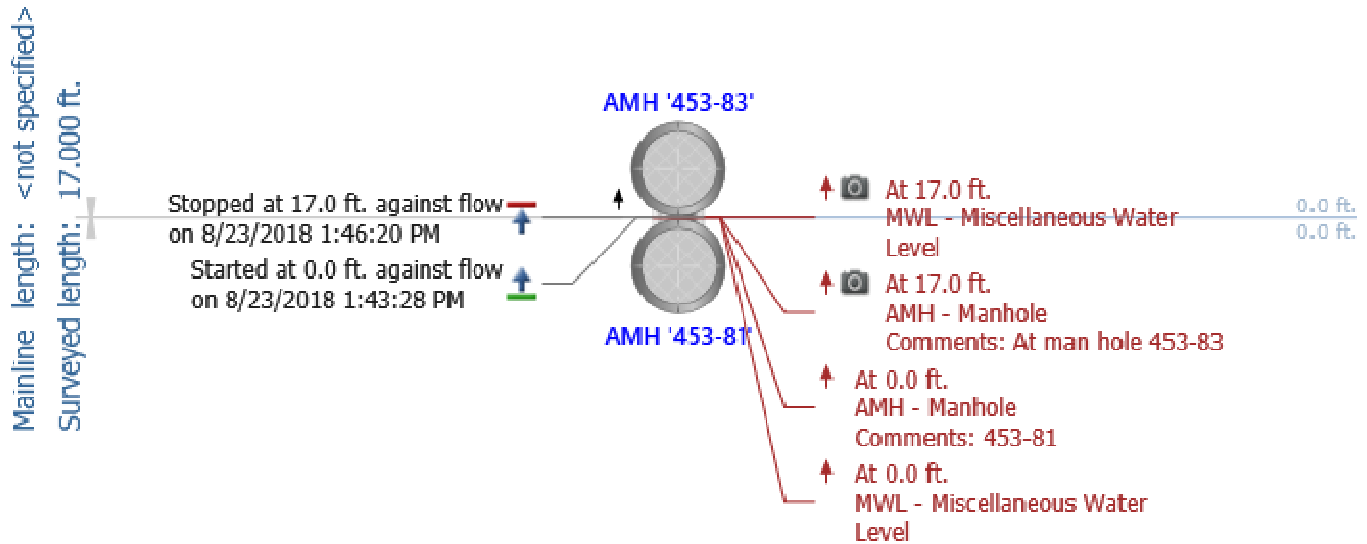
Notes: 453-83 to 453-81

- 12-in. CMP
- 17 LF
- 0-1" debris
- Surface corrosion visible in 4:00 and 8:00 position, metal loss observed at 8 LF
- Downstream invert probed, metal loss observed
- Flow: 0-1"
- Grade score of: 3

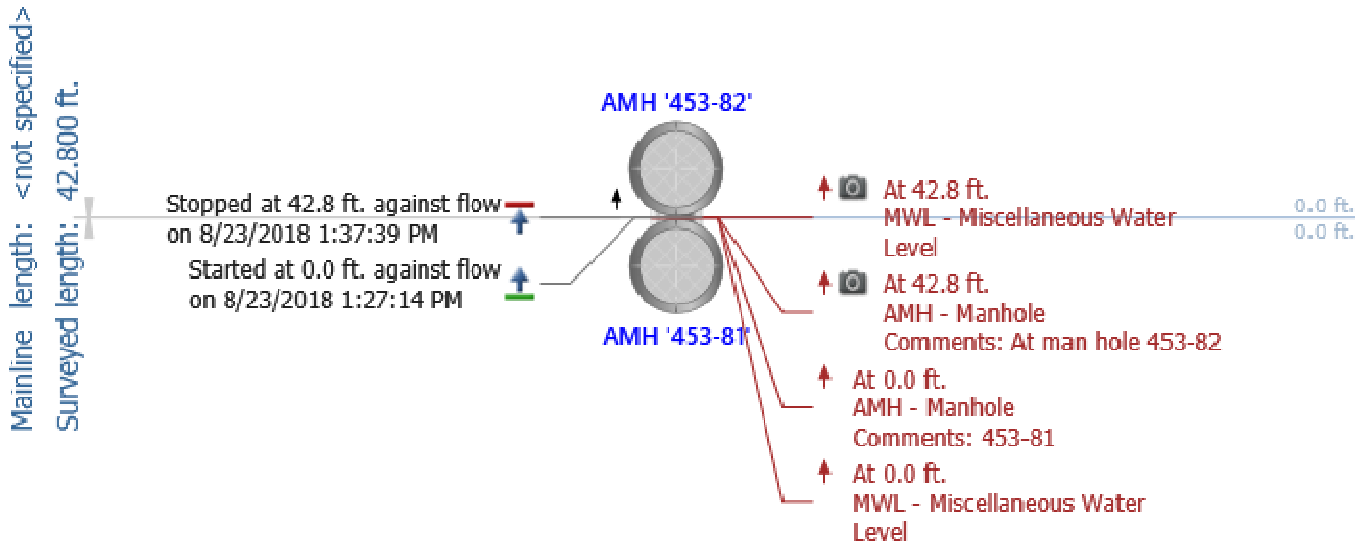
Notes: 453-82 to 453-81

- 12-in. CMP
- 43 LF
- 0-1" debris
- Surface corrosion on pipe ends at joints
- Surface corrosion/discoloration, 5:00 and 7:00 18 LF, corrosion moves to 3:00 and 9:00 position at 36 LF
- Downstream invert probed, metal appeared sound
- Flow: 0-1"
- Grade score of: 2

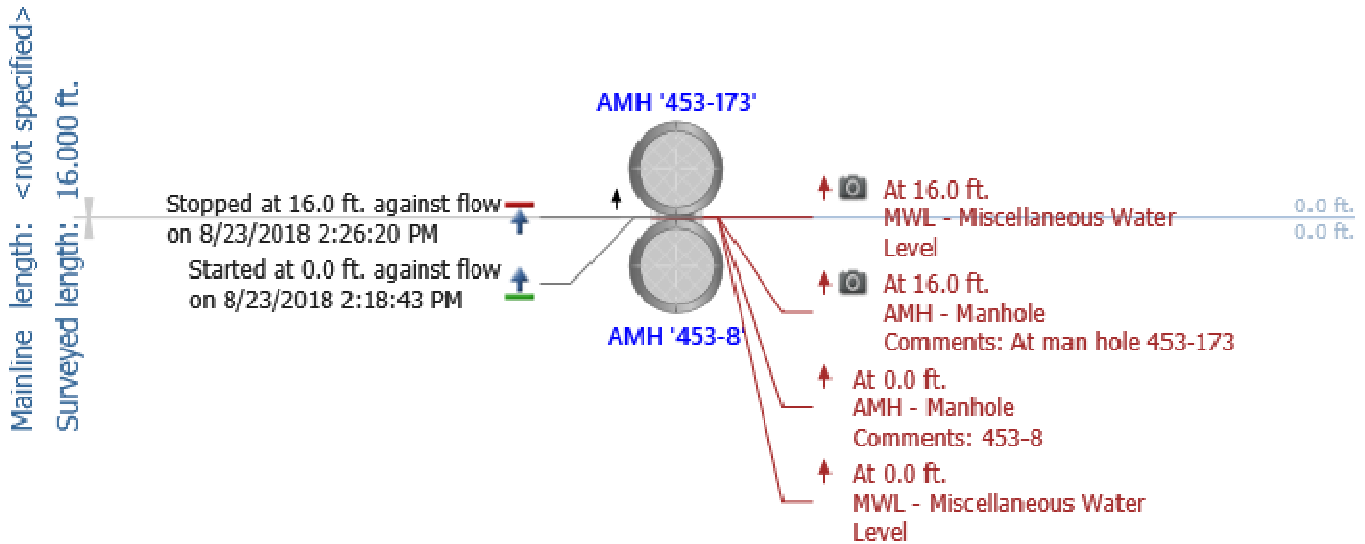
Notes: 453-173 to 453-8

- 12-in. CMP
- 16 LF
- 1-2" of debris
- Surface corrosion 3:00 to 9:00 position
- Debris buildup at upstream end
- Flow: 1-2"
- Grade score of: 3
