Alaska Department of Transportation and Public Facilities Central Region

NHS STORM DRAIN INSPECTION CONDITION REPORT PROJECT NO. 0A31055 / Z591280000

Dimond Boulevard from Jewel Lake Road to Old Seward Highway
Muldoon Road from Boundary Avenue to Northern Lights Boulevard
Debarr Road from Bragaw Street to Muldoon Road
Downtown: 5th and 6th Avenue from Gambell Street to Orca Street and
Ingra Street from 6th Avenue to 9th Avenue

May 20th, 2019

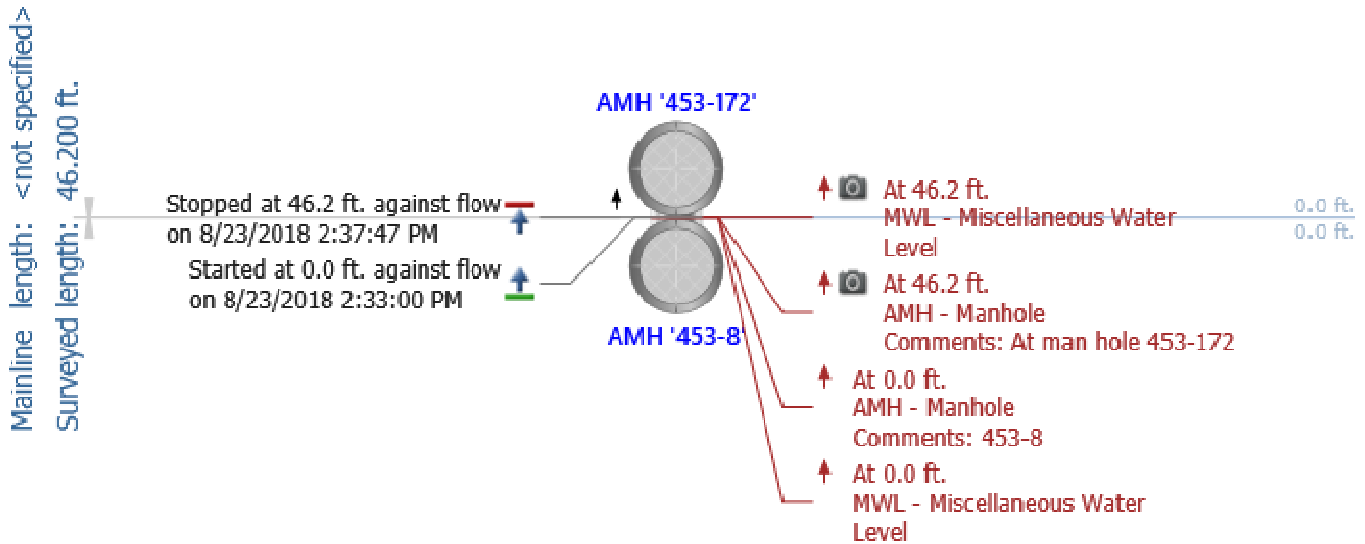
Notes: 453-172 to 453-8

- 12-in. CMP
- 46 LF
- Surface corrosion at pipe ends at joints
- Minor surface corrosion visible in 5:00 and 7:00 position 19 LF to 39 LF, spreads to 4:00 and 8:00 and metal flaking at 39 LF
- Minimal debris in pipe, 3" debris buildup at 40 LF
- Flow: 0-1"
- Grade score of: 3

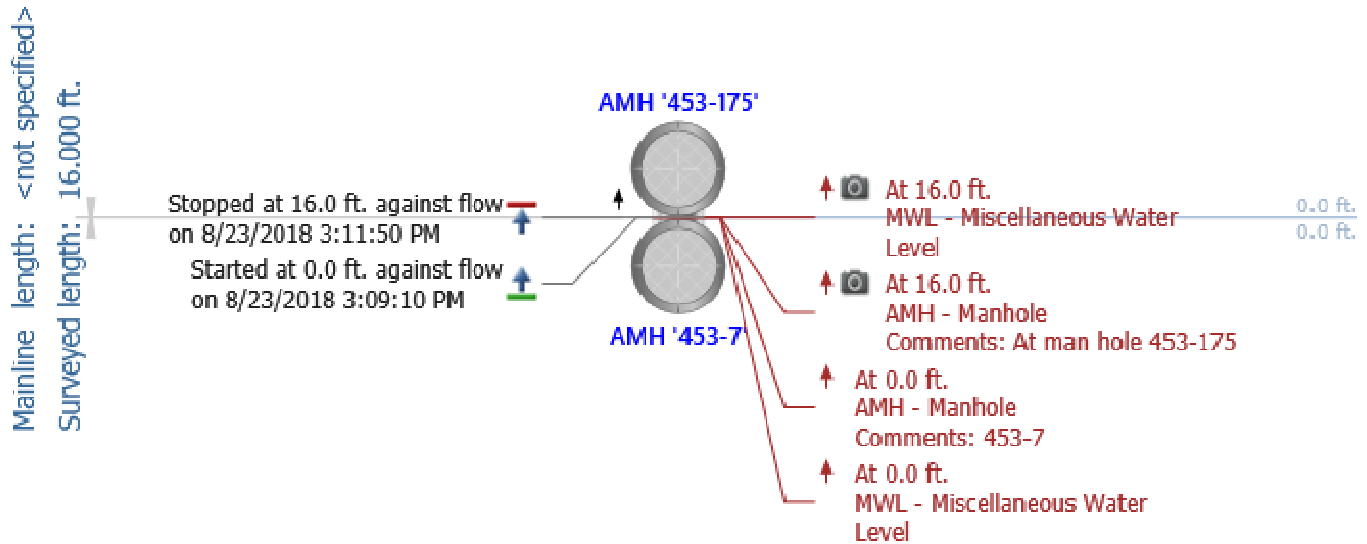
Notes: 453-175 to 453-7

- 12-in. CMP
- 16 LF
- Minimal debris in pipe
- No defects observed
- Flow: Minimal
- Grade score of: 1

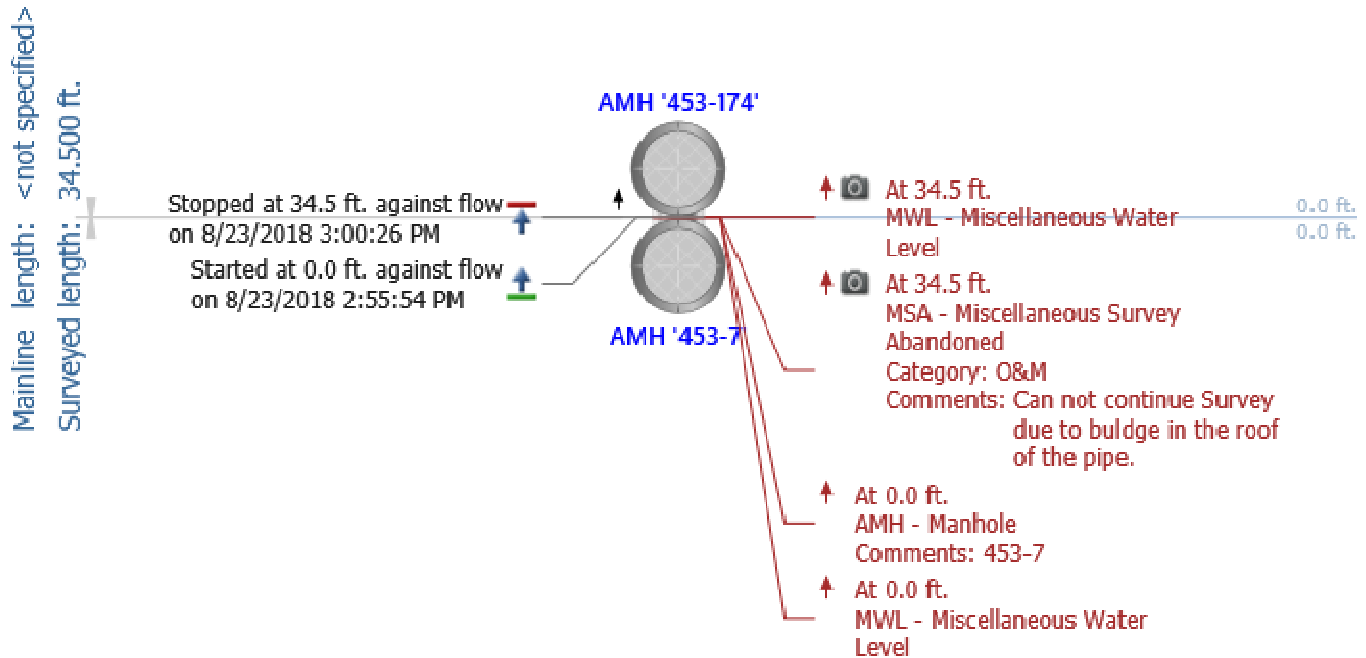
Notes: 453-174 to 453-7

- 12-in. CMP
- 35 LF
- 0-1" debris in upstream end
- Surface corrosion visible in 5:00 and 7:00 position
- Surface corrosion on pipe ends at joint
- 3-4" deformation 12:00 position at 30 LF
- 6-7" deformation, 11:00 to 4:00 position at 35 LF, camera unable to pass
- Camera zoomed to complete inspection
- Flow: 0-1"
- Grade score of: 3

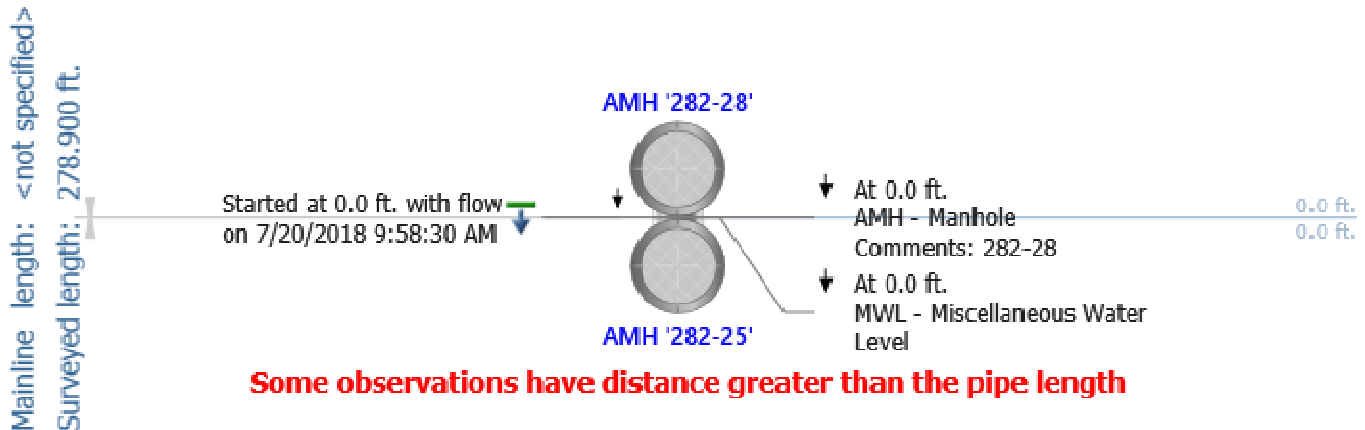
Notes: 282-28 to 282-25

- 18-in. CMP
- 279 LF
- Minimal Debris
- Upstream invert probed, metal appeared sound, corrosion visible in invert down pipe
- Minor surface corrosion at pipe end at joints
- Minor debris increase at joints, 1-2"
- Transition between pipe sticks uneven at joint at 185 LF. does not appear to affect flow properties of pipe
- Debris at downstream end
- Flow: None
- Grade score of: 2

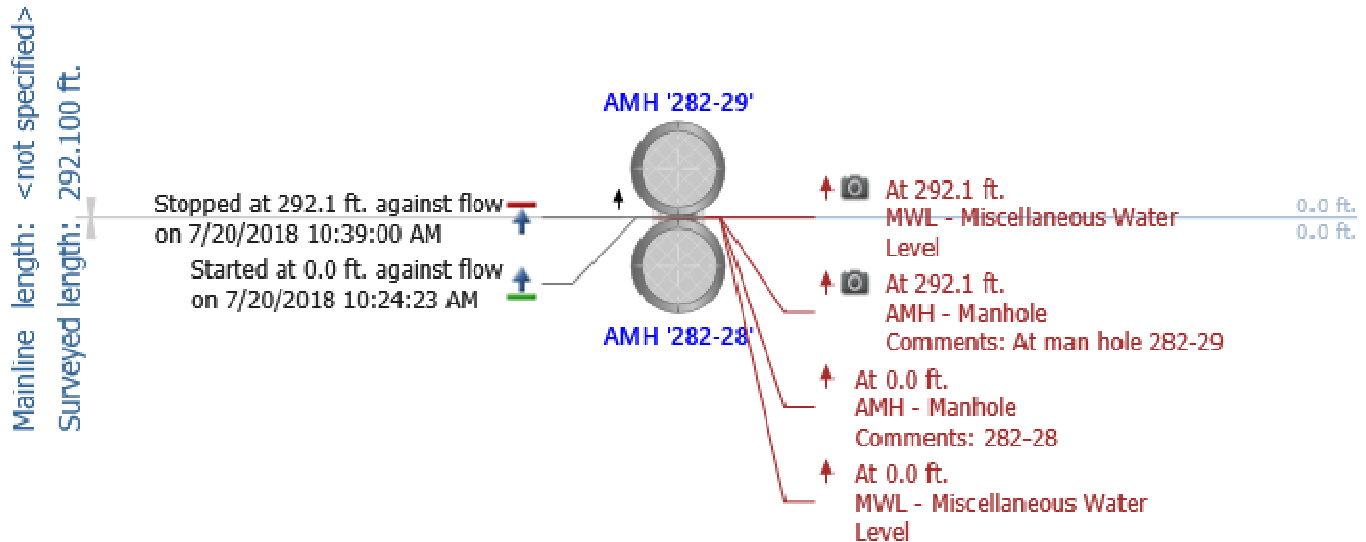
Notes: 282-29 to 282-28

- 18-in. CMP
- 292 LF
- Minimal debris, 1" debris in upstream end
- Surface corrosion visible in invert, downstream invert appeared sound when probed
- Discoloration between 5:00 and 7:00 position
- Corrosion visible at pipe ends at joints
- 2-3" deformation, 11:00 to 12:00 position at 156 LF
- Pipe oval, 229 LF, approximately 5-10% loss in cross sectional area
- 1" deformation, 10:00 position at 275 LF
- Flow: Minimal
- Grade score of: 3

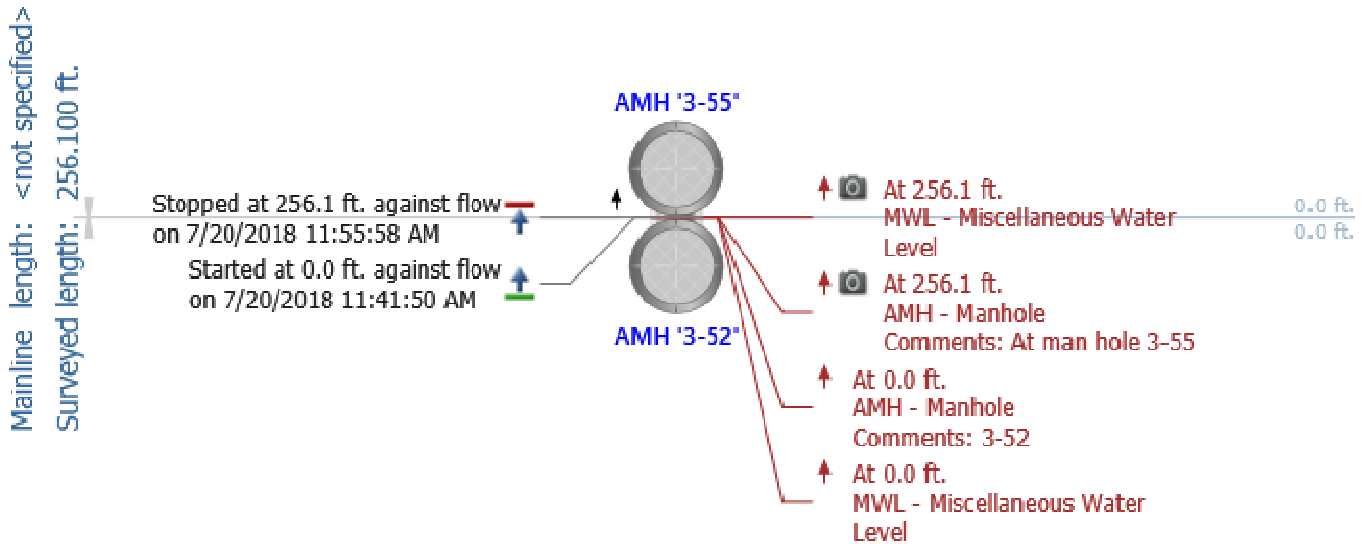
Notes: 3-55 to 3-52

- 18-in. DIP
- 256 LF
- 1-2" debris
- Debris buildup at joint at 220 LF
- Evidence of surface corrosion in invert, obscured by debris, debris is tinted rust color at various joints
- Corrosion visible at pipe ends at joints
- No major structural defects
- Flow: 1-2"
- Grade score of: 2

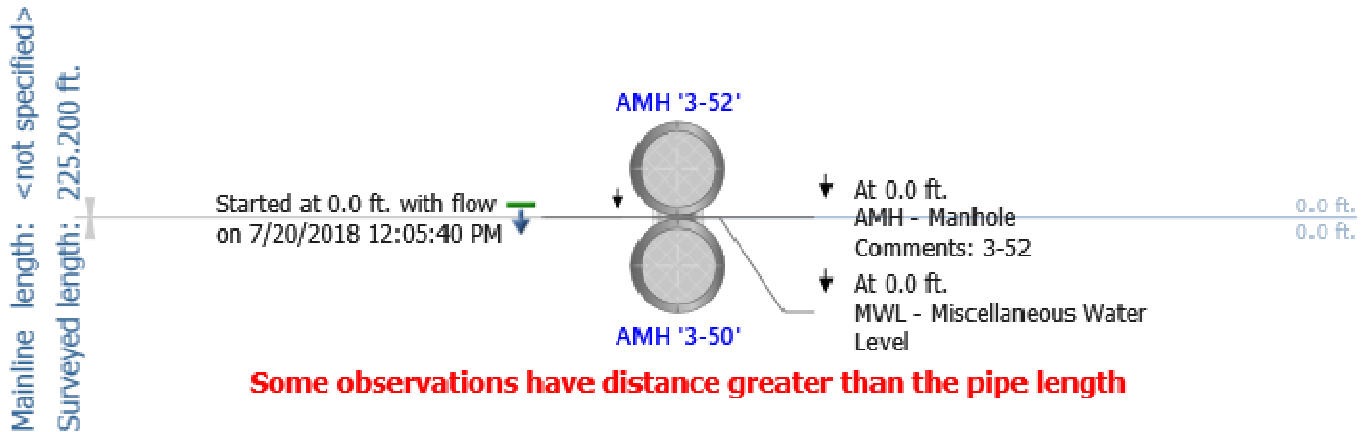
Notes: 3-52 to 3-50

- 24-in. RCP
- 225 LF
- 1-2" debris in upstream end, backs up flow to approximately 1", less than 1" debris on average throughout pipe
- Crack, 8:00 position from 93 LF to 100 LF
- Crack, 2:00 position from 123 LF to 132 LF
- Flow: 0-1"
- Grade score of: 1

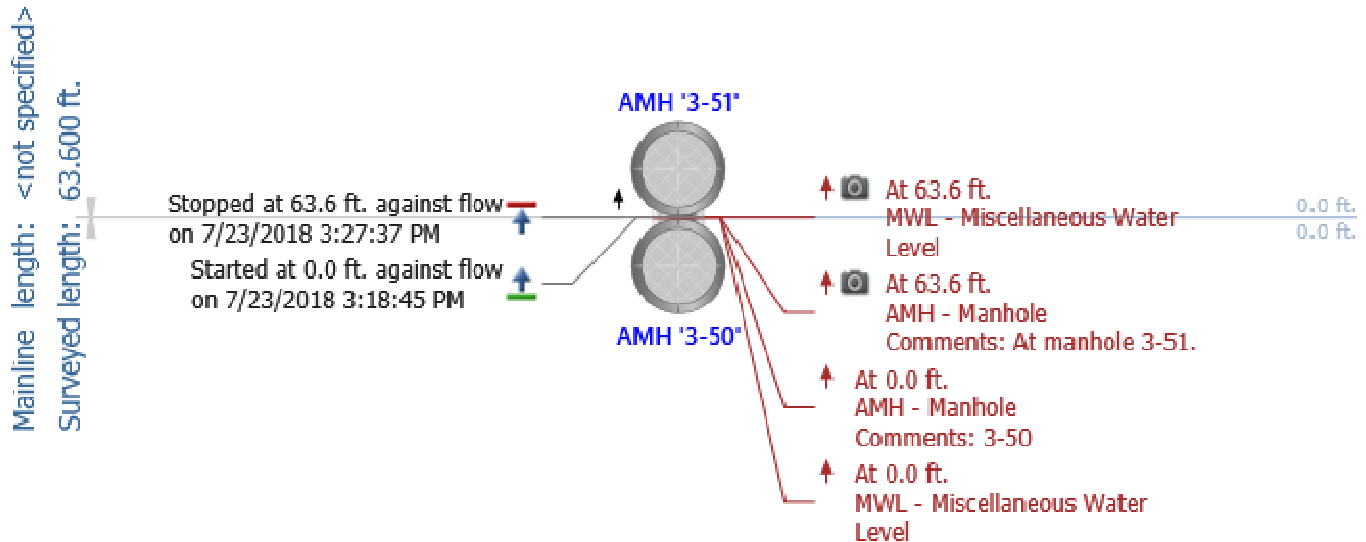
Notes: 3-51 to 3-50

- 12-in. CMP
- 64 LF
- Surface corrosion visible, 5:00 position to approximately 50 LF
- 2" deformation in 12:00 position, 8 LF
- Evidence of corrosion in invert, debris has rust tint
- 1-2" deformation, 12:00 position 12 LF
- Surface corrosion at pipe ends at joints
- 0-1" debris in pipe, 1-2" at 48 LF to end of survey
- 2-3" deformation in 12:00 position at 53 LF
- Surface corrosion in 3:00 and 9:00 position, 50 LF to end of survey
- Flow: 0-1"
- Grade score of: 3

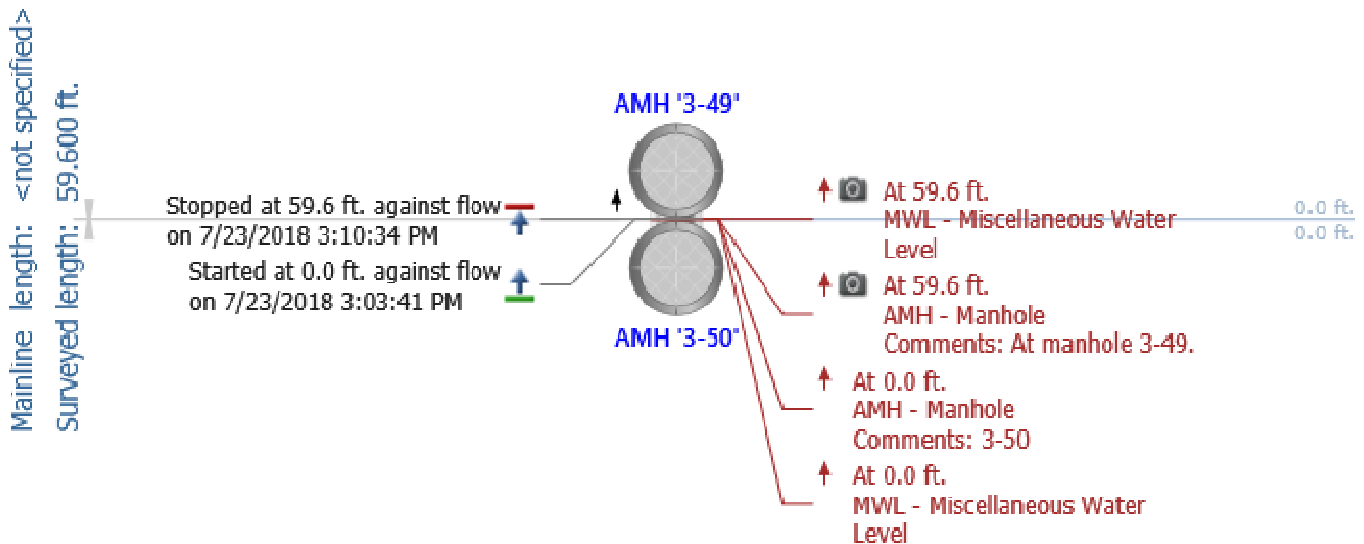
Notes: 3-49 to 3-50

- 12-in. CMP
- 60 LF
- Discoloration in bottom half of pipe
- 0-1" debris, increases to approximately 2" at 46 LF, obscures invert
- Corrosion of pipe ends at joints
- Flow: Minimal
- Grade score of: 1

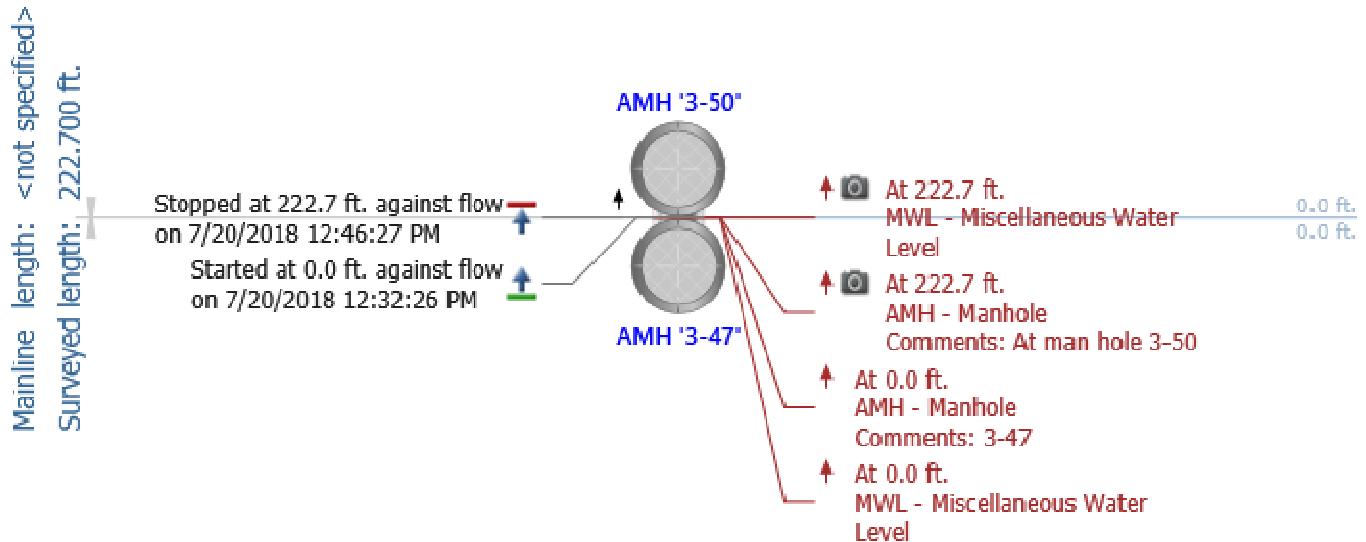
Notes: 3-50 to 3-47

- 24-in. RCP
- 223 LF
- Crack, 10:00 position, 3 LF to approximately 11 LF
- Crack, 12:00 position, 29 LF to 32 LF
- Minimal debris
- Hole in pipe, 107 LF 2:00 position
- Crack, 12:00 position at 133 LF
- Crack, 2:00 position, 198 LF
- Crack, 2:00 position, 208 LF
- Evidence of infiltration at joint, 212 LF
- Rebar exposed in downstream end
- Flow: Minimal
- Grade score of: 2

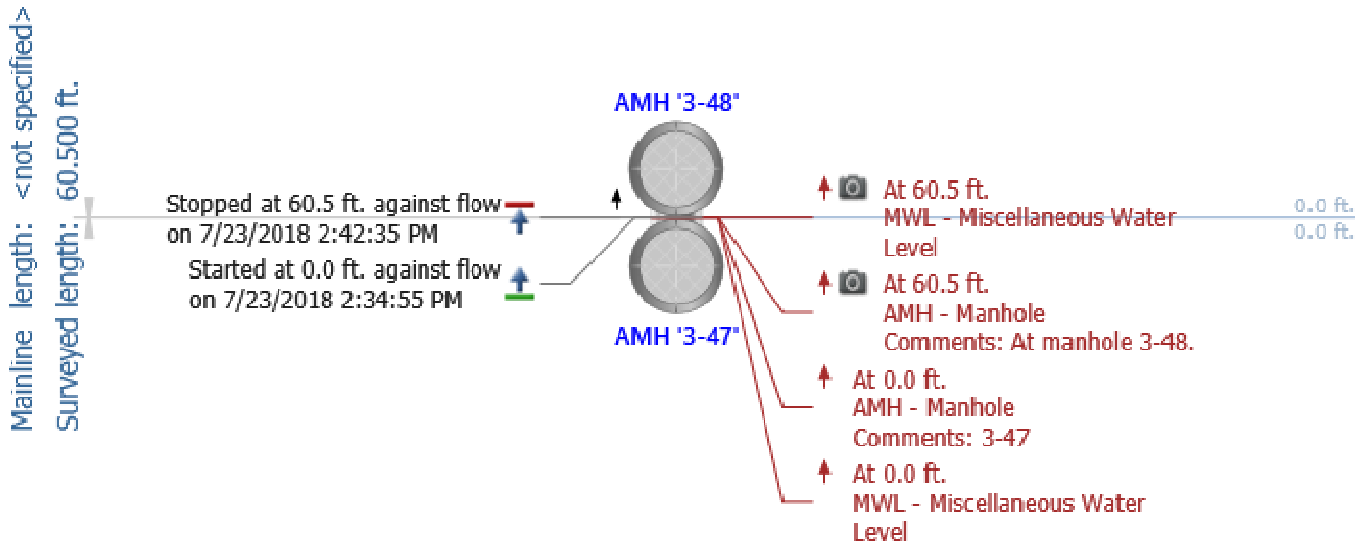
Notes: 3-48 to 3-47

- 12-in. CMP
- 61 LF
- Discoloration 3:00 position to 8:00 position
- Surface corrosion on pipe ends at joints
- Surface corrosion in 5:00 and 8:00 position, 3:00 and 9:00 position 43 LF to
- 1-2" of debris, debris buildup at 43 LF
- Water level 2-3", decreases to 0-1" after 20 LF, increases at 43 LF to 3-4"
- Unable to examine condition of invert due to debris
- Flow: Varies
- Grade score of: 3

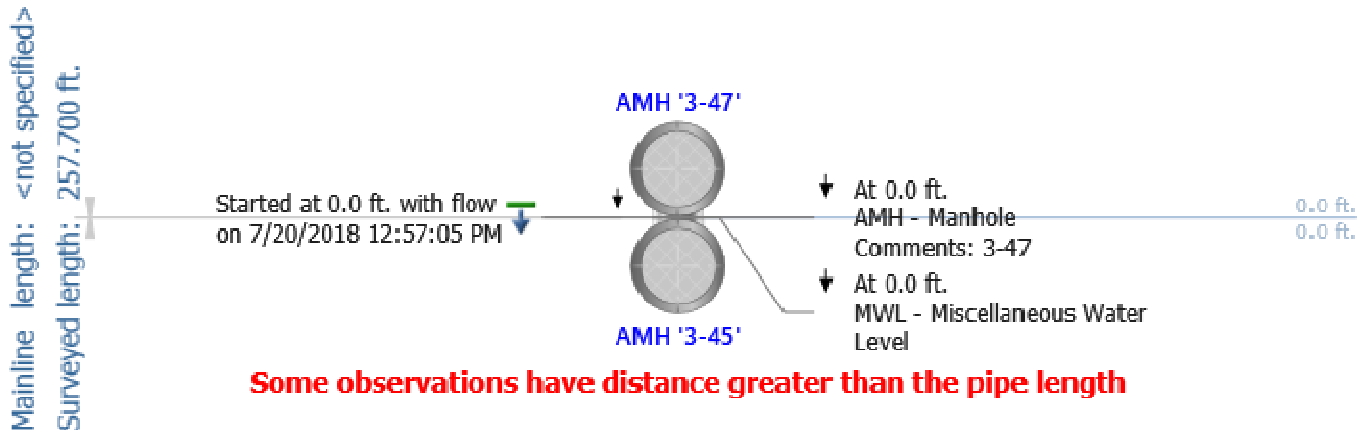
Notes: 3-47 to 3-45

- 24-in. RCP
- 258 LF
- 0-1" debris
- Crack, 1:00 position from 20 LF to 28 LF
- Cracks in 1:00 and 10:00 position, 53 LF to 58 LF
- Crack 1:00 position, 80 LF to 89 LF
- Crack 1:00 position 99 LF to 106 LF
- Crack, 10:00 position, 110 LF to 115 LF
- Circumferential crack at 131 LF
- Crack, 11:00 position 149 LF to 159 LF
- Crack, 11:00 position 180 LF to 190 LF
- Crack, 9:00 position 192 LF to 195 LF
- Circumferential cracks 193 LF and 195 LF
- Flow: 0-1"
- Grade score of: 2

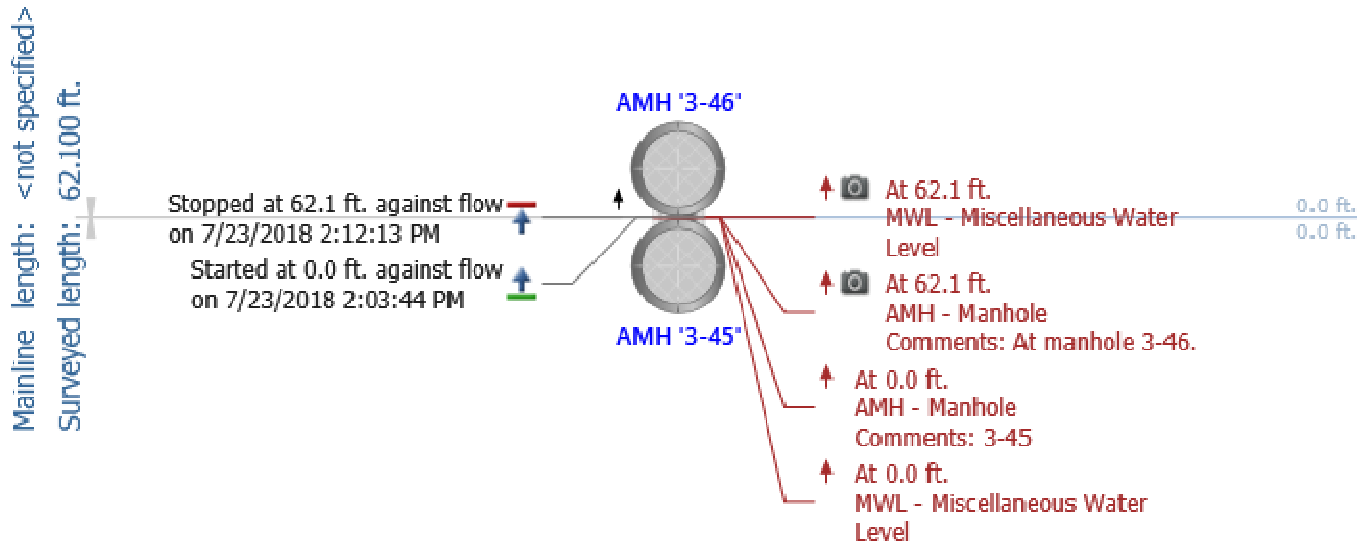
Notes: 3-46 to 3-45

- 12-in. CMP
- 62 LF
- 0-1" debris in pipe
- Discoloration in bottom half of pipe
- Surface corrosion visible at pipe ends at joint
- Surface corrosion visible, 5:00 and 7:00 position
- Surface corrosion visible 3:00 and 9:00 position, 50 LF to end of survey
- Holes in pipe, soil visible 9:00 position 60 LF
- Corrosion likely in invert, unable to verify due to debris
- Flow: None
- Grade score of: 4

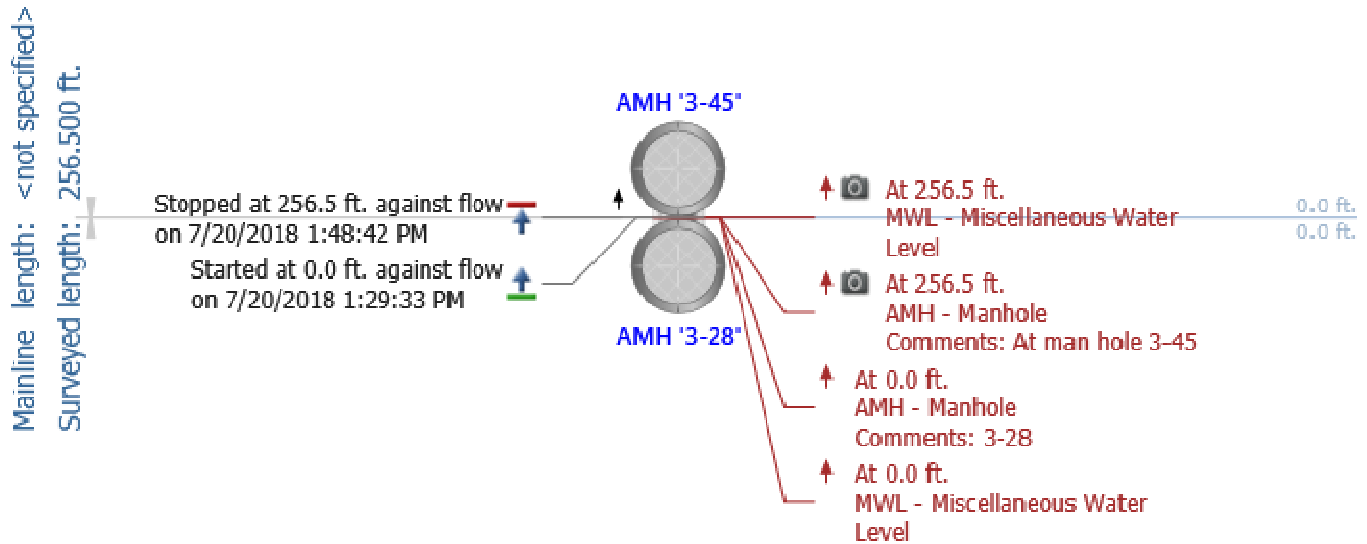
Notes: 3-45 to 3-28

- 24-in. RCP
- 257 LF
- Debris in pipe, 4:00 to 8:00 position approximately 1"
- Circumferential crack at 125 LF
- No major structural defects to pipe
- Flow: 1-2"
- Grade score of: 1

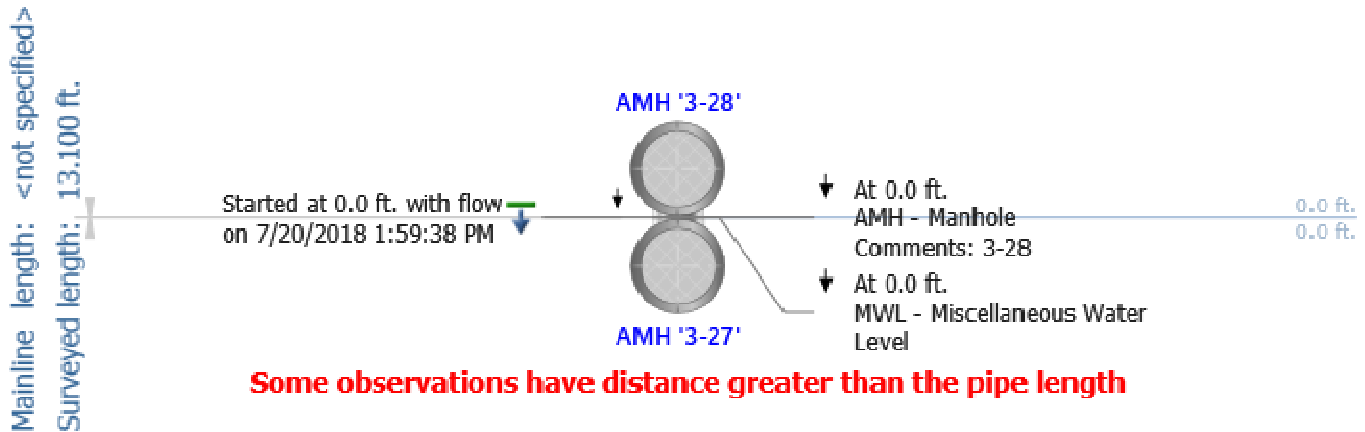
Notes: 3-28 to 3-27

- 36-in. RCP
- 13 LF
- Rebar exposed in top of pipe, 11 LF
- Inspection incomplete due to debris, unable to make conclusion about entire condition of pipe, estimating similar condition throughout
- No major structural defects observed
- Flow: 2-3"
- Grade score of: 1

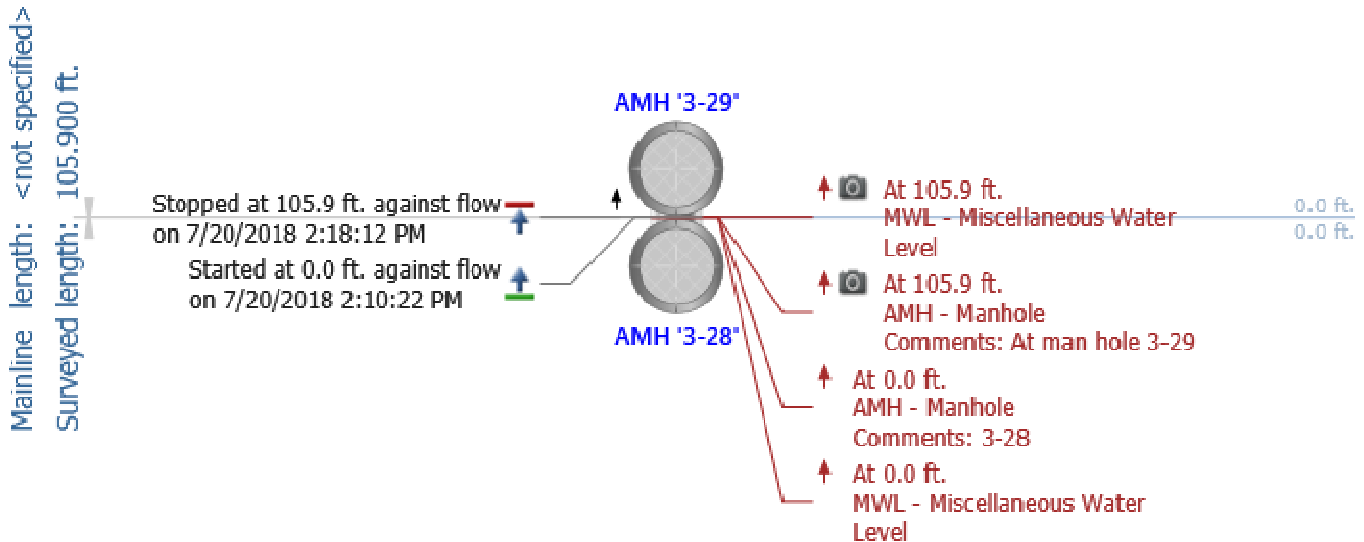
Notes: 3-29 to 3-28

- 30-in. CMP
- 106 LF
- 1-2" debris
- Surface corrosion visible in 4:00 and 8:00 position
- Corrosion visible at pipe ends at joints
- 1" deformation, 12:00 position at 64 LF
- 1" deformation, 1:00 position at 85 LF
- 2-3" deformation, 12:00 position at 88 LF
- Pipe crush, approximately half of pipe, corrosion visible, 12:00 position, at 97 LF
- Upstream invert probed, reported as soft, likely corrosion/metal loss in invert, obscured by debris in pipe
- Flow: Minimal
- Grade score of: 3

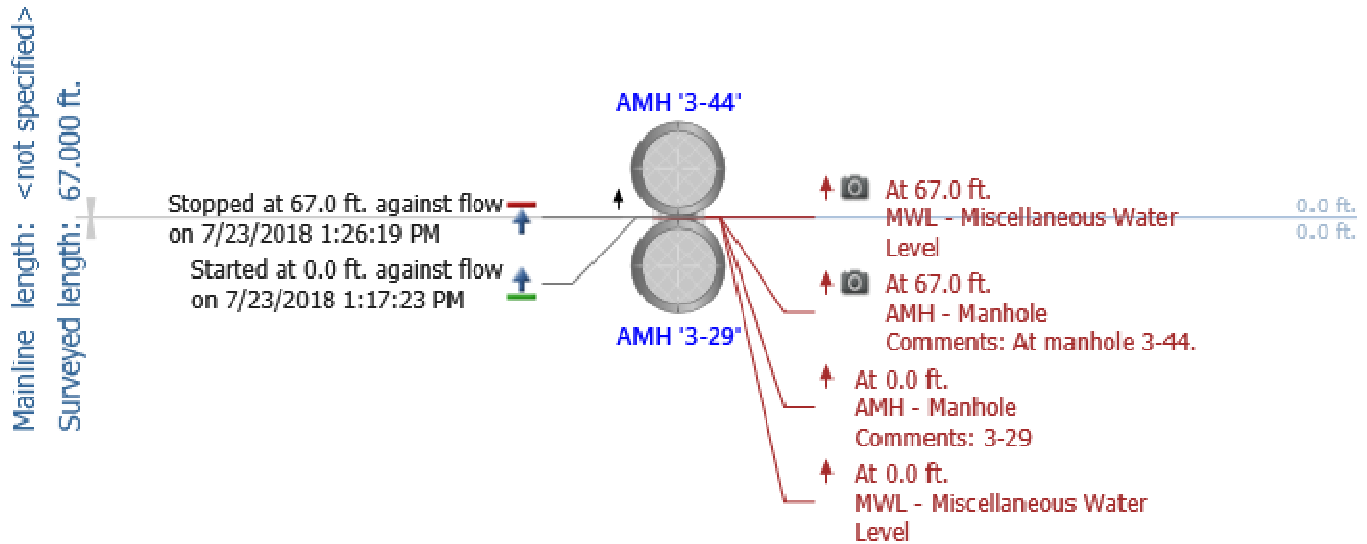
Notes: 3-44 to 3-29

- 18-in. CMP
- 67 LF
- 1-2" debris in pipe, half full of debris at upstream end
- Surface corrosion visible between 5:00 and 7:00 position
- Discoloration in bottom half of pipe
- 31 LF, pipe material changes, perforations around entire pipe
- Flow: None
- Grade score of: 3

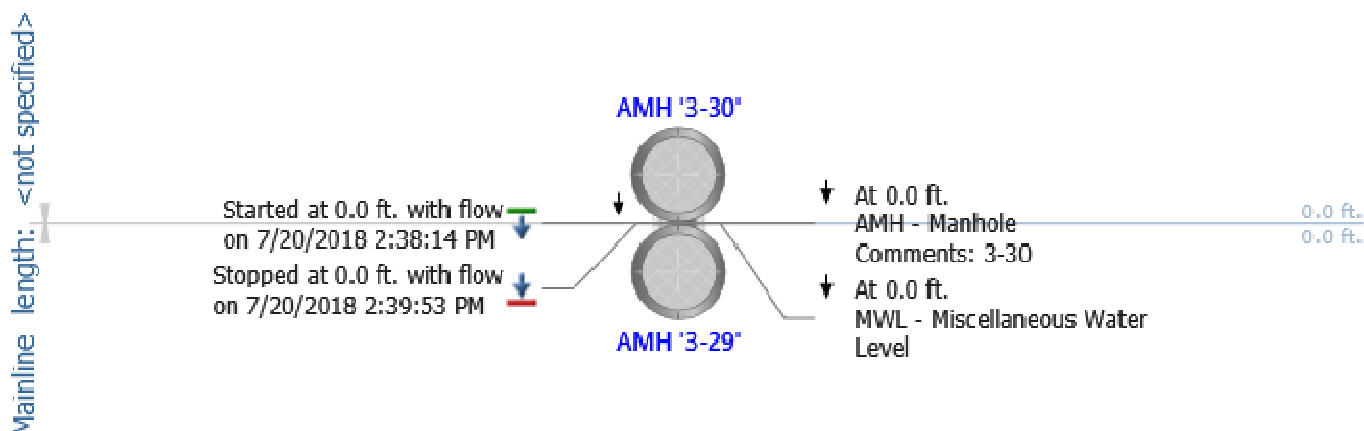
Notes: 3-30 to 3-29

- 30-in. CMP
- 208 LF
- 0-1" debris
- Corrosion visible in 4:00 and 8:00 position
- Surface corrosion visible at pipe ends at joints, 97 LF, 121 LF, 145 LF, 170 LF, 194 LF
- Invert obscured by debris, rust tinted debris shows evidence of corrosion as well as hole developed in upstream invert, inverts probed, metal is soft and metal loss found in upstream manhole
- 3" deformation in 11:00 position, 198 LF
- Flow: 0-1"
- Grade score of: 3

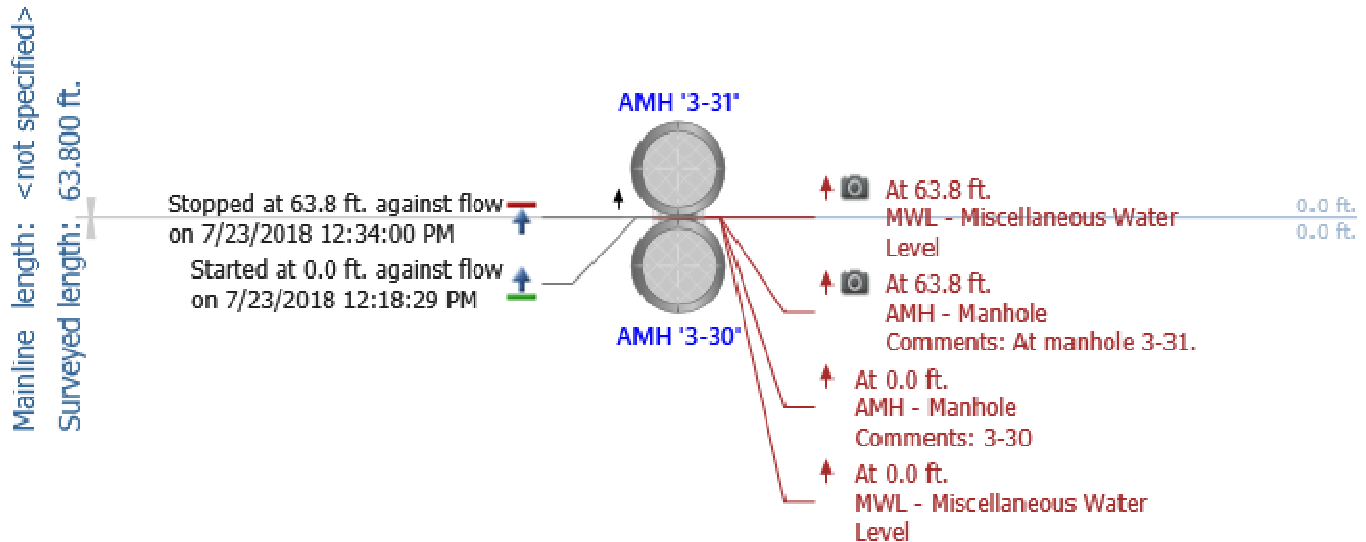
Notes: 3-31 to 3-30

- 12-in. CMP
- 64 LF
- Debris increases from 0-1" to 2-3" at 20 LF to end of pipe, 4" pile at 37 LF, knocked down by camera
- Surface corrosion 5:00 position and 7:00 position 3 LF to 20 LF, 3:00 to 9:00 position at 20 LF, 5:00 and 7:00 position 46 LF
- Corrosion visible in invert at 46 LF, likely corrosion in entire invert
- Surface corrosion on pipe ends at joints
- Flow: None
- Grade score of: 3

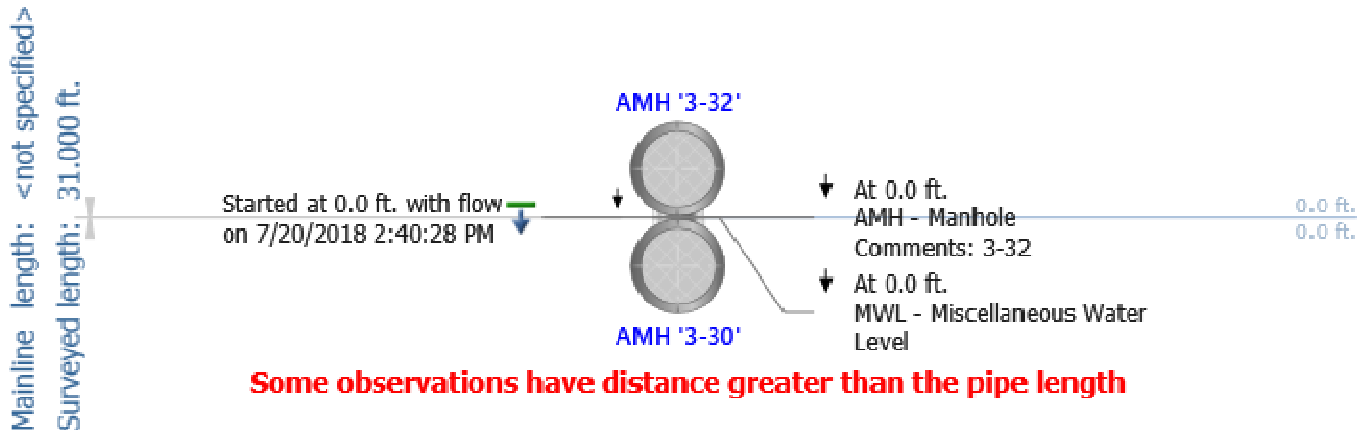
Notes: 3-32 to 3-30

- 24-in. CMP
- 31 LF
- 0-1" of debris
- Corrosion visible at pipe ends at joints
- Corrosion visible at 5:00 and 7:00
- 1" broken off invert in downstream end treatment
- Inverts probed, metal loss reported in downstream invert, metal sound in upstream, likely corrosion in invert throughout pipe, obscured by debris
- Flow: Minimal
- Grade score of: 3

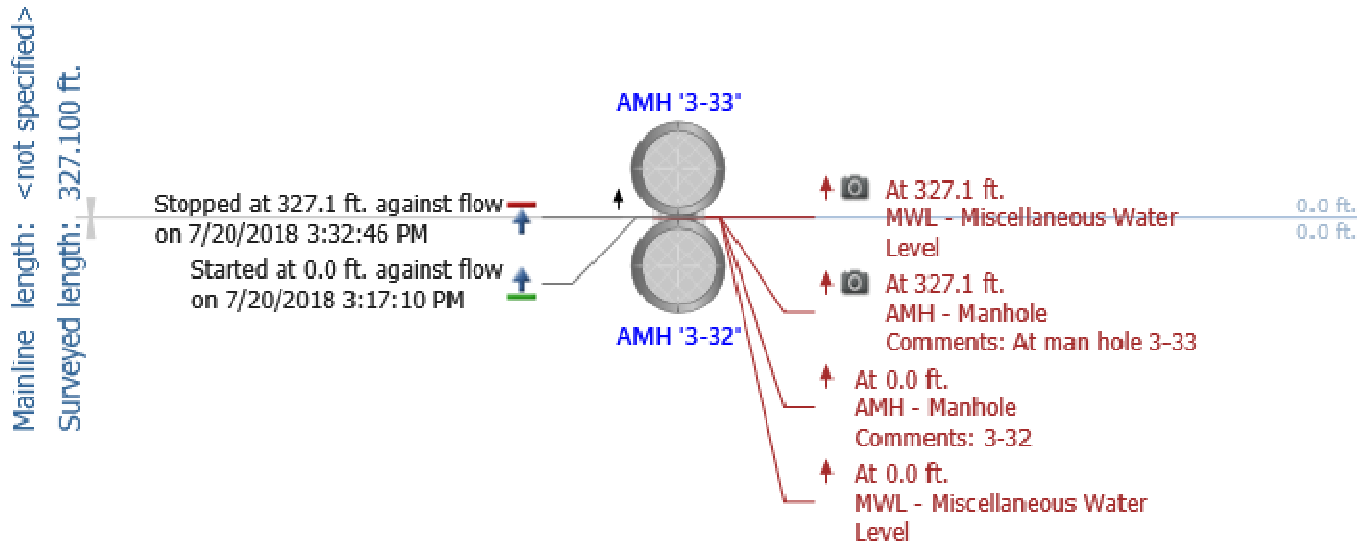
Notes: 3-33 to 3-32

- 24-in. CMP
- 327 LF
- Corrosion at pipe ends at joints
- 0-2" debris
- Surface corrosion, 5:00 and 7:00 position
- Surface corrosion in invert, obscured by debris throughout pipe, invert probed at downstream end, metal appeared sound despite surface corrosion
- Joint appears offset, 7:00 position at 146 LF
- No major structural defects observed
- Flow: 0-1"
- Grade score of: 2

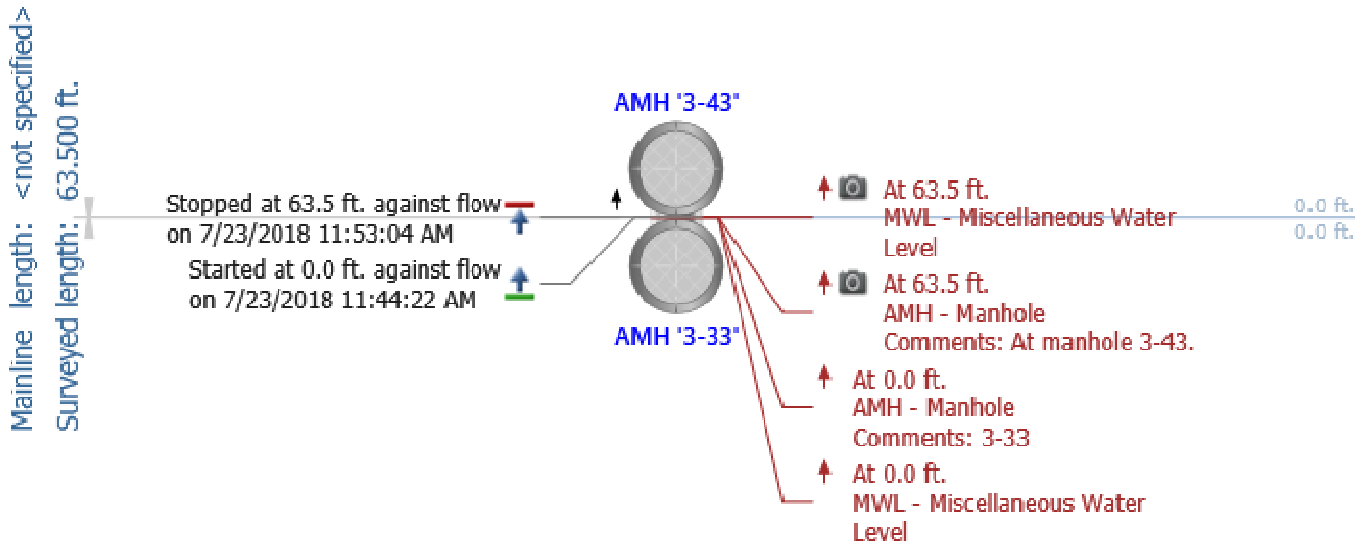
Notes: 3-43 to 3-33

- 12-in. CMP
- 64 LF
- Discoloration 5:00 to 7:00 position
- 0-1" debris. 1-2" of debris 30 LF to 40 LF
- Surface corrosion at pipe ends at joint
- Surface corrosion 5:00 and 7:00 position visible at joint 41 LF
- Surface corrosion 4:00 and 8:00 position 53 LF to end of pipe
- Visible metal loss 8:00 position at 56 LF
- Evidence of corrosion in invert, 56 LF
- Flow: Minimal
- Grade score of: 3

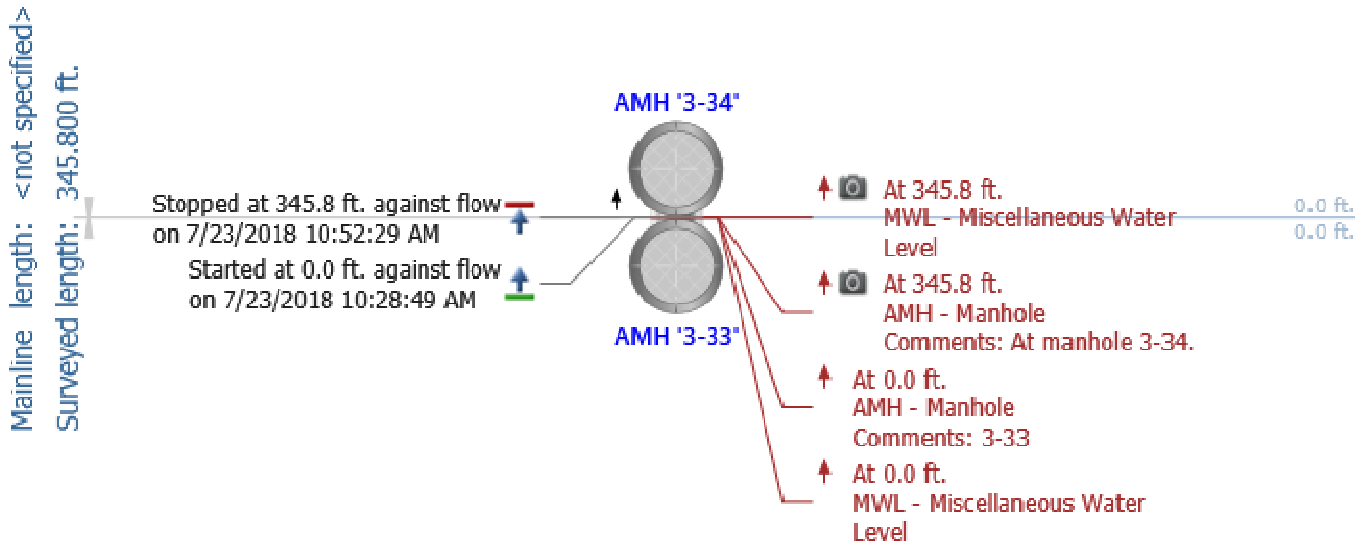
Depth of Sump: 7"

- 24-in. CMP
- 346 LF
- Surface corrosion visible, 5:00 and 7:00 position
- Surface corrosion at pipe ends at joints
- Surface corrosion visible in invert
- Minimal debris
- Multiple 1/2-1" deformations, 12:00 position 325 LF
- No major structural defects
- Flow: Minimal
- Grade score of: 2

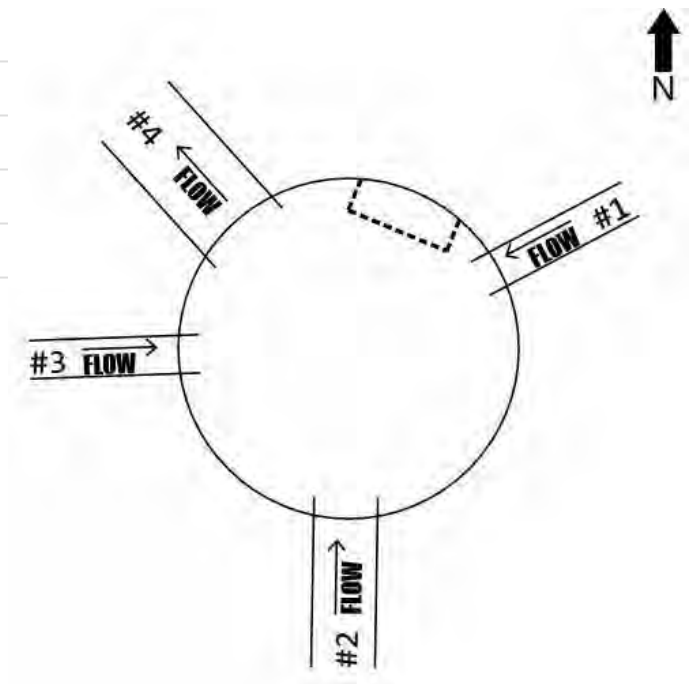
INSPECTION COMPLETED 9/20/18 78.9'

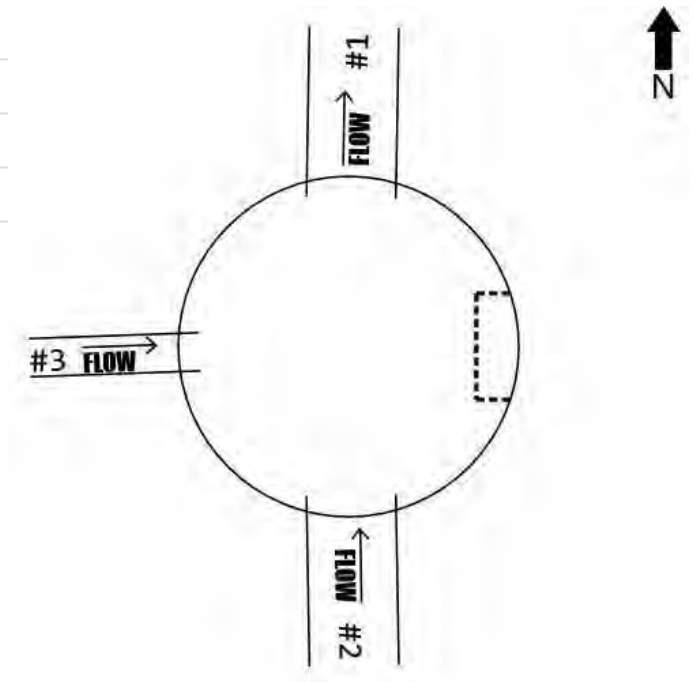
inspection 9/20/18 Stopped 63.3' due to mud. Can see next mh from stop.

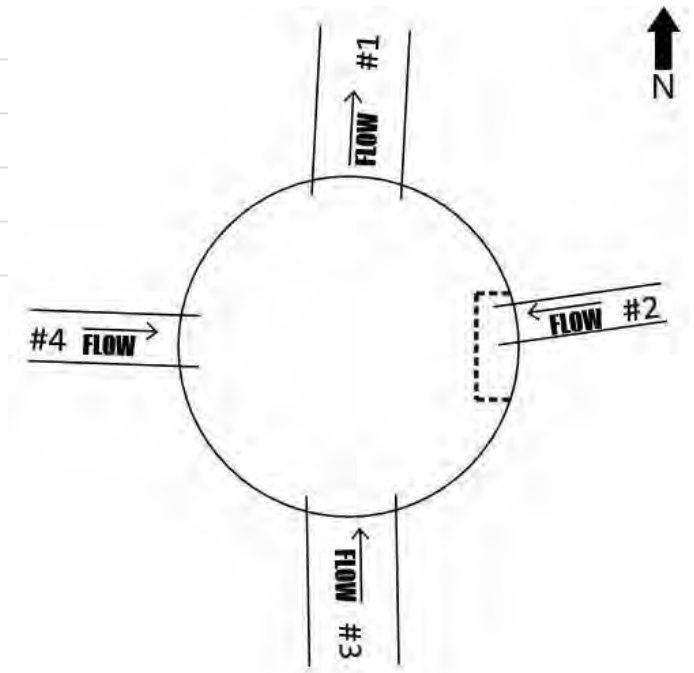
Primary Comments: steps installed under reducing slab. Base cracked circumferential. sump too full for ACCURATE measurement. 9/20/18

invert broken in mh. INSPECTION COMPLETED 9/20/18 64.8'

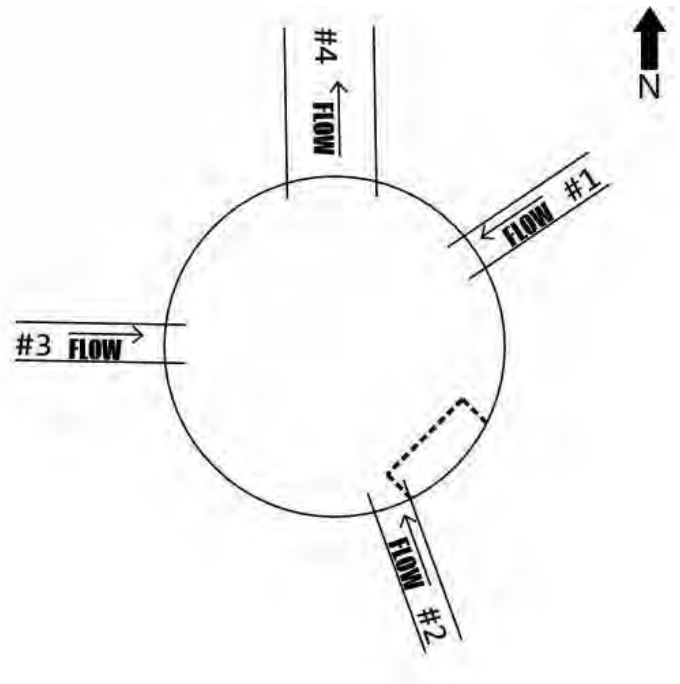
Primary Comments: inspected COMPLETE 9/20/18 Base circumferential cracked

inspection completed 9/20/18 invert PROBED METAL APPEARED SOUND 350.4

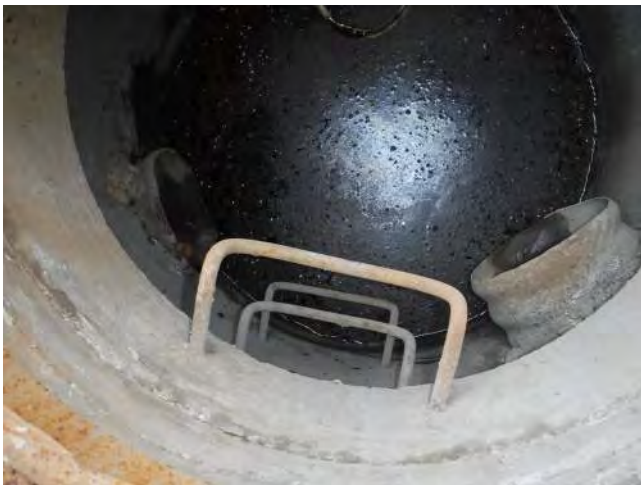
Northeast and southeast connection

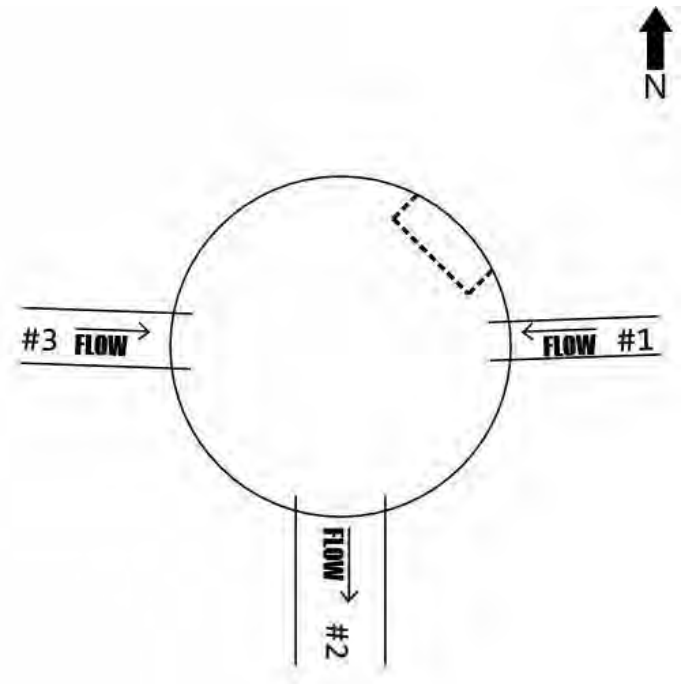
16.9' INSPECTED COMPLETE 8/22/18

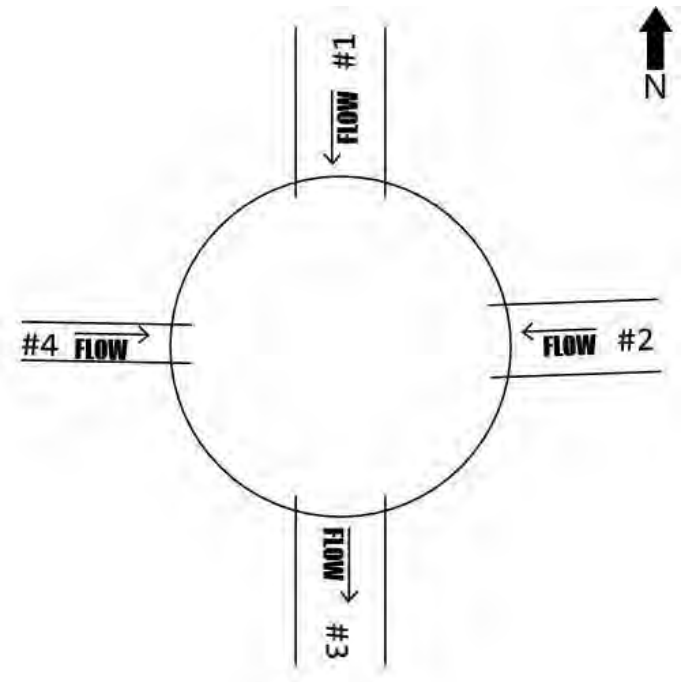
Primary Comments: MISSING RUNGS

Additional Comments: 3 CHIMNEYS, CRACK IN BASE

Surface CORROSION INVERT Inspected 26.5' COMPLETE 8/23/18

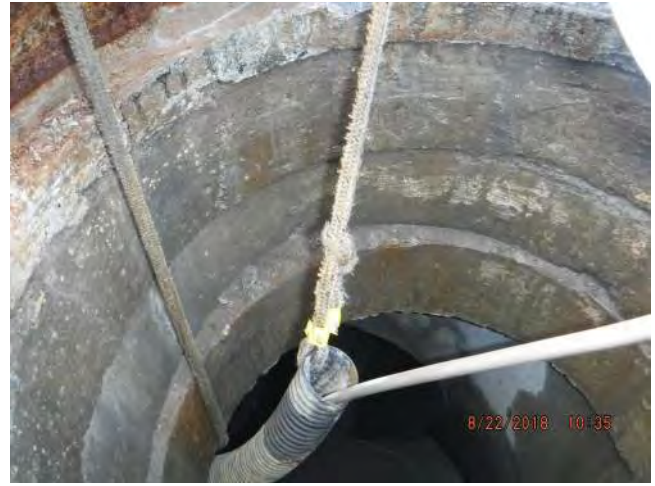
Chimneys and reducing slab

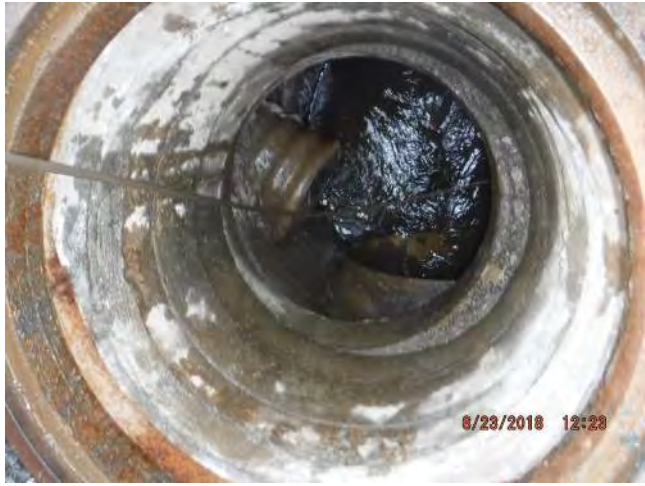
Chimney, offset from reducing slab
