Alaska Department of Transportation and Public Facilities Central Region

NHS STORM DRAIN INSPECTION CONDITION REPORT PROJECT NO. 0A31055 / Z591280000

Dimond Boulevard from Jewel Lake Road to Old Seward Highway
Muldoon Road from Boundary Avenue to Northern Lights Boulevard
Debarr Road from Bragaw Street to Muldoon Road
Downtown: 5th and 6th Avenue from Gambell Street to Orca Street and
Ingra Street from 6th Avenue to 9th Avenue

May 20th, 2019

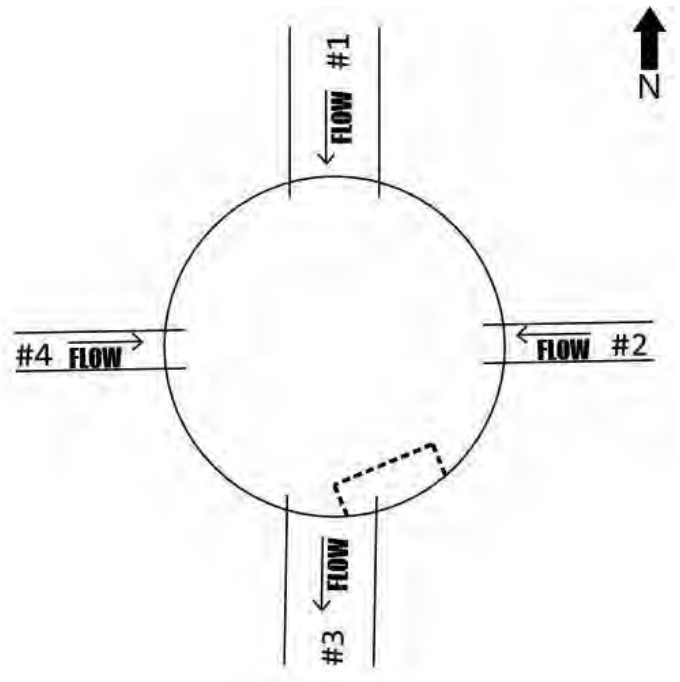
METAL LOSS IN INVERT 16.8' INSPECTED COMPLETE 8/23/18

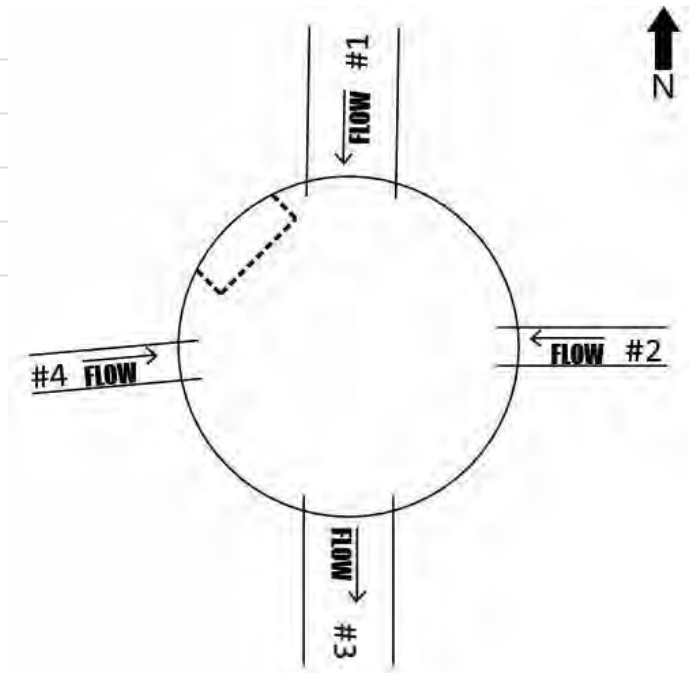
17' INSPECTED COMPLETE 8/23/18 DOWNSTREAM INVERT METAL LOSS

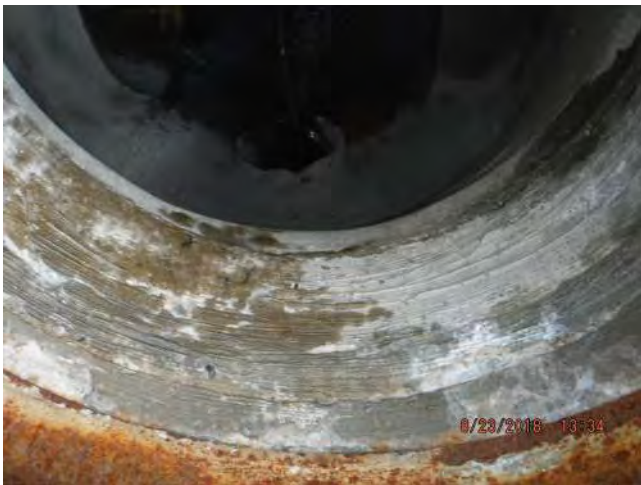
West influent pipe connection

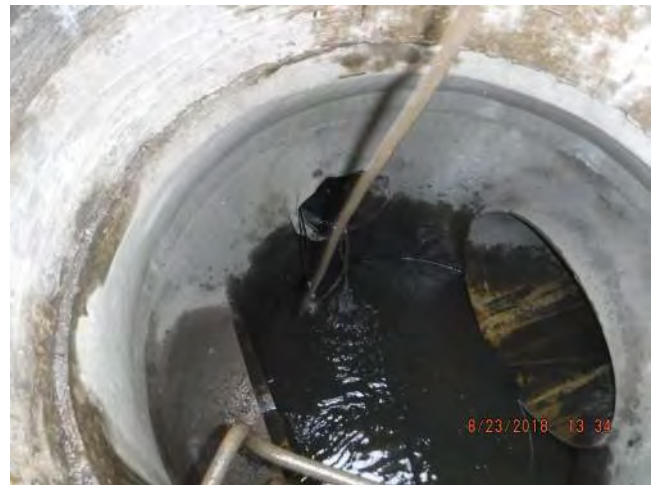
East influent pipe connection

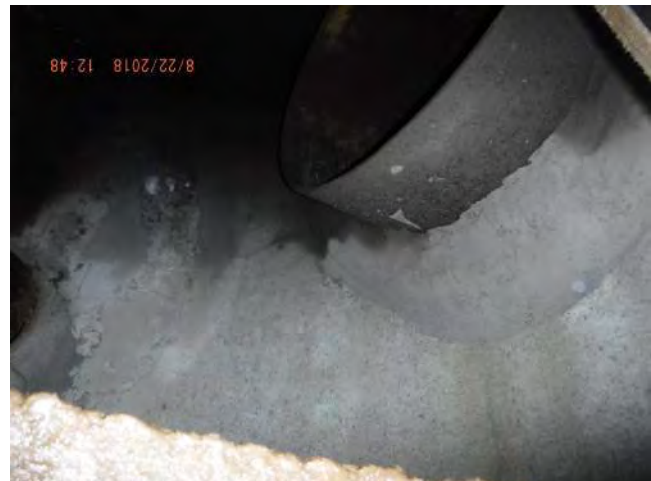
South effluent mainline connection

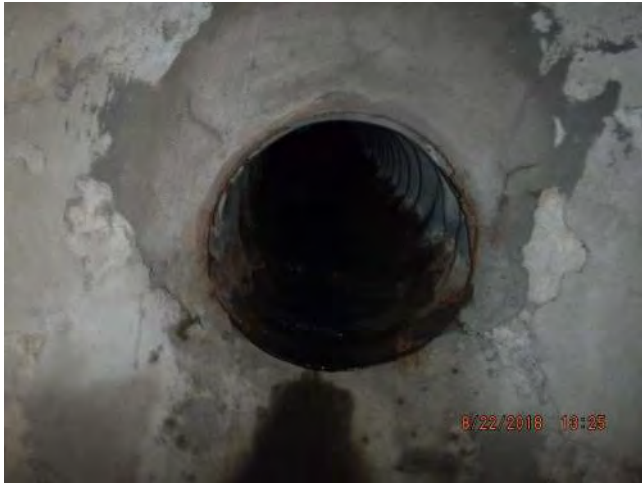
West influent pipe connection

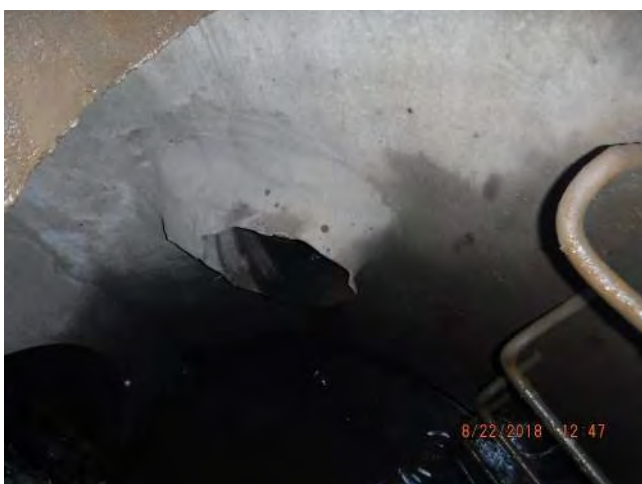
Northeast influent pipe connection

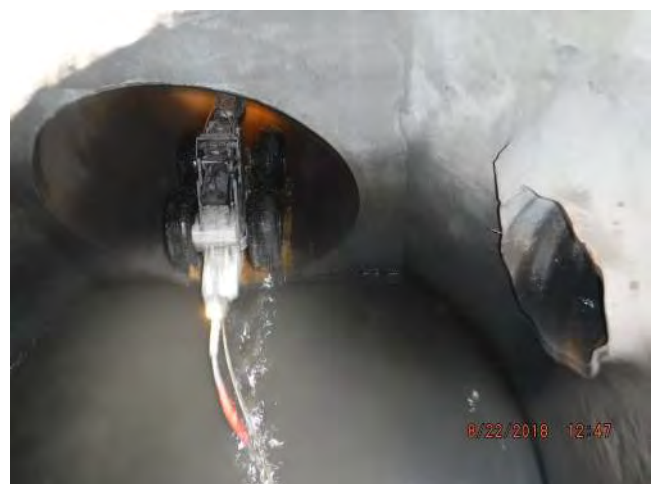
North influent mainline connection

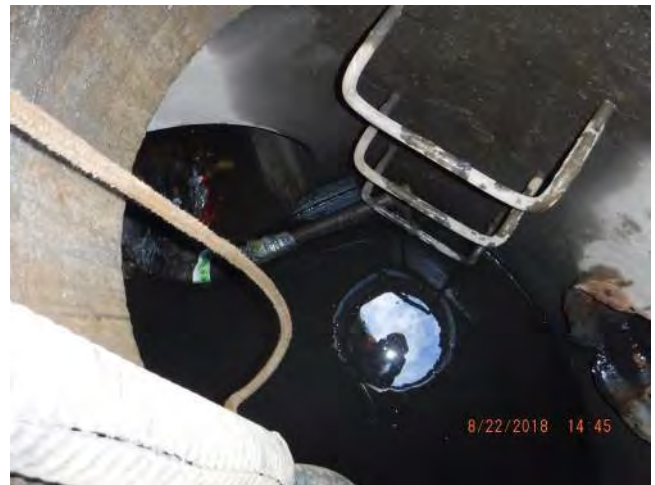
Thaw line in south effluent pipe

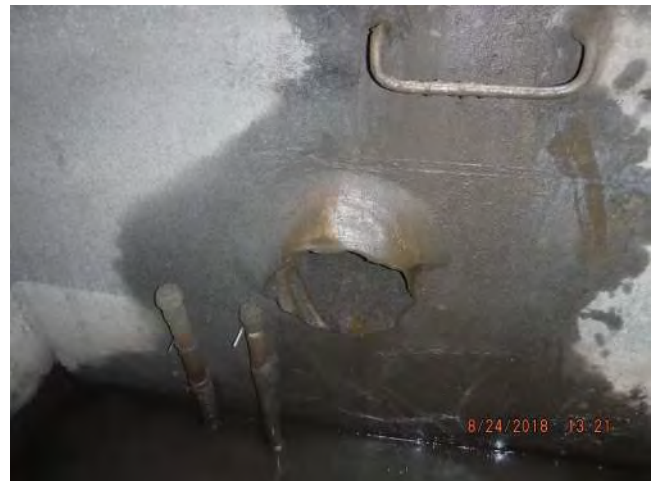
West influent pipe connection

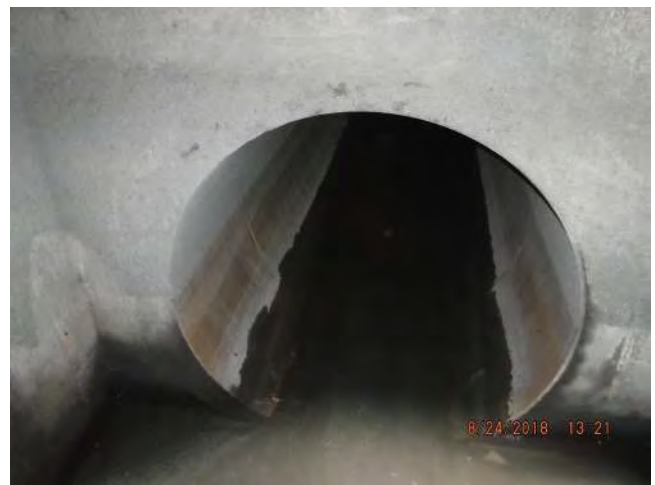
North influent mainline connection

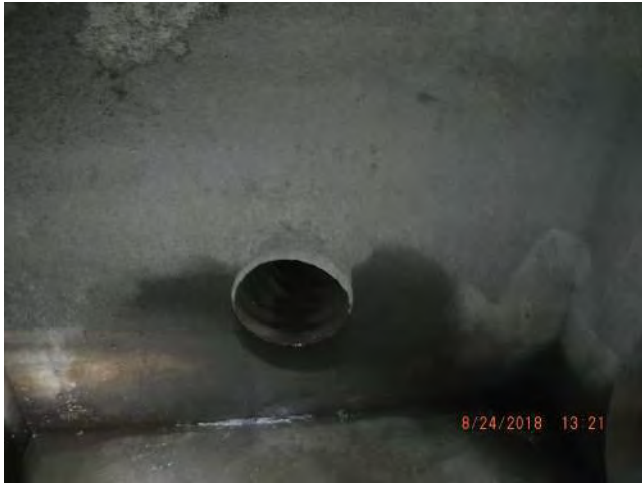
East influent connection

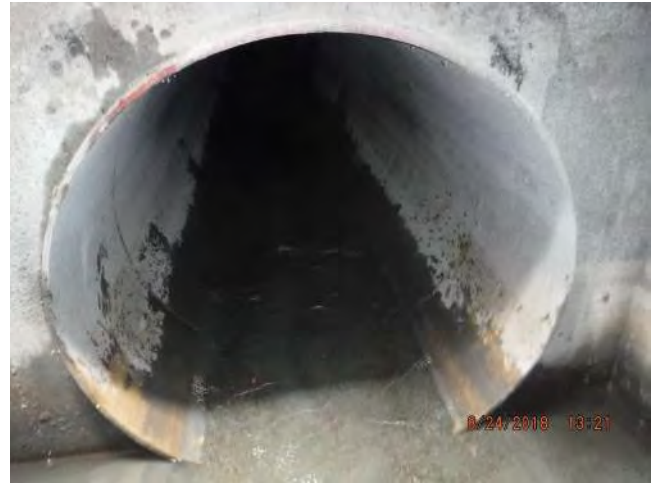
South effluent mainline connection

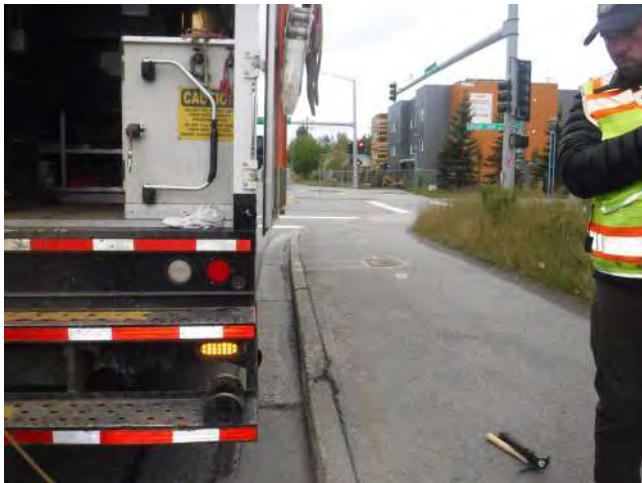
282-10 Facing South

Inspected 63.2 feet completed 8/20/18, downstream invert probed evidence of corrosion

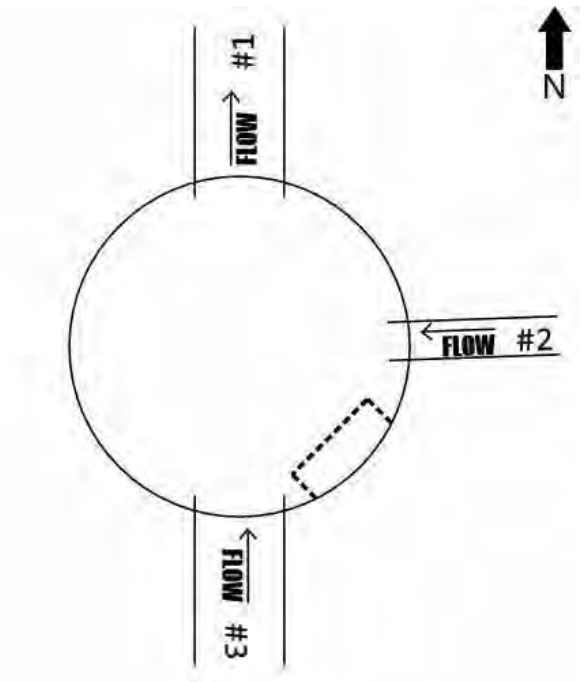
Inspected both directions 157.6 LF Complete 7/31/18, hole at 20.2' upstream (repaired by DOT O&M Aug 2018) Upstream INVERT PROBED METAL LOSS

Inspected 62.9 FEET COMPLETE 8/20/18. Downstream invert probed, surface corrosion

Downstream invert probed, SURFACE CORROSION Inspected 275' COMPLETE 8/20/18

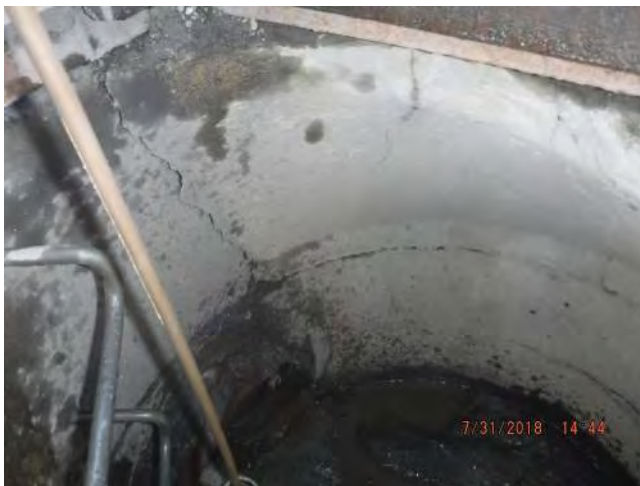
Overall Structural Condition: 3

Primary Comments: CRACK IN BASE AND CONE. BROKEN CHIMNEY BRICKS. Too much debris for ACCURATE SUMP Depth

Crack in Base and Cone

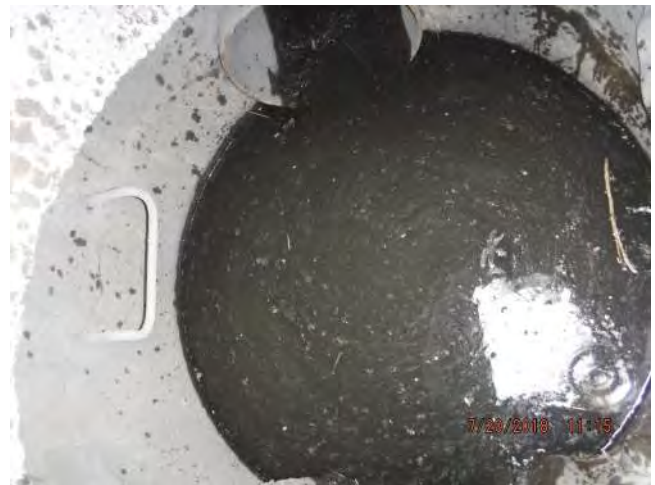
Primary Comments: BRICKS BETWEEN FRAME AND CHIMNEY BROKEN/MISSING, CIRCUMFERENTIAL CRACK IN BASE

Crack in base, North is up

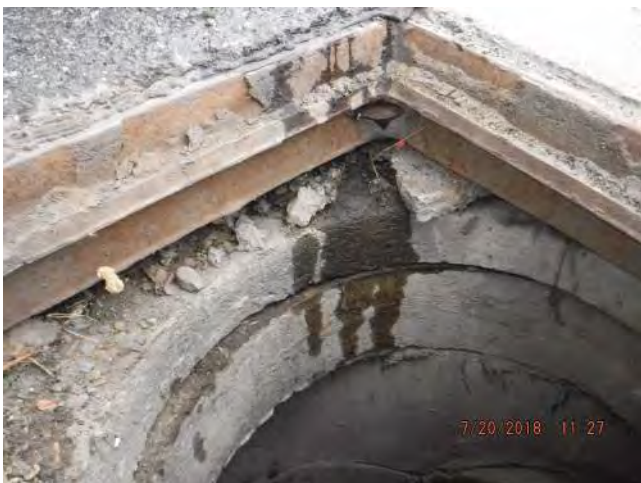
Frame and Chimney

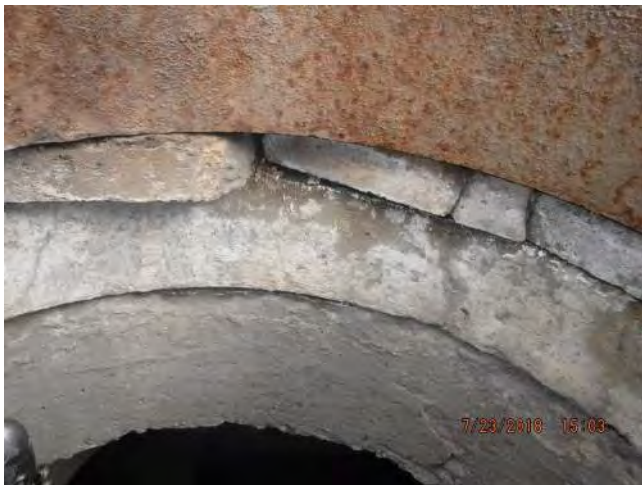
Additional Comments: 2" bricks broken, 5" chimney below

Chimney, Frame, Reducing Slab

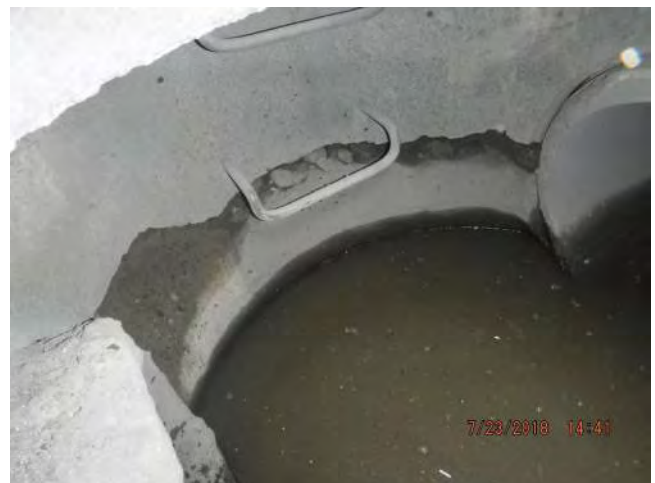
Crack in base

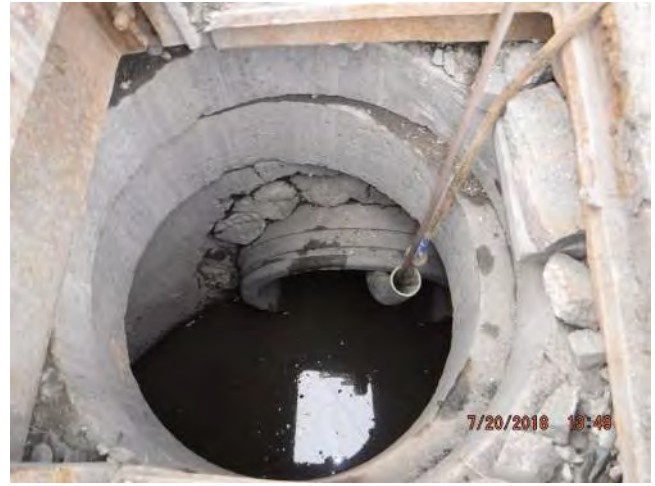
Primary Comments: Steps unusable, bricks BETWEEN FRAME AND CHIMNEY BROKEN

Chimney, Frame, and reducing slab. Missing grout on north influent pipe connection

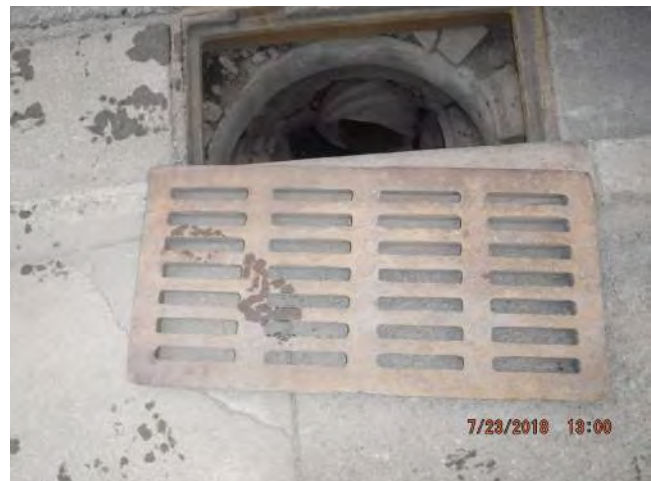
3-29 Facing North

Primary Comments: BRICK CHIMNEY BROKEN

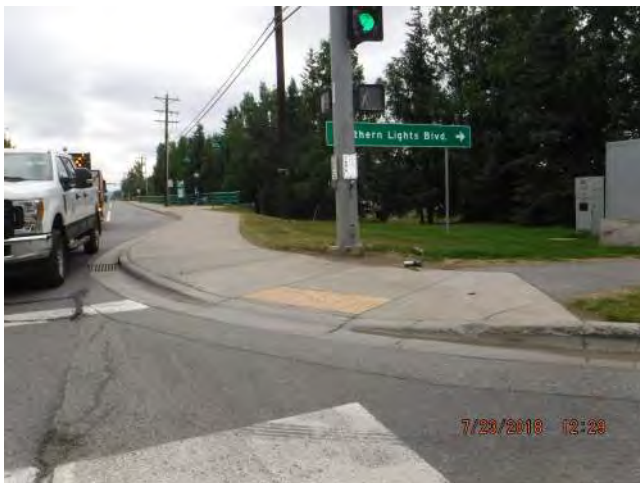
3-30 Facing North

Primary Comments: CURB INLET BROKEN, CHIMNEY BROKEN/MISSING

Additional Comments: CIRCUMFERENTIAL CRACK IN BASE, INVERTS PROBED METAL APPEARED SOUND

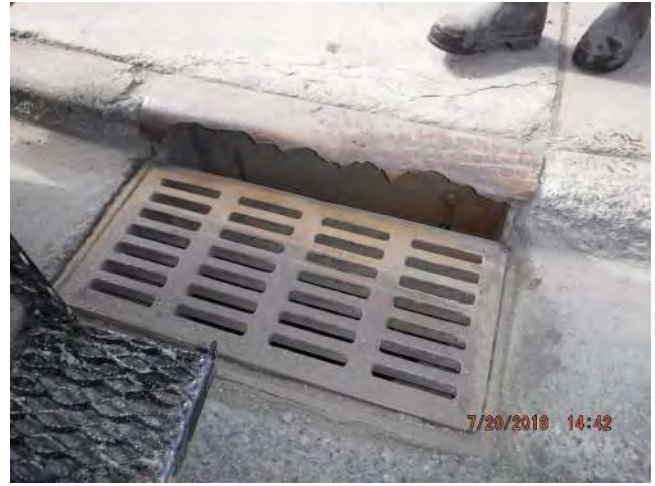
Broken curb inlet

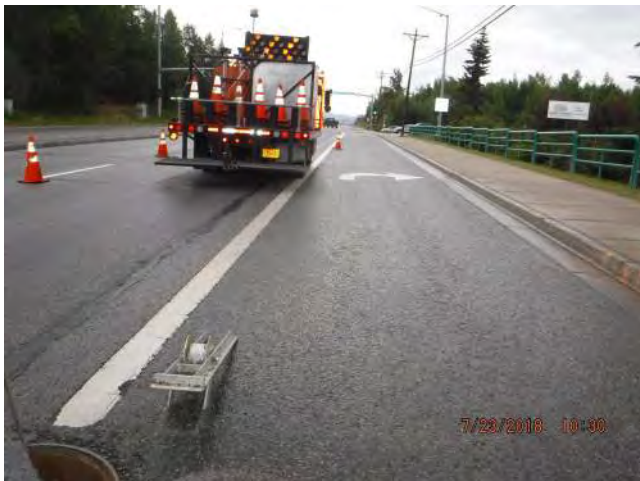
3-33 Facing South

DS GROUT MISSING

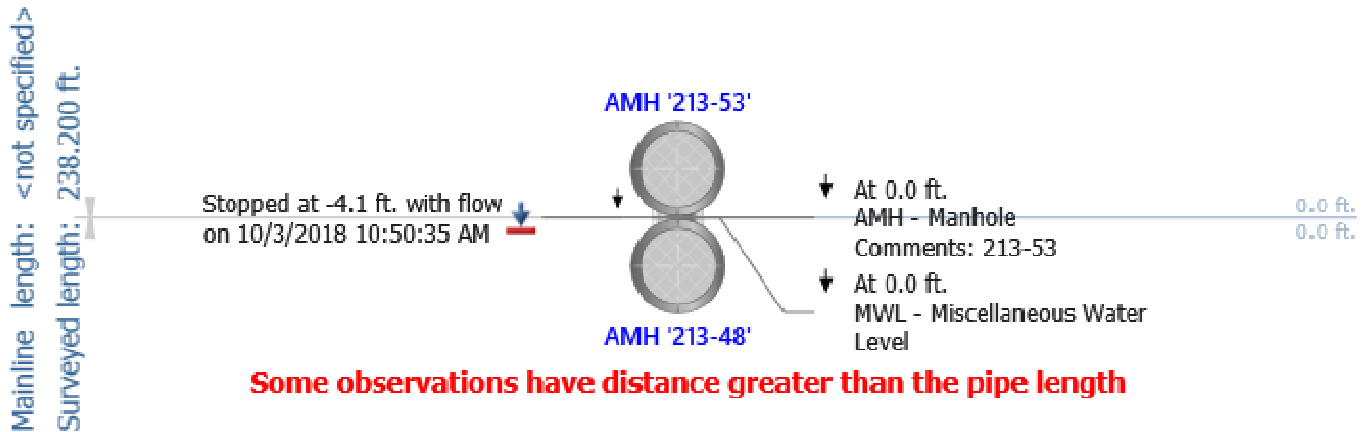
Notes: 213-52 to 213-48

- 24-in. CMP
- 238 LF
- 0-1" of debris
- No major defects observed
- Flow: 0-1"
- Grade score of: 1

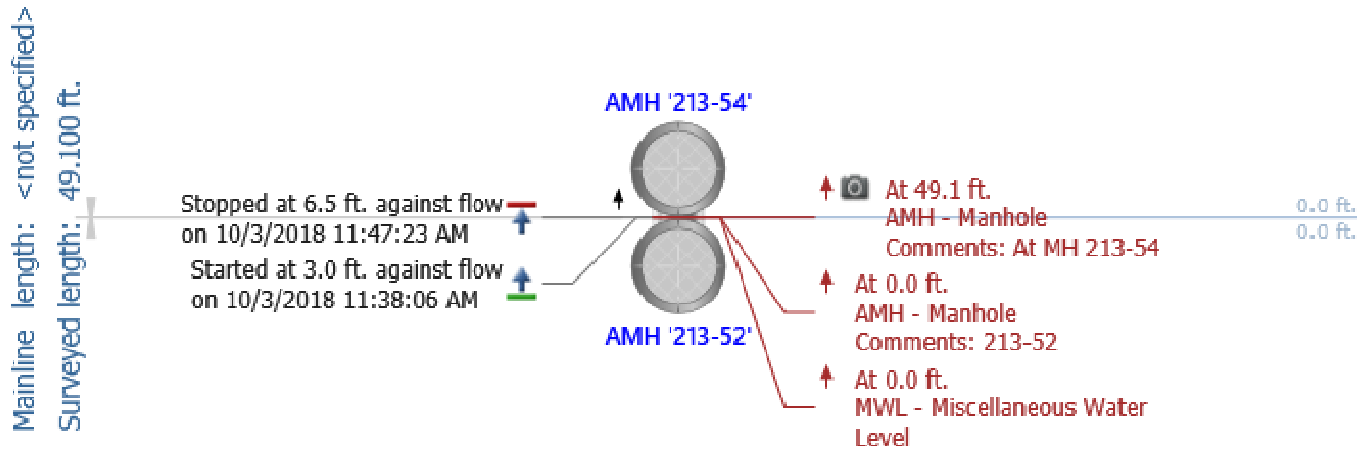
Notes: 213-54 to 213-52

- 12-in. CMP
- 49 LF
- 1-2" deformation, 12:00 position at 34 LF to about 43 LF
- Horizontal deflection at 40 LF
- Defects do not appear to inhibit flow properties of pipe
- Flow: None
- Grade score of: 2

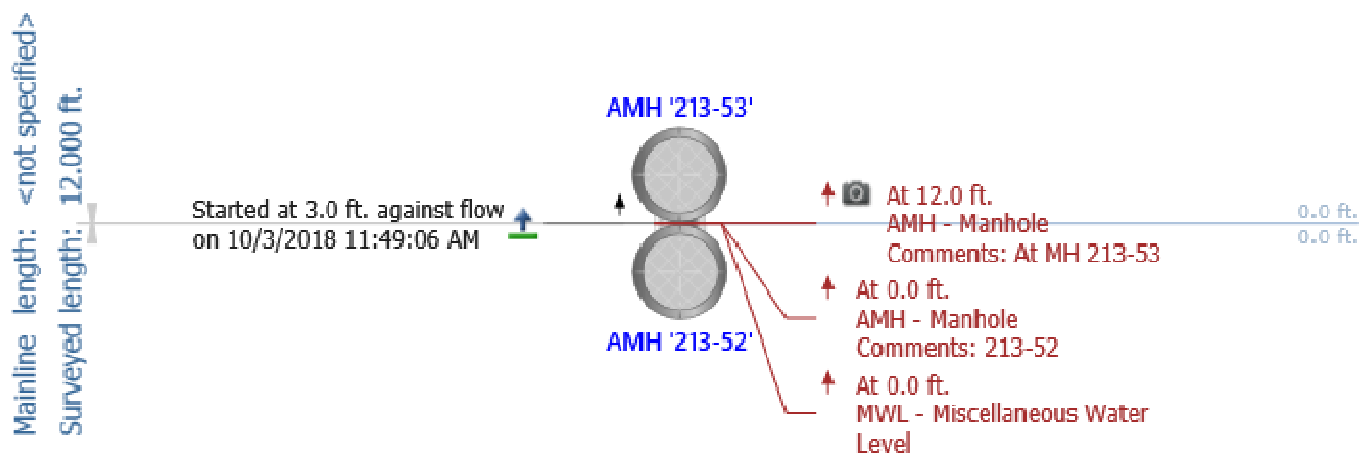
Notes: 213-53 to 213-52

- 12-in. CMP
- 12 LF
- No major defects observed
- Flow: None
- Grade score of: 1

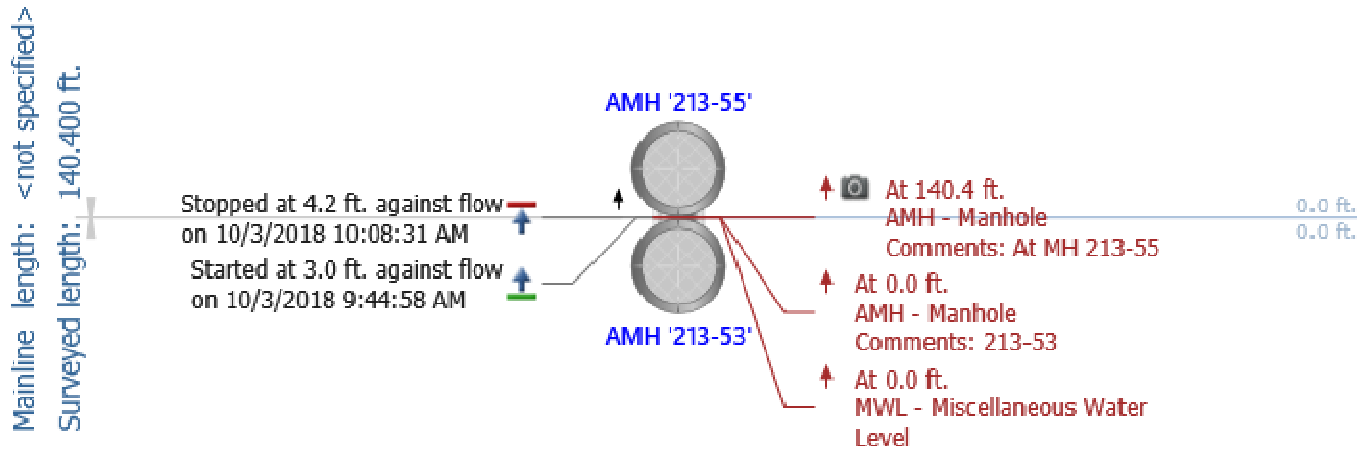
Notes: 213-55 to 213-52

- 21-in. CMP
- 140 LF
- Discoloration in bottom half of pipe
- Possible bellies upstream of various joints
- No major structural defects observed
- Flow: 0-1"
- Grade score of: 1

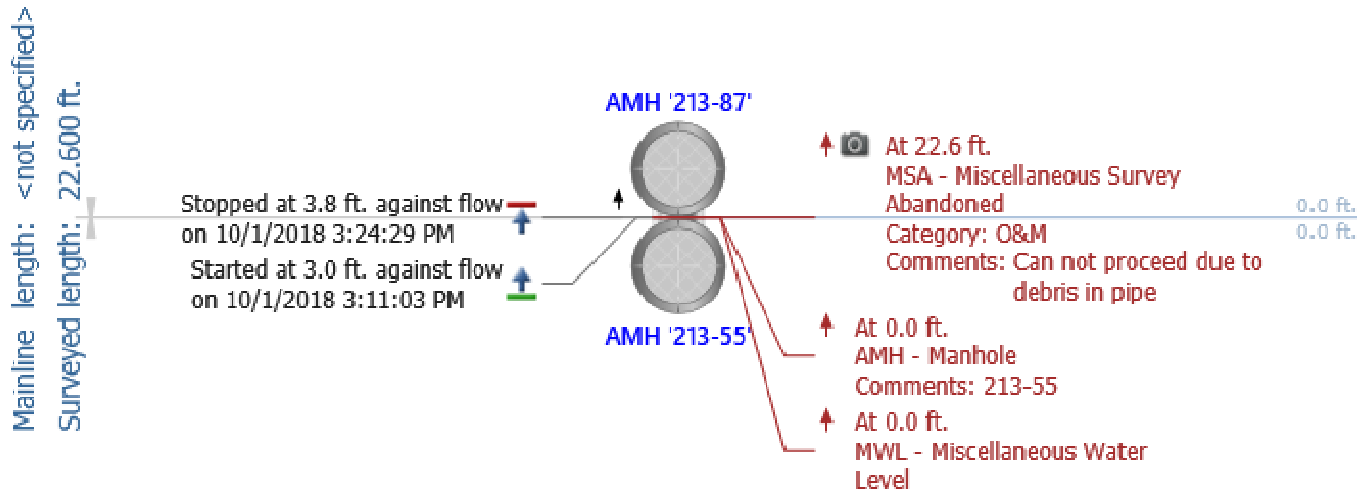
Notes: 213-87 to 213-55

- 12-in. CMP
- 53 LF
- Survey abandoned due to debris buildup at 22.6 LF, unable to identify, no defects observed.
- Flow: None
- Grade score of: 1

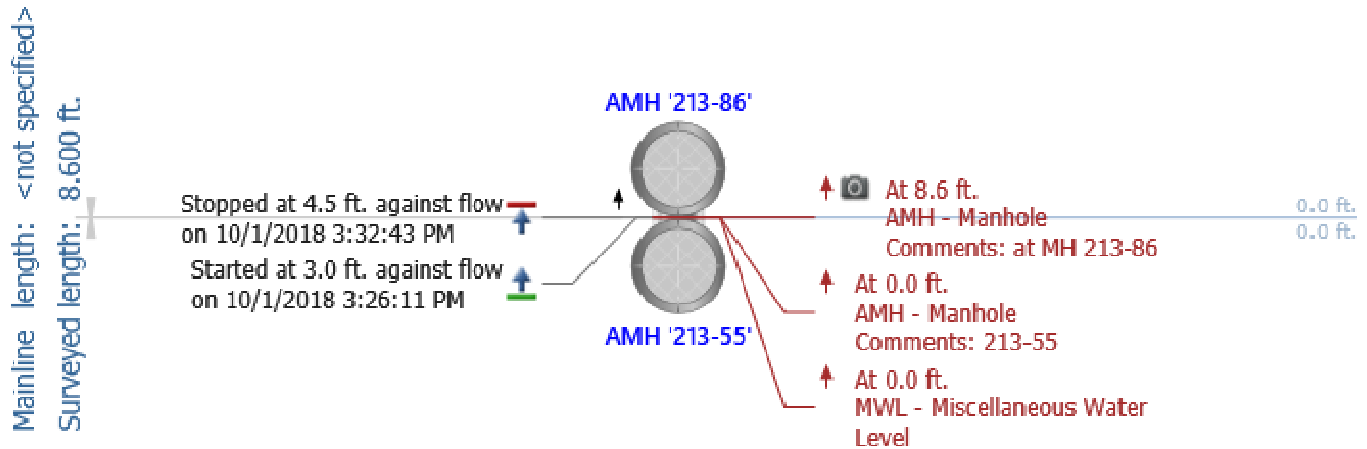
Notes: 213-86 to 213-55

- 12-in. CMP
- 9 LF
- No defects observed
- Flow: None
- Grade score of: 1

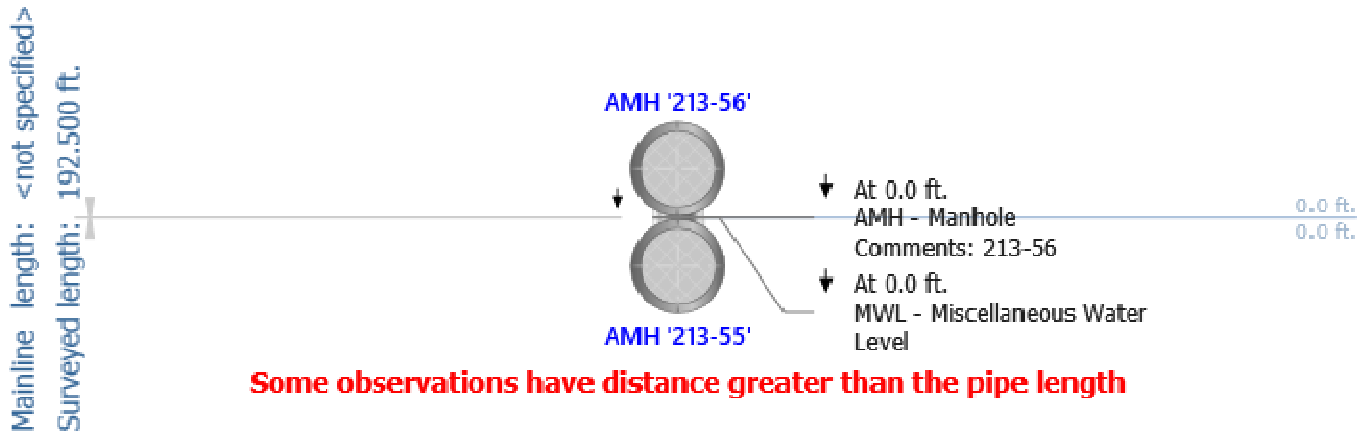
Notes: 213-56 to 213-55

- 21-in. CMP
- 193 LF
- Discoloration in bottom half of pipe
- 0-1" of debris throughout pipe
- No major defects observed
- Flow: 0-1"
- Grade score of: 1

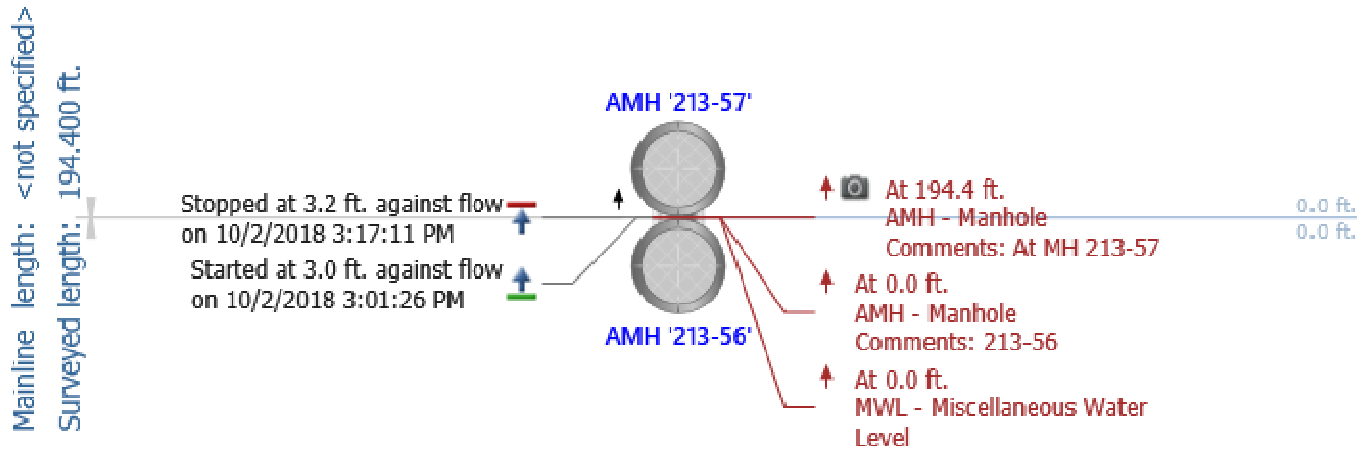
Notes: 213-57 to 213-56

- 21-in. CMP
- 194 LF
- 0-1" debris at 20 LF, varies throughout pipe
- Possible bellies upstream of joints
- Flow: 0-1"
- Grade score of: 1

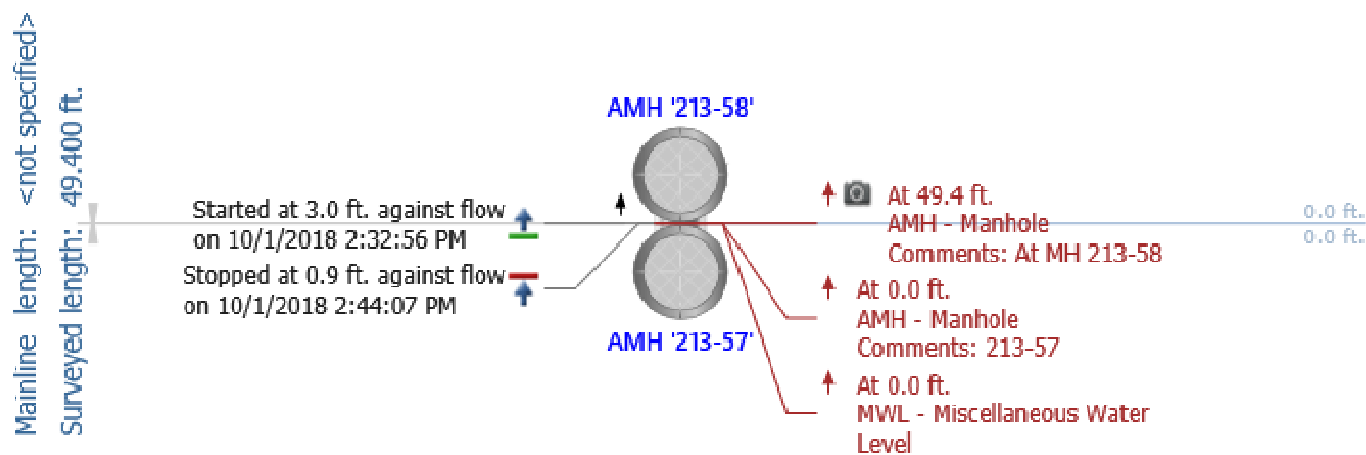
Notes: 213-58 to 213-57

- 12-in. CMP
- 49 LF
- Discoloration in 4:00 and 8:00 position from throughout pipe.
- Corrosion on spigot edge and debris buildup at joints, 18 LF and 38 LF
- Flow: None
- Grade score of: 1

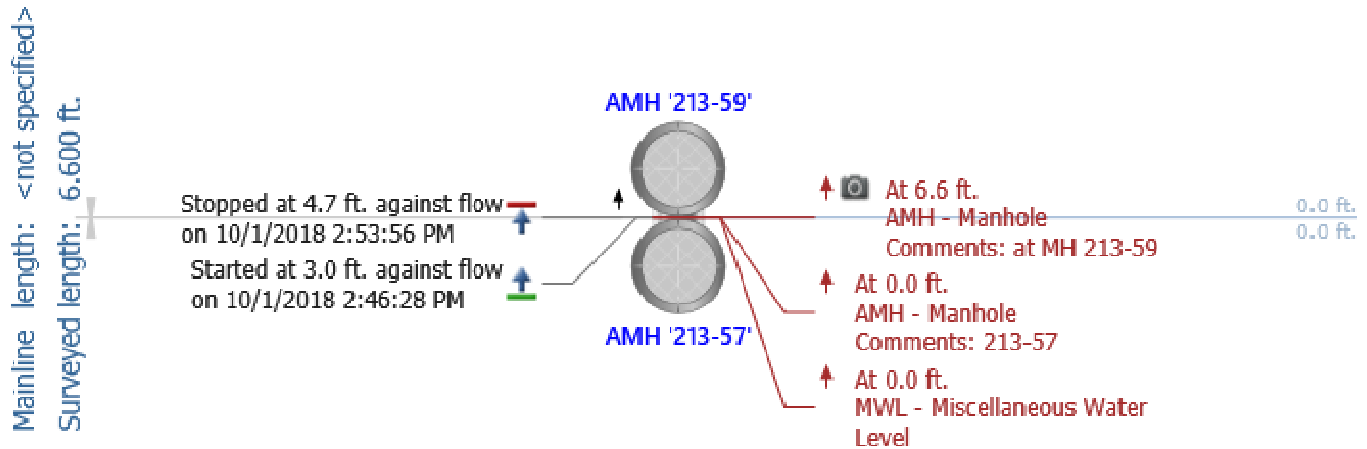
Notes: 213-59 to 213-57

- 12-in. CMP
- 7 LF
- No Defects observed
- Flow: None
- Grade score of: 1

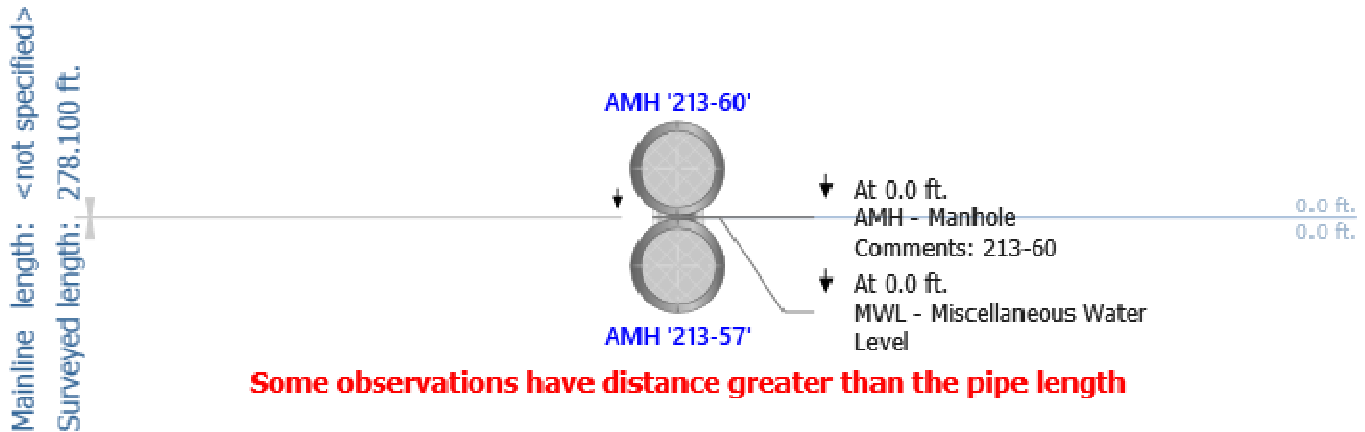
Notes: 213-60 to 213-57

- 21-in. CMP
- 278 LF
- Discoloration in bottom half of pipe
- Evidence of surface corrosion in invert
- 0-1" debris throughout pipe
- Possible bellies upstream of joints
- Flow: 0-1"
- Grade score of: 1

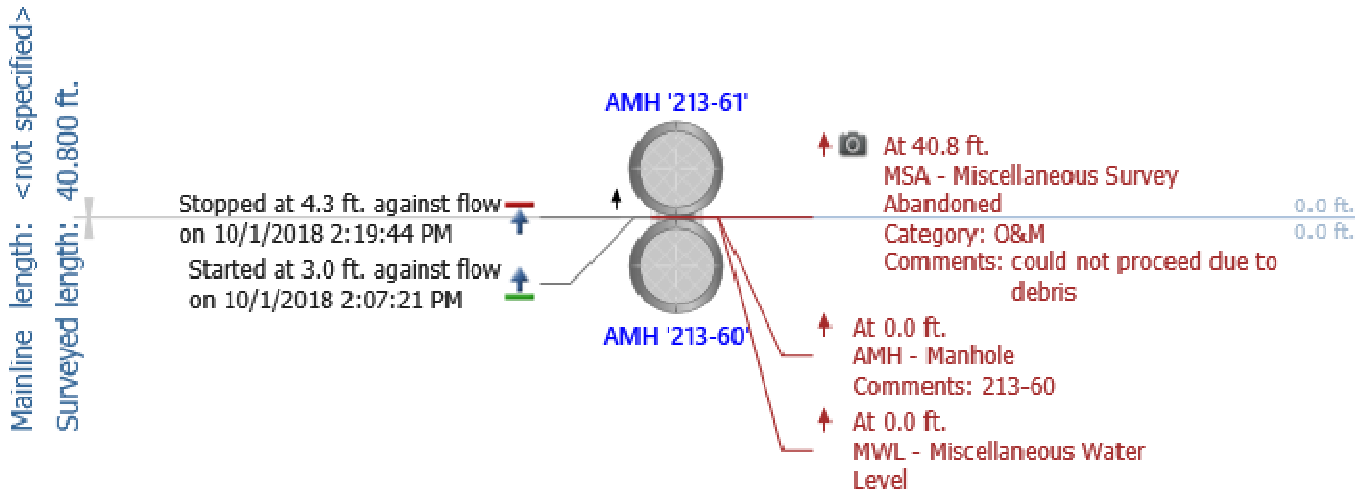
Notes: 213-61 to 213-60

- 12-in. CMP
- 51 LF
- Debris buildup at joint, 20 LF
- Pipe becomes approximately 1/4 full of debris near joint 37 LF, unable to pass
- Debris subsides closer to upstream end
- Flow: None
- Grade score of: 1

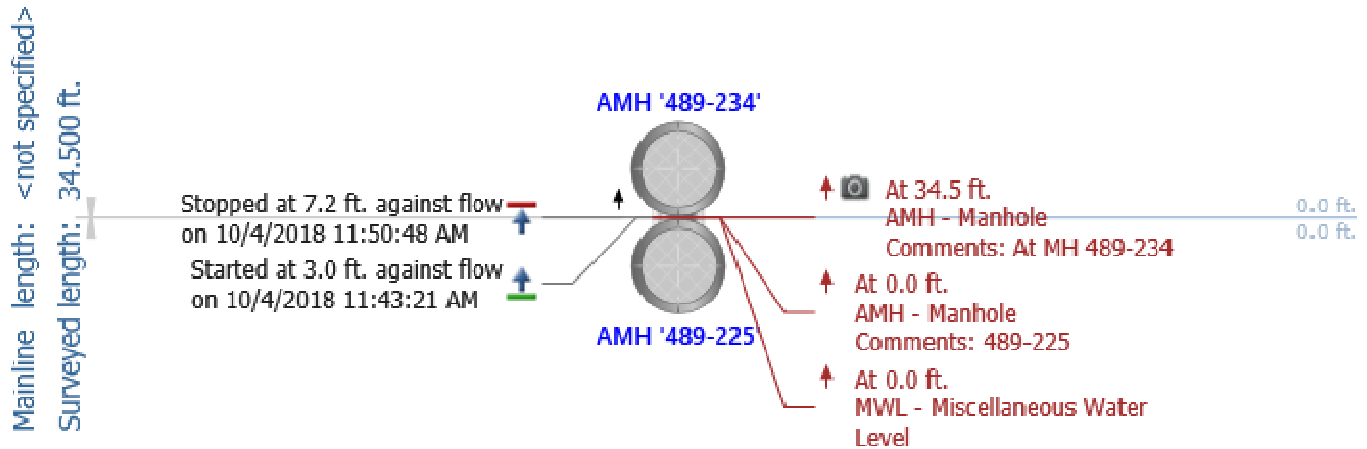
Notes: 489-234 to 489-225

- 12-in. CMP
- 35 LF
- Debris buildup at 24 LF, possible belly in pipe
- No major defects observed
- Flow: None
- Grade score of: 1

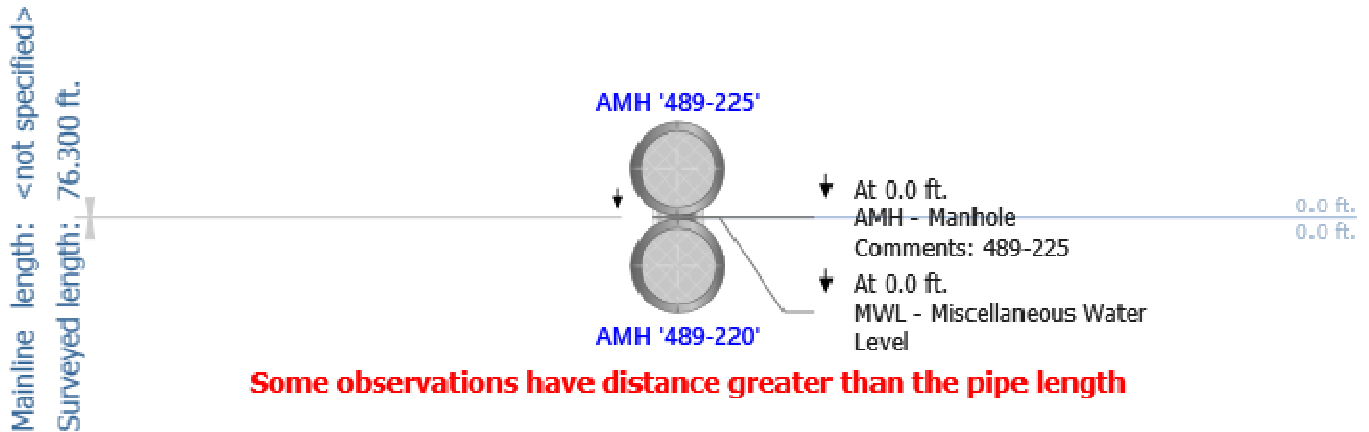
Notes: 489-225 to 489-220

- 18-in. CMP
- 76 LF
- 0-1" debris from 3 LF to end of pipe
- No major defects observed
- Flow: Minimal
- Grade score of: 1

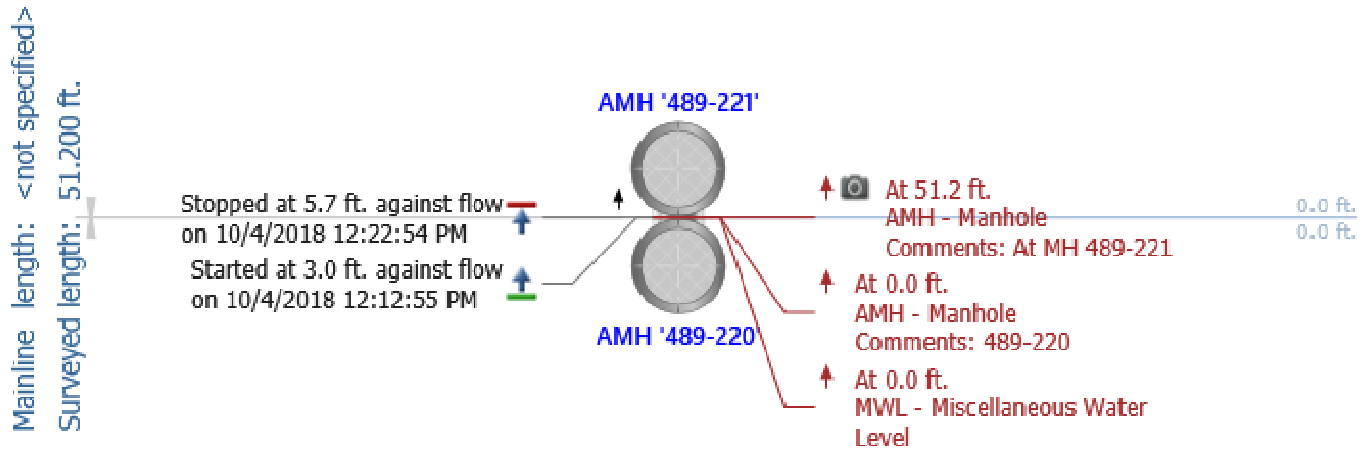
Notes: 489-221 to 489-220

- 18-in. CMP
- 51 LF
- 0-1" debris in pipe
- Bent spigot end, 12:00 position, approximately 1 inch at 40 LF
- Flow: Minimal
- Grade score of: 1

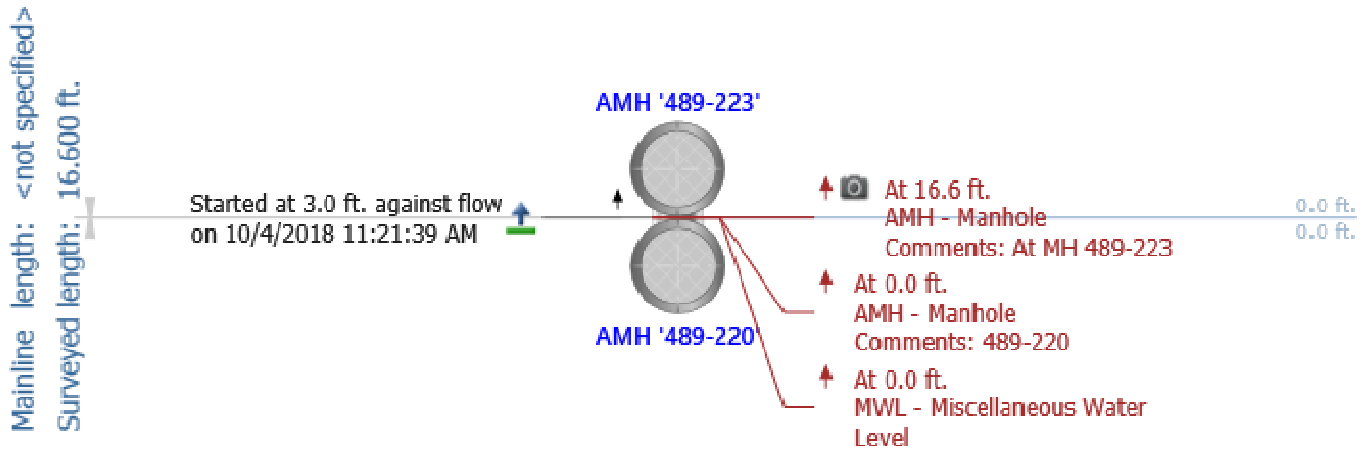
Notes: 489-223 to 489-220

- 12-in. CMP
- 17 LF
- No major defects observed
- Flow: None
- Grade score of: 1

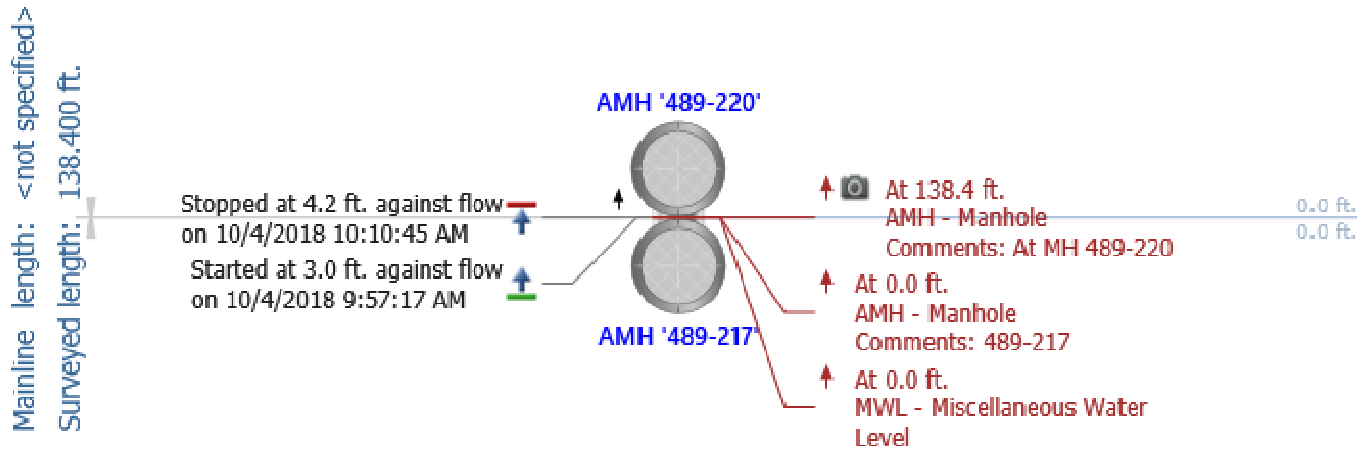
Notes: 489-220 to 489-217

- 18-in. CMP
- 138 LF
- 0-1" of debris in pipe
- Horizontal deflection at joint at 39 LF
- Flow: Minimal
- Grade score of: 1

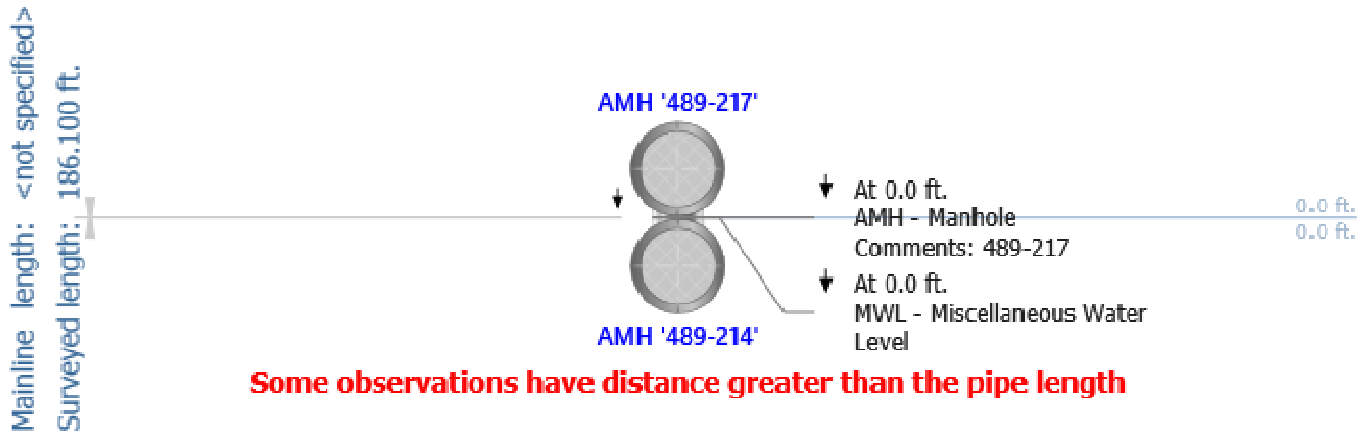
Notes: 489-217 to 489-214

- 18-in. CMP
- 186 LF
- Organic material penetrating joint, 12:00 position at 5 LF
- 0-1" debris in pipe
- Root infiltration at joint at 60 LF, 11:00 position
- Root infiltration at joint, 166 LF
- No major structural defects observed
- Flow: 0-1"
- Grade score of: 2

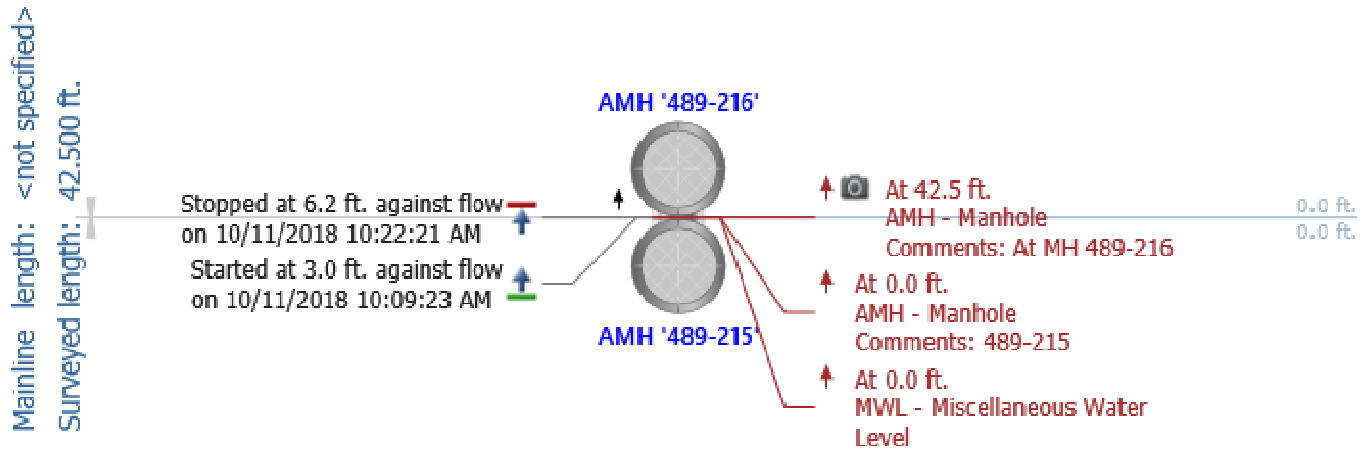
Notes: 489-216 to 489-215

- 12-in. CMP
- 43 LF
- No major defects observed
- Flow: Minimal
- Grade score of: 1

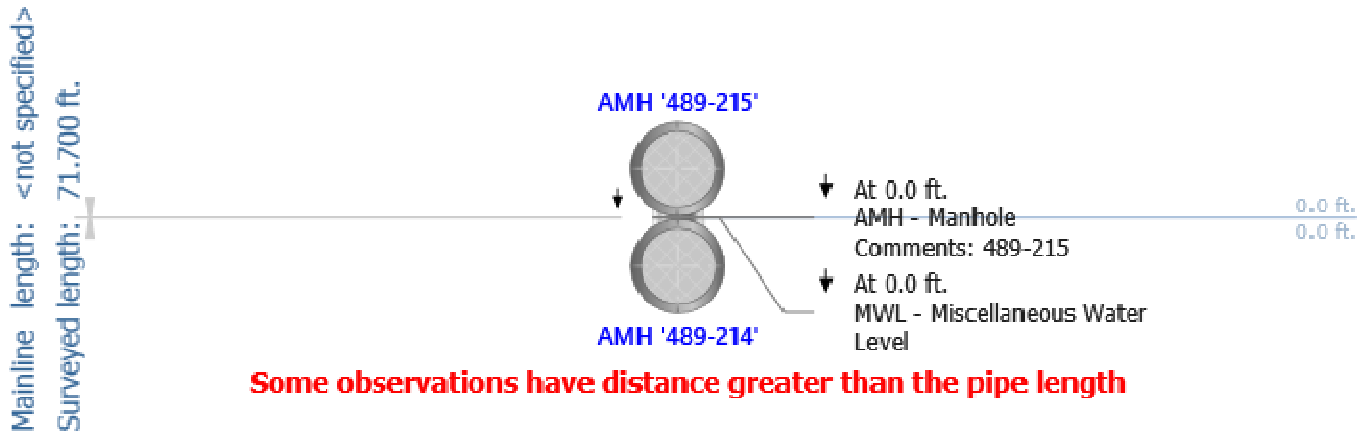
Notes: 489-215 to 489-214

- 18-in. CMP
- 72 LF
- Scattered debris throughout pipe, 0-2"
- Possible corrosion in invert, unable to confirm due to poor CCTV footage and invert view obscured by debris in some spots
- Discoloration in 5:00 and 7:00 position, 54 LF, viewed in rear camera during pullback
- Flow: None
- Grade score of: 1

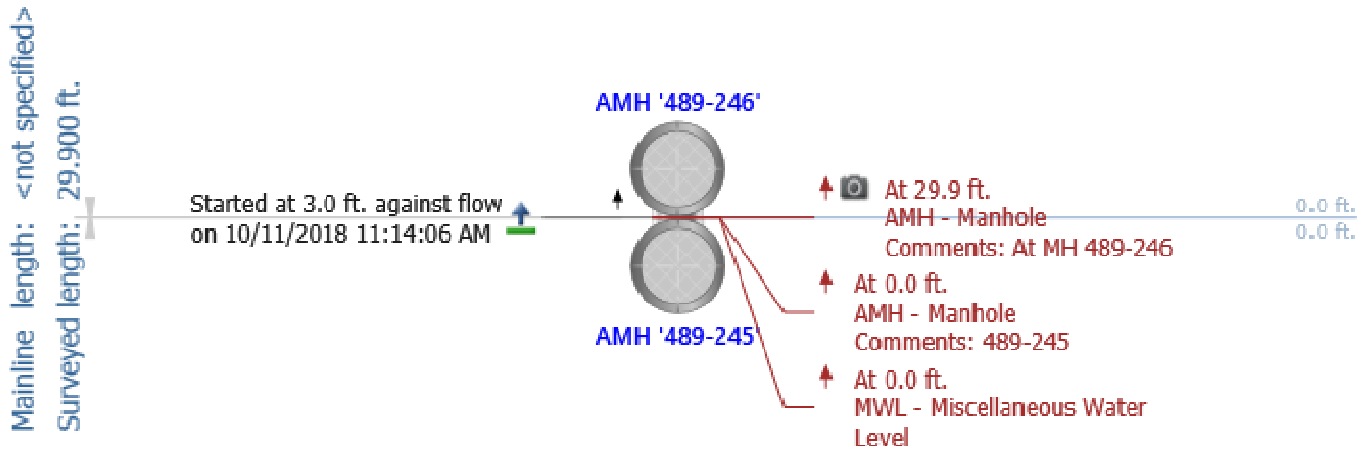
Notes: 489-246 to 489-245

- 12-in. CPEP
- 30 LF
- 2" of debris buildup at downstream end, 0-1" debris from approximately 4 LF to 8 LF
- No major structural defects observed
- Flow: 0-1"
- Grade score of: 1
