Alaska Department of Transportation and Public Facilities Central Region

NHS STORM DRAIN INSPECTION CONDITION REPORT PROJECT NO. 0A31055 / Z591280000

Dimond Boulevard from Jewel Lake Road to Old Seward Highway
Muldoon Road from Boundary Avenue to Northern Lights Boulevard
Debarr Road from Bragaw Street to Muldoon Road
Downtown: 5th and 6th Avenue from Gambell Street to Orca Street and
Ingra Street from 6th Avenue to 9th Avenue

May 20th, 2019

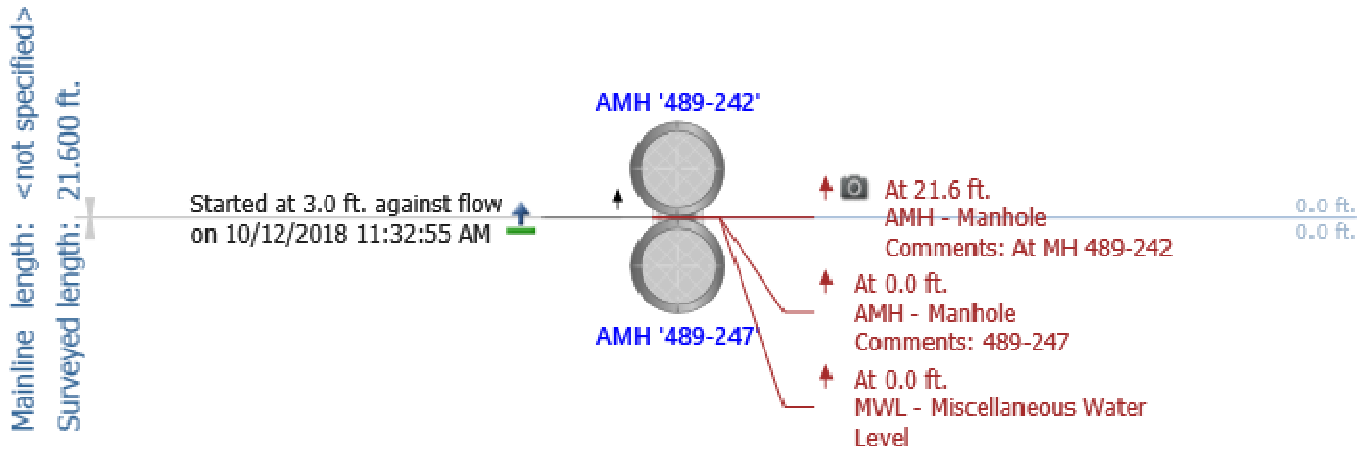
Notes: 489-247 to 489-242

- 12-in. CMP
- 22 LF
- Minimal debris in pipe
- Surface discoloration in invert, visible at joint 19 LF
- No major defects observed
- Flow: Minimal
- Grade score of: 1

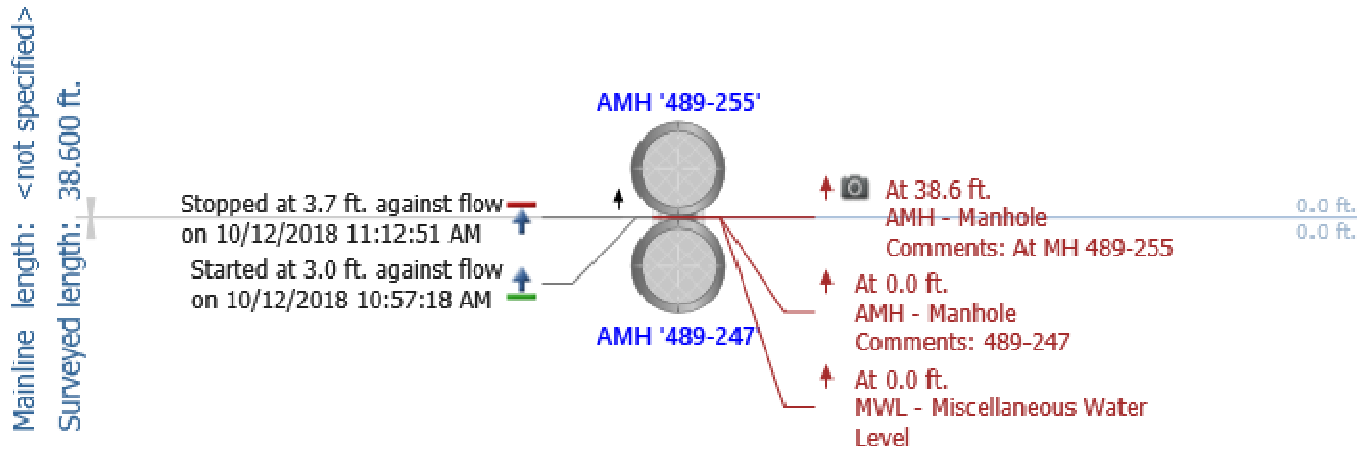
Notes: 489-255 to 489-242

- 12-in. CMP
- 39 LF
- No major defects observed
- Flow: Minimal
- Grade score of: 1

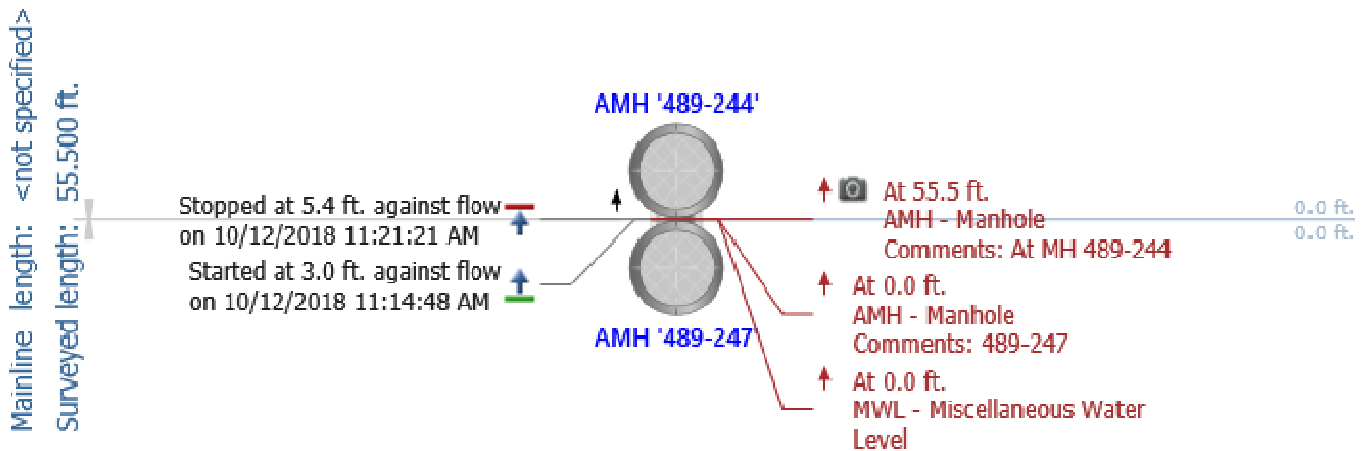
Notes: 489-244 to 489-242

- 12-in. CMP
- 56 LF
- Debris buildup at 29 LF, 4-5"
- 2" debris at upstream end
- No major defects
- Flow: Minimal
- Grade score of: 1

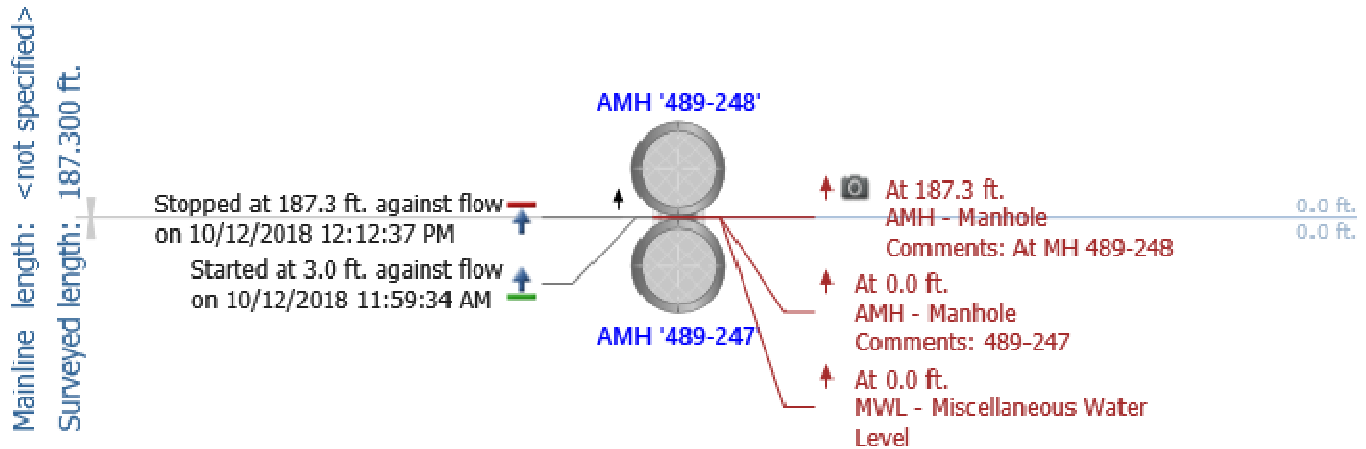
Notes: 489-248 to 489-242

- 18-in. CMP
- 187 LF
- 1-2" of debris 3 LF to 12 LF, minimal debris from 12 LF to end
- Discoloration visible in invert, 17 LF and at other joints
- Debris at joint, 1:00 position at 98 LF
- Discoloration at spring line, 98 LF to end of survey
- No major defects
- Flow: Minimal
- Grade score of: 2

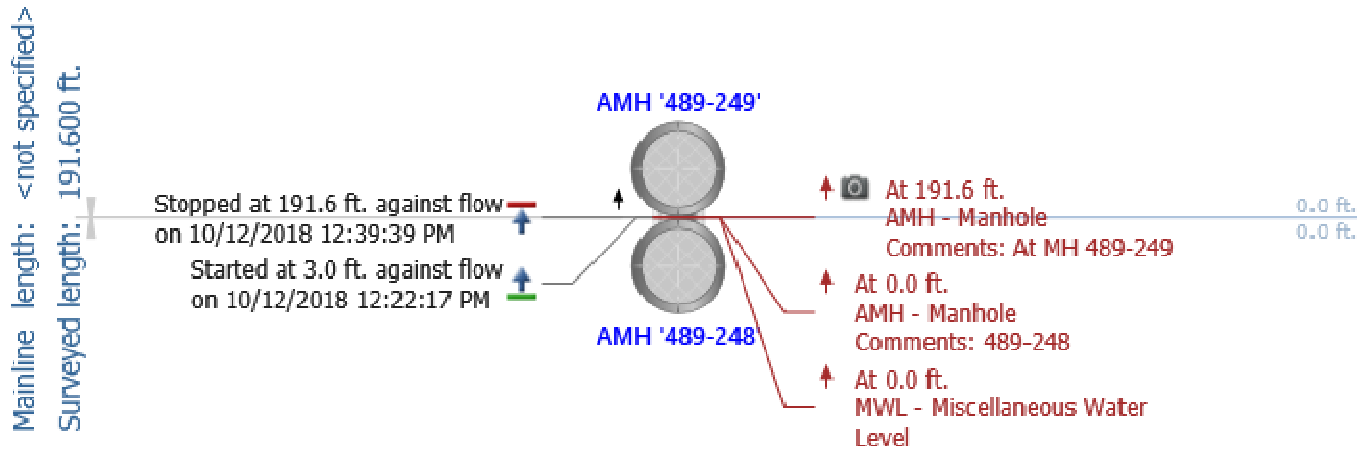
Notes: 489-249 to 489-248

- 18-in. CMP
- 192 LF
- Discoloration between 4:00 and 8:00 position, 3 LF to
- 0-2" of debris in pipe
- Discoloration in invert, visible at 20 LF, 40 LF, and at other joints, also visible at 137 LF
- Service tap at 11:00 position, 30 LF (camera did not stop to view)
- Flow: Minimal
- Grade score of: 2

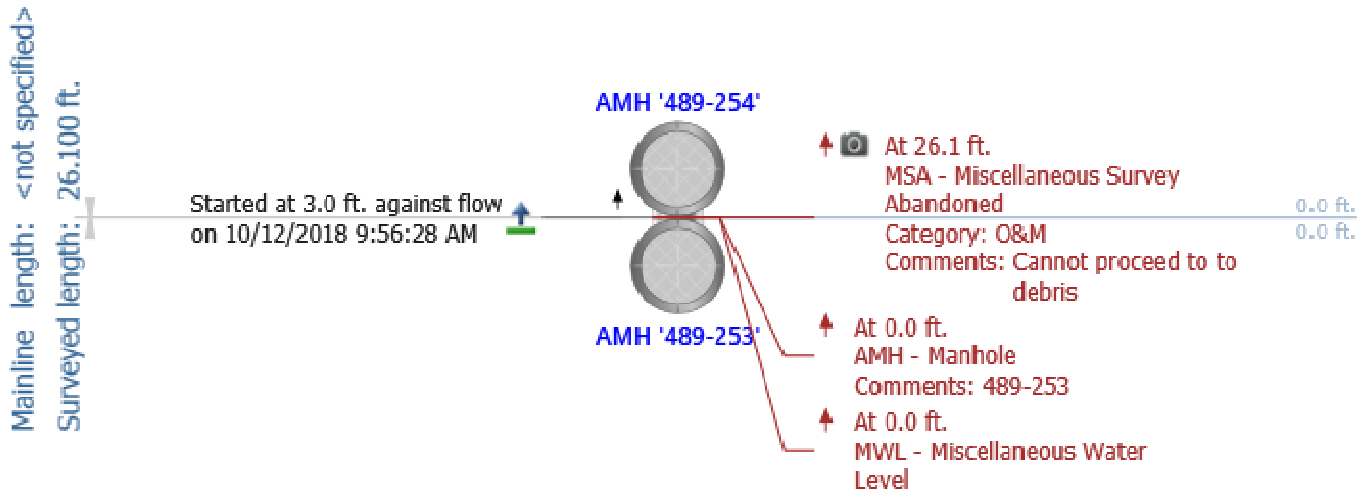
Notes: 489-254 to 489-253

489-254	489-253	North 6th Avenue at Karluk Street	12	CMP	No	10/12/2018	27	40	Upstream	2	Minimal	Stopped by debris
	489-253	489-249	North 6th Avenue at Karluk Street	18	CMP	Yes	10/12/2018	26	29	Upstream	1	Minimal	No major defects observed
13	489-250	489-249	North 6th Avenue at Karluk Street	18	CMP	Yes	10/12/2018	163	152	Upstream	1	Minimal	No major defects observed
14	489-214	489-212	West Ingra Street between 6th and 7th Ave.	18	CMP	Yes	11/5/2018	346	351	Upstream	2	Minimal	Possible surface corrosion in invert, various discoloration and minor deformations

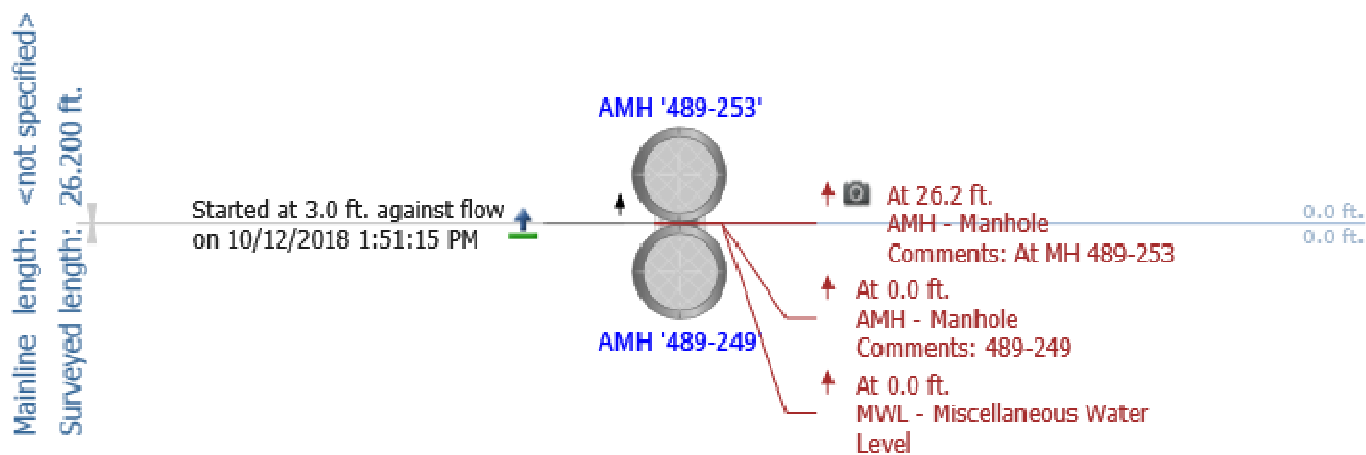
Notes: 489-253 to 489-249

- 18-in. CMP
- 26 LF
- Minimal debris
- No major defects observed
- Flow: Minimal
- Grade score of: 1

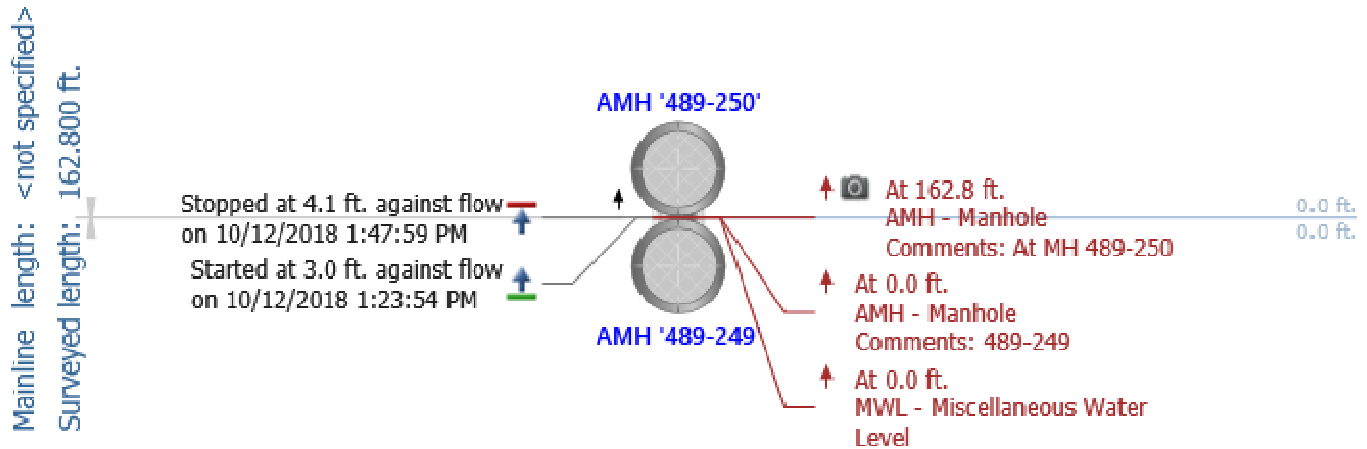
Notes: 489-250 to 489-249

- 18-in. CMP
- 163 LF
- 0-1" of debris in pipe
- Visible surface corrosion in invert, 40 LF
- No major defects observed
- Flow: Minimal
- Grade score of: 1

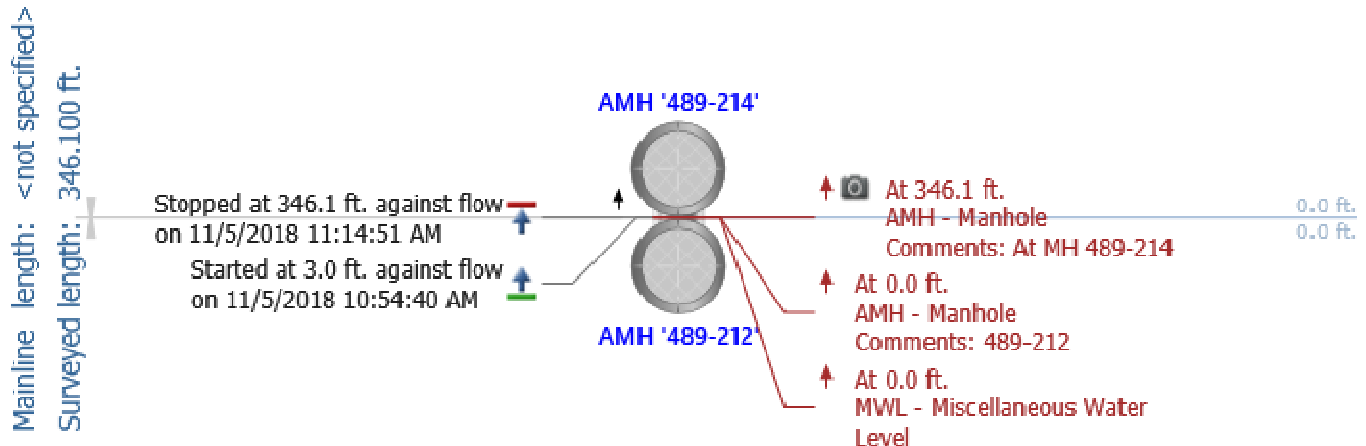
Notes: 489-214 to 489-212

- 18-in. CMP
- 346 LF
- Discoloration visible in invert when not obscured by debris
- 0-2" debris throughout pipe
- 1" deformation 12:00 position, 44 LF
- 0-1" of water in pipe, 200 LF to approximately 230 LF, 250 LF to 290 LF
- Root infiltration at 230 LF, 275 LF, 283 LF, 12:00 position
- Discoloration visible at spring line 295 LF through end of pipe.
- Small horizontal deflection, 1-3" at 340 LF
- Flow: Minimal
- Grade score of: 2

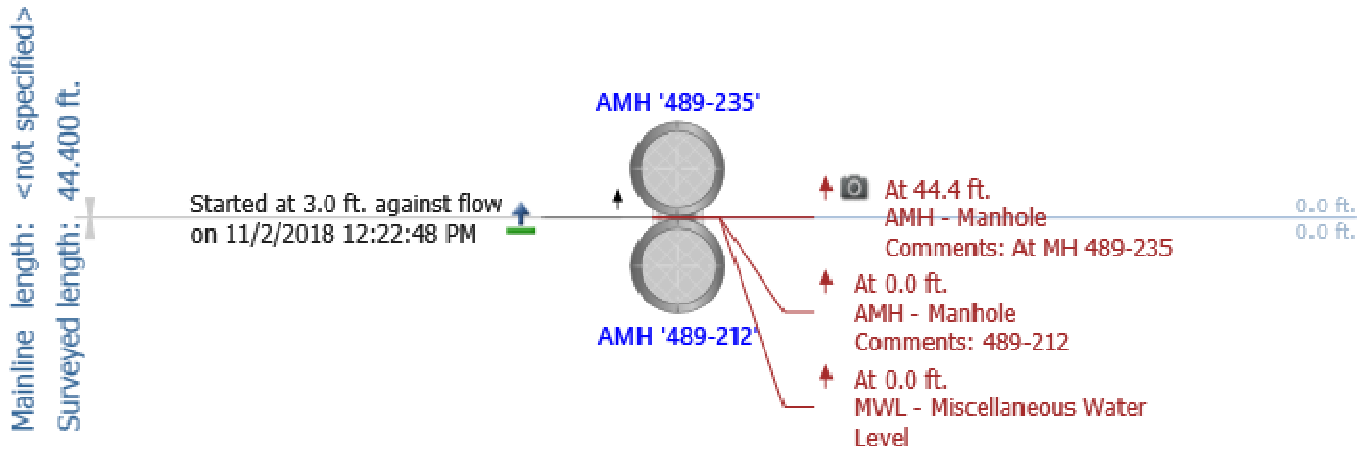
Notes: 489-235 to 489-212

- 12-in. CMP
- 44 LF
- Surface corrosion/discoloration visible in 5:00 and 7:00 position, 3 LF to
- Minimal debris throughout pipe
- Horizontal deflection approximately, 4-6" to the left (upstream direction), at approximately 42 LF
- Debris in upstream end of pipe, 1-2"
- Flow: None
- Grade score of: 2

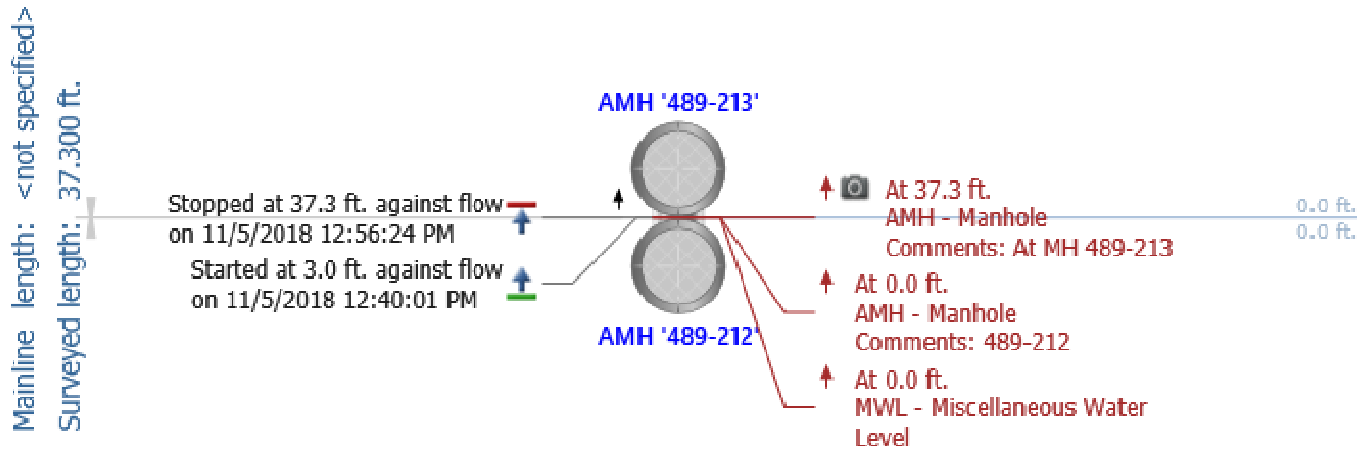
Notes: 489-213 to 489-212

- 12-in. CMP
- 37 LF
- Surface Corrosion/Discoloration in invert, visible at 3 LF and at joints, assumed to be throughout pipe
- Horizontal deflection to right (upstream) at 32 LF, left at 35 LF
- Corrosion at joint, 35 LF
- Survey concluded approximately 2 LF from end of pipe
- Flow: None
- Grade score of: 2

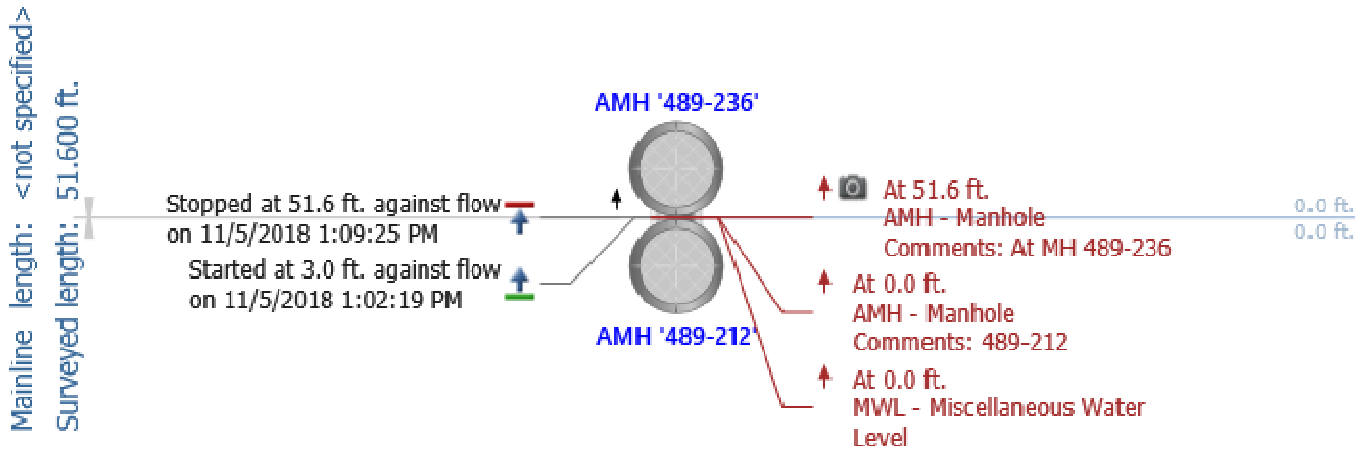
Notes: 489-236 to 489-212

- 12-in. CMP
- 52 LF
- Minor surface corrosion, 5:00 to 7:00 position, 3 LF to end of pipe
- Root infiltration, 34 LF, in 10:00 position
- Unknown debris buildup (appears to be grout) in upstream end
- Flow: None
- Grade score of: 2

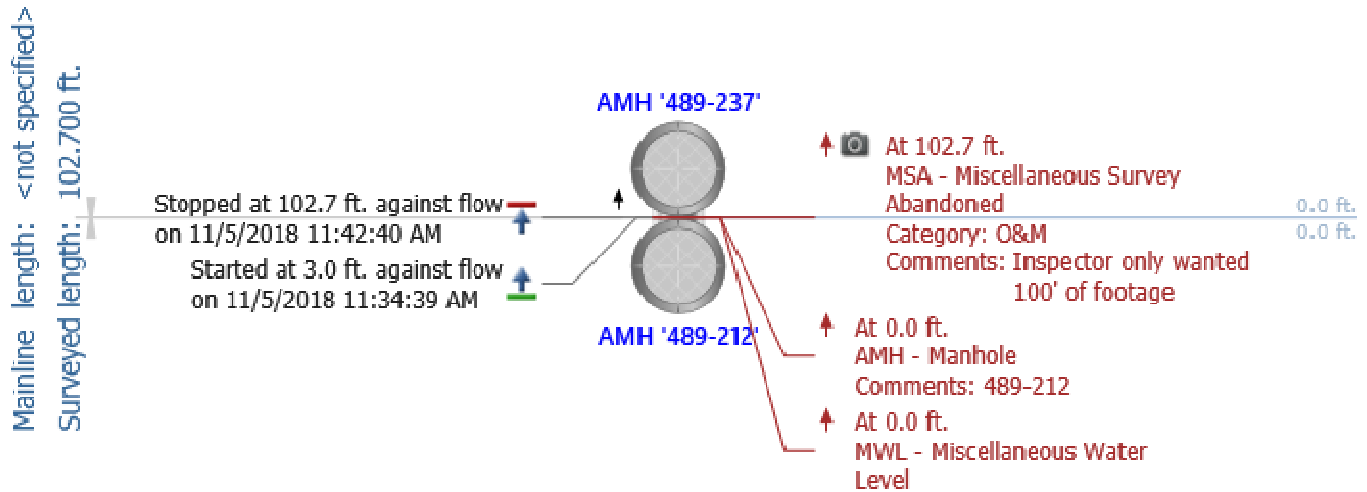
Notes: 489-237 to 489-212

- 24-in. RCP
- 293 LF
- Survey of pipe done to view condition below roadway
- 1-2" debris in pipe, no debris at 3 LF, 10 LF, 45 LF, 93 LF
- Some flow at 93 LF, 0-1"
- Flow: None
- Grade score of: 1

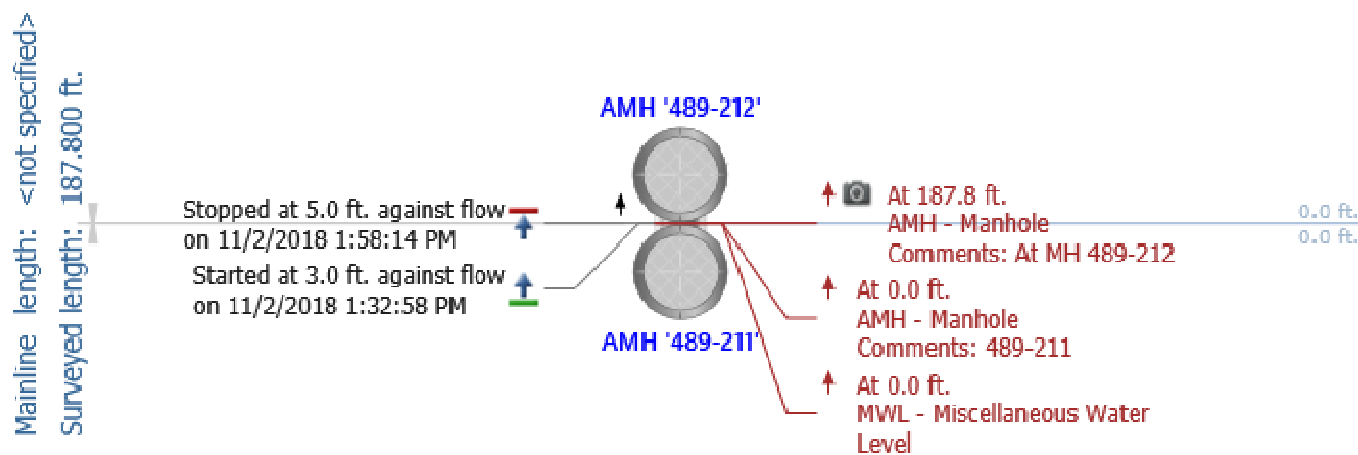
Notes: 489-212 to 489-211

489-237	489-212	Ingra Street at 7th Avenue	24	RCP	Yes	11/5/2018	103	293	Upstream	1	None	Partial survey, no major defects observed
	489-212	489-211	West Ingra Street between 7th and 8th Ave	24	RCP	Yes	11/2/2018	188	190	Upstream	3	Minimal	Possible bellies, pipe broken where pipe bored through
15	489-280	489-211	West Ingra Street between 7th and 8th Ave	12	CMP	Yes	11/2/2018	17	21	Upstream	1	None	No major defects observed
	489-281	489-211	East Ingra Street between 7th and 8th Ave	12	CMP	Yes	11/2/2018	30	29	Upstream	2	None	Surface corrosion, minor debris, grout/debris in upstream end
	489-211	489-210	West Ingra Street between 7th and 8th Ave	24	RCP	Yes	11/2/2018	156	156	Downstream	1	None	No major defects observed
	489-283	489-210	West Ingra Street at 8th Ave	12	CMP	Yes	11/5/2018	48	51	Upstream	2	Minimal	Surface corrosion in invert, no major structural defects
	489-282	489-210	East Ingra Street at 8th Ave	12	CMP	Yes	11/5/2018	54	53	Upstream	2	None	Surface corrosion, debris buildup, horizontal deflection at midspan of pipe

- 24-in. RCP
- 188 LF
- Possible bellies at upstream and downstream end
- Bored pipe at 16 LF, top of pipe, soil visible, pipe broken
- Scattered organics in roof of pipe throughout
- Longitudinal crack, 12:00 position at 72 LF
- Flow: Minimal
- Grade score of: 3

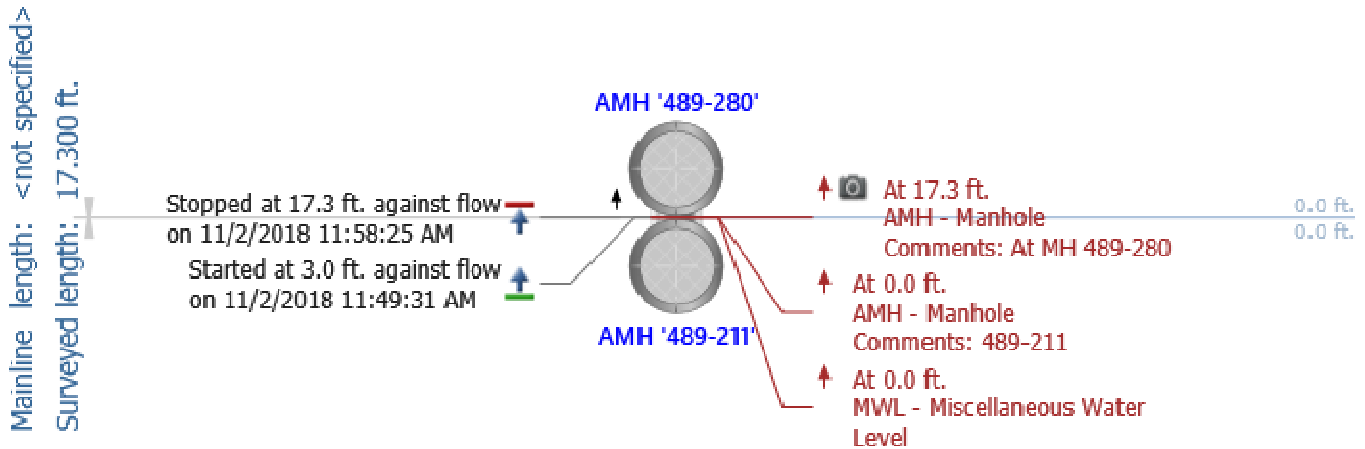
Notes: 489-280 to 489-211

- 12-in. CMP
- 17 LF
- 0-1" of debris at downstream end (beginning of survey)
- Discoloration in 4:00 position and 8:00 position, 3 LF to approx. 5 LF
- Unknown debris buildup (appears to be grout) in upstream end
- Flow: None
- Grade score of: 1

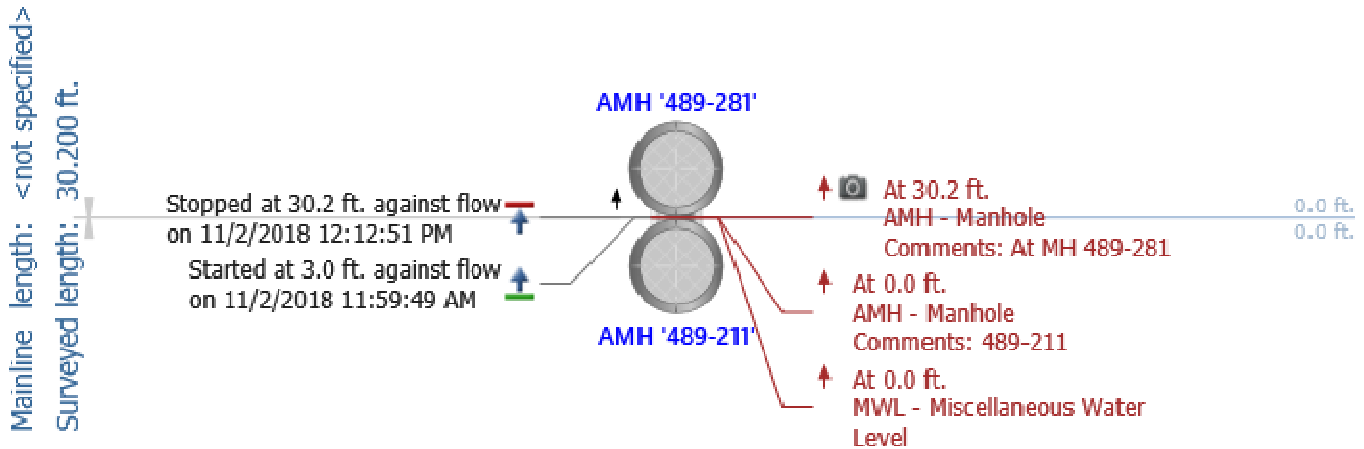
Notes: 489-281 to 489-211

- 12-in. CMP
- 30 LF
- Minor surface corrosion, 5:00 to 7:00 position, 5 LF to end of pipe
- Surface corrosion 2:00 position, 14 LF to 20 LF
- Debris buildup at joint at 20 LF
- Unknown debris buildup (appears to be grout) in upstream end of pipe
- Flow: None
- Grade score of: 2

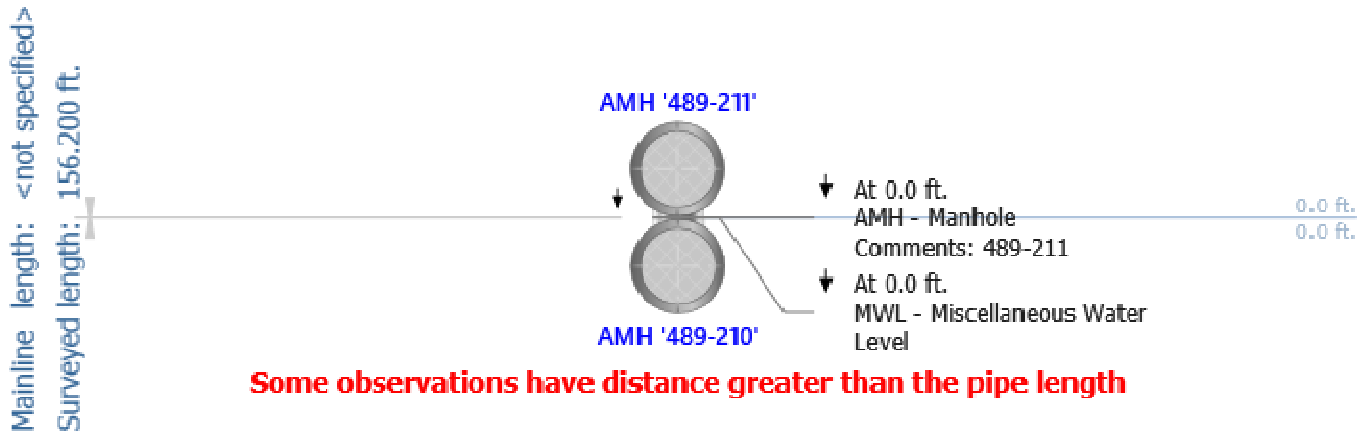
Notes: 489-211 to 489-210

- 24-in. CMP
- 156 LF
- Minimal debris
- Discoloration in invert
- Scattered organics in roof of pipe throughout pipe
- Flow: None
- Grade score of: 1

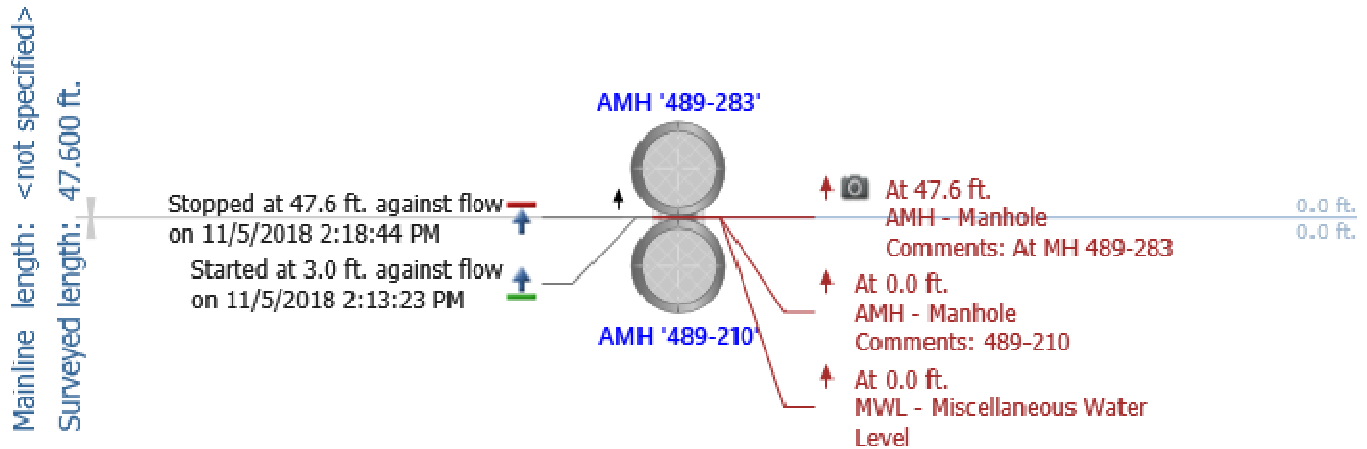
Notes: 489-283 to 489-210

- 12-in. CMP
- 48 LF
- Discoloration in 4:00 and 8:00 position, 3 LF to 36 LF, becomes surface corrosion 36 LF to end of survey
- 1" deformation, 7:00 position at 4 LF
- Surface corrosion visible in invert
- Flow: Minimal
- Grade score of: 2

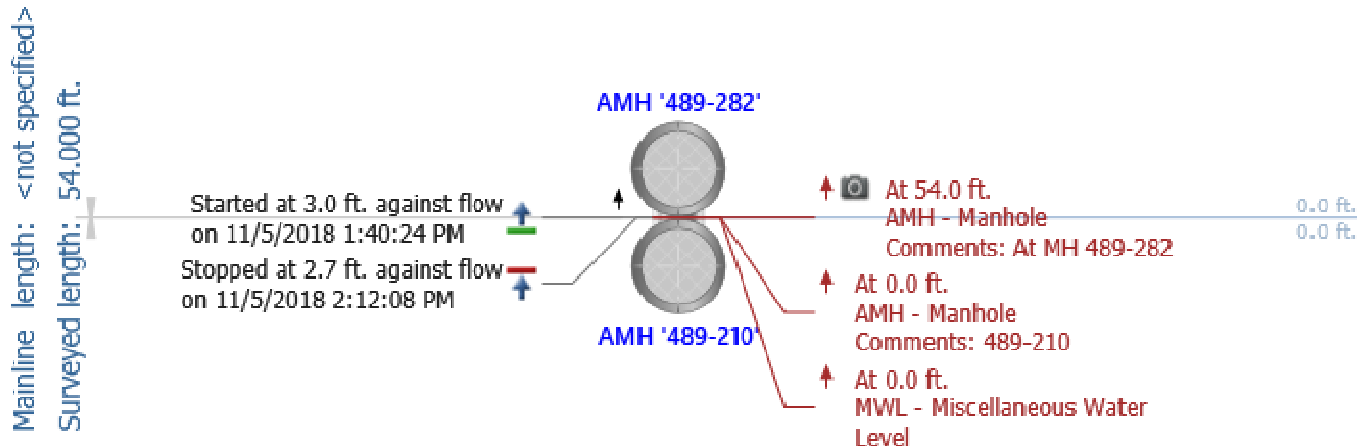
Notes: 489-282 to 489-210

- 12-in. CMP
- 54 LF
- Surface corrosion, 4:00 and 8:00 position, 3 LF to 14 LF, 5:00 and 7:00 position 14 LF to 25 LF
- Debris buildup 1-2" at joint and upstream of joint, 14 LF
- Debris buildup 2-3" in 4:00 and 8:00 position at 20 LF
- Horizontal deflection in pipe, 26 LF
- Surface corrosion visible in invert at 27 LF, 34 LF
- Corrosion, metal loss, 3:00 to 4:00 position 27 LF to 30 LF
- Debris buildup 2-4" at 47 LF/Upstream end of pipe near manhole structure
- Flow: None
- Grade score of: 2

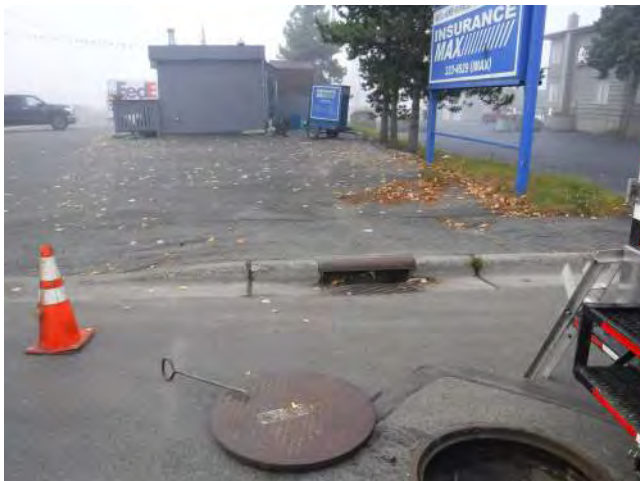
Facing South

Inspection stopped by debris 40.8' 10/1/18

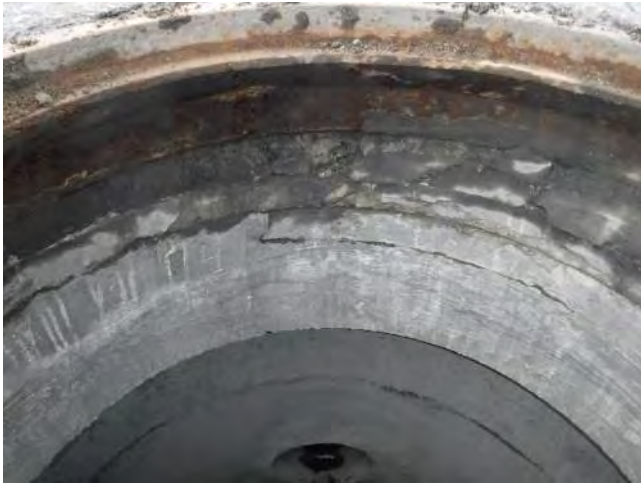
Damage to grade rings

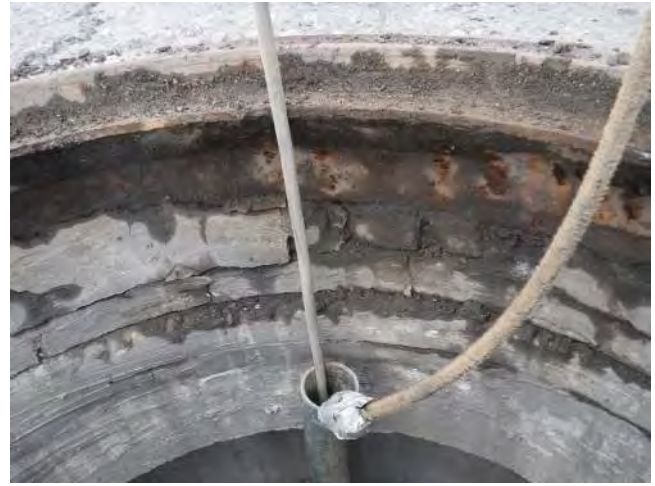
Damage to grade rings

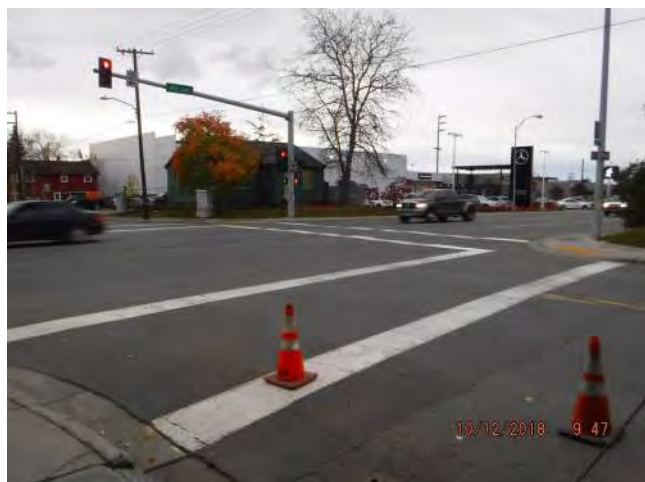
Date of Inspection: Monday, July 23, 2018

INSPECTED 26.7' STOPPED BY DEBRIS 10/12/18

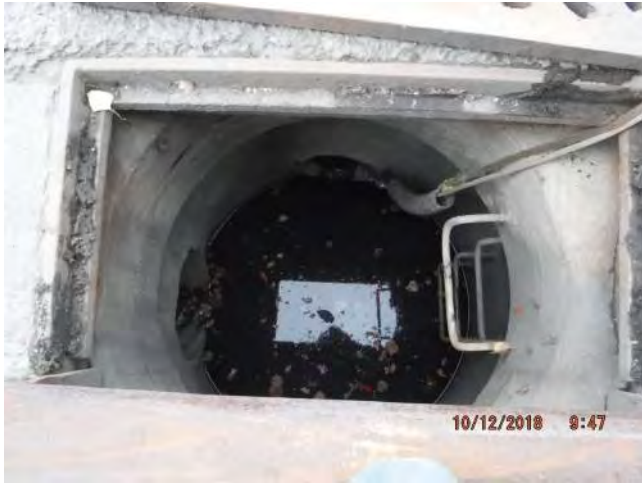
West is up

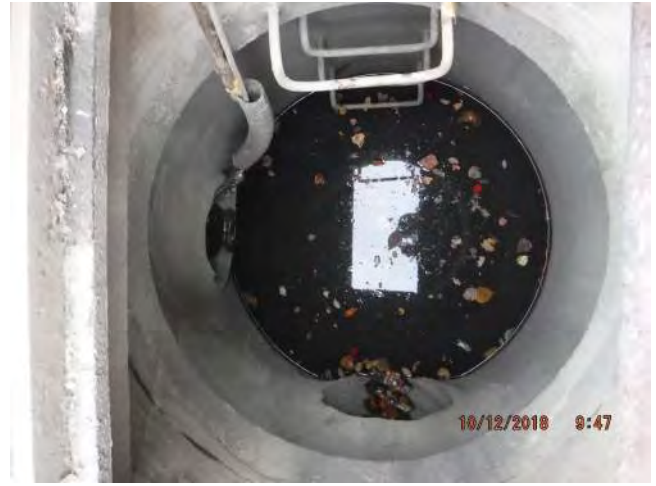
North is up

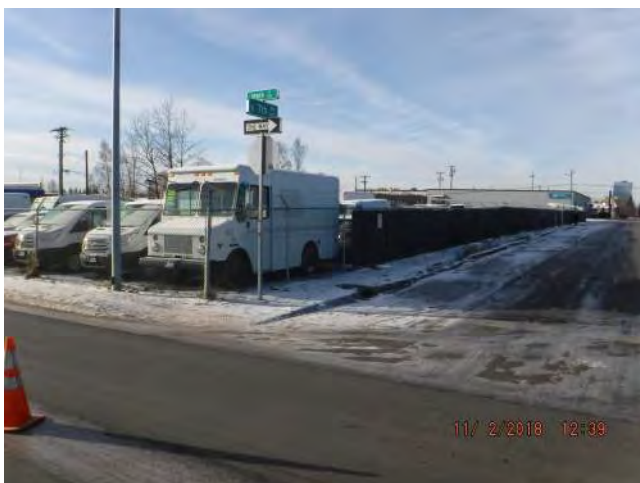
489-212 Facing West

Primary Comments: EXPOSED AGGREGATE IN CONE, CORRODED STEPS NOT IN ALIGNMENT

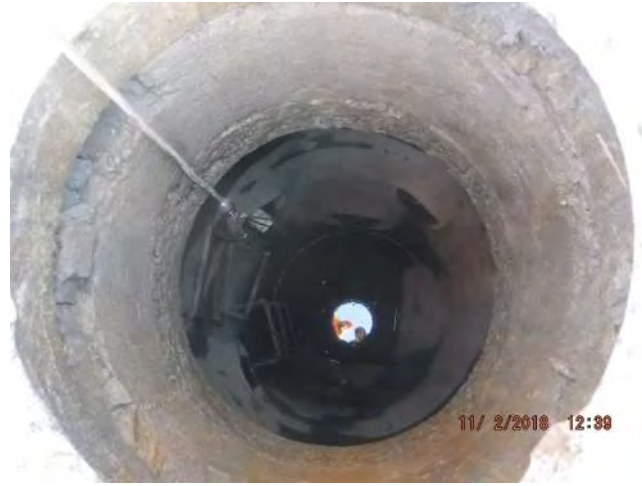
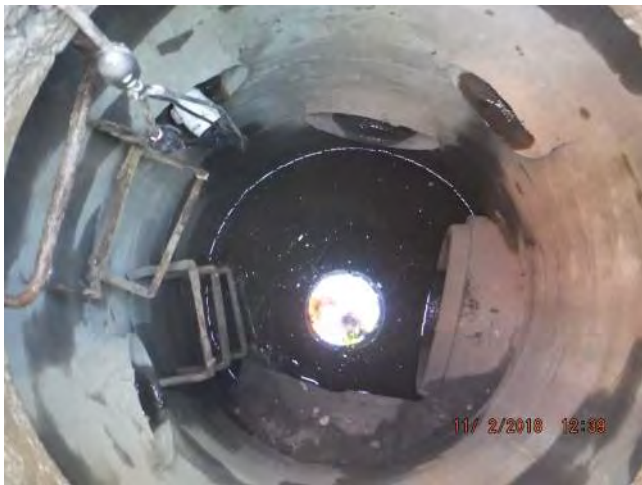
Manhole interior, North is up

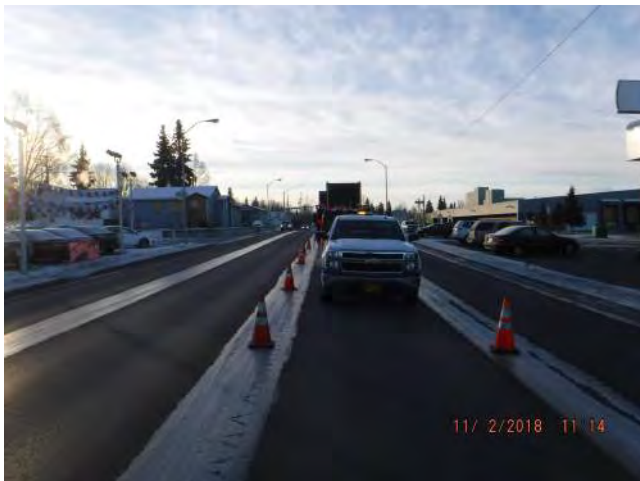
489-211 Facing South

Primary Comments: One step Northwest, loose frame, exposed aggregate in cone

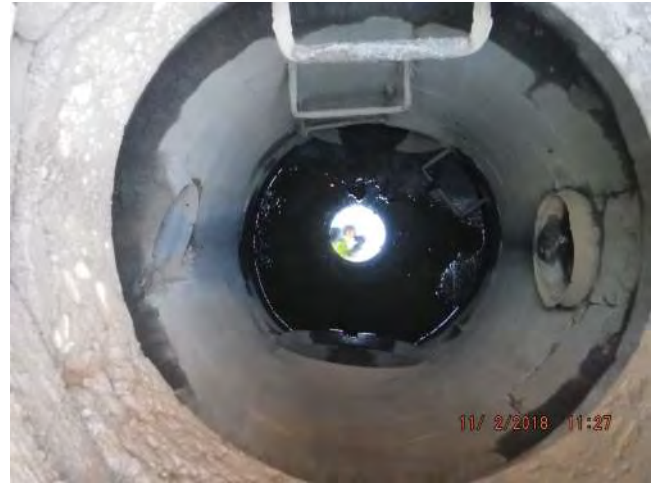
Manhole Interior, North is up
