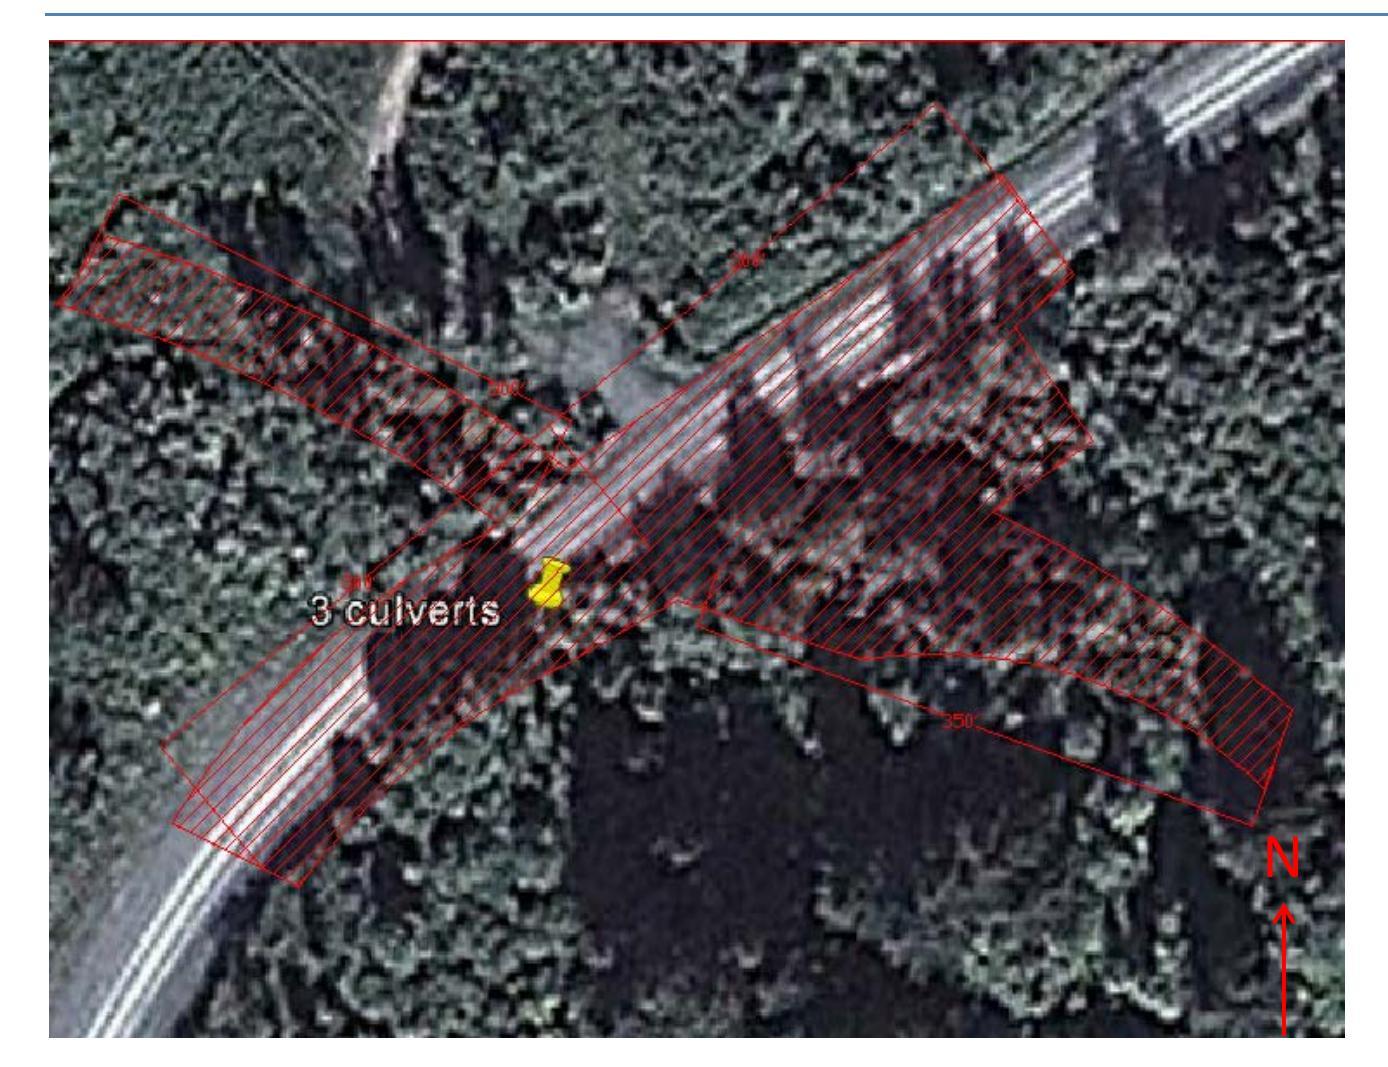
Site 5: 3 Culverts at MP 33

- Approximate CDS Milepoint 22.9-23.1
- fish passage criteria and 2 of 3 have failed
- Ditch on inlet side is shallow

• 3 culverts are hydraulically inadequate, less than minimum cover, do not meet

- Ditch on inlet side will require ditch linear grading
- Replace culverts with one culvert and raise road 1.5'

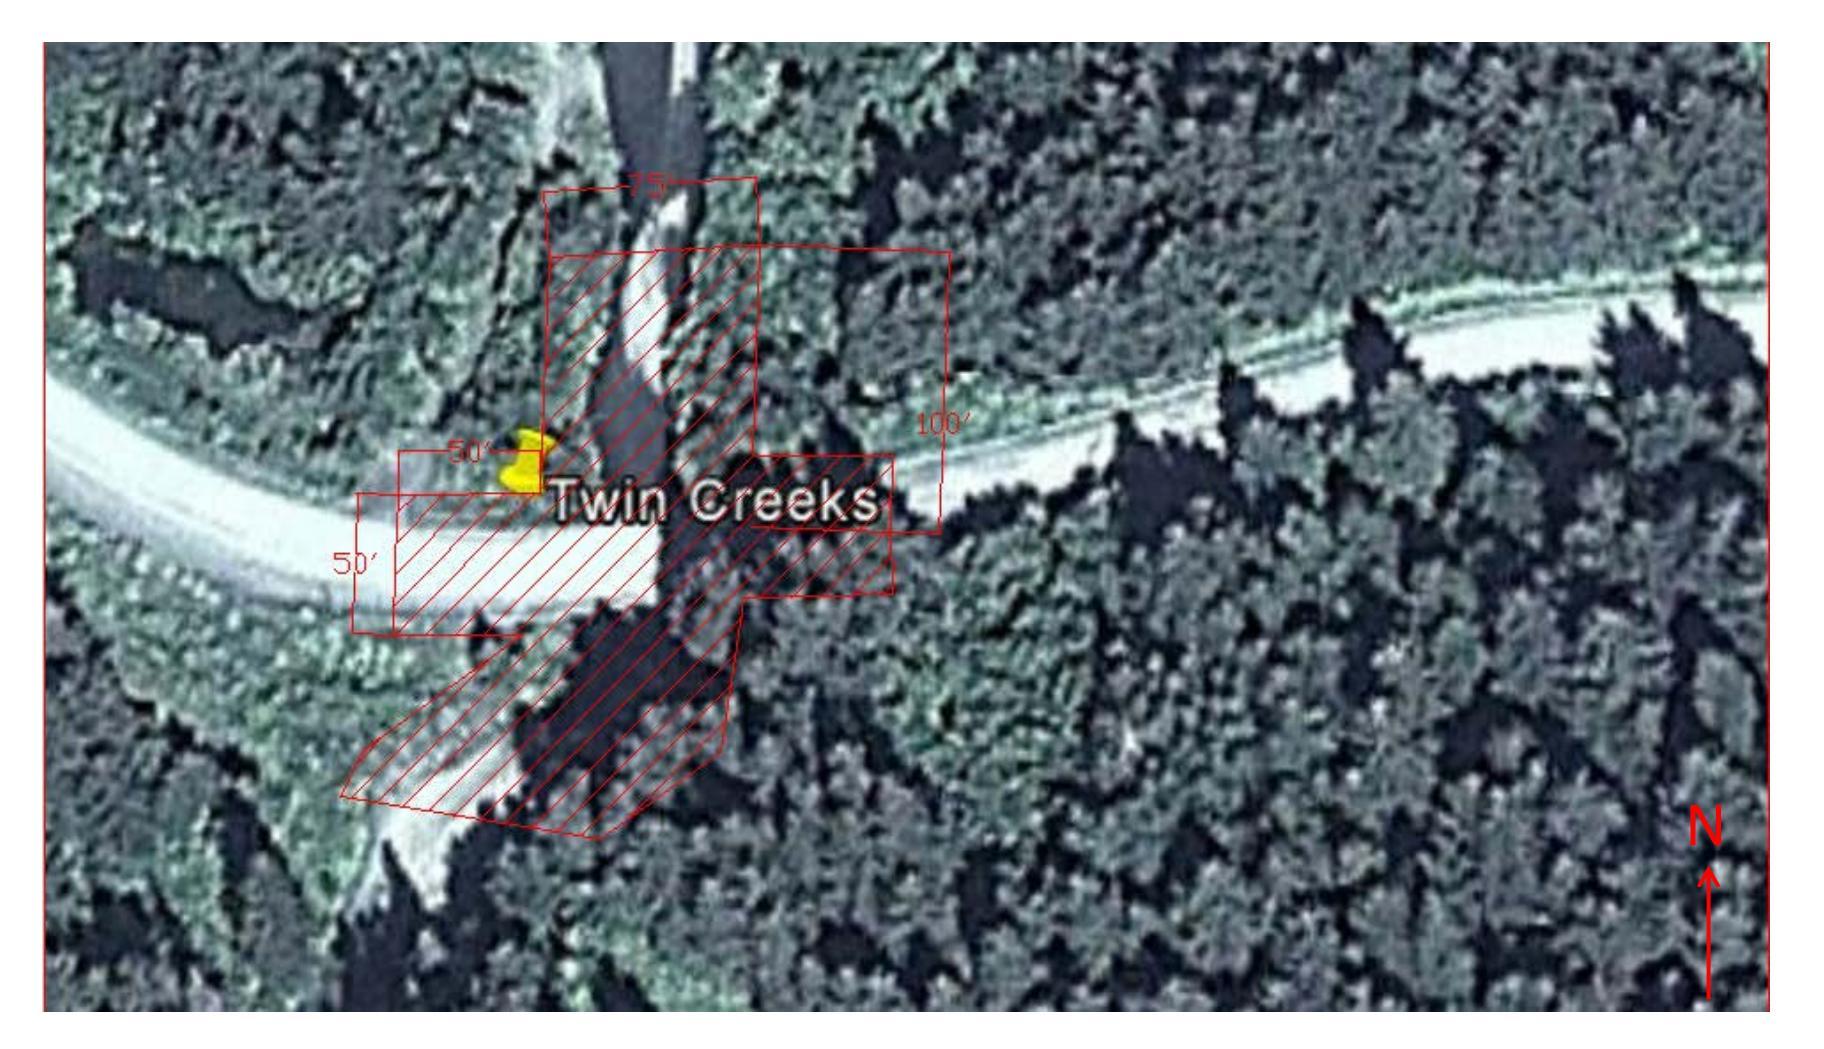
Site 7: Twin Creeks (MP 40)

- Approximate CDS Milepoint 29.9-30.0

• No recommendations
