**NOATAK RIVER BANK EROSION STUDIES**

***NOATAK RIVER BANK EROSION STUDY  
AT NOATAK, ALASKA***

ANTHC Project No. AN01-Q55

**R&M CONSULTANTS, INC.**  
9101 Vanguard Drive  
Anchorage, Alaska 99507

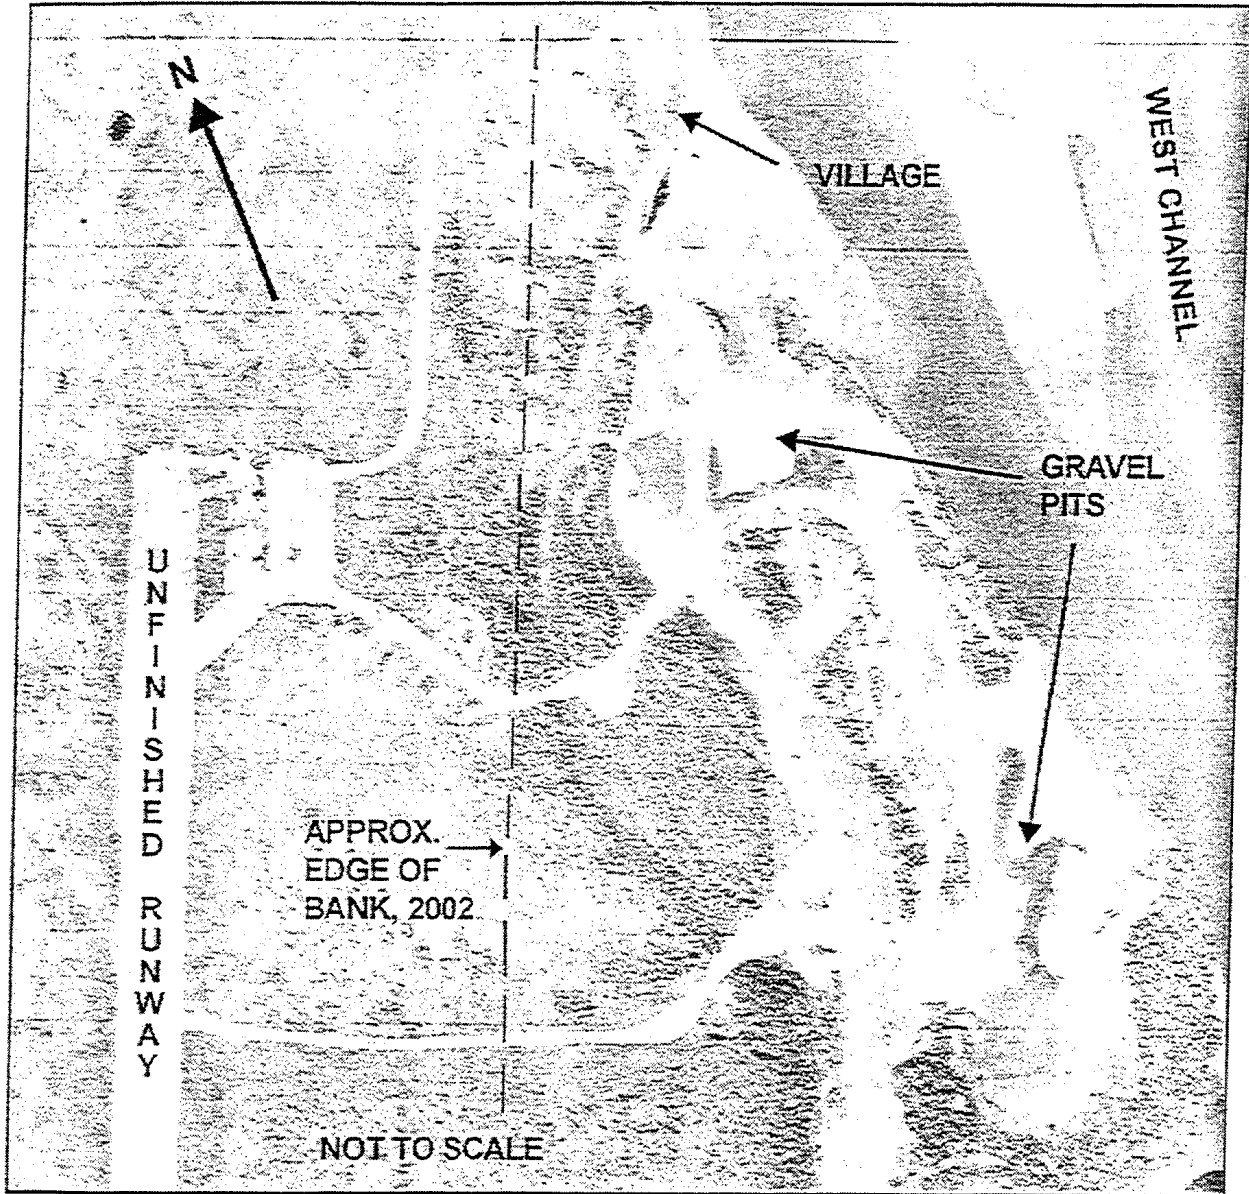
FIGURE 4

2. The airport was constructed in the early 1960s. The 1962 aerial photos show large gravel pits on a vegetated island adjacent to the north end of the airport with access roads leading to the airport (see Figure 4). It is not known how much material was taken out of the floodplain. Within a few years of mining, significant erosion began to occur along the island and adjacent bank.

GRAVEL PITS USED TO CONSTRUCT AIRPORT

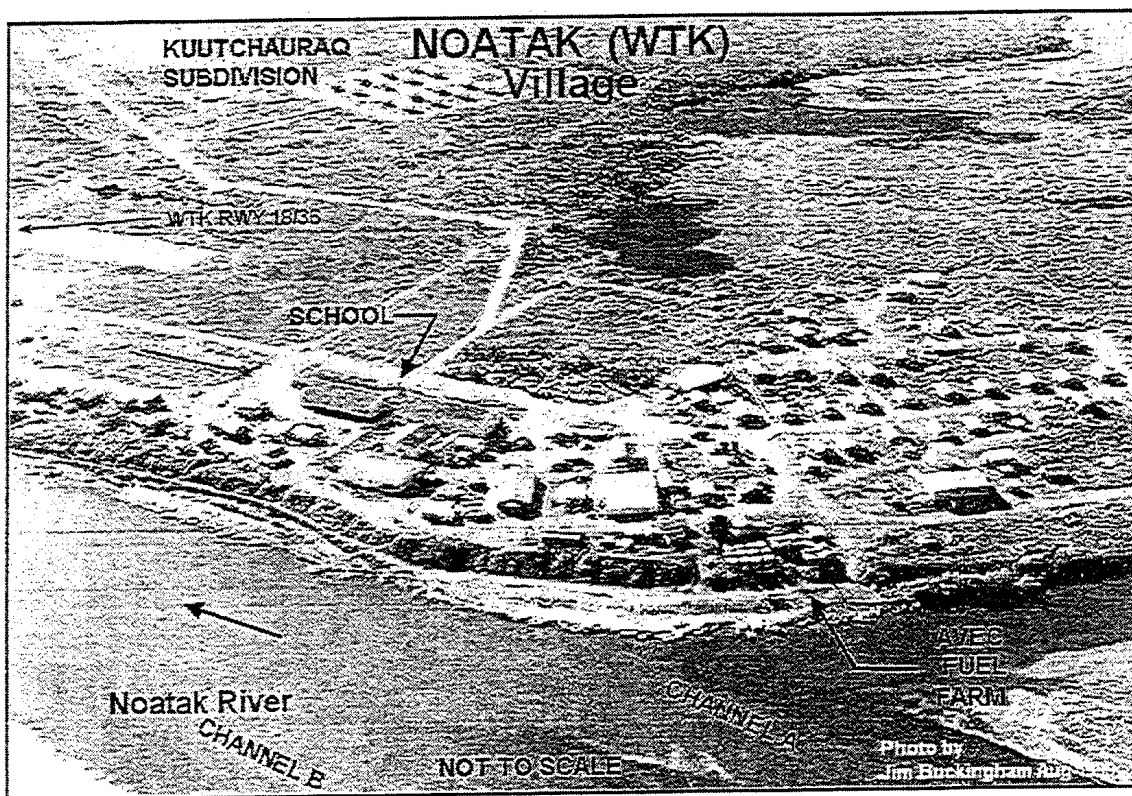
FIGURE 6

Location B consists of the section of river bank protected by a concrete erosion control structure and is shown on Drawing A-04. An oblique aerial photo of Location B is shown in Figure 6. It starts at the north end of the airport and continues upriver to the AVEC tank farm at the upriver end of the village. The banks behind the structure are vegetated and appear to have been relatively stable since it was constructed in the early 1980s.

PHOTO OF RIVER BANK AT LOCATION B

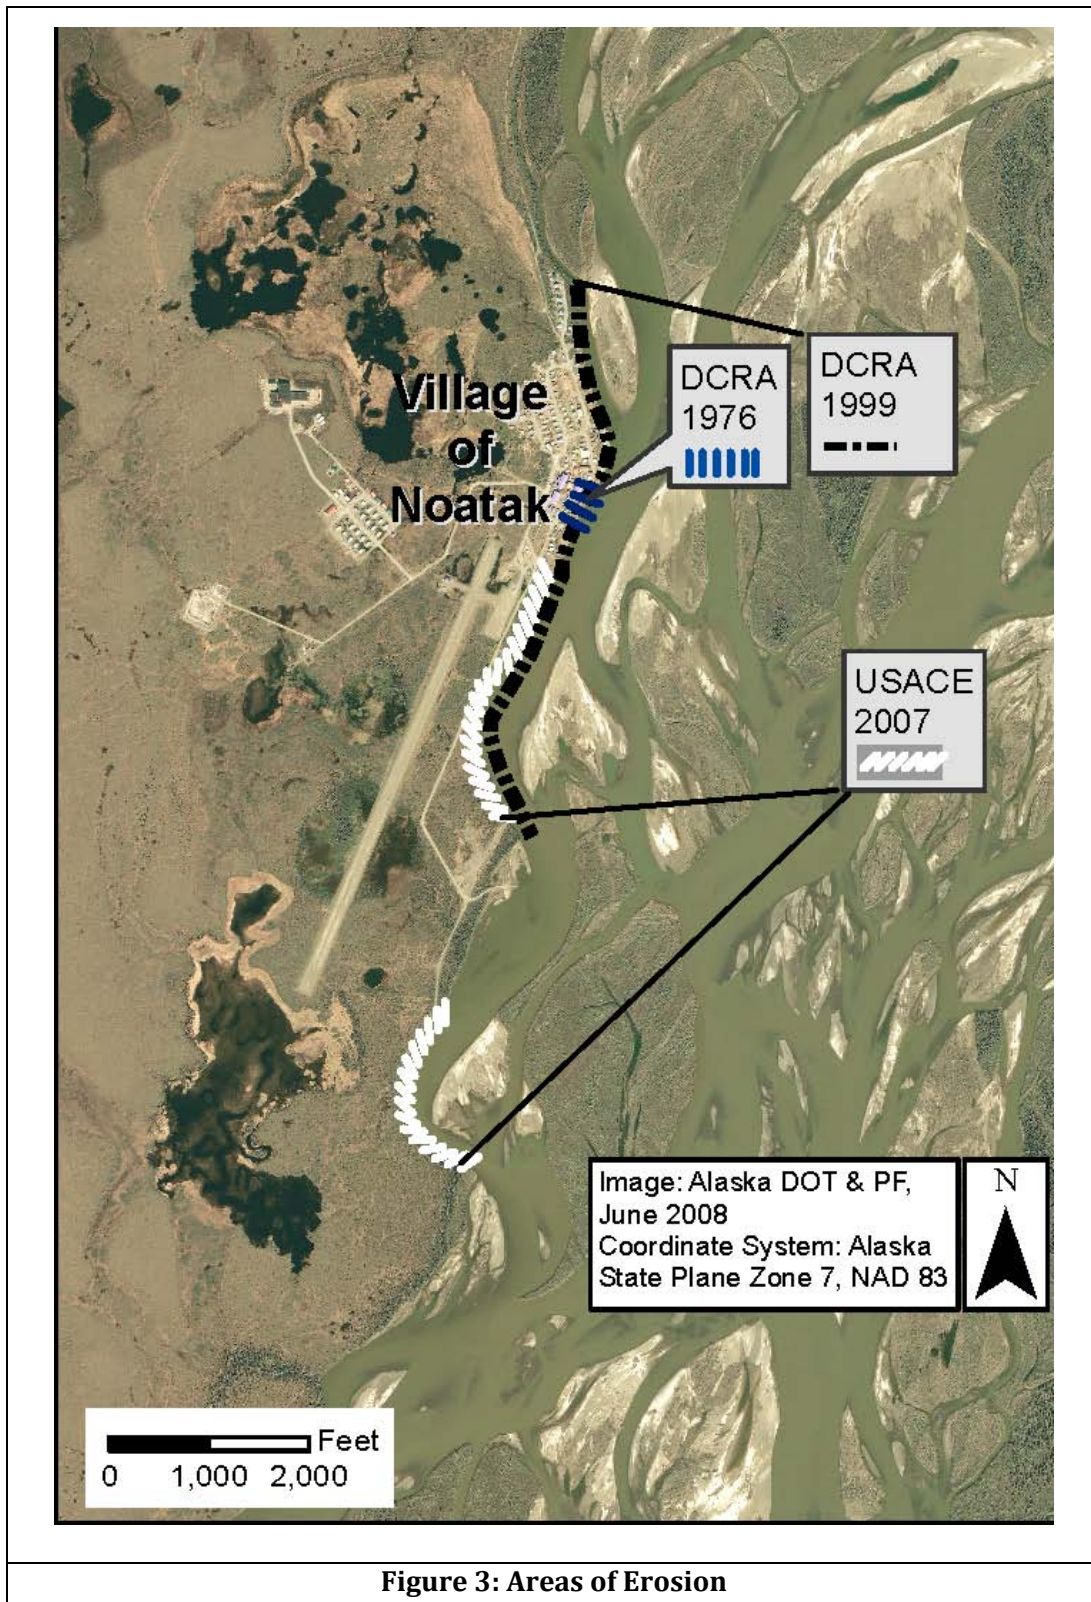
5. Current Areas Subject to Erosion. Areas depicted on maps prepared by two agencies (DCRA, 1999 and USACE, 2007) in the past 13 years are shown on Figure 3. Erosion is more apparent in areas of high, steep banks, than along the area adjacent to the airport apron. The *Alaska Baseline Erosion Assessment* (USACE, 2009) rated Noatak as a “Monitor Conditions Community,” having significant impacts related to erosion, in which taking action to prevent a problem from becoming worse would be prudent.

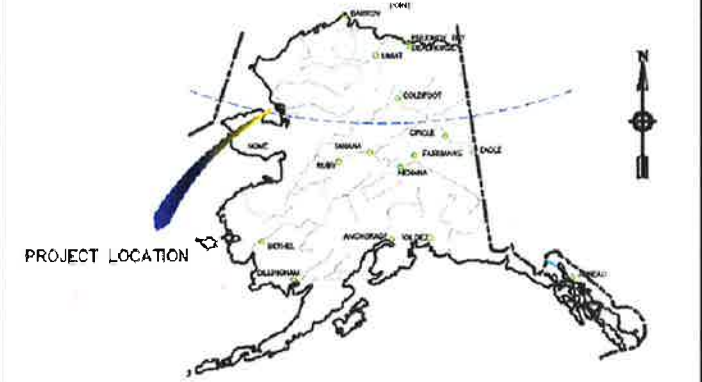
# Noatak Riverbank Erosion Update 2015

⊗ 25/03/2015 Erosion Coordinates
