GEOTECHNICAL REPORT

PARKS HIGHWAY MILE 216 NORTH REHABILITATION

FEDERAL PROJECT NO. I-0A4-3 (07)
STATE PROJECT NO. 64924

JANUARY 1991

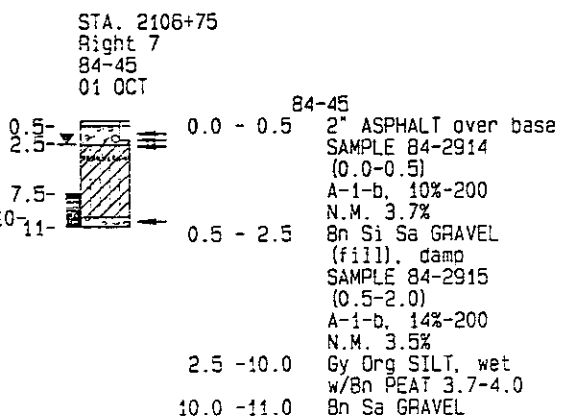
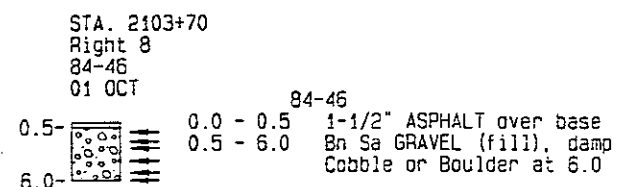
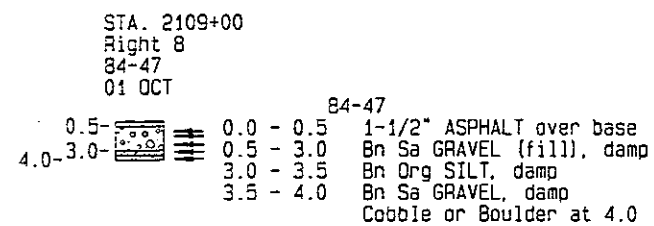
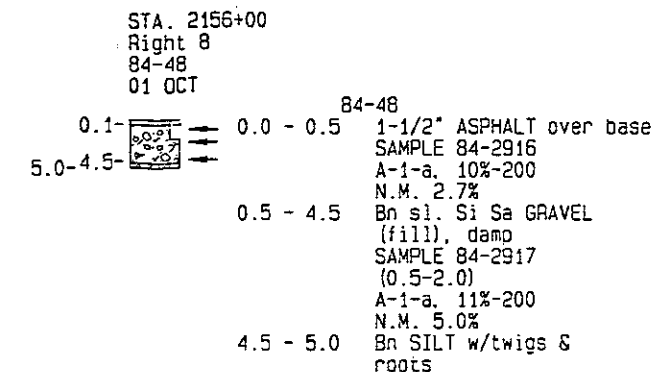
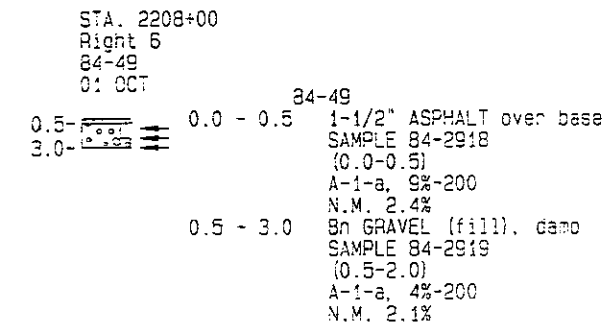
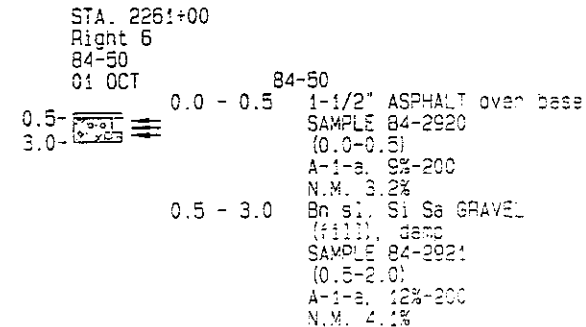
1984 TESTHOLES

This interval has deep rutting and patching. Test holes showed pavement and base course over 0.6 to 3 feet of sandy embankment gravel over 9 to 13 feet of saturated silt and organic silt and organic silty sandy gravel. The organic materials rest on sandy gravel or rubble. A water table was noted at 2.5 to 5 feet beneath the pavement surface. See TH's 84-37 through 84-42.

This short section is badly rutted and patched. Test holes showed a pavement and base course over 2 feet of sandy gravel embankment over 8 feet of organic silt. The organic material was saturated to 7.5 feet below the asphalt and was frozen from 7.5 to 10 feet in depth where frozen sandy gravel was found. See TH's 84-45 through 84-47.

As an alternative, raise the grade to provide a minimum of 4 feet of embankment over the saturated silt. Place 2 inches of board insulation 3 feet beneath the surface to reduce seasonal frost heaving.

As an alternative, raise the grade to provide at least 4 feet of embankment over the silt. Place 2 inches of board insulation 3 feet beneath the surface to reduce seasonal frost heaving.

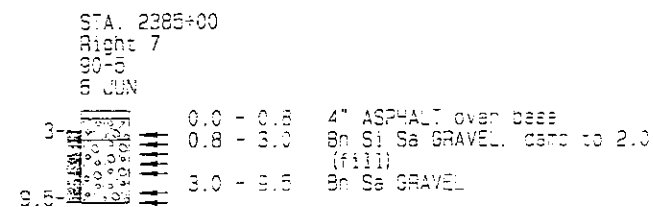
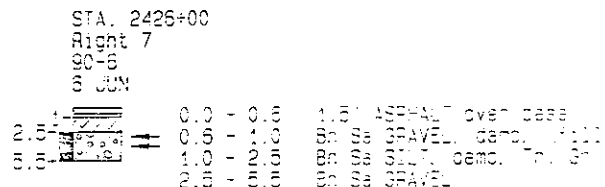
1990 TESTHOLES

A seasonal frost heave occurs every winter in this short (less than 50 feet long) interval. Test holes showed a total of 2 feet of pavement, base course and sandy gravel fill resting on 1 foot of silt overlying over sandy gravel. The silt and underlying sandy gravel were frozen. The silt layer did not extend more than 30 feet either way from the center of the bump and patch. Apparently there is sufficient moisture in the silt to cause seasonal frost heaving of the entire embankment. See TH's 90-4 and 90-7 at Station 2340+00..

A seasonal frost heave occurs here, too. Fifty to sixty linear feet of patch and chips have been placed on the highway surface. A test hole showed about 4 inches of asphalt and 5 inches of base over about 2 feet of silty sandy gravel fill. This fill rests on sandy gravel at about 3 feet beneath the road surface. Frozen soils began 2 feet beneath the surface. The silty sandy gravel apparently contains sufficient silt and moisture to cause seasonal frost heaving of the entire embankment. See TH 90-5.

This very short (ten foot long) section is another seasonal frost heave. A test hole showed a total of 1 foot of asphalt, base and sandy gravel fill over about 1.5 feet of sandy silt resting on frozen sandy gravel. Again the silty soil beneath the cleaner embankment materials seems to be the culprit causing the seasonal frost heave. See TH 90-6.

Excavate the silty sandy gravel between Station 2384+70 and Station 2385+30 about 3 feet to the underlying sandy gravel. Replace those soils with Selected Material, Type A or B. Use the excavated material to construct screening berms in the borrow sources.

Excavate the sandy silt to sandy gravel at approximately 2.5 feet beneath the road surface between Stations 2425+90 and 2426+10. Replace the sandy silt with Selected Material, Type A or B.
