APPENDIX D

DNR-OHMP (ADF&G) Fish Sampling Reports

SUBJECT: Trip Report
Gustavus

SUBJECT: Gustavus Gravel Pits and Airport
Fish Sampling Trip Report

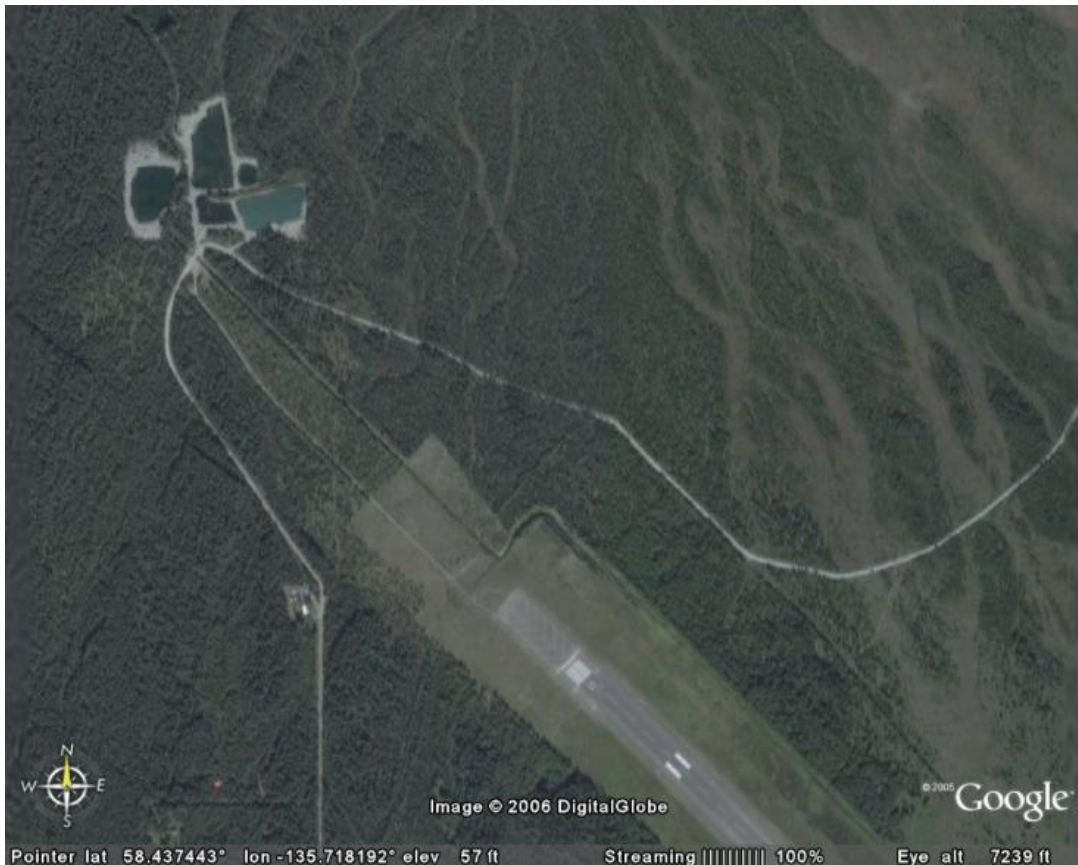
Background: DNR owns a gravel source located north of the airport that is the main source for Gustavus. The gravel source currently has little management oversight. The Division of Mining Land and Water (DMLW) and the City of Gustavus want to develop a Management and Reclamation Plan for the site. Fish have been observed in the pit ponds, which drain to a ditch (Stream No. 114-23-10199) documented as rearing habitat for coho salmon. The ditch is cataloged from the culverts on Wilson Road just below the ponds, through the airport and to the outlet to the south in Icy Straight.

Gustavus Airport showing DNR gravel pits to the north. Icy Straight is to the south.

OHMP will require that drainage be provided between the ponds and the ditch/stream system so that fish can move between the ponds and the stream. The stream currently flows through the western pond, but passage between ponds is restricted by missing or inadequate culverts. With the current pond

The ponds have the potential to be reclaimed to enhance fish rearing habitat. We will need to sample fish during winter, and measure pond depth and dissolved oxygen levels which could limit over-wintering fish habitat. Once we have the above information, we can recommend a design for reclamation of the ponds.
