HAINES HIGHWAY

ENVIRONMENTAL SITE ASSESSMENT

MARCH 2006

DOT&PF PROJECT NO. 68606
HAINES, ALASKA

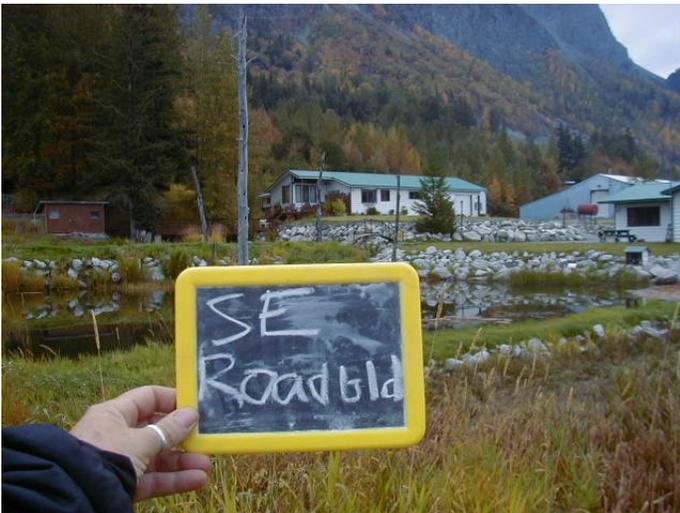
<p>Photograph No. 6</p> <p>Location: N/A</p> <p>Direction: Facing east</p> <p>Comments: Photo of pond on property</p>

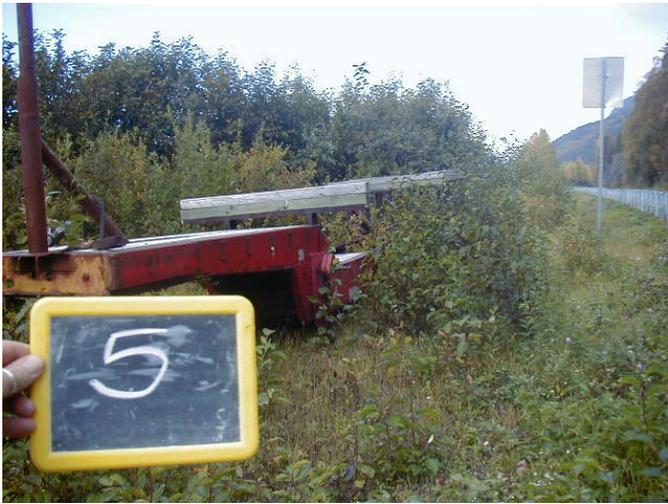
<p>Photograph No. 20</p> <p>Location: Site 7</p> <p>Direction: Facing northwest</p> <p>Comments:</p>

- Site 6: On the shoulder, between the highway and the river is a recently used firepit and old trailer.
- Site 7: A large area, which contains a dilapidated old home site, was found between the road and the mountains. Associated debris included one drum, a partially collapsed house, car, and shed with one old drum. A smaller building was also observed up the hill.

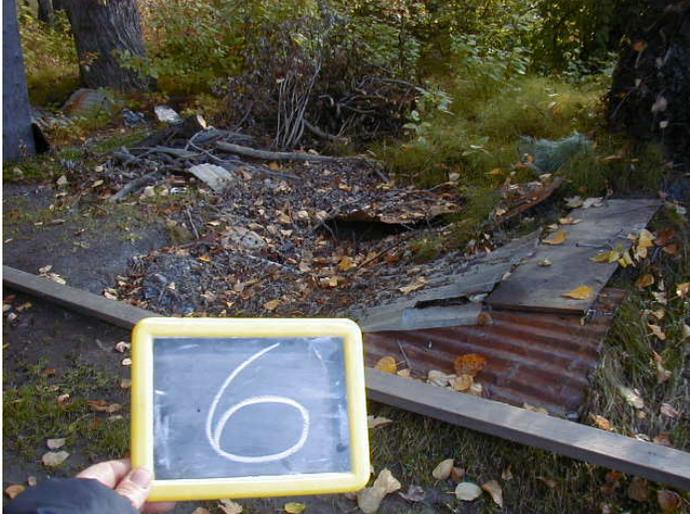
<p>Photograph No. 38 Location: Site 10 Direction: Facing east Comments:</p>

- Site 10: An abandoned car was observed in the heavily wooded area between the highway and the mountains.
- Site 11: Two porta-potties were observed on the parking area between the river and the highway.

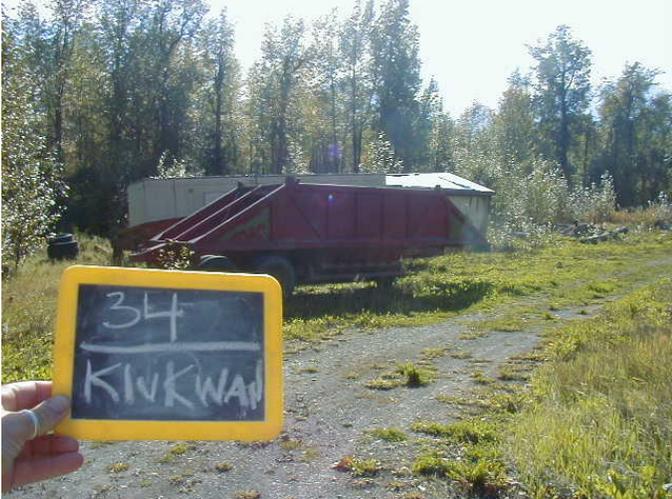
<p>Photograph No. 40 Location: Site 12 Direction: Facing west Comments:</p>

Site 12: At the Klukwan turnoff, an area was observed that contained multiple vehicles, oil buckets, and associated debris.

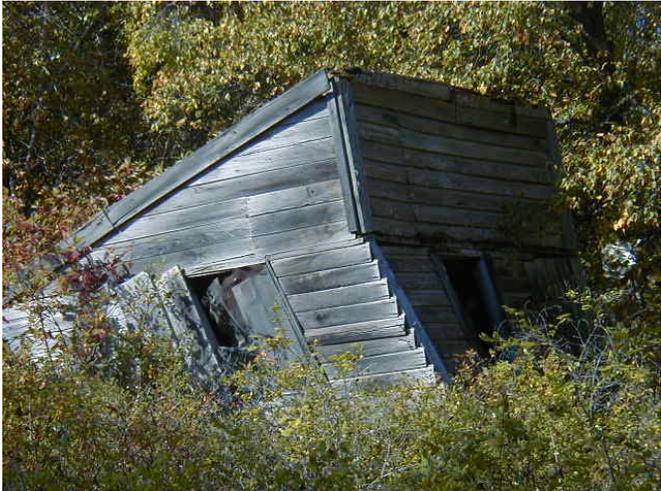
<p>Photograph No. 51</p> <p>Location: Site 14</p> <p>Direction: Facing east</p> <p>Comments:</p>

Site 14: An old abandoned structure was observed between the highway and the mountains.
