FILE No. GEO_HAZ_SUMM.PPT
PROJECT No. 063-5782

GEOLOGIC HAZARD SUMMARY
ARRANGED BY IRP 2006 STATIONING
LYNN CANAL HIGHWAY PHASE I
ZONE 4 GEOTECHNICAL INVESTIGATION

ADOT / LYNN CANAL HWY ZONE 4 / AK

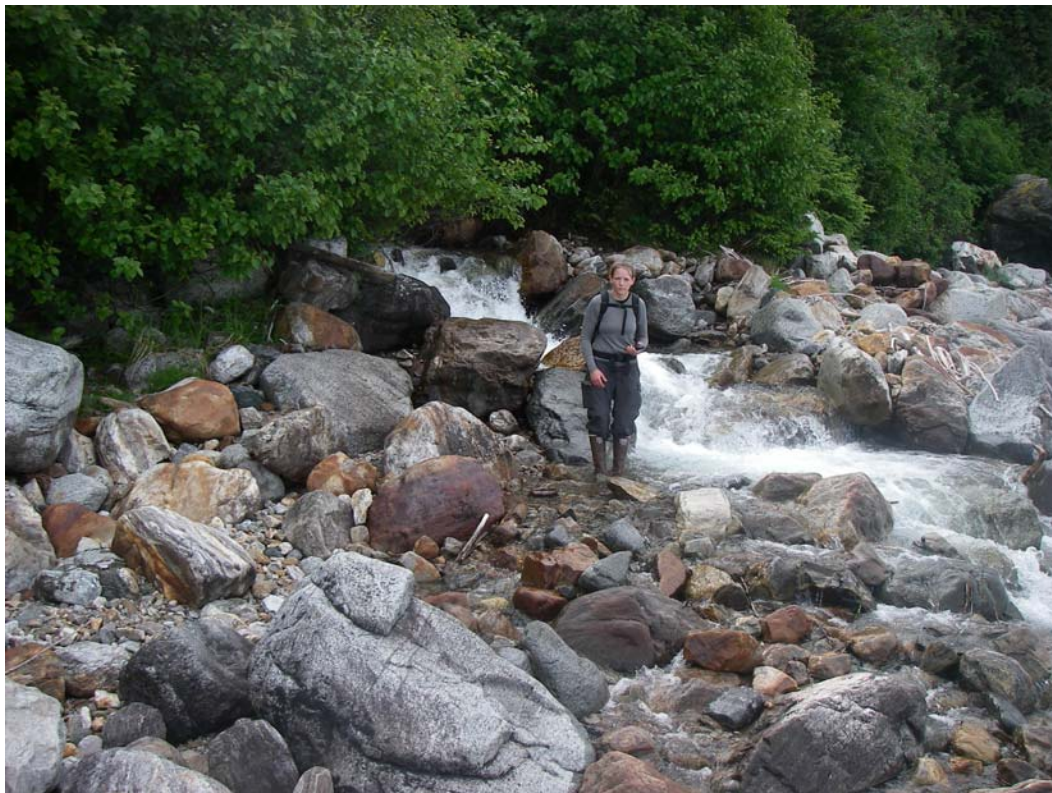
DF06. View southeast (upslope and down alignment) across debris flow deposition zone at tide line. Photo taken 20 ft left of IRP 2006 1677+50.

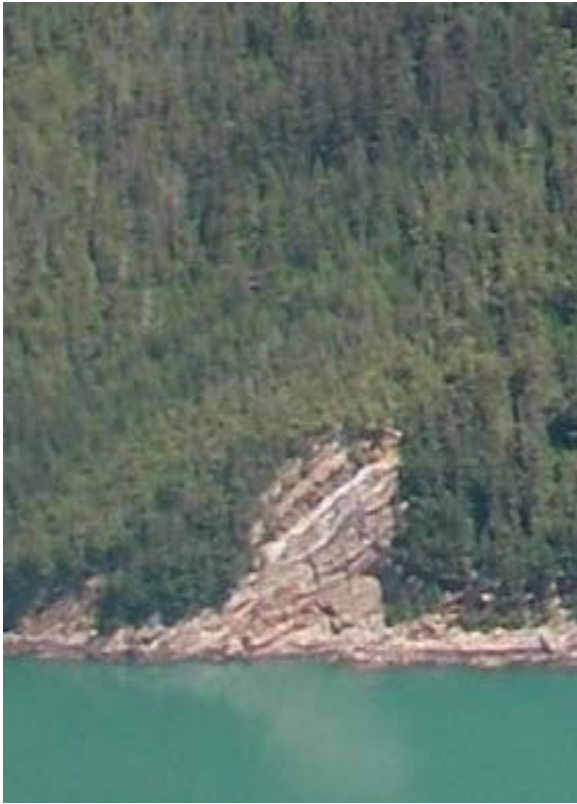
RF08. View east/upslope at rockfall hazard.

Hazard ID #:	RF08
Hazard Type:	rockfall
HIN:	183
Rating:	A
IRP 2006 Location:	1759
Frequency (yrs):	5-25
Predictability:	unpredictable
Material Volume (CY):	<10
Clast Size (ft):	4+
Source Elev. (ft):	100-500
Centerline Slope:	open_soil_slope
Alignment Location:	deposition_zone
Impact Alignment:	yes
Alignment Exposure (ft):	500+
Vegetation:	disturbed
Deciduous Trees:	no
IRP 2006 South Margin:	1759+30
IRP 2006 North Margin:	1767+00
Photo #:	5039, 5040, 5041, 5157, 6209

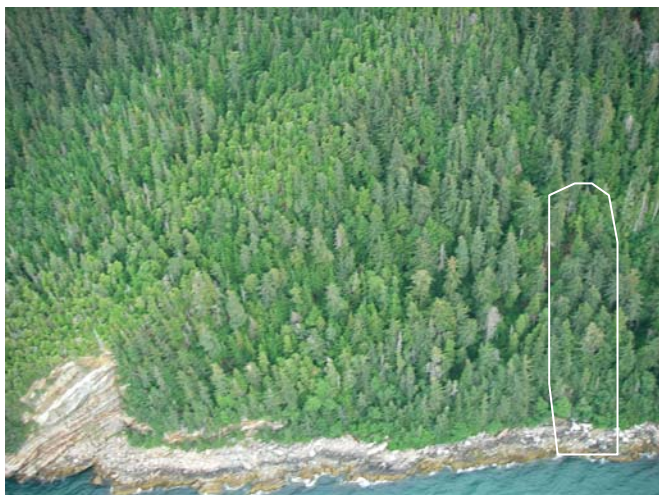
RF09. View east/upslope at area of greater frequency rockfall within rockfall area RF08.

Hazard ID #:	RF09
Hazard Type:	rockfall
HIN:	129
Rating:	A
IRP 2006 Location:	1763
Frequency (yrs):	1-5
Predictability:	unpredictable
Material Volume (CY):	<10
Clast Size (ft):	2-3
Source Elev. (ft):	100-500
Centerline Slope:	open_soil_slope
Alignment Location:	deposition_zone
Impact Alignment:	yes
Alignment Exposure (ft):	50-200
Vegetation:	disturbed
Deciduous Trees:	yes
IRP 2006 South Margin:	1763+20
IRP 2006 North Margin:	1763+80
Photo #:	3878

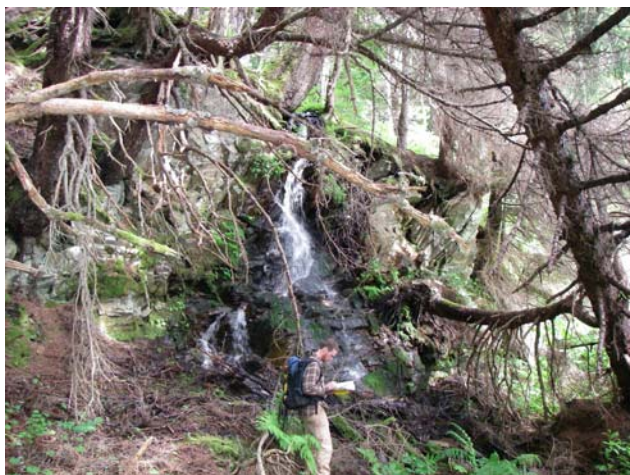
RF11. View east/upslope at minor rockfall hazard located at centerline at IRP 2006 1865+00.

Hazard ID #:	RF11
Hazard Type:	rockfall
HIN:	105
Rating:	B
IRP 2006 Location:	1865
Frequency (yrs):	5-25
Predictability:	unpredictable
Material Volume (CY):	<10
Clast Size (ft):	2-3
Source Elev. (ft):	<100
Centerline Slope:	open_soil_slope
Alignment Location:	deposition_zone
Impact Alignment:	yes
Alignment Exposure (ft):	50-200
Vegetation:	disturbed
Deciduous Trees:	yes
IRP 2006 South Margin:	1864+80
IRP 2006 North Margin:	1866+00
Photo #:	6234

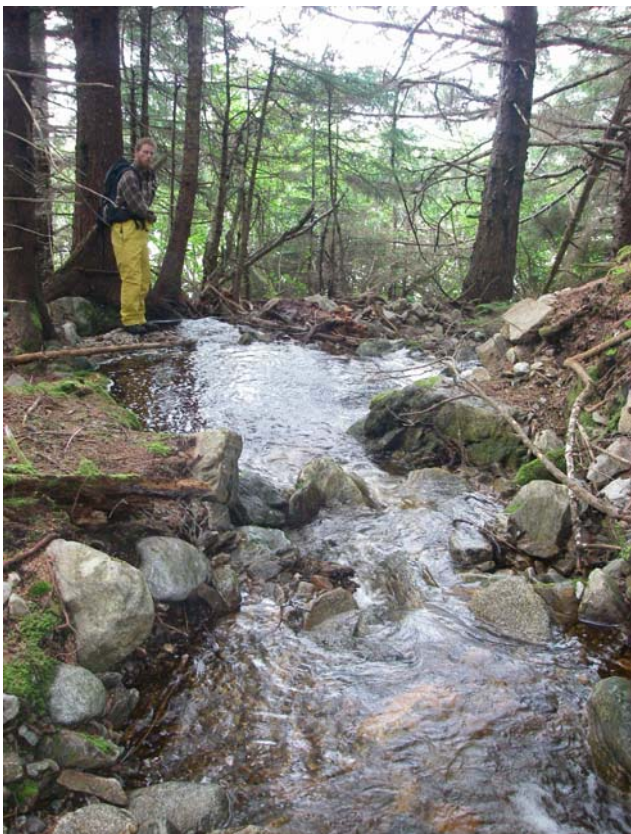
DF21. View west/downslope at debris flow deposition zone, 250 ft left of IRP 2006 1894+00.

Hazard ID #:	DF21
Hazard Type:	debris_flow
HIN:	123
Rating:	B
IRP 2006 Location:	1894
Frequency (yrs):	1-5
Predictability:	high
Material Volume (CY):	<10
Clast Size (ft):	0-1
Source Elev. (ft):	2000-3000
Centerline Slope:	single_channel
Alignment Location:	path
Impact Alignment:	yes
Alignment Exposure (ft):	50-200
Vegetation:	disturbed
Deciduous Trees:	yes
IRP 2006 South Margin:	1893+30
IRP 2006 North Margin:	1894+40
Photo #:	5161, 6238

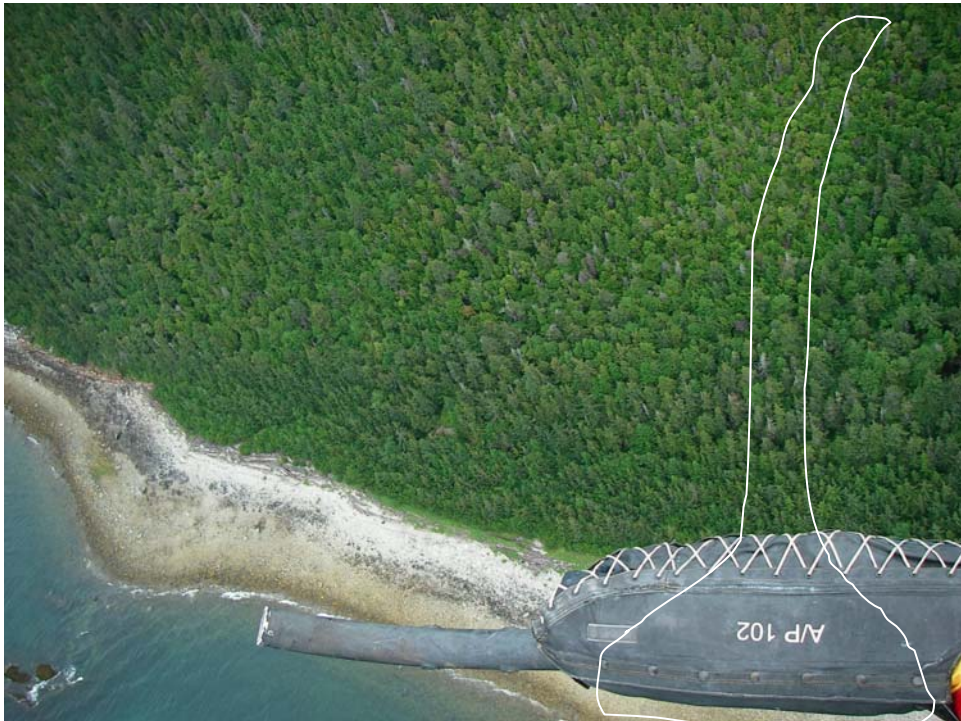
DF21. View east/upslope at moderate slope old growth covering the debris flow channel.

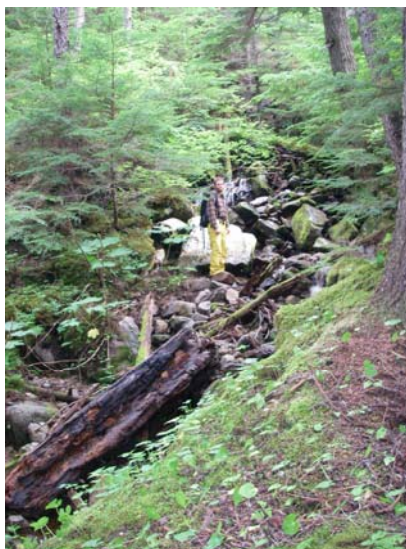
DF21. View east/upslope at debris flow channel 120 ft right of IRP 2006 1895+00.

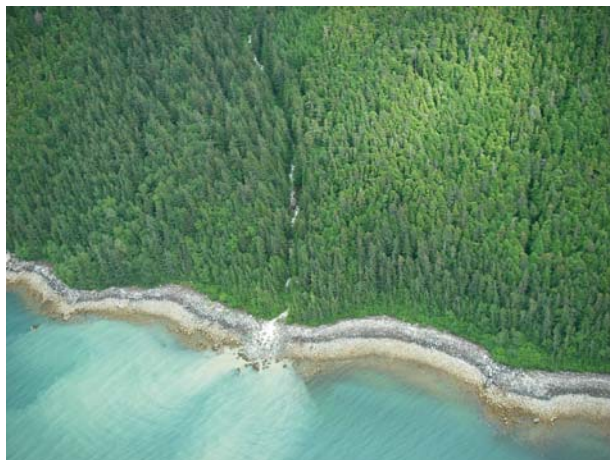
DF23. View east/upslope at debris flow channel and avalanche path ELC017.

Hazard ID #:	DF23
Hazard Type:	debris_flow
HIN:	117
Rating:	A
IRP 2006 Location:	2038
Frequency (yrs):	5-25
Predictability:	moderate
Material Volume (CY):	10-100
Clast Size (ft):	1-2
Source Elev. (ft):	3000+
Centerline Slope:	multi_channel
Alignment Location:	path
Impact Alignment:	yes
Alignment Exposure (ft):	50-200
Vegetation:	disturbed
Deciduous Trees:	yes
IRP 2006 South Margin:	2041+20
IRP 2006 North Margin:	2042+70
Photo #:	5057, 5166

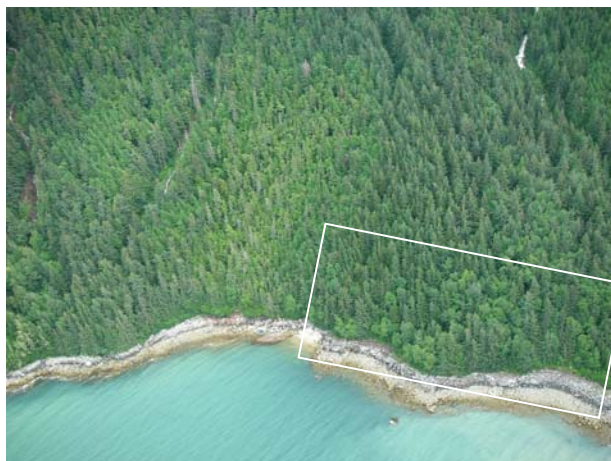
SR01. View east/upslope at soil raveling area.

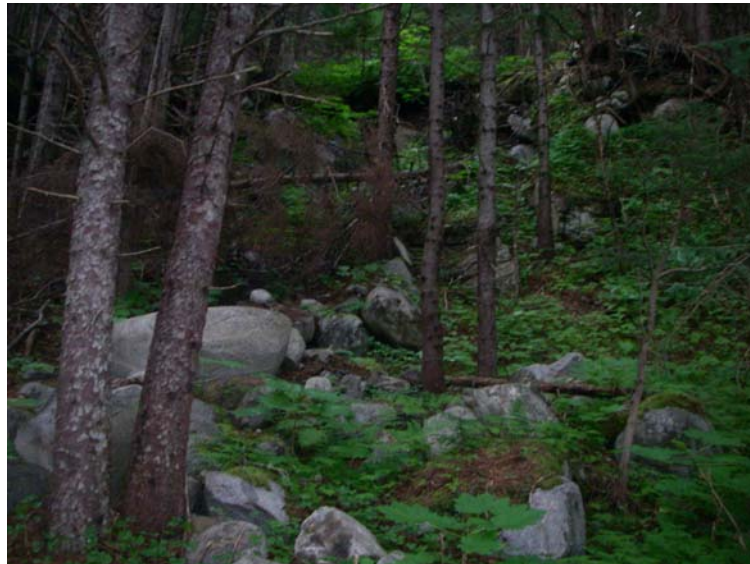
SR01. View east/upslope at soil raveling with 0-3 ft diameter boulders deposited 15 ft left of IRP 2006 alignment.

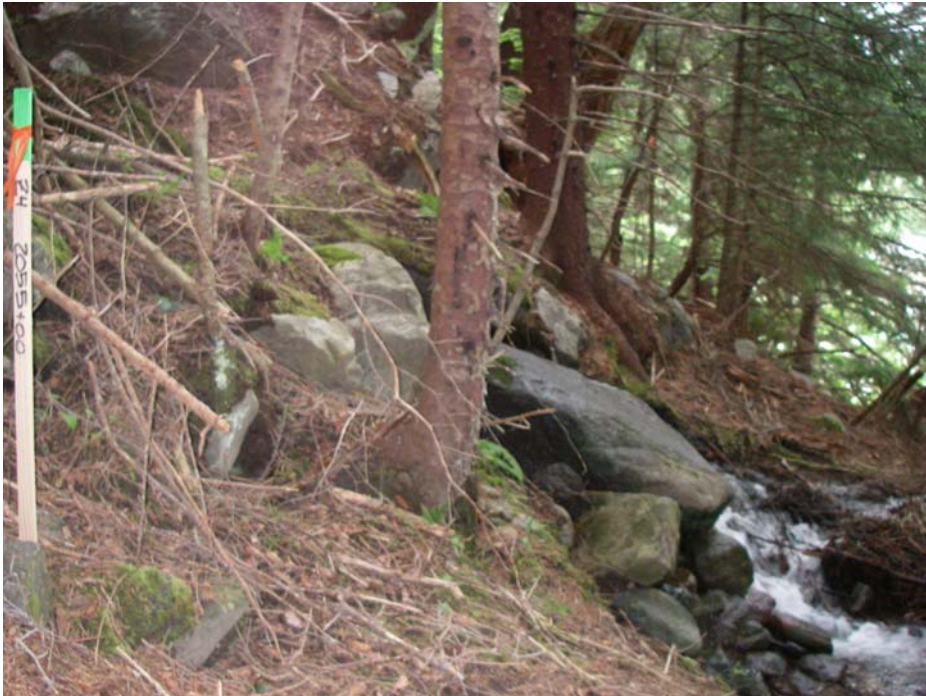
DF24. View south/ down alignment across debris flow fan terminus at IRP 2006 2055+00.

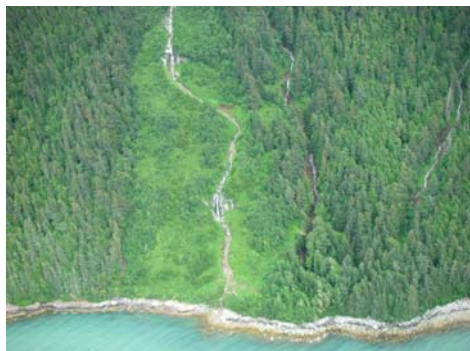
DF25. View east/upslope at debris flow channel.

Hazard ID #:	DF25
Hazard Type:	debris_flow
HIN:	129
Rating:	B
IRP 2006 Location:	2055
Frequency (yrs):	5-25
Predictability:	moderate
Material Volume (CY):	<10
Clast Size (ft):	0-1
Source Elev. (ft):	3000+
Centerline Slope:	fan
Alignment Location:	deposition_zone
Impact Alignment:	yes
Alignment Exposure (ft):	200-500
Vegetation:	disturbed
Deciduous Trees:	no
IRP 2006 South Margin:	2056+50
IRP 2006 North Margin:	2059+00
Photo #:	3462, 3463, 5093, 6195

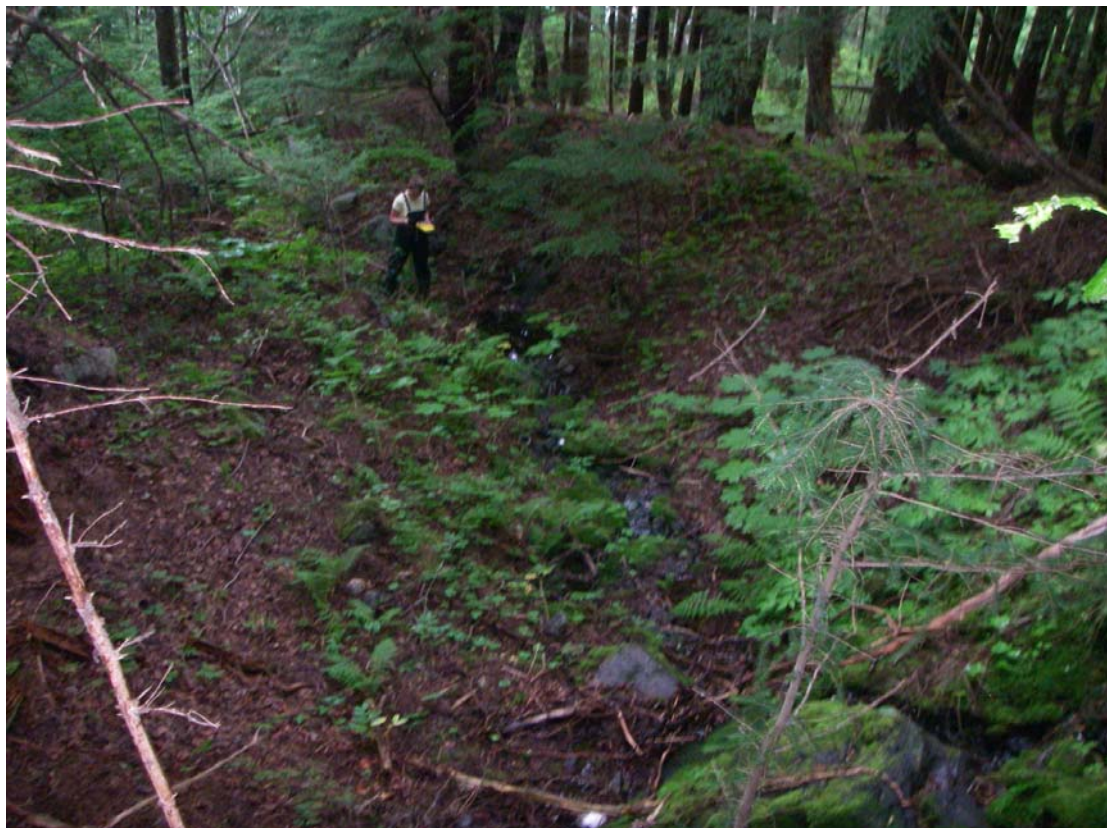
Hazard ID #:	DF27
Hazard Type:	debris_flow
HIN:	129
Rating:	B
IRP 2006 Location:	2088
Frequency (yrs):	5-25
Predictability:	Low
Material Volume (CY):	<10
Clast Size (ft):	0-1
Source Elev. (ft):	2000-3000
Centerline Slope:	open_soil_slope
Alignment Location:	deposition_zone
Impact Alignment:	yes
Alignment Exposure (ft):	50-200
Vegetation:	disturbed
Deciduous Trees:	yes
IRP 2006 South Margin:	2088+00
IRP 2006 North Margin:	2089+00
Photo #:	3885, 5167, 5924, 6247

DF27. View east/upslope at debris flow channel and avalanche path ELC019-1. Photo taken at centerline at IRP 2006 2088+50.

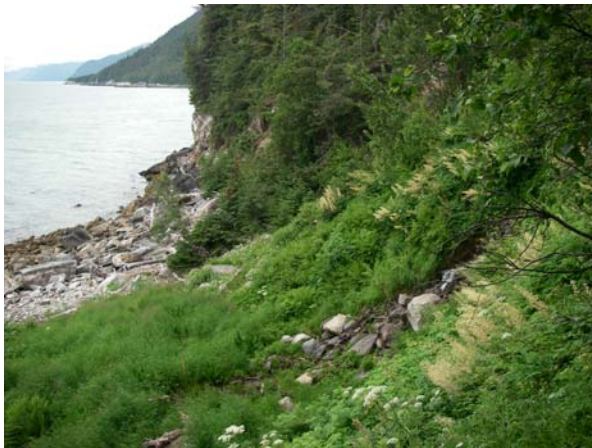
DF28. View northwest (up alignment and downslope) at IRP 2006 2103+00 at deposition fan of debris flow.

Hazard ID #:	DF28
Hazard Type:	debris_flow
HIN:	183
Rating:	A
IRP 2006 Location:	2104
Frequency (yrs):	0-1
Predictability:	high
Material Volume (CY):	10-100
Clast Size (ft):	3-4
Source Elev. (ft):	3000+
Centerline Slope:	fan
Alignment Location:	deposition_zone
Impact Alignment:	yes
Alignment Exposure (ft):	50-200
Vegetation:	denuded
Deciduous Trees:	yes
IRP 2006 South Margin:	2102+30
IRP 2006 North Margin:	2103+70
Photo #:	3886, 5916

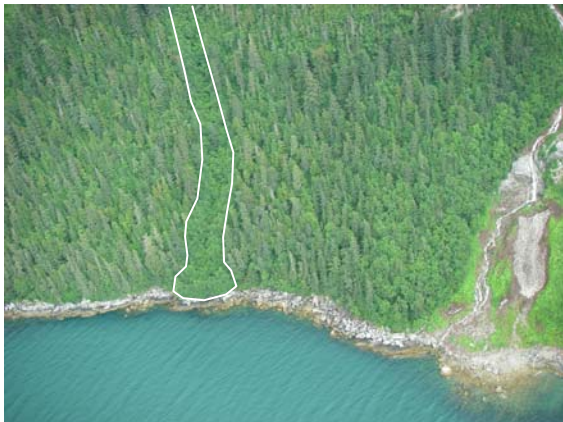
DF30. Disturbed vegetation marks path of debris flow.

Hazard ID #:	DF30
Hazard Type:	debris_flow
HIN:	135
Rating:	B
IRP 2006 Location:	2123
Frequency (yrs):	5-25
Predictability:	low
Material Volume (CY):	10-100
Clast Size (ft):	0-1
Source Elev. (ft):	1000-2000
Centerline Slope:	single_channel
Alignment Location:	deposition_zone
Impact Alignment:	yes
Alignment Exposure (ft):	50-200
Vegetation:	disturbed
Deciduous Trees:	yes
IRP 2006 South Margin:	2123+00
IRP 2006 North Margin:	2123+90
Photo #:	5168, 5927, 6250

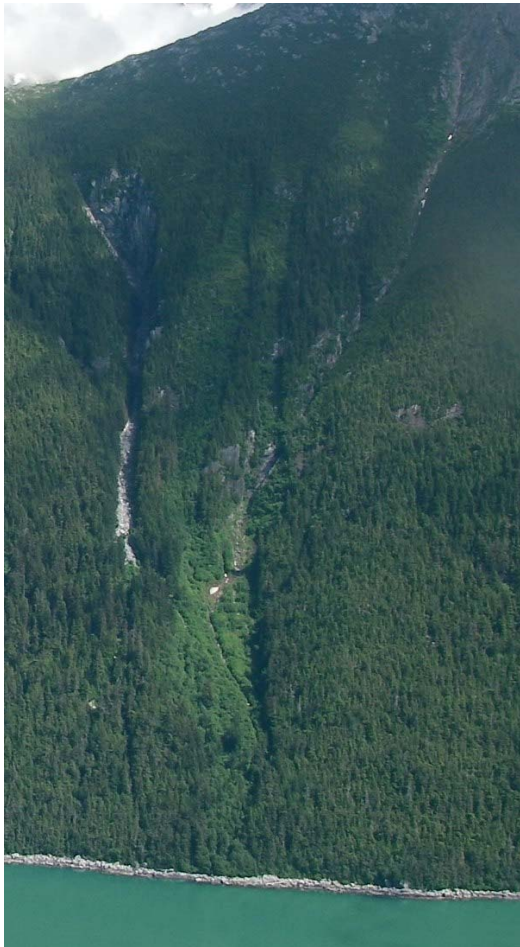
RF18. View east/upslope at rockfall area.

Hazard ID #:	RF18
Hazard Type:	rockfall
HIN:	105
Rating:	C
IRP 2006 Location:	2134
Frequency (yrs):	unknown (5-25?)
Predictability:	unpredictable
Material Volume (CY):	10-100
Clast Size (ft):	1-2
Source Elev. (ft):	<100
Centerline Slope:	open_bedrock_slope
Alignment Location:	starting_zone
Impact Alignment:	no
Alignment Exposure (ft):	<50
Vegetation:	-
Deciduous Trees:	no
IRP 2006 South Margin:	2134+00
IRP 2006 North Margin:	2134+50
Photo #:	1751, 3490, 5169, 5929

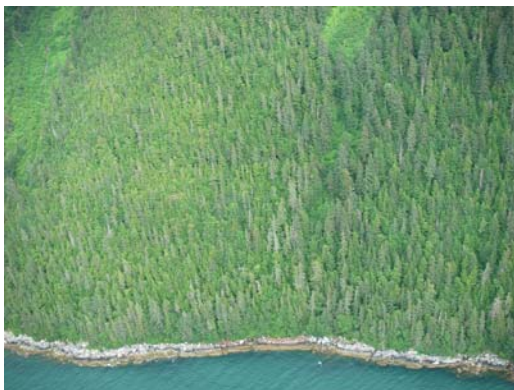
RF18. View east/upslope at rockfall area.

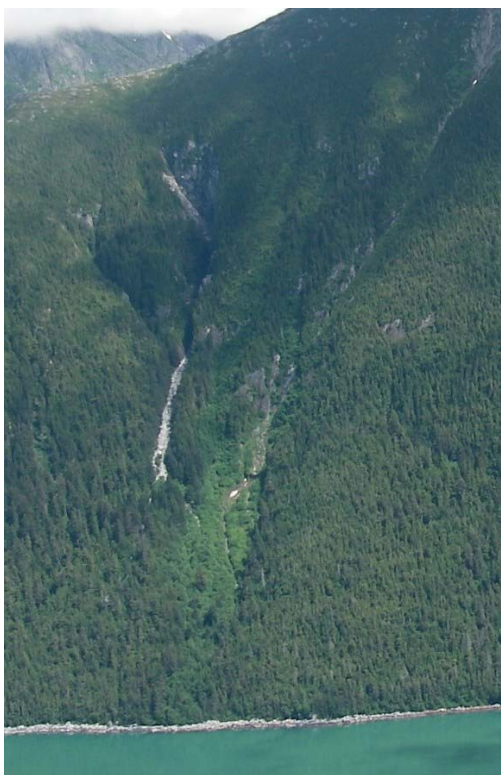
RF19. View east/upslope at large rockfall area.

Hazard ID #:	RF19
Hazard Type:	rockfall
HIN:	273
Rating:	A
IRP 2006 Location:	2144
Frequency (yrs):	1-5
Predictability:	unpredictable
Material Volume (CY):	<10
Clast Size (ft):	4+
Source Elev. (ft):	3000+
Centerline Slope:	fan
Alignment Location:	deposition_zone
Impact Alignment:	yes
Alignment Exposure (ft):	500+
Vegetation:	disturbed
Deciduous Trees:	yes
IRP 2006 South Margin:	2142+70
IRP 2006 North Margin:	2150+30
Photo #:	1357, 3491, 3493, 3495, 3498, 5130, 5168

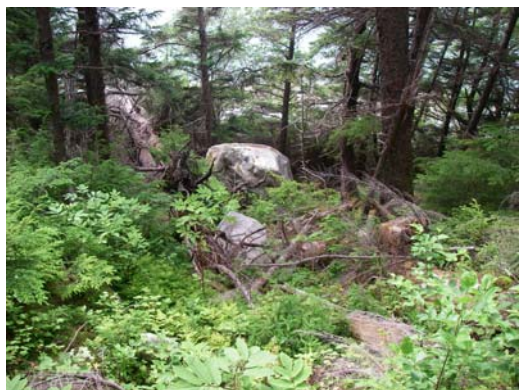
RF19. Fresh 6 ft diameter mega-boulder and related deforestation at centerline at IRP 2006 2144+00.

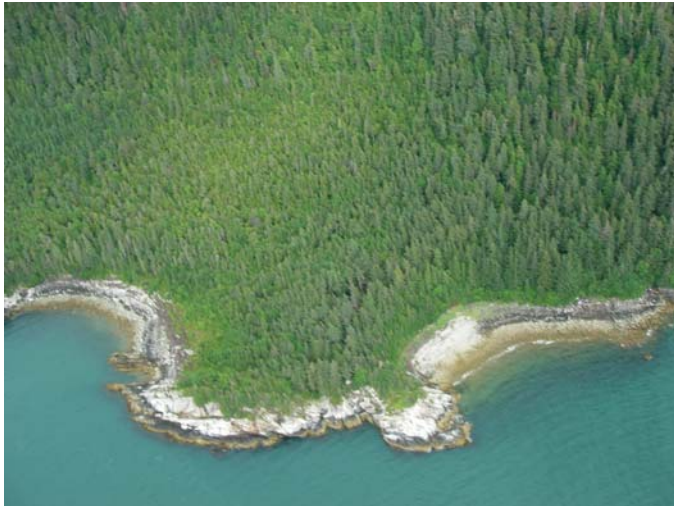
DF32. View east/upslope at outlet of debris flow.

Hazard ID #:	DF32
Hazard Type:	debris_flow
HIN:	51
Rating:	B
IRP 2006 Location:	2207
Frequency (yrs):	5-25
Predictability:	high
Material Volume (CY):	<10
Clast Size (ft):	0-1
Source Elev. (ft):	500-1000
Centerline Slope:	single_channel
Alignment Location:	path
Impact Alignment:	yes
Alignment Exposure (ft):	50-200
Vegetation:	disturbed
Deciduous Trees:	yes
IRP 2006 South Margin:	2206+60
IRP 2006 North Margin:	2207+20
Photo #:	6018

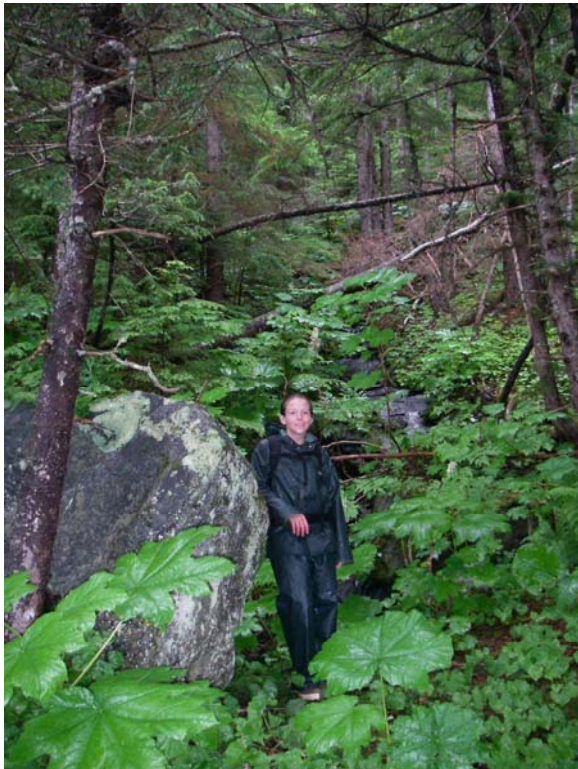
RF22. View east/upslope at fresh rockfall. Photo taken 150 left of IRP 2006 2253+50.

Hazard ID #:	RF22
Hazard Type:	rockfall
HIN:	147
Rating:	B
IRP 2006 Location:	2254
Frequency (yrs):	1-5
Predictability:	unpredictable
Material Volume (CY):	<10
Clast Size (ft):	1-2
Source Elev. (ft):	500-1000
Centerline Slope:	single_channel
Alignment Location:	path
Impact Alignment:	yes
Alignment Exposure (ft):	50-200
Vegetation:	disturbed
Deciduous Trees:	no
IRP 2006 South Margin:	2253+30
IRP 2006 North Margin:	2253+80
Photo #:	5941, 6024

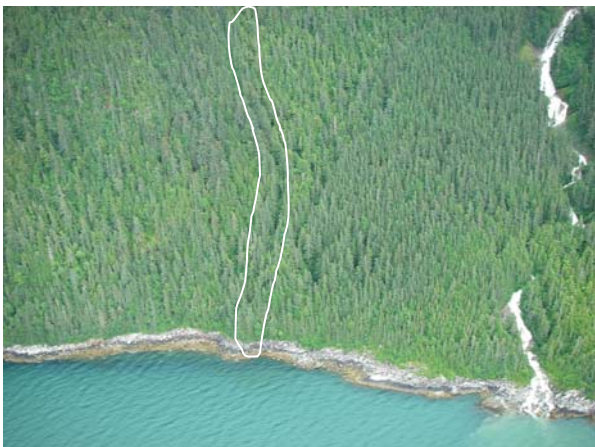
RF22. View east/upslope at rockfall path.

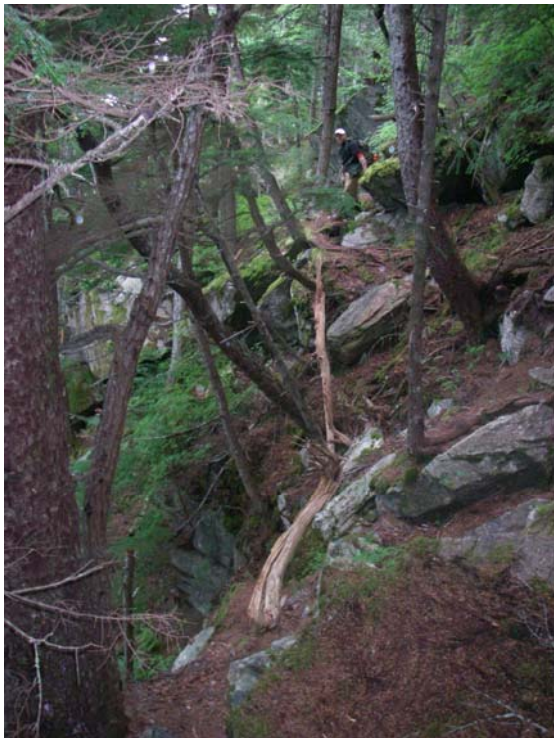
SR03. View north/up alignment at soil raveling. Photo taken at centerline at IRP 2006 2267+00.

Hazard ID #:	SR03
Hazard Type:	soil_raveling
HIN:	147
Rating:	B
IRP 2006 Location:	2265
Frequency (yrs):	1-5
Predictability:	unpredictable
Material Volume (CY):	<10
Clast Size (ft):	2-3
Source Elev. (ft):	100-500
Centerline Slope:	open_bedrock_slope
Alignment Location:	path
Impact Alignment:	yes
Alignment Exposure (ft):	200-500
Vegetation:	disturbed
Deciduous Trees:	yes
IRP 2006 South Margin:	2263+50
IRP 2006 North Margin:	2267+40
Photo #:	5579, 5580, 5581

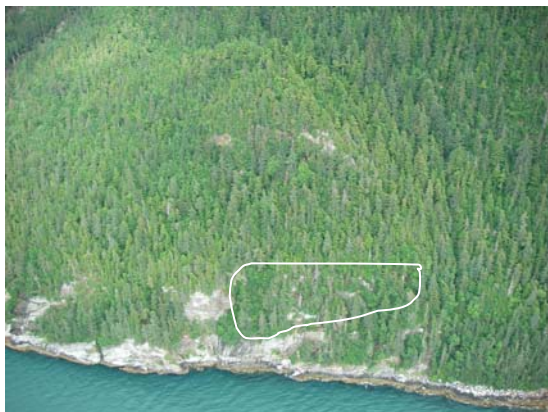
SR03. View east/upslope at soil raveling area.

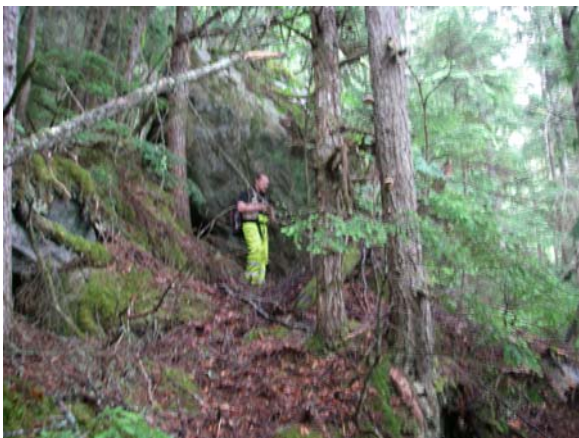
HR02. View south/down alignment at hazard rock 75 ft right of IRP 2006 2379+40.

Hazard ID #:	HR02
Hazard Type:	hazard_rocks
HIN:	99
Rating:	C
IRP 2006 Location:	2380
Frequency (yrs):	unknown (>25?)
Predictability:	unpredictable
Material Volume (CY):	<10
Clast Size (ft):	4+
Source Elev. (ft):	<100
Centerline Slope:	open_soil_slope
Alignment Location:	deposition_zone
Impact Alignment:	yes
Alignment Exposure (ft):	50-200
Vegetation:	disturbed
Deciduous Trees:	no
IRP 2006 South Margin:	2379+40
IRP 2006 North Margin:	2380+90
Photo #:	3719

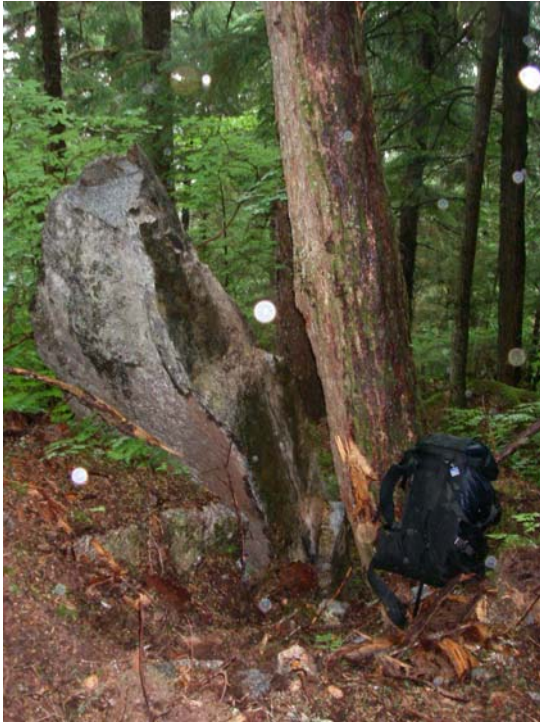
RF34. View west/downslope at rockfall hazard. Fresh scarring of spruce tree next to backpack. Photo taken 75 ft right of IRP 2006 2383+00.

Hazard ID #:	RF34
Hazard Type:	rockfall
HIN:	177
Rating:	B
IRP 2006 Location:	2383
Frequency (yrs):	25+
Predictability:	unpredictable
Material Volume (CY):	<10
Clast Size (ft):	4+
Source Elev. (ft):	100-500
Centerline Slope:	open_soil_slope
Alignment Location:	below_deposition_zone
Impact Alignment:	no
Alignment Exposure (ft):	500+
Vegetation:	undisturbed
Deciduous Trees:	yes
IRP 2006 South Margin:	2382+50
IRP 2006 North Margin:	2388+50
Photo #:	3712, 3715

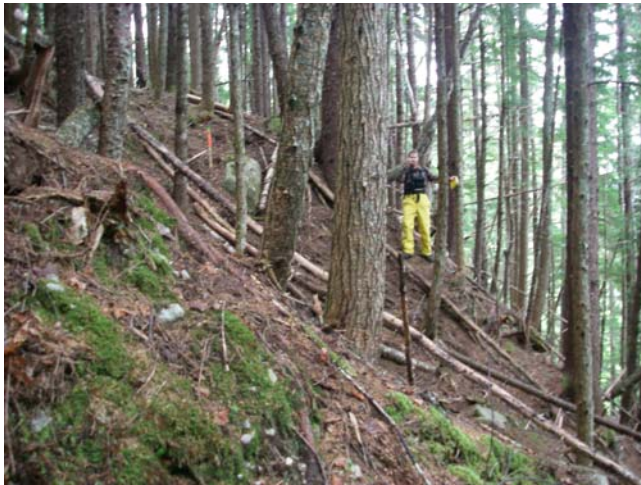
SR04. View south/down alignment at soil raveling in glacial outwash. Photo taken 30 ft left of IRP 2006 2424+00.

Hazard ID #:	SR04
Hazard Type:	soil_raveling
HIN:	105
Rating:	B
IRP 2006 Location:	2420
Frequency (yrs):	5-25
Predictability:	moderate
Material Volume (CY):	<10
Clast Size (ft):	3-4
Source Elev. (ft):	<100
Centerline Slope:	open_soil_slope
Alignment Location:	path
Impact Alignment:	yes
Alignment Exposure (ft):	500+
Vegetation:	disturbed
Deciduous Trees:	no
IRP 2006 South Margin:	2420+70
IRP 2006 North Margin:	2426+80
Photo #:	3595-3598, 5957, 6061

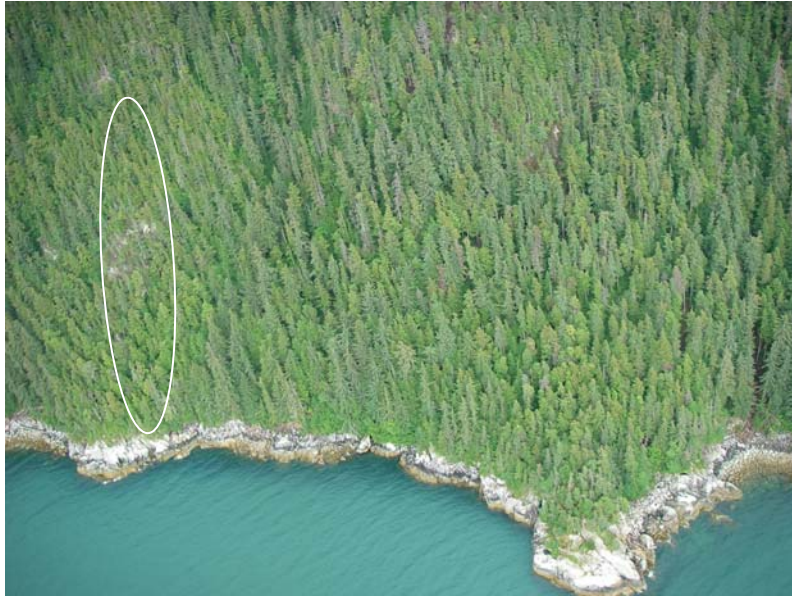
RF36. View east/upslope at rockfall hazard.

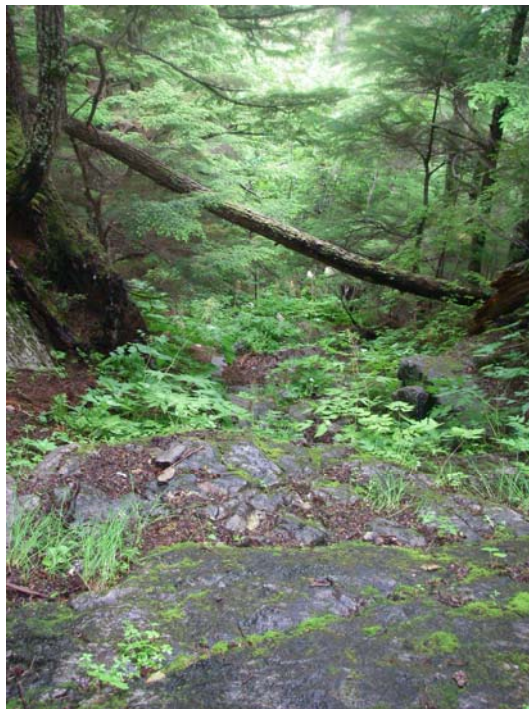
Hazard ID #:	RF36
Hazard Type:	rockfall
HIN:	129
Rating:	B
IRP 2006 Location:	2454
Frequency (yrs):	1-5
Predictability:	unpredictable
Material Volume (CY):	<10
Clast Size (ft):	3-4
Source Elev. (ft):	100-500
Centerline Slope:	-
Alignment Location:	below_deposition_zone
Impact Alignment:	yes
Alignment Exposure (ft):	50-200
Vegetation:	denuded
Deciduous Trees:	yes
IRP 2006 South Margin:	2454+50
IRP 2006 North Margin:	2455+00
Photo #:	3609, 5960

RF36. View west/downslope at rockfall chute. Photo taken 90 ft right of IRP 2006 2454+60.

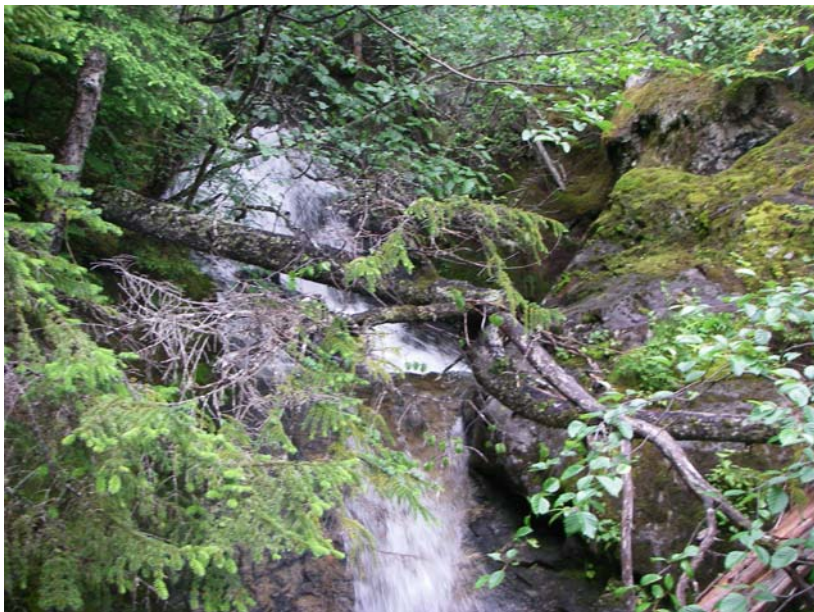
Hazard ID #:	DF41
Hazard Type:	debris_flow
HIN:	129
Rating:	B
IRP 2006 Location:	2460
Frequency (yrs):	1-5
Predictability:	high
Material Volume (CY):	10-100
Clast Size (ft):	0-1
Source Elev. (ft):	3000+
Centerline Slope:	fan
Alignment Location:	deposition_zone
Impact Alignment:	yes
Alignment Exposure (ft):	50-200
Vegetation:	denuded
Deciduous Trees:	yes
IRP 2006 South Margin:	2460+40
IRP 2006 North Margin:	2461+00
Photo #:	3616

DF41. View east/upslope at debris flow chute with active stream. Photo taken 130 ft right of IRP 2006 2461+00.

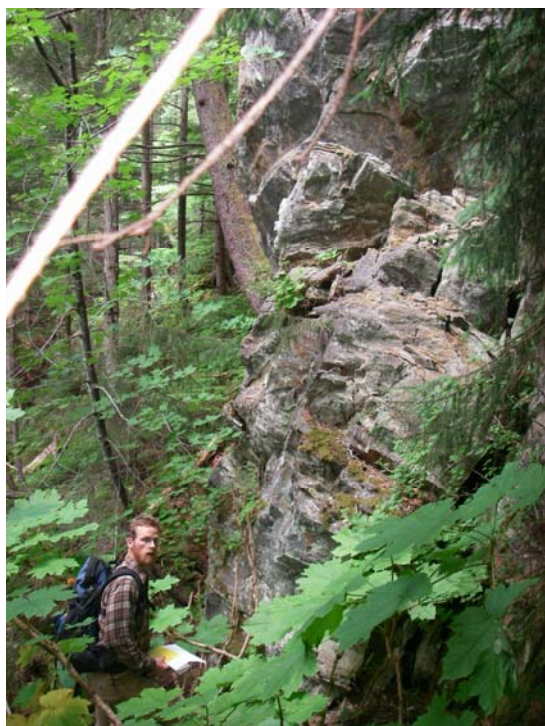
RF46. View north/up alignment at rockfall hazard cliffs. Photo taken 150 ft right of IRP 2006 2546+00.

Hazard ID #:	RF46
Hazard Type:	rockfall
HIN:	111
Rating:	A
IRP 2006 Location:	2548
Frequency (yrs):	5-25
Predictability:	unpredictable
Material Volume (CY):	<10
Clast Size (ft):	2-3
Source Elev. (ft):	100-500
Centerline Slope:	open_soil_slope
Alignment Location:	deposition_zone
Impact Alignment:	yes
Alignment Exposure (ft):	50-200
Vegetation:	disturbed
Deciduous Trees:	yes
IRP 2006 South Margin:	2546+70
IRP 2006 North Margin:	2548+30
Photo #:	5338, 5339

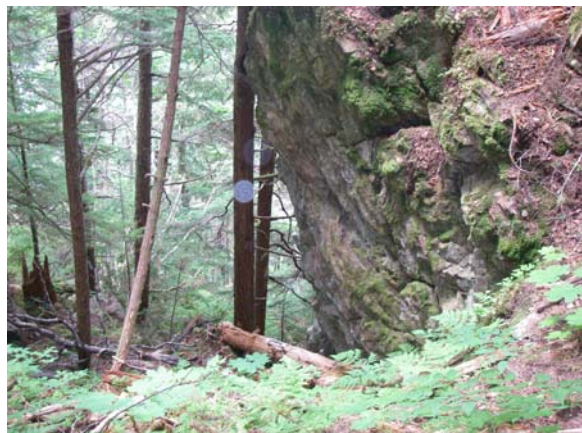
RF46. View northwest (up alignment and downslope) at rockfall hazard area. Photo taken 150 ft right of IRP 2006 2546+00.

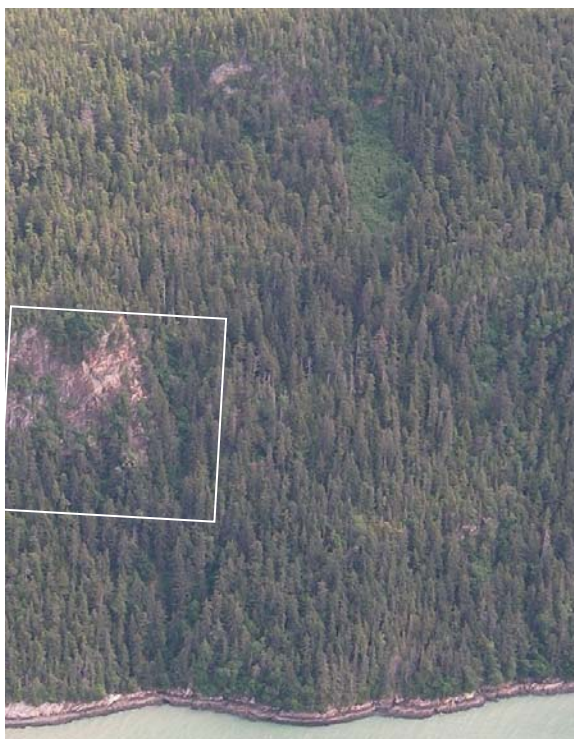
RF49. View east/upslope at rockfall hazard below cliffs and above IRP 2006 alignment.

Hazard ID #:	RF49
Hazard Type:	rockfall
HIN:	201
Rating:	C
IRP 2006 Location:	2557
Frequency (yrs):	1-5
Predictability:	unpredictable
Material Volume (CY):	<10
Clast Size (ft):	2-3
Source Elevation (ft):	100-500
Centerline Slope:	open_soil_slope
Alignment Location:	below_deposition_zone
Impact Alignment:	no
Alignment Exposure (ft):	500+
Vegetation:	disturbed
Deciduous Trees:	yes
IRP 2006 South Margin:	2556+50
IRP 2006 North Margin:	2562+00
Photo #:	3661, 3662, 3664

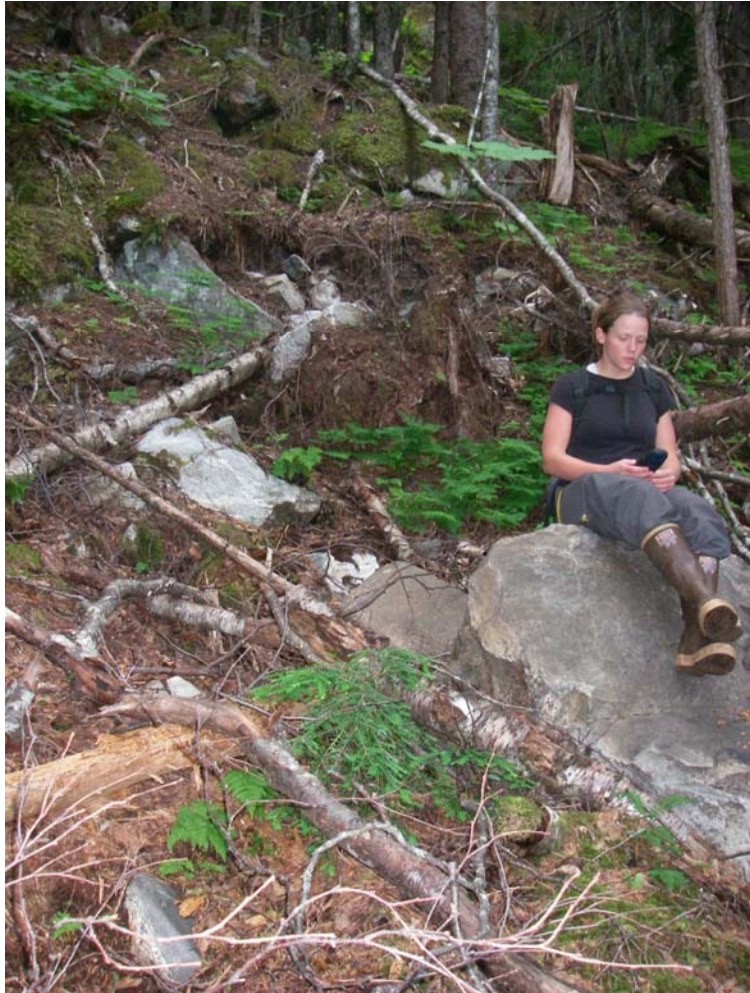
RF52. View south/down alignment at recent rockfall.
Photo taken 170 ft right of IRP 2006 2565+00.

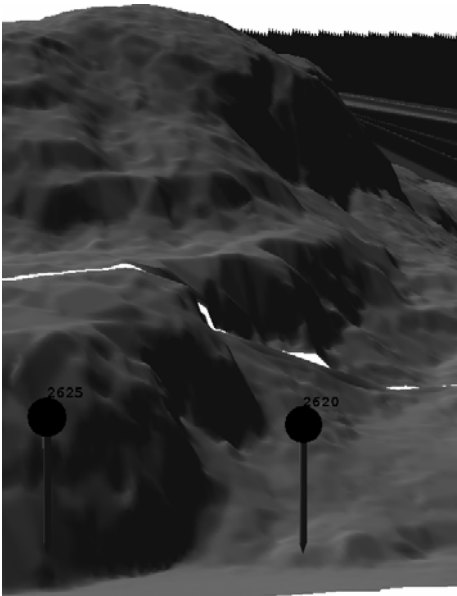
RF53. LIDAR bare earth image of local topography surrounding rockfall hazard. IRP 2006 alignment location 2620+00.
