Alaska DOT&PF

Pavement Inspection Report Bethel Airport

Bethel Airport

Airport Code: BET
Site Number: 50061.1*A

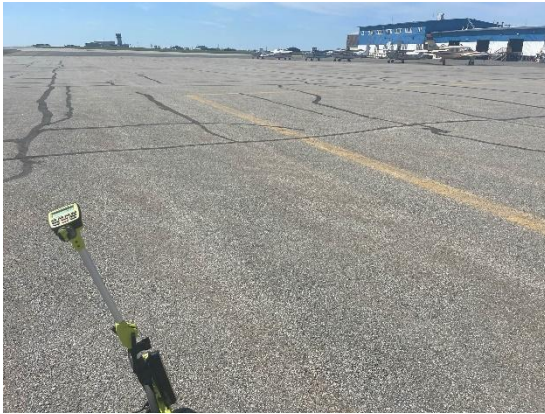
Section 4100-01 (71 PCI)

The main terminal apron consists of 4 sections with varying work history, conditions, and surface types. Section 4100-01 was initially constructed in 1989 then received a 2-inch mill and overlay in 2001 and a 2-inch overlay in 2017. Occasional crack seal operations have been performed on the section. The most common distresses observed are low to medium severity longitudinal and transverse cracking and low severity weathering. Field observations include localized spots of raveling, and low severity rutting developing near the concrete hardstand.

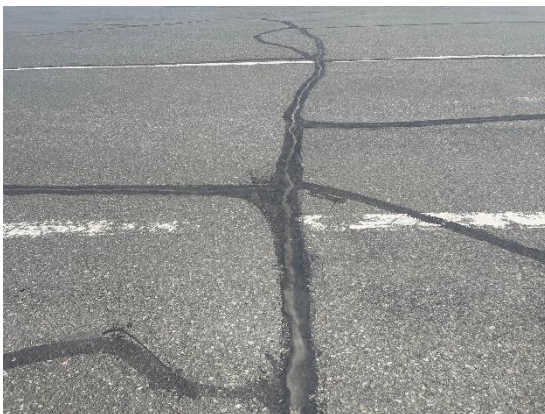
Section 4100-02 (57 PCI)

Section 4100-02 was initially constructed in 1973 then received a surface reconstruction in 2001. Occasional crack seal operations have been performed on the section. The most common distresses observed are low severity longitudinal and transverse cracking, low severity raveling, and medium severity weathering. Field observations include wearing of the surface leading to the medium severity weathering, and sealed cracks that should be touched up with additional sealant.

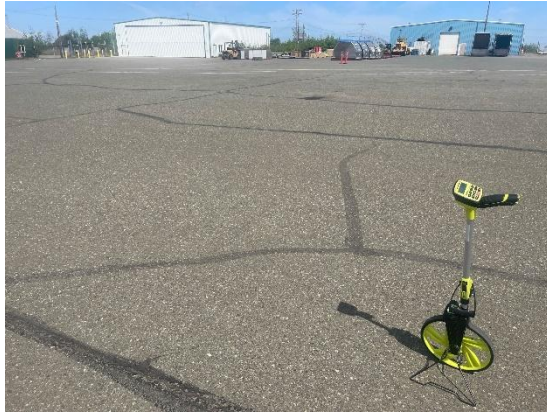
Section 4200-01 (53 PCI)

The west apron Section 4200-01 was initially constructed in 1985 and received a surface reconstruction in 2001. Occasional crack seal operations have been performed on the branch. The most common distresses observed are low to medium severity longitudinal and transverse cracking, low severity raveling, and medium severity weathering. Field observations include wearing of the surface leading to the medium severity weathering, and sealed cracks where the sealant is failing in areas.

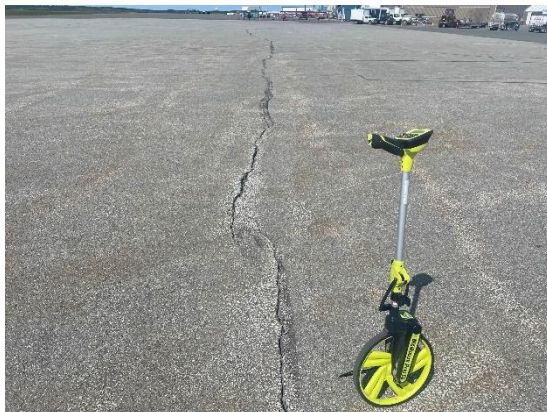
Section 4200-02 (73 PCI)

Section 4200-02 was also initially constructed in 1985 and received a surface reconstruction in 2001, but then also received a 2-inch overlay in 2017. Occasional crack seal operations have been performed on the branch. The most common distresses observed are low to medium severity longitudinal and transverse cracking and low severity weathering. Field observations include sealed cracks that should be touched up with additional sealant, plus two additional sample units that contain low and medium severity depressions.
