# Alaska DOT&PF

## Pavement Inspection Report Fairbanks Airport

Airport Name	IATA	ICAO	Latitude	Longitude	Elevation (ft)
Fairbanks International Airport	FAI	PAFA	64° 48' 55.28" N	147° 51' 24.00" W	438.9

Point of Contact	Phone	Email	Date Inspected	Date Published
Mr. Andrew Pavey, Pavement Management Engineer	(907) 269 6213	andrew.pavey@alaska.gov	June 2024	August 2025

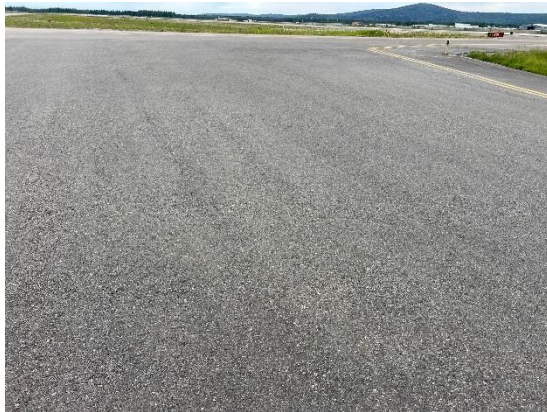
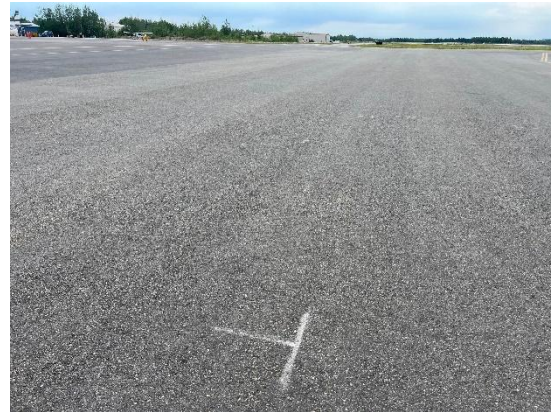
#### Section 1900-02 (98 PCI)

Taxiway S Section 1900-02 was newly constructed in 2022 together with the project on Section 1900-01. Crack seal operations have yet to be performed on the section. The most common distress was low severity weathering.

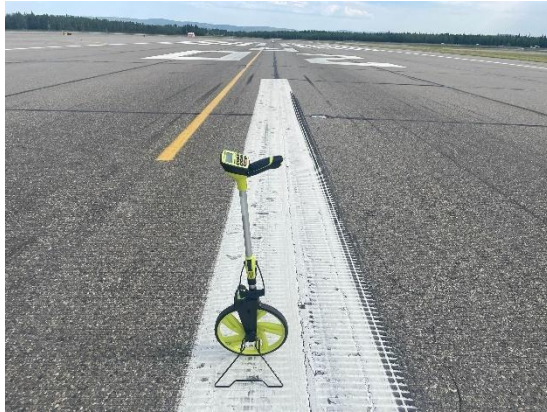
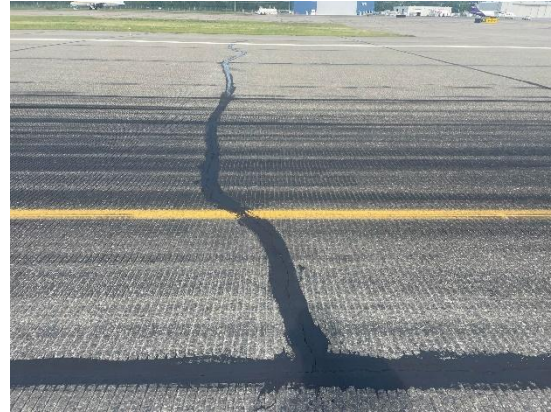
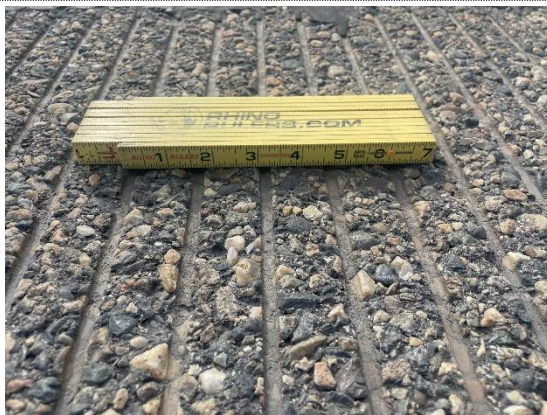
Runway 02L/20R consists of five sections, Sections 6100-01, 6100-03, and 6100-05 to 6100-07. The runway was constructed in 1987 and most recently reconstructed in 2008. Periodic crack seal operations have been performed on the branch. The most common distresses are low severity longitudinal and transverse cracking, low severity raveling, and medium severity weathering. Pavement inspectors observed the continued deterioration of the AC pavement surface, particularly the impact of the weathering on the pavement. The weather (loss of the fine aggregate) makes the pavement susceptible to future raveling and abrasion. In addition, inspectors noted the pavement surface is developing new unfilled cracks outside the planned relief cuts.

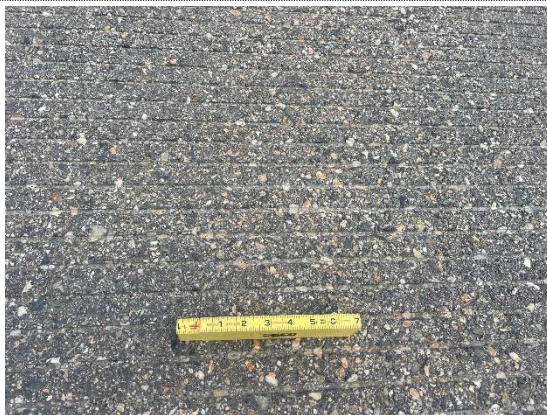
Runway 02R/20L is made up of three sections, Sections 6200-01 to 6200-03. Constructed in 2002, the runway was rehabilitated in 2022 by conducting 4 inches FDR followed by a 3-inch AC overlay. Periodic crack seal operations have been performed on the branch. The most common distresses are low severity longitudinal and transverse cracking and low severity weathering. Pavement inspectors observed the initiation of transverse cracking extending across the width of the runway, along with the gradual opening of paving joints.
