Alaska DOT&PF

Pavement Inspection Report Juneau Airport

Airport Name	IATA	ICAO	Latitude	Longitude	Elevation (ft)
Juneau International Airport	JNU	PAJN	58° 21' 16.96" N	134° 34' 42.49" W	25.0

Point of Contact	Phone	Email	Date Inspected	Date Published
Mr. Andrew Pavey, Pavement Management Engineer	(907) 269 6213	andrew.pavey@alaska.gov	April 2024	April 2025

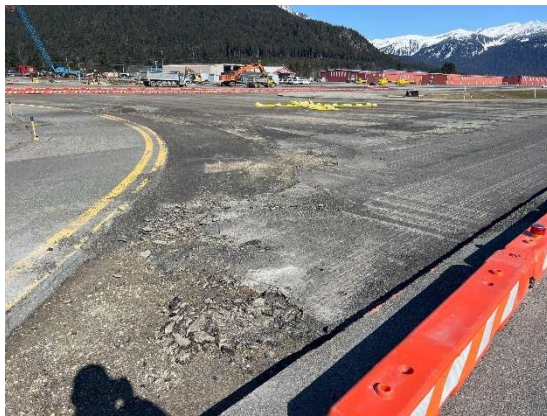
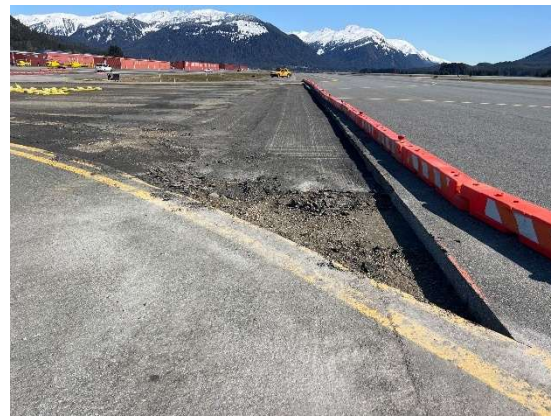
Branch ID	Branch Name	Branch Use	No. of Sections	Area (sf)	Weighted Average PCI
0310	Taxiway C1	Taxiway	2	22,128	Under Construction

Taxiway C1 was under construction during the inspection. The most recent inspection in 2021 reports a PCI of 27 for Section 0310-02 and a PCI of 67 for Section 0310-02.

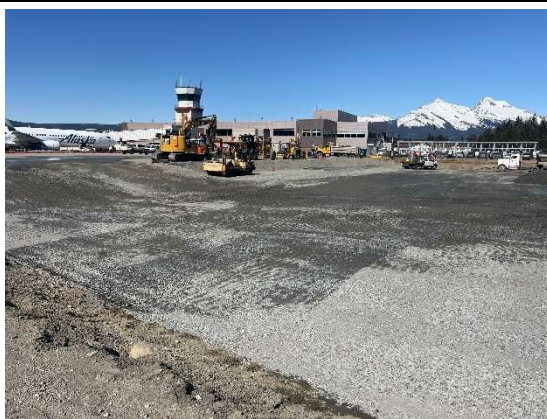
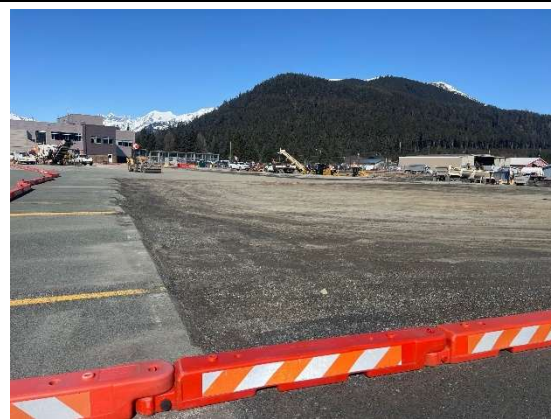
PCC Section 4100-HS1, 4100-HS2, 4100-HS3 (Under Construction)

The portland cement concrete (PCC) sections of the Terminal Apron were under construction during the inspection. The 2021 PCIs for Sections 4100-HS1, 4100-HS2 and 4100-HS3 were 75, 71, and 64, respectively.
