Alaska DOT&PF

Pavement Inspection Report Kake Airport

Airport Code: AFE
Site Number: 50393.01*A

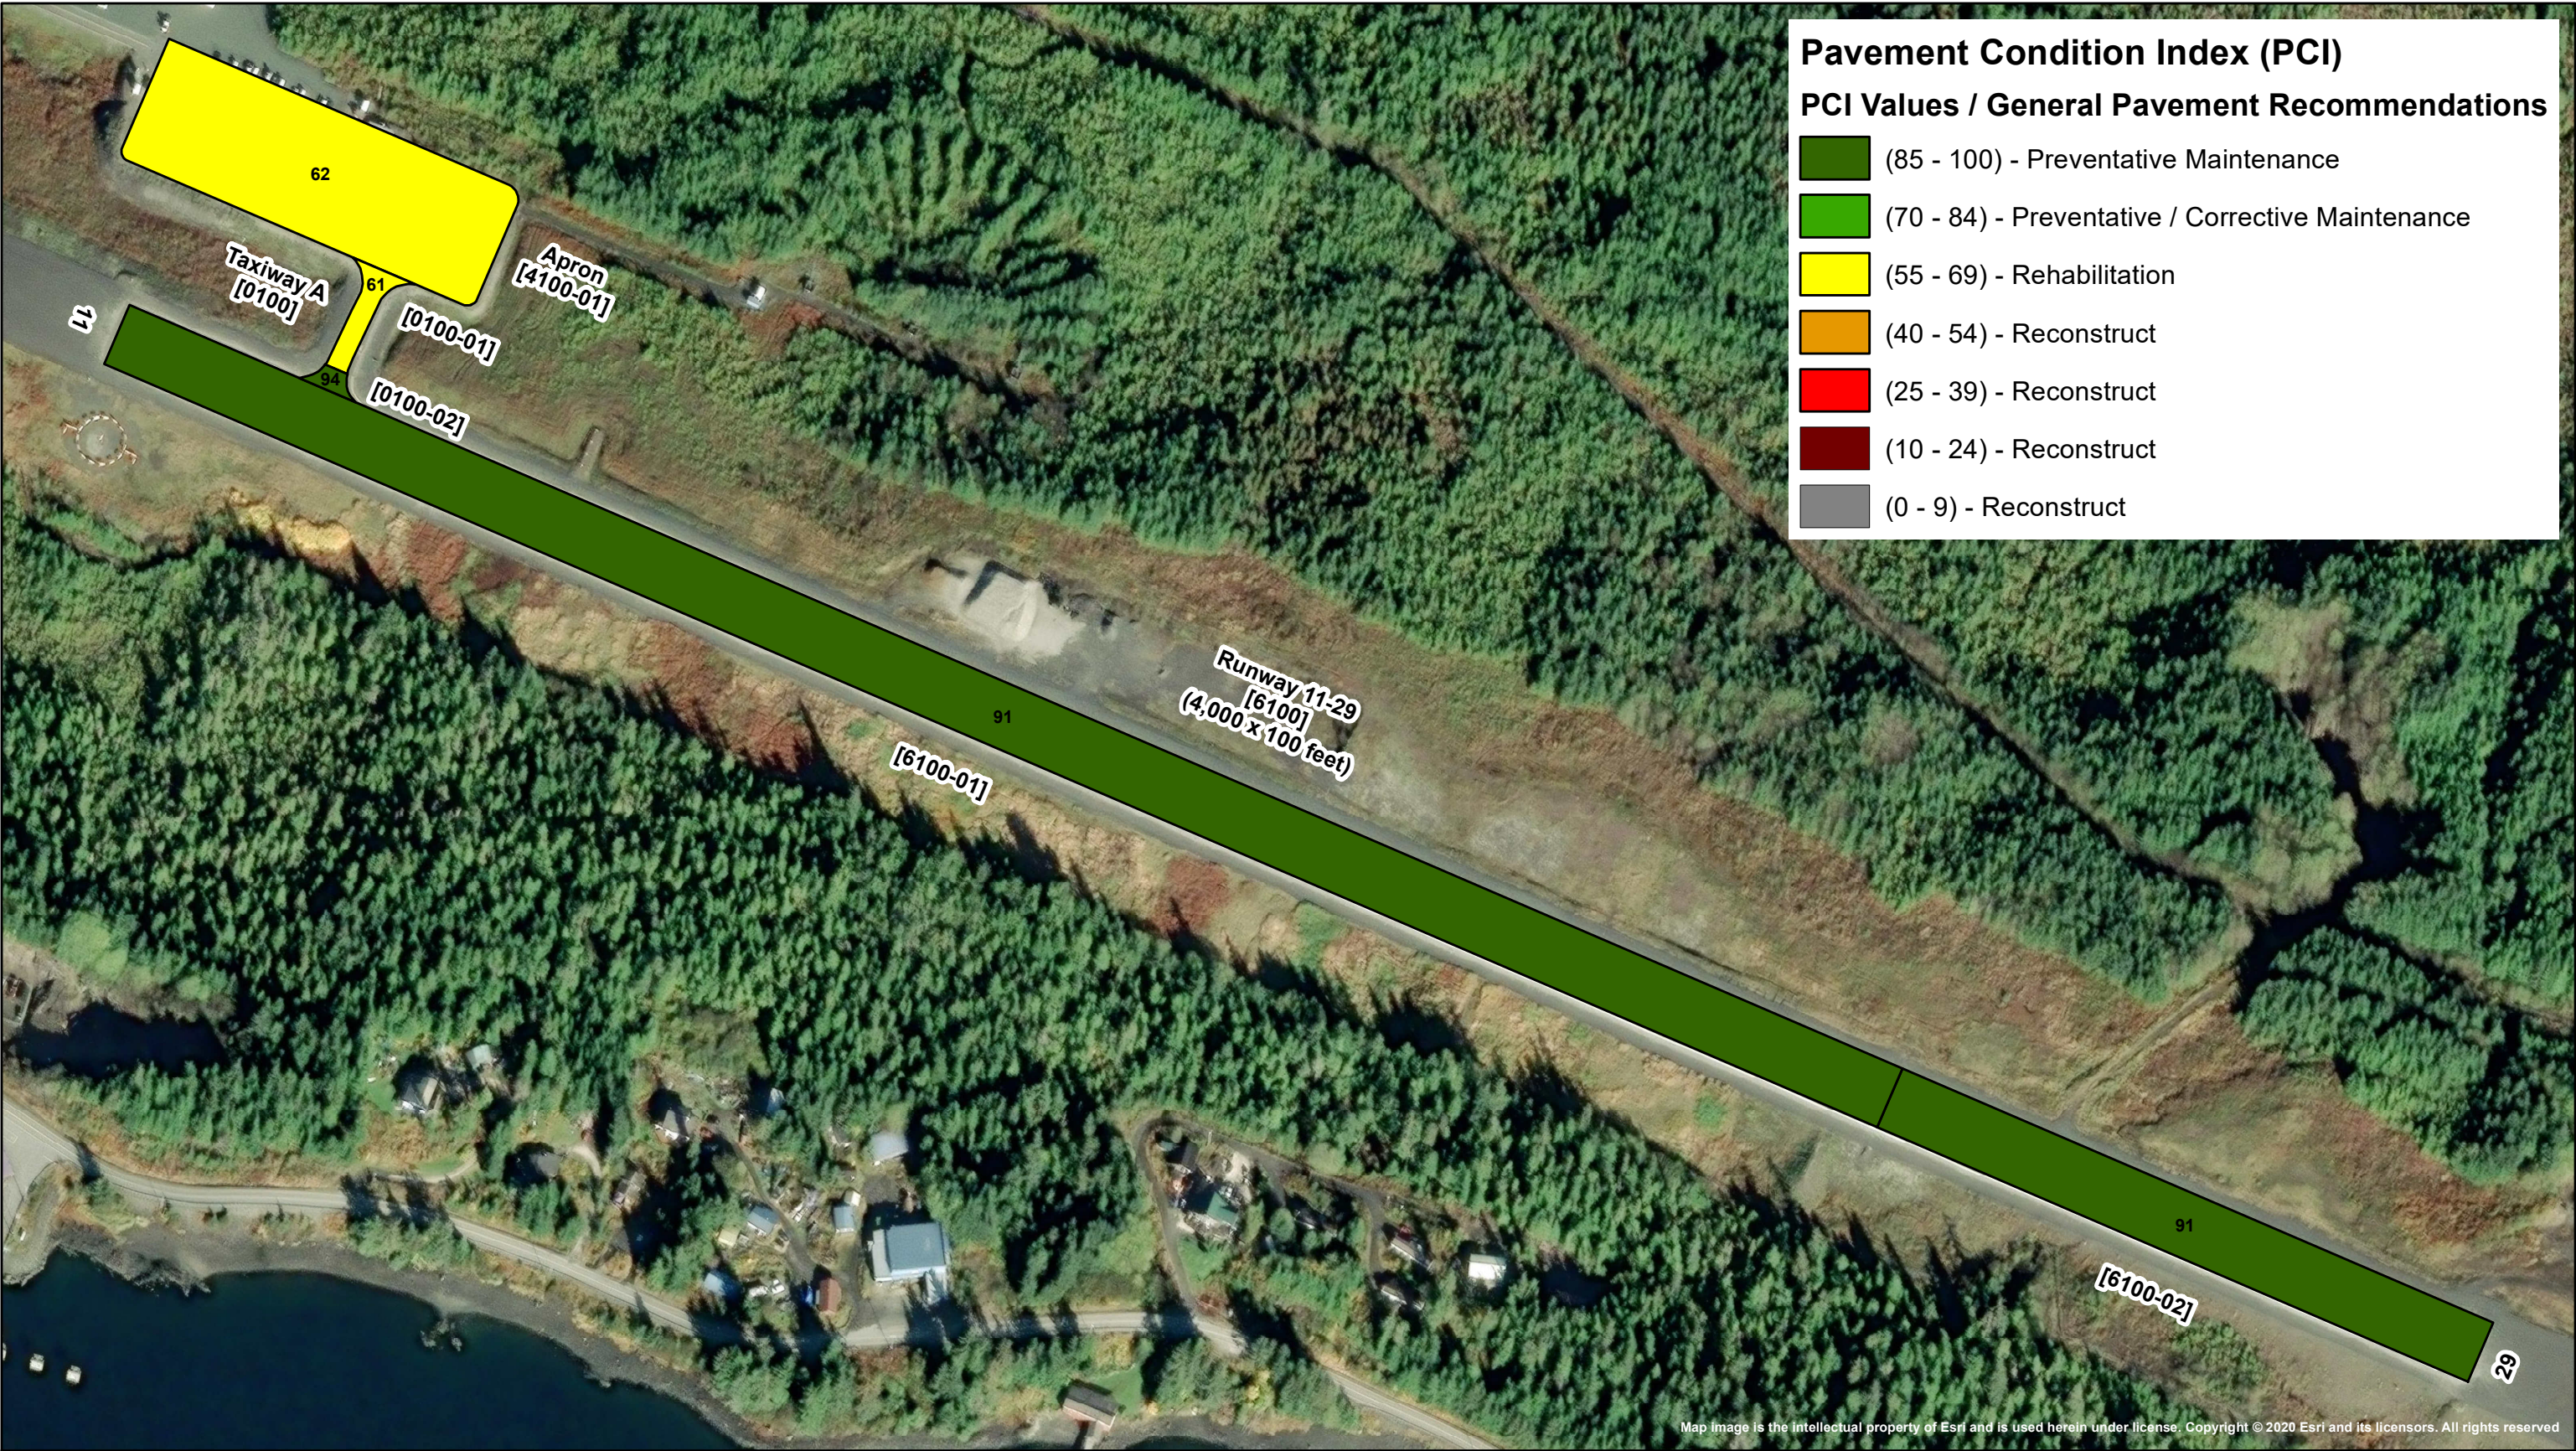
Pavement Condition Index (PCI)

Target PCI Range for Runways: 70 to 100
Target PCI Range for Taxiways and Aprons: 60 to 100

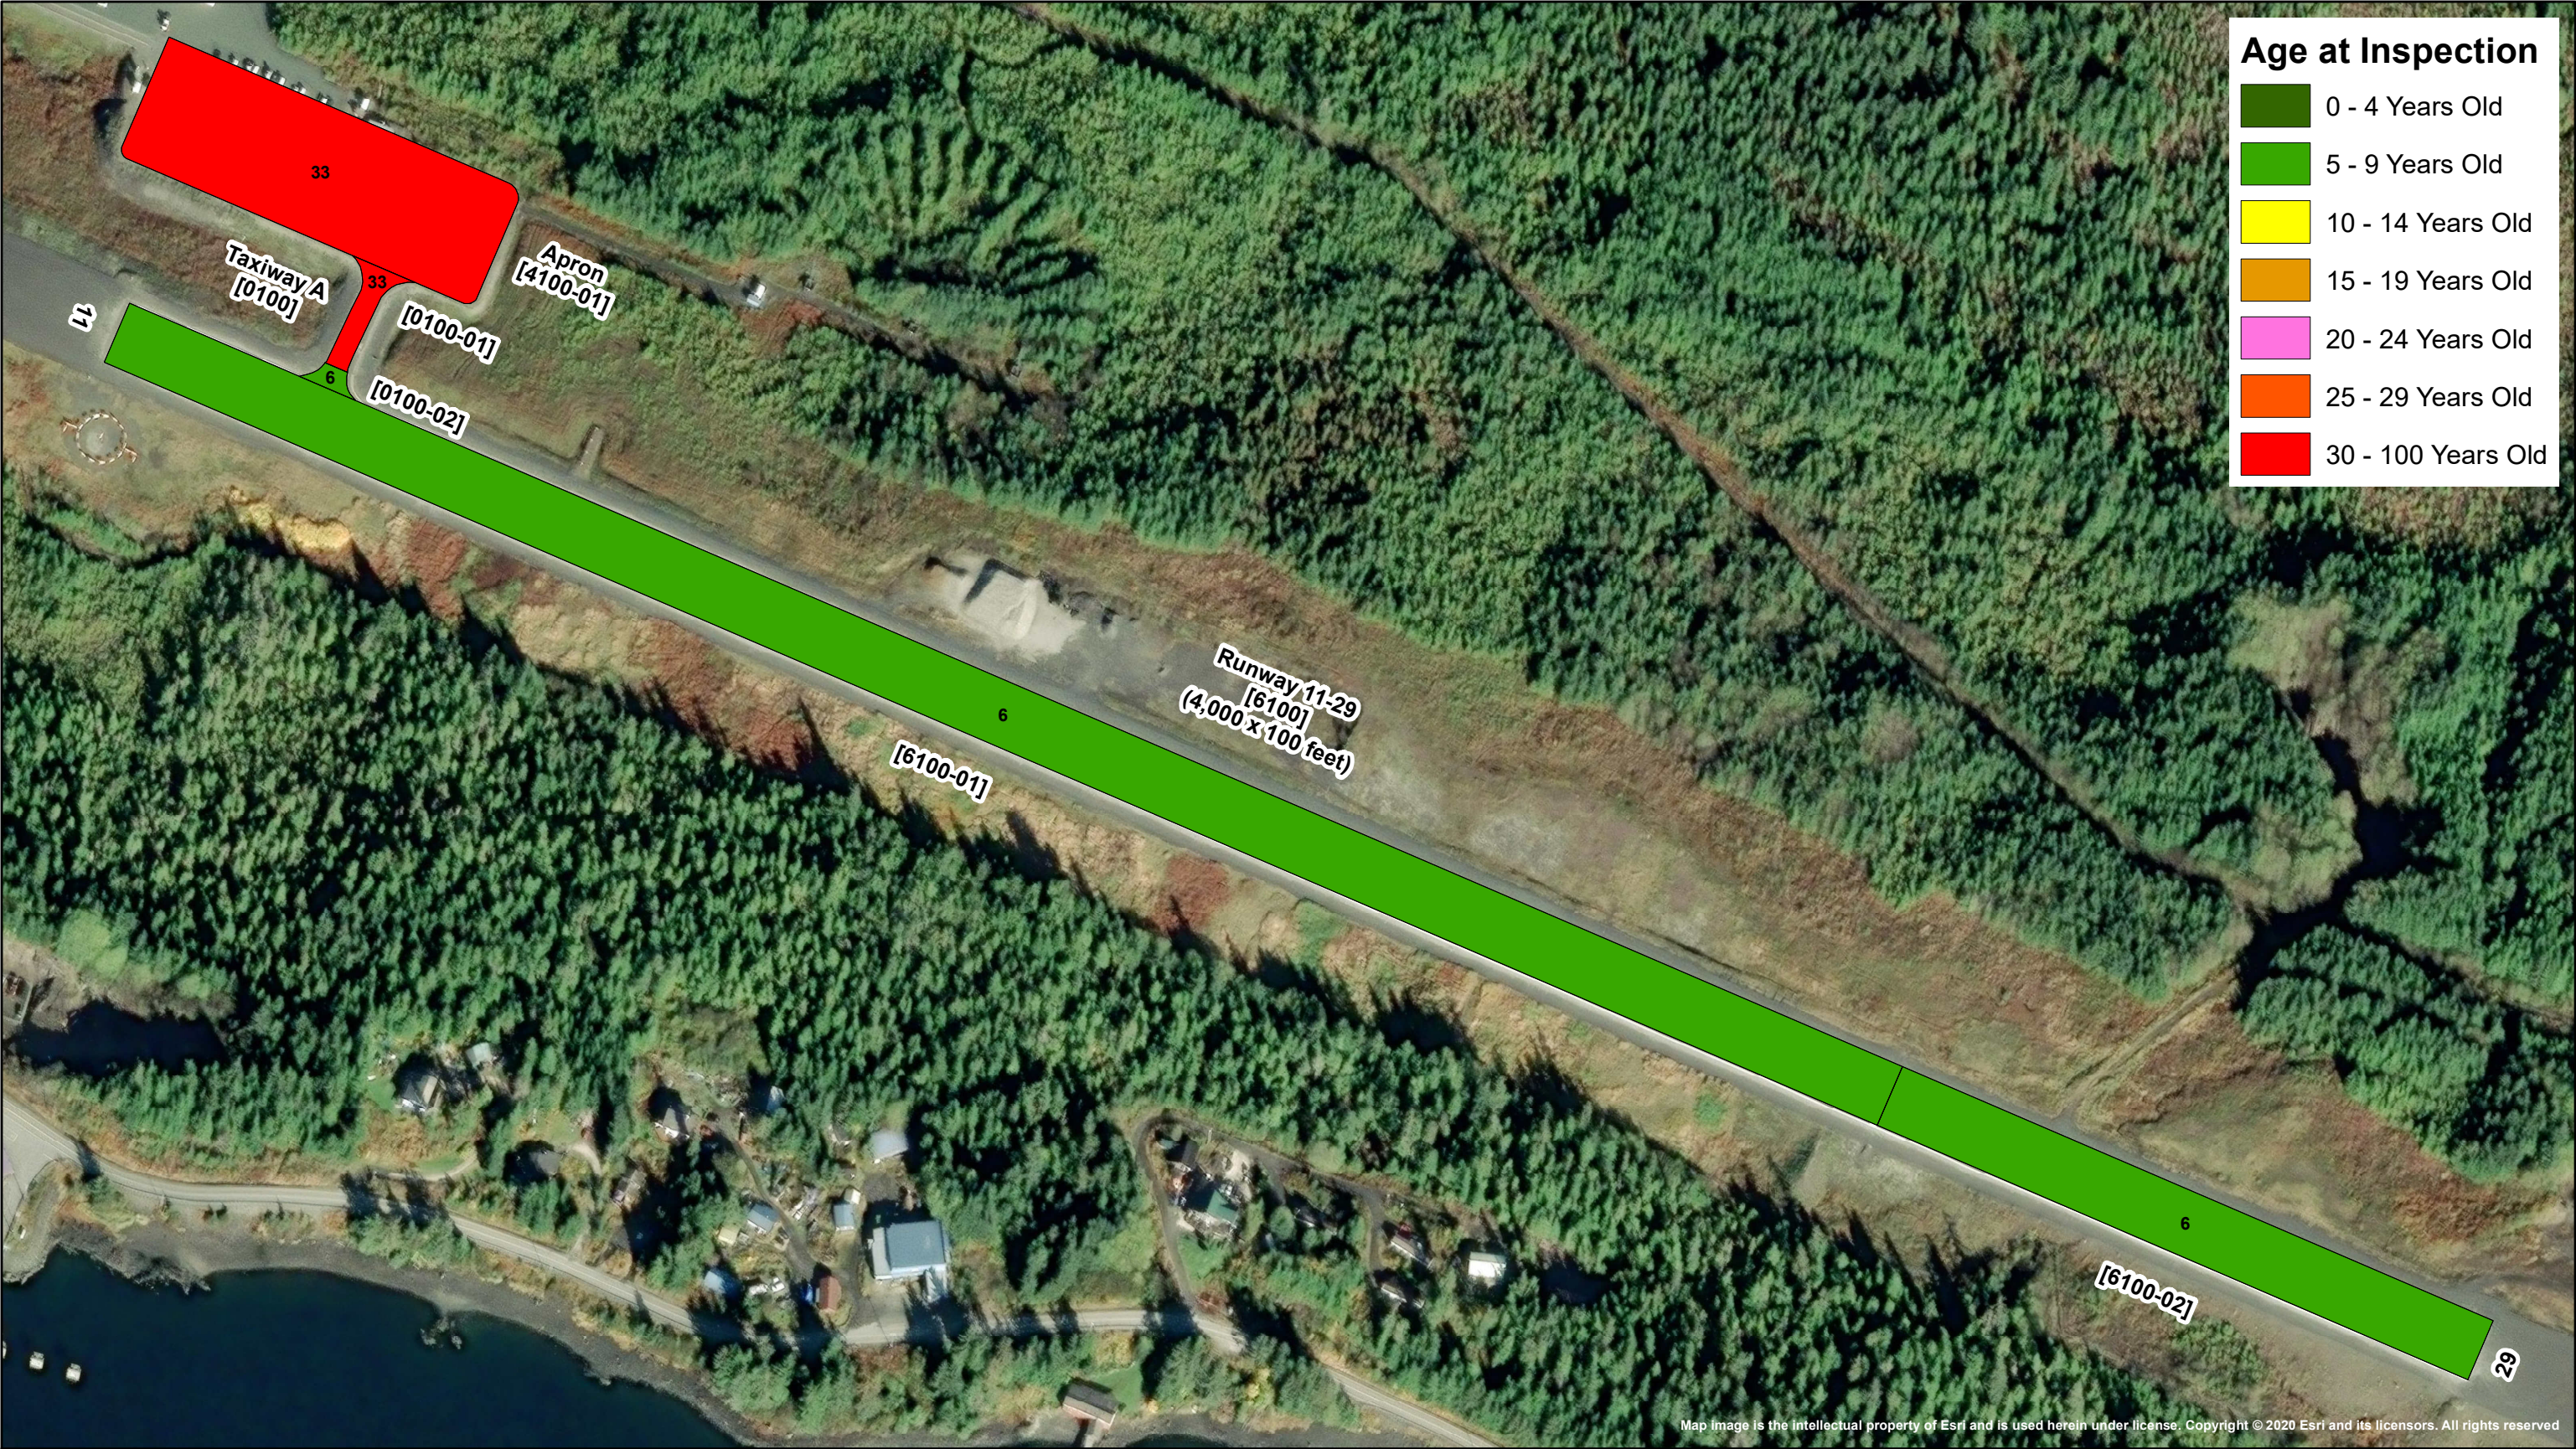
Age at Inspection

0 - 4 Years Old
5 - 9 Years Old
10 - 14 Years Old
15 - 19 Years Old
20 - 24 Years Old
25 - 29 Years Old
30 - 100 Years Old

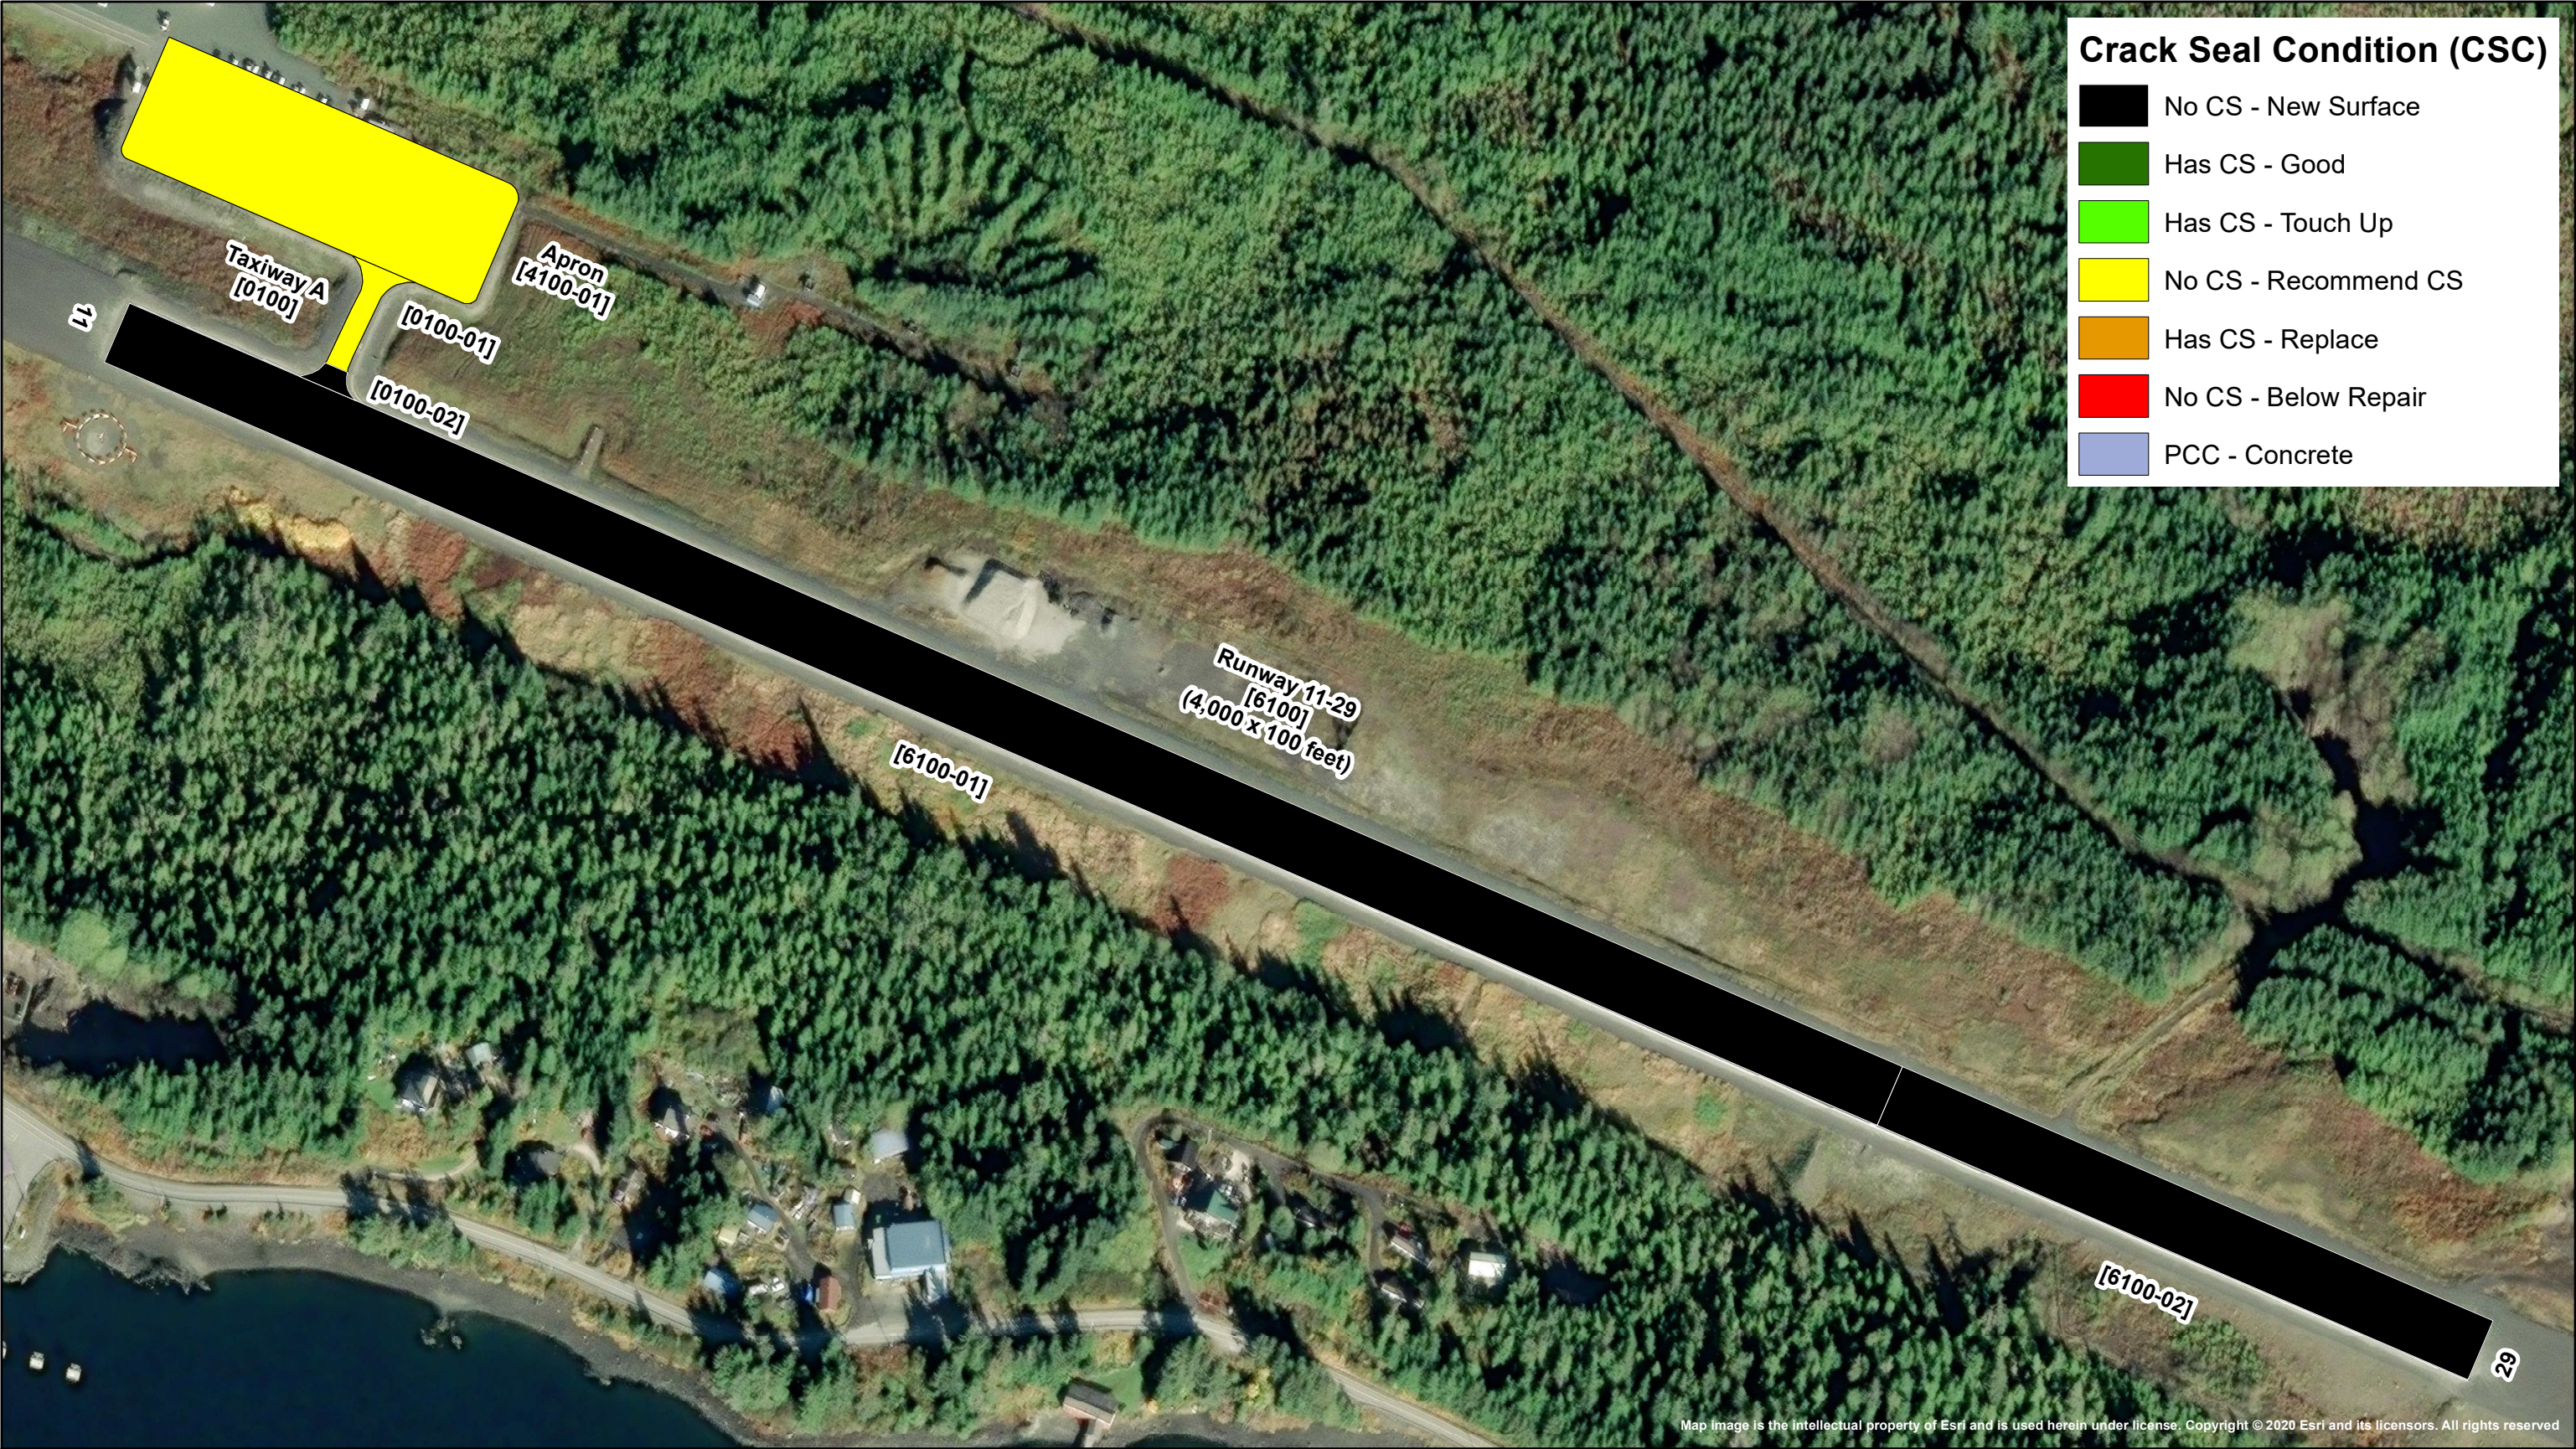
Crack Seal Condition (CSC)

No CS - New Surface

No CS - Recommend CS

Has CS - Replace

No CS - Below Repair
