# Alaska DOT&PF

## Pavement Inspection Report Kenai Airport

Airport Name	IATA	ICAO	Latitude	Longitude	Elevation (ft)
Kenai Airport	ENA	PAEN	60° 34' 24" N	151° 14' 41" W	99

Point of Contact	Phone	Email	Date Inspected	Date Published
Mr. Andrew Pavey, Pavement Management Engineer	(907) 269 6213	andrew.pavey@alaska.gov	August 2024	February 2025

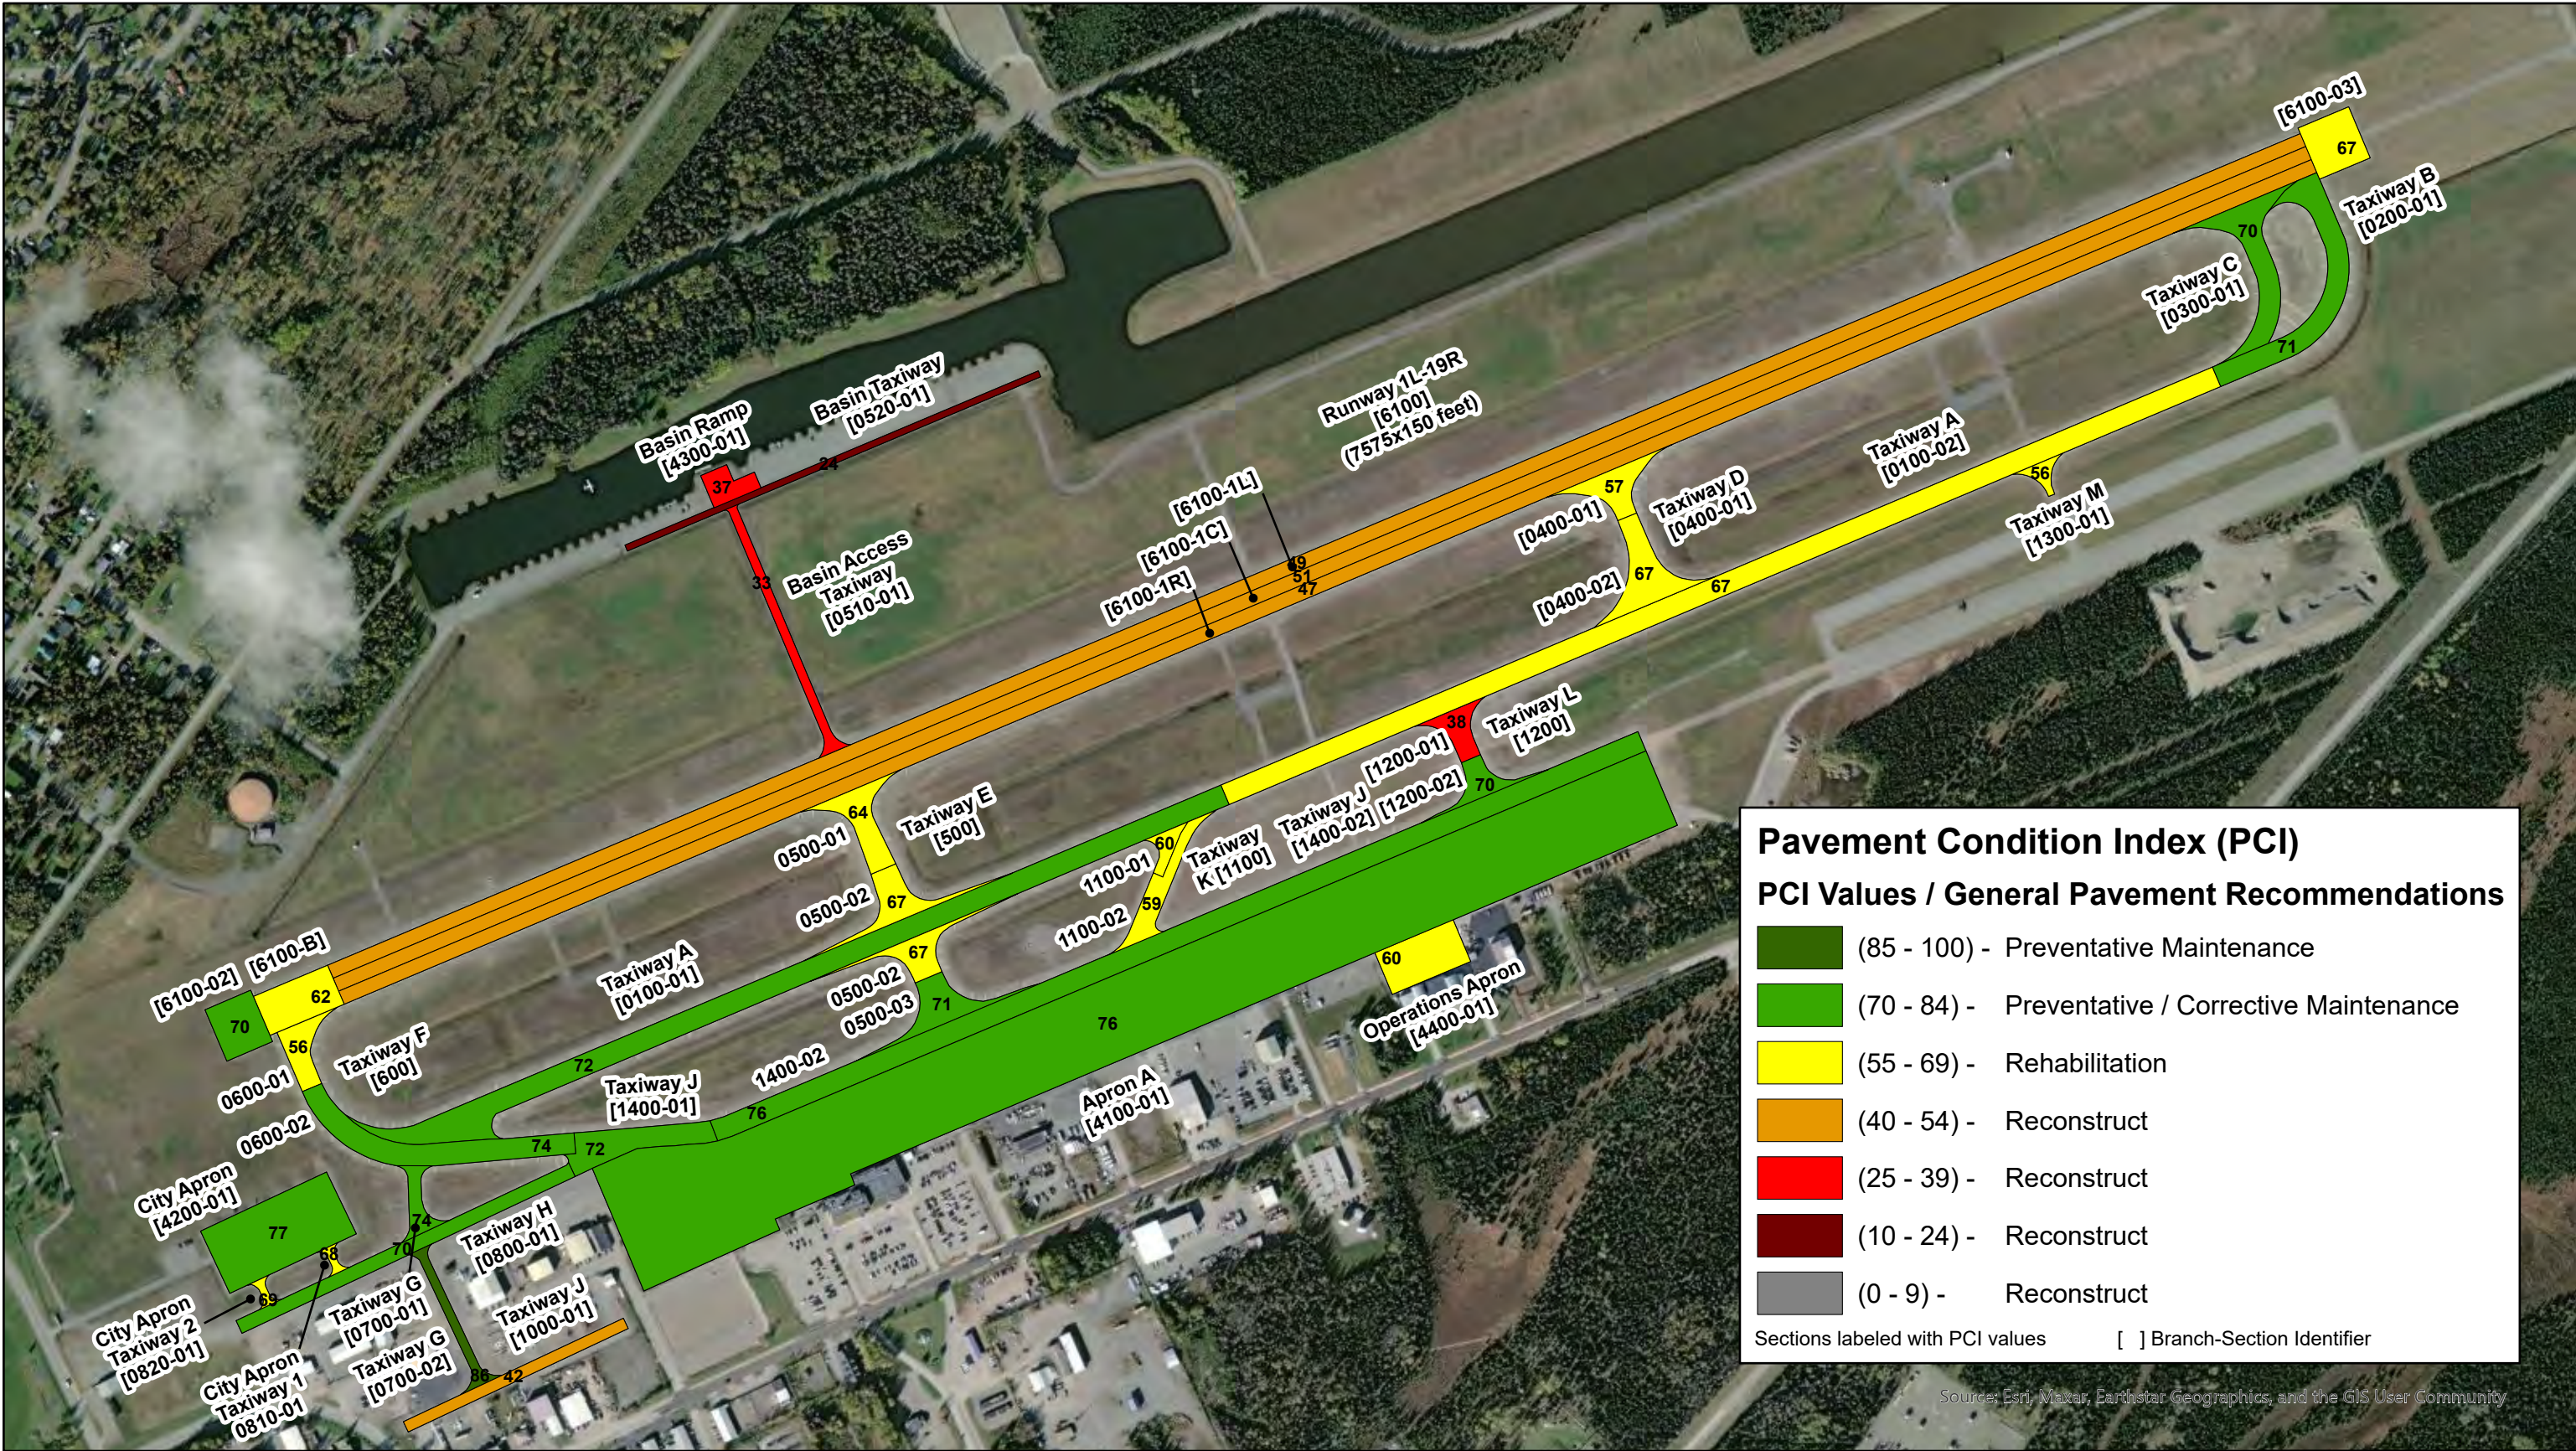
Map Created by  
State of Alaska DOT&PF  
**Map 1 of 6**

**Pavement Condition Index (PCI)**  
Target PCI Range for Runways: 70 to 100  
Target PCI Range for Taxiways and Aprons: 60 to 100

**2024 Pavement Inspection Results**  
0 250 500 1,000 1,500  
Feet

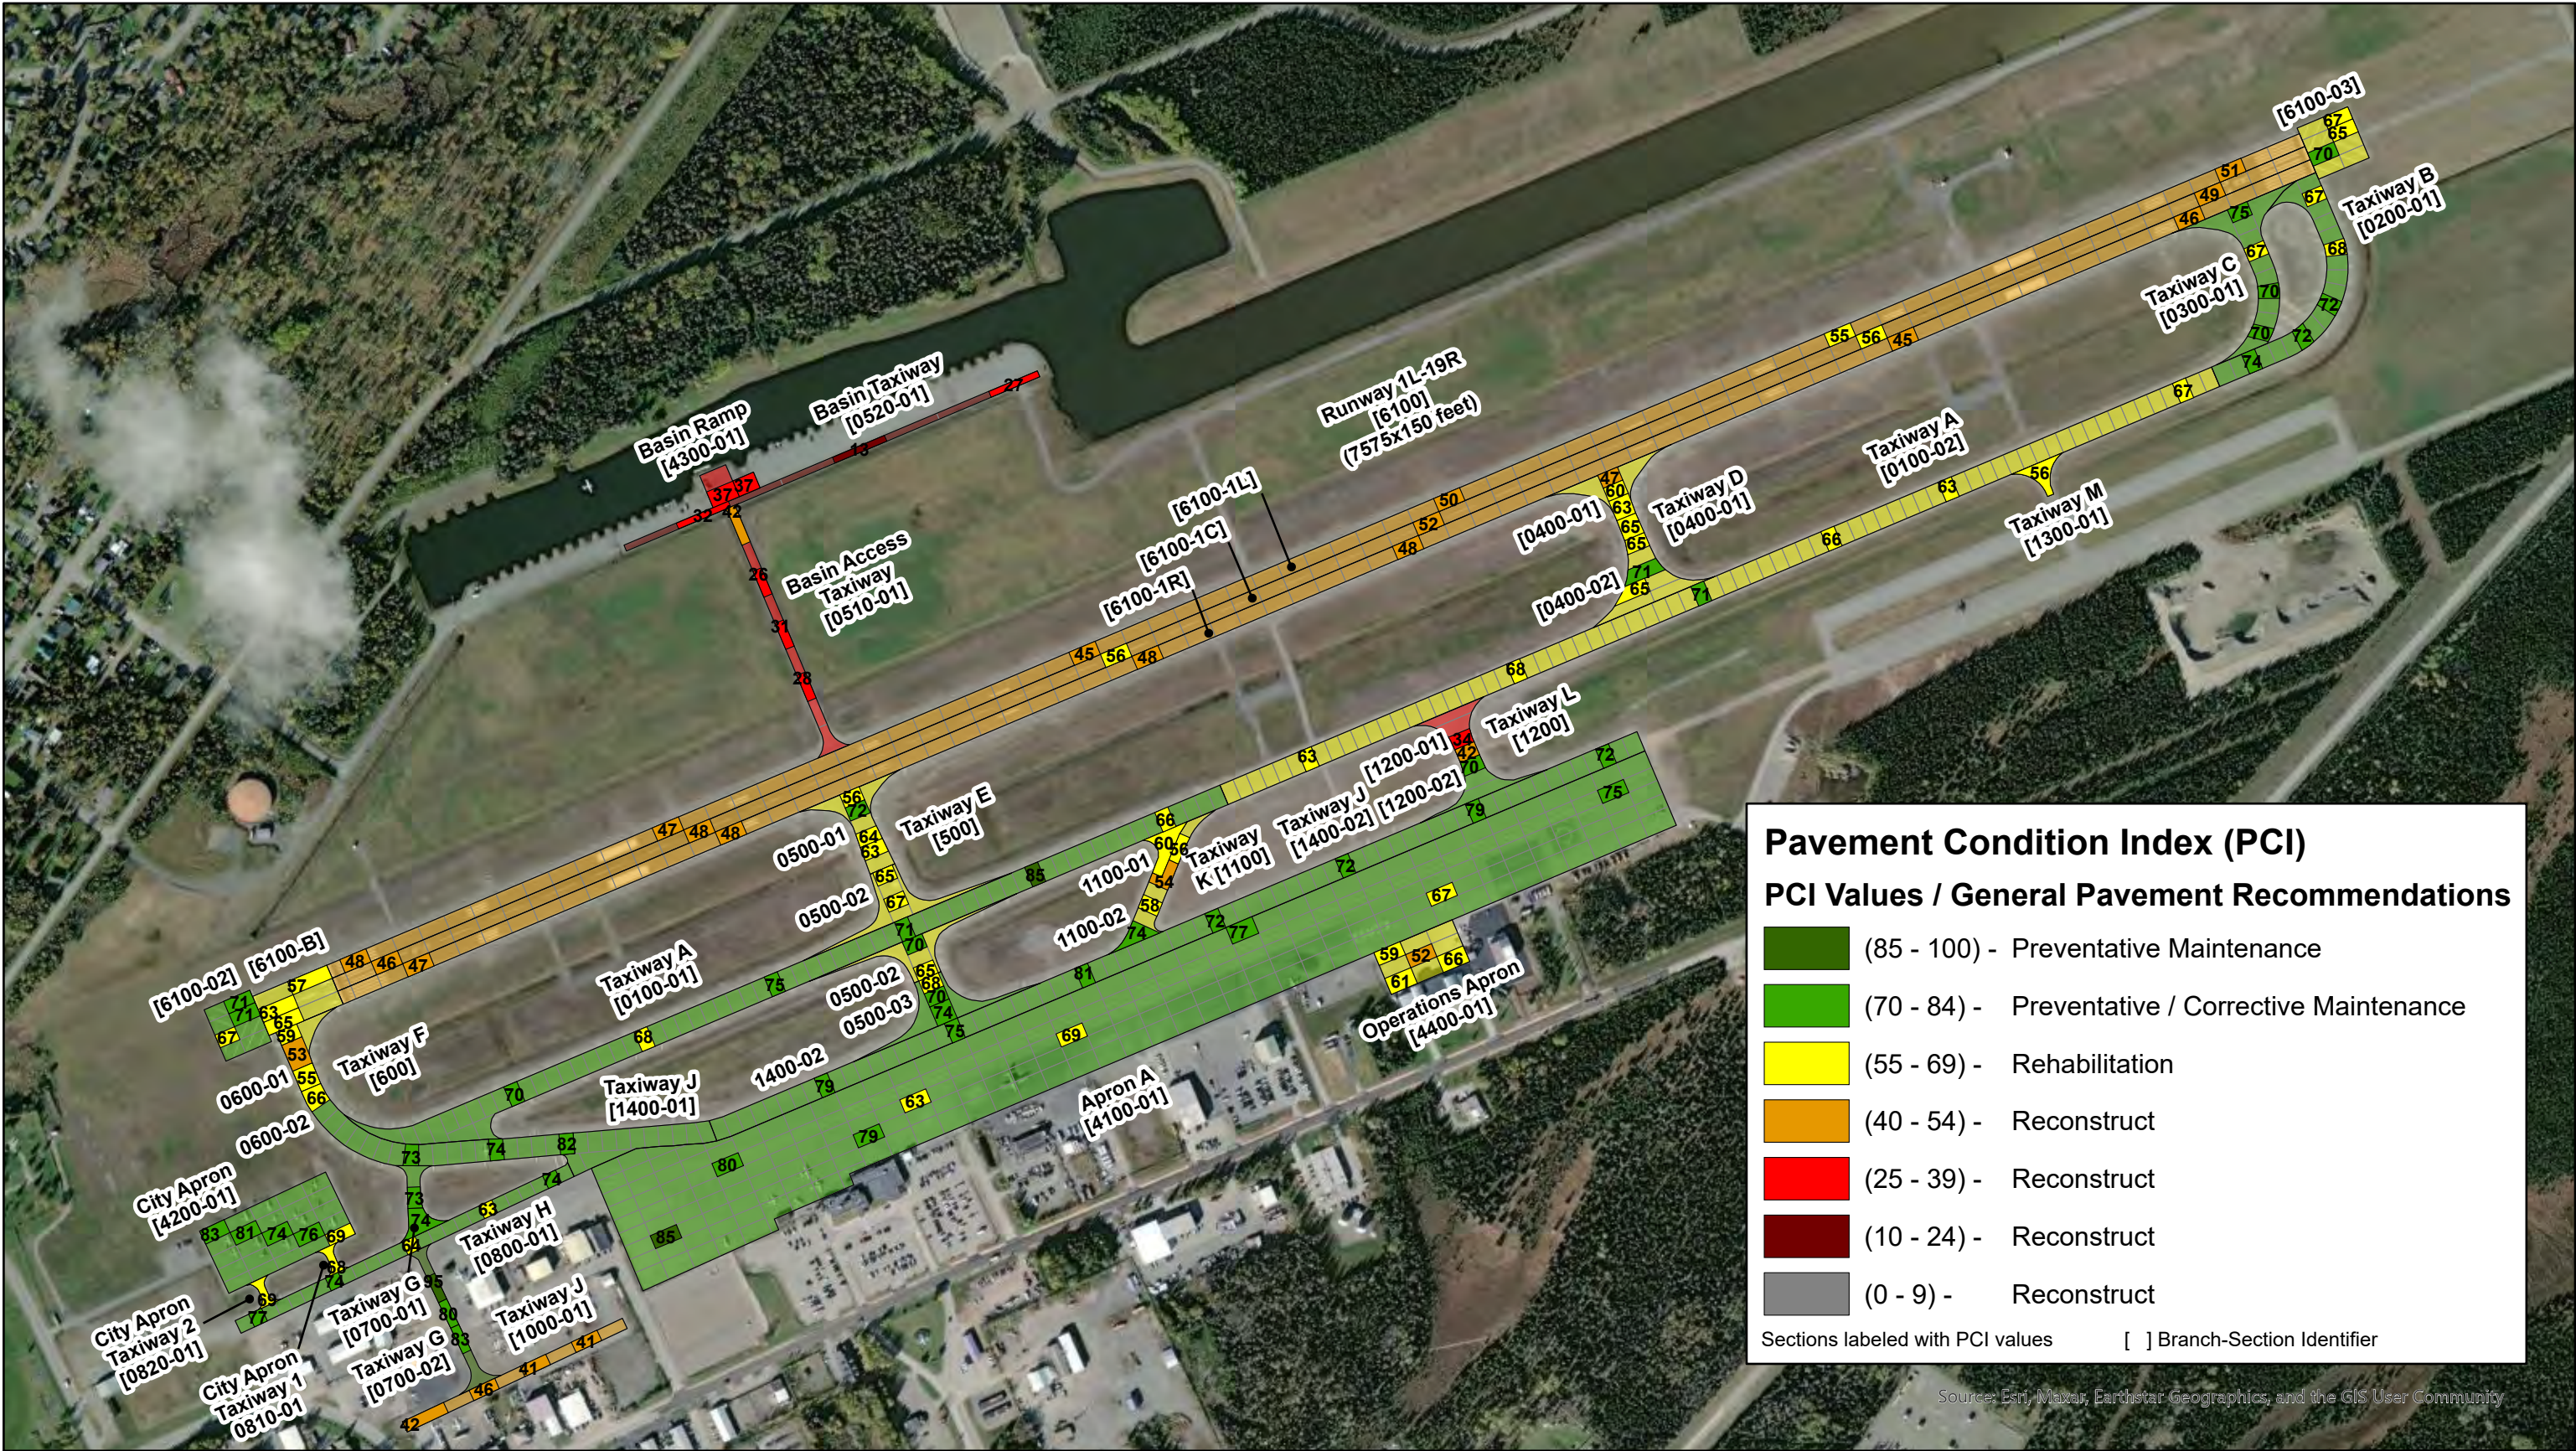
**Map 2 of 6**

**Sample Unit**  
**Pavement Condition Index (PCI)**

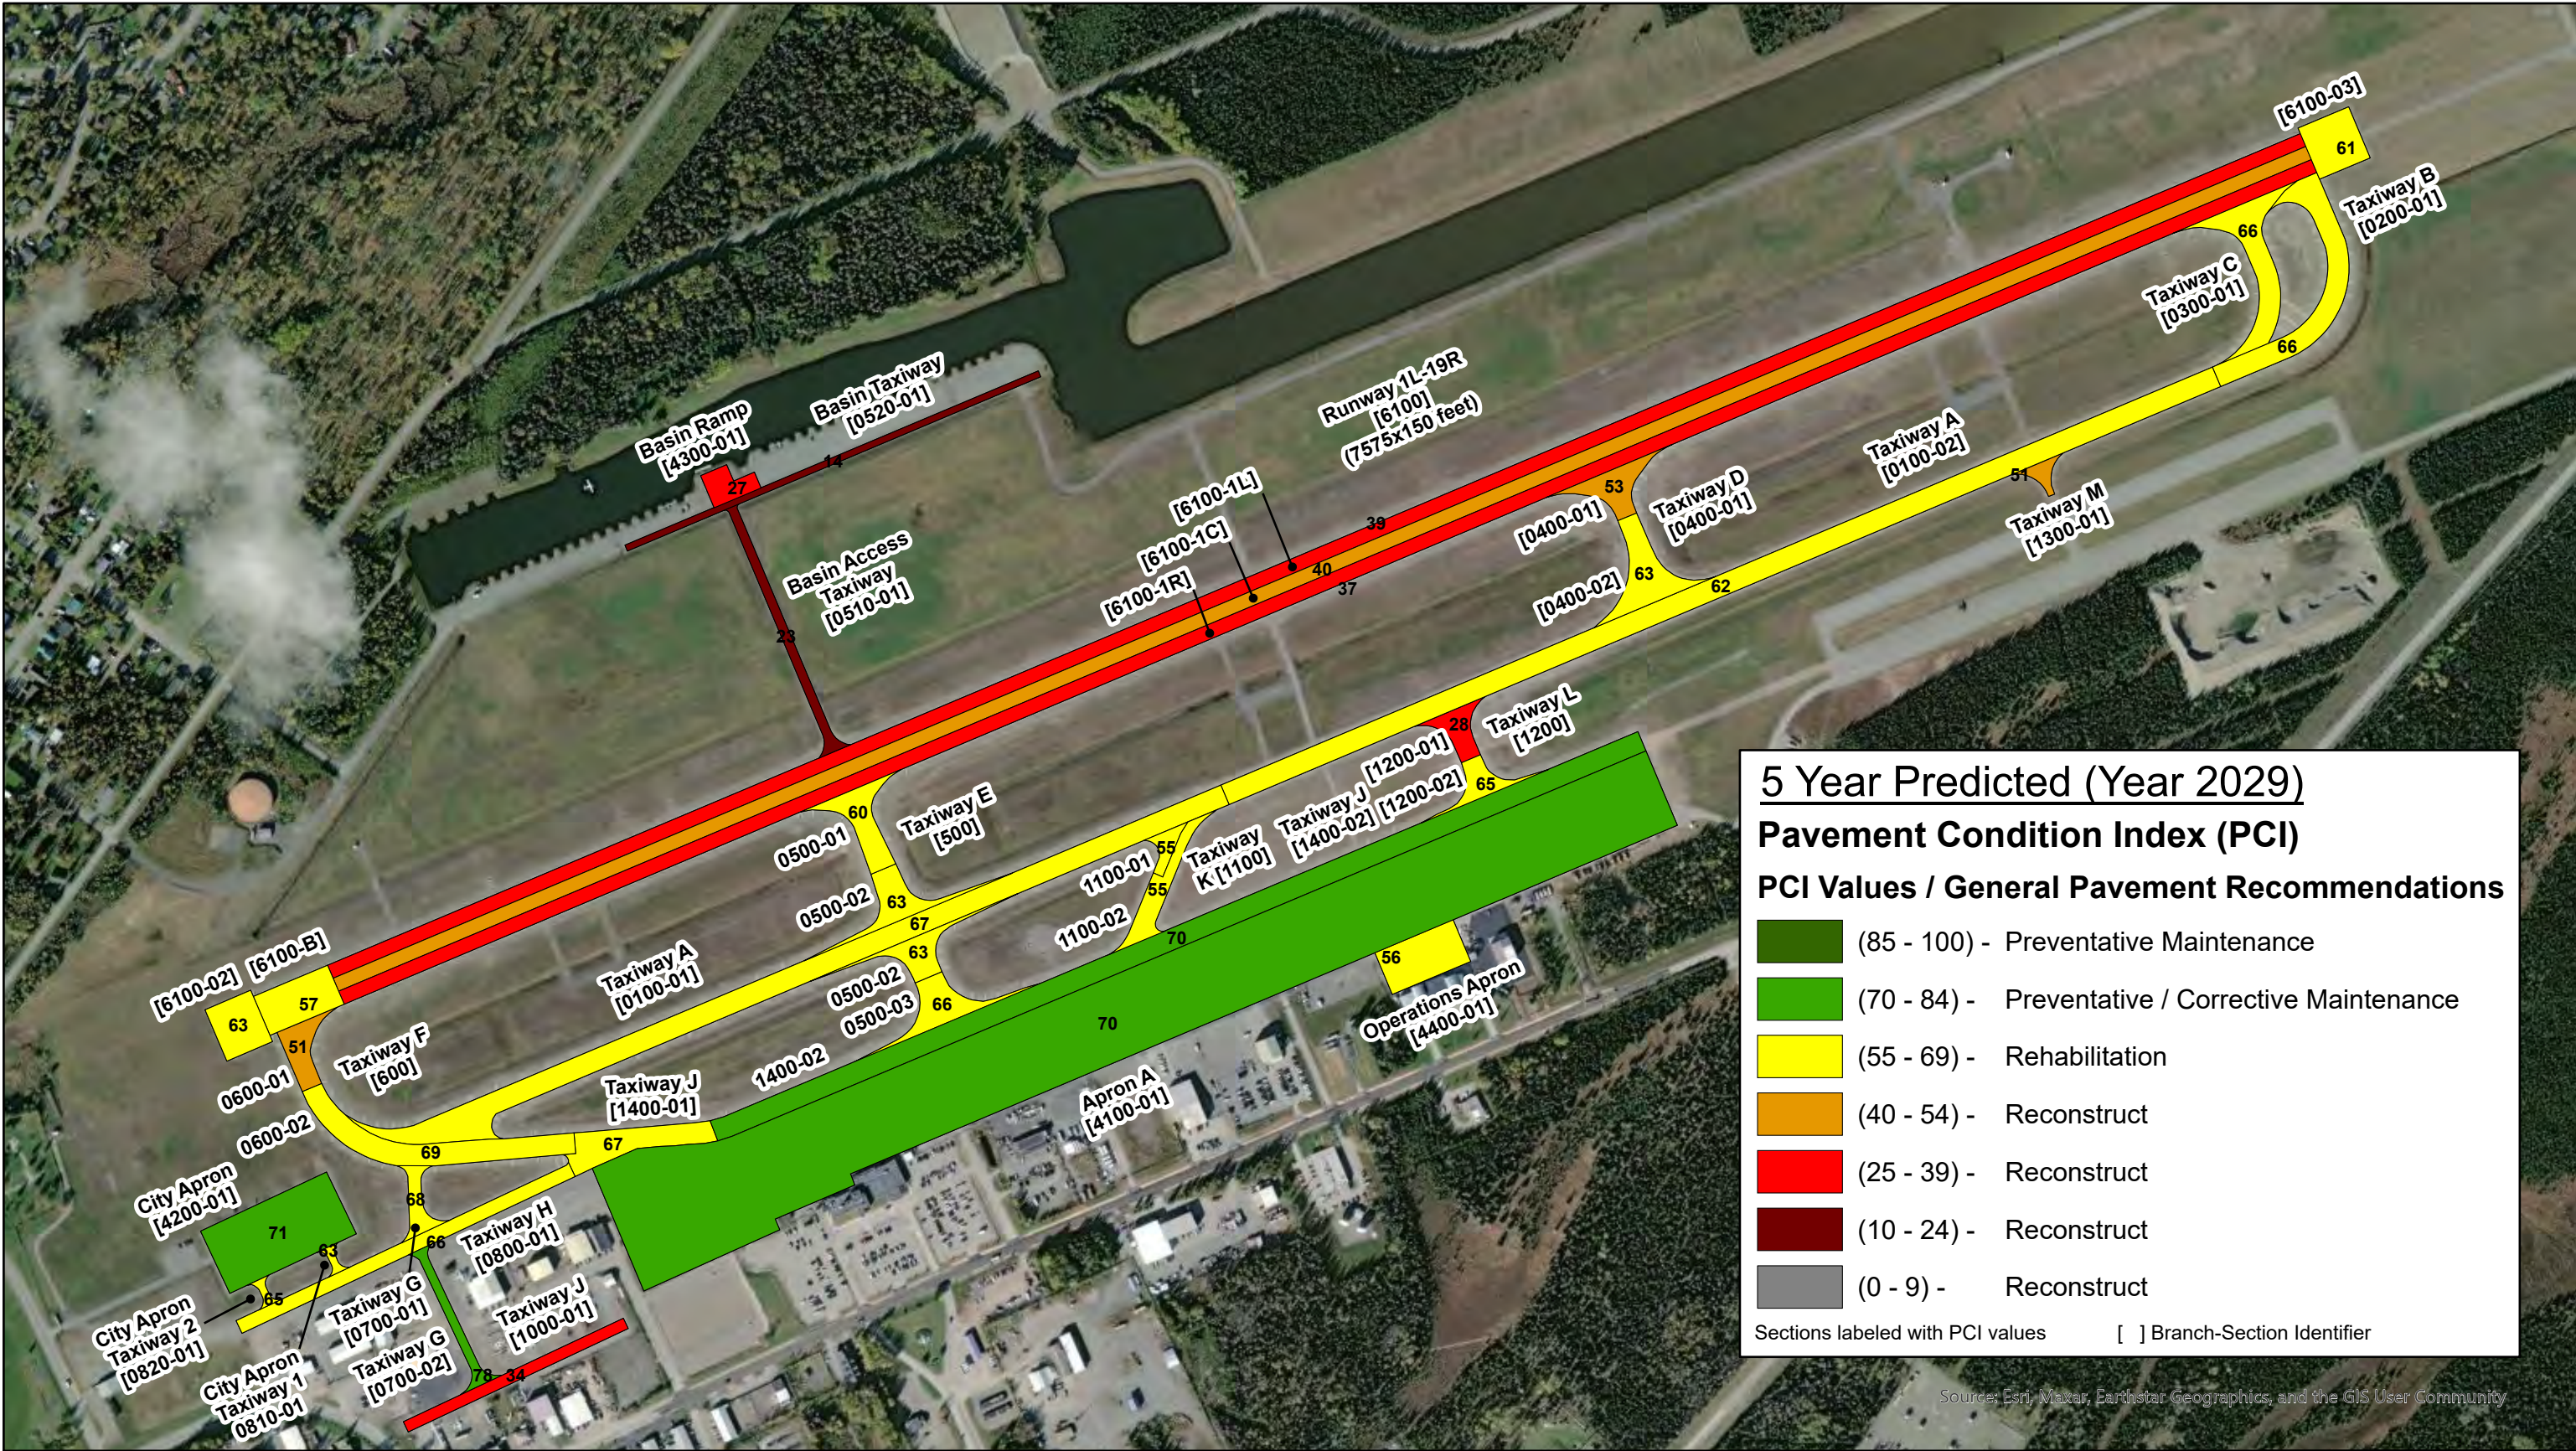
**Map 3 of 6**

**5 Year Predicted Pavement Condition Index (PCI)**  
Target PCI Range for Runways: 70 to 100  
Target PCI Range for Taxiways and Aprons: 60 to 100

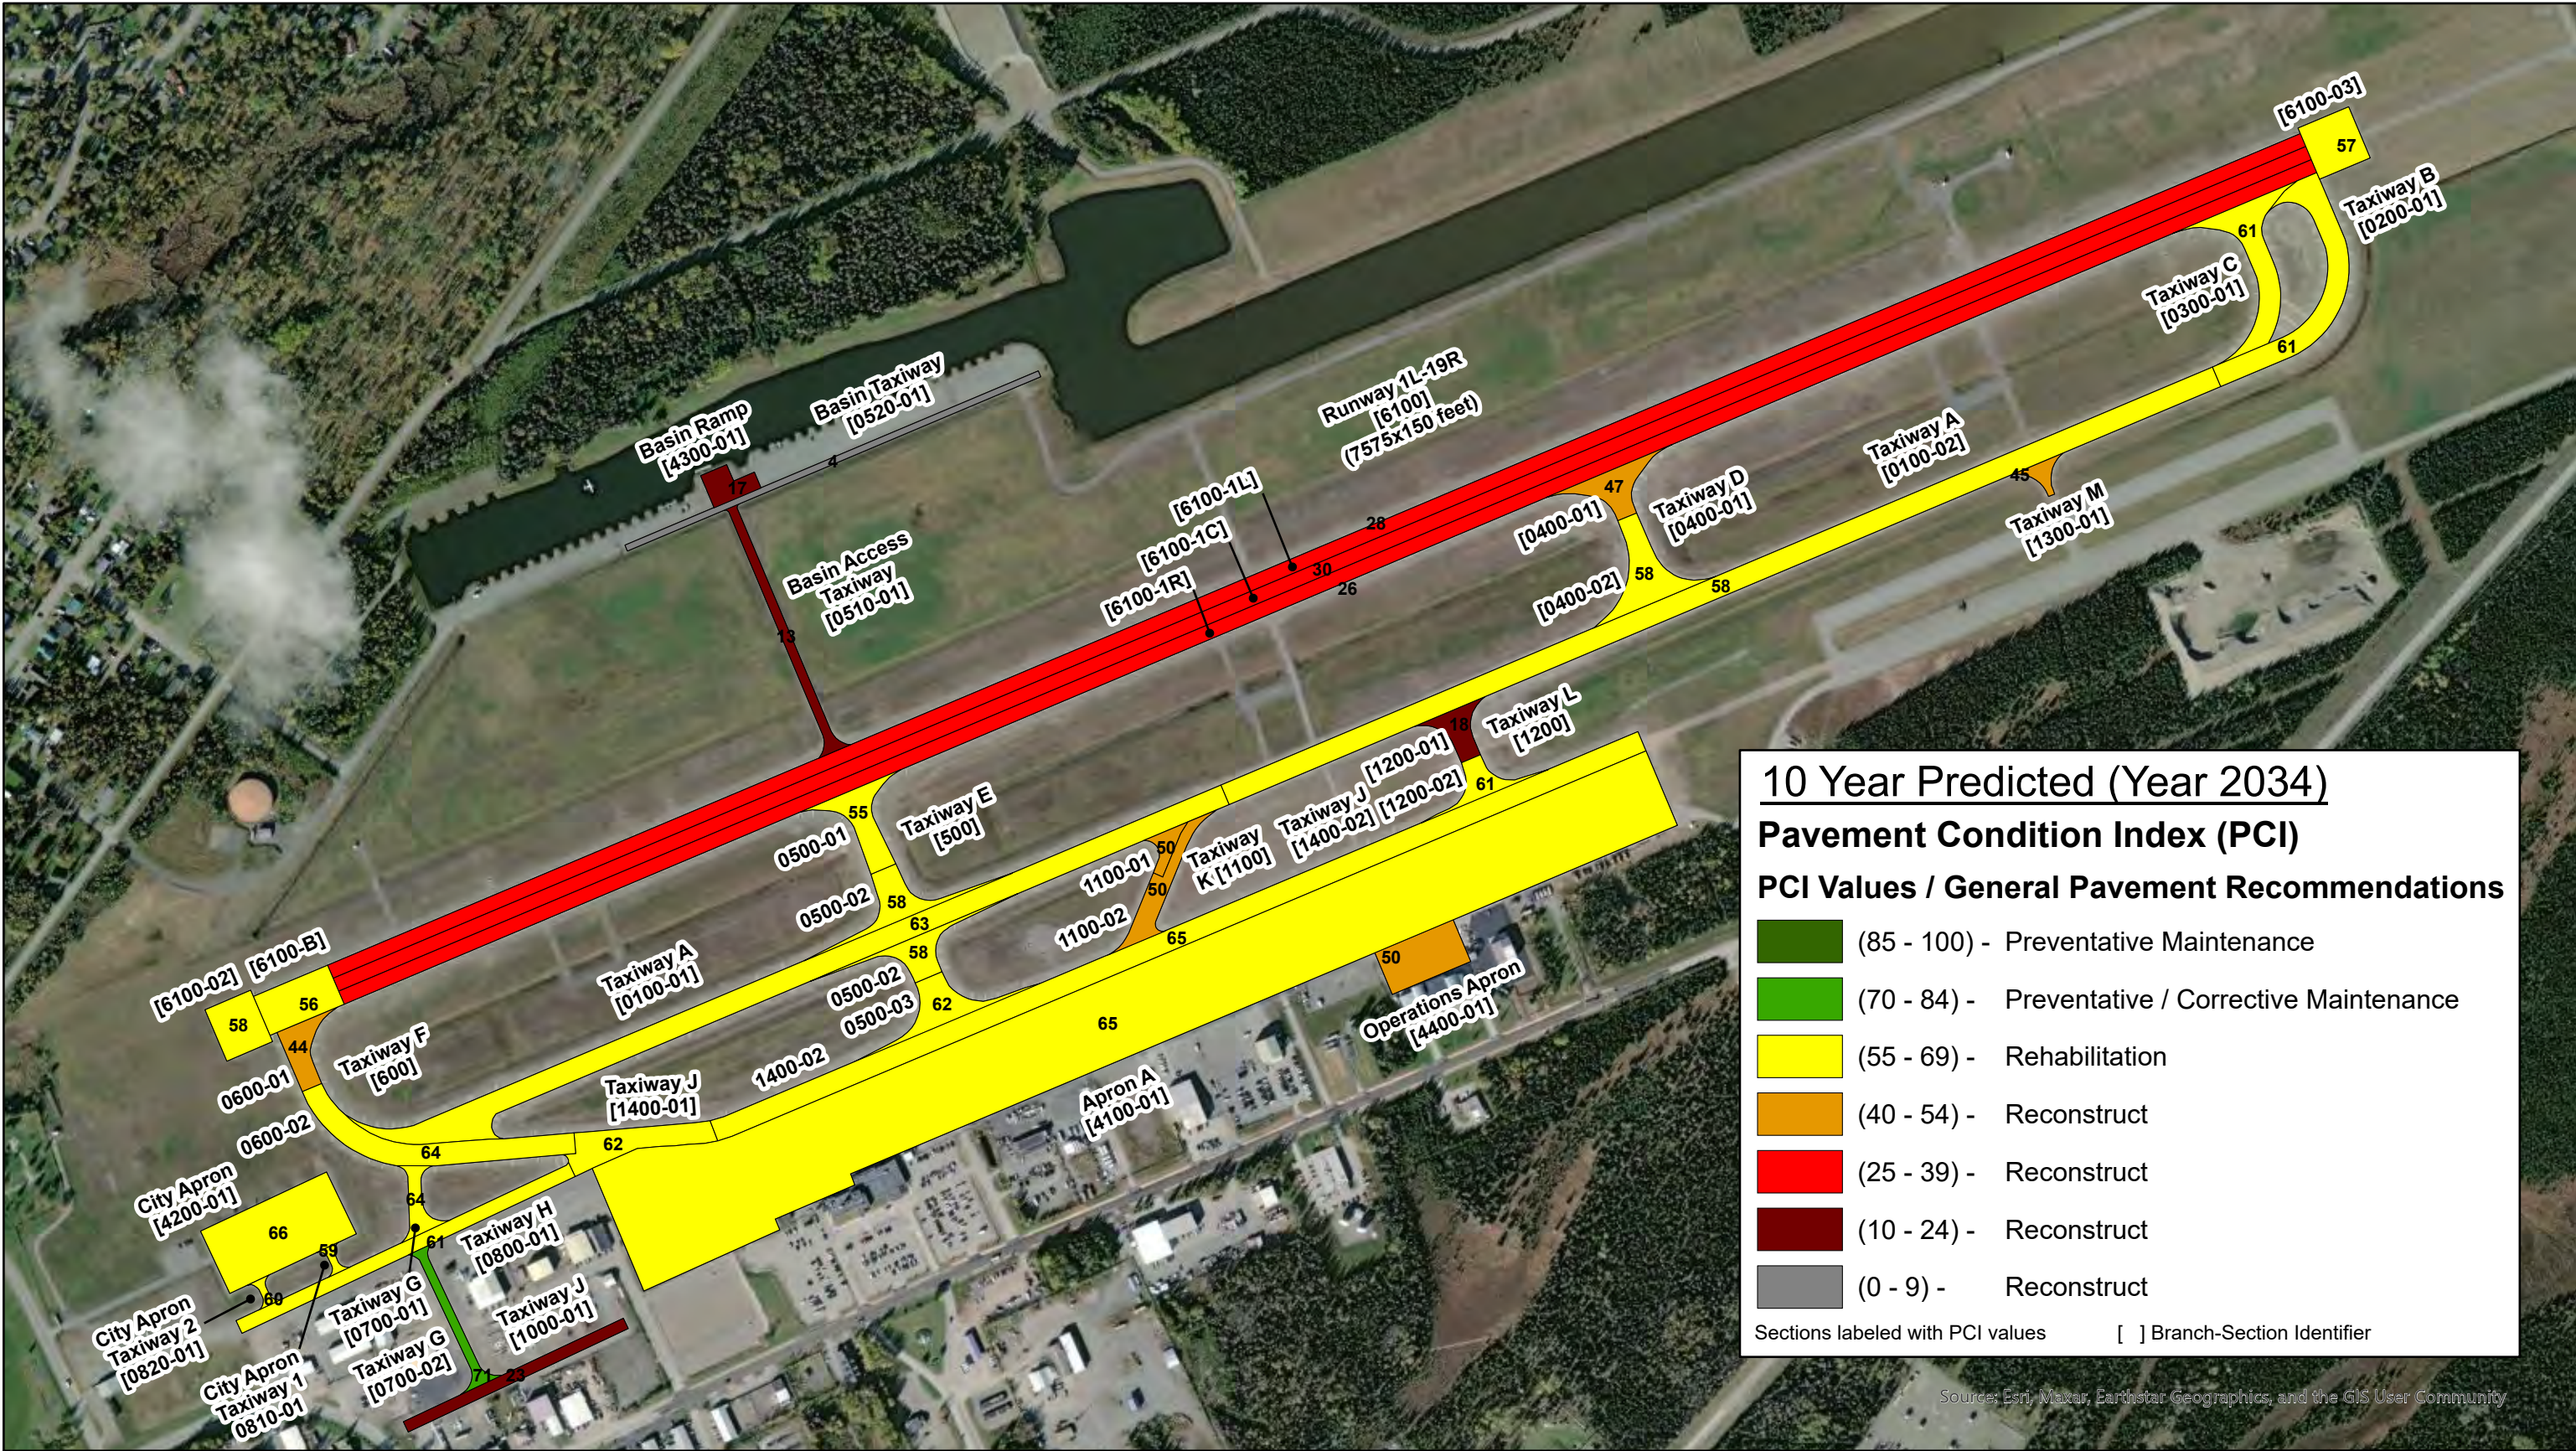
**Map 4 of 6**

**10 Year Predicted  
Pavement Condition Index (PCI)**  
Target PCI Range for Runways: 70 to 100  
Target PCI Range for Taxiways and Aprons: 60 to 100

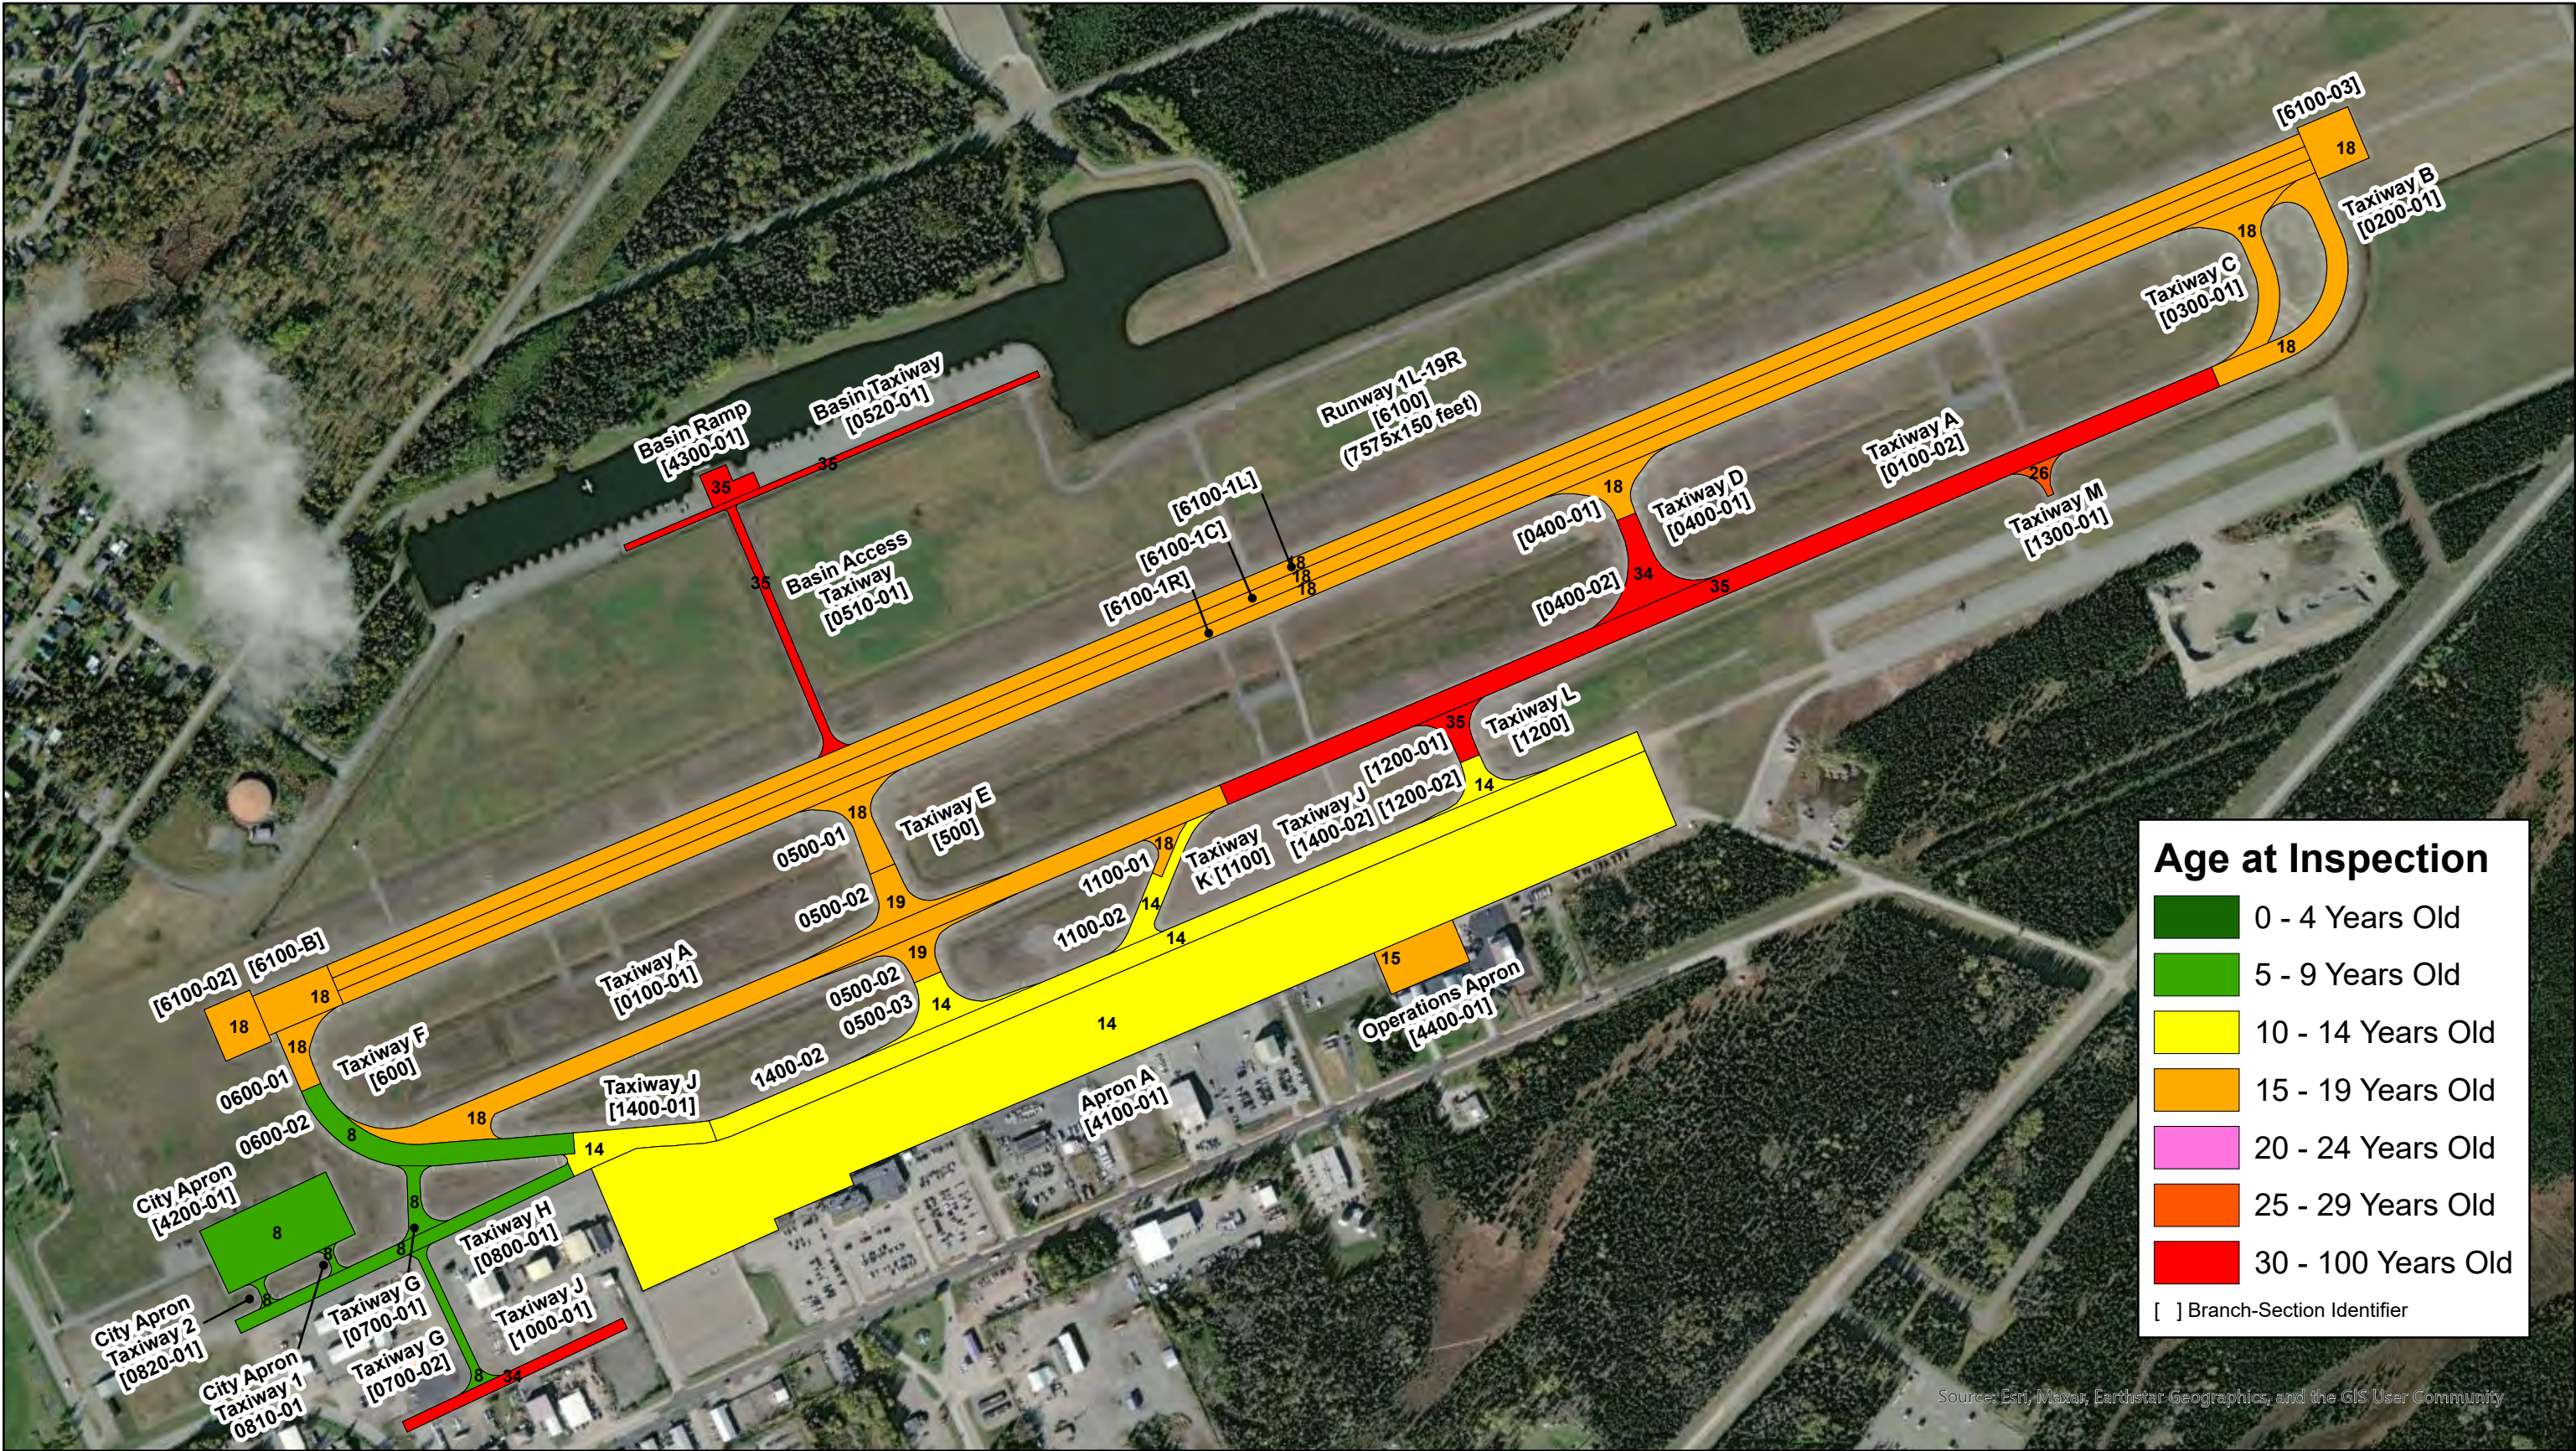
**Map 5 of 6**

**Age at Inspection**

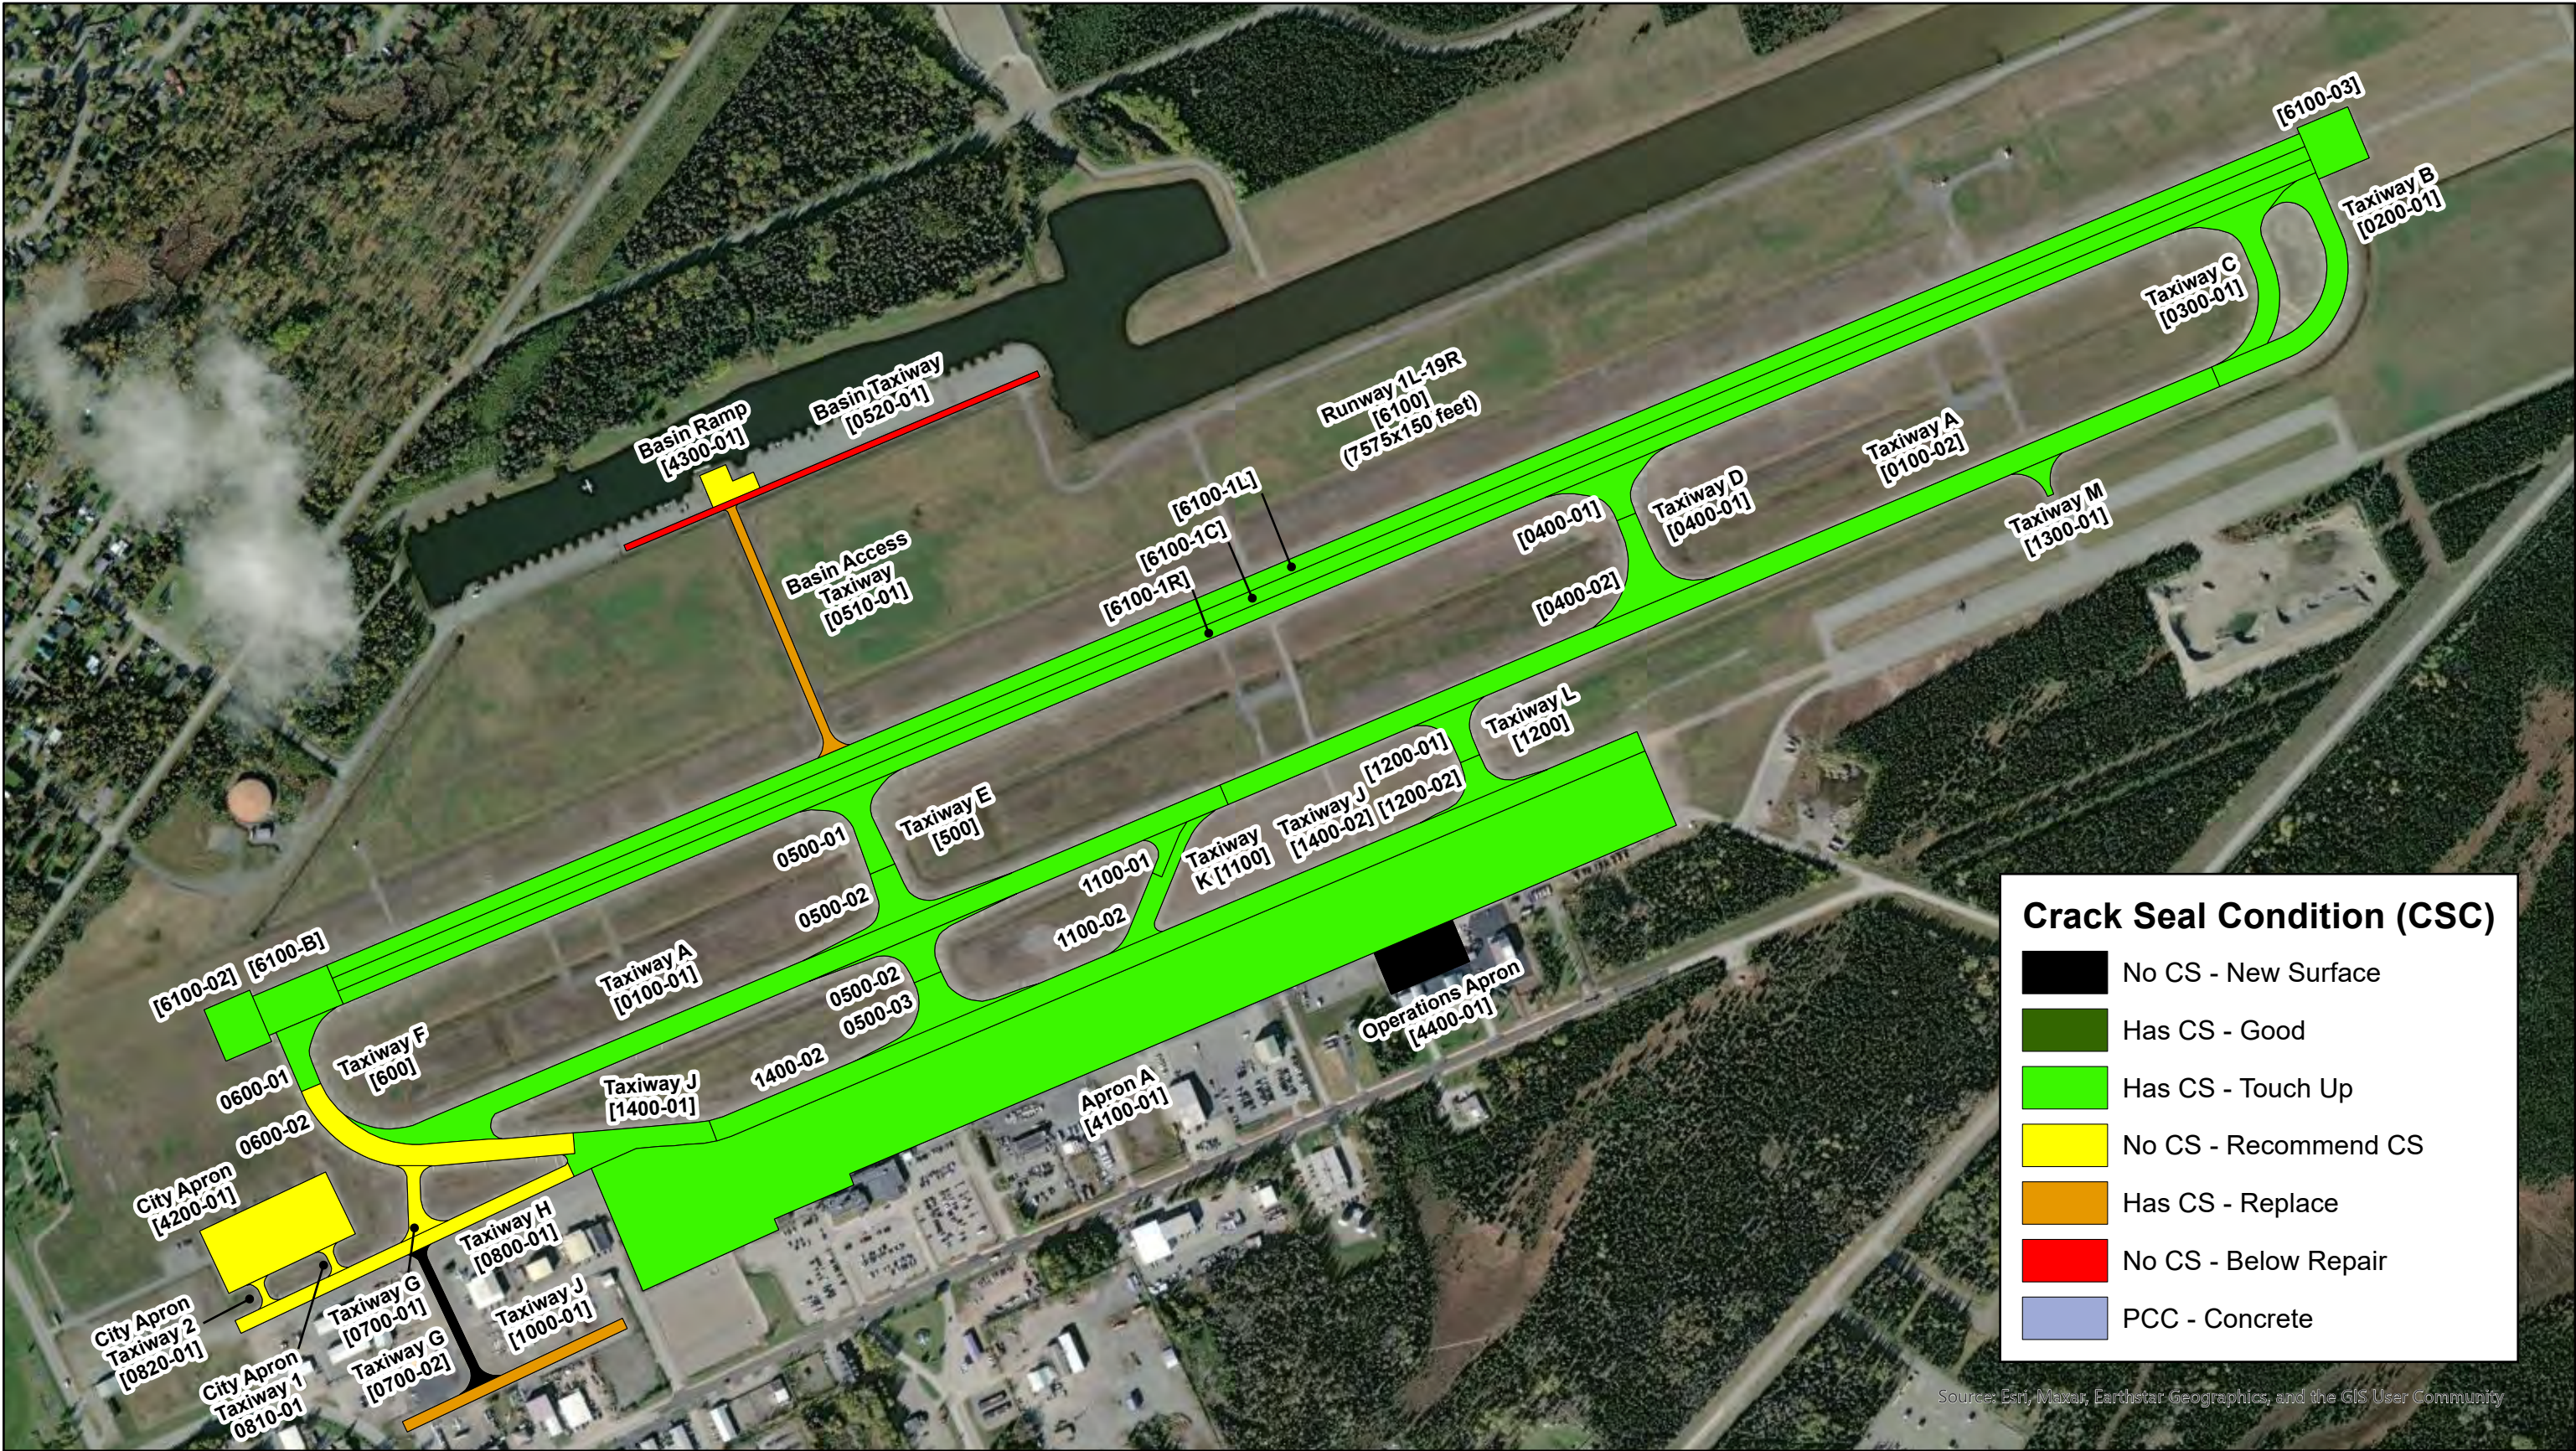
**Crack Seal Condition (CSC)**

**Pavement Crack Seal Condition (CSC)**
