Alaska DOT&PF

Pavement Inspection Report McGrath Airport

Airport Name	IATA	ICAO	Latitude	Longitude	Elevation (ft)
McGrath Airport	MCG	PAMC	62° 57' 10.0221" N	155° 36' 25.373" W	342.7

Point of Contact	Phone	Email	Date Inspected	Date Published
Mr. Andrew Pavey, Pavement Management Engineer	(907) 269 6213	andrew.pavey@alaska.gov	July 2023	February 2024

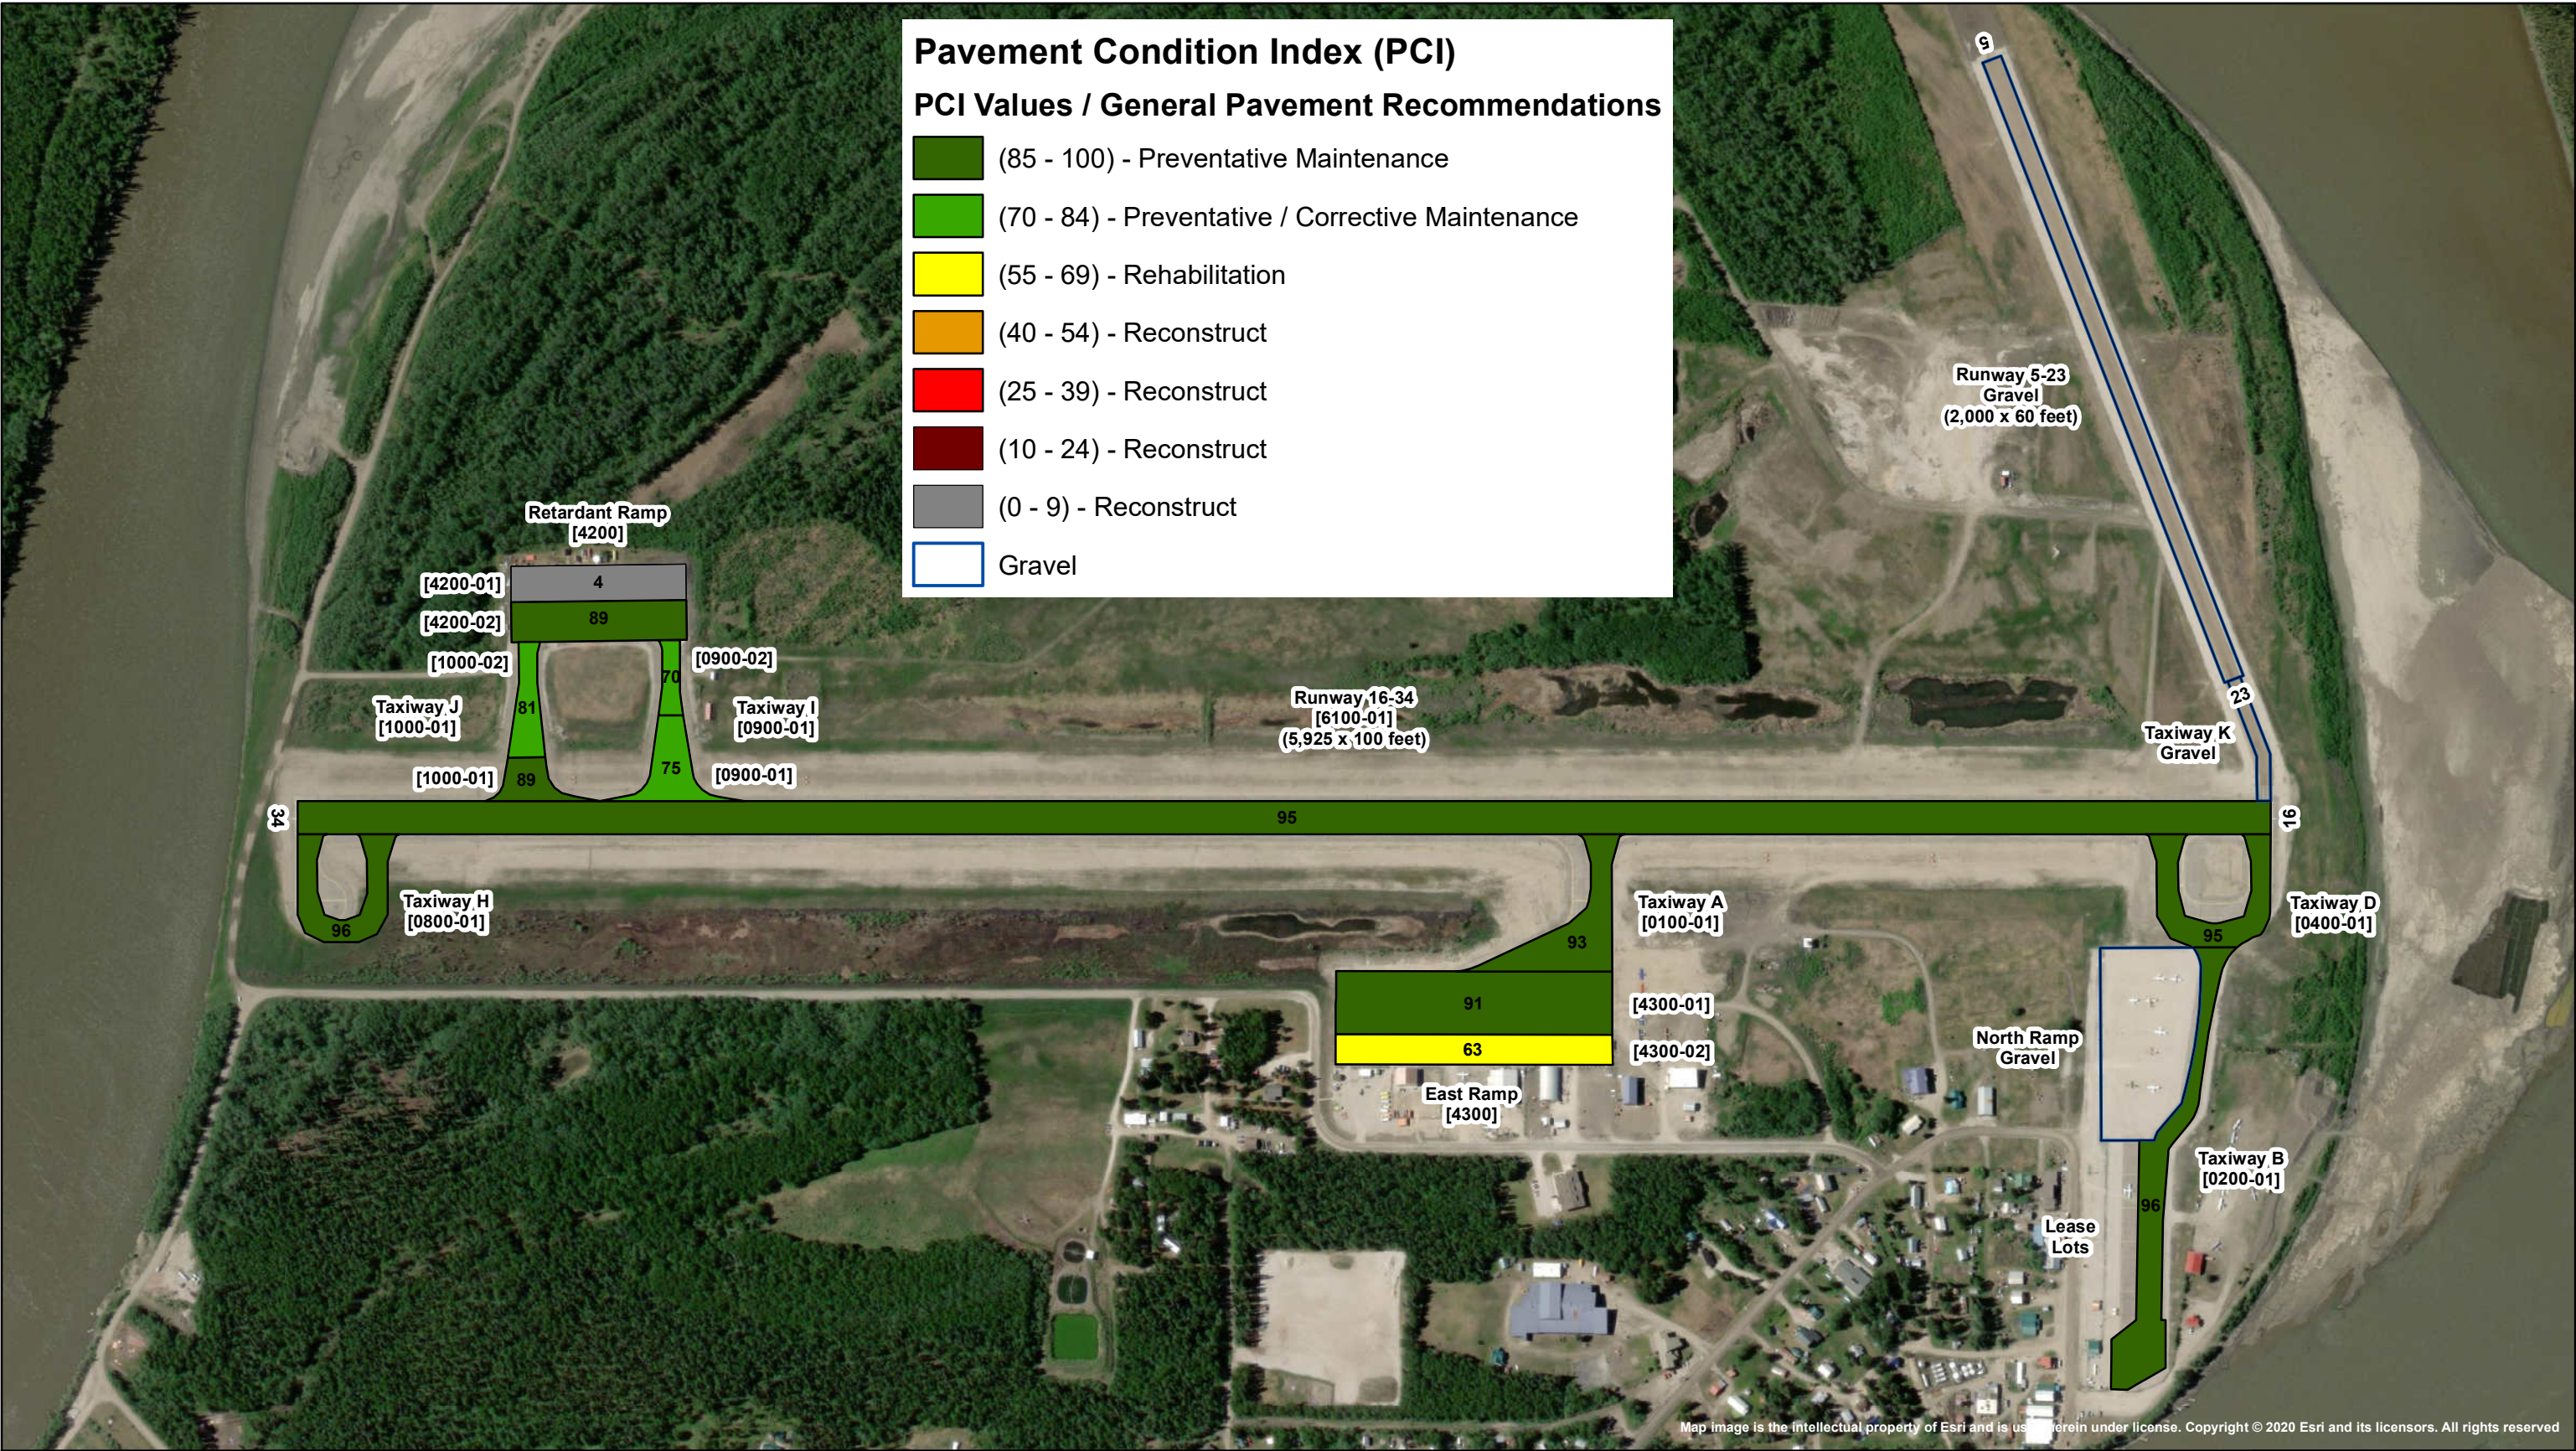
Pavement Condition Index (PCI)

Target PCI Range for Runways: 70 to 100
Target PCI Range for Taxiways and Aprons: 60 to 100

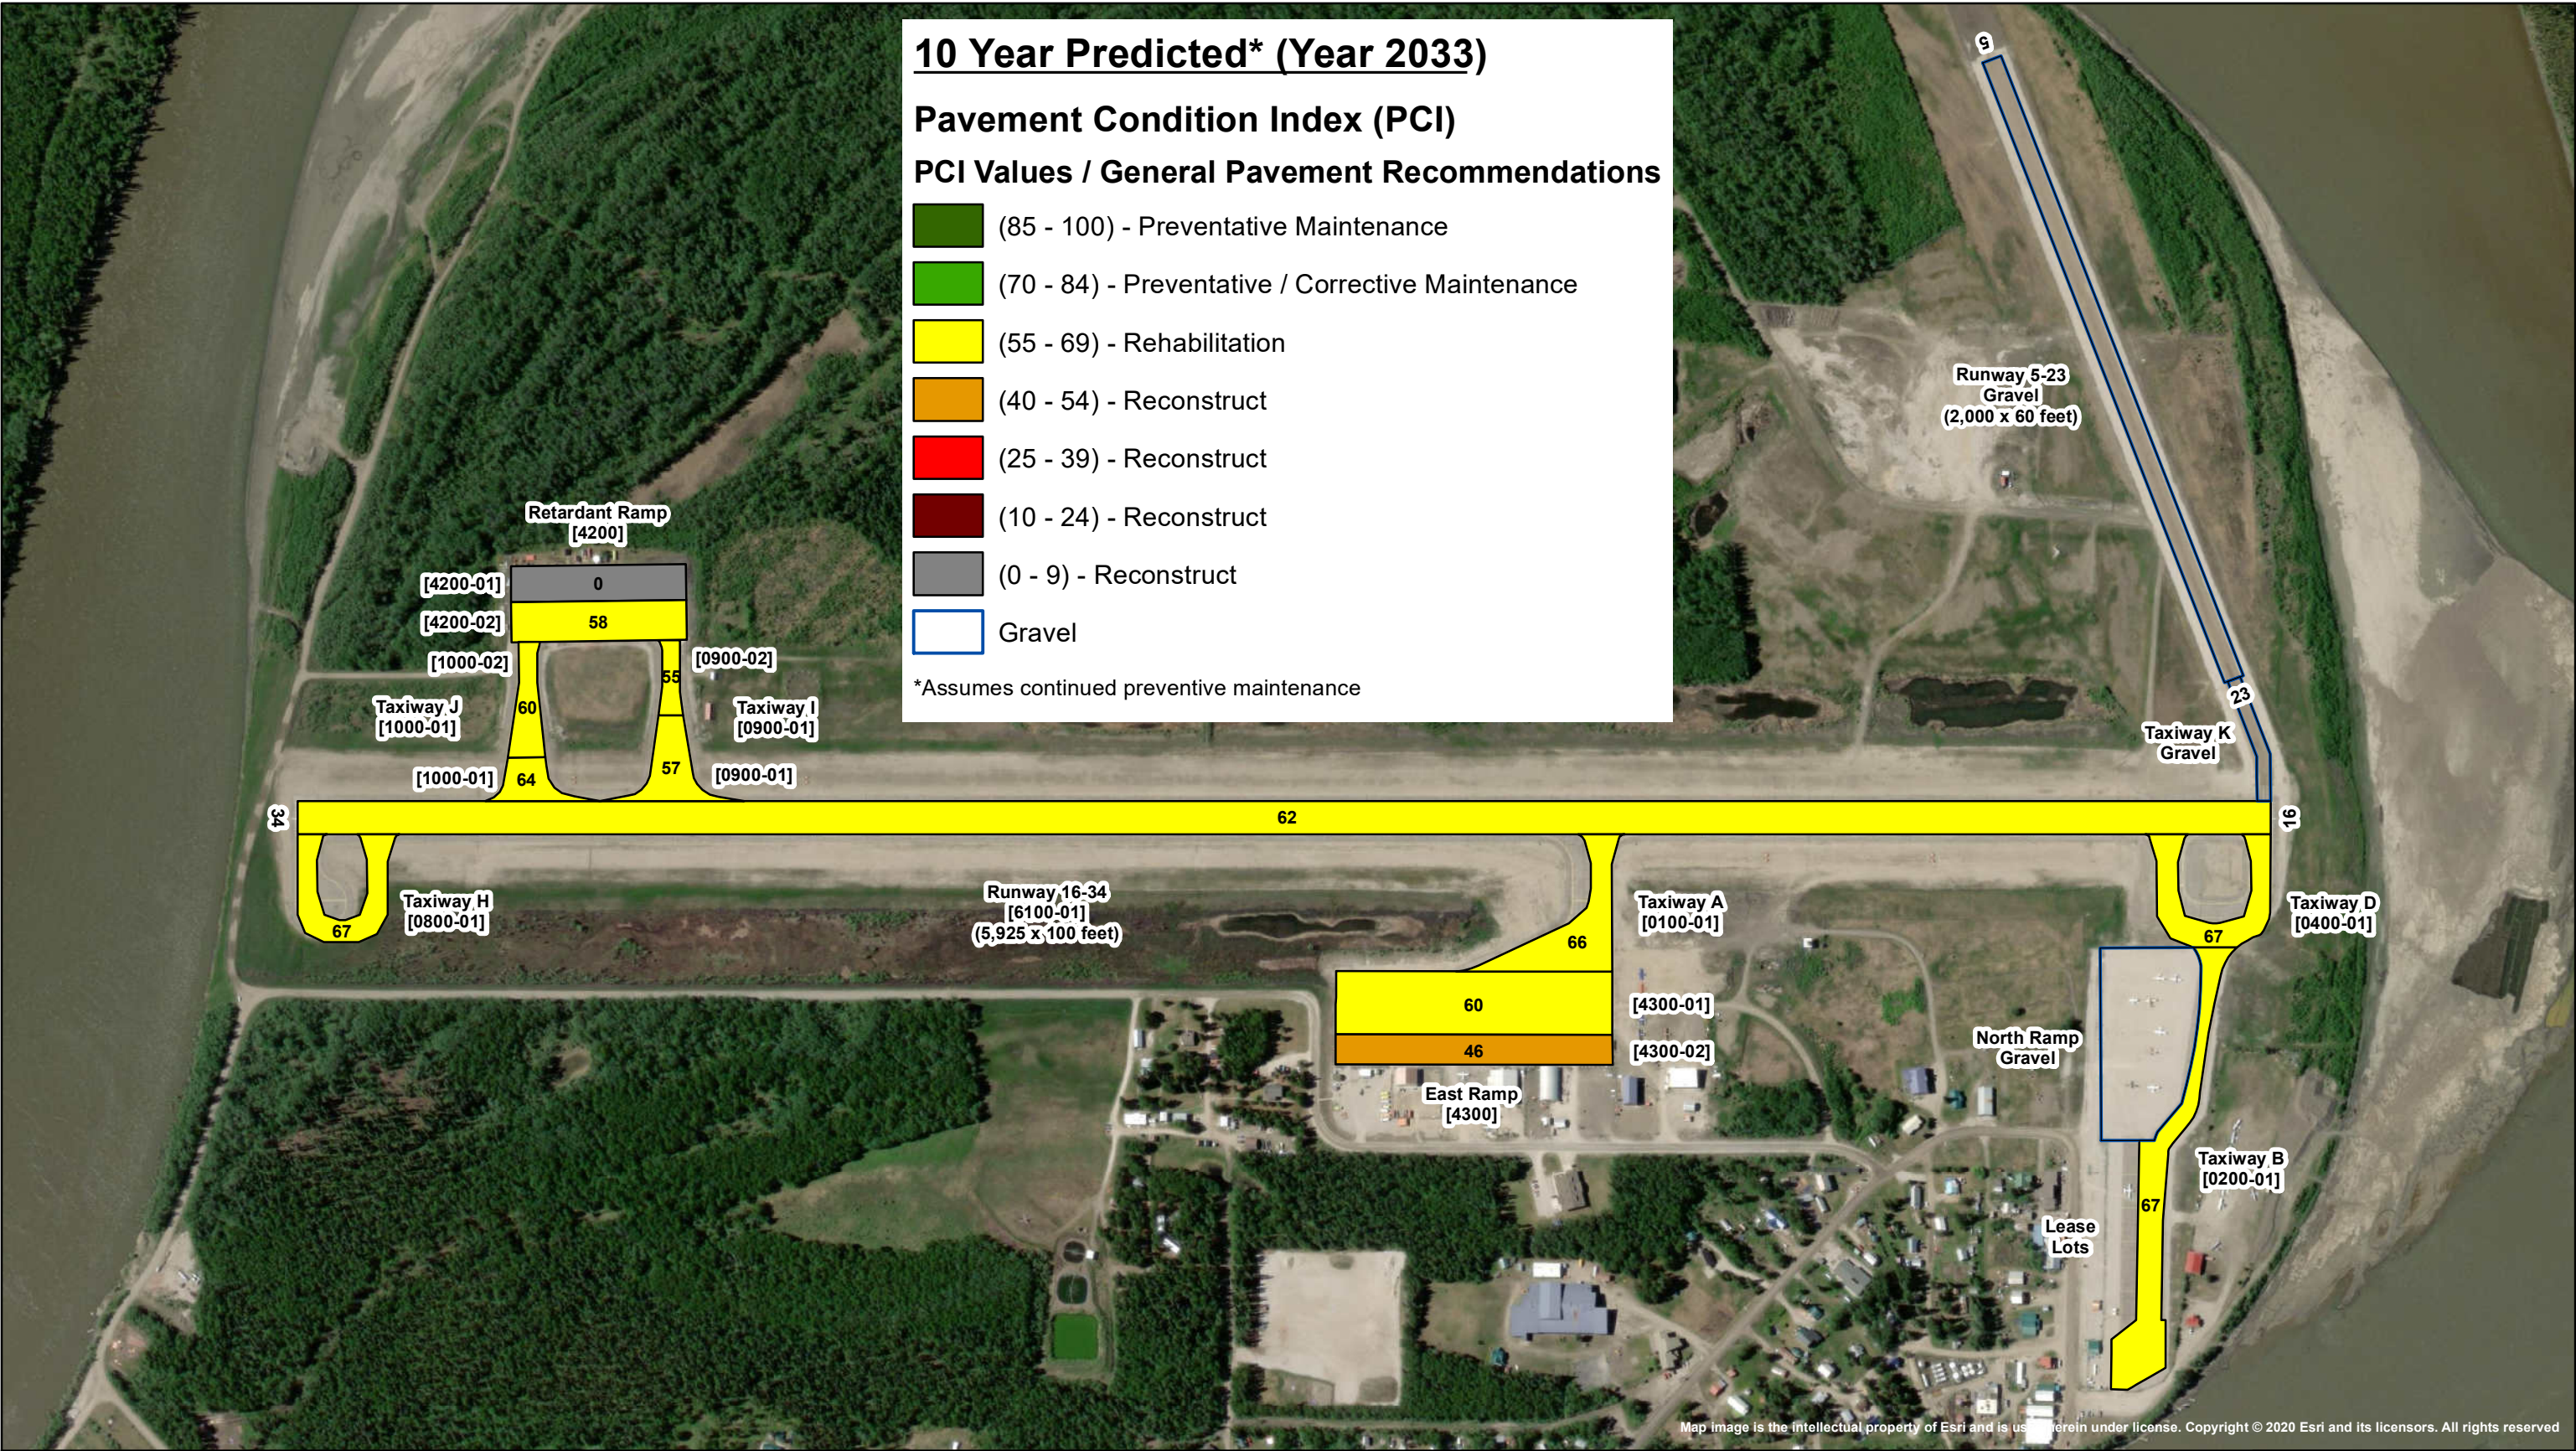
**10 Year Predicted
Pavement Condition Index (PCI)**

Target PCI Range for Runways: 70 to 100
Target PCI Range for Taxiways and Aprons: 60 to 100
