Alaska DOT&PF

Pavement Inspection Report Nome Airport

Point of Contact	Phone	Email	Date Inspected	Date Published
Mr. Andrew Pavey, Pavement Management Engineer	(907) 269 6213	andrew.pavey@alaska.gov	July 2024	August 2025

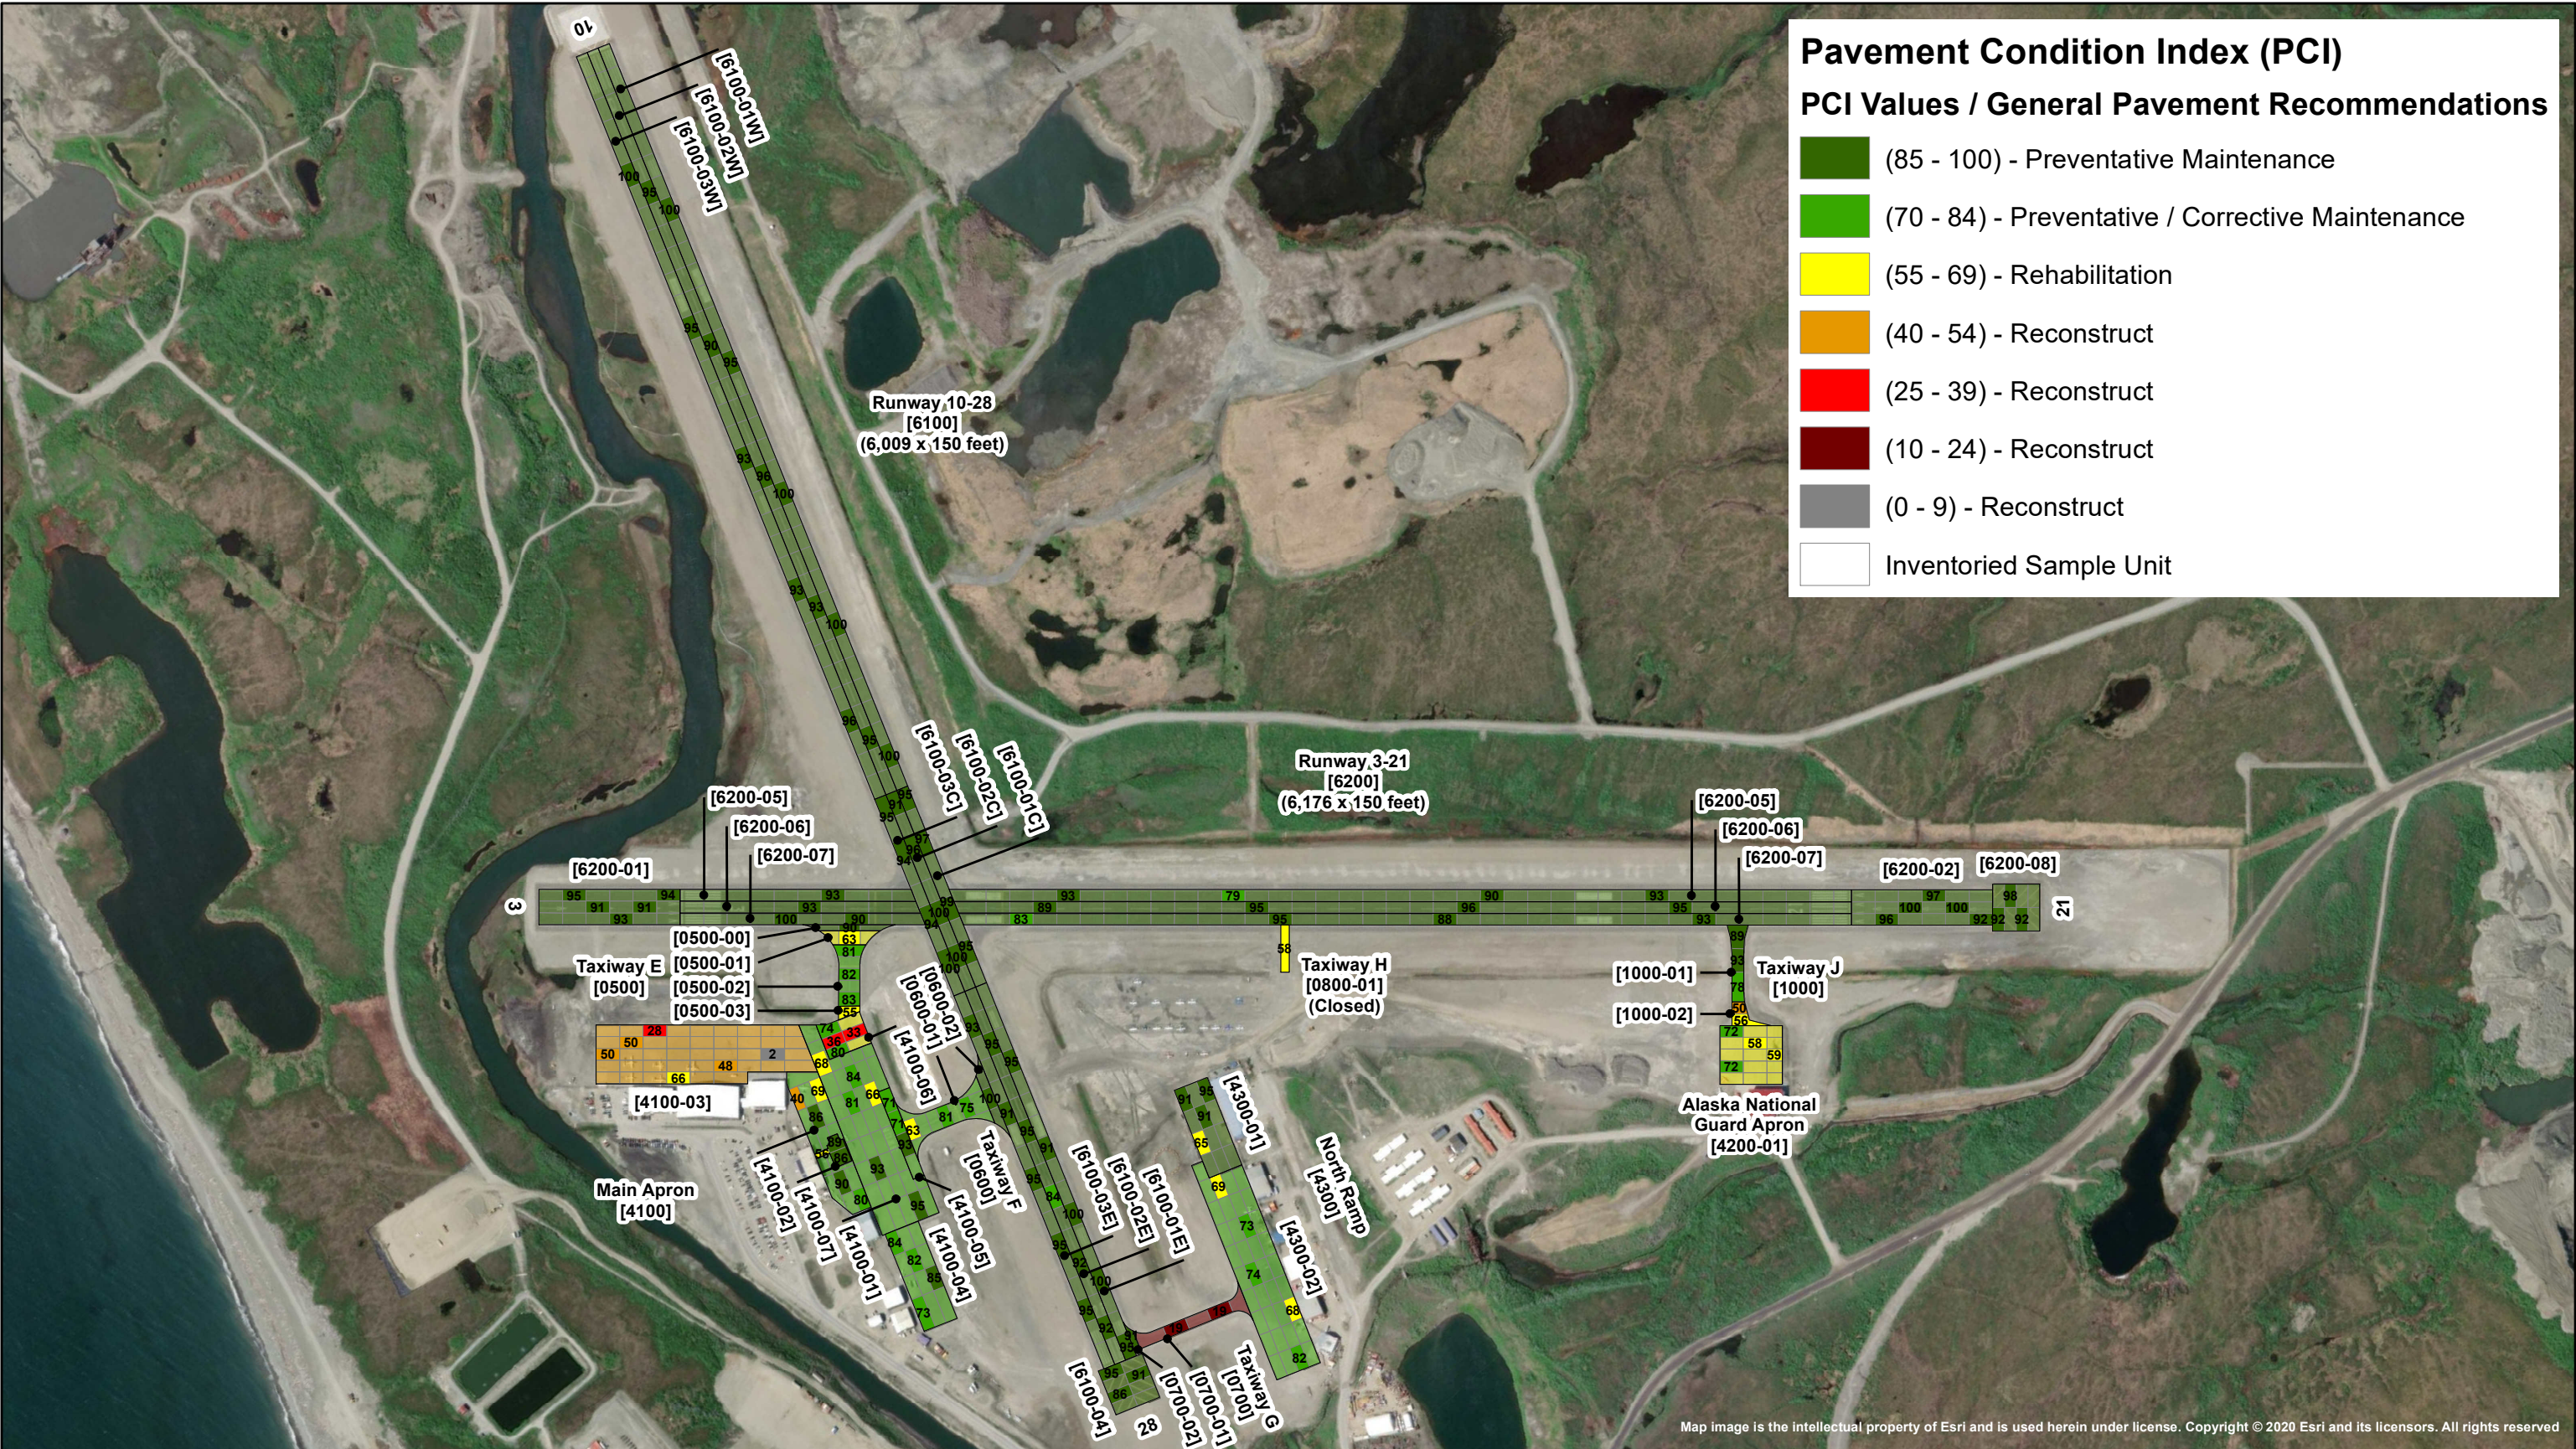
**Sample Unit
Pavement Condition Index (PCI)**

Target PCI Range for Runways: 70 to 100
Target PCI Range for Taxiways and Aprons: 60 to 100

2024 Pavement Inspection Results

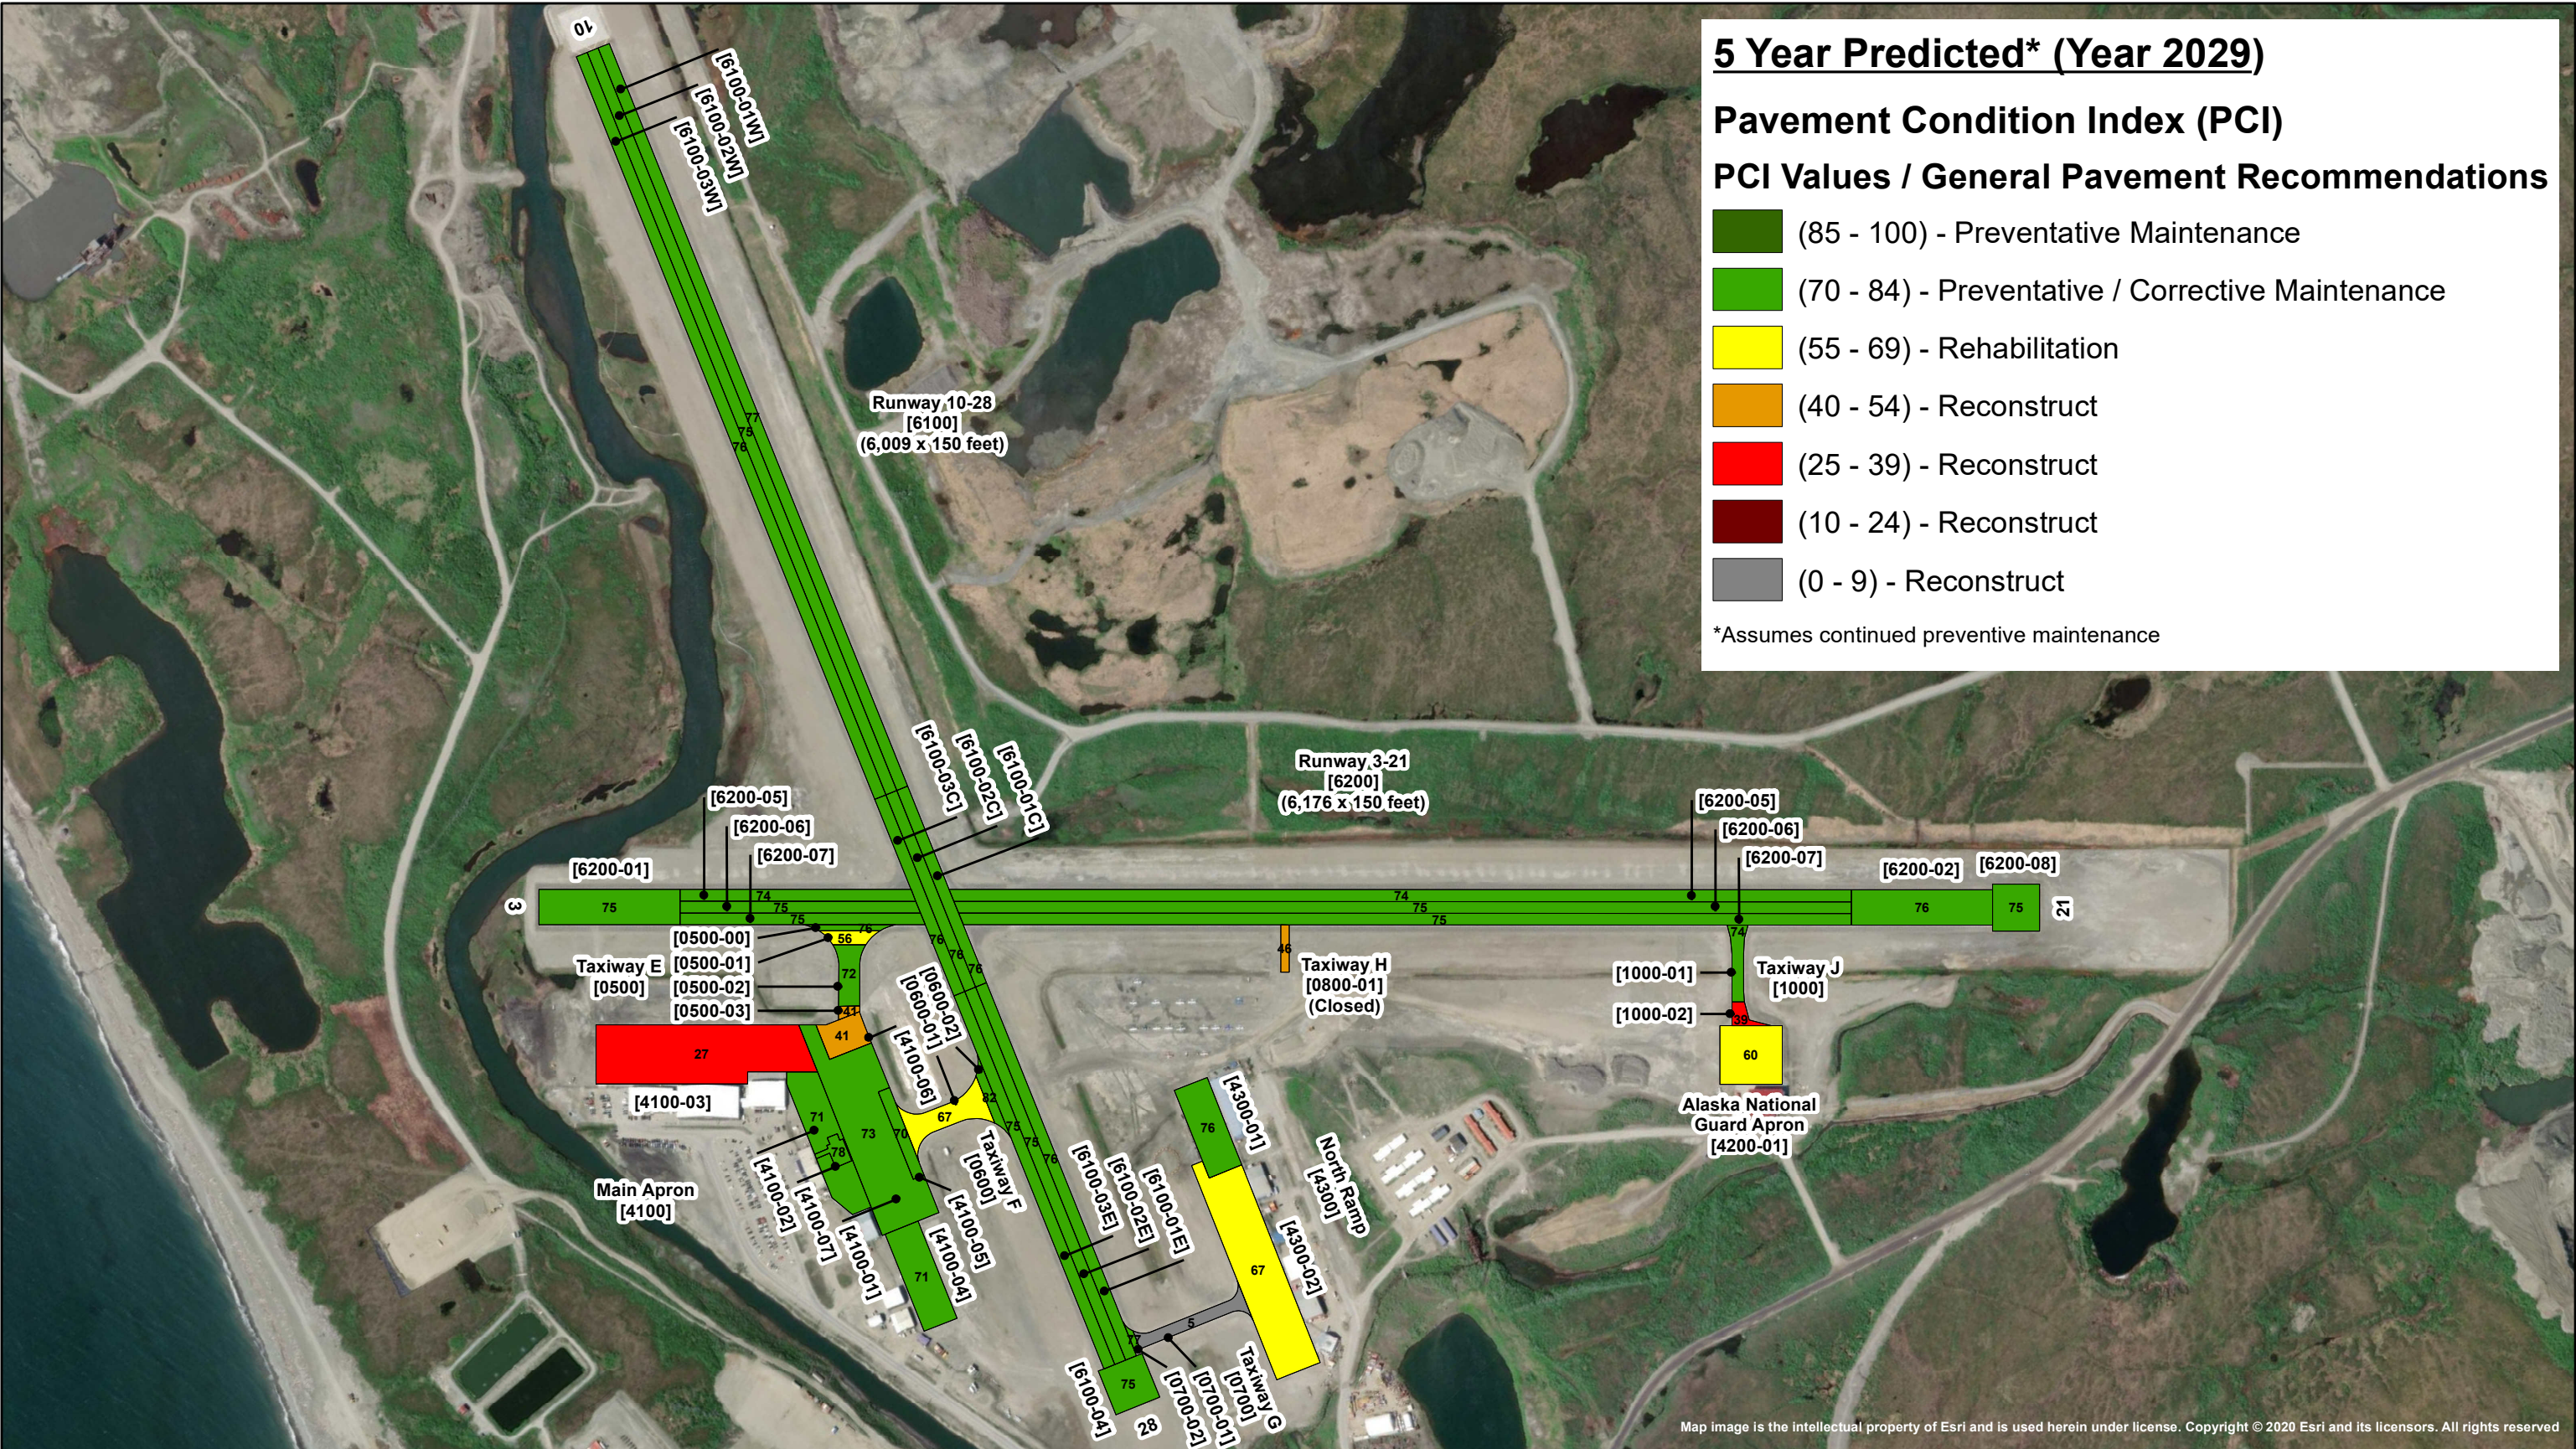
5 Year Predicted* (Year 2029)

Pavement Condition Index (PCI)

(85 - 100) - Preventative Maintenance
	(70 - 84) - Preventative / Corrective Maintenance
	(55 - 69) - Rehabilitation
	(40 - 54) - Reconstruct
	(25 - 39) - Reconstruct
	(10 - 24) - Reconstruct
	(0 - 9) - Reconstruct

*Assumes continued preventive maintenance

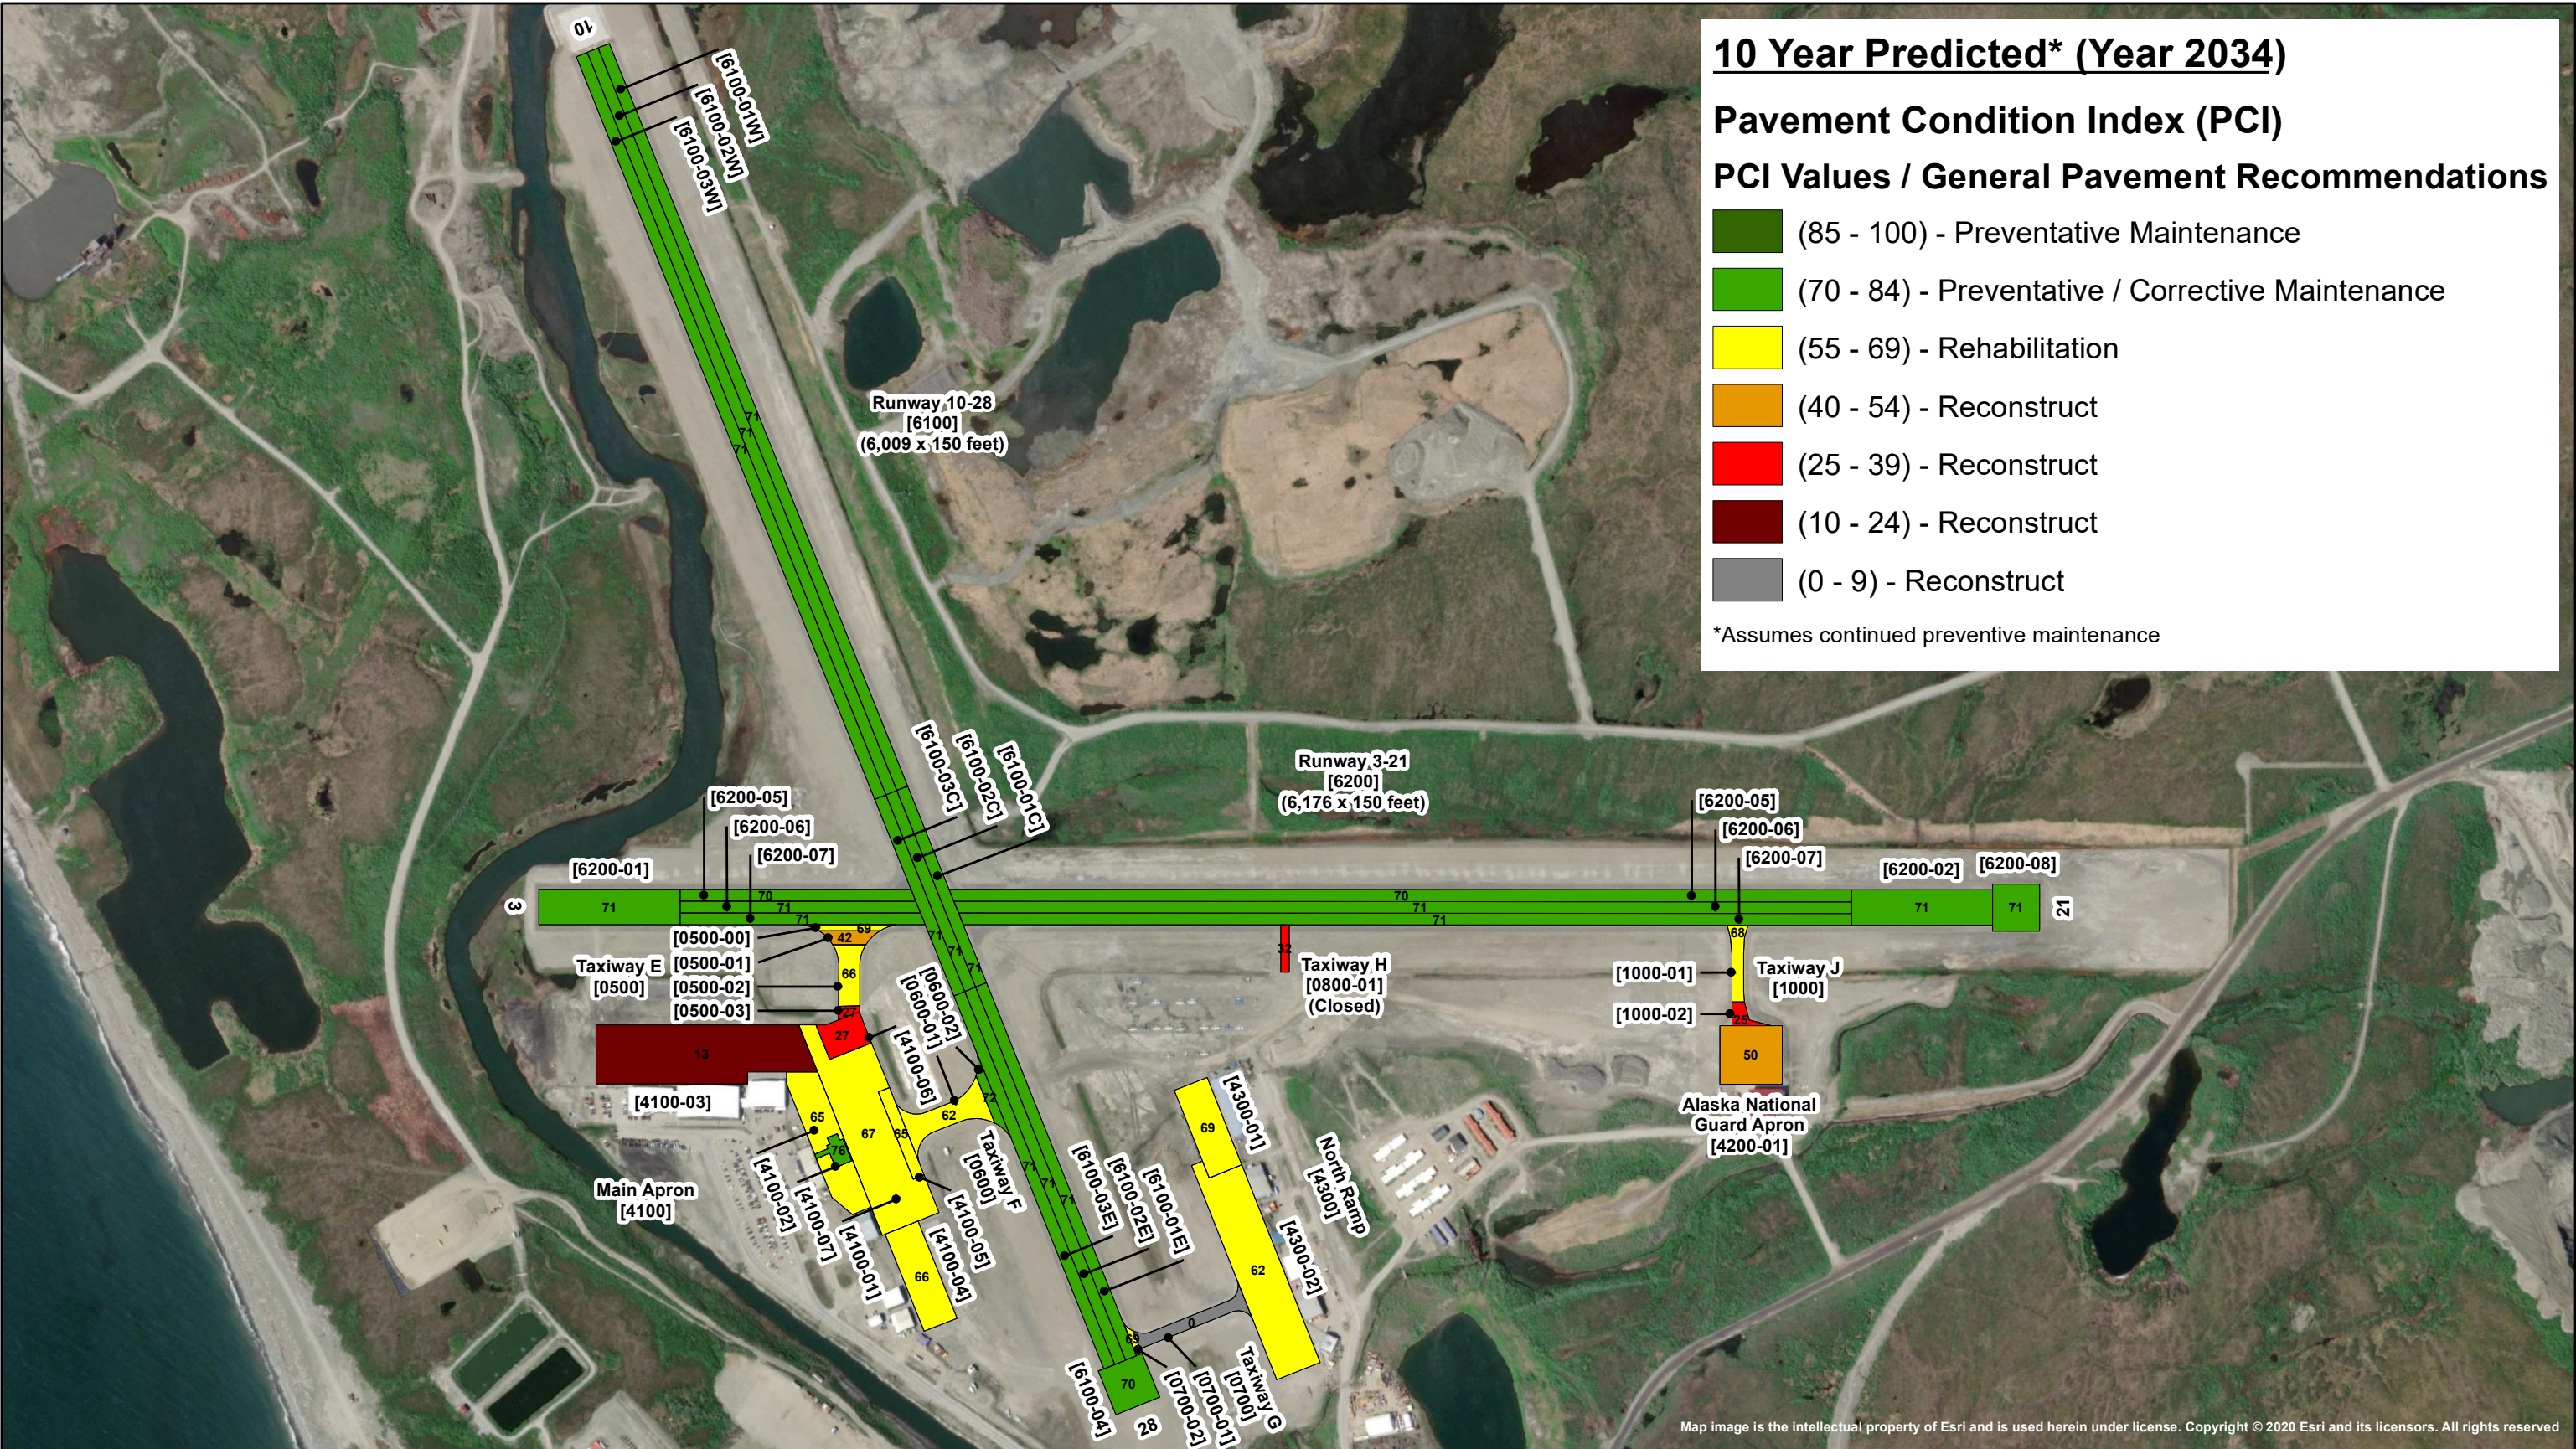
**10 Year Predicted
Pavement Condition Index (PCI)**

Target PCI Range for Runways: 70 to 100
Target PCI Range for Taxiways and Aprons: 60 to 100

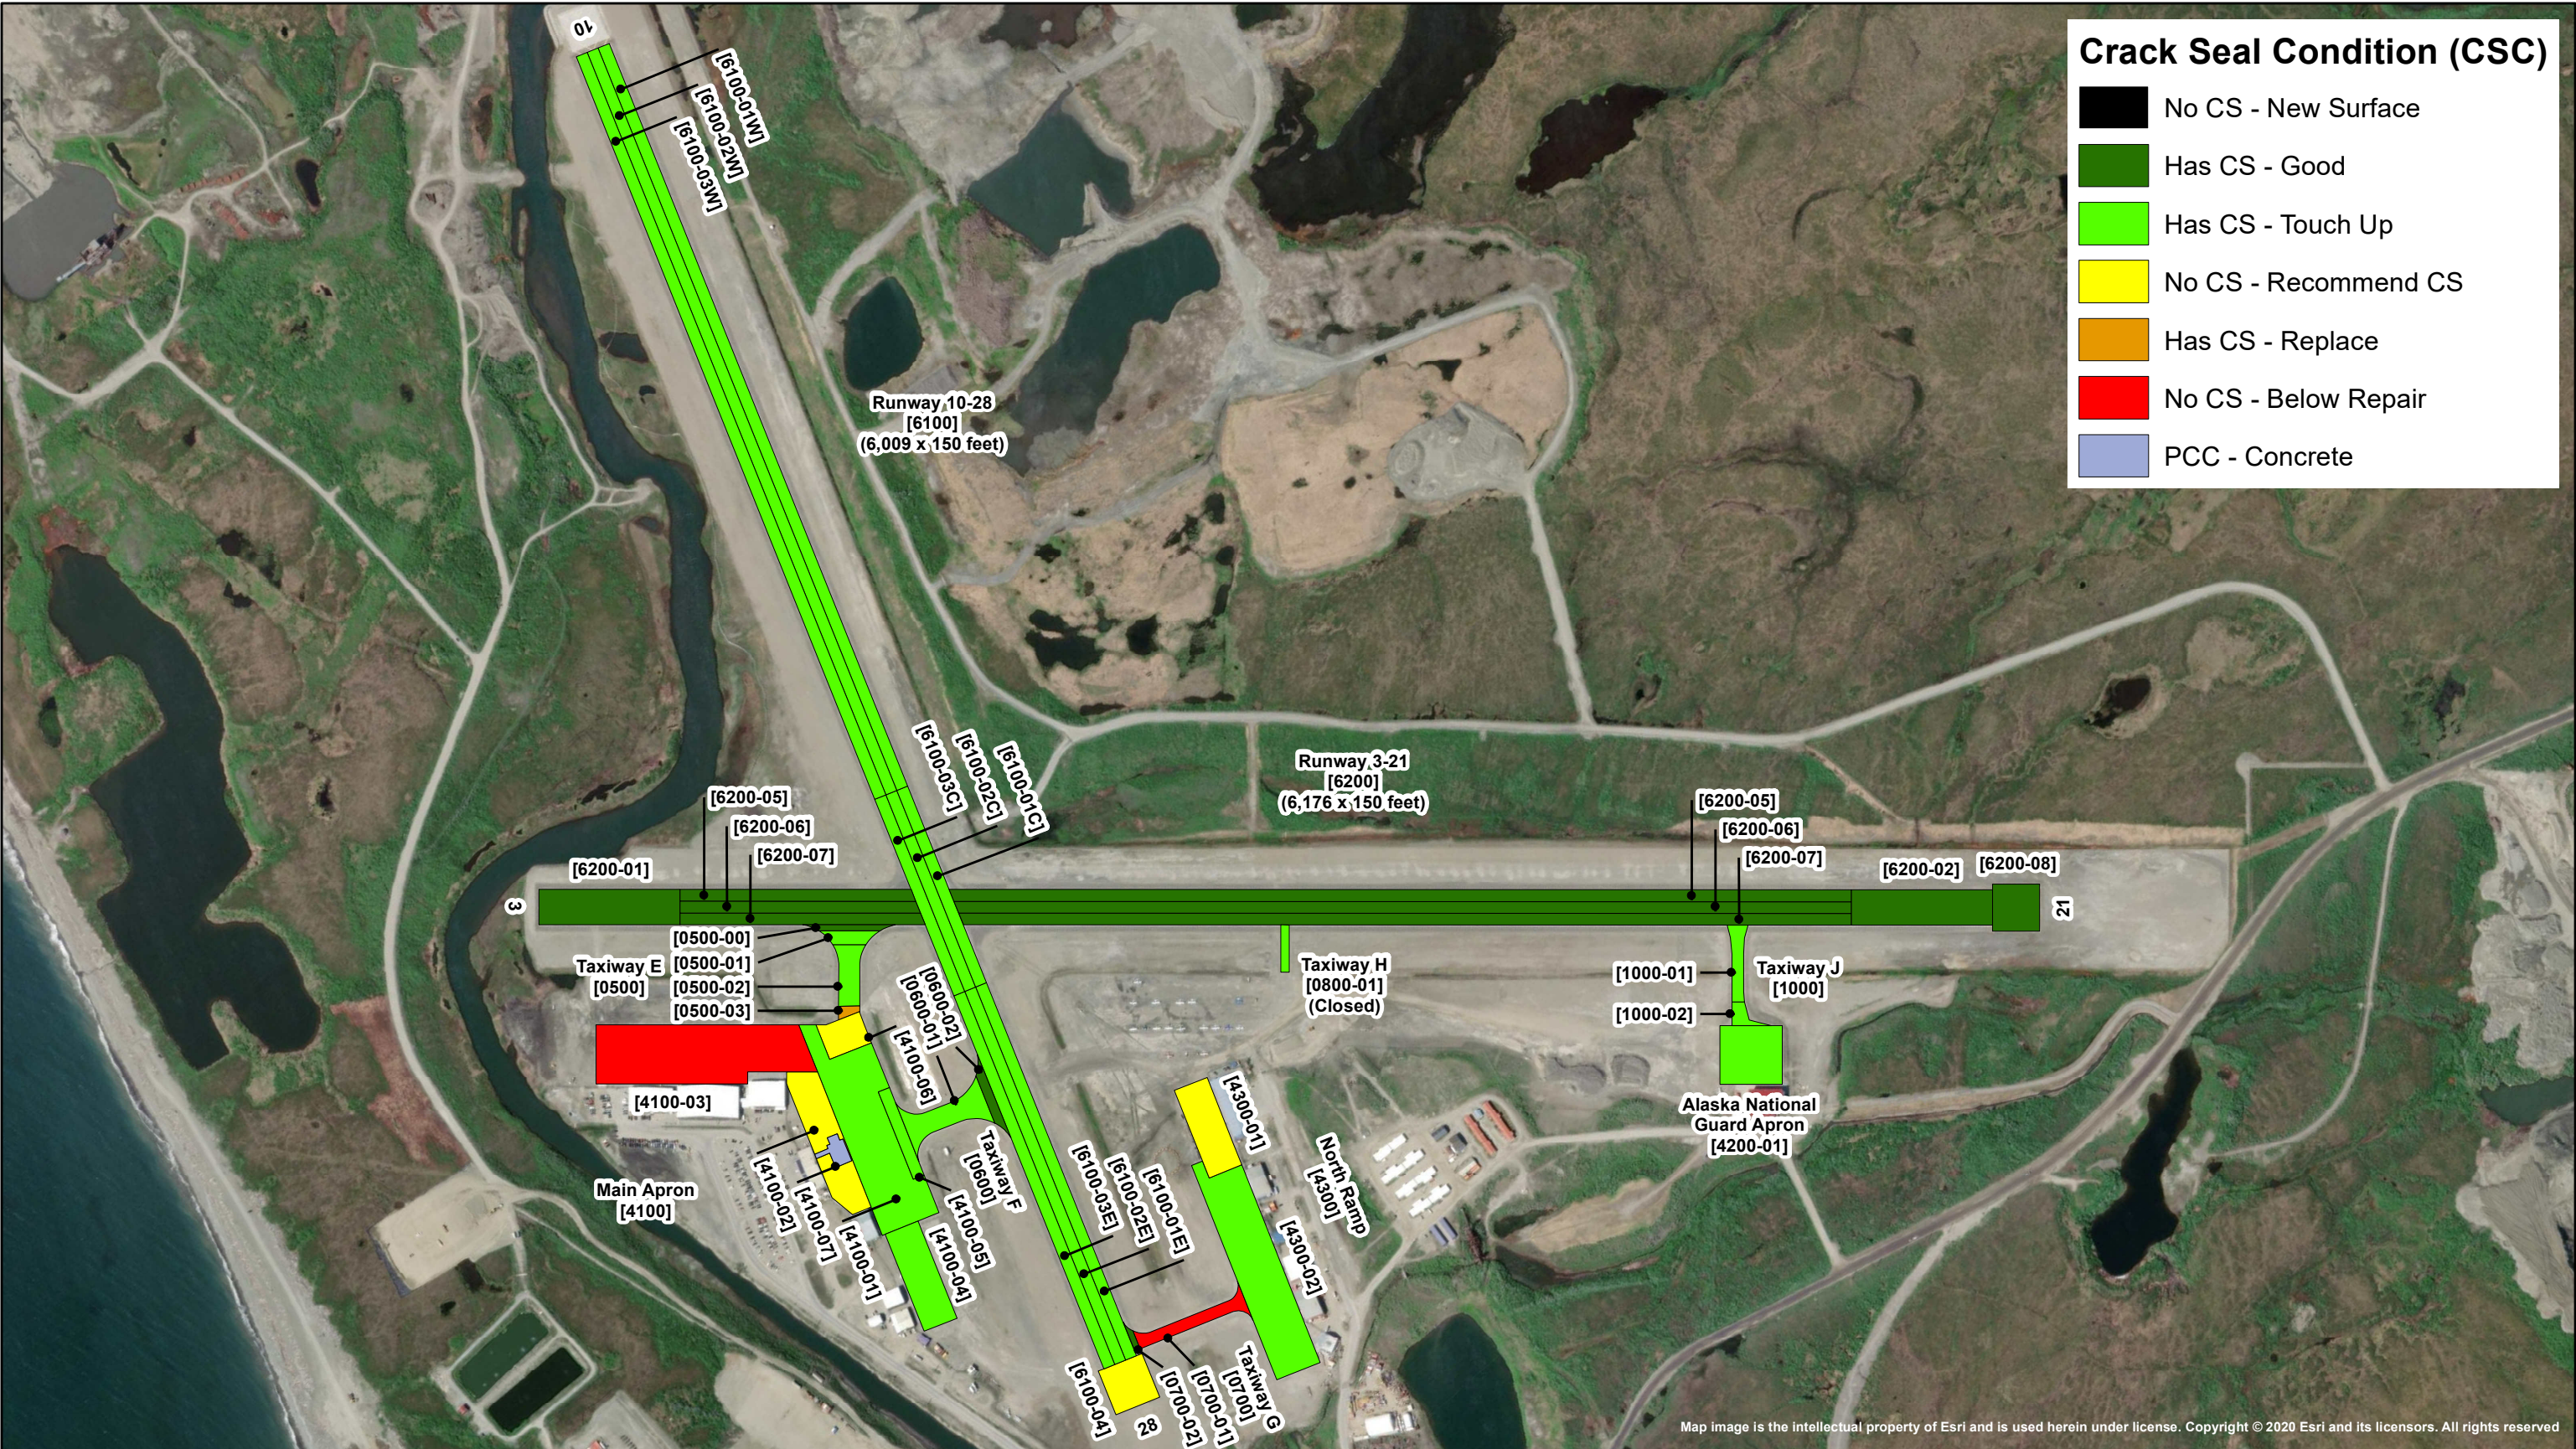
Pavement Crack Seal Condition (CSC)
