# Alaska DOT&PF

## Pavement Inspection Report Point Hope Airport

Airport Name	IATA	ICAO	Latitude	Longitude	Elevation (ft)
Point Hope	PHO	PAPO	68° 20' 55.58" N	166° 47' 57.34" W	18.3

Point of Contact	Phone	Email	Date Inspected	Date Published
Mr. Andrew Pavey, Pavement Management Engineer	(907) 269 6213	andrew.pavey@alaska.gov	July 2024	December 2024

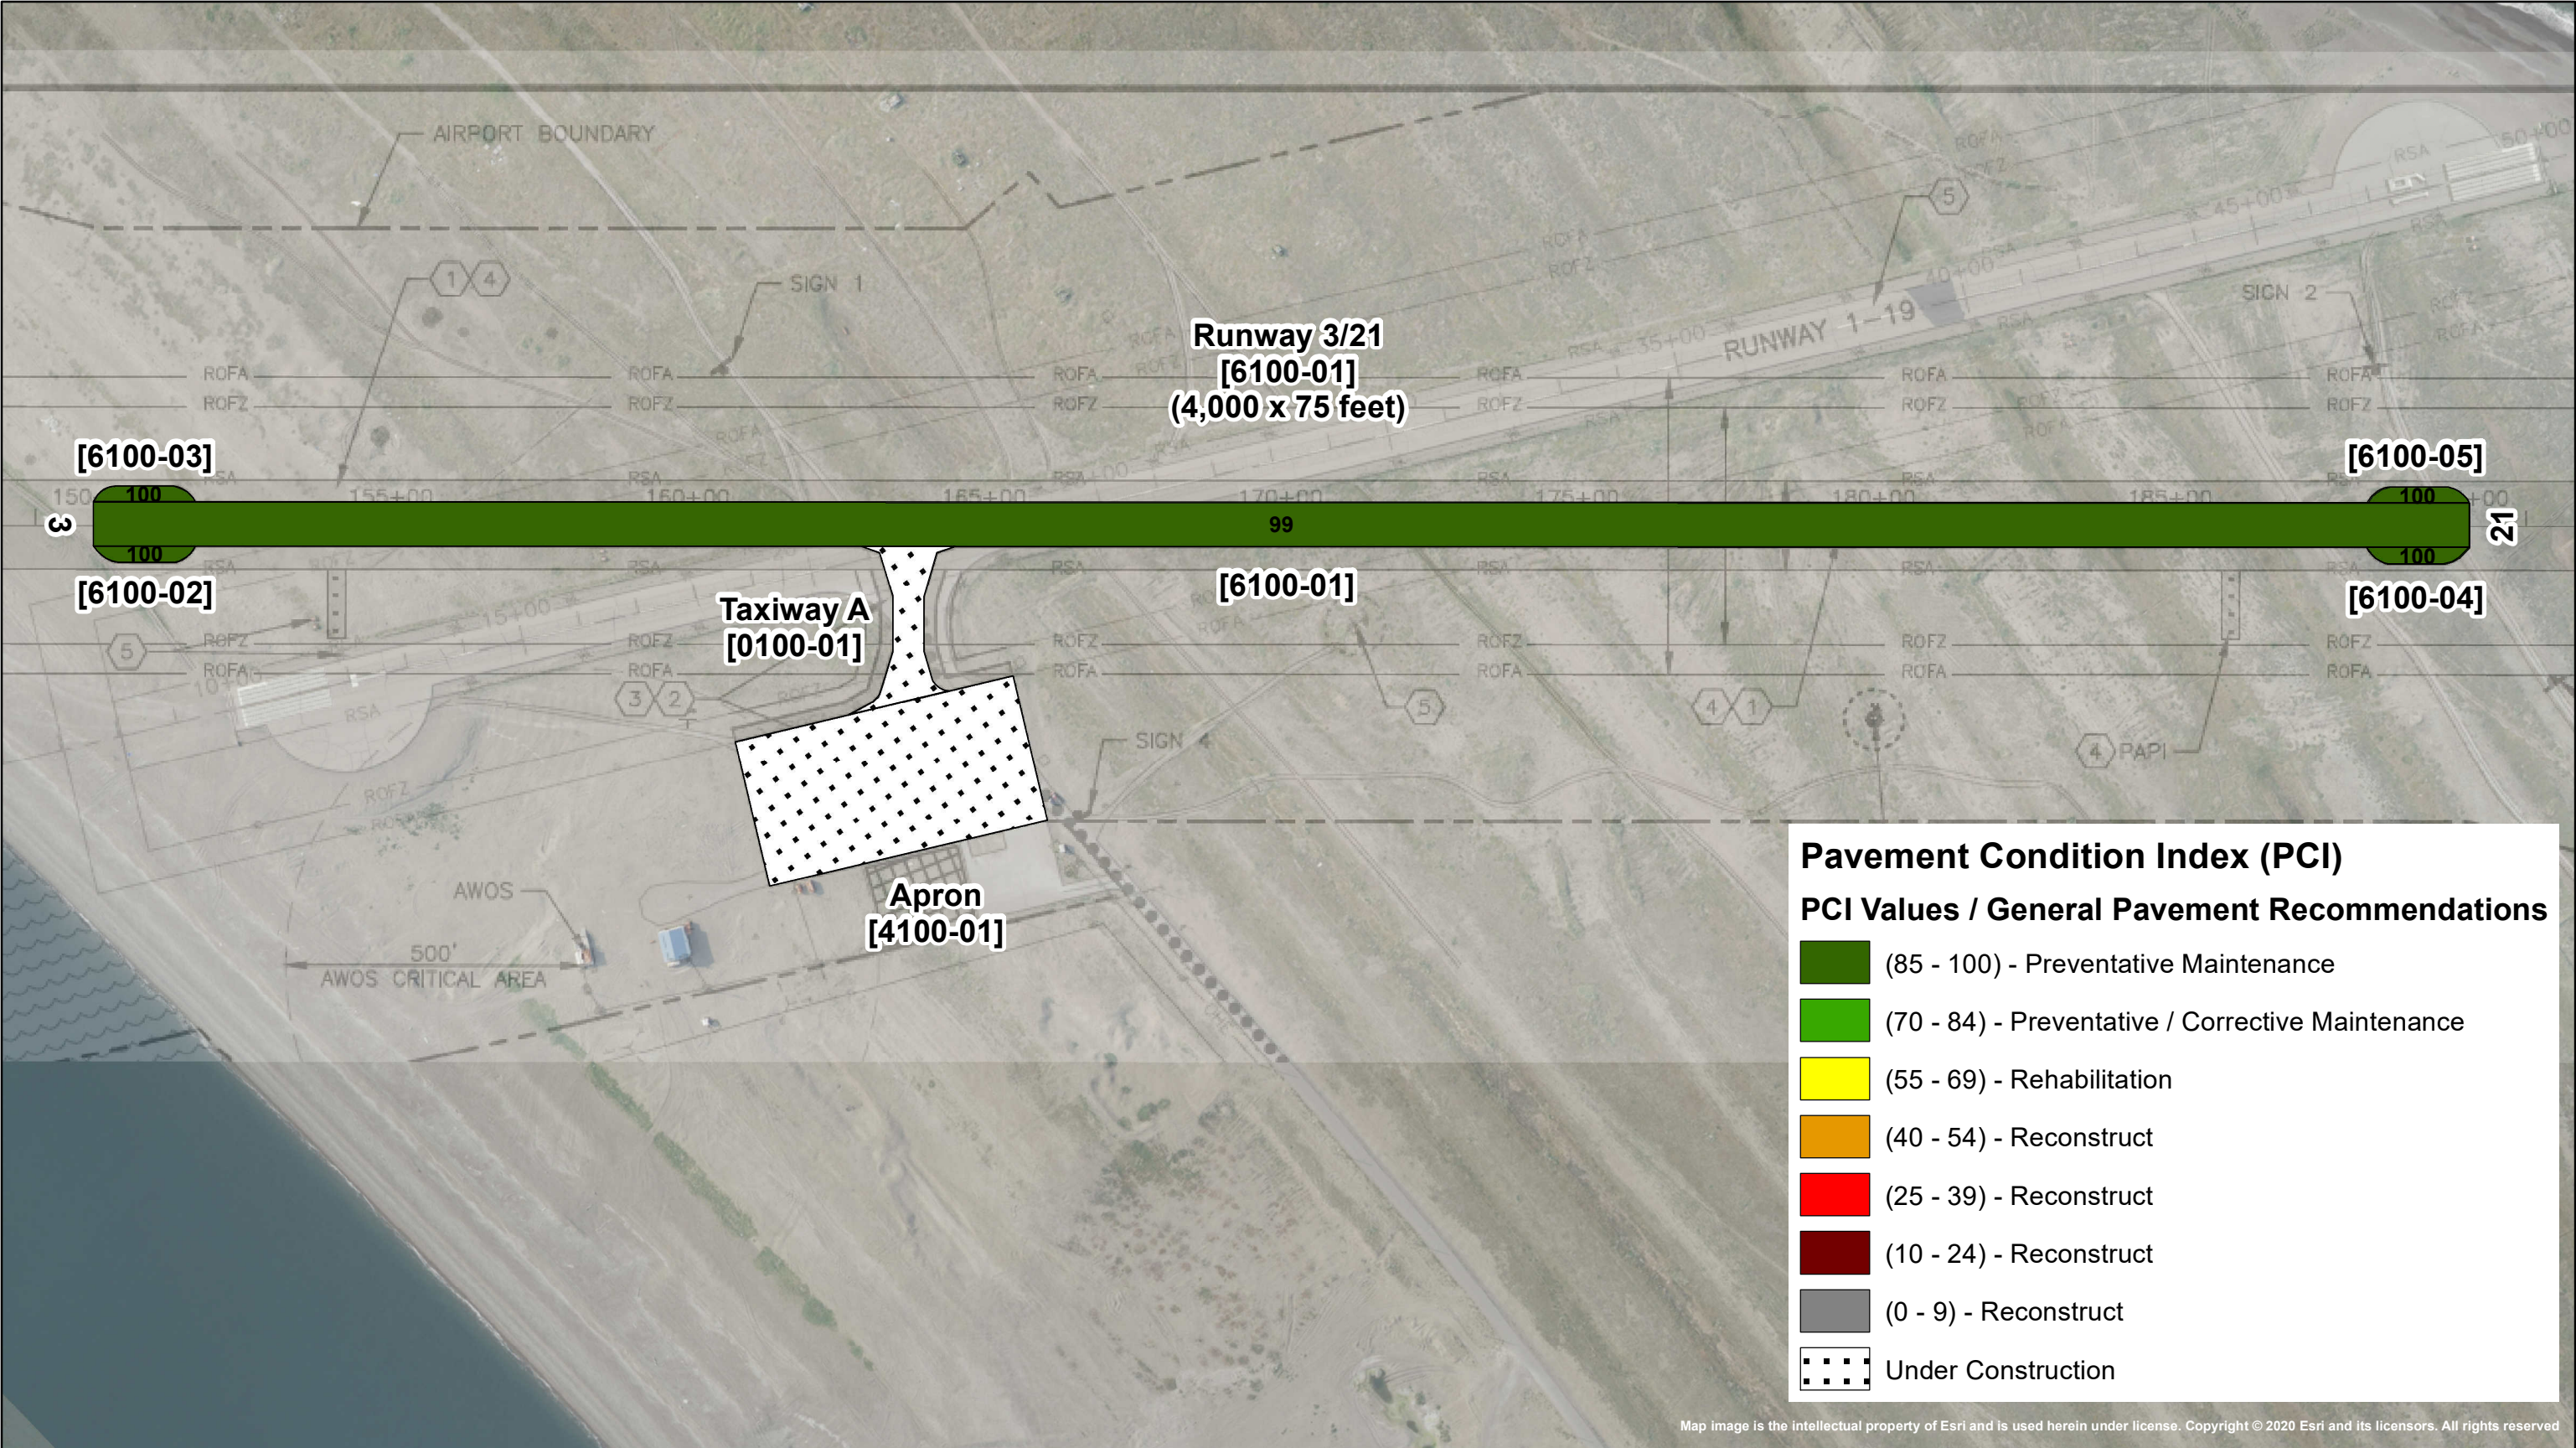
**Map 1 of 6**

**Pavement Condition Index (PCI)**

Target PCI Range for Runways: 70 to 100  
Target PCI Range for Taxiways and Aprons: 60 to 100

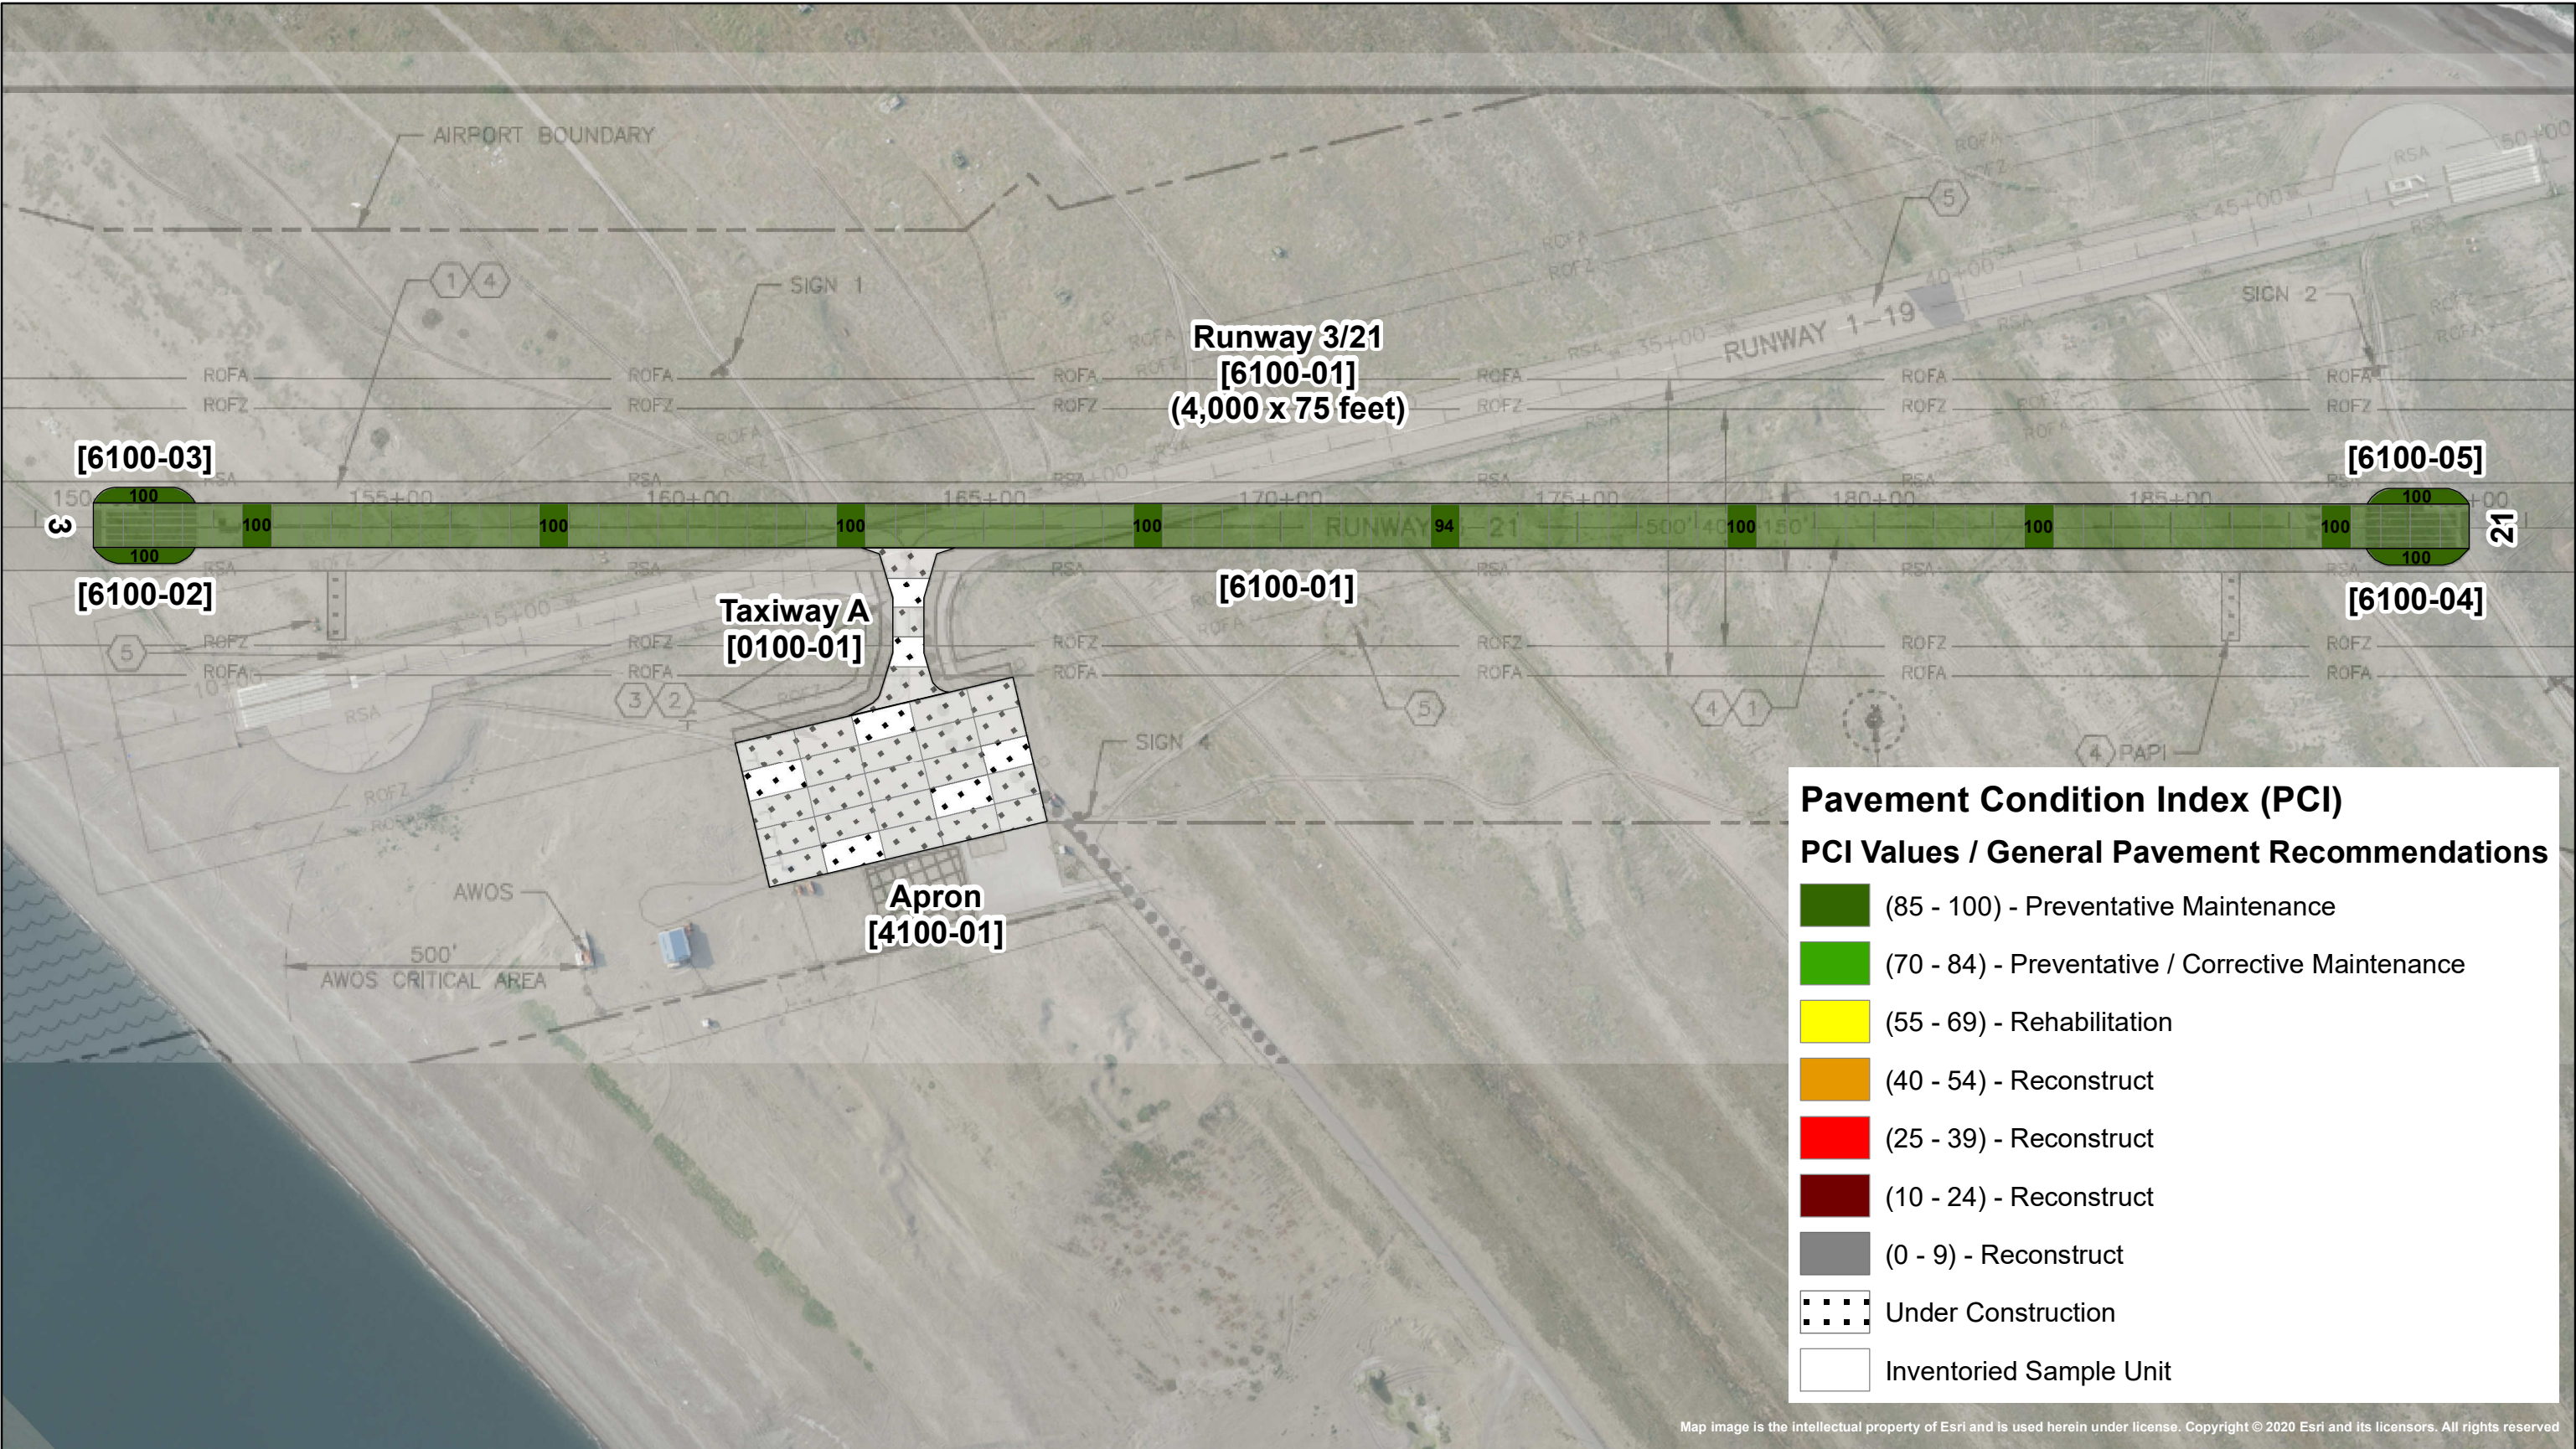
**Sample Unit  
Pavement Condition Index (PCI)**

Target PCI Range for Runways: 70 to 100  
Target PCI Range for Taxiways and Aprons: 60 to 100

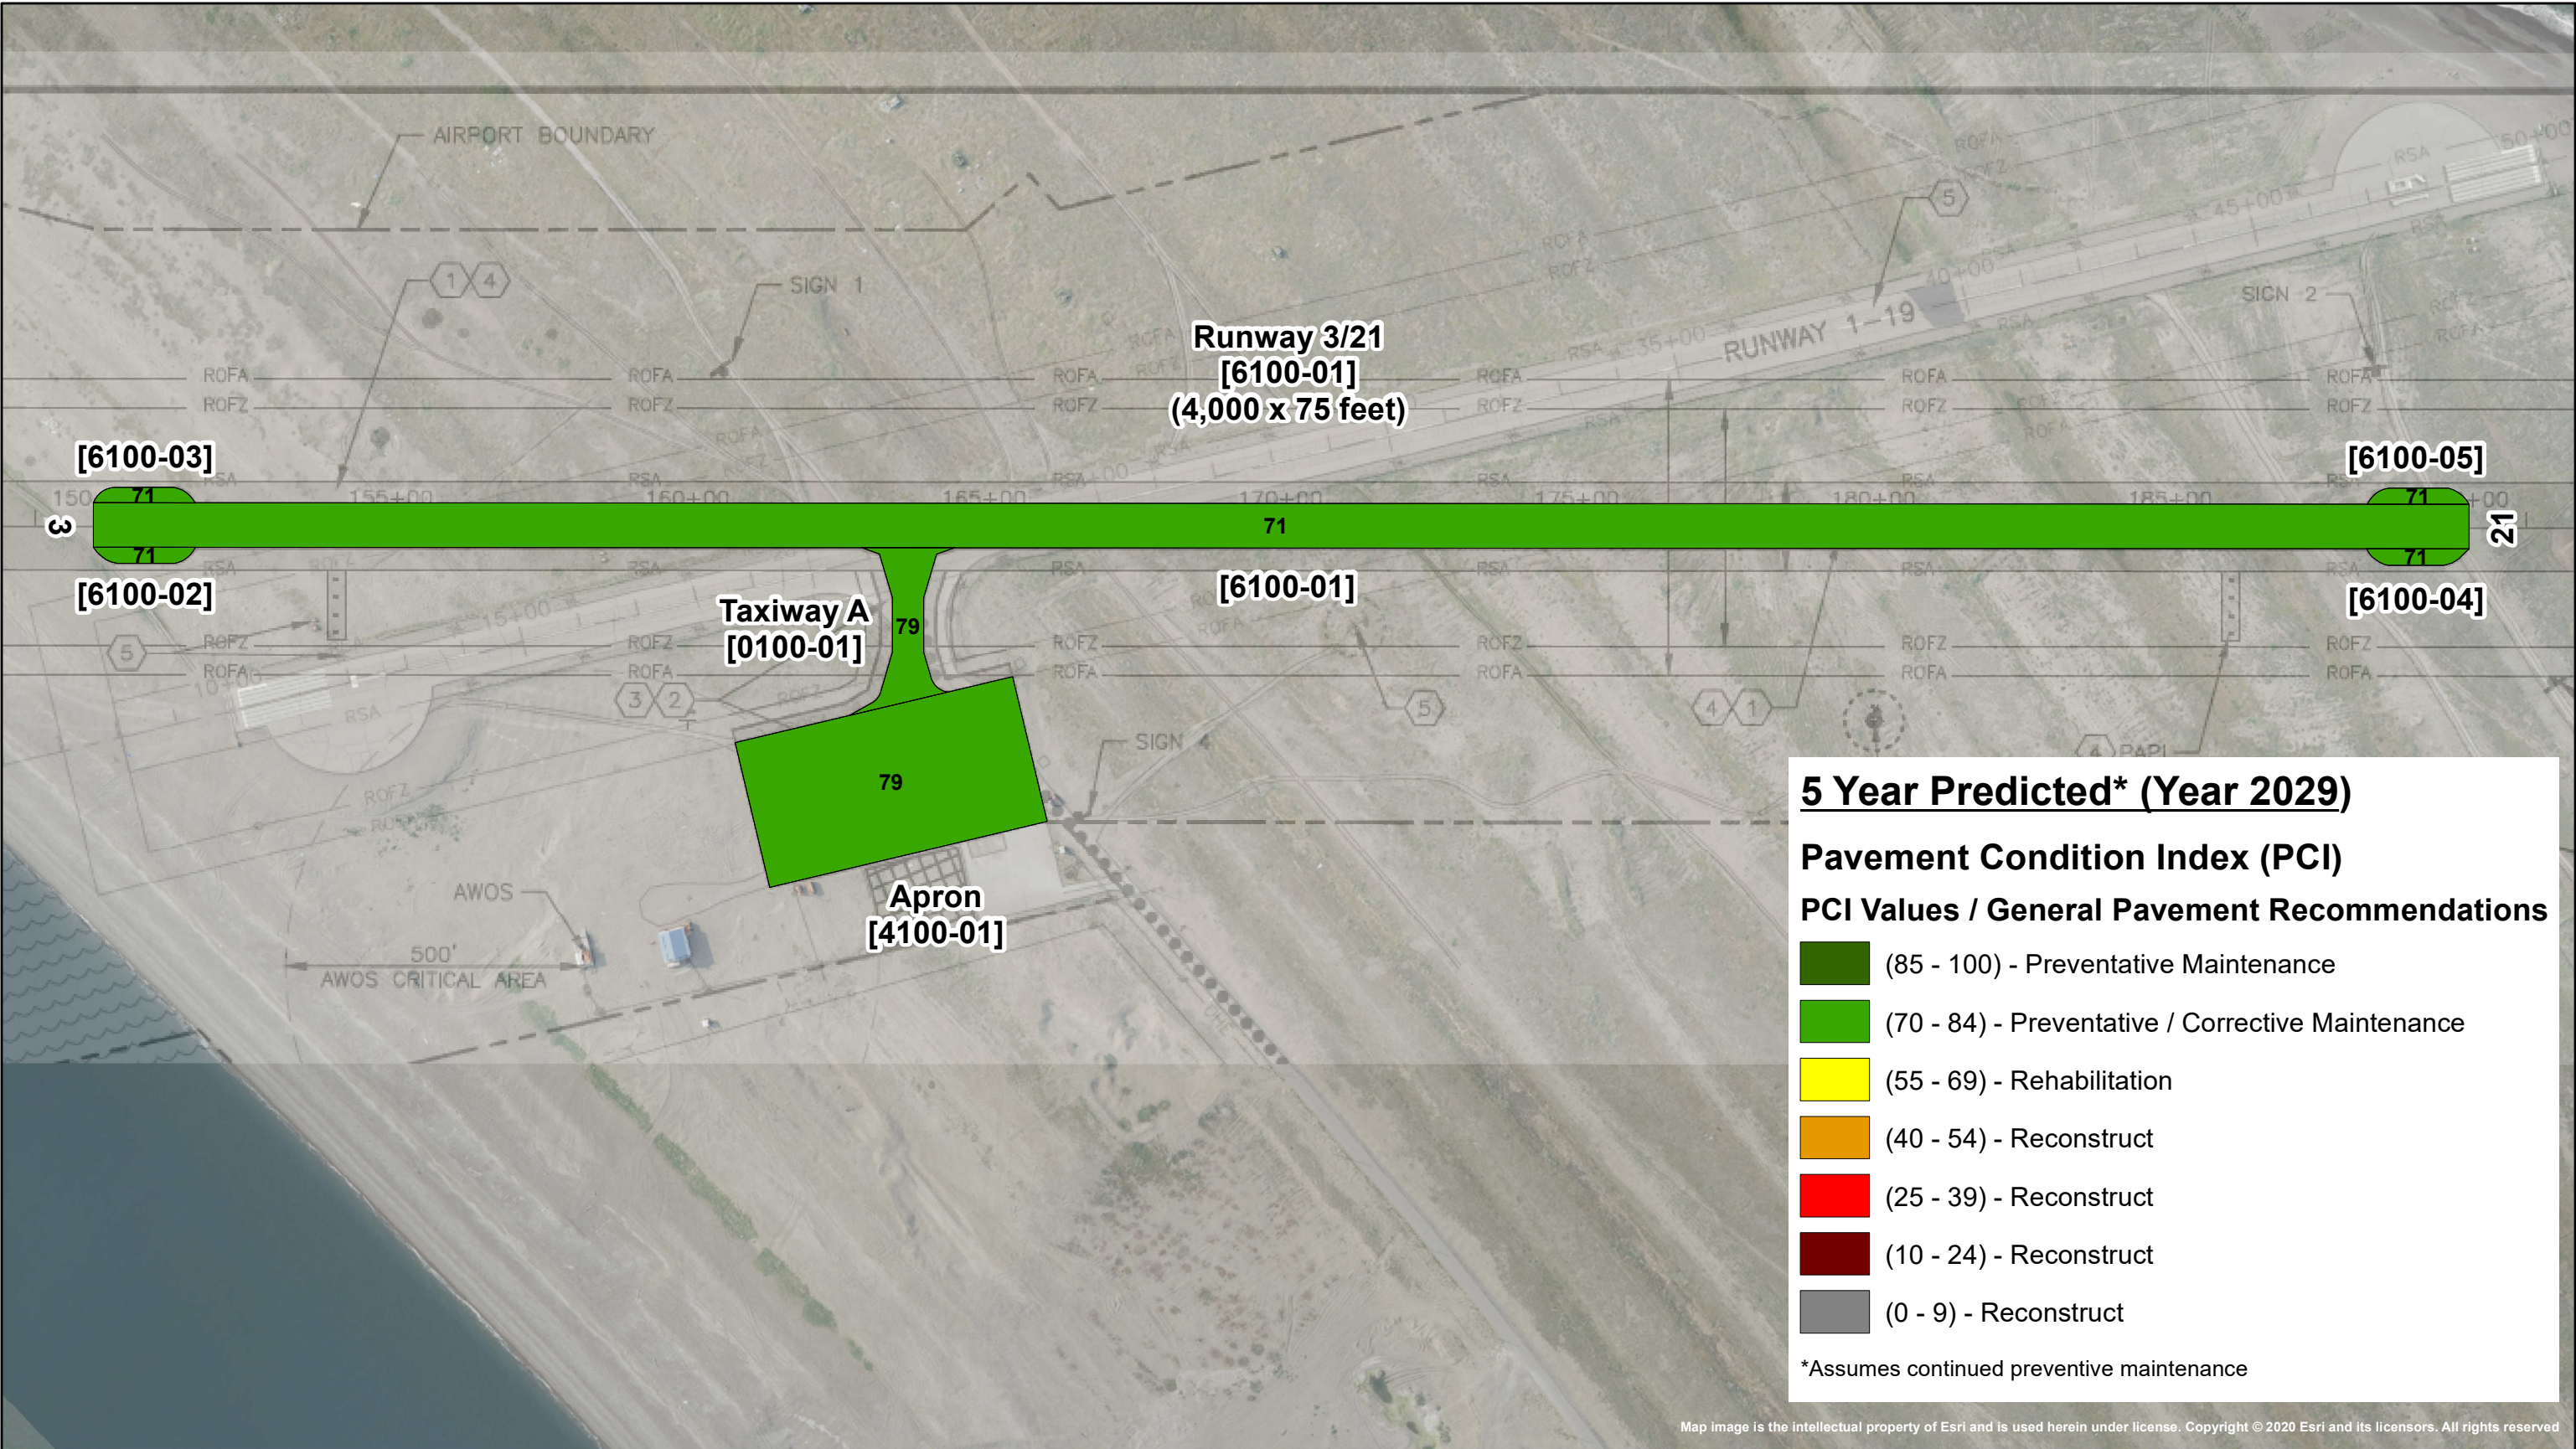
Map 3 of 6

## 5 Year Predicted Pavement Condition Index (PCI)

Target PCI Range for Runways: 70 to 100  
Target PCI Range for Taxiways and Aprons: 60 to 100

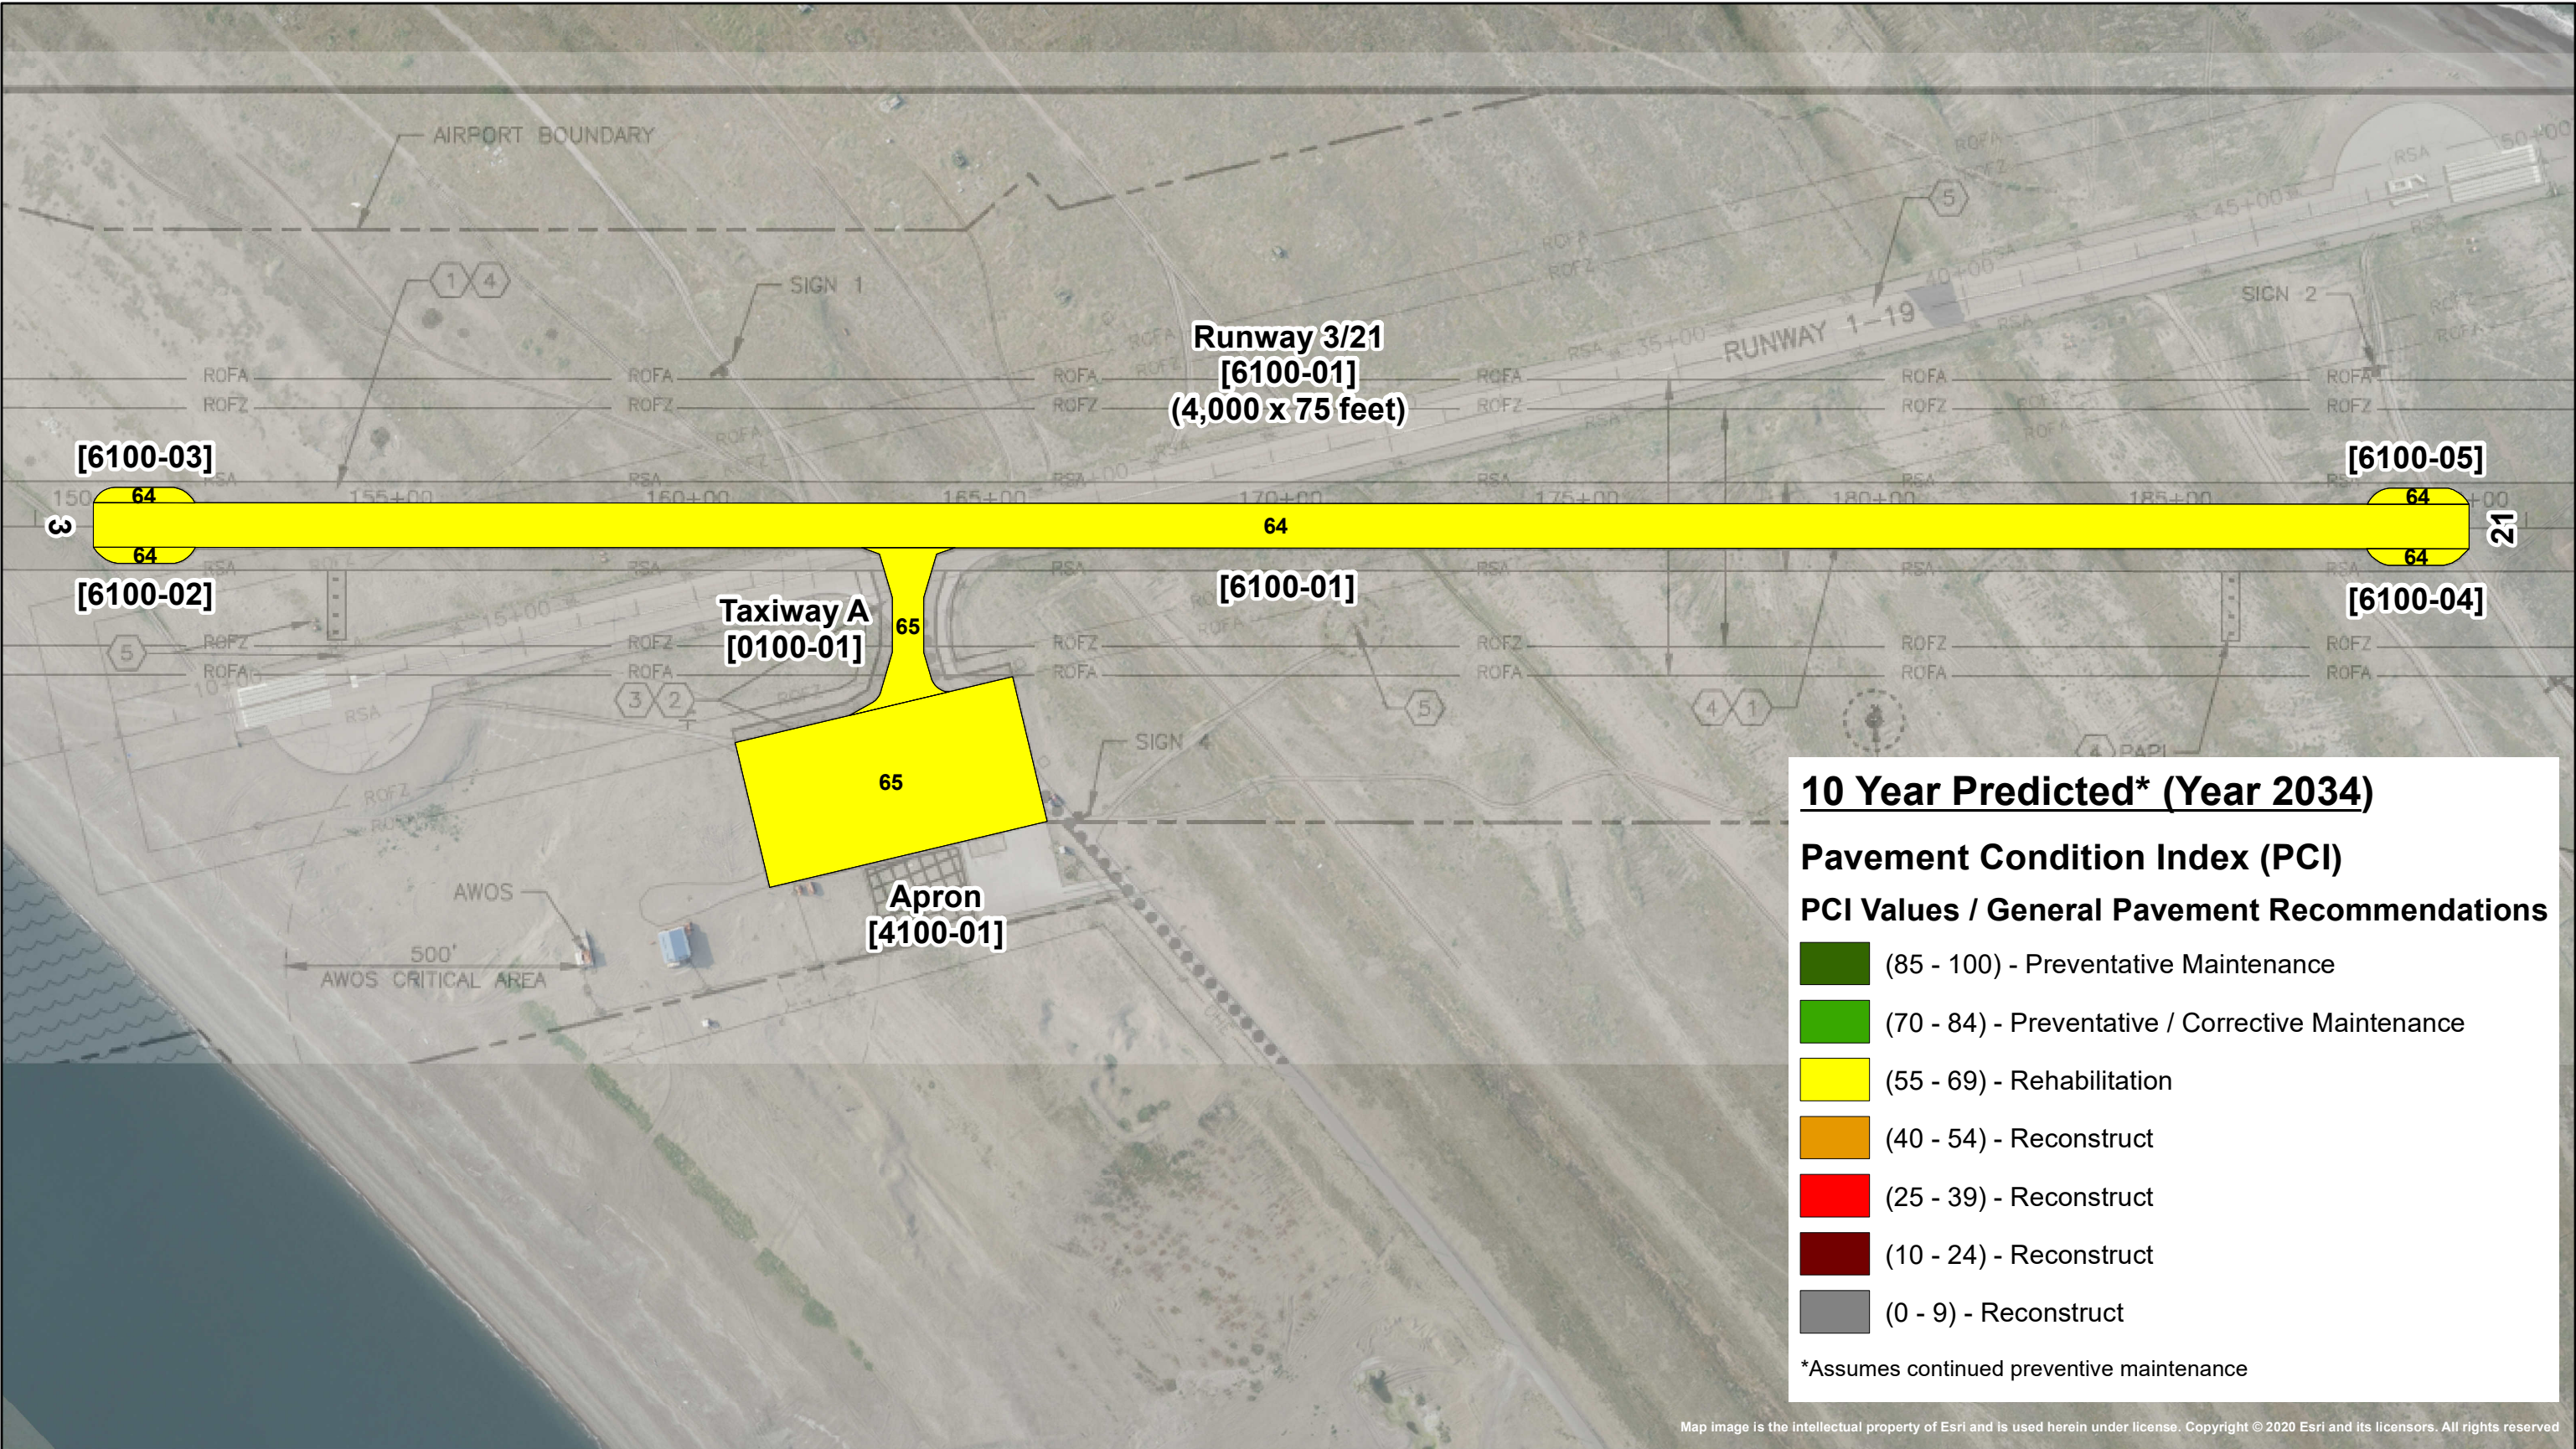
**10 Year Predicted\* (Year 2034)**

**Pavement Condition Index (PCI)**

(85 - 100) - Preventative Maintenance

(70 - 84) - Preventative / Corrective Maintenance

(55 - 69) - Rehabilitation

(40 - 54) - Reconstruct

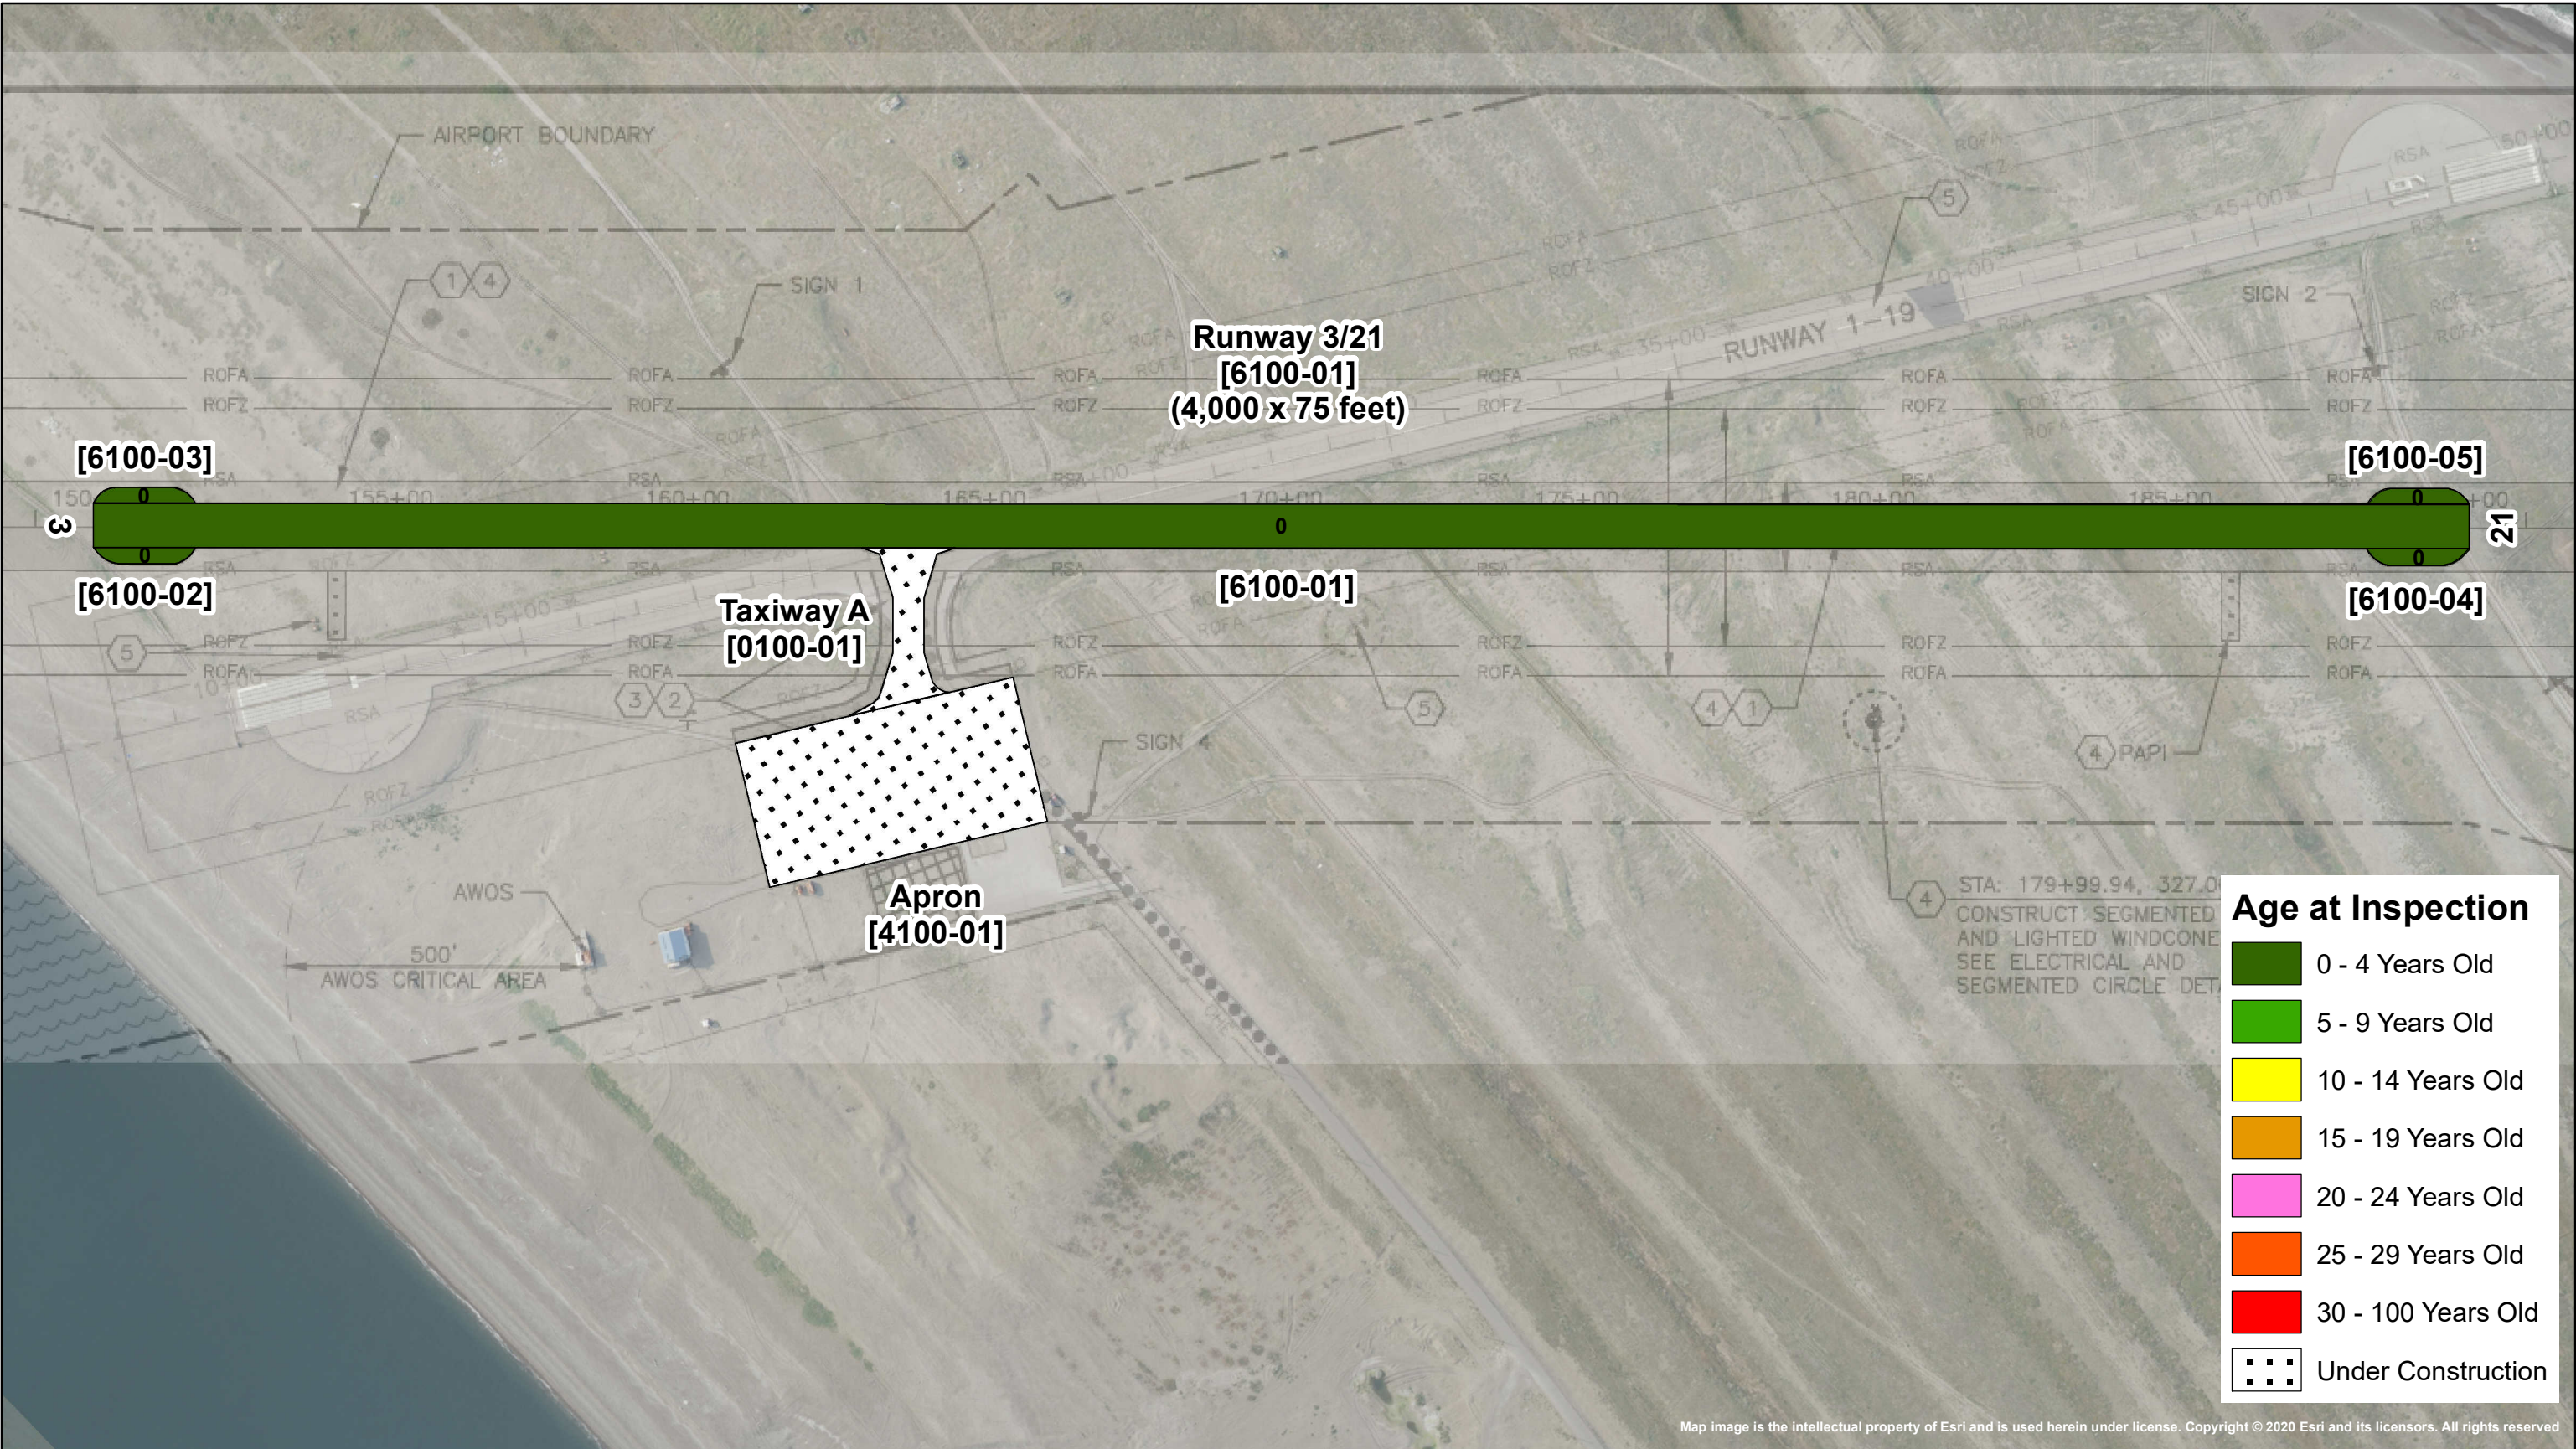
**Pavement Age at Inspection**

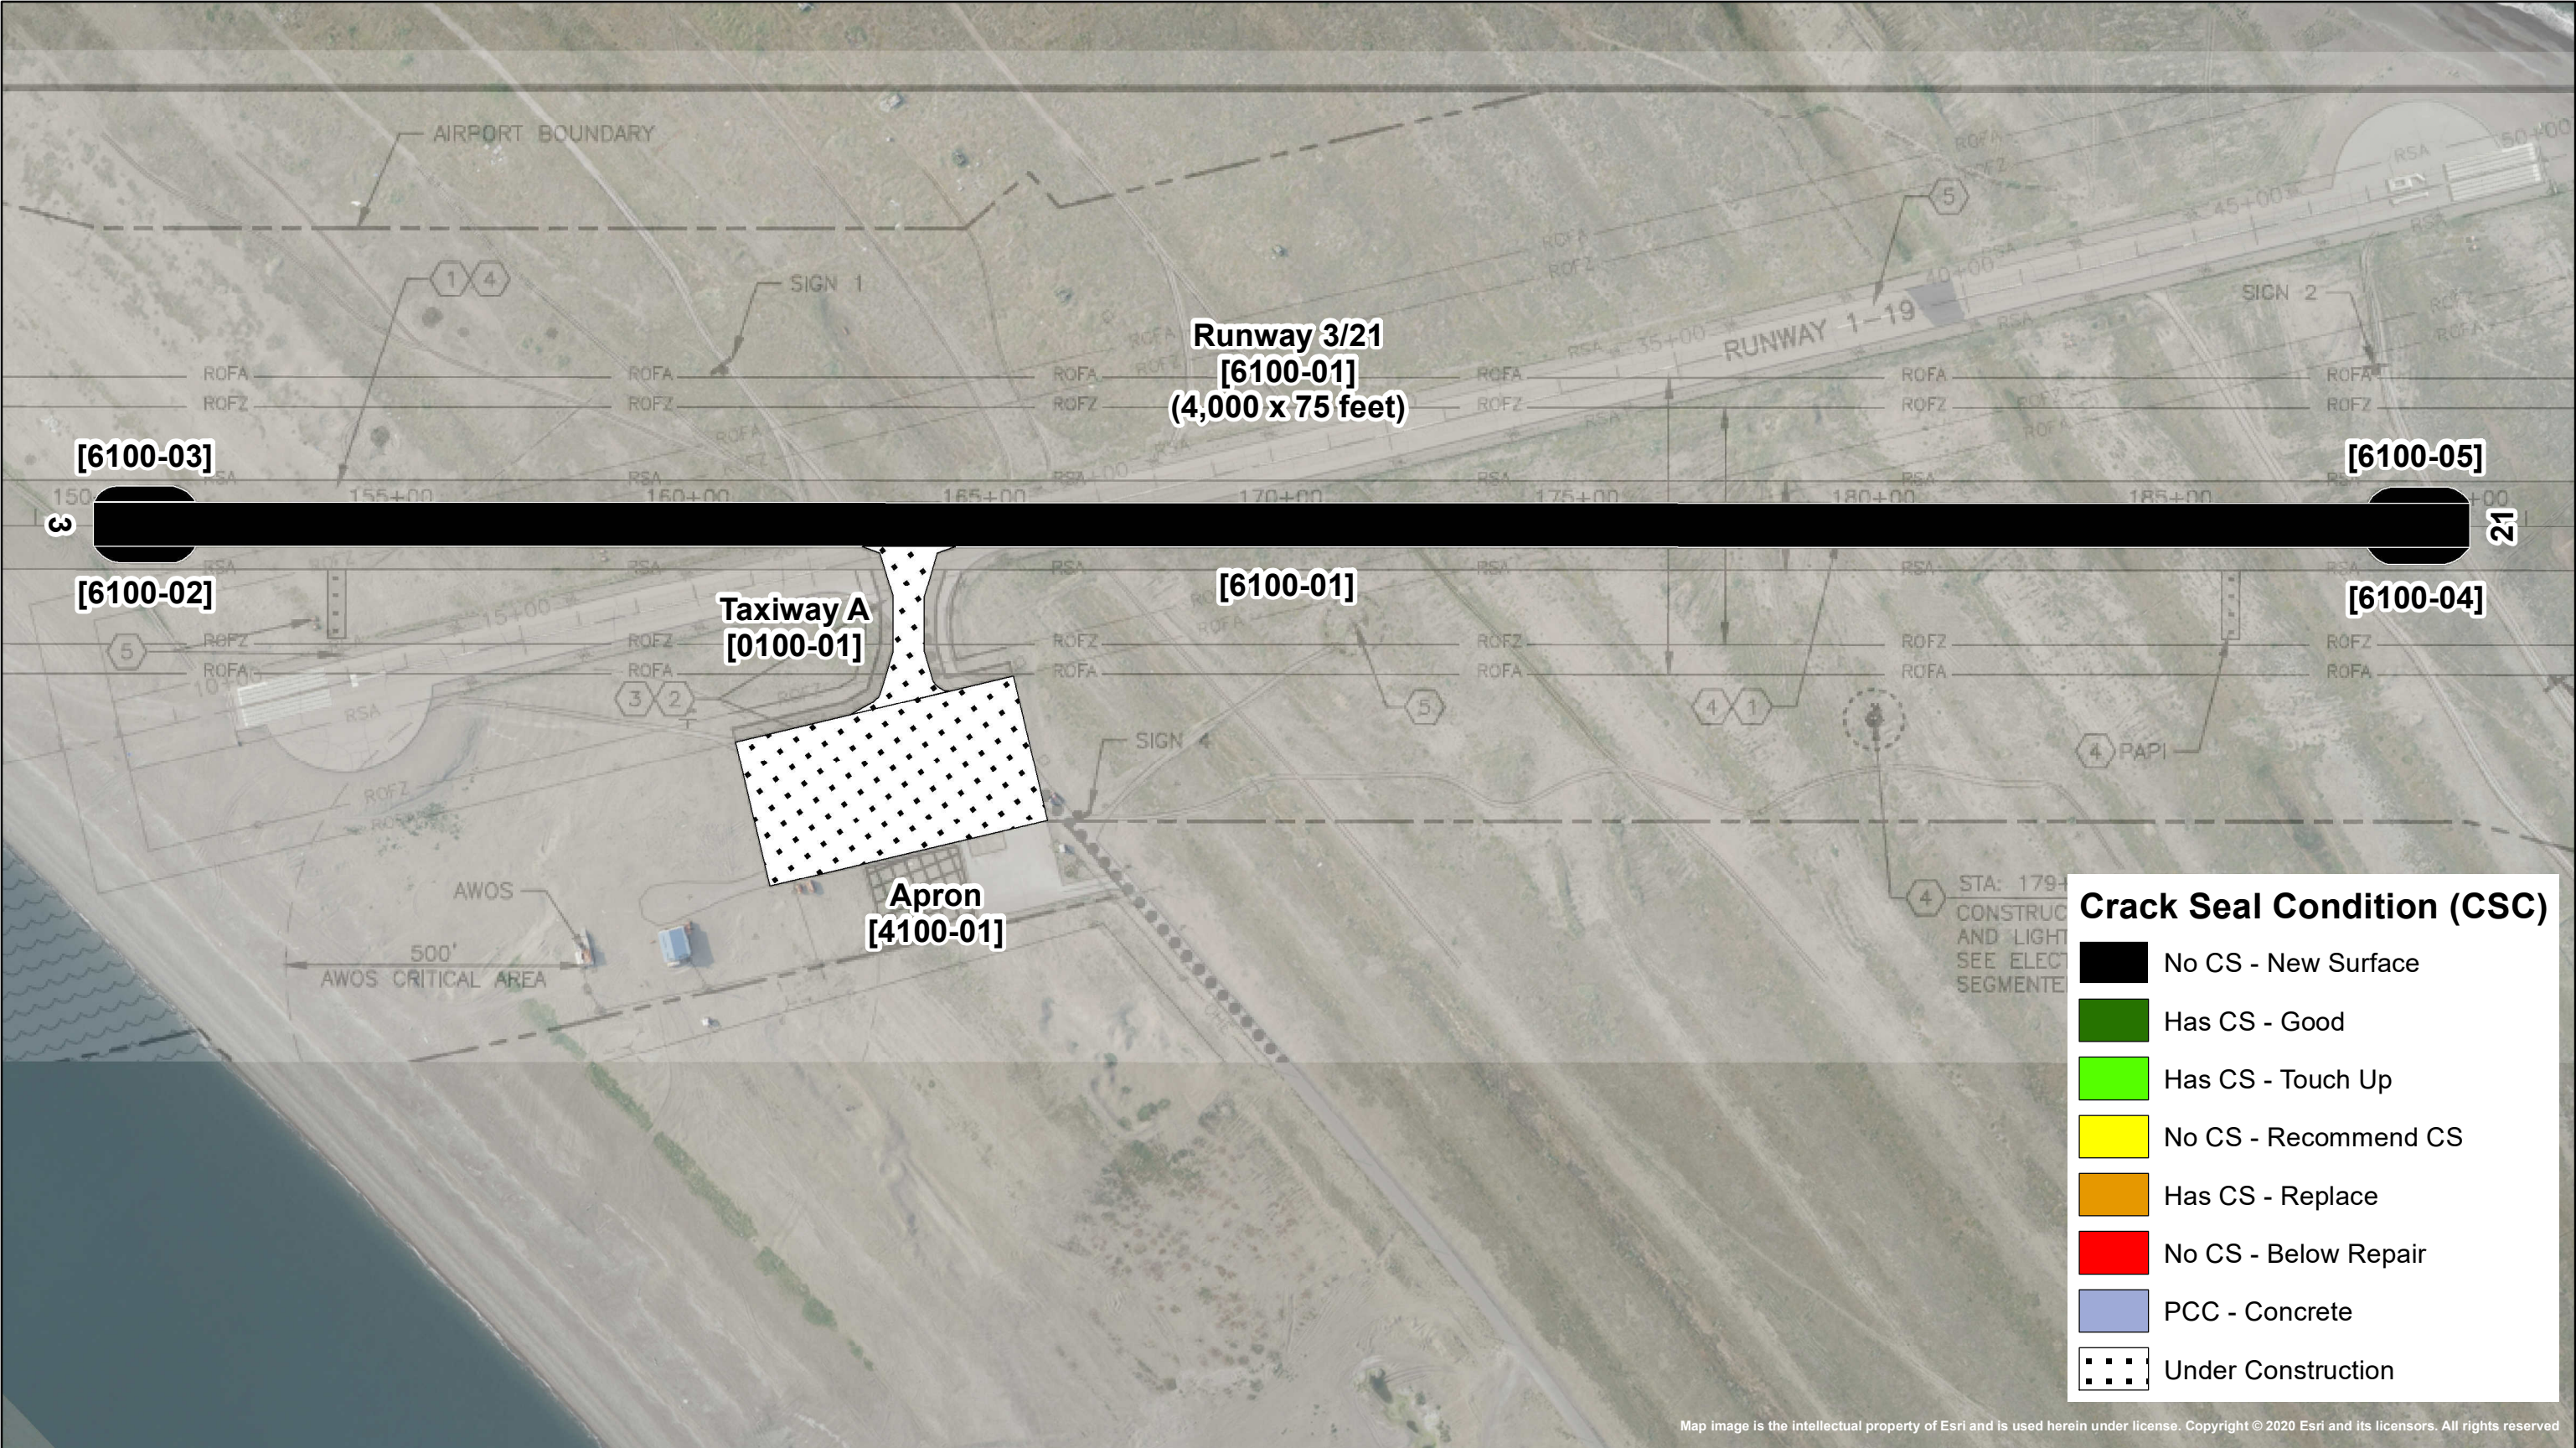
## Pavement Crack Seal Condition (CSC)
