Alaska DOT&PF

Pavement Inspection Report Saint George Airport

Airport Name	IATA	ICAO	Latitude	Longitude	Elevation (ft)
Saint George Airport	PBV	PAPB	56° 34' 38.5" N	169° 39' 49.4" W	127.9

Point of Contact	Phone	Email	Date Inspected	Date Published
Mr. Andrew Pavey, Pavement Management Engineer	(907) 269 6213	andrew.pavey@alaska.gov	May 2023	September 2023

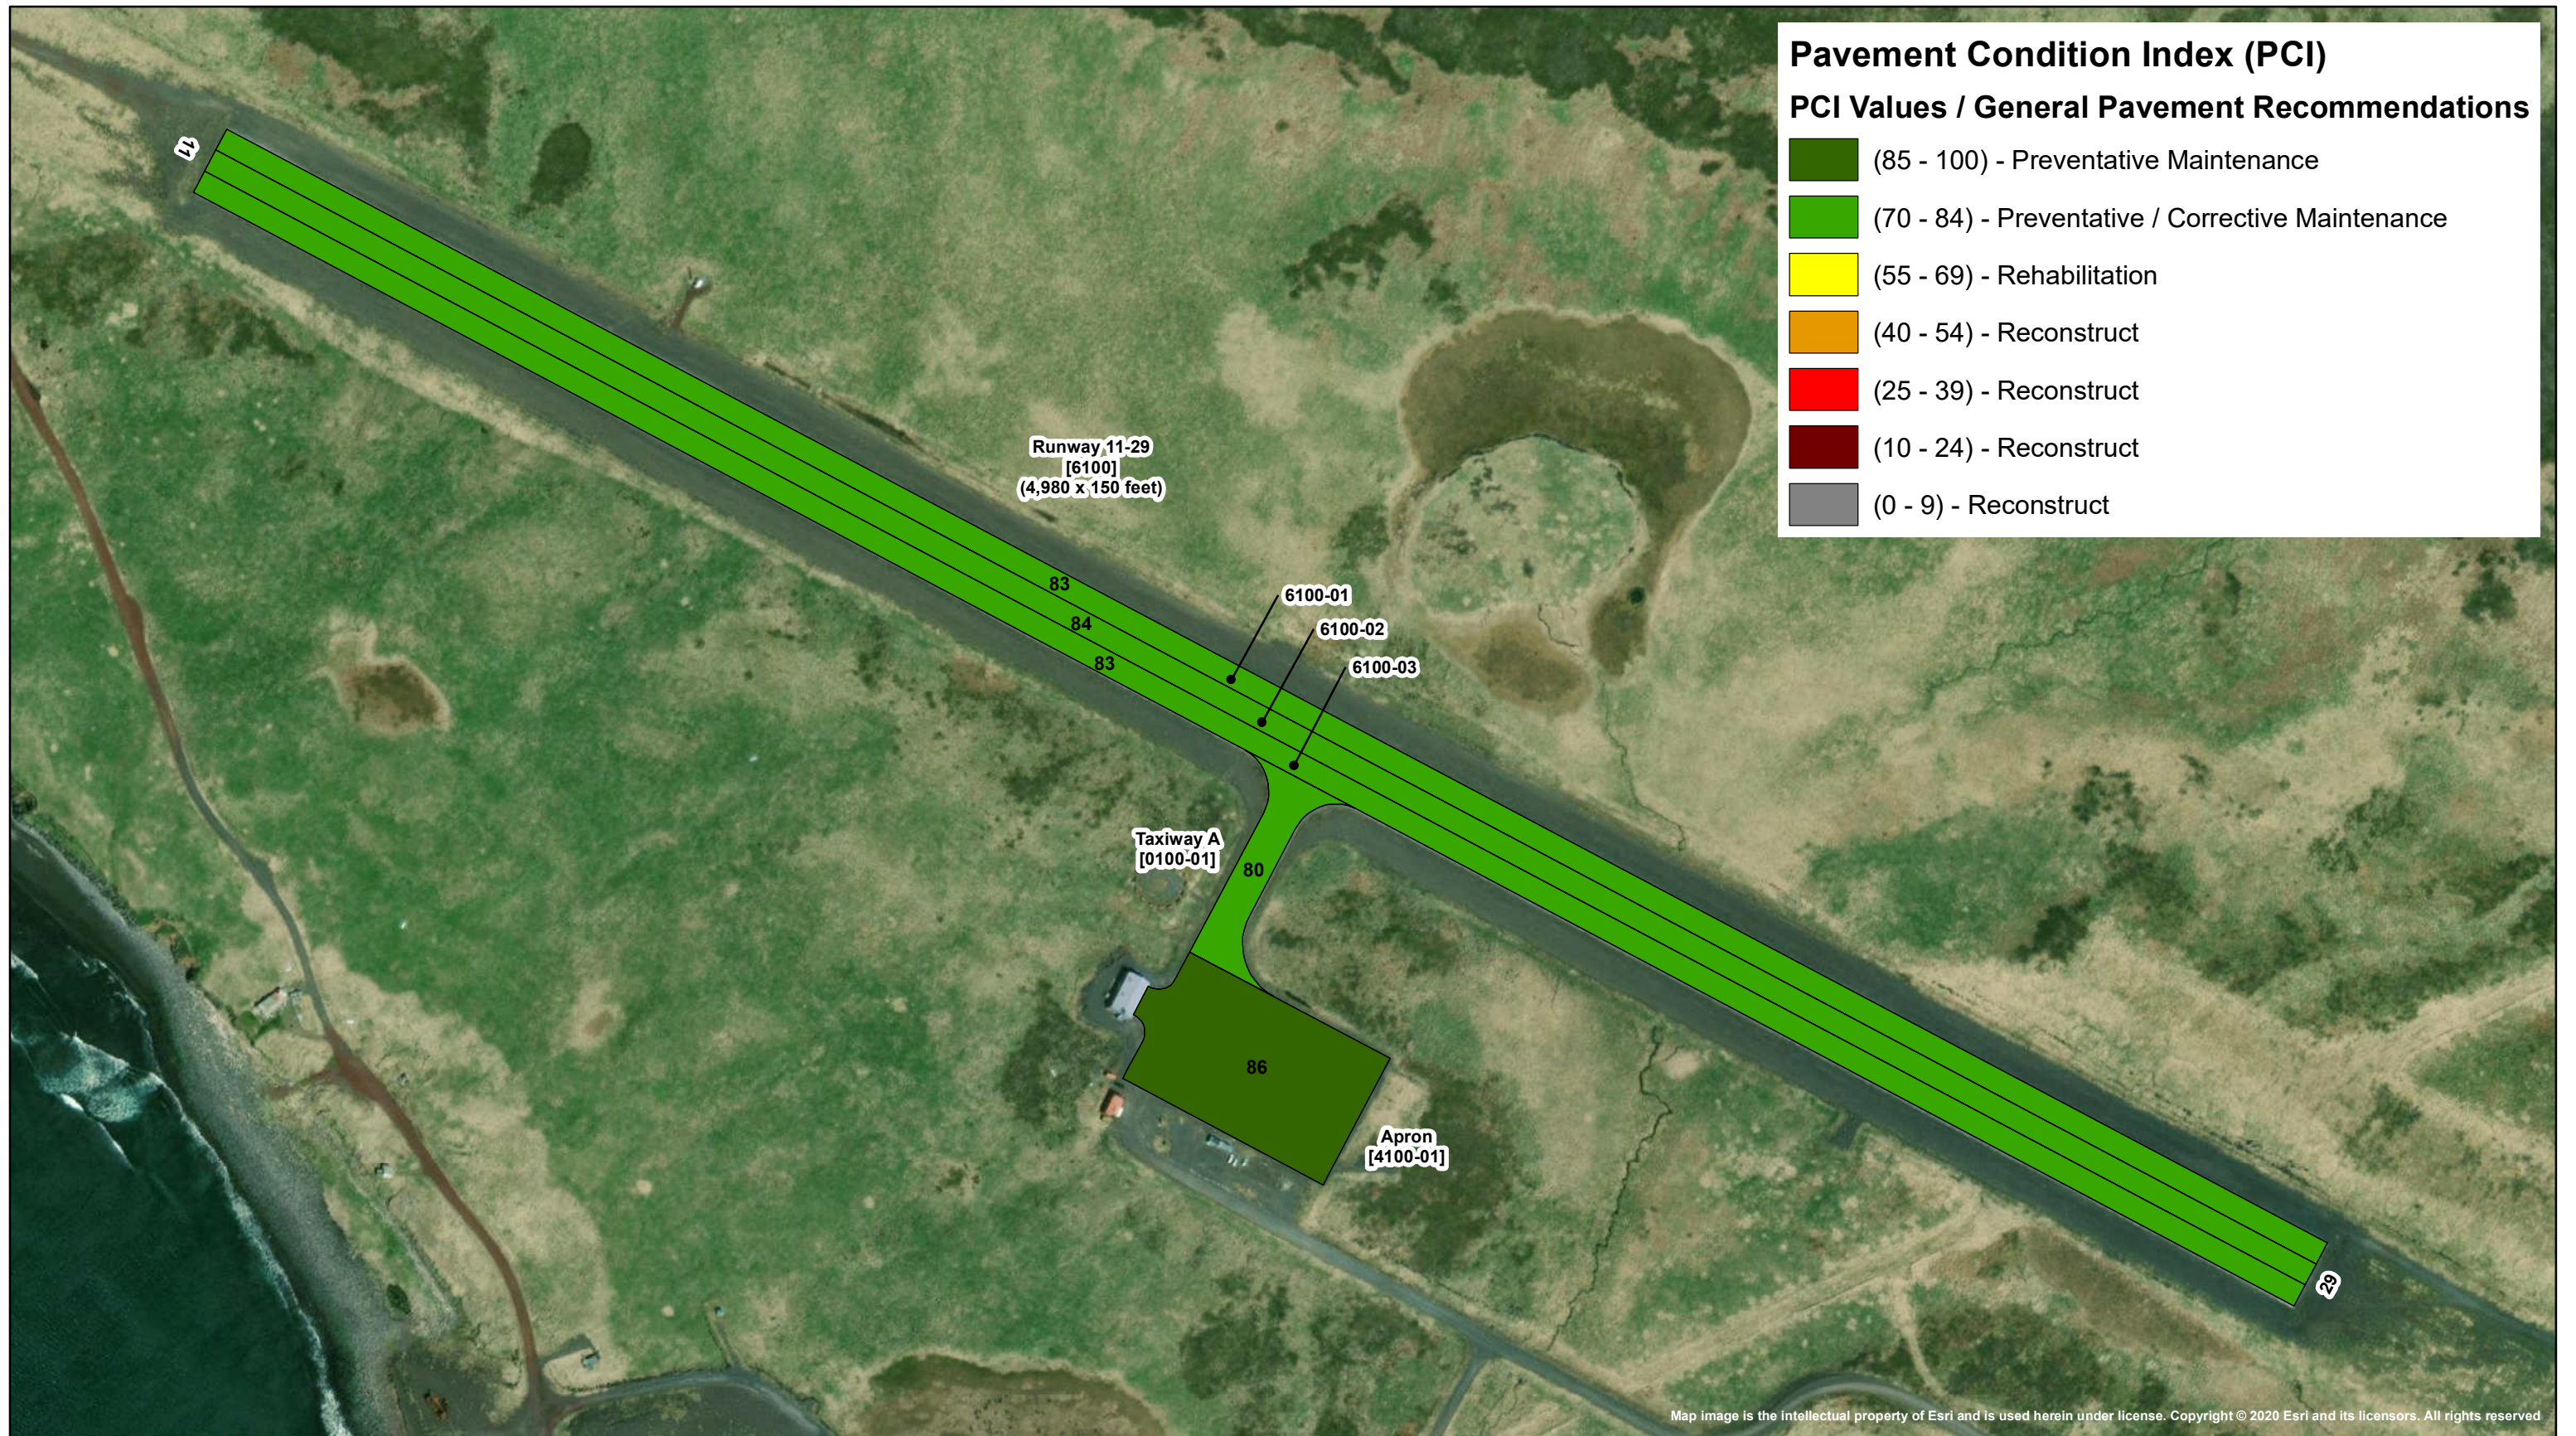
Map 1 of 6

Pavement Condition Index (PCI)

Target PCI Range for Runways: 70 to 100
 Target PCI Range for Taxiways and Aprons: 60 to 100

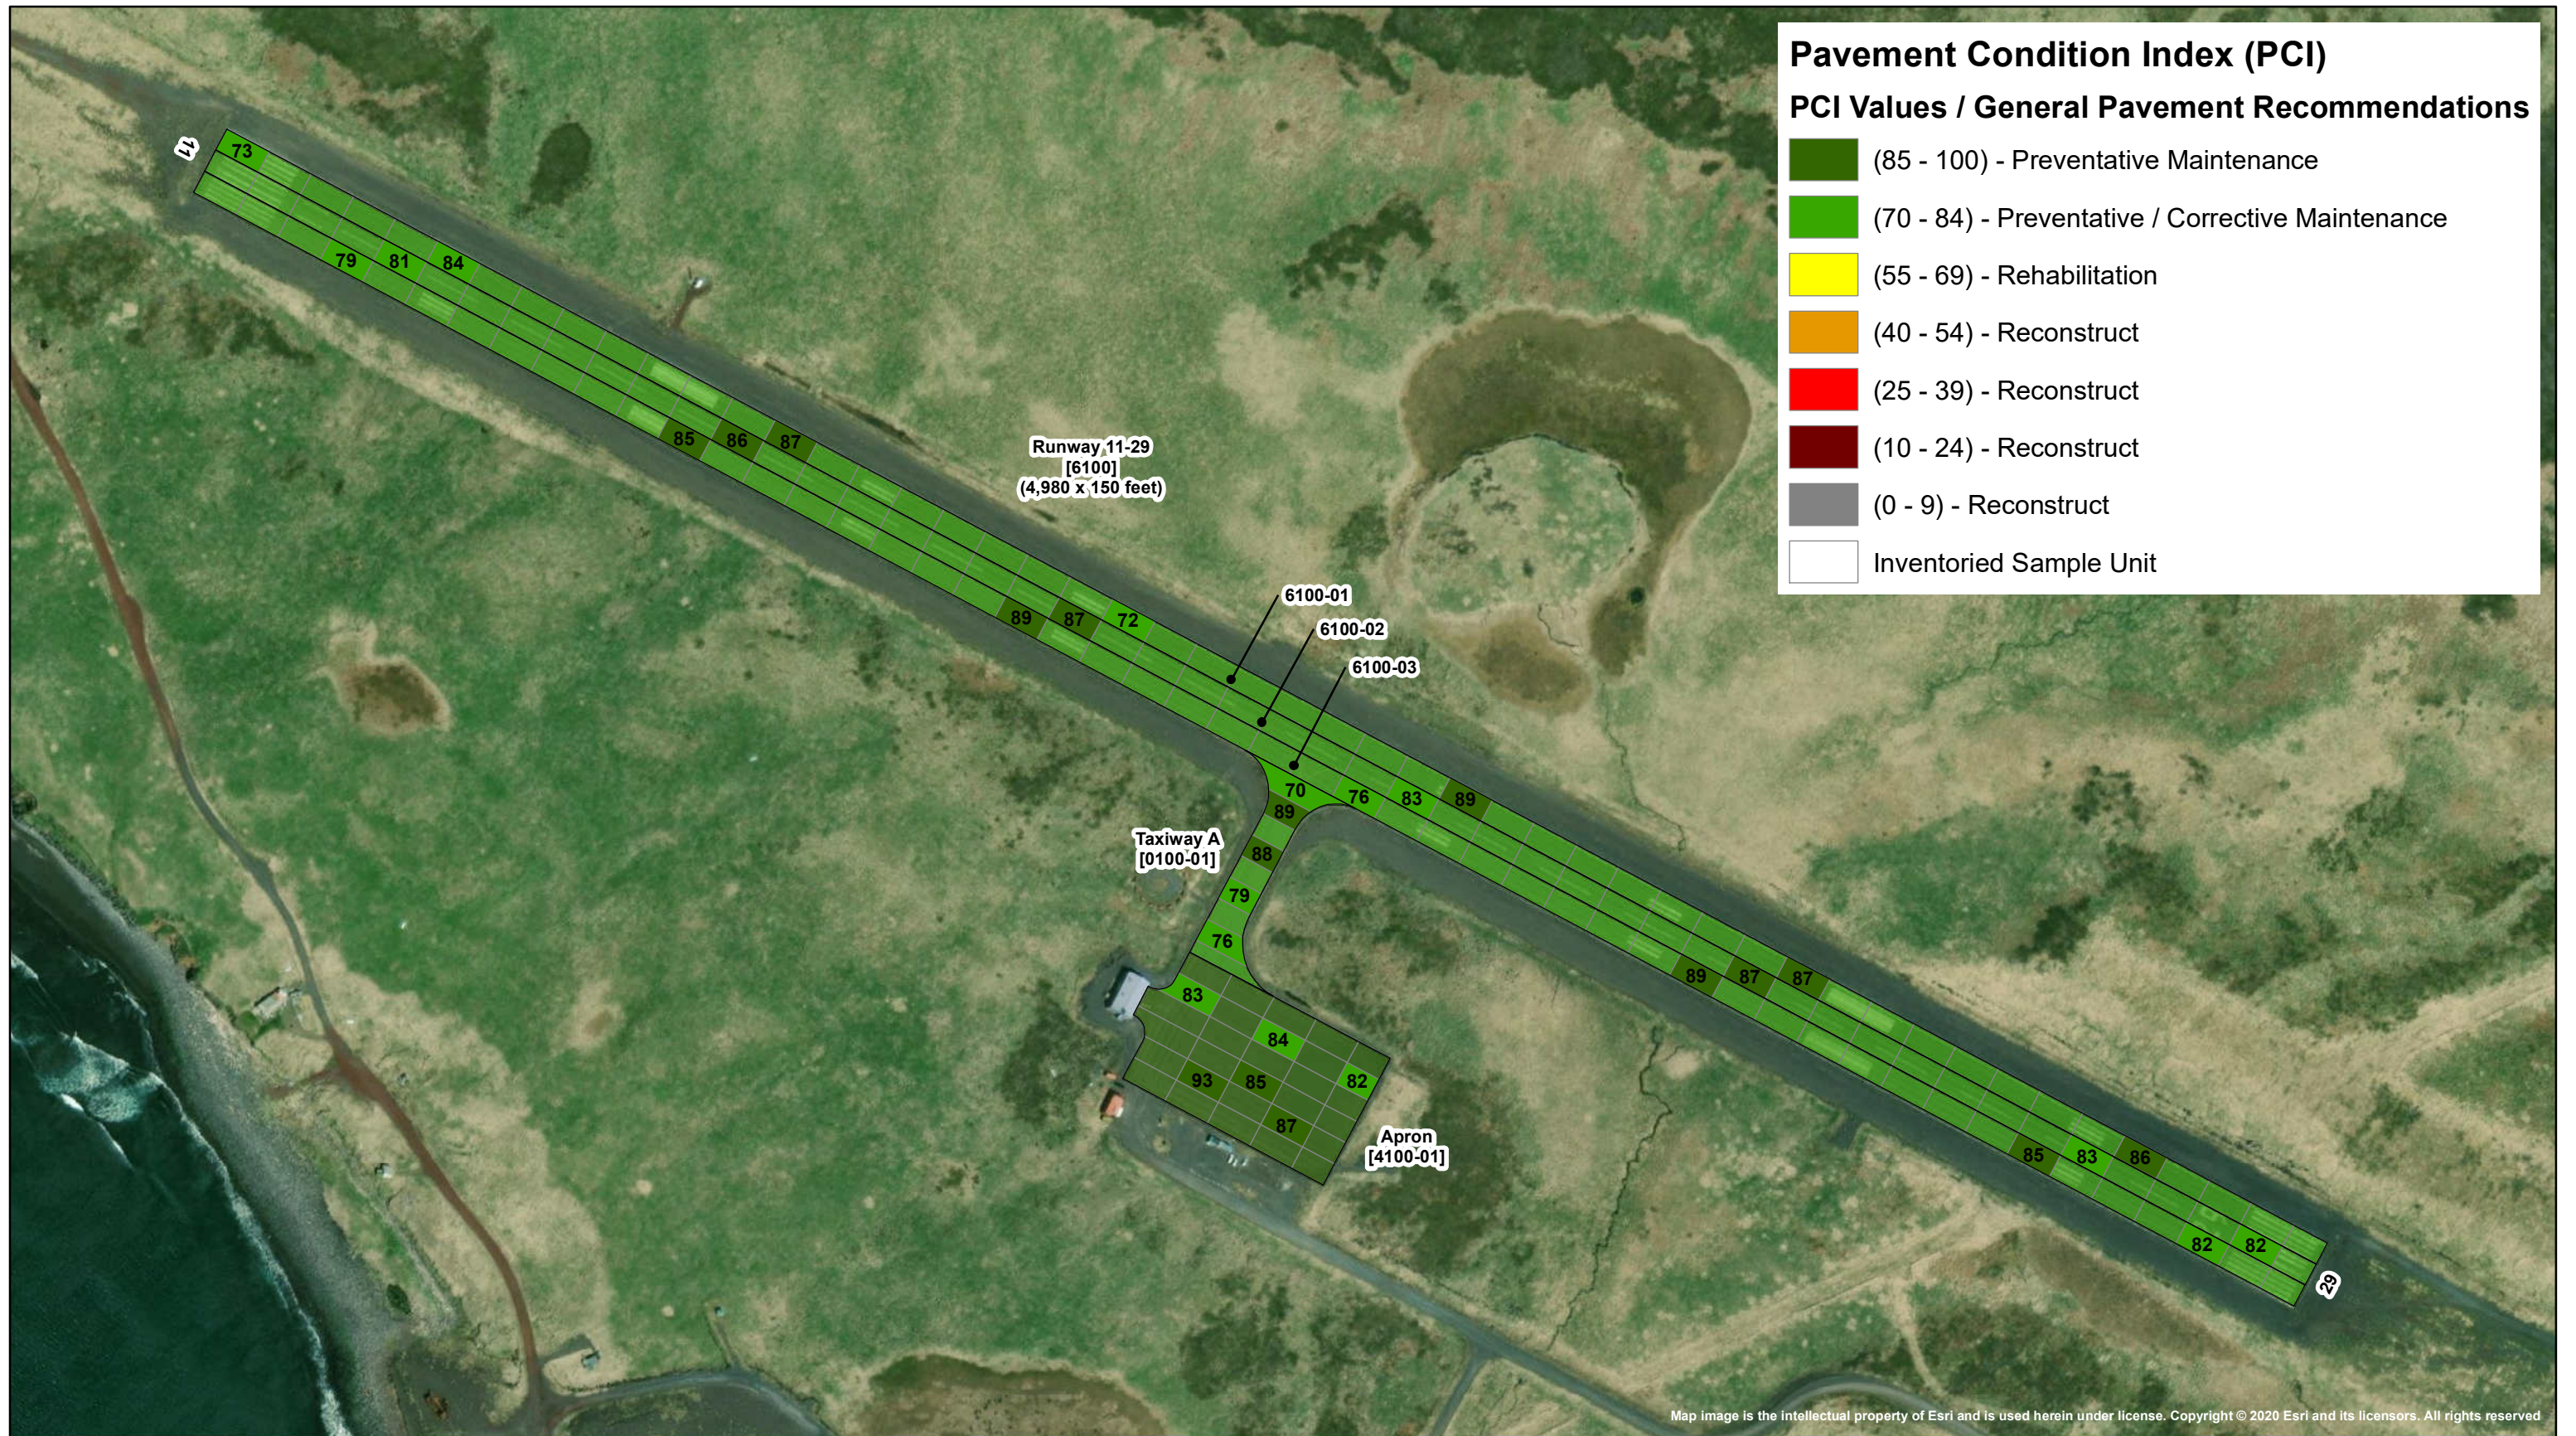
Sample Unit Pavement Condition Index (PCI)

Target PCI Range for Runways: 70 to 100
 Target PCI Range for Taxiways and Aprons: 60 to 100

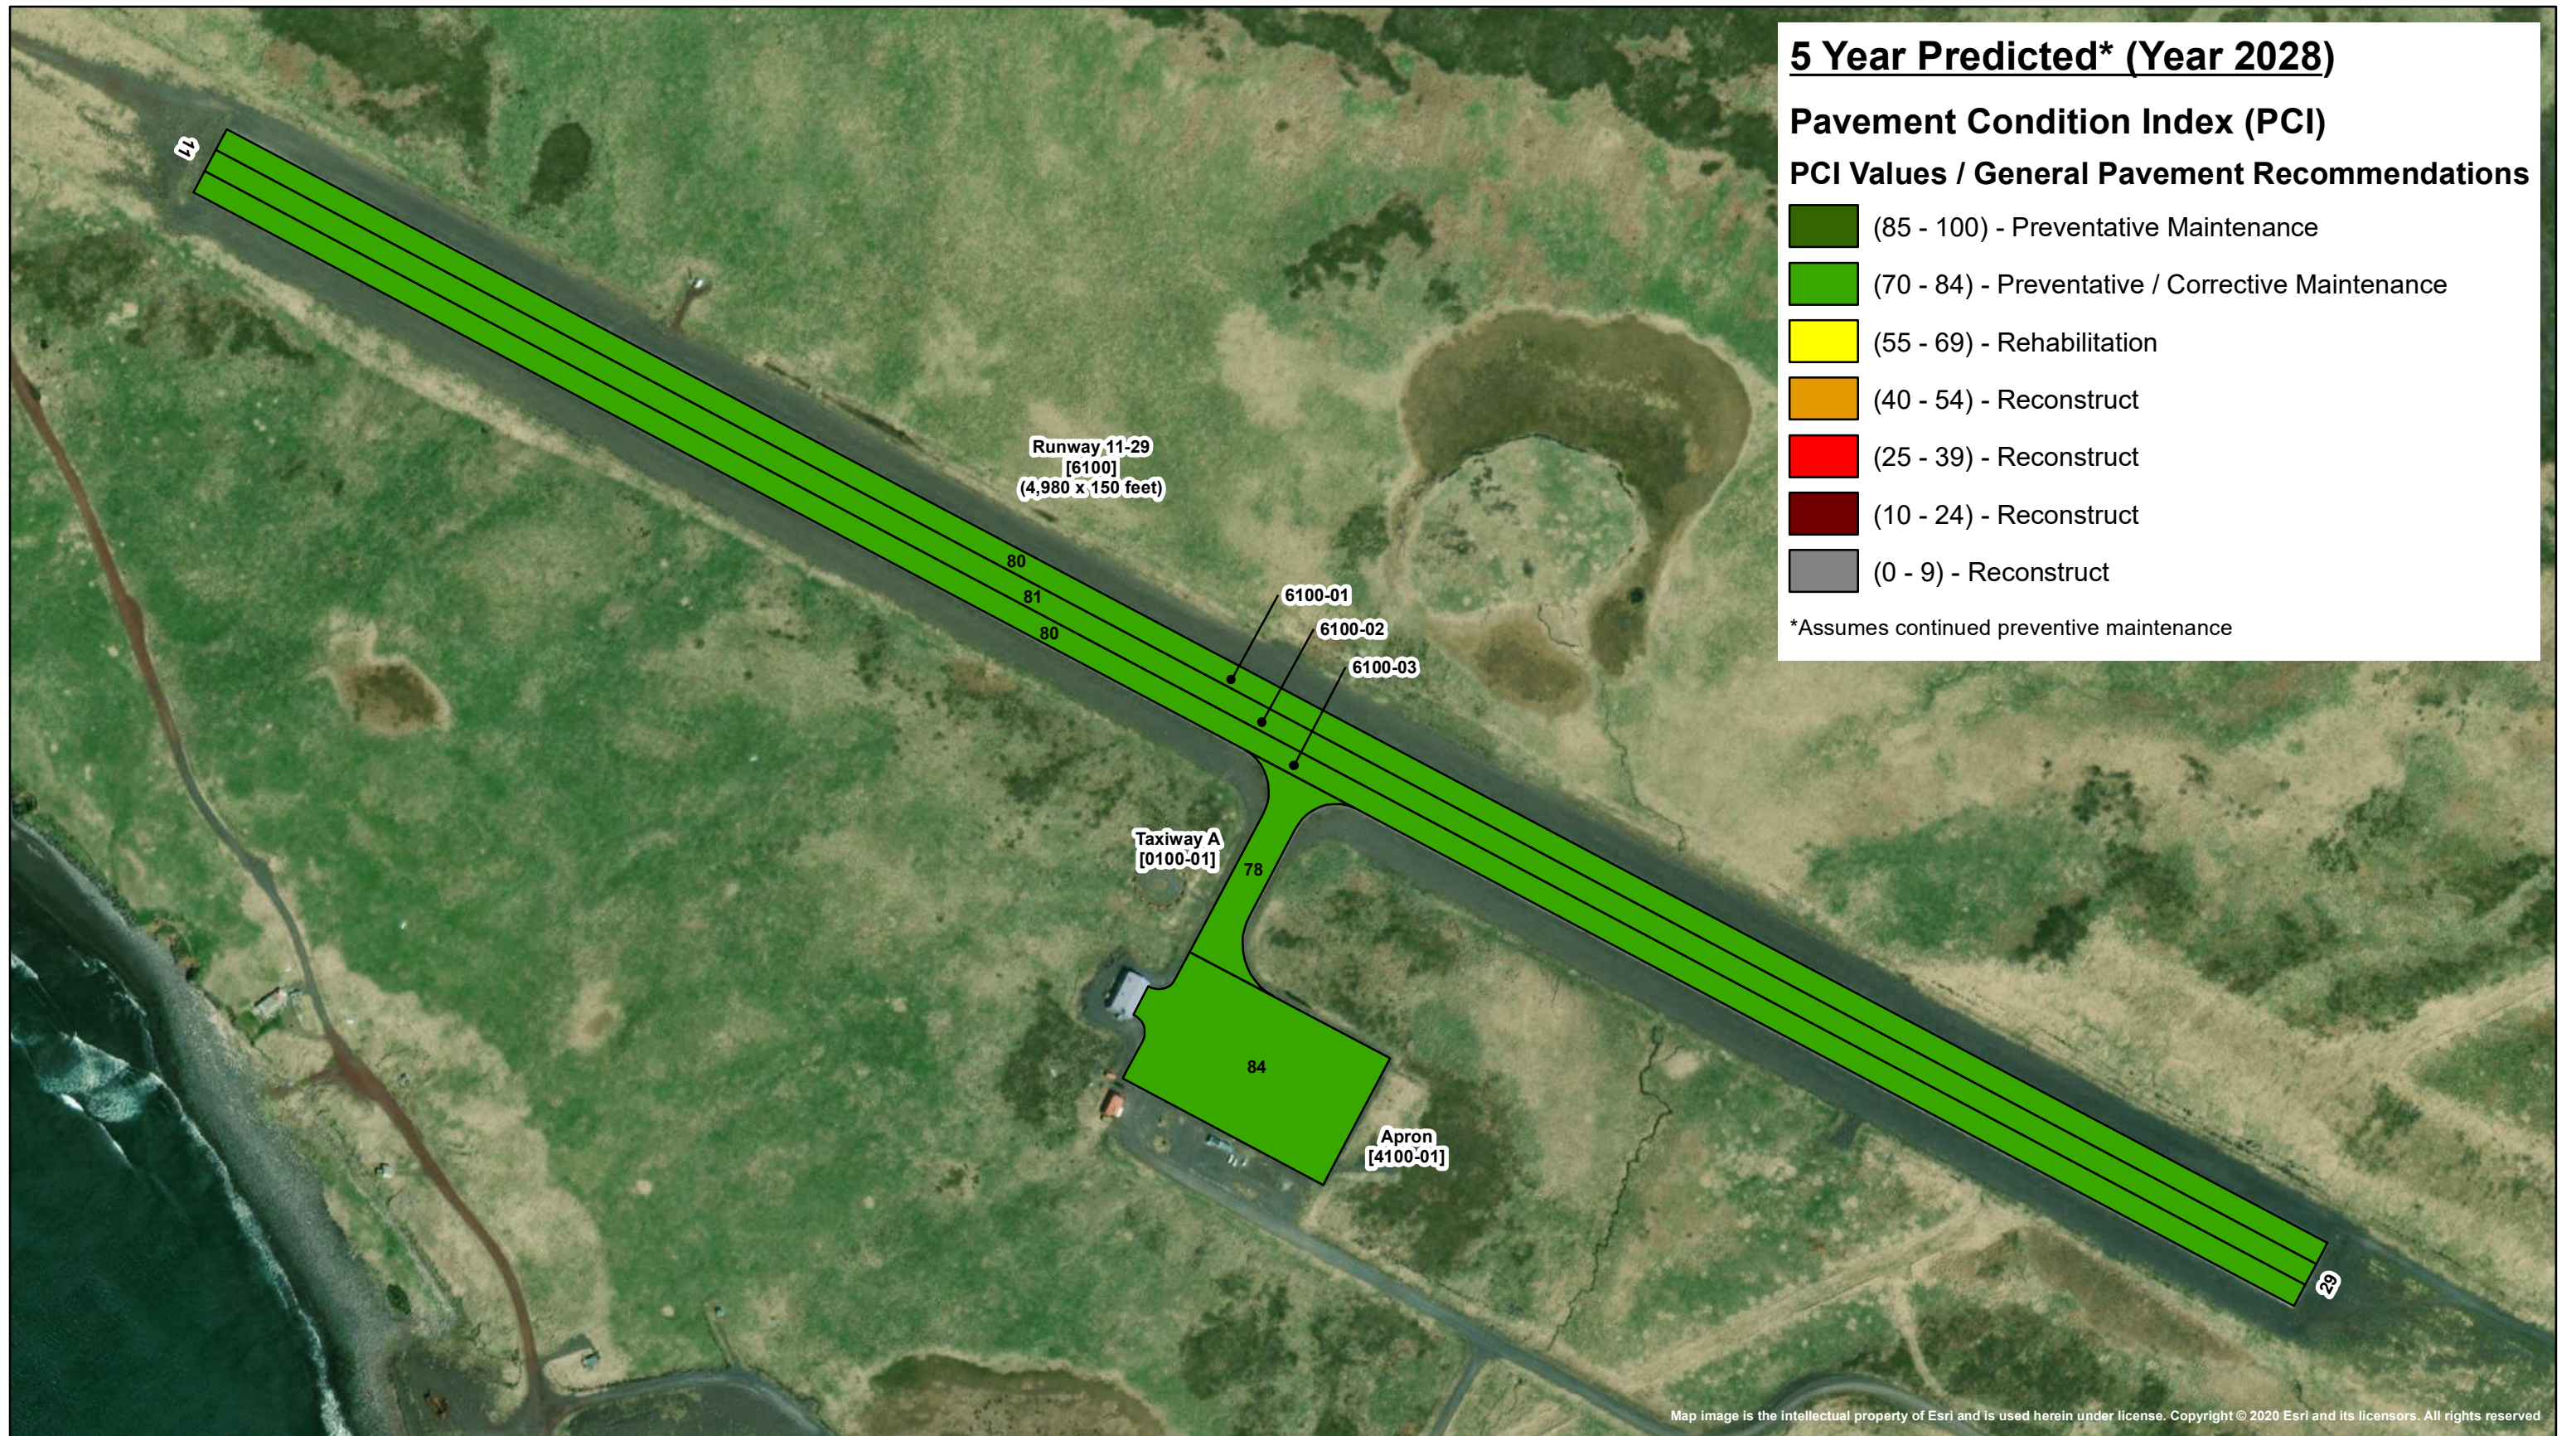
5 Year Predicted Pavement Condition Index (PCI)

Target PCI Range for Runways: 70 to 100
Target PCI Range for Taxiways and Aprons: 60 to 100

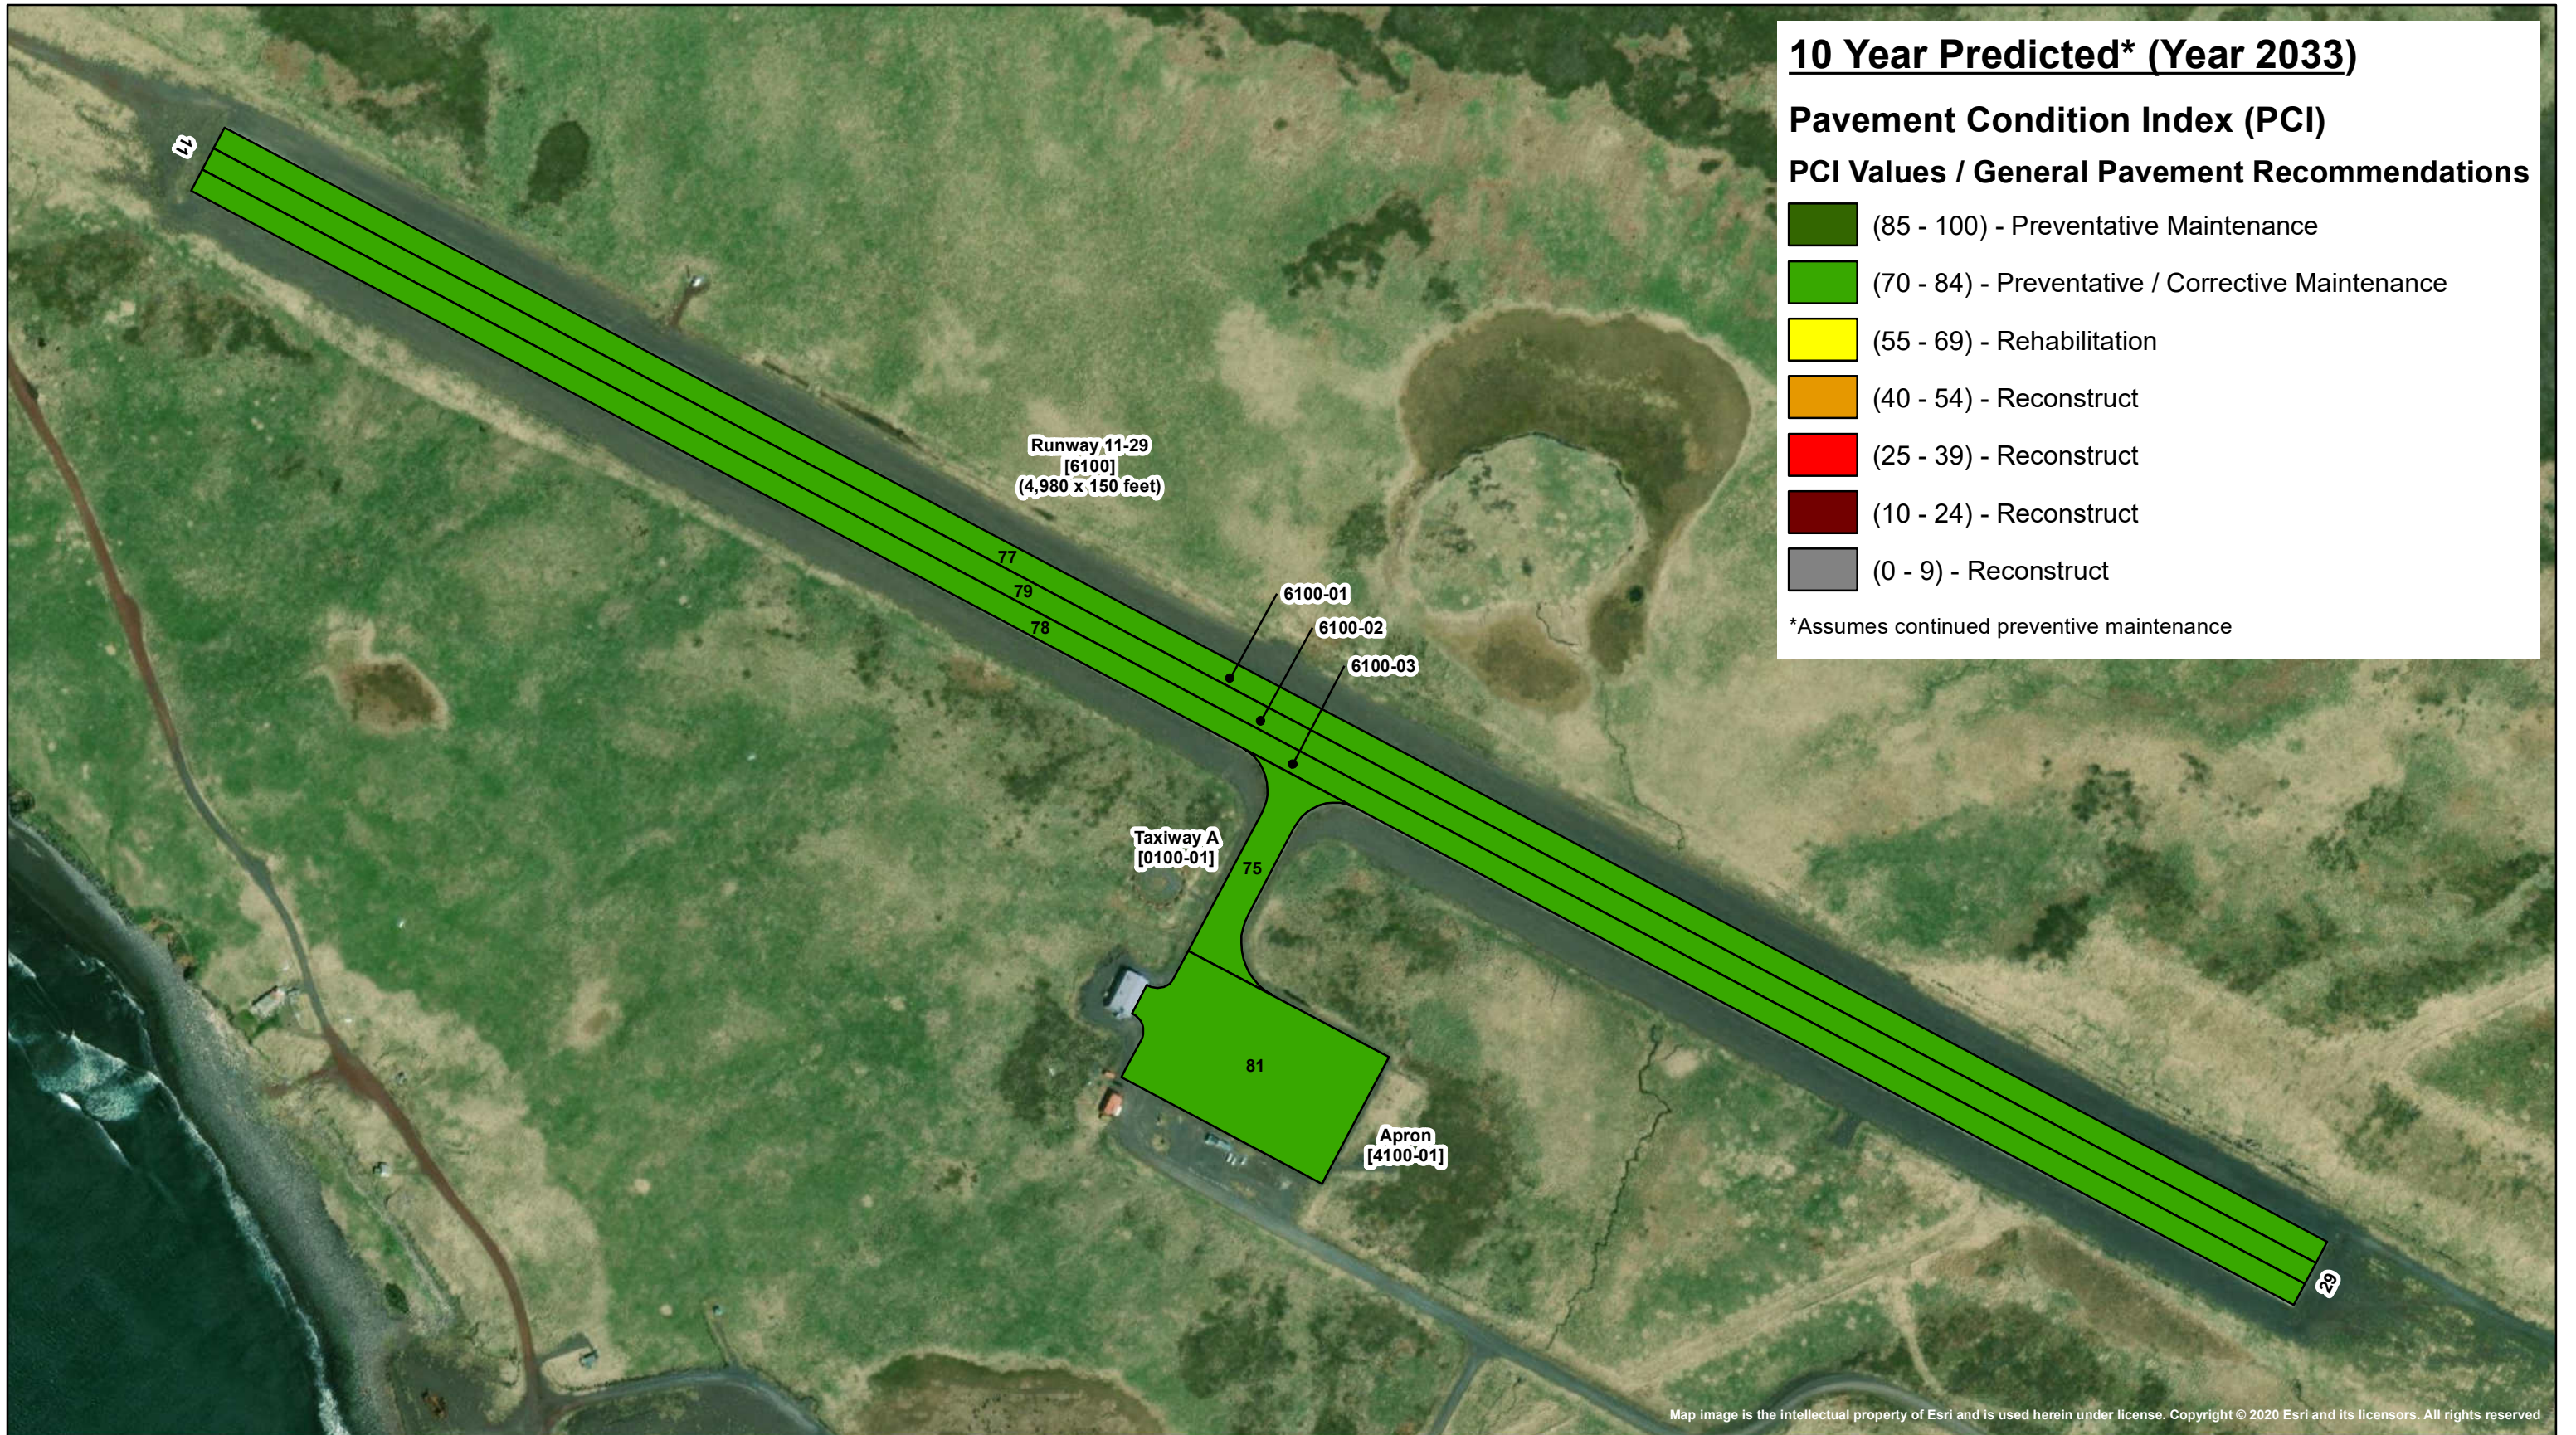
Map 4 of 6

10 Year Predicted Pavement Condition Index (PCI)

Target PCI Range for Runways: 70 to 100
Target PCI Range for Taxiways and Aprons: 60 to 100

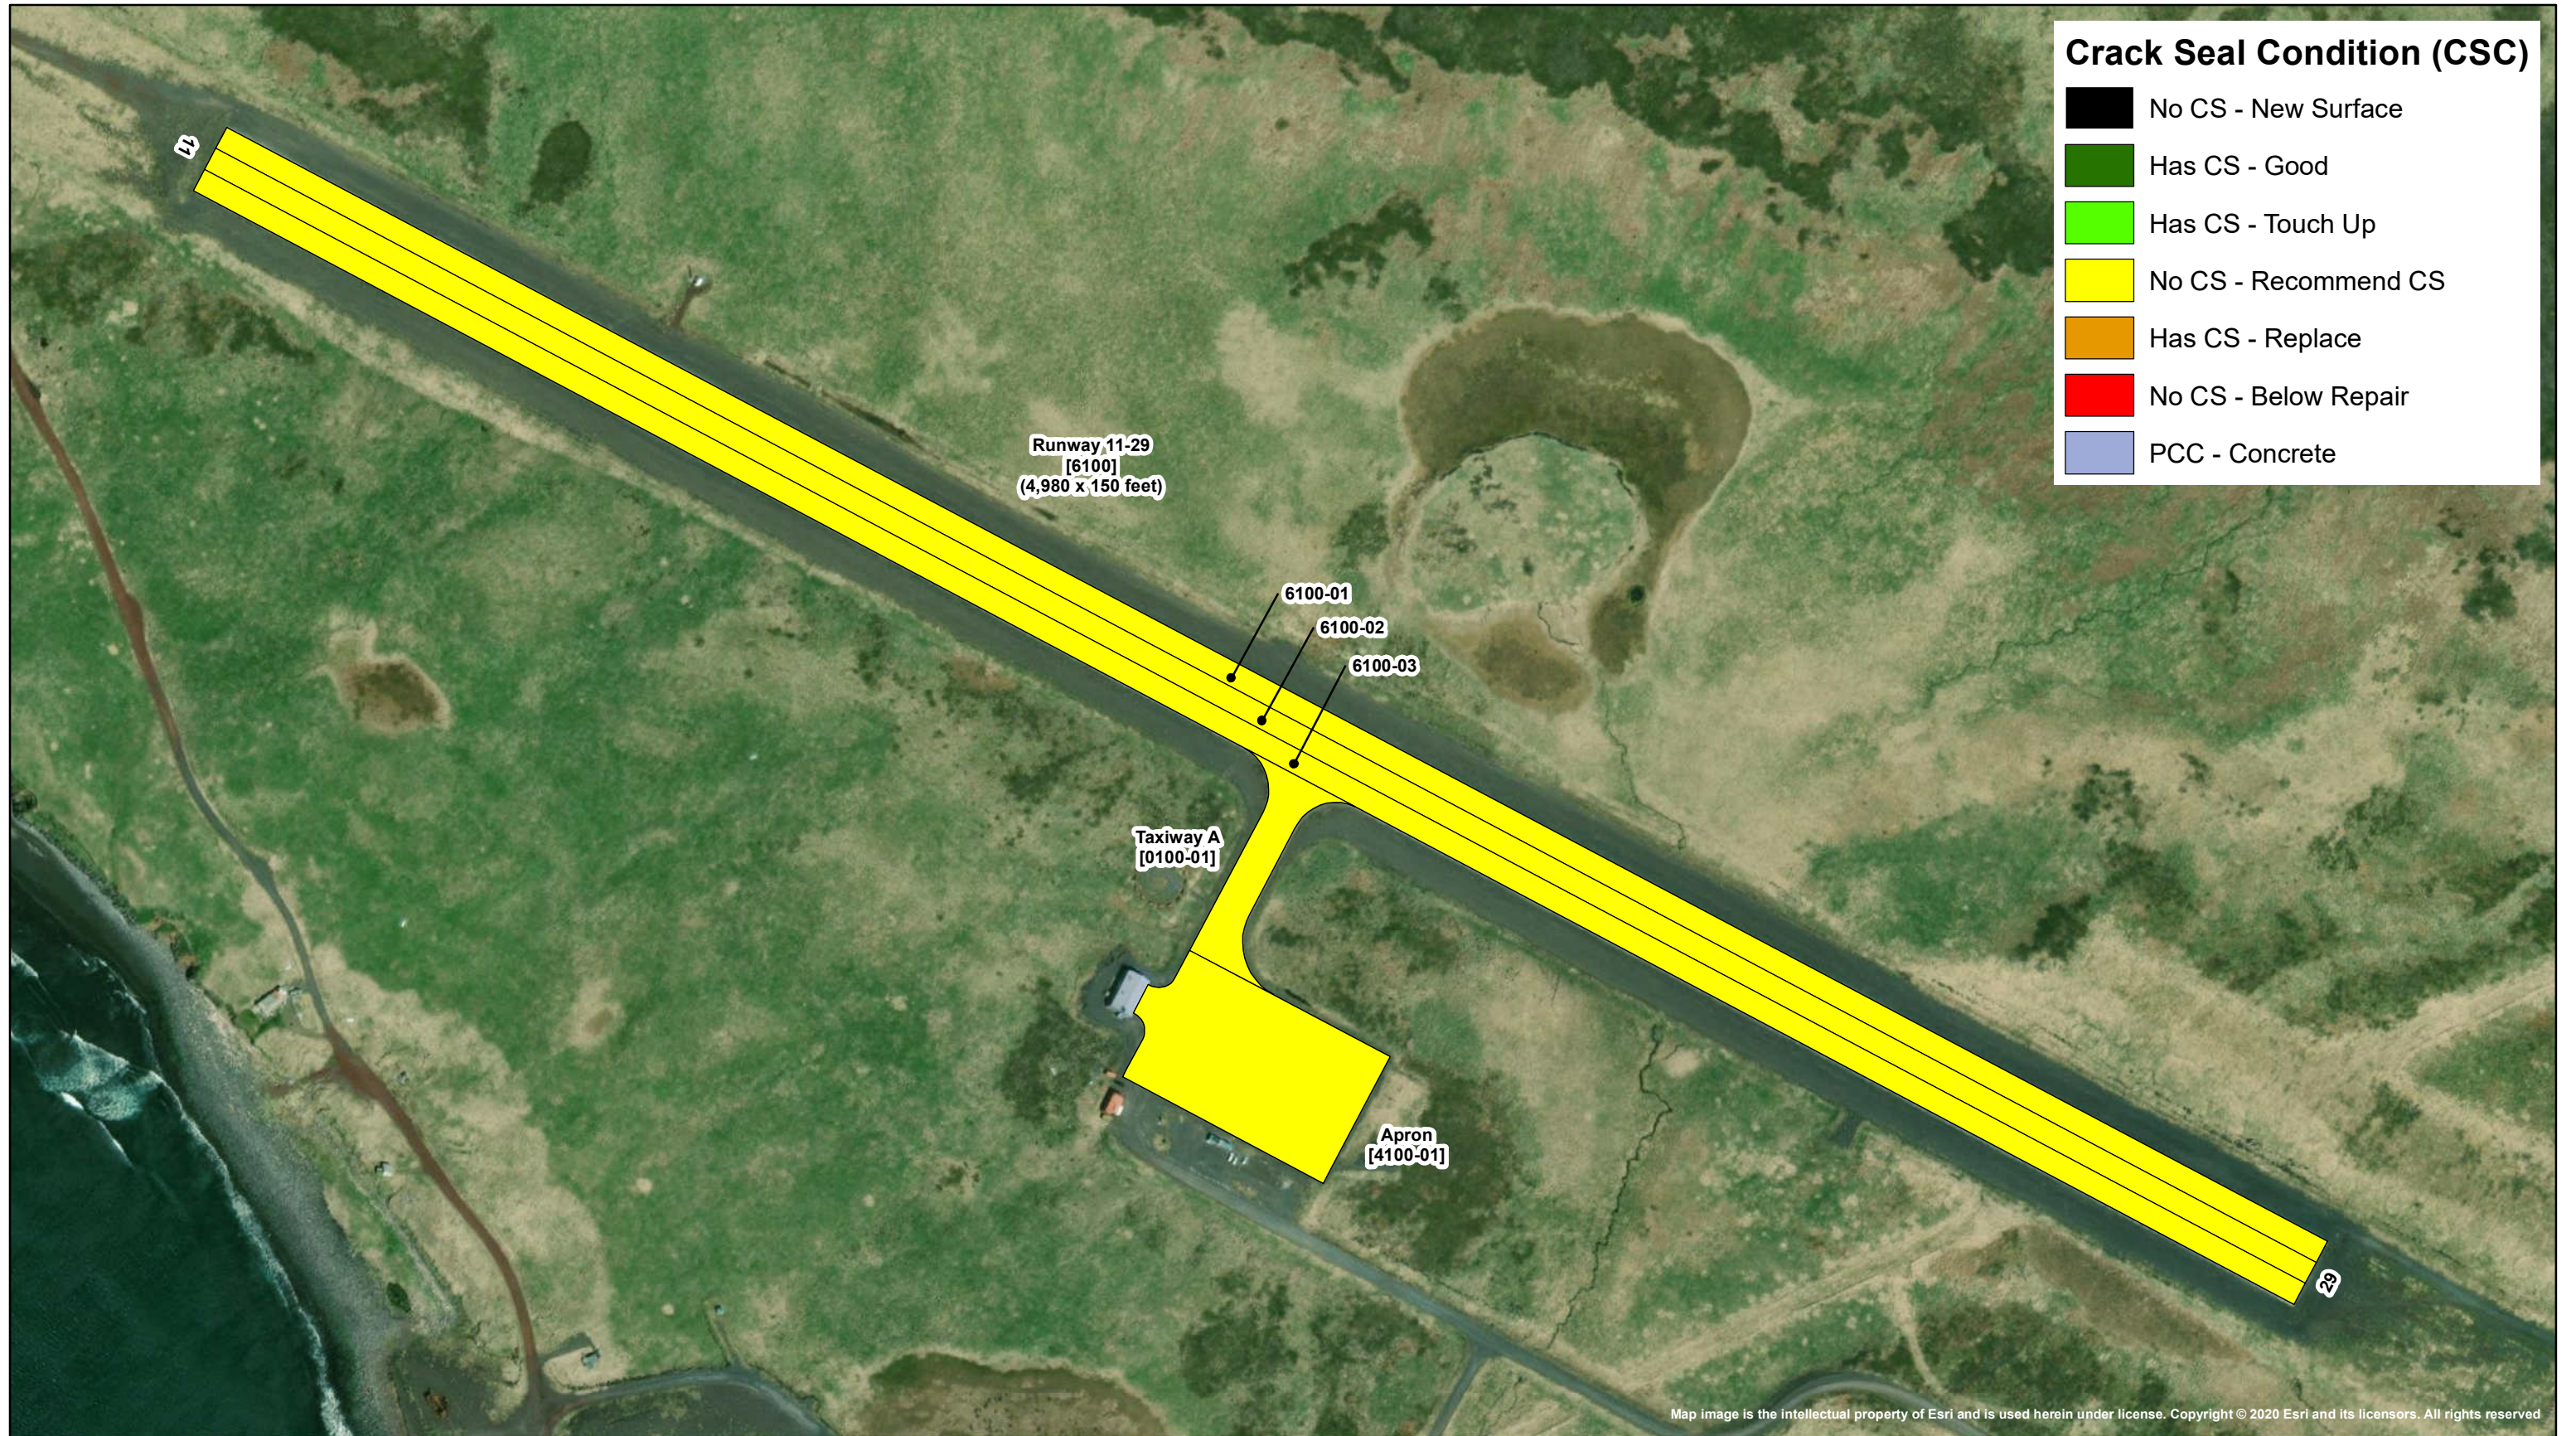
Crack Seal Condition (CSC)

Pavement Crack Seal Condition (CSC)
