# Alaska DOT&PF

## Pavement Inspection Report Saint Paul Airport

Airport Name	IATA	ICAO	Latitude	Longitude	Elevation (ft)
Saint Paul Airport	SNP	PASN	57° 9' 58.7" N	170° 13' 21.2" W	66.4

Point of Contact	Phone	Email	Date Inspected	Date Published
Mr. Andrew Pavey, Pavement Management Engineer	(907) 269 6213	andrew.pavey@alaska.gov	May 2023	September 2023

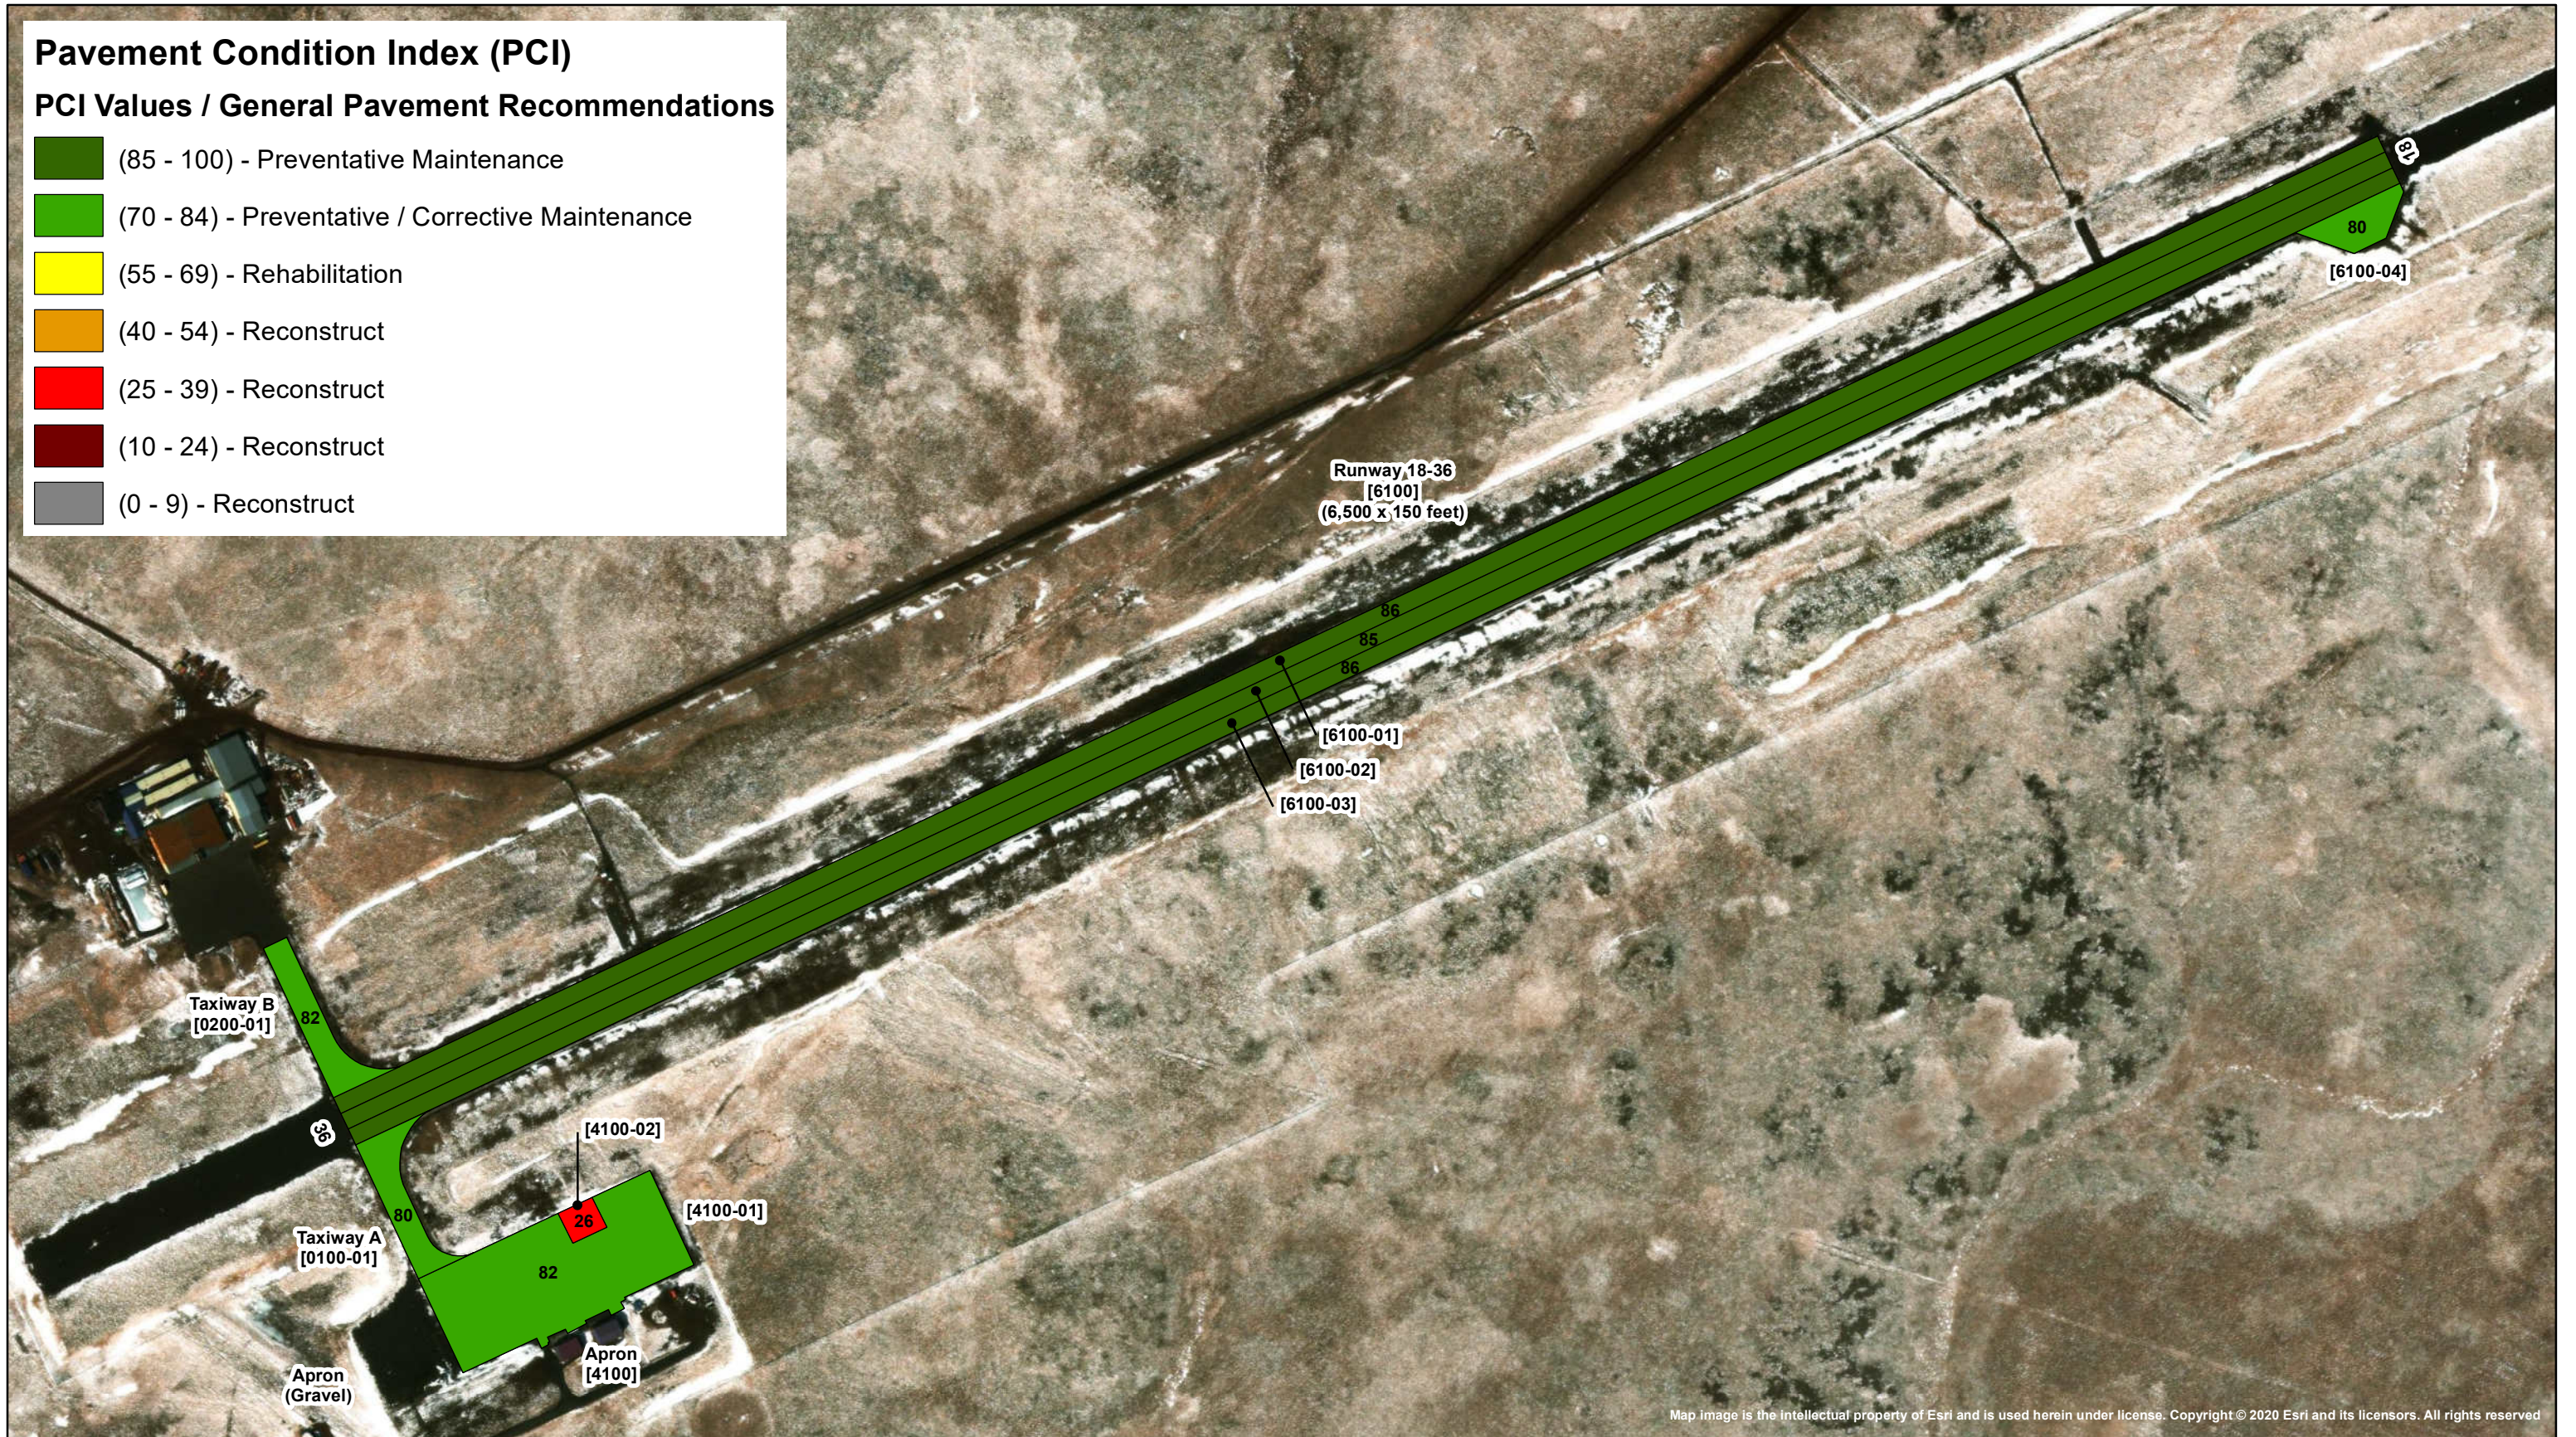
**Pavement Condition Index (PCI)**

Target PCI Range for Runways: 70 to 100  
 Target PCI Range for Taxiways and Aprons: 60 to 100

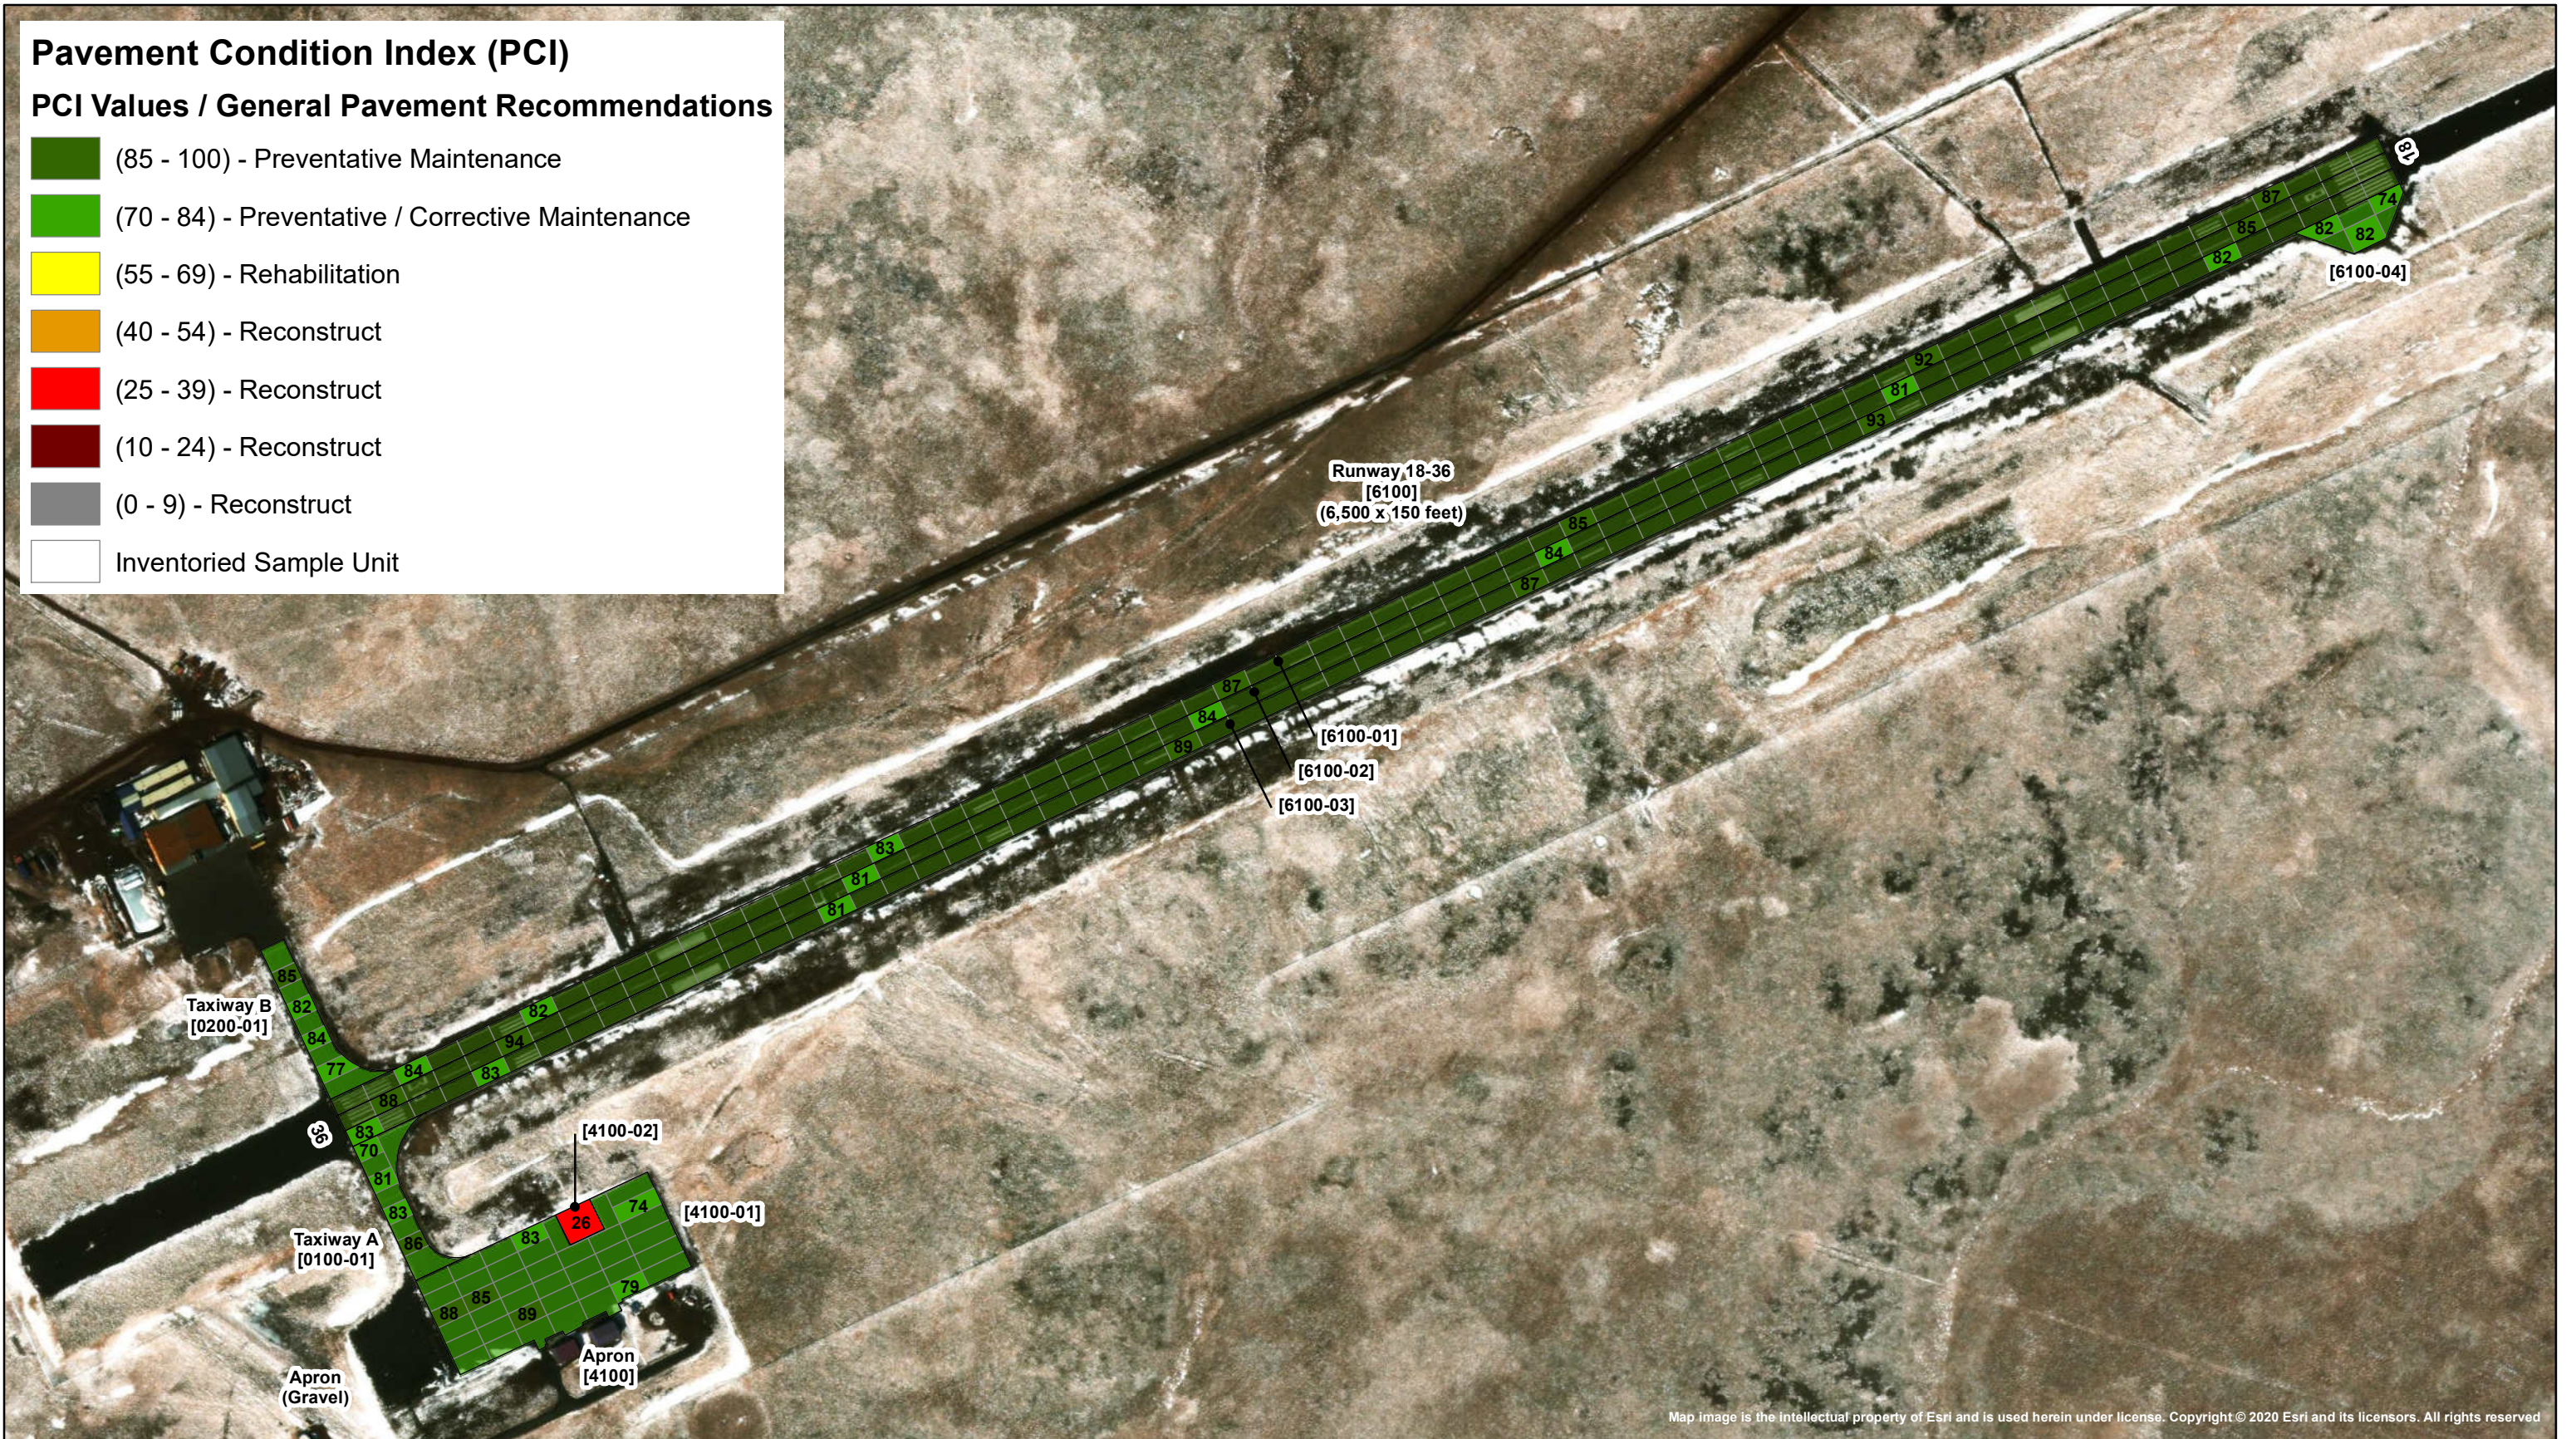
Map 2 of 6

### Sample Unit Pavement Condition Index (PCI)

Target PCI Range for Runways: 70 to 100  
Target PCI Range for Taxiways and Aprons: 60 to 100

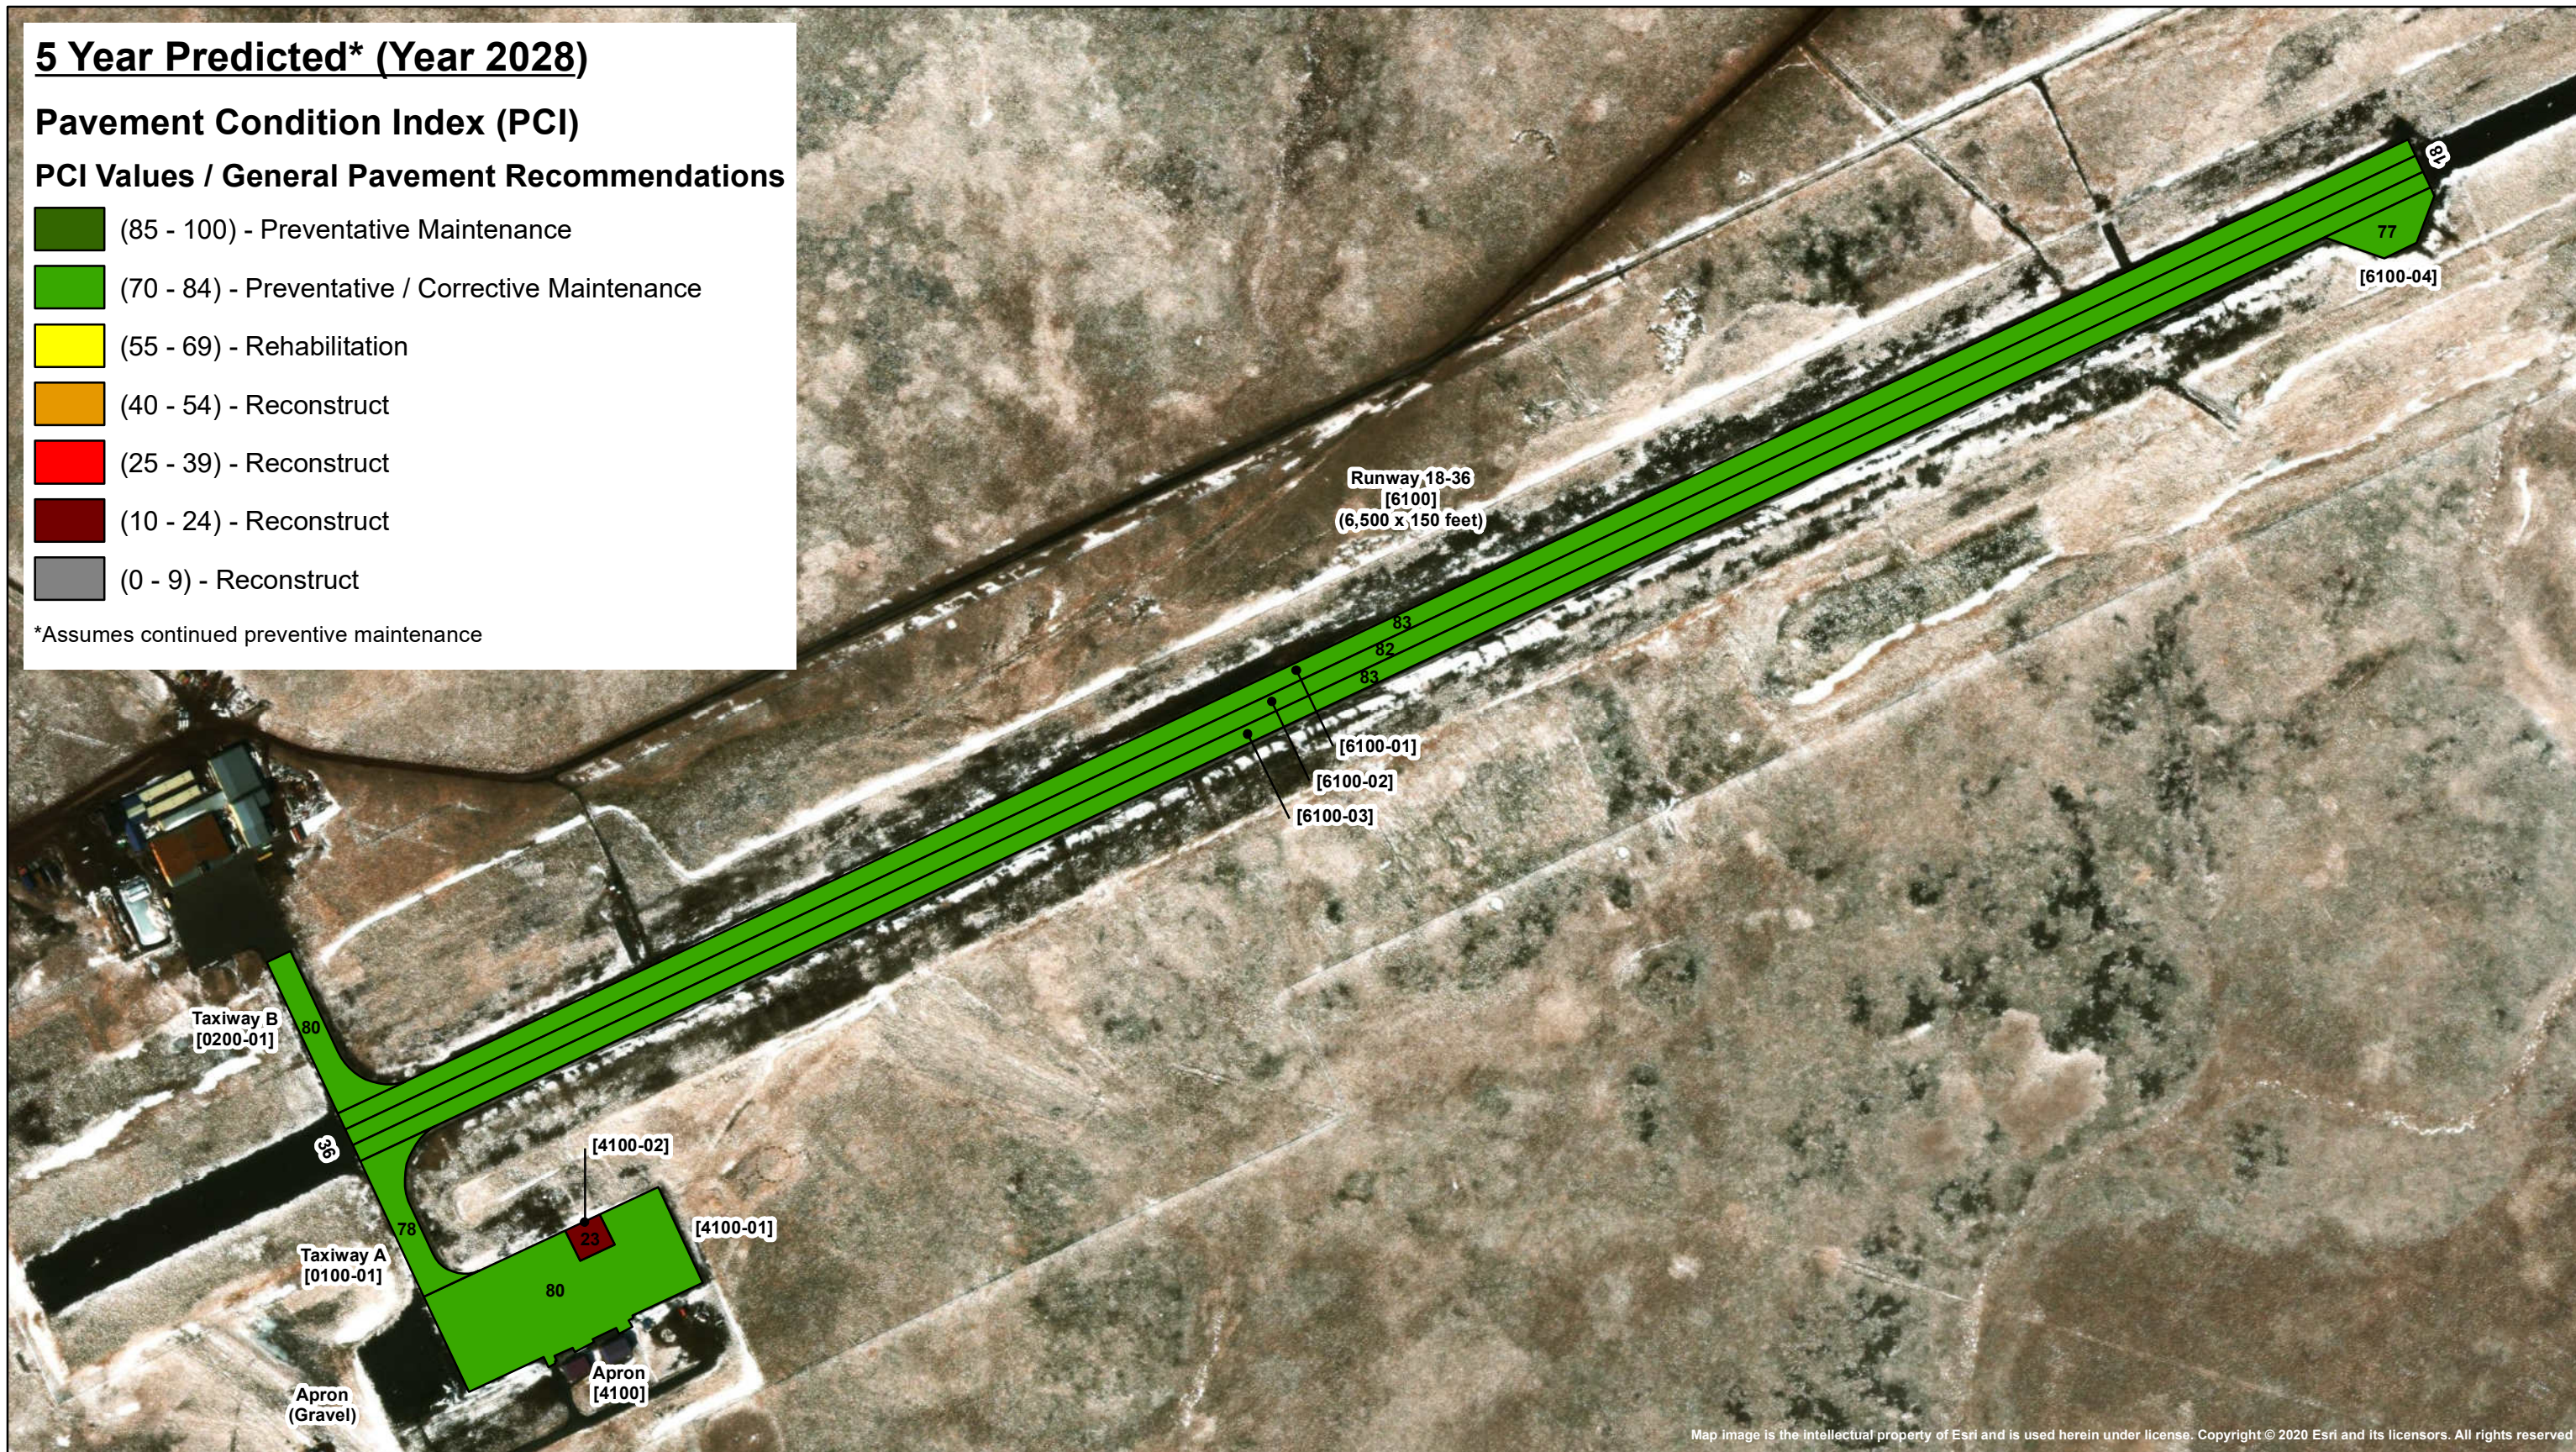
Map 3 of 6

## 5 Year Predicted Pavement Condition Index (PCI)

Target PCI Range for Runways: 70 to 100  
Target PCI Range for Taxiways and Aprons: 60 to 100

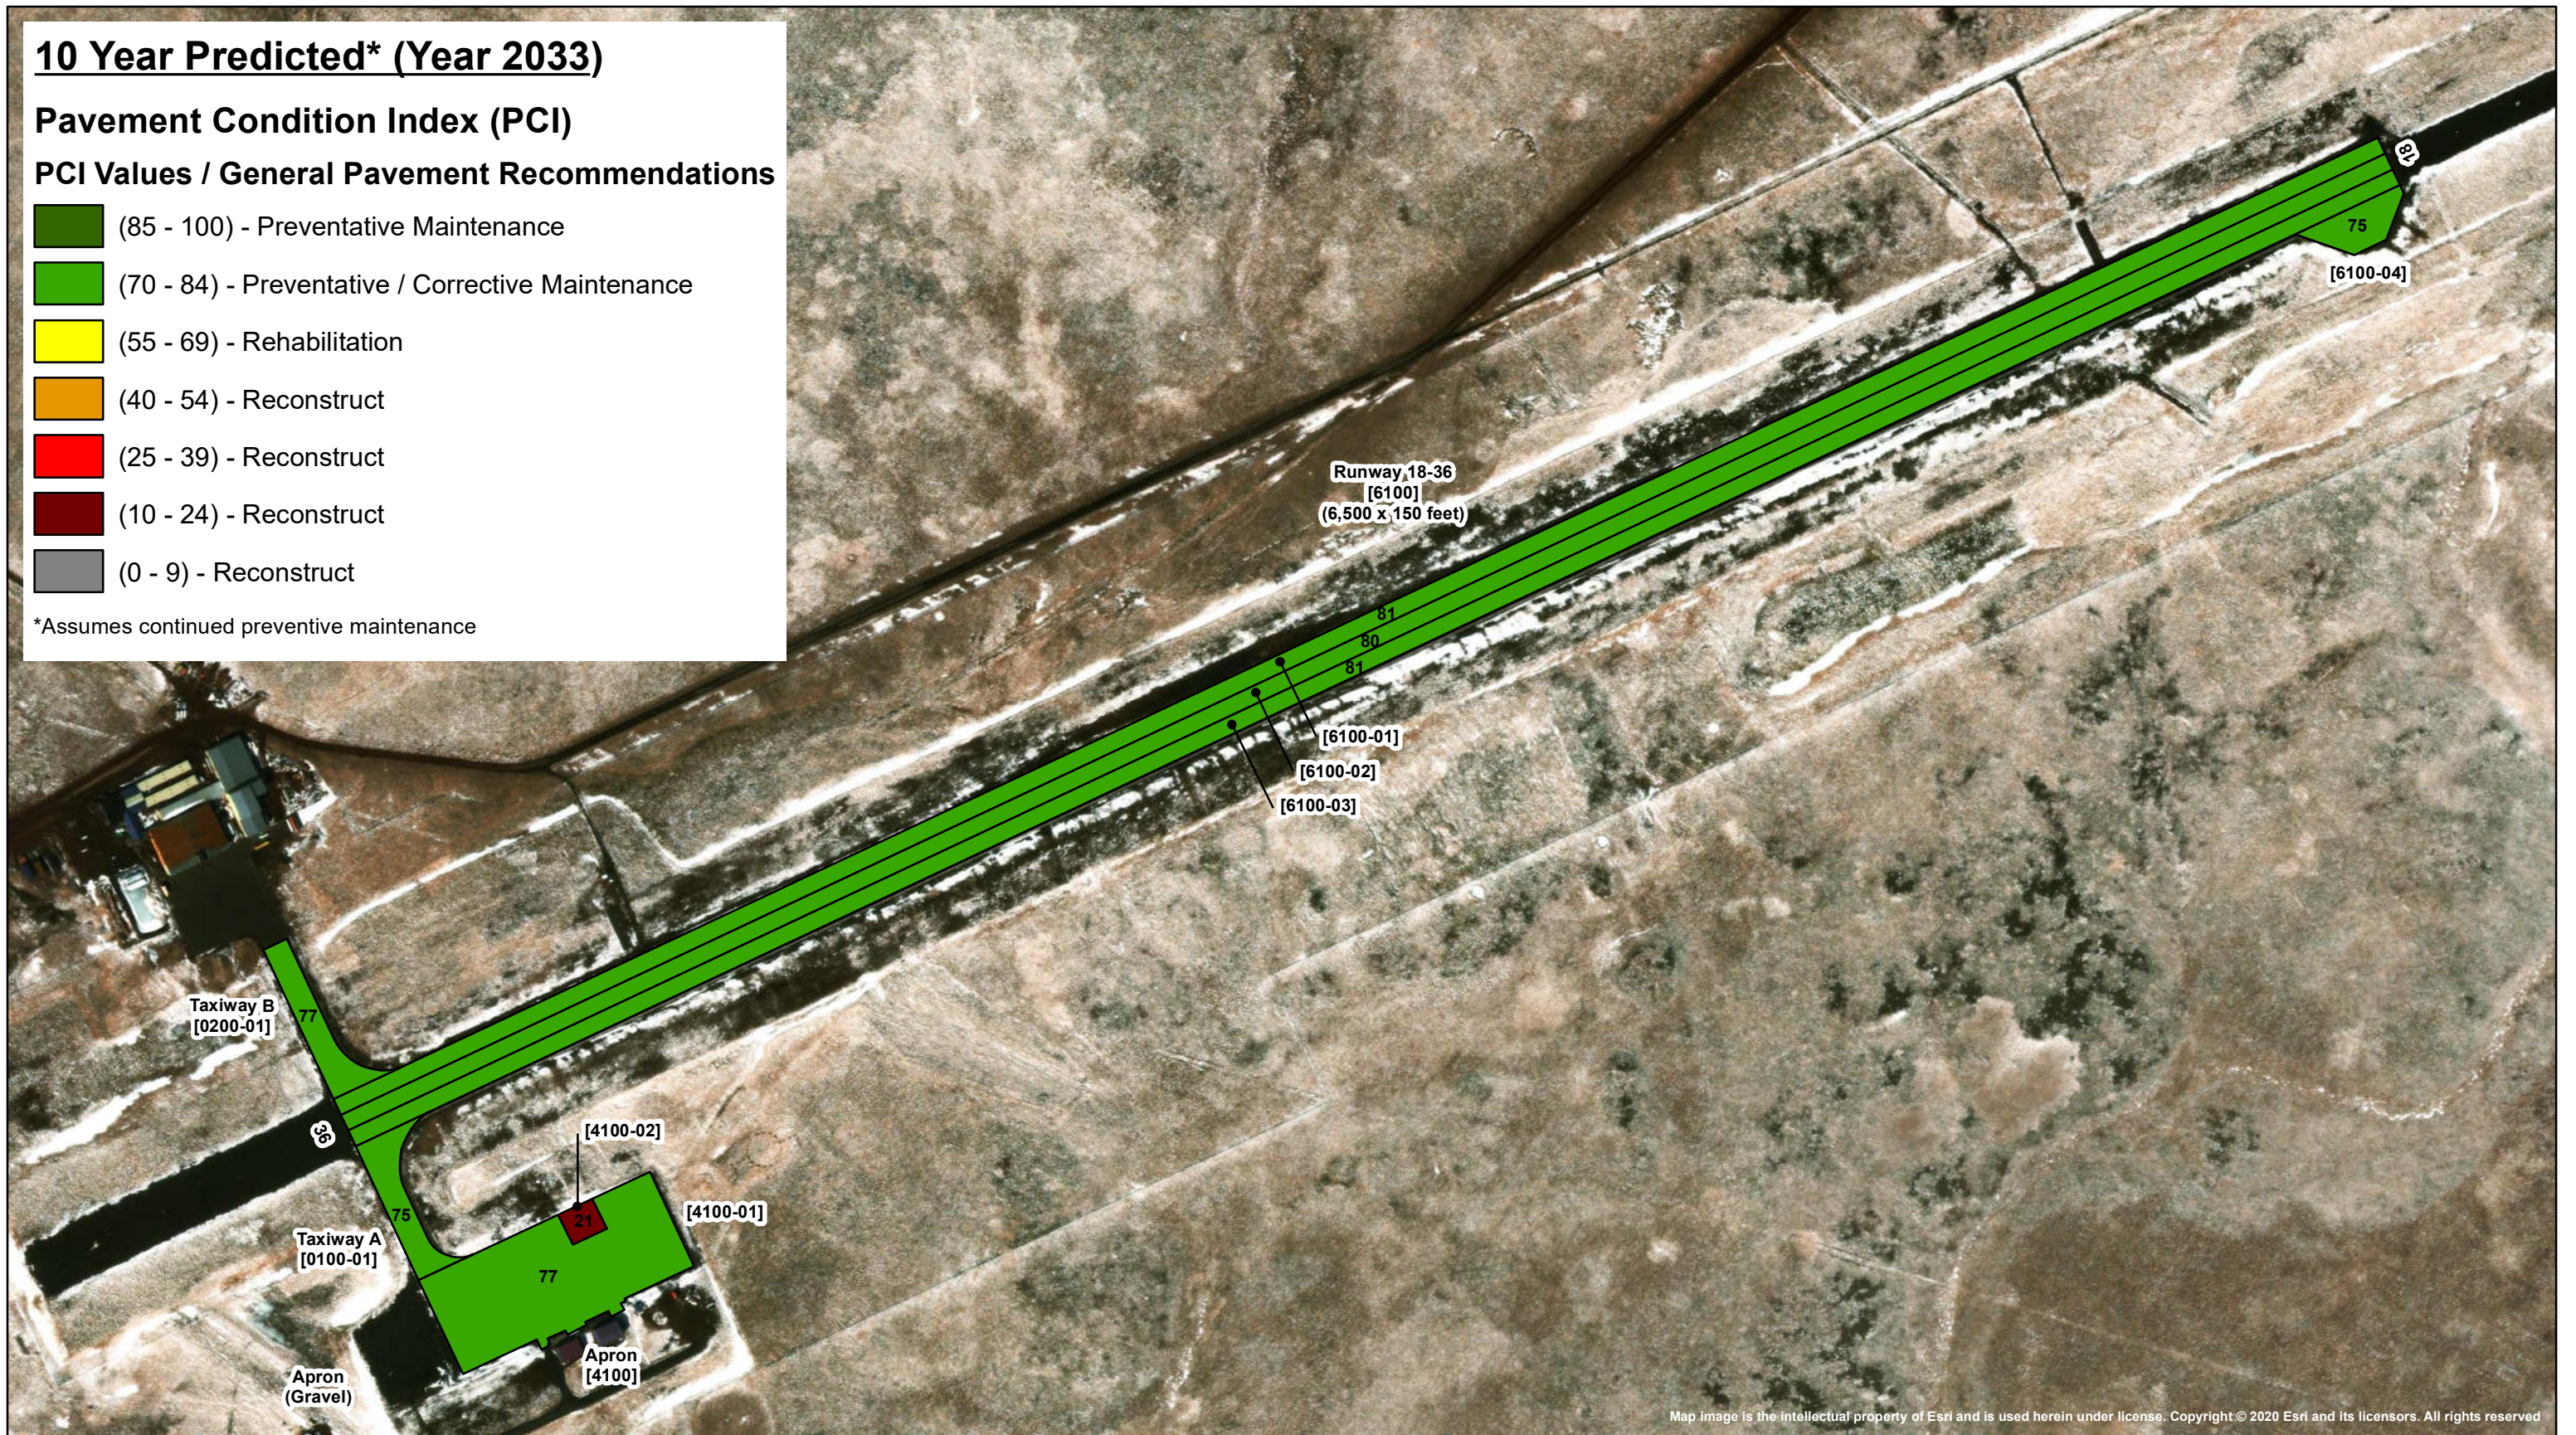
Map 4 of 6

## 10 Year Predicted Pavement Condition Index (PCI)

Target PCI Range for Runways: 70 to 100  
Target PCI Range for Taxiways and Aprons: 60 to 100

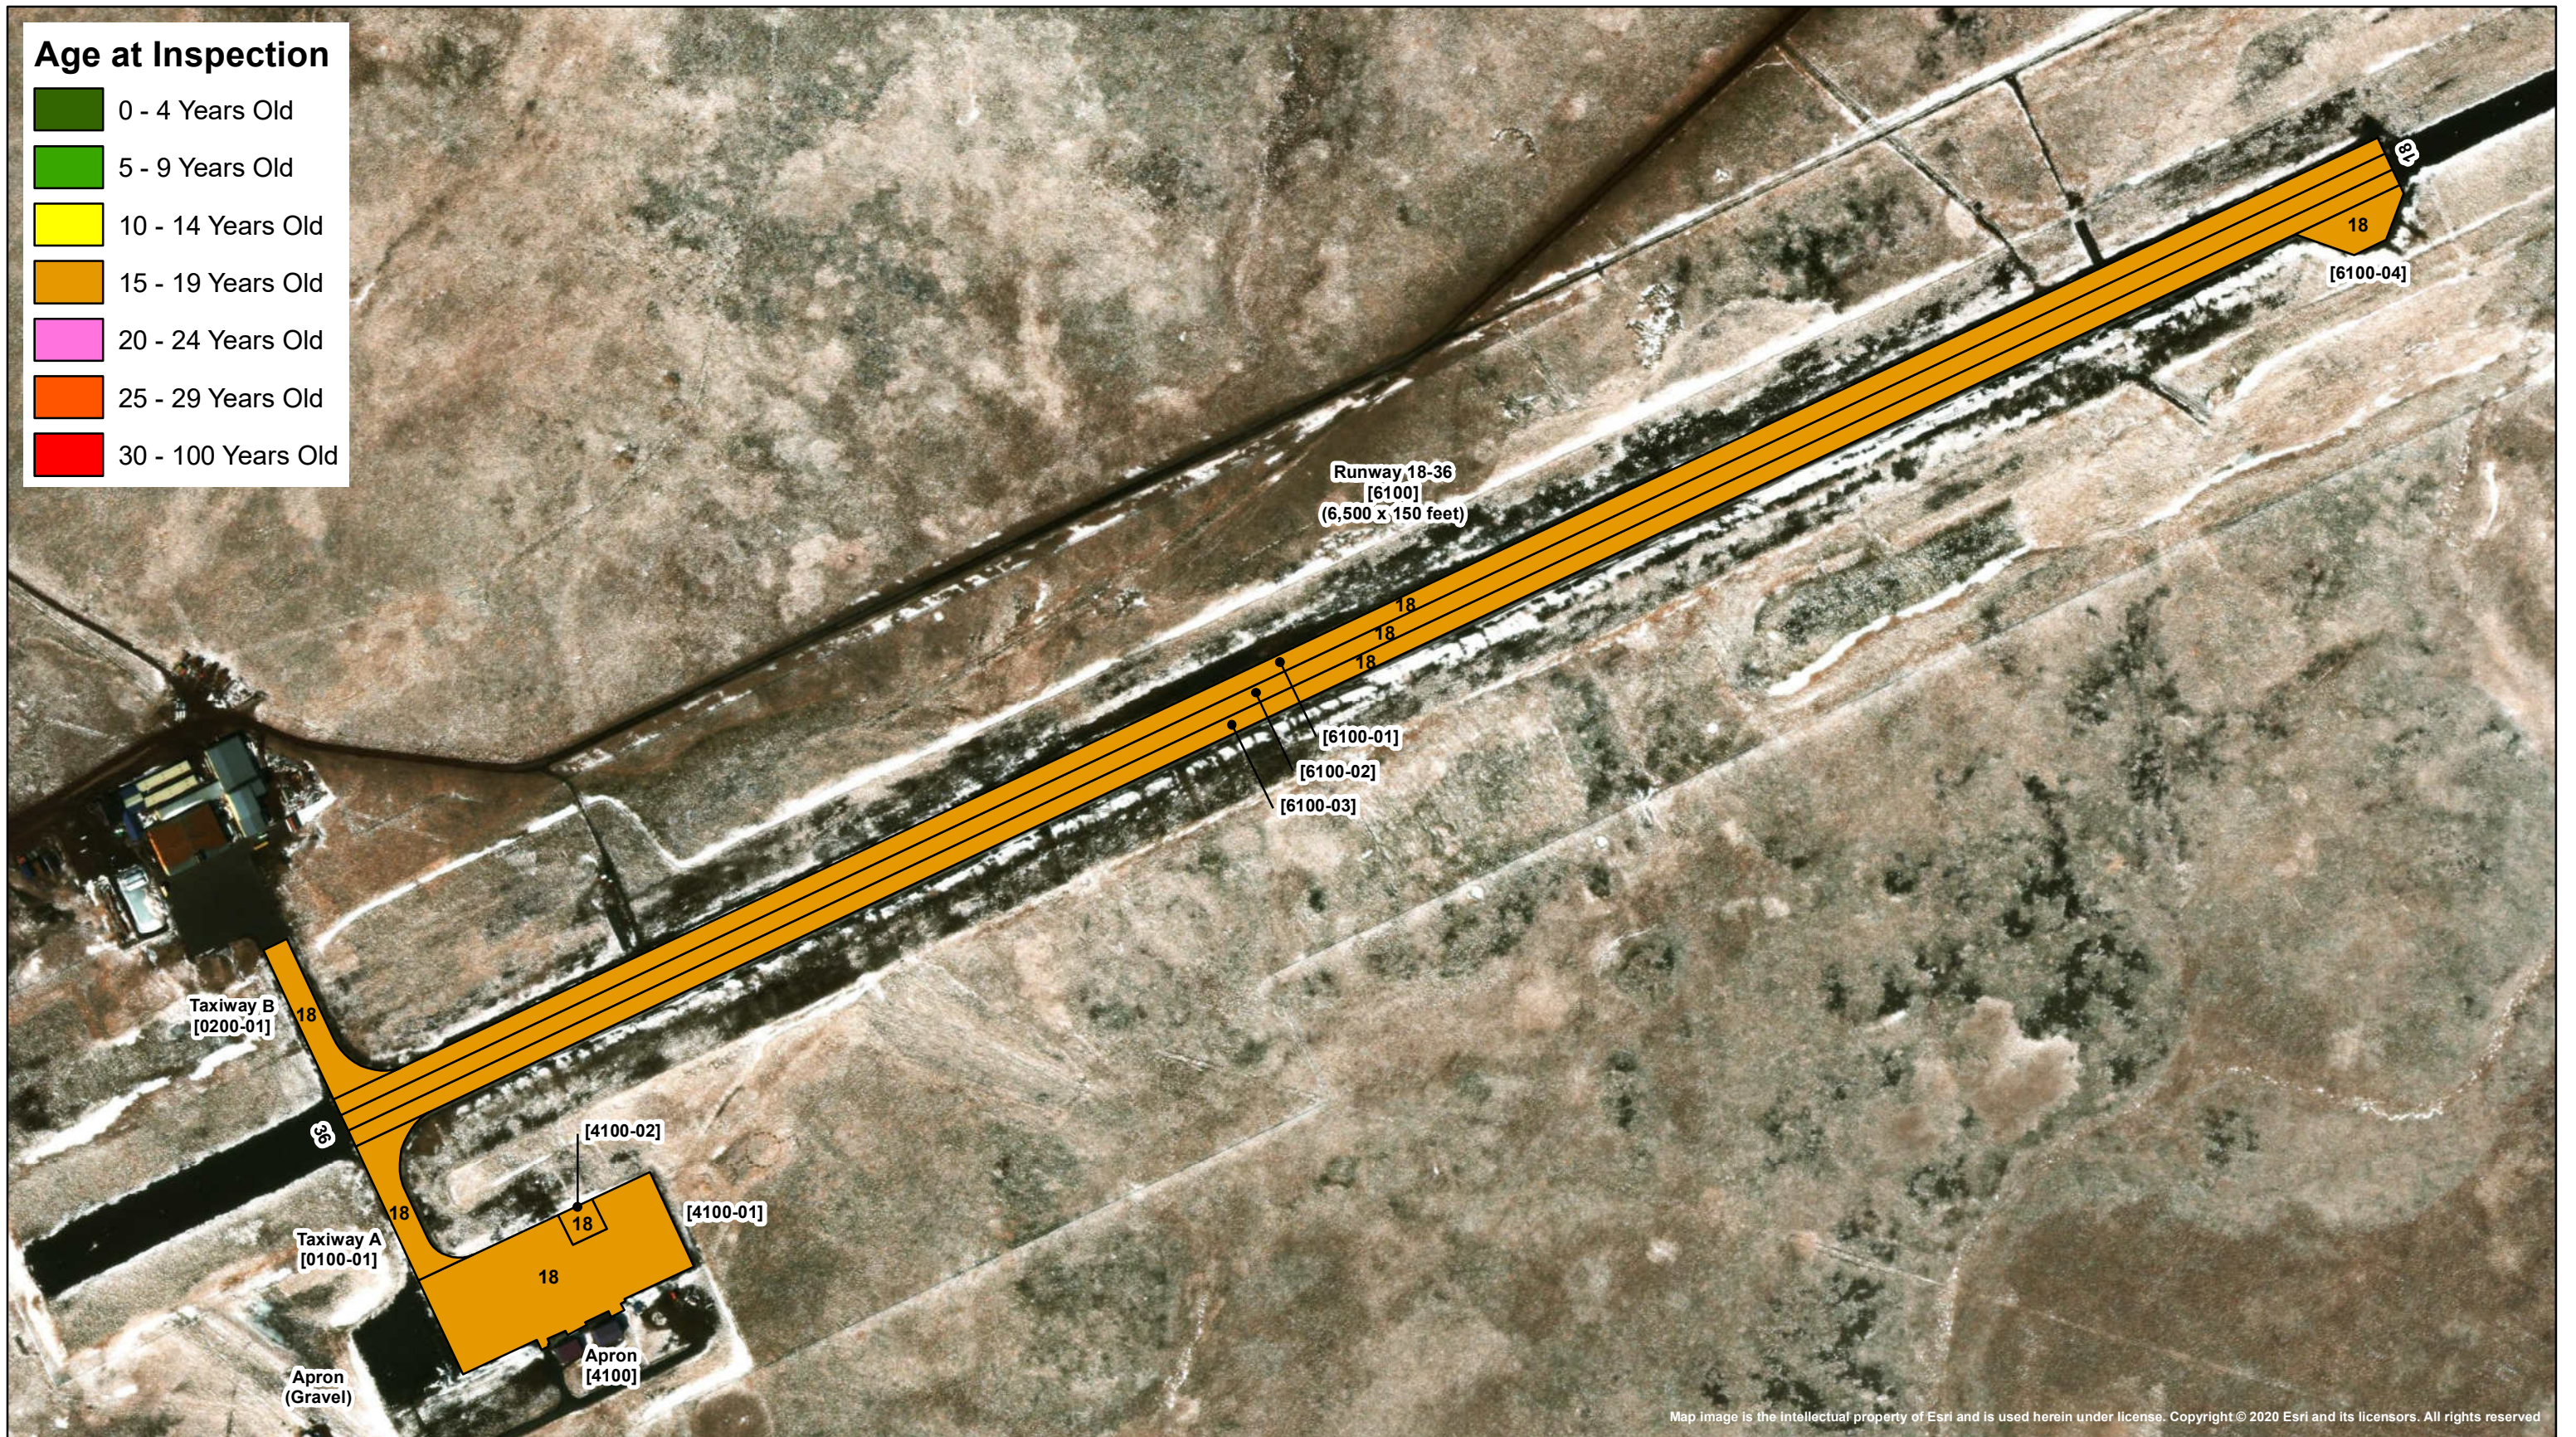
**Map 5 of 6**

### Pavement Age at Inspection

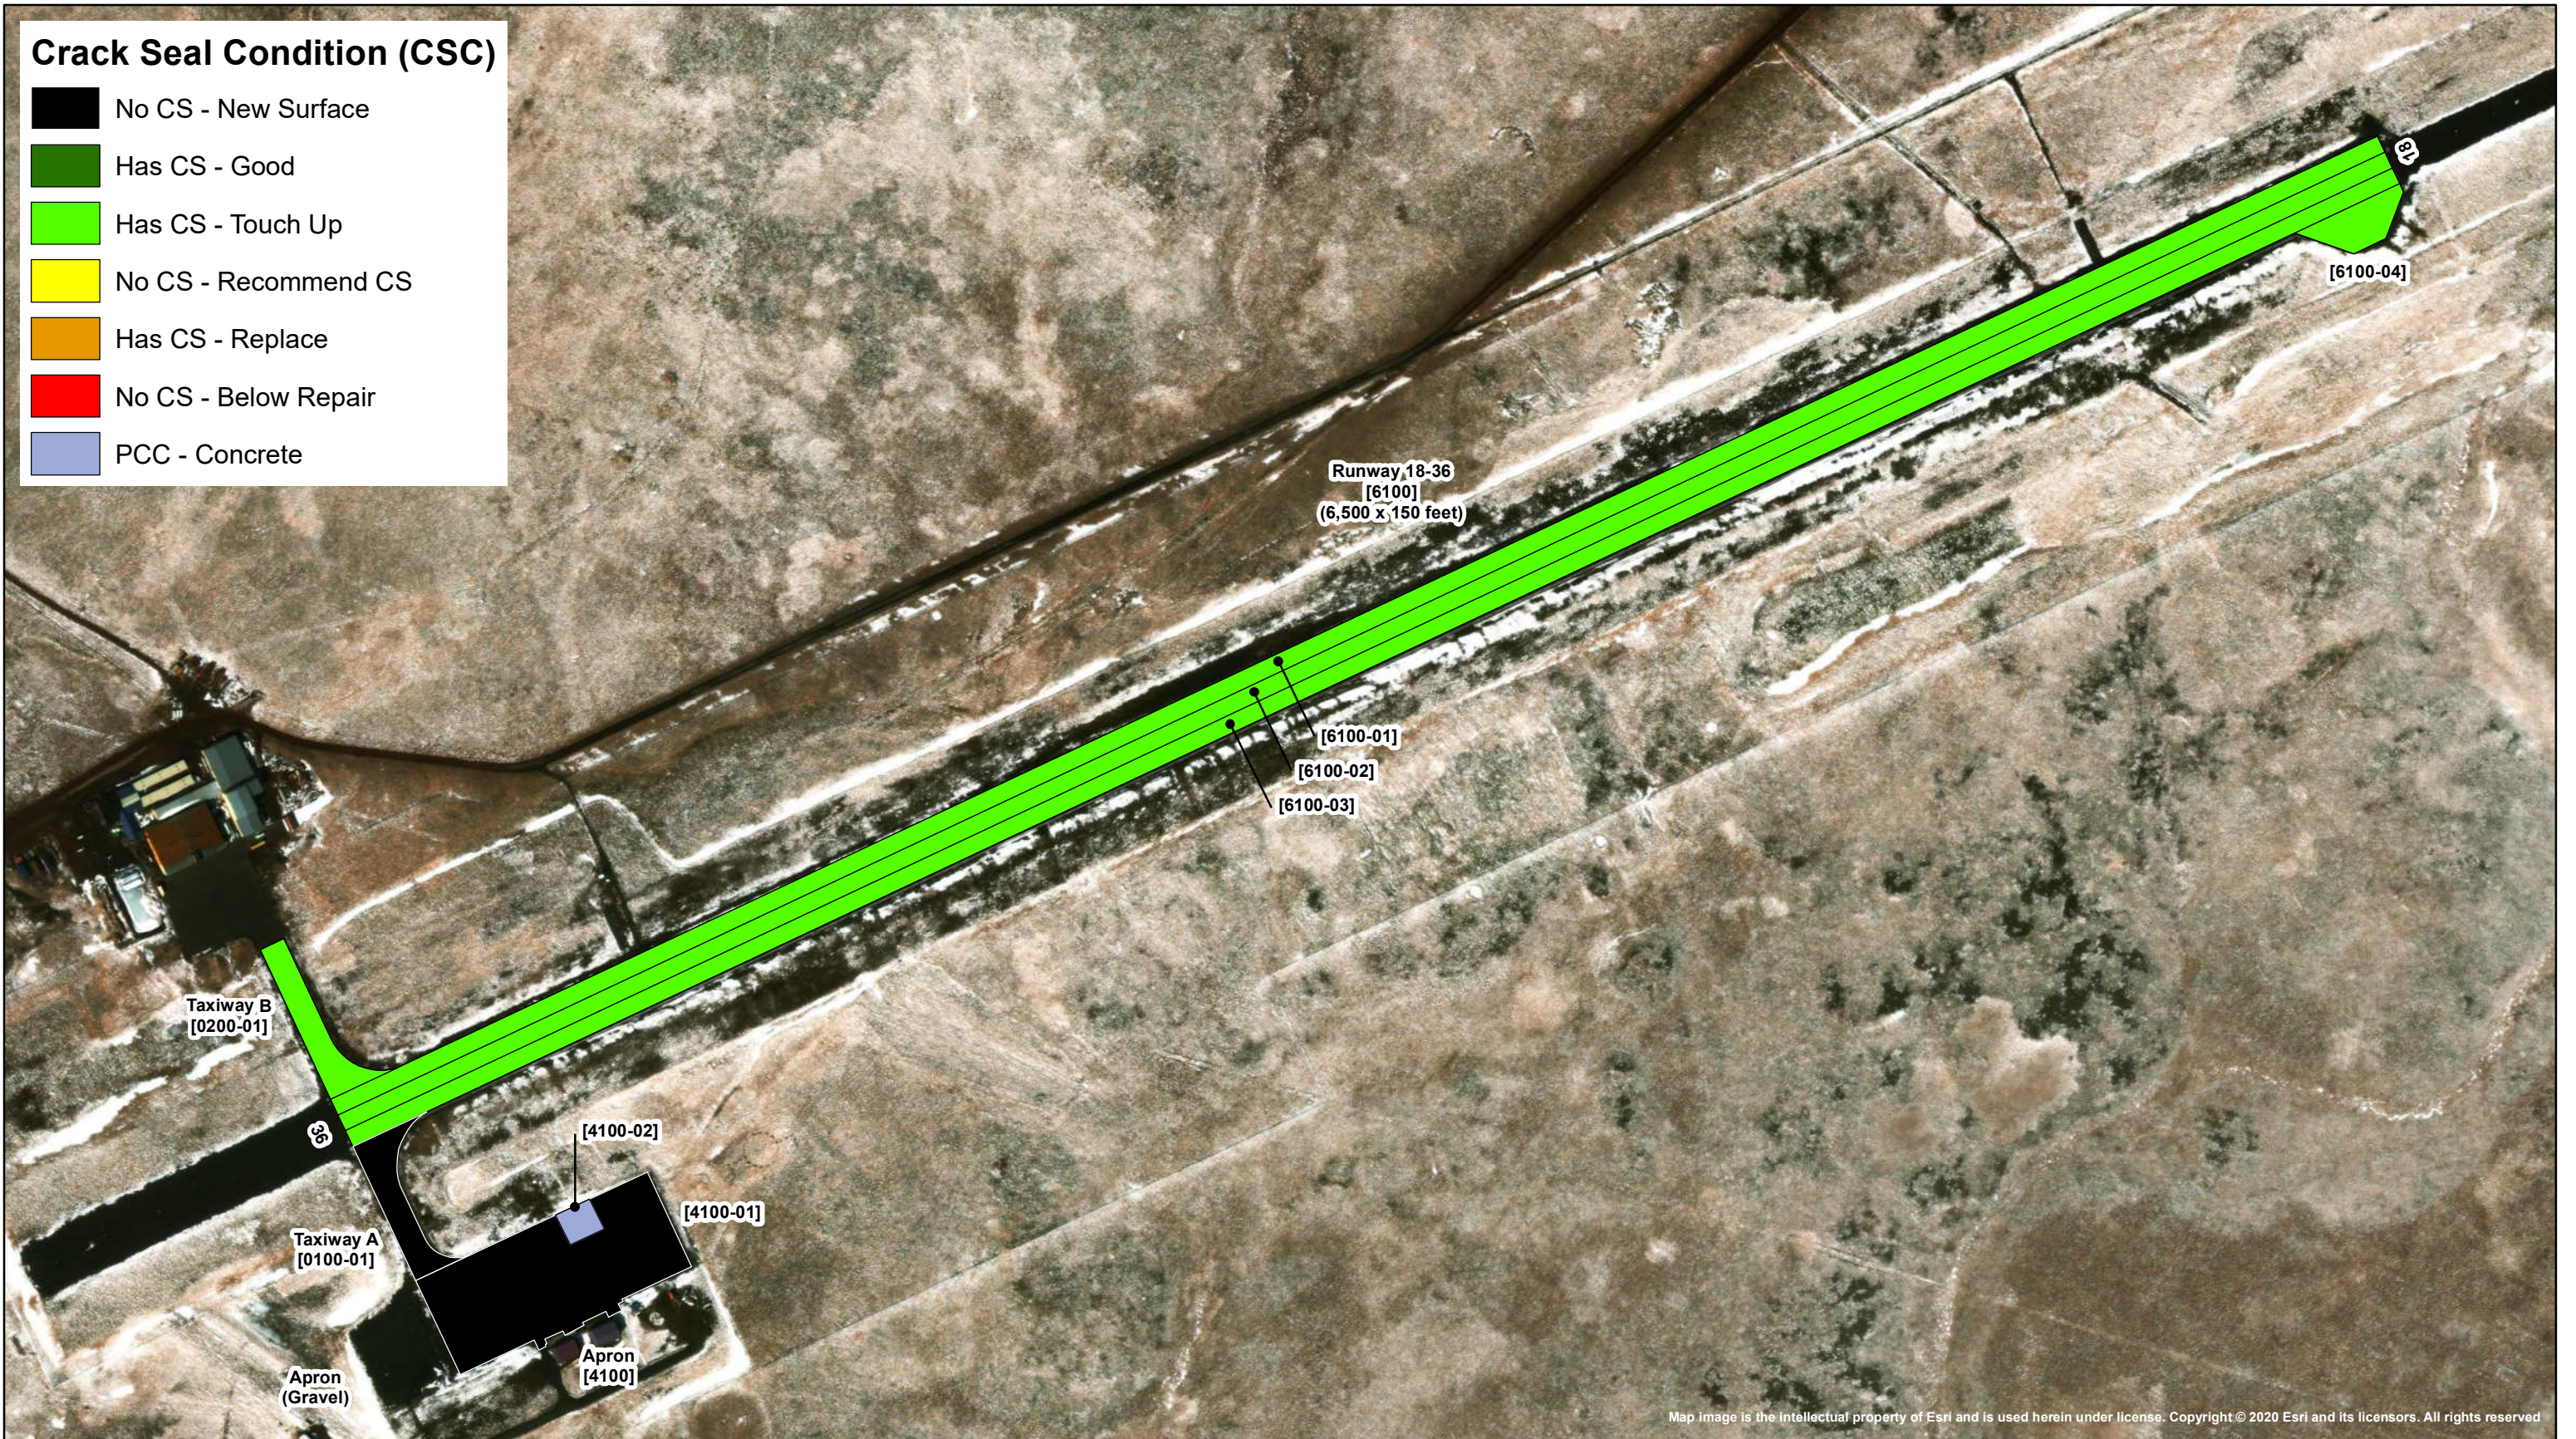
**Pavement Crack Seal Condition (CSC)**

Taxiway A was constructed in 2005 and has not received any major work since. Crack seal operations have not been performed on the branch. The most common distresses observed are low to medium severity raveling, and low severity weathering. Field observations include wearing of the pavements surface concentrated at the paving joints, and localized areas of raveling.

Like Taxiway A, Taxiway B was constructed in 2005 and has not received any major work since. Annual crack seal operations have been performed on the branch. The most common distresses observed are low severity longitudinal and transverse cracking, low to medium severity raveling, and low severity weathering. Field observations include wearing of the pavements surface concentrated at the paving joints, and localized areas of raveling.

The Apron consists of 2 sections, of which 1 is AC and 1 is PCC. The AC section was constructed in 2005 and has not received any major work since. Crack seal operations have not been performed on the branch. The most common distresses observed are low to medium severity raveling, and low severity weathering. Field observations include the degradation of the paving joints causing raveling to develop as well as localized areas of raveling across the apron.

The PCC section consists of a single hardstand constructed in 2005 and has not received major work since. The most common distresses observed are low to medium to high severity linear cracking, and high severity joint seal damage. Field observations show that 8 out of the 14 total slabs have a linear crack of various severities. Also, the joint sealant is failing as vegetation can be seen between the sealant and the concrete.

Runway 18/36 was constructed in 2005 and has not received any major work since. Annual crack seal operations have been performed, but the runway would benefit from another application. The most common distresses observed are low to medium severity longitudinal and transverse cracking, low to medium severity raveling, and low severity weathering. Field observations include development of new unfilled cracks, widening of previously filled cracks, and localized areas of increased severity and quantity of raveling throughout.
