Alaska DOT&PF

Pavement Inspection Report Seward Airport

Seward Airport
Airport Code: SWD

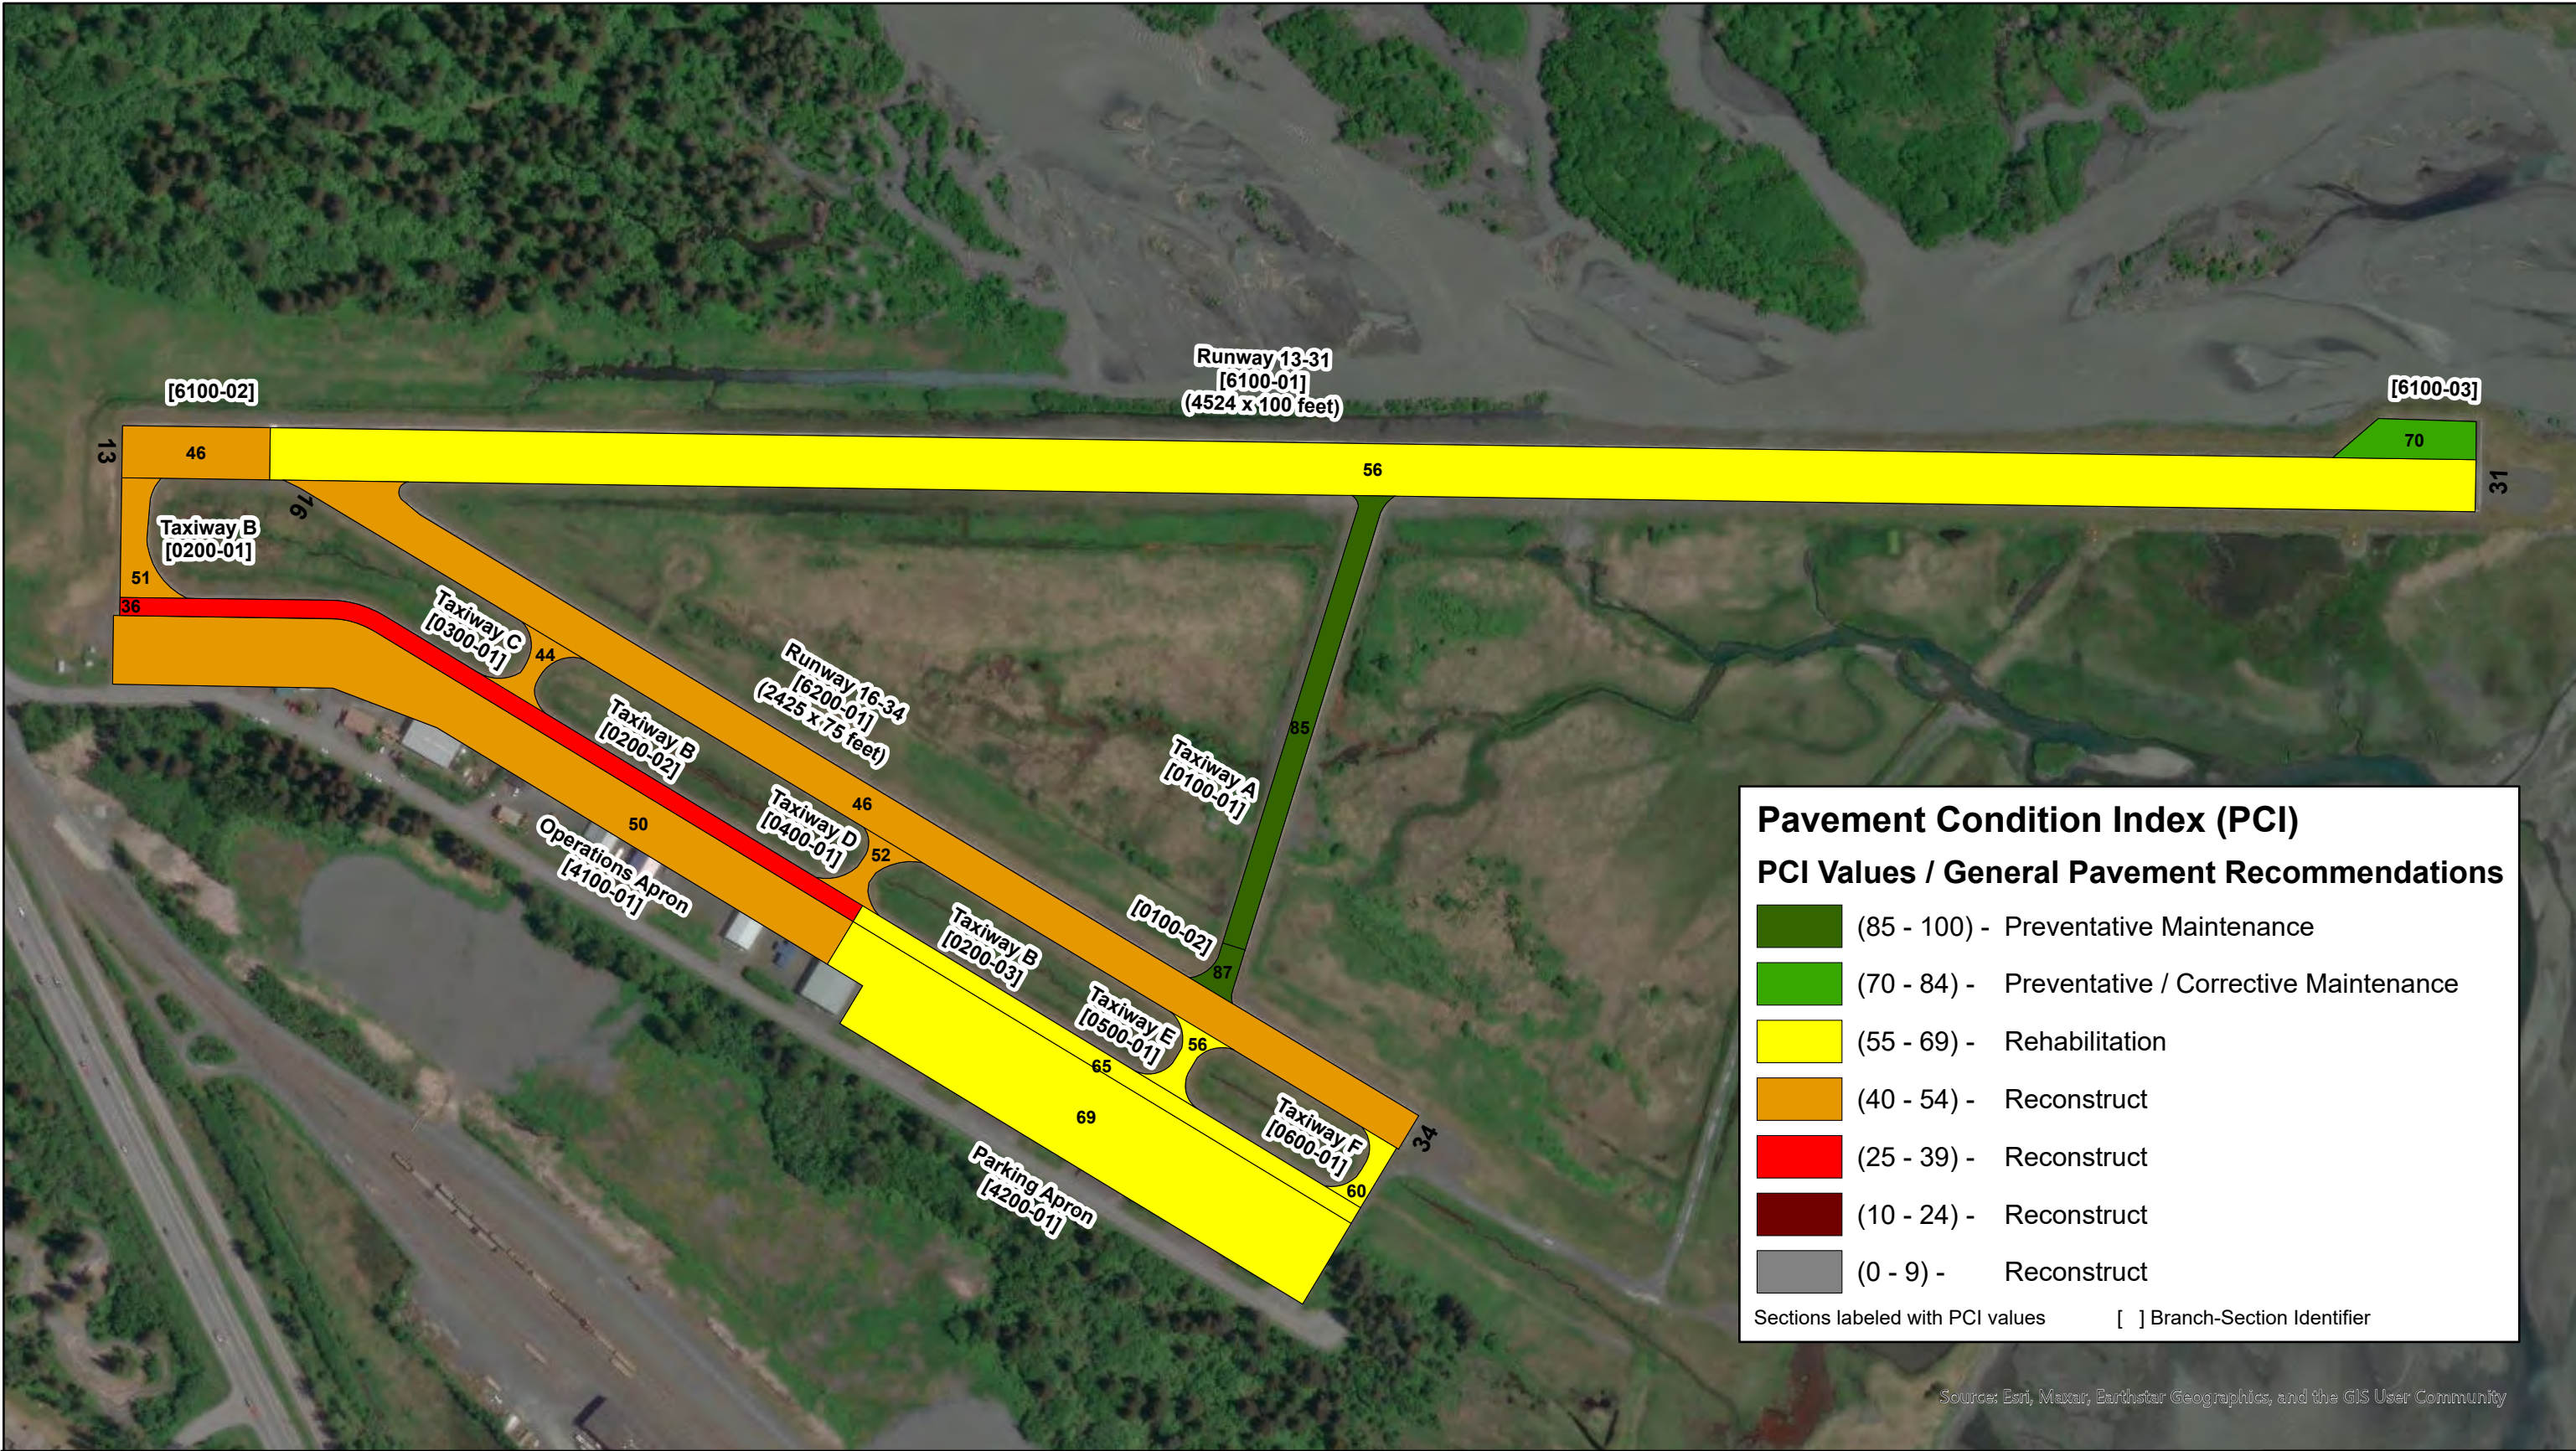
Map 1 of 6

Pavement Condition Index (PCI)
Target PCI Range for Runways: 70 to 100
Target PCI Range for Taxiways and Aprons: 60 to 100

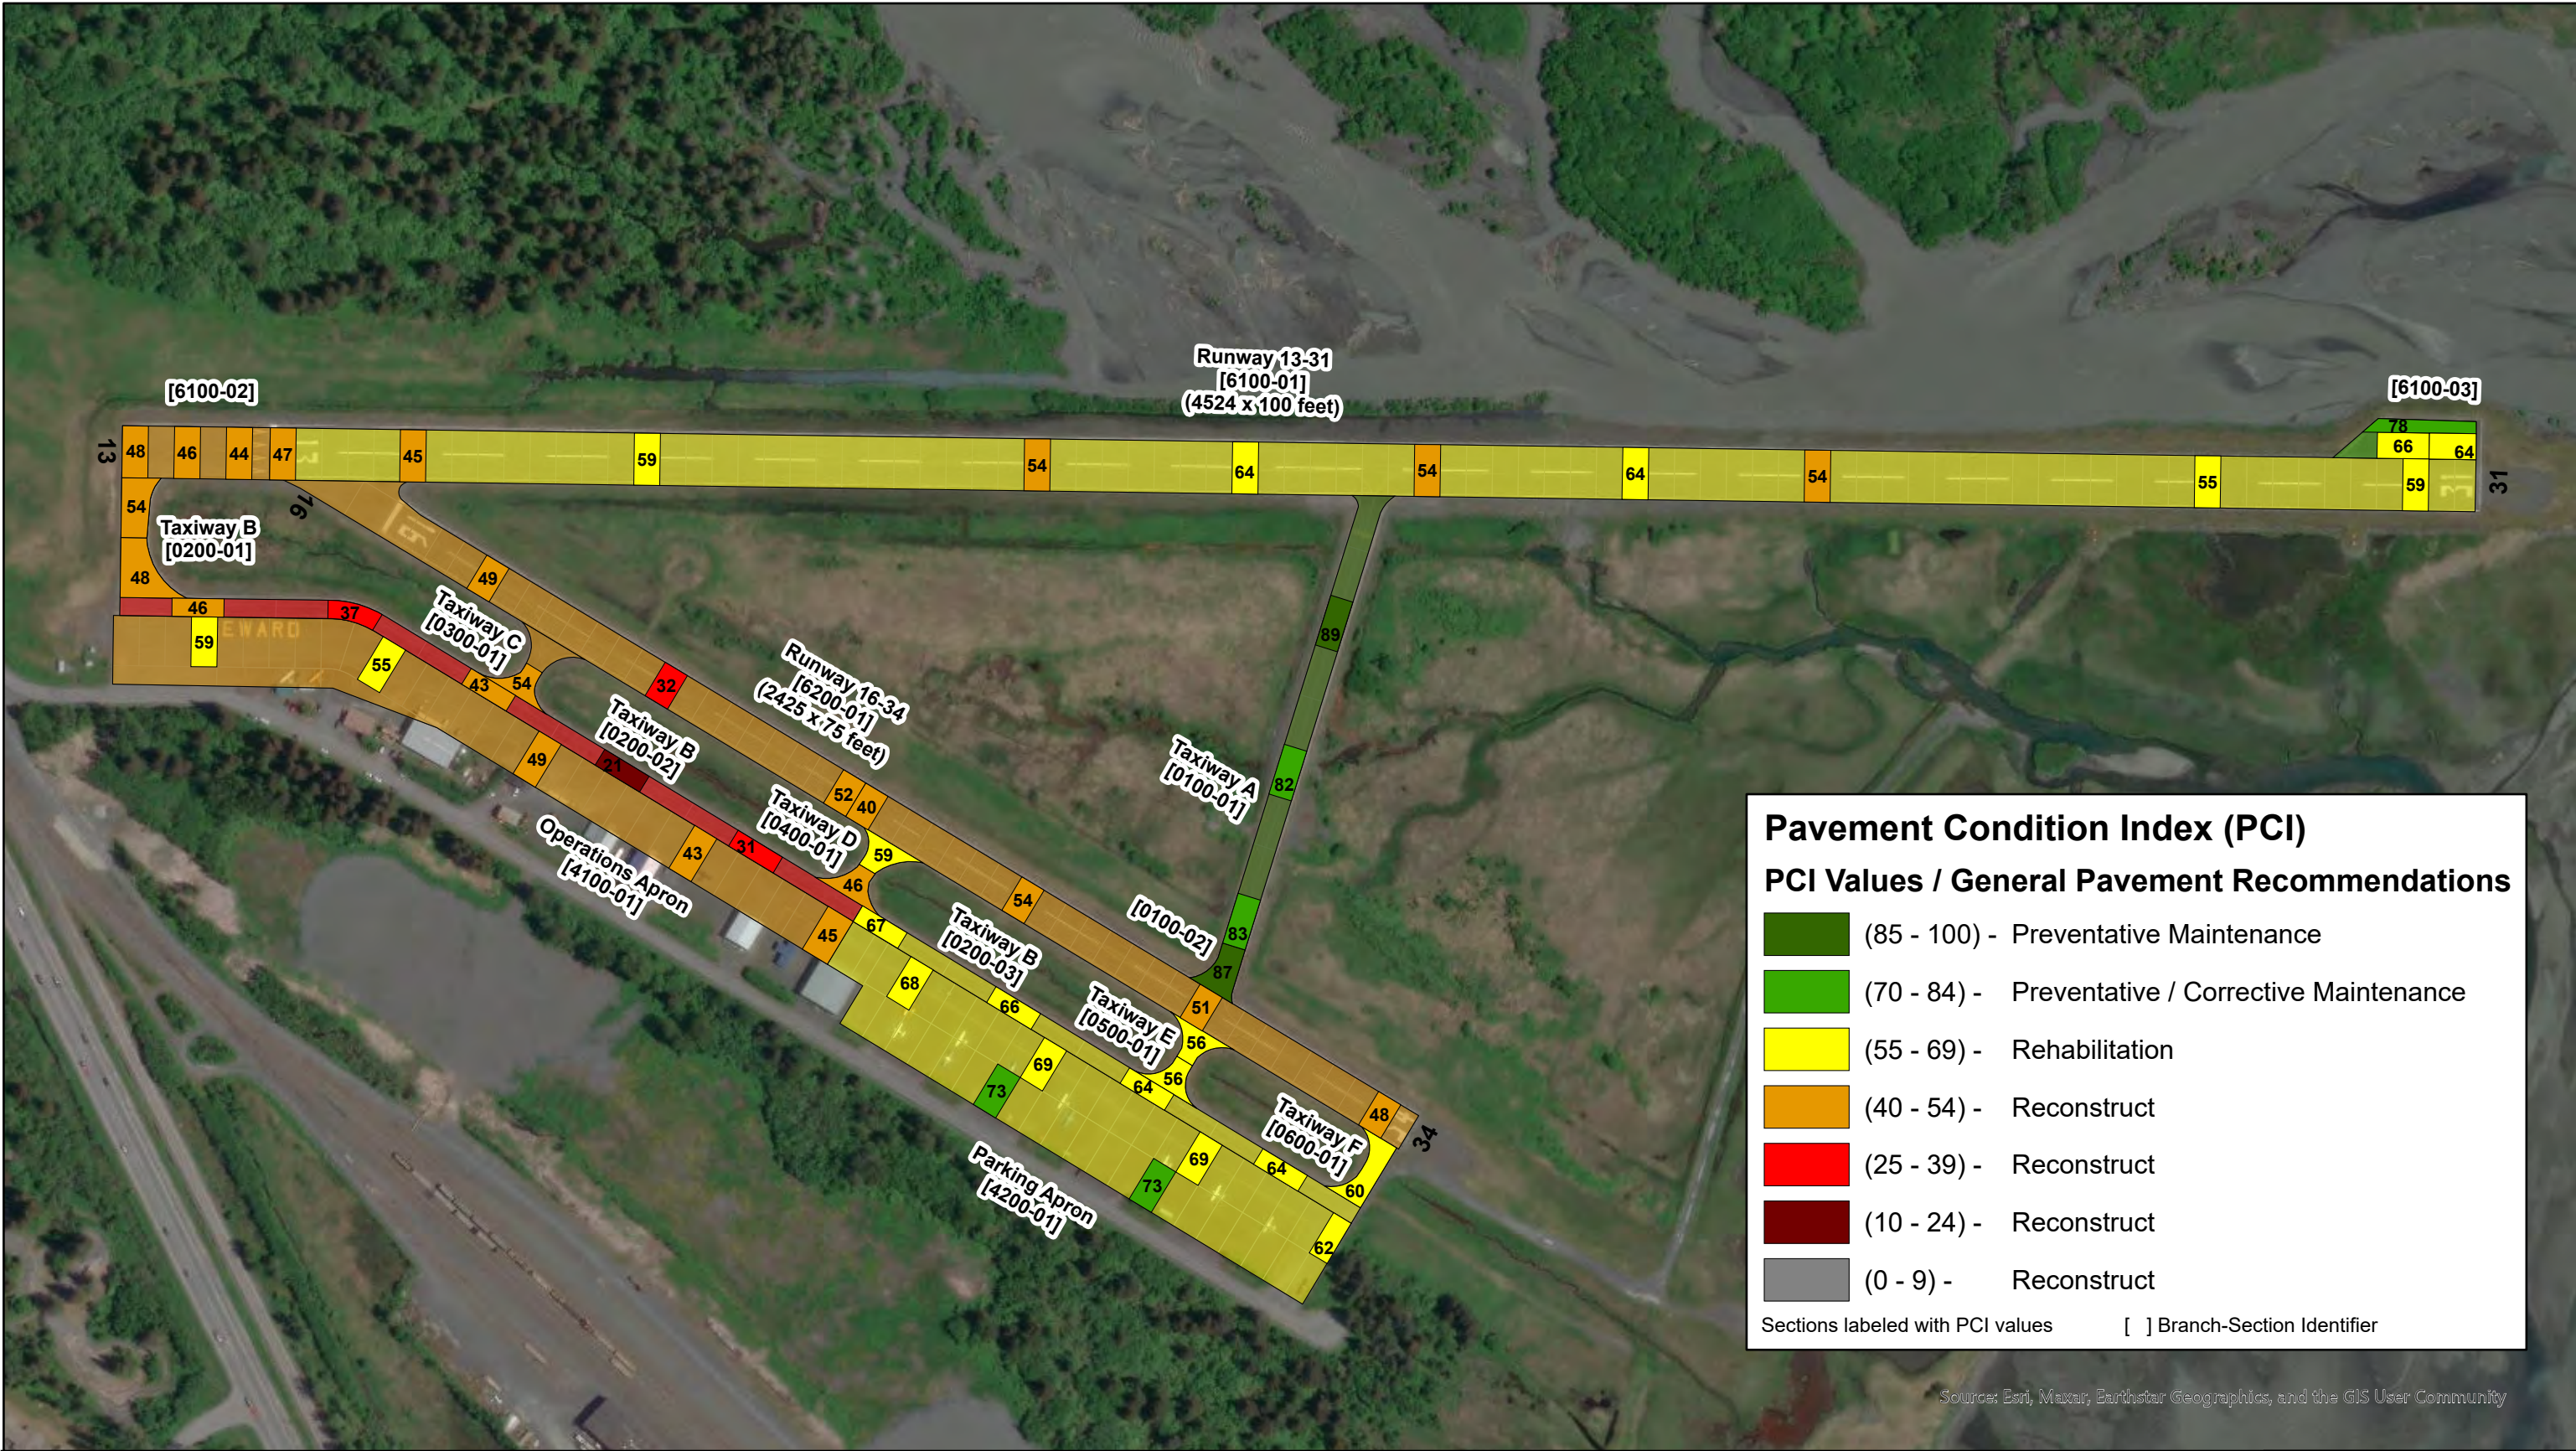
Map 2 of 6

Sample Unit
Pavement Condition Index (PCI)

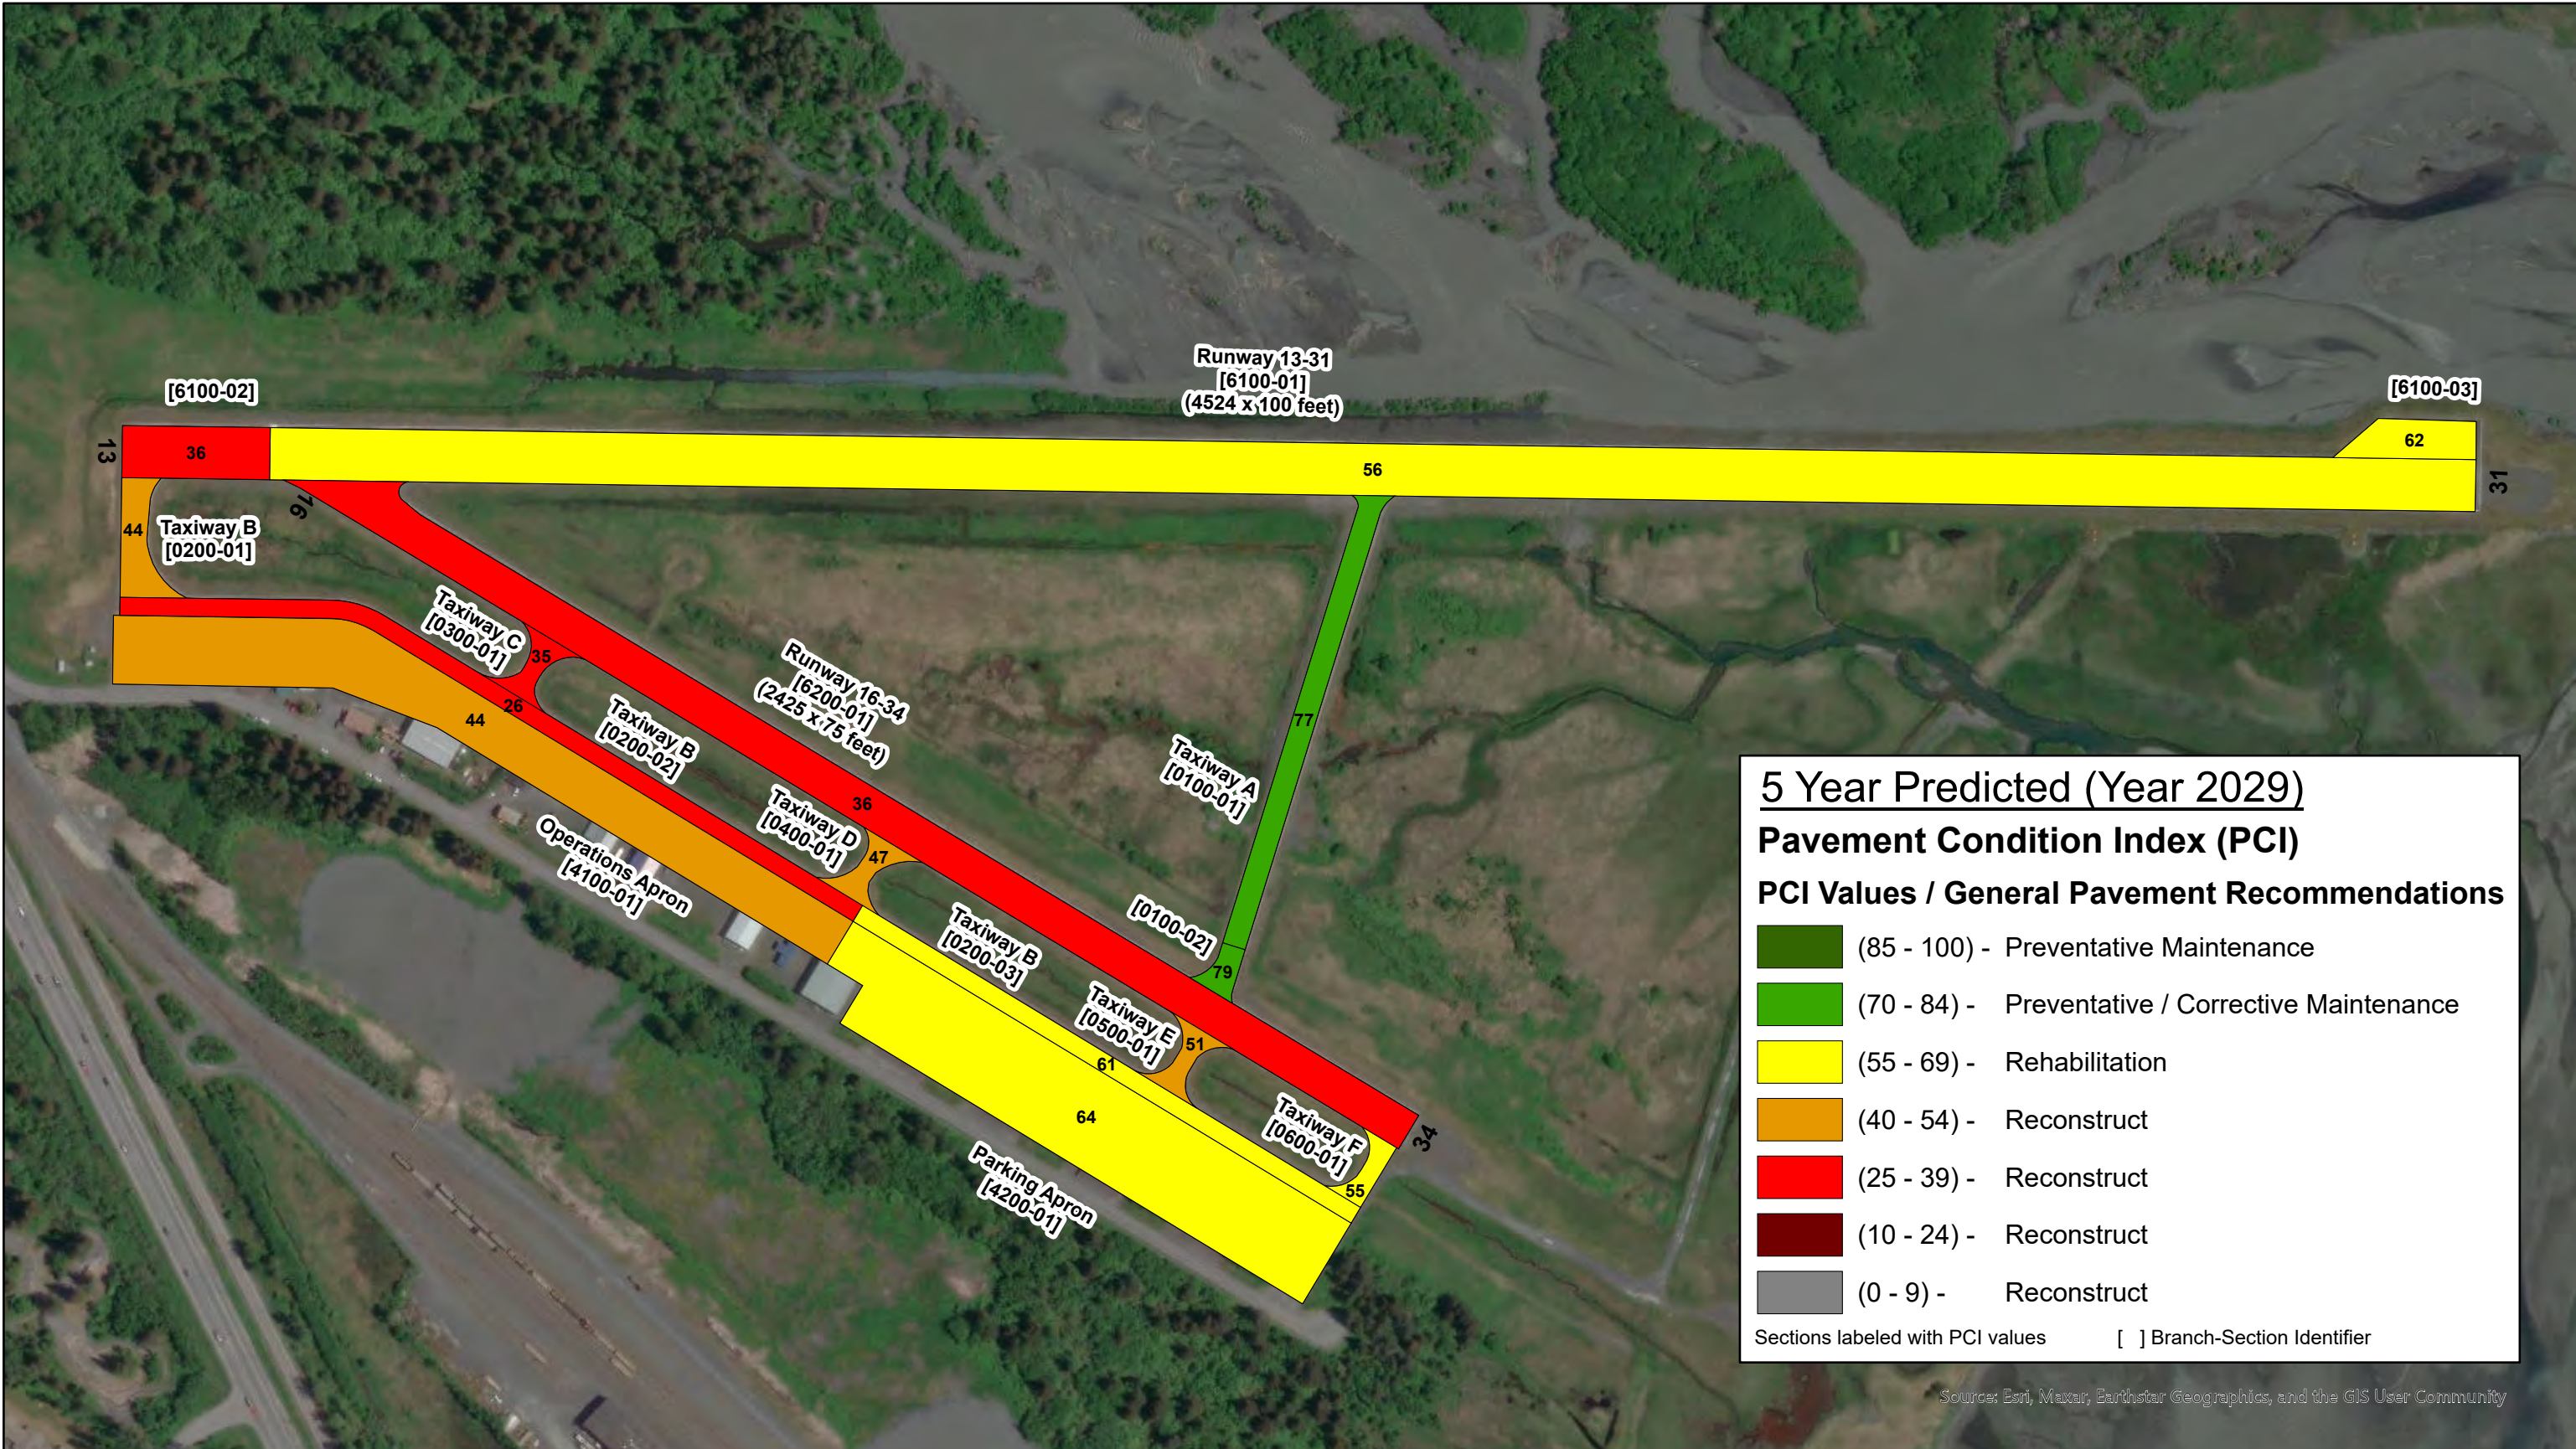
Map 3 of 6

**5 Year Predicted
Pavement Condition Index (PCI)**
Target PCI Range for Runways: 70 to 100
Target PCI Range for Taxiways and Aprons: 60 to 100

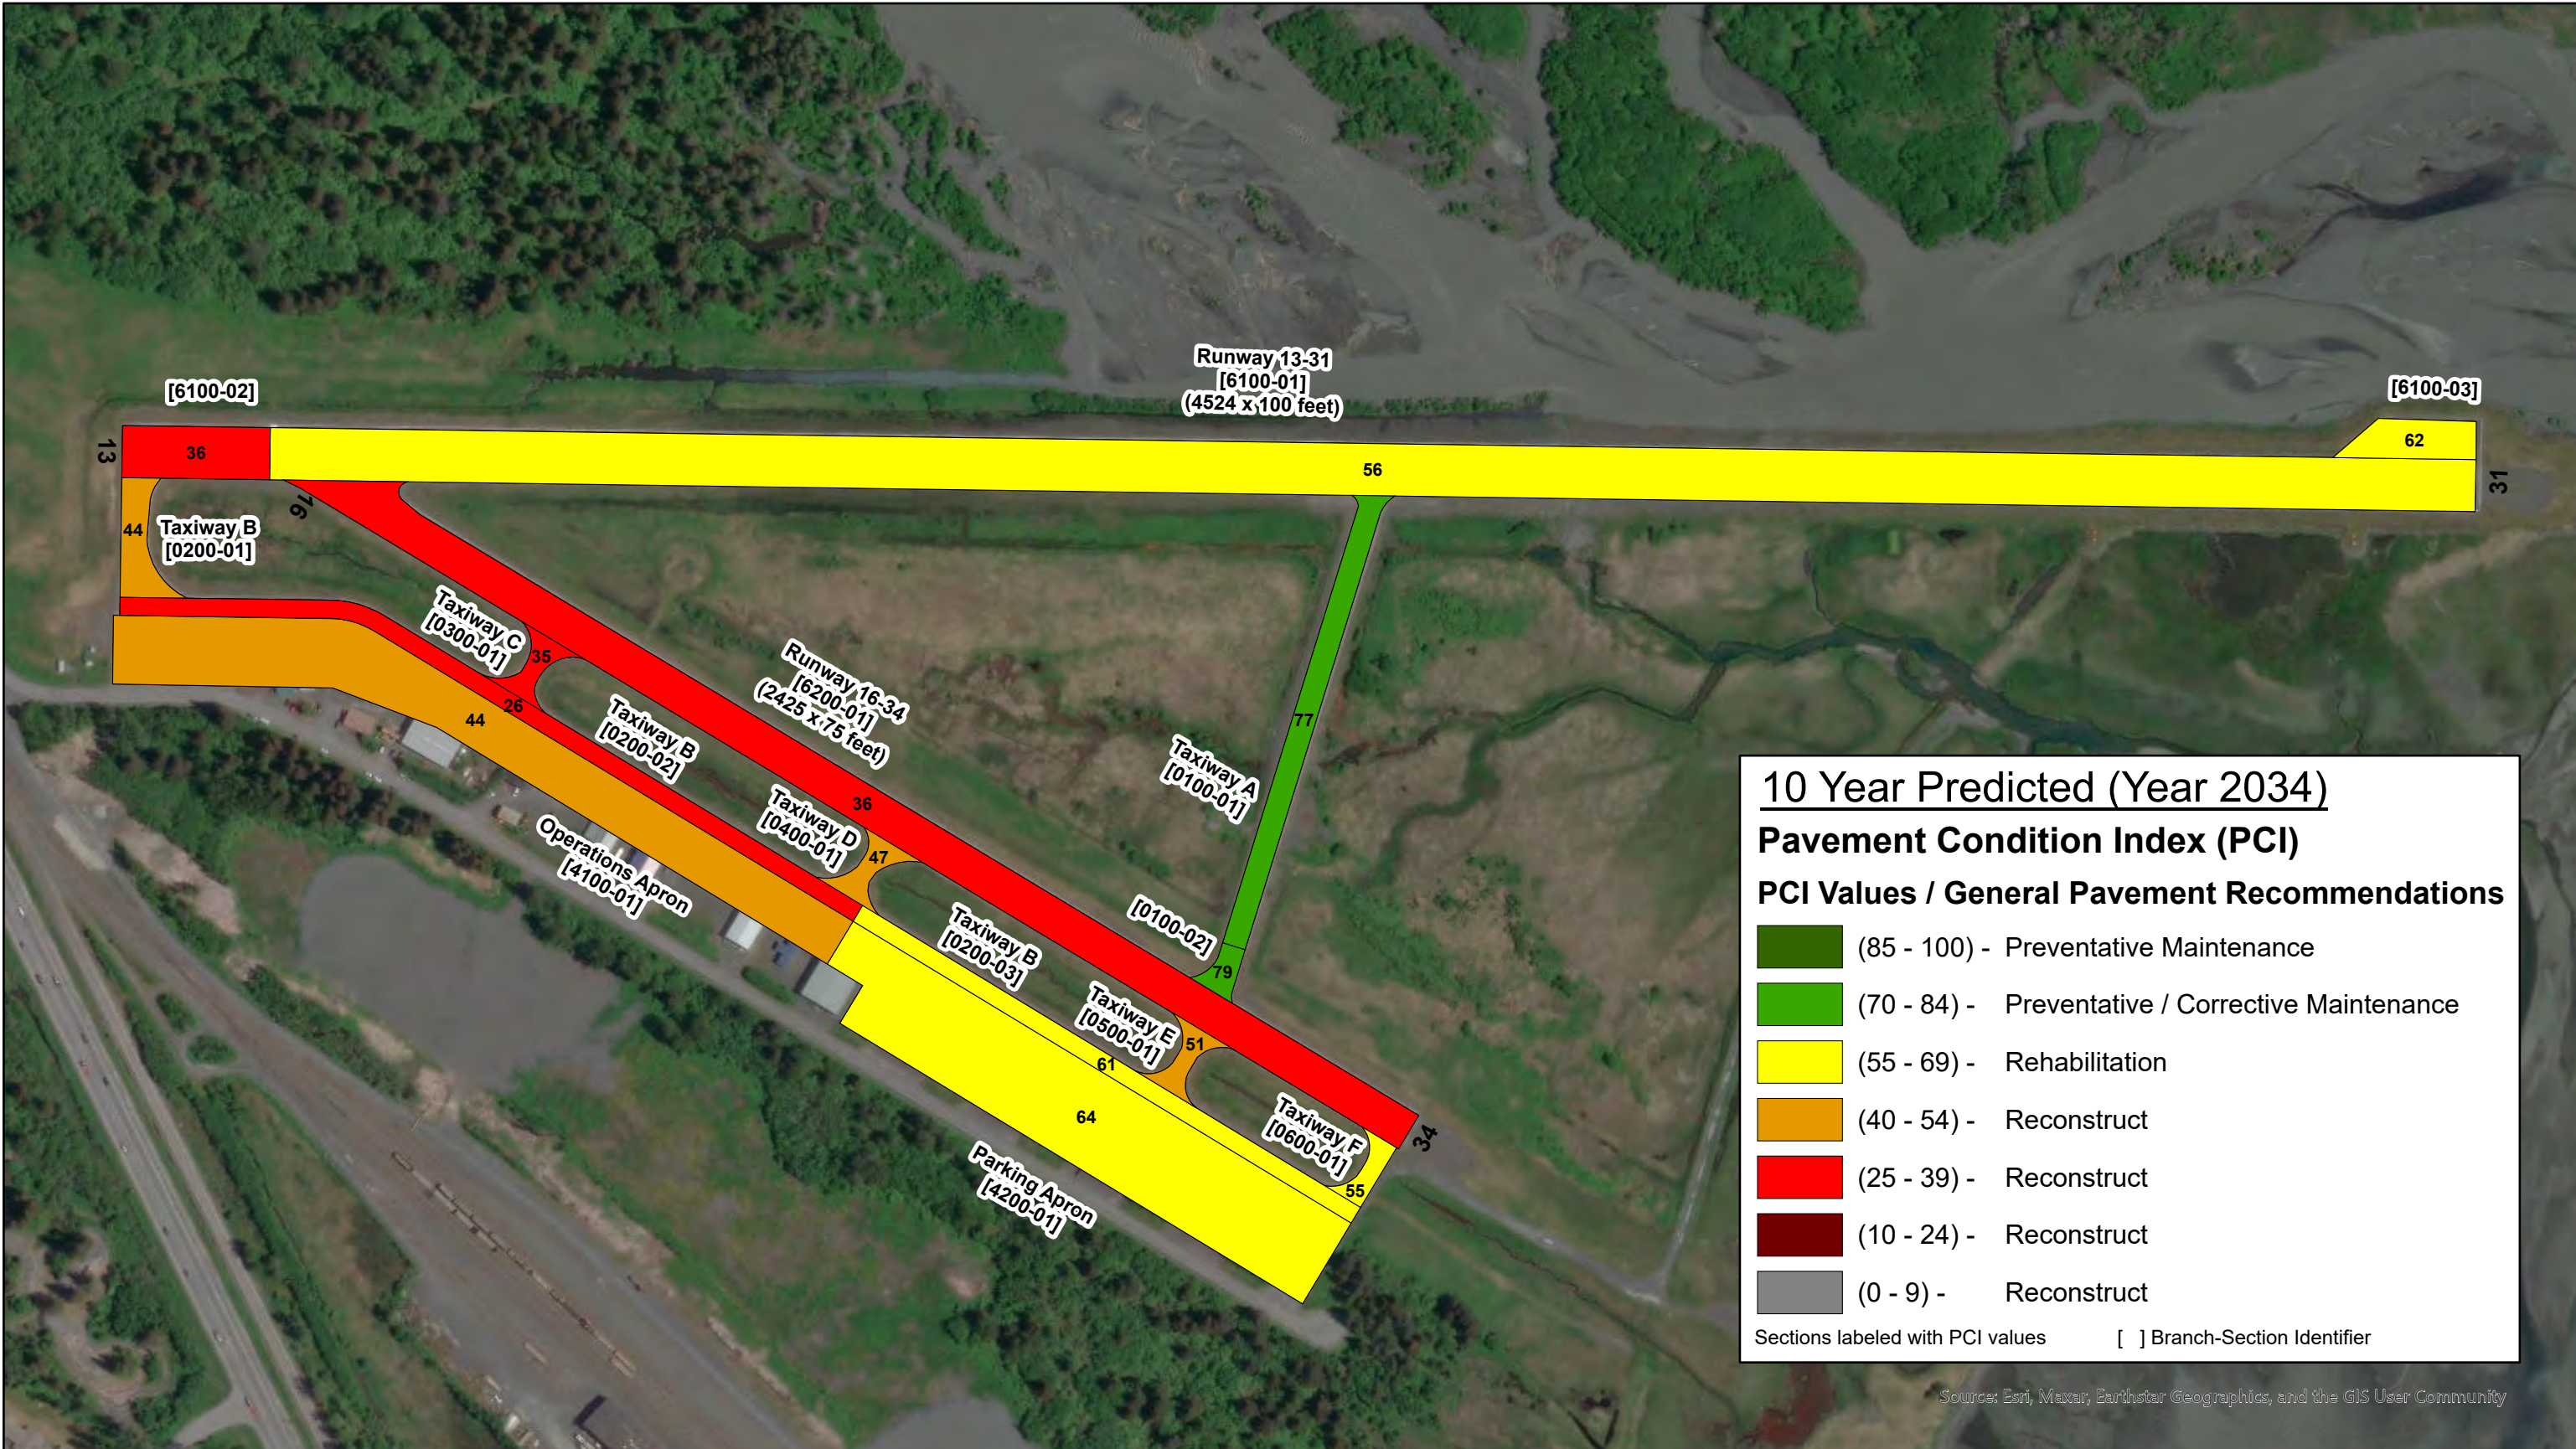
**10 Year Predicted
Pavement Condition Index (PCI)**
Target PCI Range for Runways: 70 to 100
Target PCI Range for Taxiways and Aprons: 60 to 100

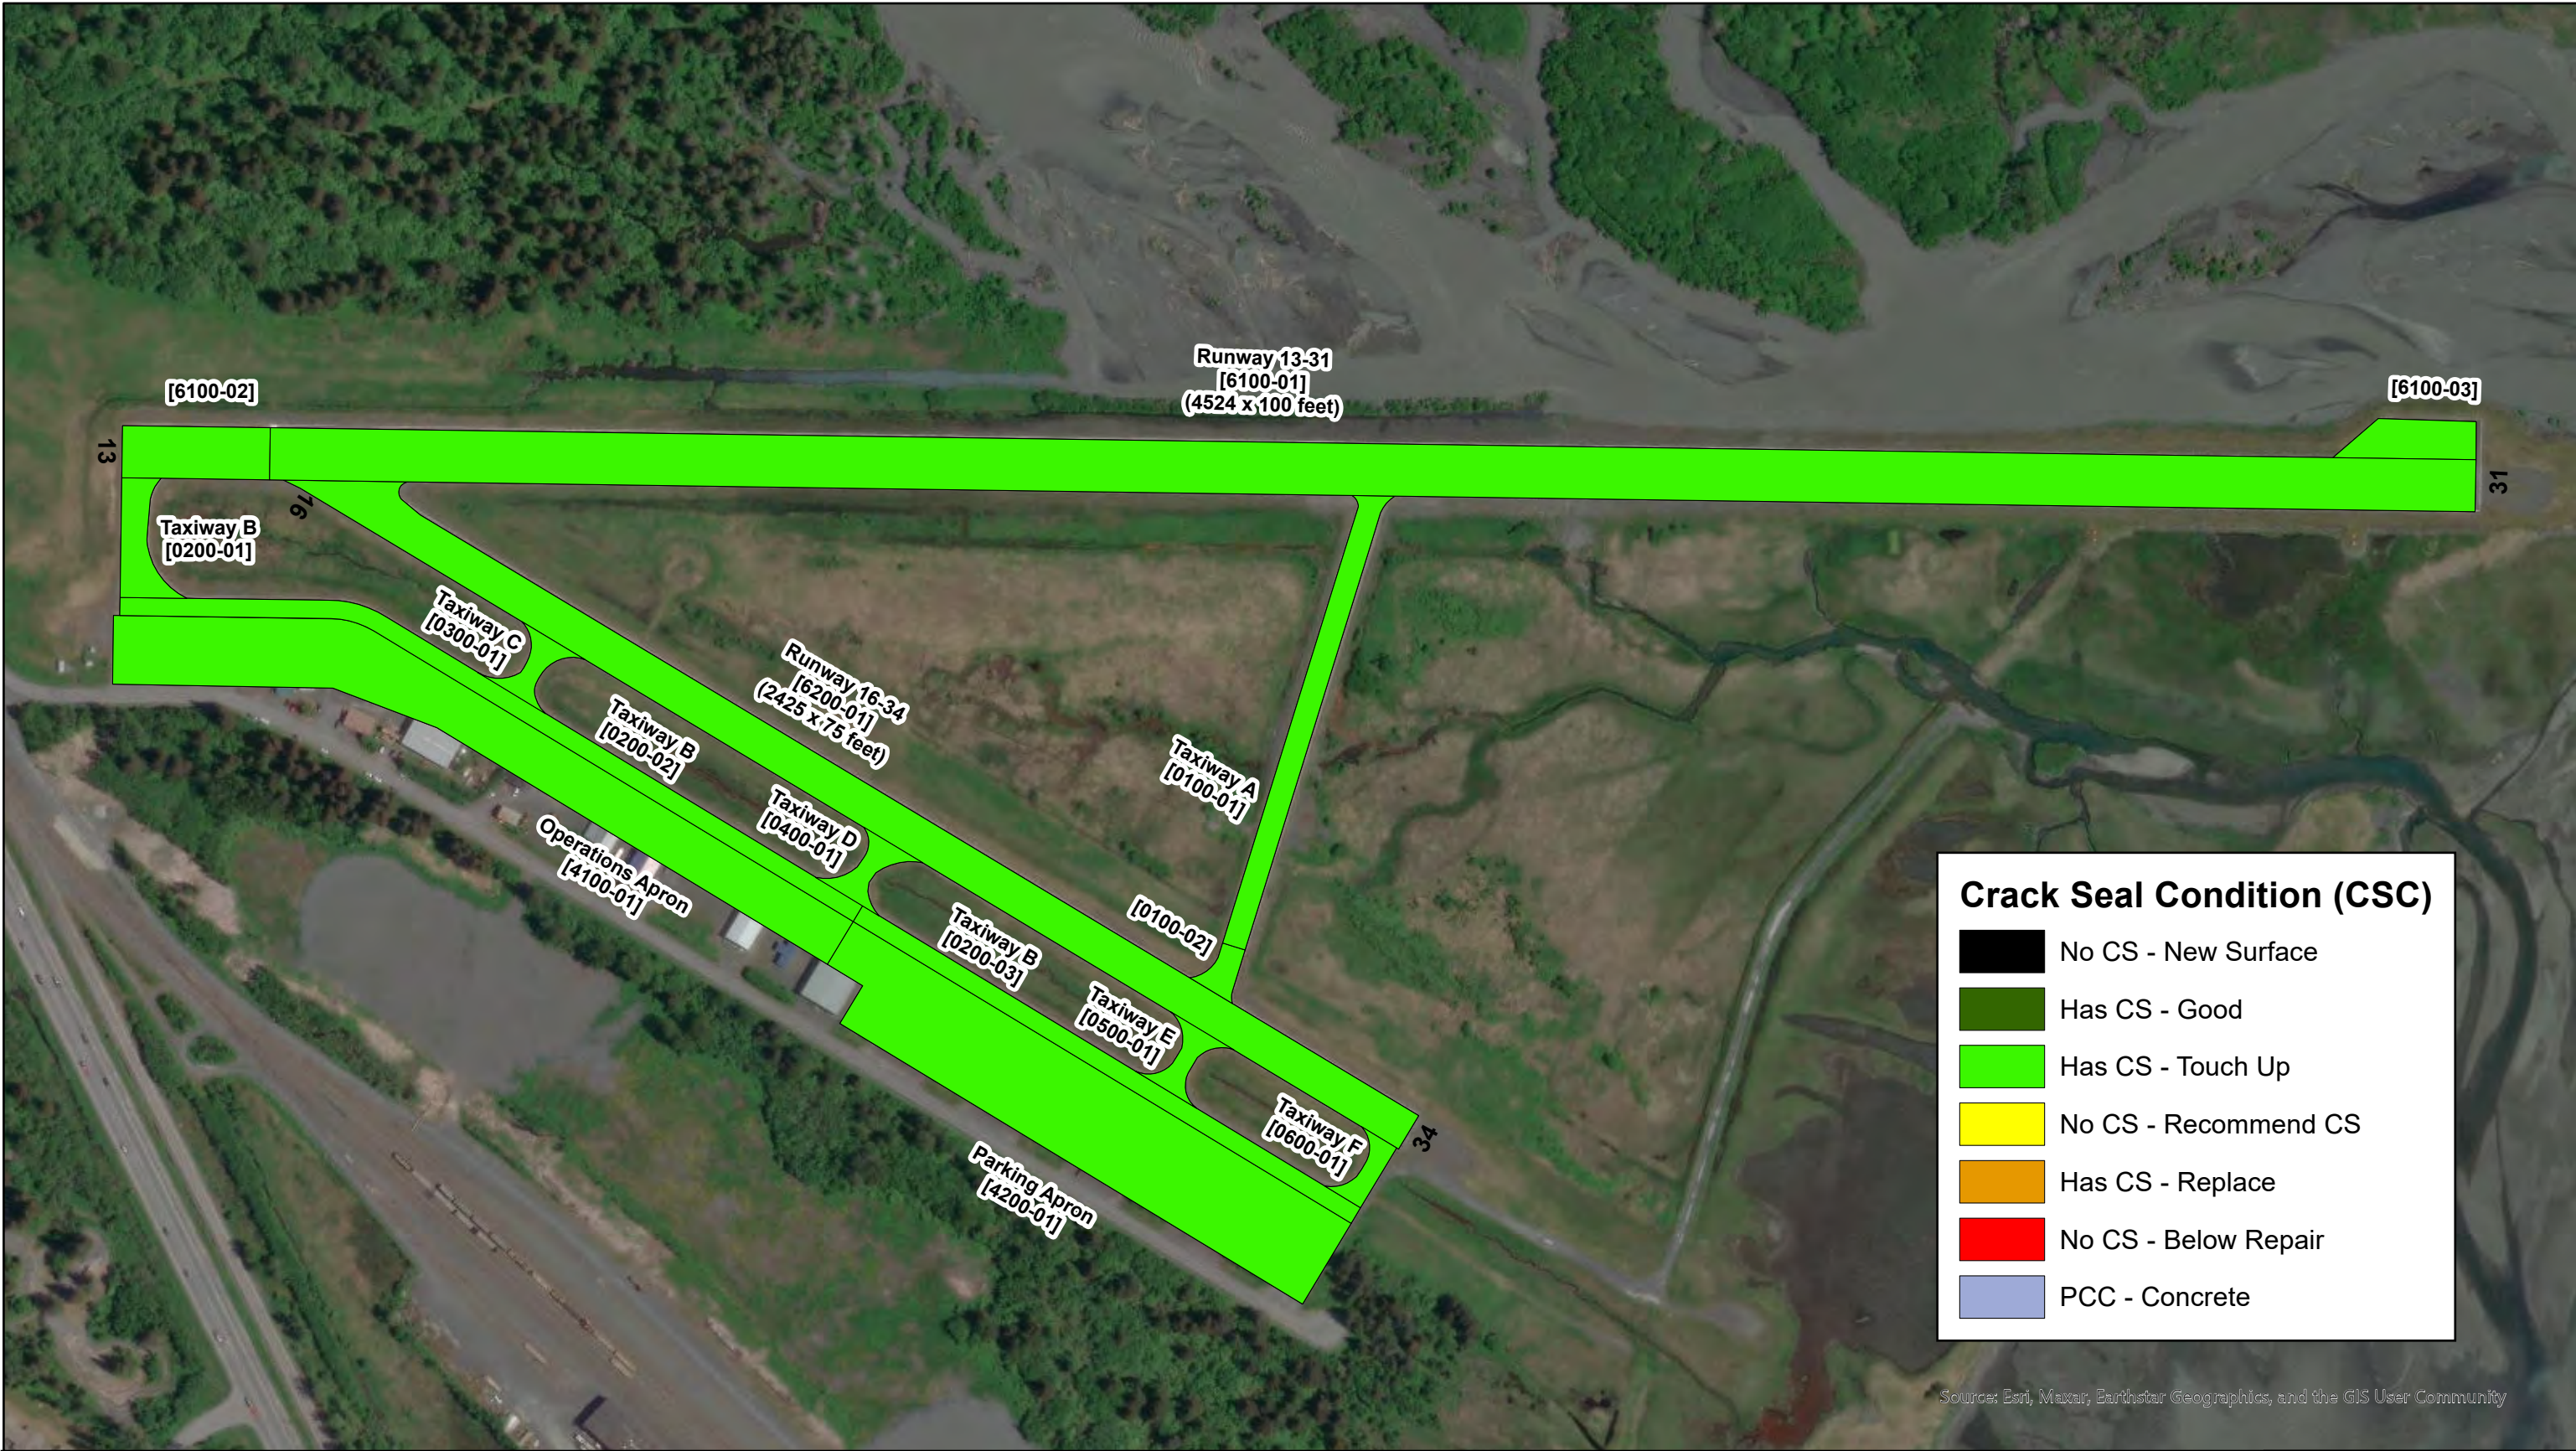
Pavement Crack Seal Condition (CSC)
