Alaska DOT&PF

Pavement Inspection Report Wasilla Airport

Airport Name	IATA	ICAO	Latitude	Longitude	Elevation (ft)
Wasilla Airport	IYS	PAWS	61° 34' 19.15" N	149° 32' 22.4" W	353.5

Point of Contact	Phone	Email	Date Inspected	Date Published
Mr. Andrew Pavey, Pavement Management Engineer	(907) 269 6213	andrew.pavey@alaska.gov	July 2024	February 2025

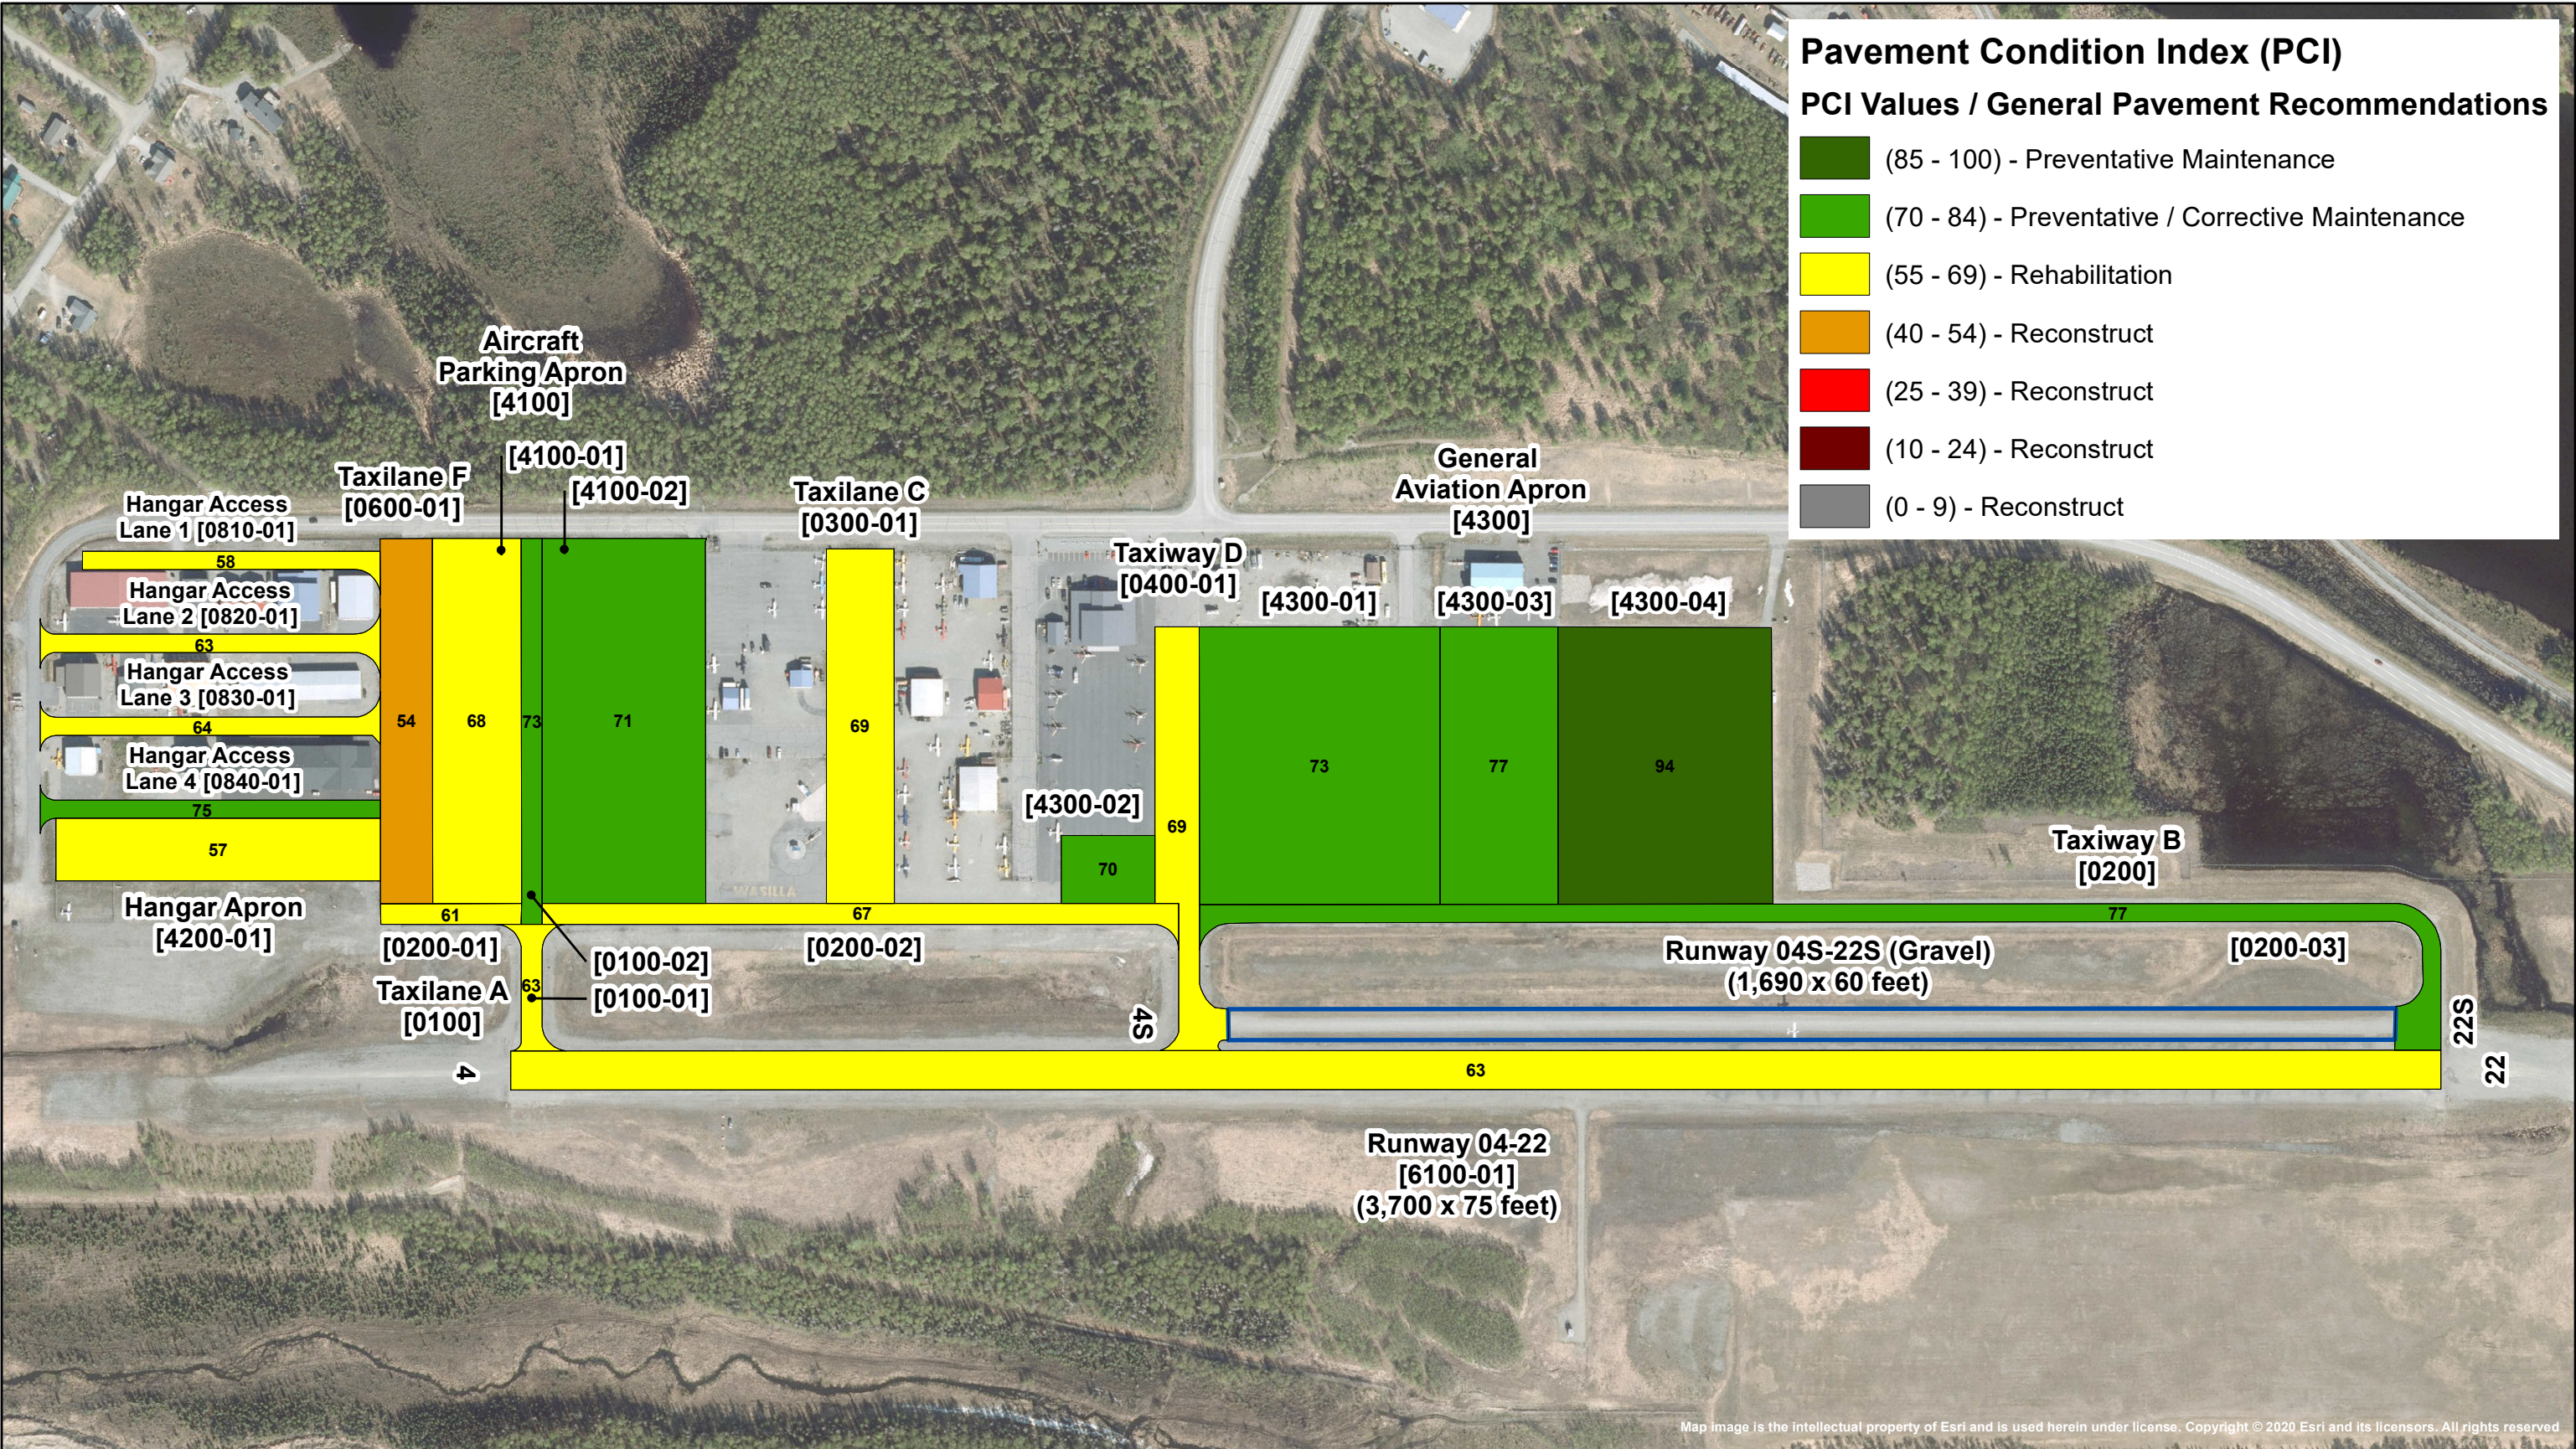
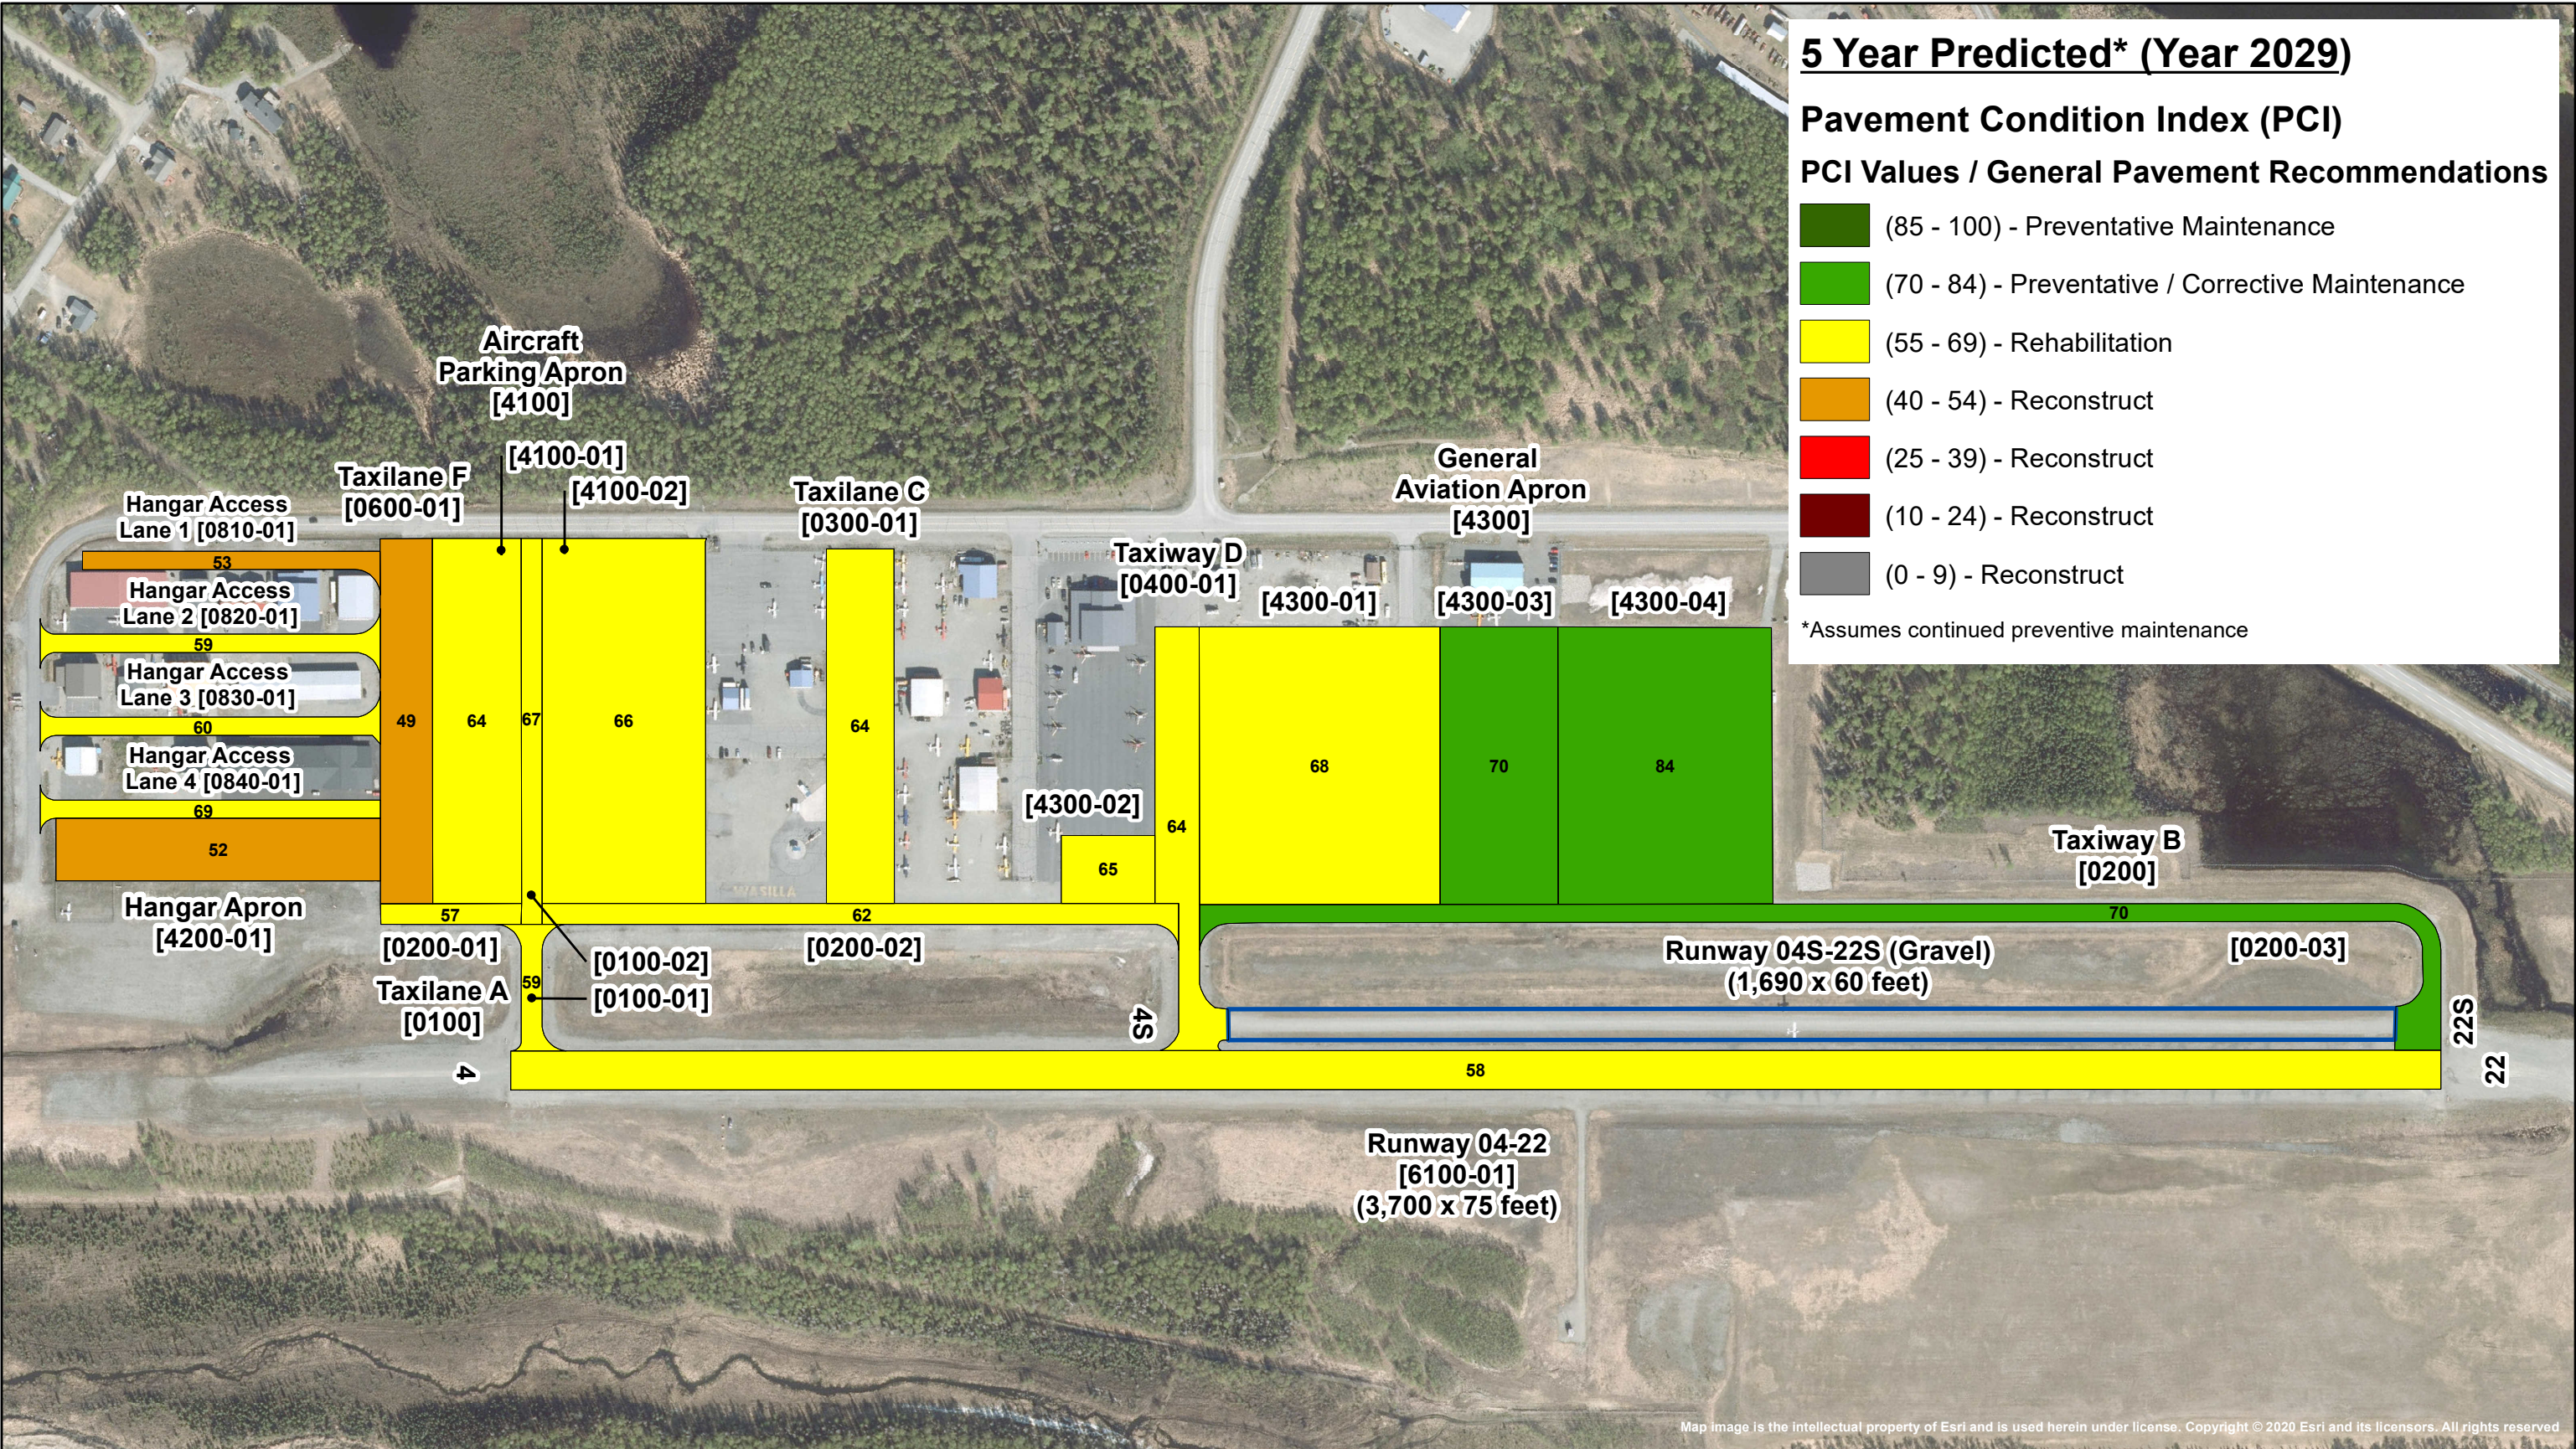
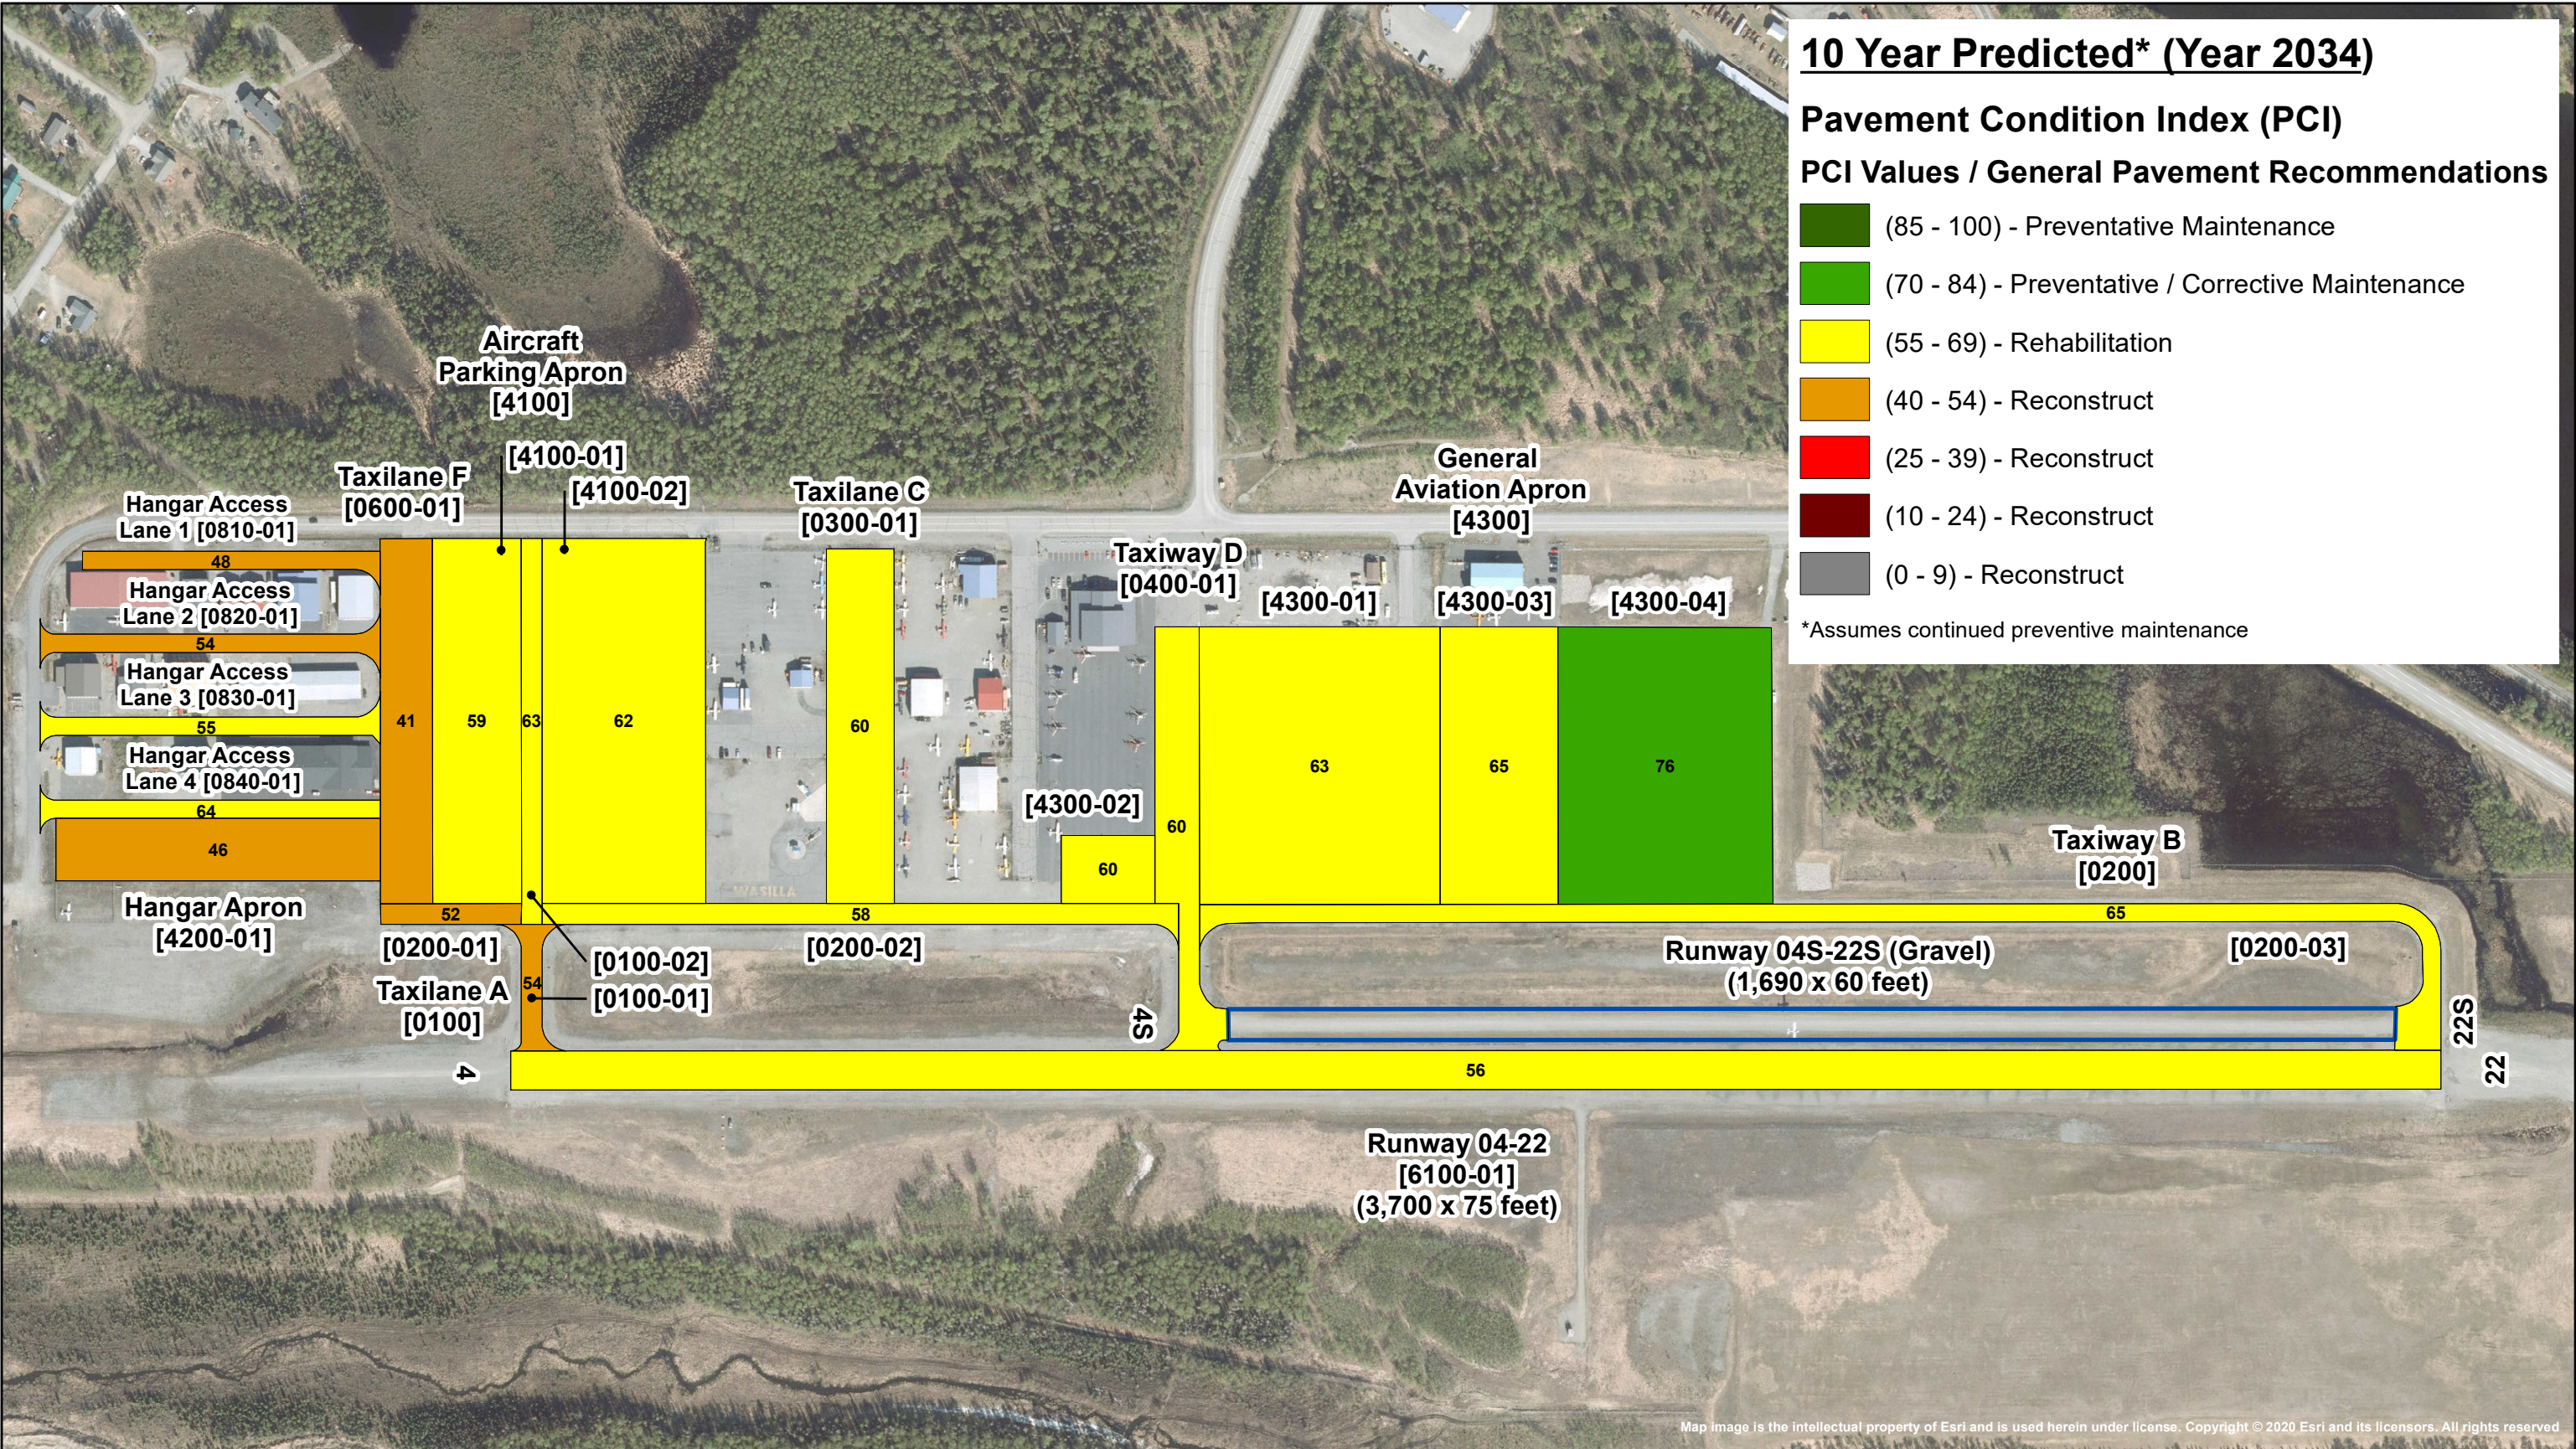
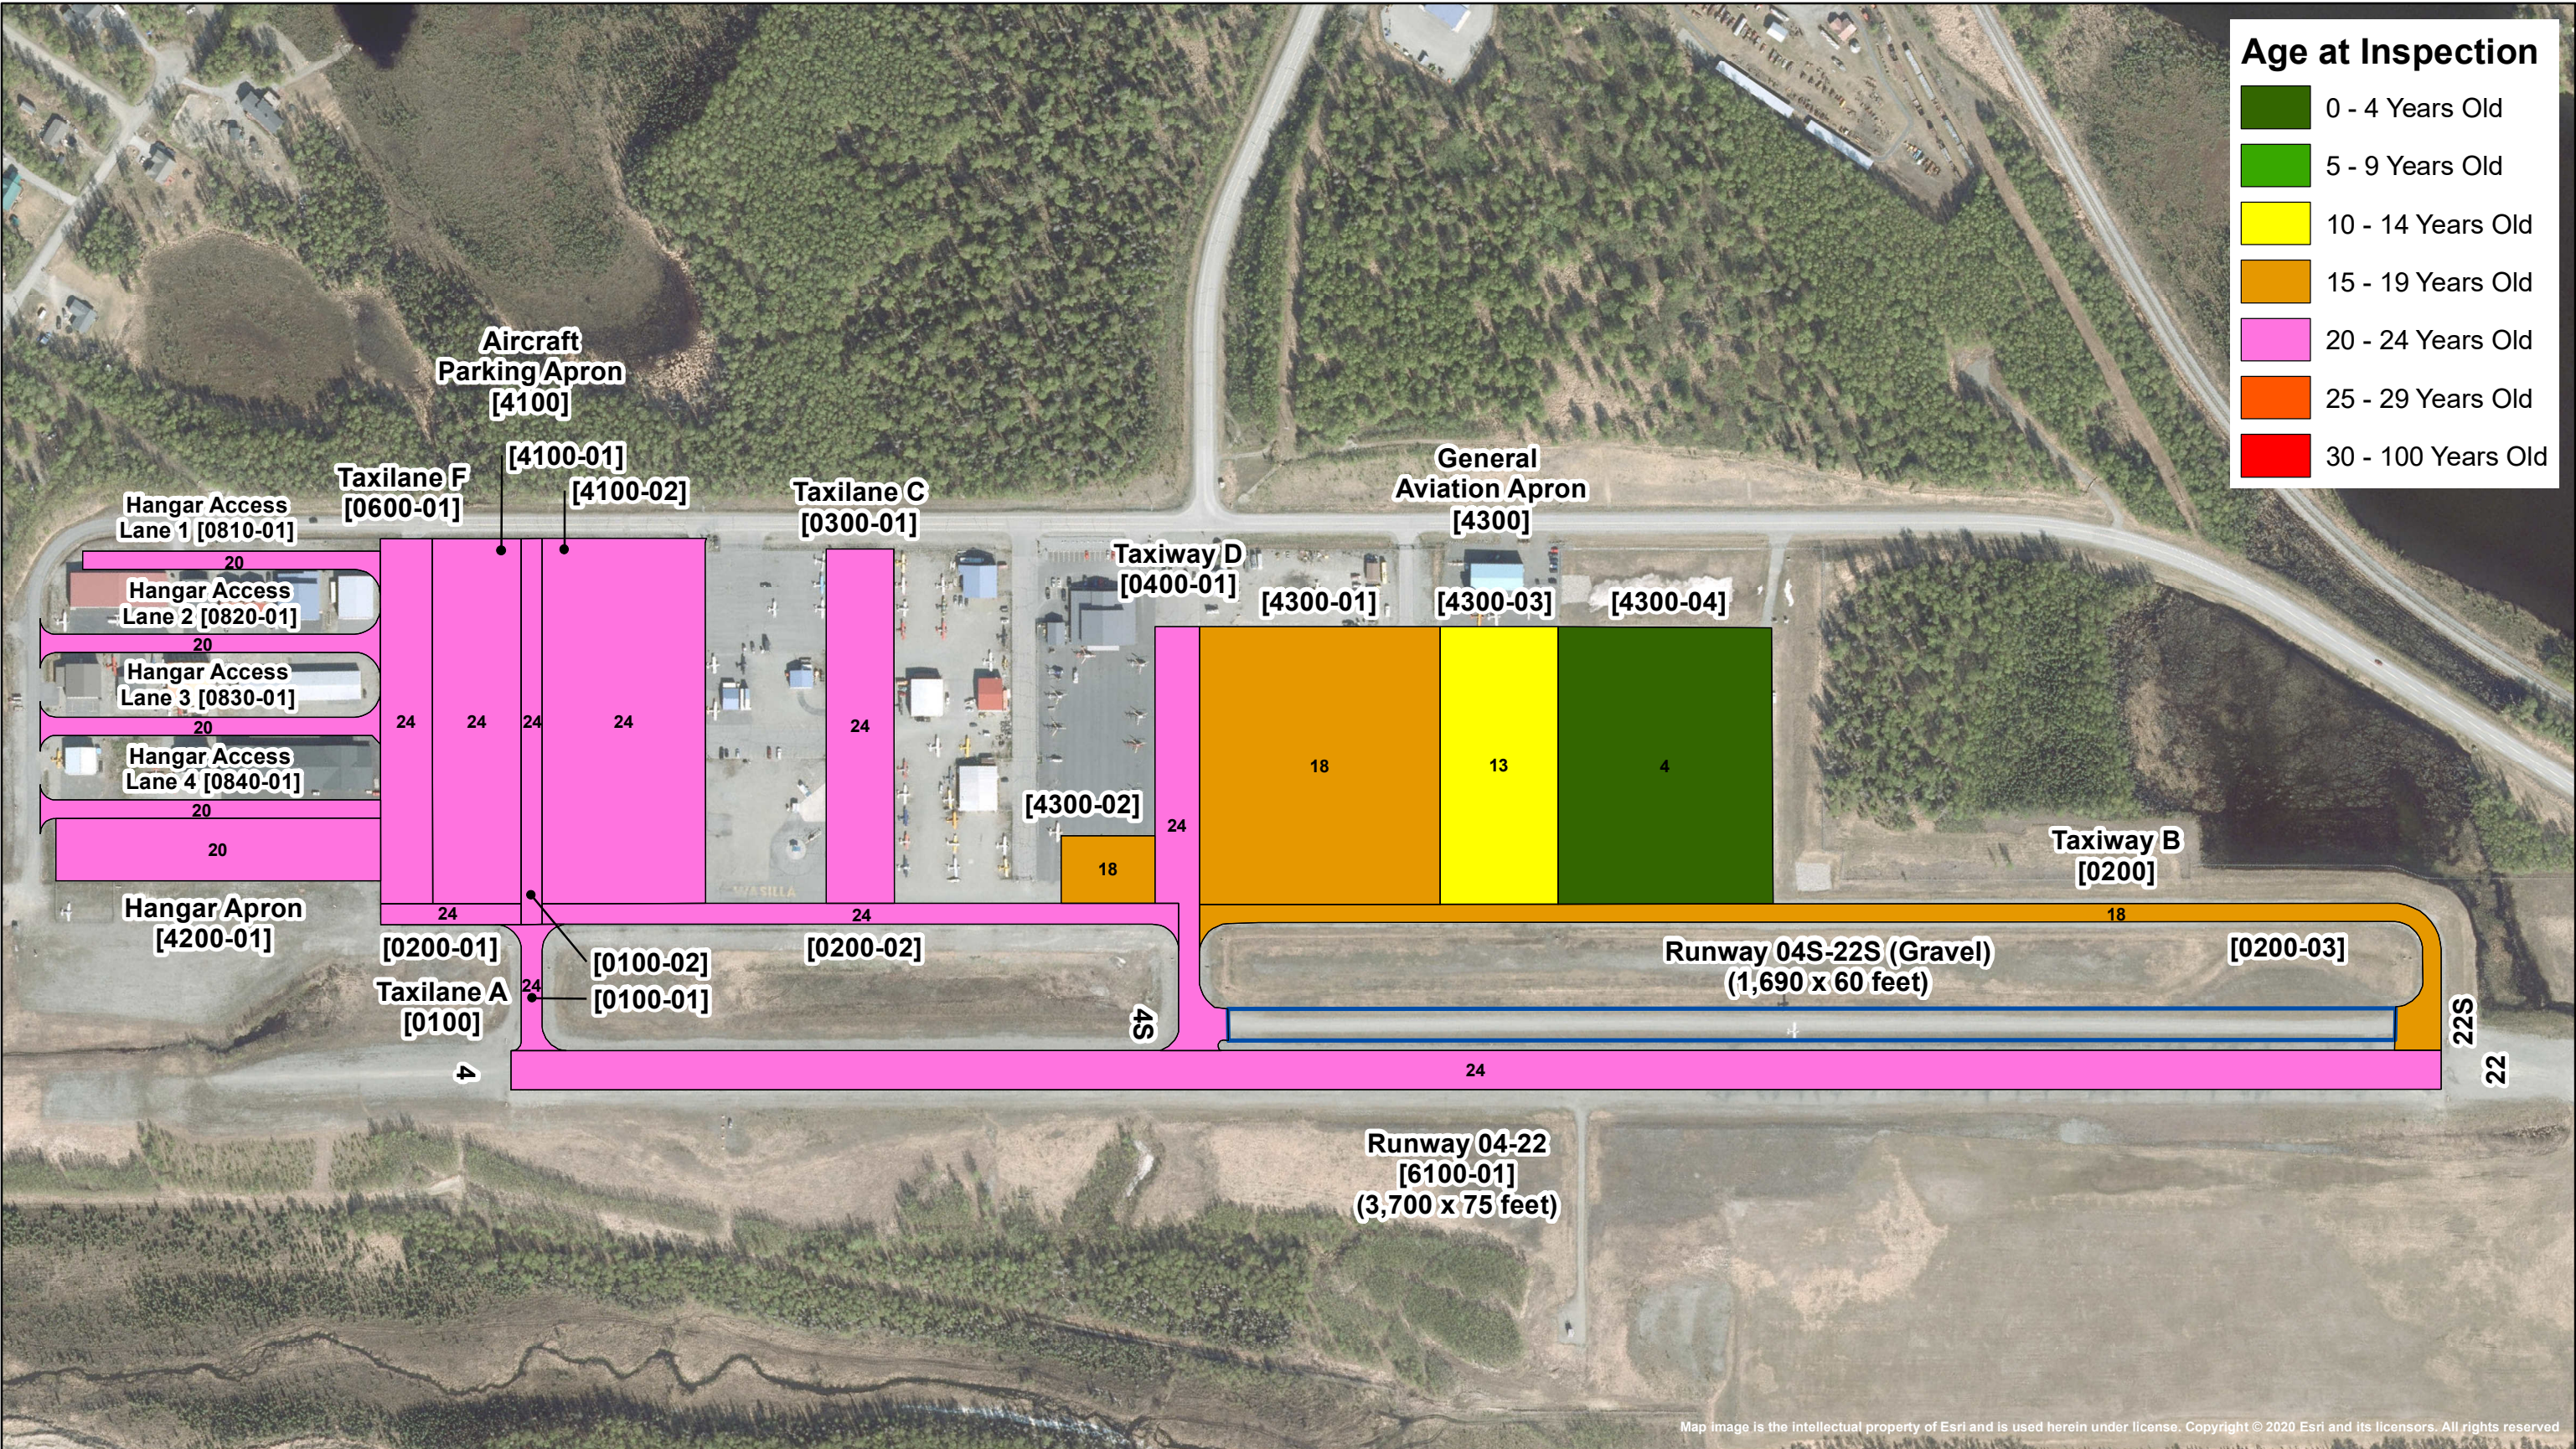
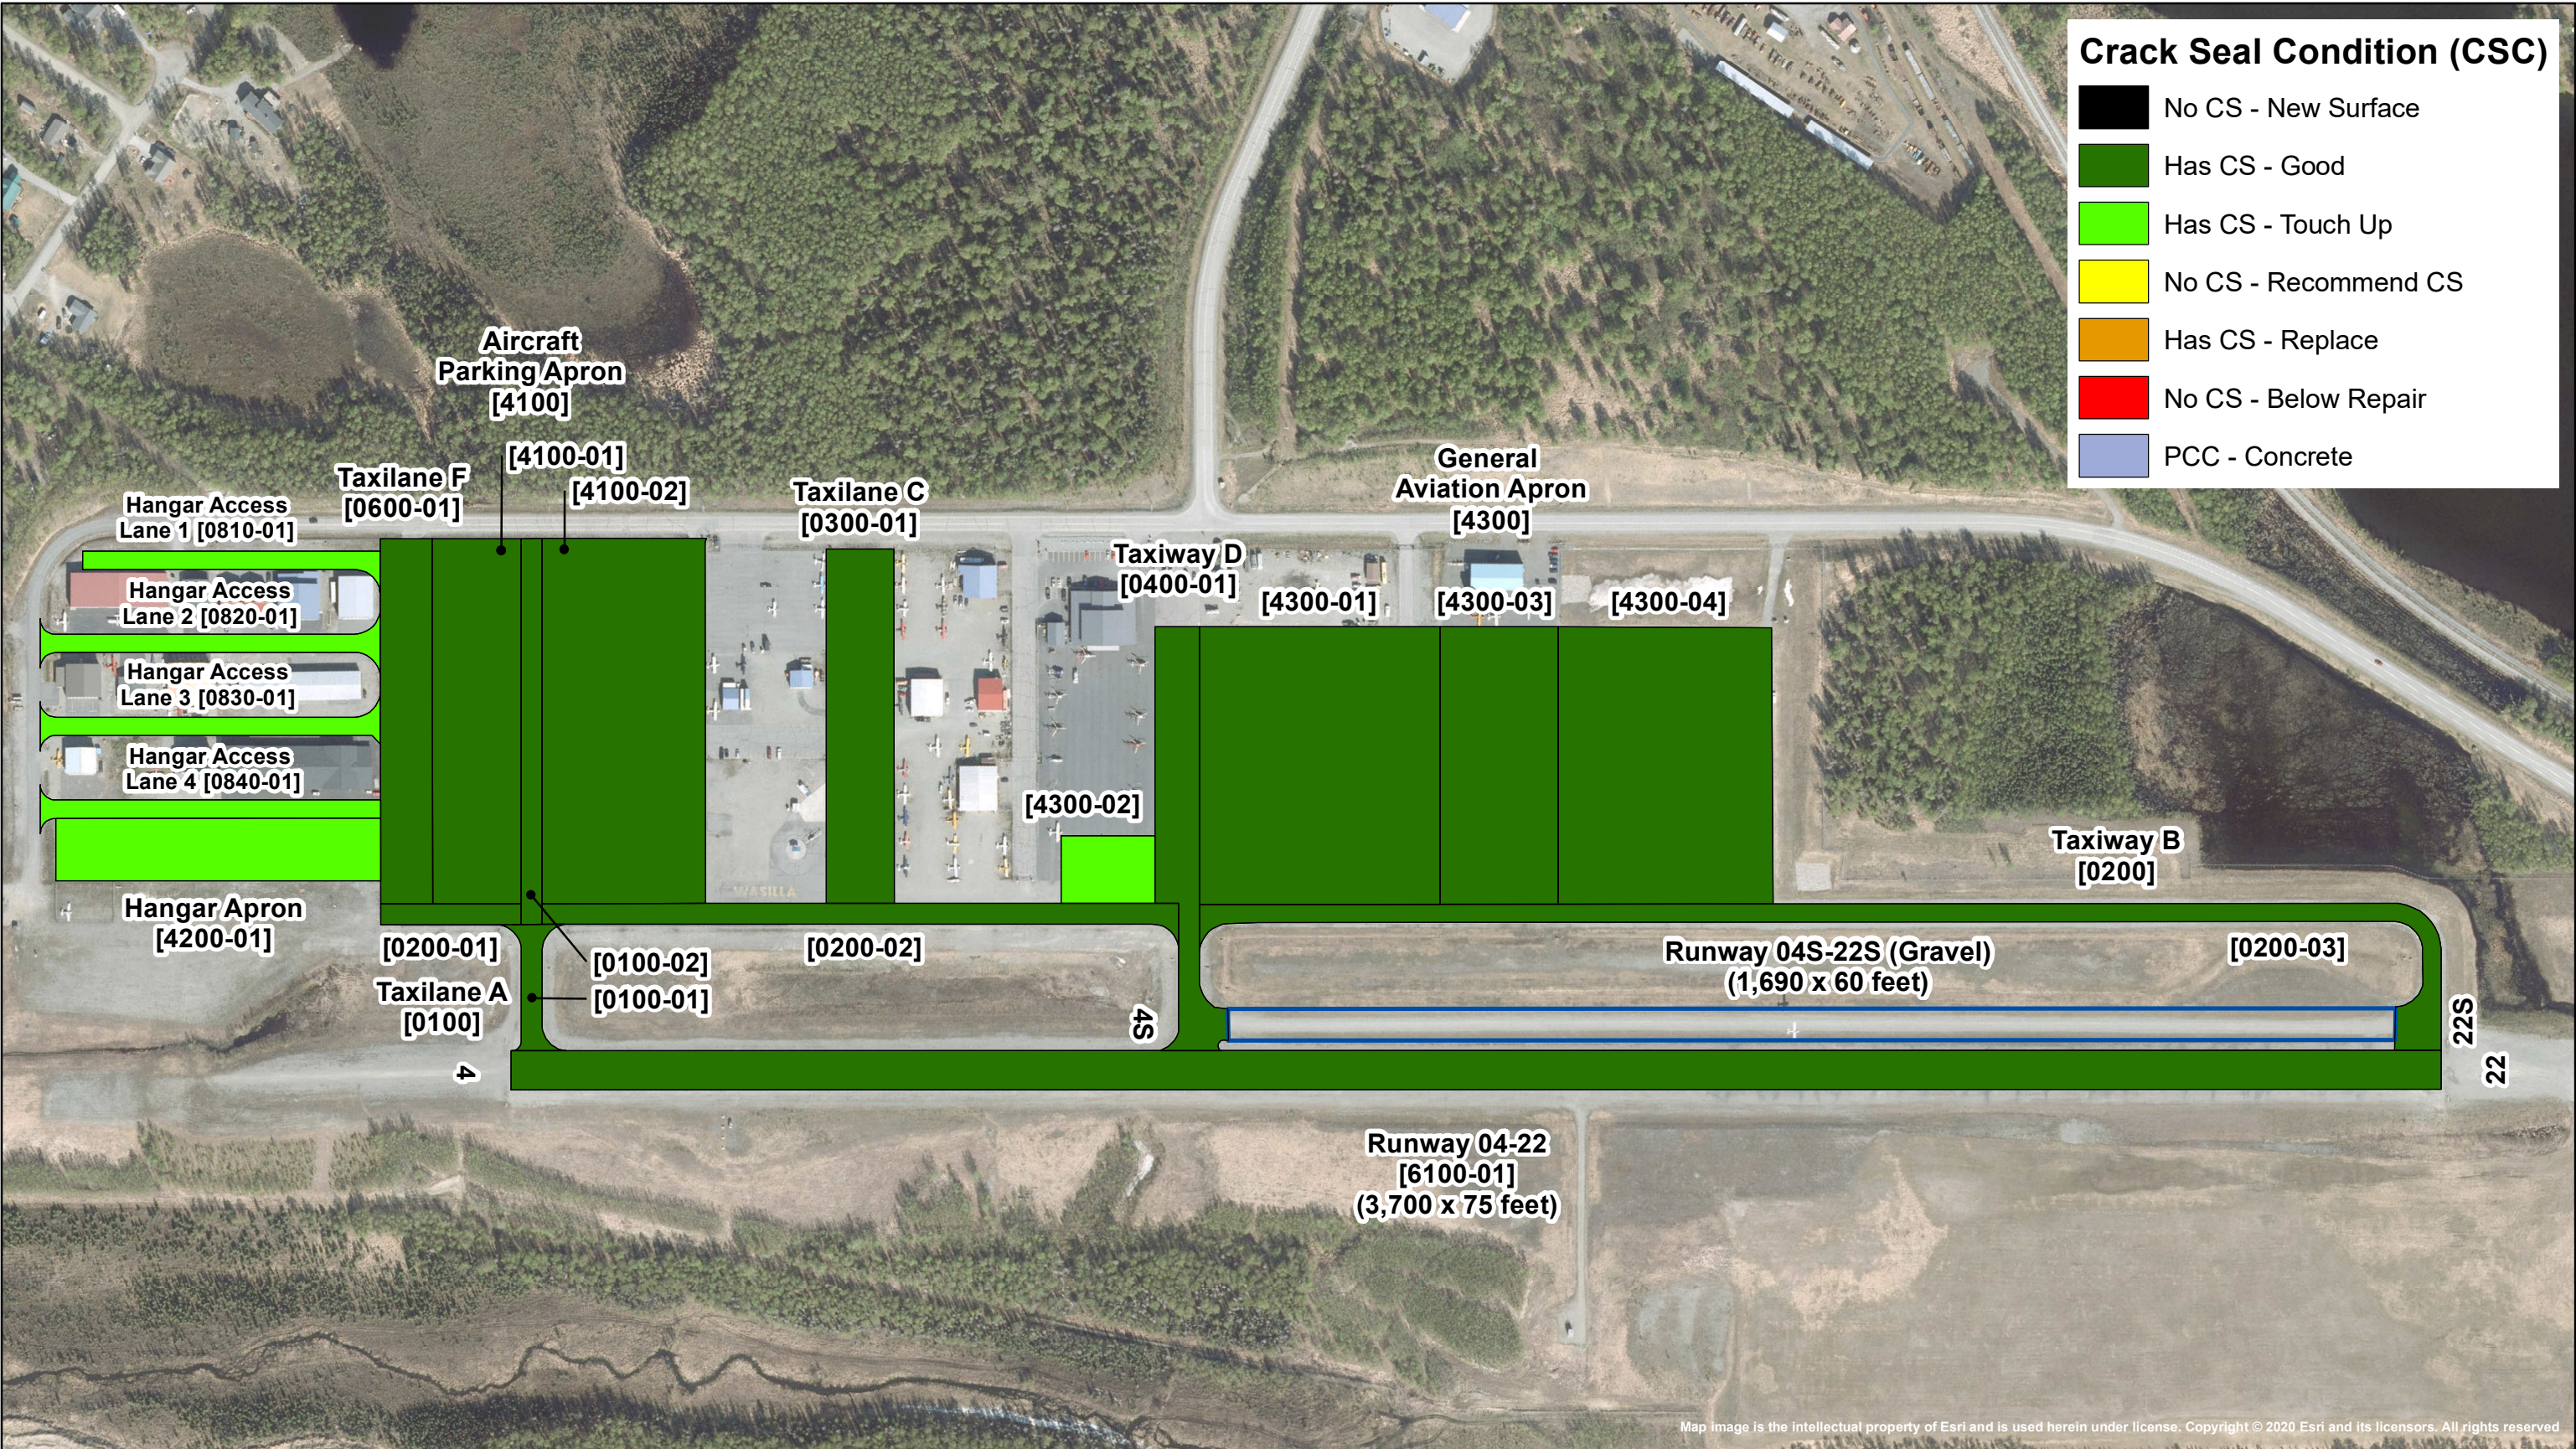
Taxilane A was initially constructed in 2000 and has not received major work since. A surface treatment was applied in 2022 to the majority of section 0100-02 but was not applied to section 0100-01. Occasional crack sealing operations have been performed on the branch. The most common distresses observed include low severity block cracking, low to high severity longitudinal and transverse cracking, low to medium severity raveling, and low to medium severity weathering. Field observations note the continued deterioration of cracks, causing the sealant to detach and allowing vegetation growth. This leads to higher severity distresses, increased water infiltration, and an accelerated rate of deterioration.
