Alaska DOT&PF

Pavement Inspection Report Wrangell Airport

Airport Code: WRG
Site Number: 50905.2*A

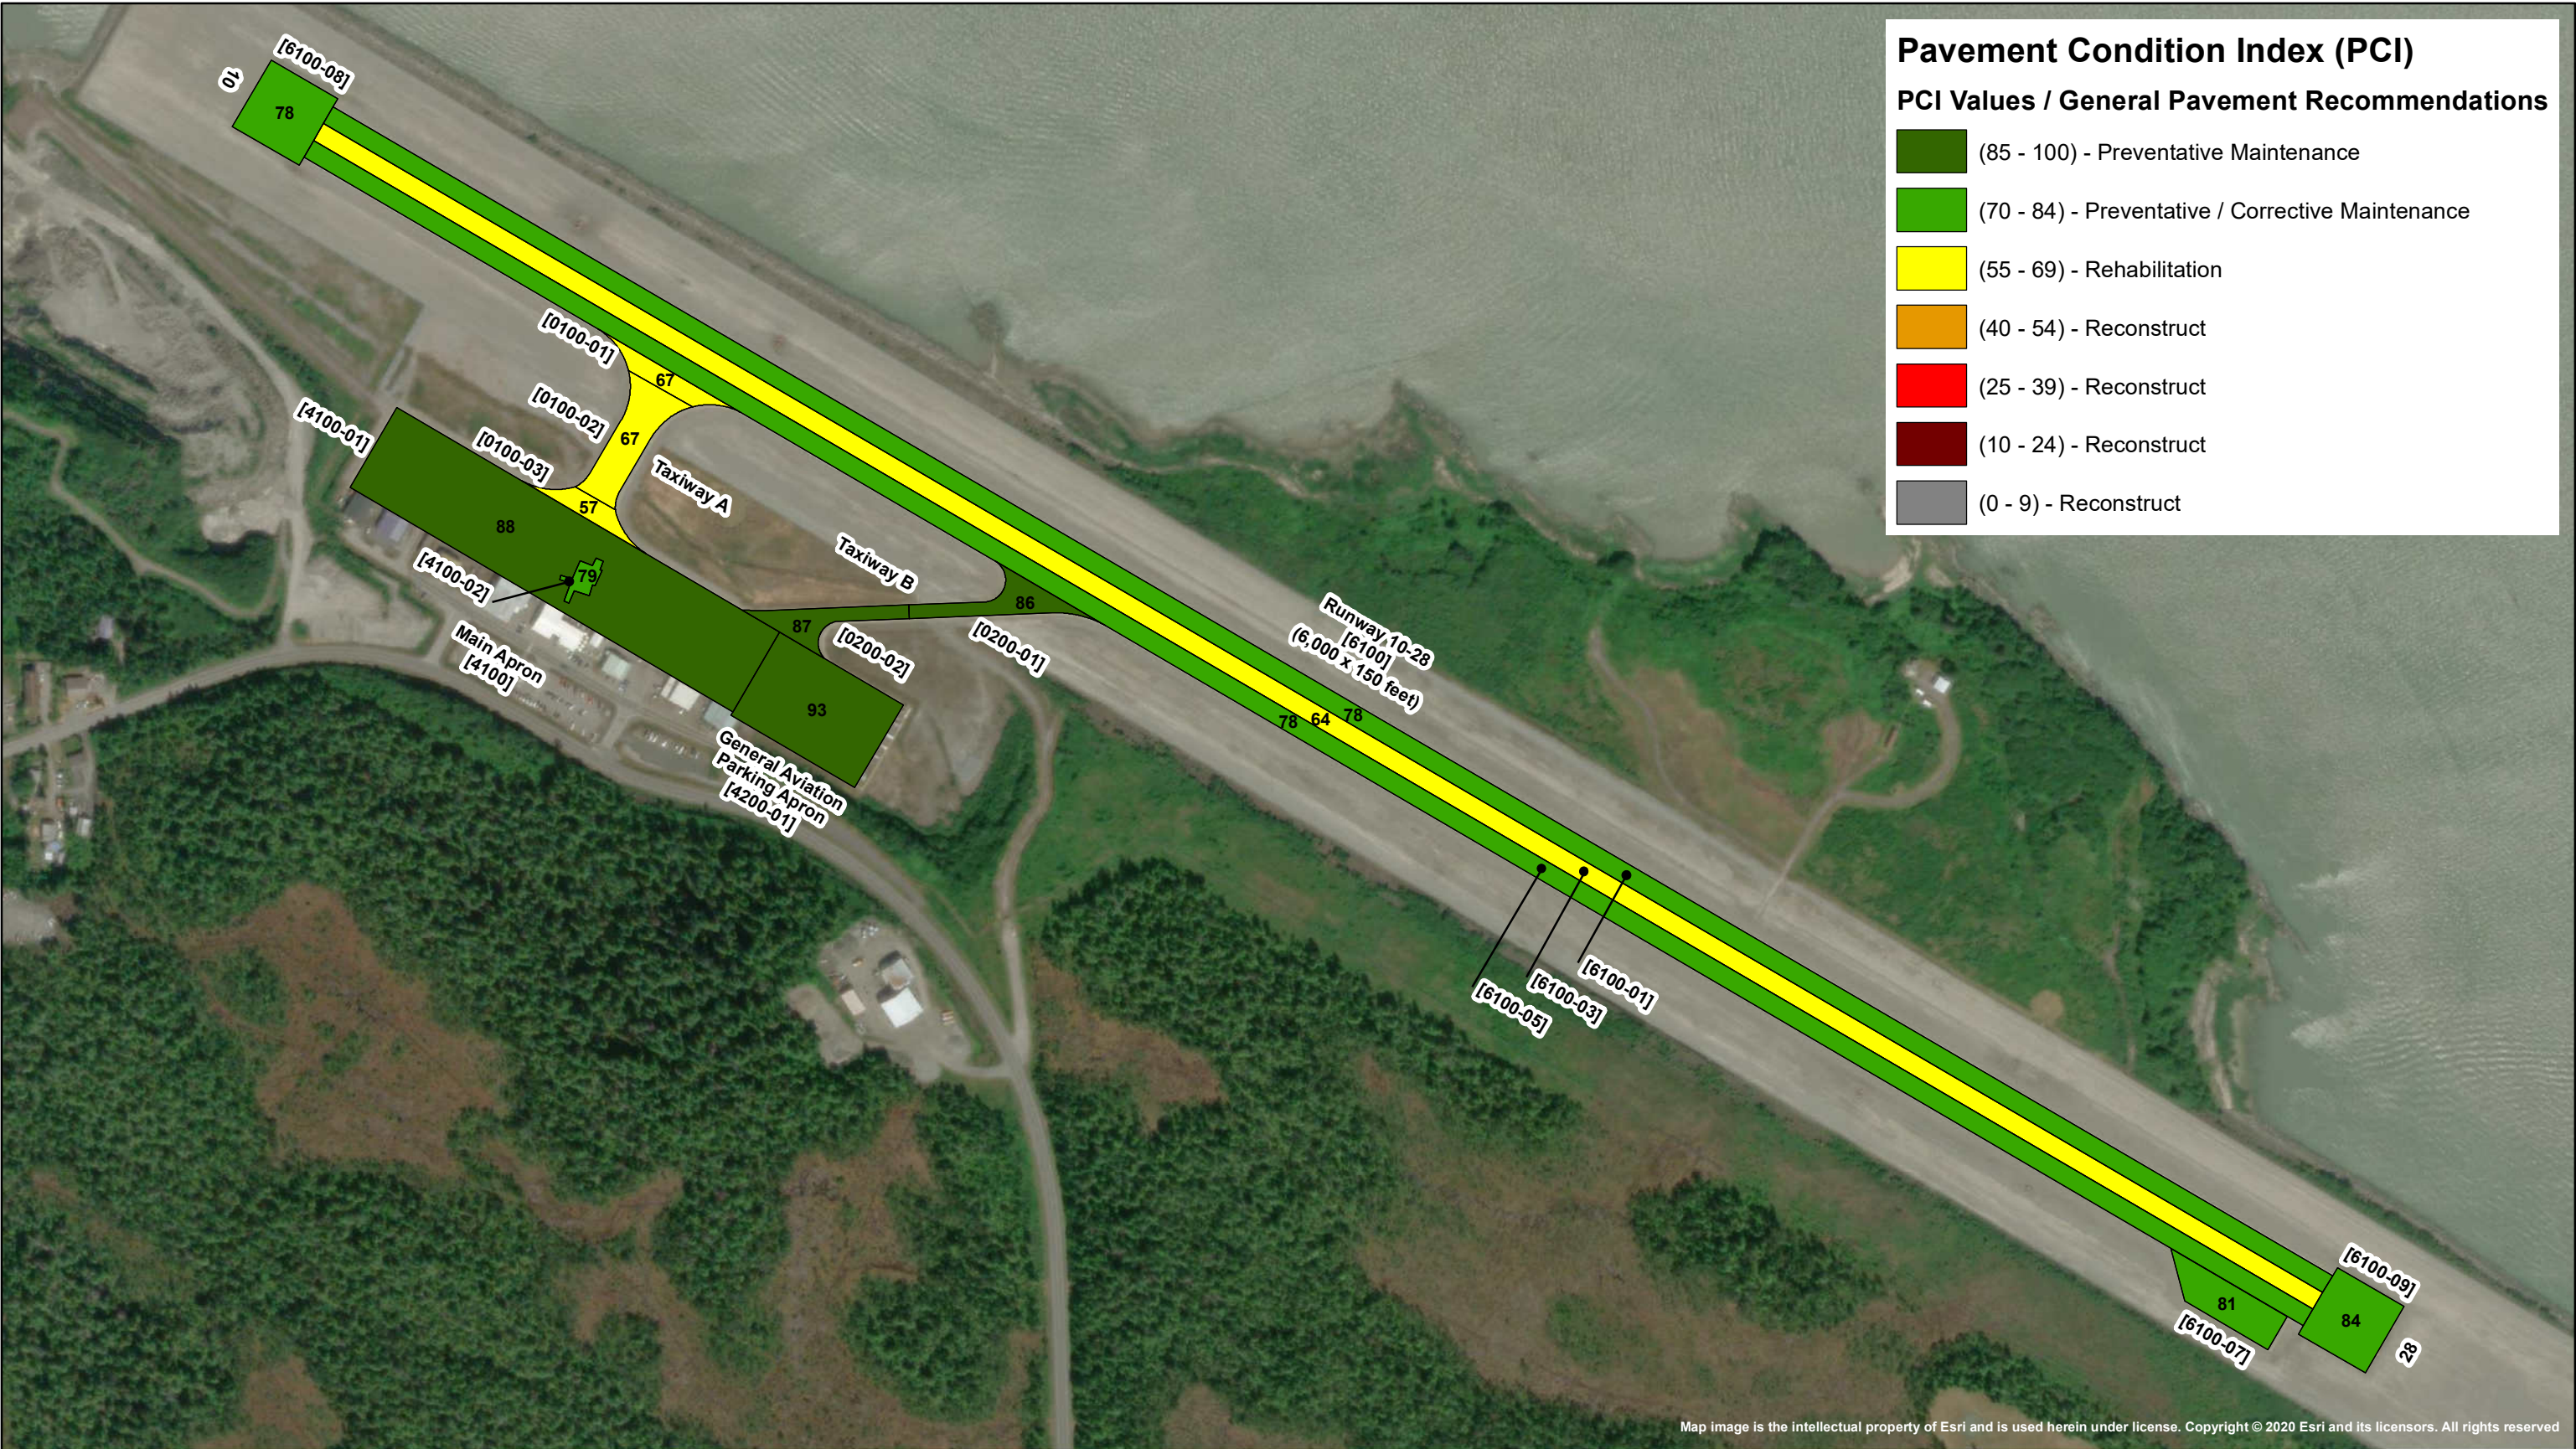
Map 1 of 6

Pavement Condition Index (PCI)

Target PCI Range for Runways: 70 to 100
Target PCI Range for Taxiways and Aprons: 60 to 100

2022 Pavement Inspection Results

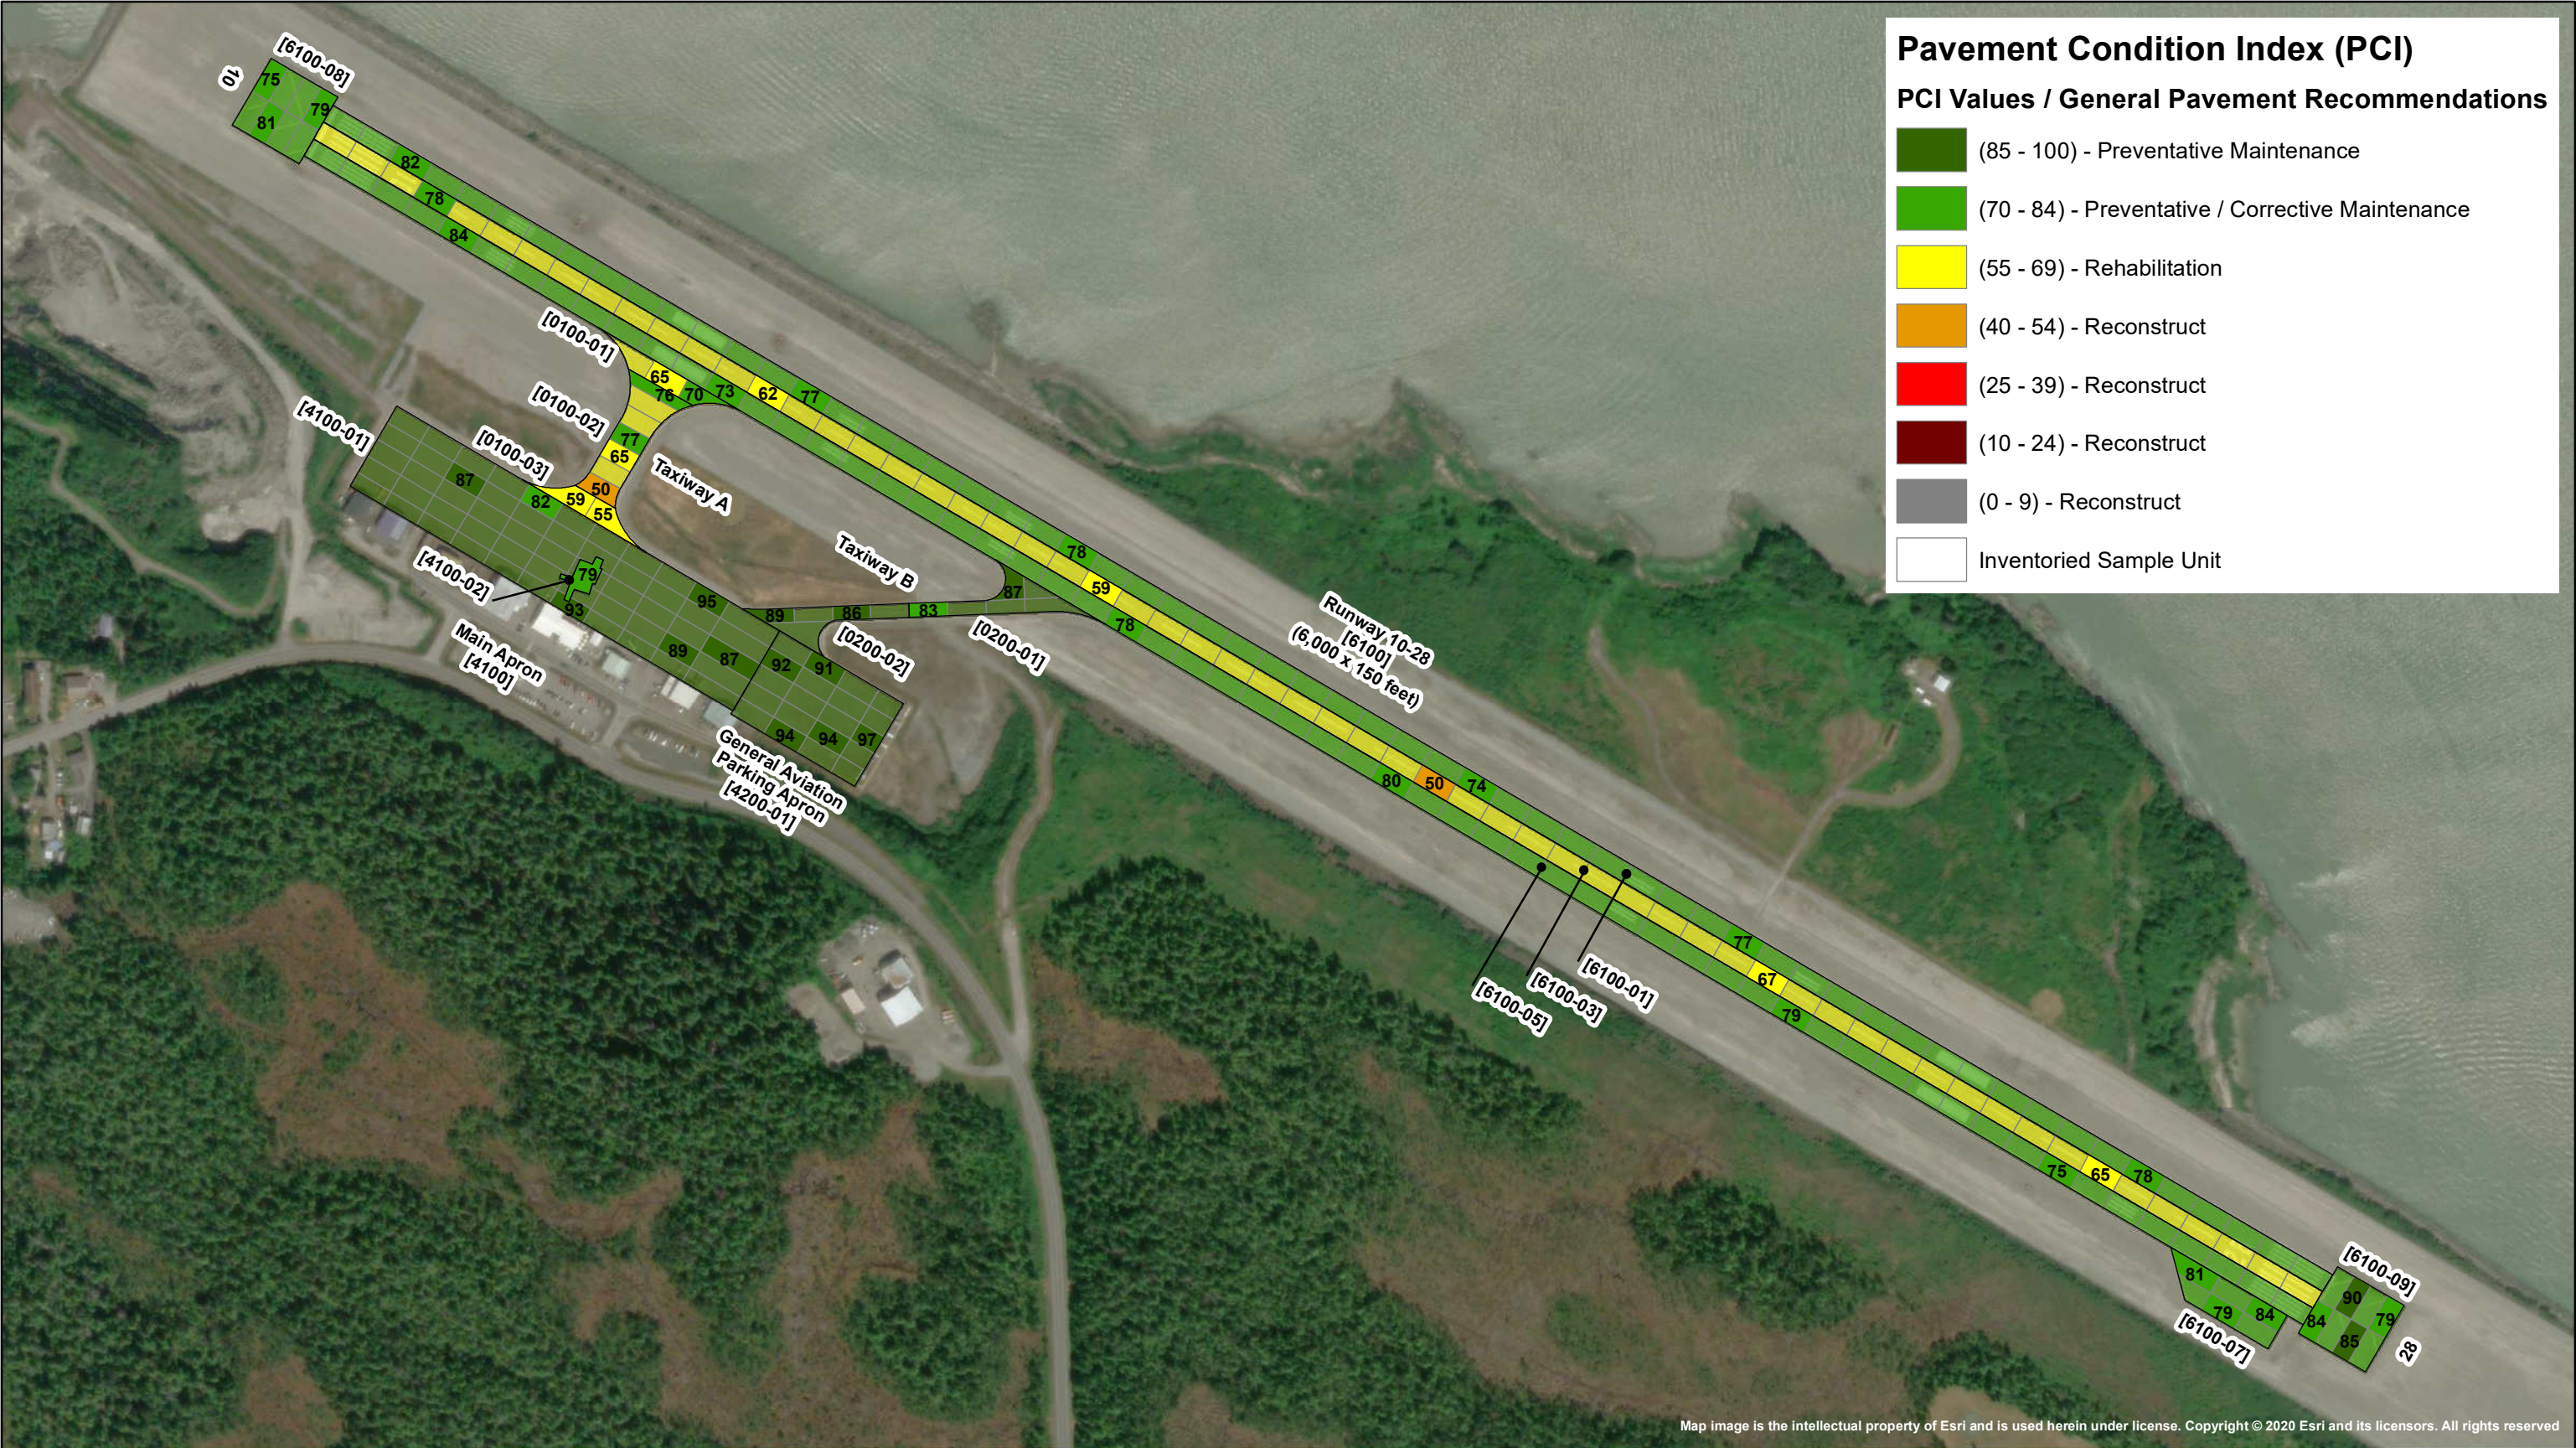
Sample Unit Pavement Condition Index (PCI)

2022 Pavement Inspection Results
