Vegetated Riprap Survey of Highways in Southcentral and Interior Alaska

Alaska Department of Transportation and Public Facilities

**Andrew Nolen
Agronomist**

**Alaska Department of Transportation
Statewide Research Office
3132 Channel Drive
Juneau, AK 99801-7898**

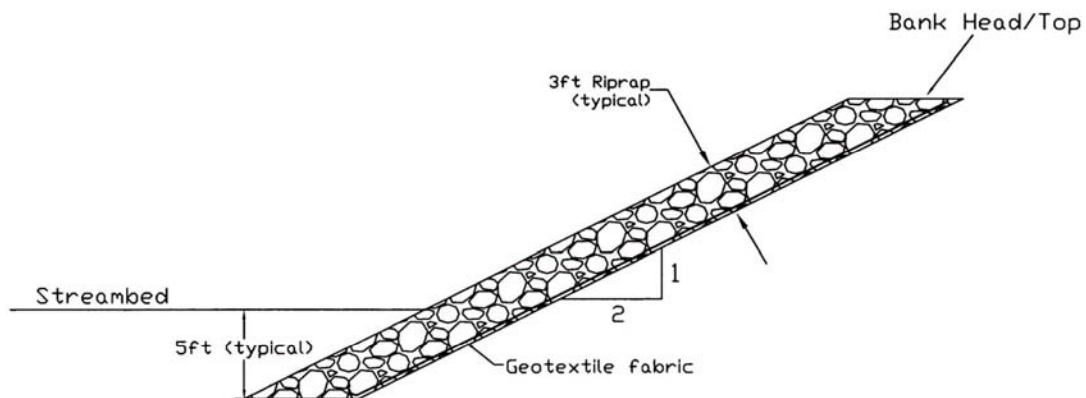
Figure 1 – Typical Riprapped Bank Cross-Section
 (If used, Geotextile Fabric installation location is illustrated)

Typically designed highway stream bank protection consists of an embankment with a 2:1 or 1 ½: 1 slope; covered by a 3 to 5 foot thick layer of Class II riprap. A geotextile fabric lining between the embankment material and the riprap may be also used. The riprap toe is usually installed several feet below the low water level or streambed elevation. (**Figure 1**) Sites observed were consistently within specifications of a typically designed embankment slope.

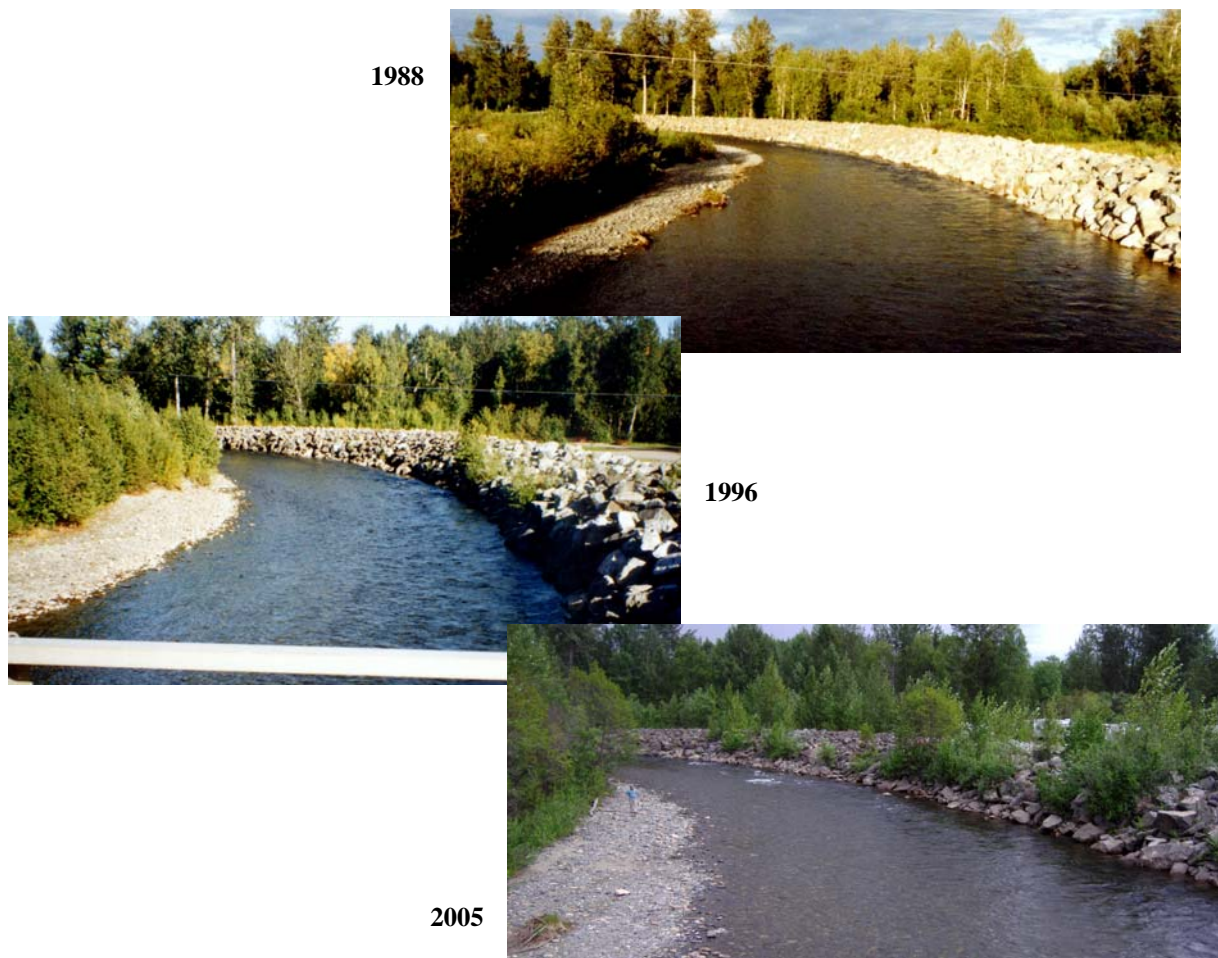
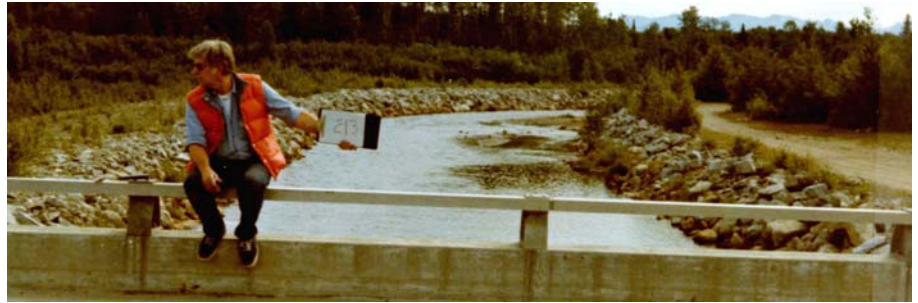
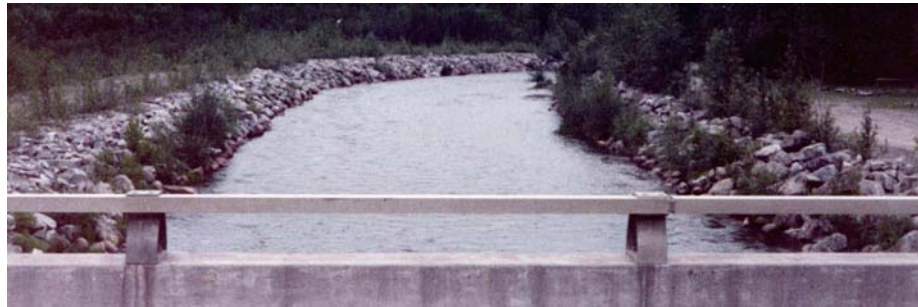
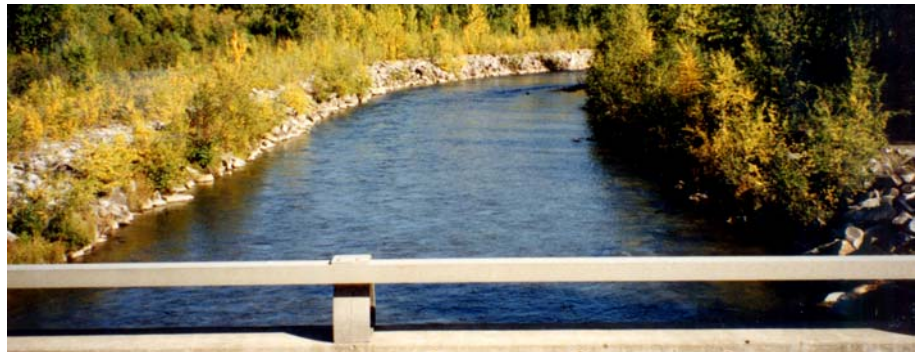
Figure 5 – Vegetative Progression Time Series;
Montana Creek (Parks Hwy)

Time is a significant limiting factor influencing the level of vegetation on a disturbed (constructed) site. By designing bank protection using hydraulic parameters specific to the stream, successful vegetation can result. Although bank protection is designed adequately, flood inundation destruction is possible. Whether planted manually or naturally, and within the universal and site specific limits discussed in this report, a specific flood event can occur and essentially wash away seedlings and sprouts, as well as fine grained bank material. Given sufficient time before an extreme event occurs, vegetation can become stable and, thus, flourish for healthy riparian habitat as well as provide reinforcement for the constructed bank armament. **Figures 5 and 6** illustrate time series vegetative progression.

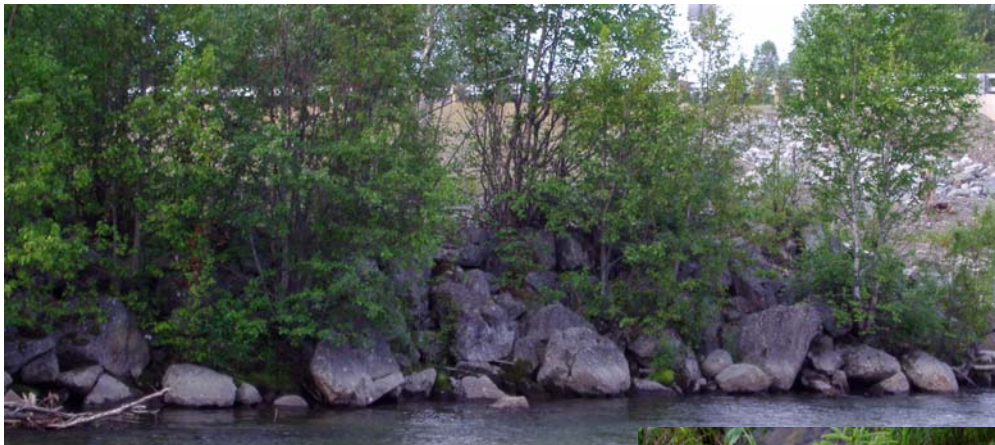
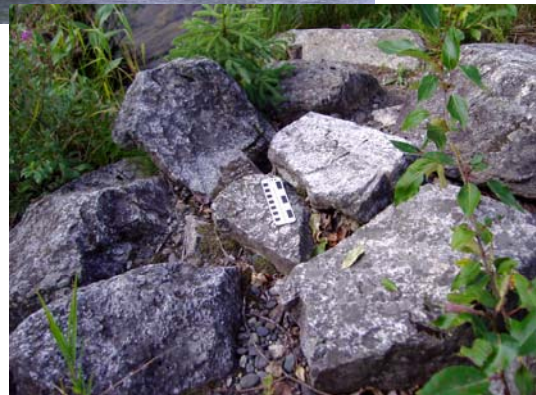
Figure 7 – Vegetated Voids
Willow Creek (Parks Hwy)

Poorly graded riprap is defined as riprap containing a high percentage of large diameter rock relative to the total quantity of rock present. The lack of smaller diameter rock leaves voids (areas, pockets, or spaces) where fine embankment material is exposed and/or fine material can be deposited manually, via sedimentation at various discharge stages, or via wind. If exposed to stream flow, the larger rock protects the void area behind or immediately downstream of it by reducing flow energy, shear stresses, and excessive ice forces. The protected space provides a stable environment for sedimentation and vegetation growth. Examples of successfully vegetated voids are in **Figures 7 - 9**.

At the time of this site survey, existing woody vegetation had not shown evidence of causing nearby riprap displacement. However, it should be noted that the possibility of further growth in the vegetation's stem diameter may potentially cause riprap instability.

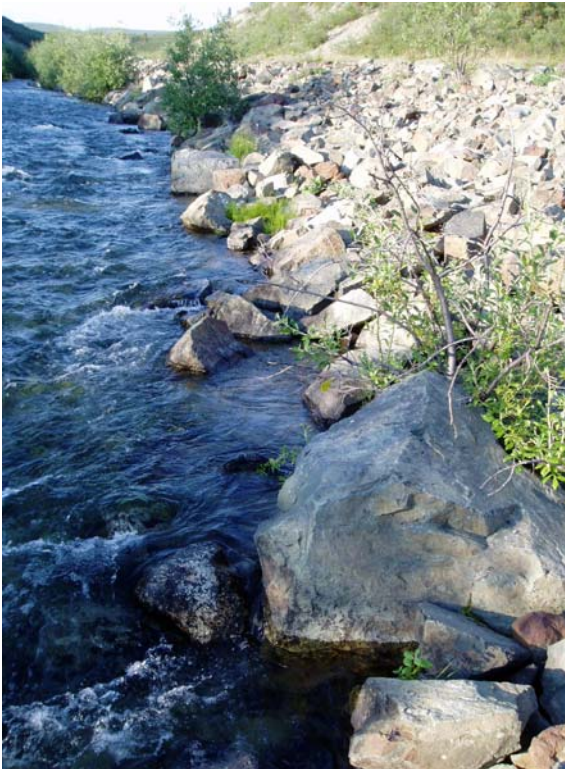
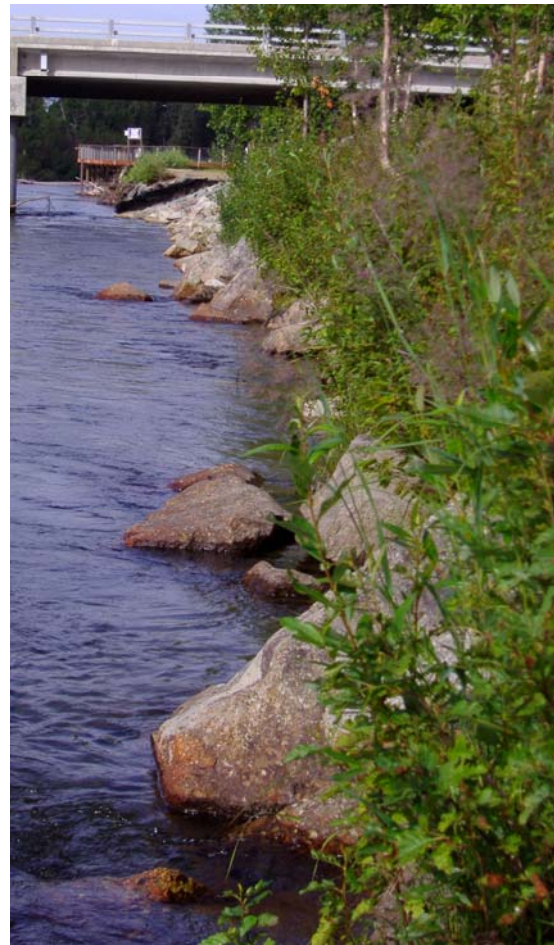
Photo 8 - Gulkana River (Richardson Hwy)

The in-stream structures noted during this study were naturally placed during the stream's ongoing process of equilibrating. In some cases, singular or clusters of 2 – 4 toe rocks were naturally resituated within 1 - 2 feet of the bank toe. Consequently, the backwater effect of the migrated rock(s) position(s) provided a pool area above (immediately upstream) the rock(s). In addition, the stream's thalweg was influenced away from the bank. The bank apparently self repaired with more rock at its toe and no erosion had taken place. Vegetation present in these areas was near the normal water surface level and overhanging the water surface.

As illustrated in the sites observed with this configuration (**Photos 7 and 8, Figure 10**), rock diameter of the toe protection and the migrated in-stream structures is relatively large.

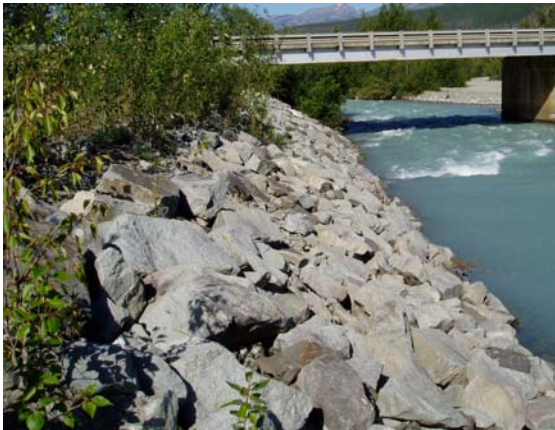
Photo 11 - King River (Glenn Hwy)

A solid-mass is considered a heavily and/or thickly riprapped bank, such that no embankment surface material is visible or penetrable; thus, no vegetation can grow from the embankment material. If geotextile fabric with a smooth texture is used as a riprap liner, sediment and fine material may not adhere to its surface. In addition, no vegetation can sprout and penetrate through this type of geotextile fabric.

Sites with solid mass bank armament primarily allowed vegetative growth at the head of the embankment, where no riprap existed. **(Photo 11)**
