Alaska Department of Transportation & Public Facilities Research & Technology Transfer

High Friction Surface Treatment Experimental Feature Final Report and 3rd Year Monitoring Results

Publication Number: FHWA-AK-RD-000S(882)

December 2019

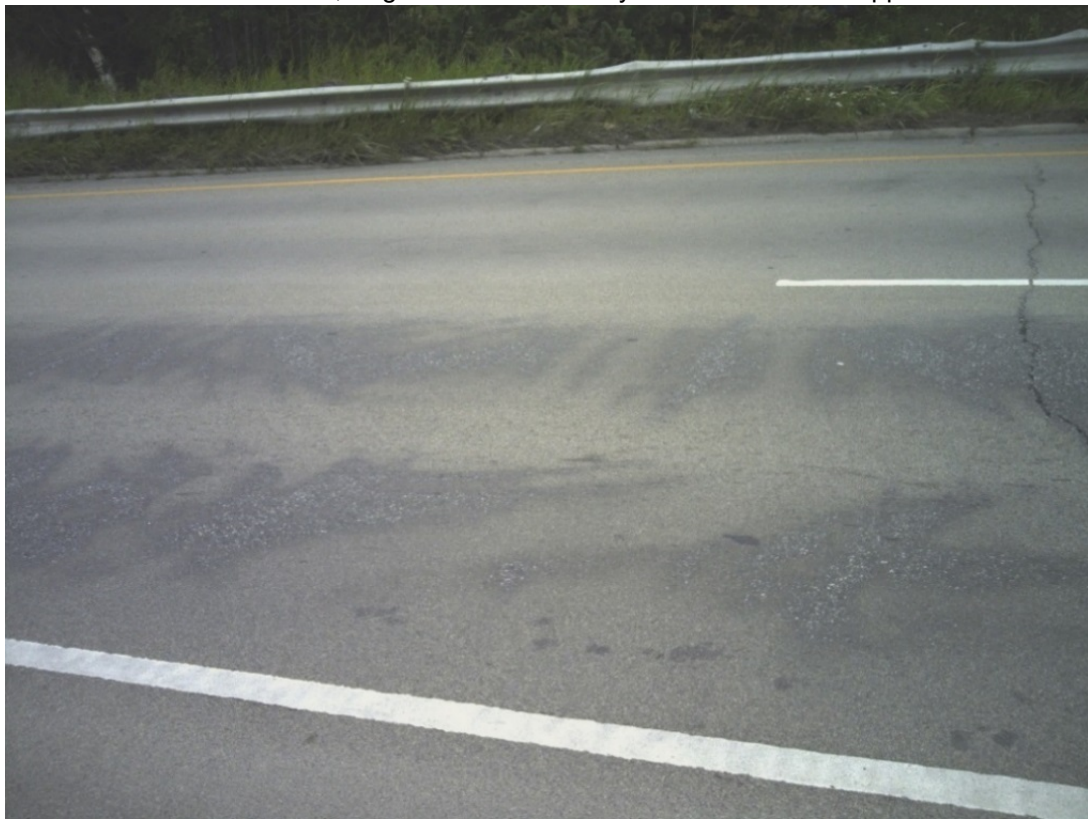
Site 30 (Eagle River Road Mile Point 0-5.3 Pavement Preservation) revealed there may have been an error with the resin application which resulted in strips of bare pavement a consistent distance from the fog line prior to the first winter (See Photo 2). This result, however, was noticeable in other areas as well with Method 2 though it has a distinctly different wear pattern (see Photo 3).

Photo 3: July 2017, Minnesota Drive one year after Method 2 application.

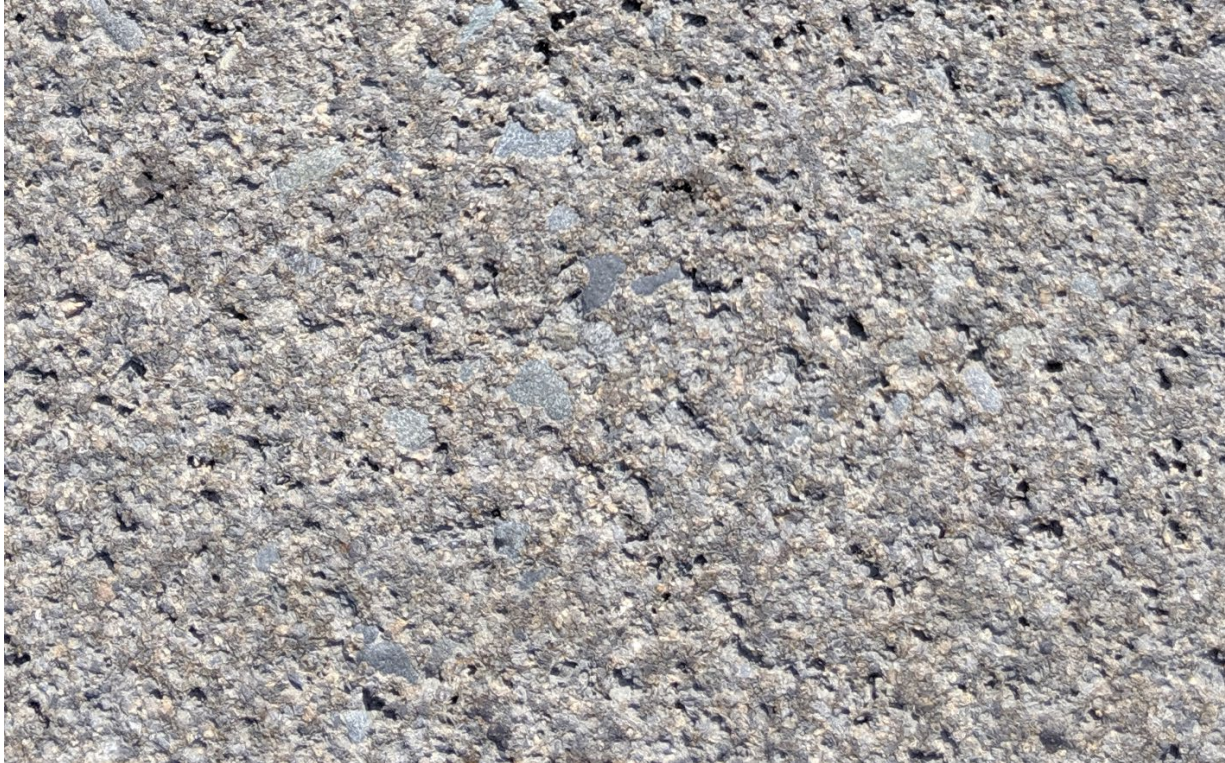
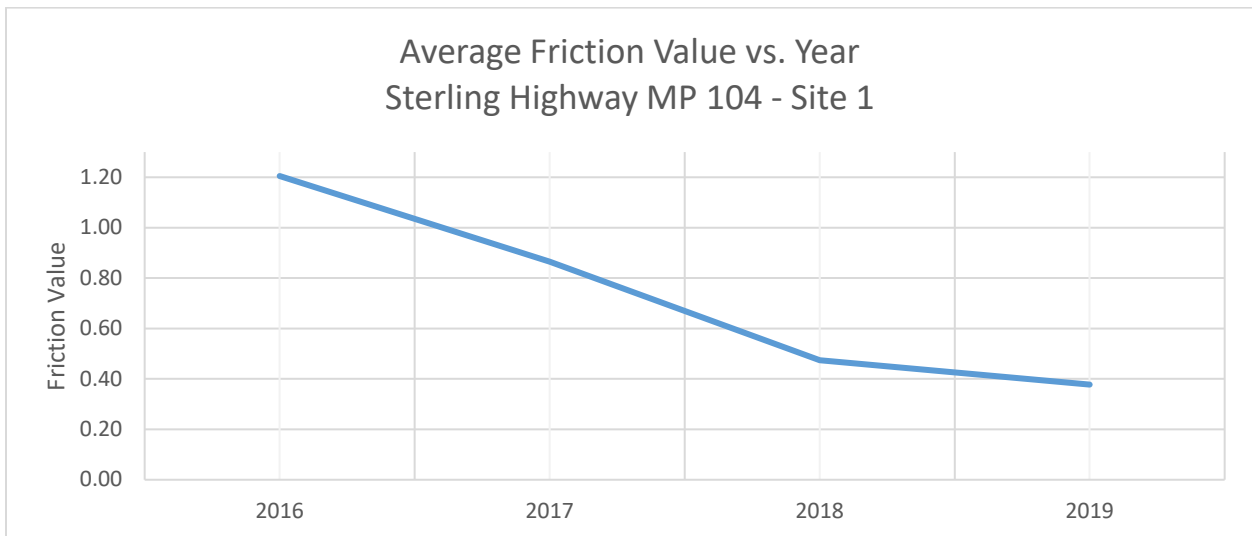
The site has lost significant friction. Four out of the five tests in 2019 were less than typical pavement value of 0.45, with an average value of 0.38. A zoomed in look at the surface texture in 2019 (below) shows visible pavement under the remaining HFST, and the HFST left in the wheelpaths shows signs of polish.

Average Friction Values				Values by Site 2019	
2016	2017	2018	2019	Sites Less Control Value	Total Sites
1.21	0.87	0.47	0.38	4	5

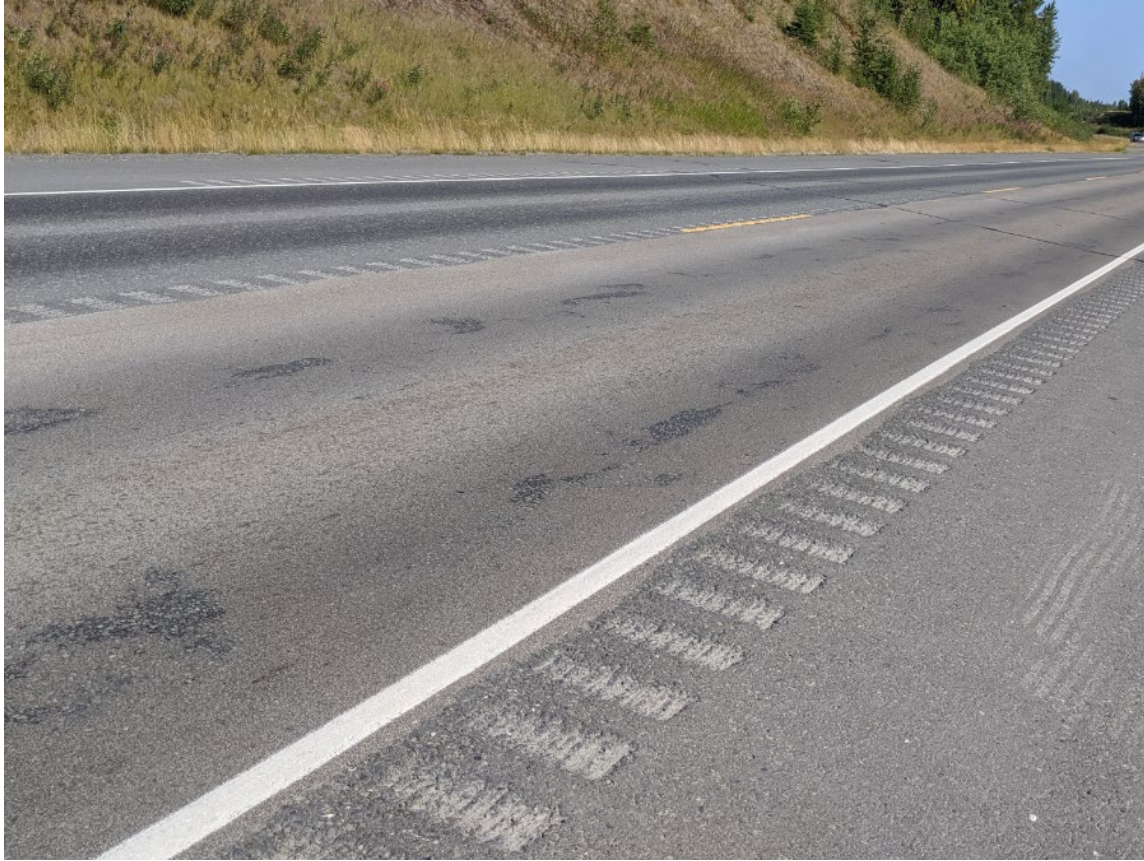
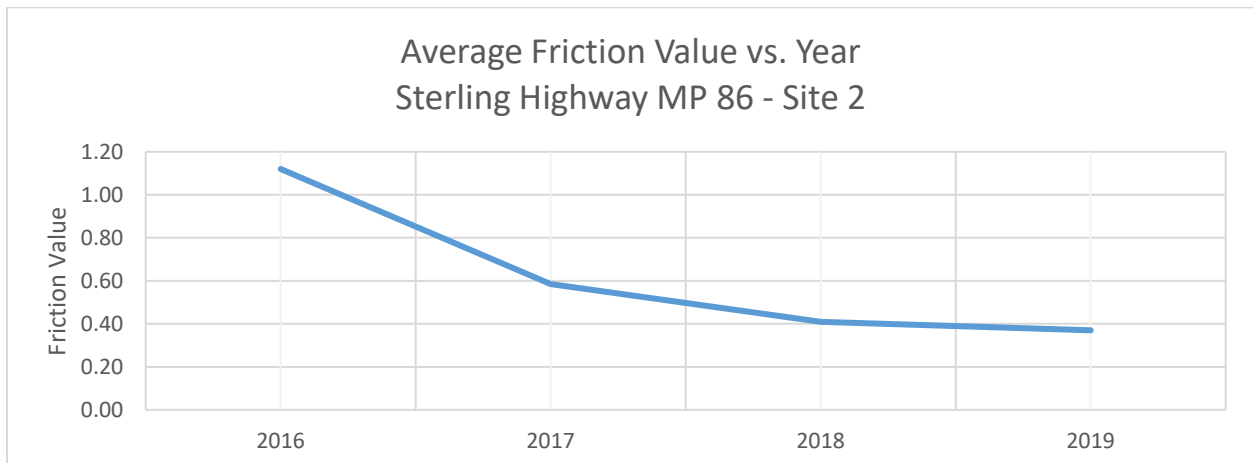
Site 2 – Sterling Highway MP 86.4 - Friction Overview

The site has lost significant friction. Five out of the six tests in 2019 were less than typical pavement value of 0.49, with an average value of 0.37. The picture below from 2019 shows bare patches of pavement, and the surface texture within the wheelpaths show significant signs of polish.

Average Friction Values				Values by Site 2019	
2016	2017	2018	2019	Sites Less Control Value 0.49	Total Sites
1.12	0.59	0.41	0.37	5	6

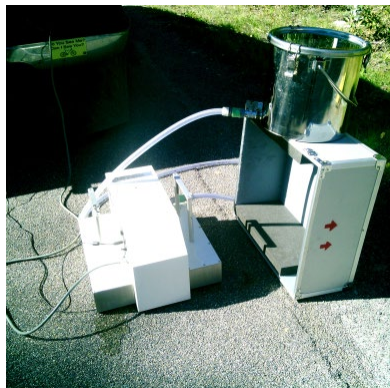
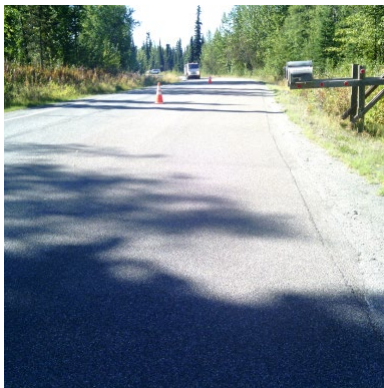
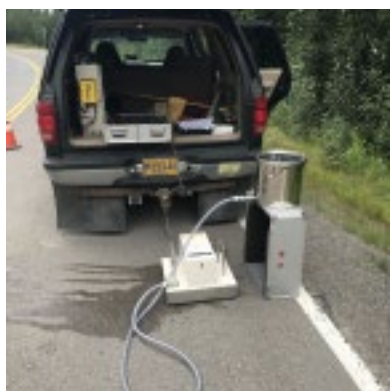
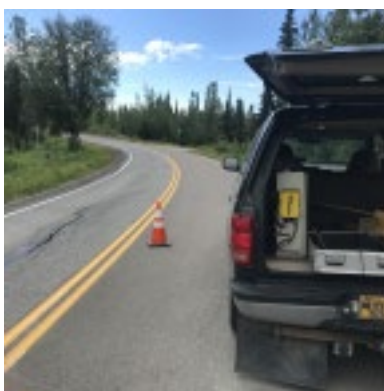
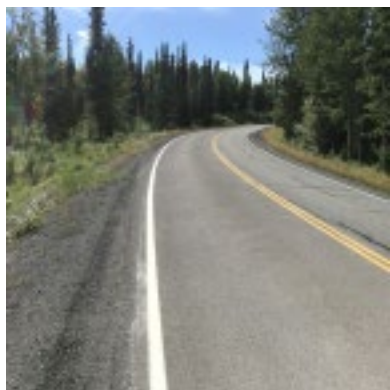
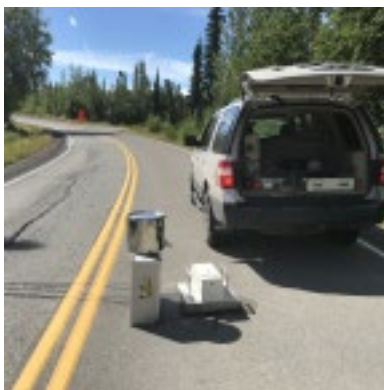
Site 3 – Photo Log

Funny River Road has lost moderate friction, but did not lose a large amount between testing in 2018 and 2019. None of the four tests in 2019 were less than typical pavement value of 0.48, with an average value of 0.67. The first picture below from 2019 does show visible wear in the wheelpaths into and out of curves. Areas in straightaways seemed to show less signs of visible wear, as shown in the second picture taken in 2019.

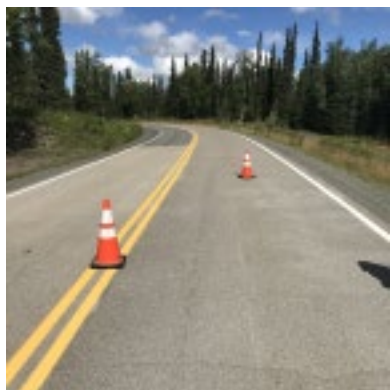
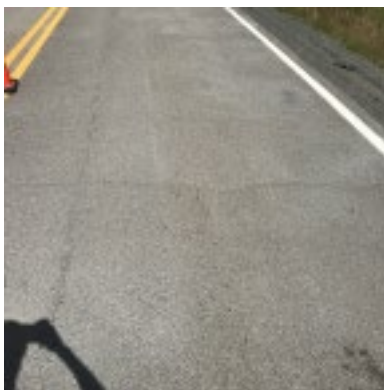
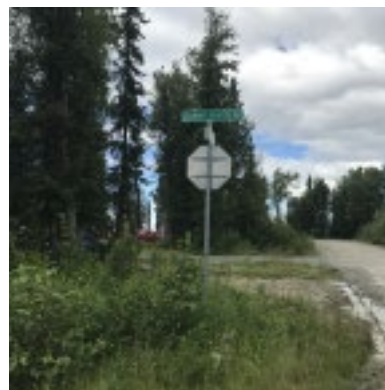
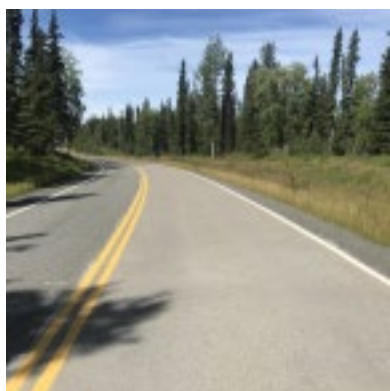
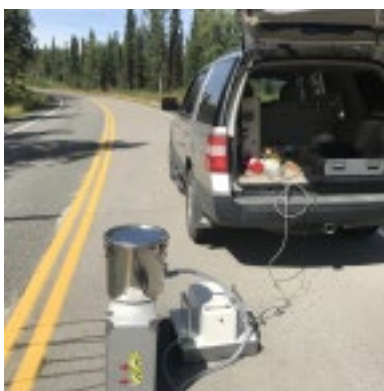
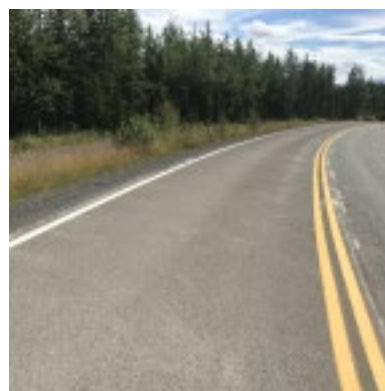
Site 4 – Photo Log

Funny River Road has lost moderate friction, but did not lose a large amount between testing in 2018 and 2019. None of the four tests in 2019 were less than typical pavement value of 0.48, with an average value of 0.61. The picture below shows slight wear in the wheelpaths, and as at Site 3 on Funny River more wear was evident into and out of curves.

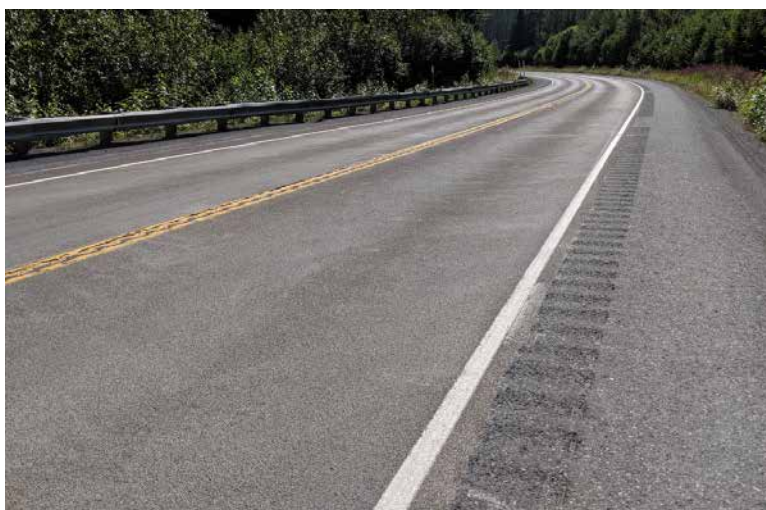
Seward Highway at milepost 15 has lost moderate friction overall, but significant friction at specific locations. Three of the six tests in 2019 were less than typical pavement value of 0.48, with an average value of 0.50. The picture from 2019 below shows wear in the wheelpaths going into and out of a curve.

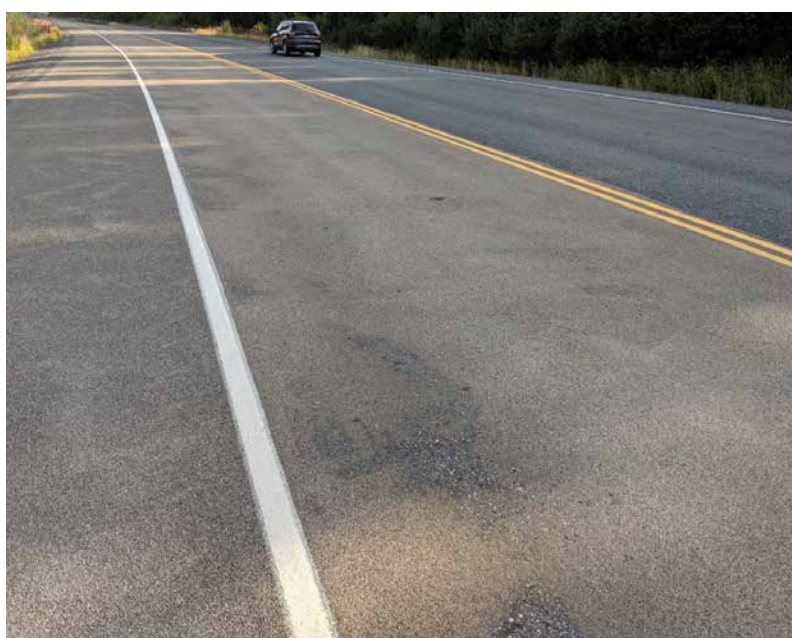
Seward Highway at milepost 39.4 has lost moderate friction overall, but significant friction at specific locations. The tests on the shoulder indicate that substantial friction is lost from snowplowing operations. Two of the five tests in 2019 were less than typical pavement value of 0.47, with an average value of 0.48. The picture from 2019 below shows areas of bare pavement in the wheelpaths.

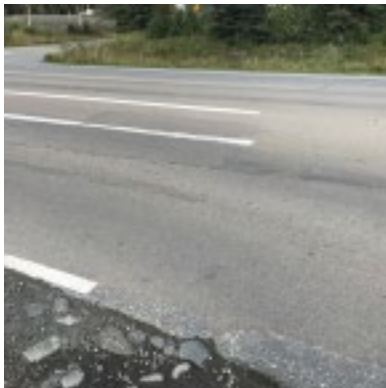
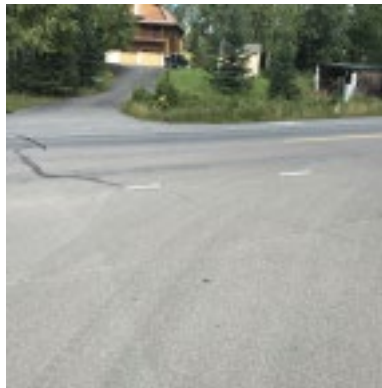
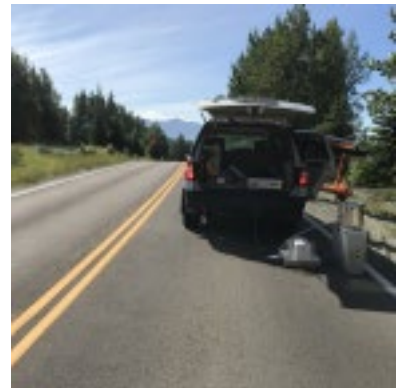
DeArmoun Road lost moderate friction overall. While the friction drop between 2017 and 2018 was not major three of the six tests in 2018 were less than typical pavement value of 0.54, with an average value of 0.55. Bare pavement was visible at locations as can be seen in the 2018 photo, below.

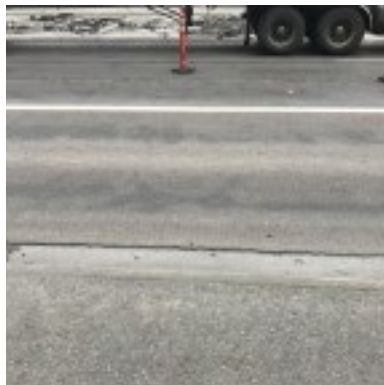
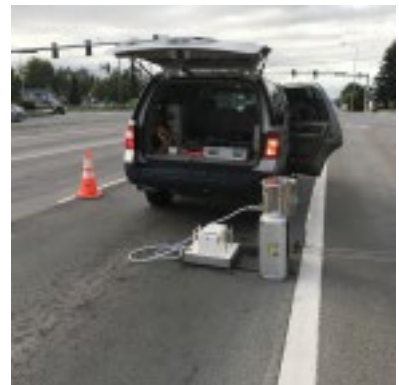
Minnesota Drive at Tudor lost significant friction. The friction drop between 2017 and 2018 was major and all four tests in 2018 were less than typical pavement value of 0.60, with an average value of 0.30. As can be seen in the 2018 photo, below, all wheelpaths show wear and show large amounts of bare pavement.

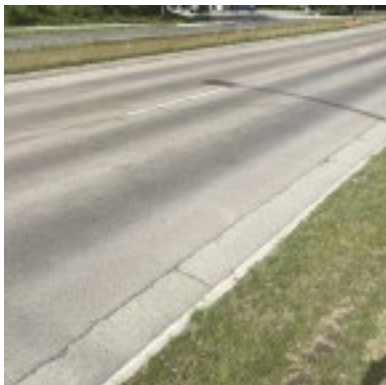
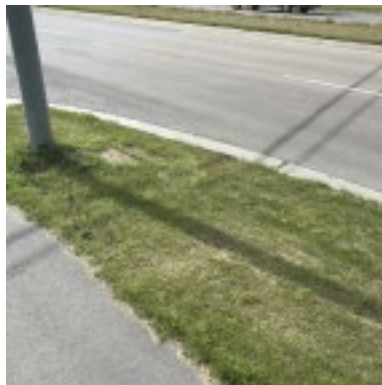
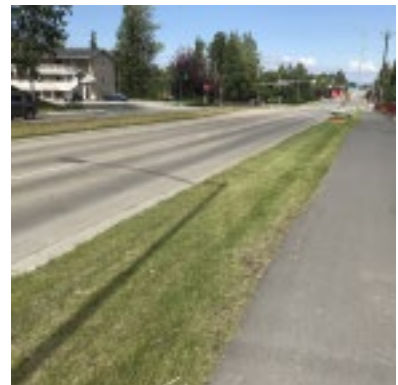
Lake Otis at Waldron lost significant friction. The friction drop between 2017 and 2018 was major and the two tests in the through lanes in 2018 were less than typical pavement value of 0.56, with an average value of 0.34. As can be seen in the 2018 photo, below, all wheelpaths show significant wear. The third test performed in 2018 was in the turn pocket, and that data can be seen at the end of the appendix summarized with other turn pocket data.

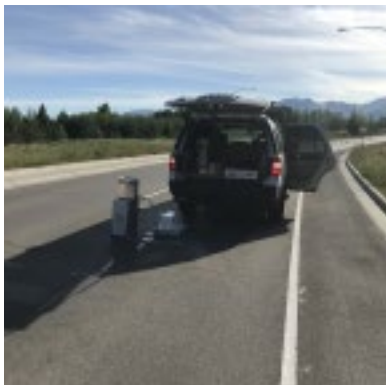
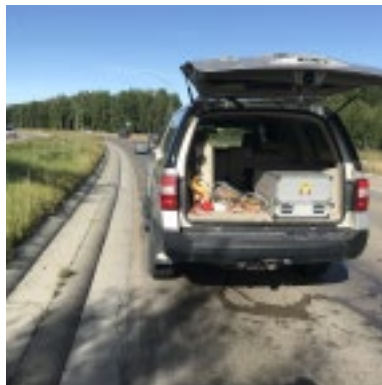
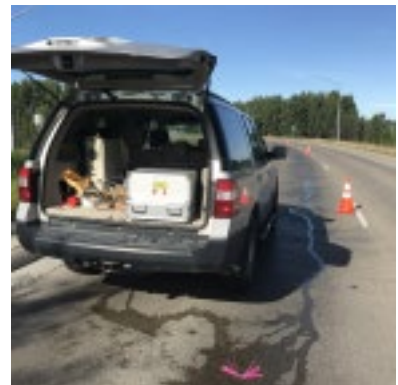
Martin Luther King showed major friction loss in all tests. The friction drop between 2017 and 2018 was significant and all seven tests were less than typical pavement value of 0.58, with an average value of 0.31. As can be seen in the 2018 photo, below, the wheelpaths in the left hand lane show significant wear, while less wear is evident in the right hand lane. The majority of traffic travels in the left lane on this road.

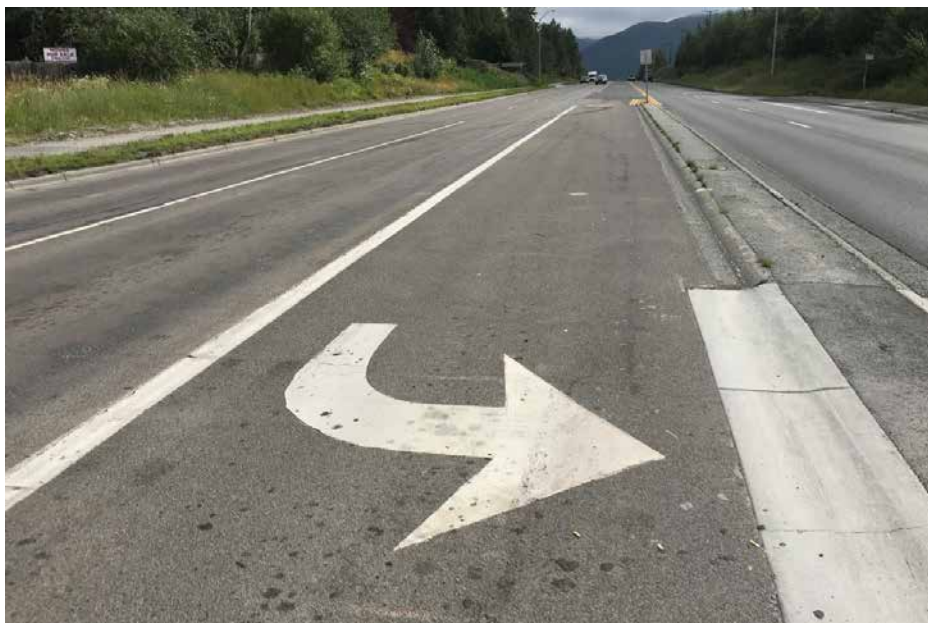
Tudor Road showed major friction loss in all tests. The friction drop between 2017 and 2018 was significant and both tests were less than typical pavement value of 0.58, with an average value of 0.31. As can be seen in the 2018 photo, below, the turn pocket shows minimal wear while the wheelpaths in the the through lanes show visible pavement and substantial wear. The third test performed in 2018 was in the turn pocket, and that data can be seen at the end of the appendix summarized with other turn pocket data.

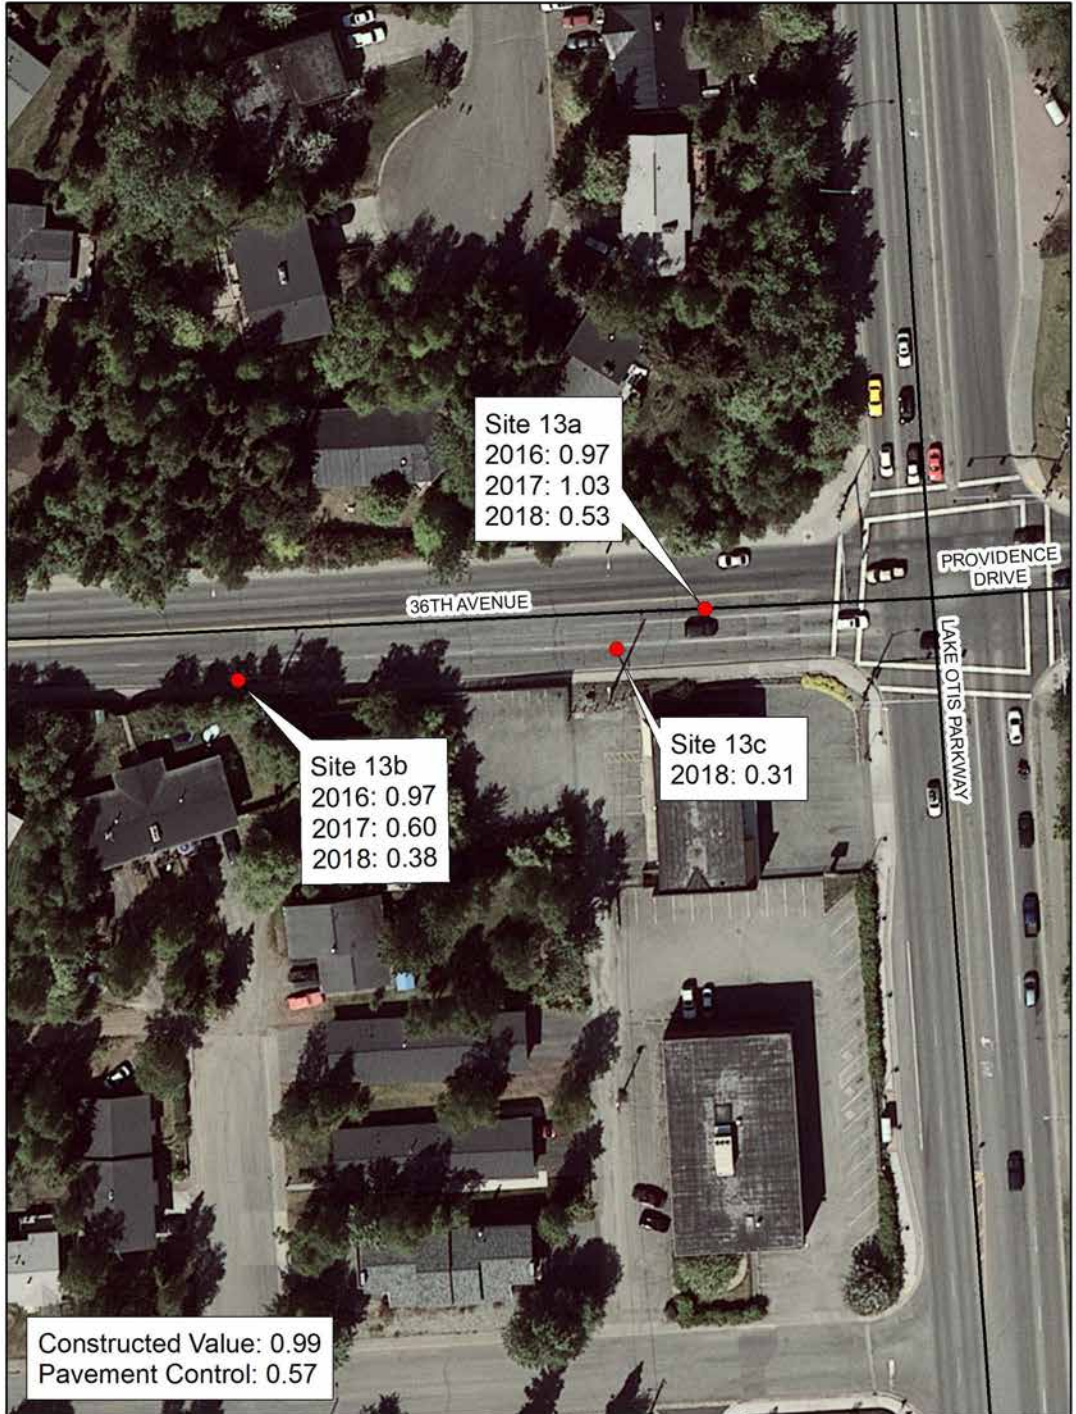
Site 13 – 36th Avenue at Lake Otis - Friction Overview

36th at Lake Otis showed major friction loss in all tests. The friction drop between 2017 and 2018 was significant and both tests in through lanes were less than the pavement control value of 0.57, with an average value of 0.35. Through lanes showed wear with visible pavement in areas. While the turn pocket showed major wear no pavement was visible. Turn pocket testing can be found at the end of the appendix summarized with other turn pocket data.

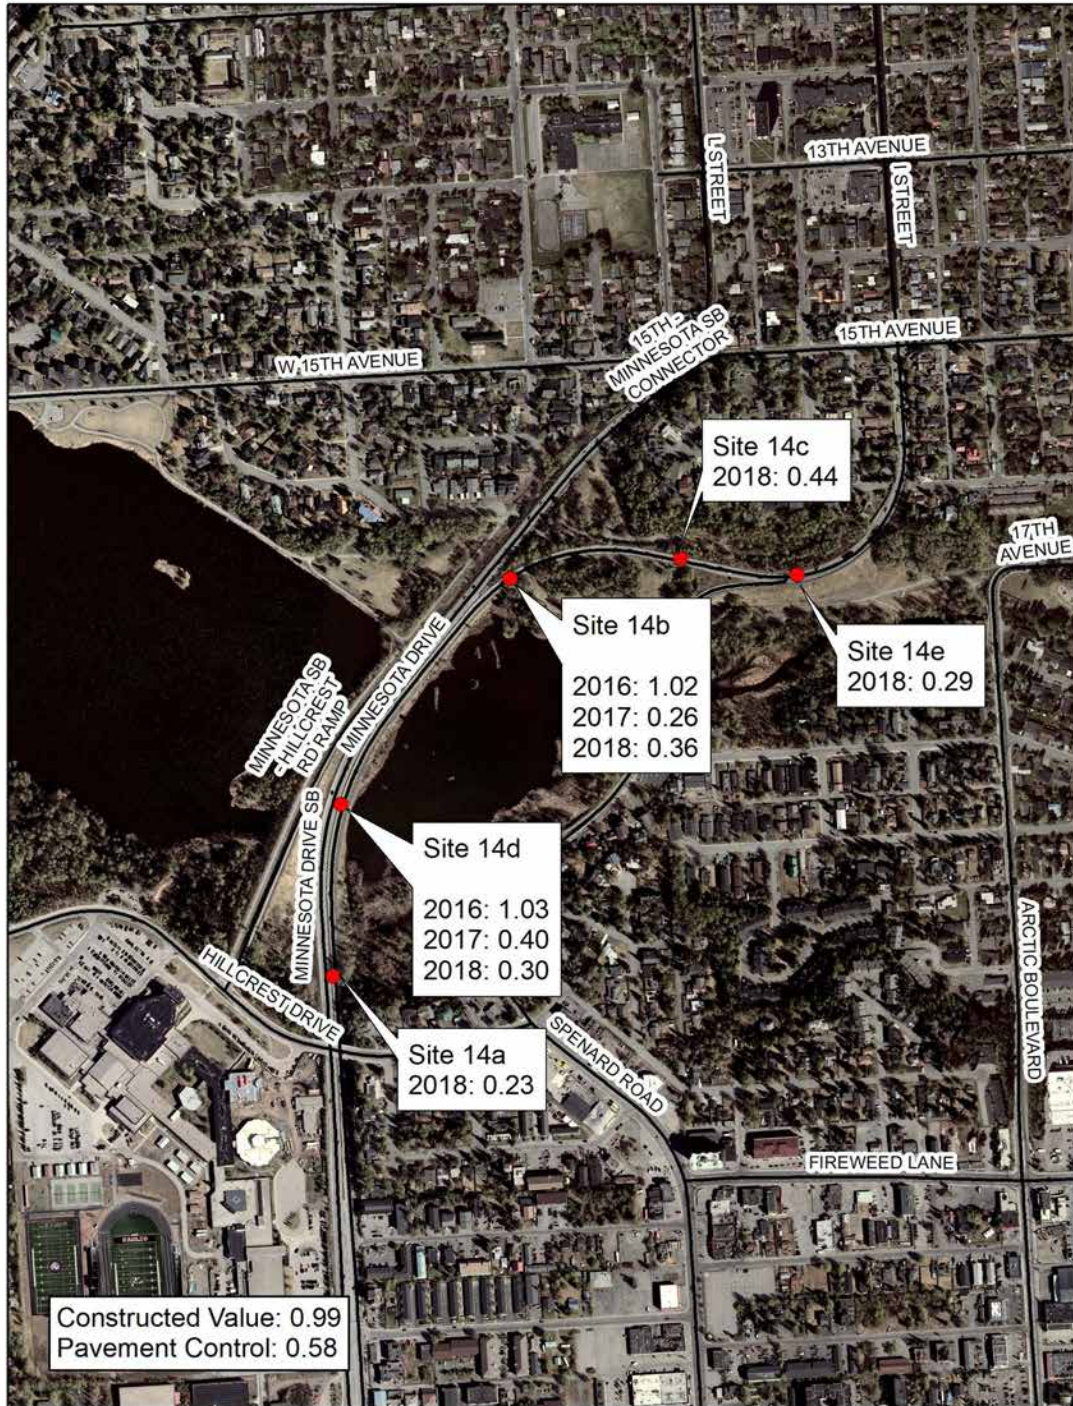
Site 14 – Minnesota Drive 25th to 15th - Friction Overview

Minnesota Drive showed major friction loss in all tests. All five tests had less friction than the pavement control value of 0.58, with an average value of 0.32. Through lanes showed bare pavement as can be seen in the 2018 photo, below.

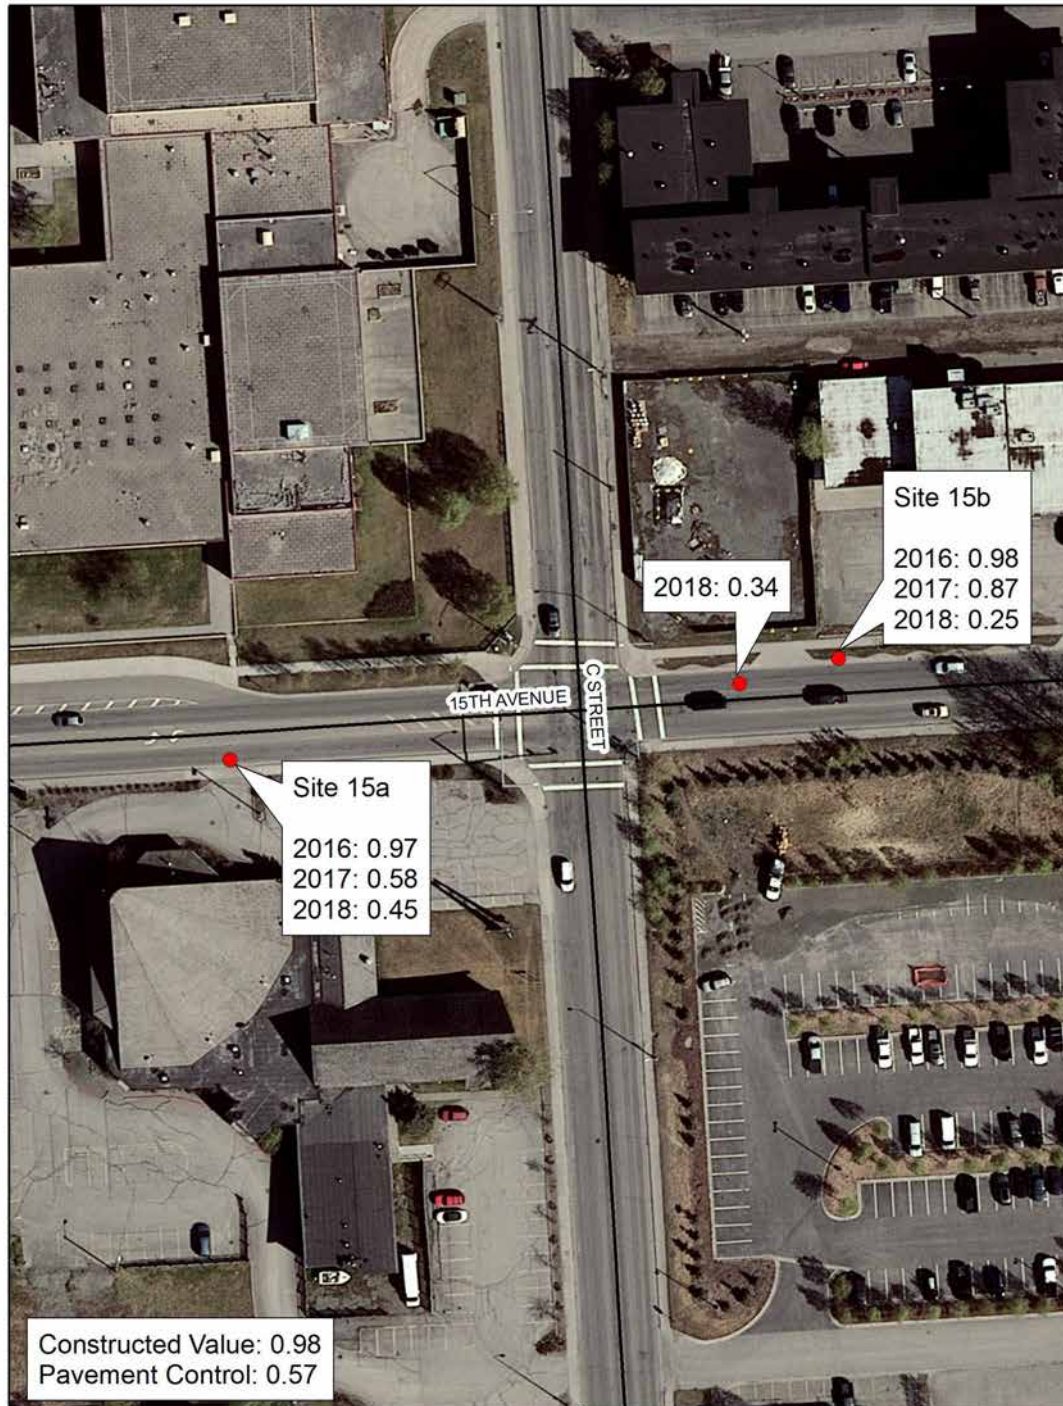
Site 15 – C Street and 15th Avenue - Friction Overview

C Street at 15th showed major friction loss in all tests. The friction drop between 2017 and 2018 was significant and both tests in through lanes had less friction than the pavement control value of 0.57, with an average value of 0.35. Through lanes showed bare pavement as can be seen in the 2018 photo, below. Turn pocket testing can be found at the end of the appendix.

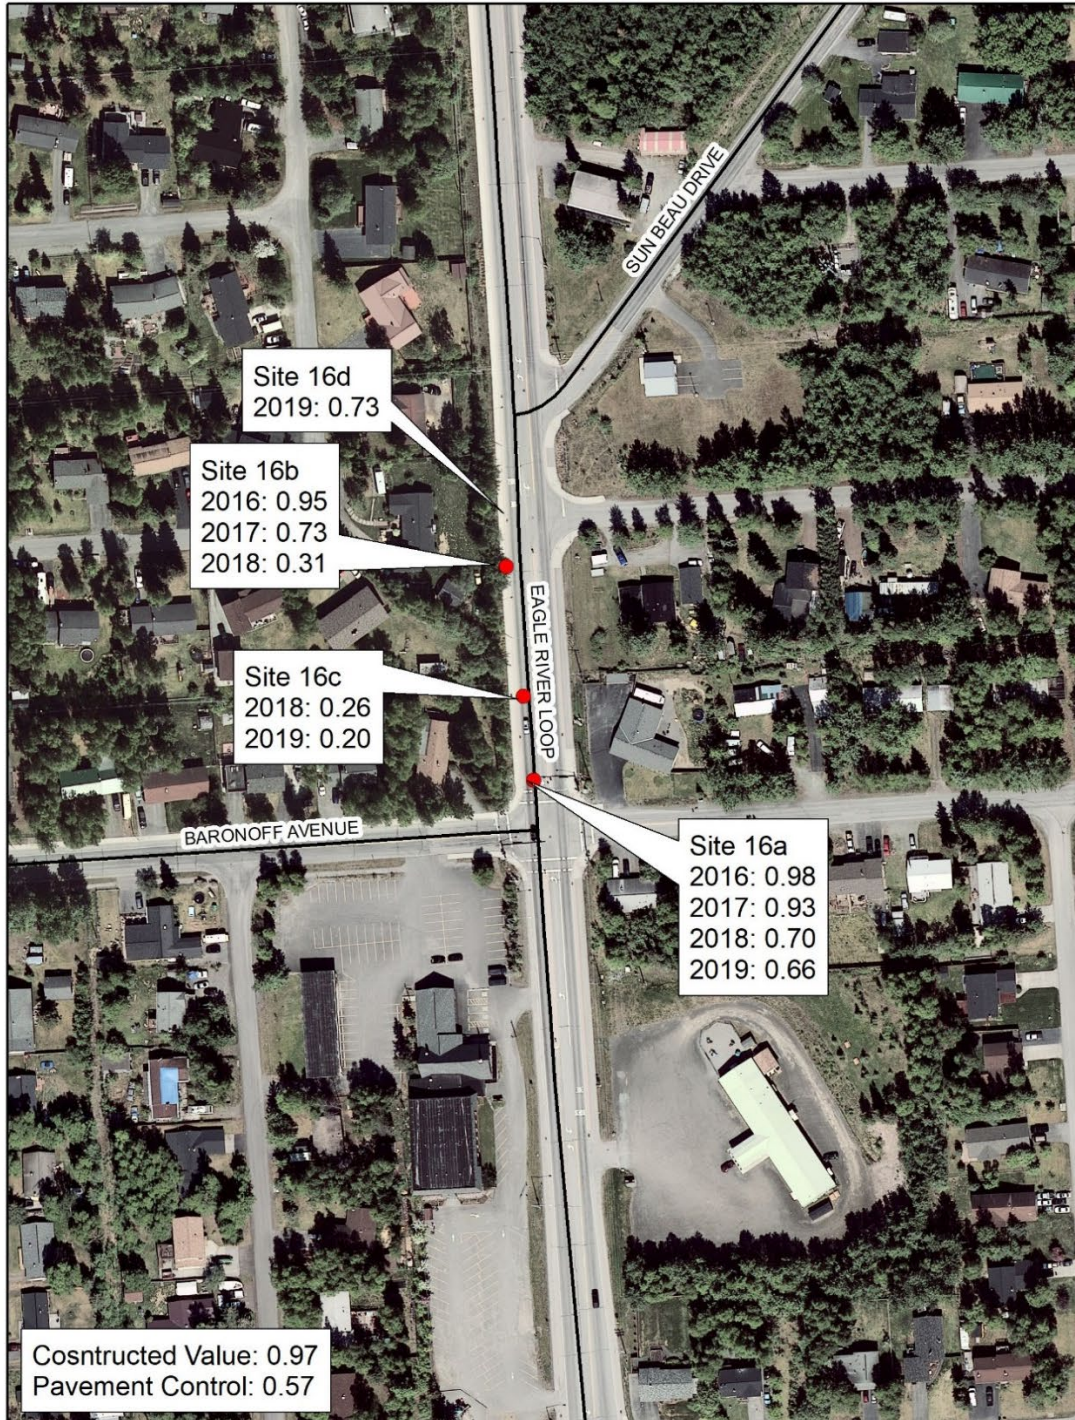
Site 16 – Eagle River Loop - Friction Overview

Eagle River Loop Road showed significant friction loss. A third test was performed in through lanes in 2019 with a value of 0.73. This value remained higher than the other two performed in the through lanes closer to the intersection with 2019 values of 0.31 and 0.20. This higher value raised the average value in 2019. Major polishing of the HFST and bare pavement can be seen in the 2019 photo, below. Turn pocket testing can be found at the end of the appendix.

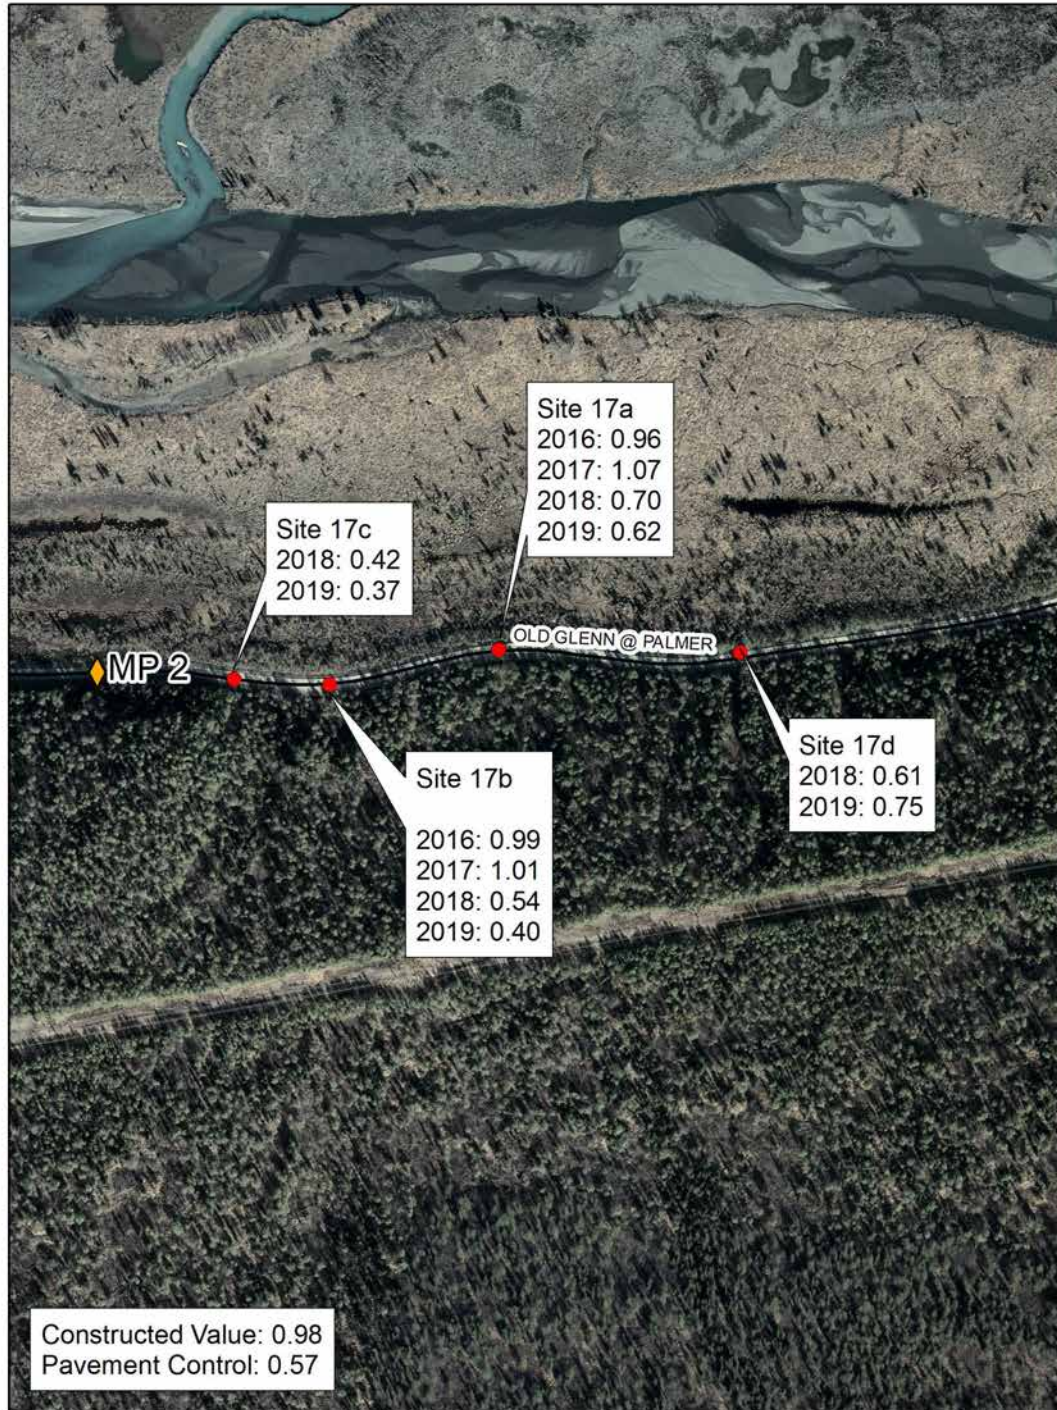
Site 17: Old Glenn MP 2

Site 17 – Old Glenn at Milepost 2 - Friction Overview

Old Glenn at MP 2 showed moderate friction loss, although not a major loss on average between 2018 and 2019. Two of the four tests had less friction than the original pavement control of 0.57, with an average of 0.54. Areas of bare pavement were visible from both studded tire wear in wheelpaths and areas where the pavement heaved in the winter and the HFST was bladed through, as can be seen in the 2019 photos, below.

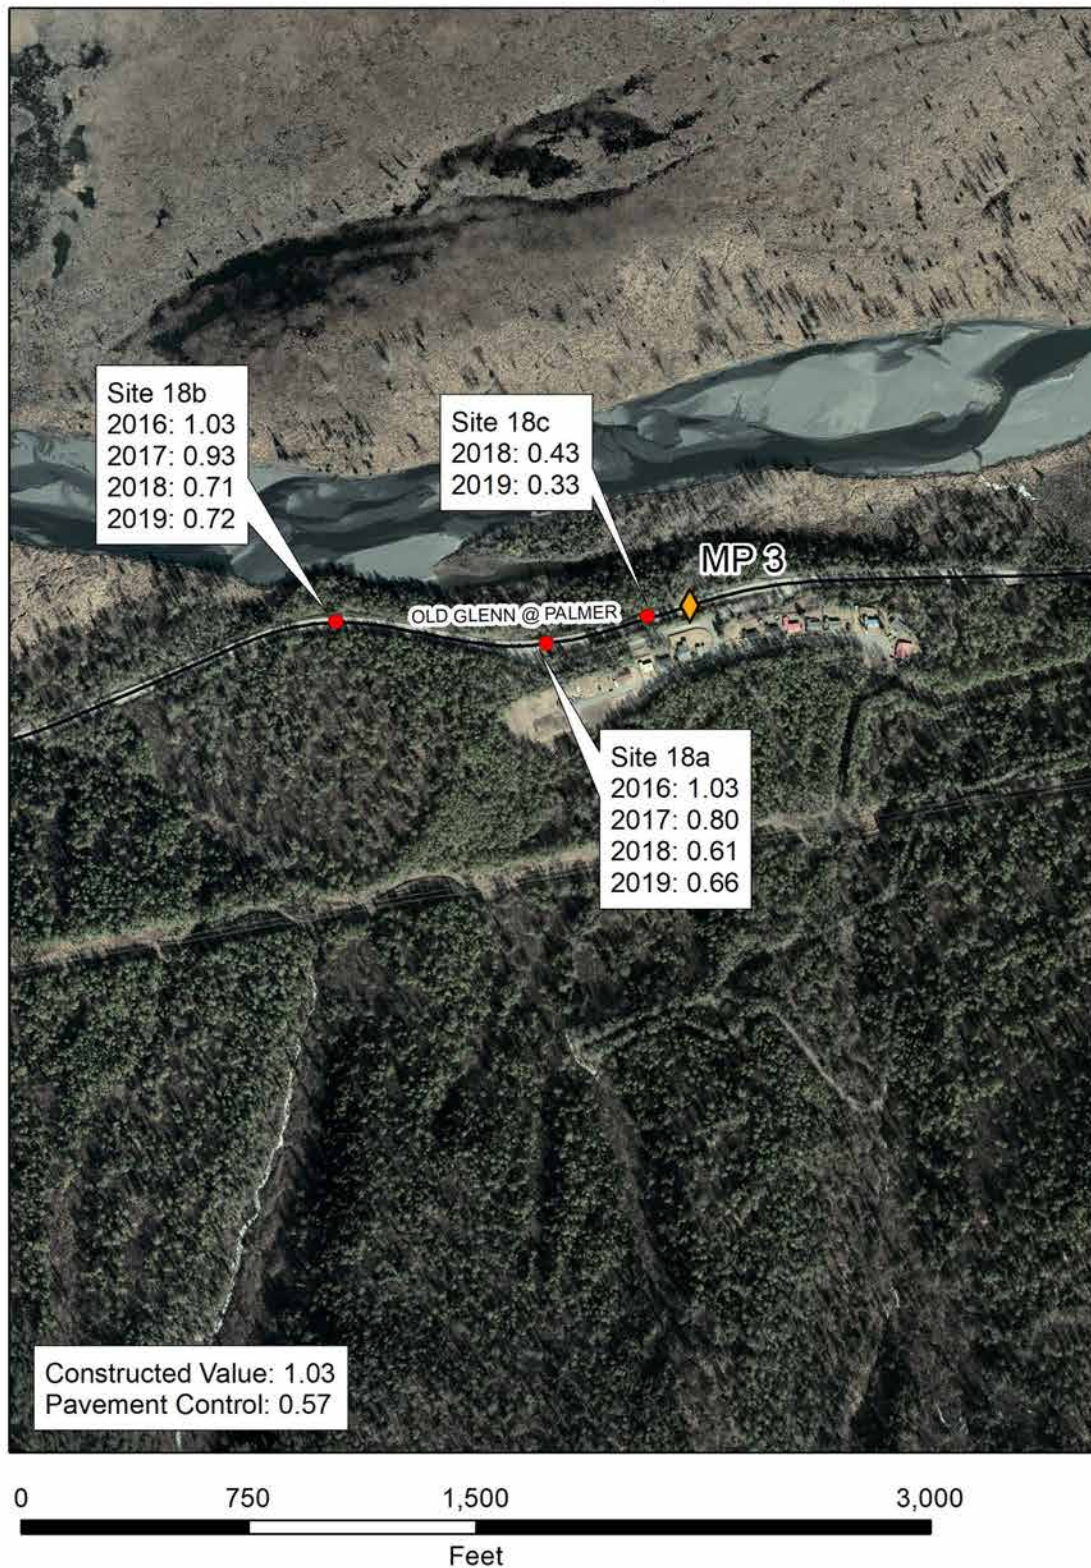
Site 18: Old Glenn MP 3 (Twin Peaks)

Site 18 – Old Glenn at Milepost 3 - Friction Overview

Old Glenn at MP 3 showed moderate friction loss, although minimal loss on average between 2018 and 2019. One of the three tests had less friction than the original pavement control of 0.57, with an average of 0.57. Areas of bare pavement were visible in wheelpaths as can be seen in the 2019 photo below.

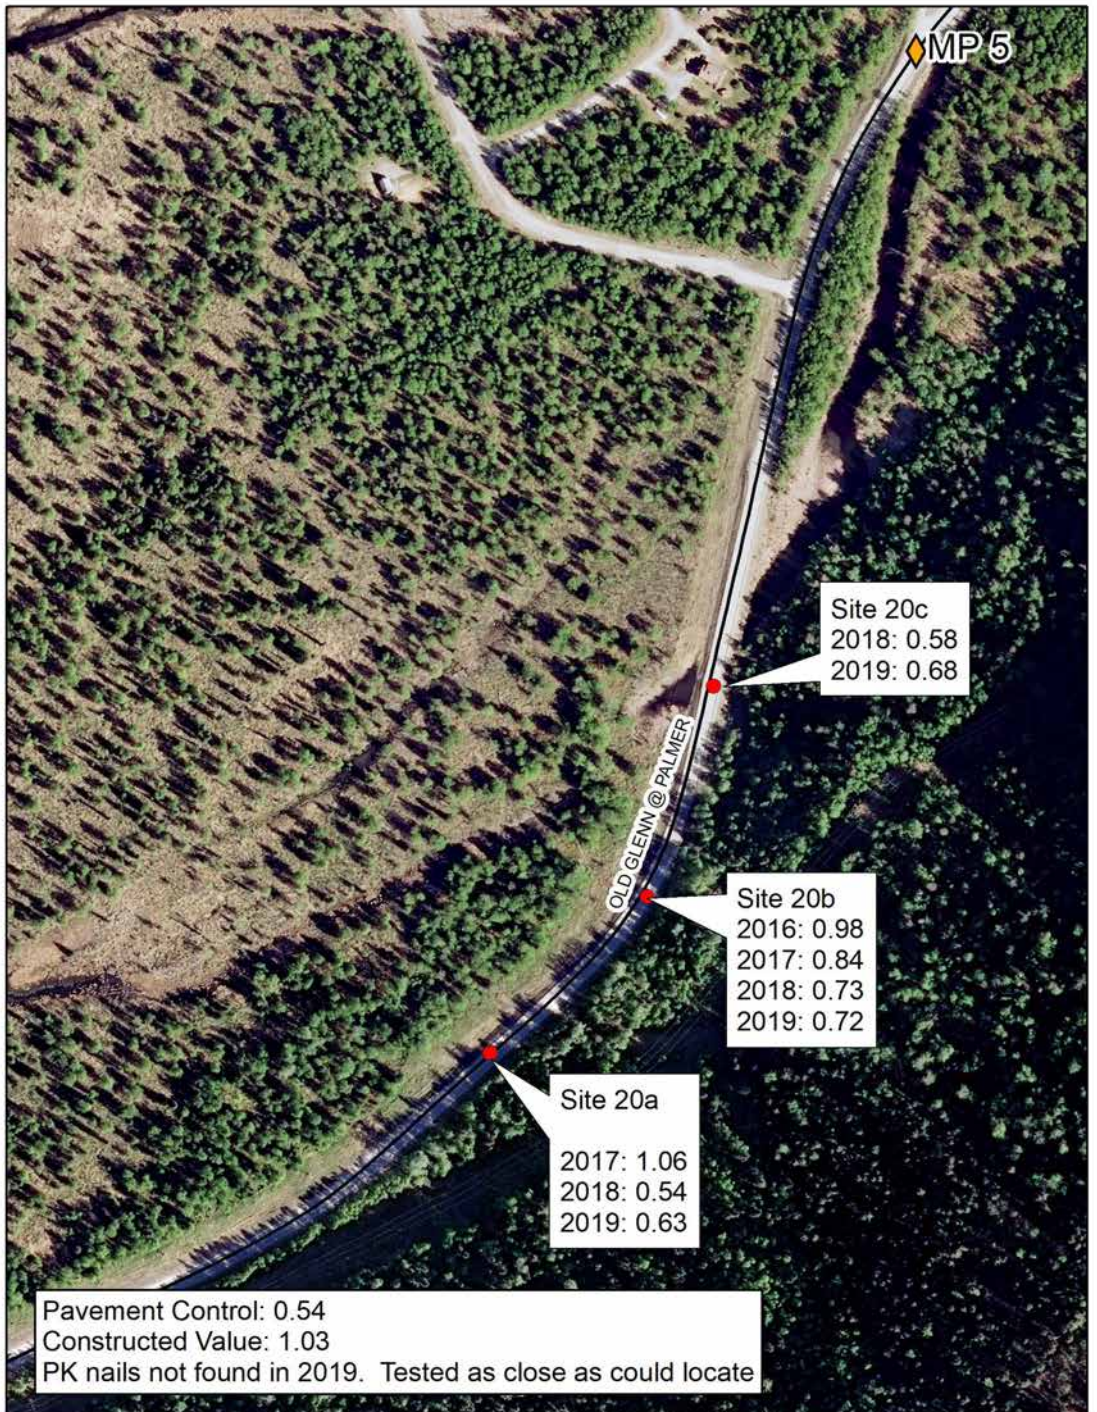
Site 20: Old Glenn MP 5

Site 20 – Old Glenn at Milepost 5 - Friction Overview

Old Glenn at milepost 5 showed moderate friction loss. None of the three tests had less friction than the original pavement control of 0.54, with an average of 0.68. The PK nails could not be located in 2019 so the testing was performed as close as the crew could manage to the original locations. This is likely the cause of the discrepancy of friction values between 2018 and 2019.

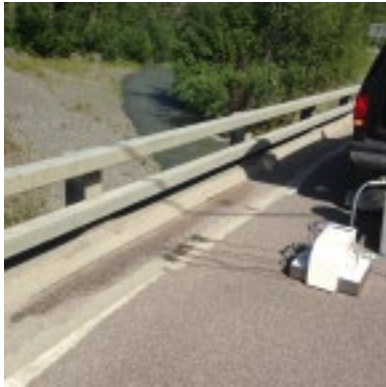
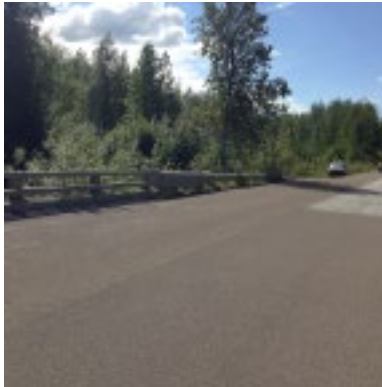
2016, Test 1

Old Glenn at at milepost 6 showed moderate friction loss, although no loss on average between 2018 and 2019. None of the three tests had less friction than the original pavement control of 0.54, with an average of 0.63. Small amounts of bare pavement was visible under the HFST, although this did not affect testing at this location. Typical wear of the HFST can be seen in the second 2019 picture adjacent to the PK nail, below.

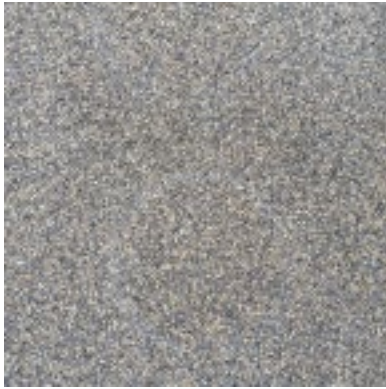
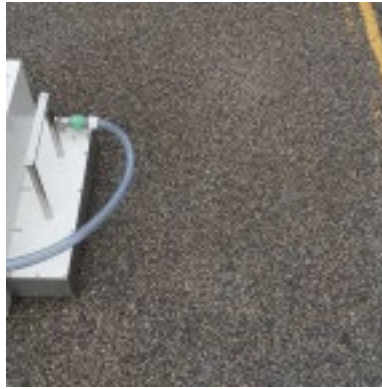
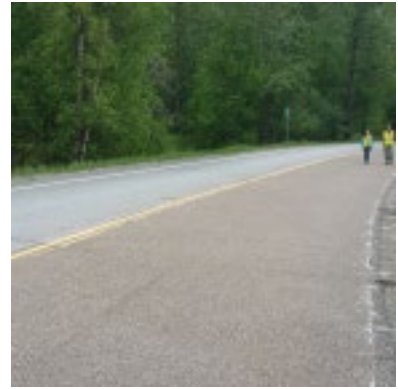
2016

Old Glenn at at milepost 7 showed moderate friction loss. One of the five tests had less friction than the original pavement control of 0.49, while the average was 0.55. Small amounts of bare pavement was visible under the HFST, likely due to snowplowing as there typically wasn't major wear evident in the wheelpaths. See the 2019 picture, below.
