Alaska Department of Transportation & Public Facilities Research & Technology Transfer

High Friction Surface Treatment Experimental Feature Final Report and 3rd Year Monitoring Results

Publication Number: FHWA-AK-RD-000S(882)

December 2019

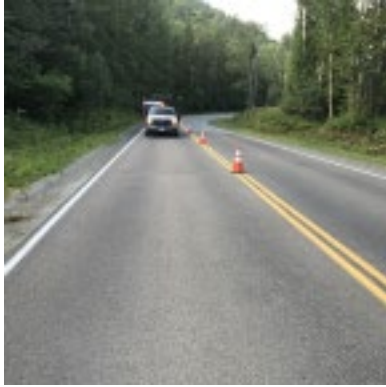
2017

Old Glenn at milepost 8 showed moderate friction loss, although minimal loss on average between 2018 and 2019. One of the five tests had less friction than the original pavement control of 0.49, while the average was 0.61. Small amounts of bare pavement was visible under the HFST, likely due to snowplowing and studded tire wear. See the 2019 picture, below and on the next page.

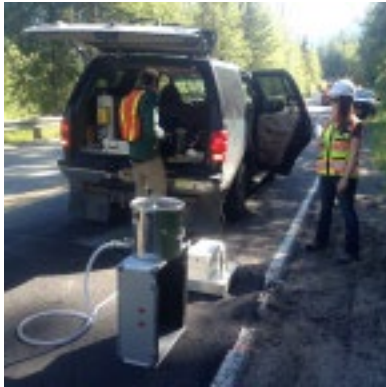
2016, Control

Old Glenn at Our Road showed moderate friction loss, although minimal loss on average between 2018 and 2019. One of the three tests had less friction than the original pavement control of 0.55, while the average was 0.59. Small amounts of bare pavement was visible under the HFST, likely due to snowplowing as some of the observed pavement is outside of wheelpaths. The surface texture observed in the 2019 photo, below, is due to the HFST application being located in the floodplain and the surface required milling to maintain elevation.

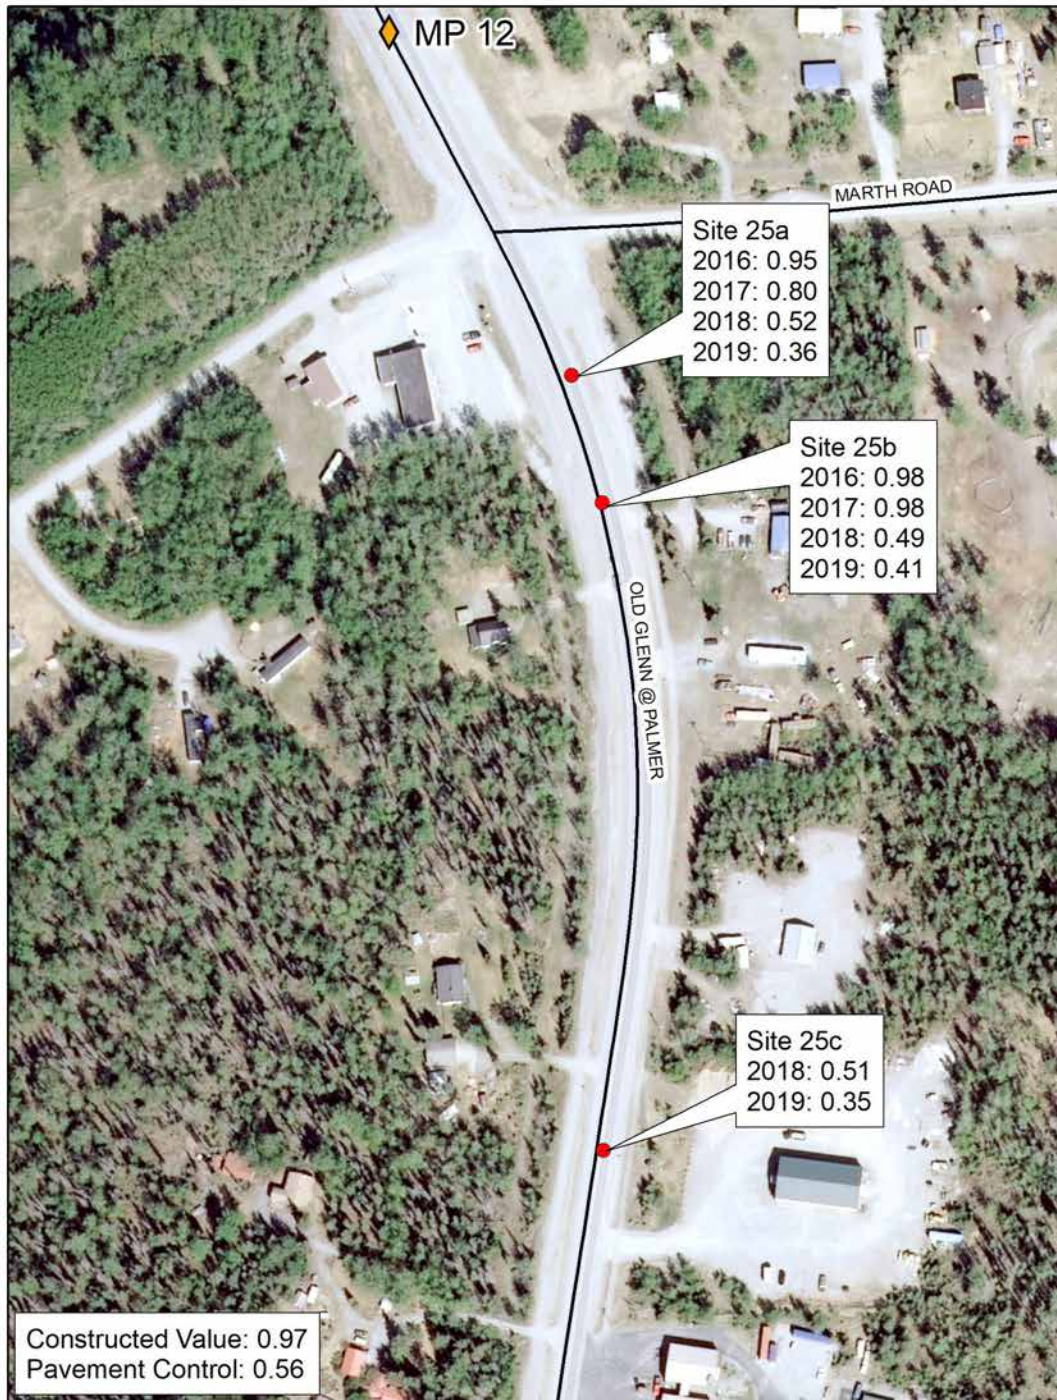
Site 25: Old Glenn MP 12

Site 25 – Old Glenn at Milepost 12 - Friction Overview

Old Glenn at milepost 12 lost significant friction. All three of the tests had less friction than the pavement control of 0.56. The average 2019 friction value was 0.37. Bare pavement was common at this site and in the 2019 photo, below, bare pavement can be observed in the wheelpath where the friction test is being performed. This site is closer to Palmer and contains higher traffic volumes than the rest of the sites on the Old Glenn Highway which is contributing to the wear compared to other Old Glenn Highway sites.

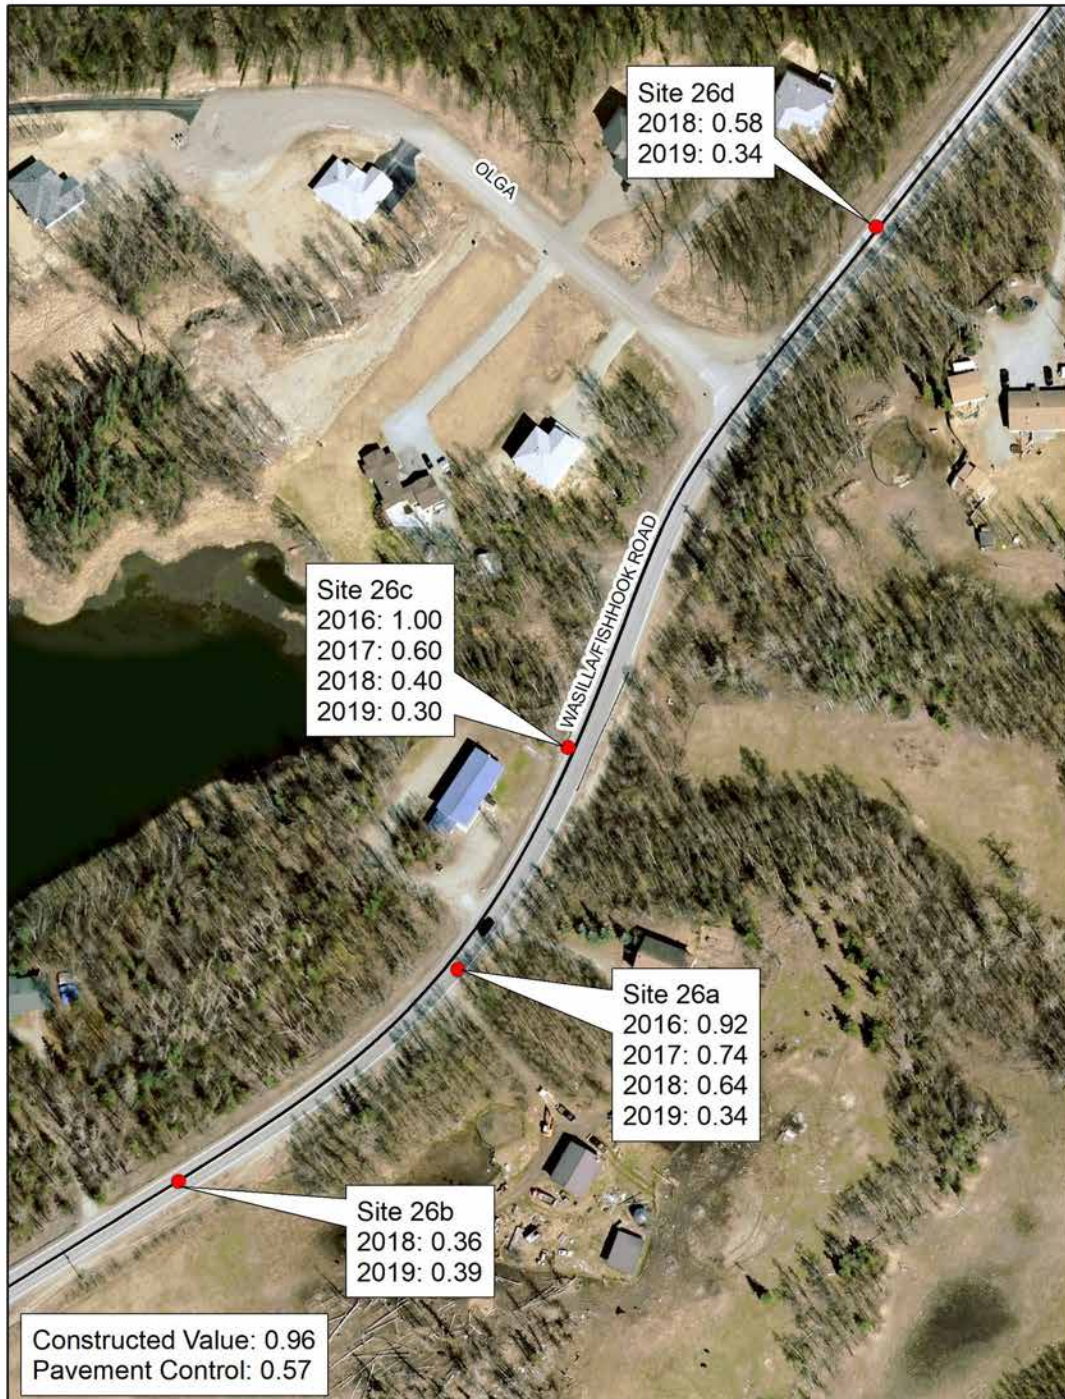
Site 26: Wasilla-Fishhook: Lakeview to Paradise Ln

Site 26 – Wasilla/Fishhook Rd: Lakeview Rad to Paradise Lane

Site 26 lost significant friction. All four of the tests performed had less friction than the pavement control of 0.57. The average 2019 friction value was 0.34. Bare pavement was common at this site and in the 2019 photo, below, bare pavement can be observed in both wheelpaths, although primarily in the right. This site is close to East Seldon and Bogard and has the highest traffic volume on Wasilla/Fishhook at almost 5,000 AADT.

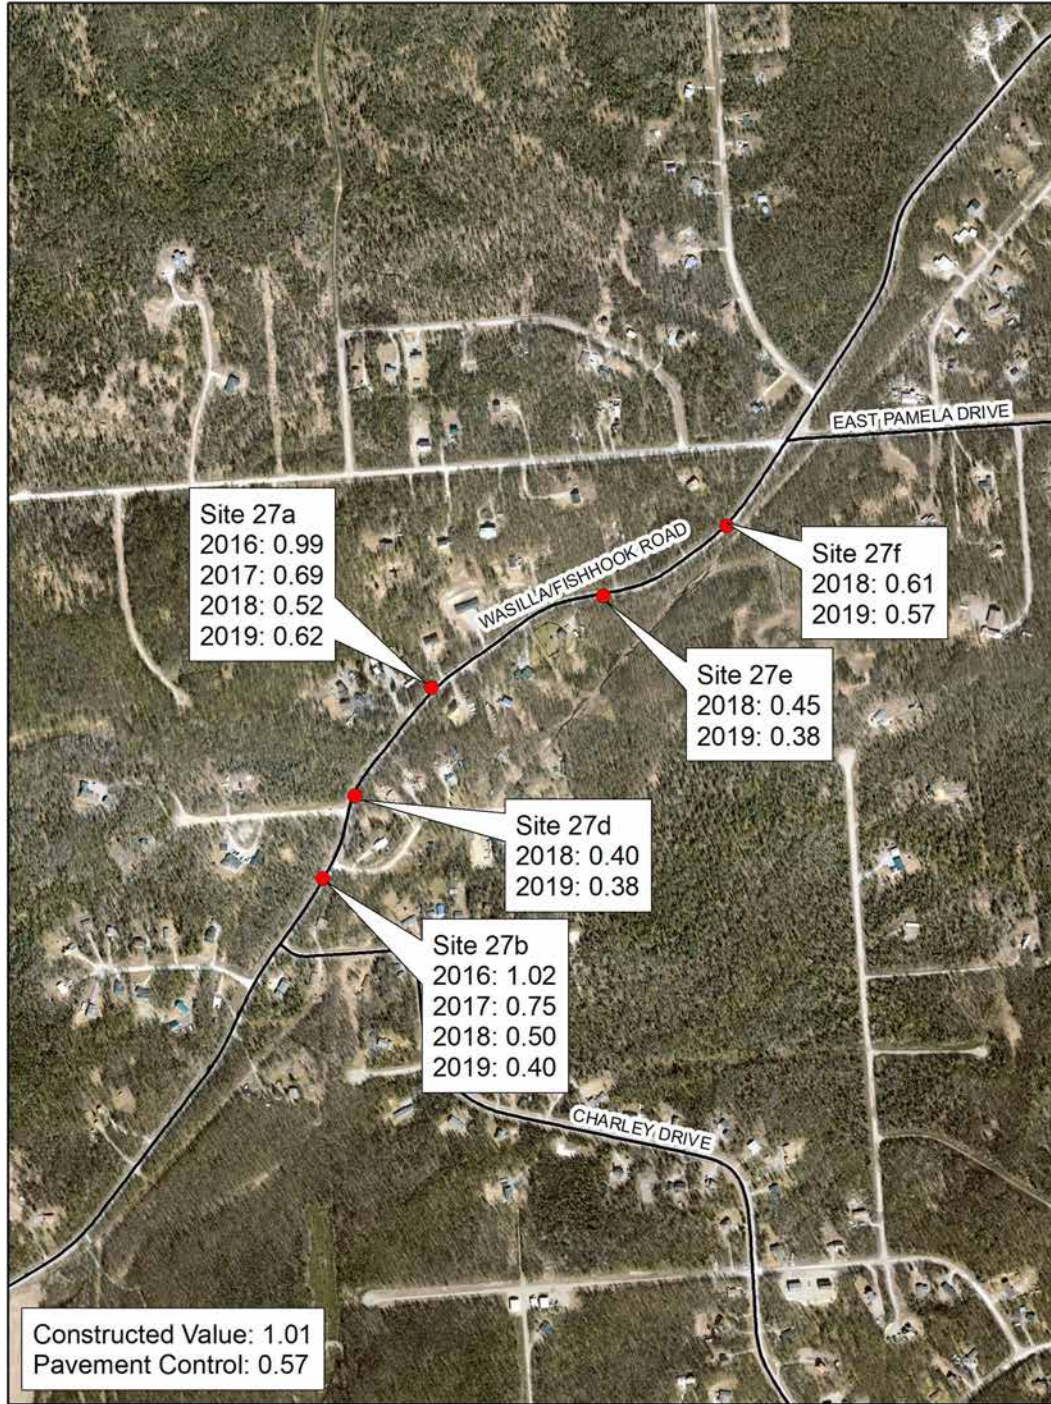
Site 27: Wasilla-Fishhook: Mariah Dr to Pamela Dr

Site 27 – Wasilla/Fishhook Road: Mariah Drive to Pamela Drive

Site 27 lost significant friction, although the average drop in friction between 2018 and 2019 was minimal. Three of the five tests performed had less friction than the pavement control of 0.57. The average 2019 friction value was 0.47. Bare pavement was visible at this site and in the 2019 photo, below, bare pavement can be observed in the left wheelpath. As with site 26 this location has a relatively high AADT at over 4,000, or twice that of the Old Glenn sites.

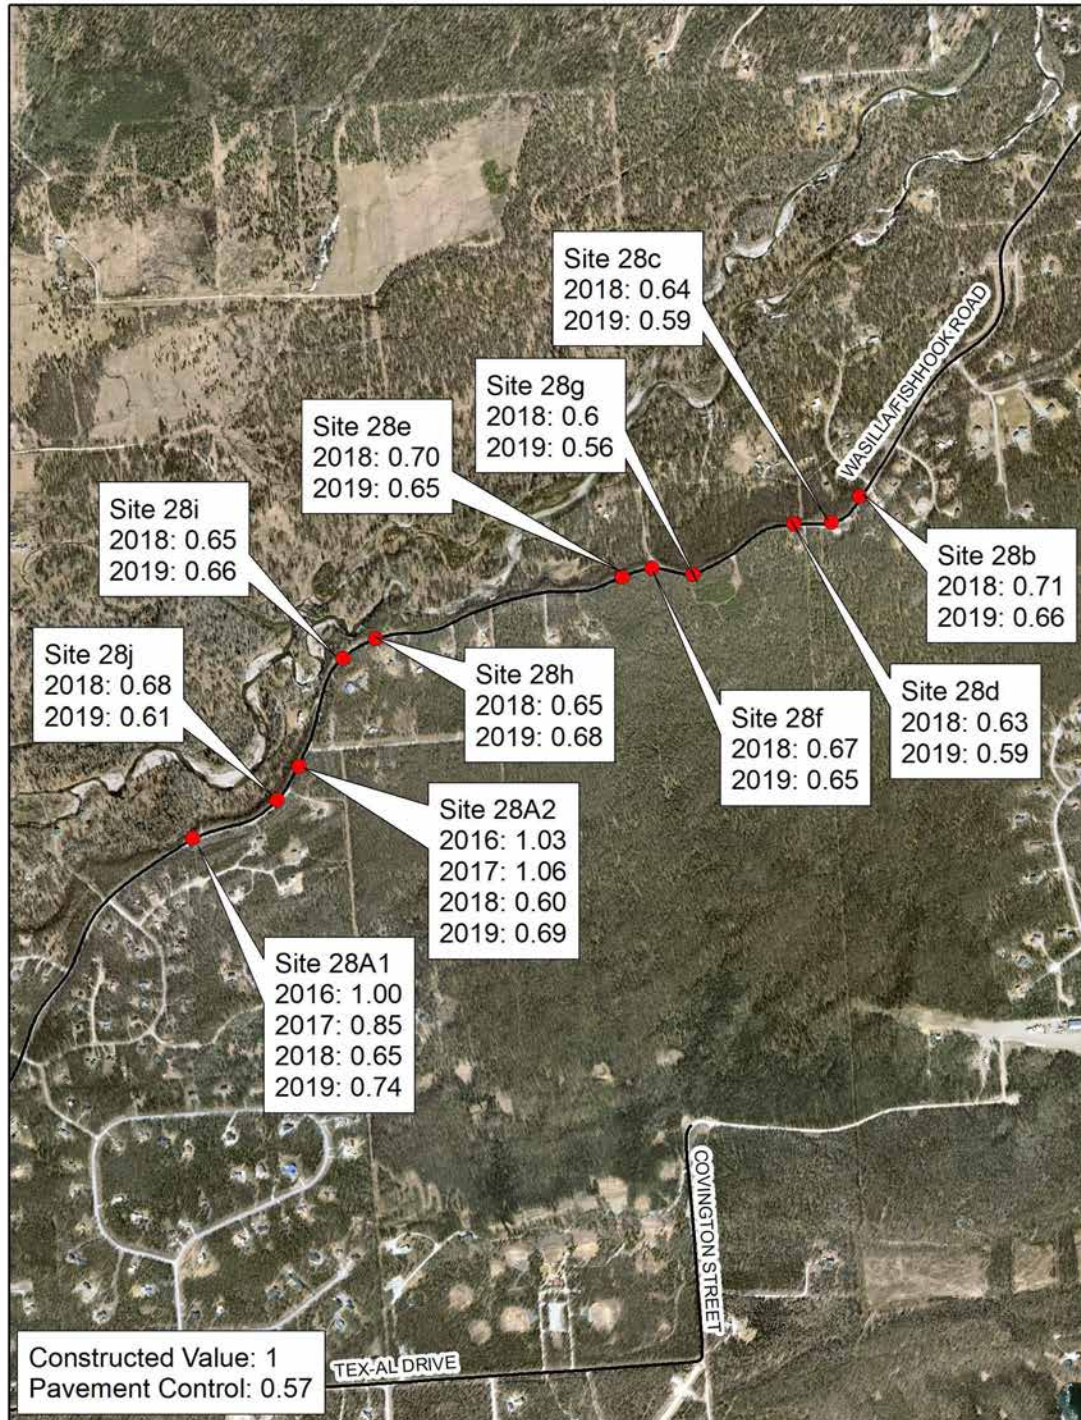
Site 28: Wasilla-Fishhook: King Cove Dr to McCCasey Dr

Site 28 – Wasilla/Fishhook Road: King Cove Dr to McCasey Dr

Site 28 lost moderate friction, although the average drop in friction between 2018 and 2019 was minimal. Only one of the eleven tests performed had less friction than the pavement control of 0.57. The average 2019 friction value was 0.64. The slight deviations in friction values between 2018 and 2019 is likely due to the original PK nails not being located during 2019 testing at those locations. While this location had less friction loss it also has less than half the traffic of the other two Wasilla/Fishhook sites.

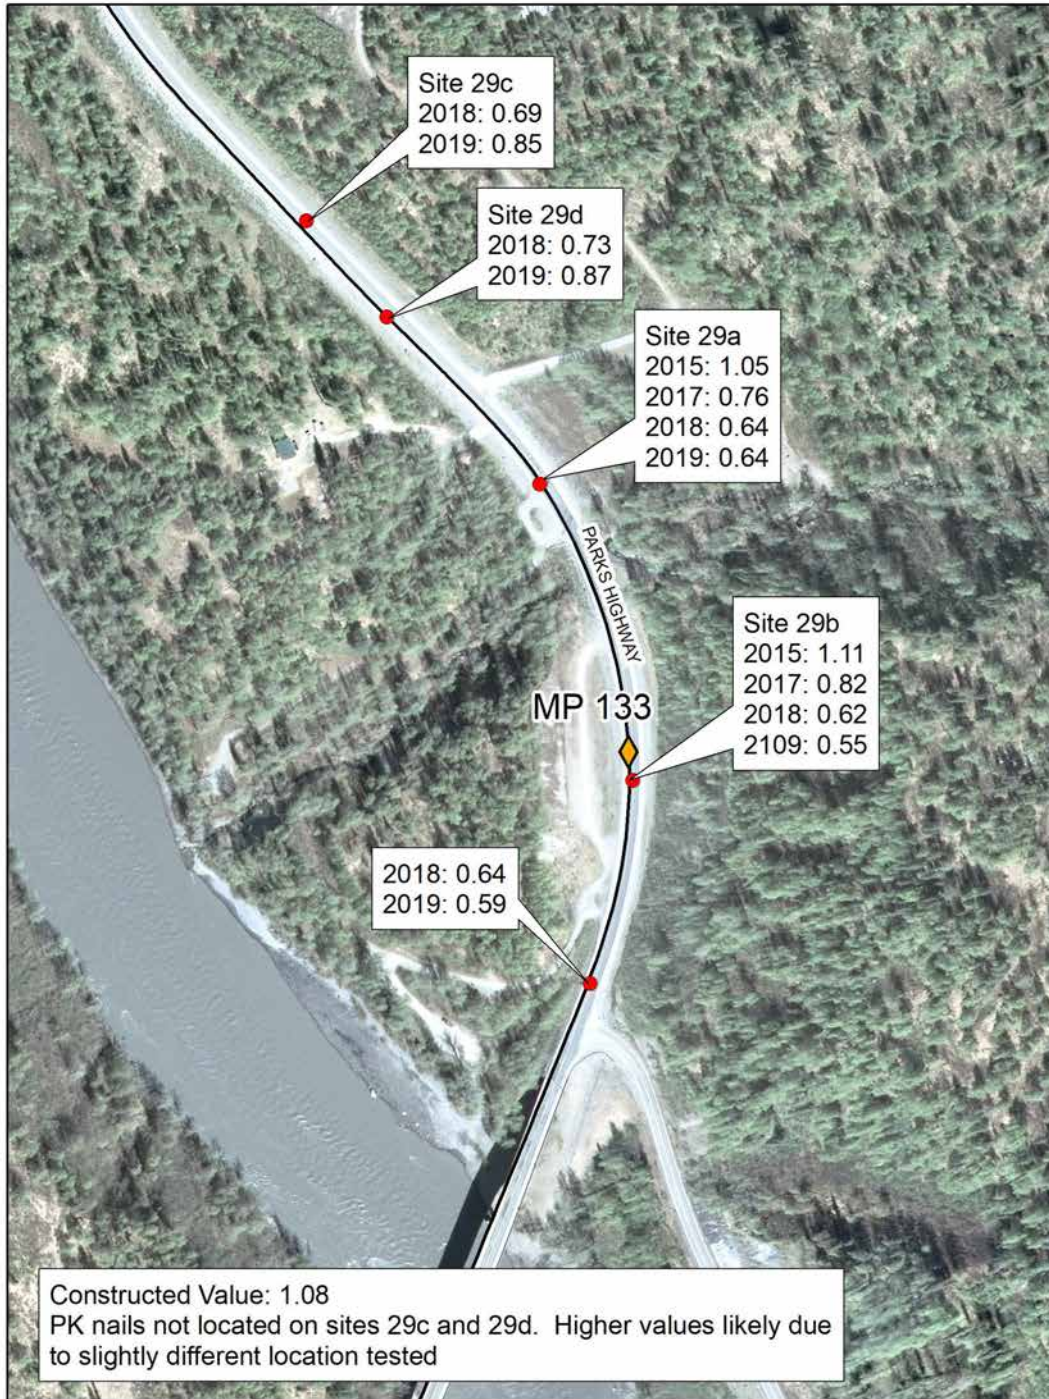
Site 29: Parks Hwy MP 133

While the Parks Highway at Chutlina lost moderate friction, it still retains higher friction than most other locations. All tests retain the friction of pavement or higher after 4 winters. The average 2019 friction value was 0.66. This was the only location tested that used fully automated application and used epoxy resin. A cracking pattern can be seen in the 2019 photo, below, that may be due to the contraction of the epoxy during the winter seasons.
