Aerial Infrared Scanning of Bridge Decks on Parks Highway to Map Delaminations

FINAL REPORT

Prepared by:
Infrasense, Inc.
Woburn, MA

Report # FHWA-AK-RD-000S(960)
March 2, 2023

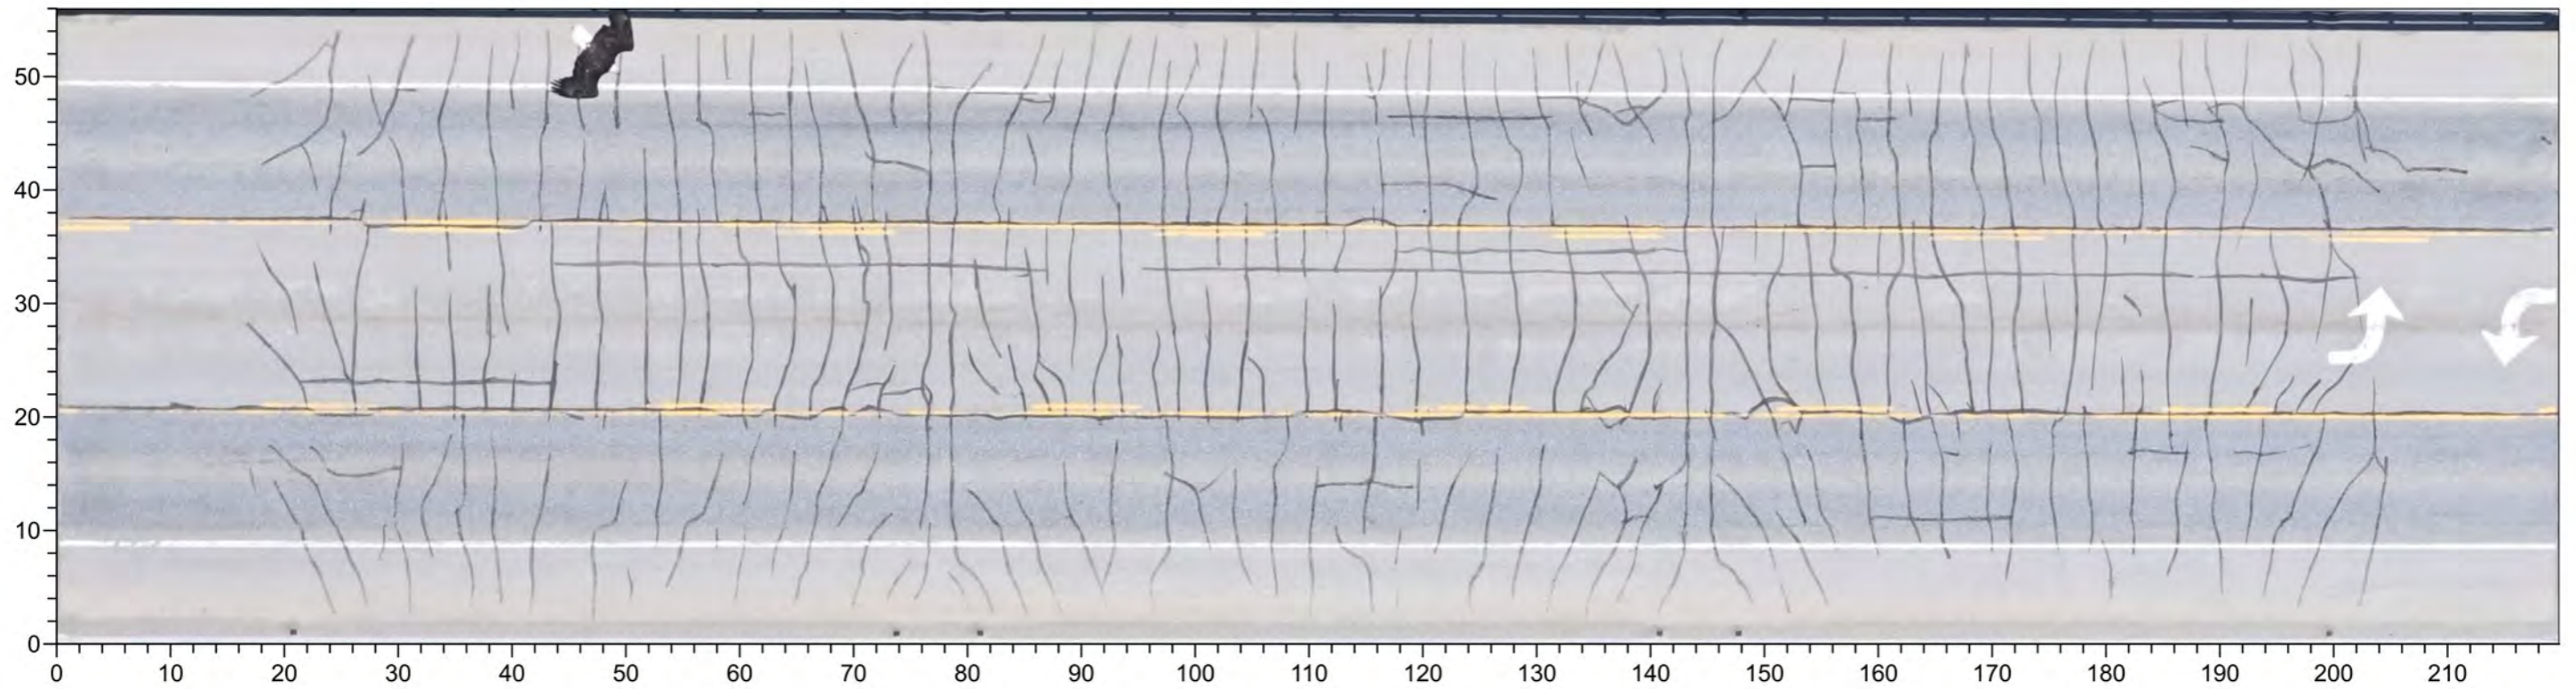
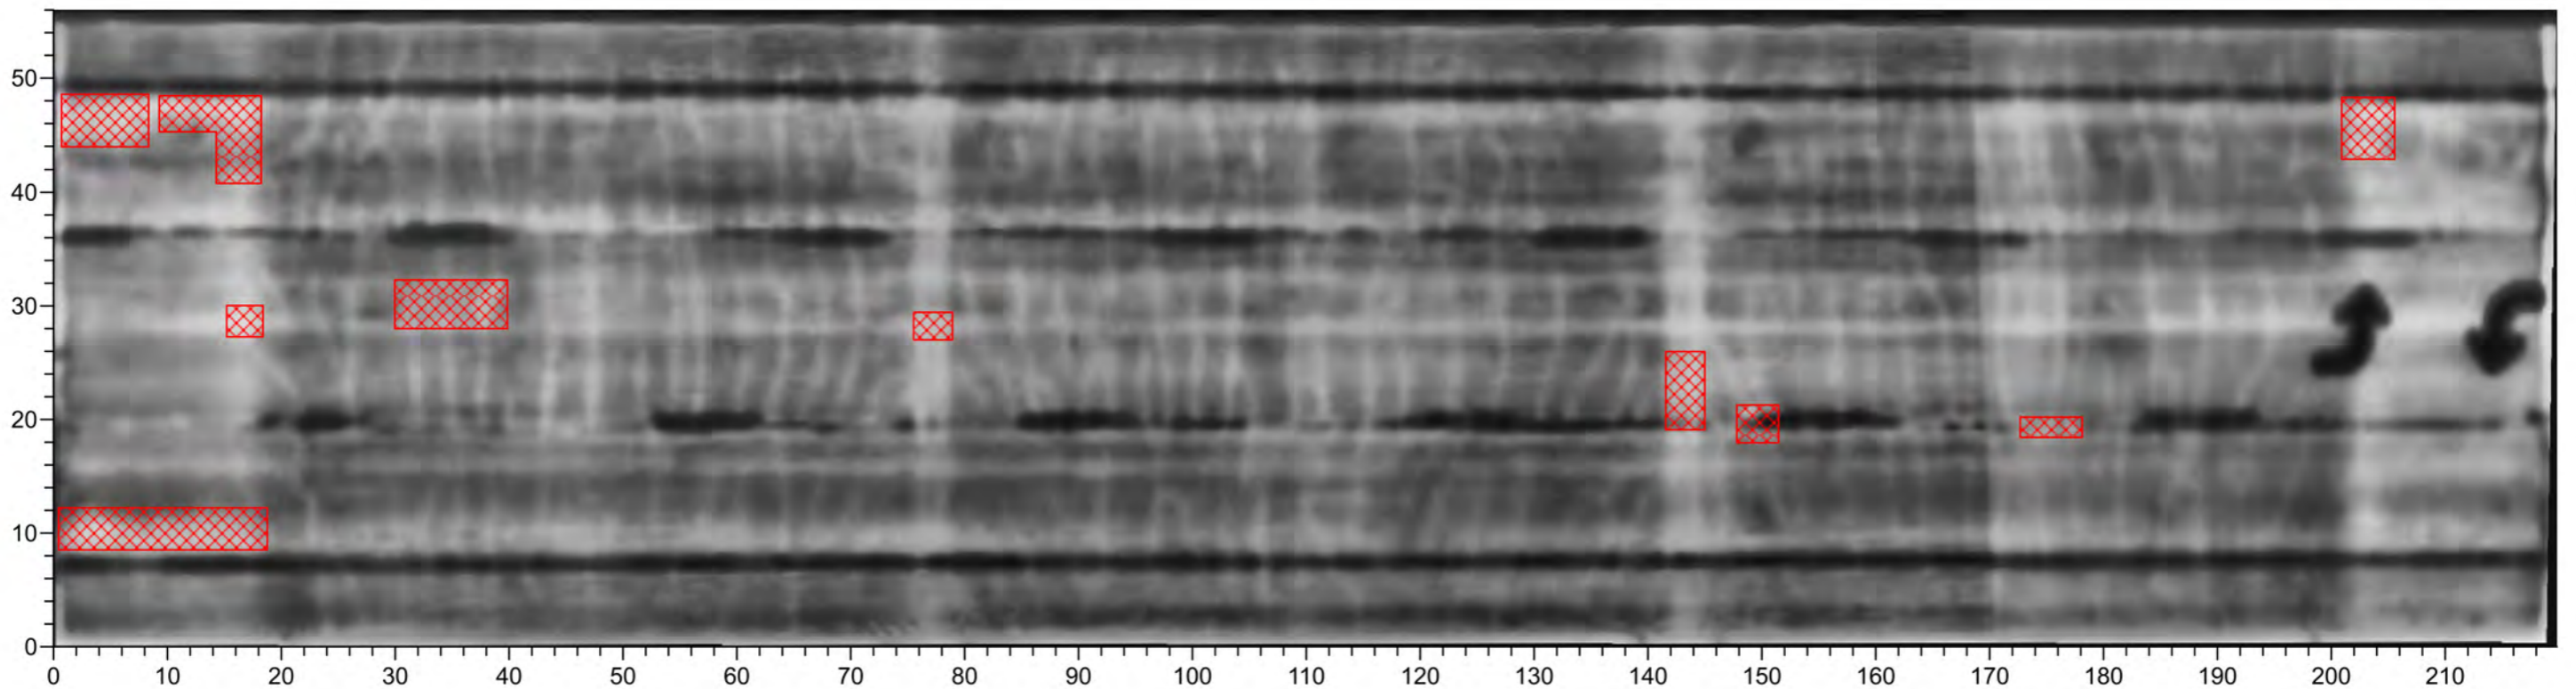
Delamination Quantity (%) 0.5 Delamination Quantity (ft ²) 214	Imagery Collected: 6/5/22 Analyzed by: EG, SB Reviewed by: AJC Completed: 10/12/22

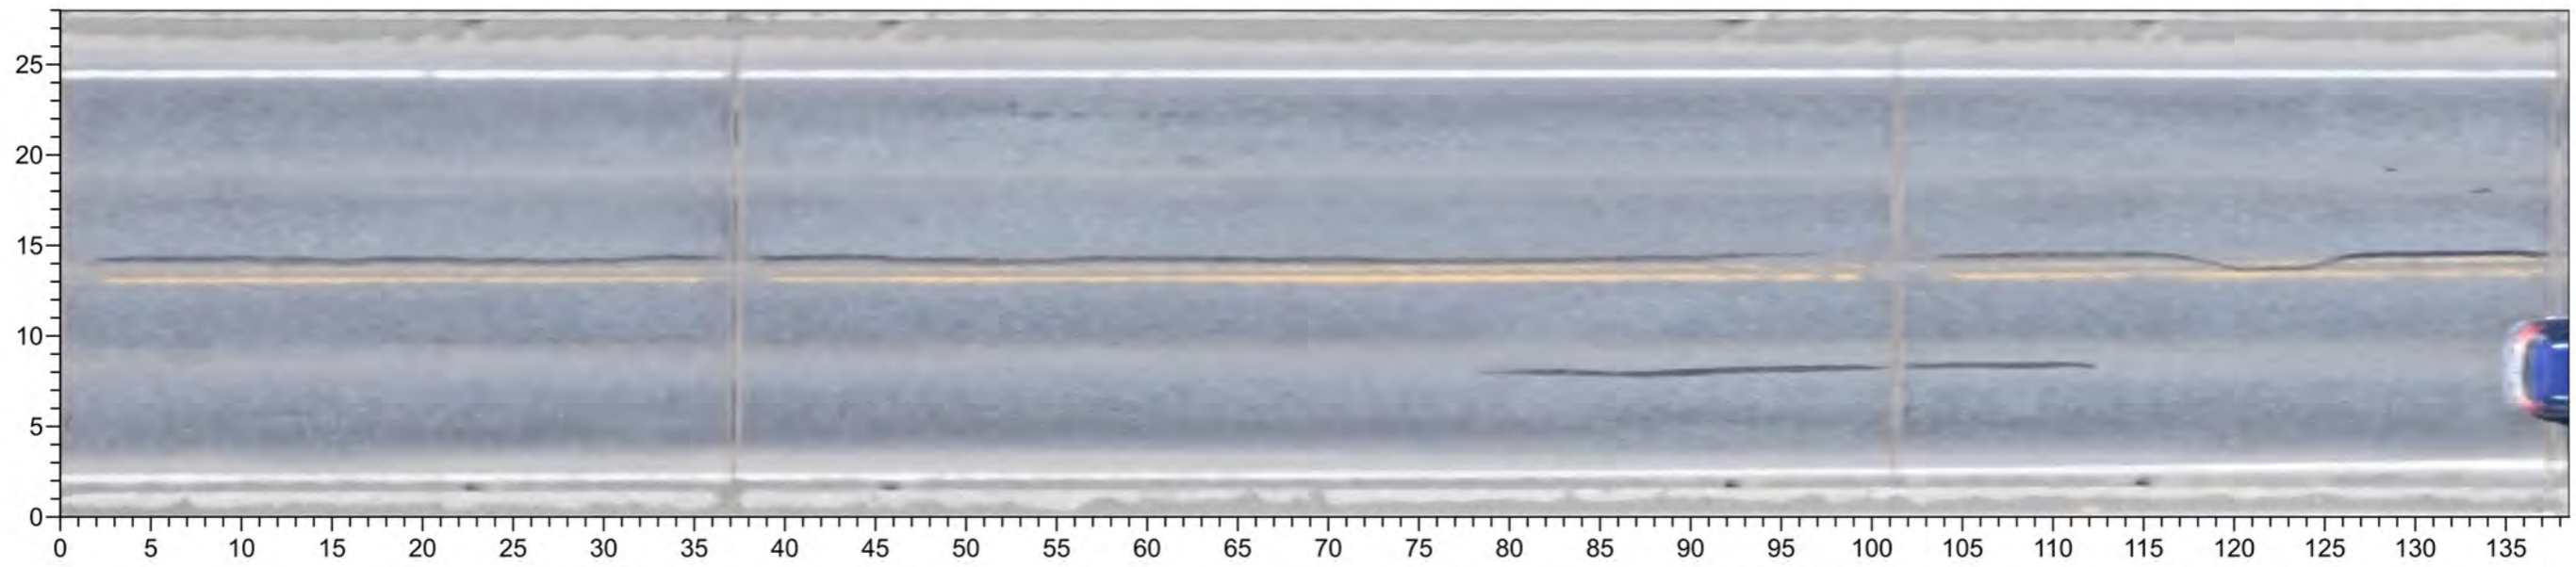
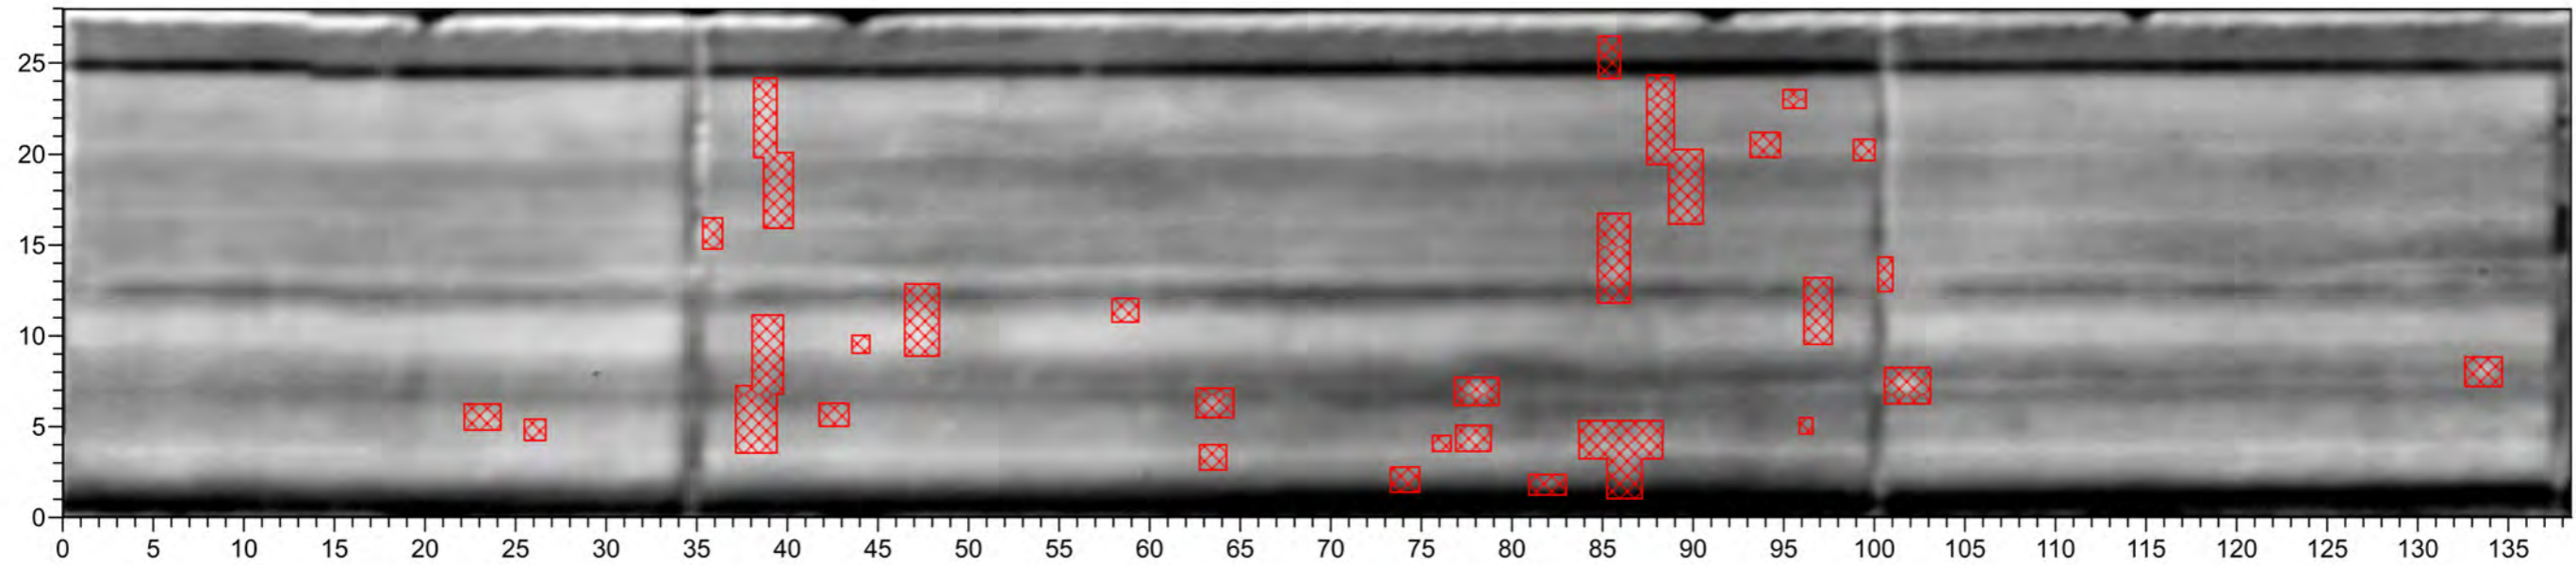
Delamination Quantity (%) 2.3	Delamination Quantity (ft ²) 280	Imagery Collected: 6/4/22 Analyzed by: SB Reviewed by: AJC Completed: 9/30/22

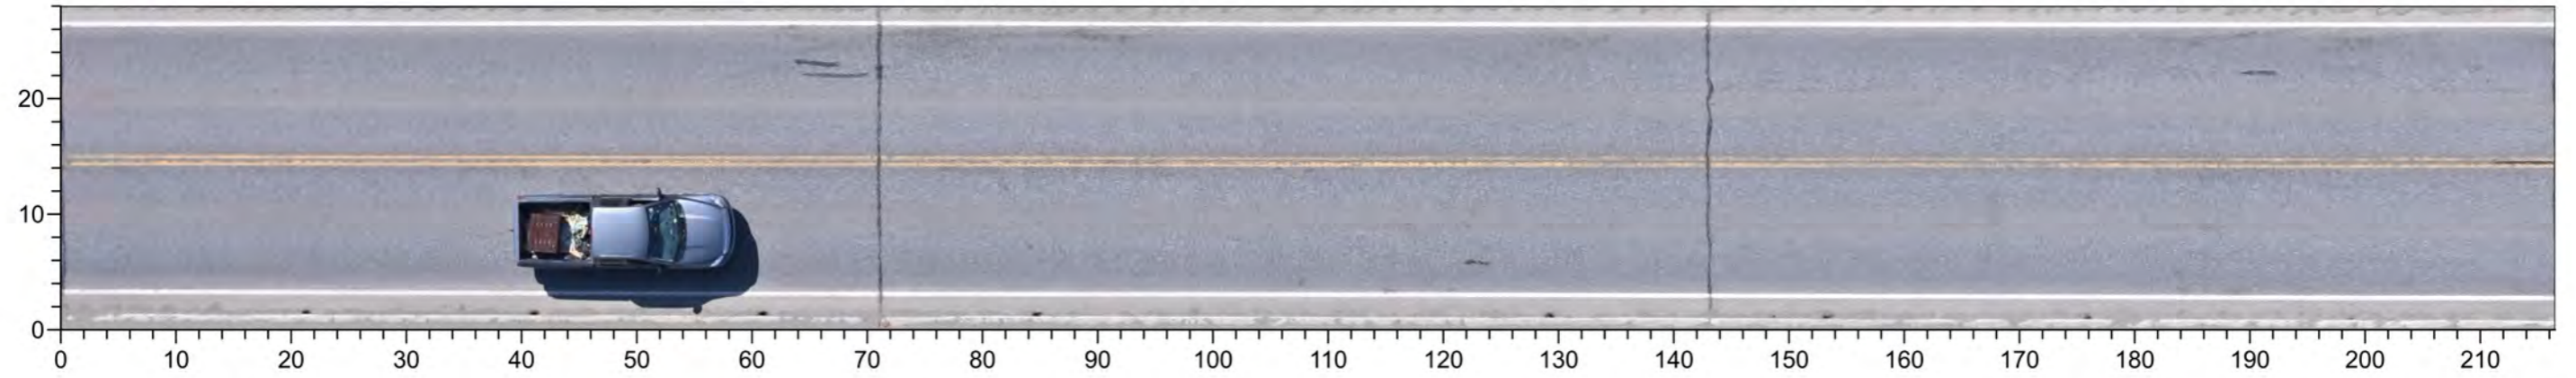
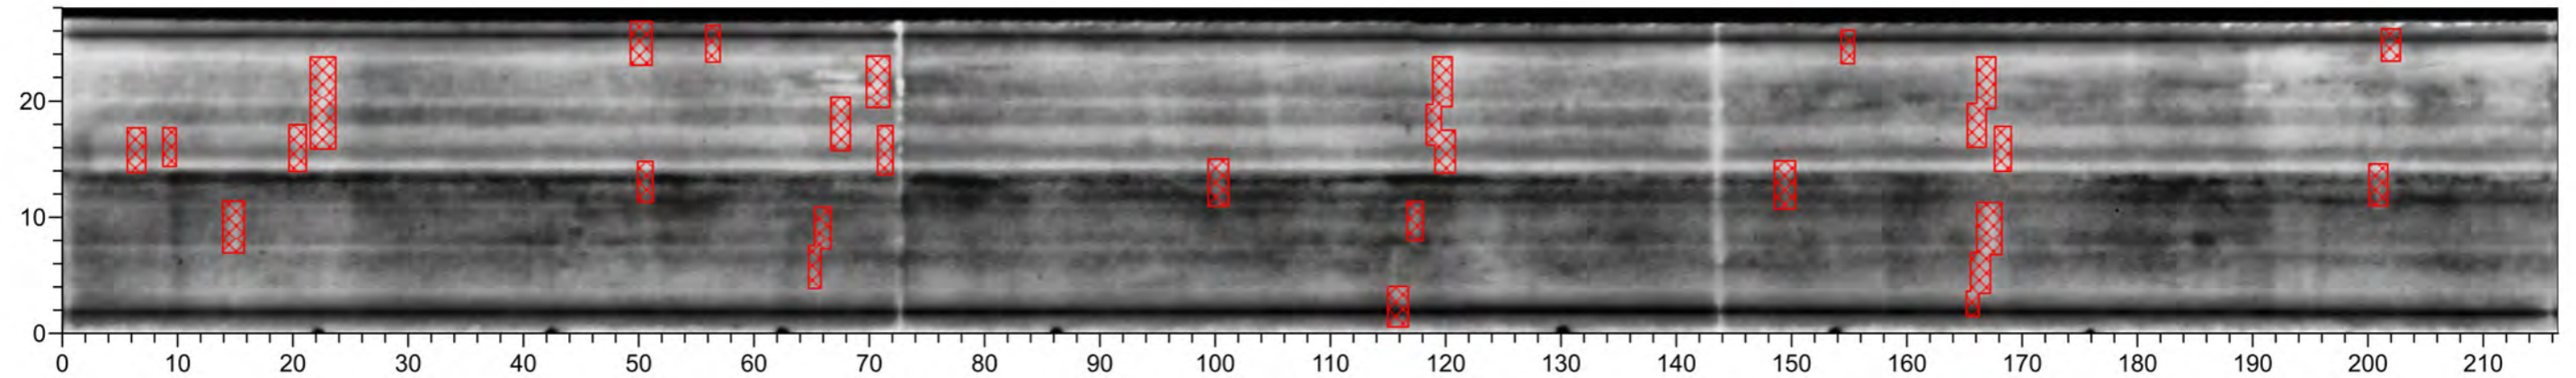
Delamination Quantity (%) 3.2 Delamination Quantity (ft ²) 125	Imagery Collected: 6/4/22 Analyzed by: SB Reviewed by: AJC Completed: 9/30/22

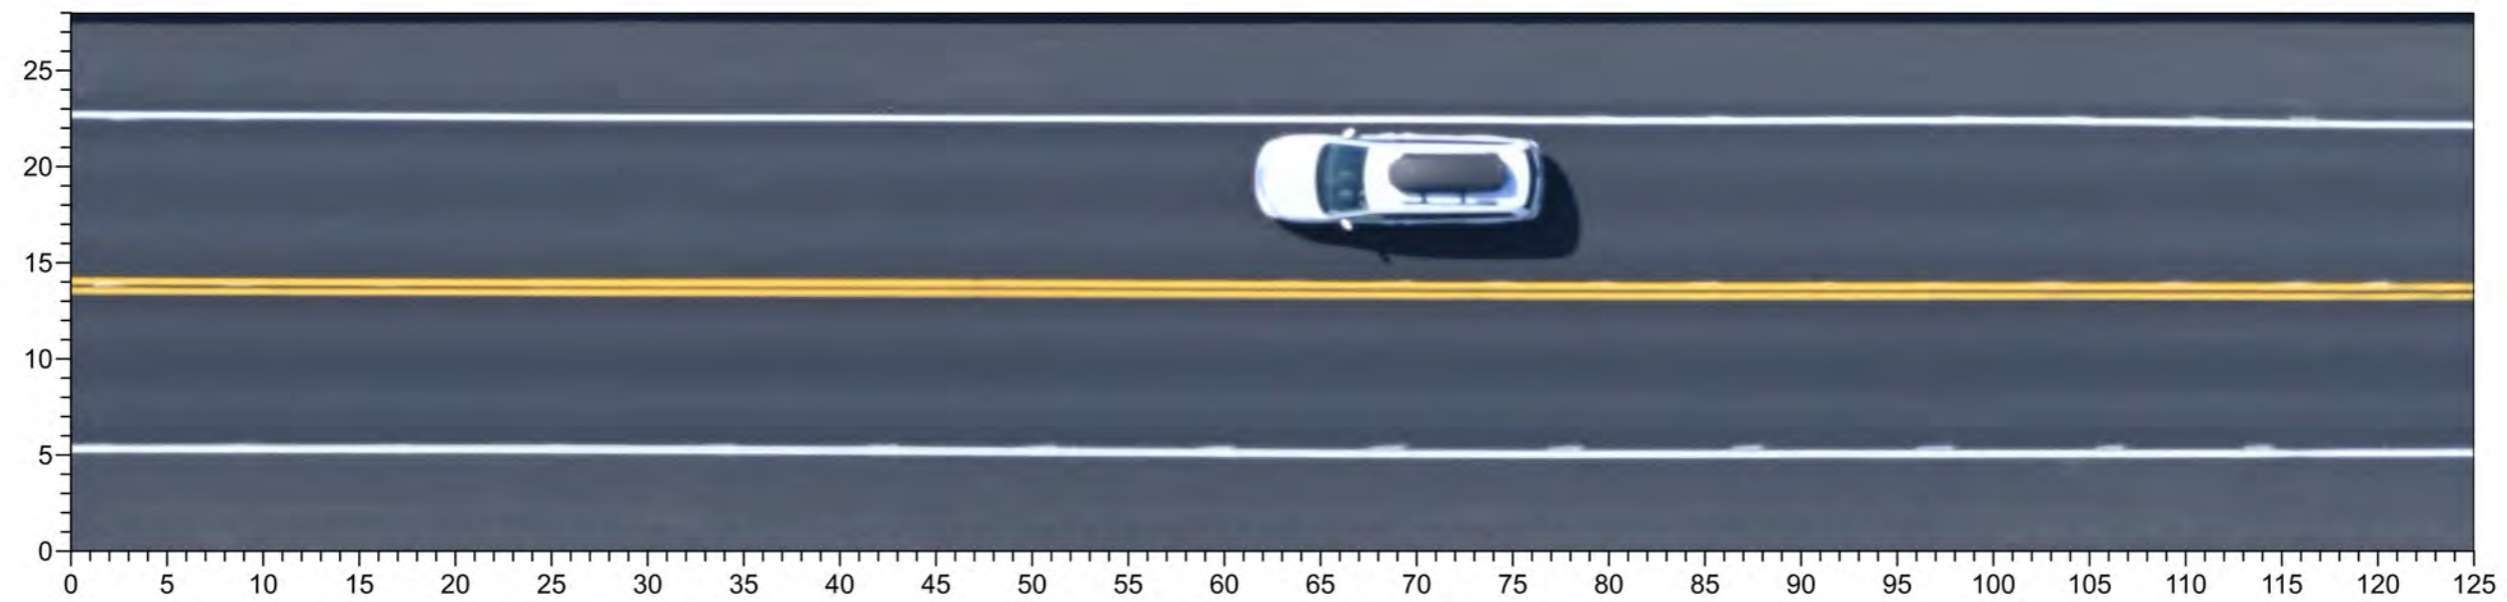
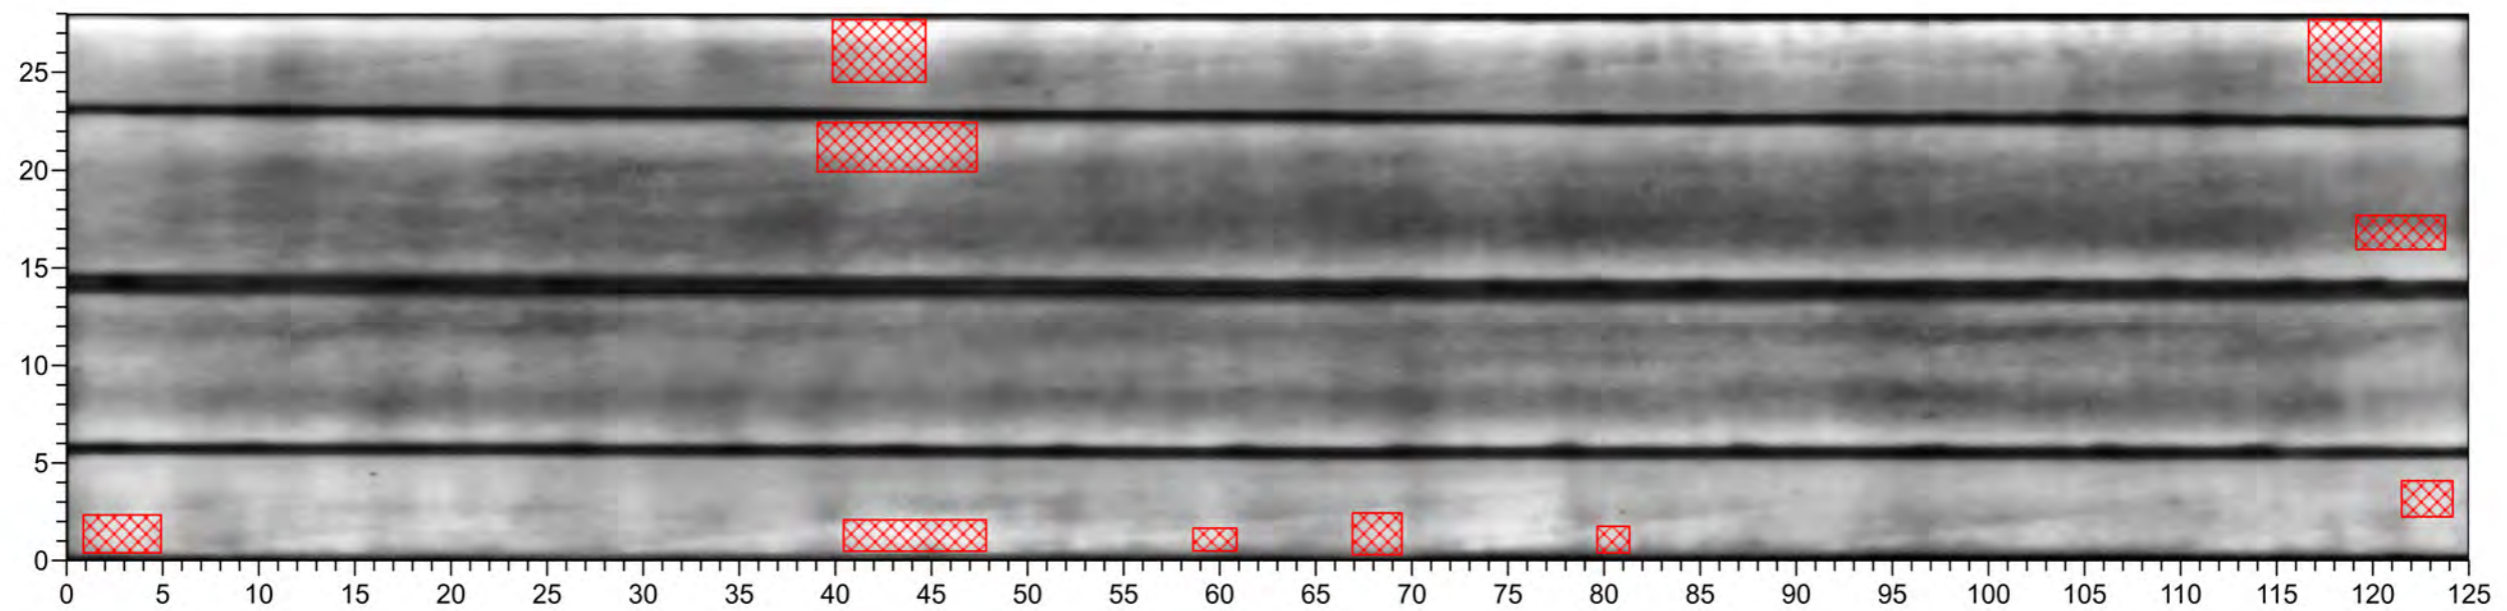
Delamination Quantity (%) 3.0	Delamination Quantity (ft ²) 181	Imagery Collected: 6/4/22 Analyzed by: SB Reviewed by: AJC Completed: 9/30/22

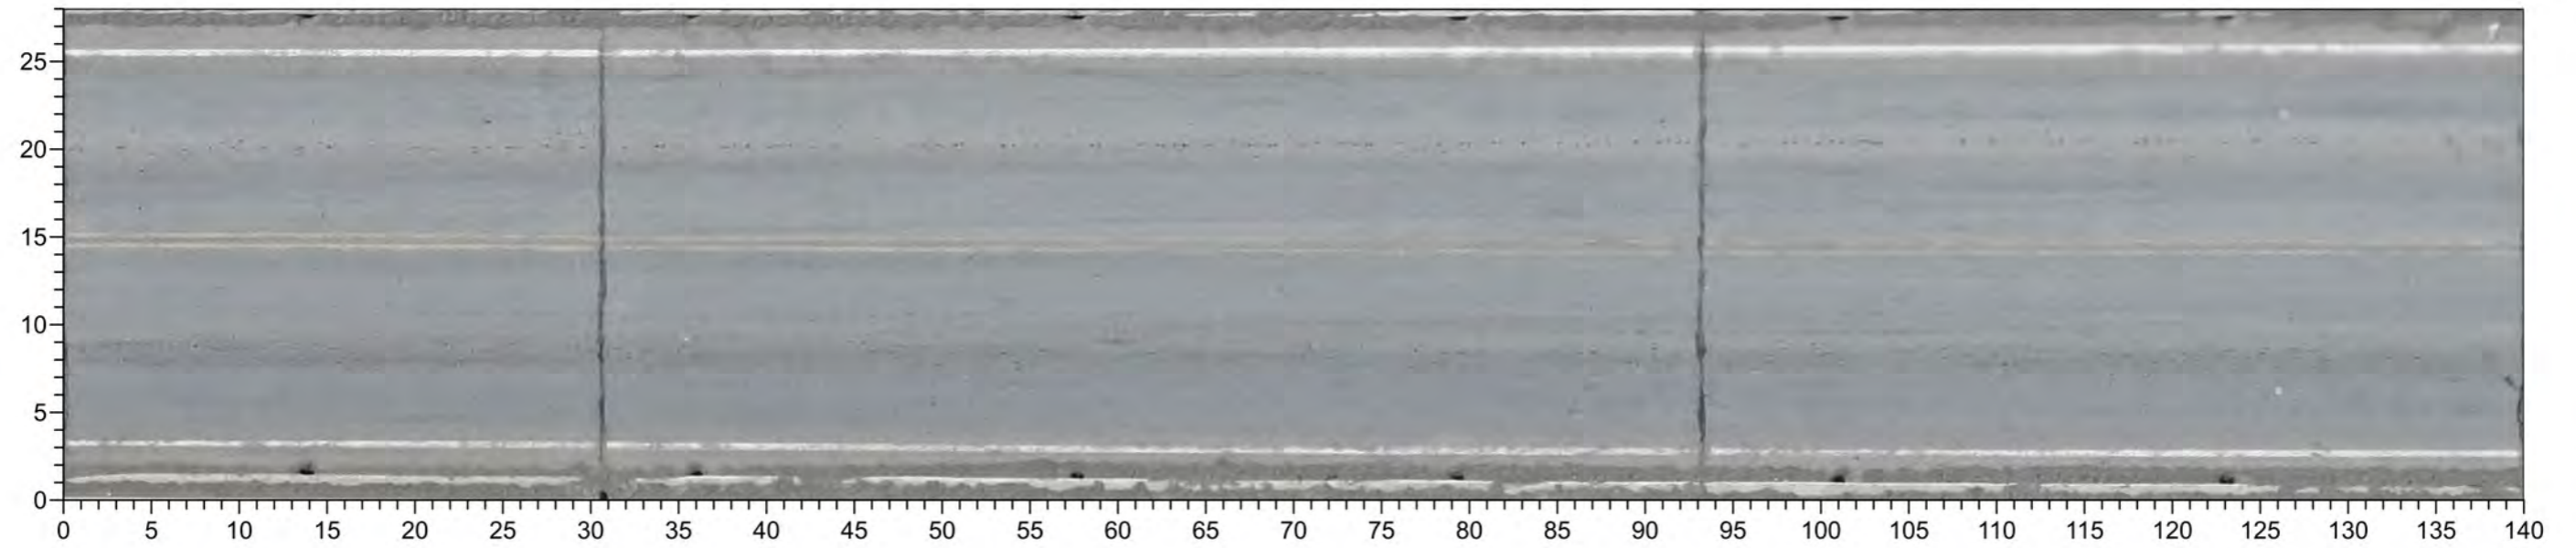
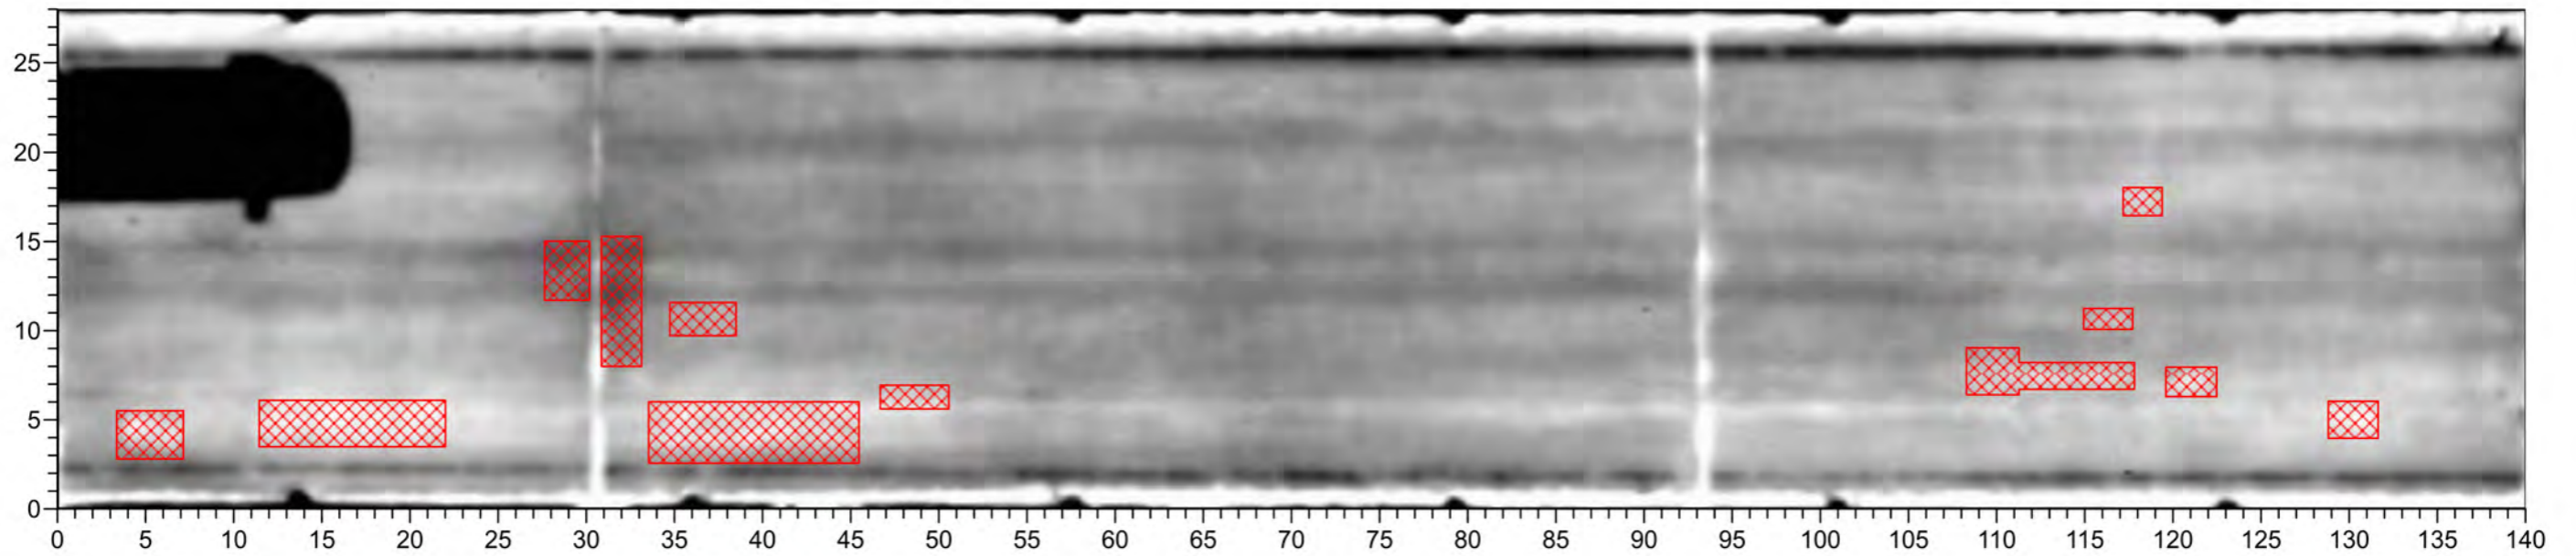
Delamination Quantity (%) 2.6 Delamination Quantity (ft ²) 92	Imagery Collected: 6/4/22 Analyzed by: SB Reviewed by: AJC Completed: 9/30/22

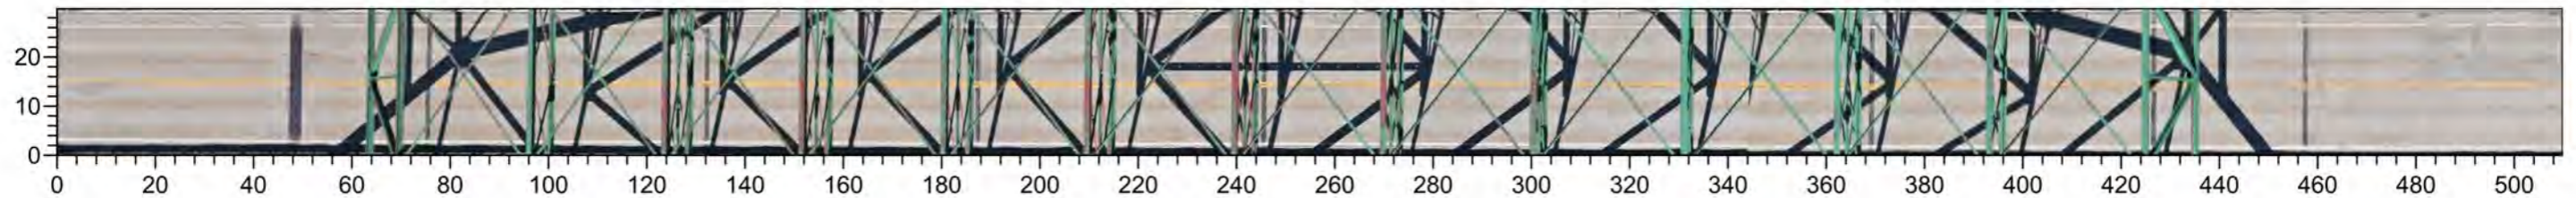
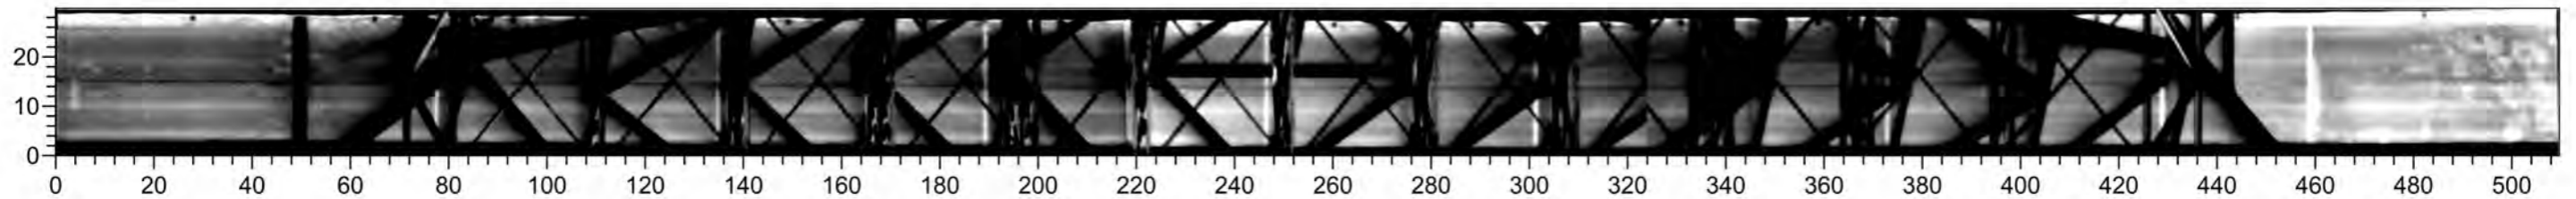
*Notes: Analysis limited in 10616 sq. ft. area obstructed by superstructure. If this area is removed from analysis, then the results would show 4.7% of the deck area as delaminated.

298 sq. ft. of thermal anomalies not mapped due to being rectilinear in shape and appearing more like subsurface patching or some other structural feature

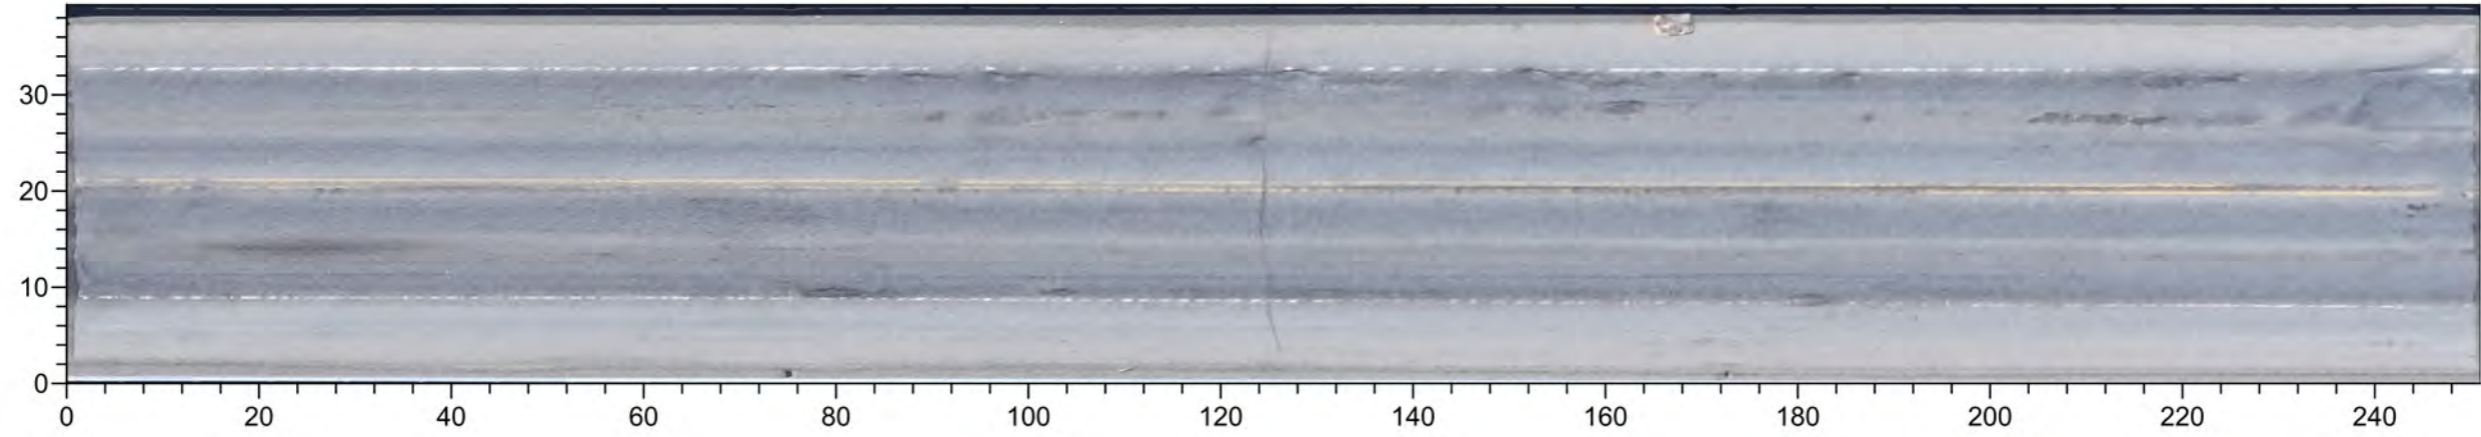
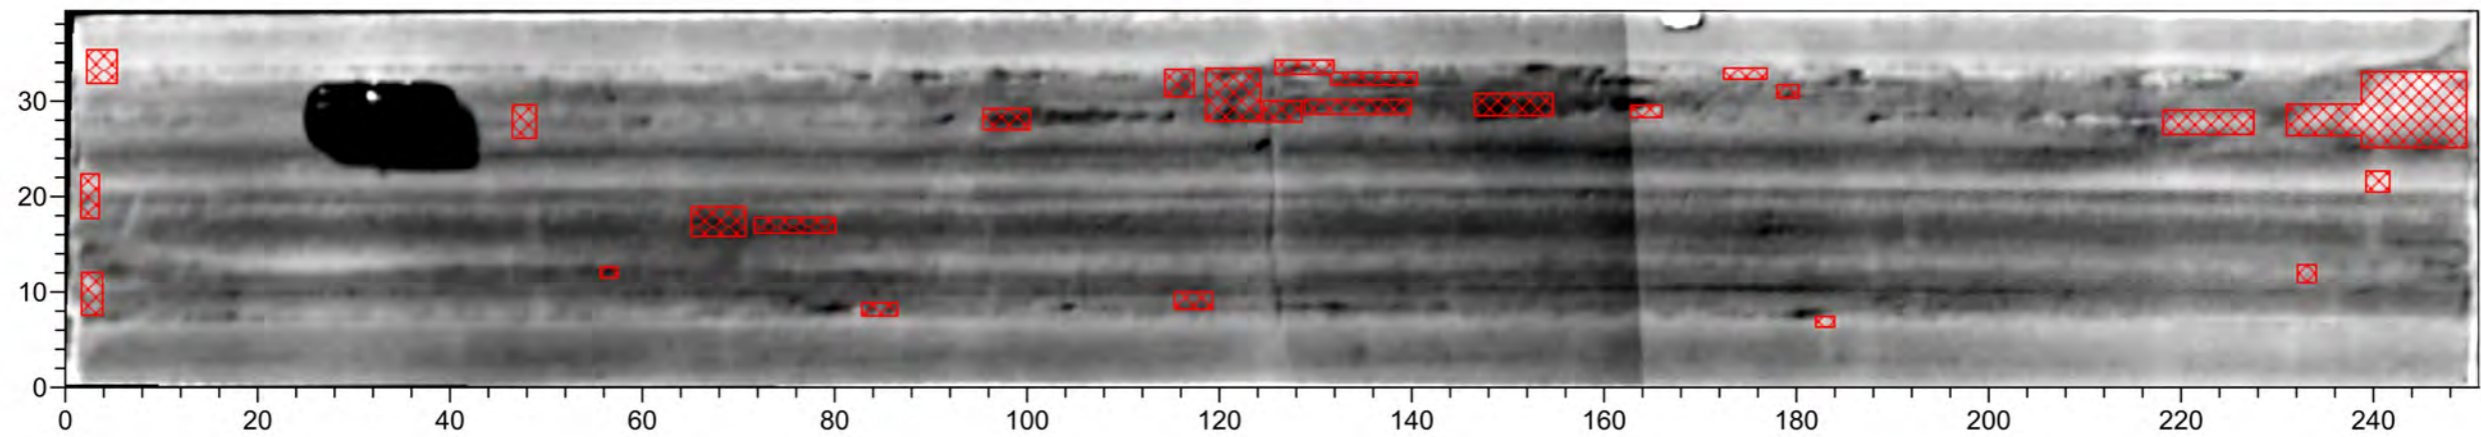
Delamination Quantity (%) 1.4 Delamination Quantity (ft ²) 219	Imagery Collected: 6/5/22 Analyzed by: SB Reviewed by: AJC Completed: 10/11/22

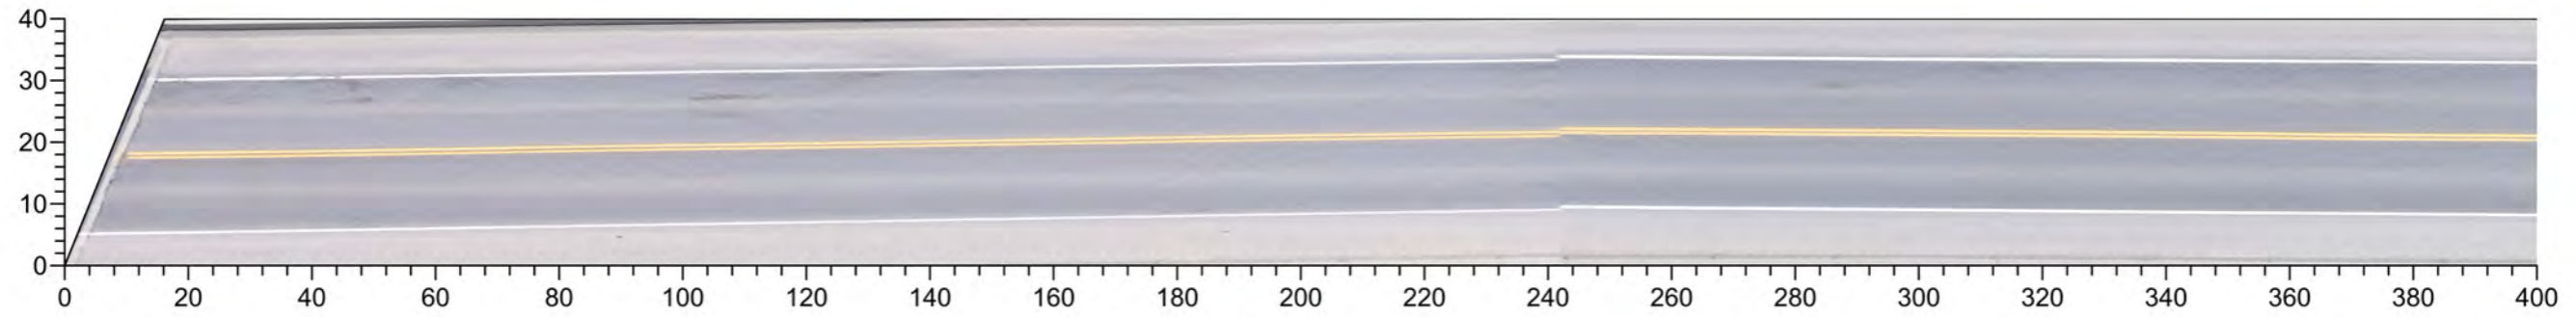
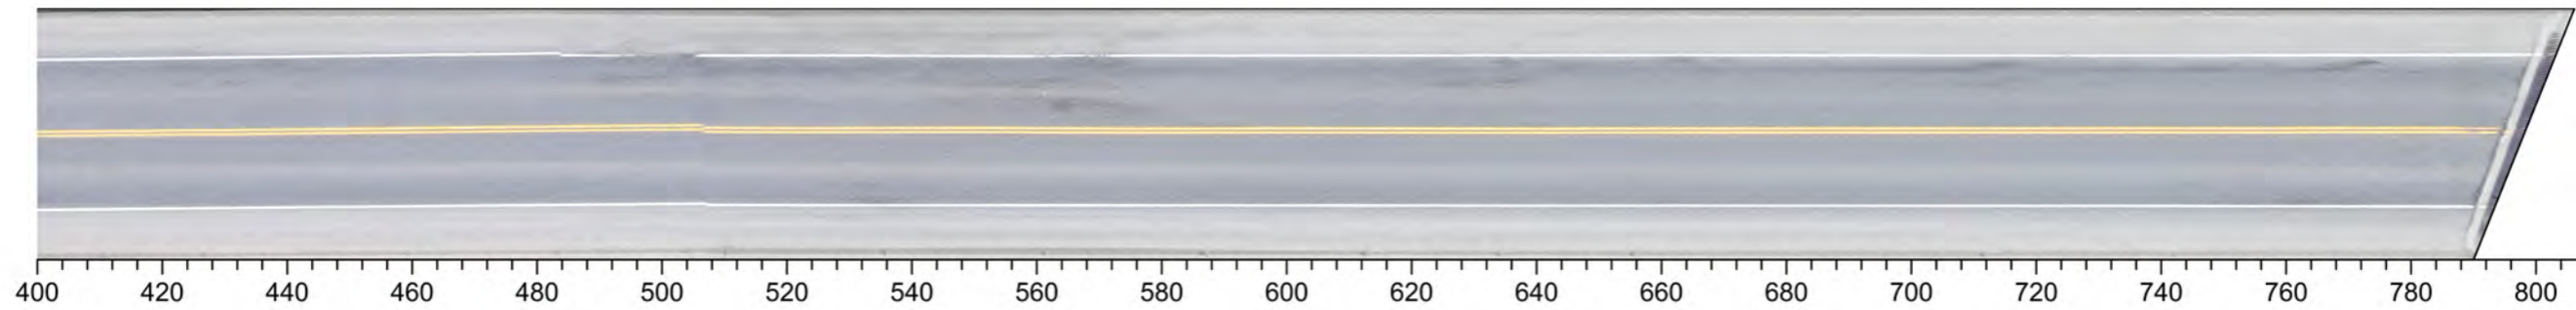
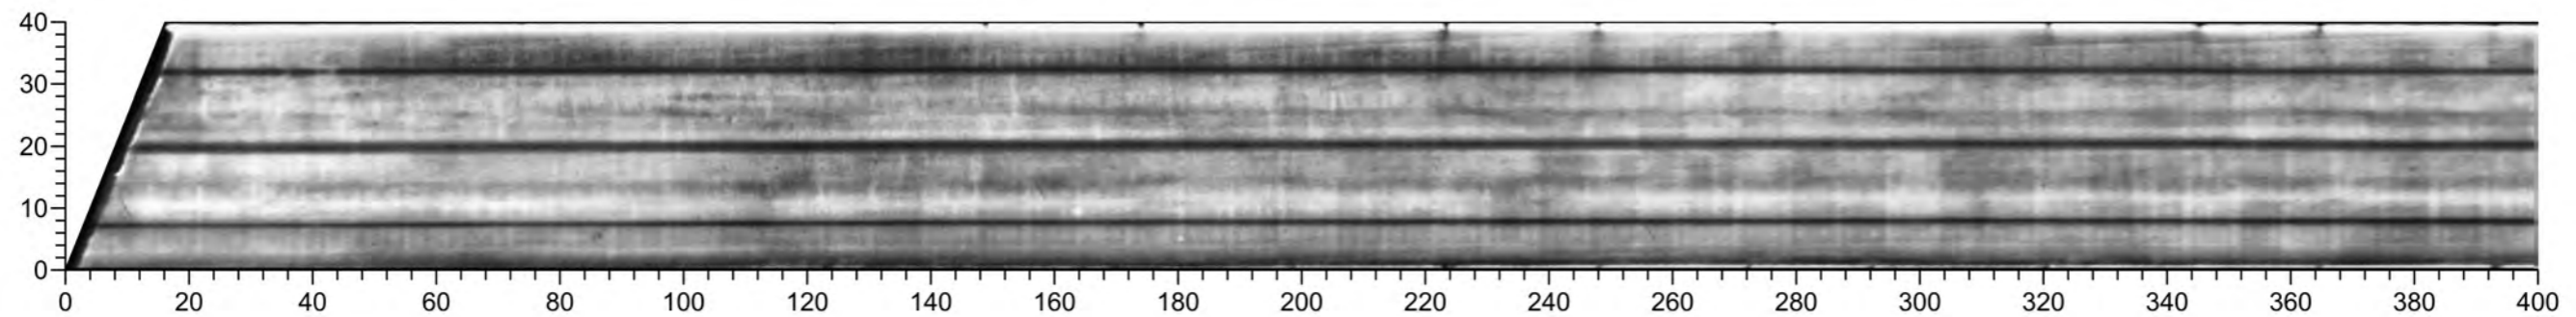
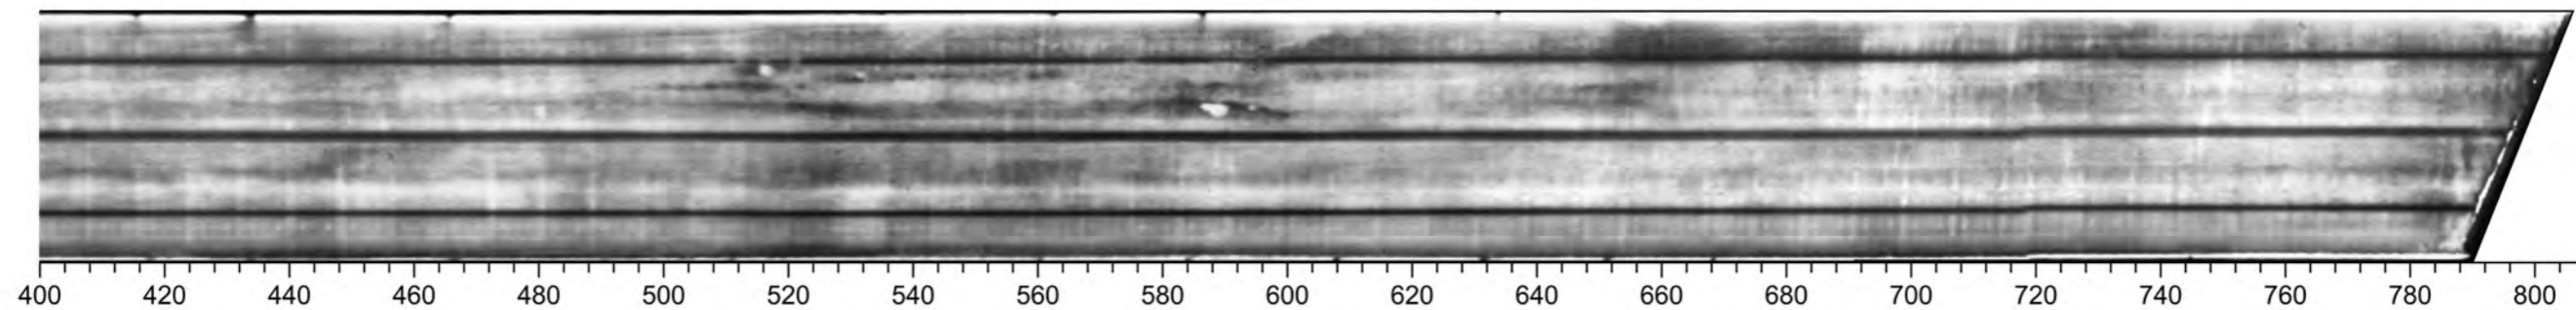
Delamination Quantity (%) 2.1 Delamination Quantity (ft ²) 660	Imagery Collected: 6/4/22 Analyzed by: SB Reviewed by: AJC Completed: 10/12/22
