Aerial Infrared Scanning of Bridge Decks on Parks Highway to Map Delaminations

FINAL REPORT

Prepared by:
Infrasense, Inc.
Woburn, MA

Report # FHWA-AK-RD-000S(960)
March 2, 2023

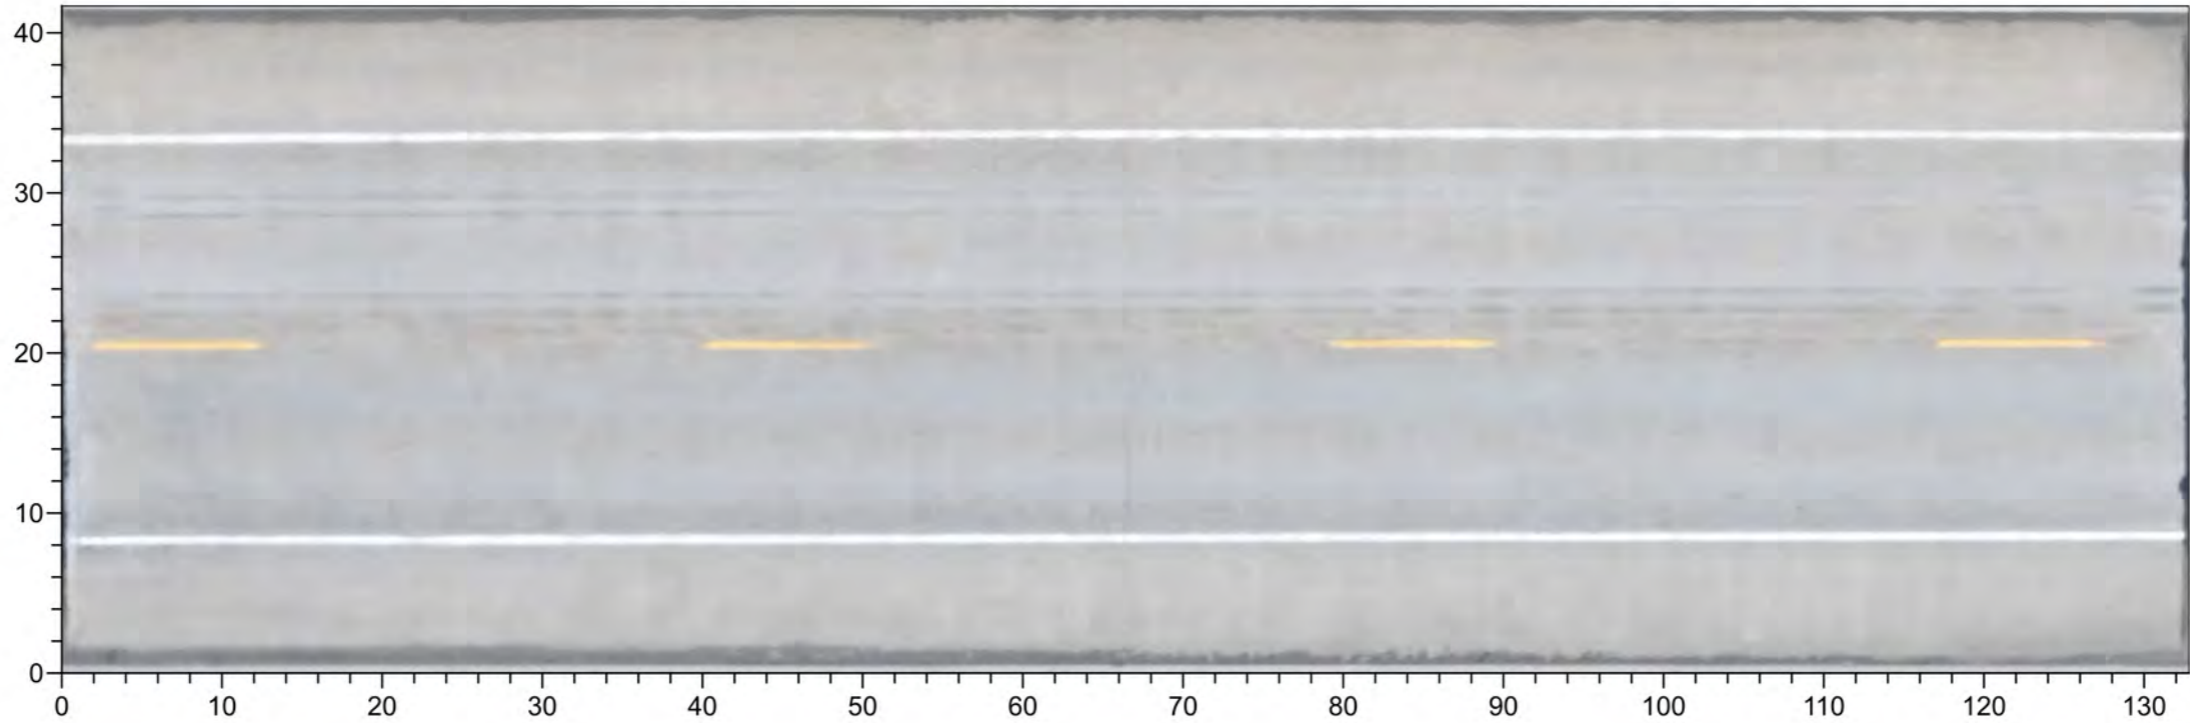
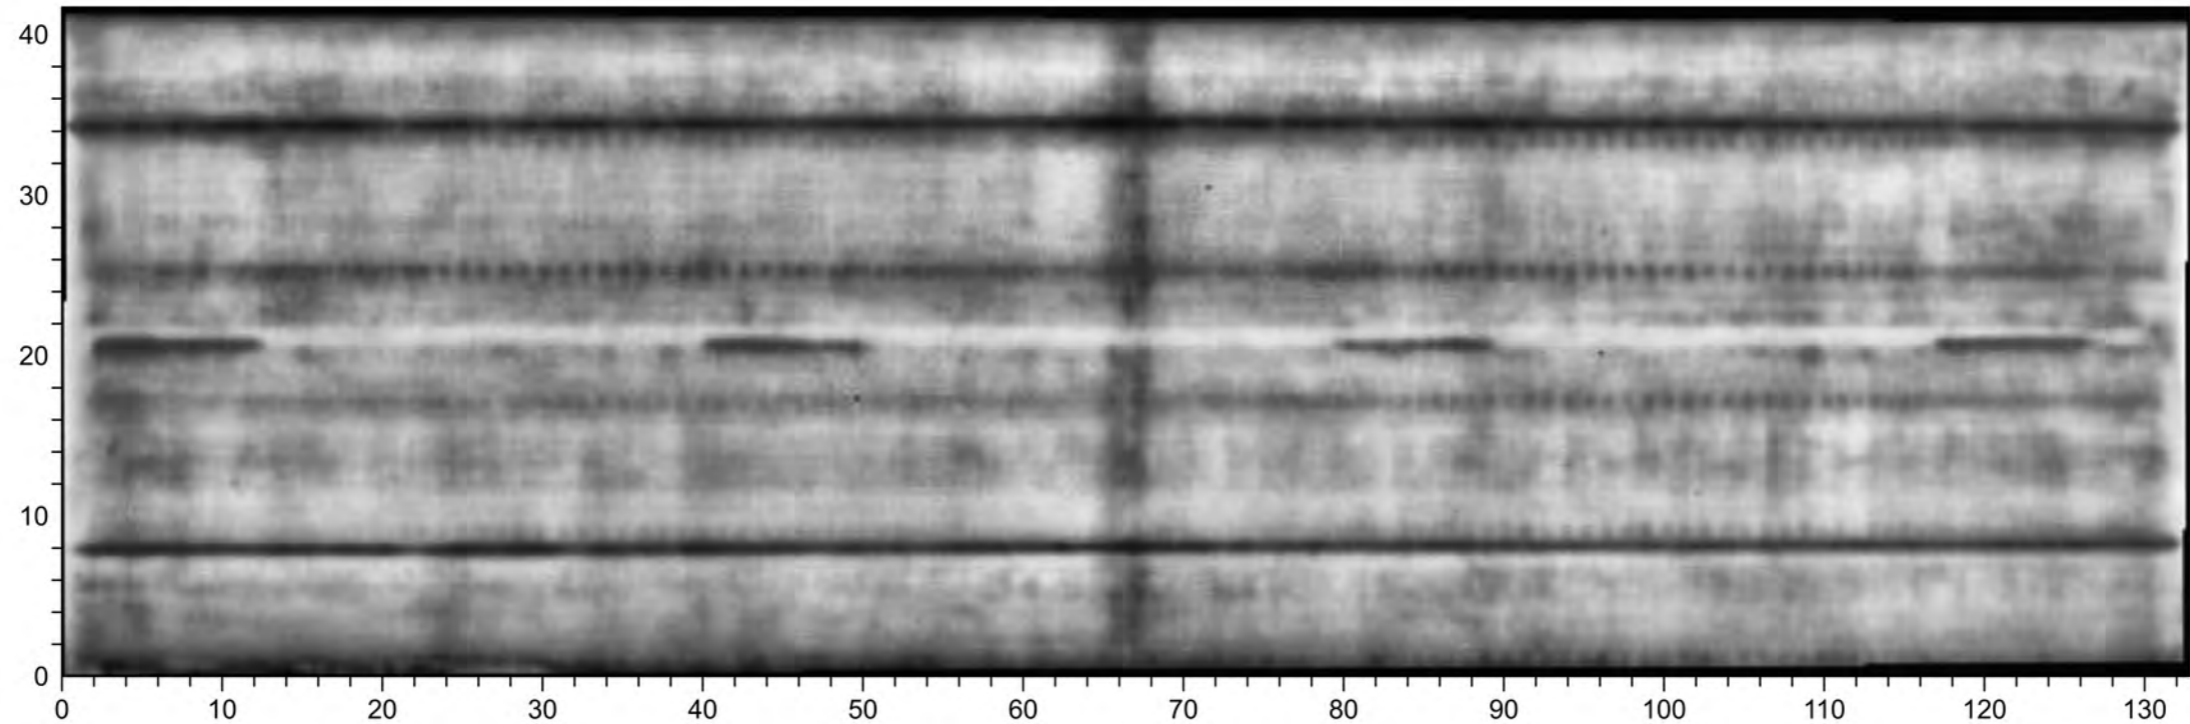
Delamination Quantity (%) 1.1		Imagery Collected: 6/4/22 Analyzed by: SB Reviewed by: AJC Completed: 10/2/22	
			Delamination Quantity (ft ²) 355

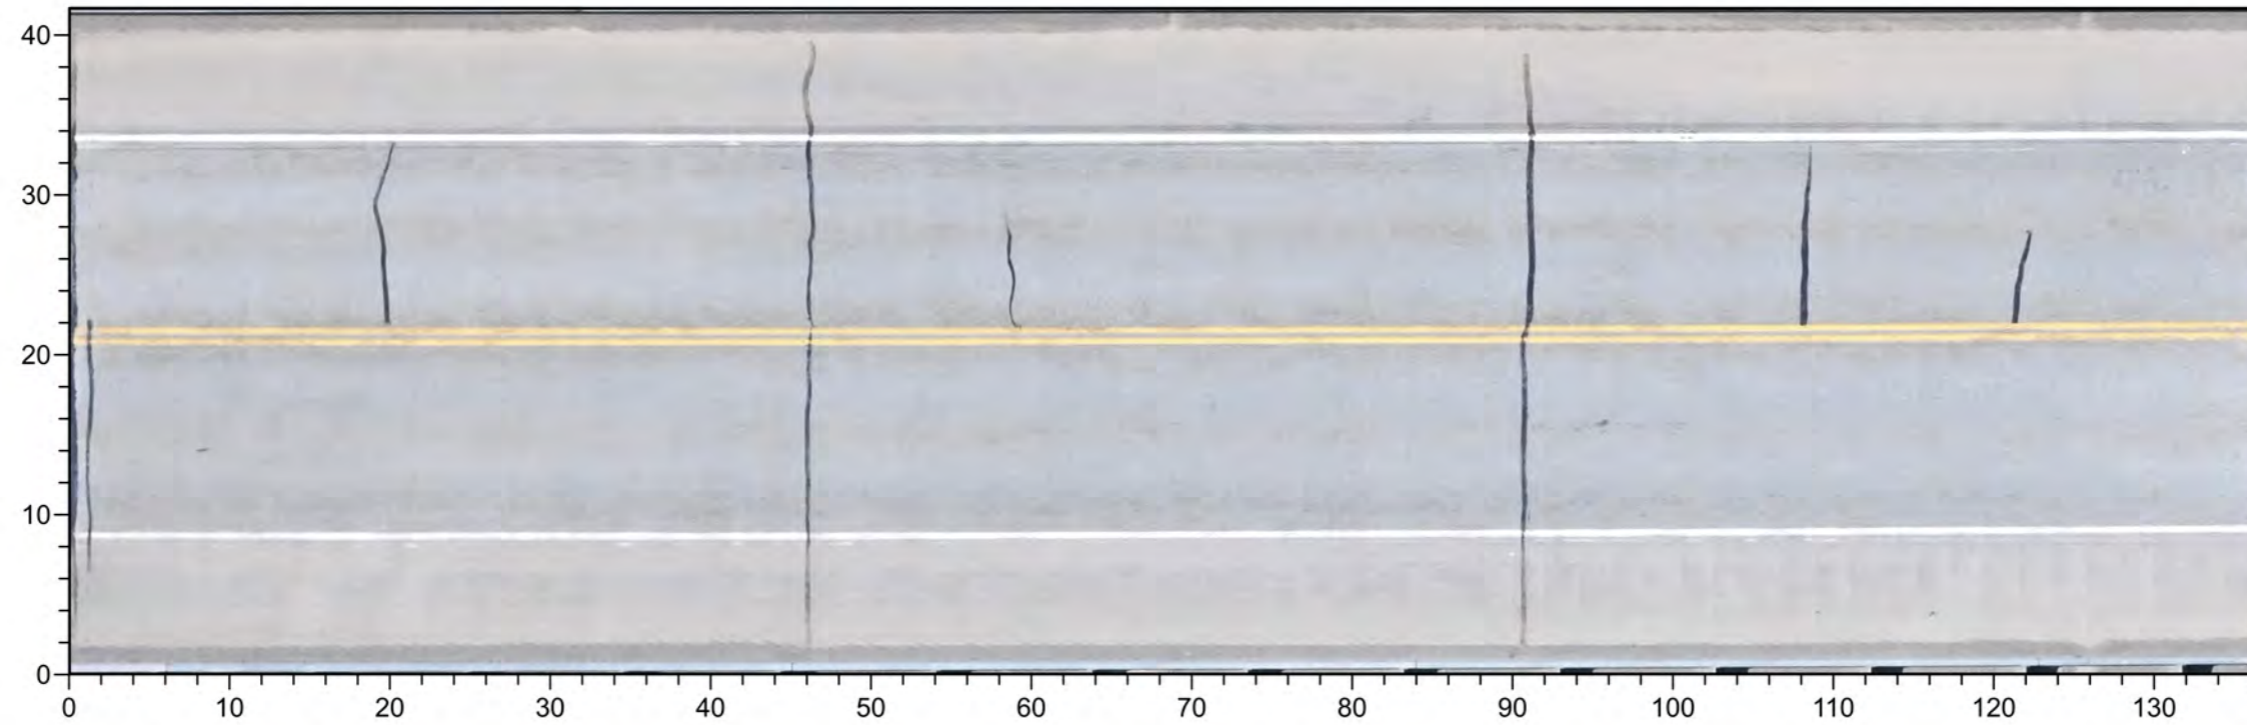
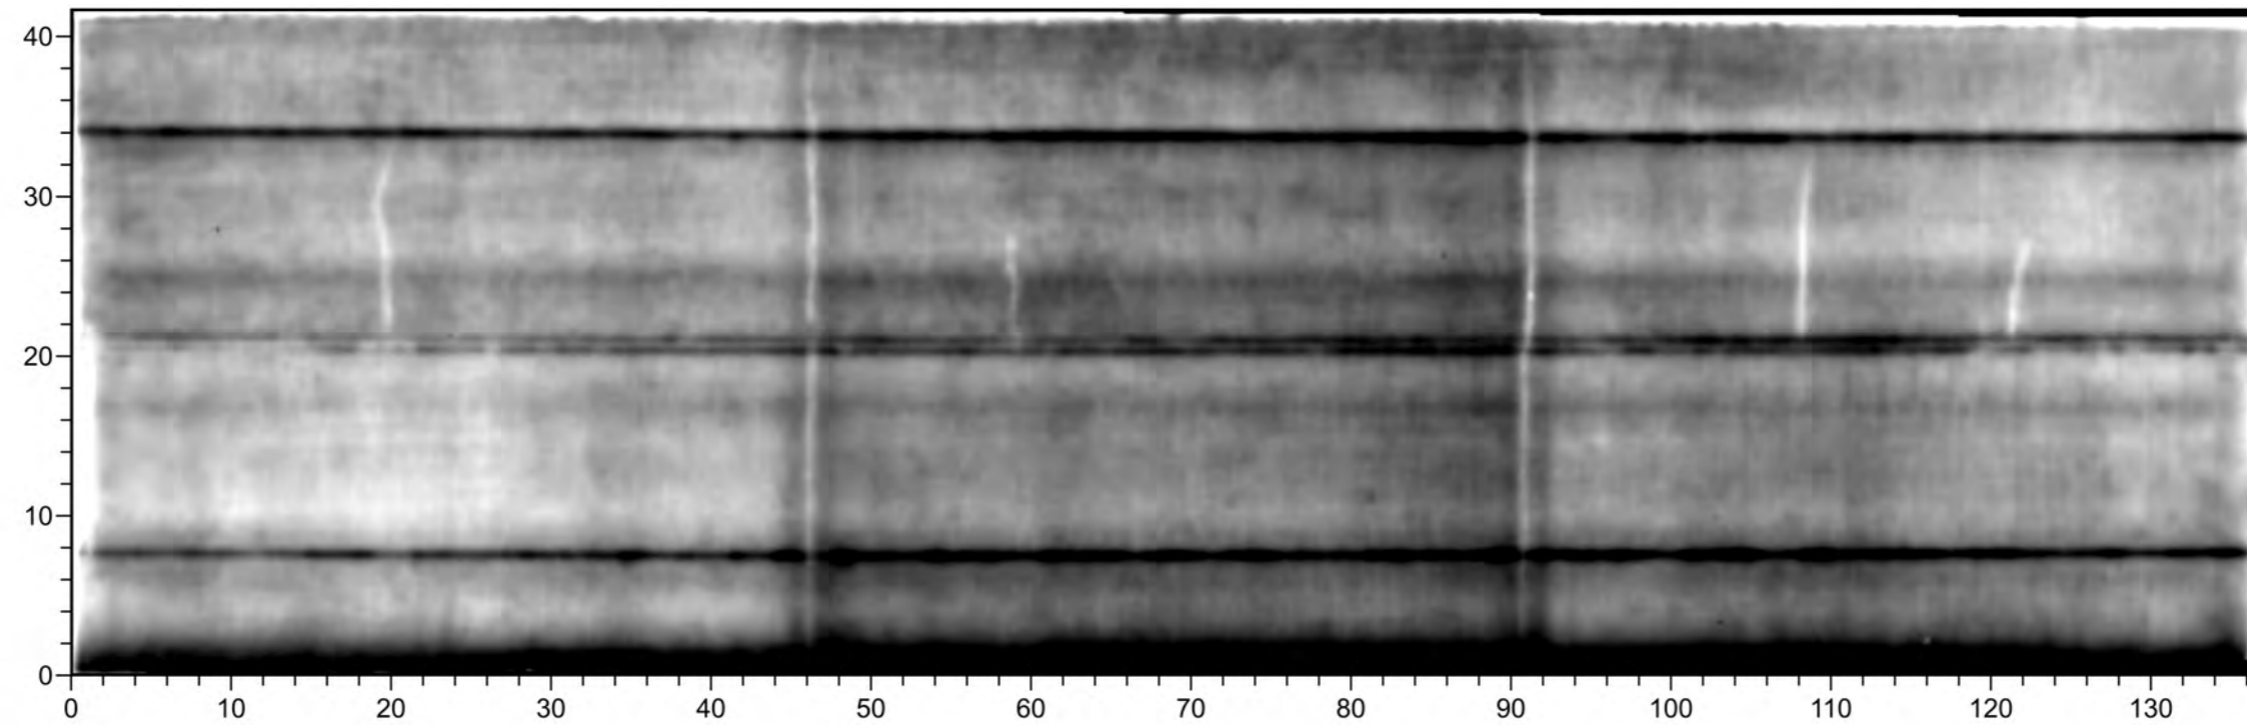
Delamination Quantity (%) 0.9 Delamination Quantity (ft ²) 49	Imagery Collected: 6/4/22 Analyzed by: EG, SB Reviewed by: AJC Completed: 10/4/22

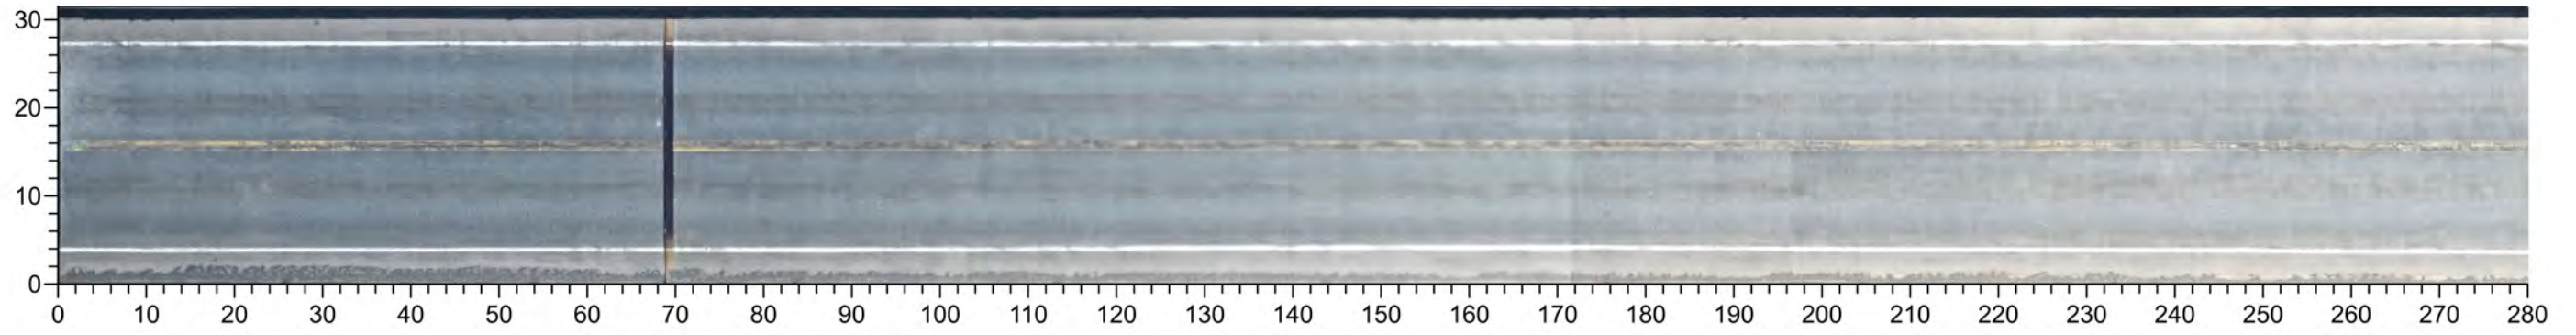
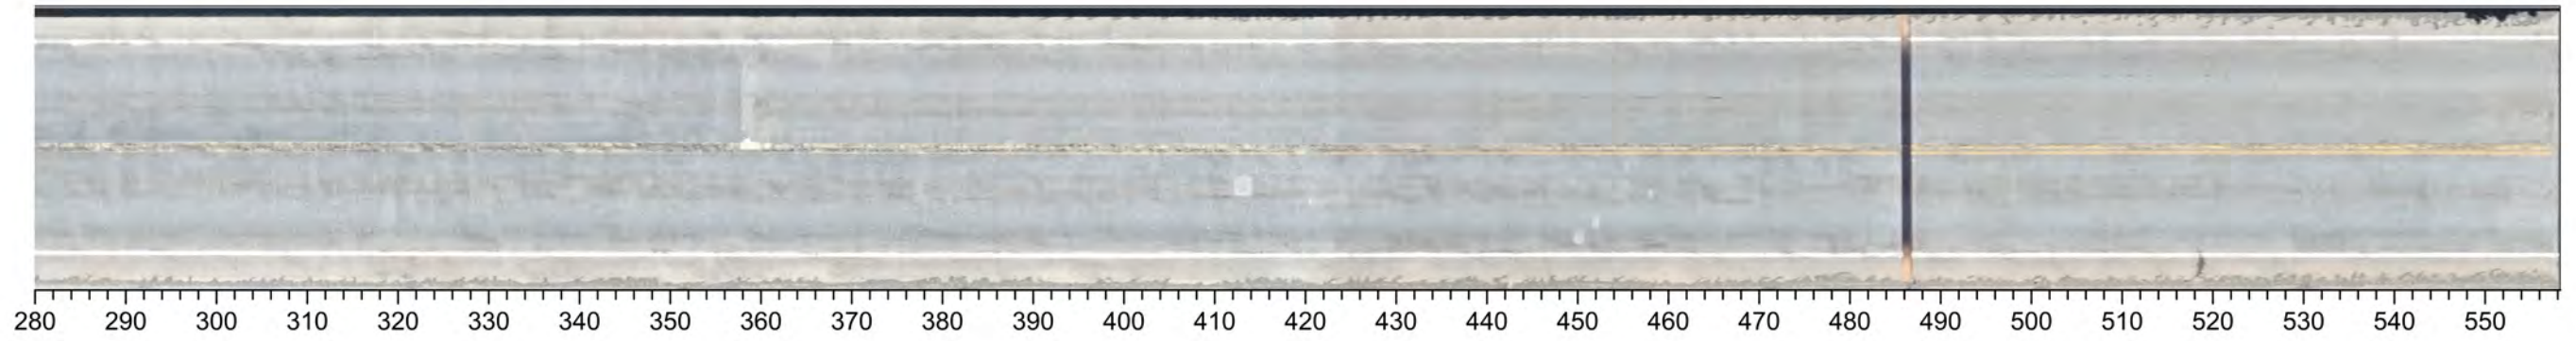
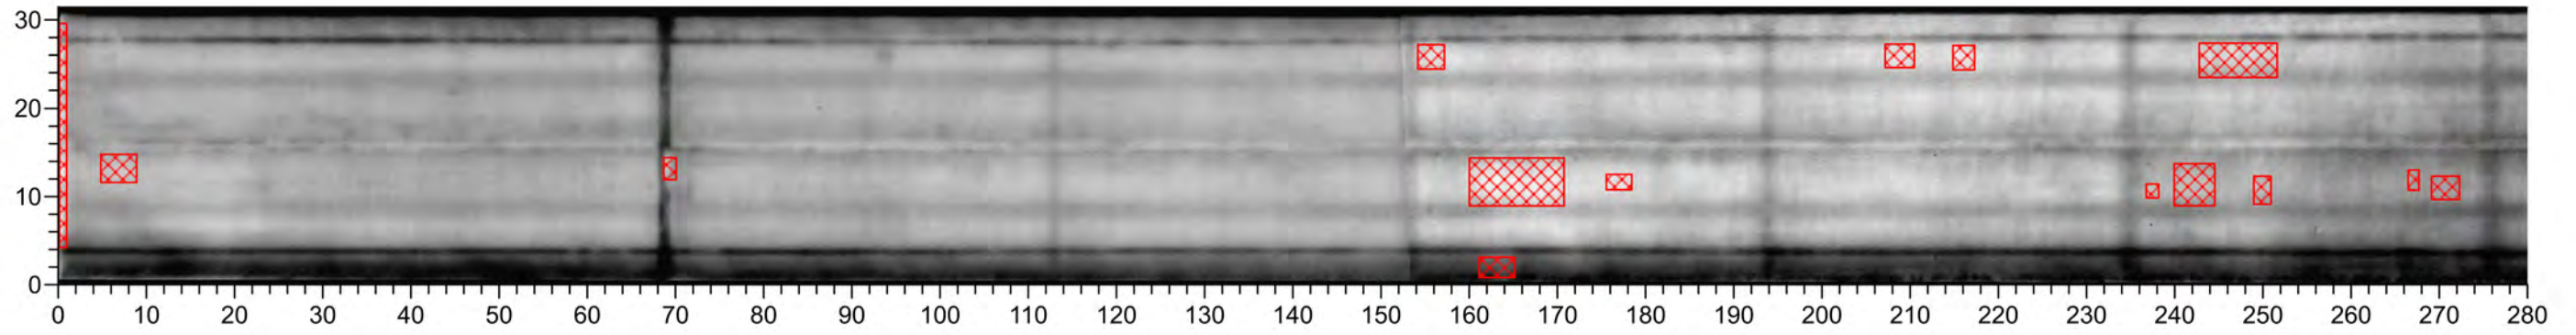
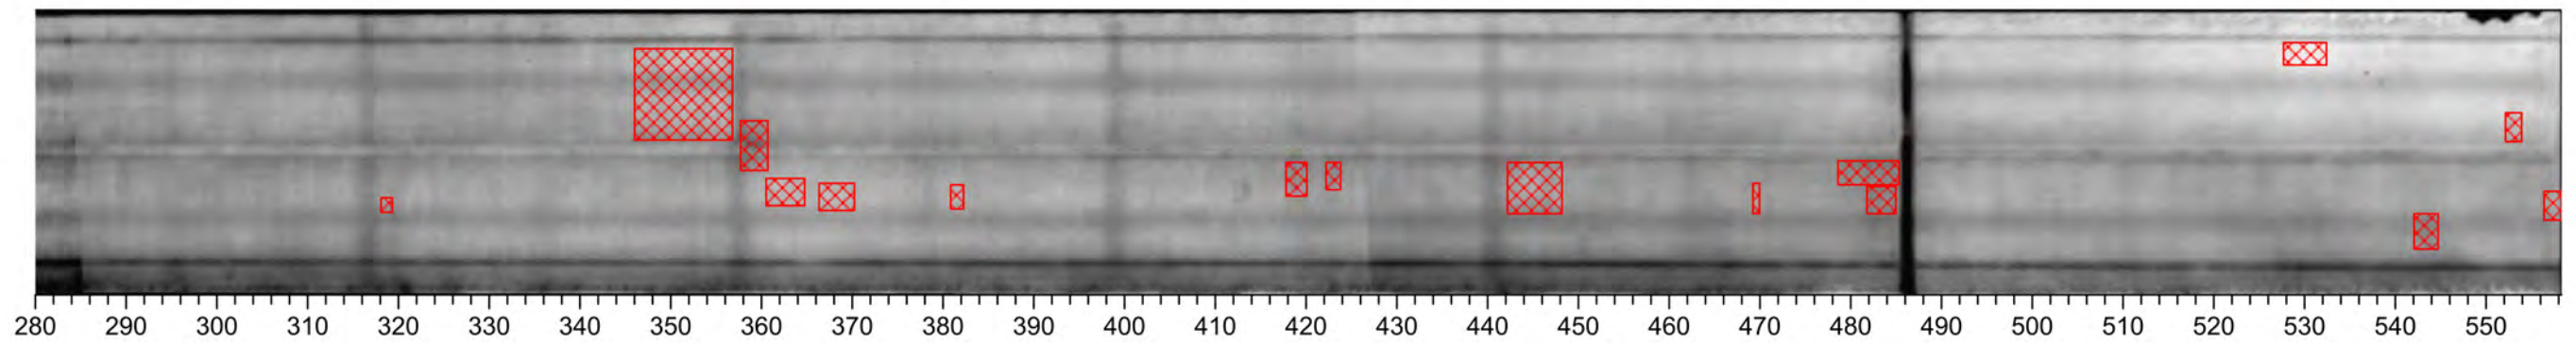
Delamination Quantity (%) 0.6		Imagery Collected: 6/4/22 Analyzed by: EG, SB Reviewed by: AJC Completed: 10/5/22	
			Delamination Quantity (ft ²) 32

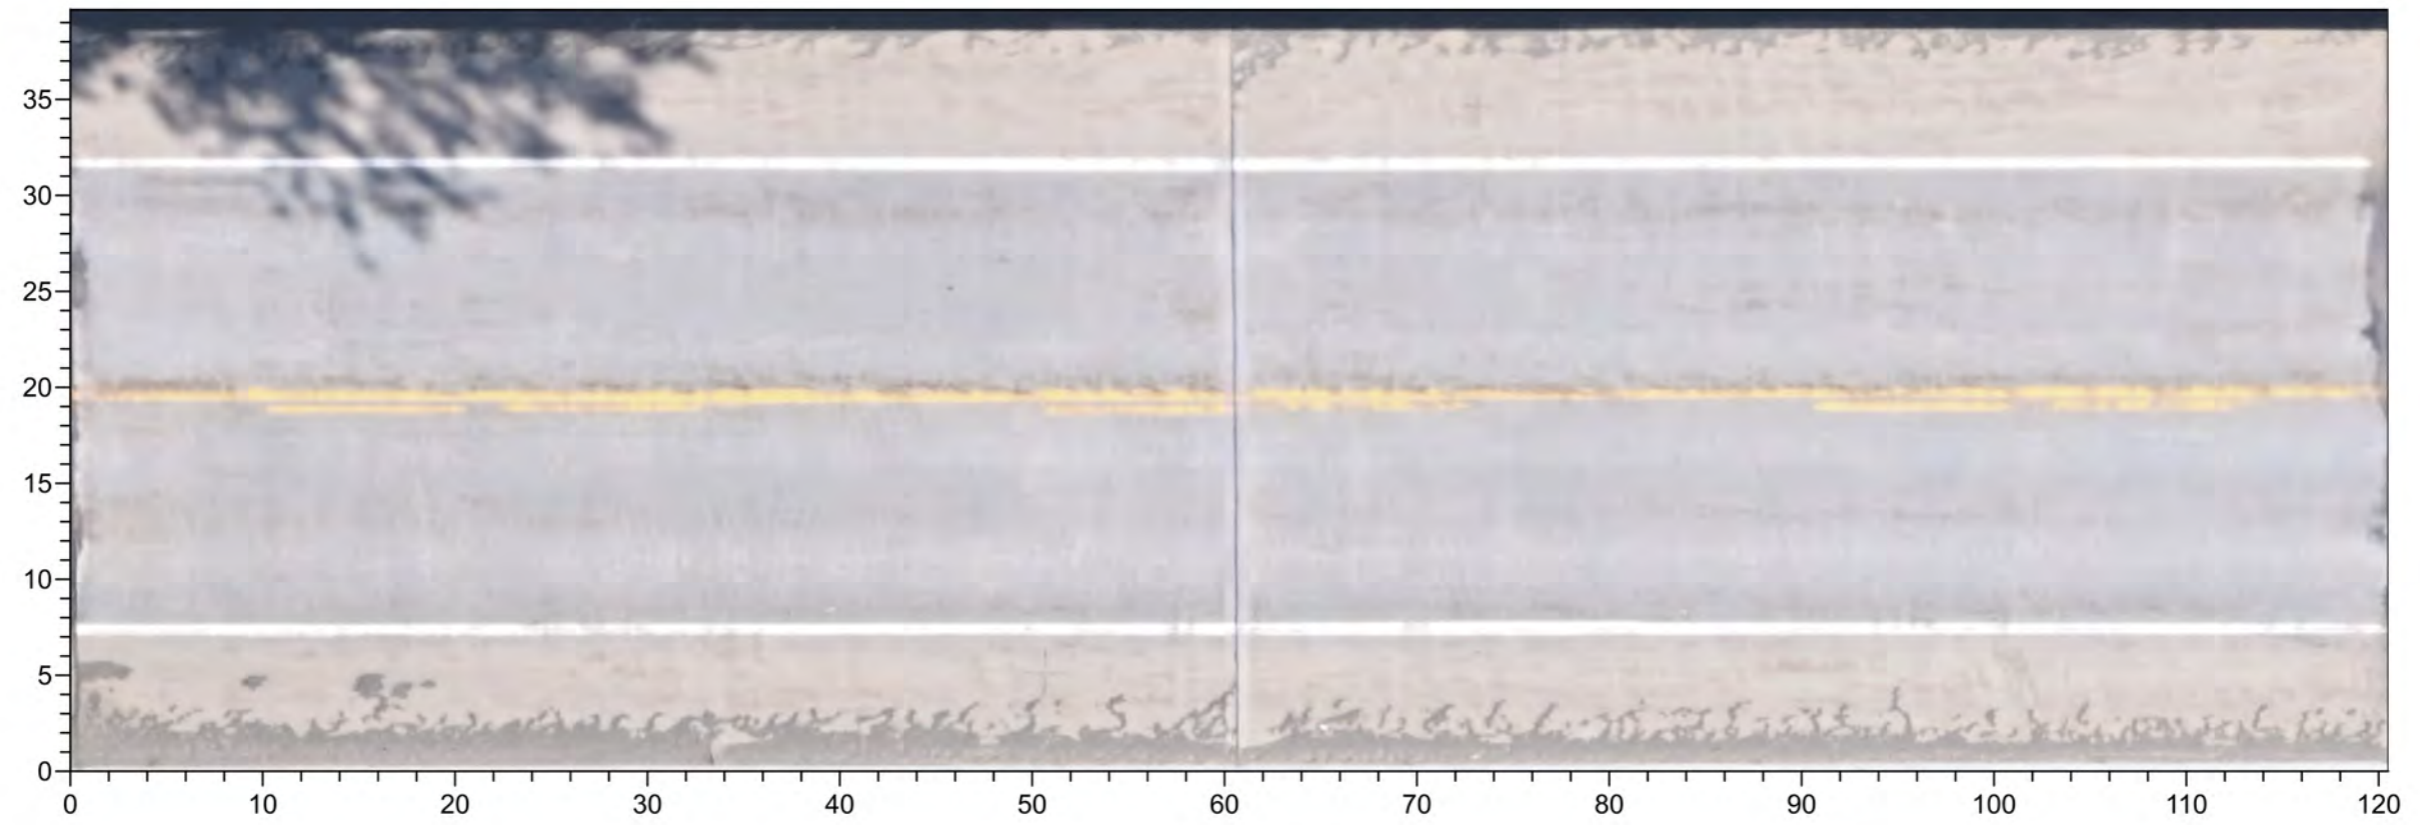
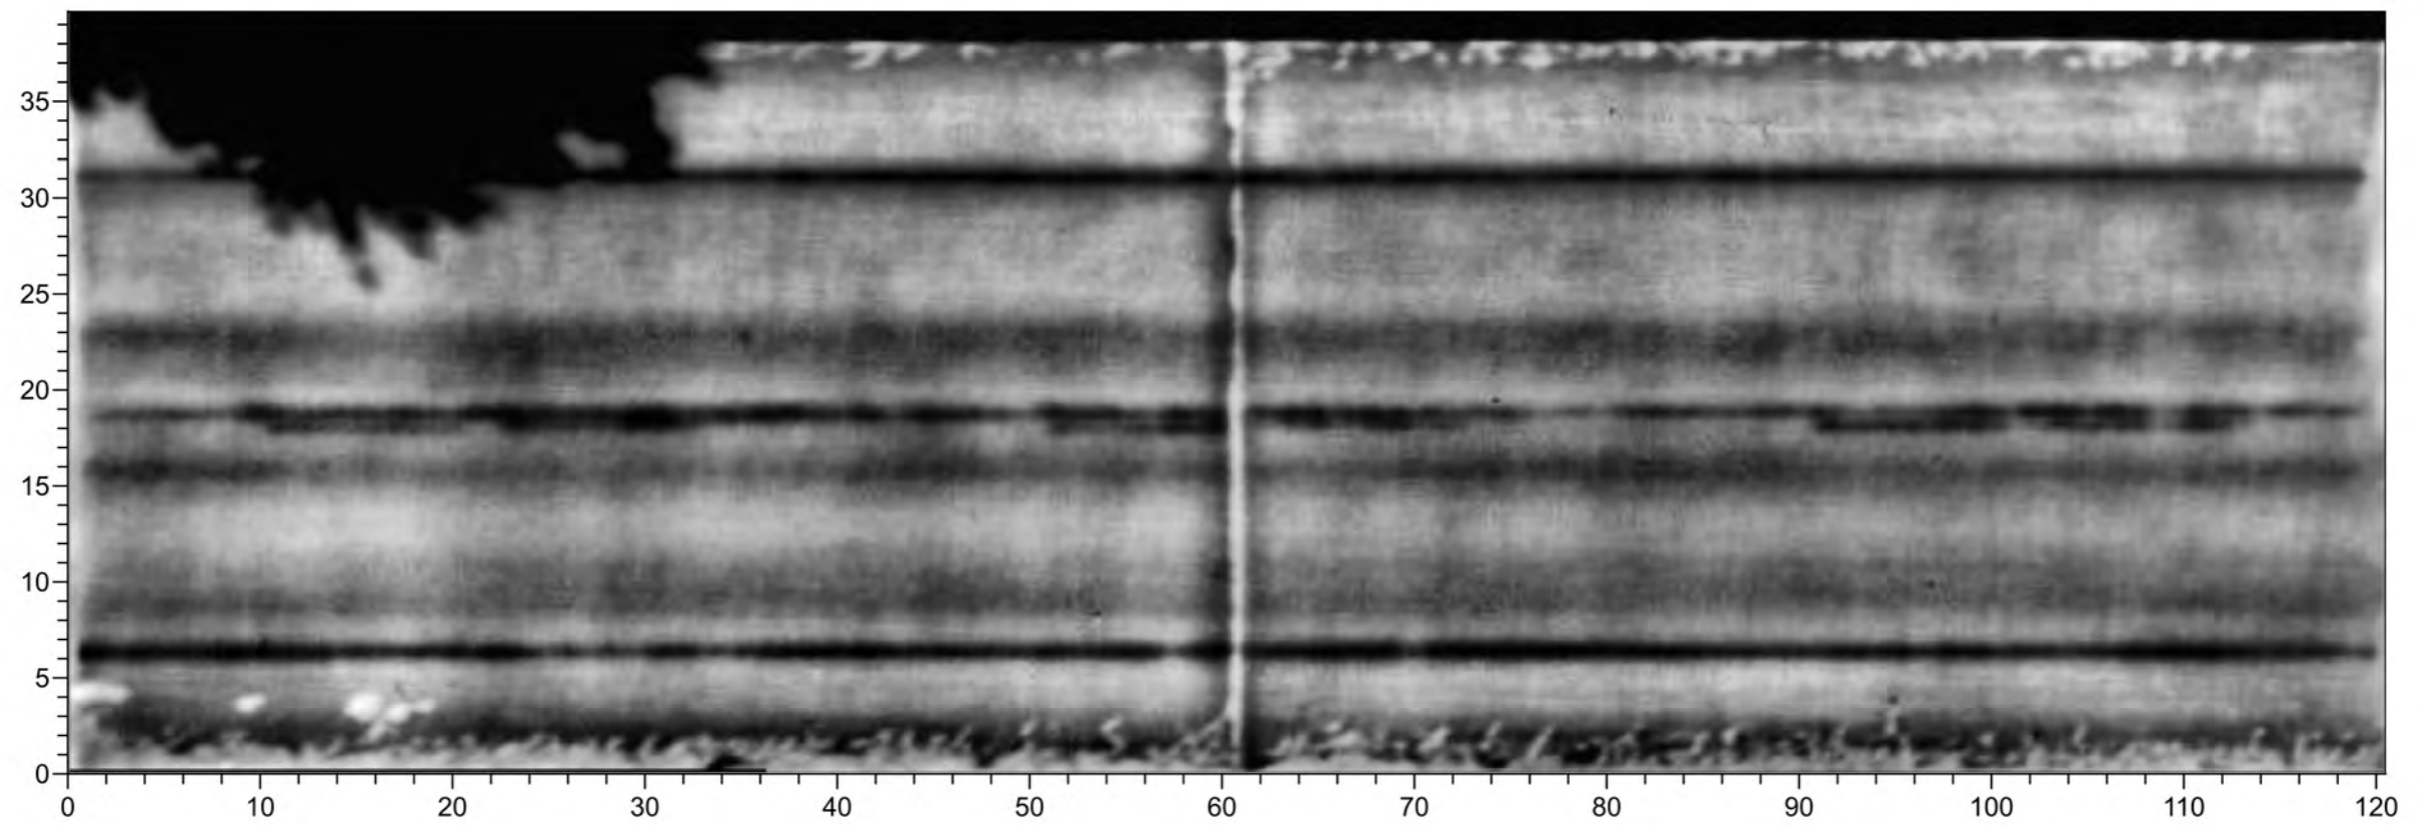
Delamination Quantity (%) 2.7 Delamination Quantity (ft ²) 477	Imagery Collected: 6/4/22 Analyzed by: SB Reviewed by: AJC Completed: 10/4/22

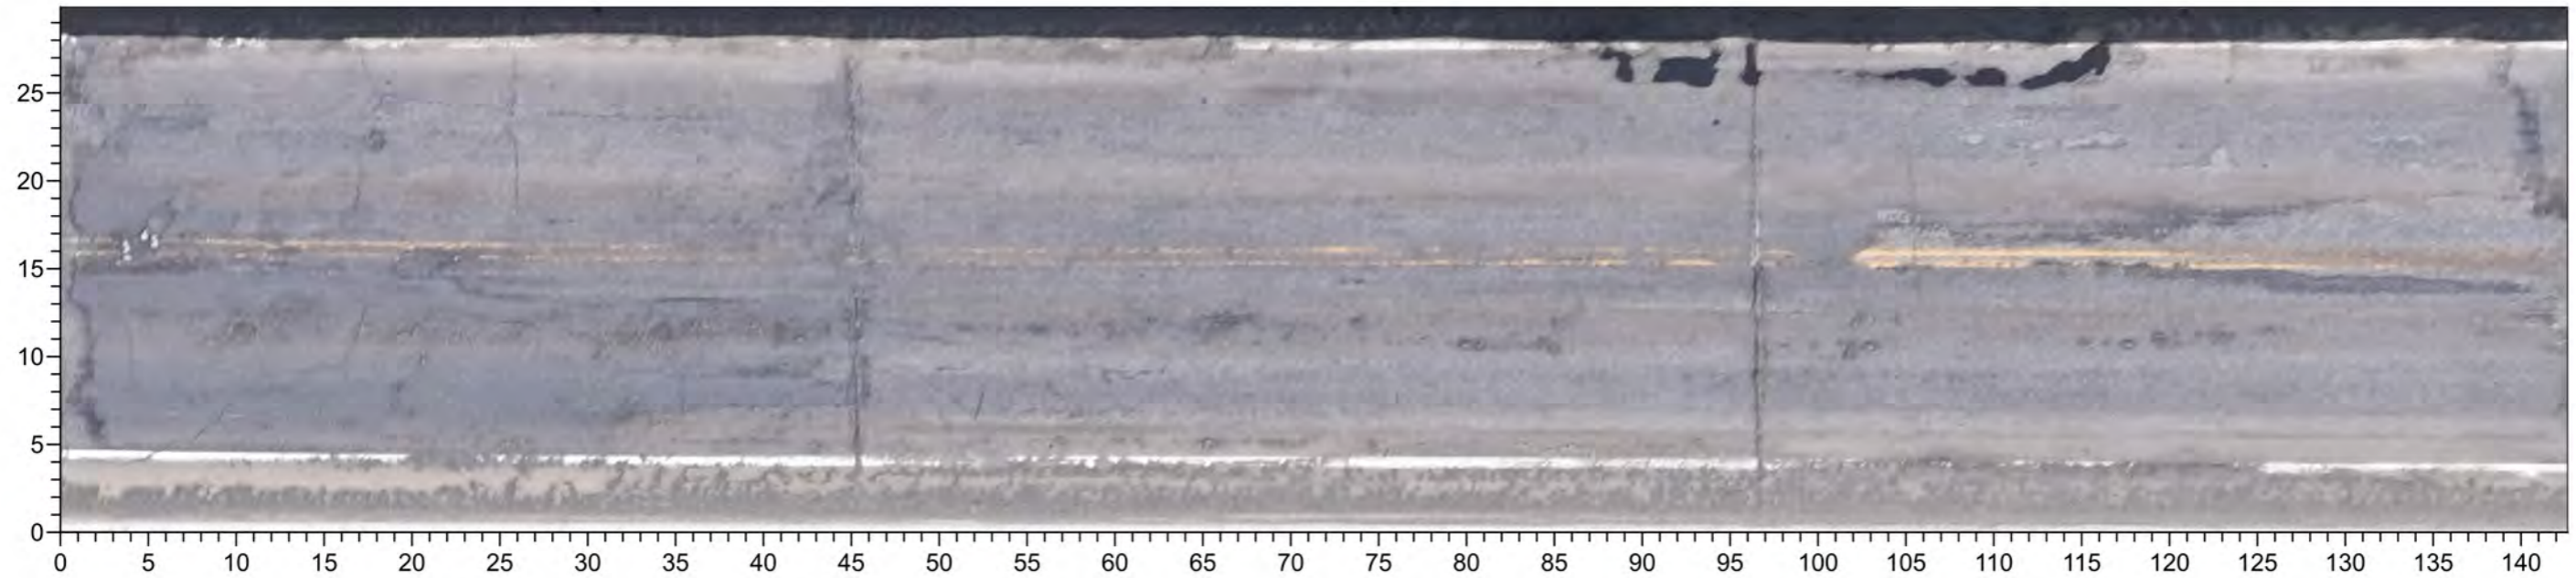
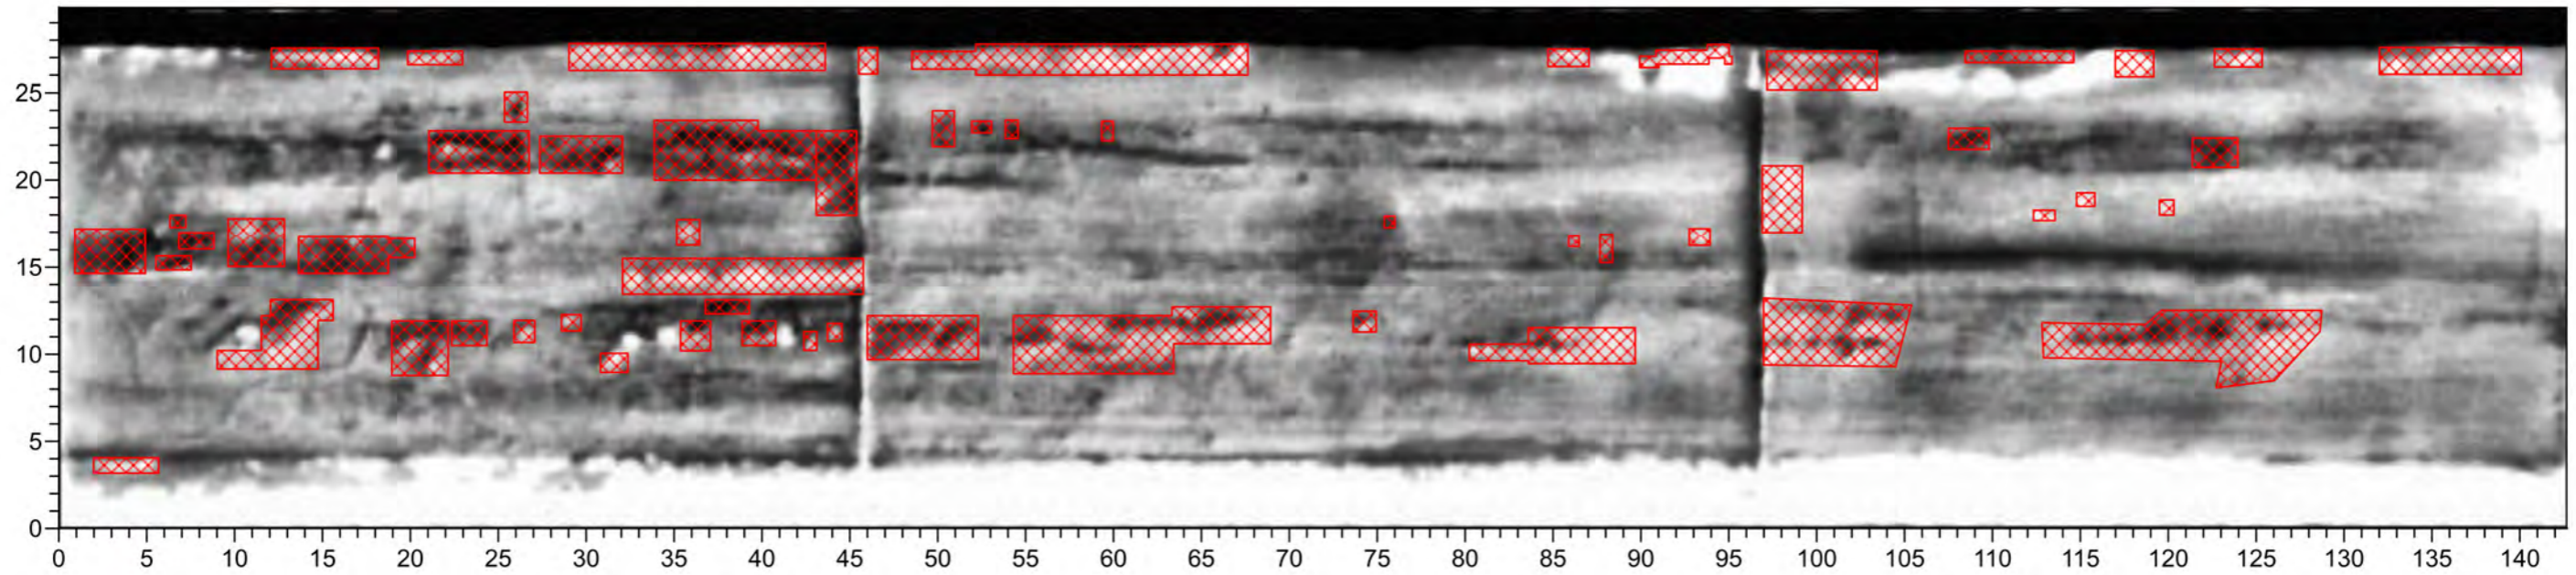
Delamination Quantity (%)	0.8	Imagery Collected: 6/4/22 Analyzed by: SB	
			Delamination Quantity (ft ²)	40	Reviewed by: AJC Completed: 10/4/22

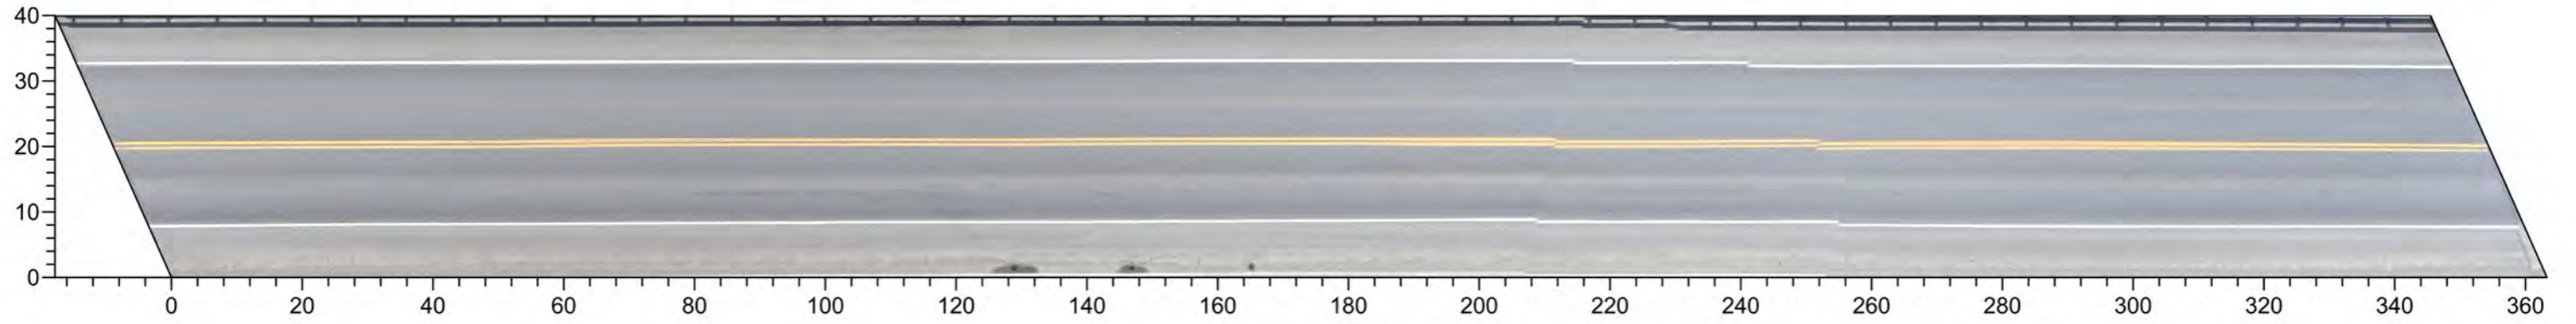
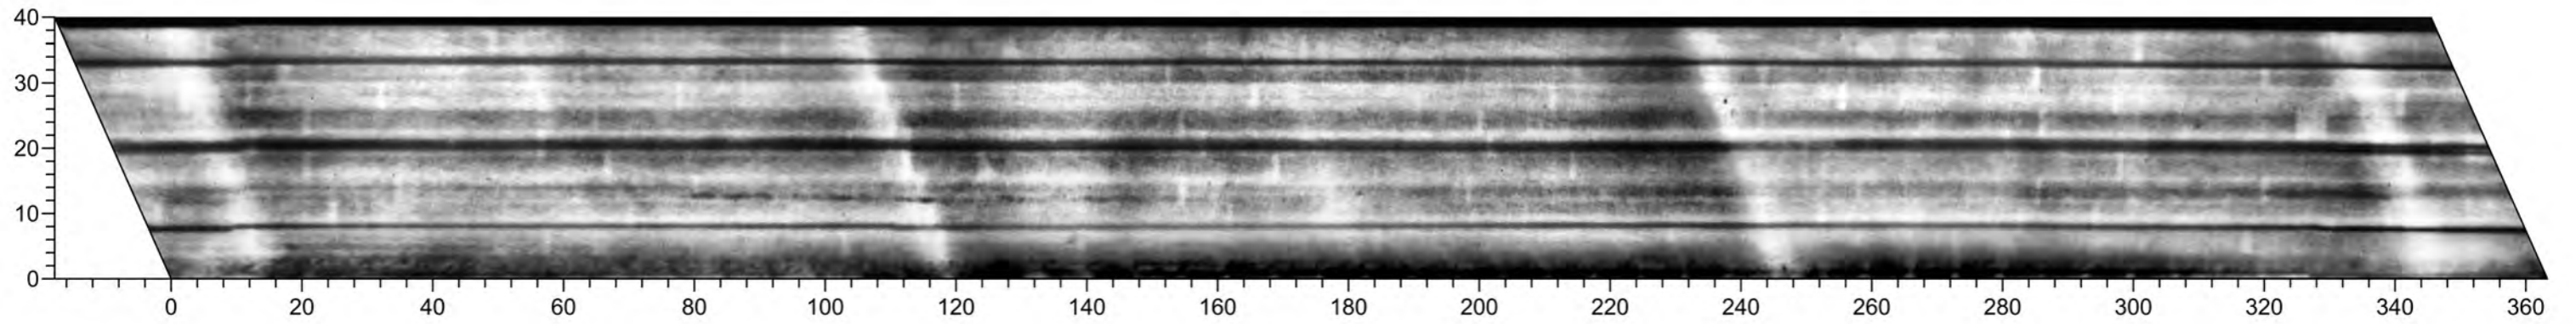
Delamination Quantity (%) 10.8	10.8	Imagery Collected: 6/4/22 Analyzed by: SB Reviewed by: AJC Completed: 10/4/22	
			Delamination Quantity (ft ²) 461	461

*Note: 294 sq. ft. of thermal anomalies not mapped due to being rectilinear in shape and appearing more like subsurface patching or some other structural feature

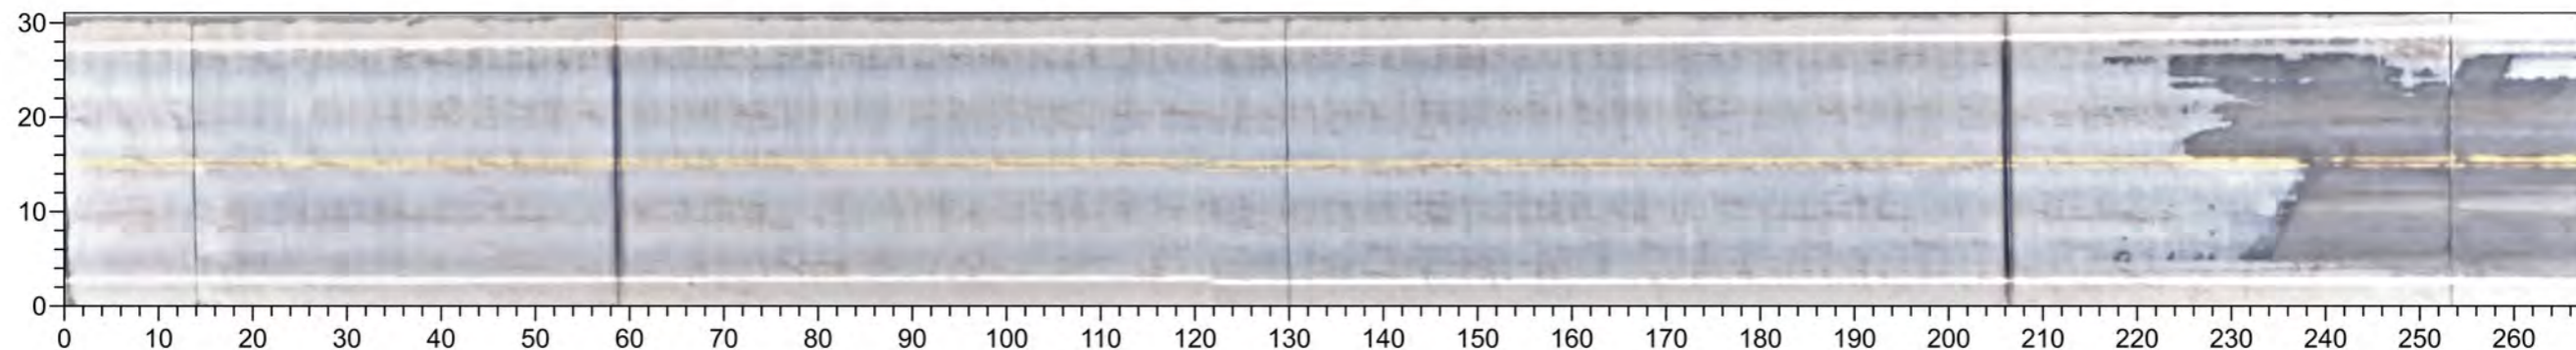
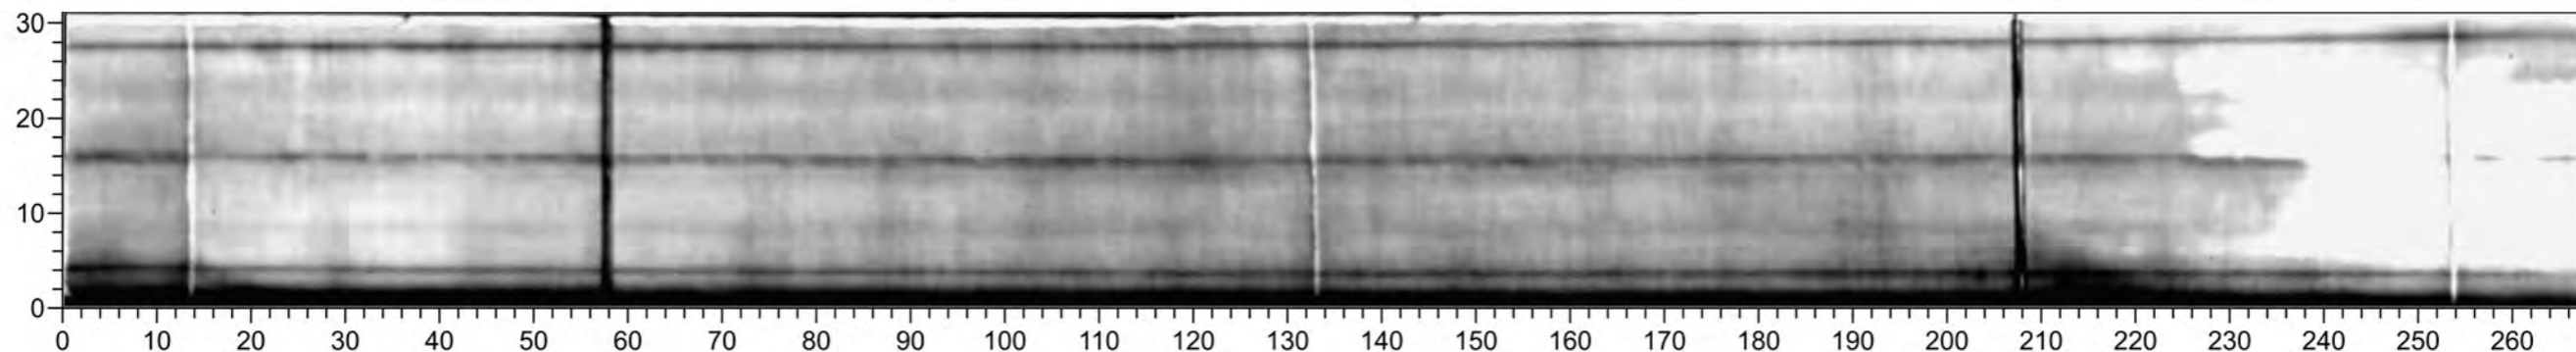
Delamination Quantity (%) 0.2 Delamination Quantity (ft ²) 23	Imagery Collected: 6/4/22 Analyzed by: SB Reviewed by: AJC Completed: 10/4/22
