Aerial Infrared Scanning of Bridge Decks on Parks Highway to Map Delaminations

FINAL REPORT

Prepared by:
Infrasense, Inc.
Woburn, MA

Report # FHWA-AK-RD-000S(960)
March 2, 2023

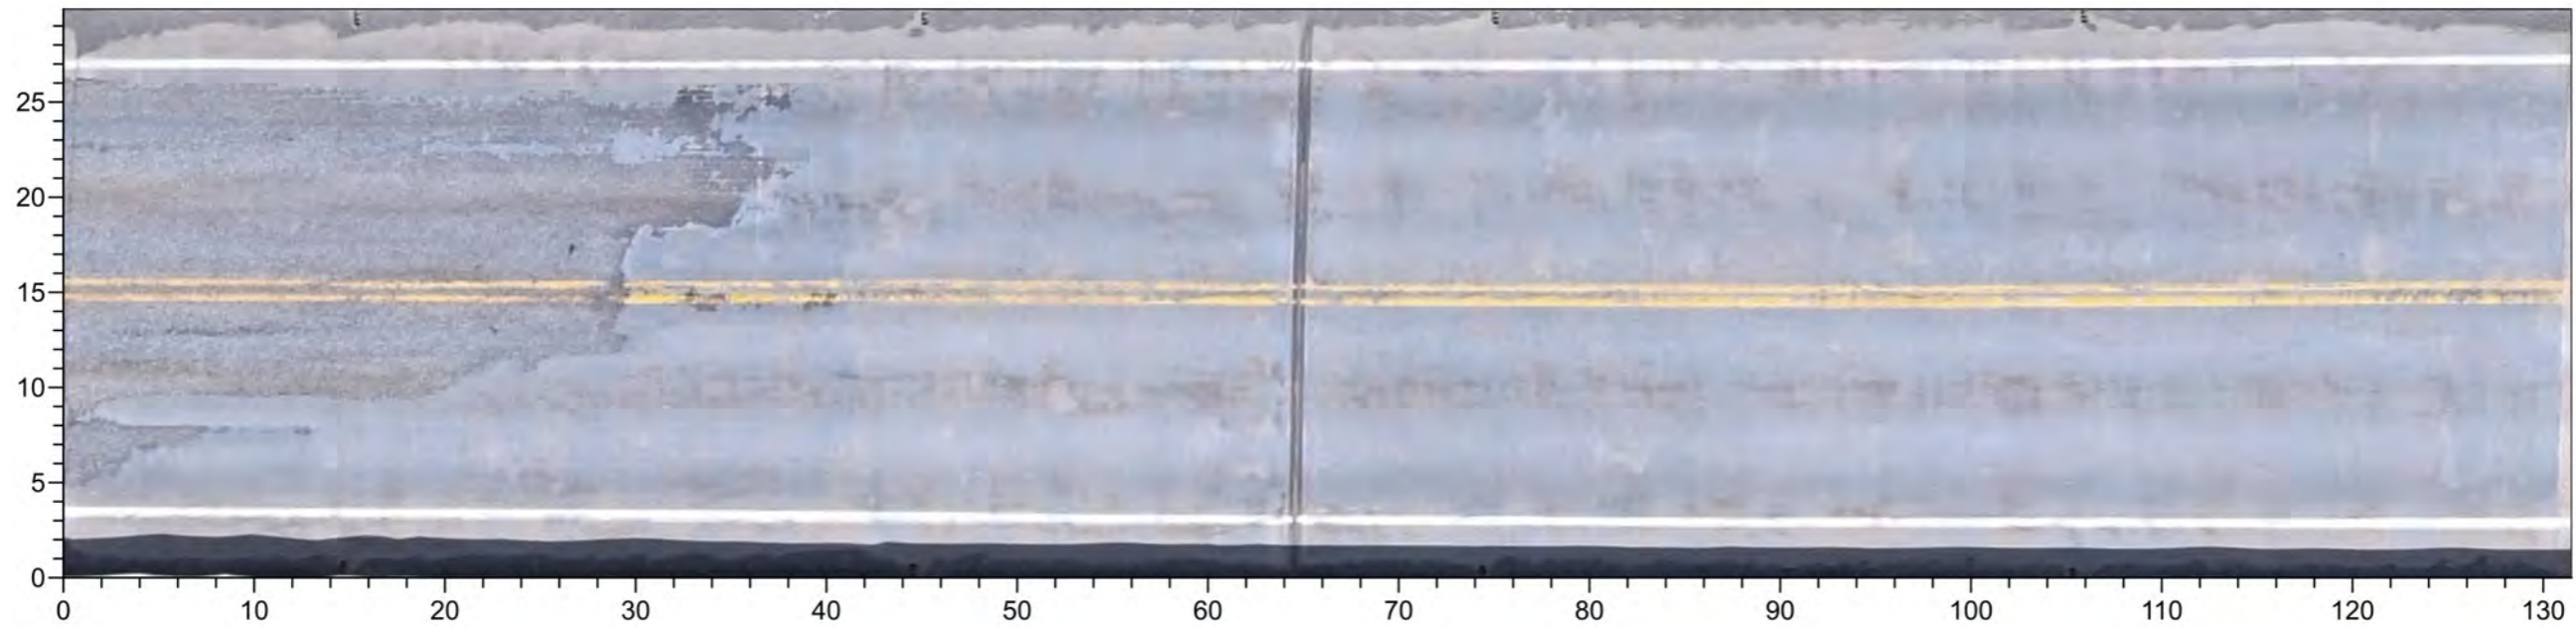
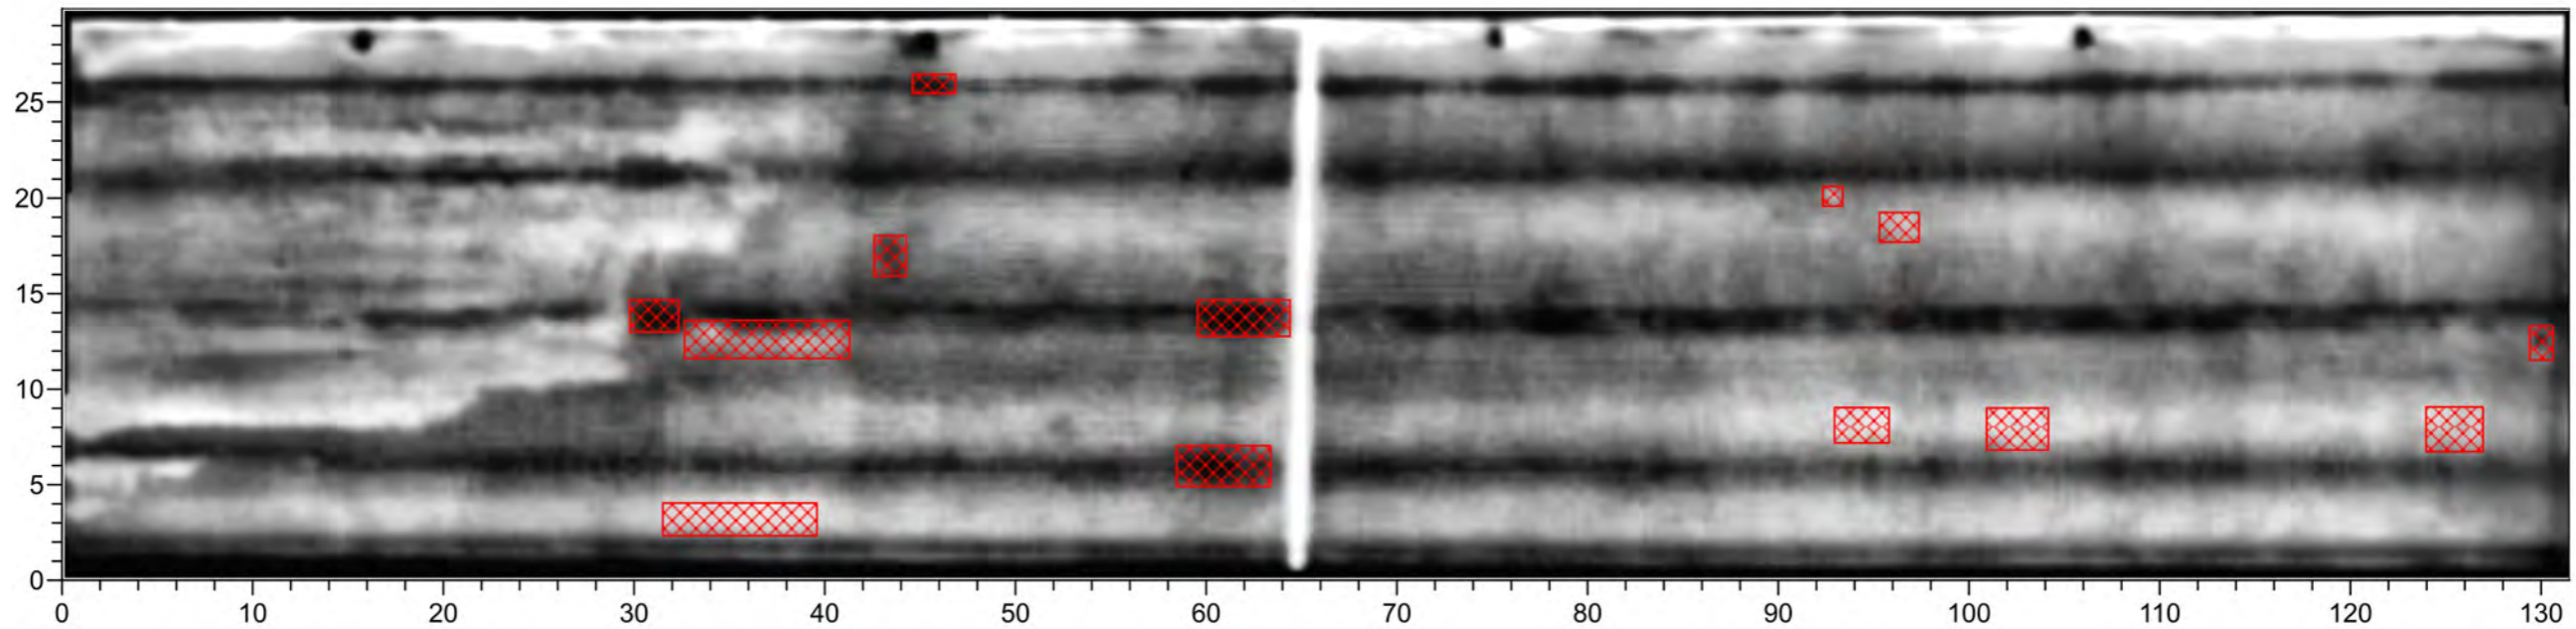
Delamination Quantity (%) 1.4	Delamination Quantity (ft ²) 117	Imagery Collected: 6/4/22 Analyzed by: SB Reviewed by: AJC Completed: 10/4/22

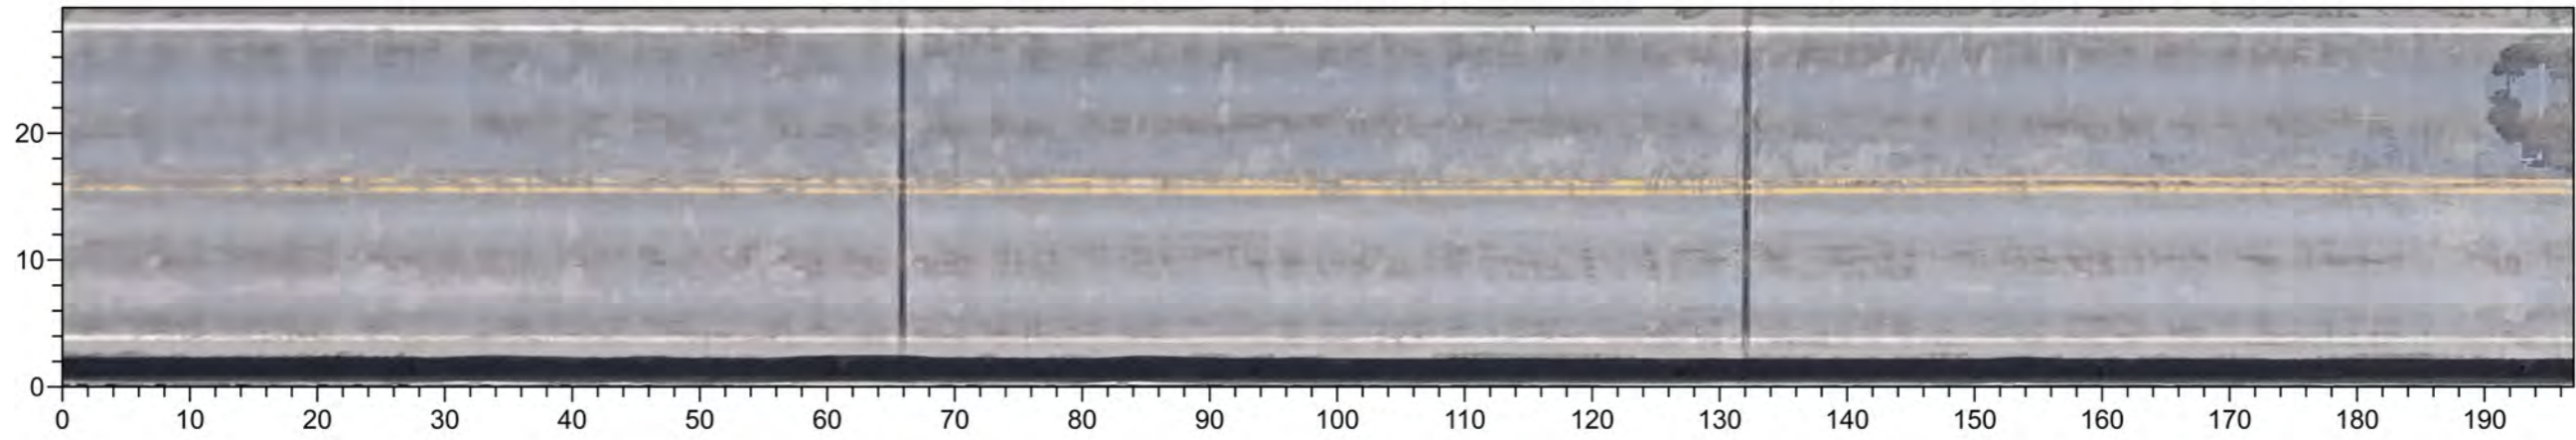
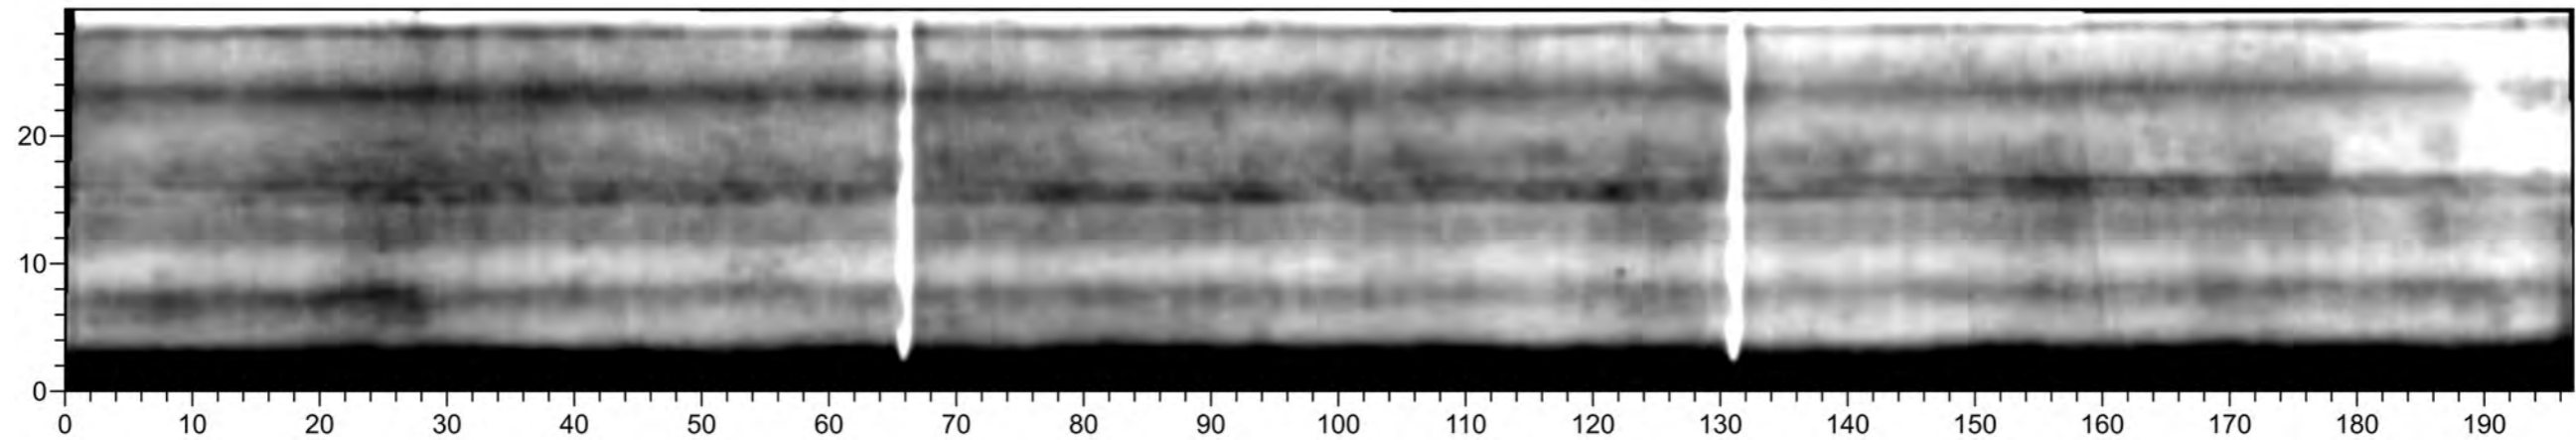
Delamination Quantity (%) 2.2	Delamination Quantity (ft ²) 87	Imagery Collected: 6/5/22 Analyzed by: SB Reviewed by: AJC Completed: 10/4/22

Note: Delamination locations not shown as quantity is less than 2%.

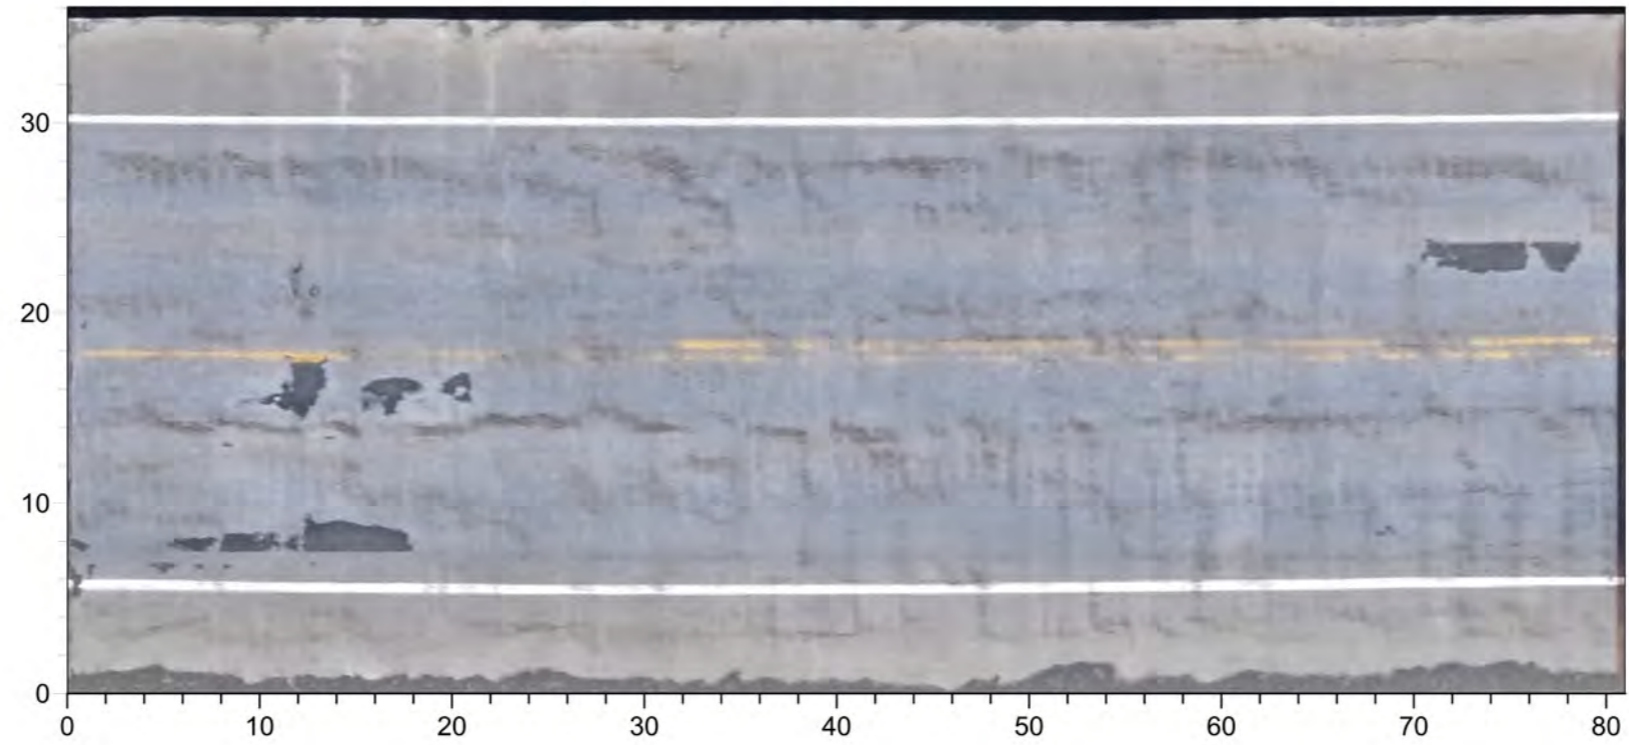
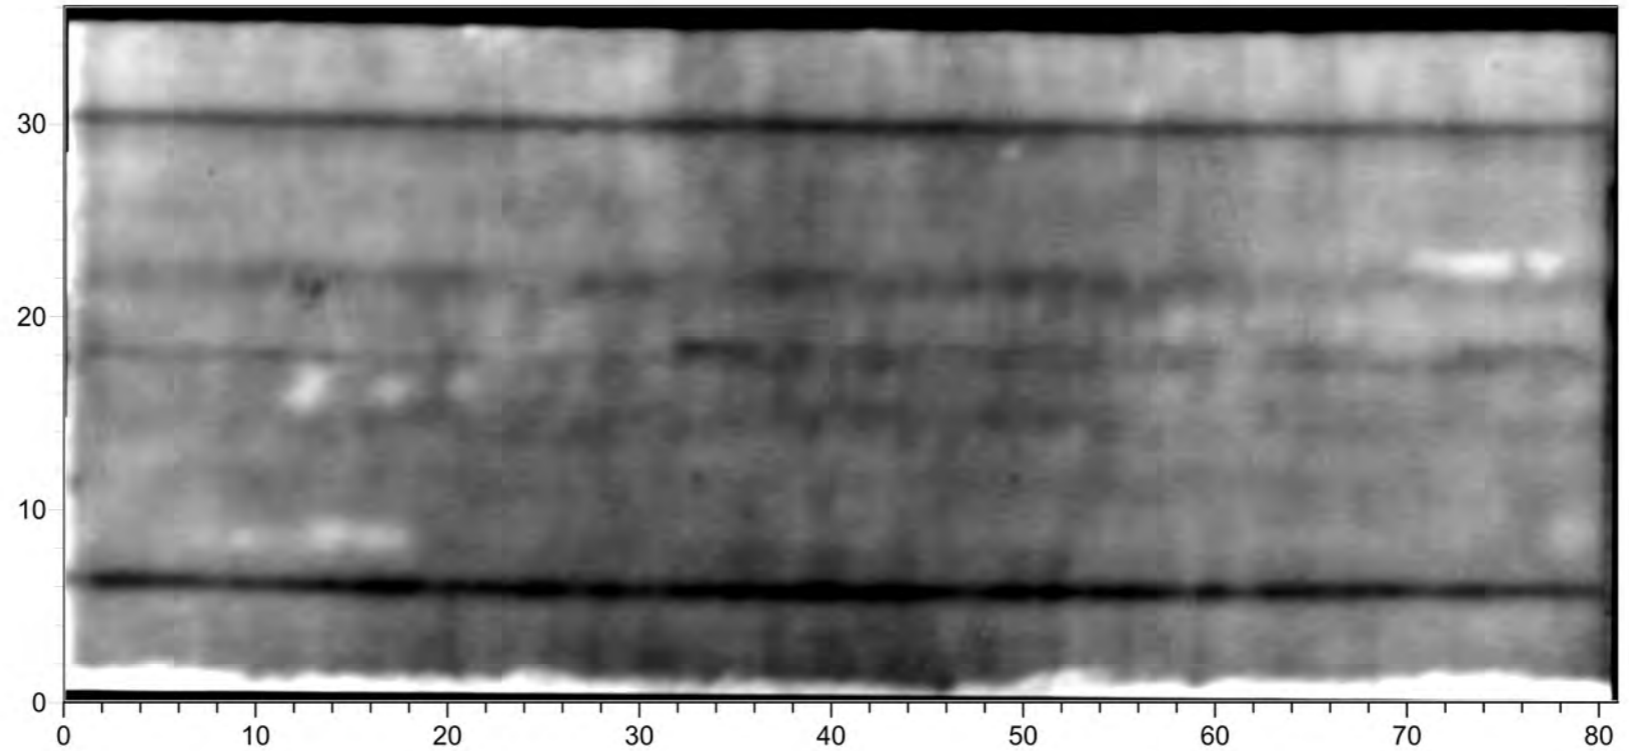
Delamination Quantity (%) 1.1		Imagery Collected: 6/5/22 Analyzed by: EG, SB Reviewed by: AJC Completed: 10/6/22	
			Delamination Quantity (ft ²) 65

Note: Delamination locations not shown as quantity is less than 2%.

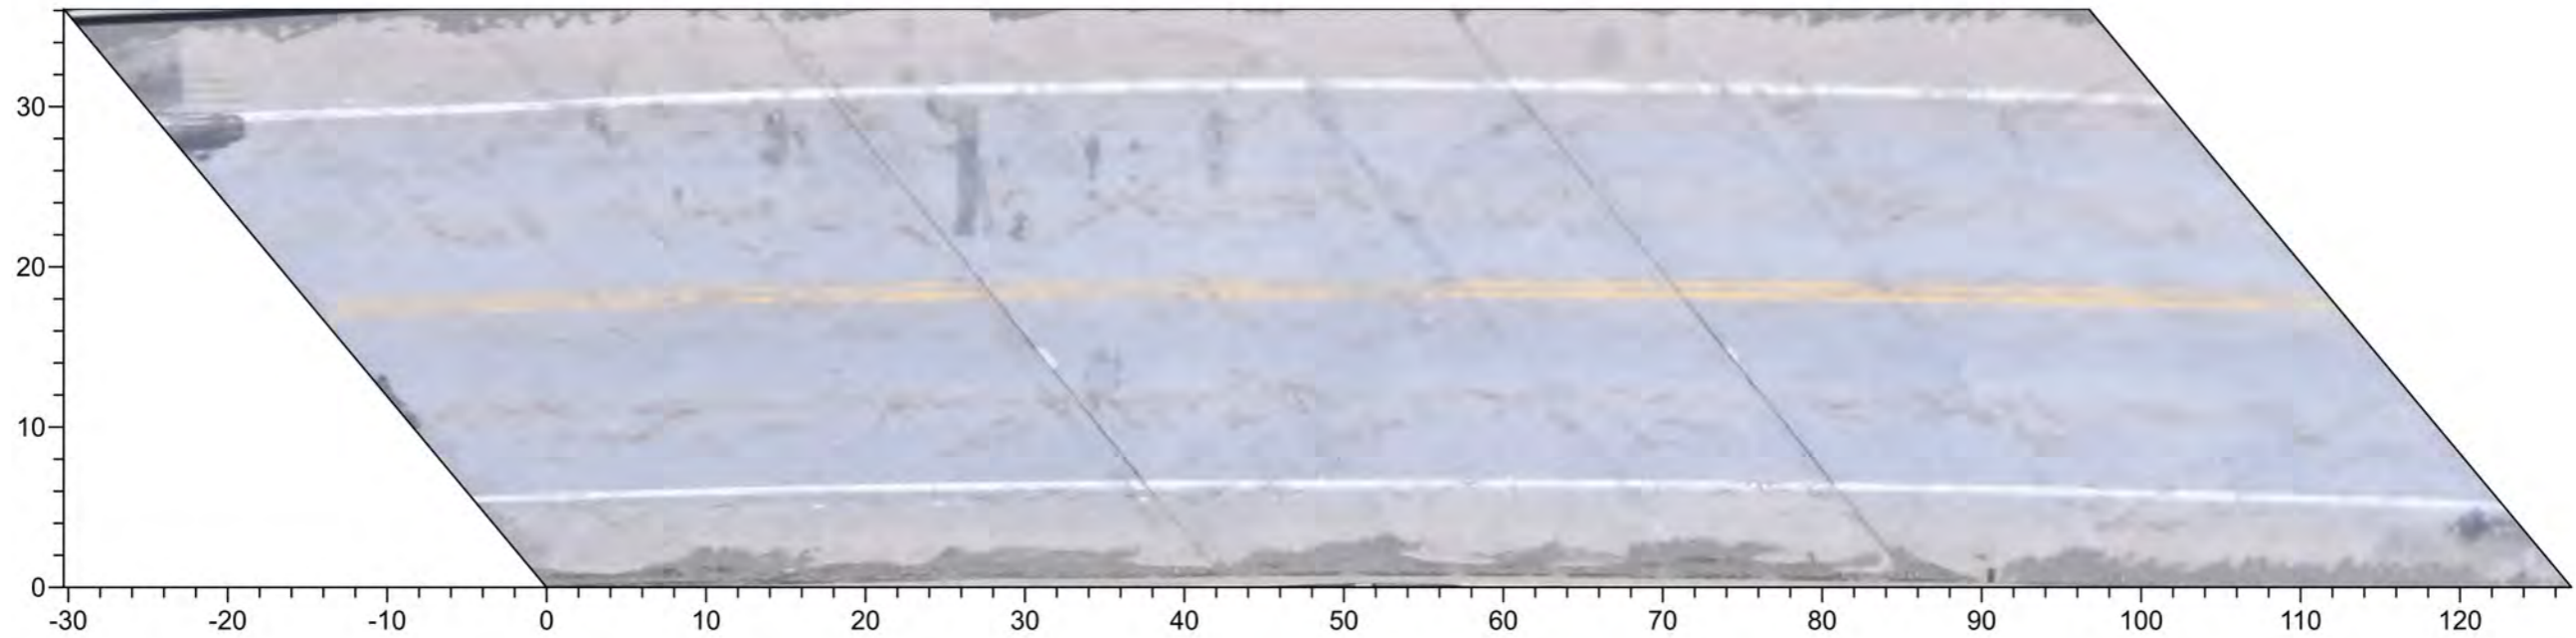
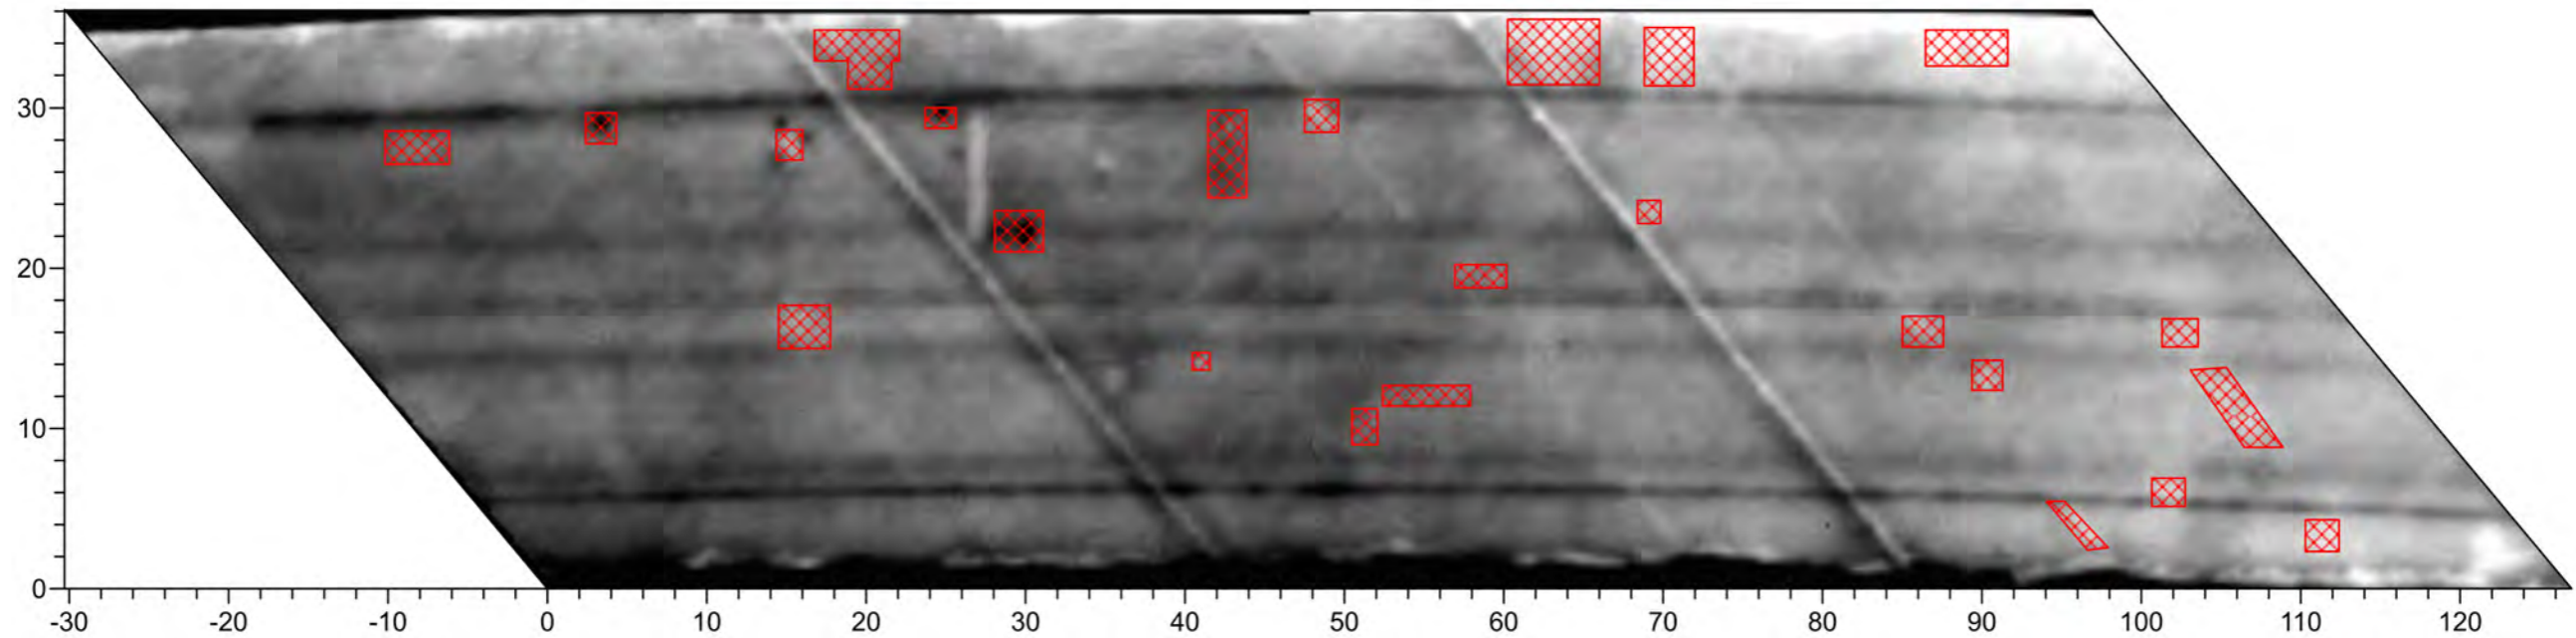
Delamination Quantity (%) 1.8		Imagery Collected: 6/5/22 Analyzed by: EG, SB Reviewed by: AJC Completed: 10/6/22	
		Delamination Quantity (ft ²) 52.6

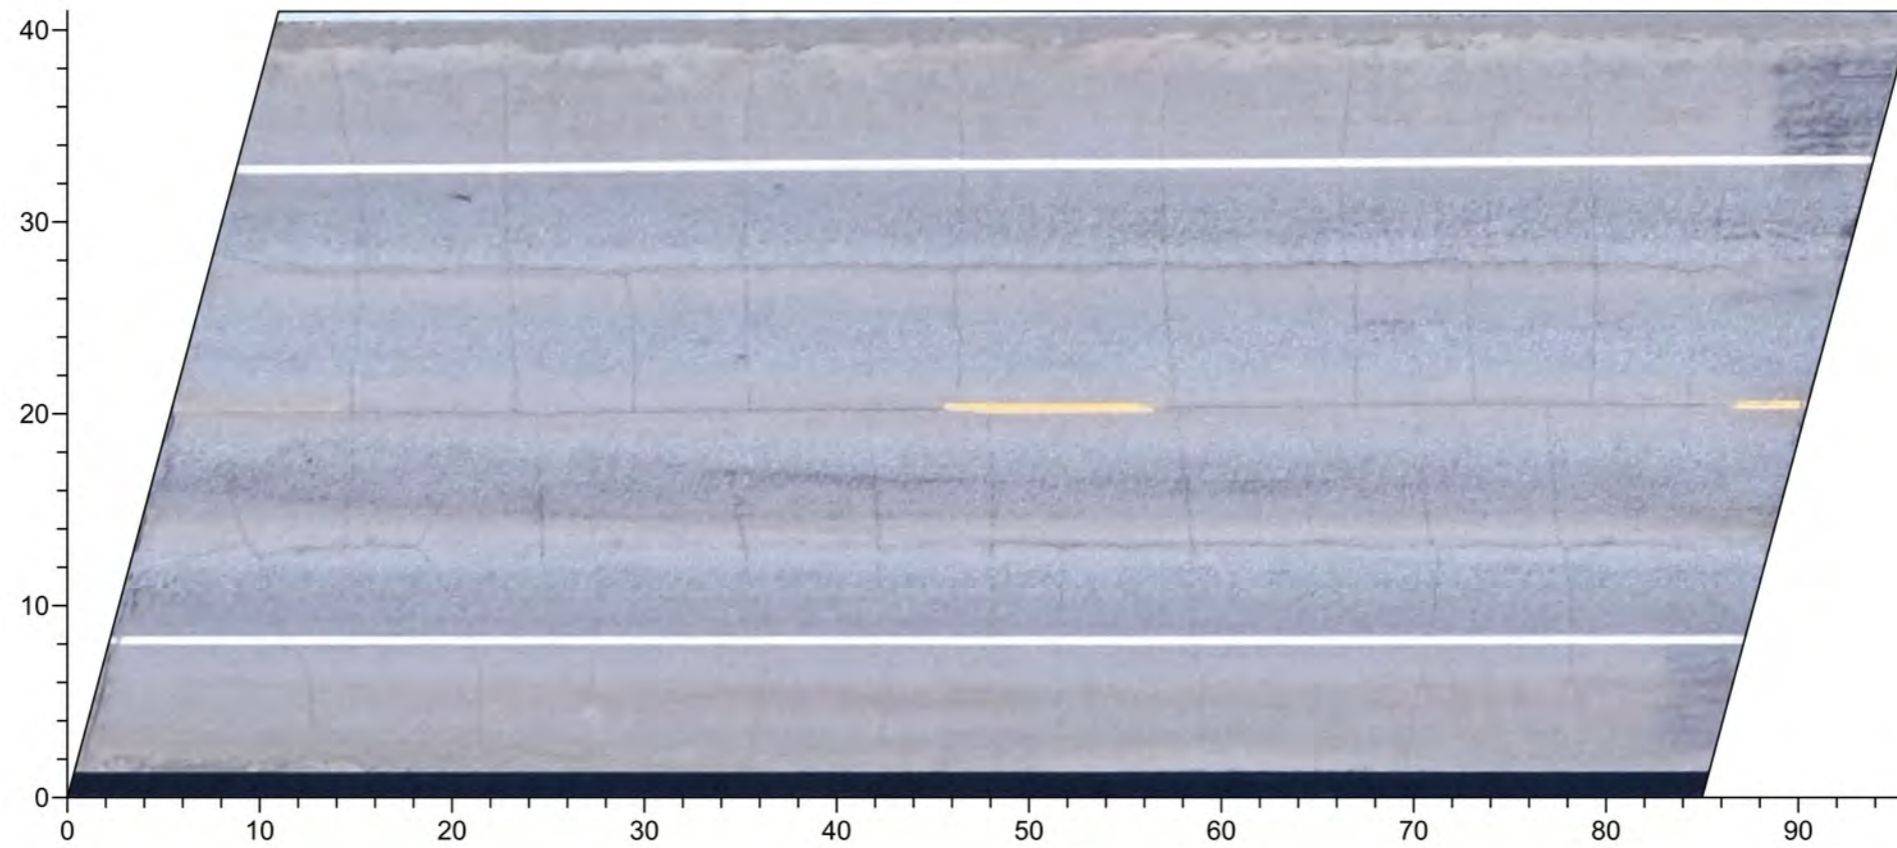
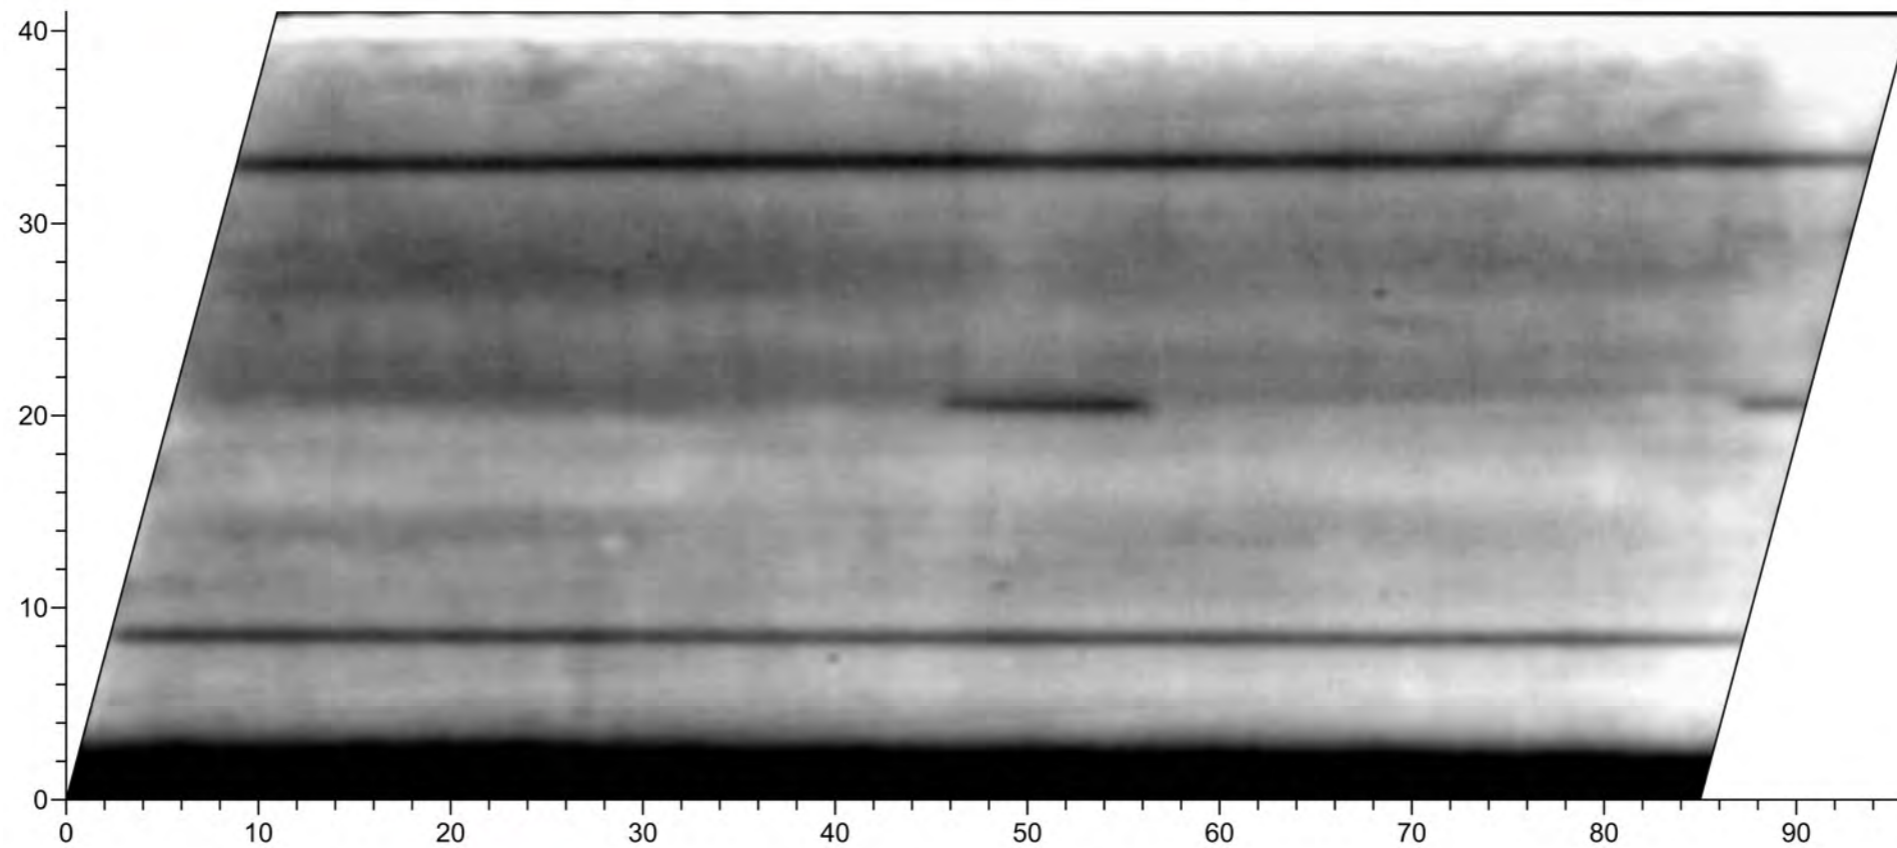
Delamination Quantity (%)	3.7	Imagery Collected: 6/5/22 Analyzed by: SB Reviewed by: AJC Completed: 10/4/22	
		Delamination Quantity (ft ²)	168

Note: Delamination locations not shown as quantity is less than 2%.

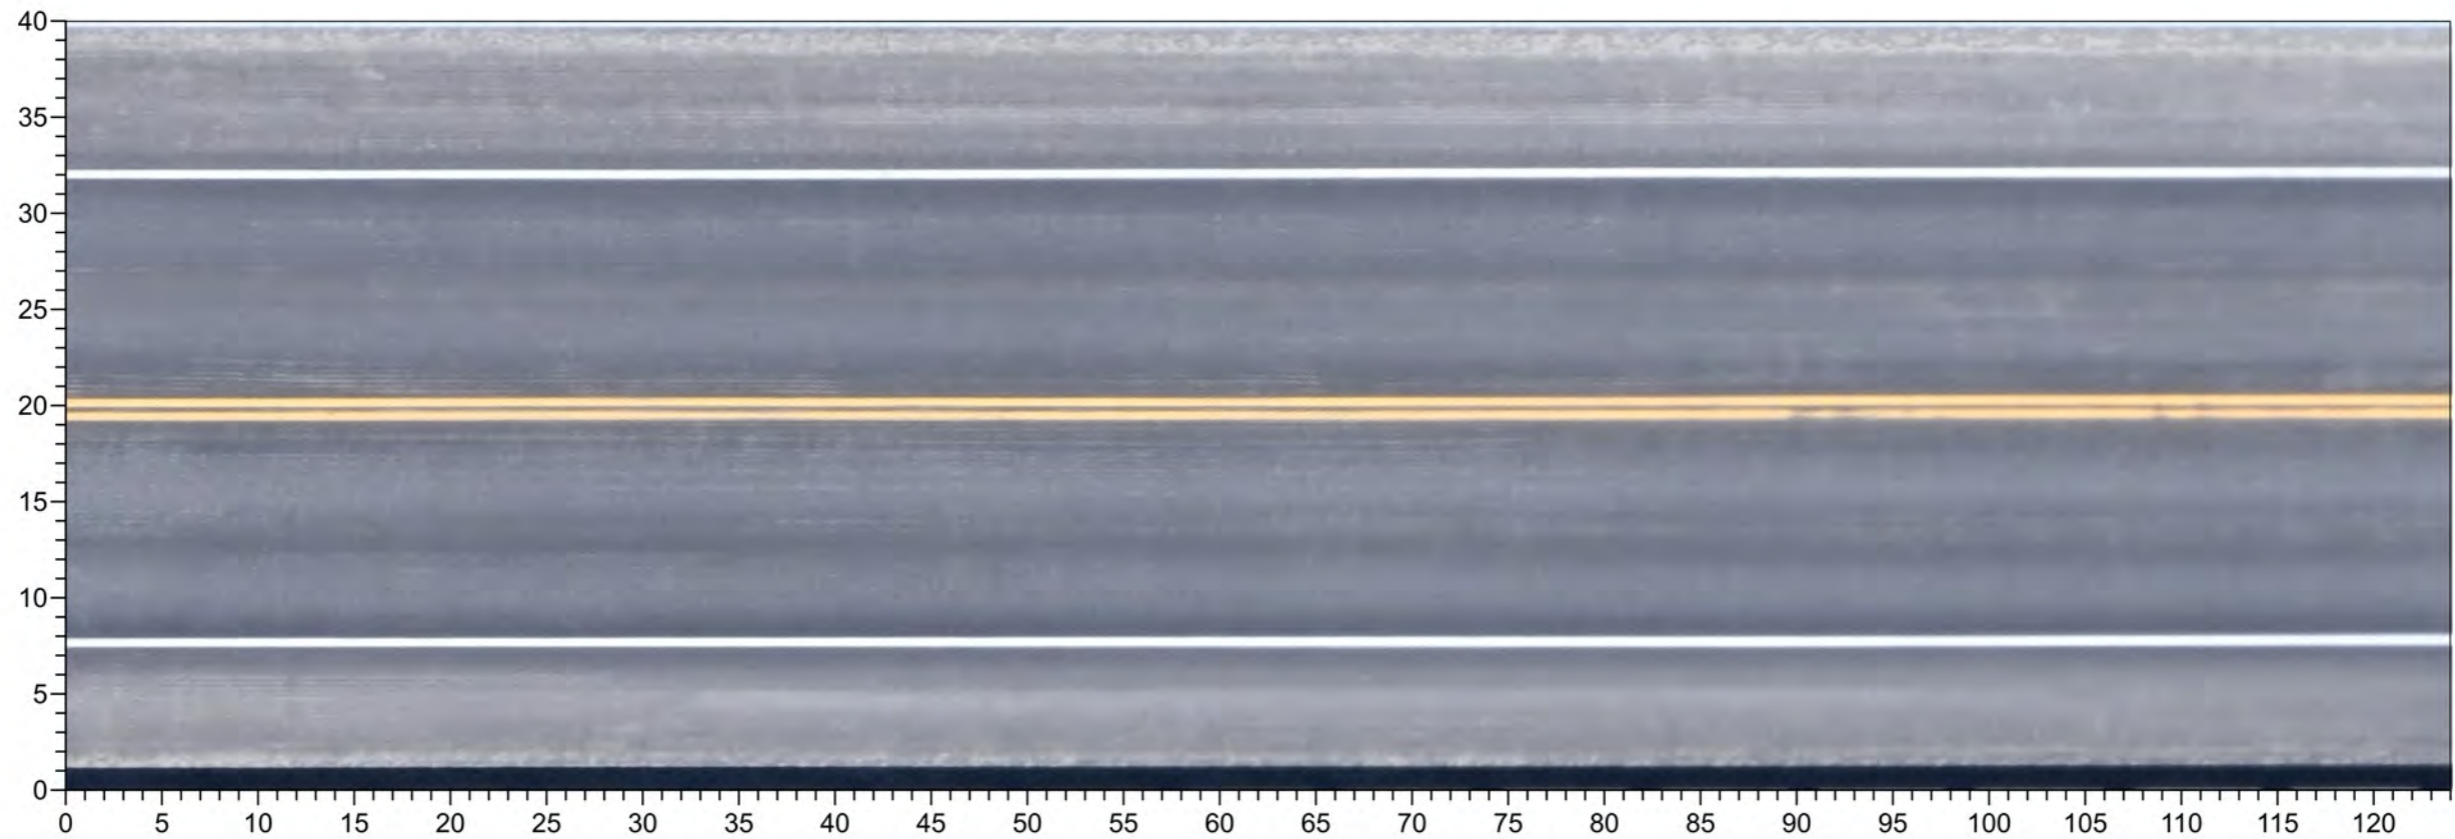
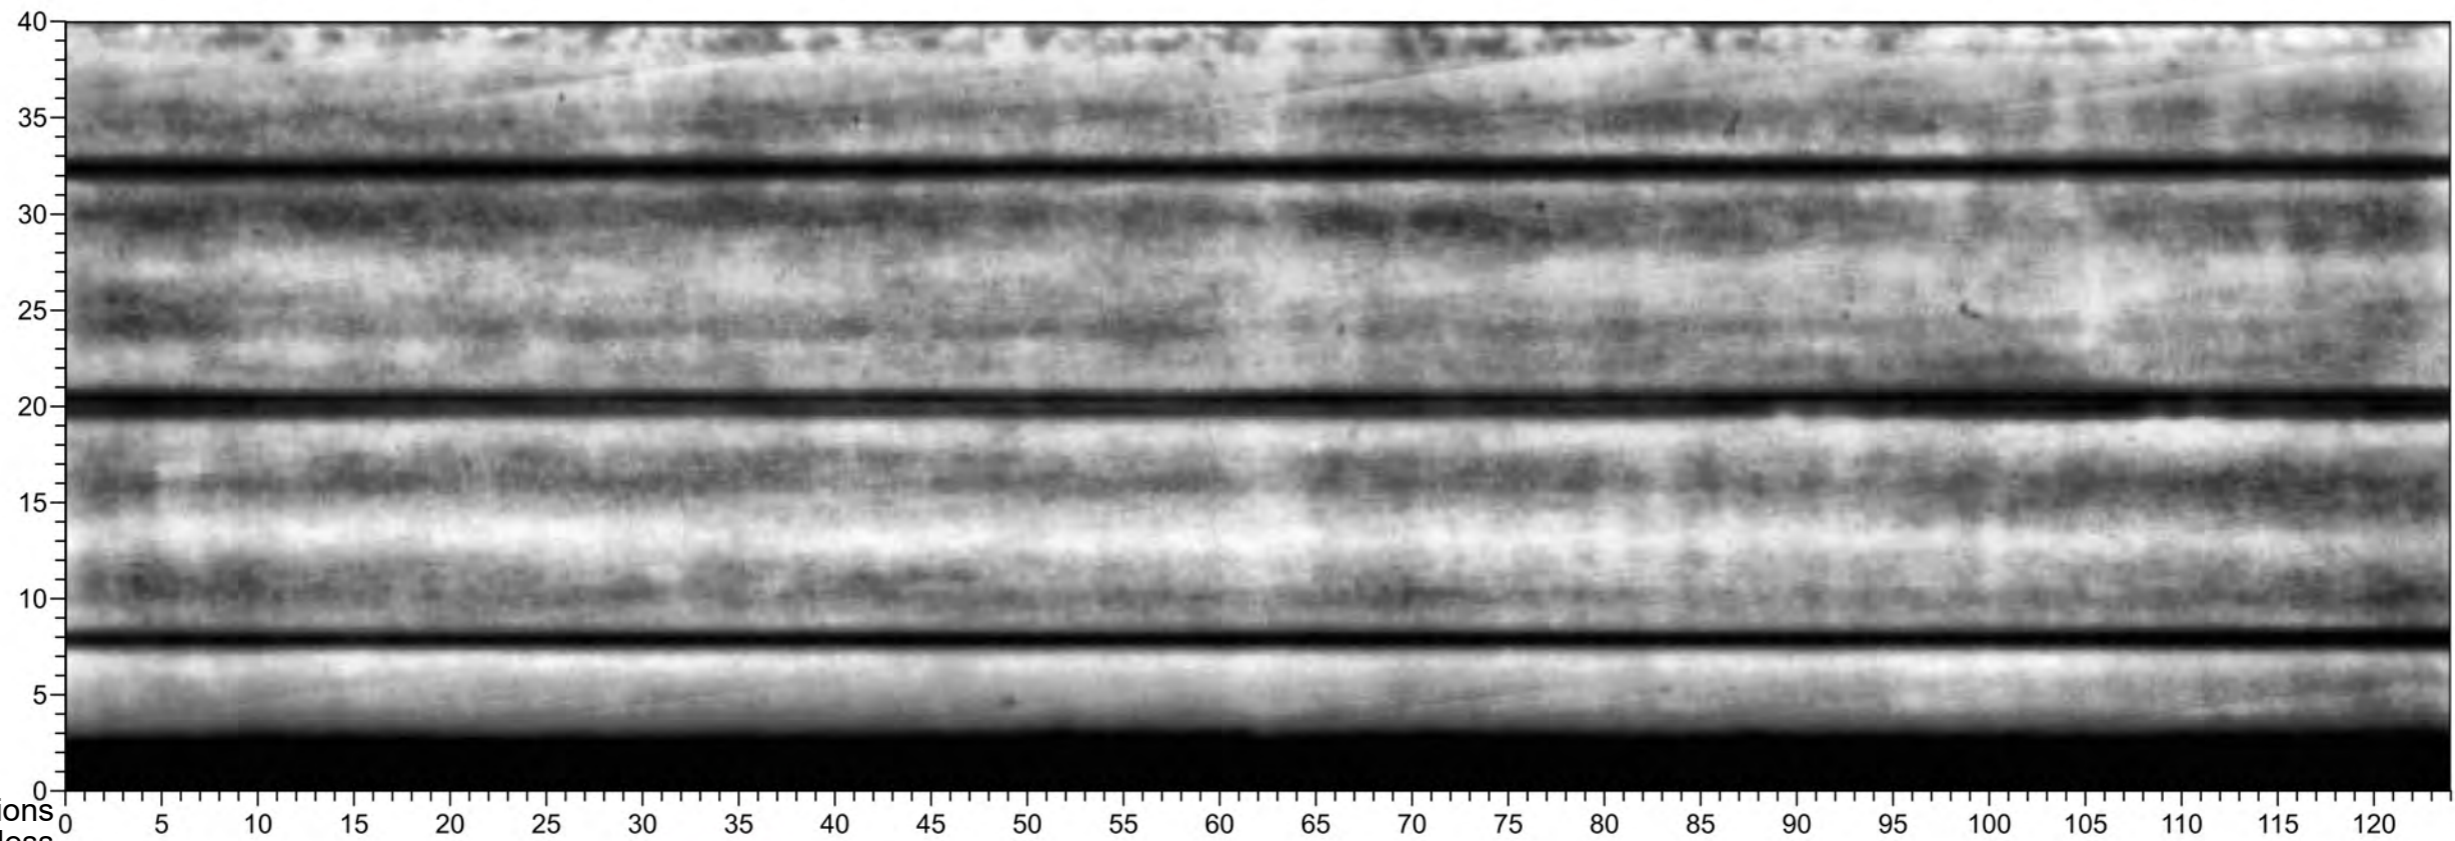
Delamination Quantity (%) 0.2 Delamination Quantity (ft ²) 8	Imagery Collected: 6/5/22 Analyzed by: SB Reviewed by: AJC Completed: 10/4/22

Note: Delamination locations not shown as quantity is less than 2%.

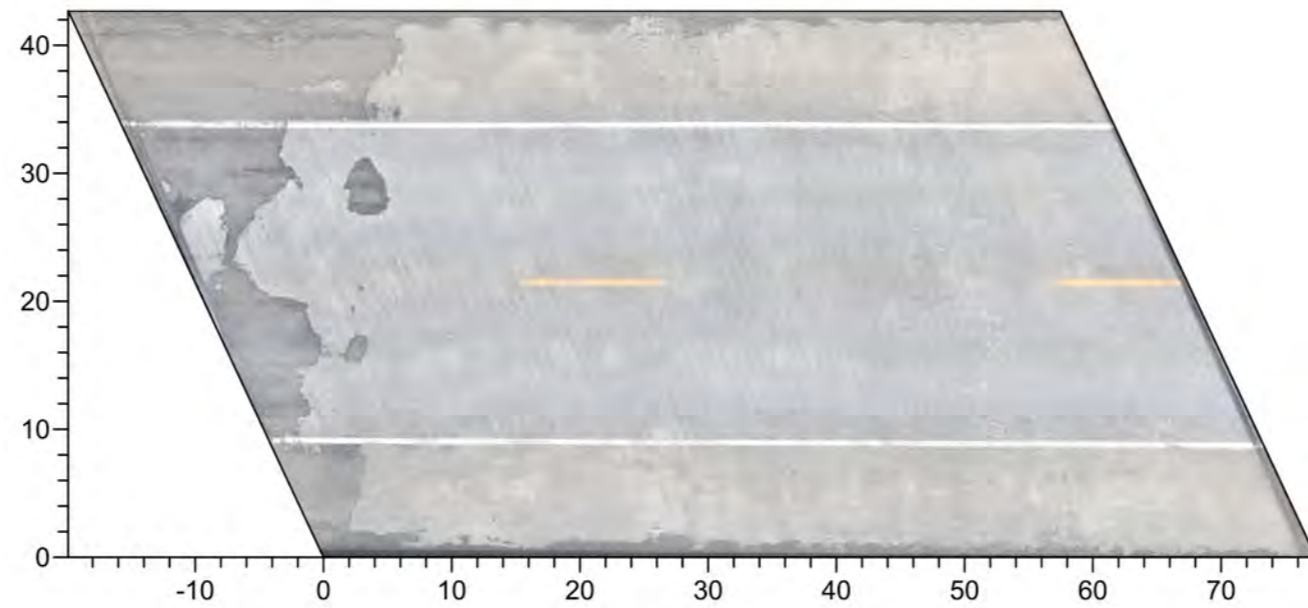
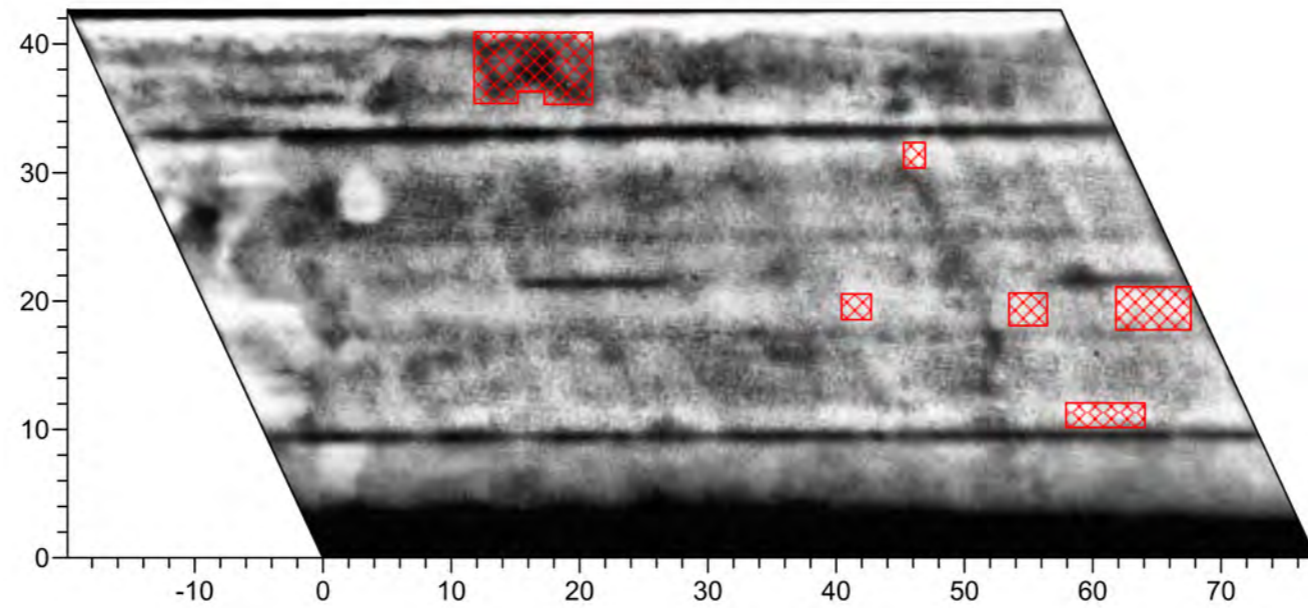
Delamination Quantity (%)	1.3	Imagery Collected: 6/5/22 Analyzed by: SB Reviewed by: AJC	
			Delamination Quantity (ft ²)	64	Completed: 10/4/22

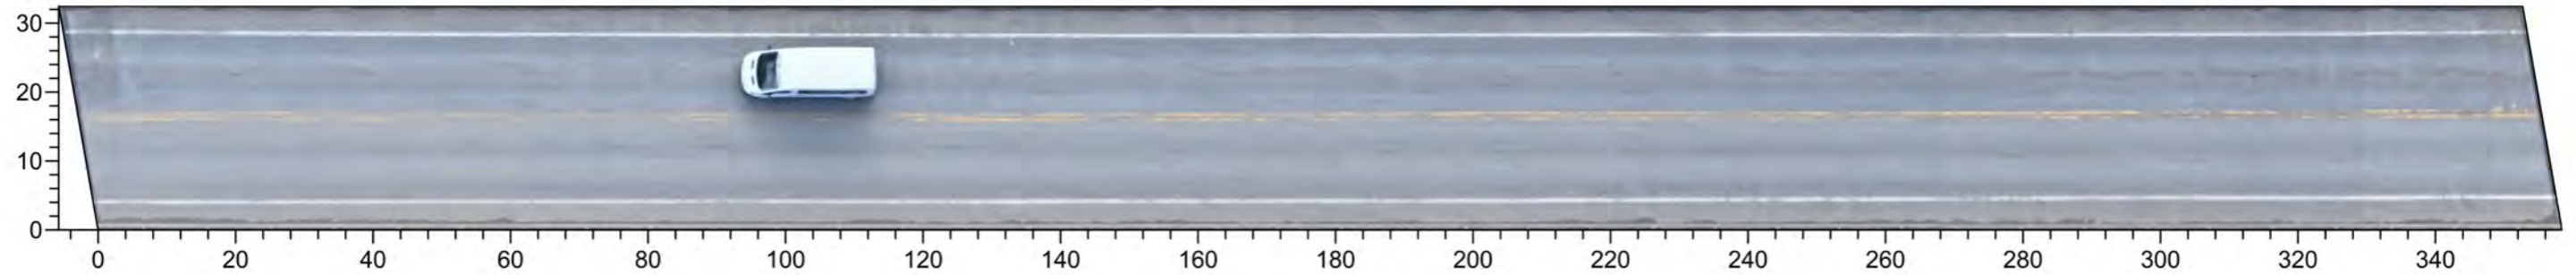
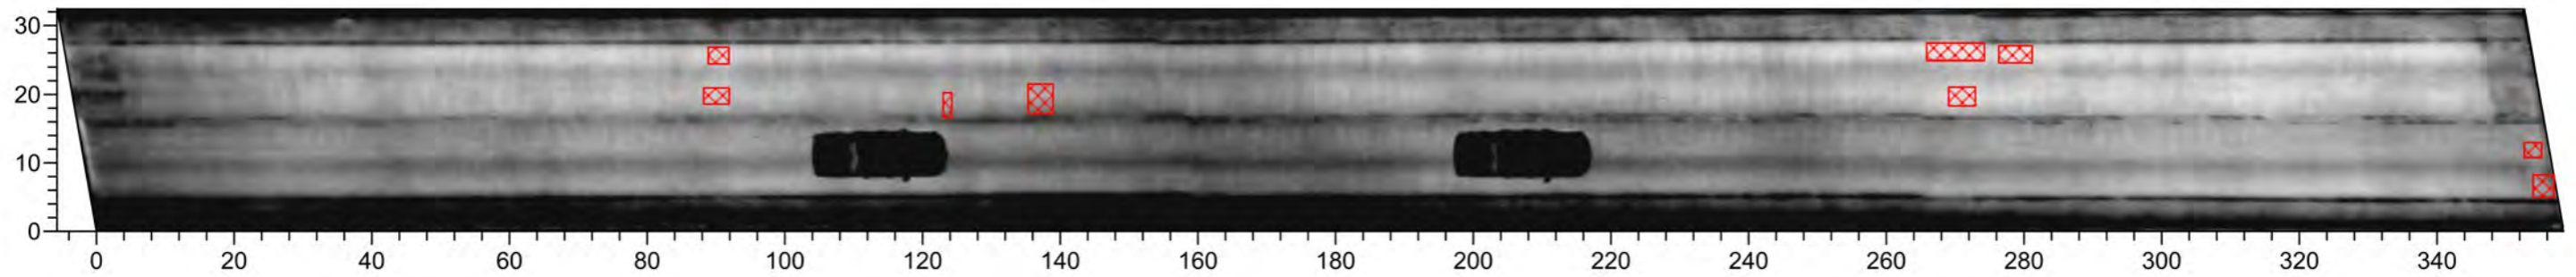
Delamination Quantity (%) 2.9		Imagery Collected: 6/5/22 Analyzed by: SB Reviewed by: AJC Completed: 10/4/22	
			Delamination Quantity (ft ²) 96
