Aerial Infrared Scanning of Bridge Decks on Parks Highway to Map Delaminations

FINAL REPORT

Prepared by:
Infrasense, Inc.
Woburn, MA

Report # FHWA-AK-RD-000S(960)
March 2, 2023

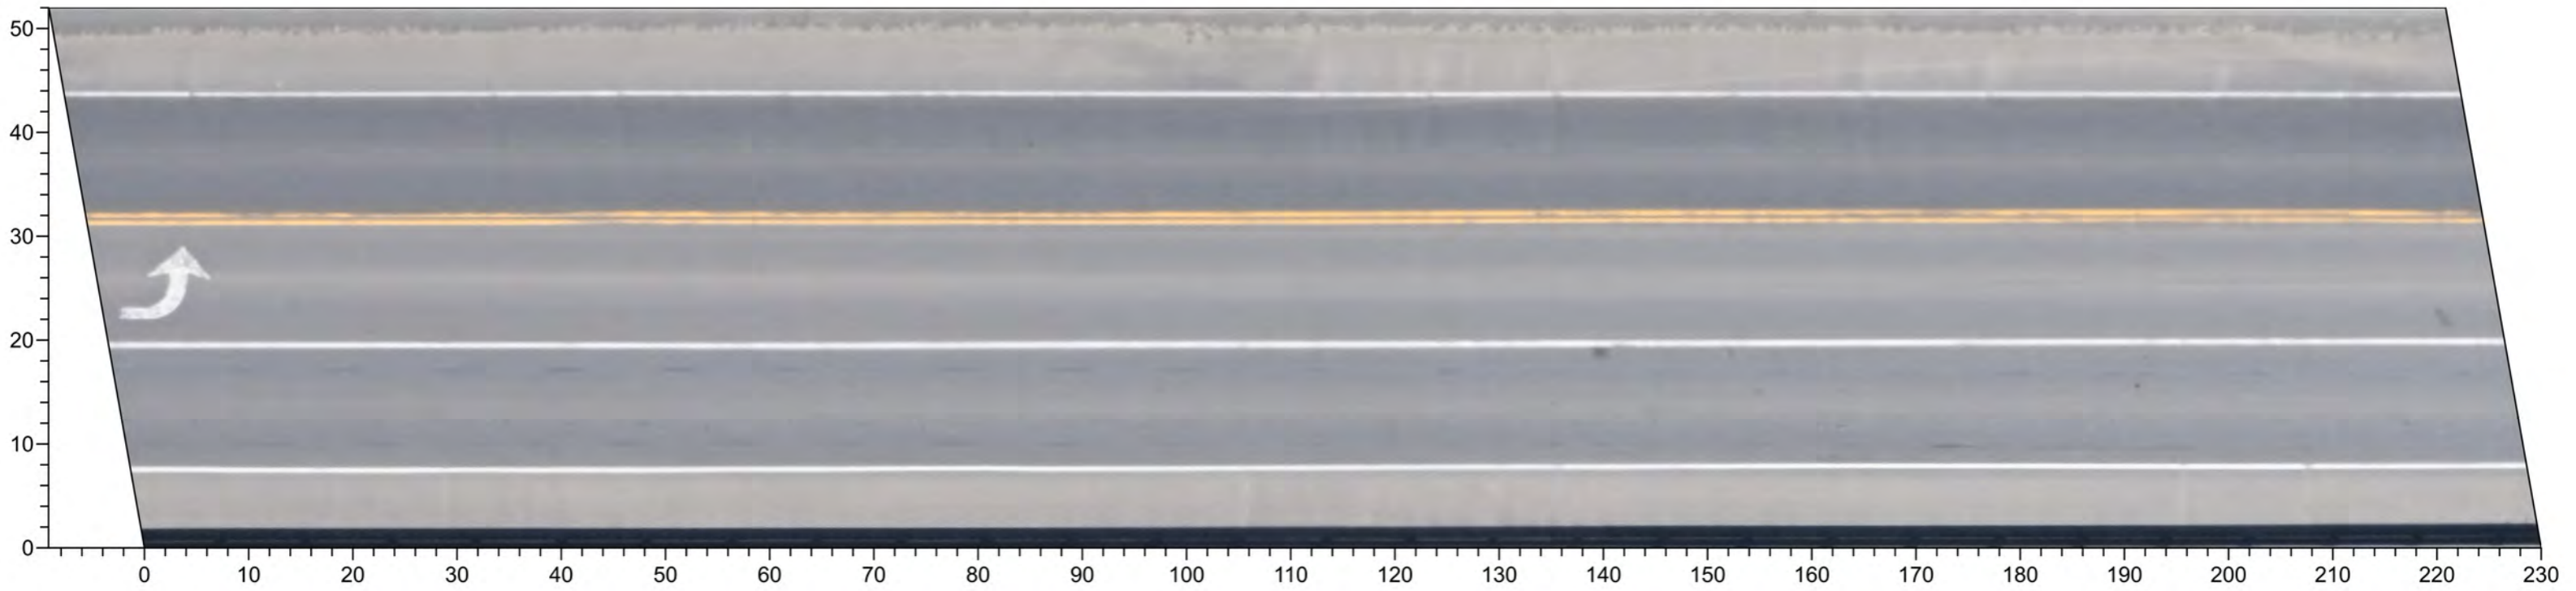
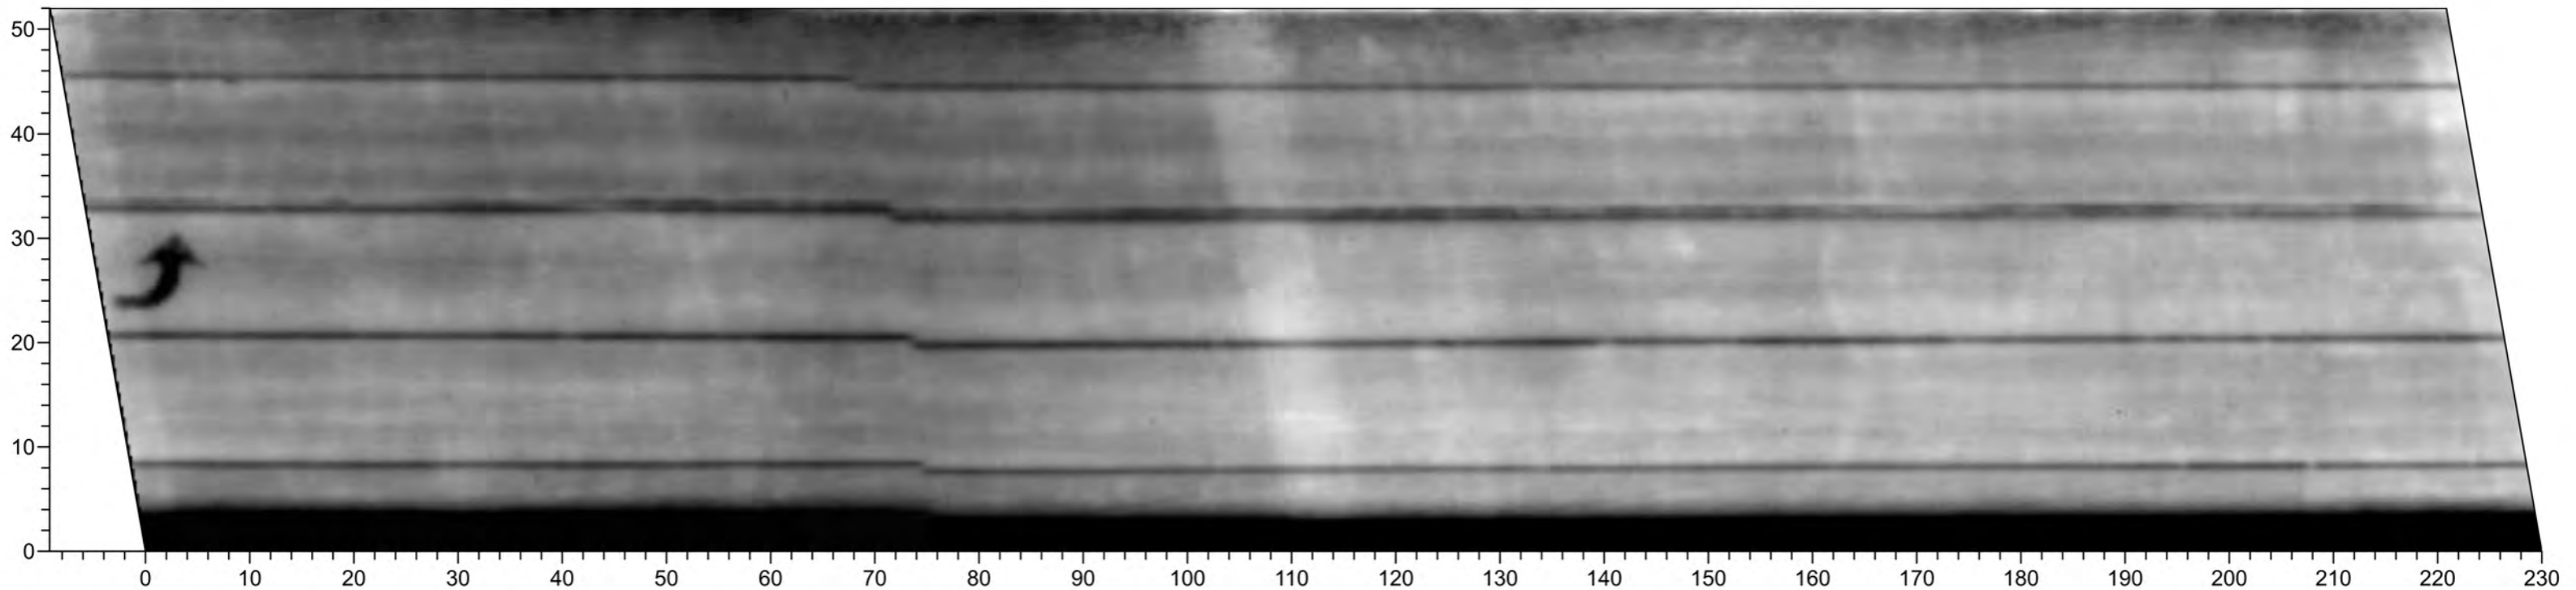
Delamination Quantity (%)	0.8	Imagery Collected: 6/5/22 Analyzed by: SB Reviewed by: AJC Completed: 10/4/22	
		Delamination Quantity (ft ²)	96

Note: Delamination locations not shown as quantity is less than 2%.

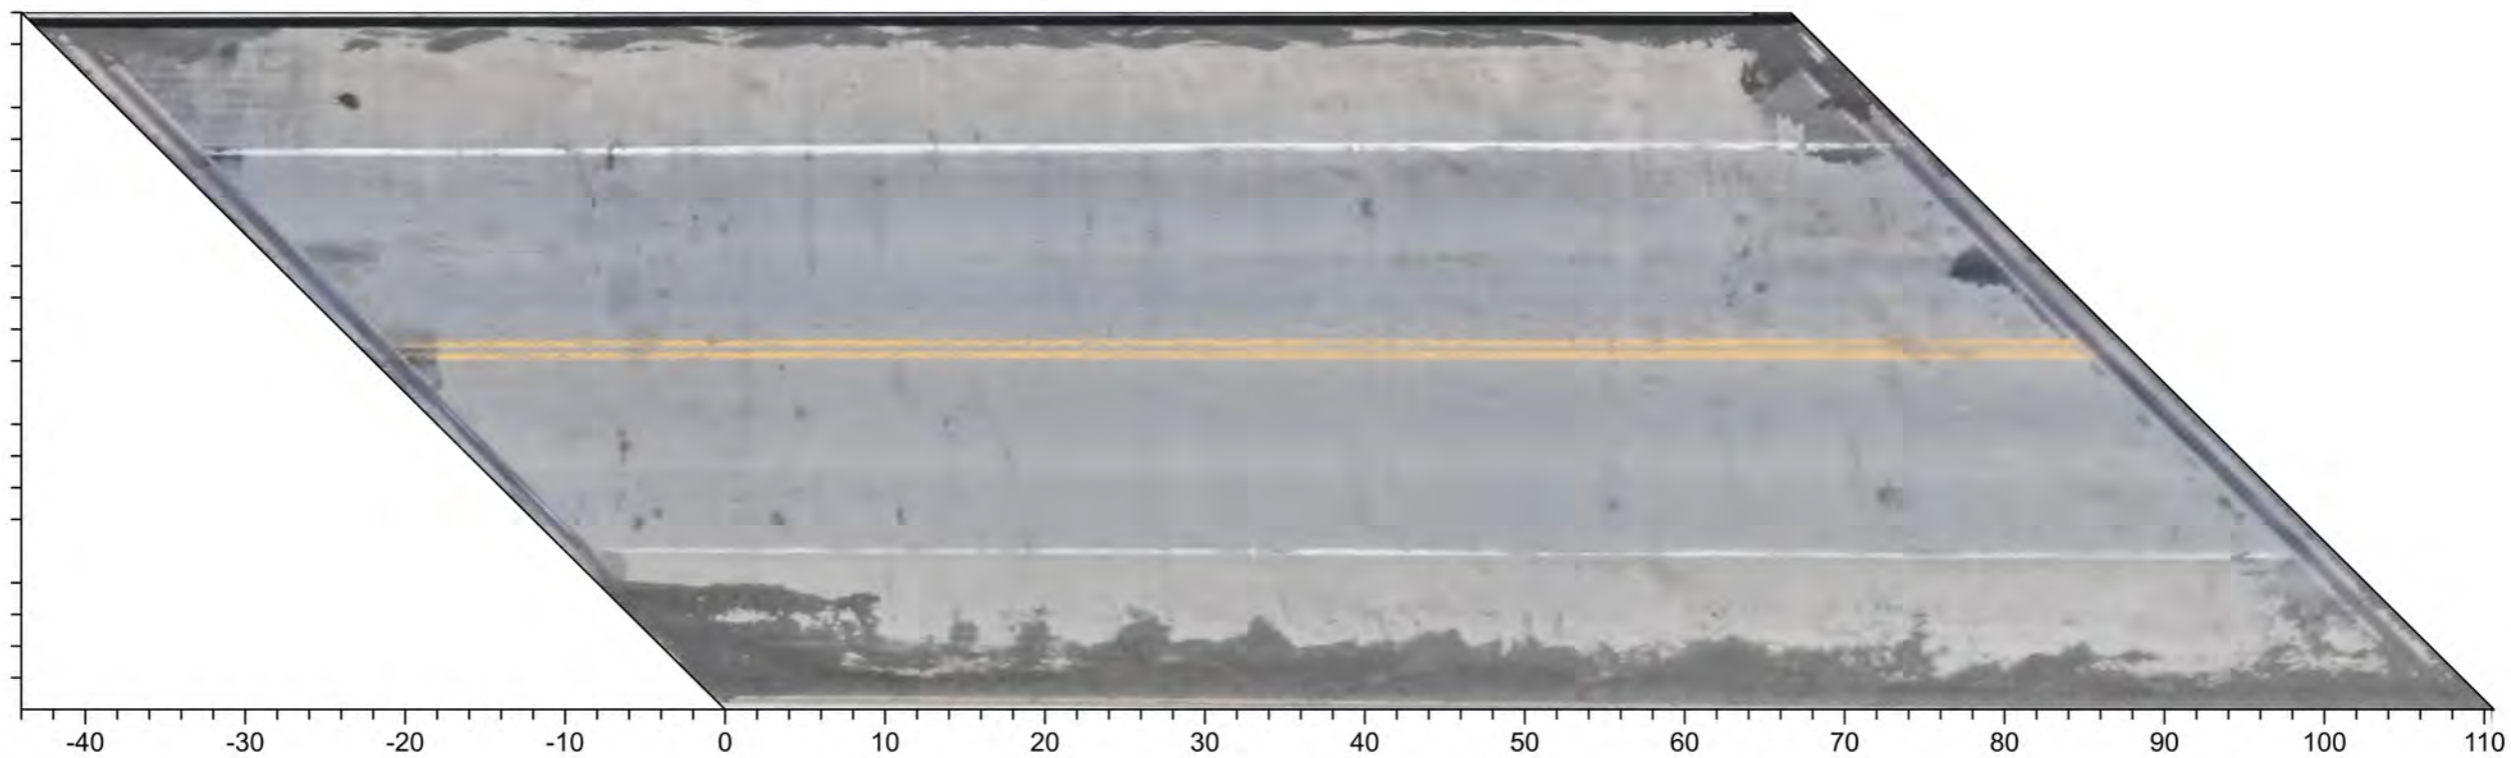
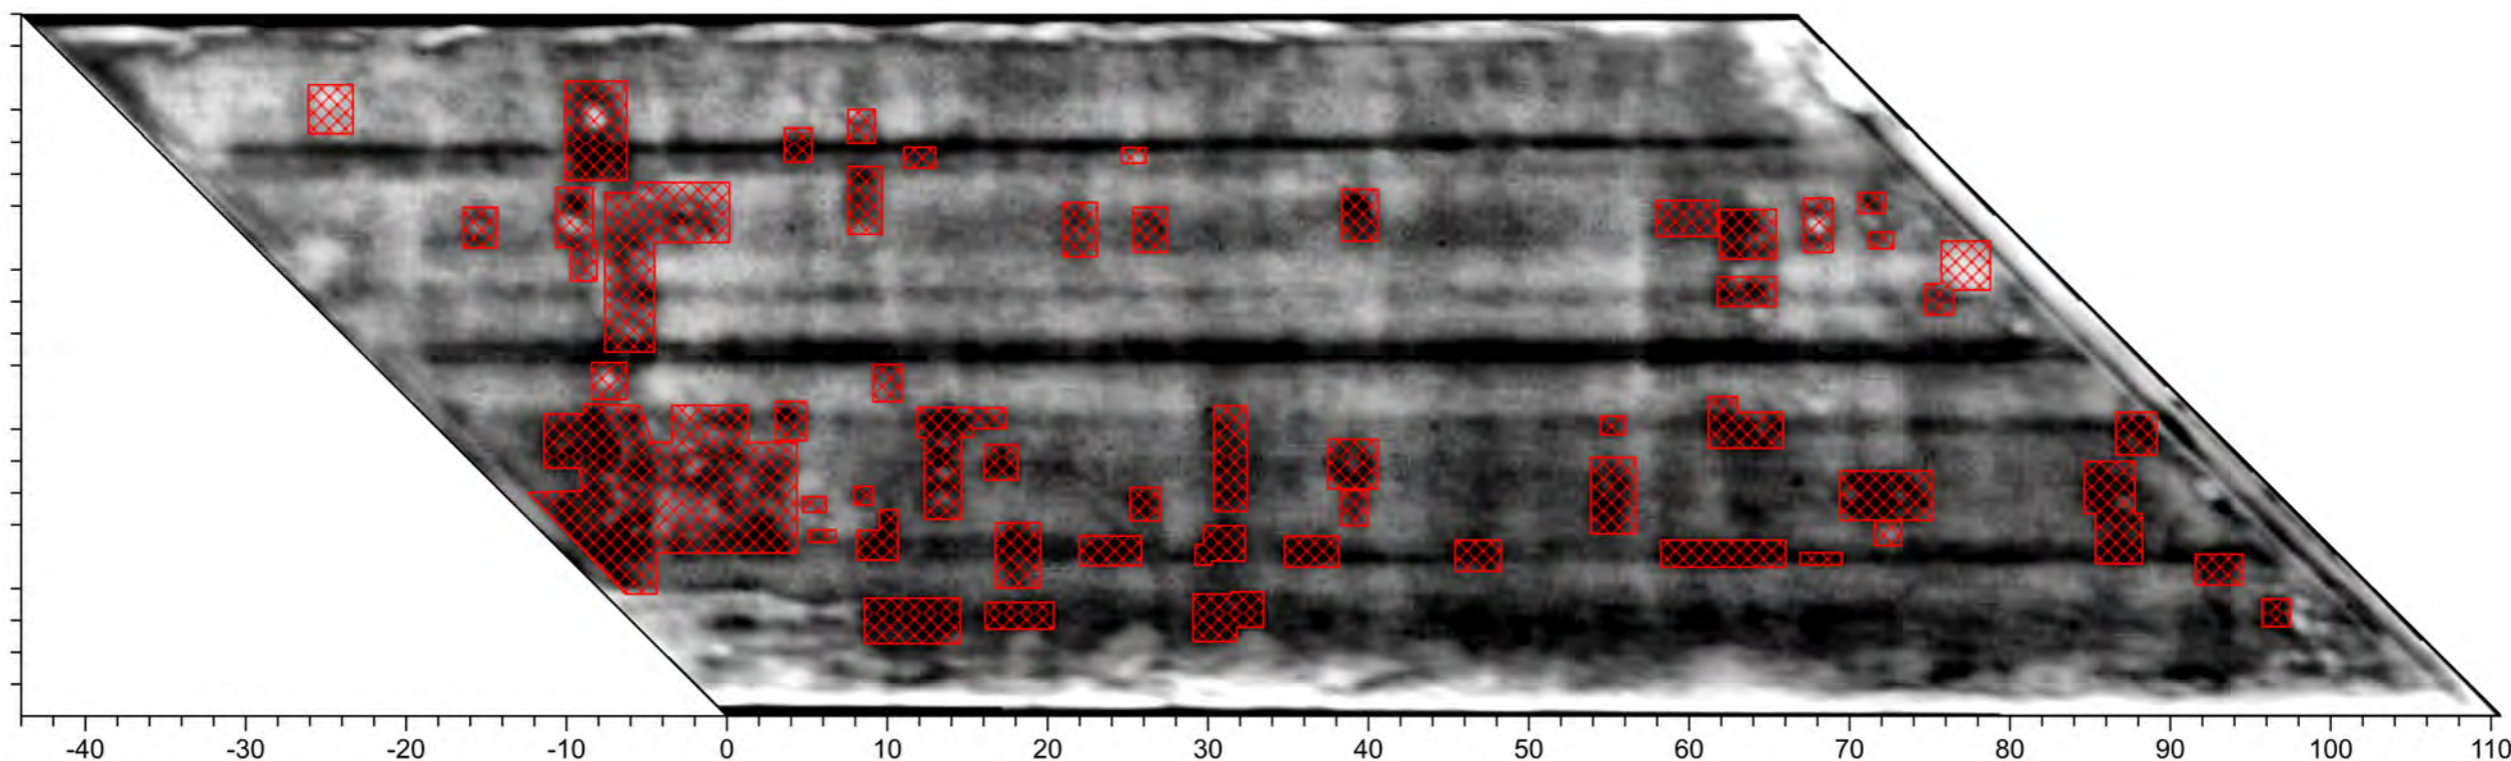
Delamination Quantity (%) 0.4		Imagery Collected: 6/5/22 Analyzed by: SB Reviewed by: AJC Completed: 10/5/22	
			Delamination Quantity (ft ²) 47

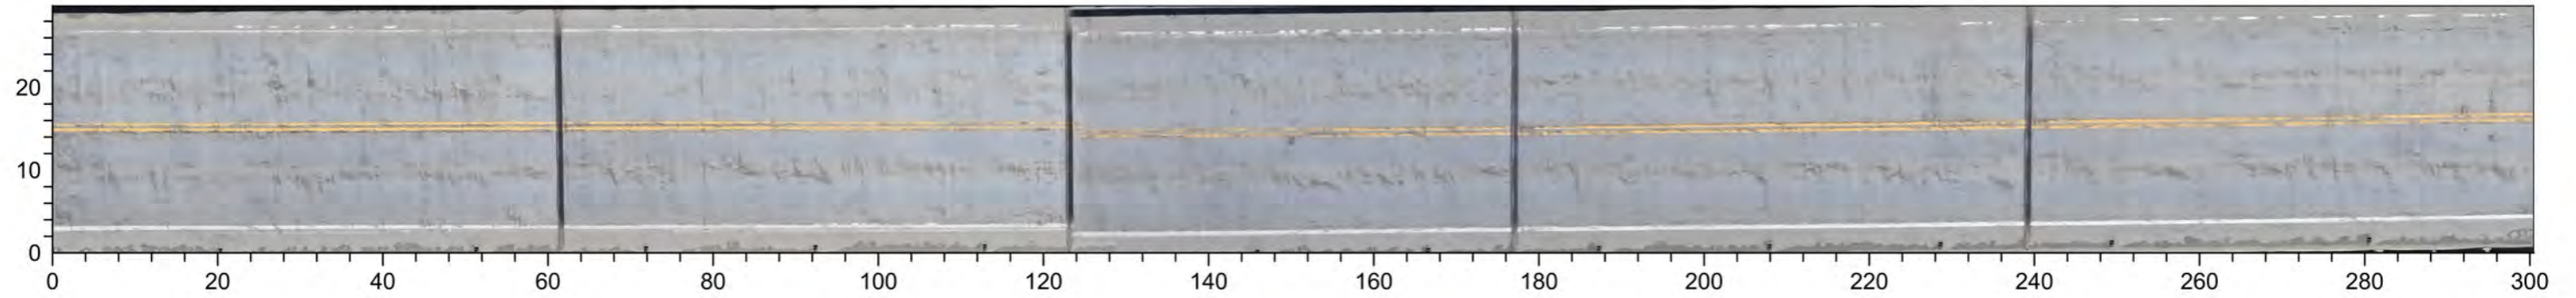
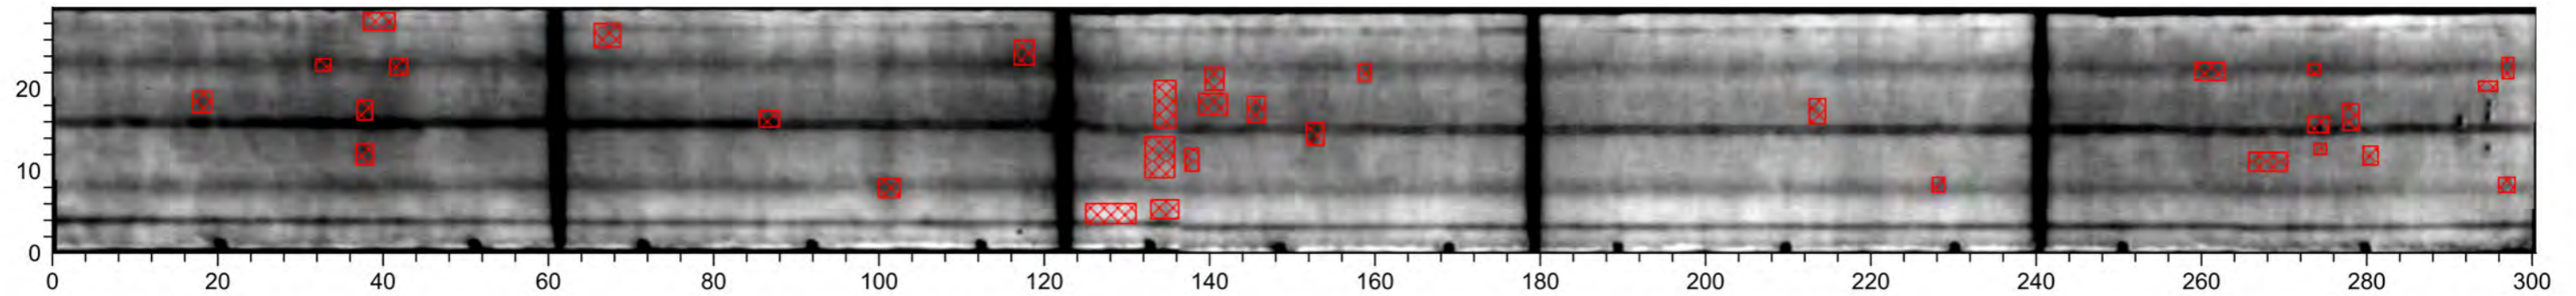
Delamination Quantity (%) 3.8		Imagery Collected: 6/5/22 Analyzed by: SB Reviewed by: AJC Completed: 10/5/22	
			Delamination Quantity (ft ²) 97

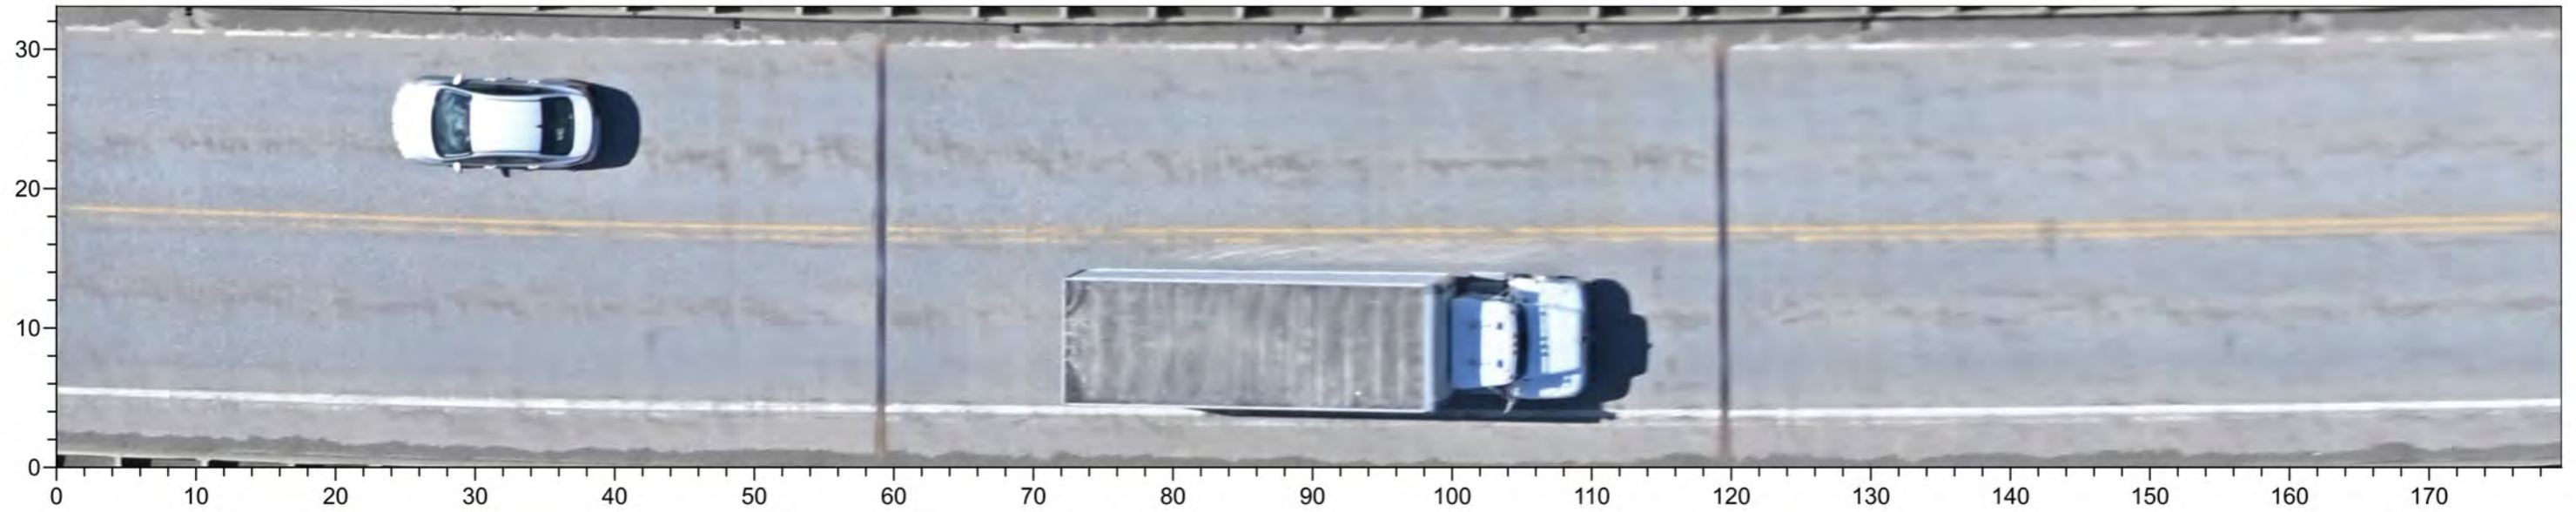
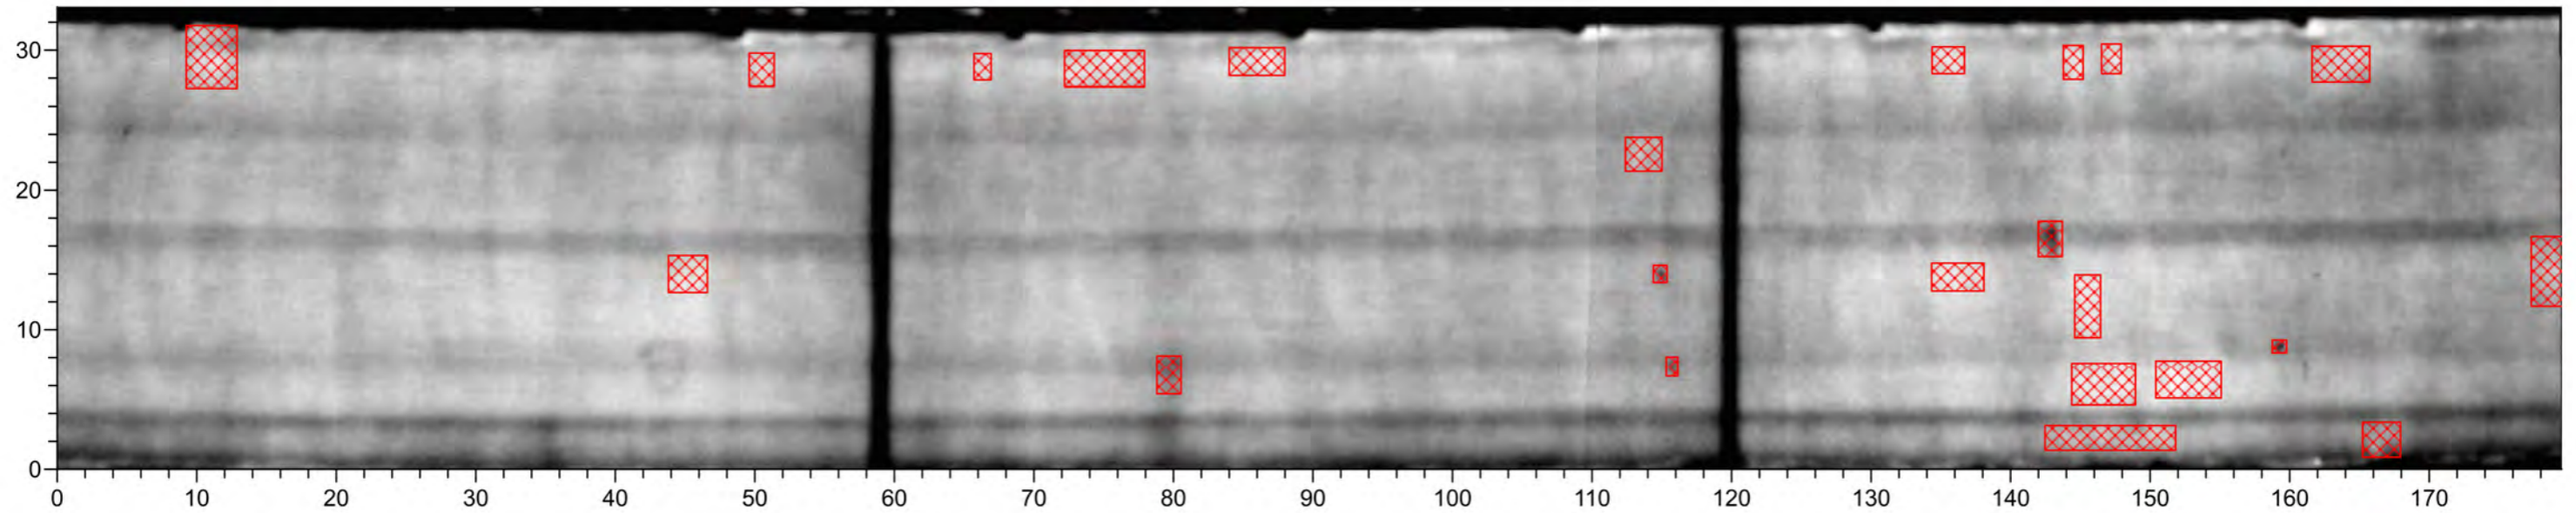
Delamination Quantity (%) 2.3	Delamination Quantity (ft ²) 207	Imagery Collected: 6/5/22 Analyzed by: EG, SB Reviewed by: AJC Completed: 10/9/22

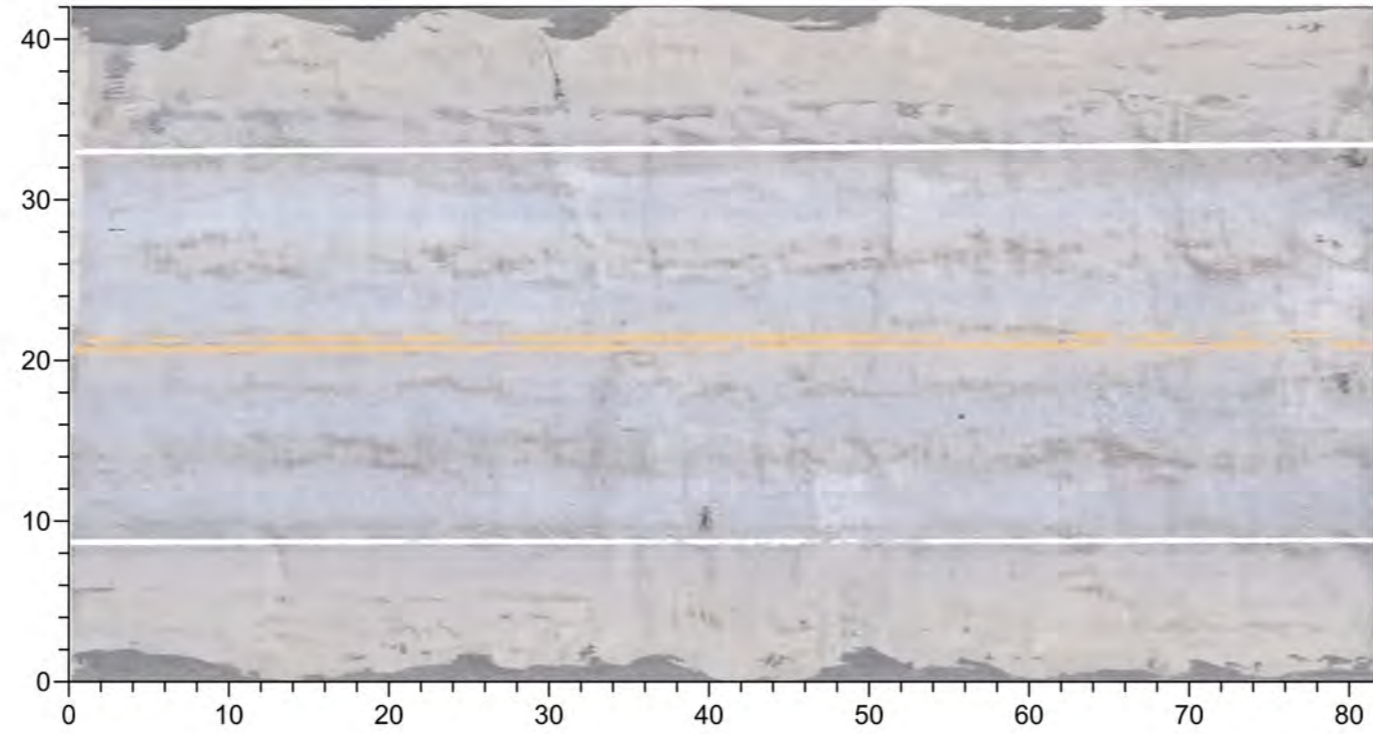
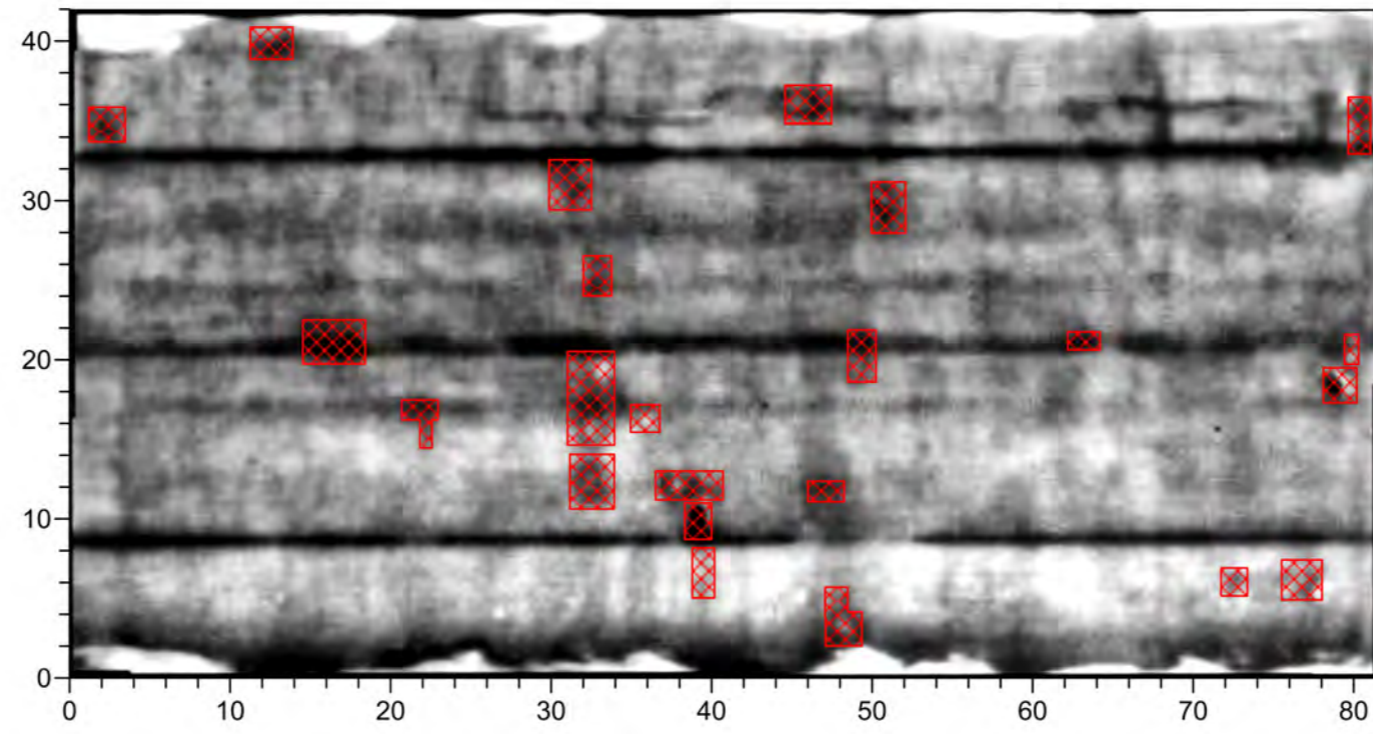
Delamination Quantity (%) 2.6 Delamination Quantity (ft ²) 157	Imagery Collected: 6/5/22 Analyzed by: SB Reviewed by: AJC Completed: 10/5/22

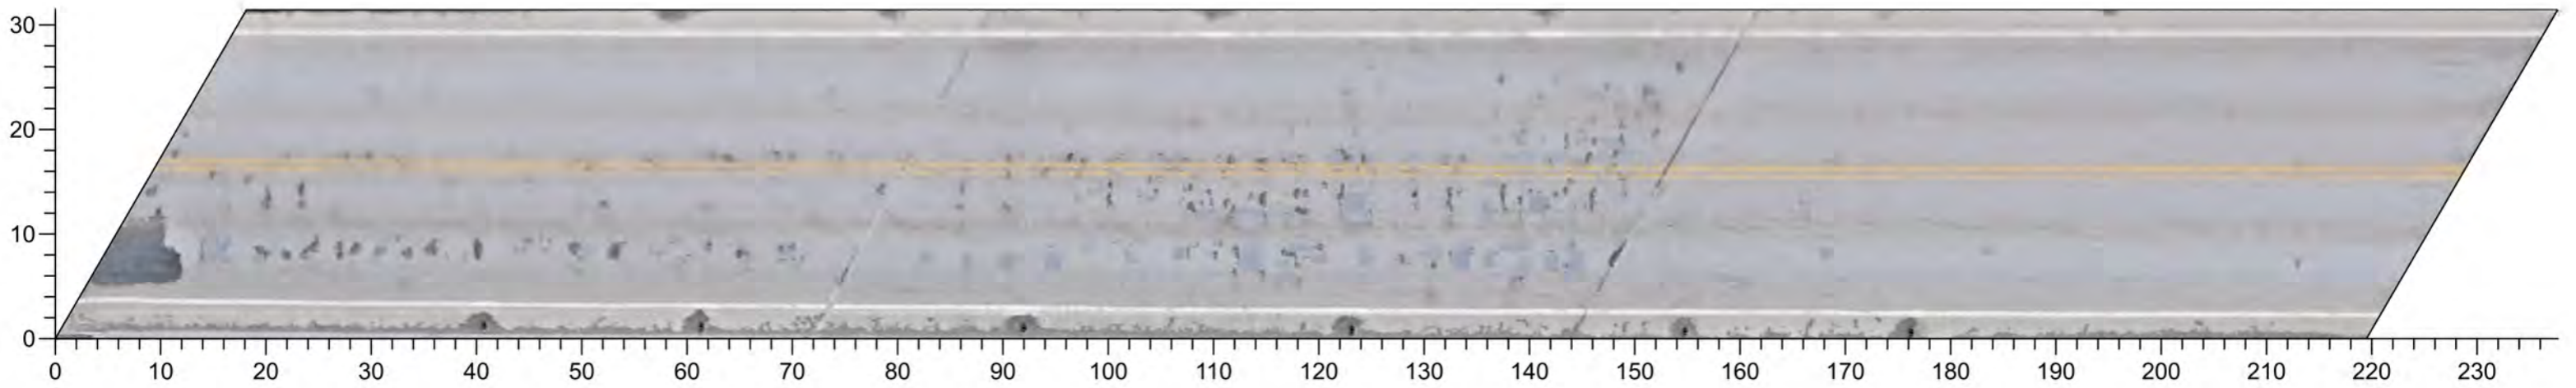
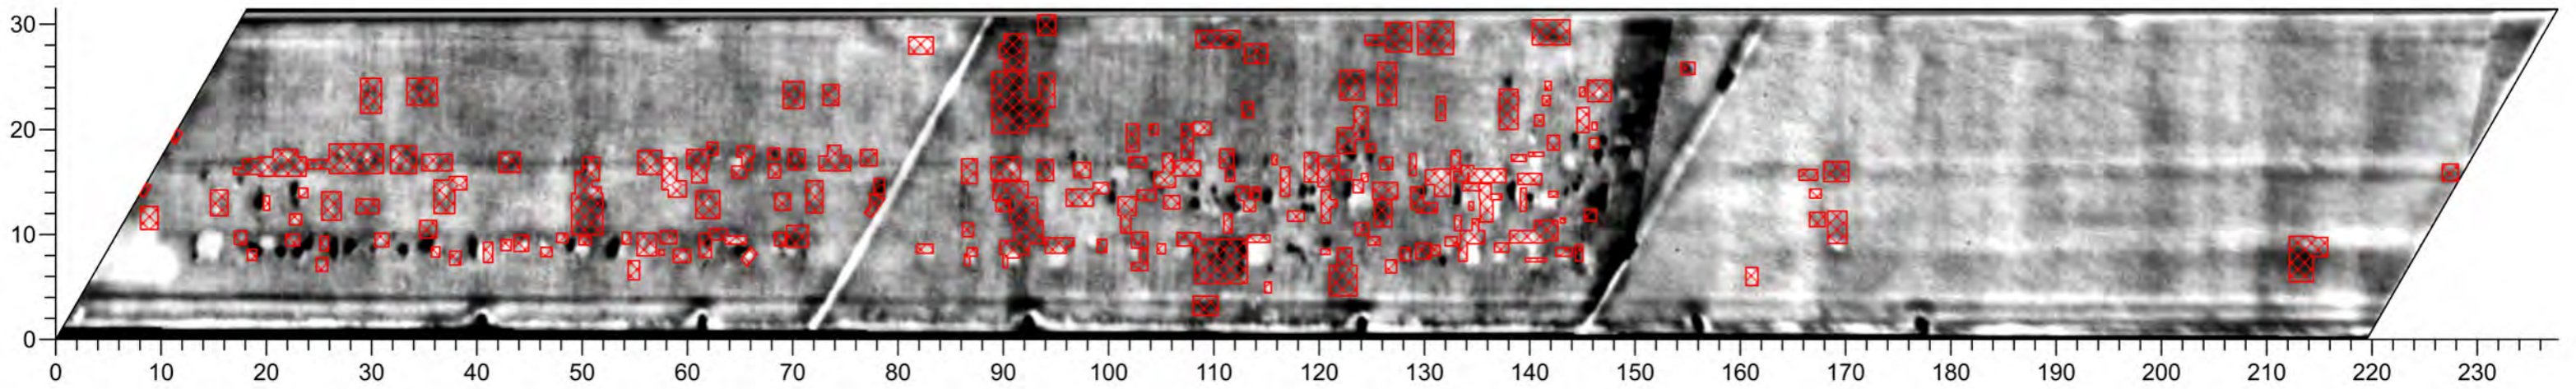
Delamination Quantity (%) 4.0		Imagery Collected: 6/5/22 Analyzed by: EG, SB Reviewed by: AJC Completed: 10/9/22	
			Delamination Quantity (ft ²) 136

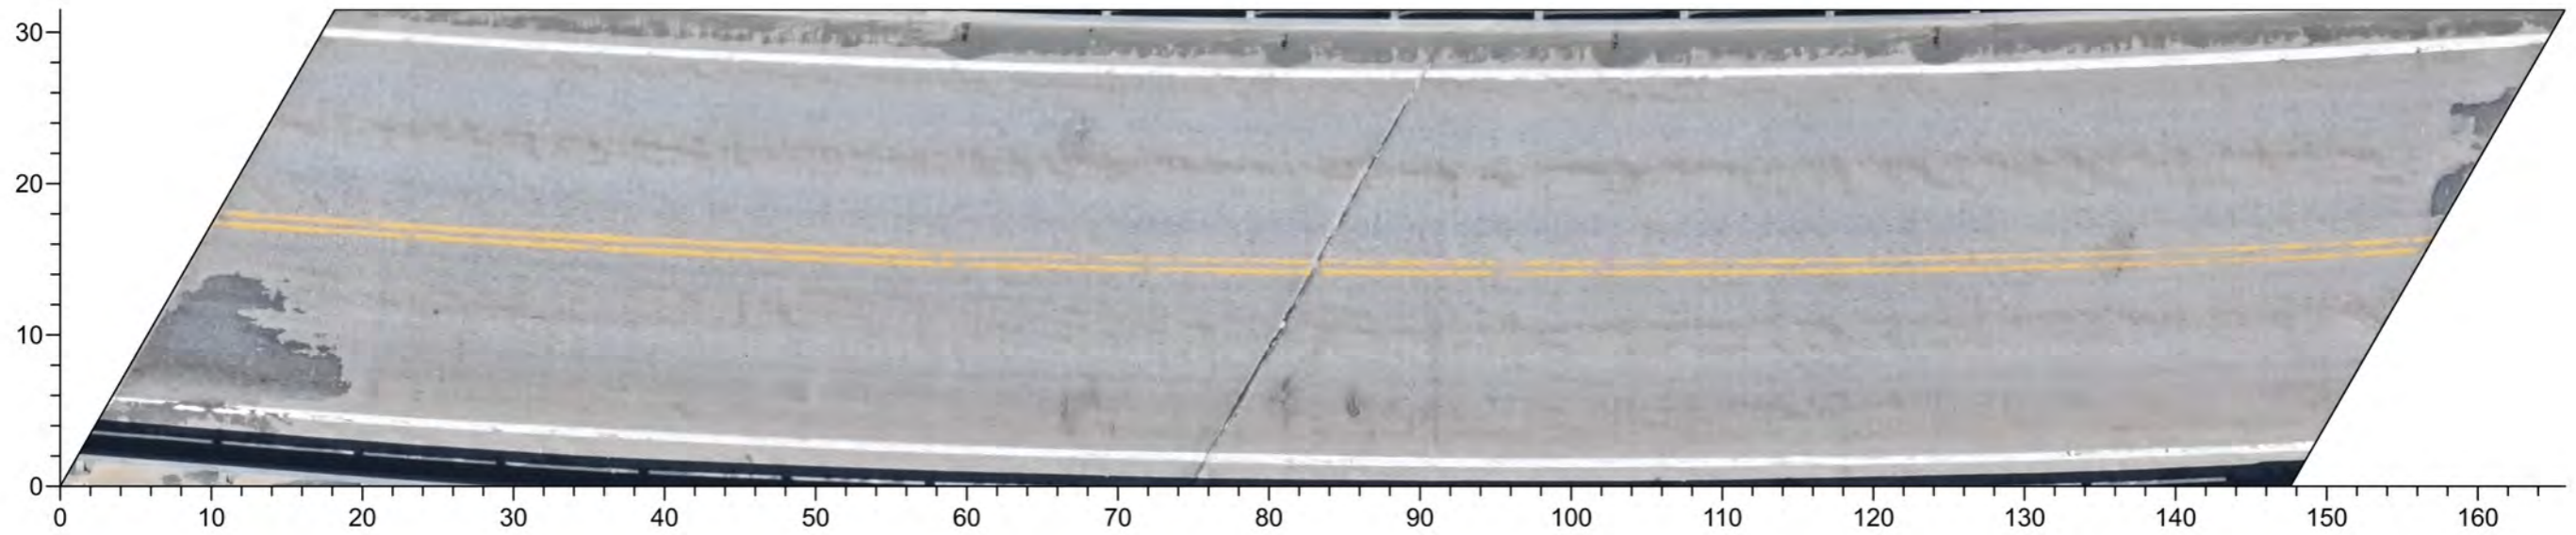
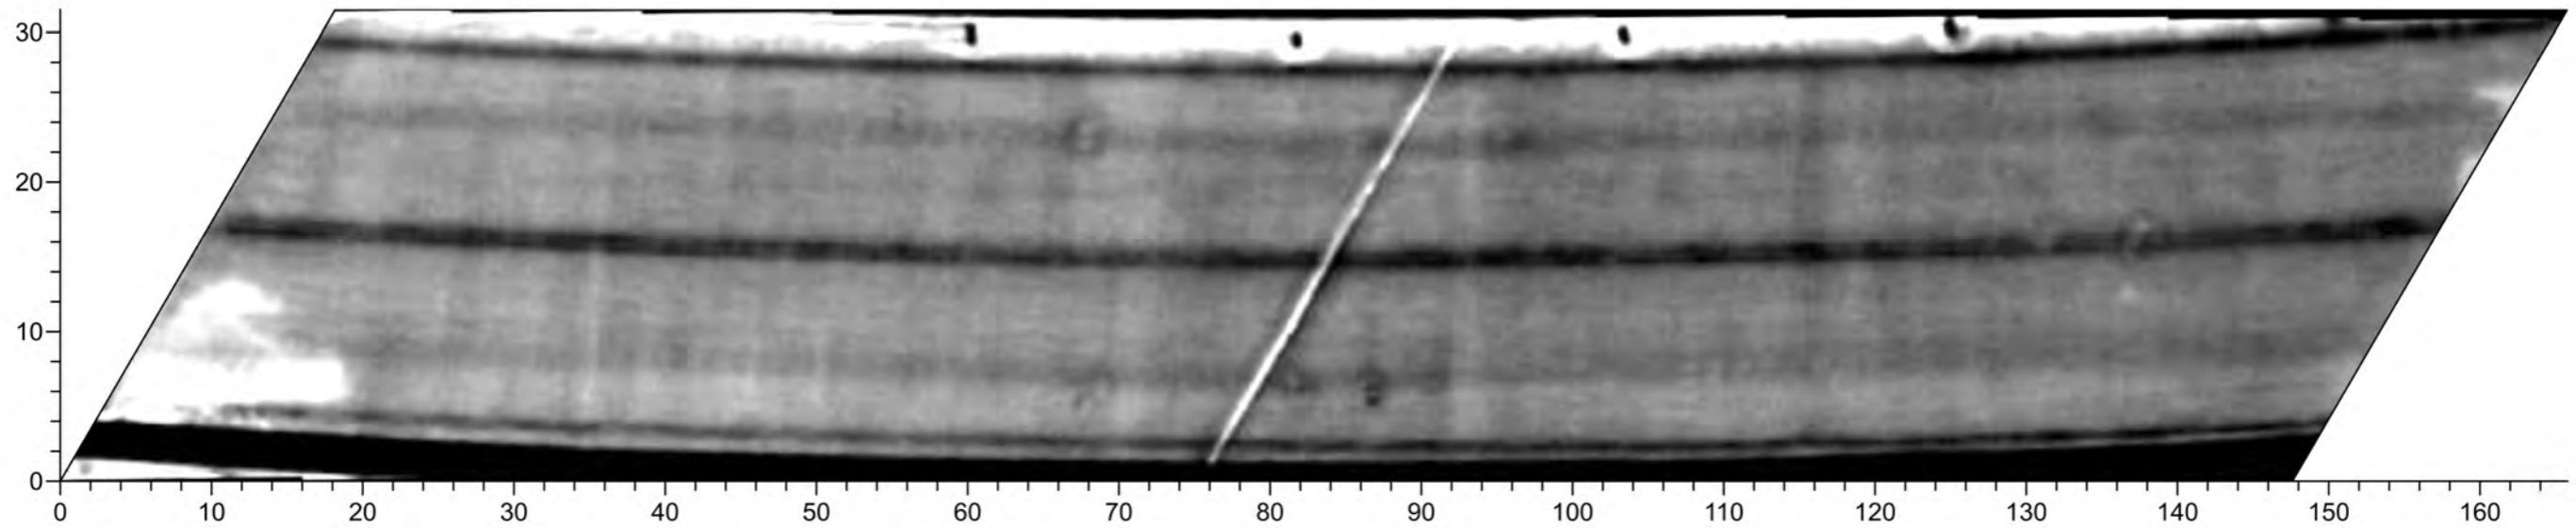
Delamination Quantity (%) 8.5		Imagery Collected: 6/5/22 Analyzed by: EG, SB Reviewed by: AJC Completed: 10/10/22	
			Delamination Quantity (ft ²) 591

Note: Delamination locations not shown as quantity is less than 2%.

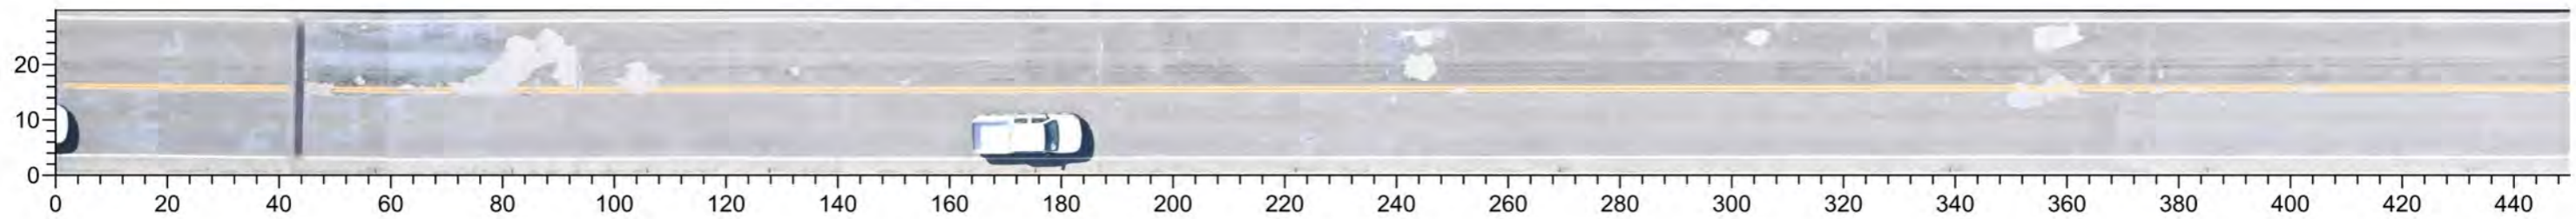
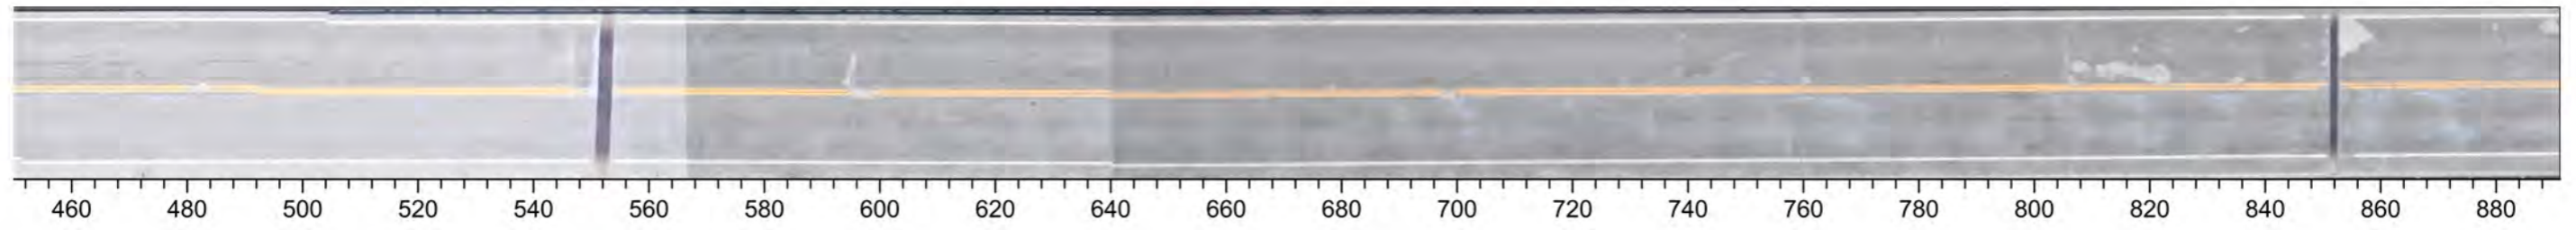
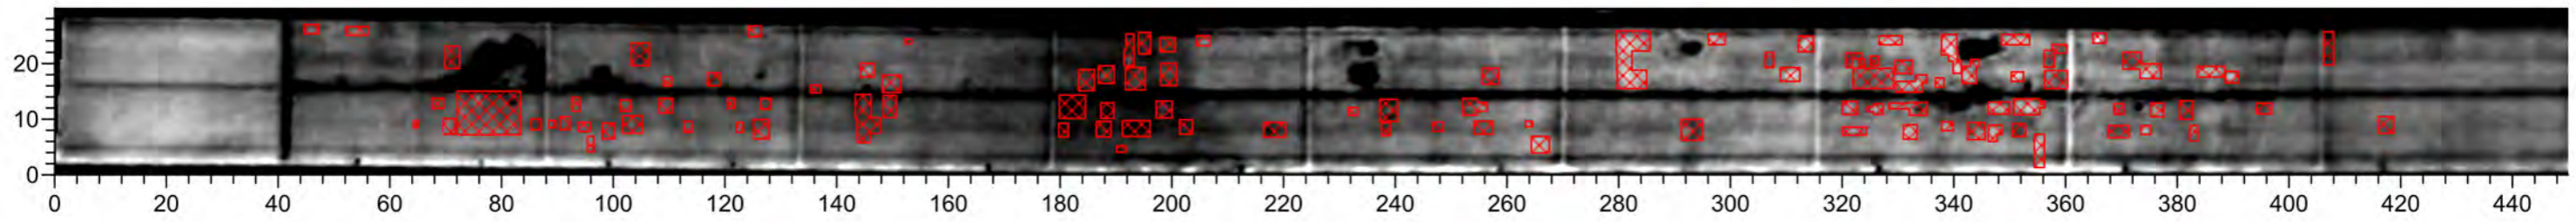
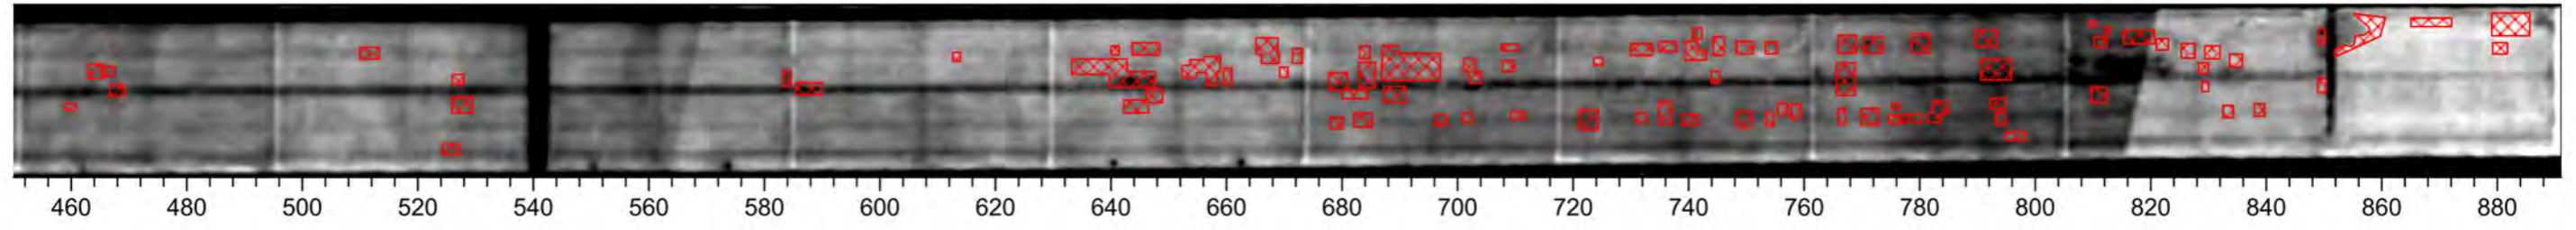
Delamination Quantity (%) 1.3		Imagery Collected: 6/5/22 Analyzed by: SB Reviewed by: AJC Completed: 10/10/22	
			Delamination Quantity (ft ²) 63

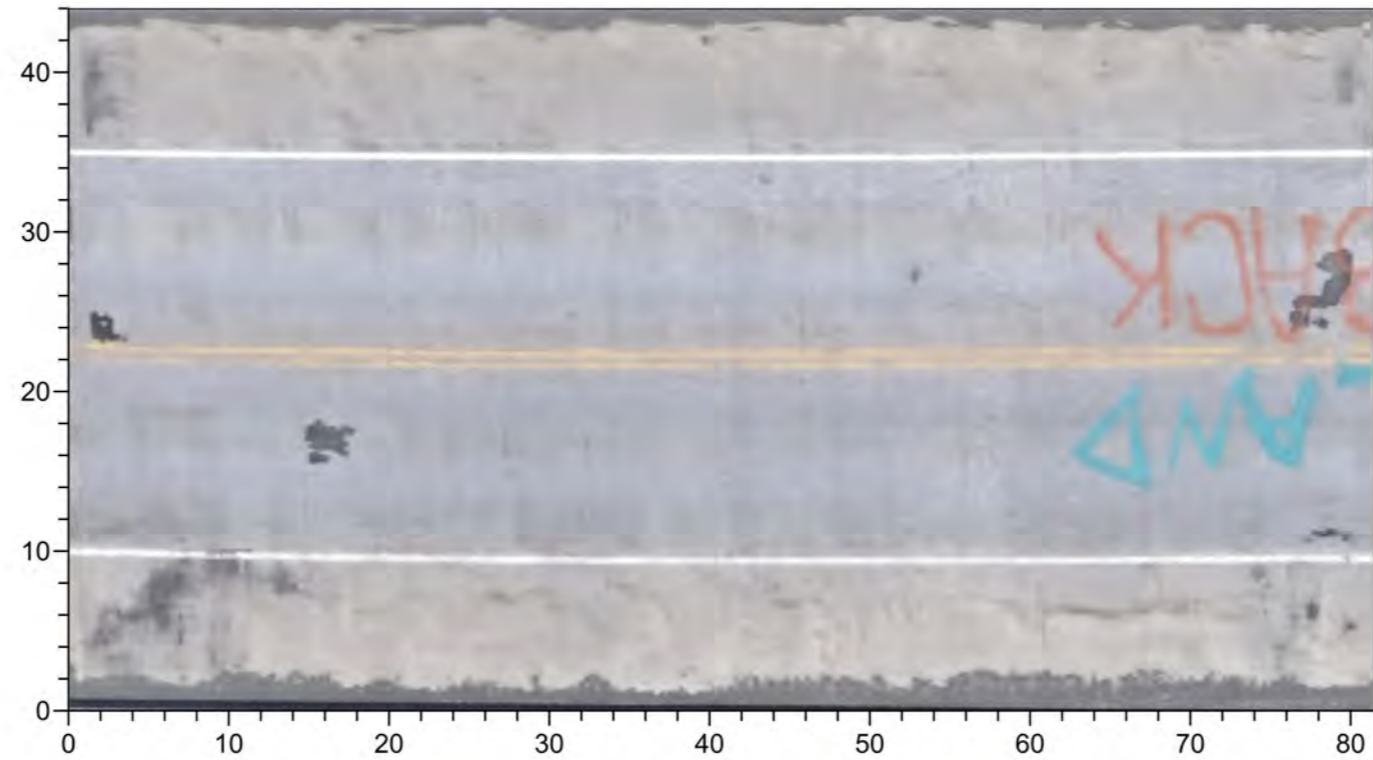
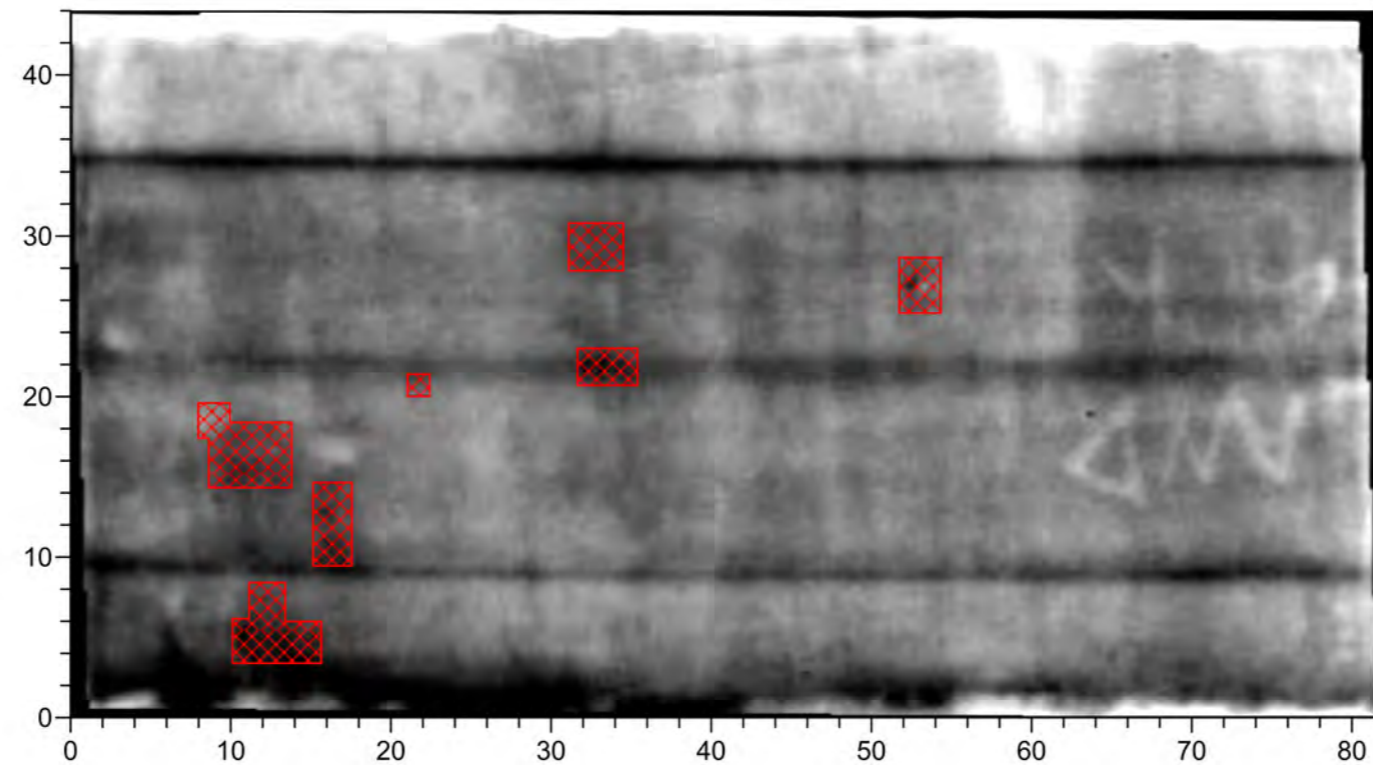
Delamination Quantity (%) 5.8 Delamination Quantity (ft ²) 1546	Imagery Collected: 6/5/22 Analyzed by: EG, SB Reviewed by: AJC Completed: 10/10/22
