Aerial Infrared Scanning of Bridge Decks on Parks Highway to Map Delaminations

FINAL REPORT

Prepared by:
Infrasense, Inc.
Woburn, MA

Report # FHWA-AK-RD-000S(960)
March 2, 2023

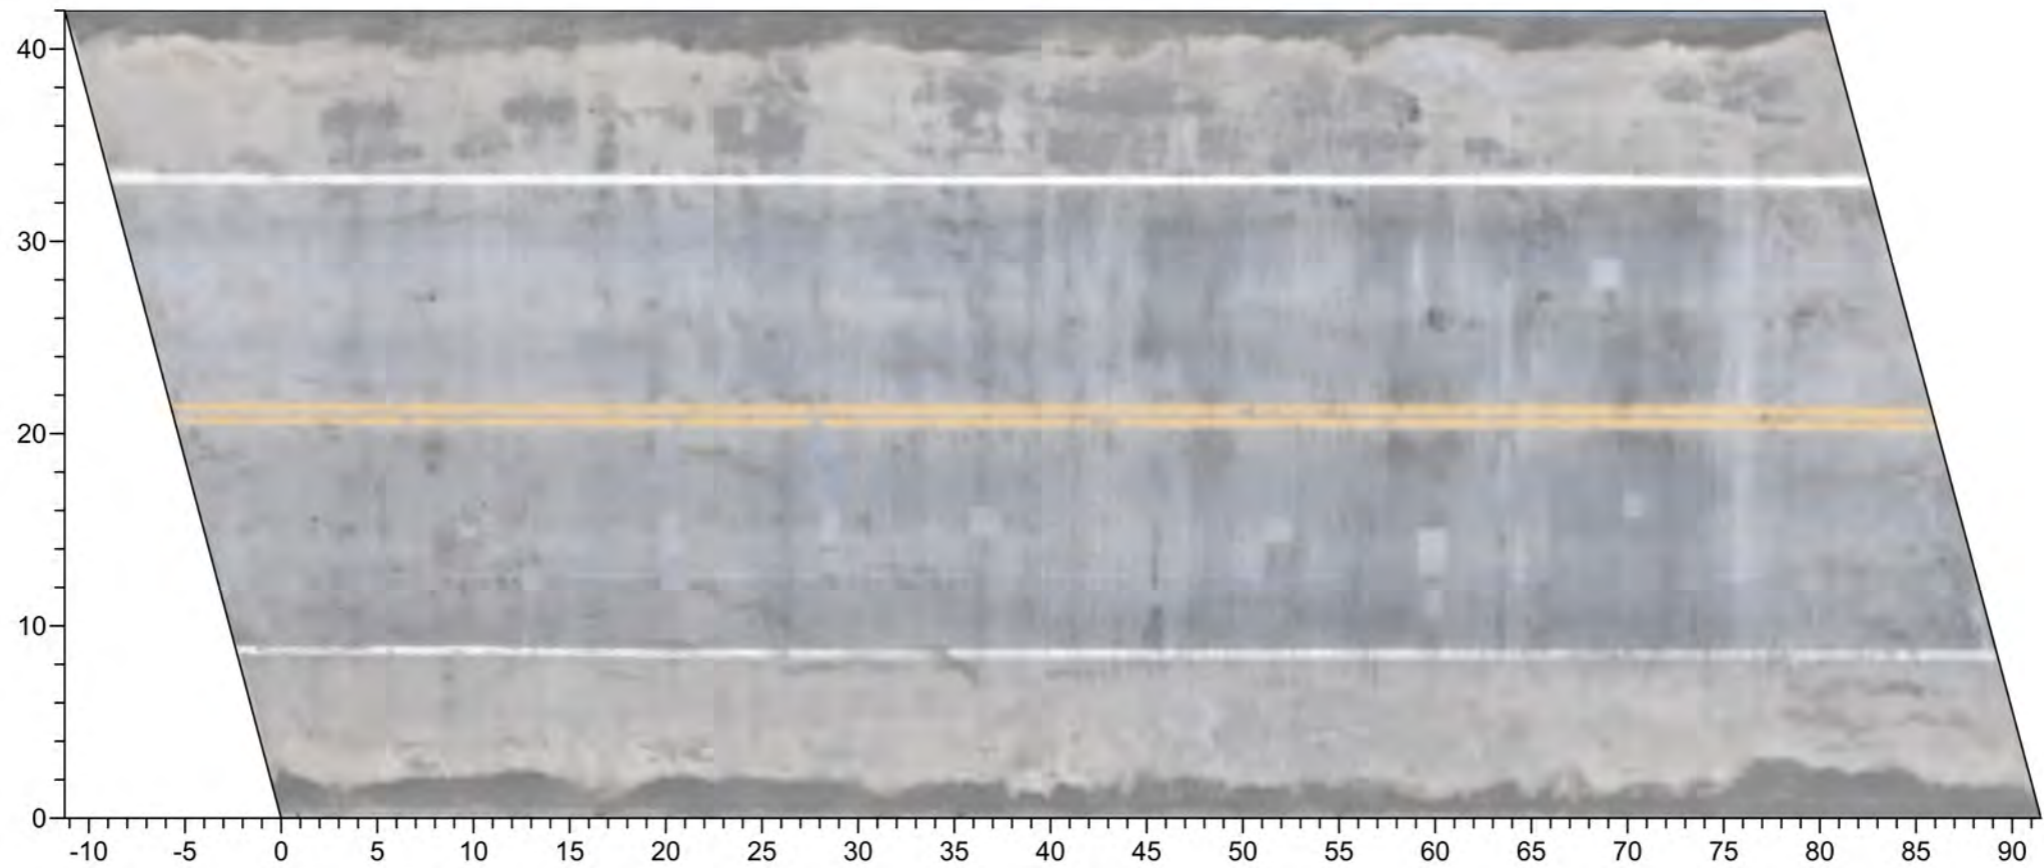
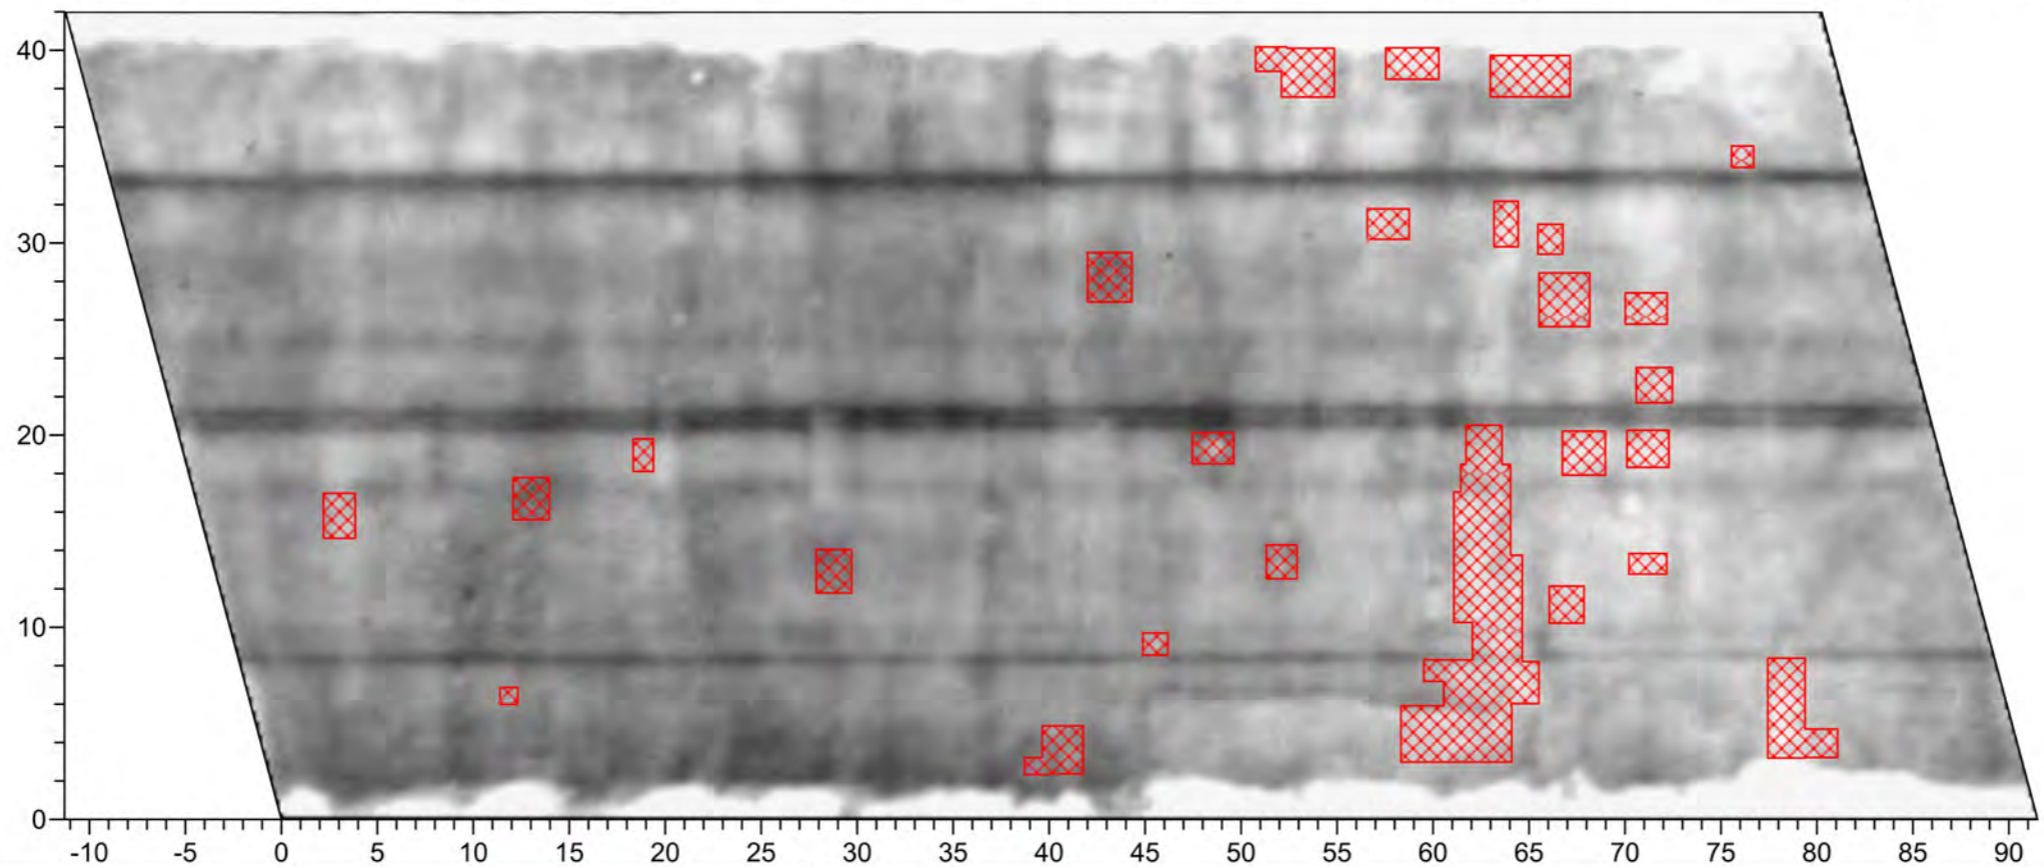
Delamination Quantity (%) 2.4		Imagery Collected: 6/5/22 Analyzed by: EG, SB Reviewed by: AJC Completed: 10/10/22	
			Delamination Quantity (ft ²) 87

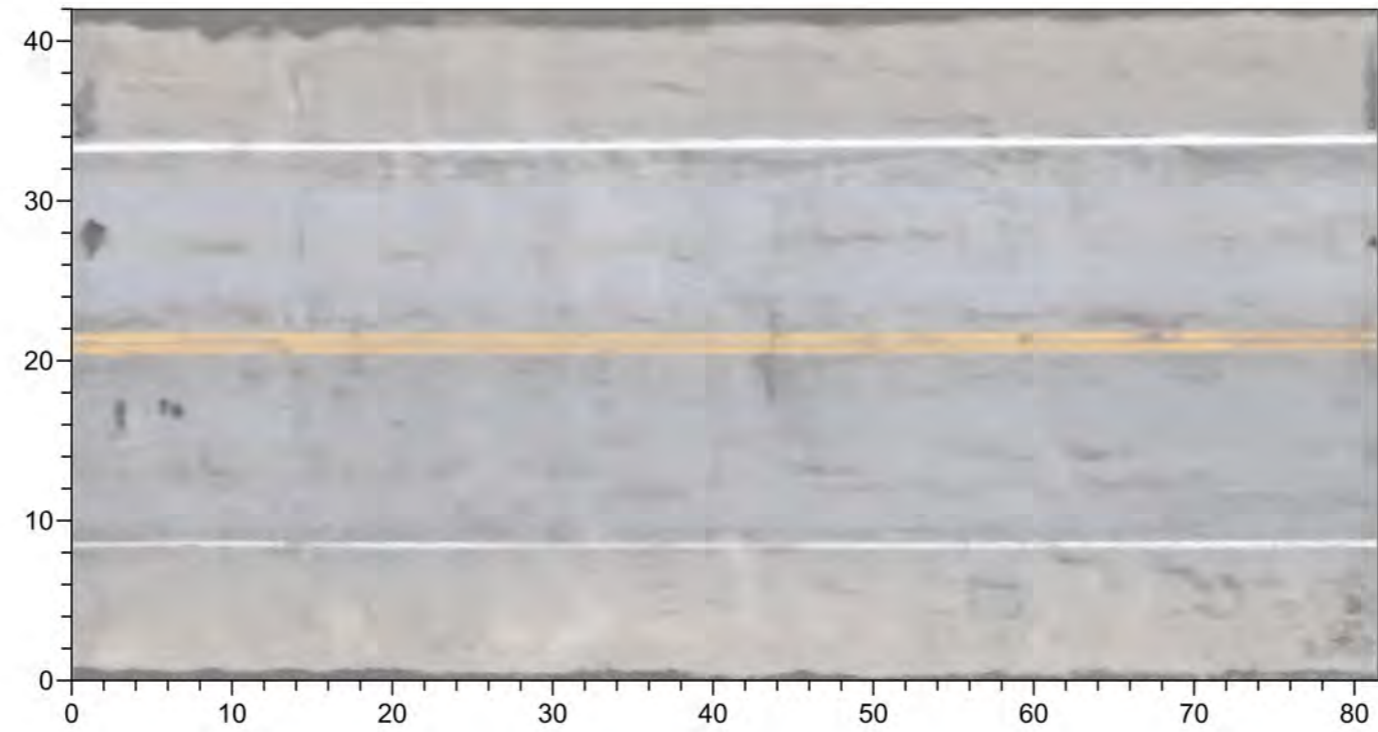
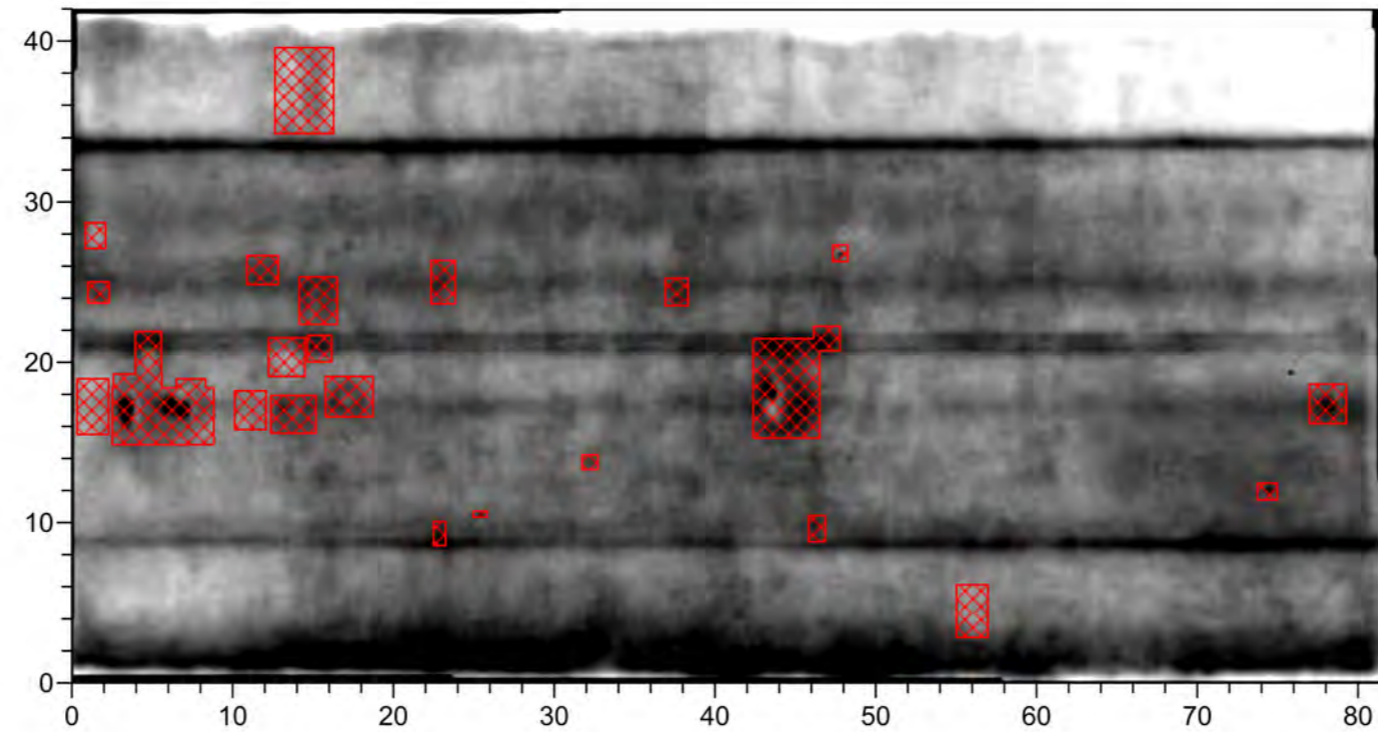
Delamination Quantity (%) 4.5		Imagery Collected: 6/5/22 Analyzed by: SB Reviewed by: AJC Completed: 10/10/22	
		Delamination Quantity (ft ²) 173

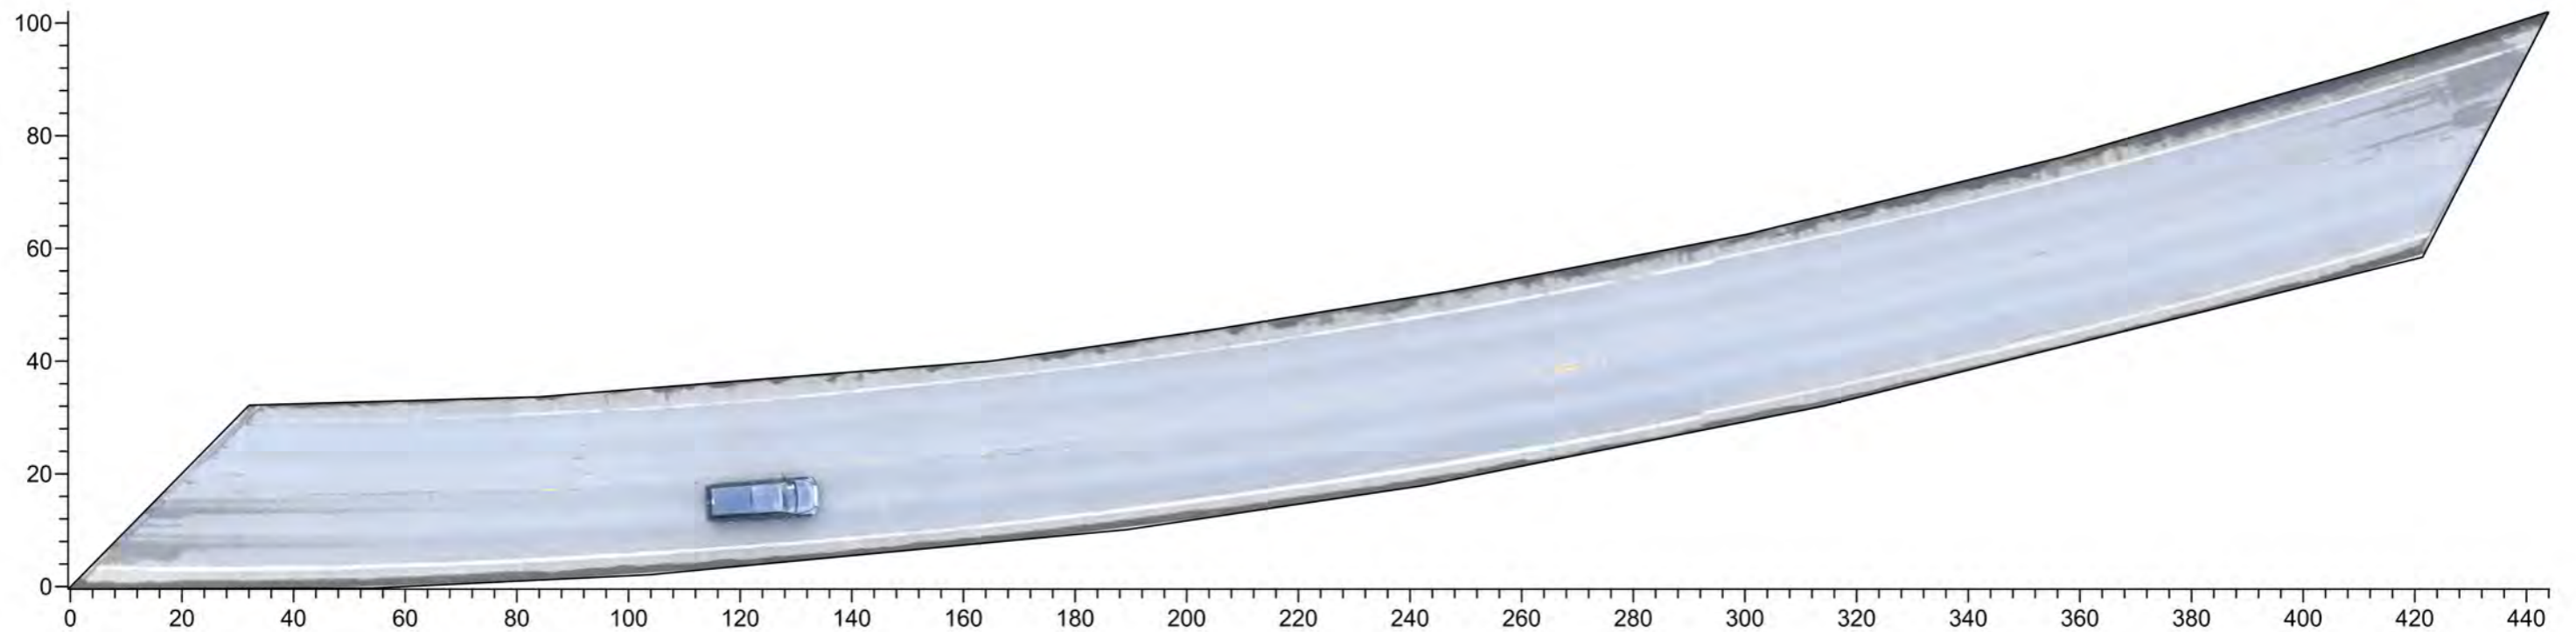
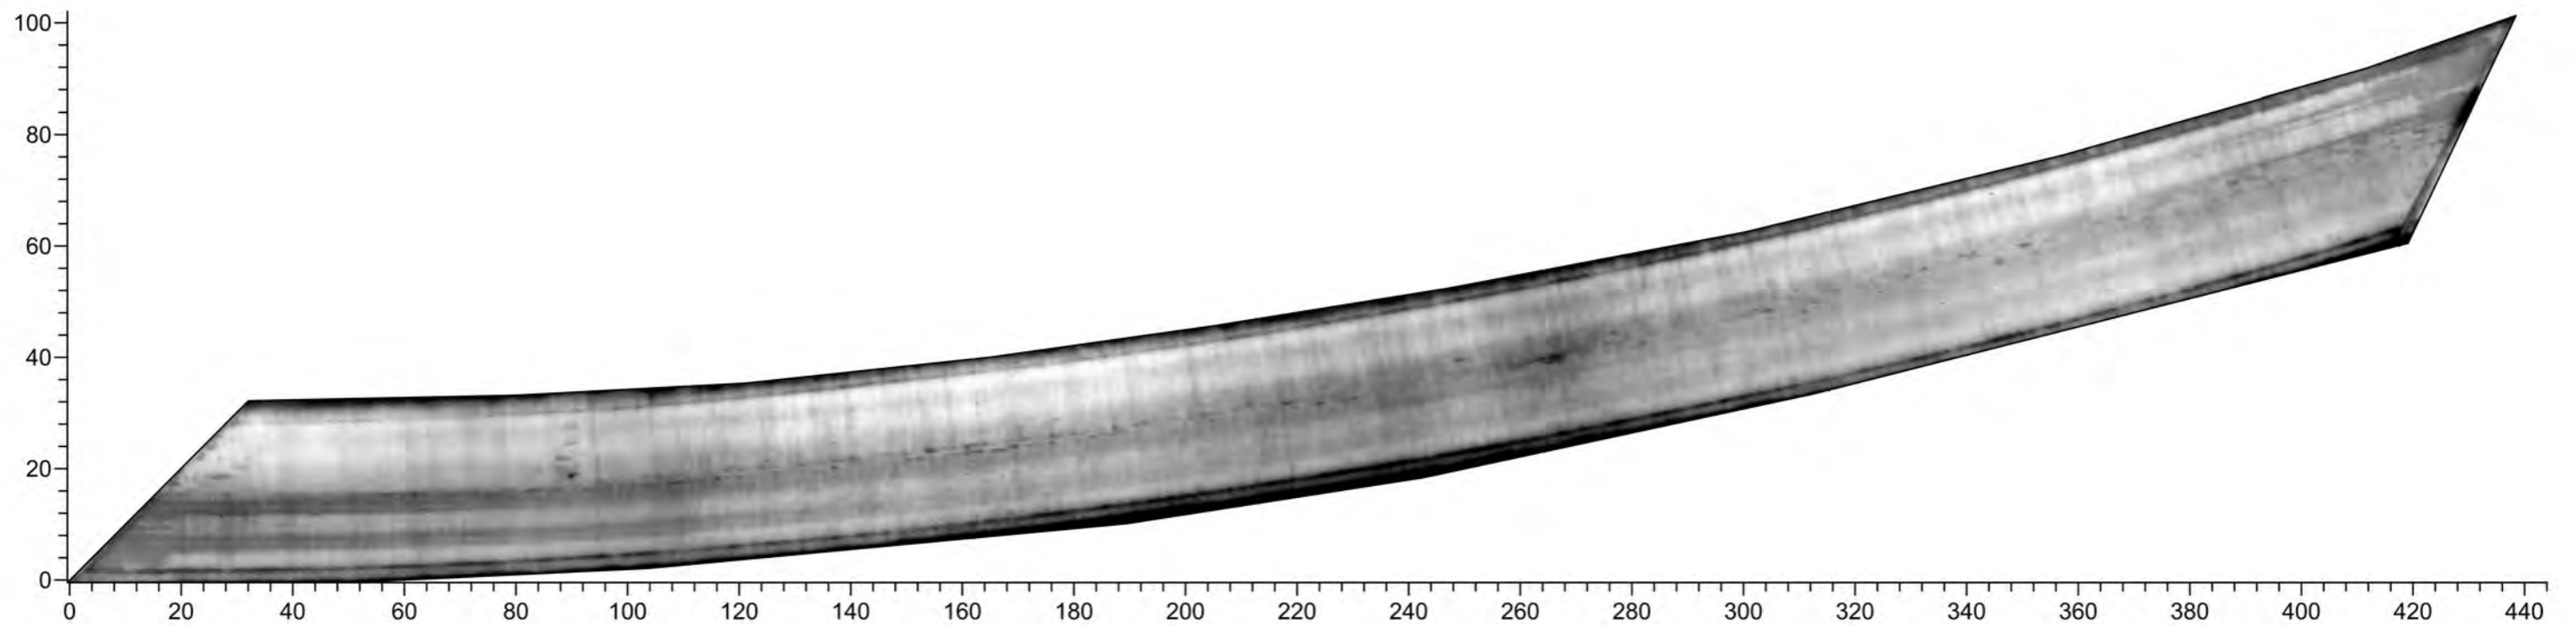
Delamination Quantity (%) 1.3 Delamination Quantity (ft ²) 251	Imagery Collected: 6/5/22 Analyzed by: SB Reviewed by: AJC Completed: 10/10/22

Note: Delamination locations not shown as quantity is less than 2%.

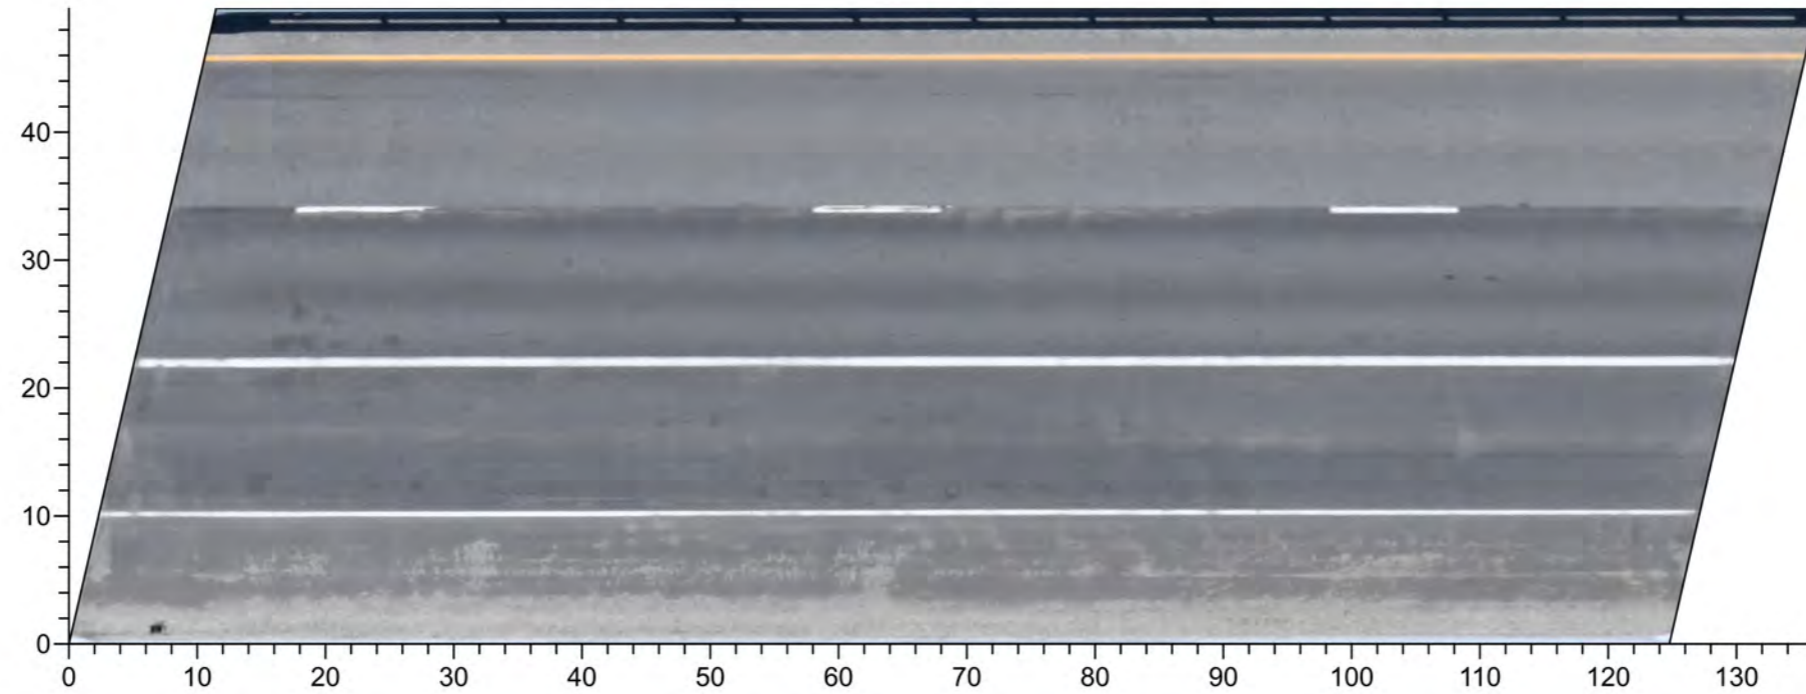
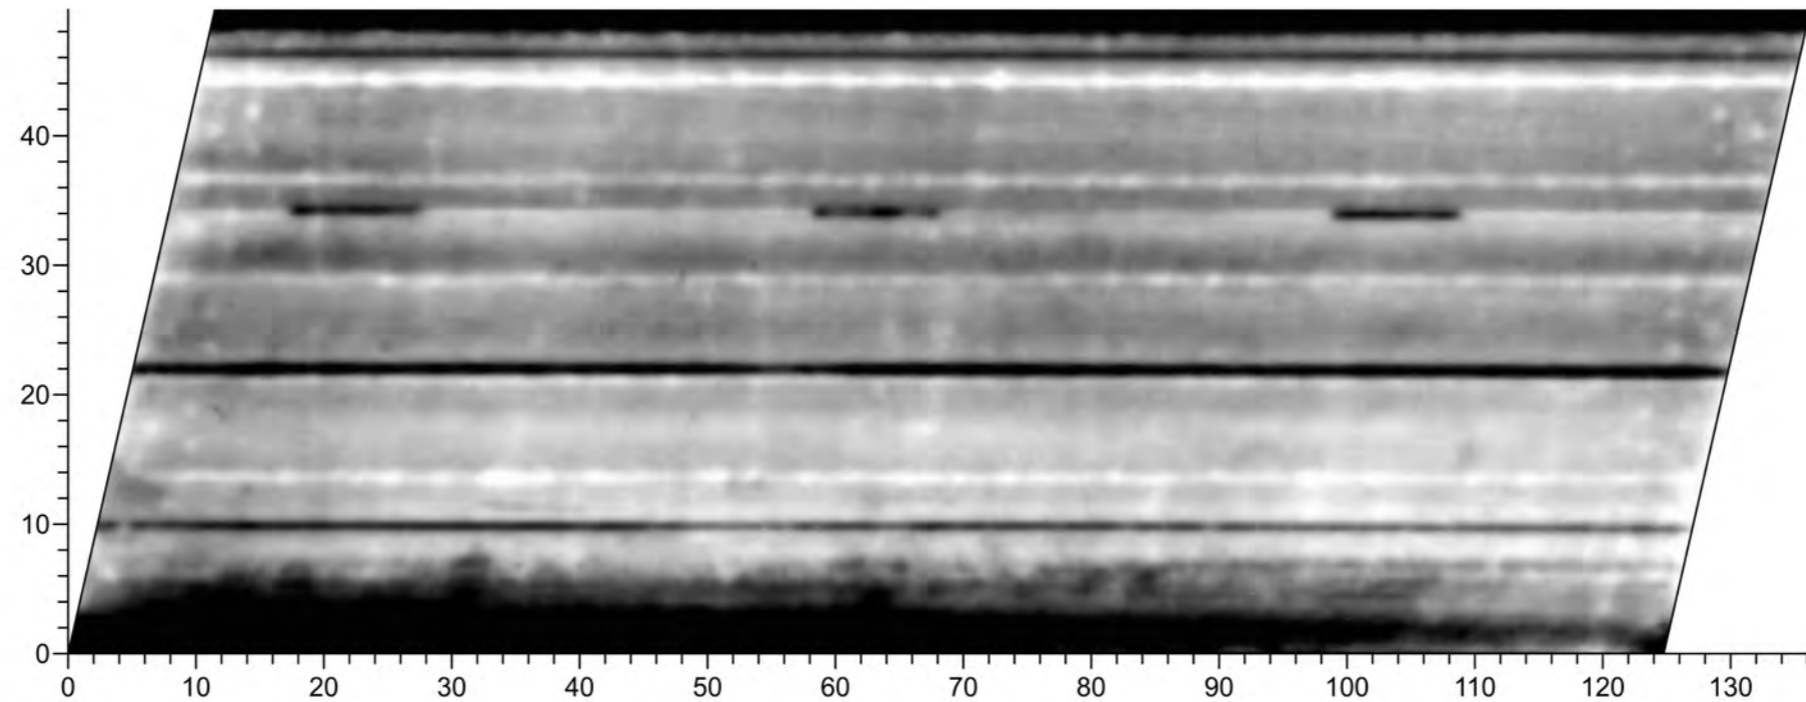
Delamination Quantity (%) 0.2		Imagery Collected: 6/5/22 Analyzed by: SB Reviewed by: AJC Completed: 10/10/22	
		Delamination Quantity (ft ²) 29

Note: Delamination locations not shown as quantity is less than 2%.

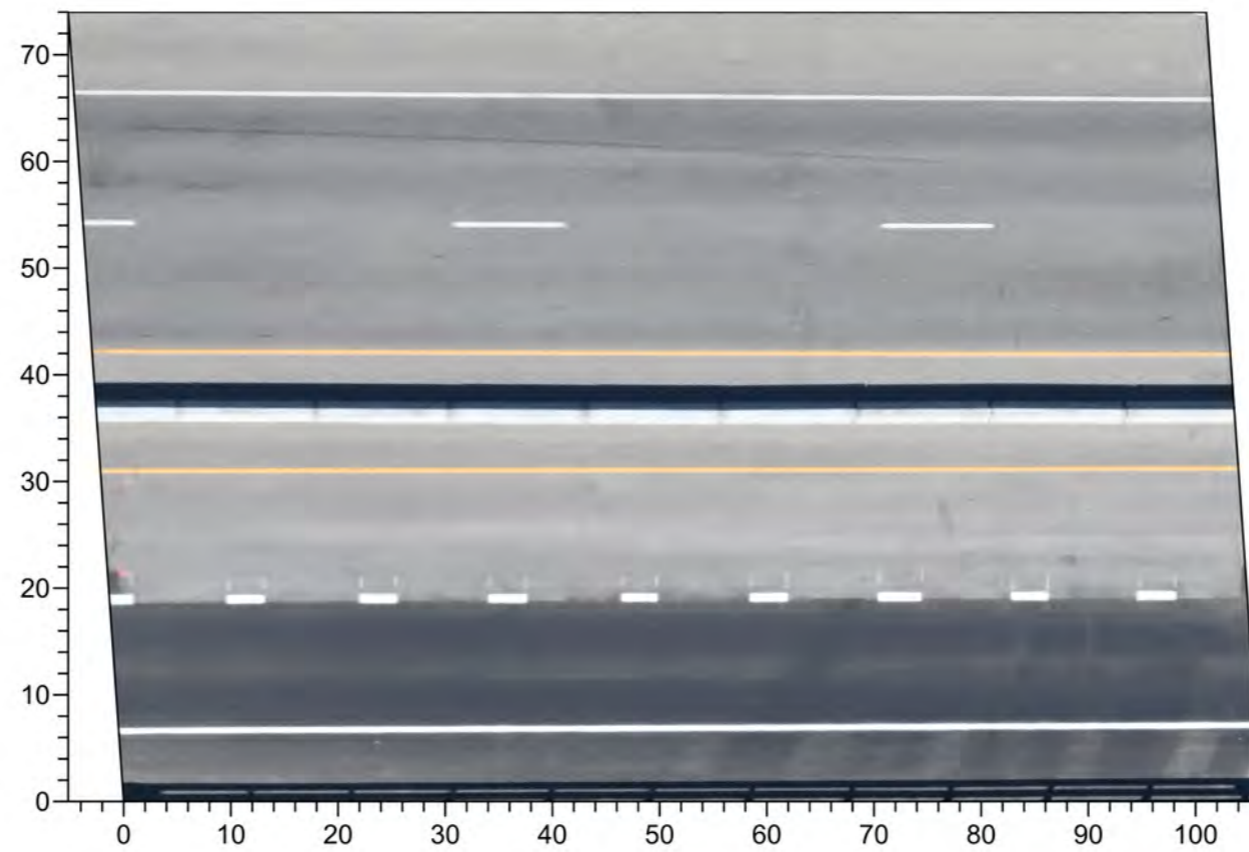
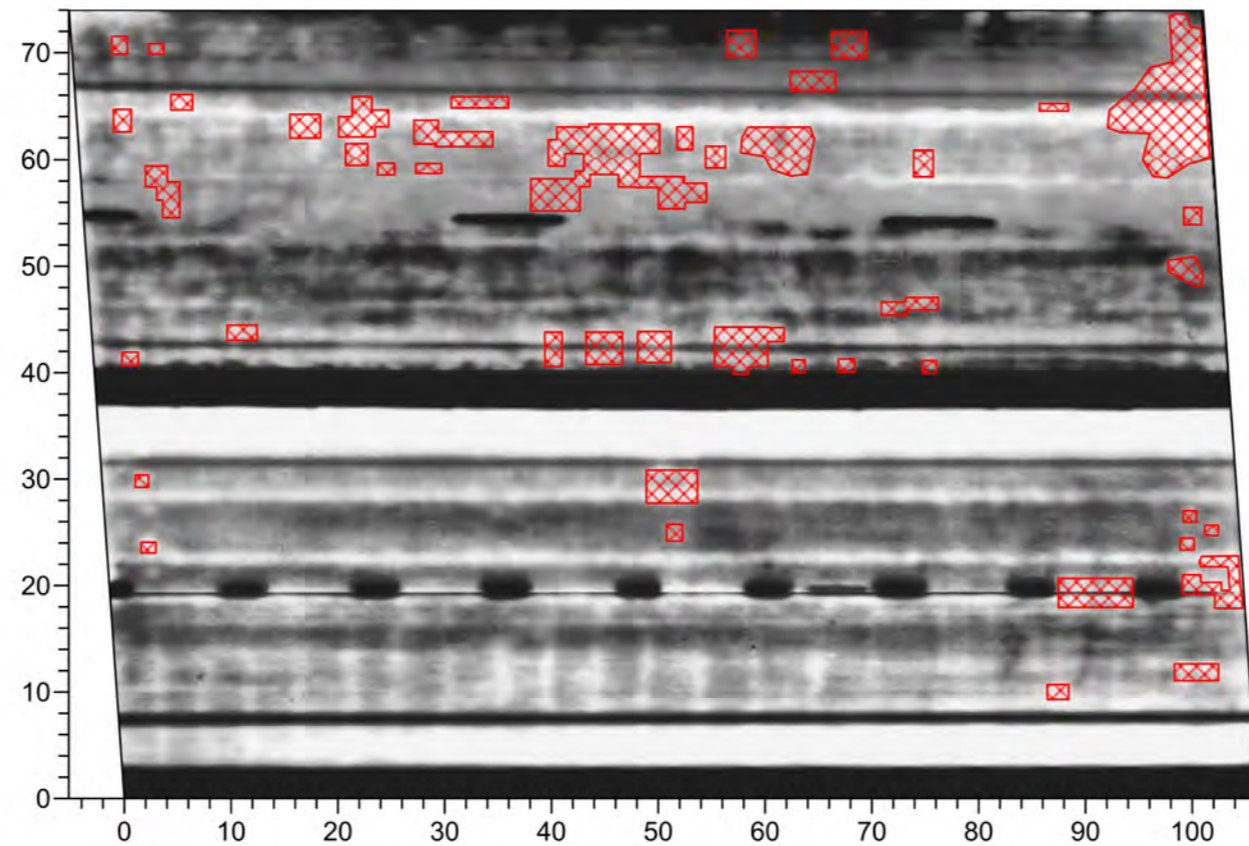
Delamination Quantity (%) 1.5		Imagery Collected: 6/5/22 Analyzed by: SB Reviewed by: AJC Completed: 10/10/22	
			Delamination Quantity (ft ²) 95

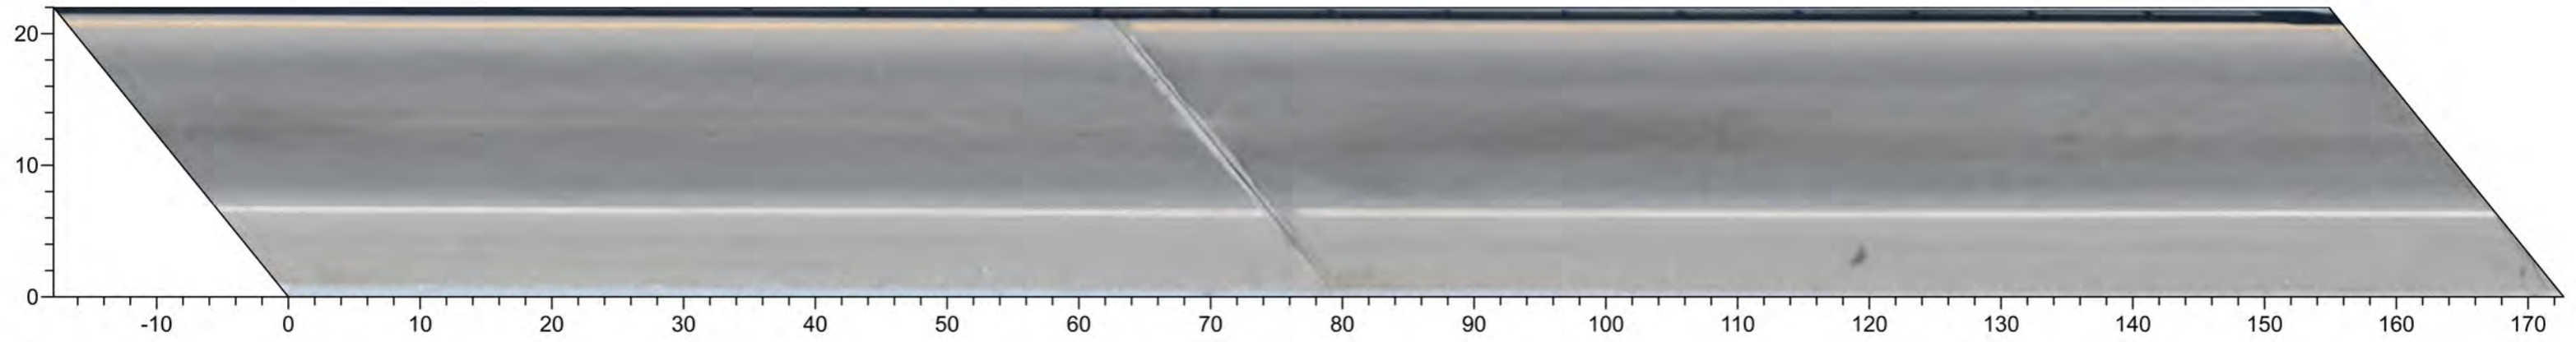
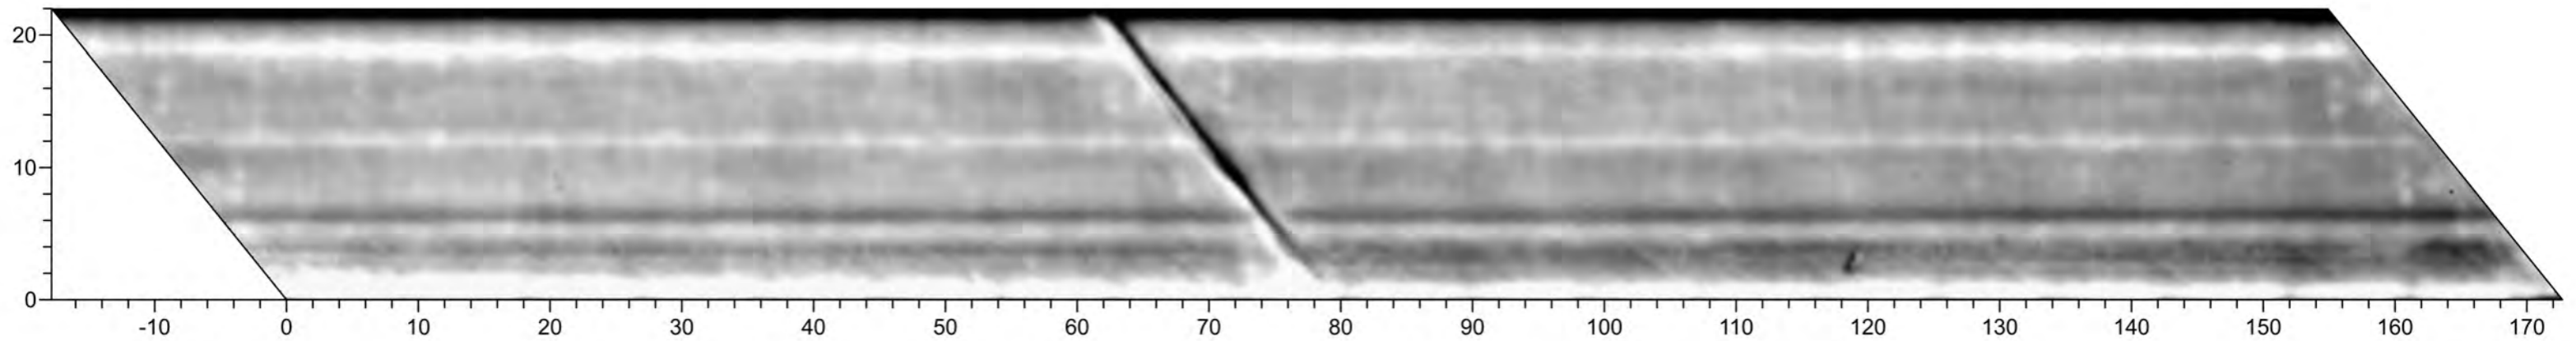
Delamination Quantity (%) 5.3		Imagery Collected: 6/5/22 Analyzed by: SB Reviewed by: AJC Completed: 10/10/22	
			Delamination Quantity (ft ²) 414

Note: Delamination locations not shown as quantity is less than 2%.

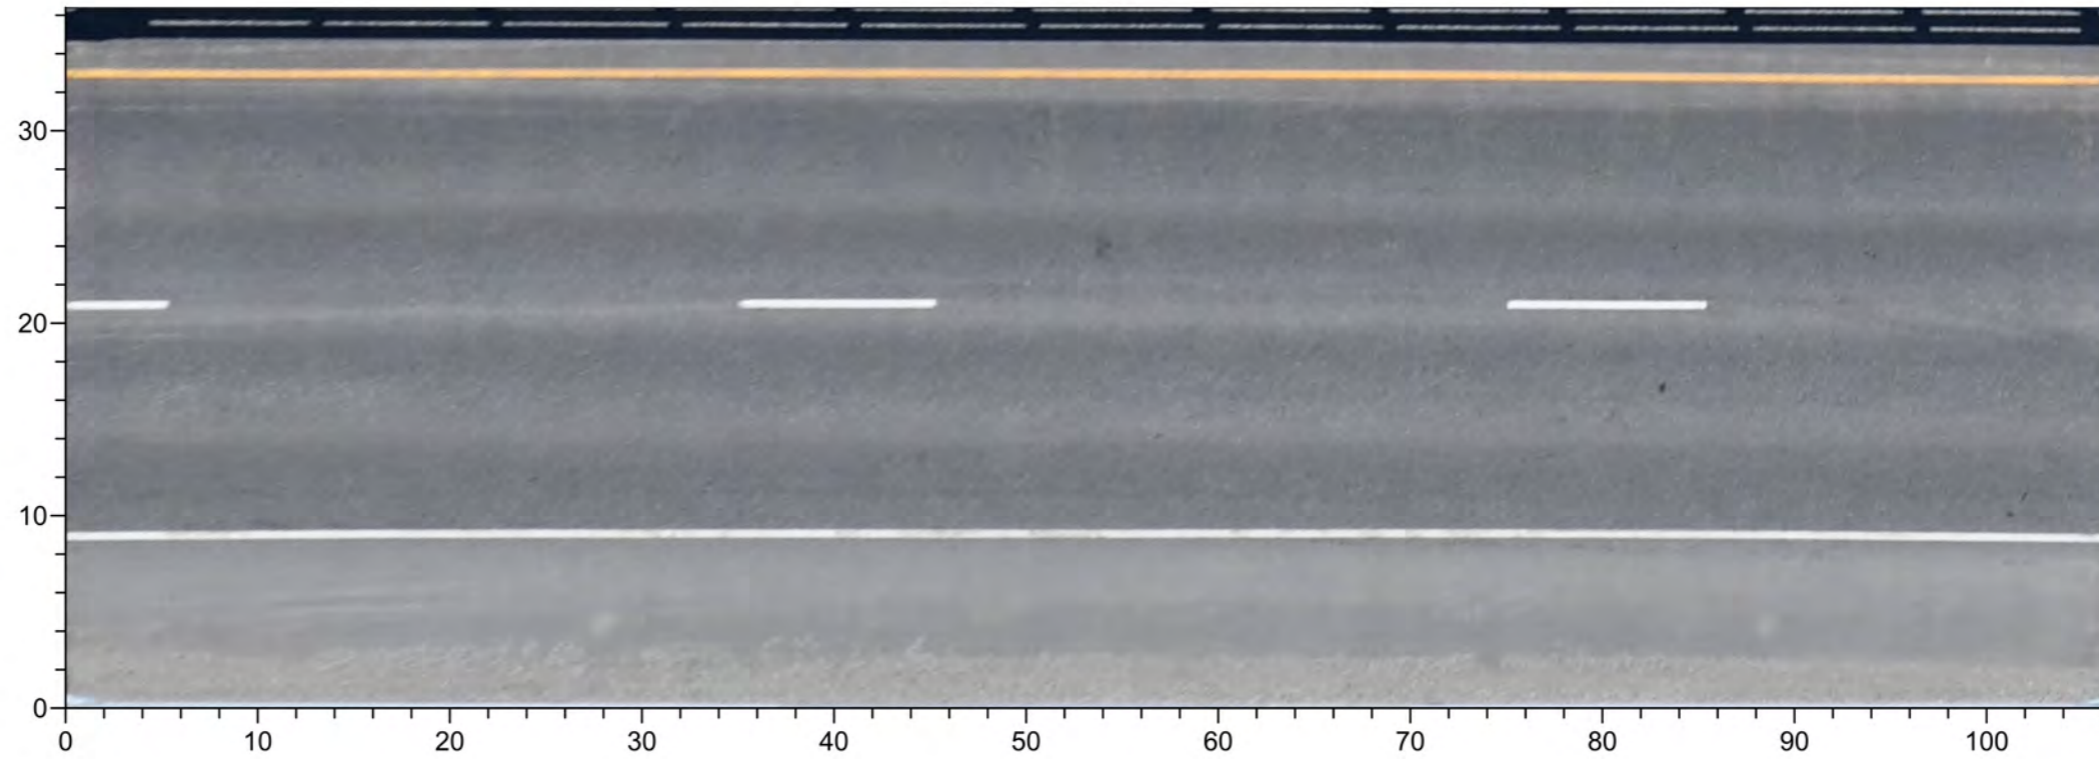
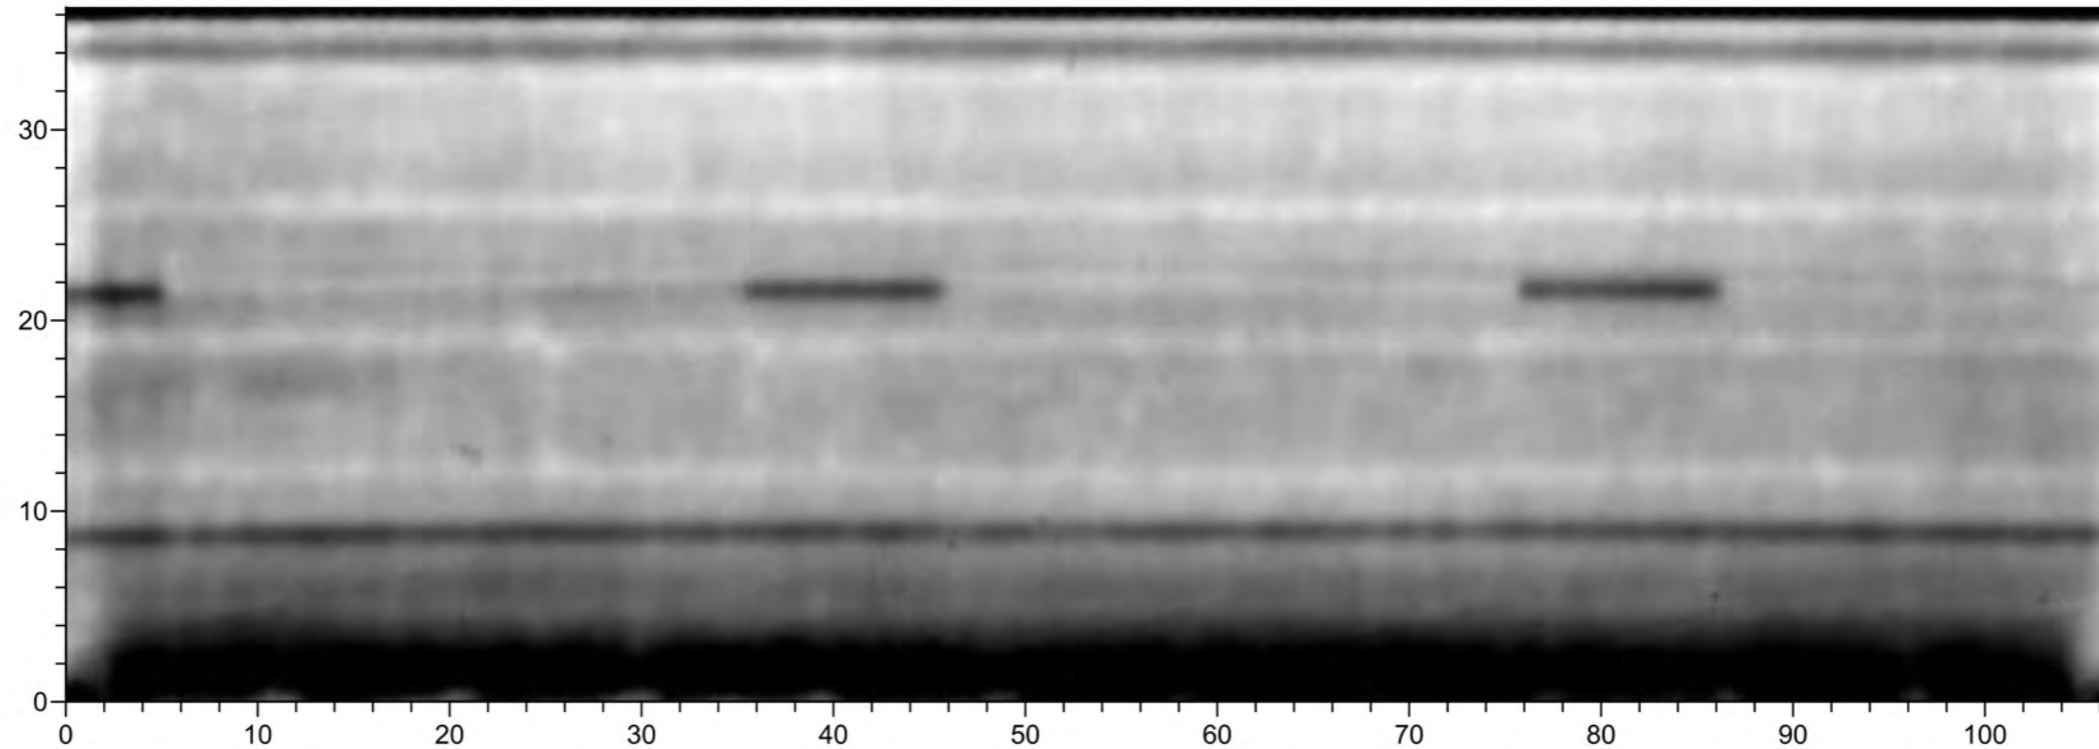
Delamination Quantity (%) 1.5 Delamination Quantity (ft ²) 56	Imagery Collected: 6/5/22 Analyzed by: SB Reviewed by: AJC Completed: 10/10/22

Note: Delamination locations not shown as quantity is less than 2%.

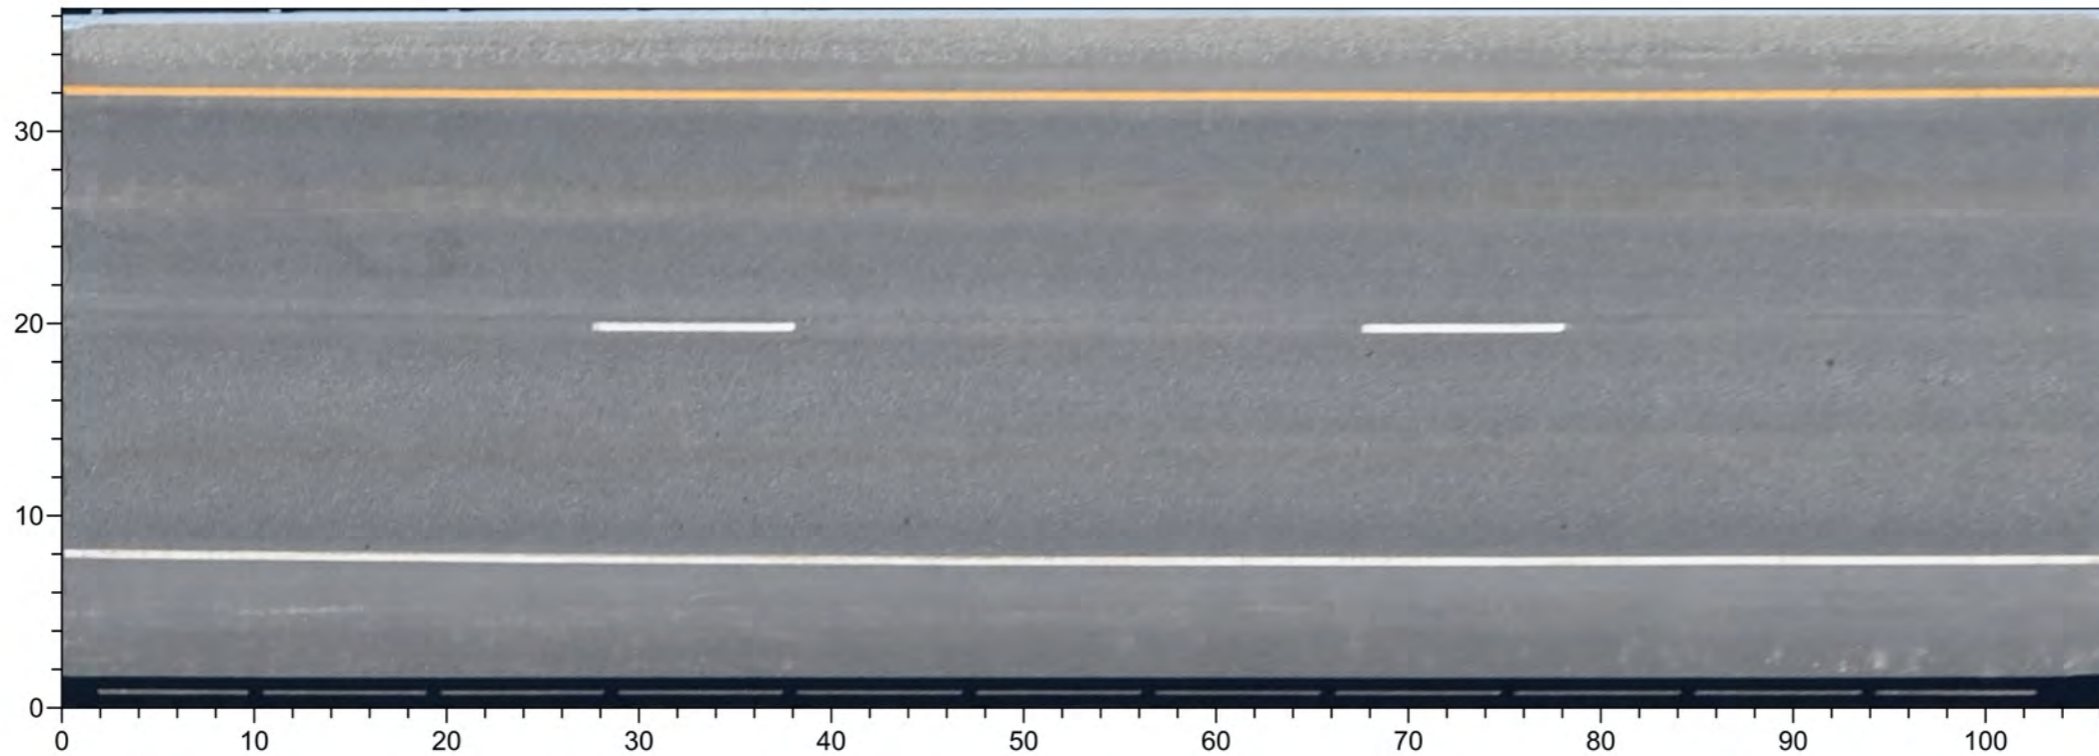
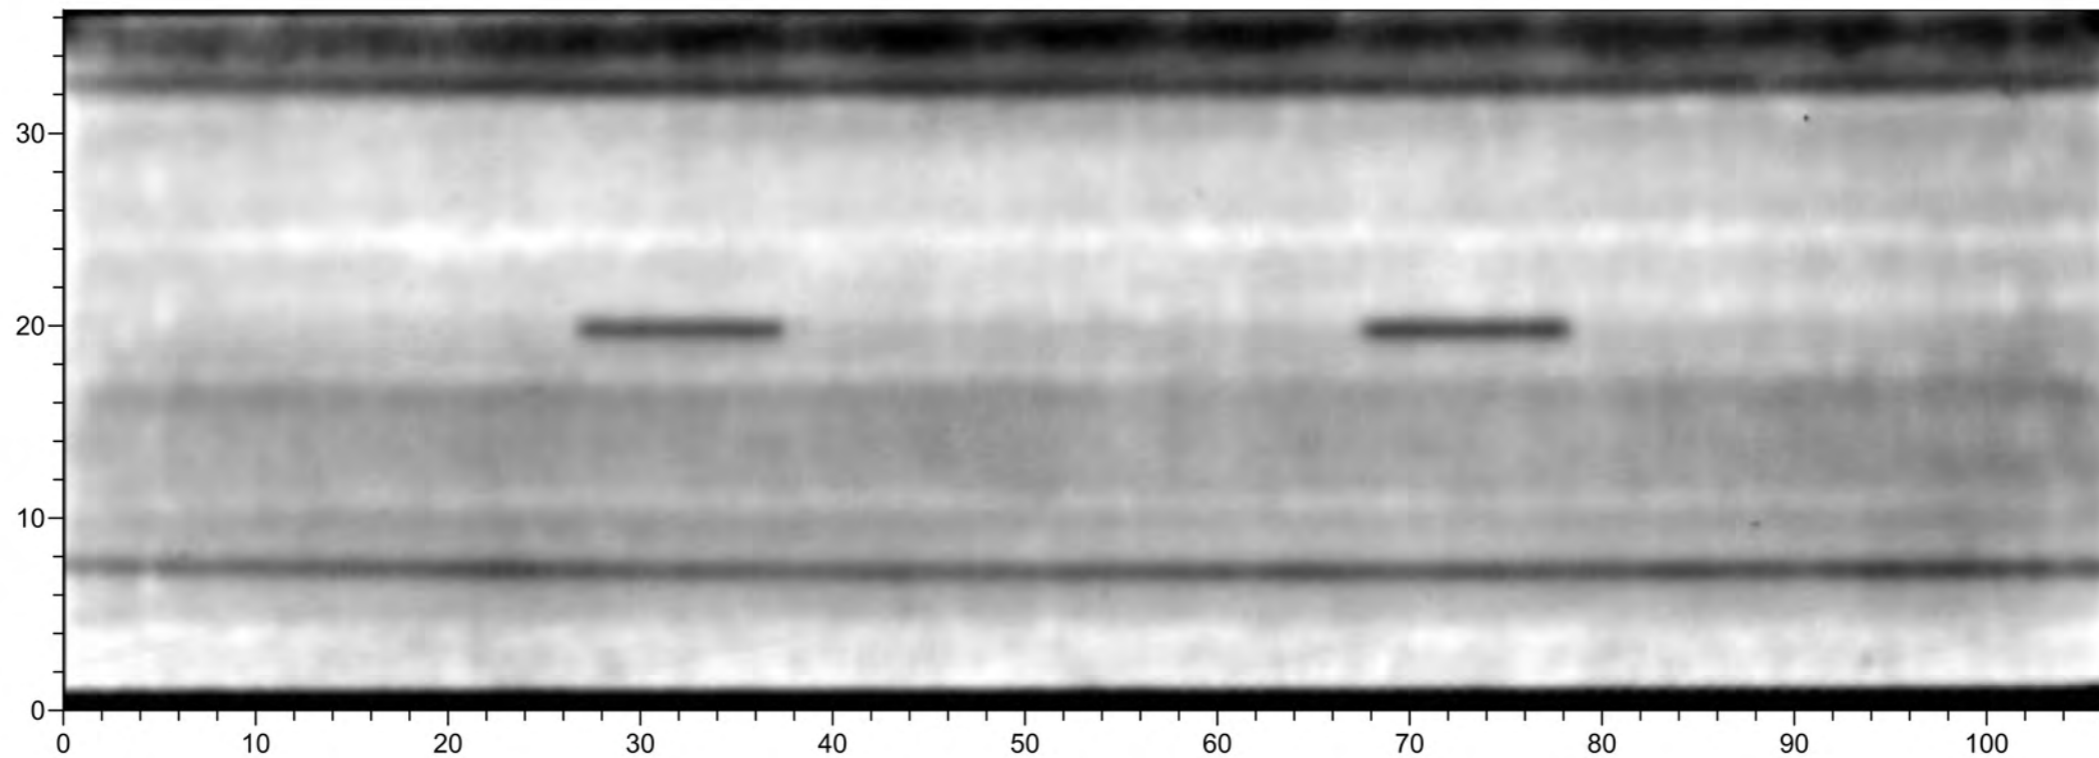
Delamination Quantity (%)	0.9	Imagery Collected: 6/5/22 Analyzed by: SB Reviewed by: AJC Completed: 10/10/22	
		Delamination Quantity (ft ²)	36

Note: Delamination locations not shown as quantity is less than 2%.
