Aerial Infrared Scanning of Bridge Decks on Parks Highway to Map Delaminations

FINAL REPORT

Prepared by:
Infrasense, Inc.
Woburn, MA

Report # FHWA-AK-RD-000S(960)
March 2, 2023

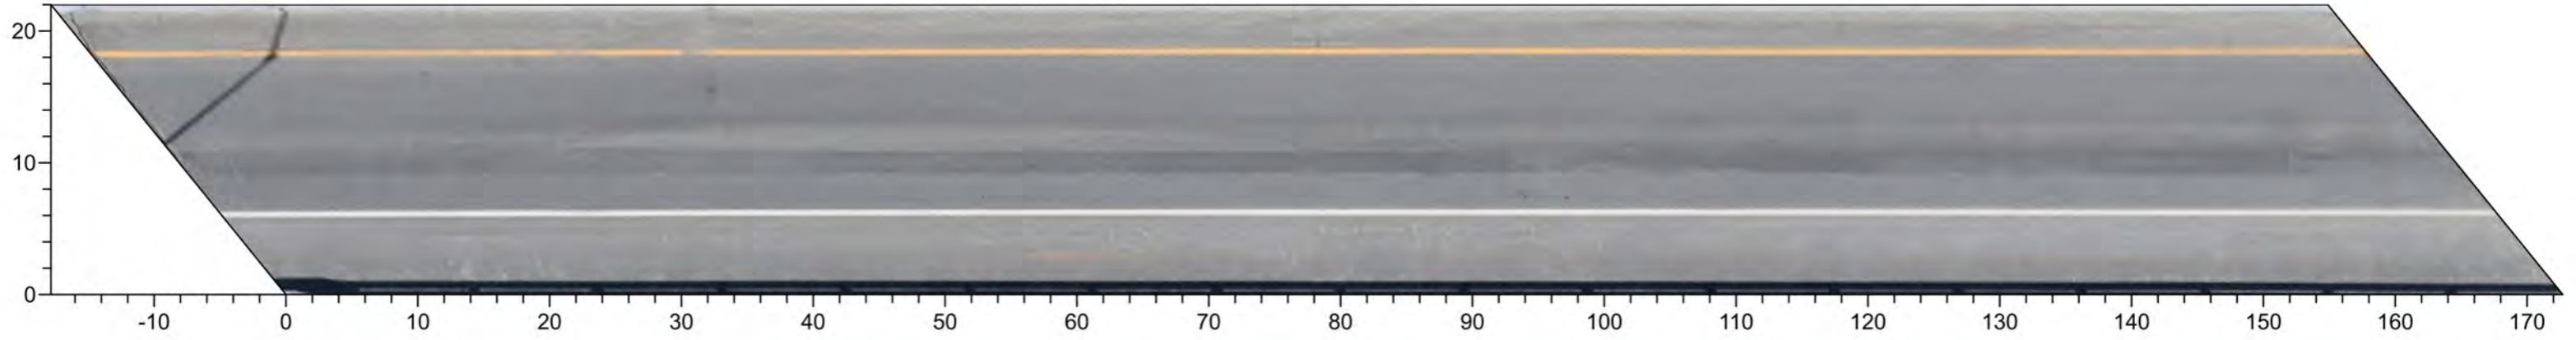
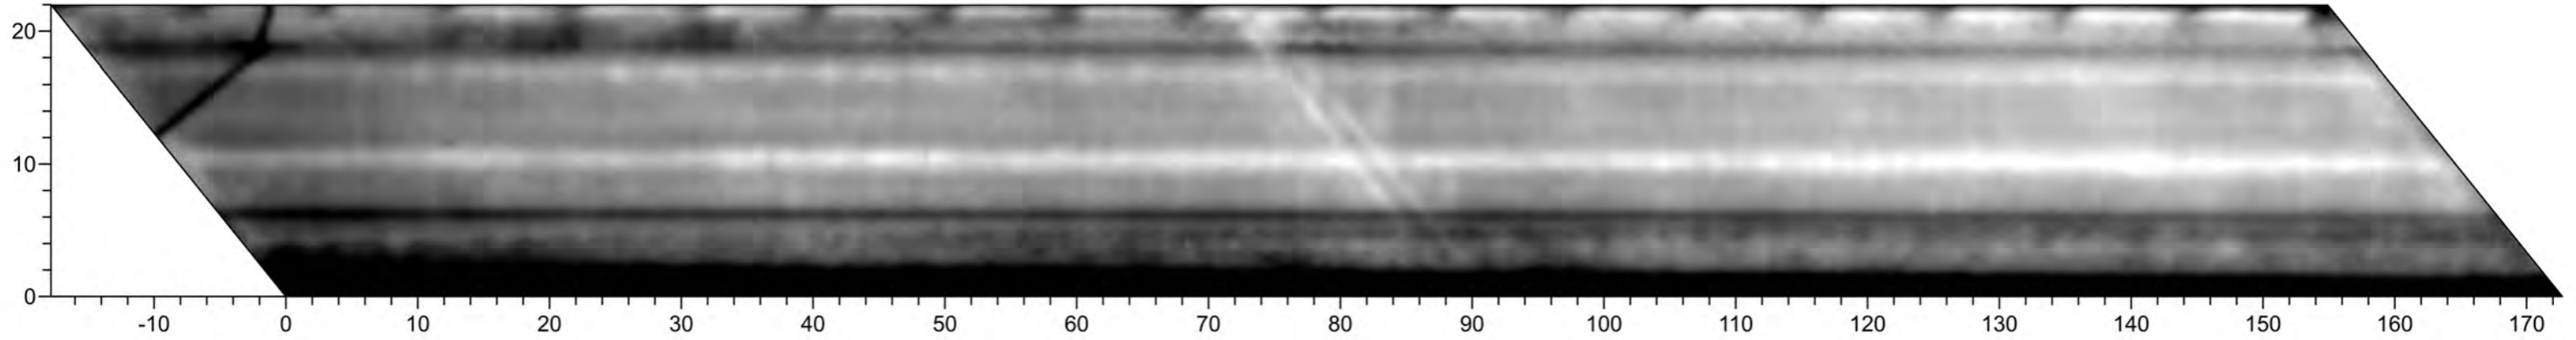
Delamination Quantity (%) 0.7 Delamination Quantity (ft ²) 28	Imagery Collected: 6/5/22 Analyzed by: SB Reviewed by: AJC Completed: 10/10/22

Note: Delamination locations not shown as quantity is less than 2%.

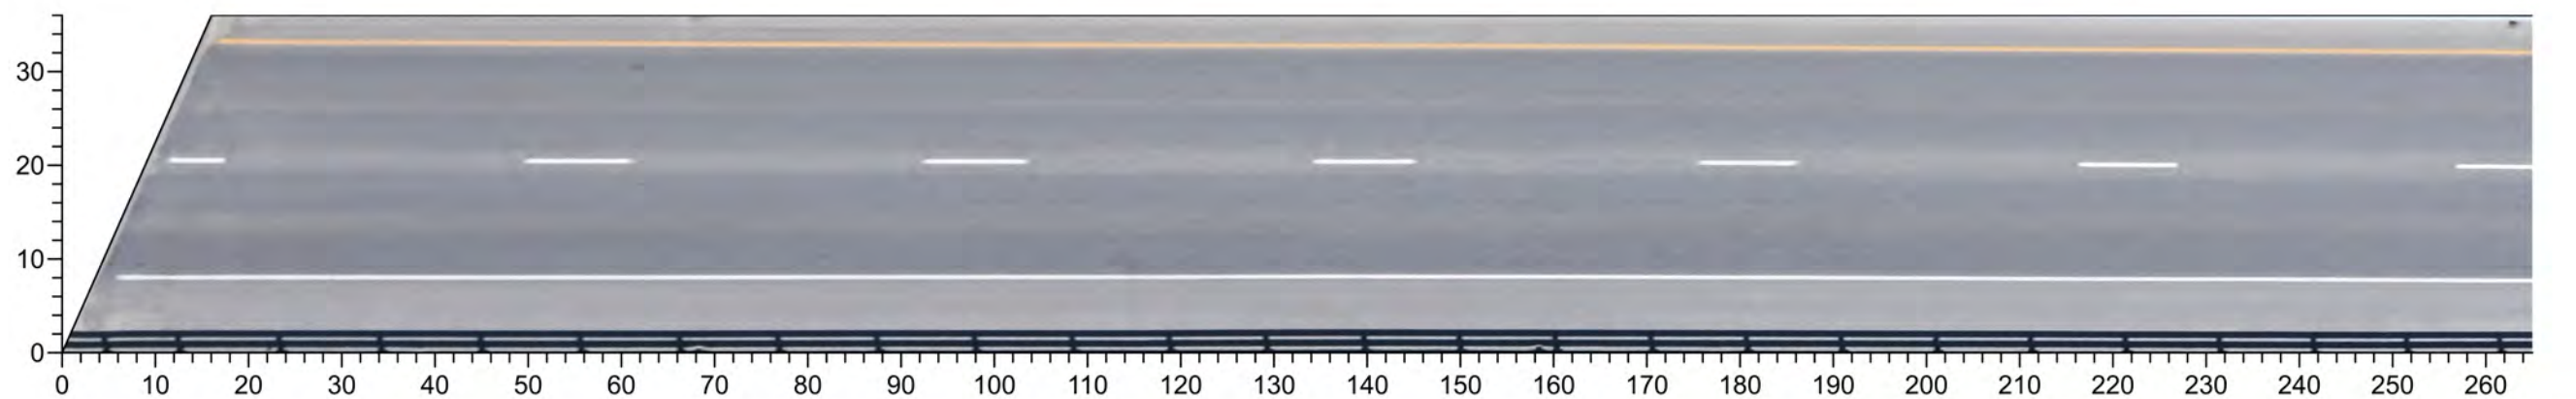
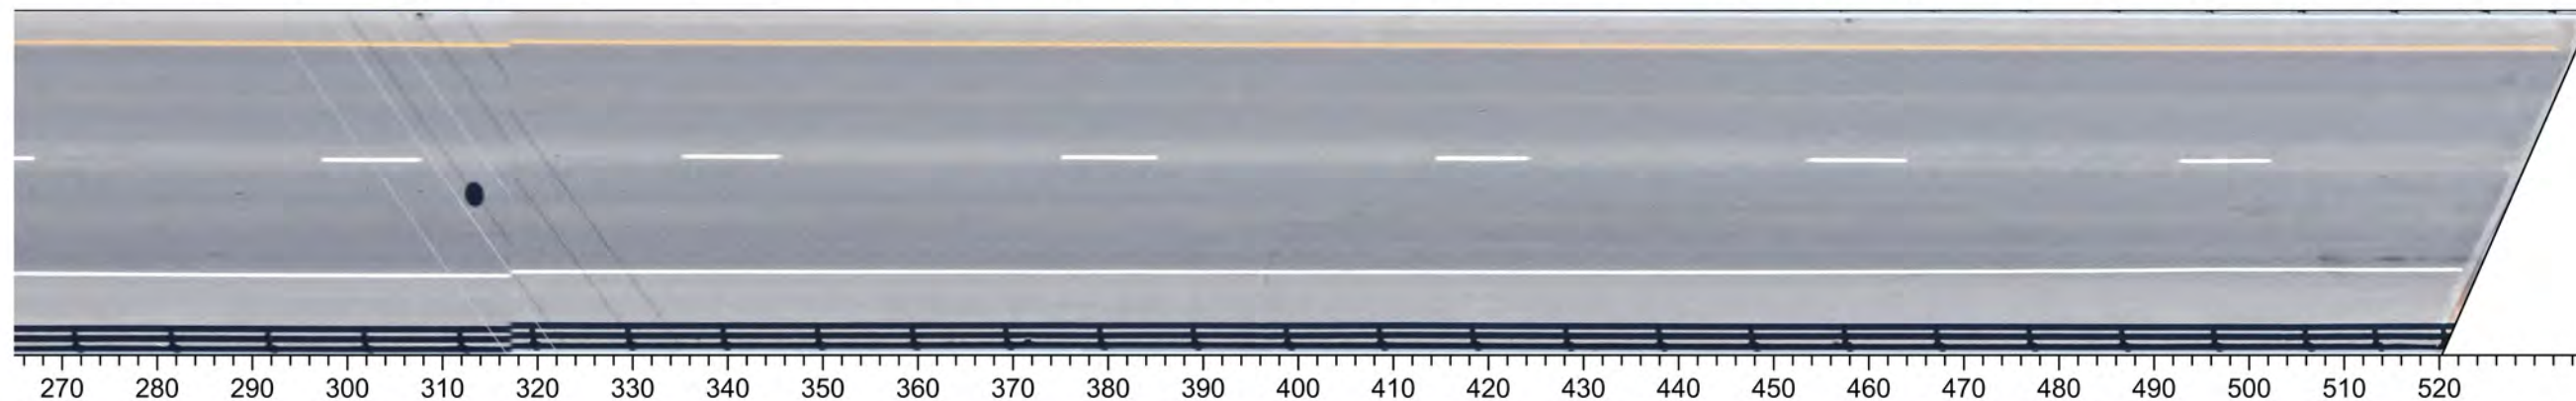
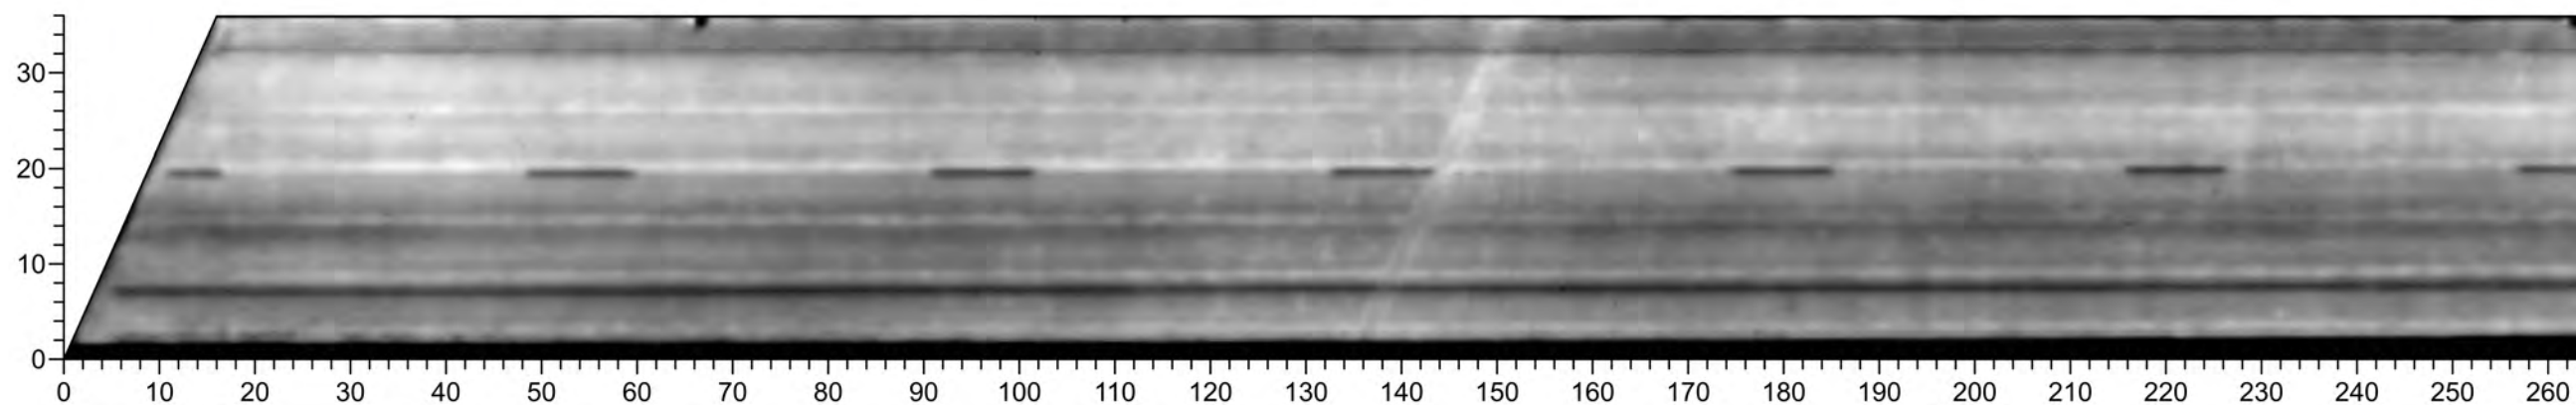
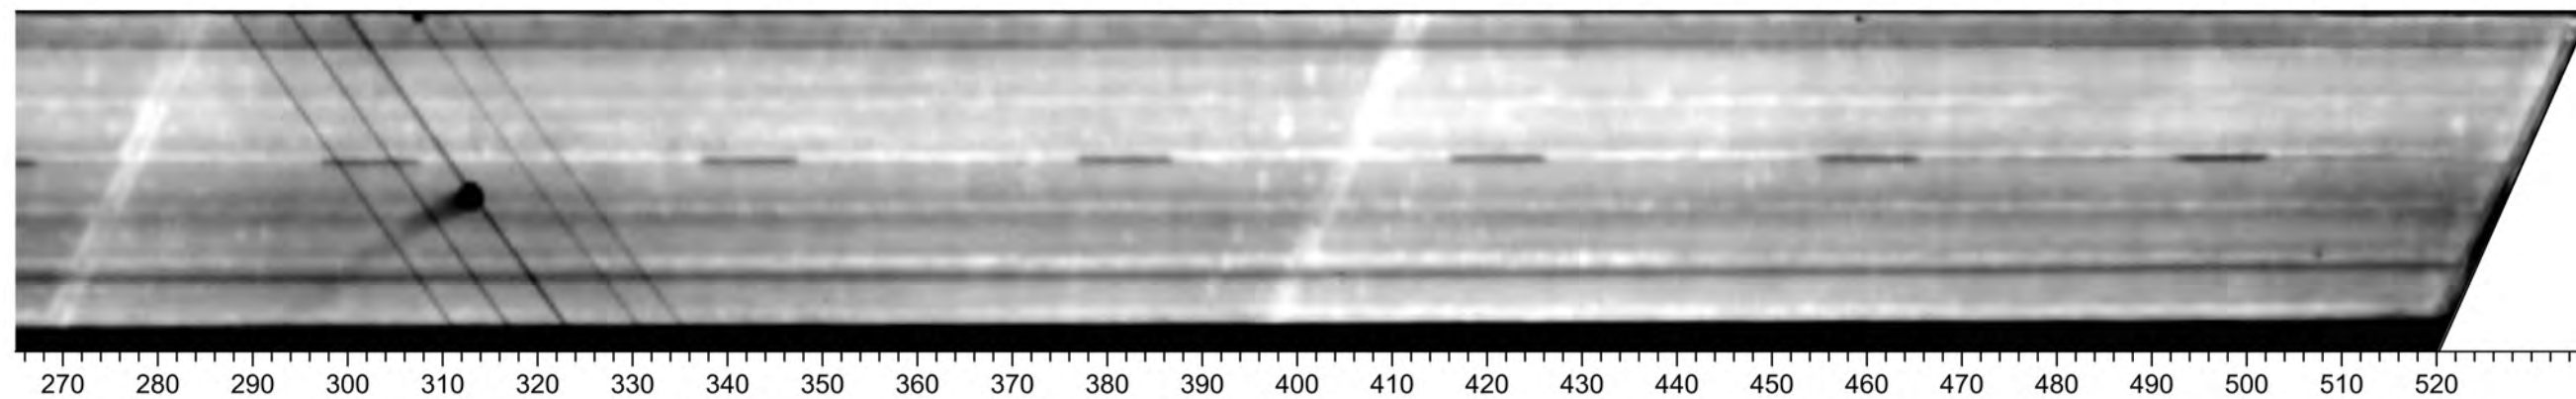
Delamination Quantity (%) 0.6		Imagery Collected: 6/5/22 Analyzed by: SB Reviewed by: AJC Completed: 10/10/22	
			Delamination Quantity (ft ²) 22

Note: Delamination locations not shown as quantity is less than 2%.

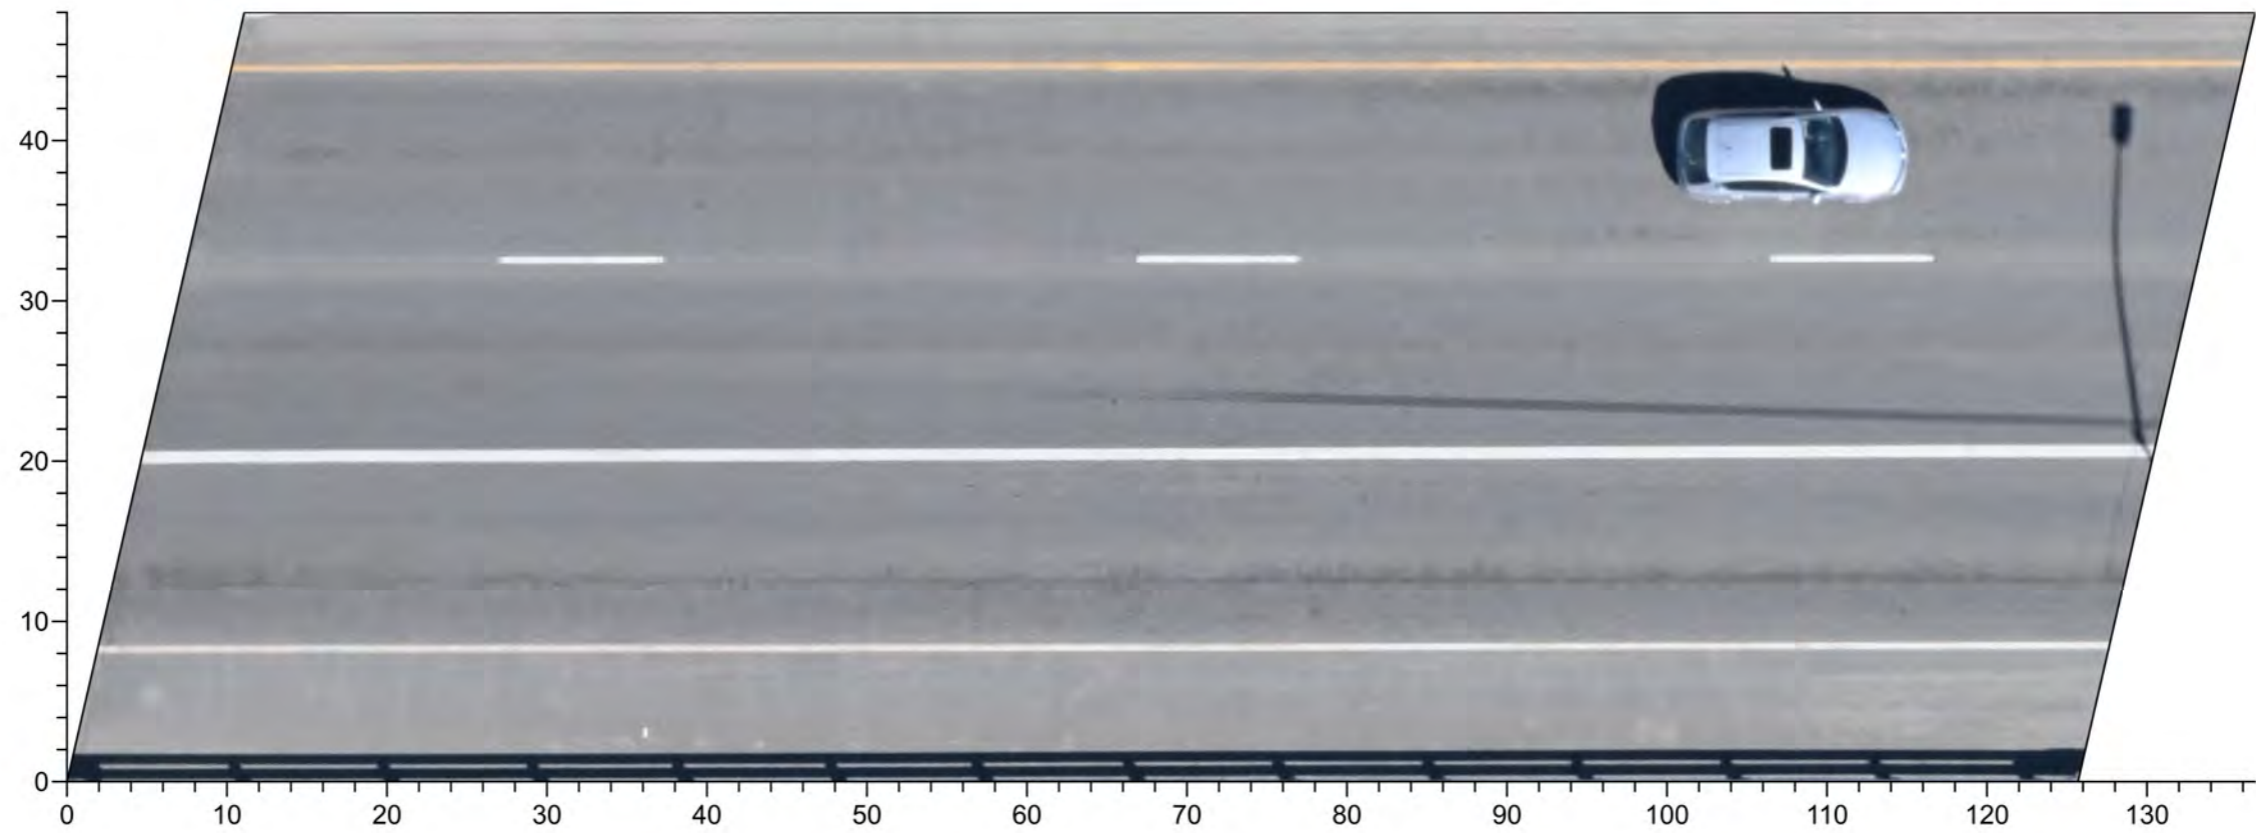
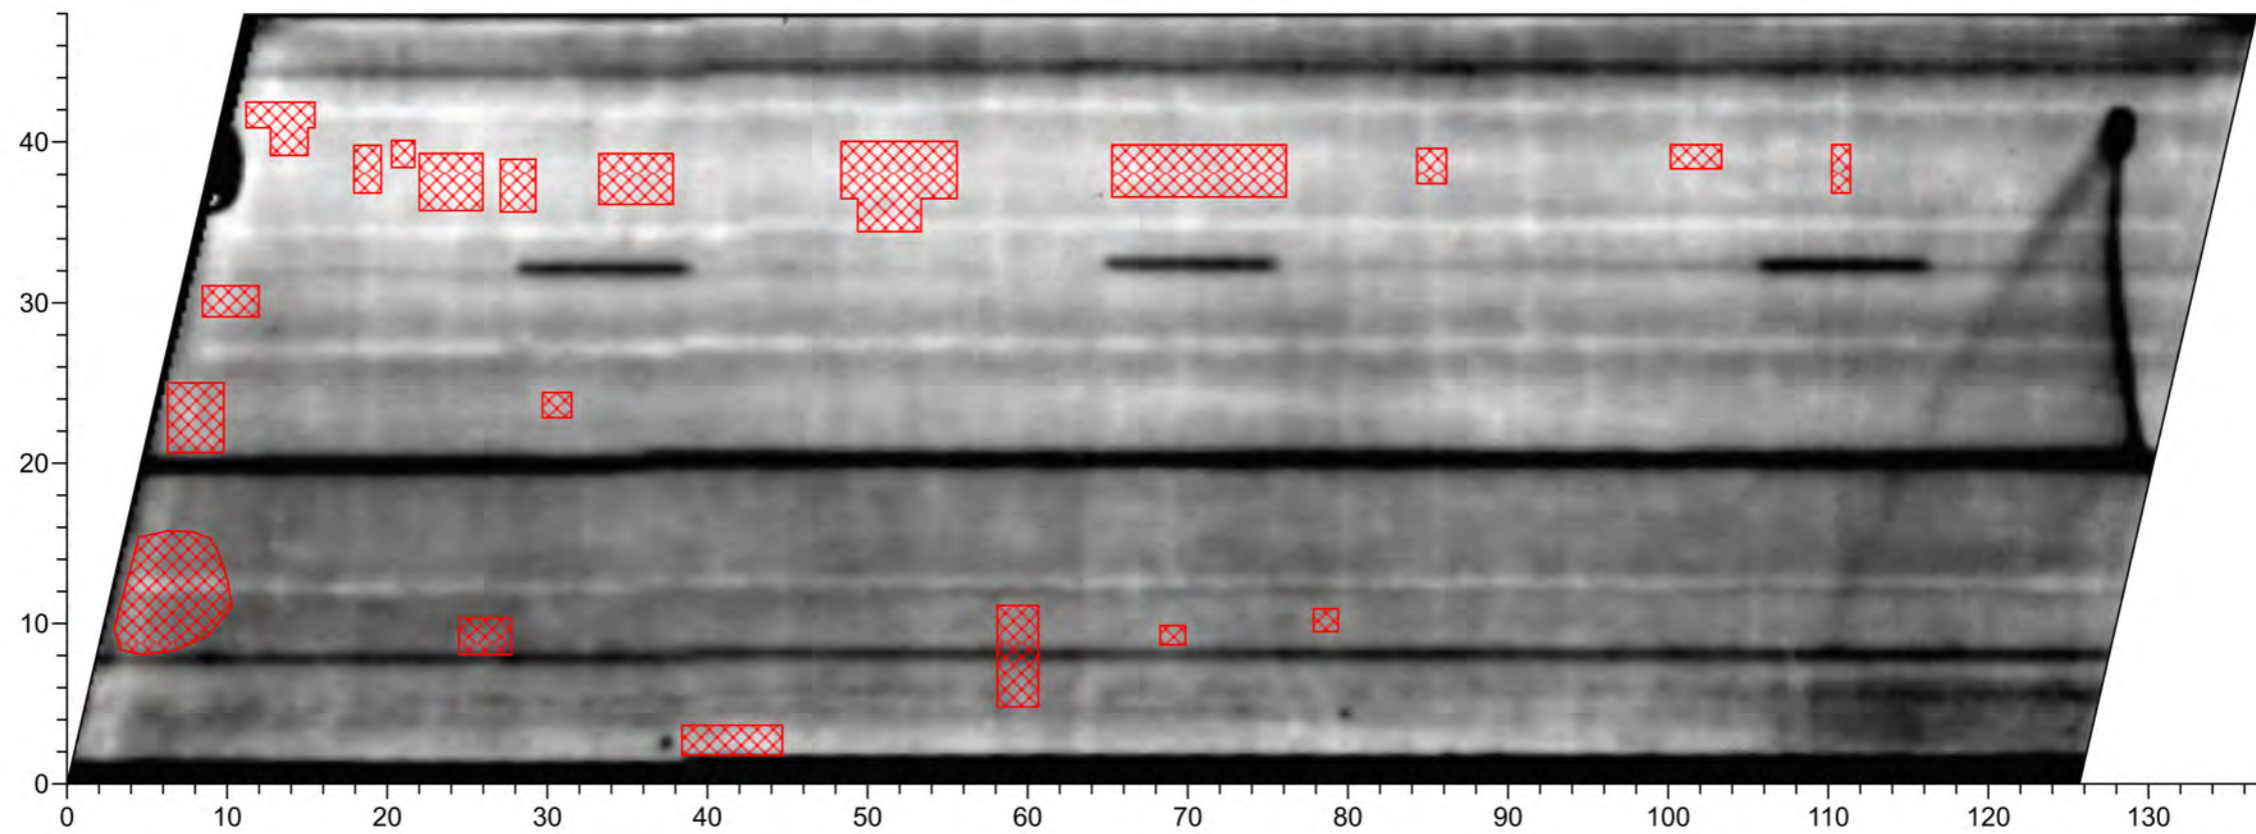
Delamination Quantity (%) 1.2 Delamination Quantity (ft ²) 216	Imagery Collected: 6/5/22 Analyzed by: SB Reviewed by: AJC Completed: 10/10/22

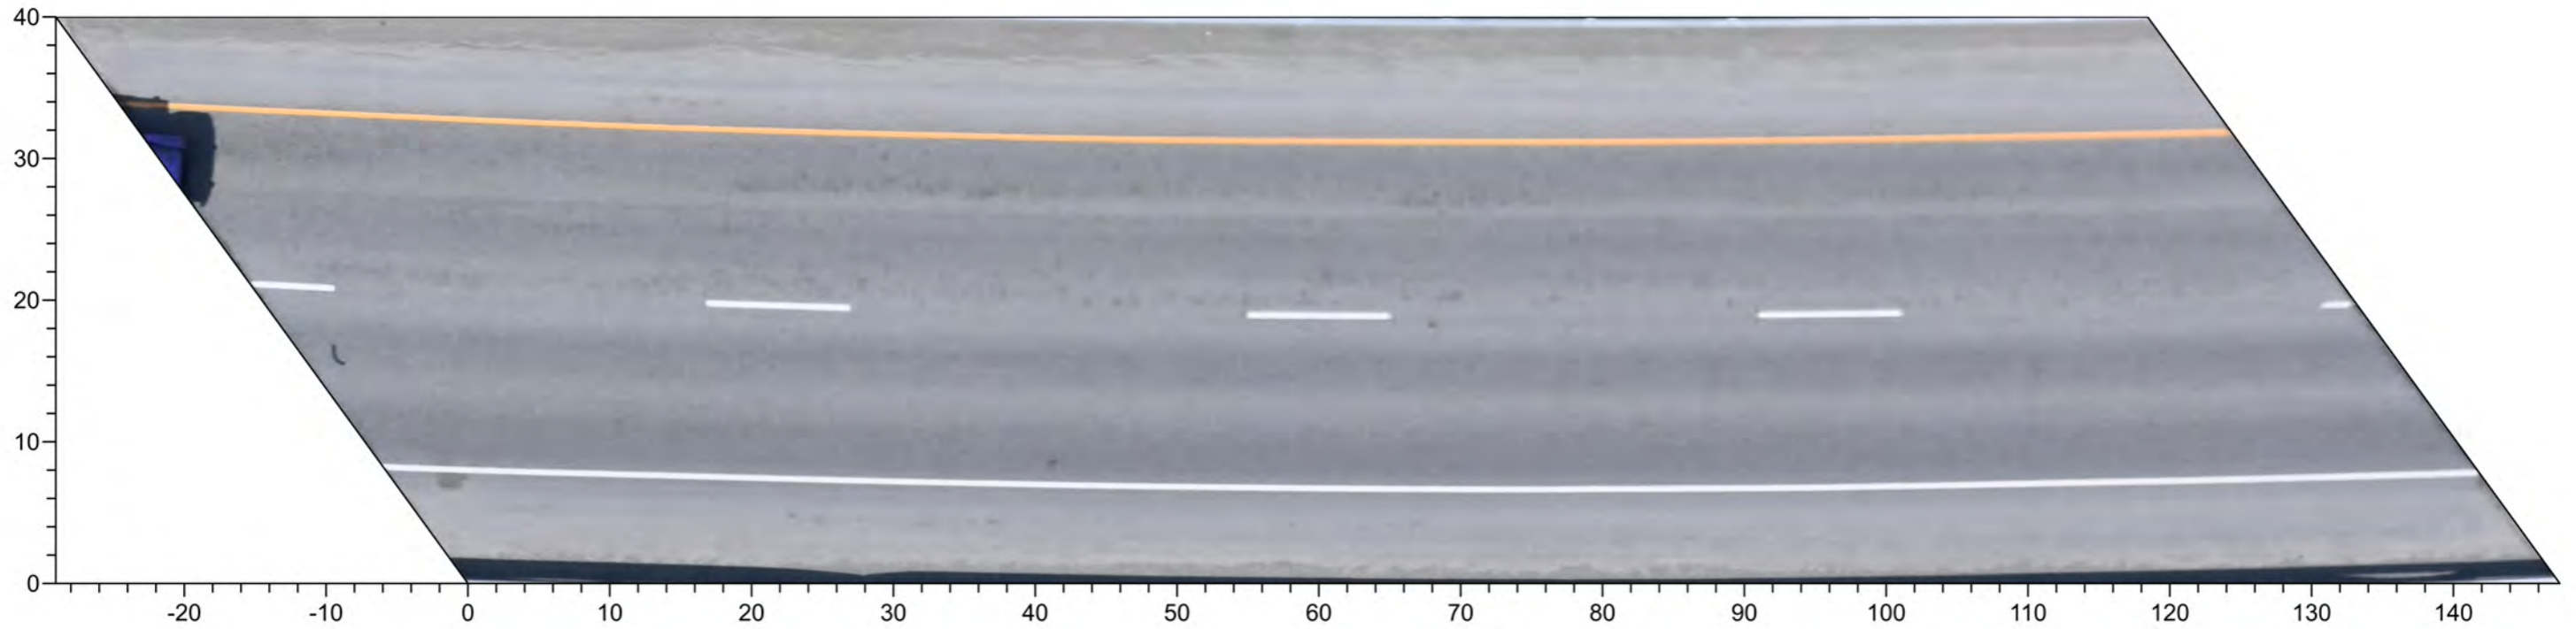
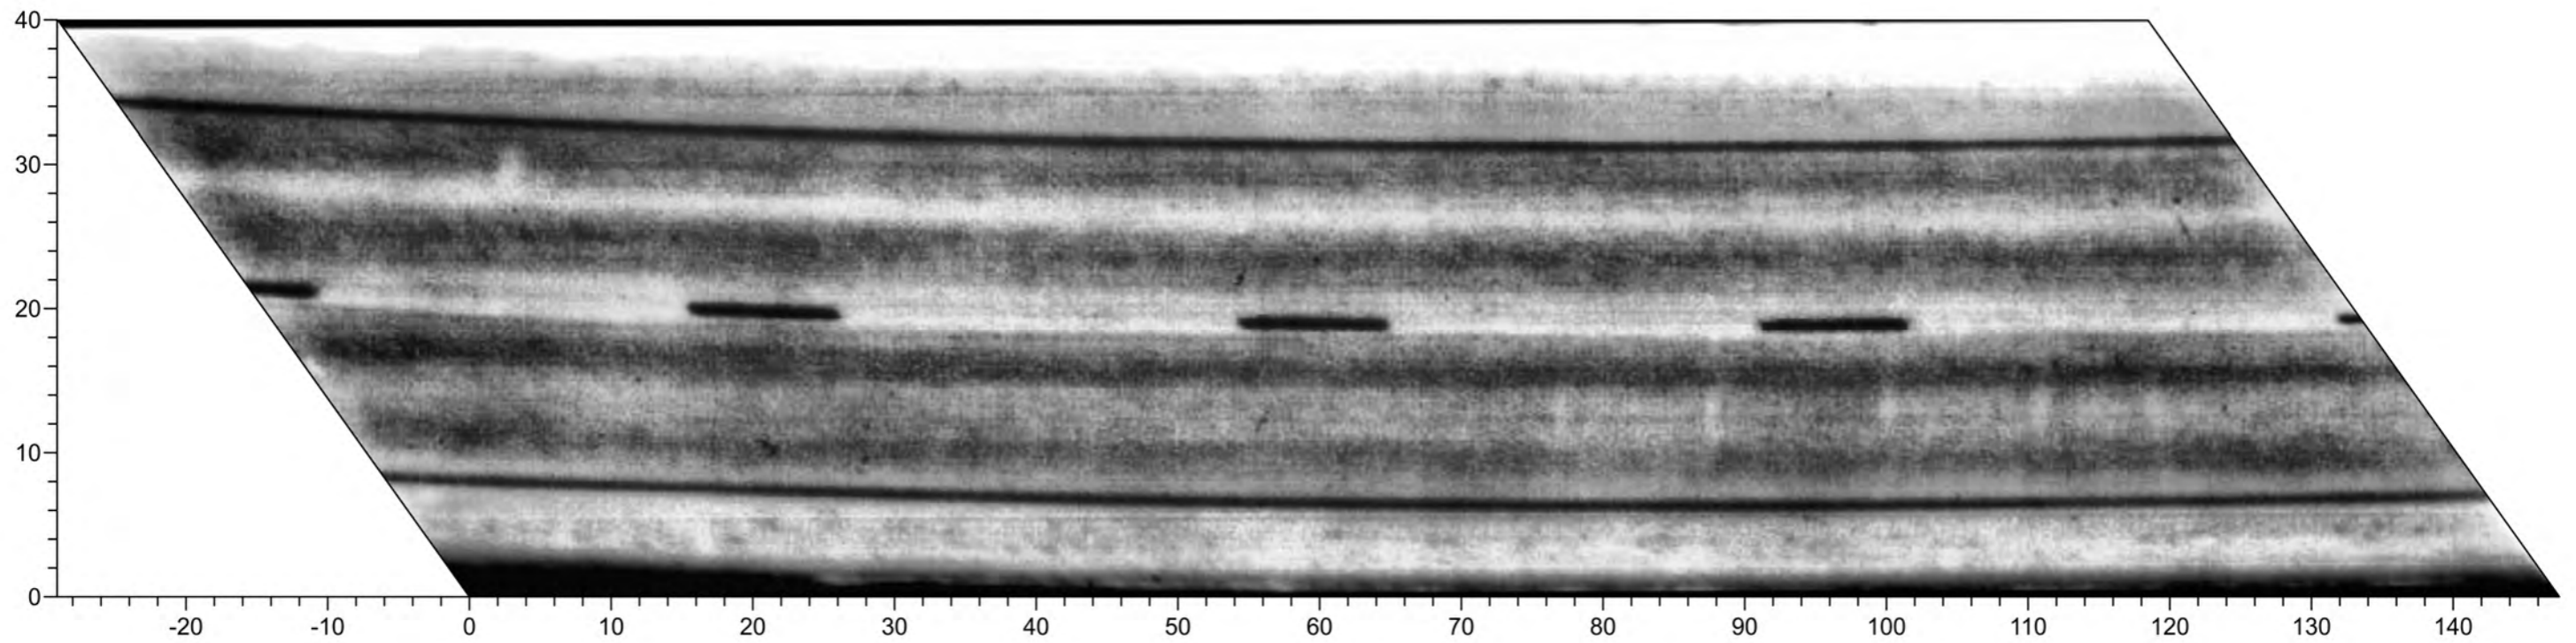
Delamination Quantity (%) 4.0		Imagery Collected: 6/5/22 Analyzed by: SB Reviewed by: AJC Completed: 10/10/22	
			Delamination Quantity (ft ²) 242

Note: Delamination locations not shown as quantity is less than 2%.

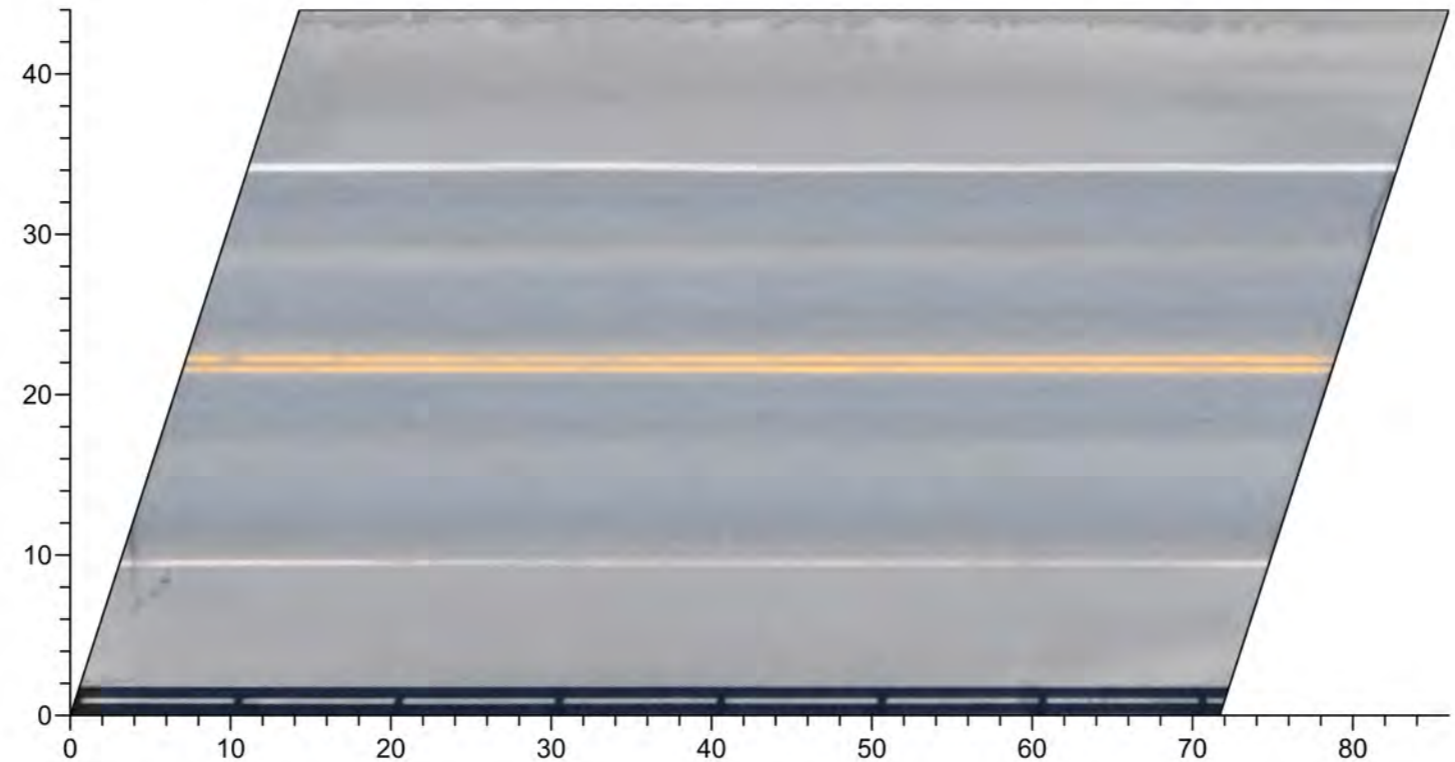
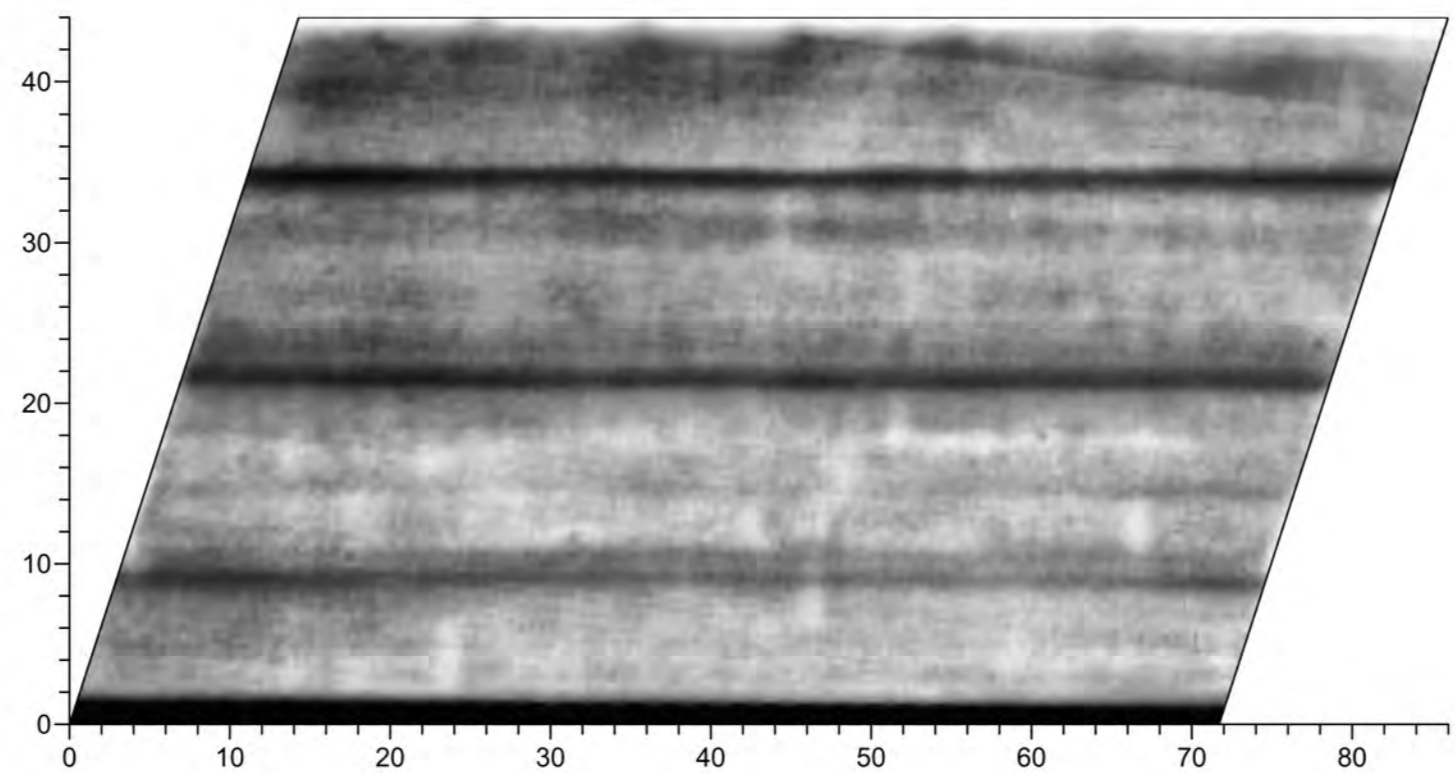
Delamination Quantity (%) 0.6 Delamination Quantity (ft ²) 94	Imagery Collected: 6/4/22 Analyzed by: SB Reviewed by: AJC Completed: 10/6/22

*Note: 40 sq. ft. of thermal anomalies not mapped due to being rectilinear in shape and appearing more like subsurface patching or some other structural feature

Note: Delamination locations not shown as quantity is less than 2%.

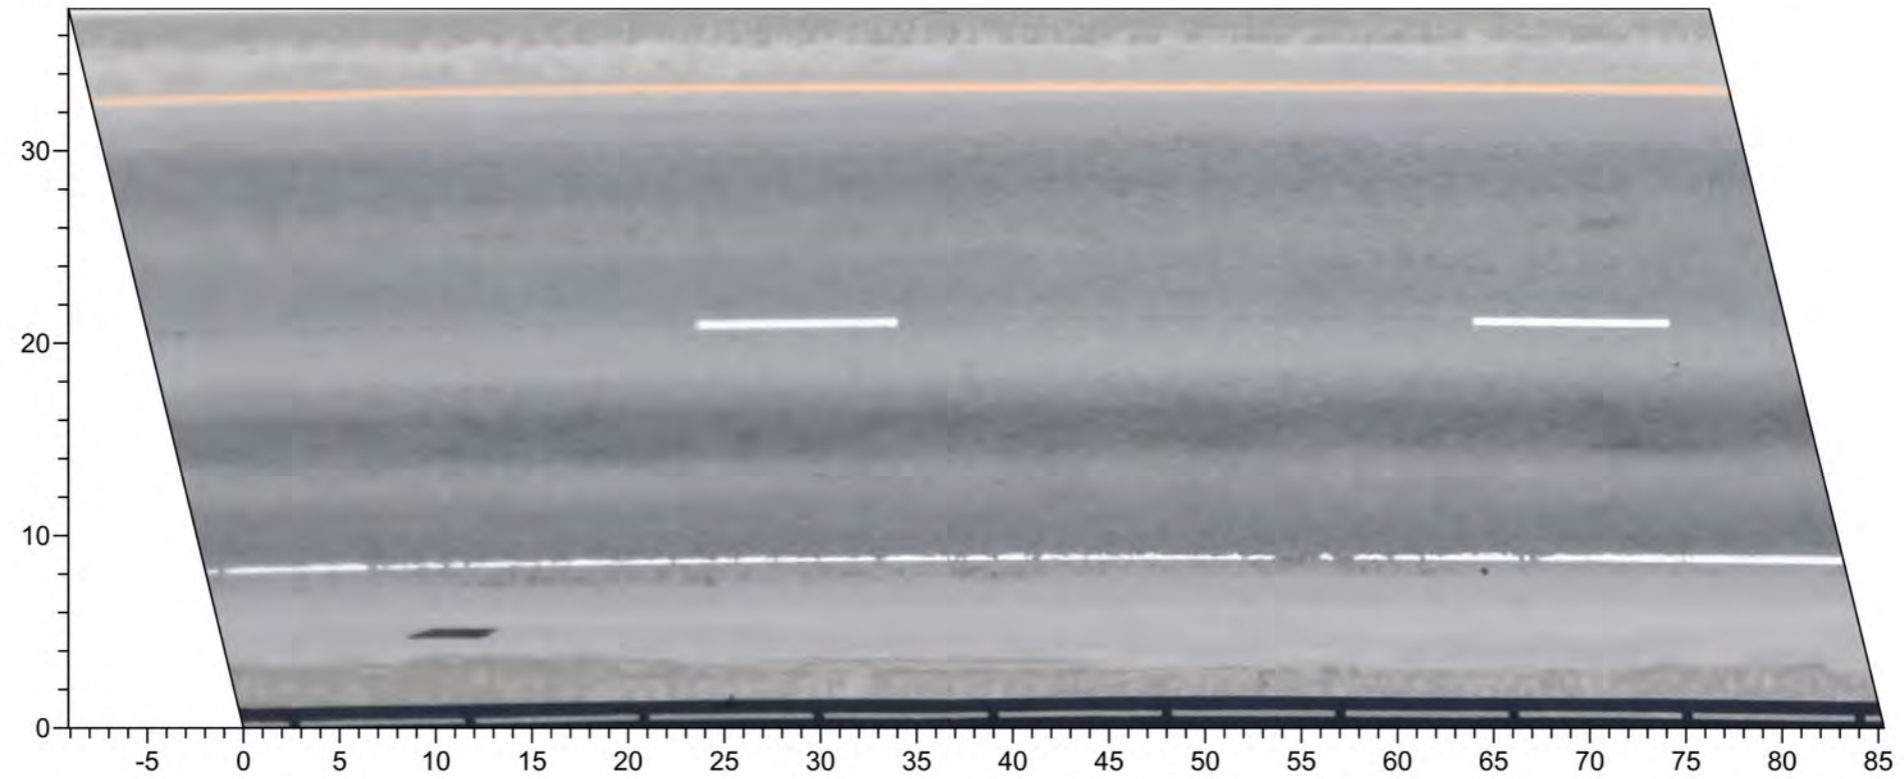
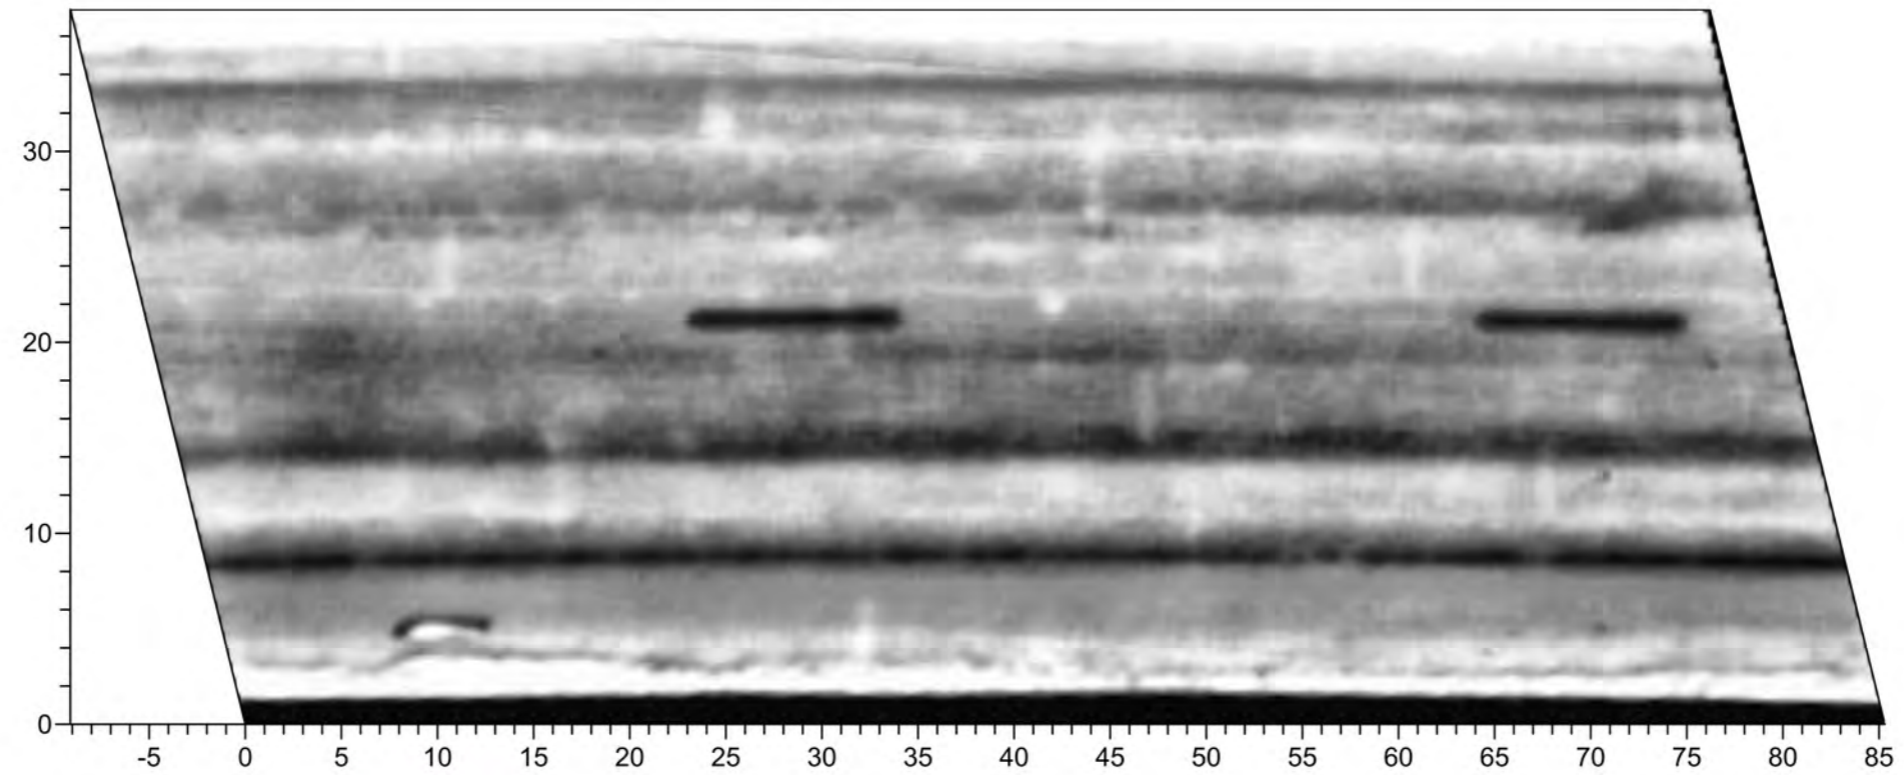
Delamination Quantity (%) 0.3		Imagery Collected: 6/5/22 Analyzed by: SB Reviewed by: AJC Completed: 10/6/22	
		Delamination Quantity (ft ²) 9

*Note: 44 sq. ft. of thermal anomalies not mapped due to being rectilinear in shape and appearing more like subsurface patching or some other structural feature

Note: Delamination locations not shown as quantity is less than 2%.

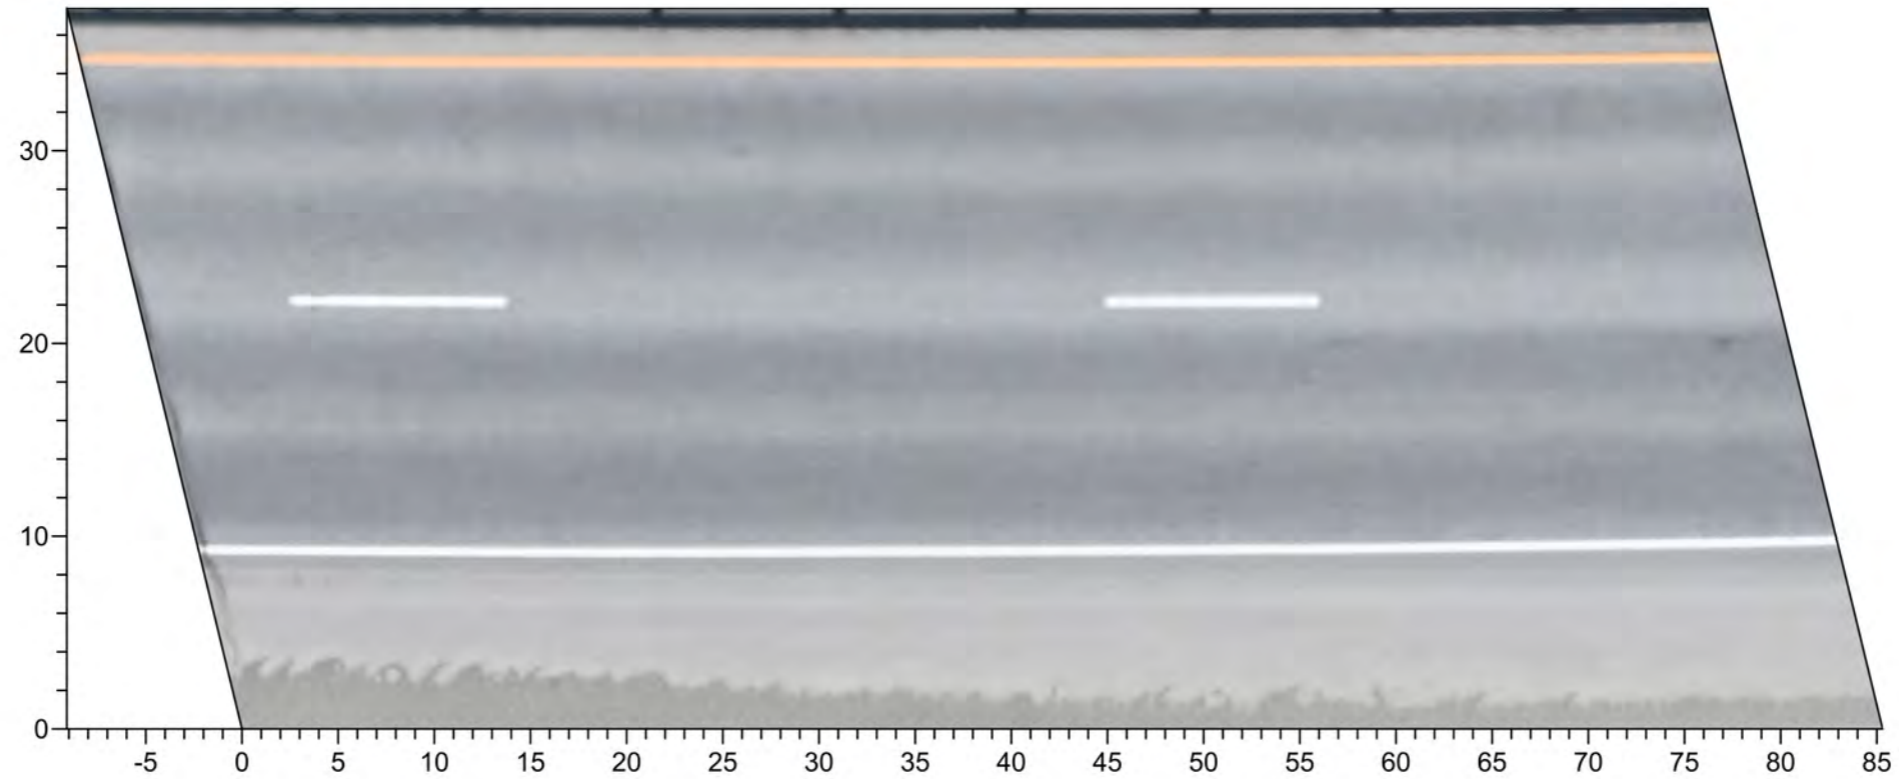
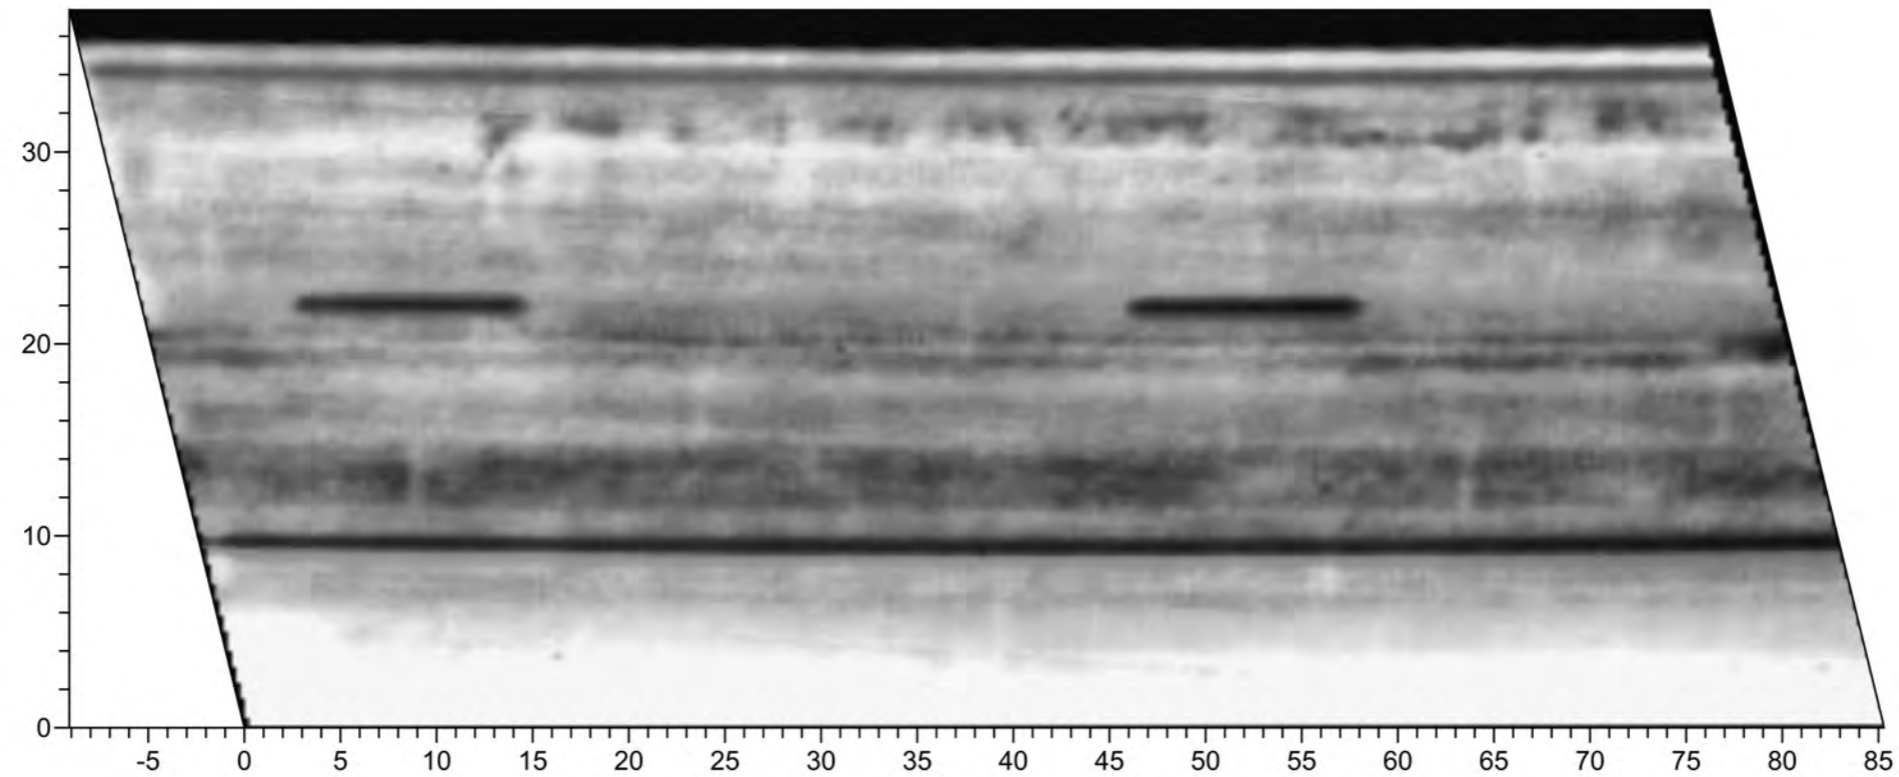
Delamination Quantity (%) 1.0 Delamination Quantity (ft ²) 32	Imagery Collected: 6/4/22 Analyzed by: SB Reviewed by: AJC Completed: 10/5/22

Note: Delamination locations not shown as quantity is less than 2%.
