Aerial Infrared Scanning of Bridge Decks on Parks Highway to Map Delaminations

FINAL REPORT

Prepared by:
Infrasense, Inc.
Woburn, MA

Report # FHWA-AK-RD-000S(960)
March 2, 2023

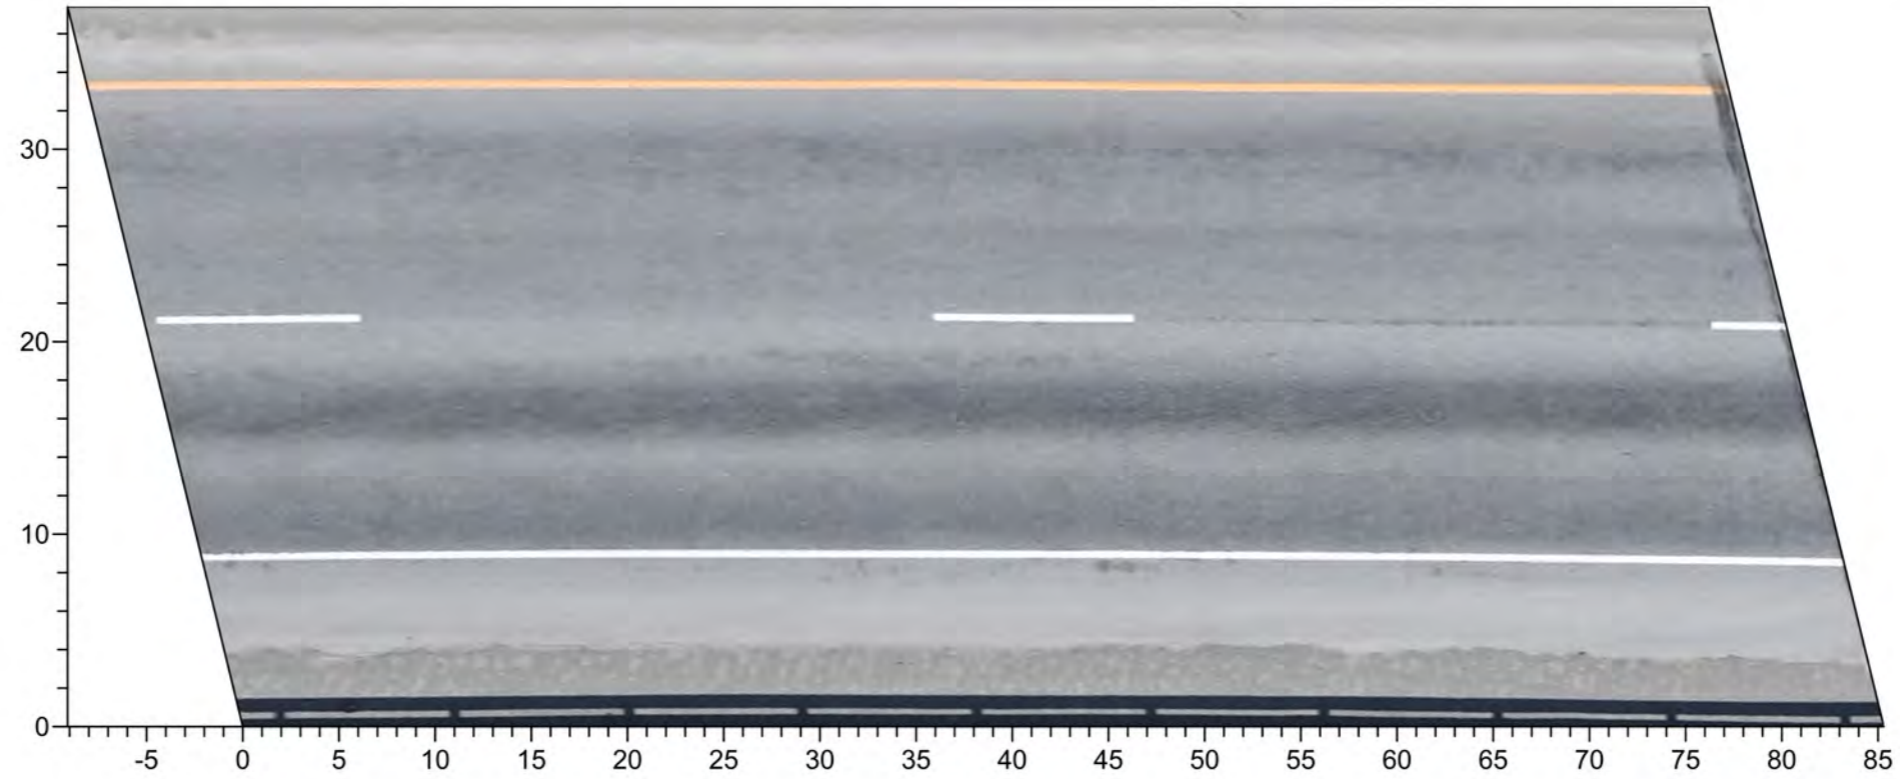
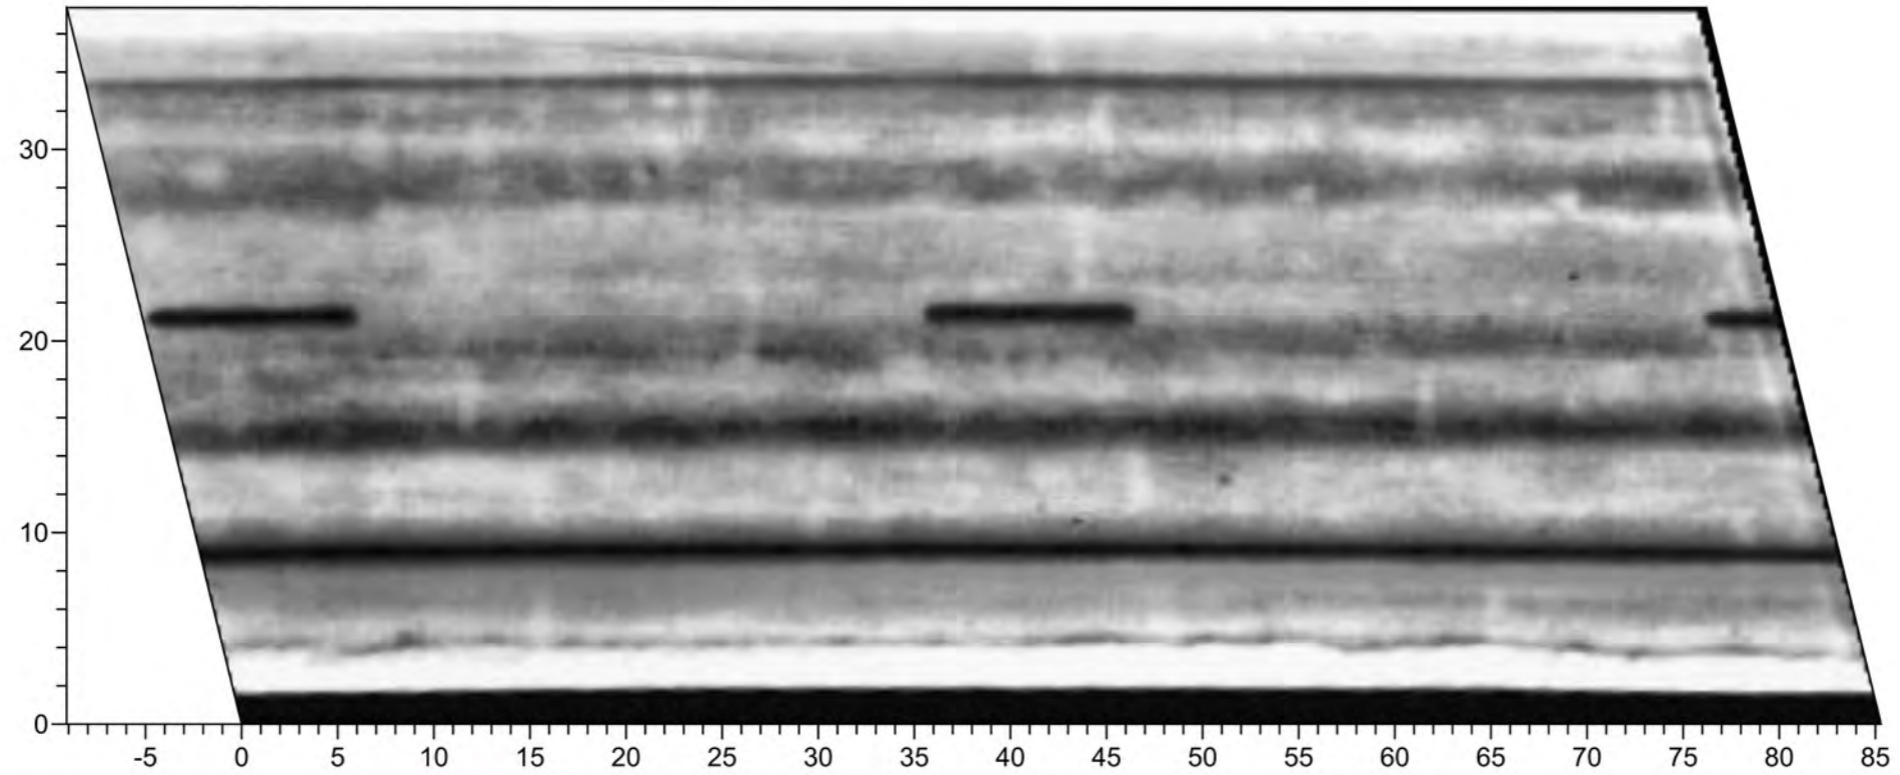
Delamination Quantity (%)	1.6	Imagery Collected: 6/4/22 Analyzed by: SB Reviewed by: AJC Completed: 10/5/22	
		Delamination Quantity (ft ²)	52

*Note: 51 sq. ft. of thermal anomalies not mapped due to being rectilinear in shape and appearing more like subsurface patching or some other structural feature

Note: Delamination locations not shown as quantity is less than 2%.

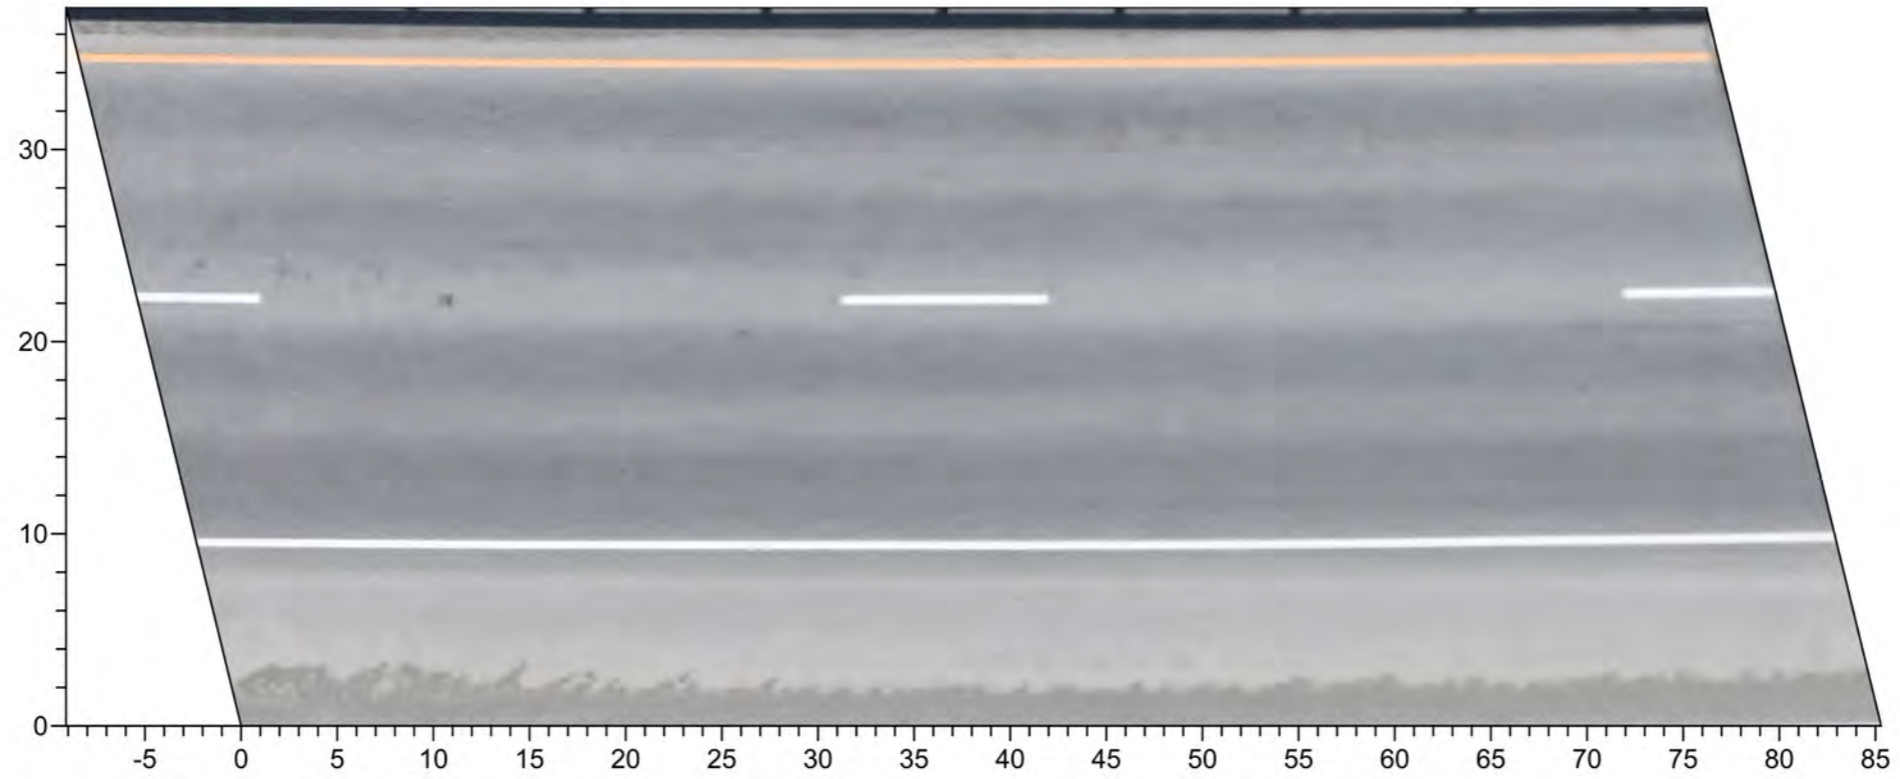
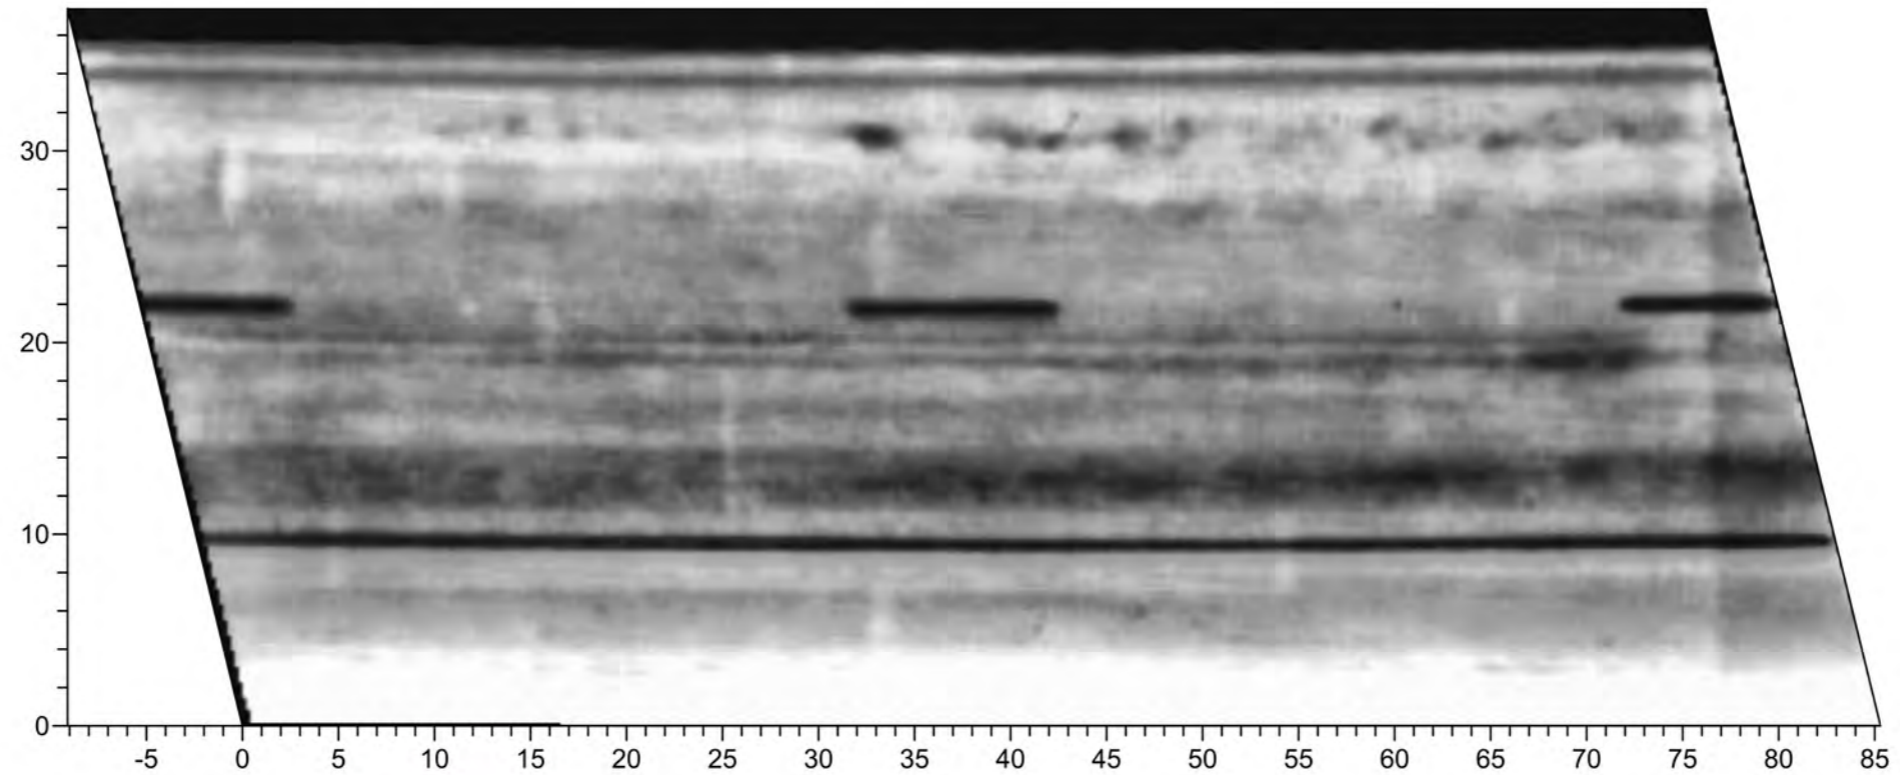
Delamination Quantity (%) 0.9 Delamination Quantity (ft ²) 28	Imagery Collected: 6/4/22 Analyzed by: SB Reviewed by: AJC Completed: 10/11/22

*Note: 66 sq. ft. of thermal anomalies not mapped due to being rectilinear in shape and appearing more like subsurface patching or some other structural feature

Note: Delamination locations not shown as quantity is less than 2%.

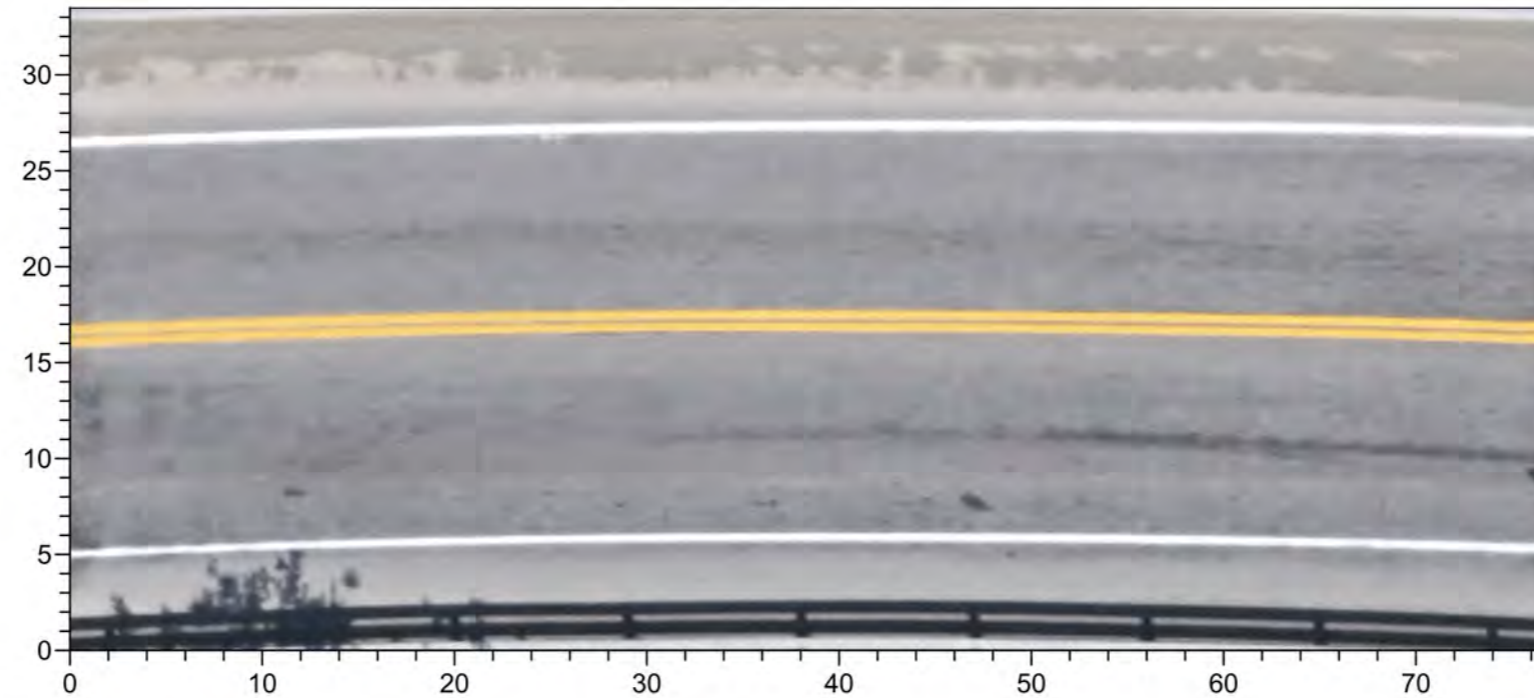
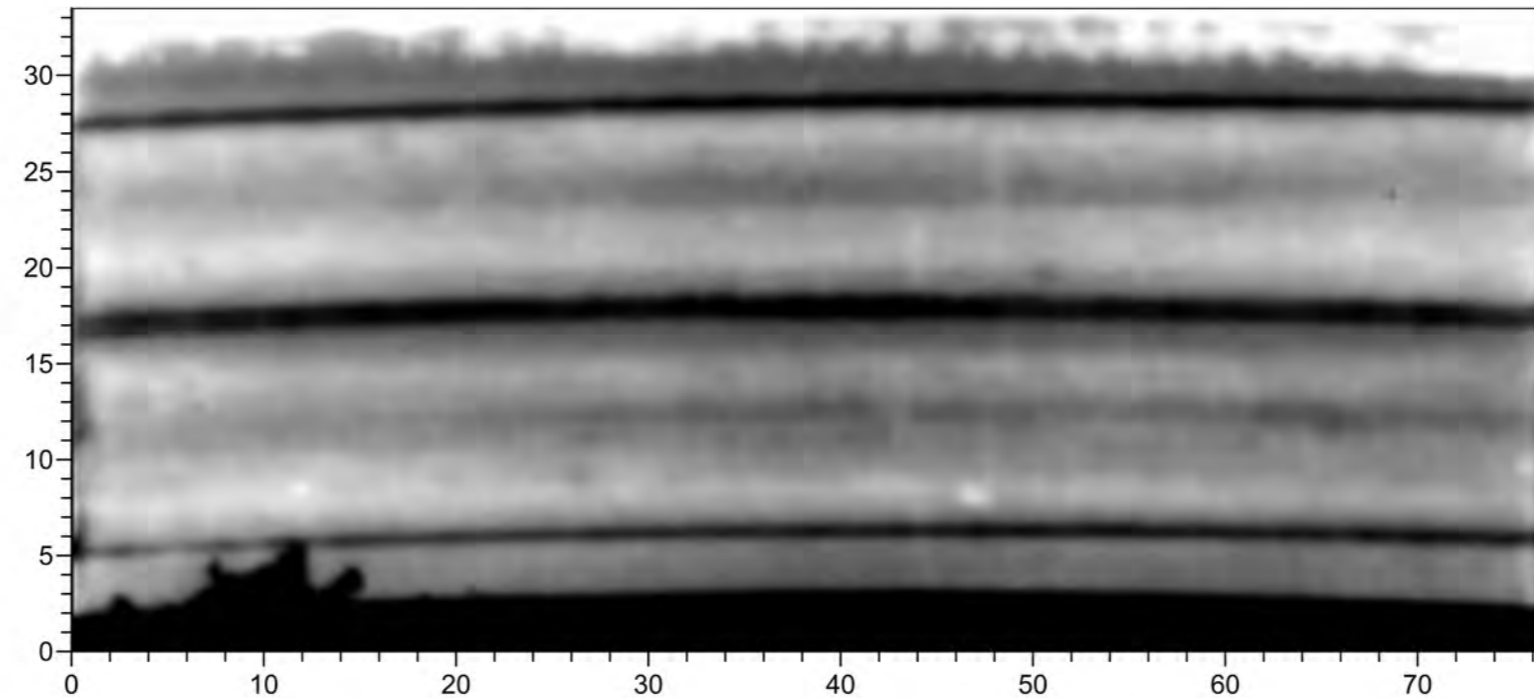
Delamination Quantity (%) 0.2 Delamination Quantity (ft ²) 5	Imagery Collected: 6/4/22 Analyzed by: SB Reviewed by: AJC Completed: 10/5/22

Note: Delamination locations not shown as quantity is less than 2%.

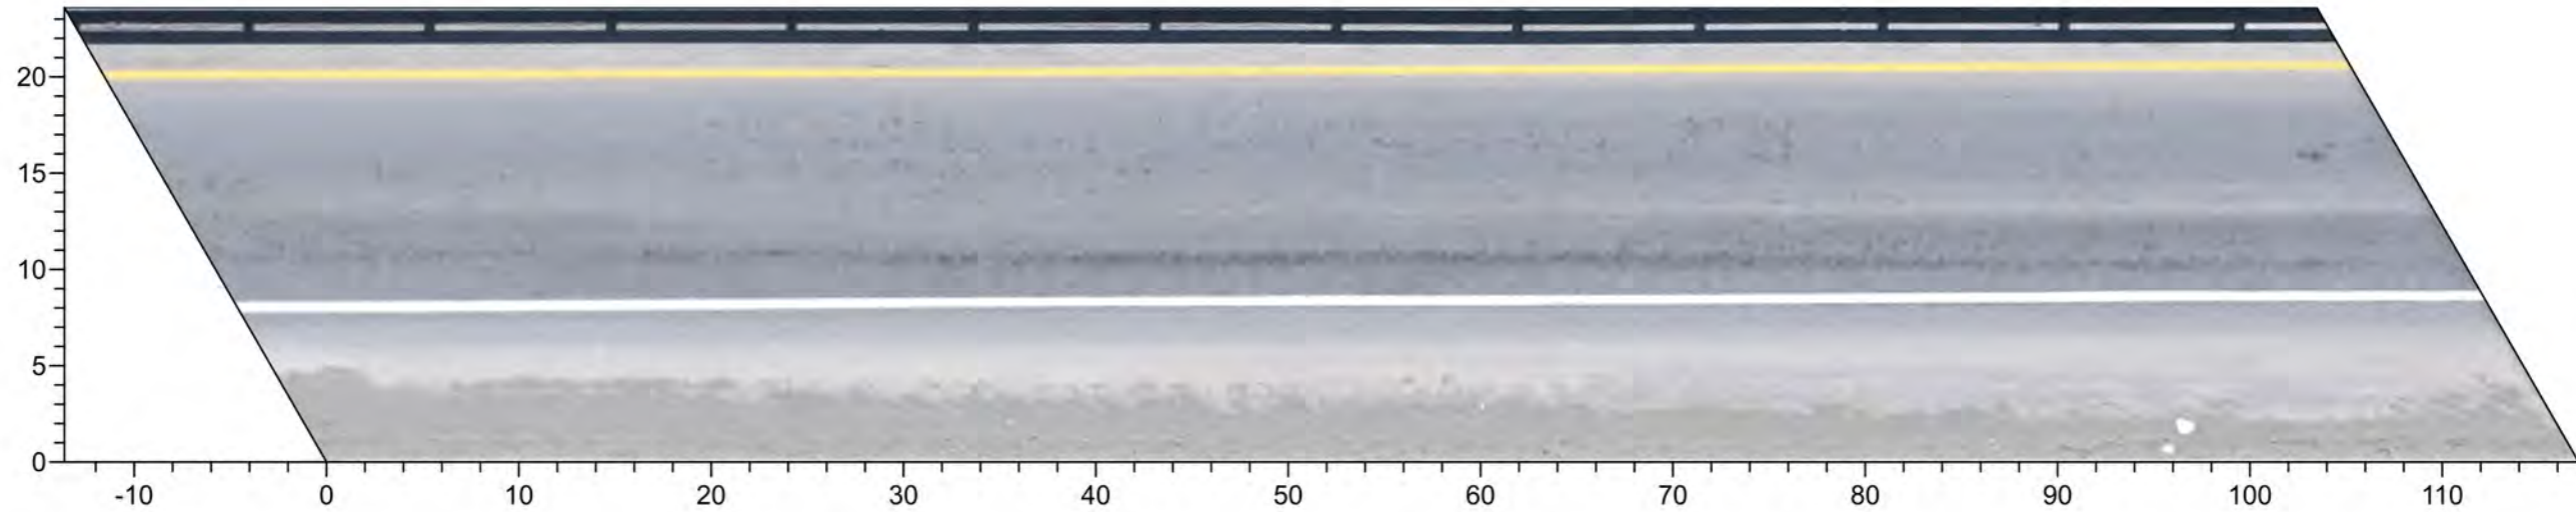
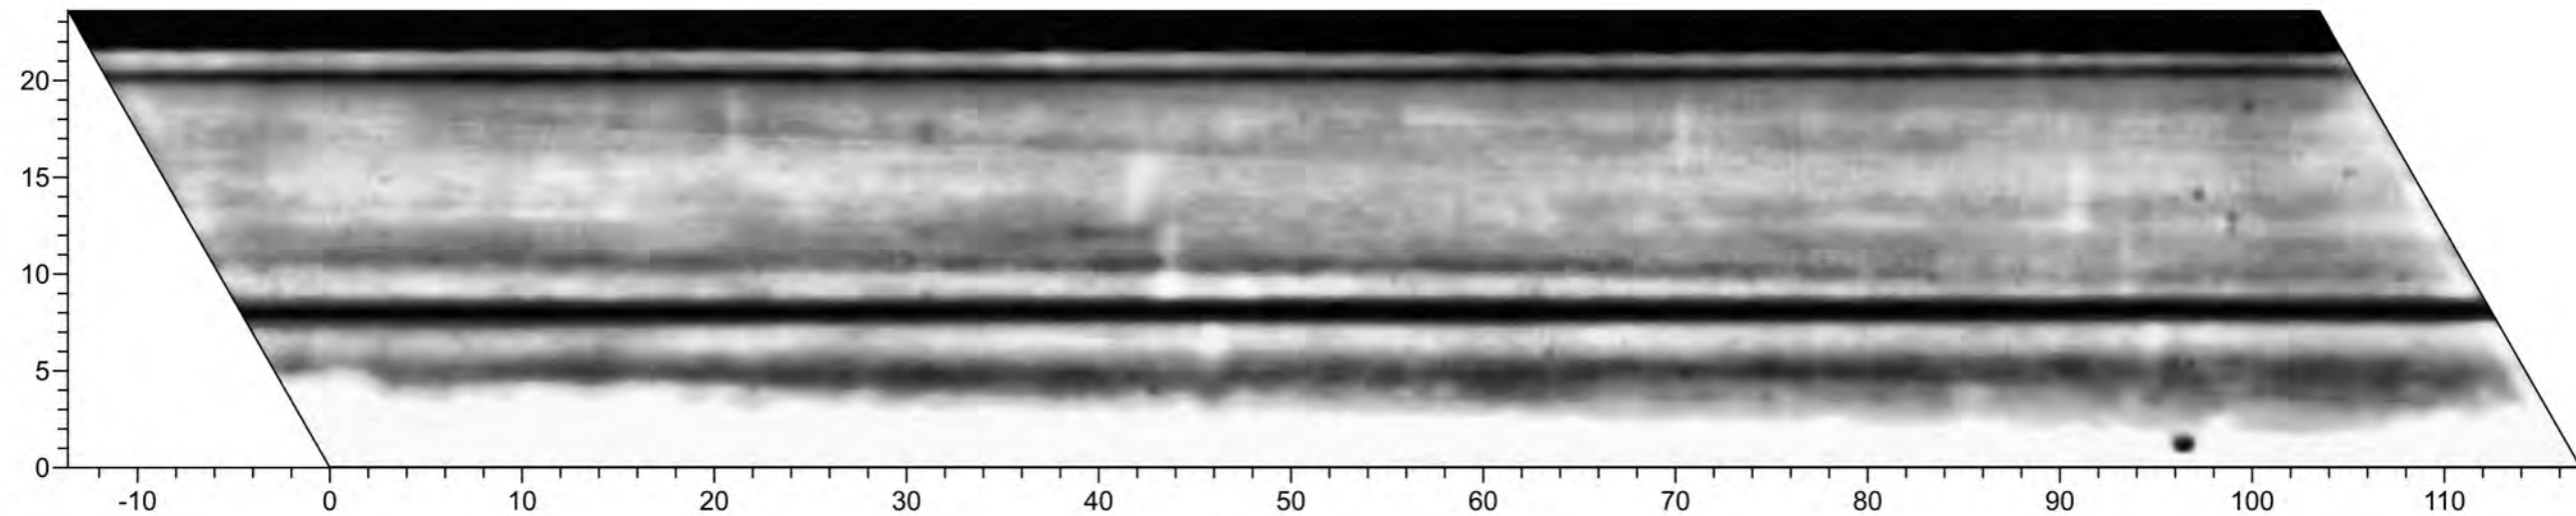
Delamination Quantity (%)	1.3	Imagery Collected: 6/4/22 Analyzed by: SB Reviewed by: AJC Completed: 10/5/22	
		Delamination Quantity (ft ²)	34

*Note: 47 sq. ft. of thermal anomalies not mapped due to being rectilinear in shape and appearing more like subsurface patching or some other structural feature

Note: Delamination locations not shown as quantity is less than 2%.

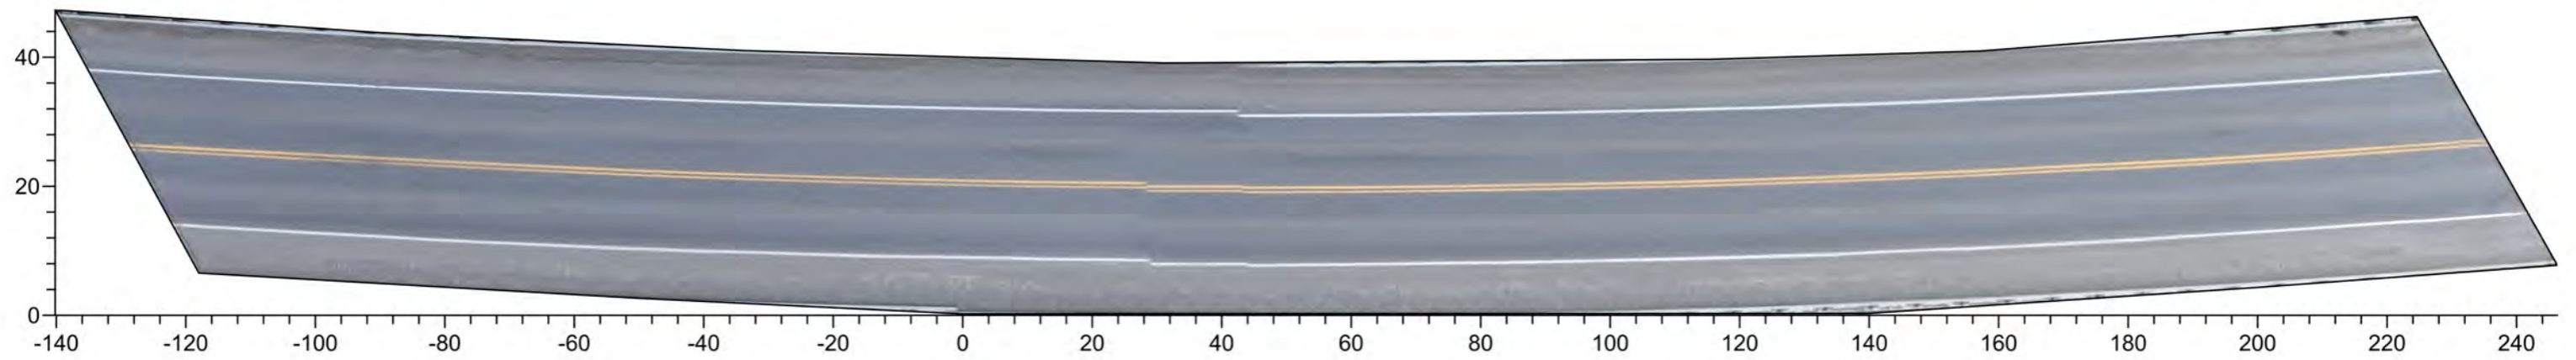
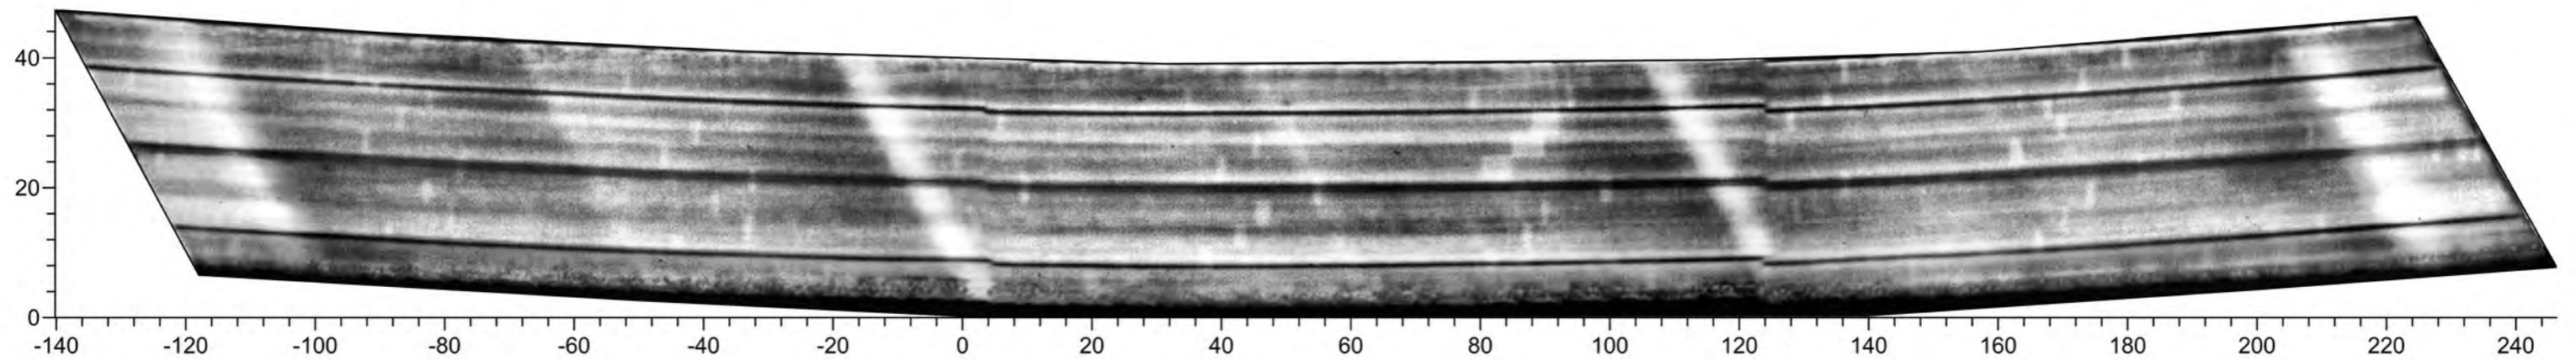
Delaminations Detected by Aerial Infrared	Quantity Summary		Analysis Information	Bridge No.: 2036 WASILLA CR NB RAMP PARKS HIGHWAY
1-in = 10-ft

Delamination Quantity (%) 0.6 Delamination Quantity (ft ²) 16	Imagery Collected: 6/4/22 Analyzed by: SB Reviewed by: AJC Completed: 10/5/22

*Note: 409 sq. ft. of thermal anomalies not mapped due to being rectilinear in shape and appearing more like subsurface patching or some other structural feature

Note: Delamination locations not shown as quantity is less than 2%.

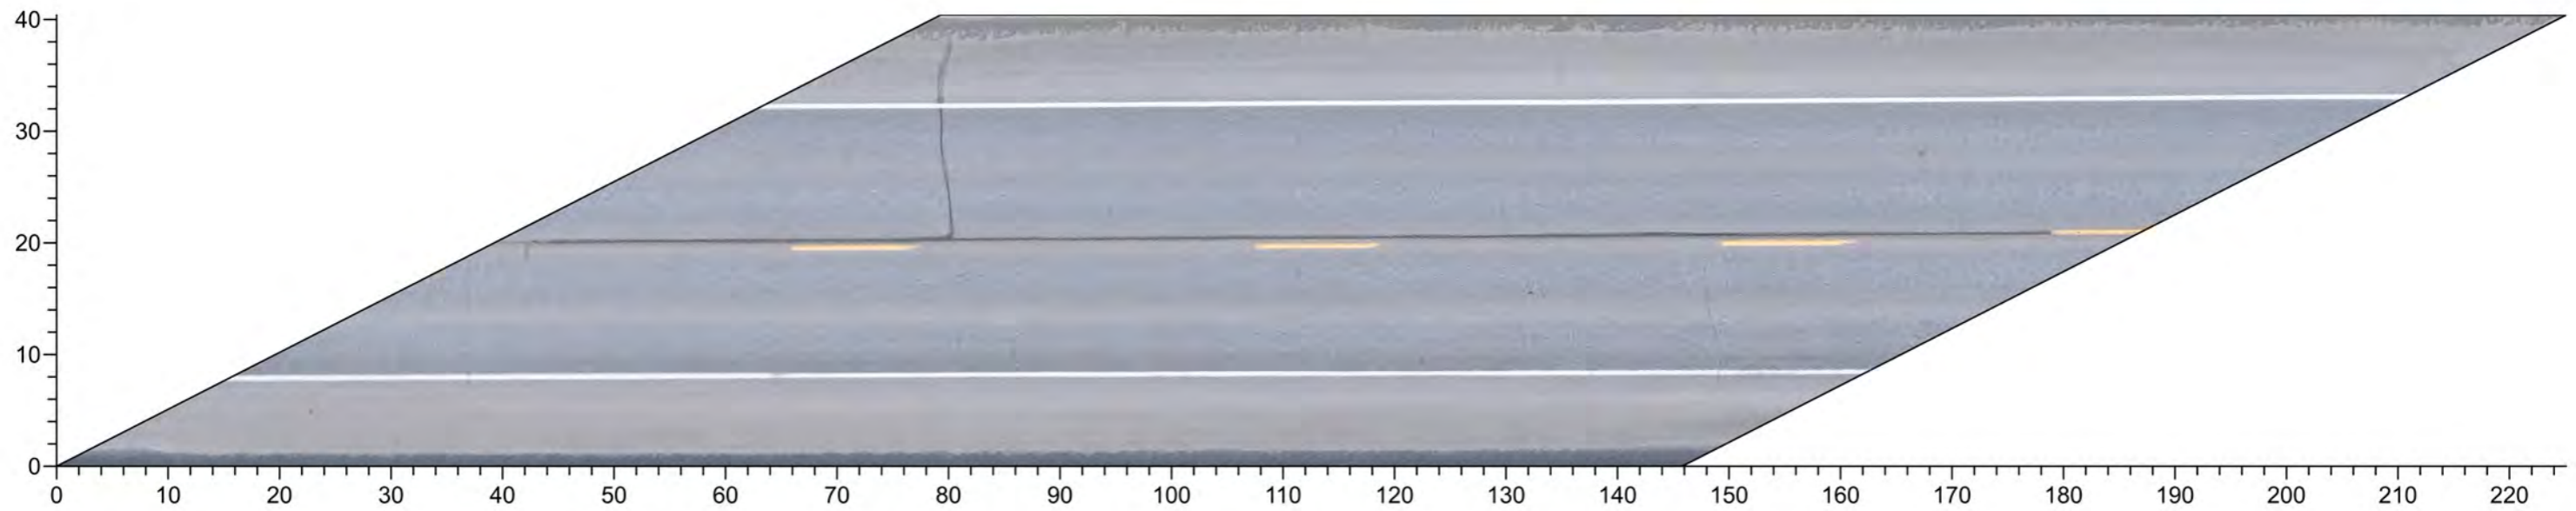
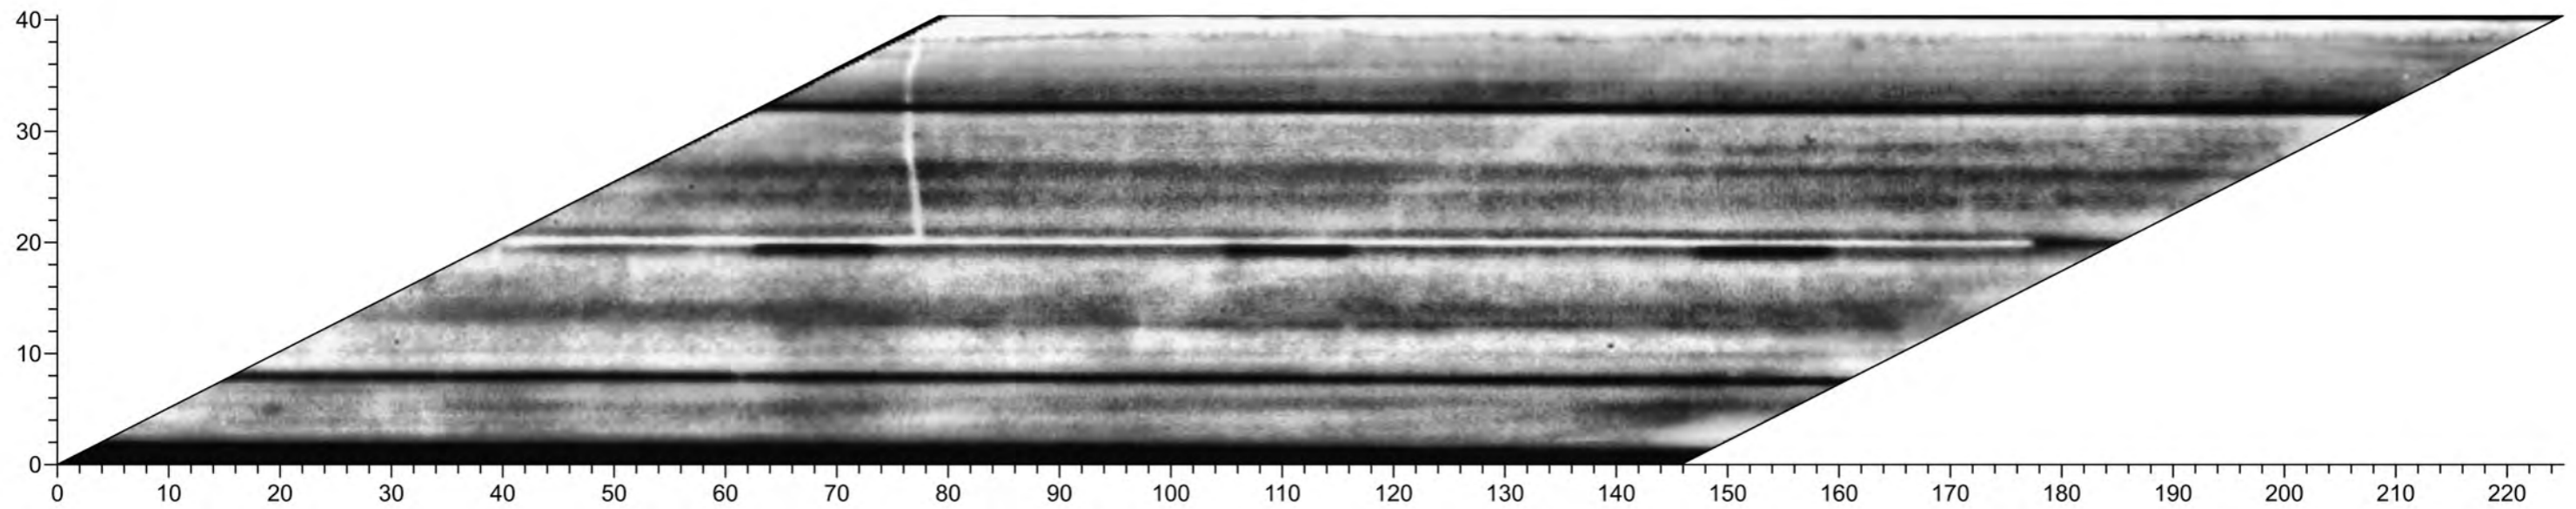
Delamination Quantity (%) 0.3 Delamination Quantity (ft ²) 37	Imagery Collected: 6/4/22 Analyzed by: SB Reviewed by: AJC Completed: 10/5/22

Note: Delamination locations not shown as quantity is less than 2%.

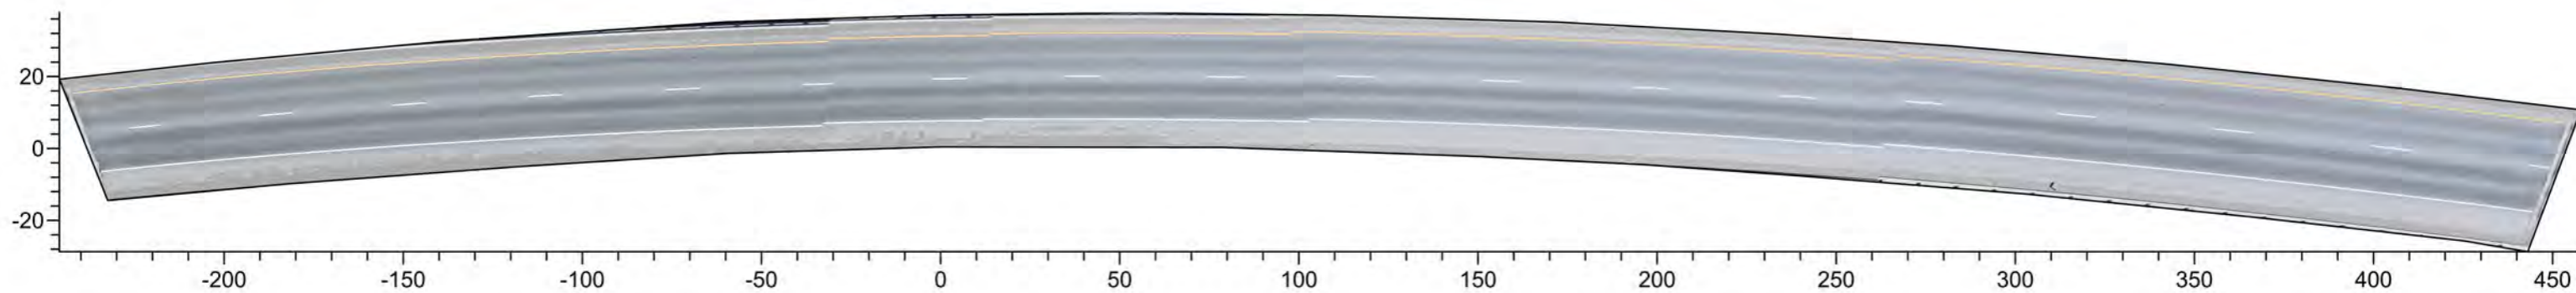
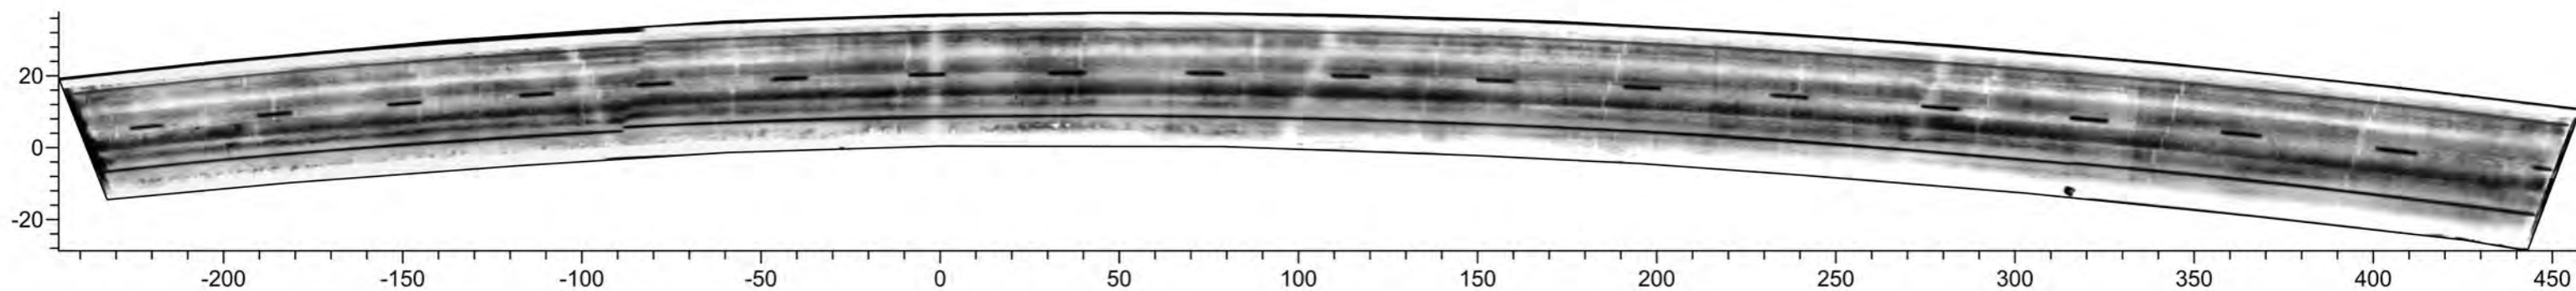
Delamination Quantity (%) 1.1 Delamination Quantity (ft ²) 67	Imagery Collected: 6/5/22 Analyzed by: SB Reviewed by: AJC Completed: 10/5/22

*Note: 321 sq. ft. of thermal anomalies not mapped due to being rectilinear in shape and appearing more like subsurface patching or some other structural feature

Note: Delamination locations not shown as quantity is less than 2%.

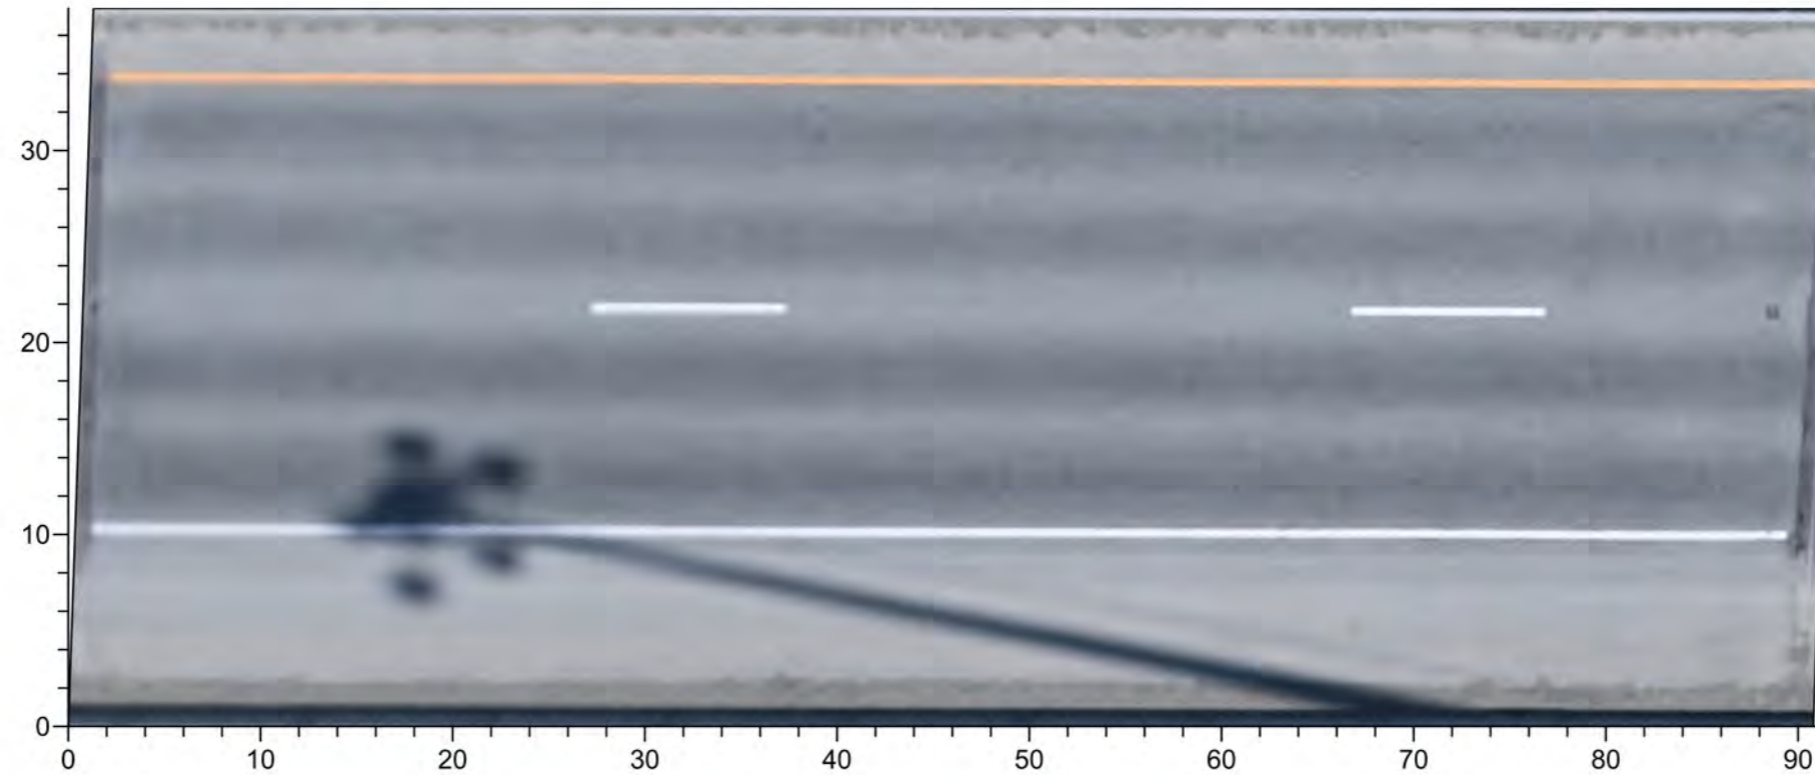
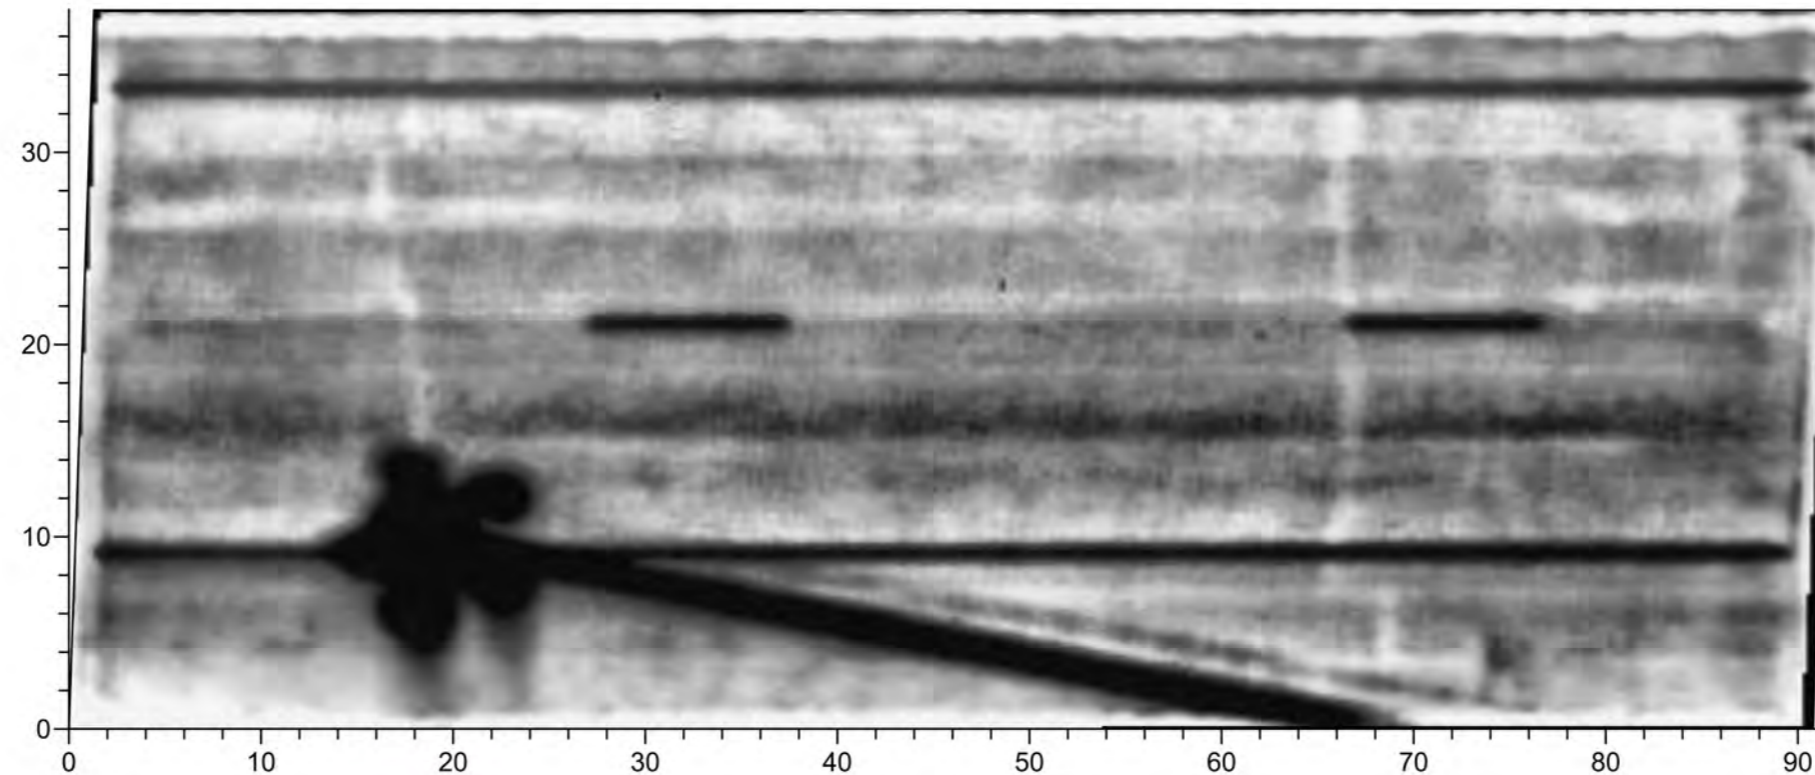
Delamination Quantity (%) 0.7 Delamination Quantity (ft ²) 219	Imagery Collected: 6/4/22 Analyzed by: SB Reviewed by: AJC Completed: 10/11/22

*Note: 63 sq. ft. of thermal anomalies not mapped due to being rectilinear in shape and appearing more like subsurface patching or some other structural feature

Note: Delamination locations not shown as quantity is less than 2%.

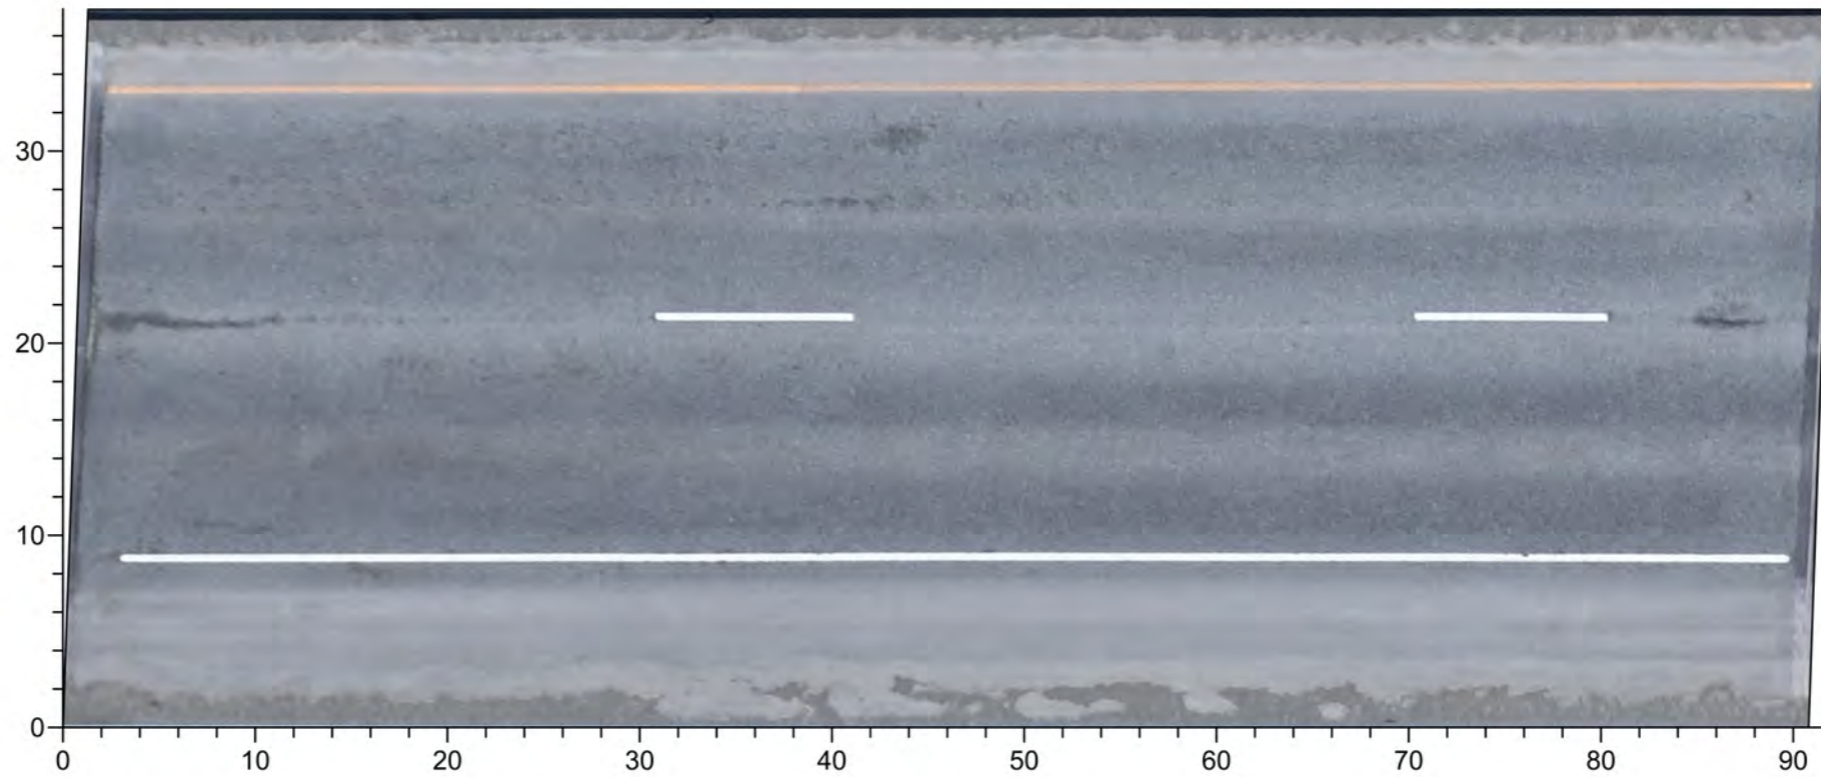
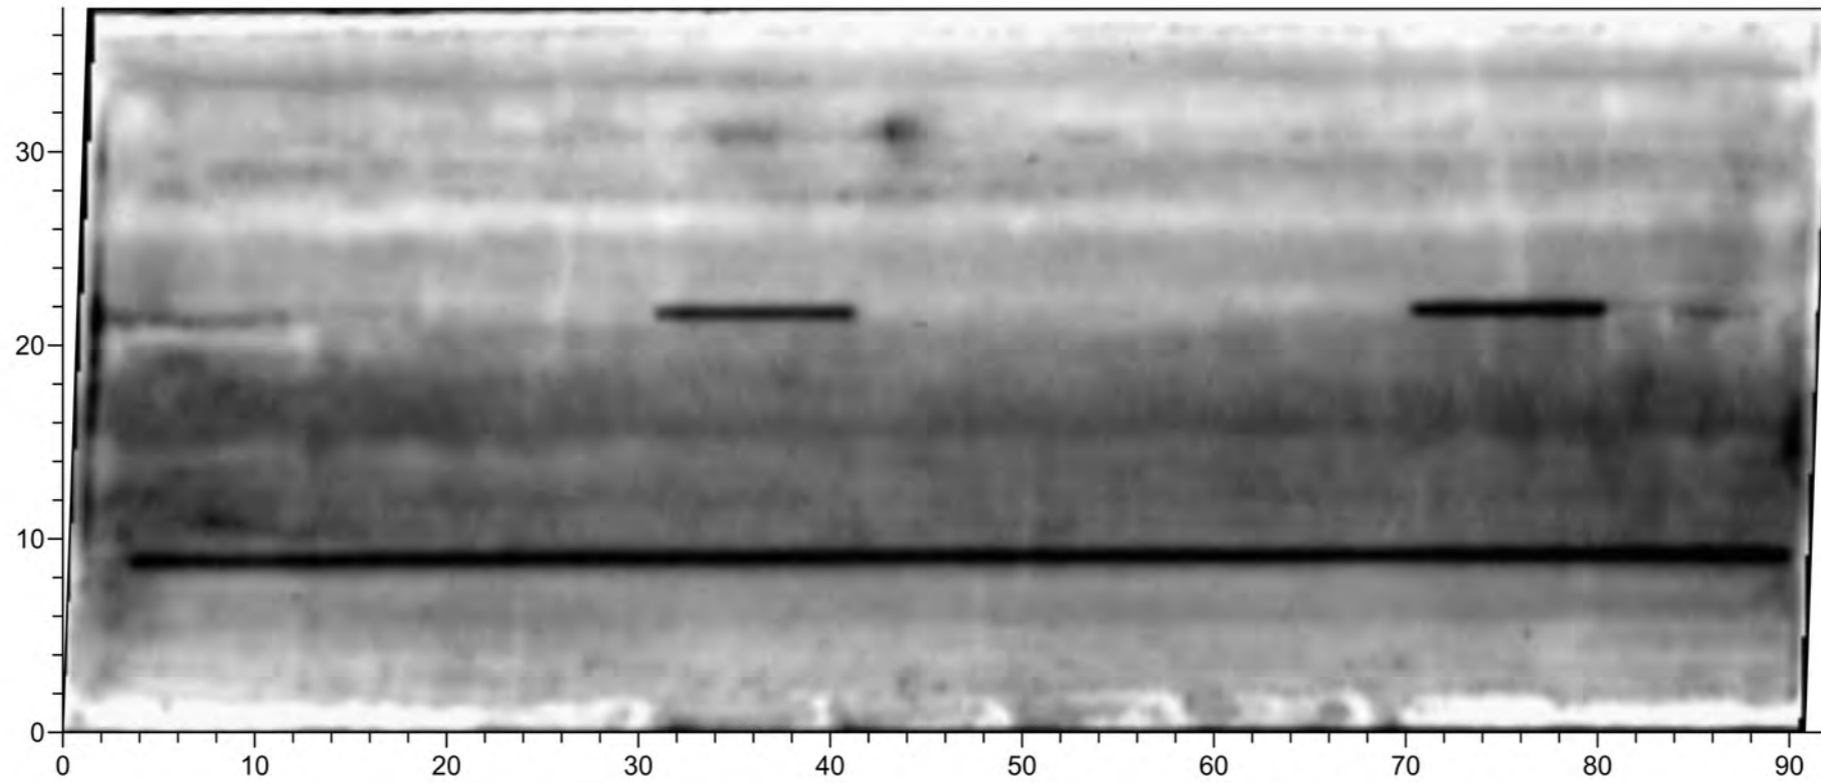
Delamination Quantity (%) 0.8 Delamination Quantity (ft ²) 26	Imagery Collected: 6/4/22 Analyzed by: SB Reviewed by: AJC Completed: 10/5/22

Note: Delamination locations not shown as quantity is less than 2%.
