Aerial Infrared Scanning of Bridge Decks on Parks Highway to Map Delaminations

FINAL REPORT

Prepared by:
Infrasense, Inc.
Woburn, MA

Report # FHWA-AK-RD-000S(960)
March 2, 2023

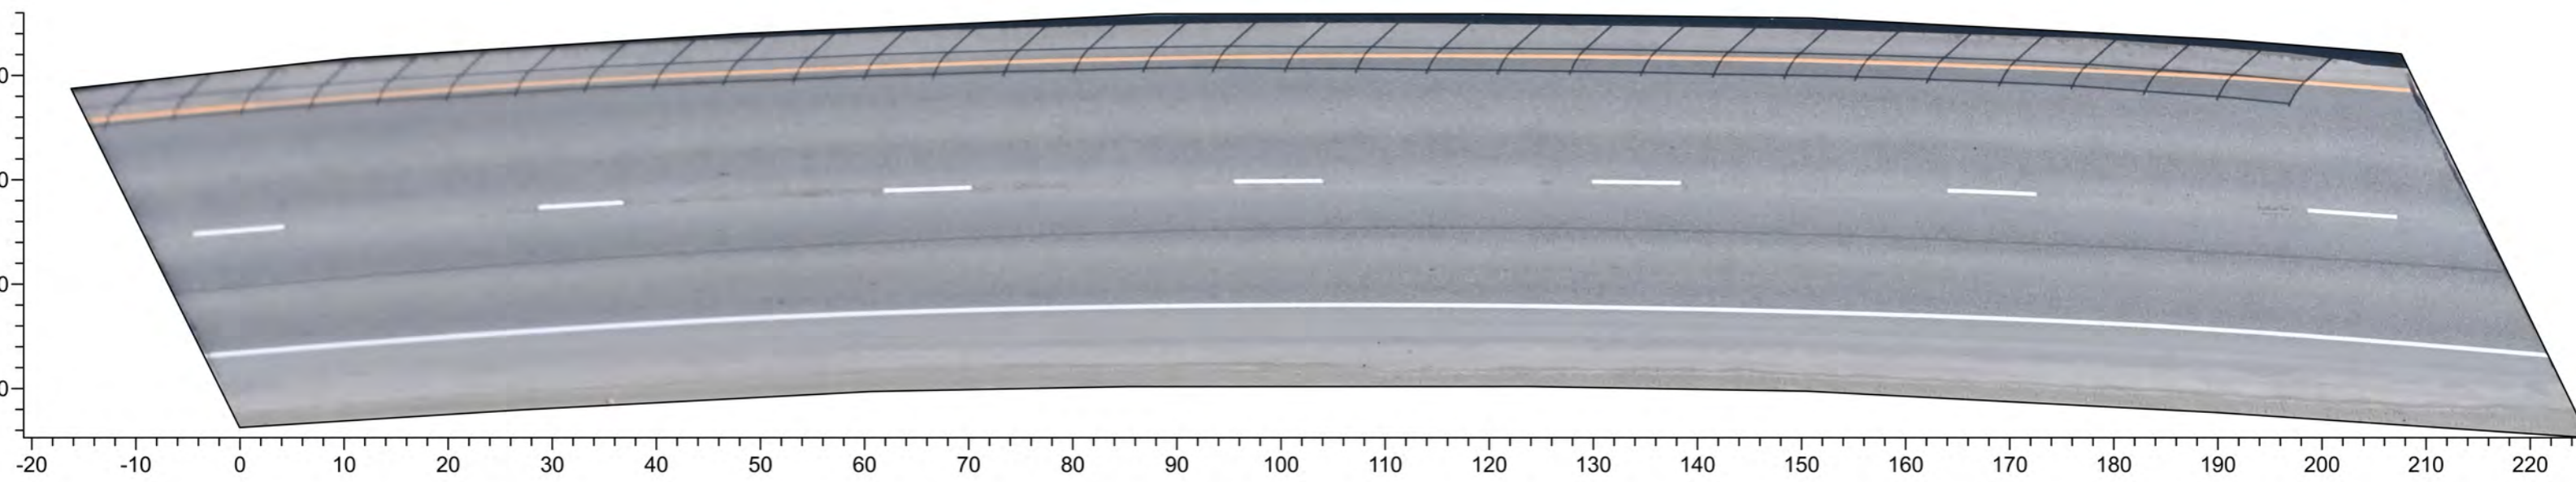
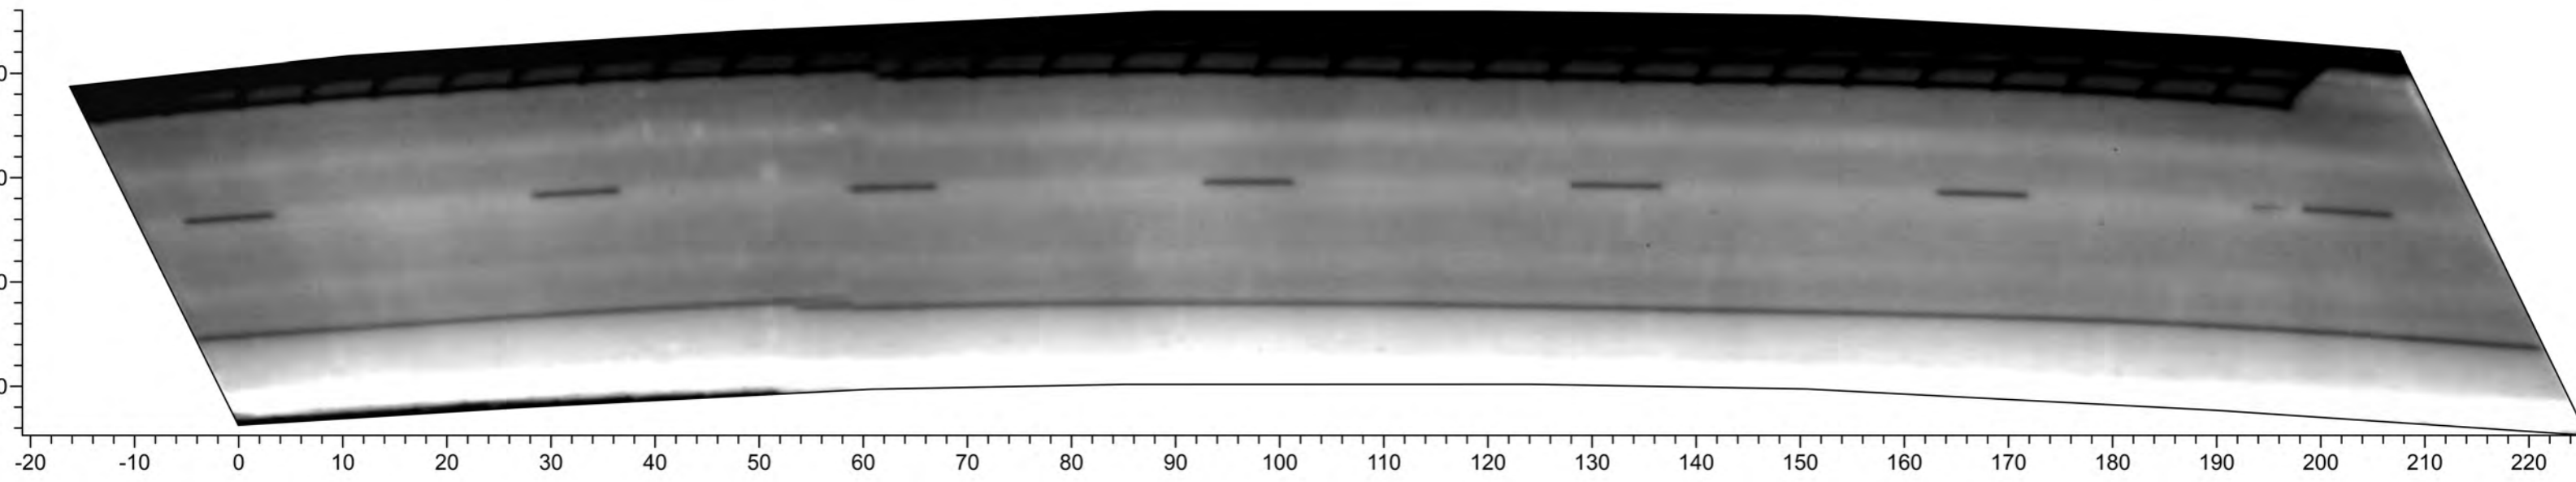
Delamination Quantity (%)	1.5	Imagery Collected: 6/4/22 Analyzed by: SB Reviewed by: AJC Completed: 10/5/22	
		Delamination Quantity (ft ²)	52

Note: Delamination locations not shown as quantity is less than 2%.

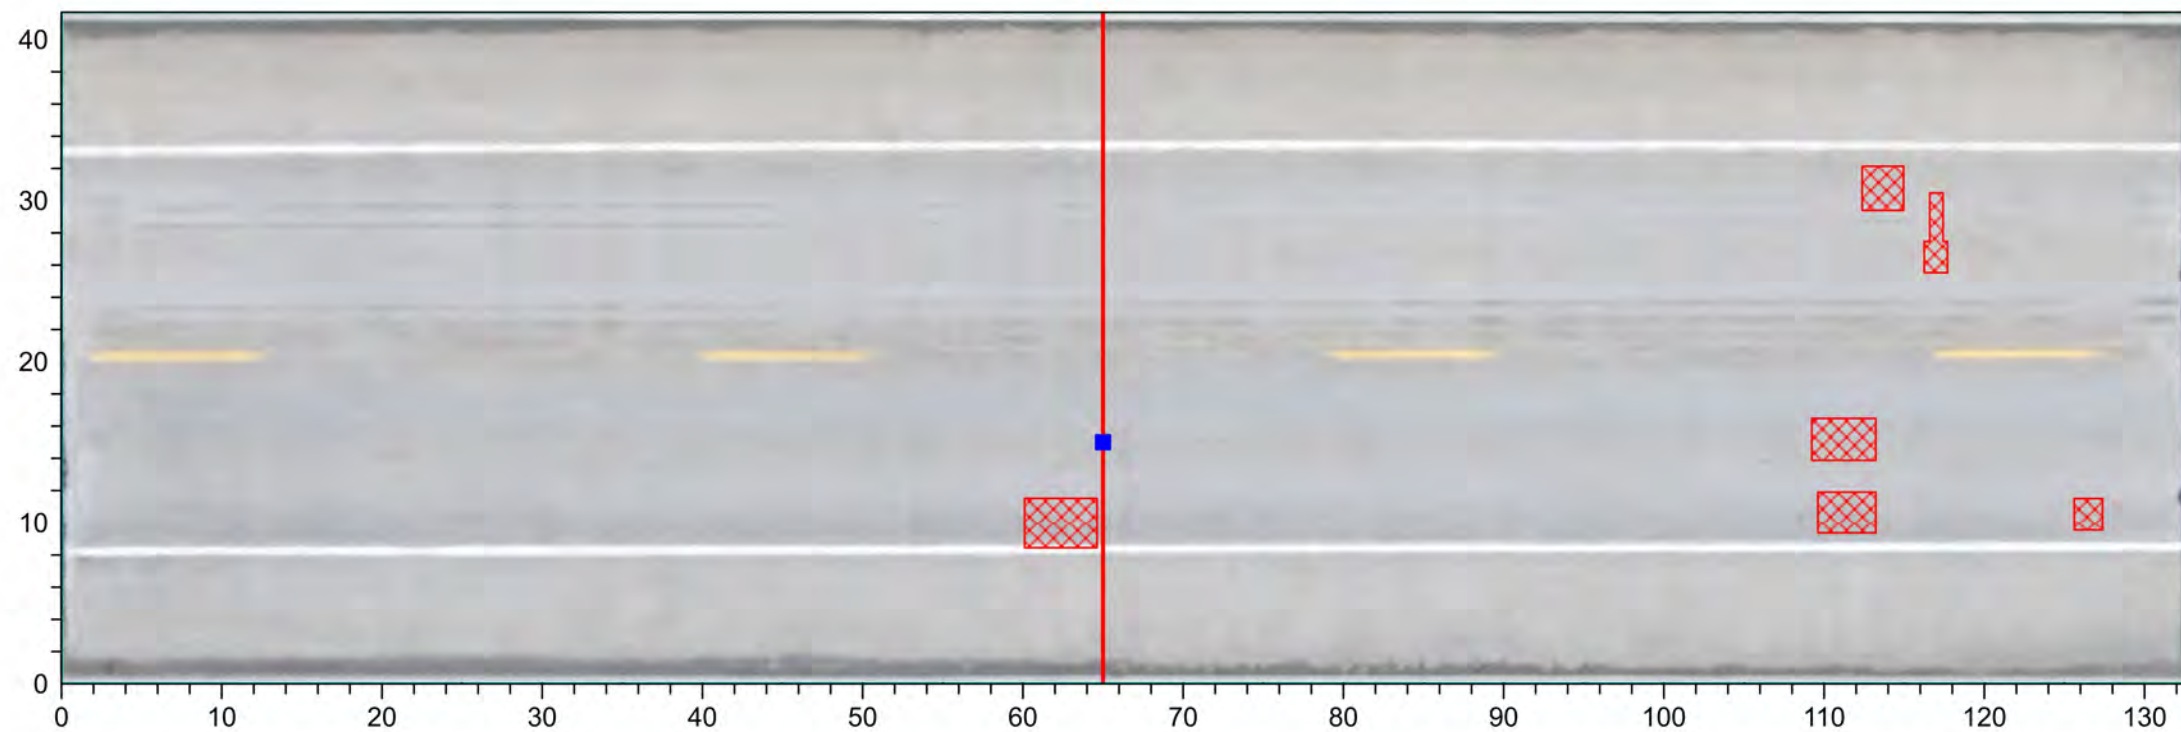
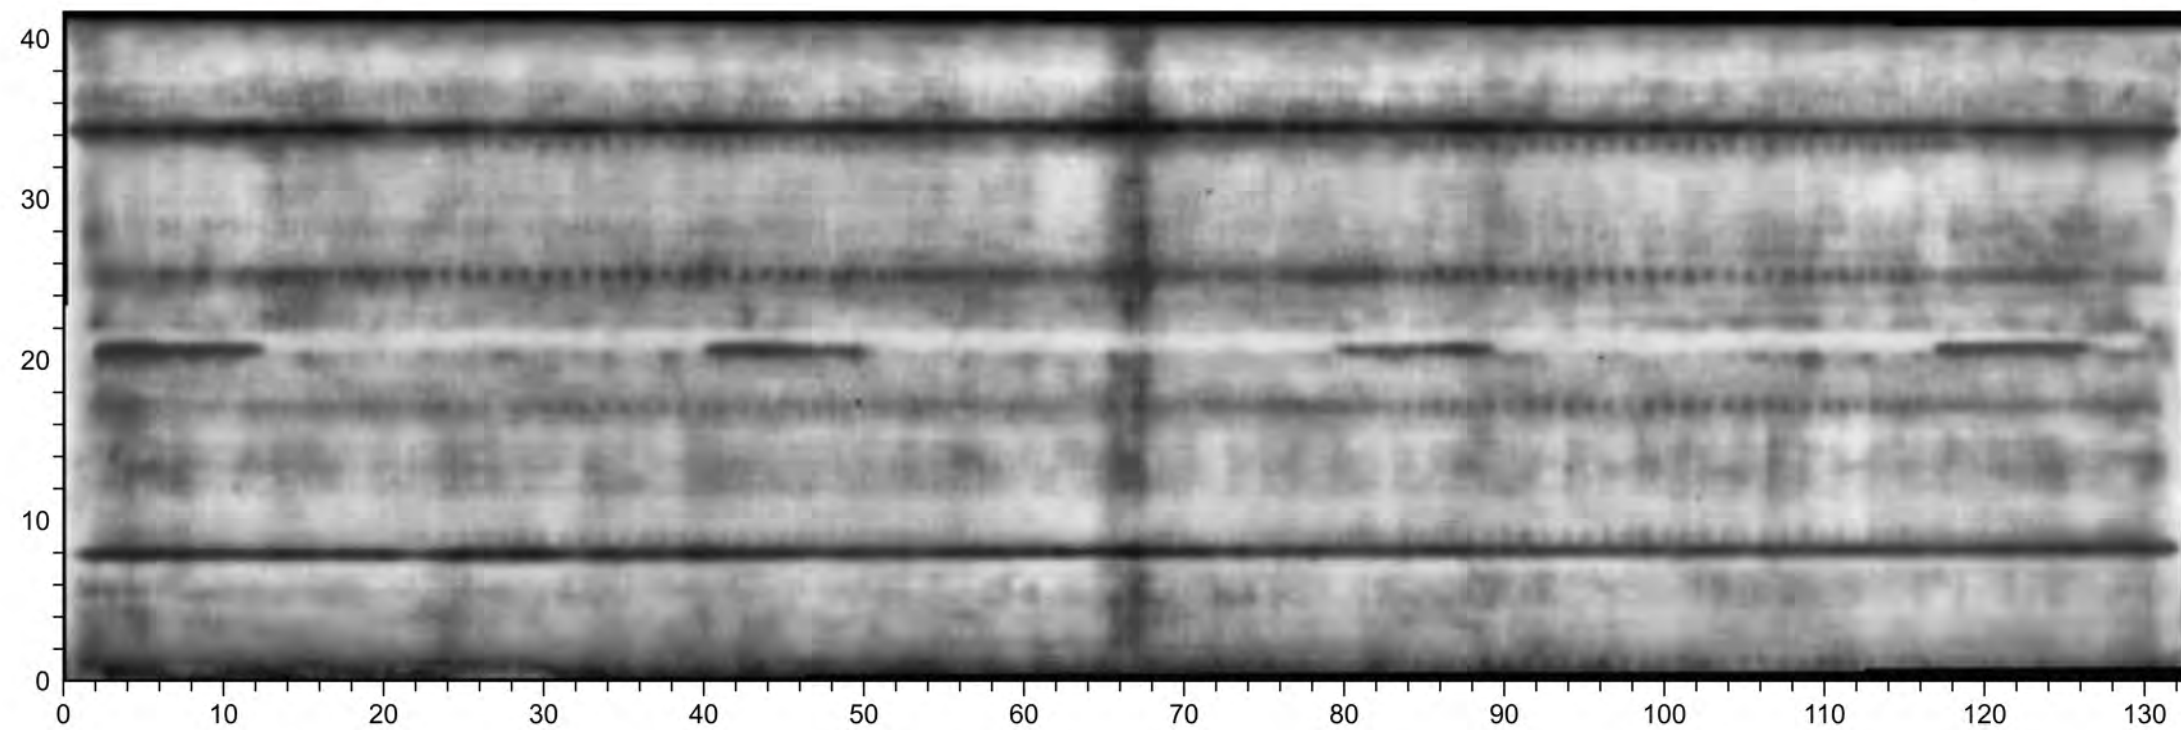
Delaminations Detected by Aerial Infrared	Delamination Quantity (%) 2.1 Delamination Quantity (ft ²) 660	Imagery Collected: 6/4/22 Analyzed by: SB Reviewed by: AJC Completed: 10/12/22	Bridge No.: 0254 SUSITNA RIVER PARKS HIGHWAY

Chain Drag Delamination Quantity (%)	<0.1
Chain Drag Delamination Quantity (ft ²)	1

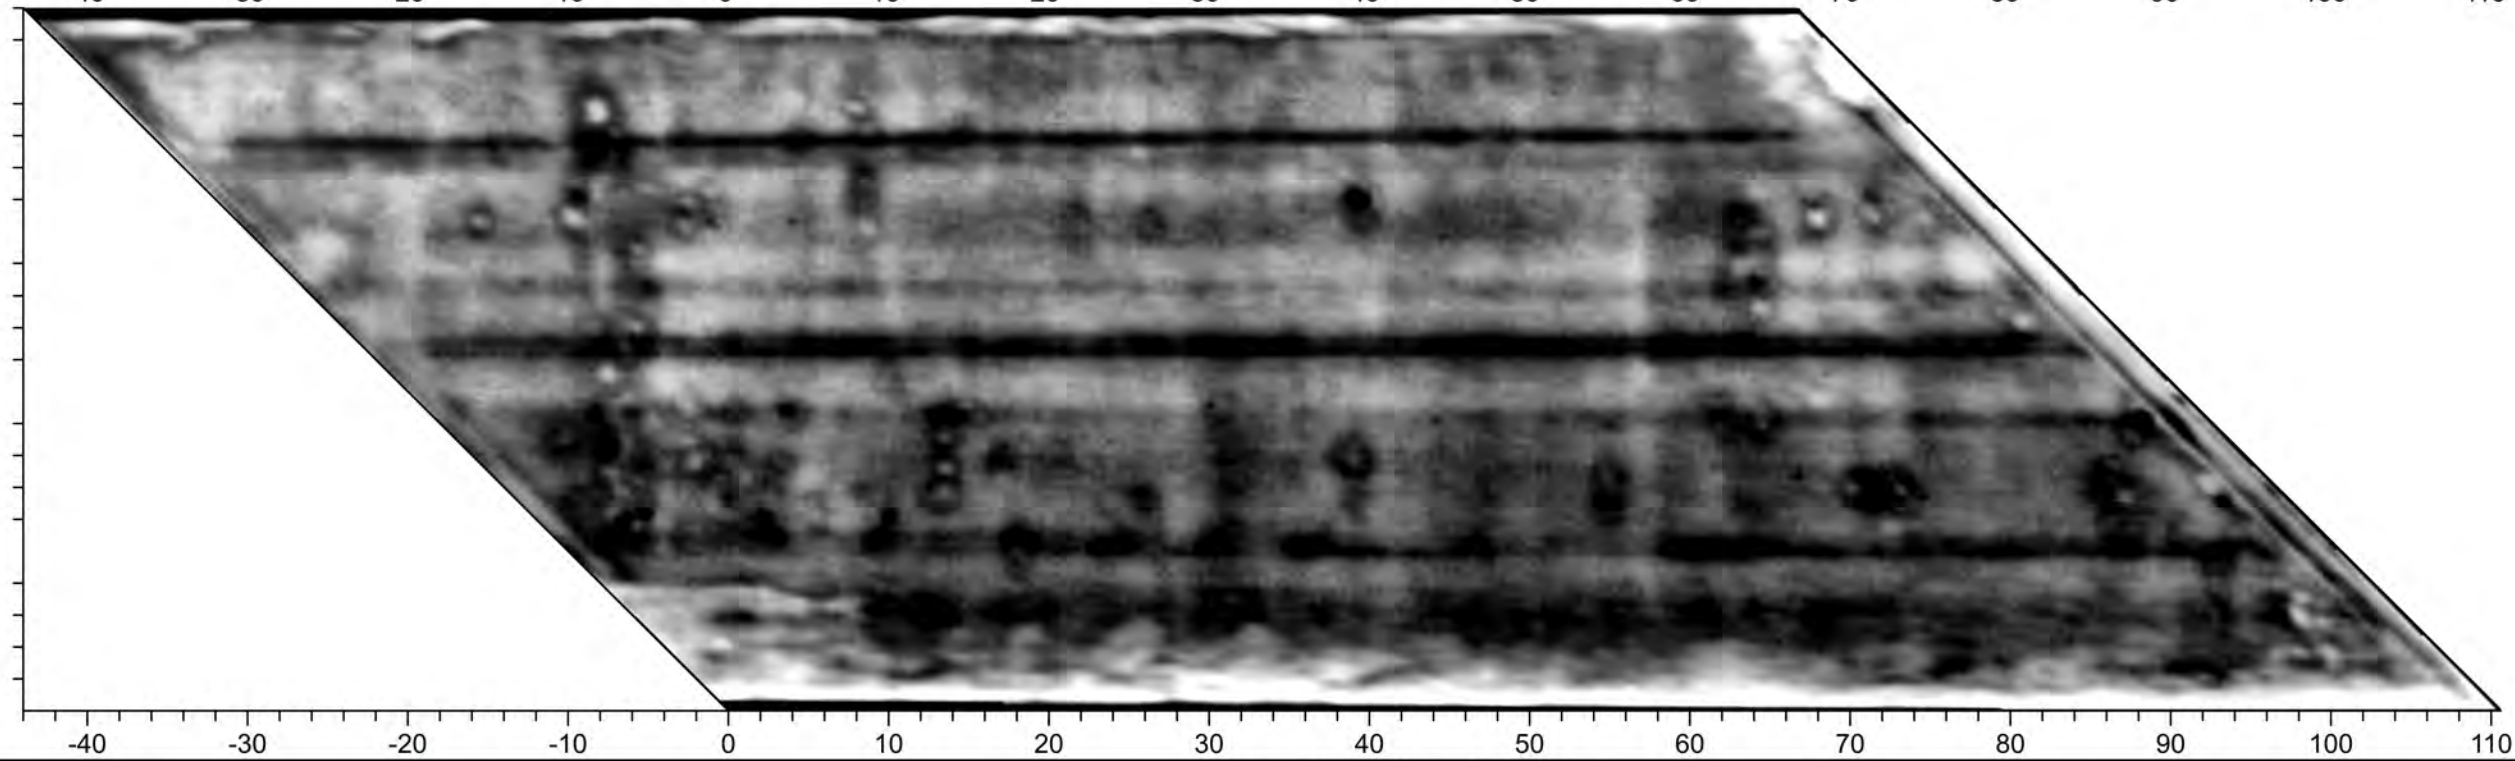
Delaminations Detected by Aerial Infrared	Quantity Summary		Analysis Information Imagery Collected: 6/5/22 Analyzed by: EG, SB Reviewed by: AJC Completed: 10/6/22	Bridge No.: 0311 BEAR CREEK PARKS HIGHWAY
			Delamination Quantity (%)	1.8

Chain Drag Delamination Quantity (%)	3.1
Chain Drag Delamination Quantity (ft ²)	153

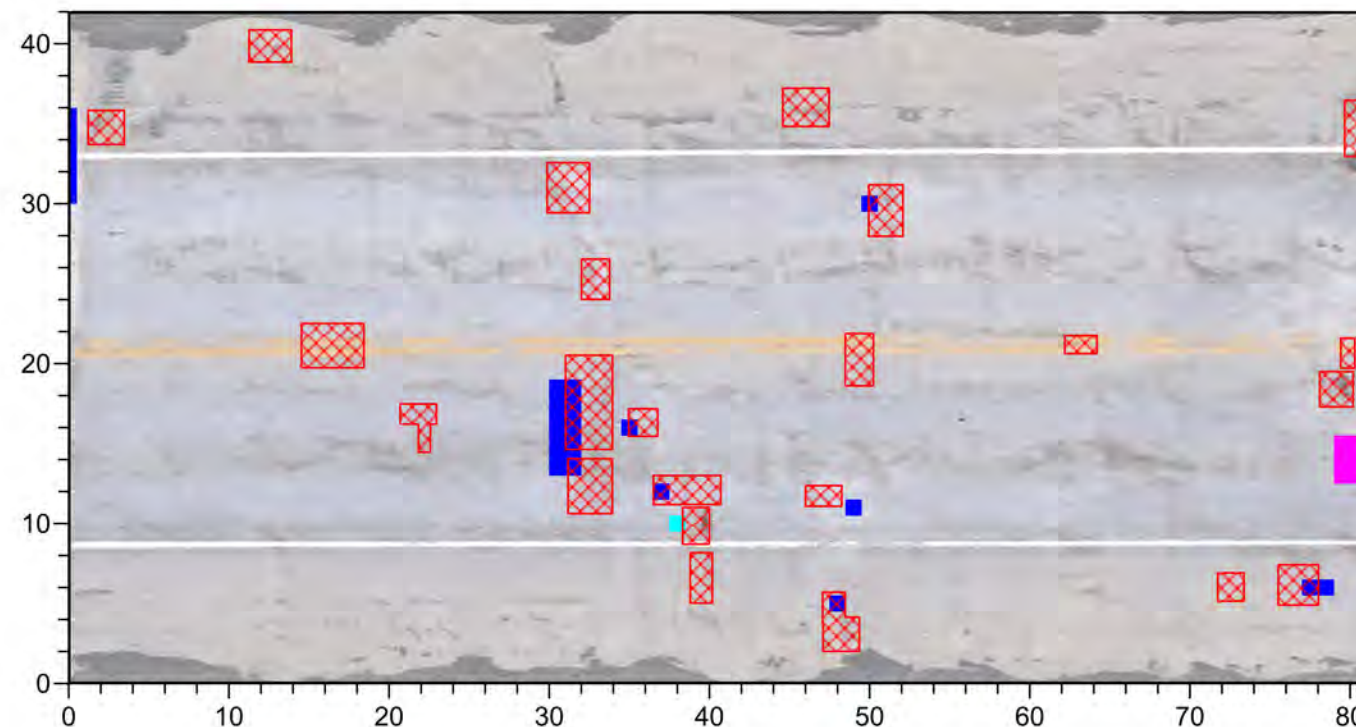
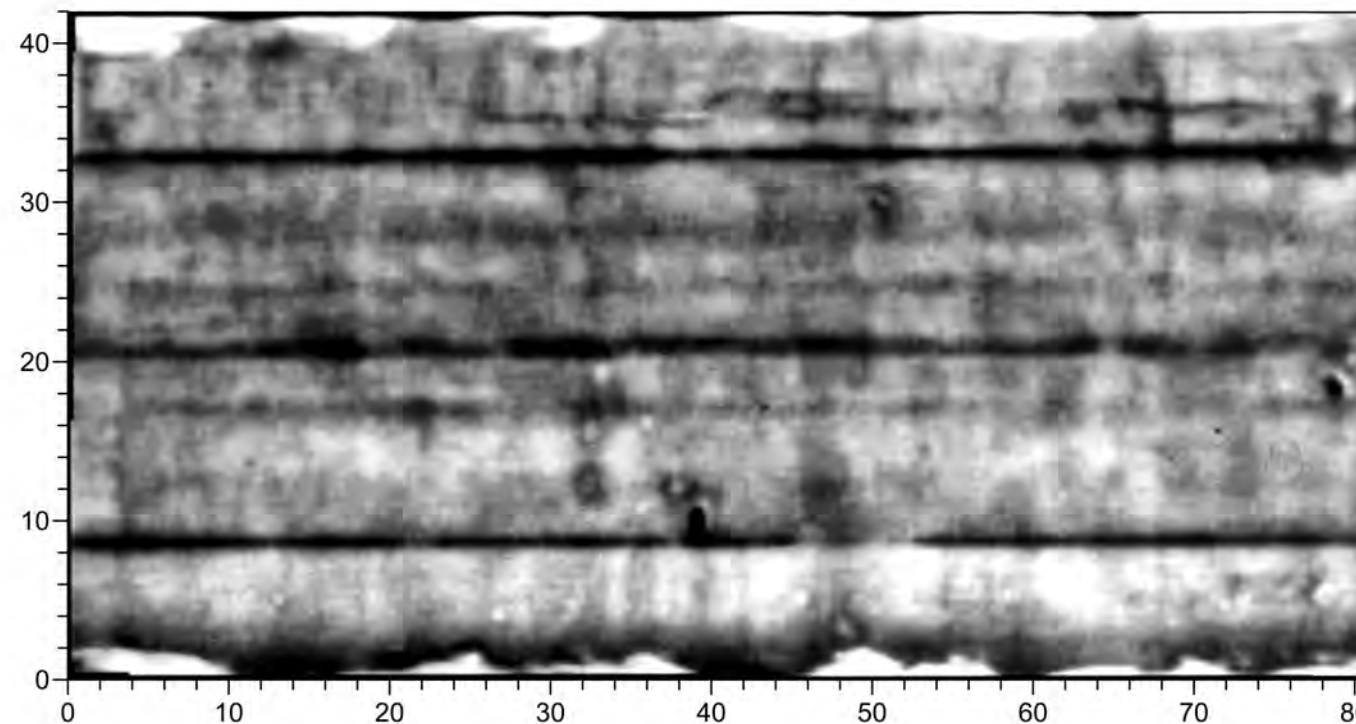
Delaminations Detected by Aerial Infrared	Delamination Quantity (%)	2.3	Imagery Collected: 6/5/22 Analyzed by: EG, SB Reviewed by: AJC Completed: 10/9/22
			Delamination Quantity (ft ²)	207

Chain Drag Delamination Quantity (%)	0.9
Chain Drag Delamination Quantity (ft ²)	31
Chain Drag Spalling Quantity (%)	<0.1
Chain Drag Spalling Quantity (ft ²)	1
Chain Drag Delam/Spall Quantity (%)	0.2
Chain Drag Delam/Spall Quantity (ft ²)	6
