Alaska Department of Transportation & Public Facilities  
**Research & Technology Transfer**

# Experimental Study of Various Techniques to Protect Ice-Rich Cut Slopes

August 2014

**Number:** 4000(113)B

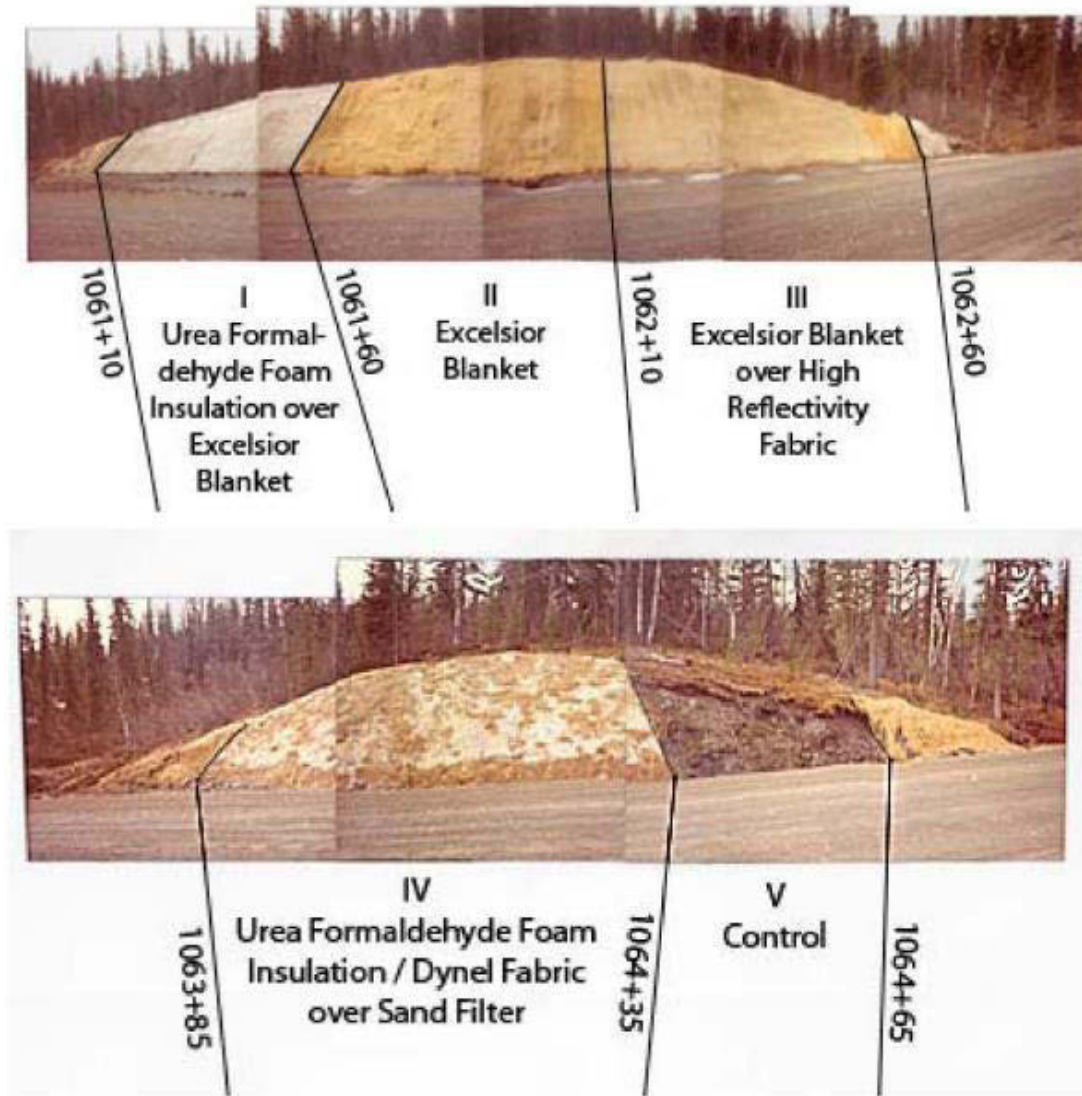
Figure 2.2 Four test sections and control section at Hess Creek, Alaska (after APSC, 1974)

1.5:1 (horizontal to vertical) into ice-rich silt (APSC, 1974, 1975). The test sections, originally monitored during the 1973 and 1974 summer seasons, are shown in Figure 2.2. The findings were summarized in Vinson and McHattie (2009). All test sections were sprayed with the same grass seed mixture after construction. For Test Section I, during the second summer, large thaw-induced depressions developed under the insulation and large downslope movements of the thawed soil occurred. The slope movements destroyed 70% of the insulation. Thaw depths averaged 0.7 m (2.3 ft) in 1974. Test Section II experienced failure during the first summer, especially near the toe, with much of the failed material flowing into the ditch. By the end of the second summer, 50% of the slope was covered with the excelsior blanket, a vertical scarp had formed at the top of the slope, and the overall appearance was similar to Test Section I. Thaw depths averaged 0.8 m (2.6 ft) in 1974.

Test Section III, which was originally burlap (East) or nylon (West) coated with high-reflectivity titanium dioxide paint, became soaked and distorted with mudflows during construction. Two layers of excelsior blanket were placed over this material. Test Section III failed repeatedly in 1973. Mass movements in this test section were greater than in the other four sections during 1973. Thaw depths in 1974 were 0.9 m (3 ft) at the toe and greater than 1.5 m (5 ft) at the top of the slope. The insulation layer in Test Section IV was treated with straw mulch and seed to stimulate vegetation growth. It was intended that the sand filter layer would intercept meltwater and reduce excess pore water during periods of rapid thawing. Very little evidence of soil movement, sloughing, or meltwater release was observed in this section through 1974. Thaw depths were 0.6 to 0.9 m (2 to 3 ft) in 1974. Test Section V (control) experienced considerable caving and sloughing in 1973. The material was not transported far from the slope, as was the case for Test Sections I and II. By the end of the summer (1973), a vertical scarp developed at the top of the slope. No caving, sloughing, or erosion was observed in 1974, and sparse vegetation appeared on the slope surface. Thaw depths were 0.9 to 1.2 m (3 to 4 ft) in 1974.

Longer-term performance of the test sections was evaluated during two field investigations conducted in the 1983 summer season. The investigators noted that all the slopes were stable. However, significant slope deterioration caused by large-volume reduction and downslope movement occurred on the majority of the test sections. Revegetation was well established on

slopes that had experienced significant displacement and consequent flattening. Revegetation on steeper, less deformed slopes was not well established or was non-existent.

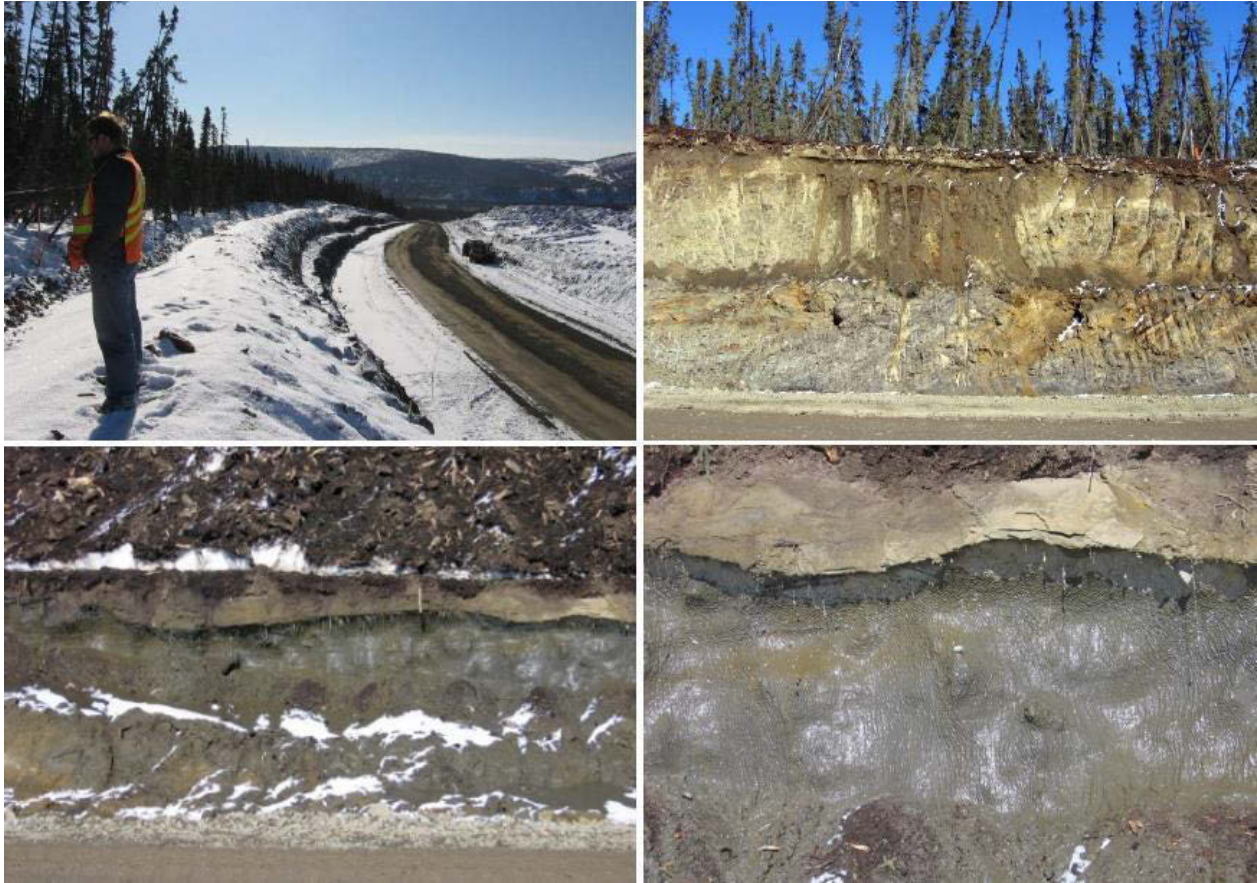
**Figure 2.3 Dalton Highway cut in ice-rich permafrost (Vinson and McHattie, 2009)**

A recent example (Vinson and McHattie, 2009) related to thermal erosion of cut slopes in ice-rich permafrost is located along the Dalton Highway, Milepost 37 to 49 (see Figure 2.3). The cut volume, originally considered bedrock and weathered bedrock, was actually highly weathered ice-rich bedrock. The cut design, though appropriate for weathered bedrock, was inappropriate for the unexpected ice-rich mineral soils. Uncontrolled erosion, thawed slurry runoff, and slope failure resulted in significant environmental concern.

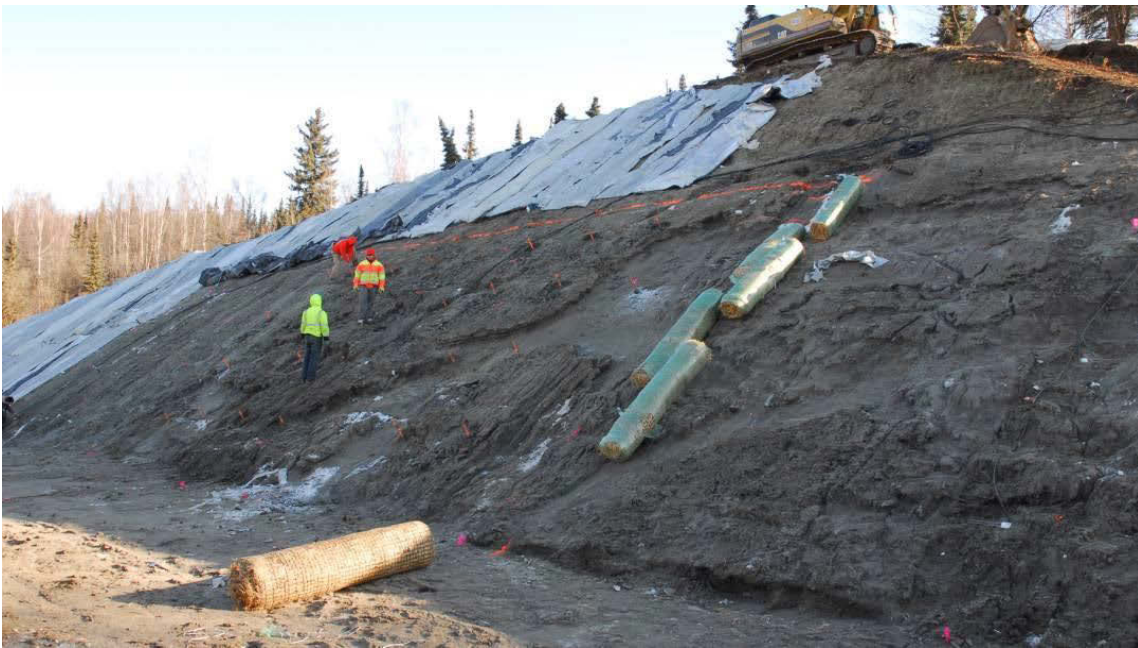
**Figure 4.7 Cut slope erosion during construction**

Due to high afternoon temperatures, thawing at the cut slope surface created obvious areas of erosion. Compared with the slope before construction (see Figure 4.1), significant erosion can be seen on the slope shown in Figure 4.7, especially within Sections C and D. Close-ups of this erosion are shown in Figures 4.8 and 4.9. To protect the slope from erosion during construction, insulating tarps (normally used to aid concrete curing during cold weather) were used to cover the entire cut slope, as shown in Figure 4.10. Nails were used to affix the tarp sections to the cut slope surface.

As mentioned previously (and shown in Figure 4.7), significant erosion was observed after the drilling process on the slope. The eroded, uneven slope surface quickly became unsuitable for placement of the coconut erosion control matting and the Tecco-mesh. It was necessary that both of these treatments be placed on a smooth ground surface to prevent air circulation between the treatment matting and the cut slope surface. Such air circulation would reduce the thermally protective effects of both treatment types. Therefore, prior to placement of the coconut matting (Section B) and Tecco-mesh (Section C) slope coverings, the bucket of a large backhoe excavator was used to smooth the uneven surface of the cut slope. This operation is shown in Figure 4.13. Then Sections B and C were seeded. Figure 4.14 shows a small area of the cut slope after seeding.

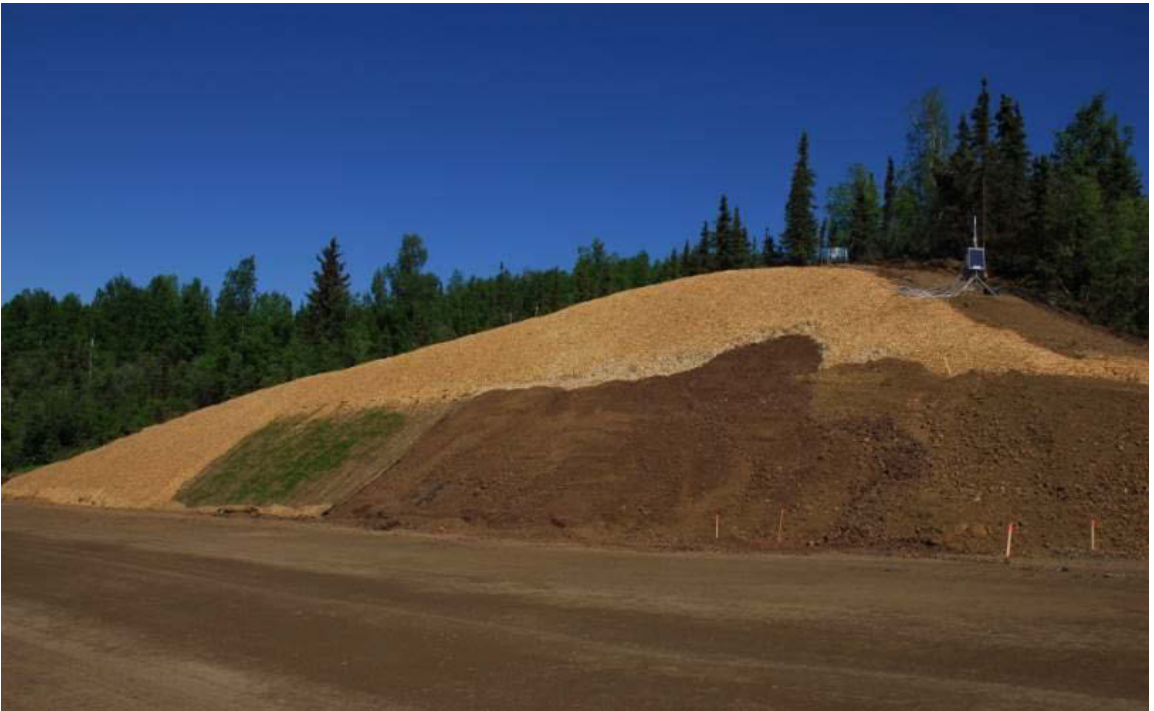
**Figure 6.8 Cut slope after construction on Section C**

According to the recommendations listed above, on June 17, 2013, Tecco-mesh and the coconut erosion control blankets at Section C were removed (shown in Figure 6.5). The great loss of volume in cut slope soil at Section C can be seen in Figure 6.6, especially where massive ice is exposed. Crushed rock was hauled to the test site, and an excavator was used to cover Section C with crushed rock (see Figure 6.7). The hollow rebar anchors were left intact during these repairs to serve as survey and photogrammetric reference points. Figure 6.8 shows the cut slope after completion of repairs on June 17, 2013.

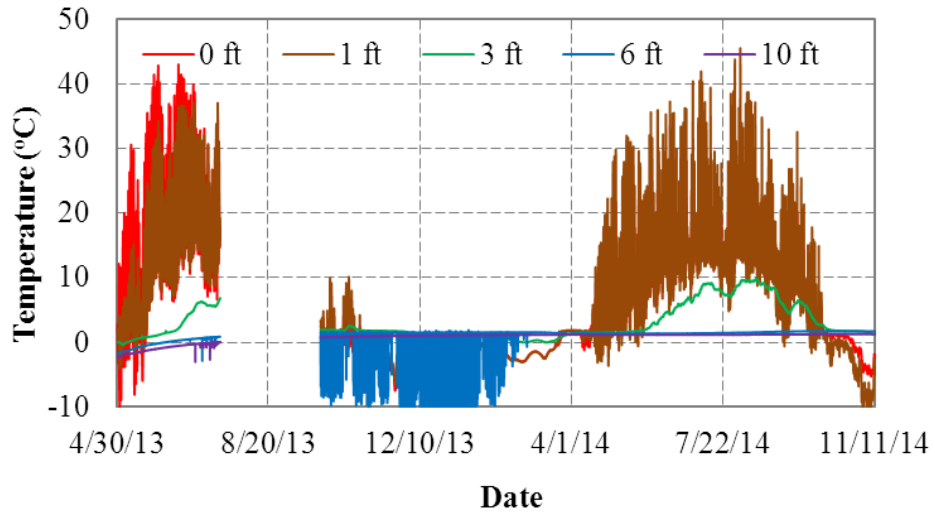
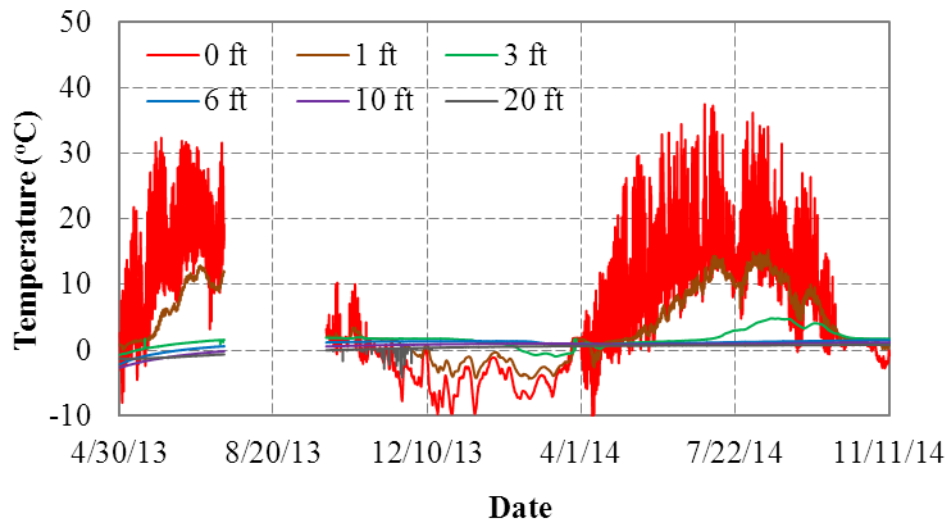
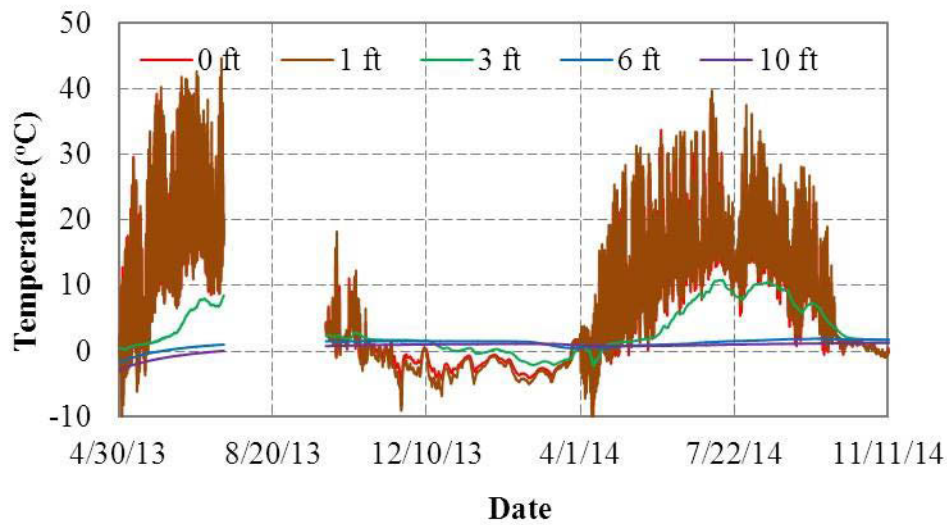
**Figure 7.11 Temperature variations in Section B**

Figure 7.11 shows temperature changes at the bottom, middle, and top of Section B (coconut blanket) at different depths (0, 1, 3, 6, 10, and 20 ft). For Section A, temperature variations at different depths are presented in different colors.

Similar to the temperature variation in Section A, due to the air temperature increase during the time period between April 30 and July 15, 2013, soil temperatures increased throughout the monitoring period at different depths and decreased during the time period between November and December 2013, as seen in Figure 7.11. Then, in March, soil temperature at 0 ft started to rise up with fluctuations till the end of June. The soil temperature at depths below 0 ft continuously decreased from January to April and then rose up till the end of June. At the slope surface, the temperature changes closely followed air temperature variation. Also, the temperature variations for the bottom, middle, and top of the section were consistent with one another due to the thickness uniformity of the coconut blanket, except for the temperatures at the middle with depths of 1 and 3 ft. At 1 ft below the slope surface in this section, especially for the temperatures at the top and bottom of this slope, the soil temperature changes closely followed the daily air temperature variation. Compared with the layer of wood chips, the coconut blanket (as expected) offered essentially no insulative benefit. Three ft below the slope surface of this section, soil temperature changes smoothly followed the long-term increase in air temperature—in a damped response compared with the soil at 1 ft depth.

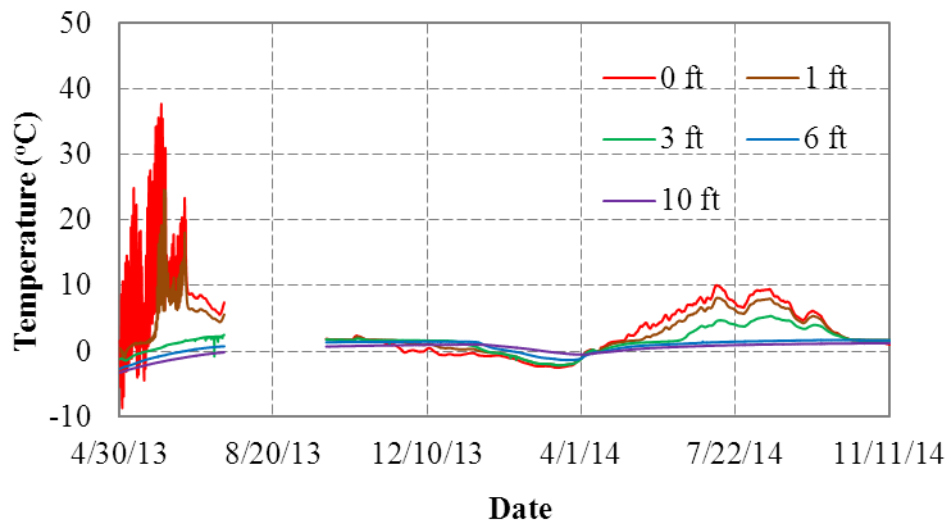
**Figure 7.12 Temperature variations in Section C**

Figure 7.12 shows temperature changes at the bottom, middle, and top of Section C (Tecco-mesh and coconut blanket) at different depths (0, 1, 3, 6, 10, and 20 ft). Temperature variations at different depths are presented in different colors. Due to thaw-related slope failures in this

section, the Tecco-mesh and coconut blanket were removed and replaced by crushed rock on June 17, 2013. The layer of crushed rock was of variable thickness due to the uneven surface of the damaged slope. The thickness of the rock blanket ranged from about 1 to 3 ft. Temperature sensors located at depths of 6 and 10 ft at the bottom of Section C stopped working after the June 17, 2013 repair work.

Before the major repair work on June 17, 2013, temperature variations within Section C were generally similar to those of Sections A and B, as seen in Figure 7.12. At the slope surface and 1 ft below, temperatures followed the daily air temperature variation. Compared with the wood chip section (Section A), the coconut blanket together with the Tecco-mesh offered essentially no insulative benefit, as expected. After the replacement of the Tecco-mesh and coconut blanket with a rock blanket, temperature sensors at the original slope surface and originally 1 ft below indicated that a period of cooling occurred. No such period of cooling was seen in Sections A or B. Soil temperatures variations between October, 2013 and August 2014, which was after the repair work on June 17, 2013, were also similar to that in Sections A and B.

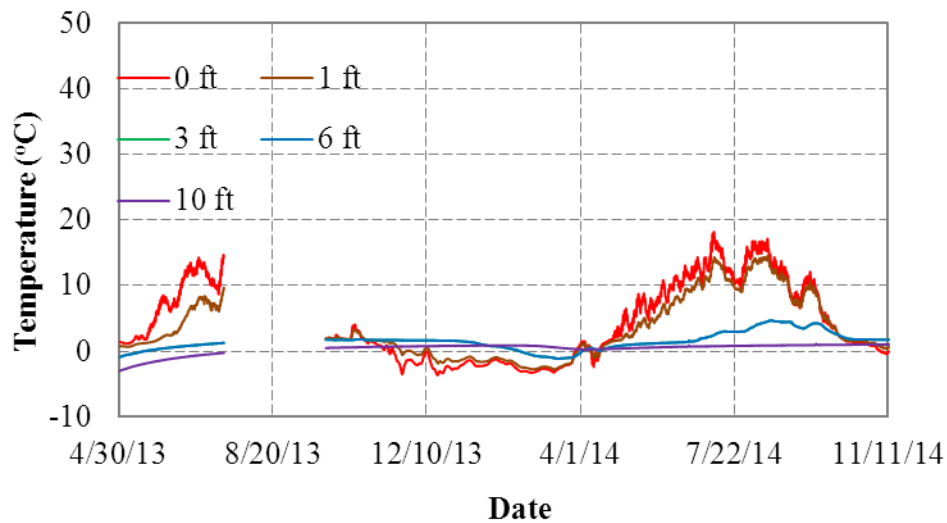
**Figure 7.13 Temperature variations in Section D**

Figure 7.13 shows the temperature changes at the bottom, middle, and top of Section D (crushed rock) at different depths (0, 1, 3, 6, 10, and 20 ft). At the top of Section D, no temperature data were obtained from the sensor at a depth of 3 ft due to malfunctioning. Due to erosion in Section D, associated with repairs and placement of crushed rock in Section C, more crushed rock was placed in Section D.

As shown in Figure 7.13, soil temperature variations follow the same pattern as for Sections A through C except that the soil temperature response is damped by the overlying rock blanket. Due to the presence of the covered 1 ft of crushed rock, soil temperatures at 0 and 6 ft were higher and lower than that in Sections B and C in summer and winter, respectively.

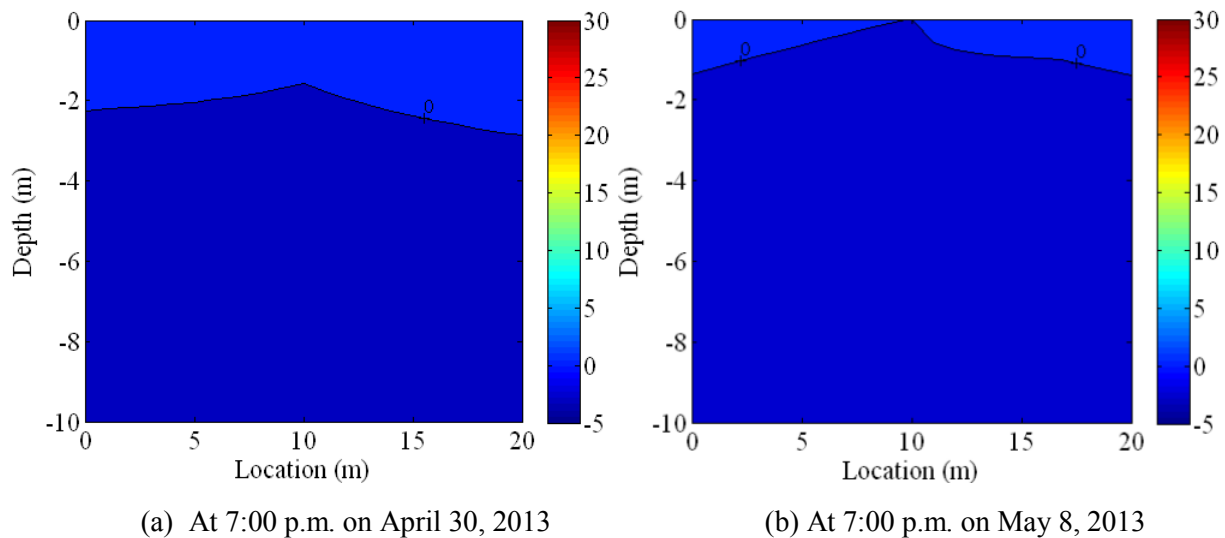
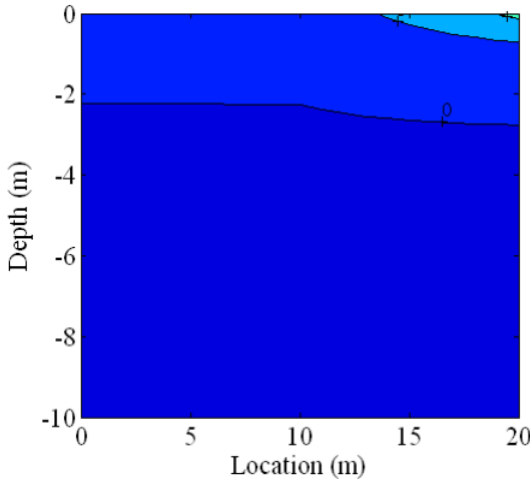
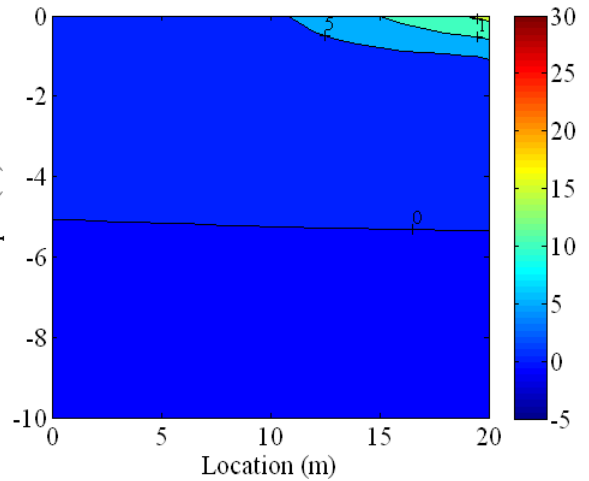
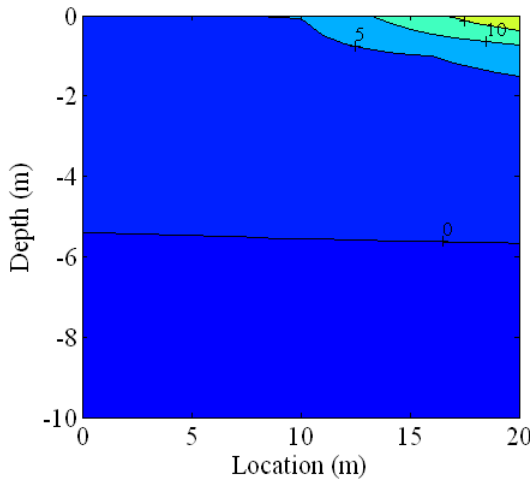
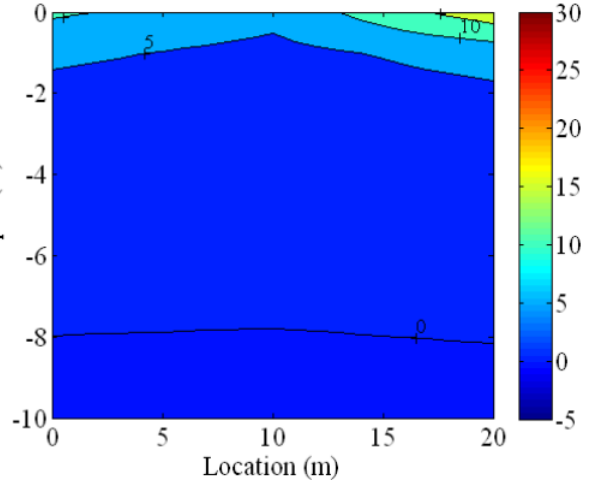
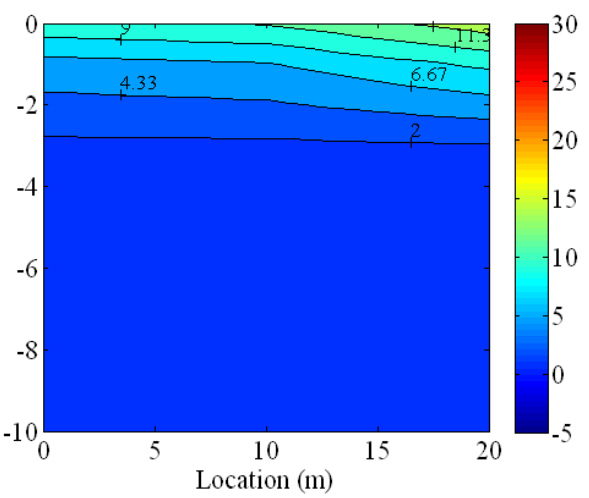
**Figure 7.14 Temperature contours at different times in Section A**

Besides the temperature variations with time at individual slope locations, temperature contours at different times in degrees Celsius for four sections are presented in Figures 7.14 to 7.17. Each plot provides soil temperature contours for a specific date, interpreted from the temperature sensor data recorded on that date. Each plot provides a “map” of isothermal contours of soil temperatures at various depths from the bottom of the slope (left side of plot) to the top of the slope (right side of plot) for the indicated date. For Section A shown in Figure 7.14, the isotherms were approximately parallel to the slope surface right after construction on April 30, 2013. Also, the temperature gradient was almost evenly distributed with depth. However, after construction, the temperature varied dramatically within 1 to 2 ft below the slope surface. The maximum temperature variation occurred at the top of the section, possibly because, as was discussed previously, the wood chip thickness was greater at the bottom than at the top of the slope. The highest and lowest temperatures were both identified to be at the top of the section in summer and winter, respectively. In Section B, as shown in Figure 7.15, the temperature varied

dramatically within 3 to 4 ft of the slope surface. A comparison of Figures 7.14 and 7.15 strikingly illustrates that the single-layer coconut blanket provided essentially no thermal protection for the frozen cut slope soils compared with 1 ft of wood chips. The isothermal lines more or less parallel the slope face at the different times plotted. In Section C, as shown in Figure 7.16, isothermal lines were at an angle to the slope surface, which is different from the other sections. The bottom of the slope within Section C, the Tecco-mesh section, was warming much faster than at the top of the slope for reasons that are yet unknown. Unfortunately, due to construction of the Section C slope protection replacement on June 17, 2013, the temperature sensors at the bottom of the slope stopped working. After that date, temperature information for defining a 3-point isotherm was not available; hence, Figure 7.16e and 7.16f only present half of the isotherm lines. Soil temperatures for Section D are presented in Figure 7.17. Until late May, 2013, the bottom of the slope experienced more rapid warming than the upper portions of the slope. This accentuated warming at the bottom of the slope was similar to what occurred at Section C, but not as severe. Penetration of the thaw front within this section appears to have been somewhat slowed by the additional rock placed in Section D during the Section C repairs.

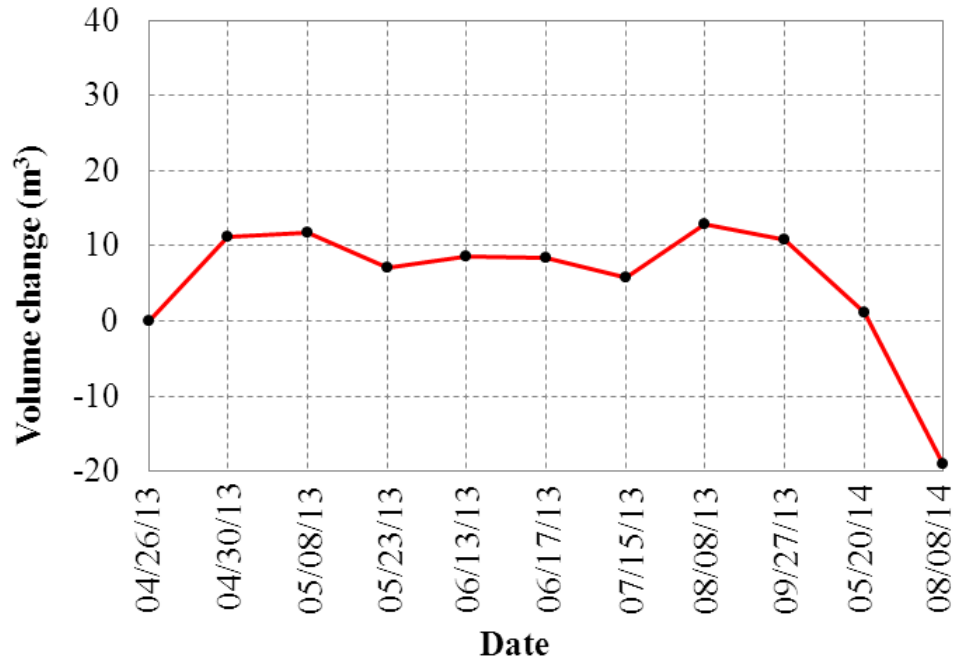
A record of the cumulative surface volume changes for Section A between April 26 and September 27, 2013, is shown in Figure 7.23. In this figure, volume changes are indicated on various dates between April 26 and August 8, 2014: a volume *increase* relative to the slope face condition on April 26 is shown as a positive value; a volume *decrease* relative to April 26 is shown as a negative value. Figures 7.24 and 7.25 are photos of Section A on April 26 and April 30, 2013 respectively. Figure 7.23 indicates that the volume along the Section A slope face actually increased (varying between 8 and 12 m<sup>3</sup>) during this period. Part of the increase is due to the additional wood chips applied over Section A after April 26. Another reason for the increase is the light snow cover on Section A from snowfall between April 26 and 30, 2013. After April 30, 2013, there were small fluctuations in the volume of material added to the surface of Section A. Observation of this section identified no significant erosion throughout the 2013 monitoring period, as indicated by the excellent condition of the slope on September 27, 2013 (see photo in Figure 7.26). However, based on two volume change measurement results in 2014 (May 20 and August 08 as shown in Figures 27 and 28), volume of Section A continuously decreased significantly as presented in Figure 23. There were two reasons for this is which is the melting of ground ice in the slope and the possible movements of the anchors in Section C, which were used as control points for survey purpose, due to frost heave in the slope during winter time.

**Figure 7.23 Surface volume change on Section A**

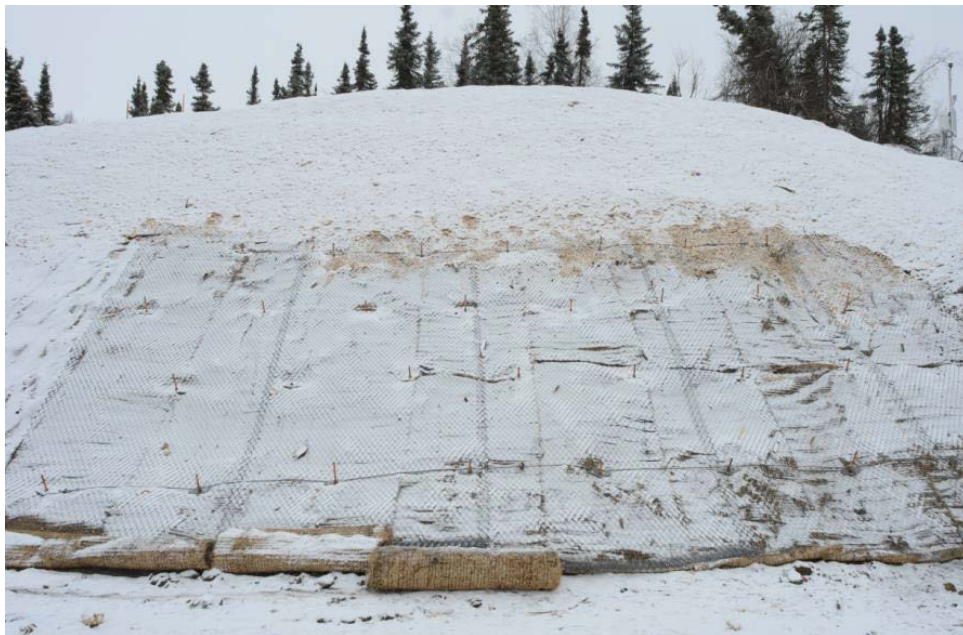
**Figure 7.35 Section C on April 30, 2013**

At the beginning of the photogrammetric record, April 26, measurements indicated a small surface volume increase due to the snow cover shown in Figure 7.35. During the period between about April 30 and June 13, 2013, a rather large volume of icy soil (and massive ice) materials, originally located beneath the Tecco-mesh slope cover, were lost to runoff and thaw-consolidation. Photogrammetric measurements, as indicated in Figure 7.34, keyed on the surface of the Tecco-mesh, and therefore provided no indication of the volume loss that was occurring under the Tecco-mesh. Figure 7.36 shows obvious signs of the actual condition of the cut slope face under the Tecco-mesh by June 13, 2013. Obviously, the deterioration process of the cut slope face under the Tecco-mesh was not detected by the photogrammetric process!

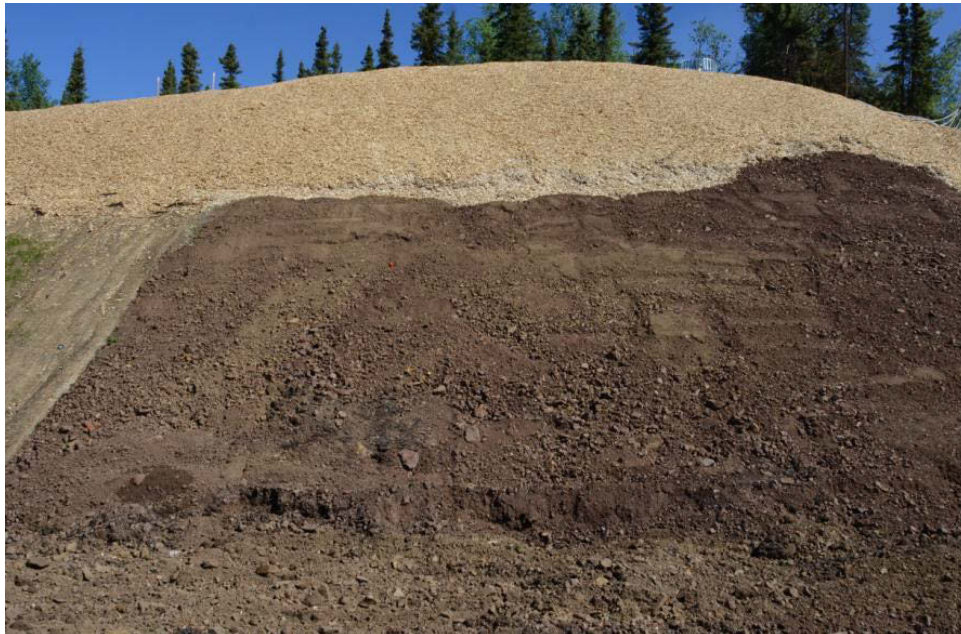
**Figure 7.37 Section C on June 17, 2013**

On June 17, the Tecco-mesh and coconut blanket on this section were removed and replaced by crushed rock as shown in Figure 7.37. This significant slope surface volume change (due to the added crushed rock) was captured by the subsequent set of photogrammetric measurements (indicated on the right-hand side of Figure 7.37). Figure 7.38 shows the appearance of Section C on September 27, 2013. Figure 7.34 indicates that an attenuation of thaw-related volume change was occurring in Section C prior to September 27, 2013. In 2014, slope surface volume continuously decreased till May 20, 2014 as shown in Figure 34. Figure 7.39 shows the appearance of Section C on May 20, 2014. However, after that, a volume increase change was captured on August 8, 2014. One reason for this volume increase was the grass grown as shown in Figure 7.40.
