Continued Field Evaluation of Precutting for Maintaining Asphalt Concrete Pavements with Thermal Cracking

August 2017

INE/AUTC 17.17

FHWA-AK-RD-4000(155)

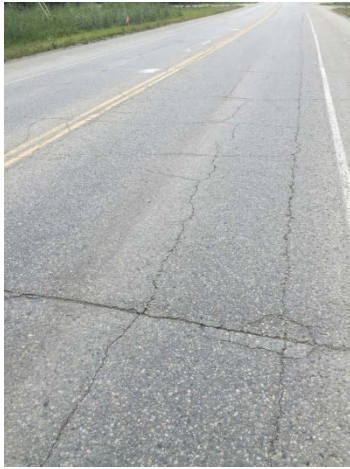
(a) Block cracks

In summary, the Phillips Field Road precut site was 32 years old, but its general driving condition was found to be good. Potholes needed to be maintained, but all the cracks, including transverse cracks, active precuts, longitudinal cracks, and block cracks seemed not to deteriorate the pavement condition significantly.

Figure 4.1 Field observations of 32-year old Phillips Field Road, Fairbanks, Alaska

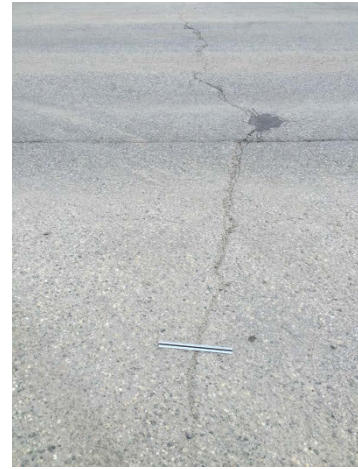
(c) Transverse crack

After 32 years of service, even the active precuts showed acceptable appearance (Figure 4.1e). Better appearance of the inactive precut was also observed (Figure 4.1d). In contrast, the natural crack (Figure 4.1c) offered a broken and crooked appearance, which is unpredictable and more difficult to maintain. The driving public and state agencies would tend to prefer the “nicely designed” precuts rather than broken natural cracks. The long-term, regular appearance of pavement surfaces is considered important. For Portland cement concrete road pavements, sidewalks, etc., use of expansion joints and regularly spaced scoring has long been the standard way of controlling appearance and damage severity due to inevitable thermal cracking. Therefore, the precut technique for asphalt concrete can be considered “successful” for its effectiveness in controlling the locations of many more natural cracks that could have developed.

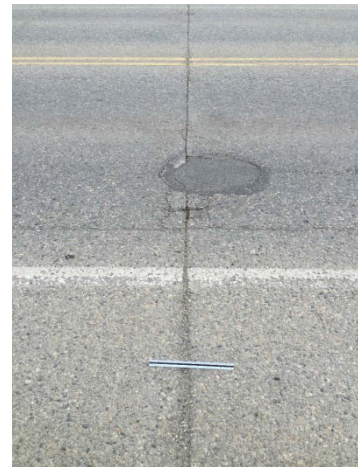
(f) Pothole

Several small potholes were observed where longitudinal cracks and precuts intersected (Figure 4.1f). The observation about potholes was consistent with Minnesota's experience of precutting asphalt pavement (Janisch and Turgeon 1996). Their report indicated that "a cupped depression developed approximately 5–7 years after implementation of precuts." However, the small potholes that accumulated over 30+ years on Phillips Field Road required minimal patching and did not significantly influence ride quality.

It is important to emphasize the success of this precut test. Except for a few small potholes that received attention during the life of the pavement, the section made it successfully through 32 years of heavy traffic with essentially no other maintenance including the lack of routine sealing. That period represents more than 1½ times the normal 20-year pavement design life.

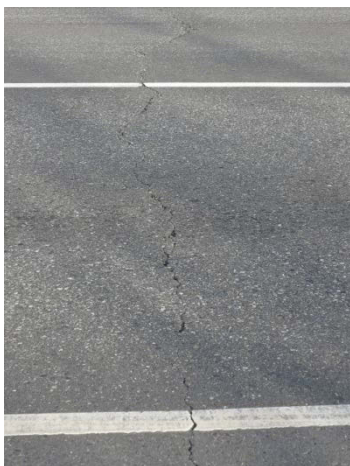
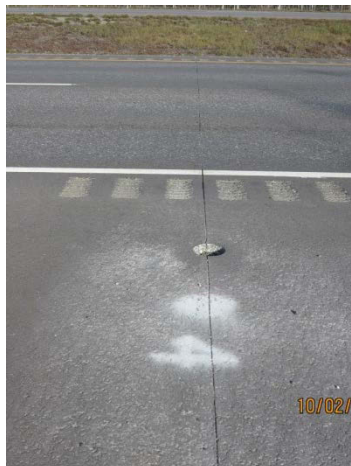
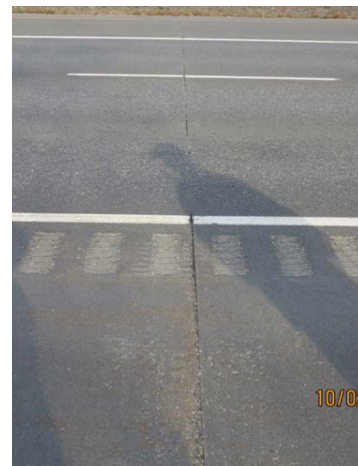
The details of the field surveys (Figure 4.2) conducted in 2013 and 2014 can be found in a previous project report (Liu et al. 2015). Figure 4.3 presents select survey photos of observed natural cracks, and both non-active precut and active precut cracks.

Figure 4.3 Select field survey photos in 2013 and 2014 (Liu et al. 2015)

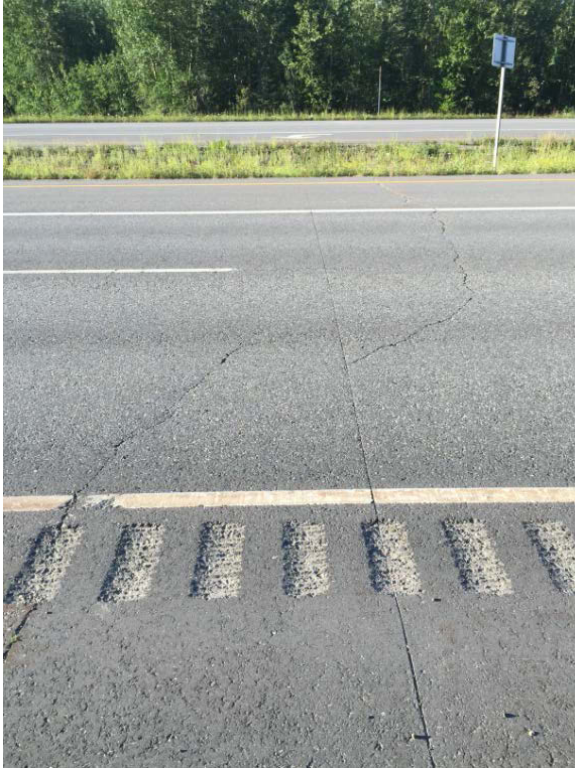
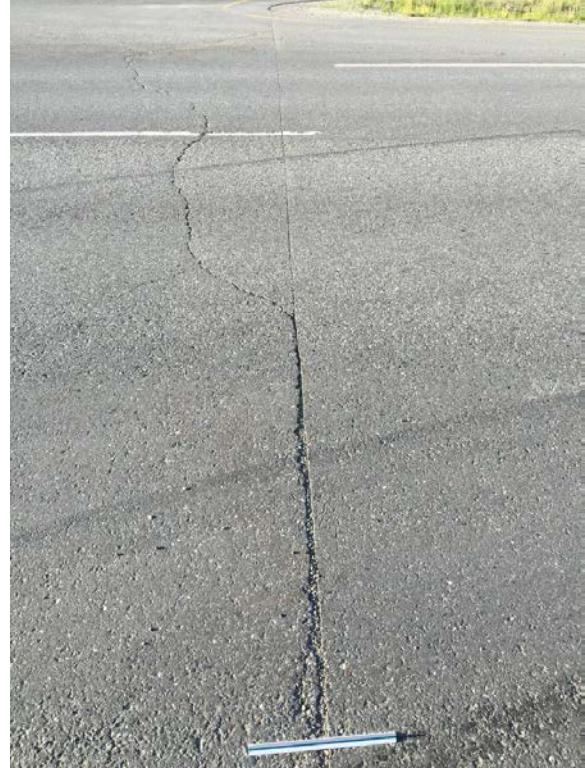
The three sections, No. 8 to No. 10 in Table 3.1, were specially designed for the Moose Creek project. The objective was to evaluate the effectiveness of precutting on the locations of pre-existing cracks. Figures 4.11 to 4.13 present the observations that are worth some discussion. Figure 4.11 shows two cases of transverse cracks near precuts. The crack shown in Figure 4.11a was not controlled by the precut at all, but the one shown in Figure 4.11b was partially re-located (partially captured) by the precut. According to the survey maps presented in Appendix B8 to B10, a big portion of the transverse cracks occurred on or adjacent to precuts in these sections. The idea of precutting at the old thermal crack location seems reasonable, but it is still difficult to determine how effective it can be.

Figure 4.11 Natural transverse cracks near precuts—where precuts are at locations of old thermal cracks on the Moose Creek project: (a) high severity (section No. 8); (b) low severity (section No. 8)

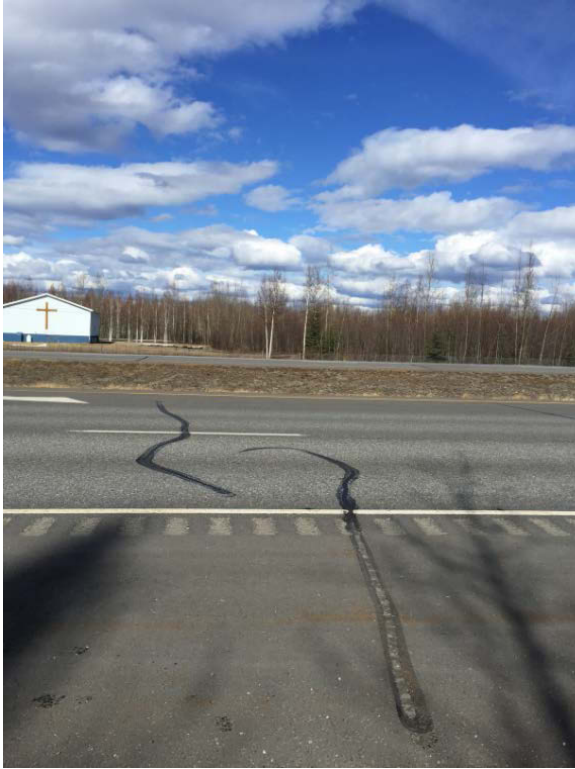
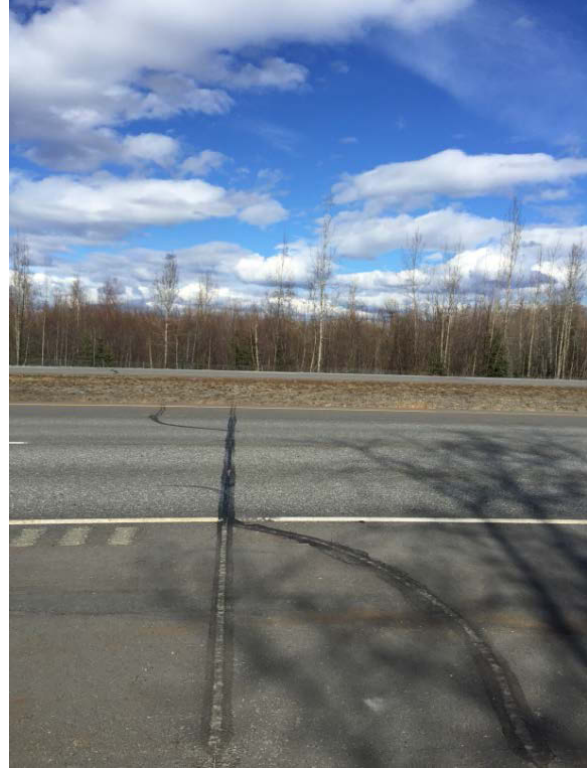
Figure 4.19 Newly documented crack sealing spots in section No. 10 of Moose Creek project in summer 2017: (a) case 1; (b) case 2

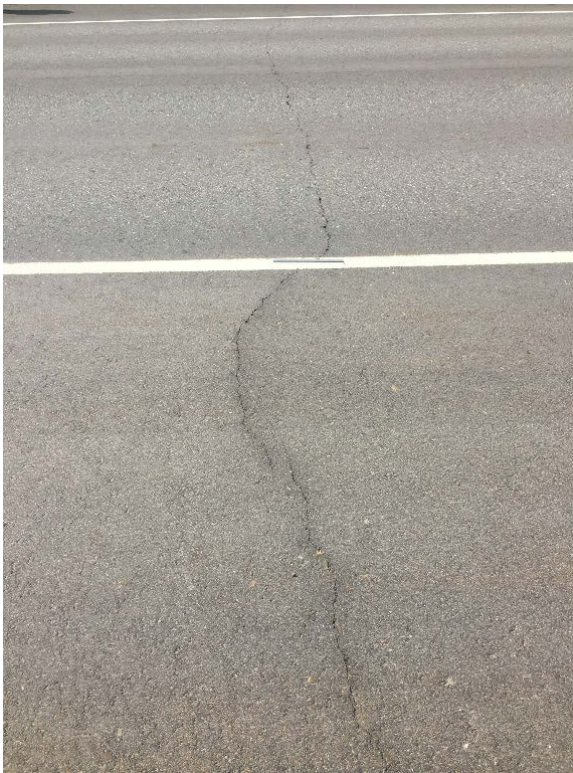
Figure 4.23 Transverse cracks observed: (a) low-severity crack (on precast section) (section No. 6); (b) high-severity crack (on control section) (section No. 2)

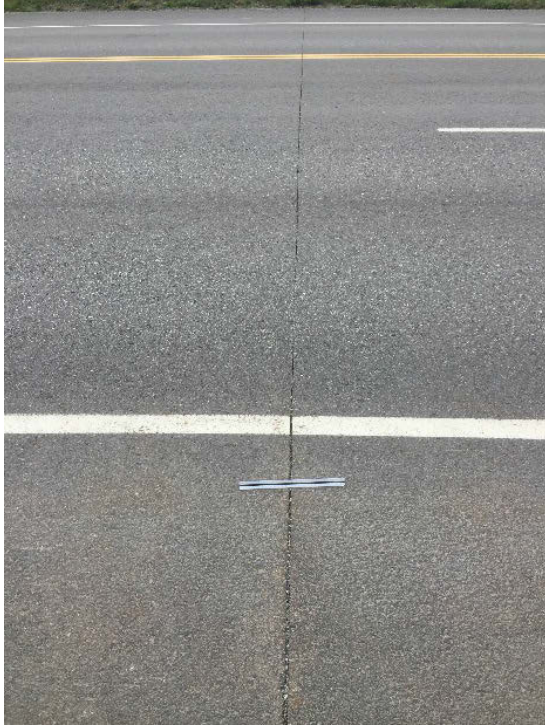
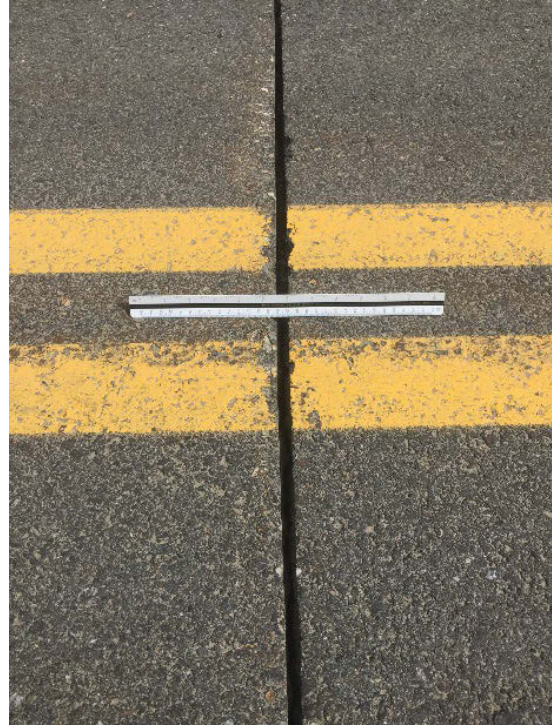
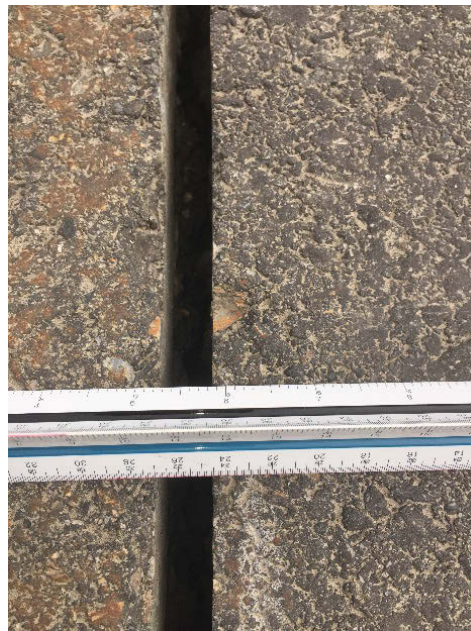
Healy sections were visited in summer 2016. Detailed survey maps and photos showing all the distress can be found in Appendix C. Figures 4.22–4.24 show some general observations documented as survey results for Healy sections, including overview of the field site, transverse cracks, and precut status. Note that some highly active precuts (Figure 4.24c) were observed on the Healy experimental sections.

Figure 4.24 Precuts observed: (a) non-active precut (section No. 9); (b) active precut (section No. 8); (c) highly active precut (section No. 3)

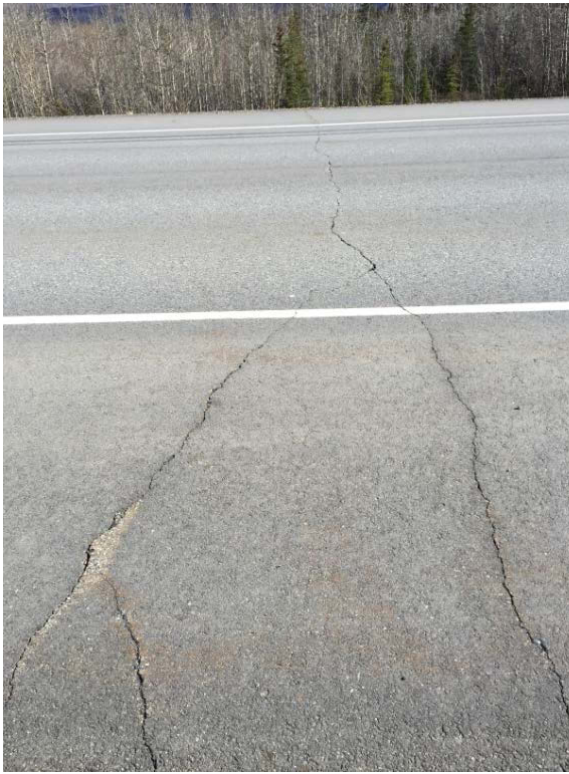
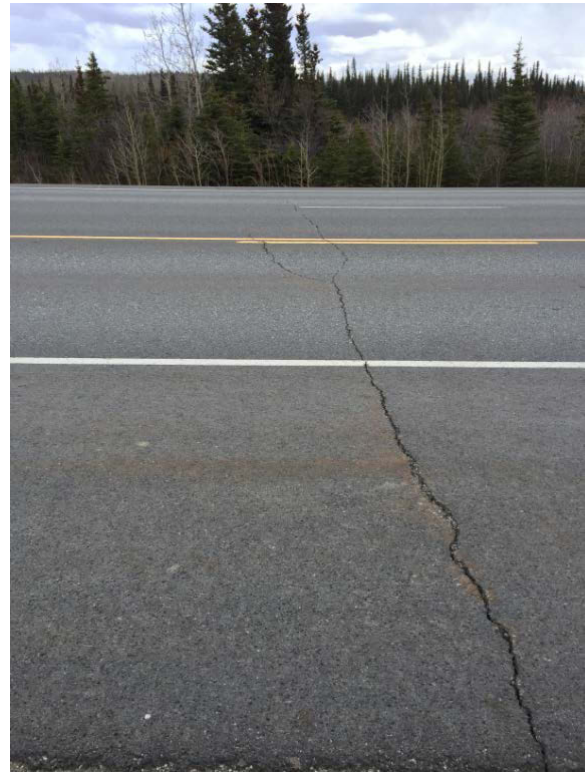
Healy sections were revisited in summer 2017. Detailed survey maps and photos can be found in Appendix E. Figures 4.25–4.32 show some newly observed features worth discussion. Three forms of precuts were observed: completely closed (non-active) (Figure 4.25), partially active (Figure 4.26), and very active (Figure 4.27). Figure 4.28 presents natural transverse cracks with irregular shapes but low levels of severity. Some of the natural cracks obviously extended past the edge of the pavement and into the unpaved shoulder, as can be clearly seen in (Figure 4.29). Some natural crack paths were found to be redirected and partially captured by precuts (Figure 4.30). On the other hand, Figure 4.31 shows examples of natural transverse cracks located quite near precuts but without the apparent tendency to be captured or even influenced by precuts. Examples of low-severity bifurcating transverse cracks are shown located in a control section (Figure 4.32a) and between precuts (Figure 4.32b).

Figure 4.32 Bifurcating cracks: (a) section No. 5; (b) section No. 13

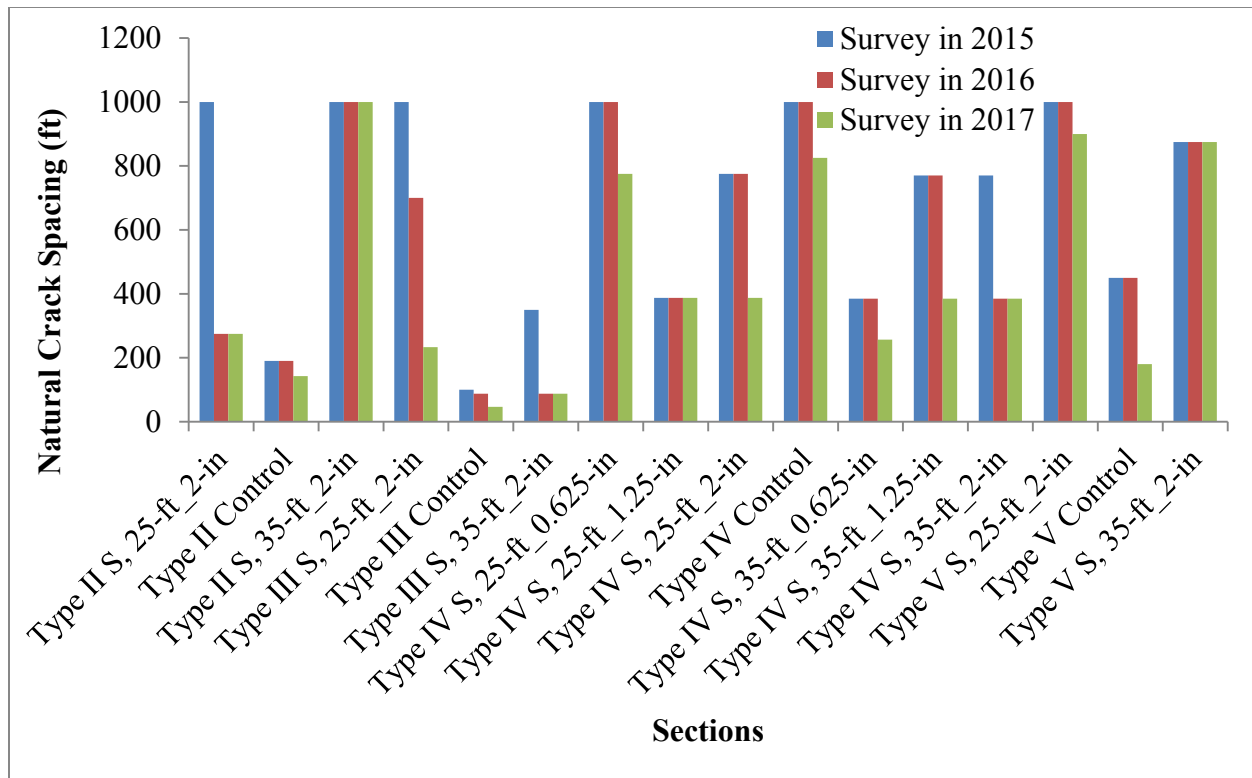
Figure 5.3 Healy project survey results

Figure 5.3 presents the natural transverse crack spacing results for all the sections included in the Healy project. Data collected in 2015 were also included in Figure 5.3 to show crack development with time. As some sections demonstrated no transverse crack, the natural crack spacing of 1,000 feet was used to represent these sections for data presentation in one

chart. As expected, and consistent with observations at the Moose Creek project, natural crack spacing decreased or remained the same with time, which means the number of cracks increased with time. Data comparison of the control section and precut sections can be seen in Figures 5.4–5.6. It was found that the precut sections demonstrated higher natural crack spacing compared with the control section, regardless of precut interval and pavement age for pavement structures II, III, and V. No natural transverse crack was found on the control section of pavement structure IV in 2015 and 2016, and only one crack was observed in 2017.

To make interpretation of Figures 5.3–5.6 easier, the reader should note that only one precut depth (2 inches) was used in structures II, III, and V. Multiple cut depths (0.625, 1.25, and 2 inches) were used only in structure IV. Also, each structure has its own control section, so there are 4 control sections in total for the Healy area tests. In addition, according to Figures 5.1 and 5.3, the reported natural crack spacing data of Moose Creek sections (structure I) were considerably lower than those of Healy sections (structures II, III, IV, and V). The significant difference may be due to Moose Creek pavement being older; this pavement was also the thinnest construction treatment, which perhaps facilitated faster/more reflection cracking from the previously cracked layers beneath.

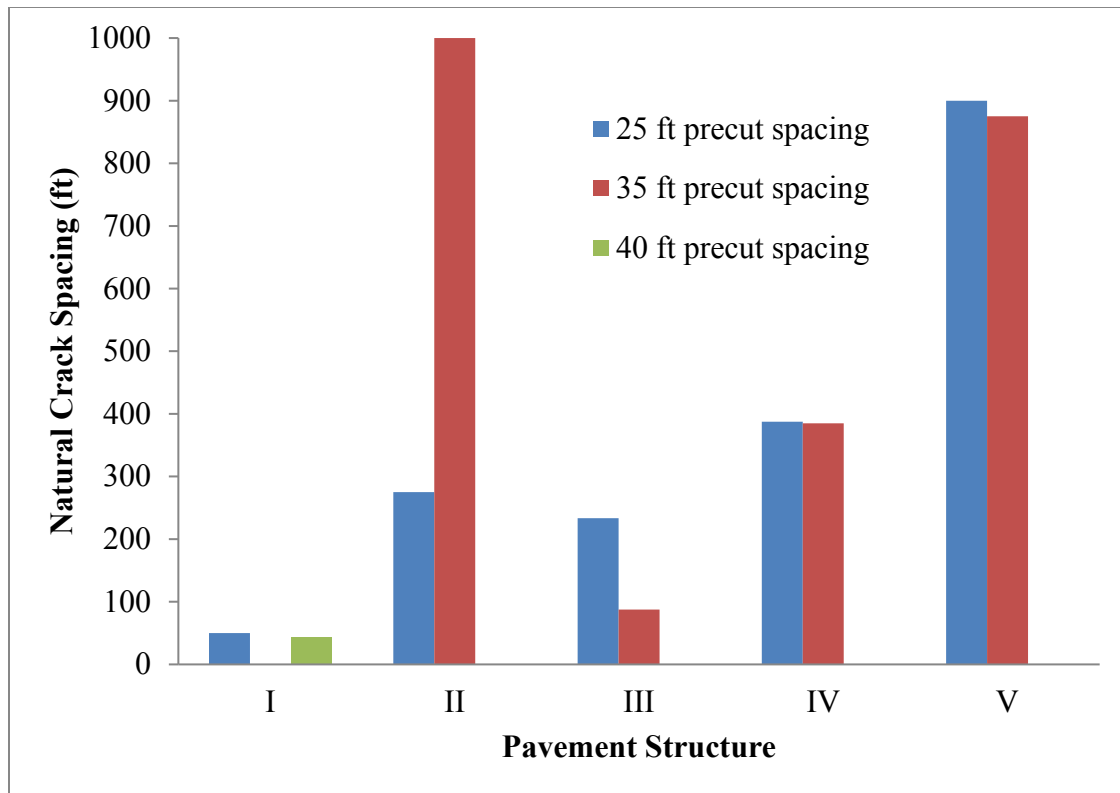
Figure 5.7 Effect of precut spacing

In order to evaluate the effect of precut spacing, the survey results collected in 2017 were used for both projects and the precut depth ratio was held at $\frac{3}{4}$. The organized results for comparison are presented in Figure 5.7. Pavement structures I, III, and V showed comparatively higher natural crack spacing when a shorter precut spacing was adopted. The two different precut spacings resulted in similar natural crack spacings for sections built on pavement structure IV. For pavement structure II, the section with the larger precut interval showed higher natural crack spacing, which is opposite of what was observed on structures I, III, and V. Most of these preliminary observations indicate that shorter precut spacing is more promising in controlling the location of natural cracks.

- Recommended precutting interval = 35 feet.
- Recommended precut depth = $\frac{3}{4}$ of total asphalt concrete pavement thickness.

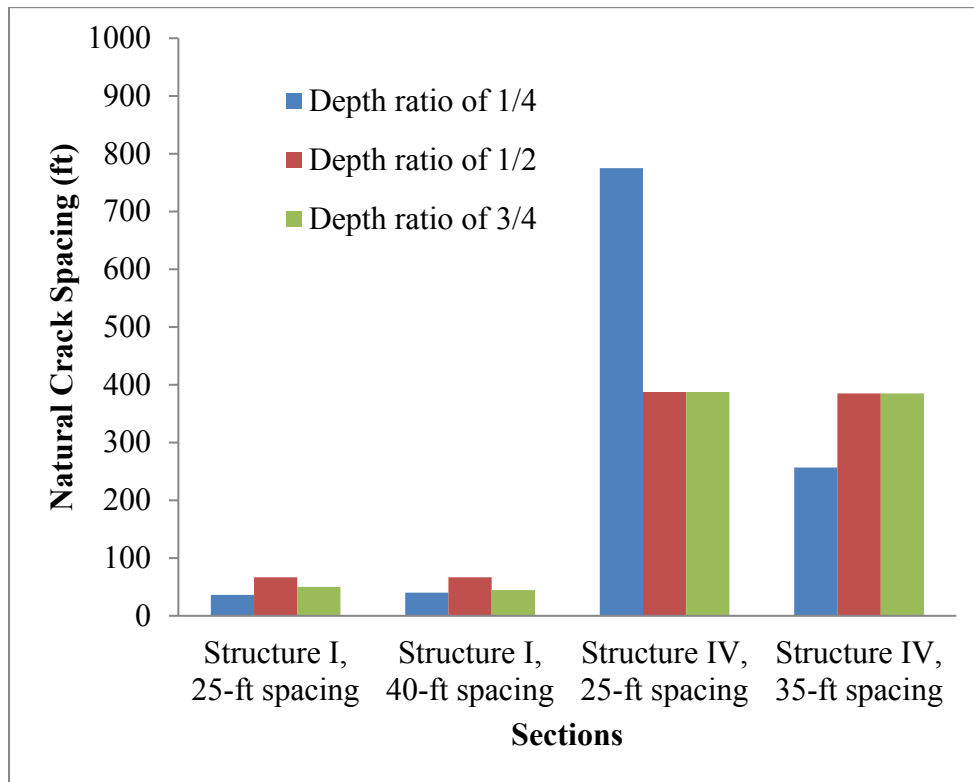
Figure 5.8 Effect of precut depth

Figure 5.8 shows the relation between precut depth and the natural cracking interval for four precut test locations. These relationships are grouped according to pavement structure and precut spacing. Each group contains natural crack spacing data at three precut depth-to-HMA thickness ratios: $1/4$, $1/2$, and $3/4$.

Sections with a depth ratio of $1/2$ indicated a slightly higher natural crack interval in two of the four groups, although the depth ratio of $3/4$ tied for greatest natural crack spacing in two groups. Is there an optimum precut depth? These observations are not conclusive. They do not strongly point to any of the three precut depths as being best or worst. However, there is a tenuous indication that more success (longer natural crack intervals) is connected to deeper precuts. Based on field data collected to date, the authors suggest using a precut ratio of $3/4$.

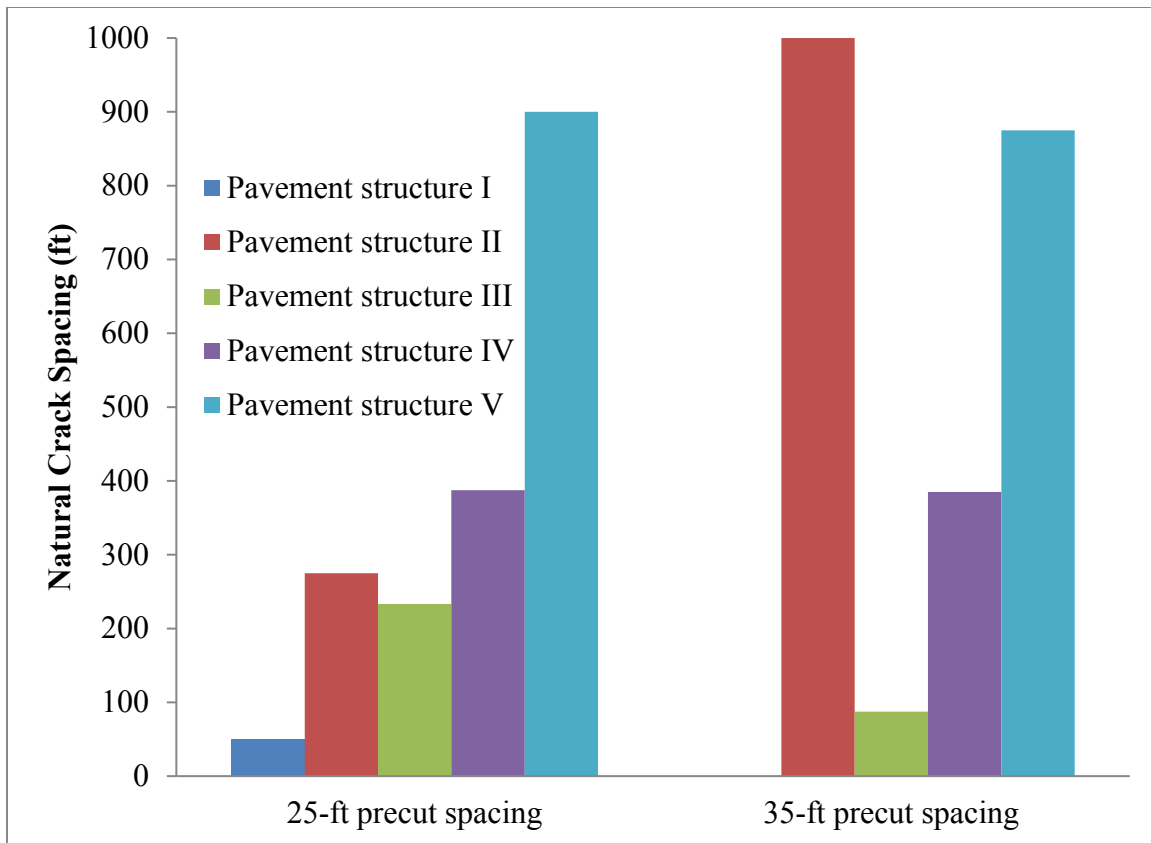
Figure 5.9 Effect of pavement structure

To evaluate the effect of pavement structure, the results were organized into two groups in terms of precut spacing, as shown in Figure 5.9. The 35-foot spacing was not used in pavement structure I; thus, the data of pavement structure I were only used in groups with 25-foot spacing. Based on the results of two groups, the sections built on structure V showed the highest natural crack spacing, followed by sections on pavement structures II, IV, III, and I. Structure V was the strongest and soundest structure for the road, followed by structures II, IV, III and I. This ranking was consistent with the robustness ranking of pavement structure, as shown in Table 3.3, indicating that stronger and/or perhaps simply thicker pavement structure is likely to be more effective in controlling the locations of natural transverse cracks when the precut technique is used.

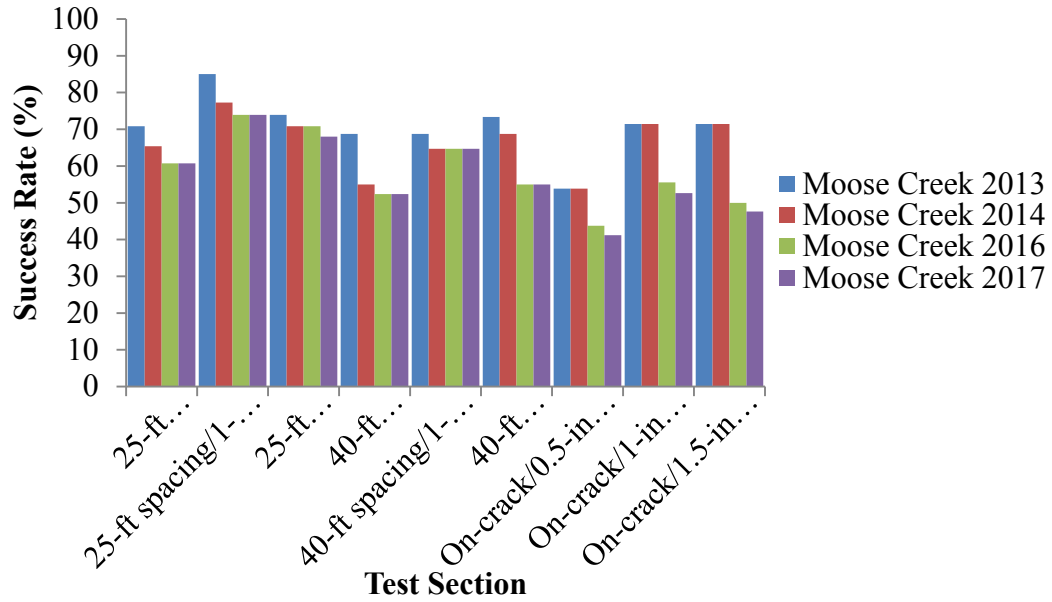
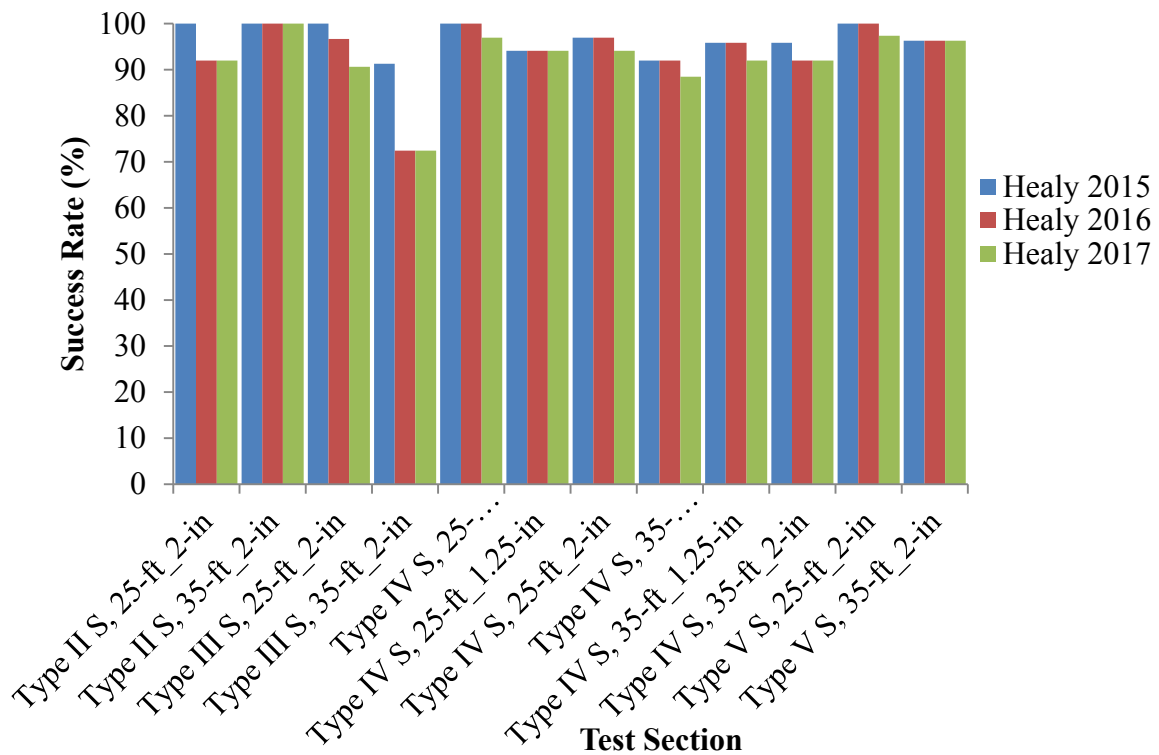
Figure 5.11 Results of success rates: (a) Moose Creek project; (b) Healy project

Figure 5.11 presents the results of success rates of all the precut sections evaluated in this study. It can be seen in this figure that the data of most Moose Creek sections are below the 85% criteria, and that those of most Healy sections are higher than 85%. Transverse cracks (even with precutting) increase with time, and the older pavement (Moose Creek sections) would be expected to show a lower score. Note that calculation of the success rate is highly dependent on the number of natural cracks—the lower the number, the higher the success rate. However, pavement with a strong structure (e.g., Healy sections) may be favored by this calculation, as cracks are rarely seen on strong pavement structure, even on a control section. This suggests that success rate may not be a good statistic for determining the effectiveness of the precut technique, especially since the precut technique is used not only to reduce natural cracks, but also to re-direct cracks to a better shape.

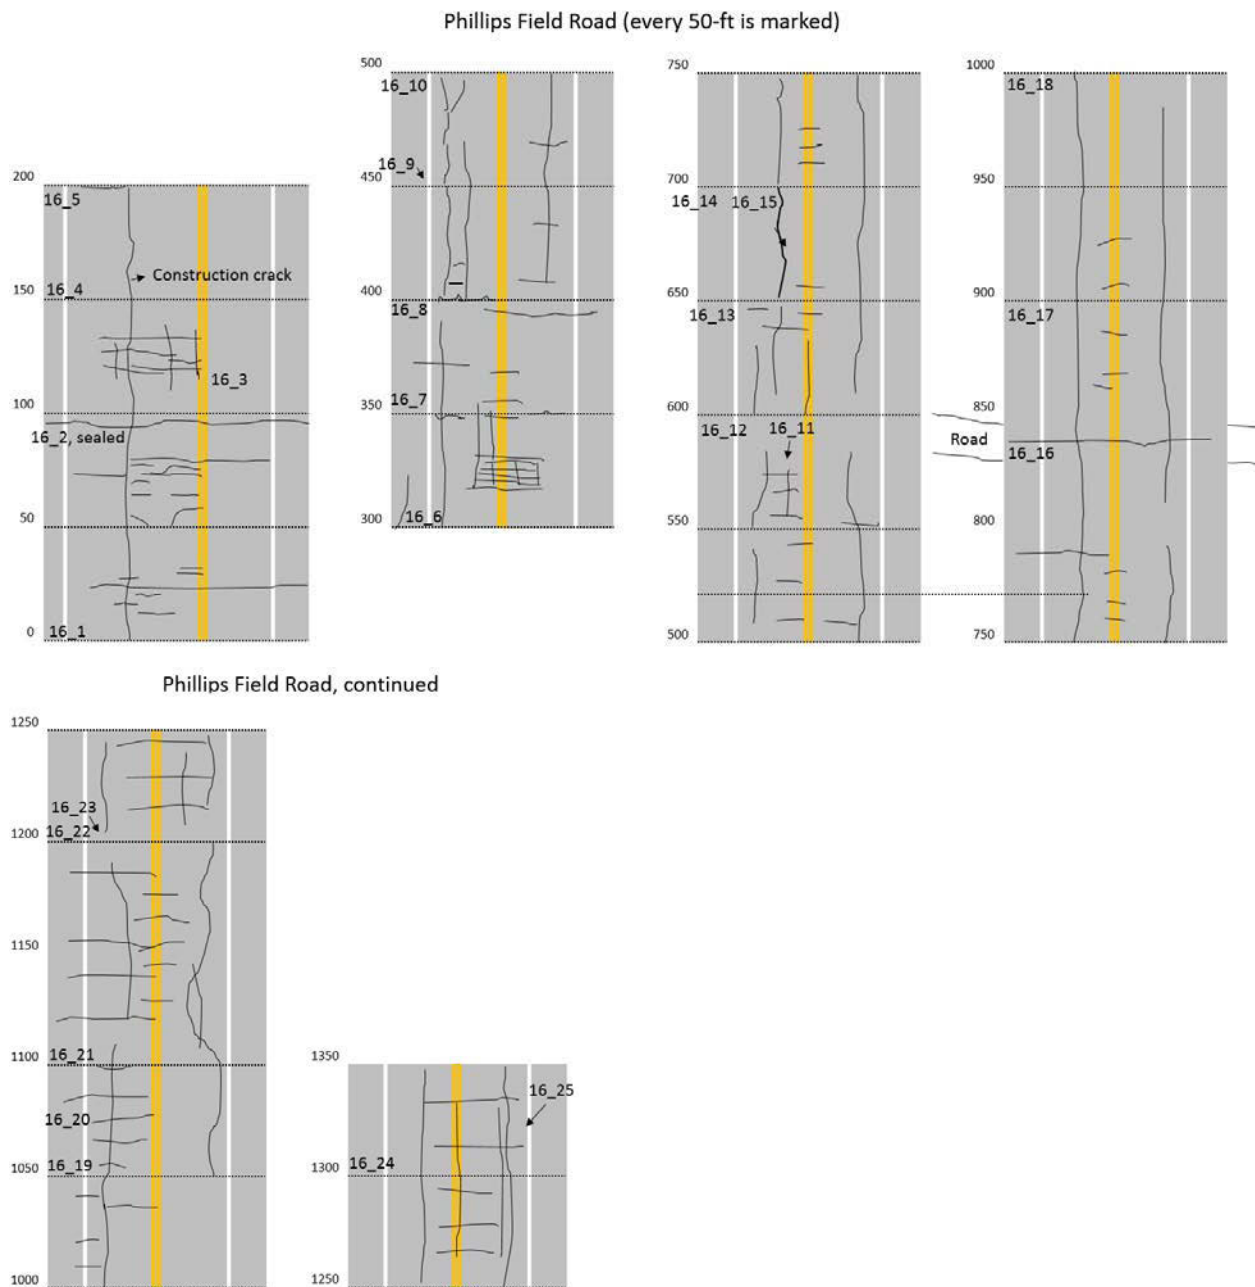
Appendix B1. Phillips Field Road Survey Map

- Conclusions regarding the Phillips Field Road precut test section were based on 32 years of casual observation and a final careful inspection and mapping of thermal cracks in 2016. The 1984 construction of this section included new pavement and 4–6 feet of new embankment. This test section received heavy traffic for the entire 32-year period. The precut treatment is considered a great success, as very few natural transverse thermal cracks developed outside of the precut locations. In this precut test section, many of the precuts became active.

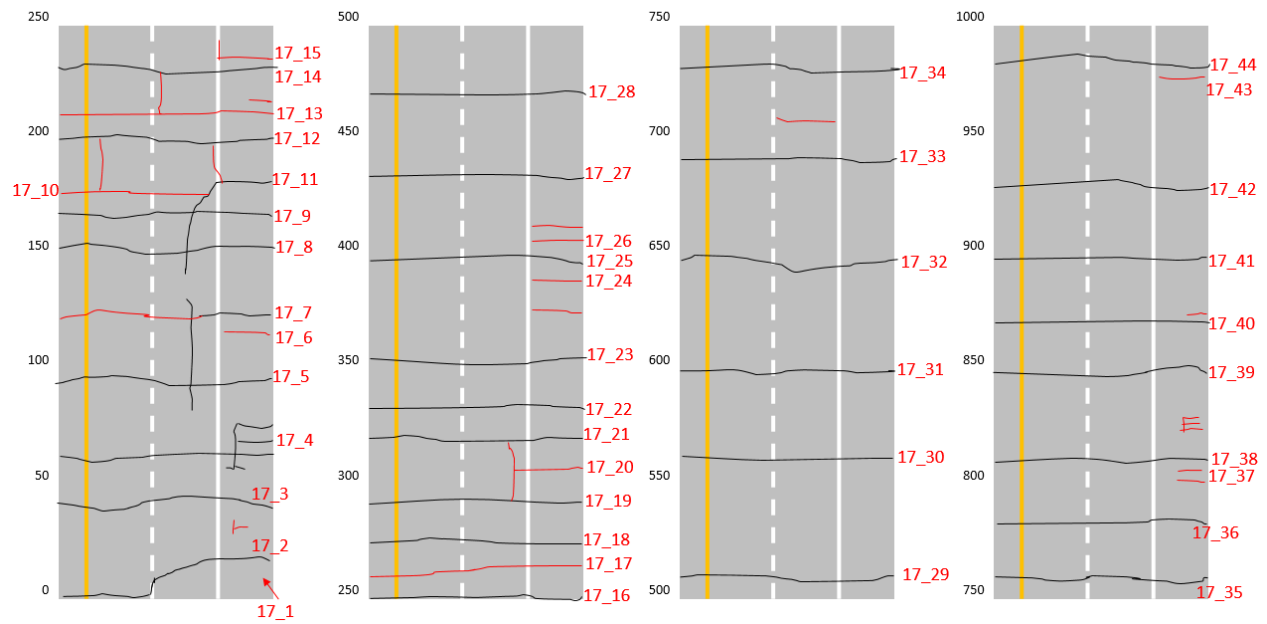
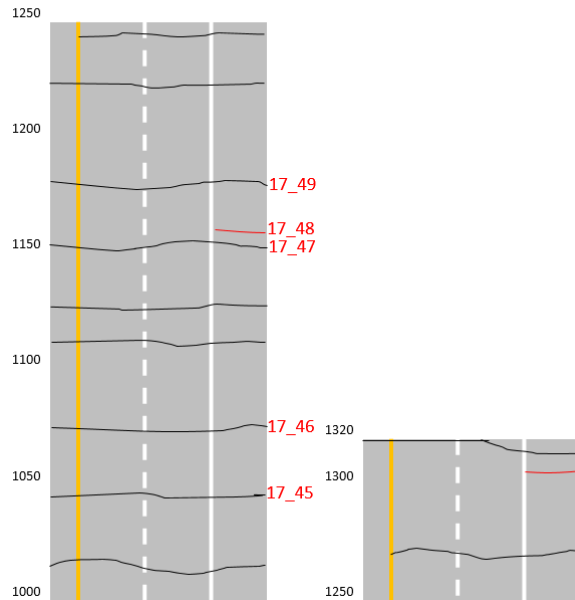
Appendix E1. Moose Creek section 1

Moose Creek Section 1_2017 (new crack marked in red)
