Minnesota Drive Ramps Microsurfacing Experimental Feature

Year 2 Monitoring Report

Alaska Department of Transportation and Public Facilities
Statewide Materials and Asset Management

January 2023

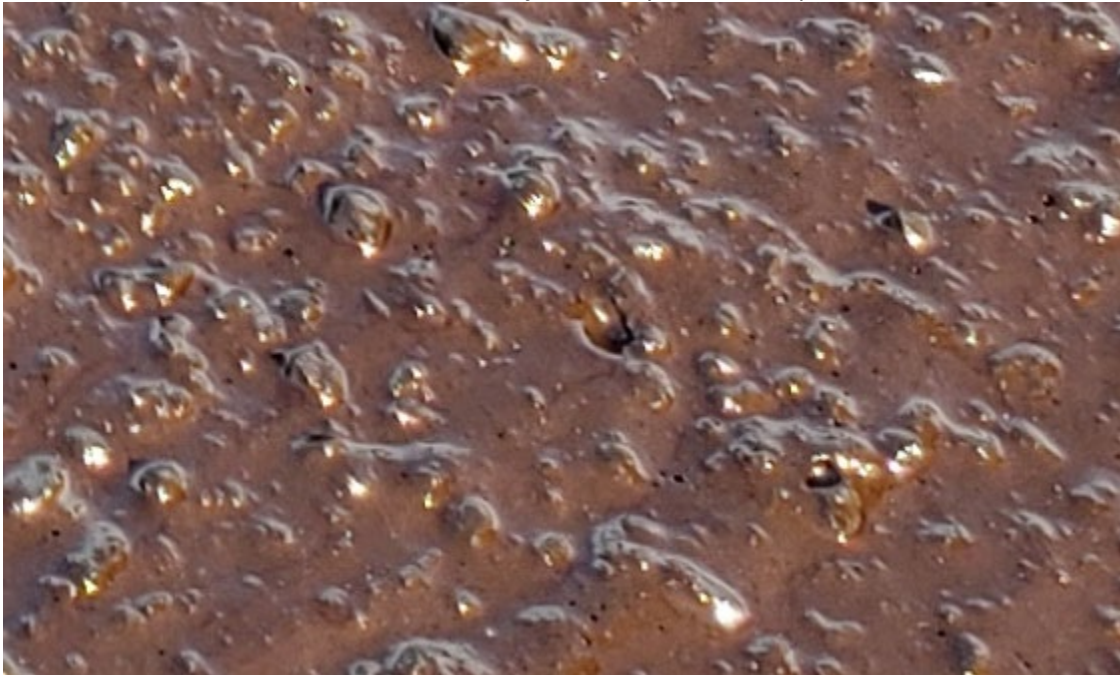
Photo 5 - Bubbles from Slurry on Test Strip

After the microsurfacing was placed on the test strip, small holes/bubbles were observed on the surface which were not seen with the previous formulation using lime. This indicates water is escaping the system as it sets and, while difficult to see, can be observed in the photo below.

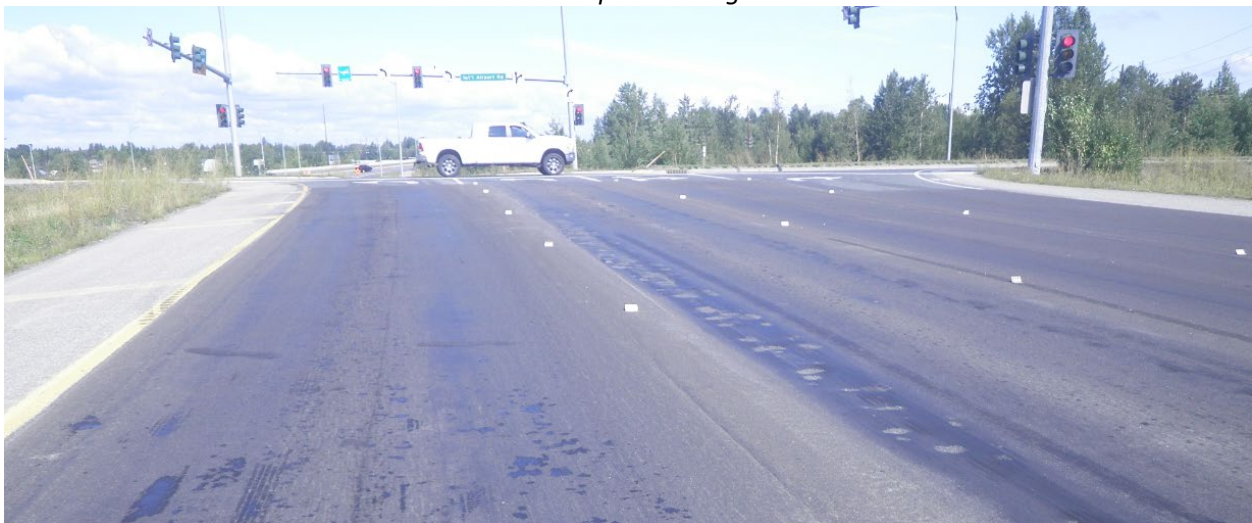
Photo 82 - Ramp 2 Flushing Distress

Photo 8 is from August 13th where severe flushing and shoving occurred at the signalized intersection on Ramp 2. The resulting surface was not sticky, and tracking was not observed at any locations, but there was a loss of friction and the fines were visible at the surface.

In August 2020 the observed flushing distresses were considered to be severe enough to perform friction testing on five of the seven ramps, which validated the observed loss of friction. The microsurfacing on those ramps was removed by HMA mill and fill in September 2020.

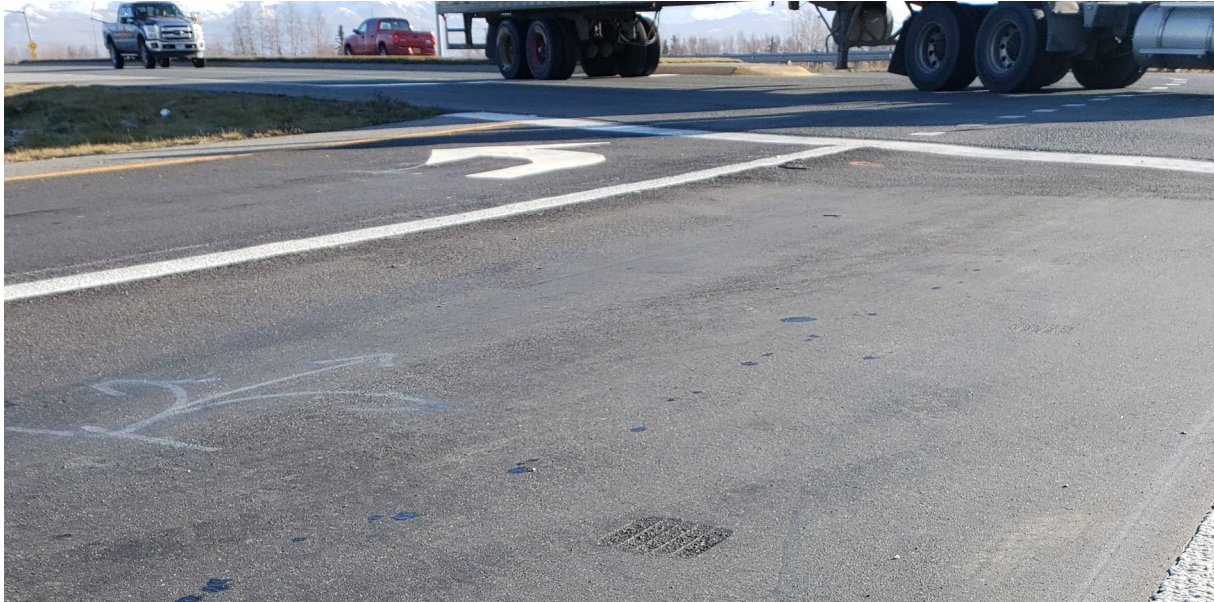
Photo 9 - Ramp 6 Deformation

In October of 2020, prior to the first snowfall, the ramps remained in good condition, although it was noted that hand worked areas did look rough and there was deformation observed on Ramp 6 and flushing was present on Ramp 11 (noted in orange in Table 3). Ramp 6 was one of two ramps with stoplights, the other being Ramp 2, which was removed by mill and fill in September of 2020. The deformation on Ramp 6 was likely from static loading of the trucks as the deformation occurred at the stoplight (see Photo 9). Rut depth data collected at Ramp 6 in 2021 and 2022 did not show a significant increase in rutting between those two years.

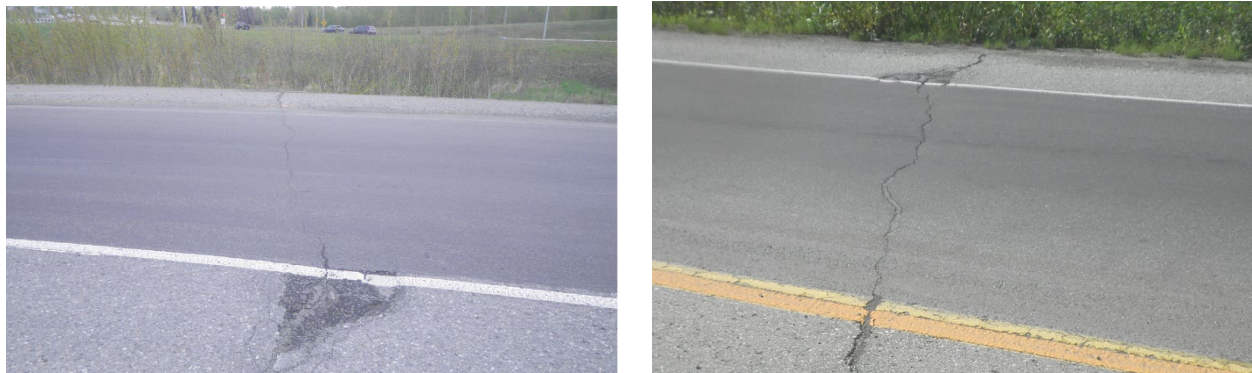
Photo 11 - Ramp 7 – General Transverse Cracking Conditions 2021 (left) and 2022 (right)

Photo 11 shows the condition on Ramp 7, the International Airport Cloverleaf, in May of 2021 (left) and September 2022 (right). It displays the typical condition on ramps where there is damage at transverse cracking. It can be seen that while the transverse crack is still smaller than it was previously, as indicated by the shoulder condition, the crack has spalled over the winter between 2021 and 2022.

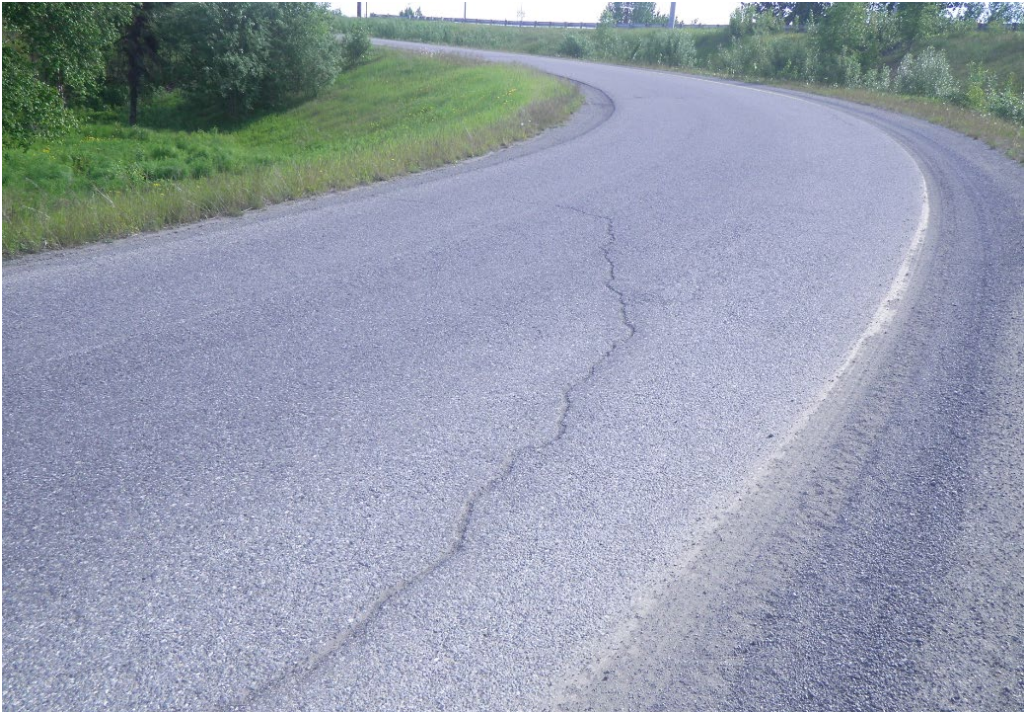
This ramp is a cloverleaf with minimal rutting, minor raveling and isolated moderate severity cracking.

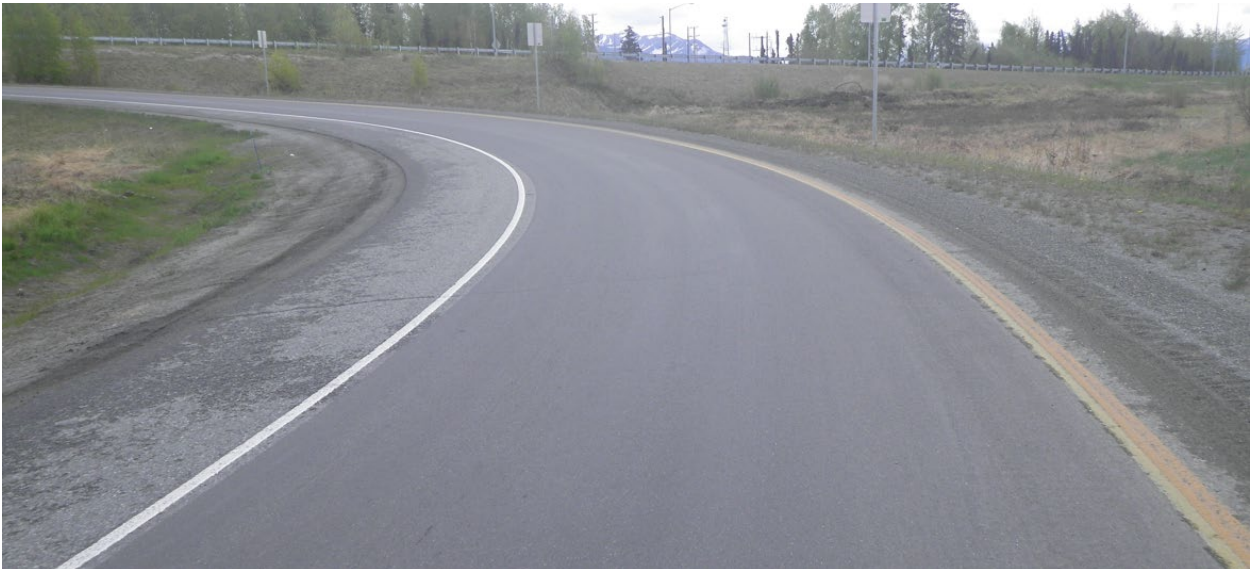
The ramp remained in good condition although cracks on the ramp did reflect through the micro.

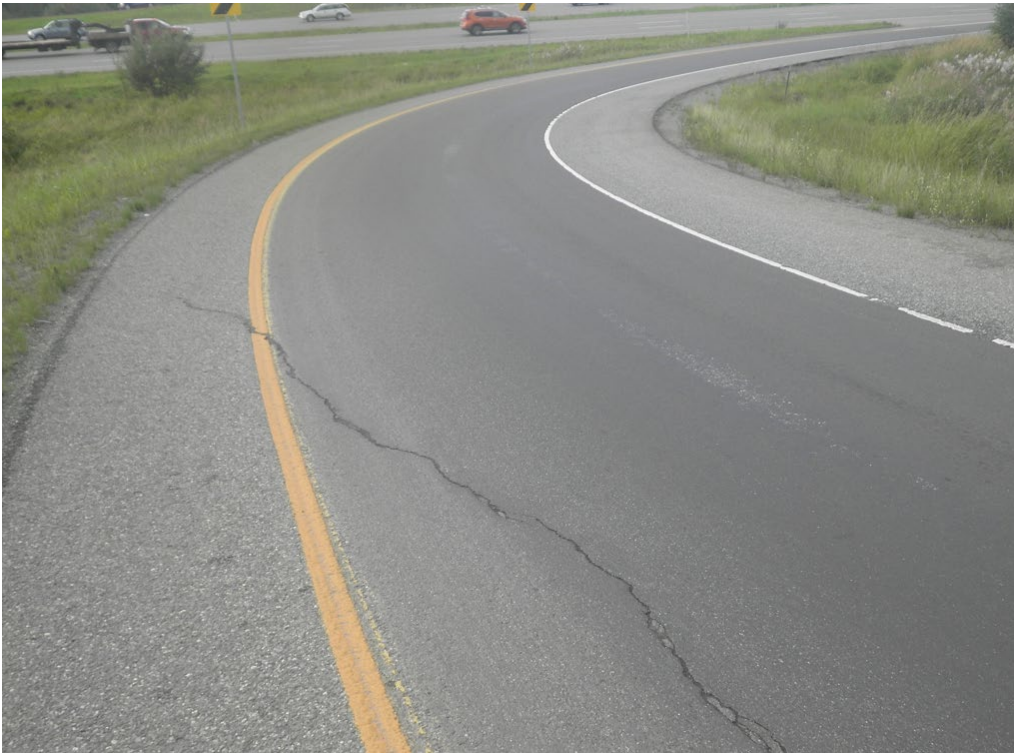
There is increased severity in reflective cracking and plow damage along the centerline.

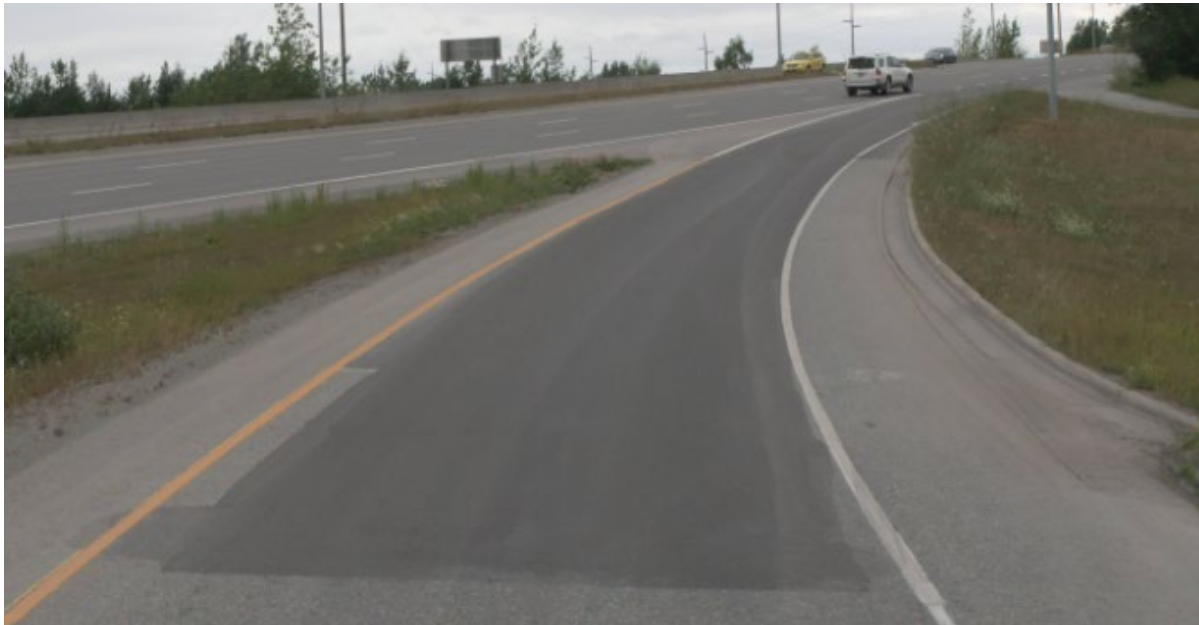
The microsurfacing still remains in good condition with slight plow damage and reflective cracking.

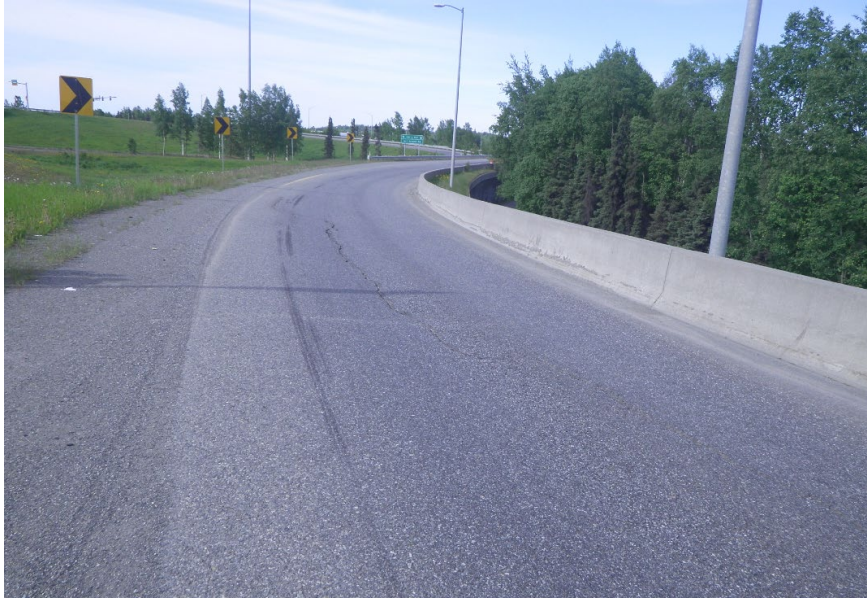
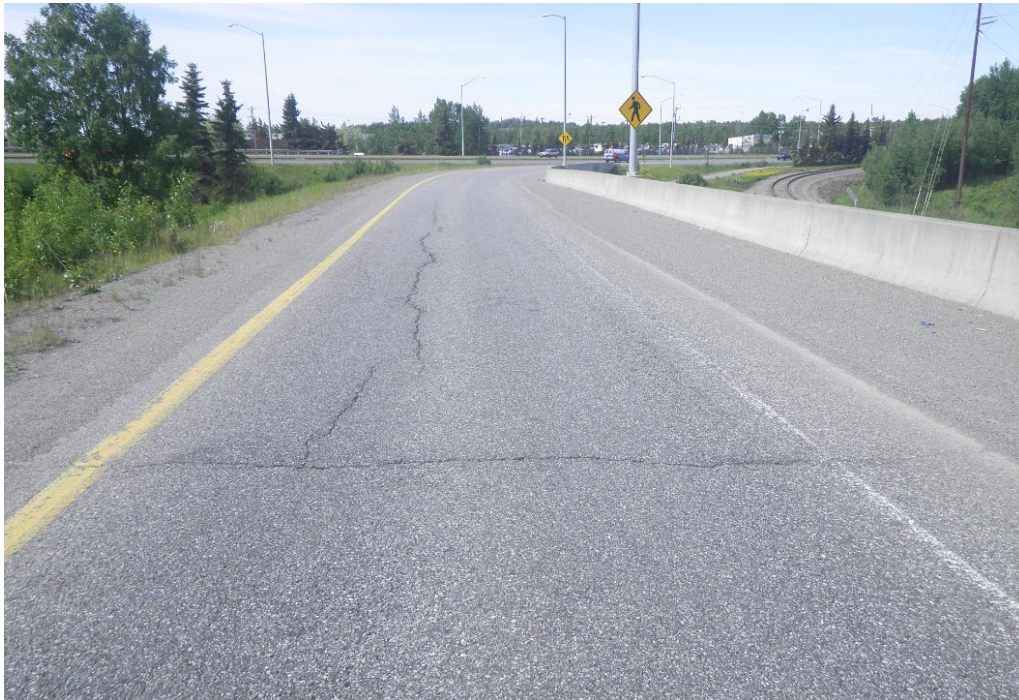
The initial part of this ramp had high severity longitudinal cracking. The worst of this was fixed as part of the earthquake repair portion of the project and did not receive microsurfacing. The rest of the cracking received crackseal and hot mix tamped in place. The later part of the ramp had moderate severity transverse and longitudinal cracking and minor raveling.

This ramp was removed by mill/fill in 2020.

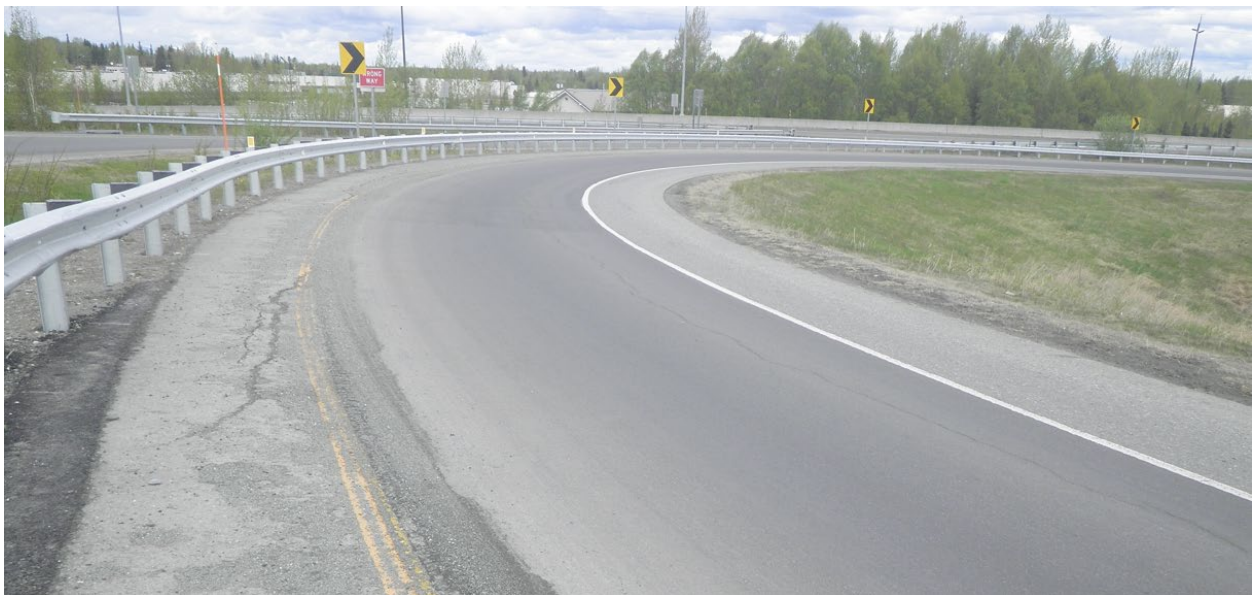
Cracks reflected through the microsurfacing but remained in low severity on this ramp, which is in good condition overall.

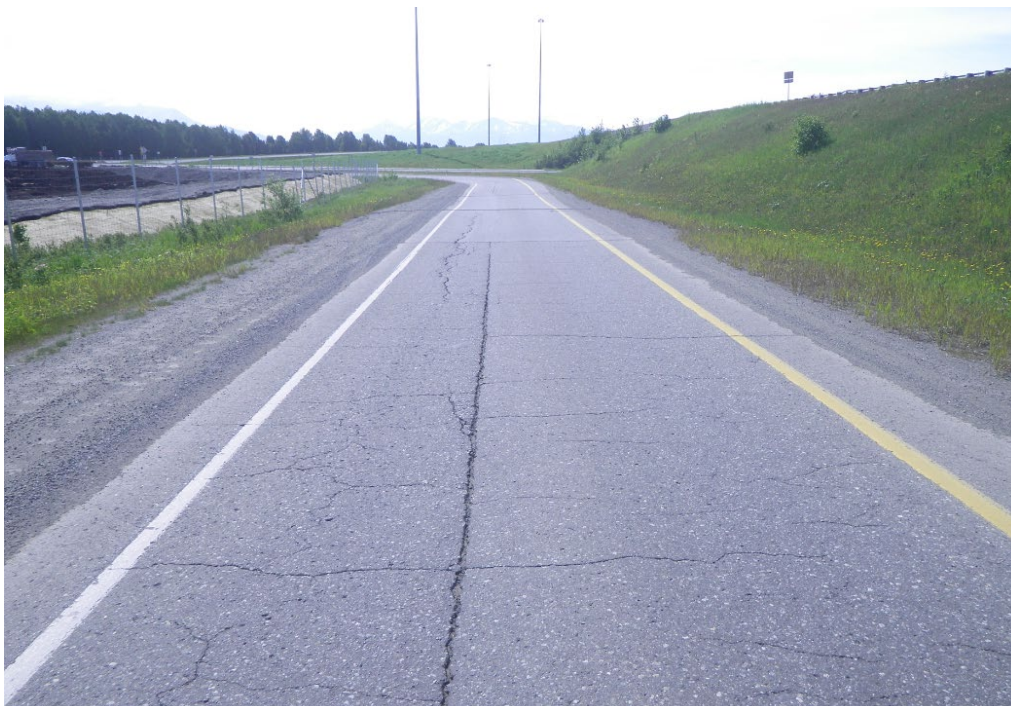
At the beginning of this ramp there was high severity center crack with fatigue cracking forming in the right wheelpath. The conditions improved at the International Airport sign, although faint wheelpath cracking was beginning to form in areas.

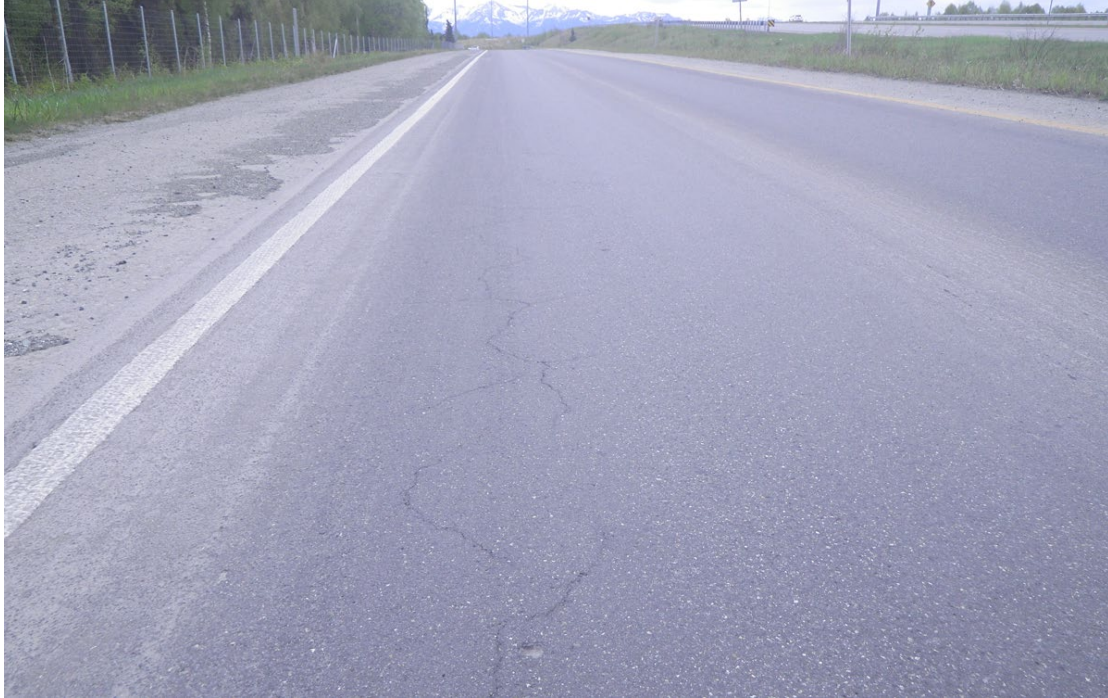
The block cracking and fatigue cracking reflected through the microsurfacing, but the largest cracks to reflect and experience damage were the transverse cracks on the ramp. The ramp remains in moderate condition.

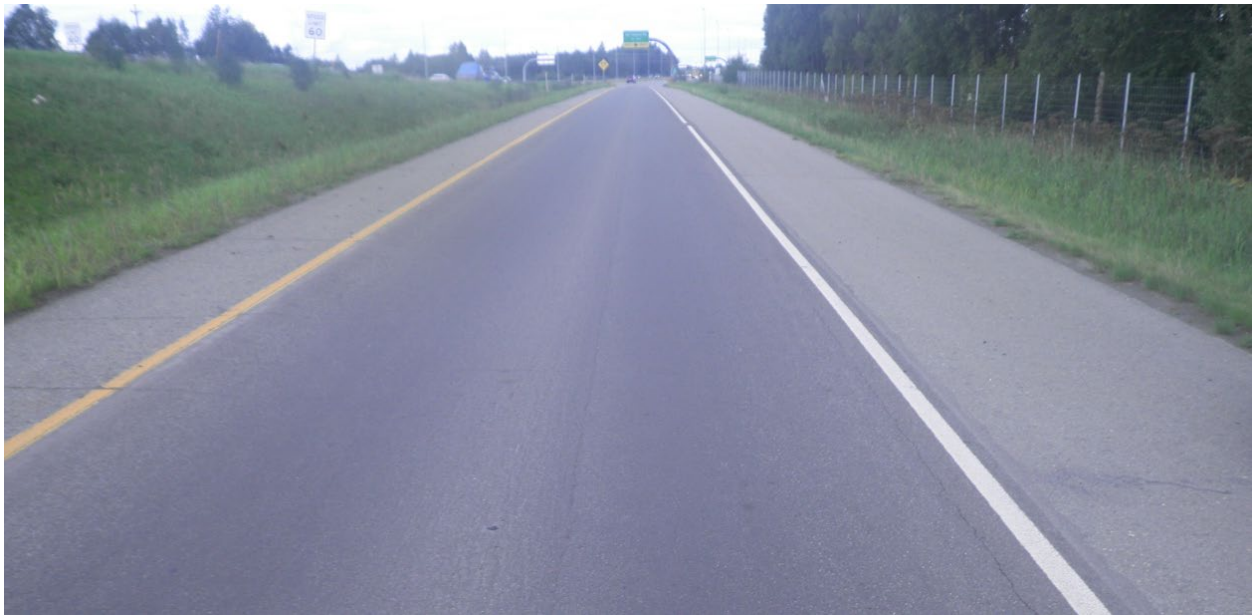
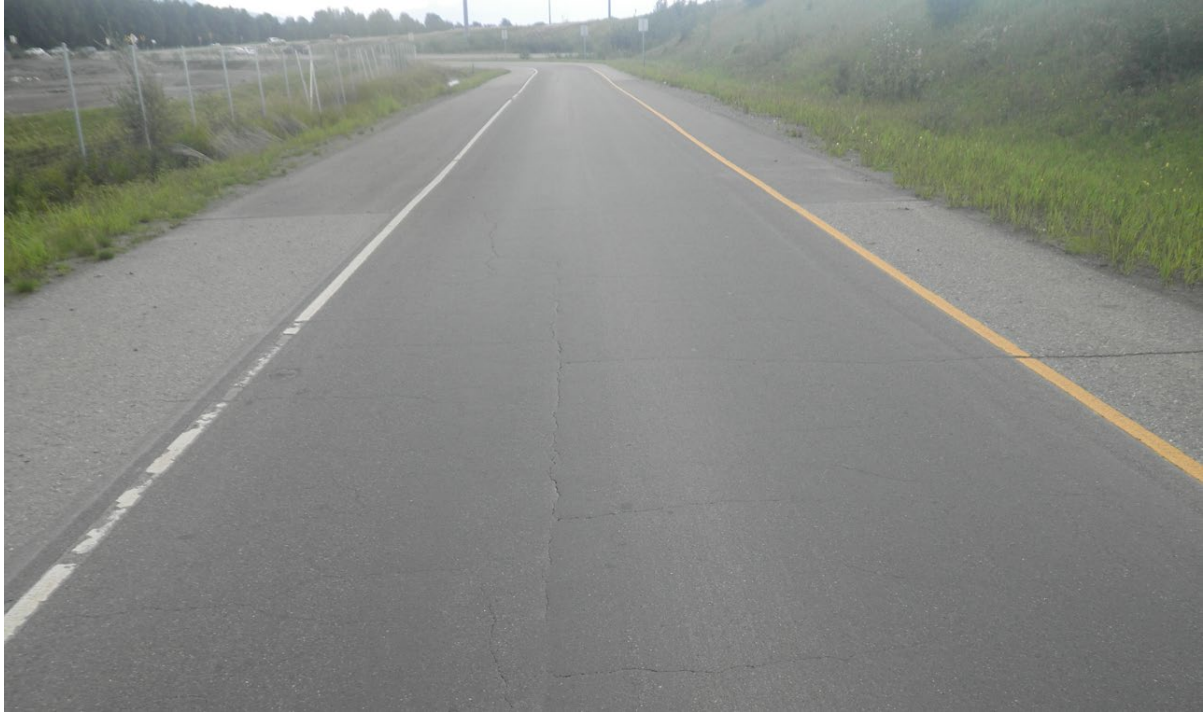
The quantity of reflecting cracking has increased from 2021 to 2022 and the ramp has deformation rutting that occurred post construction, but did not significantly increase in depth from 2021 to 2022.

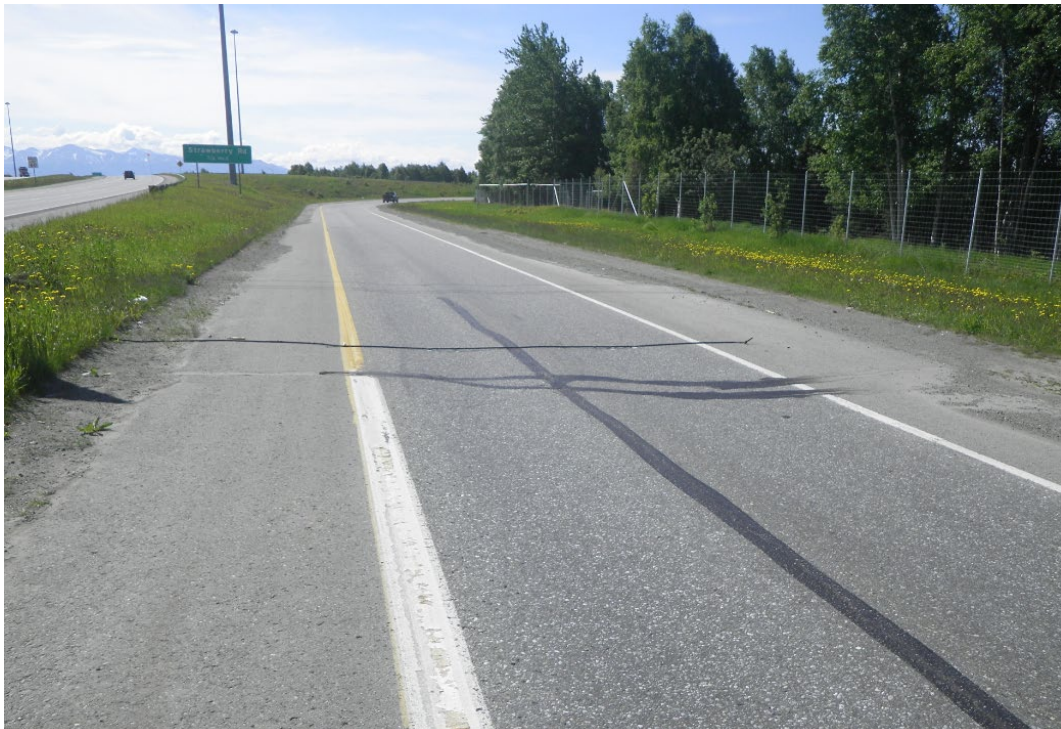
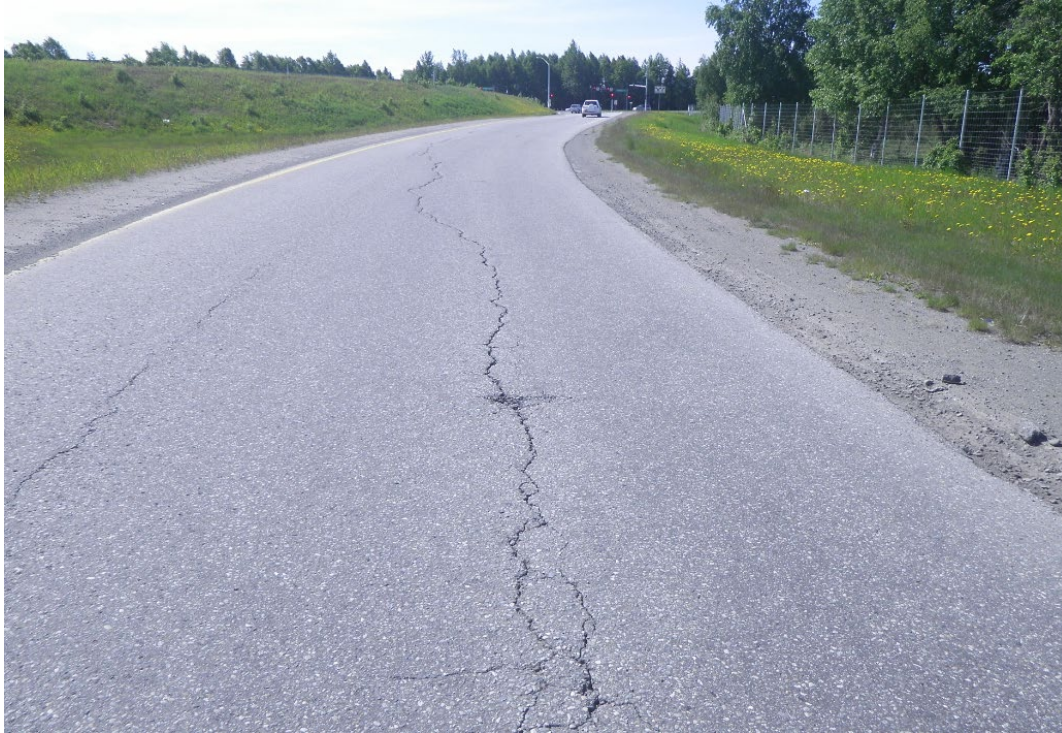
The beginning of this ramp had high rut depths that received hot mix for rut fill prior to the micorsurfacing application. Farther down the ramp there was moderate to high severity longitudinal and transverse cracking with less severe rut depths. This ramp was removed by mill/fill in 2020.

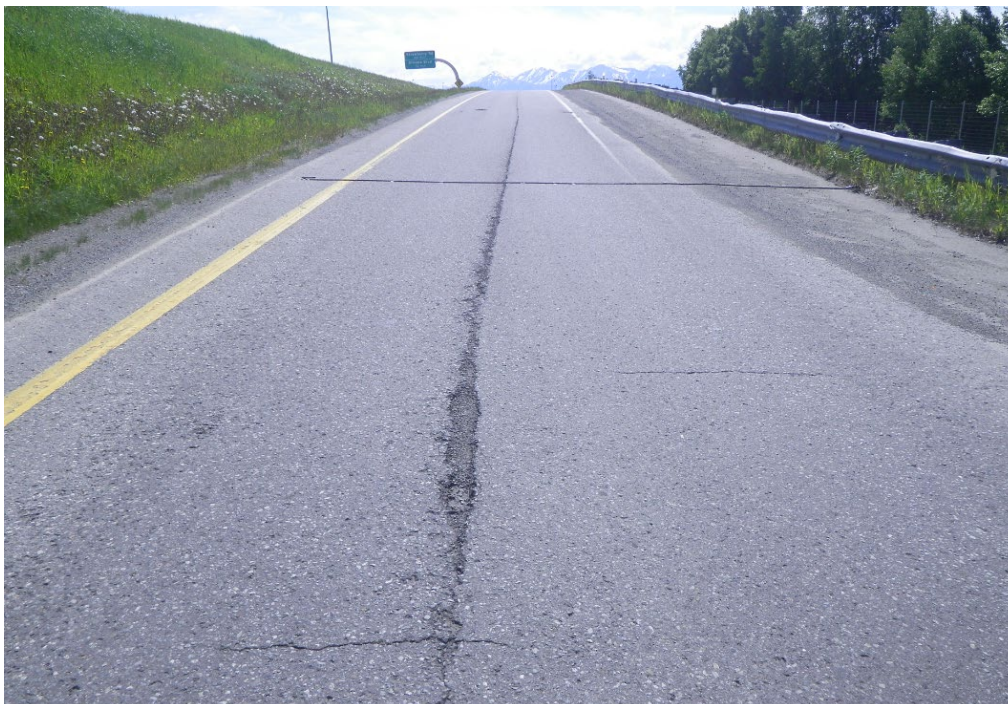
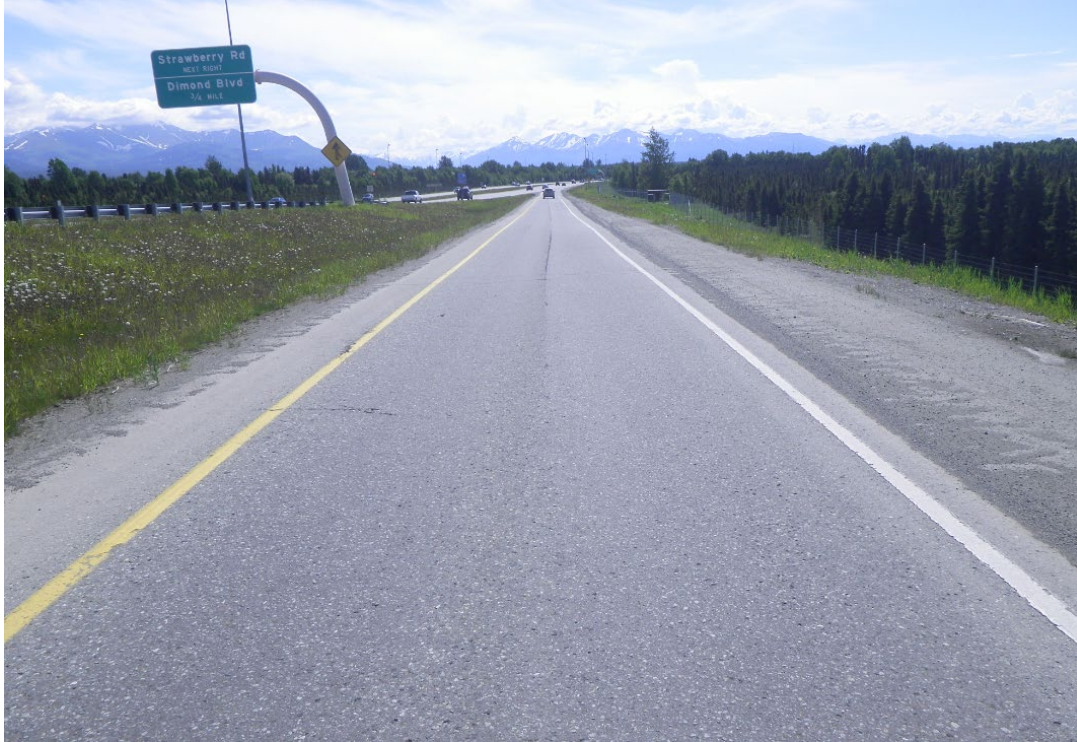
The primary distress on this ramp was a longitudinal joint crack and intermittent transverse cracks with associated potholes. The rut depths were minor with the exception of the southern end where traffic accelerates to begin merging with Minnesota where it neared ½" on average.

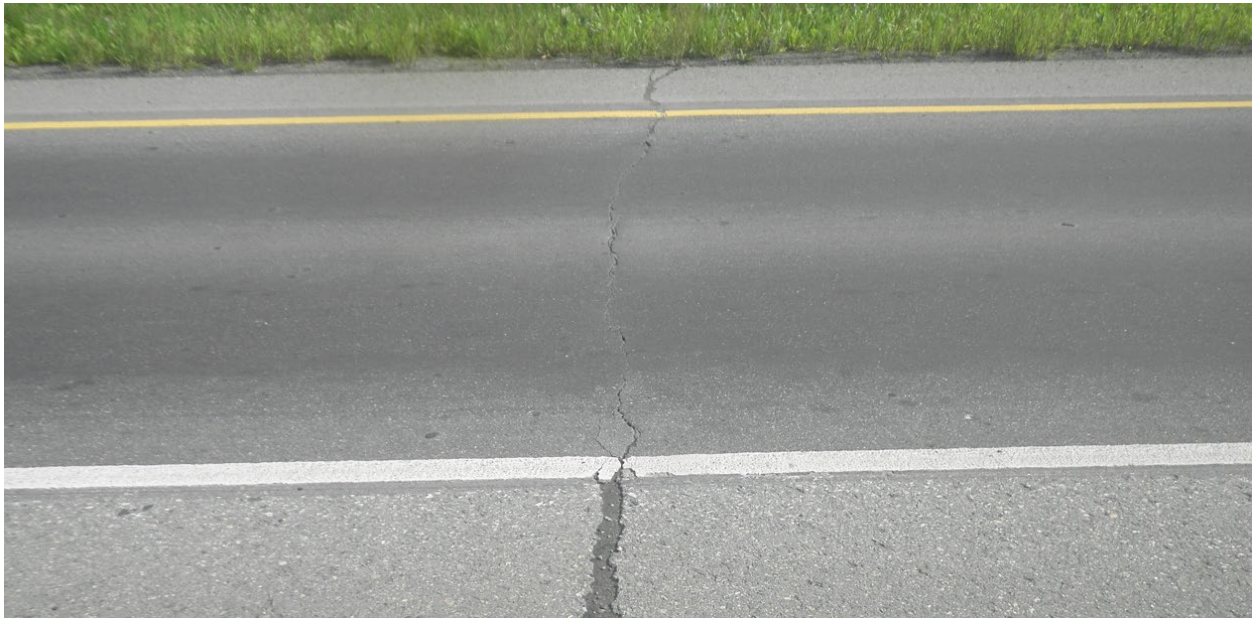
There is significant flushing on this ramp, especially at the beginning of the ramp in the curve and at the end where the deepest ruts were. The reflective transverse cracks are still significantly less severe than they were originally, but the joint raveling along the centerline is opening up since 2021.

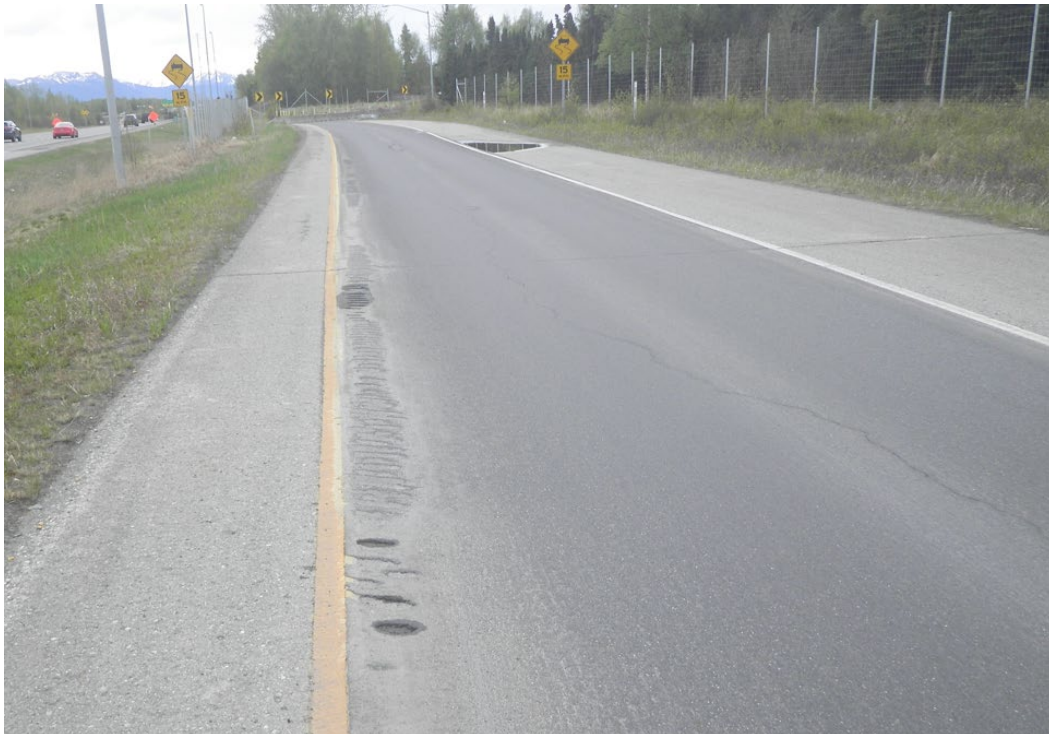
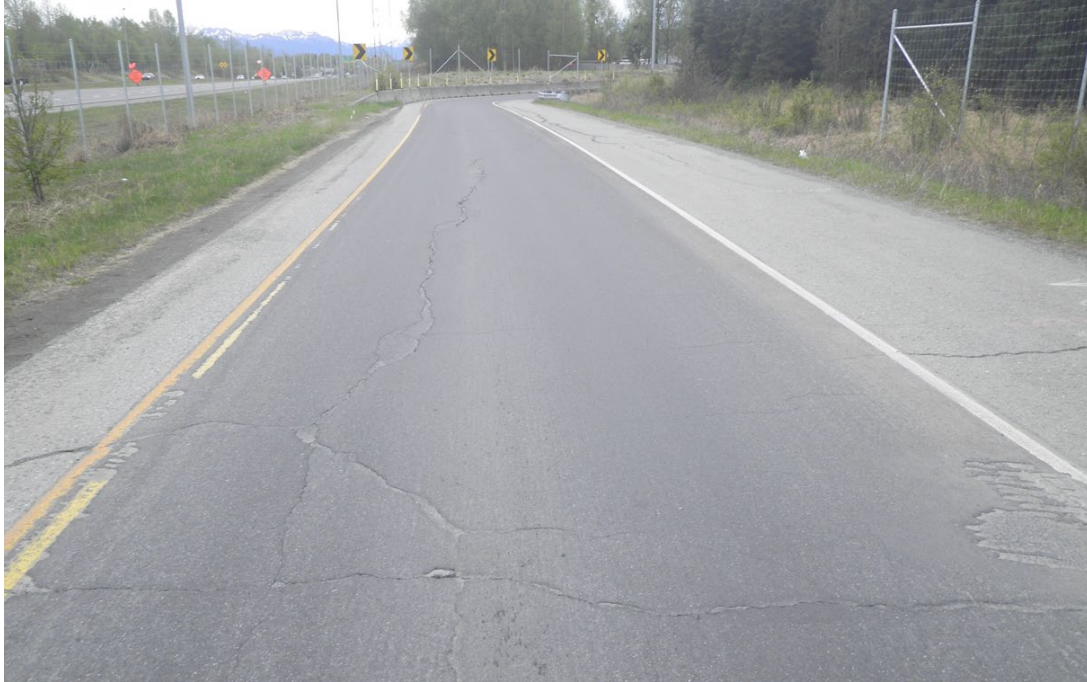
In March of 2021, after a freezing rain, significant plow damage was noted along the centerline and edge of the lane on Ramp 12, the Strawberry Ramp. It is suspected there was significant down pressure on the snowplow to clear the ice off of the ramp that caught the microsurfacing along the longitudinal crack near the centerline that reflected through over the winter. This damage had increased when inspected in 2022.

This ramp is in poor condition from plow damage along the centerline and edges of the ramp. The damage was noted after a night of freezing rain when there was likely a large amount of down pressure put on the snowplow to remove ice.

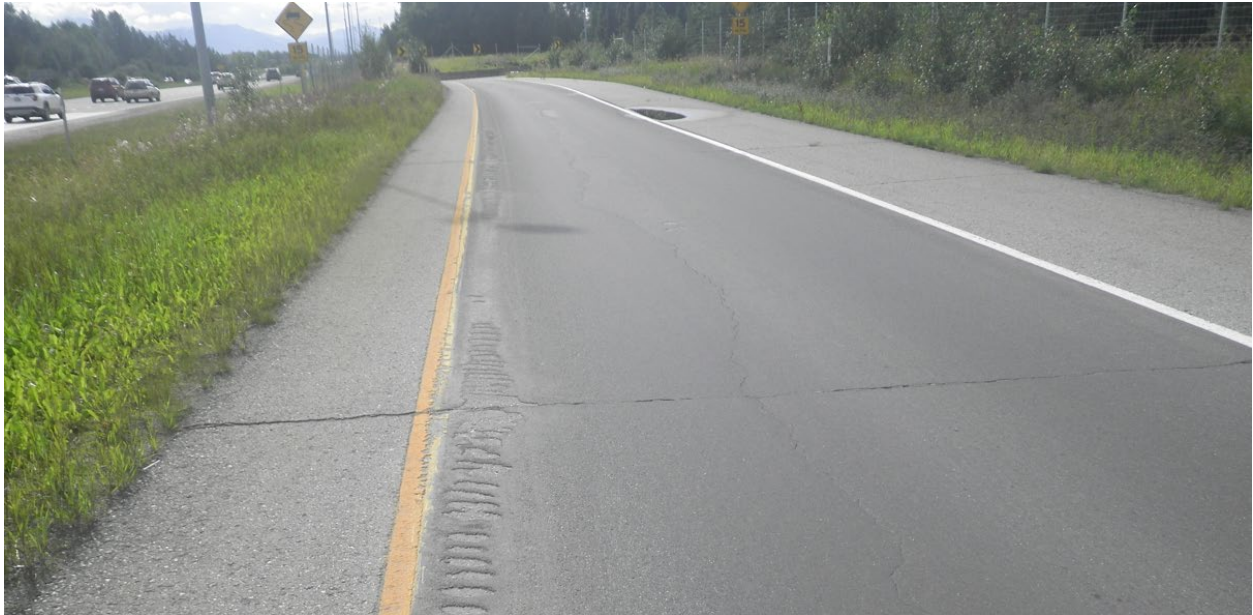
The ramp remains in poor condition with an increased amount of surfacing worn off the center of the road from plows.

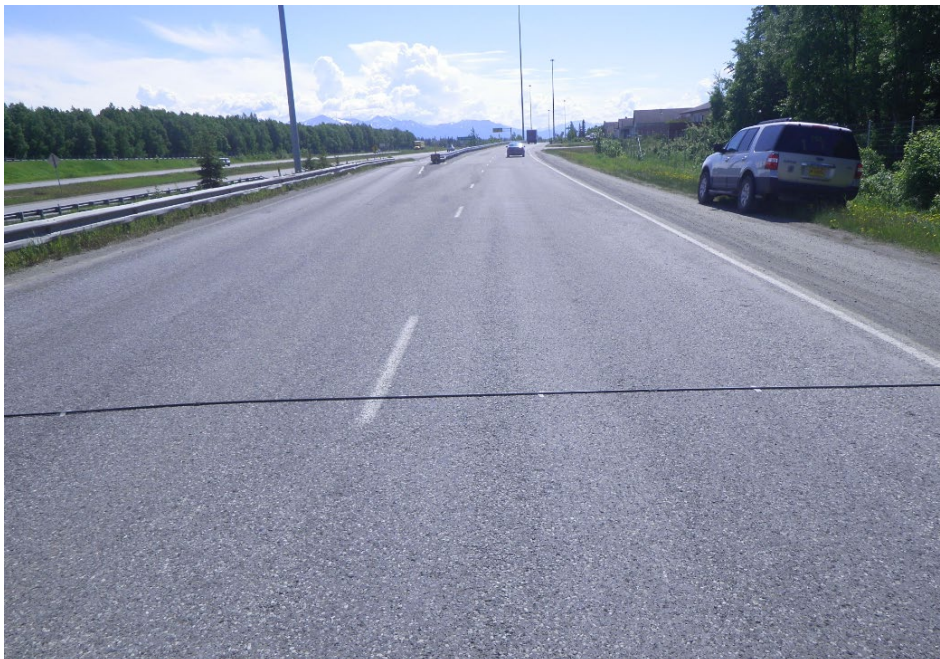
There were moderate rut depths on the left portion of the ramp that accelerates and merges onto Minnesota, which received pre-level prior to the microsurfacing application. The rest of the ramp was in good condition with ruts less than half an inch and low severity raveling.

The portion of the ramp that received pre-level was removed and replaced with a mill/fill due to observed flushing in 2020. The microsurfacing remains on the rest of the ramp.

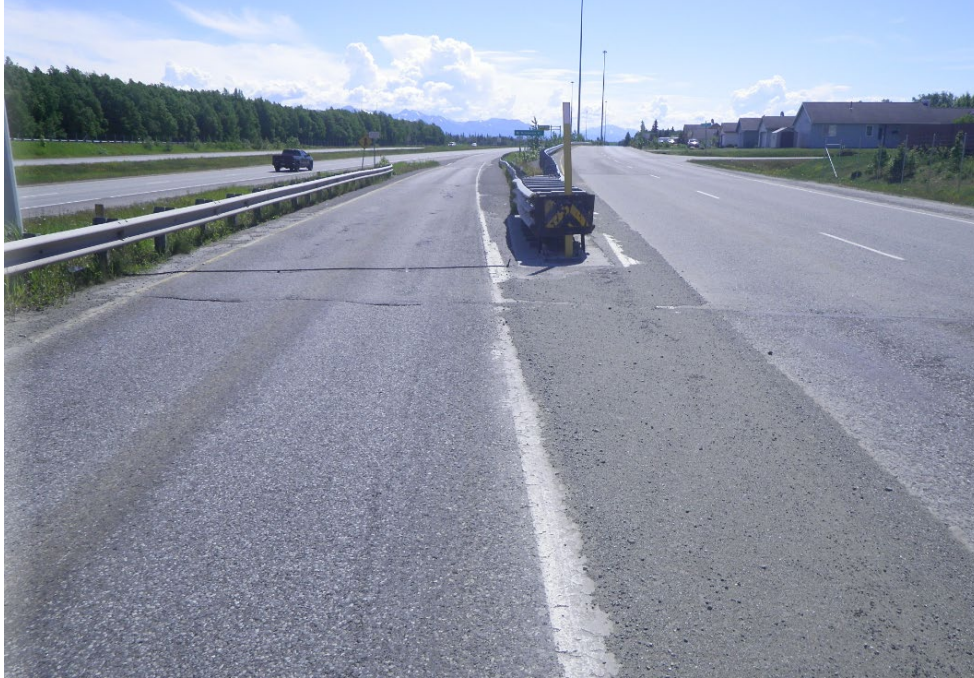
Year 1 Monitoring Photos

The photo below provides a comparison of the removal area (left) with hot mix, while the microsurfacing remains on the right. The ramp remains in overall good condition with some plow damage on transverse cracks that have reflected through the microsurfacing.

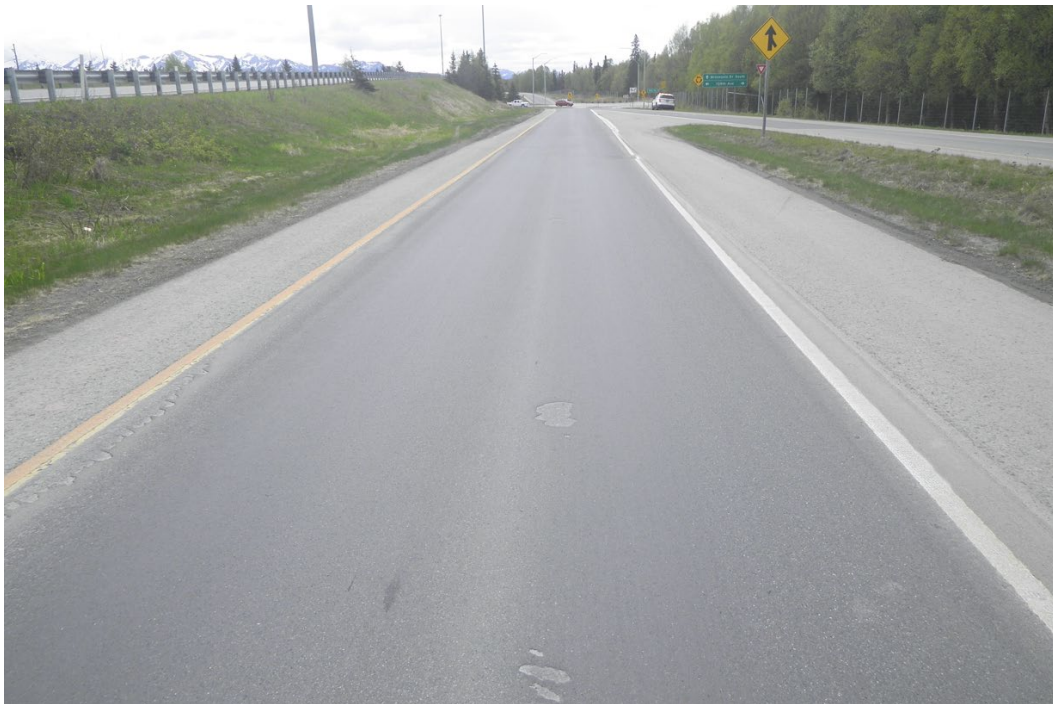
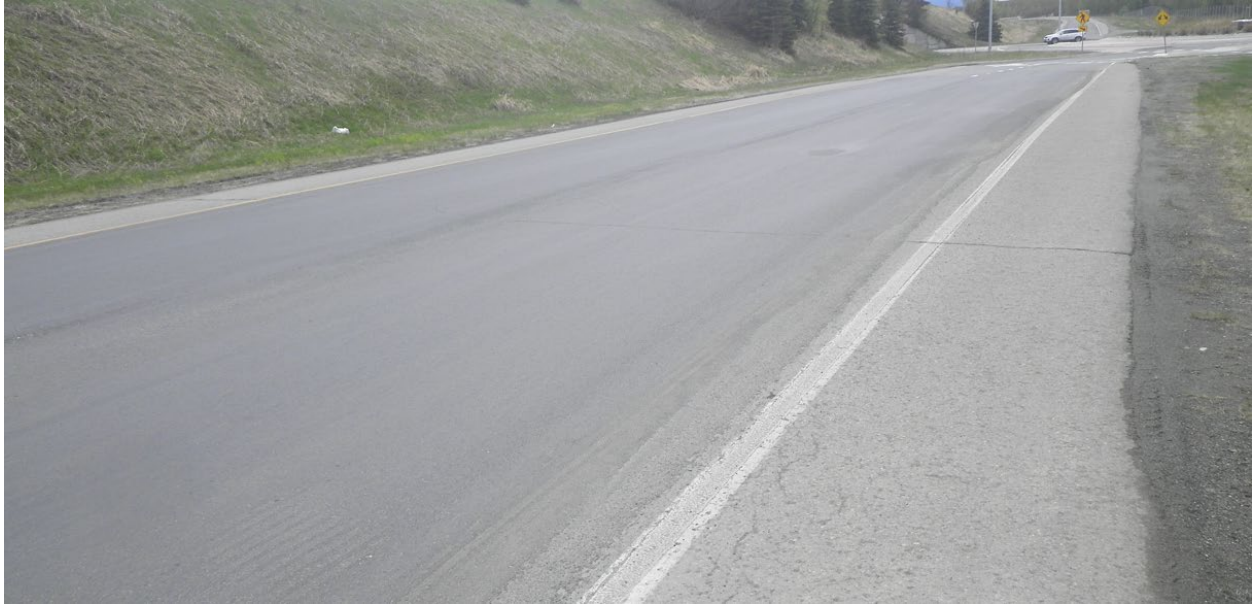
The ramp has some plow damage along the left-hand side and centerline of the off ramp and transverse cracks reflected through the microsurfacing. The ramp remains in moderate condition.

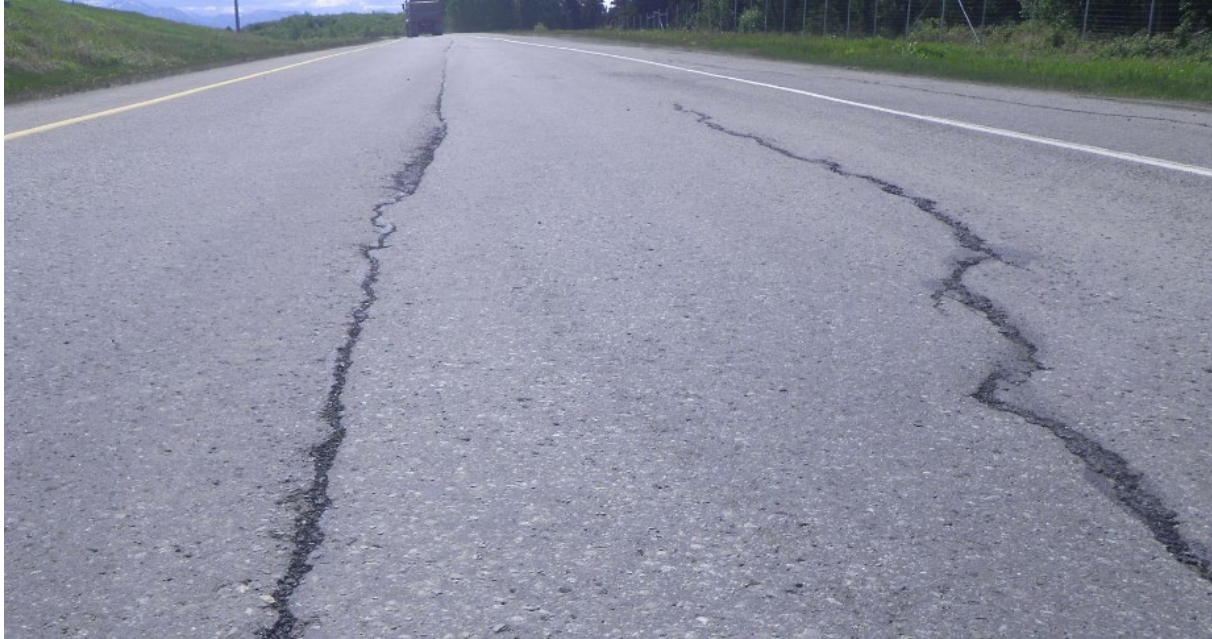
Year 1 Monitoring Photos

The high severity longitudinal cracking reflected through the microsurfacing near 100th Avenue, but it remained at low severity. Transverse cracks reflected, but overall the ramp remains in good condition outside of the distress near 100th Avenue.

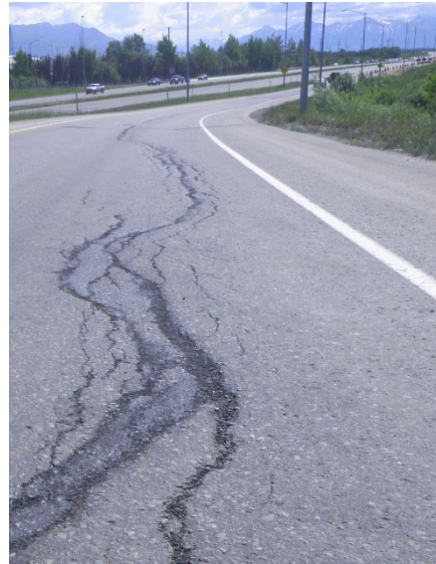
Photo 2 – Ramp 1 After Surface Preparation

The primary distress is high severity longitudinal cracking down the center and right of the lane starting near International Airport Road. There is low raveling, and studded tire wear that deepens near the bottom of the ramp near Minnesota, which received rut fill using hot mix. At the end of the guardrail, pattern cracking has formed around the cracks. The cracks are near 1.5" at the widest and received crackseal and HMA to fill. The photo on the left is prior to surface preparation, and the right is after, with the larger crack being filled with both crackseal and hot mix.

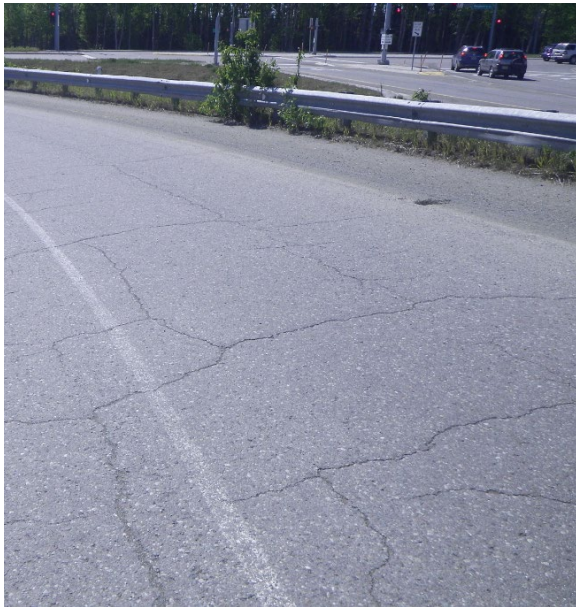
Photo 3 - Ramp 8 General Condition

This cloverleaf ramp has block cracks of moderate severity for nearly the entire length along with a wide joint crack. Fatigue based cracking is beginning to appear in the wheel paths in addition to the block cracking. See photo below to the left that shows the general ramp condition.
