Minnesota Drive Ramps Microsurfacing Experimental Feature

Year 2 Monitoring Report

Alaska Department of Transportation and Public Facilities
Statewide Materials and Asset Management

January 2023

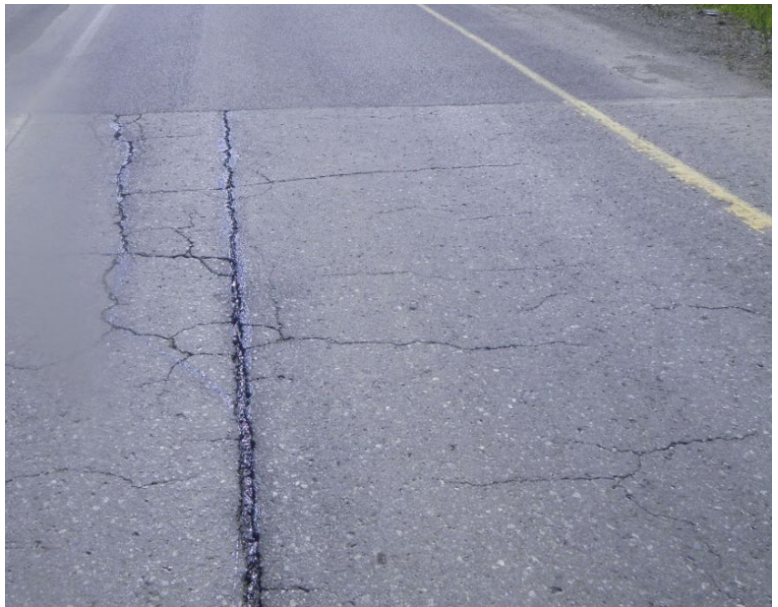
Photo 4 - Ramp 9 General Condition

A longitudinal joint crack is present for the majority of the ramp, along with block cracking that has developed into alligator cracking in the right wheel-path that extends to near the end of the ramp at the International Airport sign. From then on, faint block cracking is beginning to develop along with moderate severity transverse cracks. See the photo above and to the right.

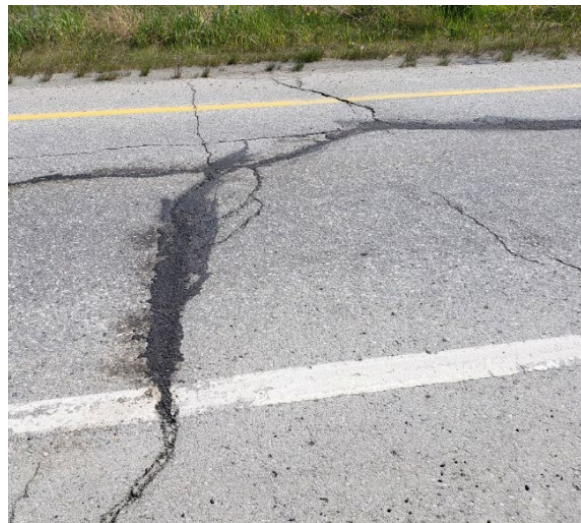
Photo 6 - Ramp 12 - Cracks after Surface Preparation

There is high severity longitudinal cracking and potholing beginning approximately halfway down the ramp. Transverse cracking varies between low to high severity throughout the ramp. See the above right photo.

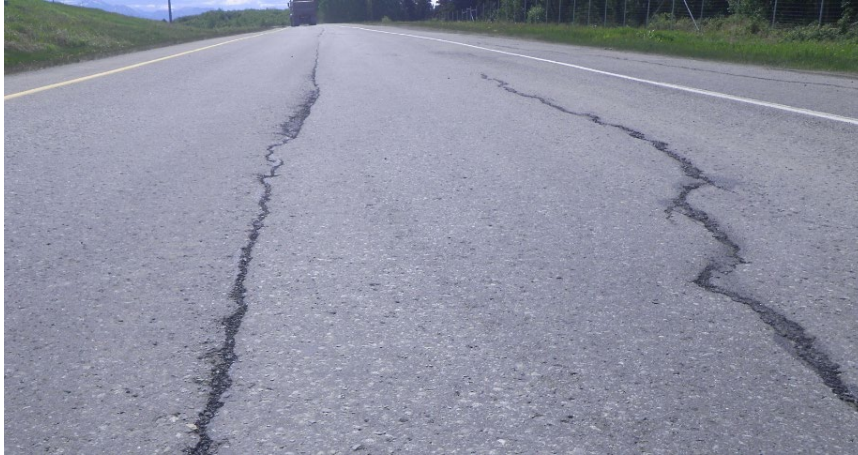
Photo 7 - Ramp 15 After Surface Preparation

There is high severity longitudinal cracking for the first 200' of the ramp near 100th Avenue. There is also moderate to high severity joint raveling consistently along the ramp that has opened up to near $\frac{3}{4}$ " in width. High severity transverse cracking is present where the ramp ties into Minnesota.

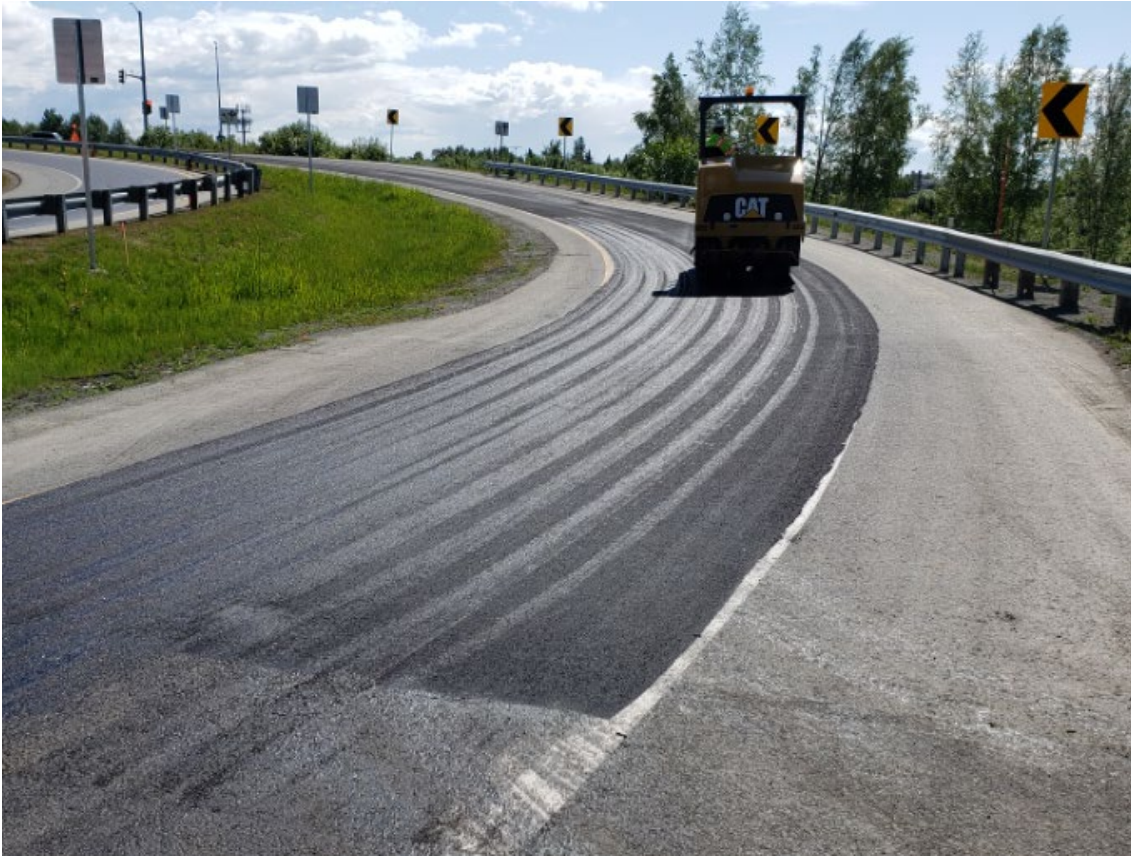
A pneumatic roller finishing a portion of Ramp 6 that was unable to be completed on the first day of production due to the crude source changing for the emulsion. The ramps were able to be rolled and opened to traffic in between 1.5 -2 hours instead of the 4 hours it was taking the first day of production.

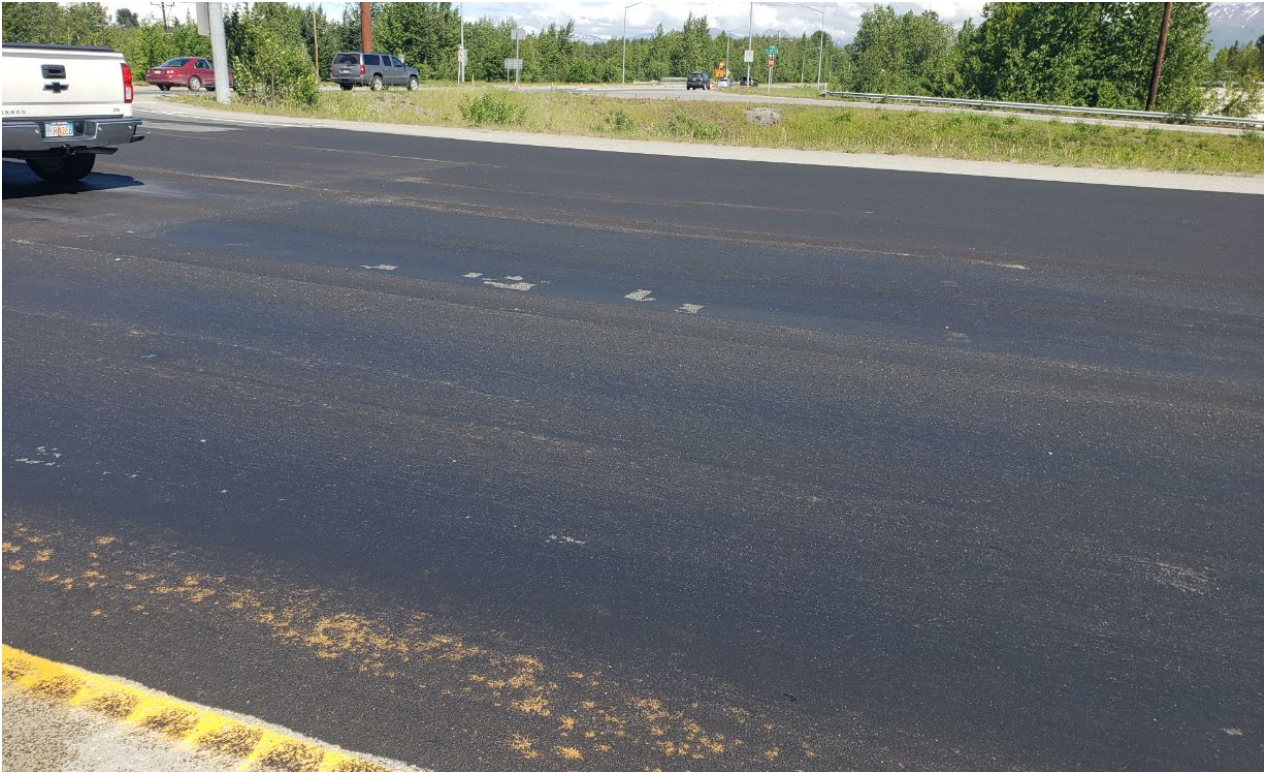
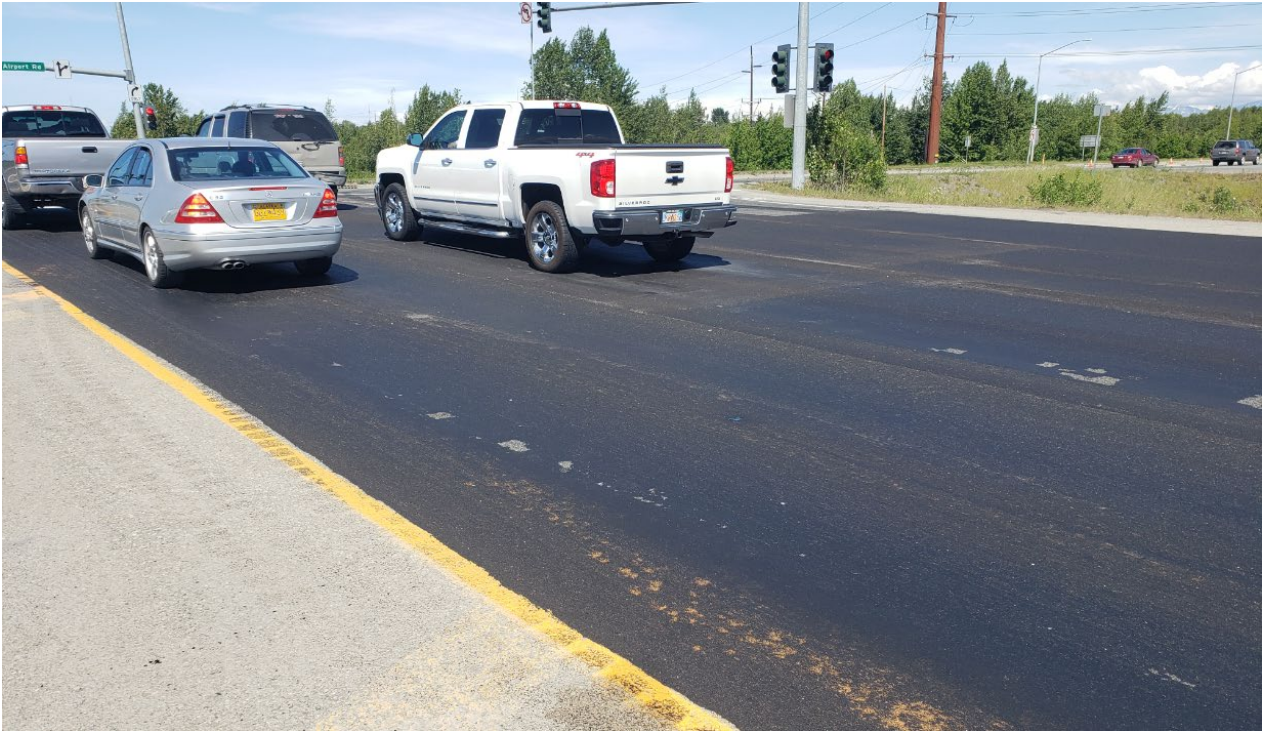
There was some pickup by traffic on the scratch course on Ramp 2 on the fourth day of production. This is at the signalized intersection that the major pickup and deformation occurred on the surface course.

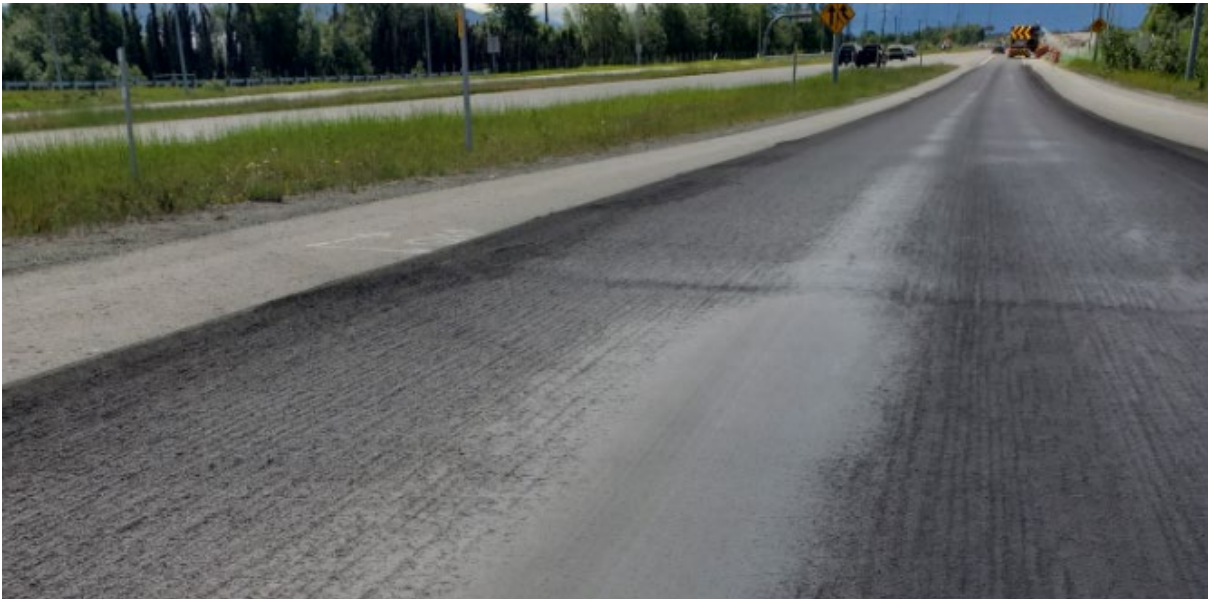
Construction continued on the surface course without issue until Saturday, June 13th when distress was reported on the surface course of Ramps 1 and 2 at International Airport Road. The flushing distress on Ramp 1 at the transition of the rut fill that extends down the ramp as indicated by QAP mark on the left.

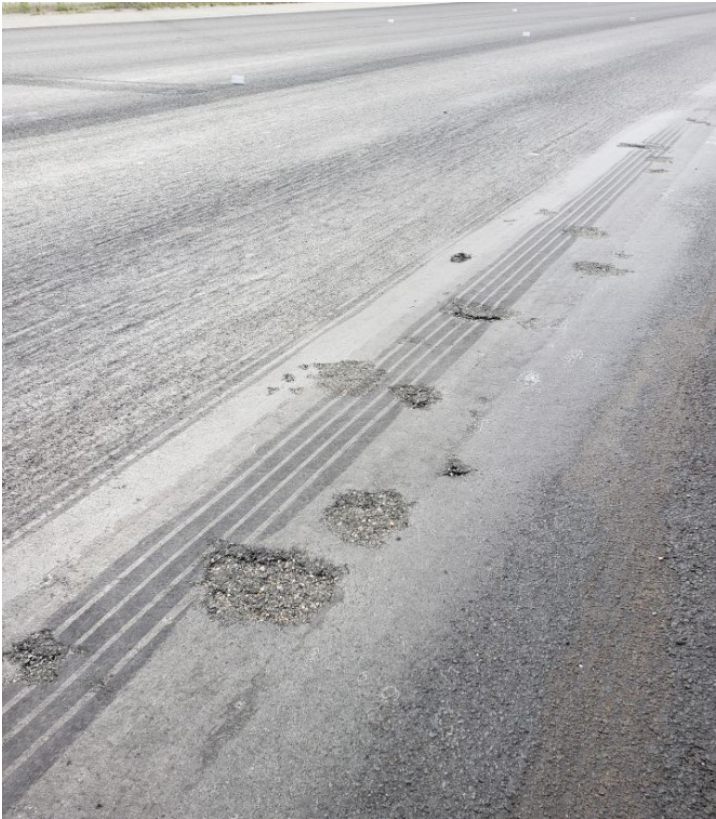
Ramp 2, shown below, had extreme flushing and pickup, caused by the static loading and turning motion of trucks hauling material to the Anchorage International Airport.

The flushing distress and pickup by traffic can be observed on Ramp 2

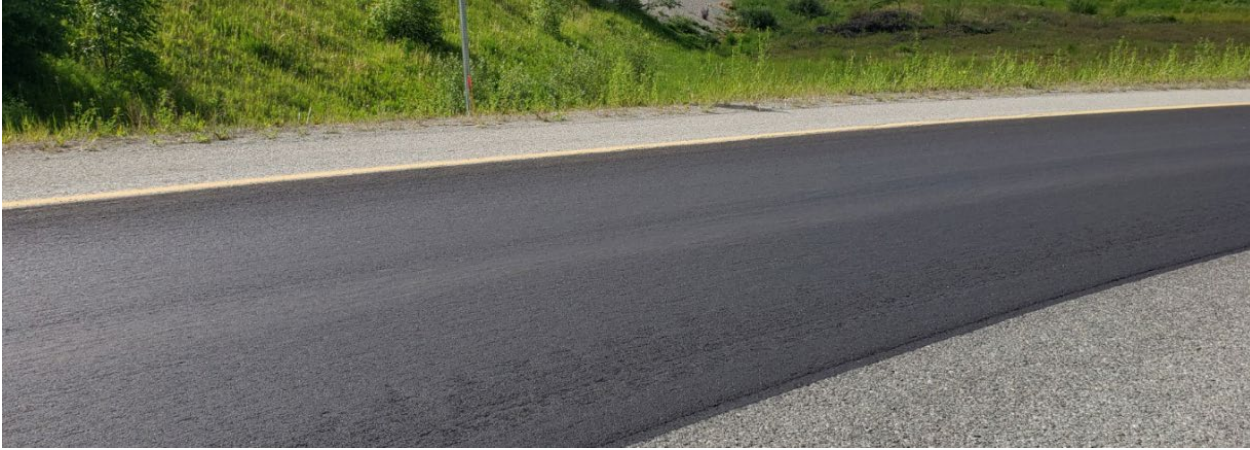
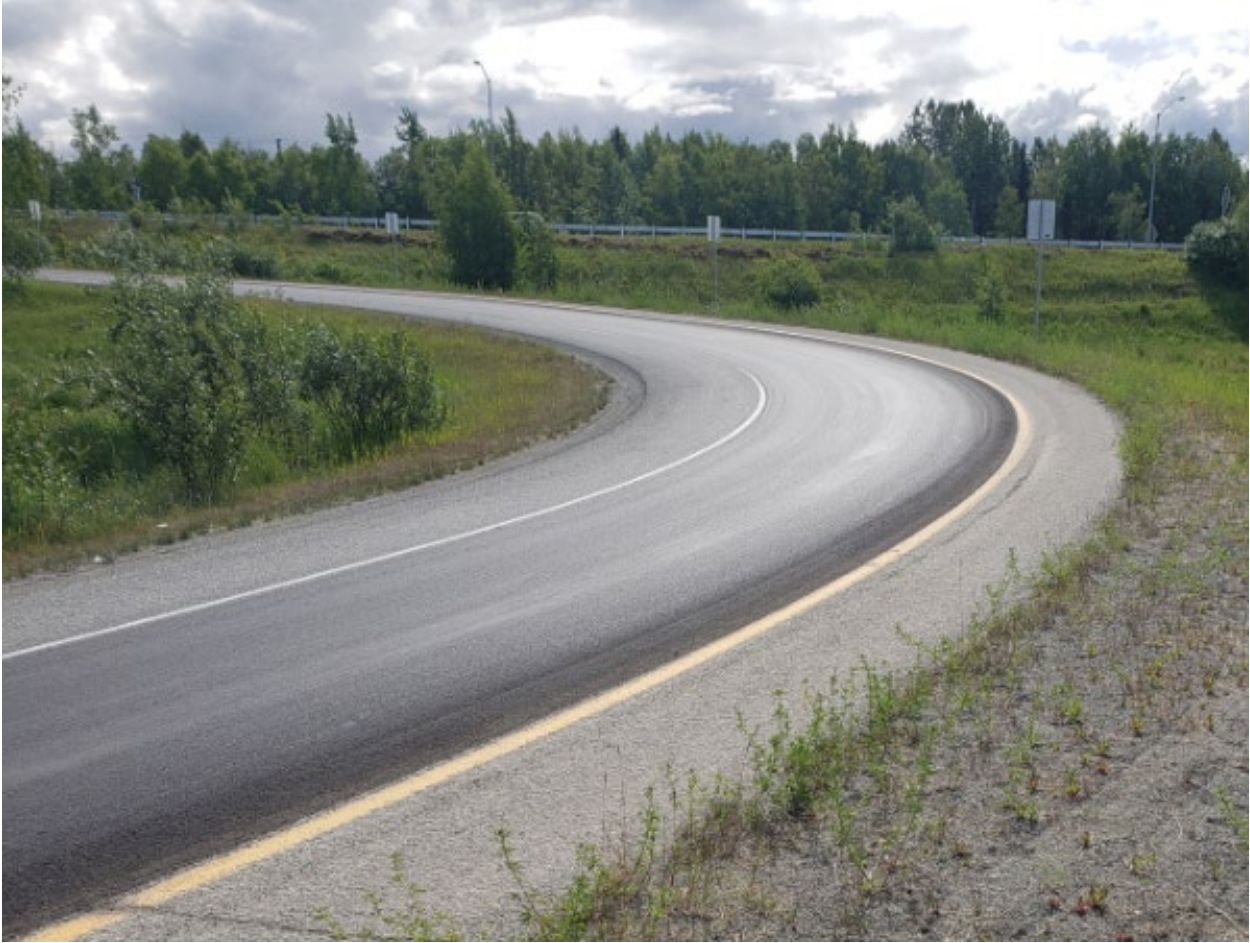
Ramp 3 was reviewed while out looking at Ramps 1 and 2 and no flushing, bleeding or other distresses were present on the ramp. This is the same location that was hand worked in the previous photos.

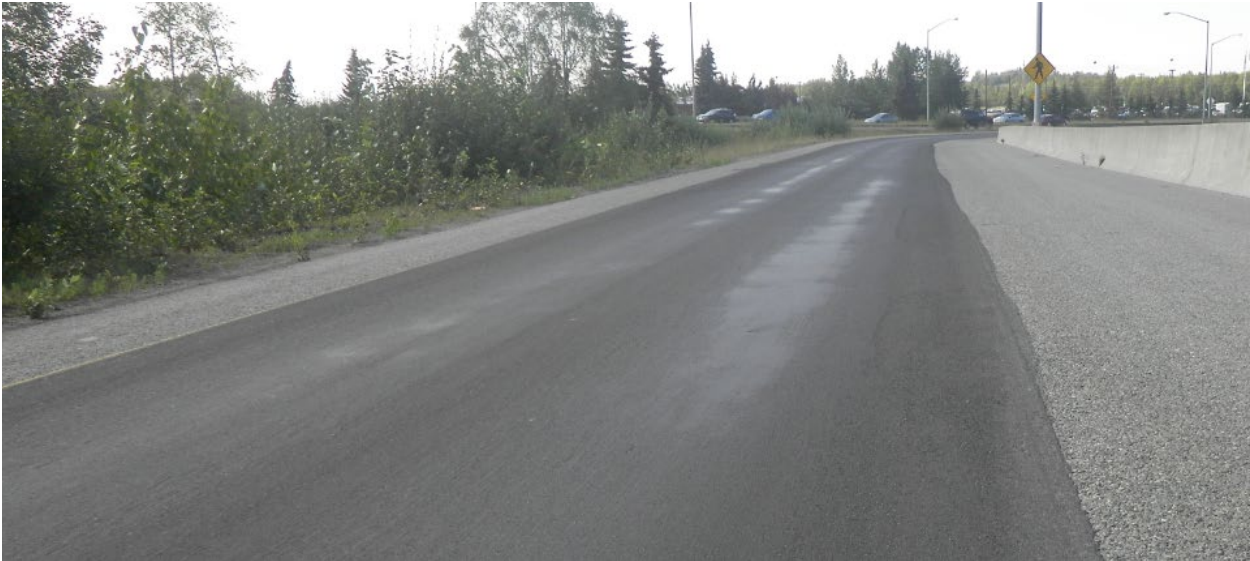
More severe flushing was visible in the area closer to merging onto International.
