## ALASKA DEPARTMENT OF TRANSPORTATION

# Evaluation of Wearing Surfaces for the Yukon River Bridge

July 2009

FHWA-AK-RD-09-07

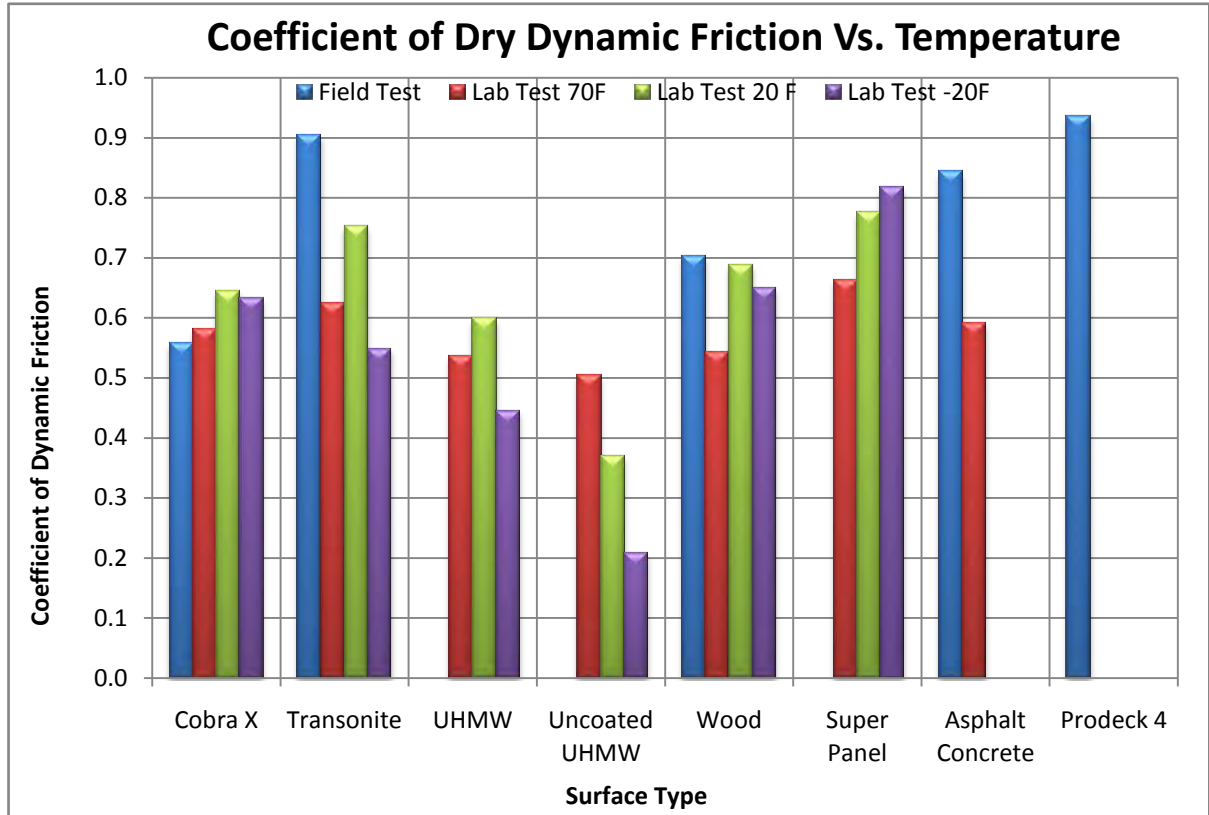
Figure 1.3 Dynamic traction values from field and laboratory tests

In 2007, the Yukon River Bridge deck wearing surfaces were replaced with a new two-layer timber wearing surface. Before replacement, we field tested for traction of the bridge timber deck wearing surface and the experimental features (see Figure 1.3). Test results represent end-of-life values.

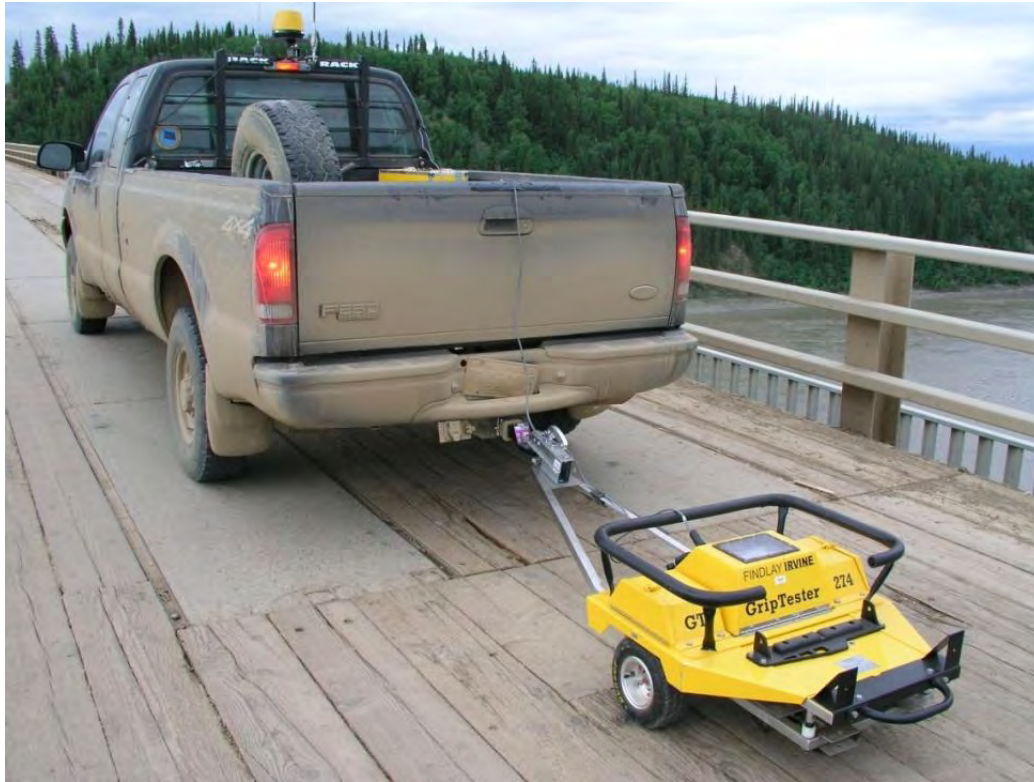
Figure 1.6 Field traction measurements using Grip Tester Type 292/16.

On June 21, 2007, we conducted preliminary traction test measurements on asphalt pavement at the Duckering Building parking lot of the University of Alaska Fairbanks (UAF) campus. This pavement has been in service over ten years. The purpose of these tests was to become familiar with our testing equipment and to provide a field-test measurement that would serve as a baseline for used pavement measurements. The average traction for the parking lot was 0.84. Traction for end-of-life wearing surfaces at the Yukon River Bridge was measured the following day, on June 22, 2007 (see Figure 1.6 and Table 1.4).

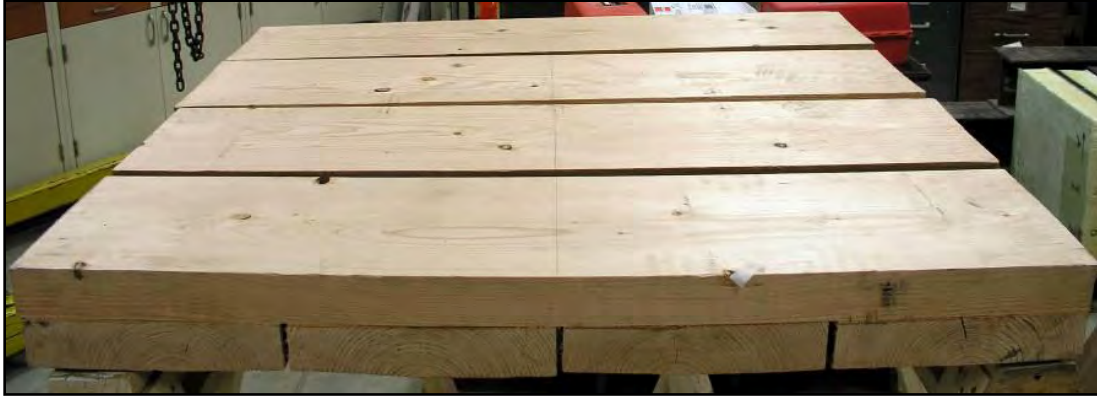
Figure 2.3 Timber on timber composite (rough sawn, two layers of 2½ in. by 12 in.

| Ranking | Future use | Wearing surface | Age (yr) | Condition | Performance |
|---|---|---|---|---|---|
| 2 | yes | Two-layer timber system | 8 | Timbers layers are lagged together | Installed in 1999. <i>Observed:</i> It is slick when wet or icy. Its life is reduced by decay, chains, and equipment damage. <i>Predicted:</i> It likely will prematurely crack because one layer carries more load. |

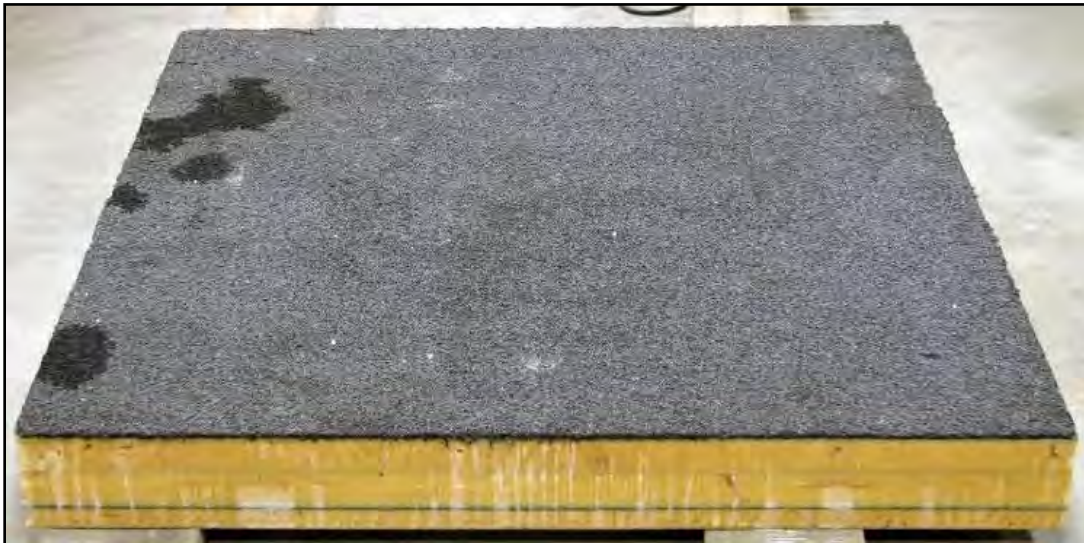
Figure 2.4 Transonite by Martin Marietta (side view).

| Ranking | Future use | Wearing surface | Age (yr) | Condition | Performance |
|---|---|---|---|---|---|
| 4 | no | Transonite | 2 | Composite is fastened to the steel deck | This experimental feature was installed in 2005. <i>Observed:</i> The wearing surface was damaged the first year. In addition, it appears that the panel was not sealed at the fastener penetrations, and subsequently, it was unable to drain. |

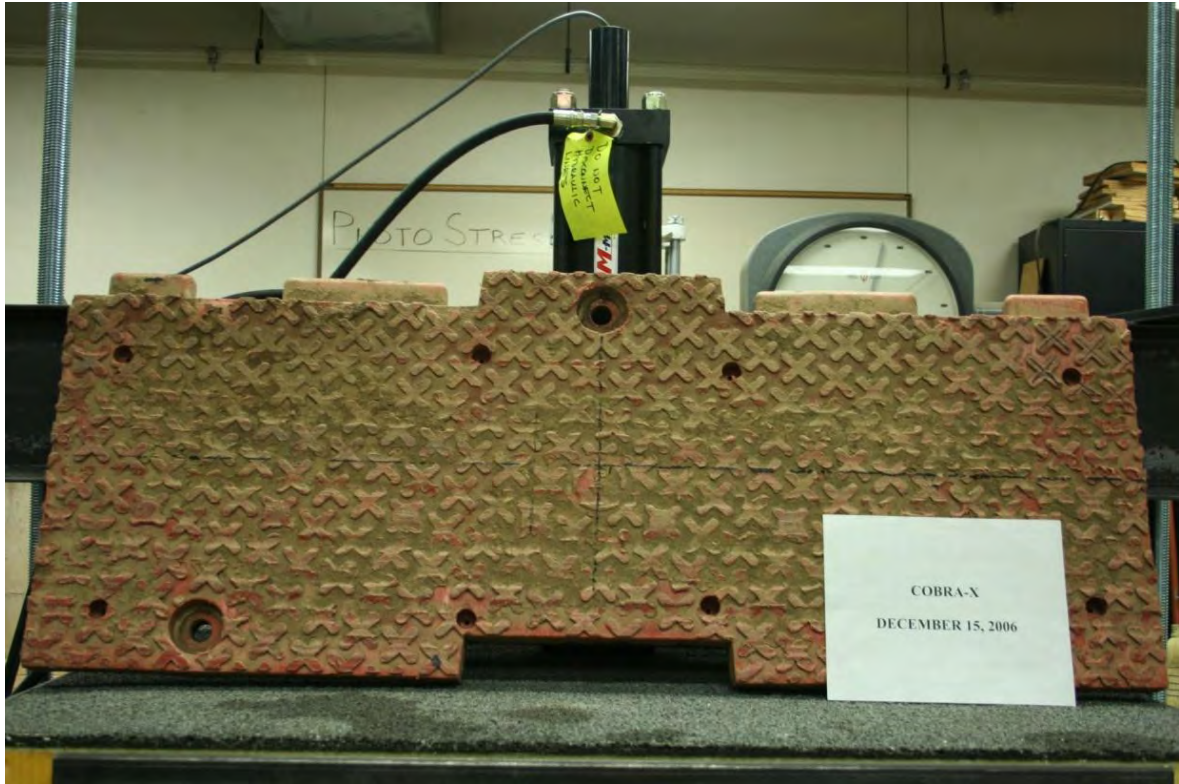
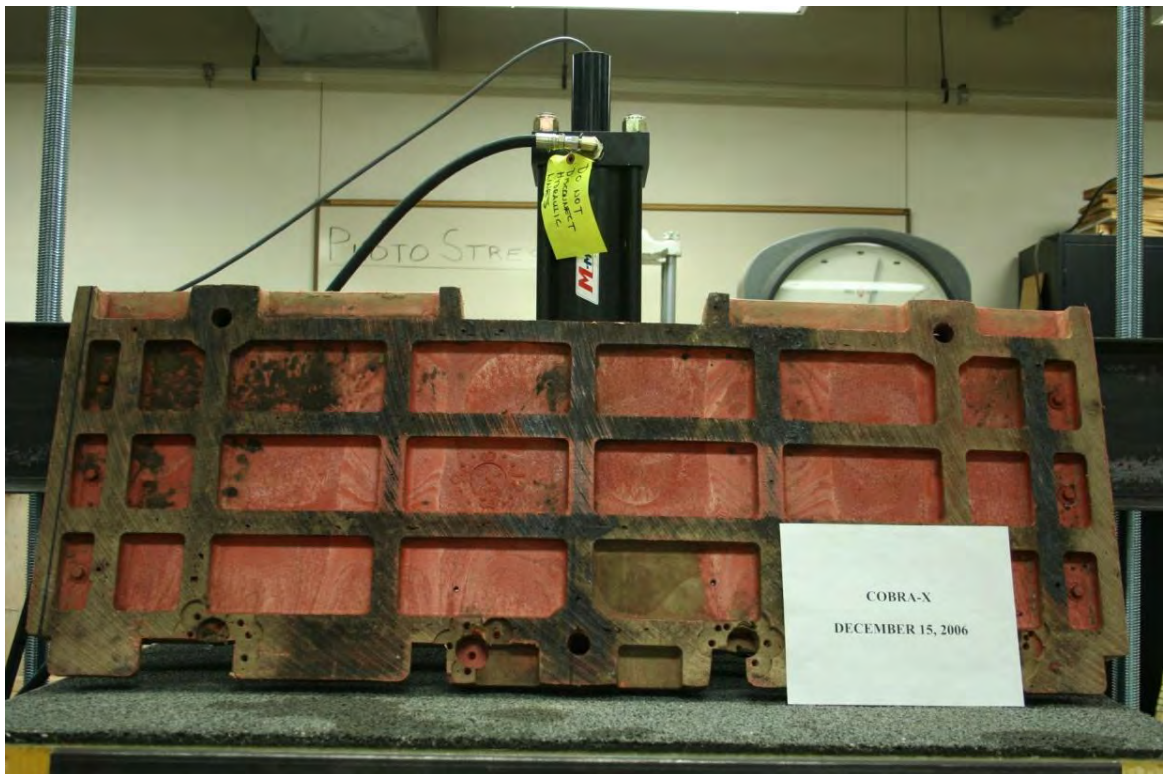
| Ranking | Future use | Wearing surface | Age (yr) | Condition | Performance |
|---|---|---|---|---|---|
| 1 | yes | Cobra X on timber under layer | 15 | Fastened to timber underlayment | This experimental feature was installed in 1992. <i>Observed:</i> It has performed well. |

Figure 2.8 Cobra X top surface, typical bridge-deck panel.

Figure 2.9 Cobra X bottom side, typical bridge-deck panel.

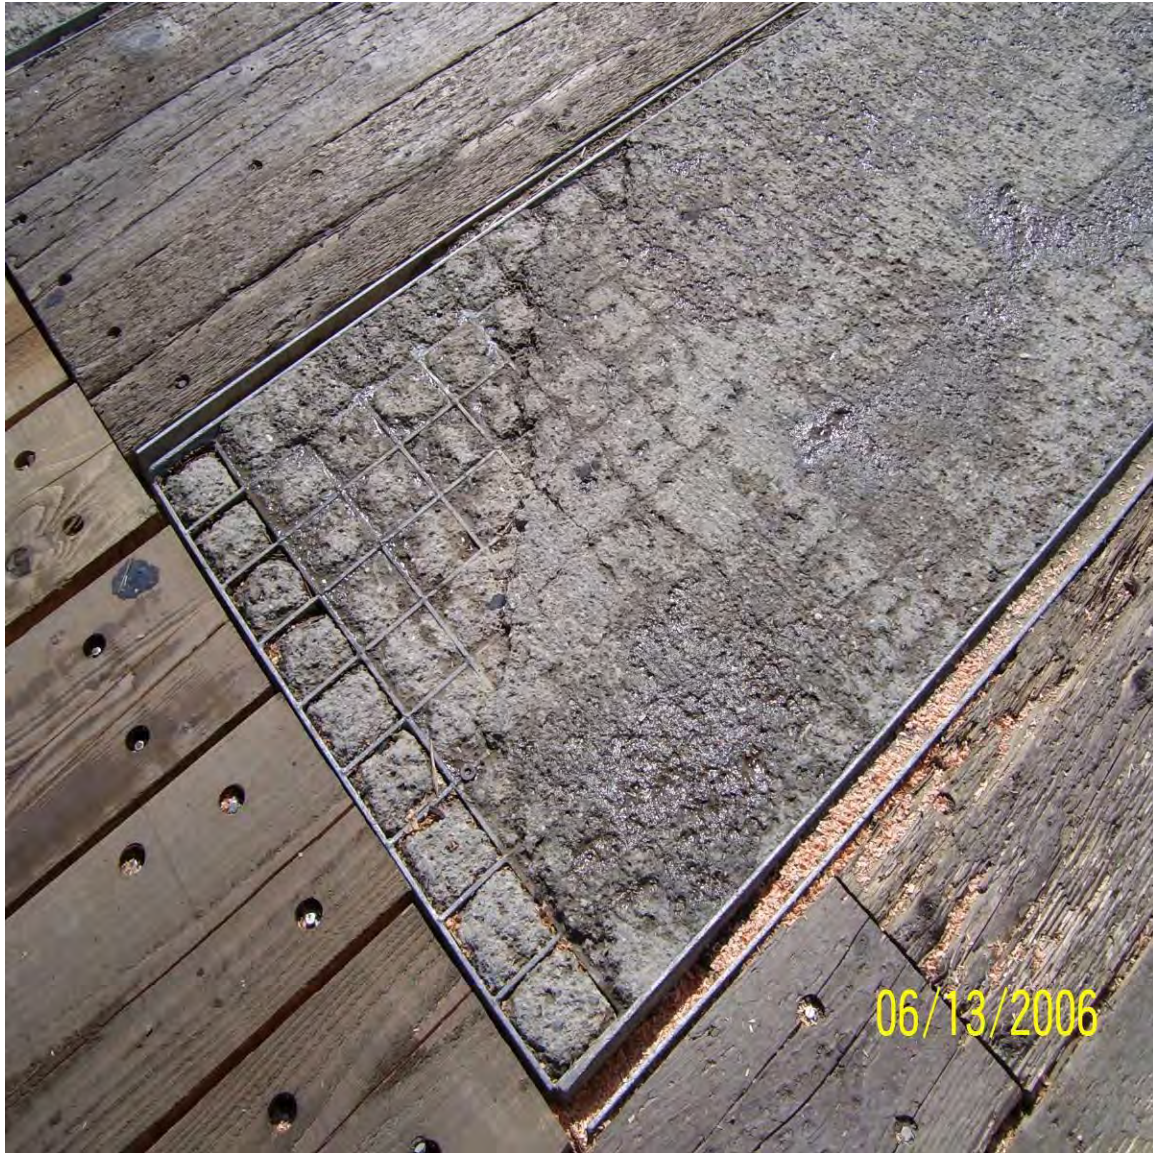
A test section of concrete in a steel grid was installed in July 1999. While it continues to serve as a wear surface, it shows signs of impending failure. The concrete above the top of the grid is starting to separate from the grid, and only concrete blocks are left within the grids (see Figure B.6).

Figure B.6 Concrete-filled steel grid wearing surface (7 years old).

Because of concrete loss over time, it is likely that in the distant future only the steel grid will be left. Once there is only a steel grid, the expected traction will be very low or similar to a slick surface typical of metal grid decking. The concrete wearing surface at the in-place experimental test panels were slightly higher than the surrounding wood deck. Figure B.6 shows that the most damaged area is at the end of the test section. The direction of traffic in this figure is from left to right. This suggests that the majority of damage may be due to

snow-removal equipment blades scraping the higher surface. We believe this could be eliminated if the surface of this test section and surface of the wood were at the same elevation. Not all damage was at the ends. There were some areas with concrete missing near the center of the test panels, and much of the concrete surface showed signs of cracking along lines of the steel grid below (see Figure B.7).

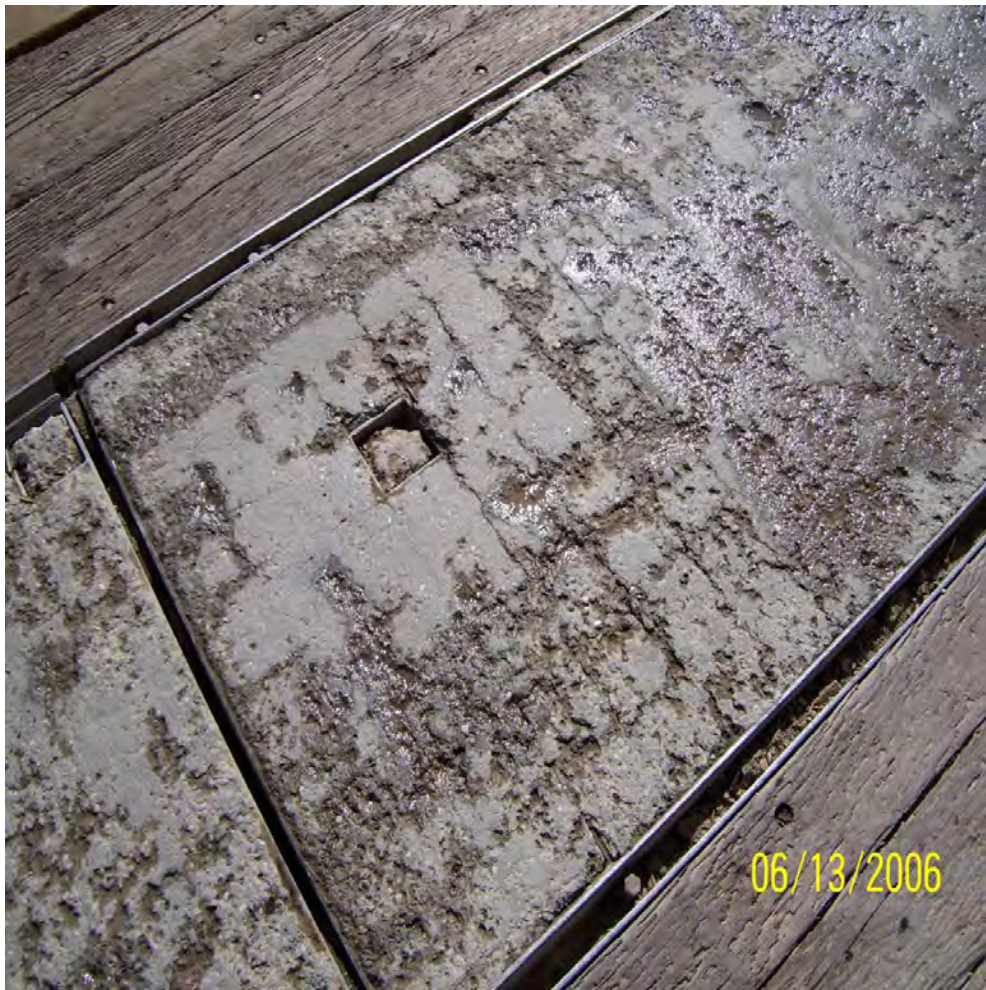
Figure B.7 Another concrete-filled steel grid wearing-surface test section.

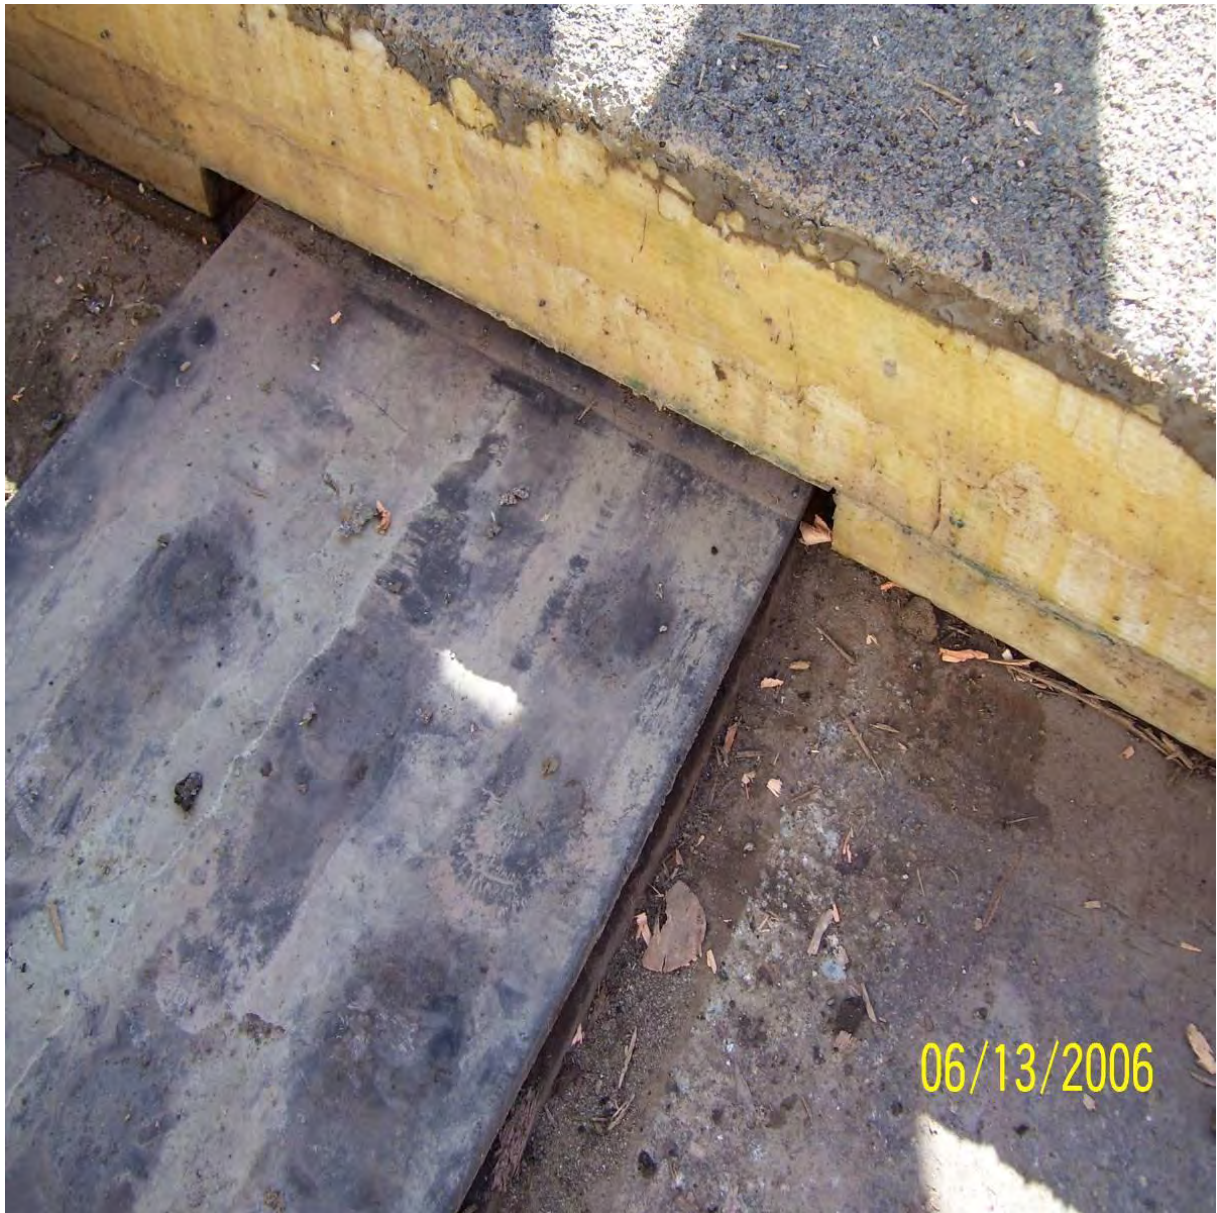
Each panel was a three-part system: a top layer, inner layer, and bottom layer. The top layer consisted of a wear surface bonded to the panel. This wear surface was about 3/8 in. thick and appeared to be an epoxy concrete with an aggregate broadcast. The inner layer consisted of a 4 in. thick Transonite panel. Transonite panels are made of foam sandwiched between fiberglass panels, with pillars of fiberglass connecting the panels through the foam. The bottom layer was bonded to the inner layer. This bonded bottom layer was a 1-3/16-in.-thick Transonite panel. The bottom layer did not exist over the bolt splice plates in the steel deck. In this area, a neoprene strip was located over the bolt heads, and a plate of sheet metal was bonded to the panel. Figure B.9 shows a panel in place on the deck. This figure shows both the layered system and the neoprene strip. The panel assembly was bolted to the steel deck with studs.

Figure B.9 Fastening details between deck and the Transonite.

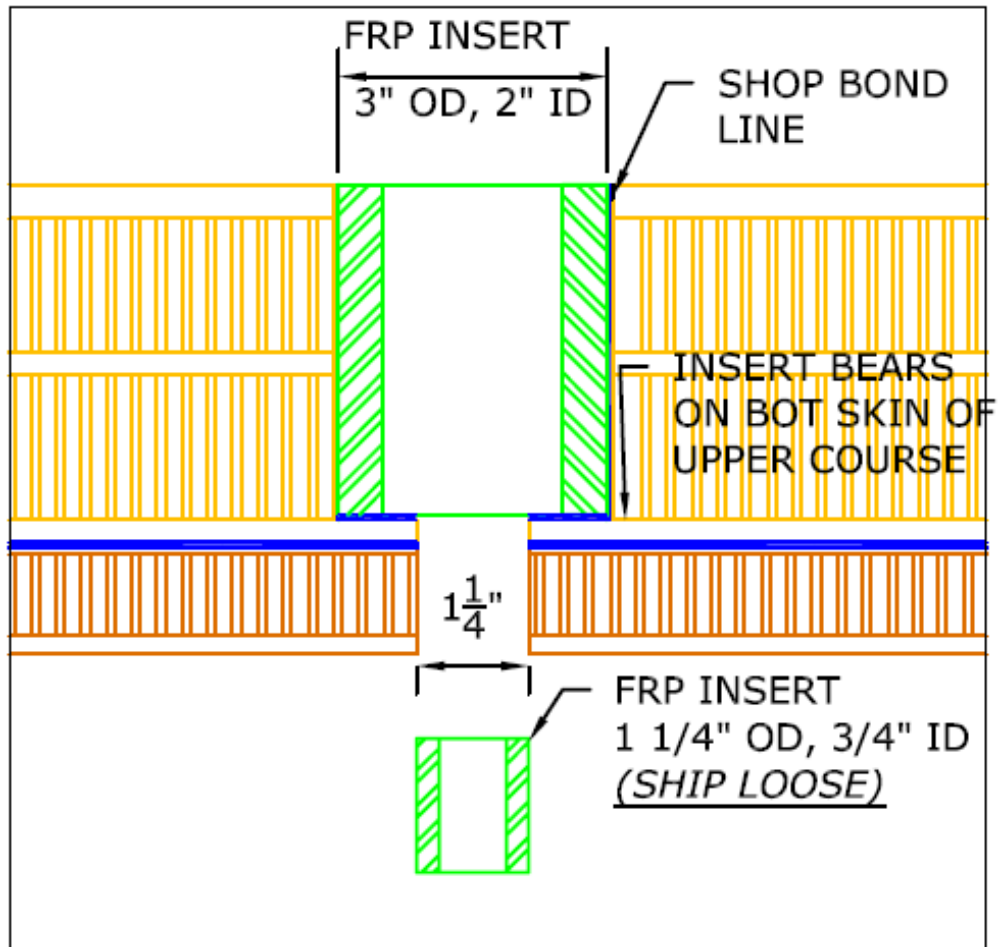
Martin Marietta shop drawings for these test panels show a typical section for an attachment hole (see Figure B.17).

Figure B.17 Insert detail: Martin Marietta shop drawing.

In this case, sealant was to be placed over the top of the nut. The idea was to prevent water from entering from the top. In many cases, however, the sealant had collapsed into the hole, allowing water to enter. Further, no sealer was placed around the insert, and this

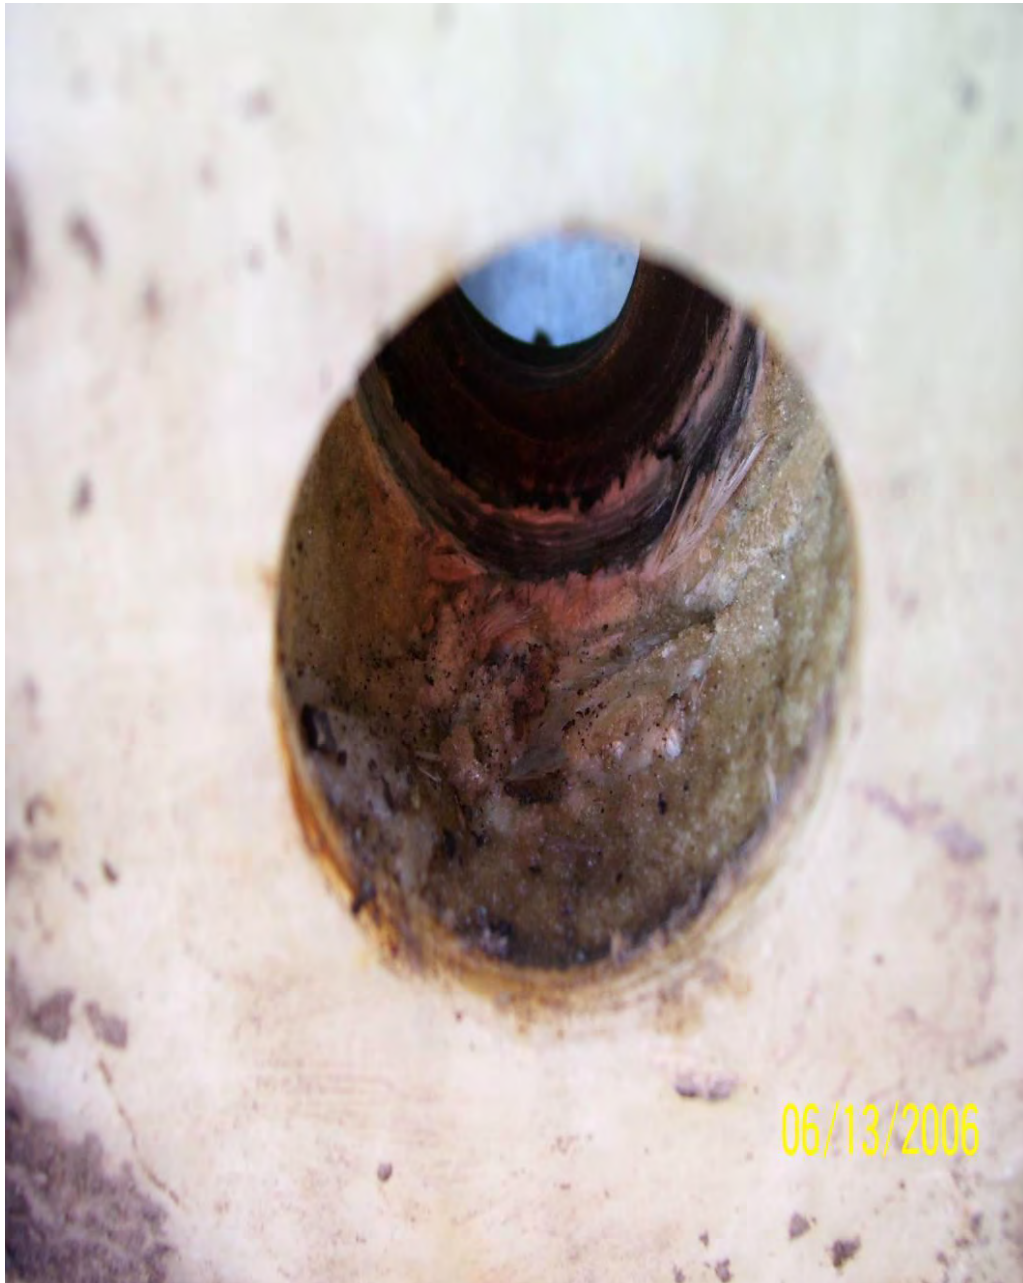
allowed water to enter the foam. Figure B.18 shows one of these holes from the bottom side of the panel; the FRP insert is removed in this picture. Foam inside the hole was wet, degraded, and soft. The foam in another hole nearby was dry and showed no sign of foam damage. Based on these observations, the foam will likely suffer from freeze damage.

Figure B.18 Hole for the insert: looking from the bottom.

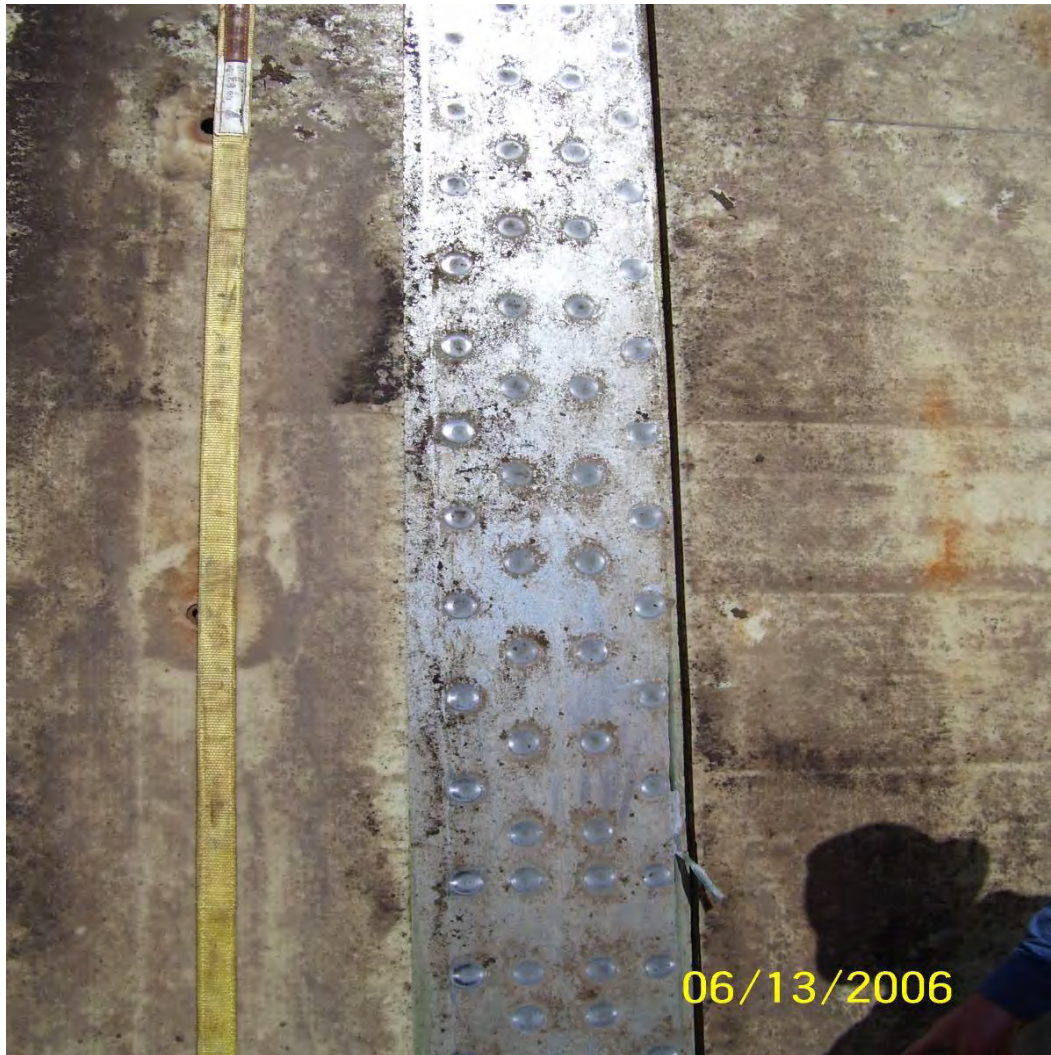
Panels appeared to be sliding on the steel deck. The bolts in the splice plate had worn shiny spots on the metal above them (see Figure B.19). This does not appear to be causing damage to the bolts or the panel, where the metal protects the fiberglass.

Figure B.19 Bolted splice plate supporting deck panels

Unless the panel fiberglass is protected, relative movement between the panel and the deck may be problematic. Panel under-surfaces are susceptible to damage, so the old timber surface was removed before the panels were placed. Studs used to hold the timber down were cut off and ground to be flush with the deck surface. Two studs appeared to have been left

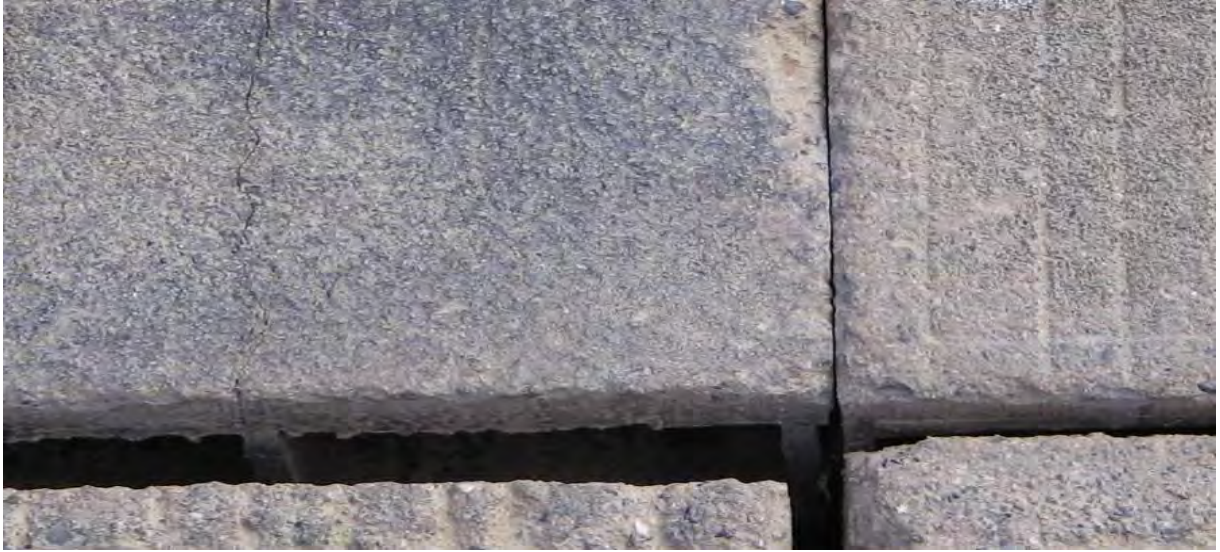
The left-to-right marks are part of the original wearing surface. The surface is about  $\frac{3}{4}$  in. thick, so some wear is allowable before failure. Cracks appeared near corners of several of these test panels. Cracks appeared to initiate in the fiberglass and not in the wear surface (see Figure B.23).

Figure B.23 Prodeck 4 test panel: Cracks propagated from the fiberglass.

A crack was found to run along one of the webs in the FRP panel below the wear surface. There was a crack in the FRP web at the edge of the panel. It would appear that the crack is the result of bending in the panel. The failure of the panel may be due to the unevenness of the steel deck. When installed, all of the panels on the northbound lane were higher than the surrounding surface at their southwest corners. Heavy trucks deflect the panels downward, but the panels return when load is removed.

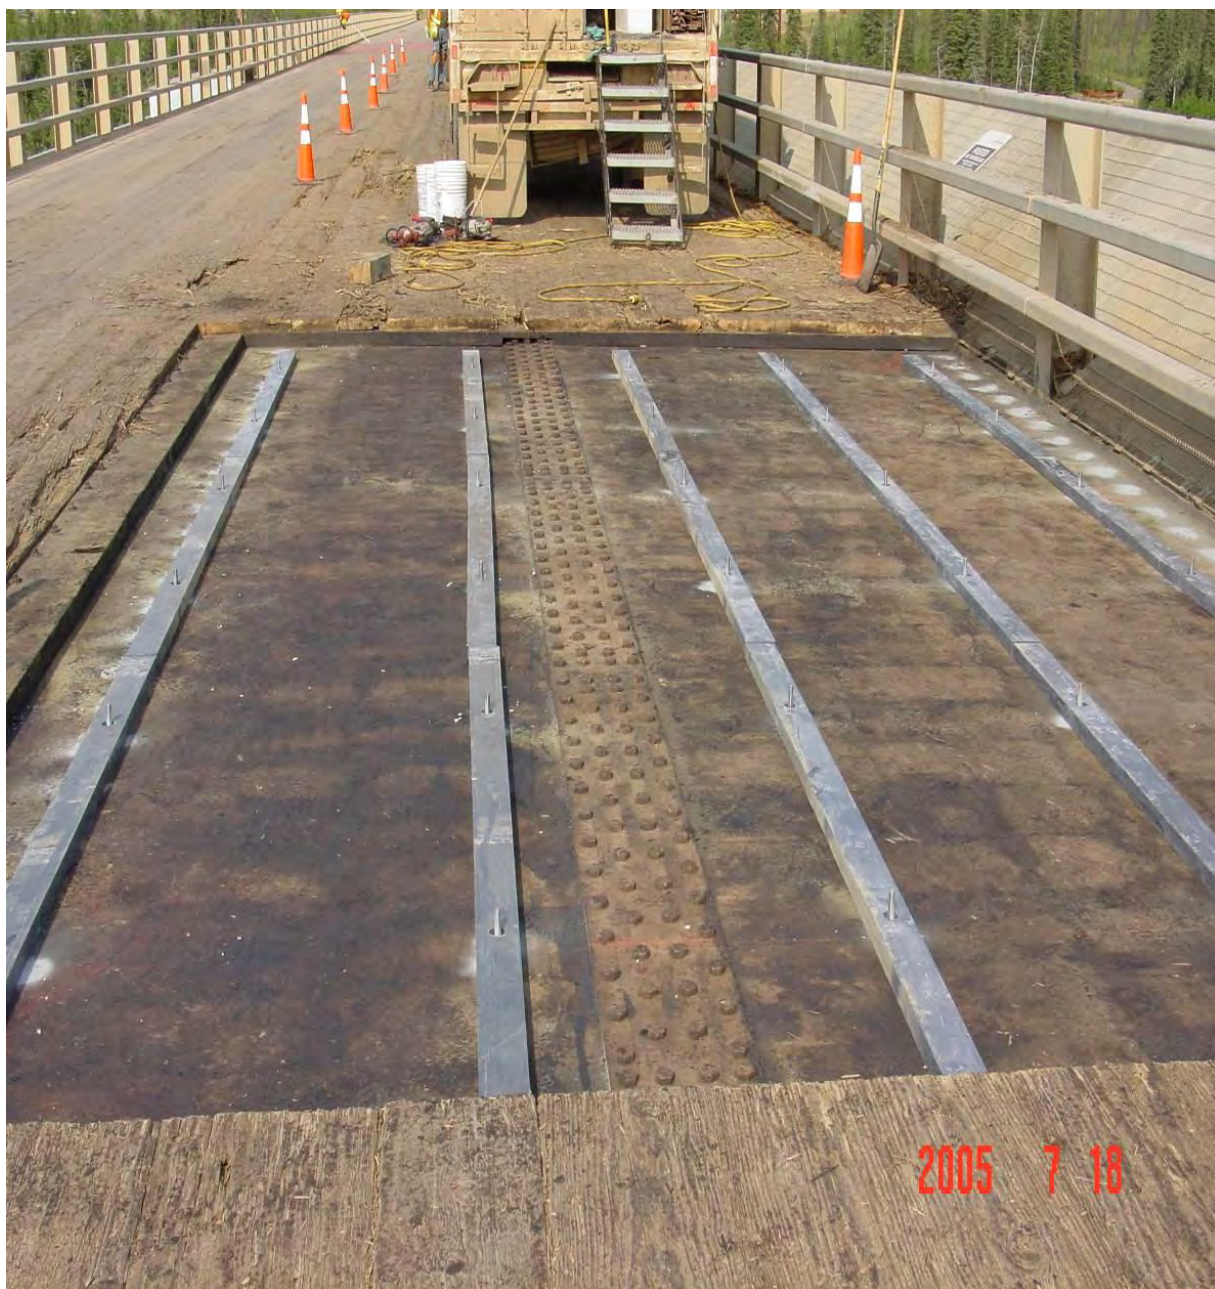
Figure B.25 Installation of Prodeck 4 on the Yukon River Bridge (after AKDOT&PF).

Installation reports for these test panels were provided by AKDOT&PF. These reports are identified by —Yukon River Bridge Rehabilitation Test Panel Installation (Surface Deck) DP-065-2(13)/60431.” Drawings were provided by the supplier. It was not possible to determine from the installation pictures and from these reports if the spacers were located over the ribs. No matter what spacing is used for the FRP spacers, inspections should be conducted to check for damage to the steel deck (see Figure B.25).

placed. These narrow strips transmit the traffic line loads, which cause high states of stress. Orthotropic steel decks like the one used on the Yukon River Bridge are sensitive to fatigue and have been shown to have problems with cracking. Subsequently, spacers should be positioned so that the load is applied to the ribs below the deck plate. This would minimize future problems.

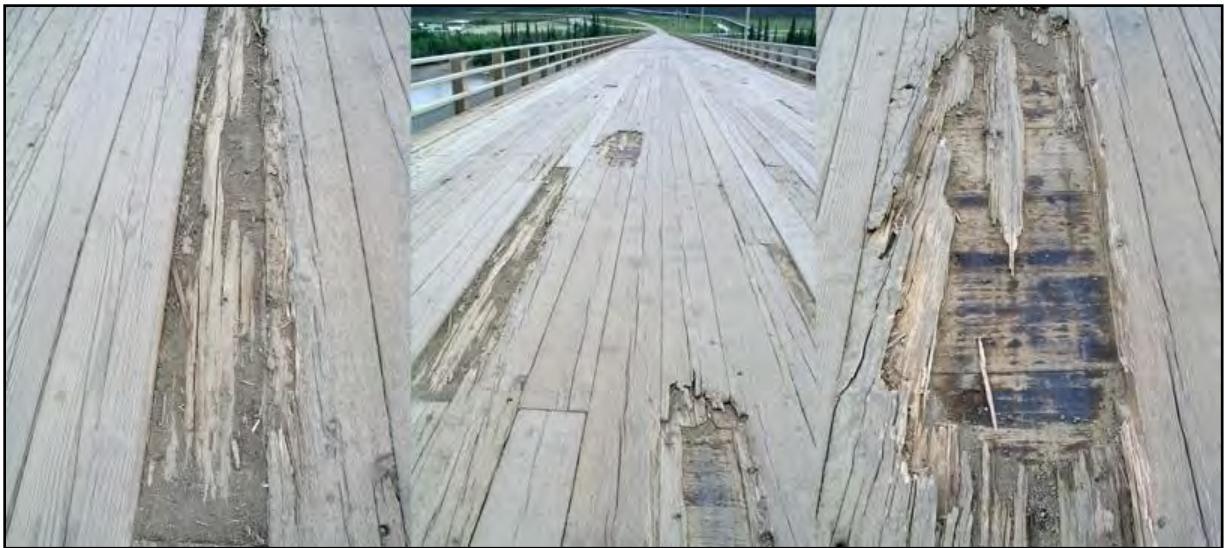
Figure C.1 Timber wearing surface, months before it was replaced.

A steep grade, severe climate, and use by heavy trucks requiring tire chains to gain traction on slick timber running planks have been a wearing-surface challenge for the Yukon River Bridge. Timber quality is on the decline, as timber replacement costs are on the incline. The condition of the timber wearing surface in 2007, prior to replacement, is shown in Figure C.1. Intermediate sections of the deck were replaced in the summer of 2006. The age of the failed timbers in the photograph are estimated to be only a few years.

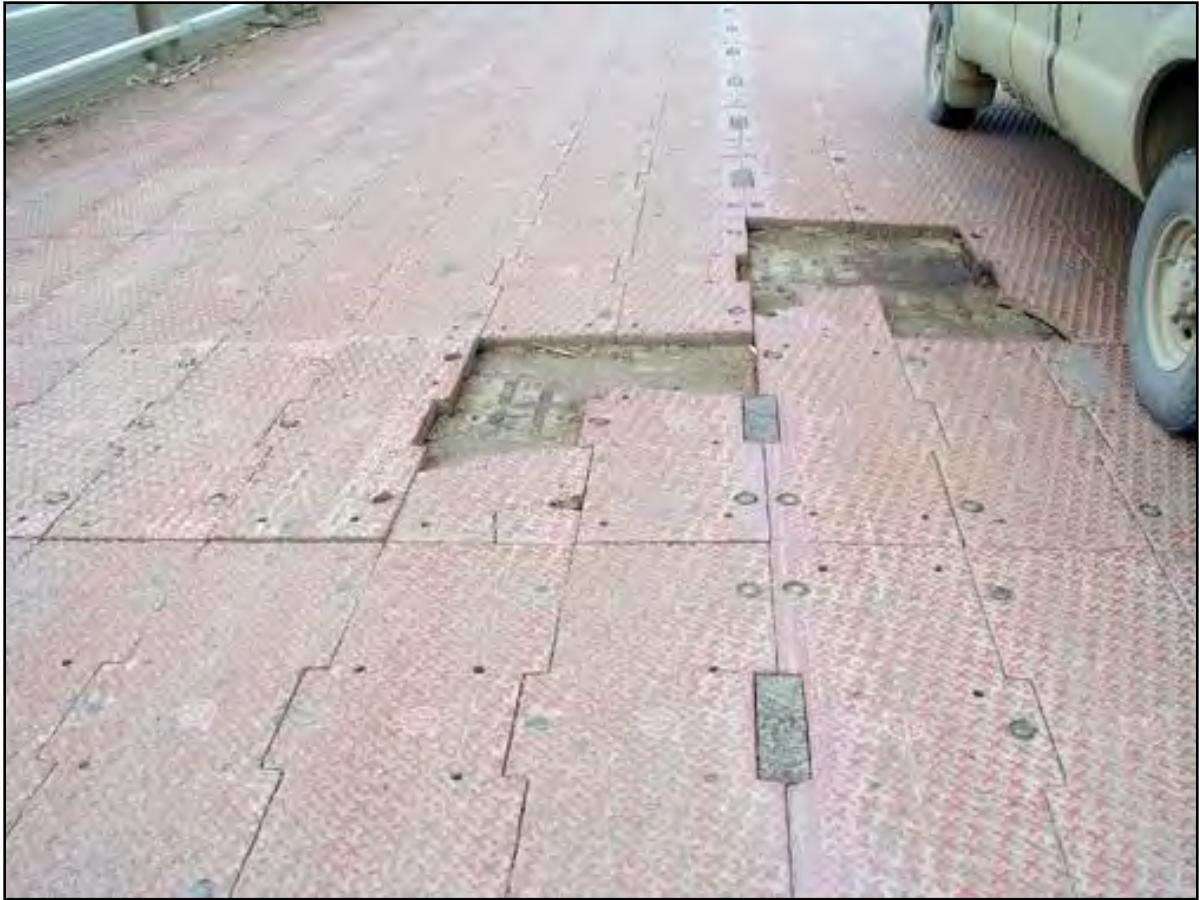
Figure C.2 Cobra X crossing module; summer of 2007.

A 1996 bridge inspection concluded that the Cobra X panels had performed successfully throughout the period of the study. The skid surface showed minimal wear, and it was recommended that annual inspections be continued until it was possible to estimate the service life of the wearing surface. It was stated in the 1996 bridge inspection report that the Cobra X test panels were in place for 15 years and were performing comparatively well in comparison with the timber running planks that had only been on the bridge for 5 years. The lag screw method for attaching the panel to the underlying timber running planks had been an area of failure. The photograph shown in Figure C.2 shows the failure of a number of panels. The test section was replaced in the summer of 2007 with two new layers of timber running planks.

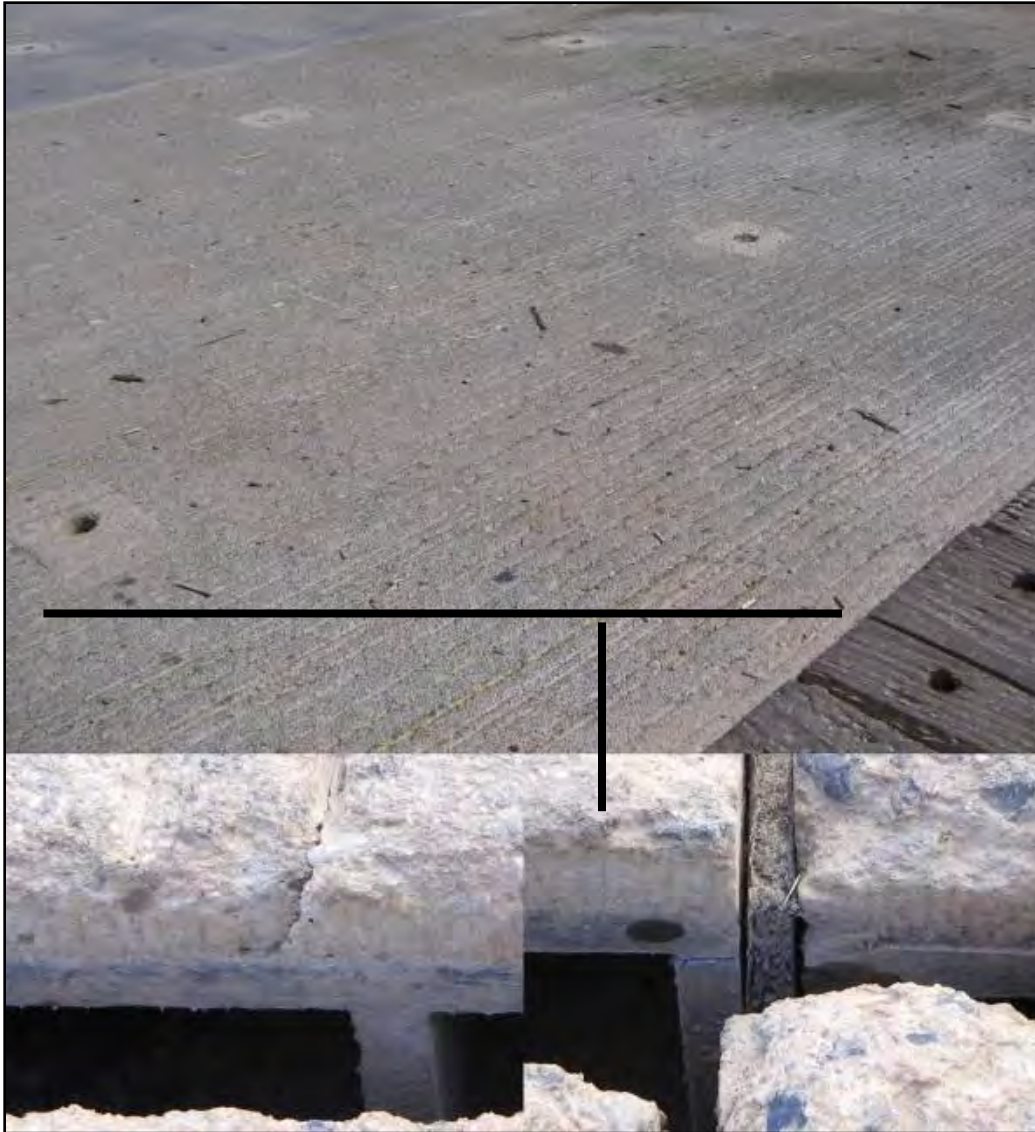
Figure C.3 Bedford Reinforced Plastics, Inc. Prodeck 4 panel.

A year after installment (2006), the FRP composite bridge deck showed signs of fatigue; yet traction of the polymer concrete surface was reliable and little wear was seen. A close inspection revealed web-flange intersections and concrete surfaces with signs of high tensile strains. Figure C.3 (summer 2006) shows a traction surface, cracked polymer concrete, and fracture of the web-flange intersection.

It was believed that the Bedford Prodeck 4 panel was too stiff to be used on the Yukon River Bridge. The steel orthotropic deck is a flexible system. Subjecting a contrasting stiff system to the flexibility in the deck may cause tension failure in the surface. Cracking of the polymer concrete traction surface and fracture of the web-flange intersection were valid as evidence that this wearing-surface system was too stiff. The Bedford Prodeck 4 panel is not recommended as an alternative wearing surface for the Yukon River Bridge. The photograph

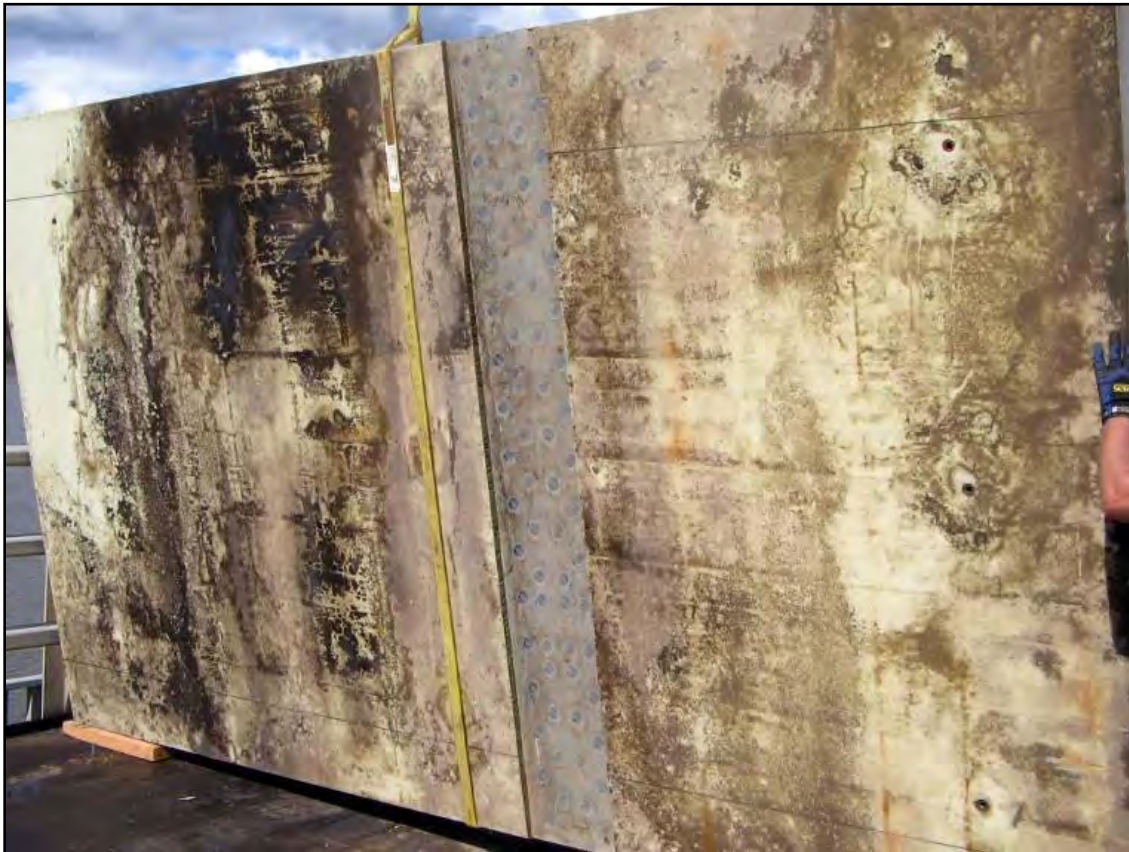
Figure C.5 Transonite panel, bottom side inspection.

The lower FRP sheet of the Transonite panel had been penetrated by Nelson studs that were intended to be grinded down flush with the steel deck prior to installation of the panel. Water had infiltrated into the foam core through these penetrations and around the holes manufactured to allow the panel to be fastened to the deck. The presence of water seemed to be deteriorating the foam, but the neighboring FRP sheet remained intact. The 3-D fiber insertions that were exposed due to the cut in the bottom of the panel to allow for the splice plates were seen to be failing along the edge. It was believed that the failure of the 3-D fiber insertions was caused by shear failure or possible crushing, but the failure did not appear to affect the integrity of the system. The structural durability of the panel appeared to be sufficient despite the fatigued appearance of the bottom of the panel. The traction surface of the Transonite panel showed signs of wear as a 3 in. section of the polymer concrete overlay had been chipped away. Figure C.6 shows the wear in the traction coating of the Transonite panel.

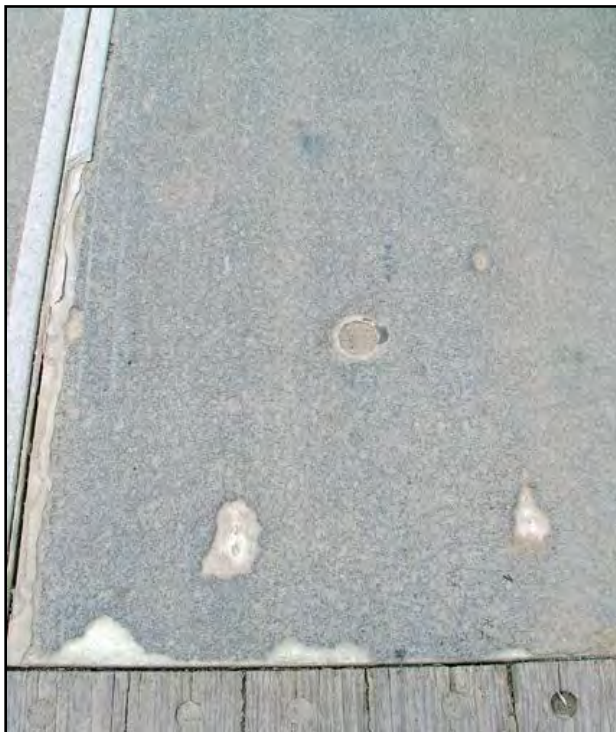
Figure C.7 Transonite panel, 2007 (2 years old).

During a return inspection of the Yukon River Bridge in the summer of 2007, the traction surface of the Transonite panel showed very little signs of additional wear from the previous year. It was believed that the chip section in the polymer concrete would progress and cause a greater loss of area, but this was not seen. Figure B.6 provides a photograph of the same chipped area seen in Figure B.7, but one year later.

The Transonite panel was a more flexible system than the Bedford Prodeck 4 panel. Added flexibility of the system allowed the panel to conform to movement of the steel orthotropic deck, thus limiting high levels of strain in the traction surface. However, panel deterioration after two years of installation on the bridge was cause for concern, and it is not recommended as an alternate wearing surface for this structure.
