## ALASKA DEPARTMENT OF TRANSPORTATION

# Evaluation of Wearing Surfaces for the Yukon River Bridge

July 2009

FHWA-AK-RD-09-07

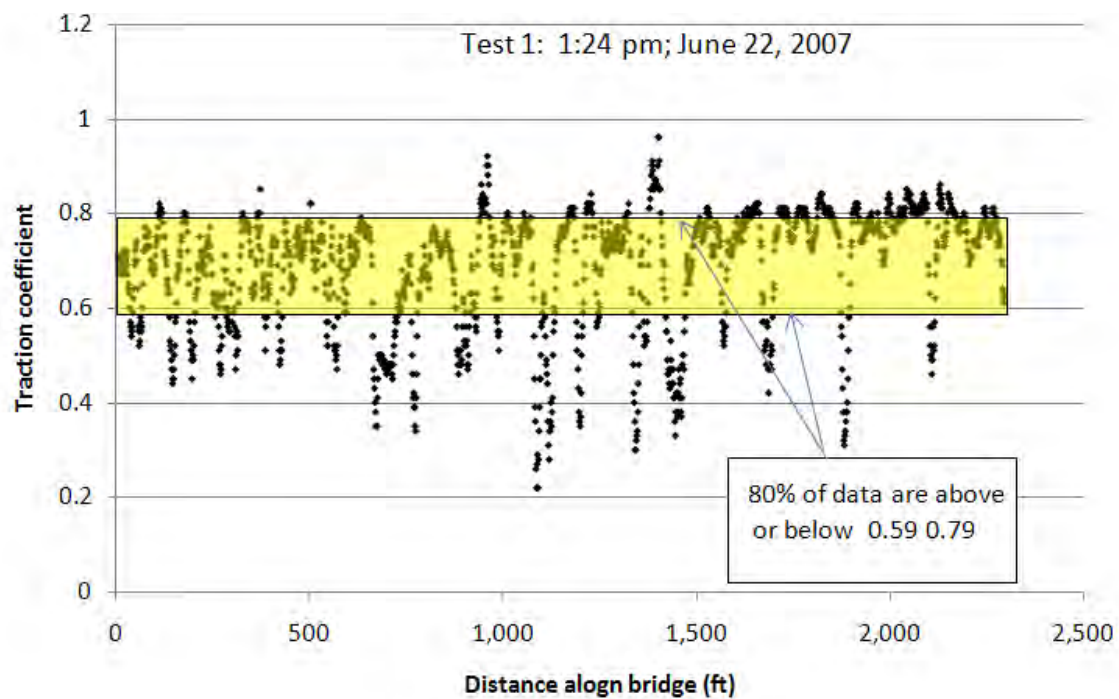
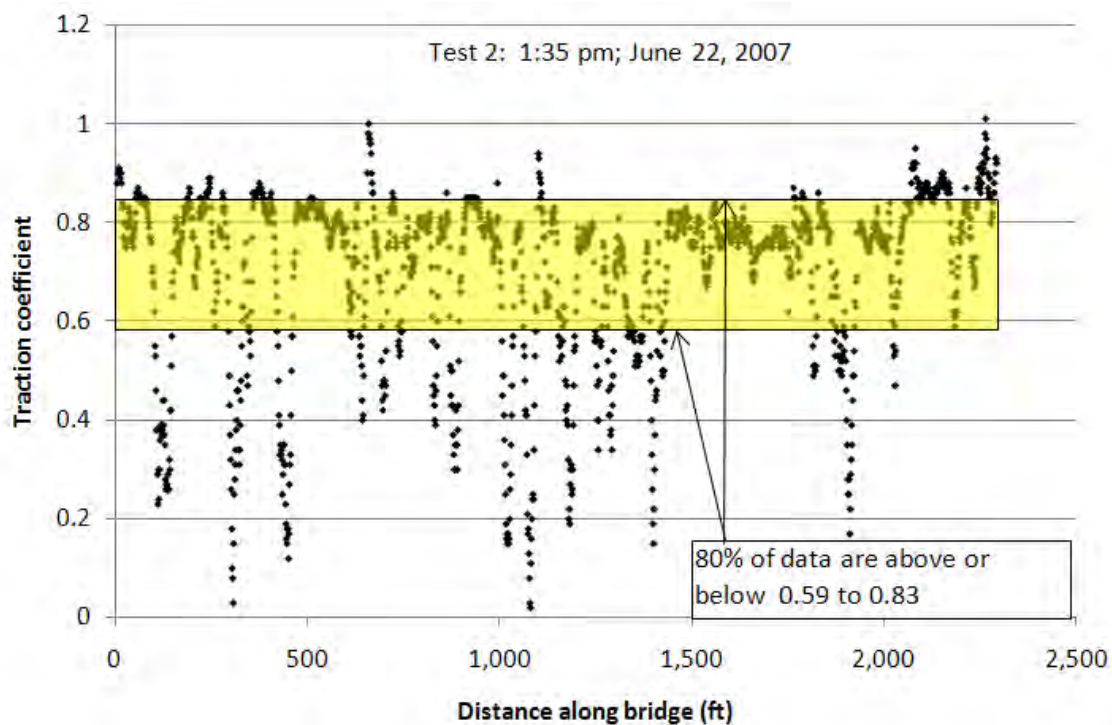
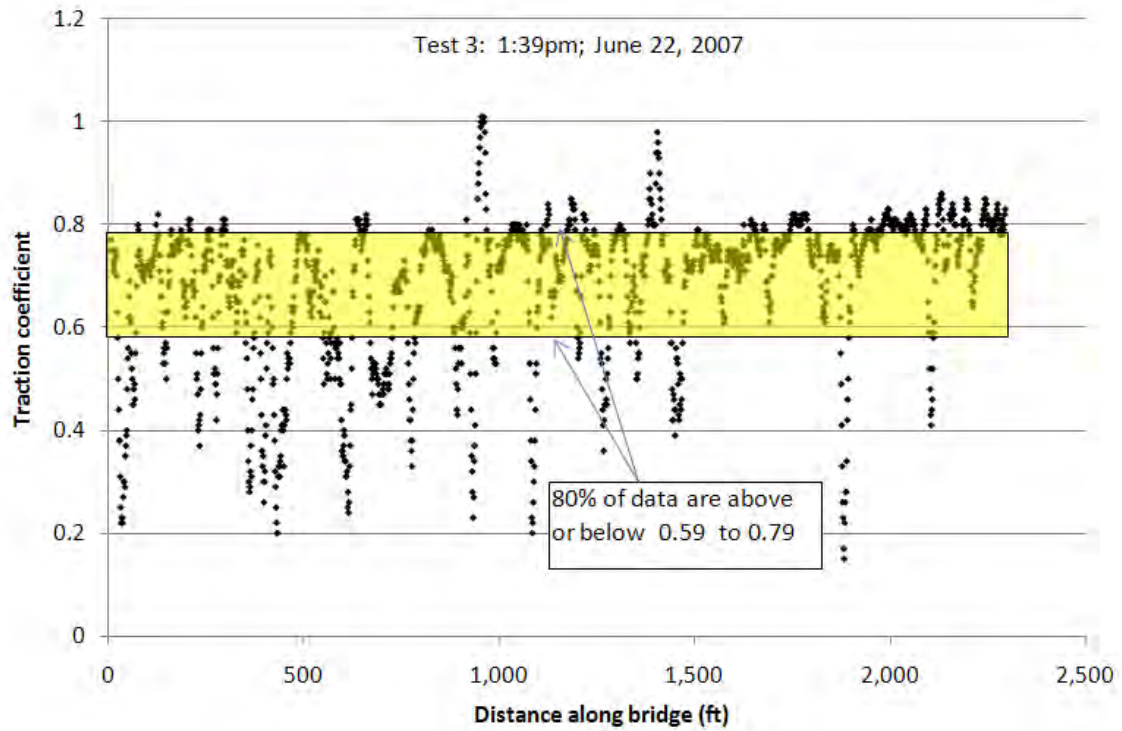
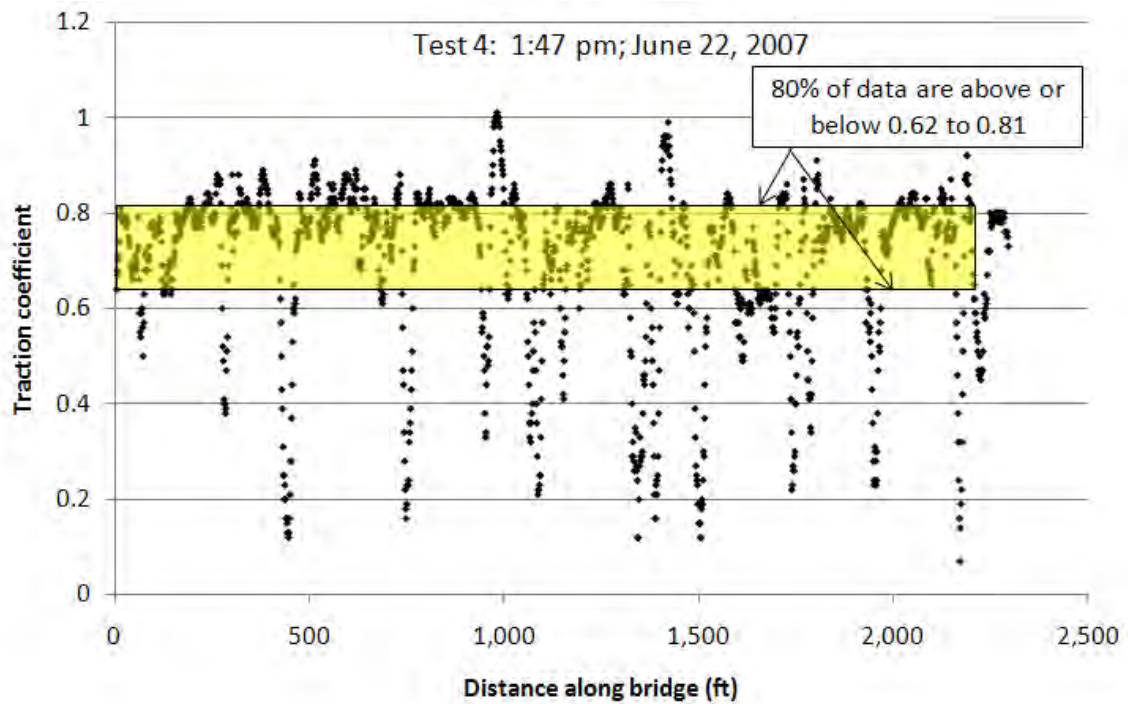
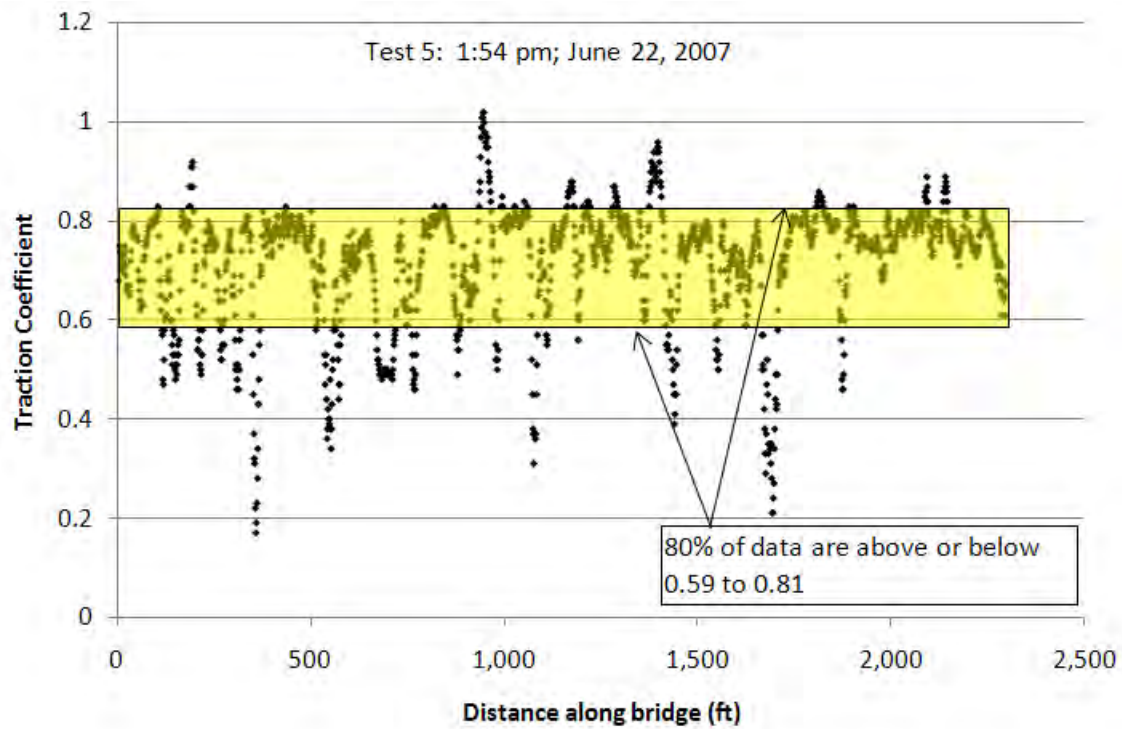
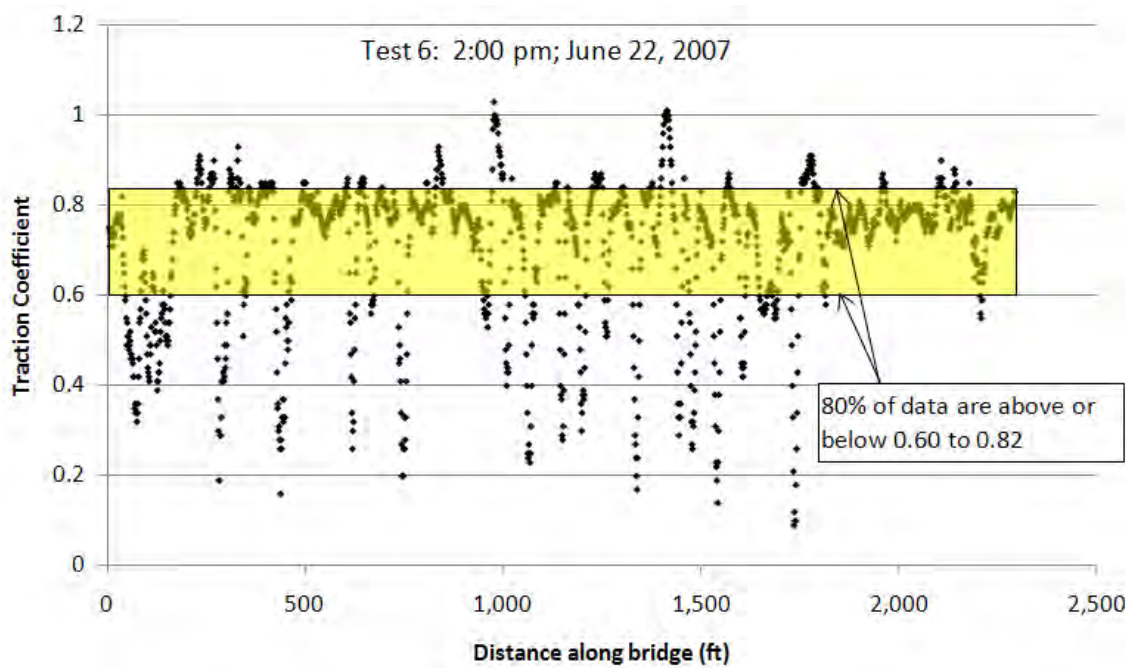
The test results are provided herein for review and consideration. They are listed in Figures E.1 to E.8. The coefficients were within 0.59 to 0.83 for 80% of the data being either below or above these values. The tests were conducted by first driving upgrade from north to south. The researchers turned around and drove downgrade, taking data. This was repeated four times for a total of eight tests. Locations of the experimental features were recorded, and the friction data for these sites were recorded for Tests 3 to 8.
