# Landslide Collides with Highway: Measuring Its Impact to Inform Future Mitigation – FINAL REPORT

Margaret M. Darrow, University of Alaska Fairbanks  
Ronald P. Daanen (posthumously), Alaska Division of  
Geological & Geophysical Surveys  
December 31, 2023

Alaska Department of Transportation & Public Facilities  
Statewide Research Office  
3132 Channel Drive  
Juneau, AK 99801-7898

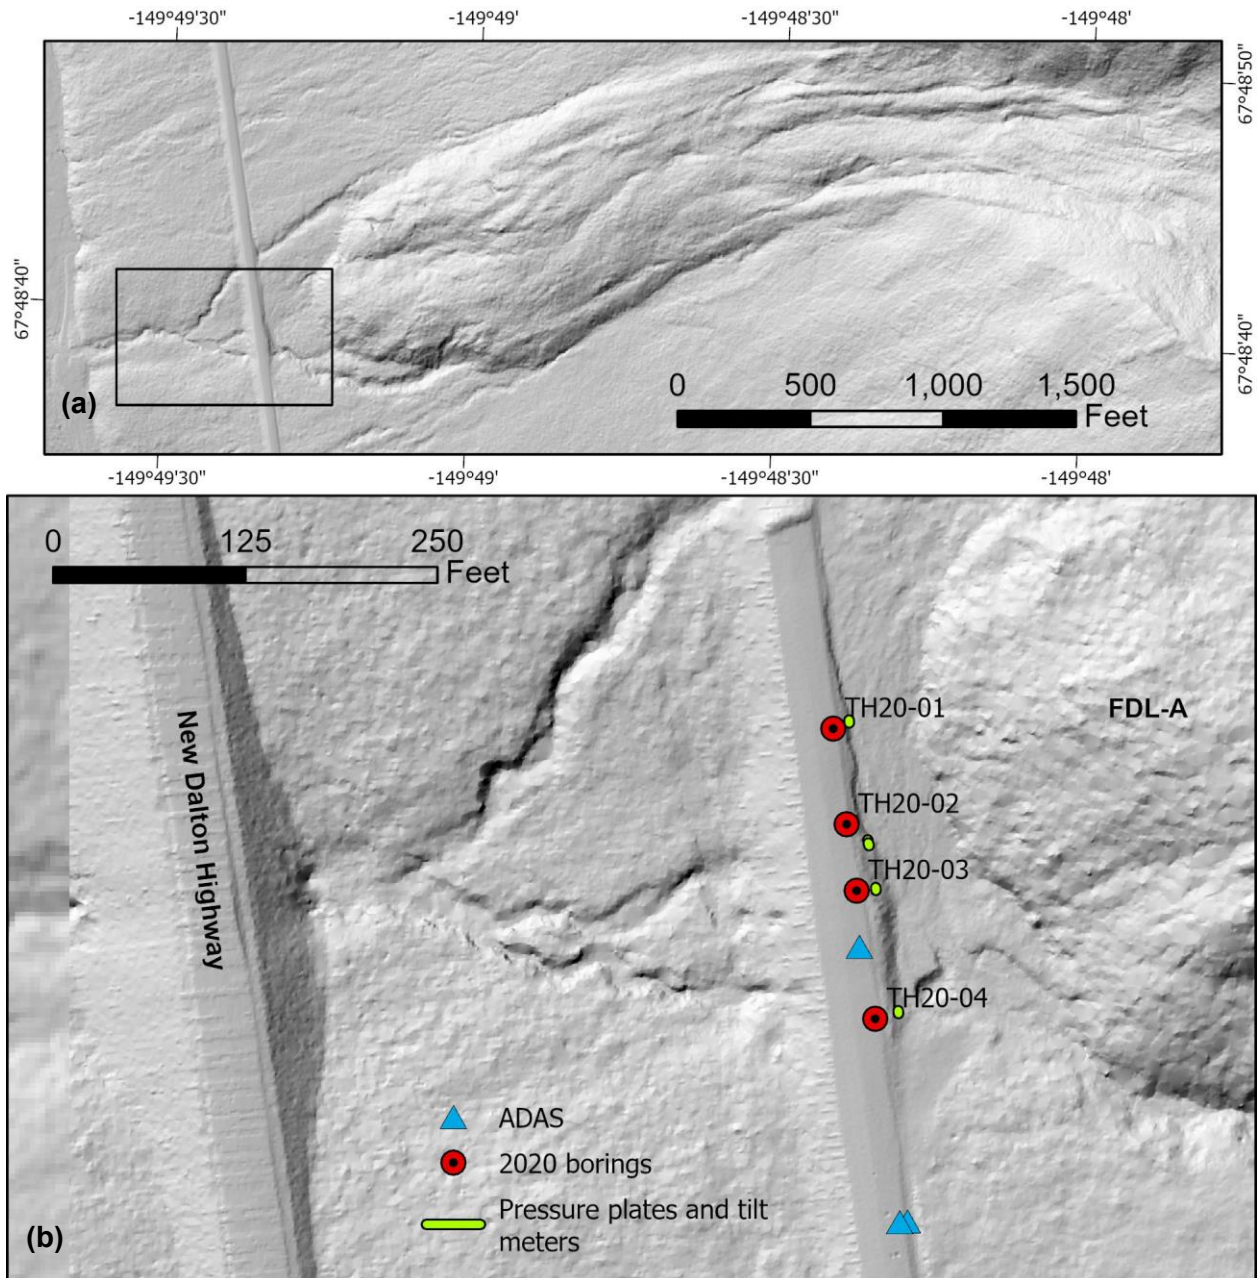
Figure 3. Project location: (a) FDL-A to the east of the original Dalton Highway alignment (background imagery is unpublished 2015 lidar); (b) location of borings and instrumentation relative to the toe of FDL-A, and the original and new Dalton Highway embankments (background imagery is unpublished 2020 lidar).

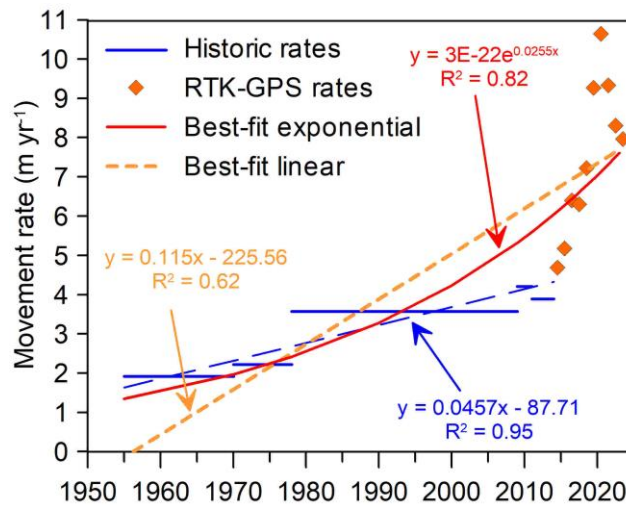
Figure 6. Integration of historic and recent movement rates of FDL-A. Note that the vertical scale is in  $\text{m yr}^{-1}$ .

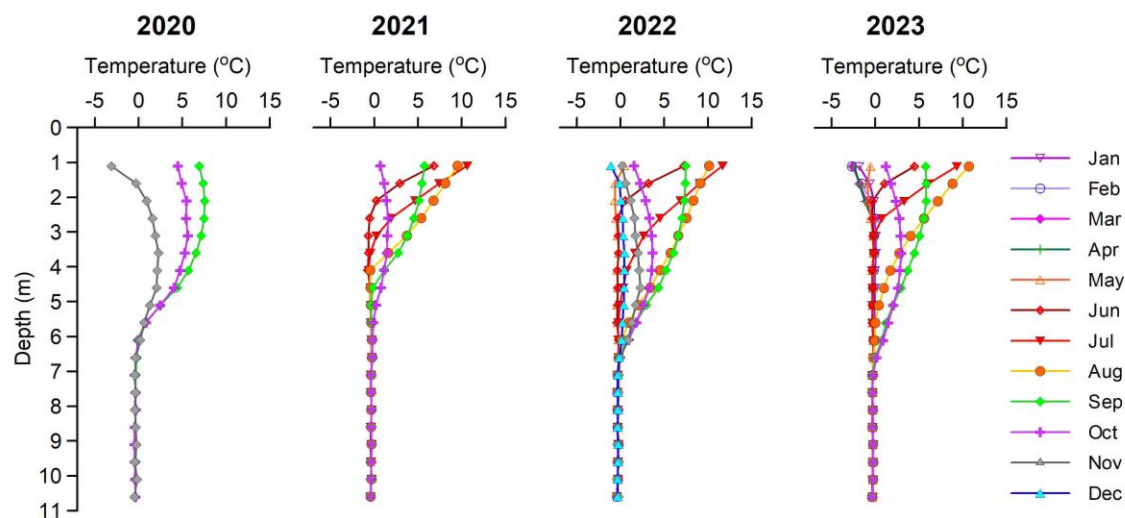
measurements (Darrow and Jensen 2012). Figure 8 contains an example of the temperature profiles for TH20-01 for months for which we have complete data (note that this figure is in SI units).

Figure 8. Temperature profiles from TH20-01.

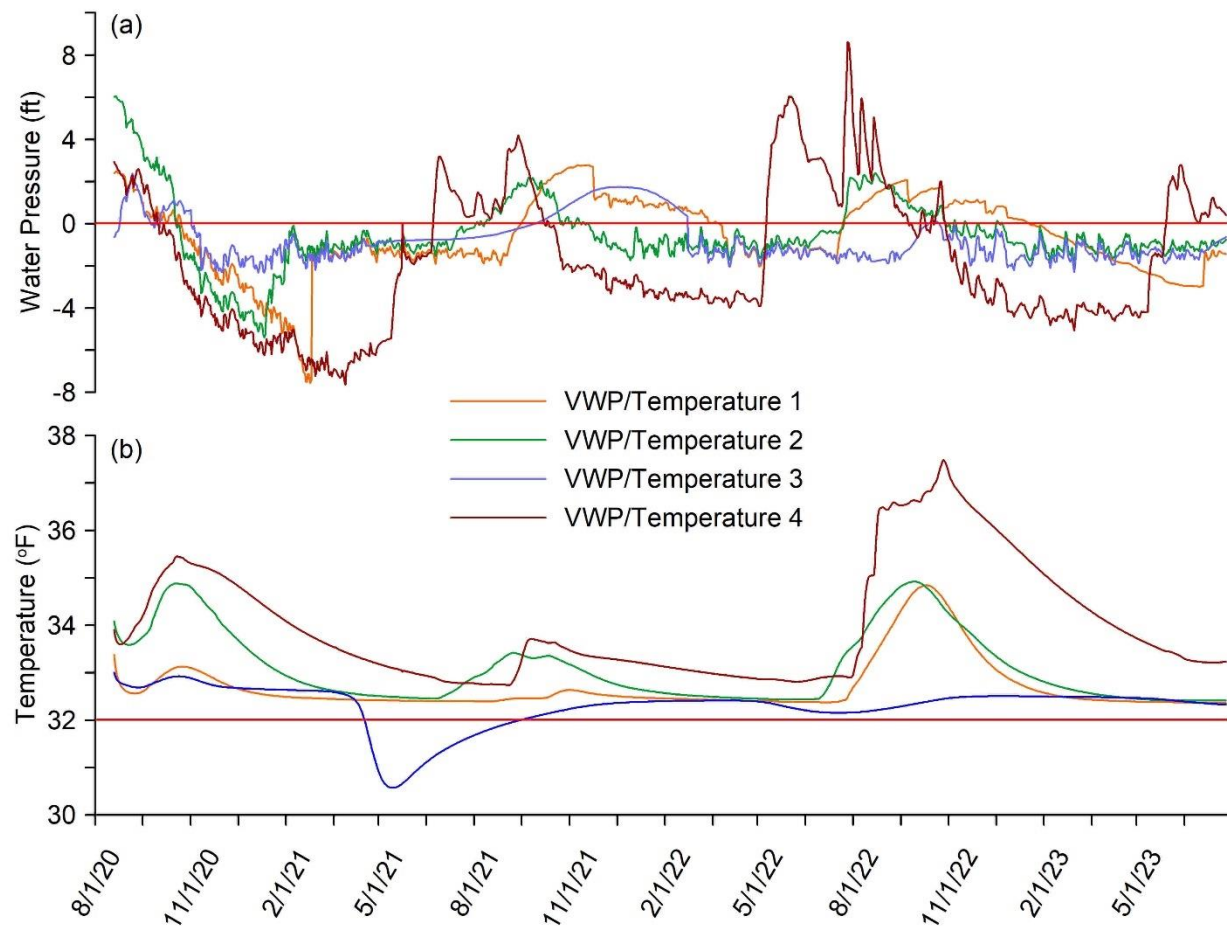
Figure 9 contains the VWP water pressure and temperature readings over the project measurement period. The southern VWP (TH20-04) was located close to the pre-existing culvert, and thus is interpreted as experiencing groundwater pulses within the old drainage channel. This location demonstrated two yearly peaks in groundwater, which represents snowmelt (late May/early June) and the summer rainy period (July). The VWPs in TH20-01 and TH20-02 also demonstrated increases in groundwater pressure in the late summer but with slower response times.

Figure 9. VWP data (a) and their associated temperatures (b) over the project measurement period. Red horizontal lines represent 0 ft and 32°F in (a) and (b), respectively.

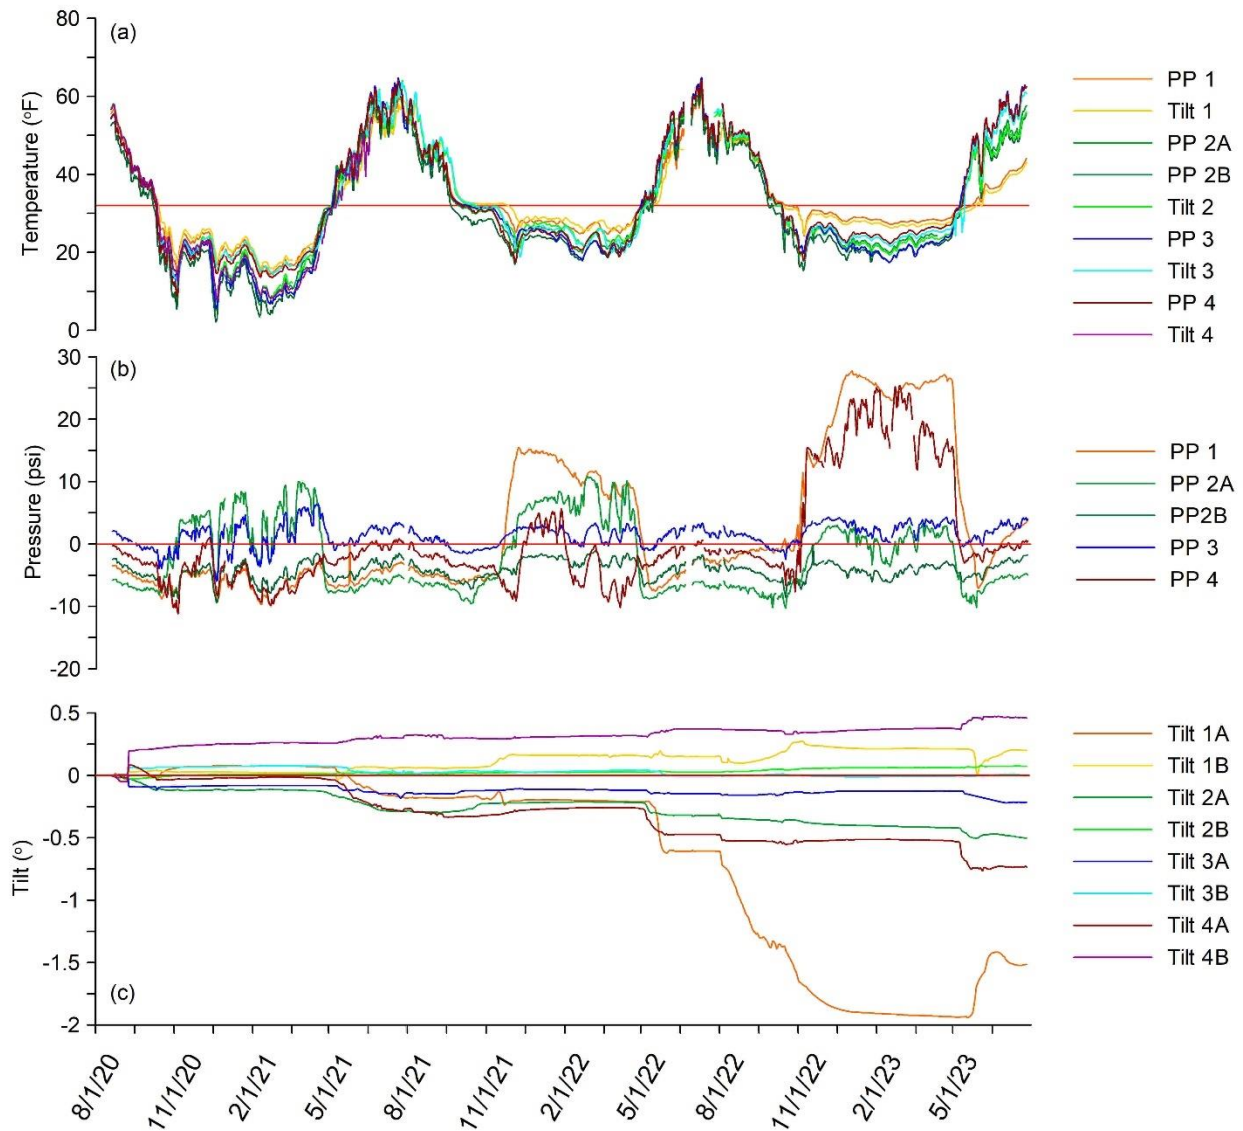
Figure 10 contains graphs of (a) the temperatures recorded by the tilt meters and pressure plates, (b) the pressure plate readings, and (c) the tilt meter readings. As all of these devices were buried within 2 ft of the surface, the temperatures are closely dependent on air temperature and demonstrate the seasonal temperature fluctuations. All of these temperatures generally follow each other well. Thus, it is notable that the temperatures from pressure plate 1

(PP 1) and tilt meter 1 (Tilt 1; both installed near TH20-01) are about 4.3°F warmer in the winter of 2022/23 and about 7.6°F cooler in the summer of 2023 than the other readings. We attribute this to the fact that toe of FDL-A covered this part of the embankment in the late summer of 2022.

As we attached the pressure plates to steel plates to make them more robust against the impact of FDL-A, the steel plates may be adding additional temperature sensitivity to the pressure plate readings (Figure 10b), as the readings increase with sub-freezing temperatures, and then decrease as the embankment thaws in the spring. The pressure plate readings near TH20-01 (PP 1) increased during the winters of 2021/22 and 2022/23; however, the readings also dropped back down to the average values during the summer. We suspect that these elevated values indicate that FDL-A is beginning to push on the plate. One of the tilt sensors at the TH20-01 location (Tilt 1A) also started to deviate from the other readings on August 2, 2022. This is most likely due to the impact of FDL-A. We recommend on-going monitoring to obtain proof of concept for the tilt meter and pressure plate instrumentation.

Figure 10. Pressure plate and tilt meter measurements over the project measurement period: (a) temperatures from all pressure plate and tilt meter devices; (b) pressure plate readings; (c) tilt meter readings.
