Rapid Seismic Repair of Column to Footing Connections – Phase 2

Prepared By: Taylor J. Brodbeck, Ph.D. Student Zachary A. Shurow, MS Mervyn J. Kowalsky, Professor, Ph.D. Rudolf Seracino, Professor, Ph.D.

1. AGENCY USE ONLY (LEAVE BLANK)	2. REPORT DATE	3. REPORT TYPE AND DA	TES COVER	ED
	May 31, 2022	FINAL REPORT, Jan.	2019 thro	ugh May 2022
4. TITLE AND SUBTITLE Rapid Seismic Repair of Column to F	Footing Connections – Phase 2		5. FUNDING	NUMBERS

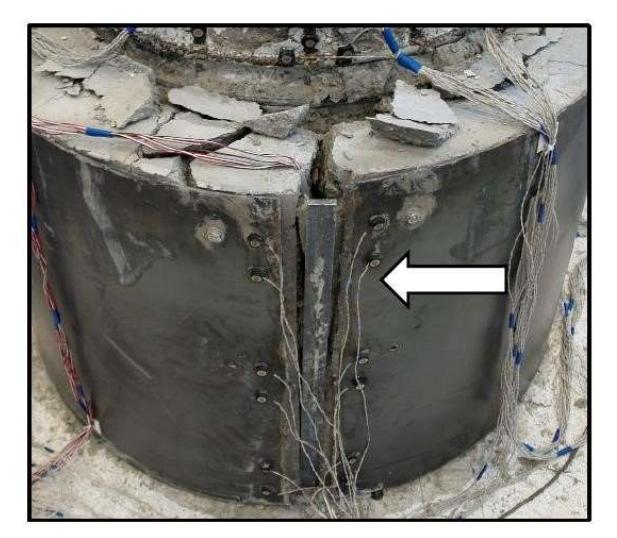
Figure 2.5: Weld Failure during Repair #5 (Krish, 2018).

While this test started off well, the repair suffered an early failure due to rupture of the weld in the steel sleeve, which is shown in Figure 2.5. This failure led to conclusions that the use of a welded connection requires careful cutting and surface preparations for the thin sleeve. This was one reason that a mechanically bolted connection was investigated in this project. Despite the weld rupture, which was initiated during ductility 3, an analysis of the repair was conducted up to that point. For the two new anchorage mechanisms, the bar with the headed stud showed no signs of debonding. Although it was believed that this would have continued if the weld had not ruptured, the headed stud required so much labor for installation it was recommended only if complete bar anchorage was absolutely necessary. As for the bars that had the surrounding concrete removed,

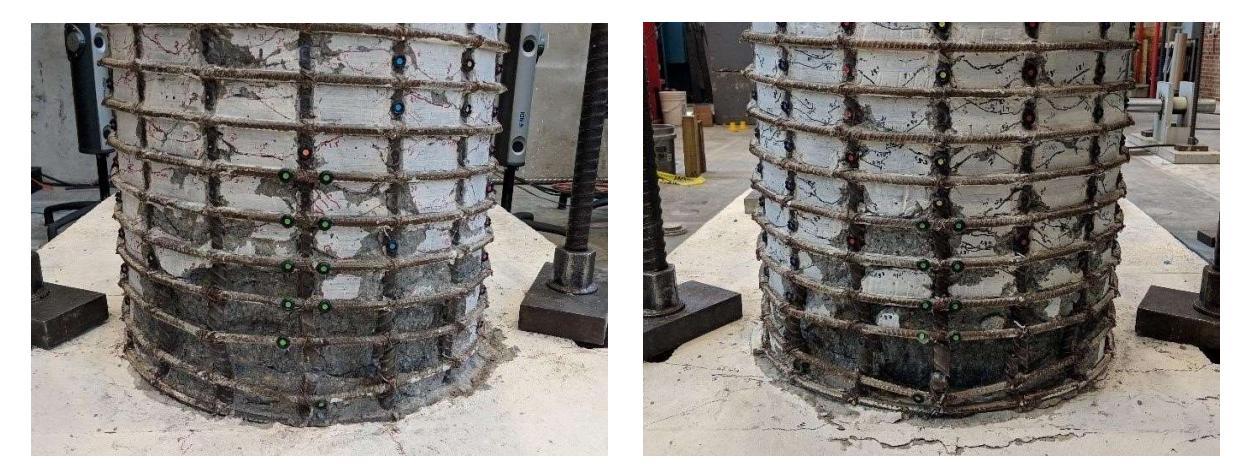
The column repaired in this test was severely damaged, having 7 longitudinal bar fractures along with a substantial loss in core concrete. The repair was designed following the steps described in Section 5.1. The damaged state of the column is shown in Figure 4.1, and the repaired cross section and bolt configuration are shown in Figure 4.2. The properties for the original column, comparison column, and repair are summarized in Table 4.1.

Figure 4.1: Damaged Column for Repair #1 on the North (left) and South (right) sides.

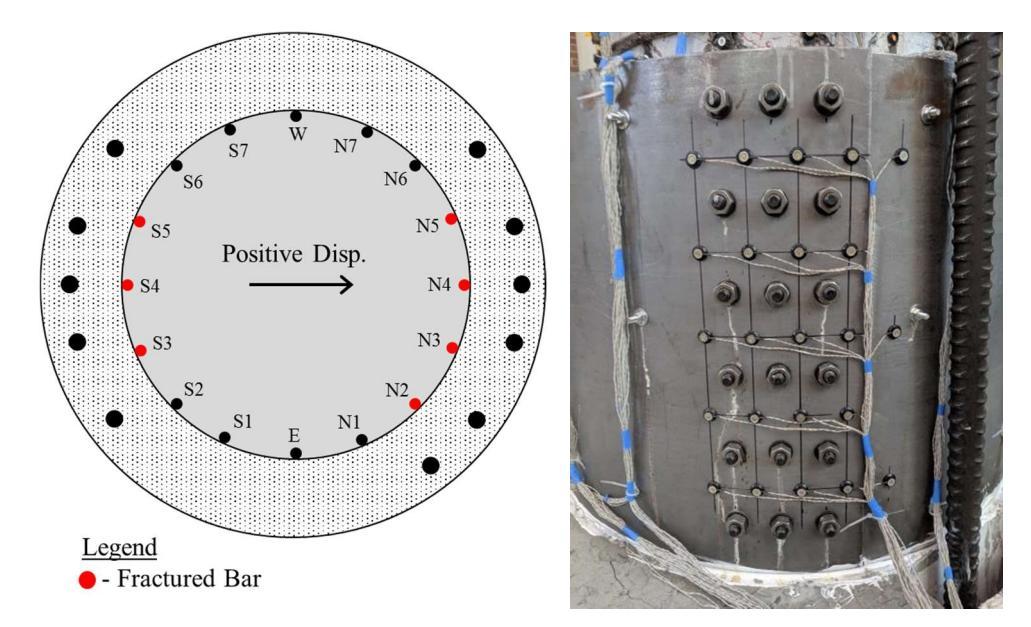
4.2). The holes for these bolts were inadvertently oversized and drilled to 5/8" instead of 9/16". As a note, the conservative design for this repair was later refined, and the updated design is described in Section 5.3.

Figure 4.2: Repair Cross Section and Bolt Configuration for Repair #1.

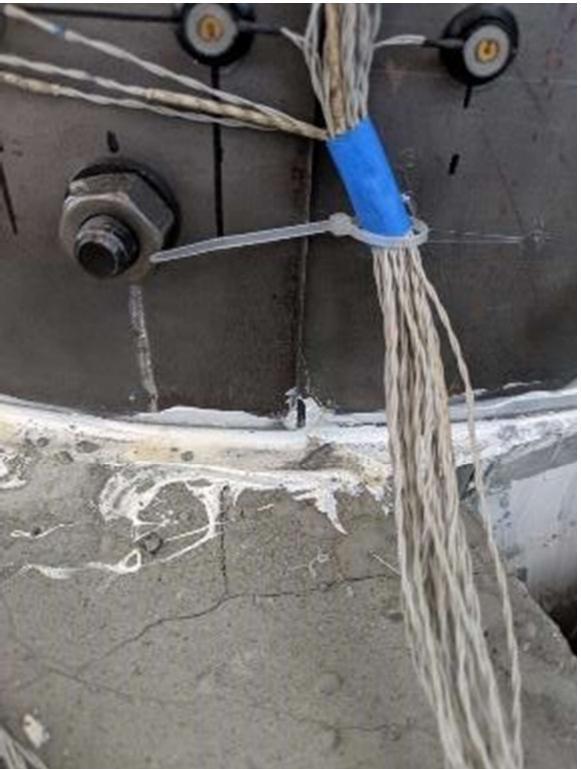
During the test, it was observed that the plates were slipping relative to each other. This was most noticeable at the base where the silicone was used to seal the sleeve and by the end of the test a visible gap had formed which is shown in Figure 4.7.

Figure 4.7: View of silicone sealant where gap formed due to plates slipping.

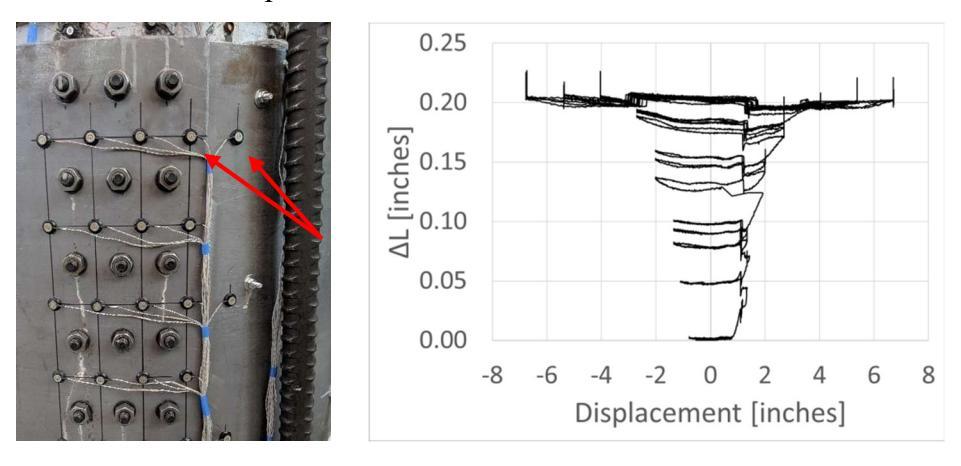
Using Optotrak data from LEDs on separate plates at the connection, plate slip can be monitored throughout the duration of the test. An example of two of these LEDs is shown on the left of Figure 4.9, and on the right is a plot of the length change between the two markers vs. the top displacement of the column. This data shows that the first push of the early cycles would cause the plates to slip, and there was almost no rebound. Eventually (at around 3 inches of displacement), enough of the bolts began to bear on the holes and there is minimal subsequent increase in slip. While some amount of this change in length would be due to the strain in the sleeve, it is believed that this would be minimal until the bolts were bearing on the holes. With no strain developing in the sleeve, the confining stresses from the sleeve would be minimal, which would diminish the anchorage effect of the fractured bars within the repair. While the oversized holes would have worsened this behavior, prevention of plate slip completely would theoretically lead to a behavior similar to a welded connection where there would be no slip.

Figure 4.9: Slip of Plates in Repair #1.

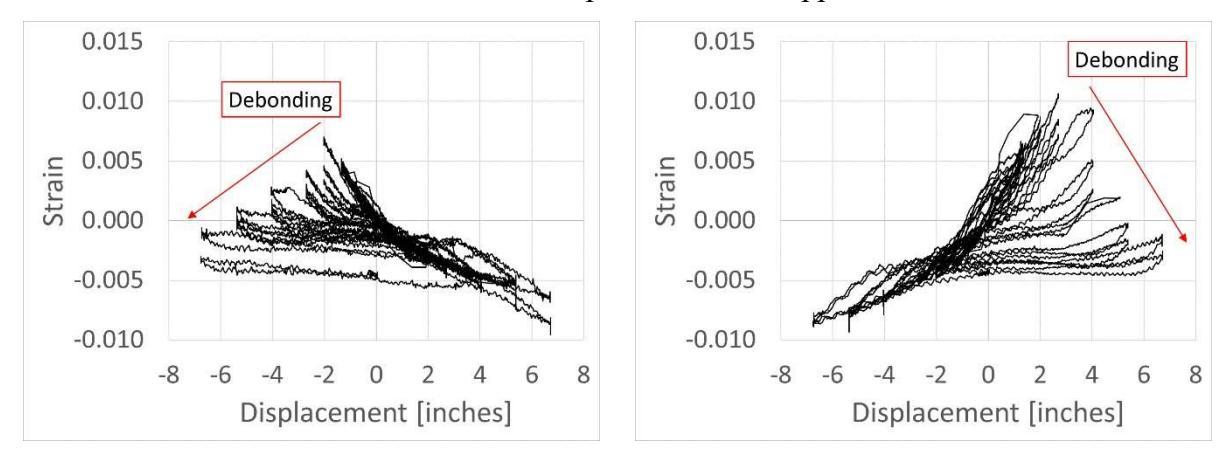
With an understanding of what the strain history in a longitudinal bar typically looks like, the strains in the N4 and S4 bars will now be analyzed. These are the most extreme bars on each side and were expected to debond during the repair test because they had fractured during the original column test. From Figure 4.11 it can be seen that the initial behavior of the bars is similar to the well anchored bar analyzed previously, but once the column reaches a displacement of around 2 inches, the strains begin to drop off. This indicates that the bar has debonded and is no longer sustaining any load or contributing to the repaired column's response. While this was expected, the reduction in confinement from slip of the plates is believed to have worsened this, causing the bars to debond earlier and at a lower strain than if the plates had not slipped.

Figure 4.11: Strain in Longitudinal Bars N4 (left) and S4 (right).

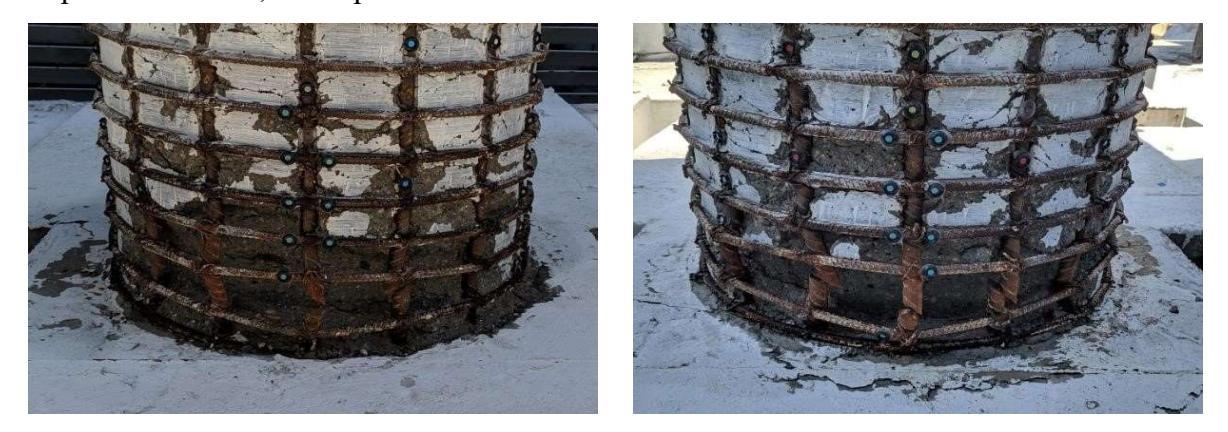
The column repaired for this test was nominally identical to the previous column aside from the longitudinal bars coming from a different steel mill. The original column test resulted in 5 bars being fractured and a significant amount of concrete spalled off. Although Repair #1 contained 7 fractured bars, the south sides of the columns from both tests contained 3 fractured bars and had 5 repair bars. This gives an optimal location for comparison of local strains between the two tests. The damaged state of the column prior to repair as well as the repaired cross section are shown in the following Figures 4.12 and 4.13. The properties for the original column, comparison column, and repair are summarized in Table 4.2.

Figure 4.12: Damaged column for Repair #2 on the North (left) and South (right) sides.

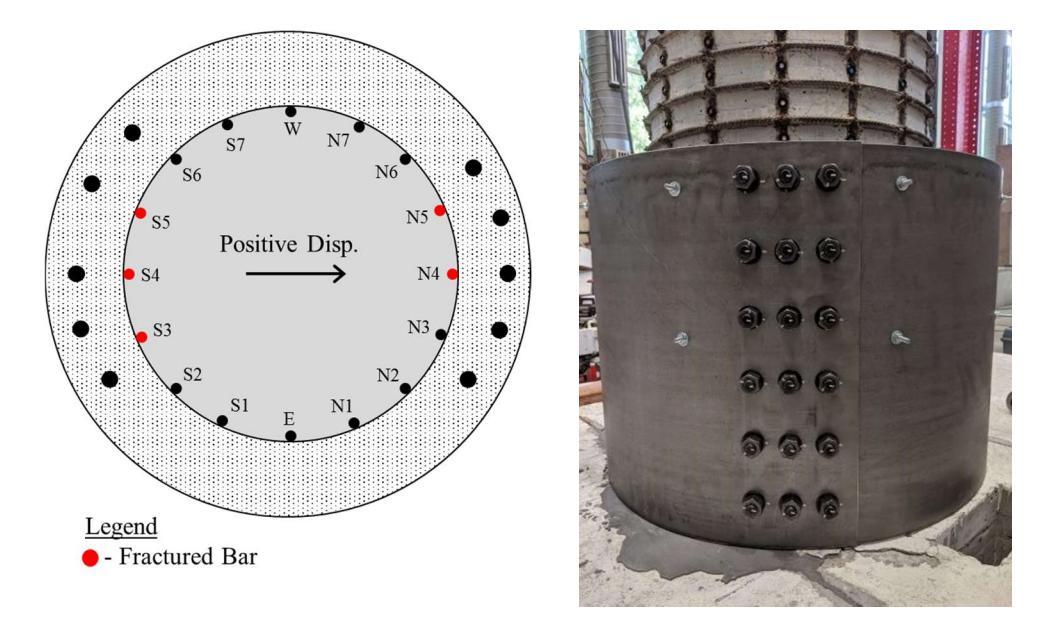
A calibrated torque wrench was used to apply the pre-tension of 250 ft-lbs to the bolts. Although it is known that this is not the most reliable method of pre-tensioning, due to the relationship between torque and pre-tension being heavily dependent on friction of the bolts, it was deemed acceptable because any amount of pre-tensioning would be an improvement compared to the previous repair. The method used for determining the size and number of bolts to prevent slip is given in Section 5.4. Following this, it was found that keeping the same pattern of 6 rows and 3 columns of bolts but using larger 5/8" diameter ASTM F3125 Grade A490 bolts should prevent plate slip.

Figure 4.13: Repair cross section and bolt configuration for Repair #2.

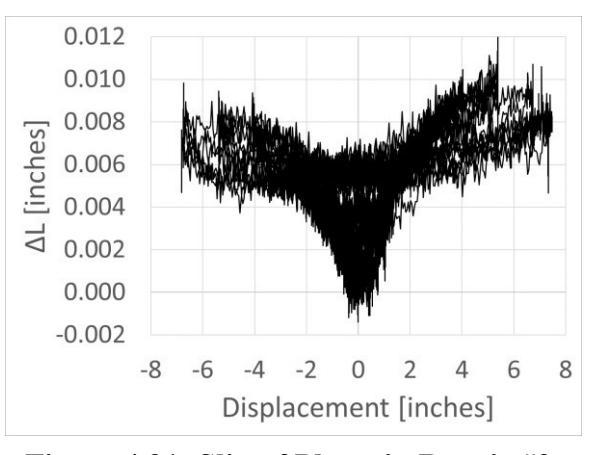
Using the same process as Repair #1, slip of the steel plates can be monitored using Optotrak LEDs on the two plates. Figure 4.21 shows that the maximum change in length of the two markers was around 0.01 inches. For comparison, Repair #1 had a maximum change in length of 0.20 inches. With this information, we can conclude that the pretensioned bolts succeeded in minimizing the plate slip. It is worth reiterating that the values above are the change in length of the two LEDS. For this reason, the values are not a direct measure of slip because strain within the sleeve would also contribute to the change in length. In other words, a change in length of 0.01 inches does not imply that the plate slipped 0.01 inches, because steel strain would also be

included in this. Further analysis would need to be done to determine actual slip length, but it must be less than 0.010 inches which is negligible.

Figure 4.21: Slip of Plates in Repair #2.

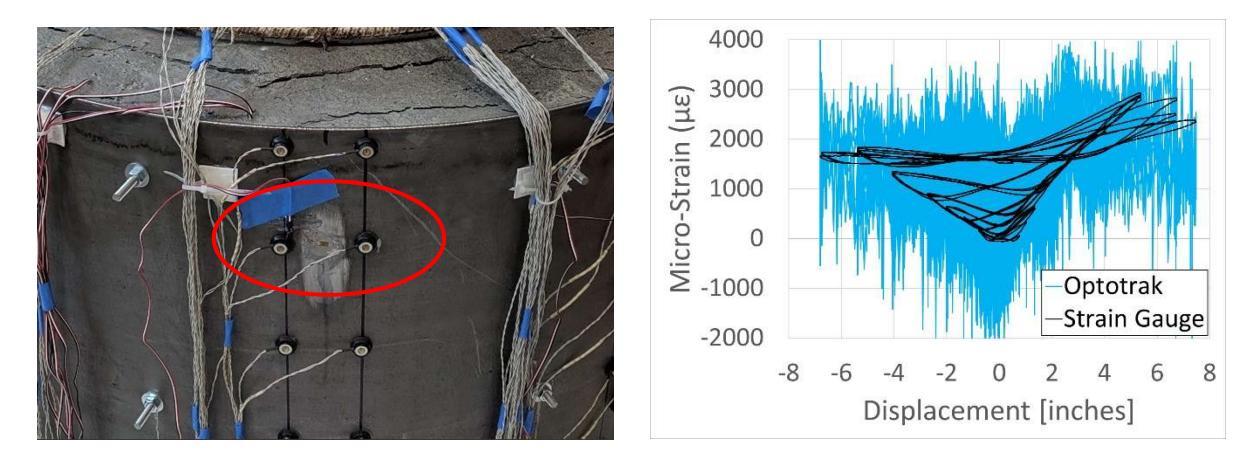
Focusing on the strain gauge data in Figure 4.23, the peak measured strain in the steel sleeve was 2934 $\mu\epsilon$ at a displacement of 5.38 inches. With the A36 steel used in this repair having an expected yield strain of 1500 $\mu\epsilon$, the sleeve yielded during this repair test. This is concerning because yielding of the sleeve leads to plastic deformation. Similar to how plate slip reduced the confining pressure in Repair #1 at smaller displacements, plastic deformation at higher displacements would limit the confining pressure that can be developed. Although yielding of the sleeve was observed in the previous research using the welded connection for the sleeve, it was not considered to be detrimental to the repair's response.

Figure 4.23: Location (left) and comparison of strains on the North side of the steel sleeve (right).

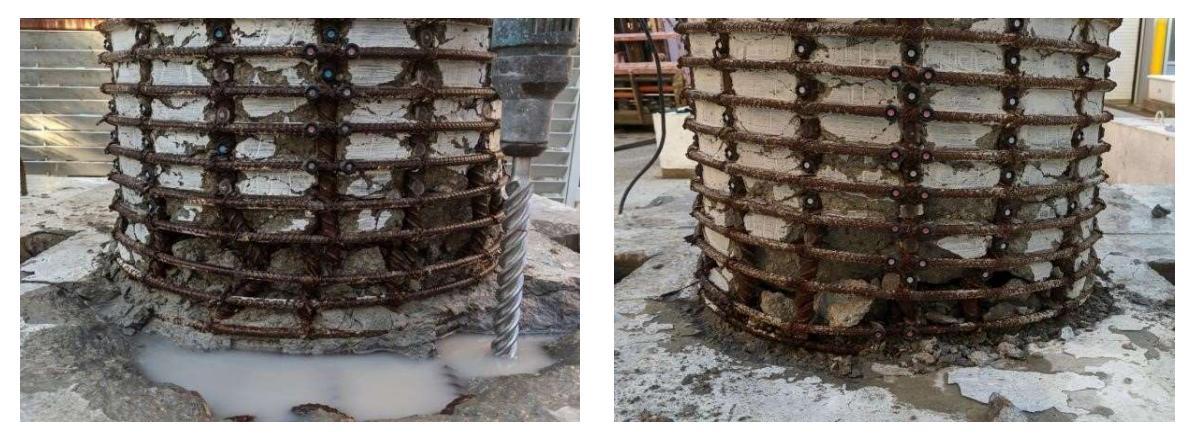
In contrast with the previous two repairs, the column repaired in this test had transverse reinforcement of #3 spirals spaced at 1½ inches instead of 2 inches. The original column test resulted in three bars fracturing on each side of the column and a significant amount of concrete spalled off. This symmetrical damage state gave an ideal opportunity to investigate a method of improving the anchorage of the fractured bars.

Figure 4.24: Damaged column for Repair #3 on the North (left) and South (right) sides.

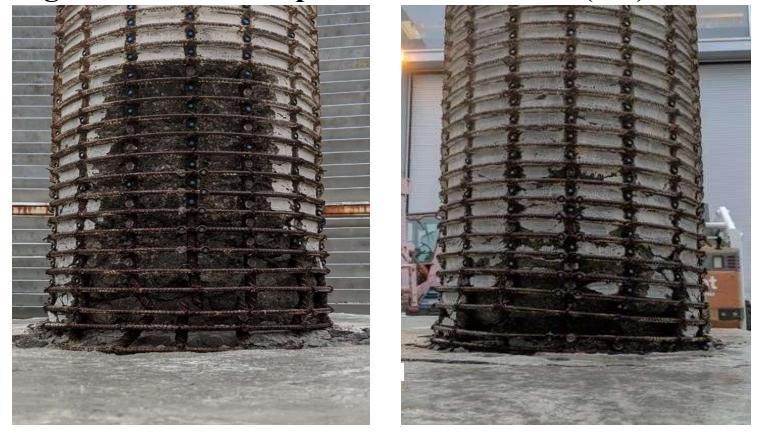
In the previous work by Krish (2018), one method of doing this was removing the concrete around the perimeter of the fractured bars within the height of the repair. This concrete is likely damaged from the original column test and bar fracture, so removing it makes it so that the repair grout will completely surround the bars which should improve their anchorage. When this was done by Krish (2018), it was found to slightly improve the peak strain that a bar could sustain before it would debond, but ultimately the bar still debonded; so in the interest of keeping the repair rapid the technique was not recommended. With the larger sleeve thickness expecting to improve the anchorage of the bars, the effectiveness of this technique was re-evaluated by chipping the concrete out on the North side and leaving the South side as it was. The damage after the original column test is shown in Figure 4.24. A comparison of the two sides after chipping is included Figure 4.25, and the

Figure 4.25: Repair conditions for the North (left) and South (right) sides.

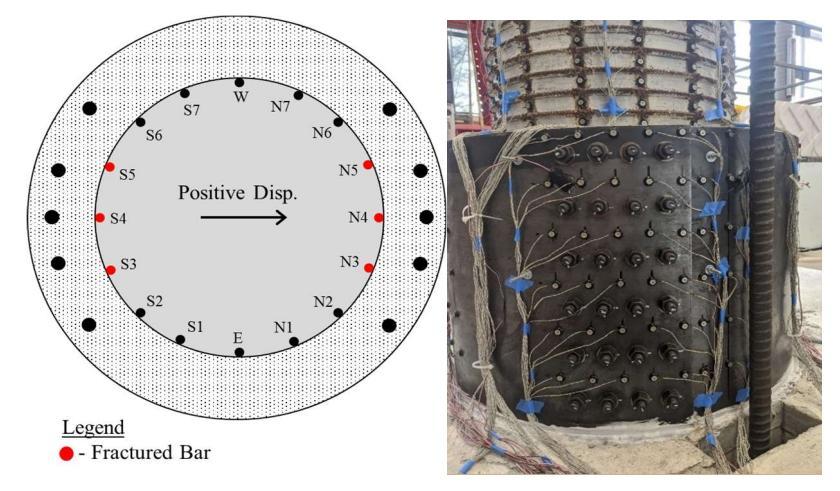
The steel sleeve in the previous repairs was cold-rolled from a 10-gauge plate with a thickness of 0.1345 inches, which was the maximum thickness that could be rolled by the NC State machine shop. Although increasing the sleeve thickness required this work to be done elsewhere, there was now no reasonable limit to the sleeve thickness. Following the design process in Section 5.2, it was believed that a thickness of 0.25 inches would conservatively prevent yielding of the sleeve. Since doing this has the potential to increase the demand to the bolted connection, a 4th column of bolts was added to ensure that slip of the plates would be prevented. Using the Optotrak data from Repair #2, the assumed stress distribution along the height of the connection was determined to be triangular, reducing the assumed forces on the sleeve by 2.

Figure 4.26: Repair cross section and bolt configuration for Repair #3.

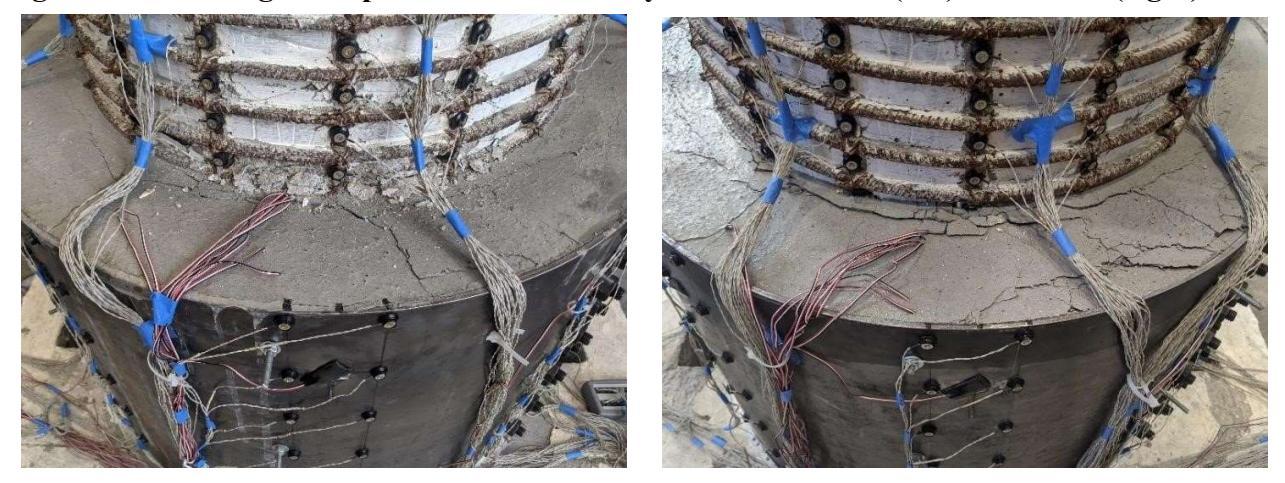
Figure 4.30: Damage Comparison after Ductility 2.

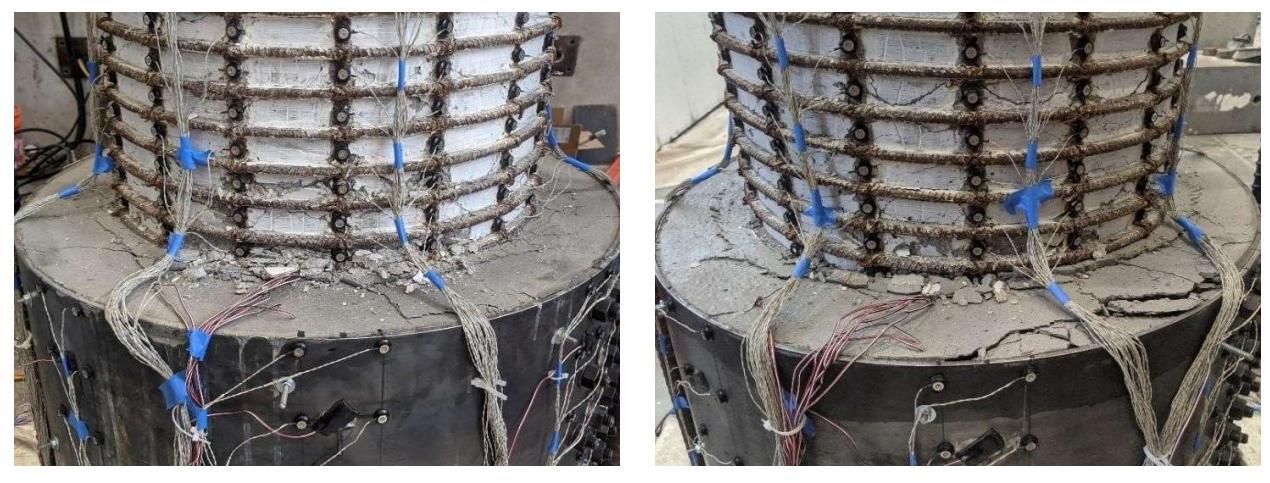
Figure 4.31: Damage Comparison after Ductility 3.

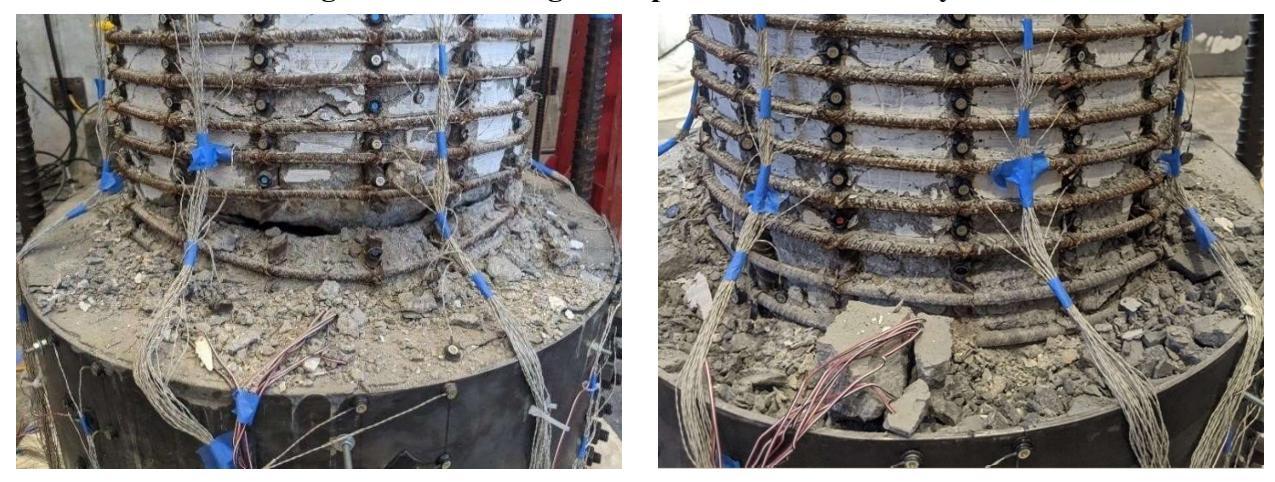
In the second cycle of ductility 4, buckling was observed in the 3 extreme bars (N3 to N5) on the north side. On the next cycle the 2 next extreme bars (N2 & N6) buckled, but there was still no visible buckling on the south side (though it is possible it buckled below the top of the repair grout). For the very first pull at ductility 5, N3 fractured followed shortly by N4.During the next pull cycle, N5 fractured and for the first time buckling was observed in S2 and S6. It was at this point that the large crack seen on the left of Figure 4.33 was noted. After this, one more push cycle was completed which fractured S2 and S6, the column was brought back to zero displacement and the test was complete.

Figure 4.33: Damage Comparison during the final cycle of Ductility 5.

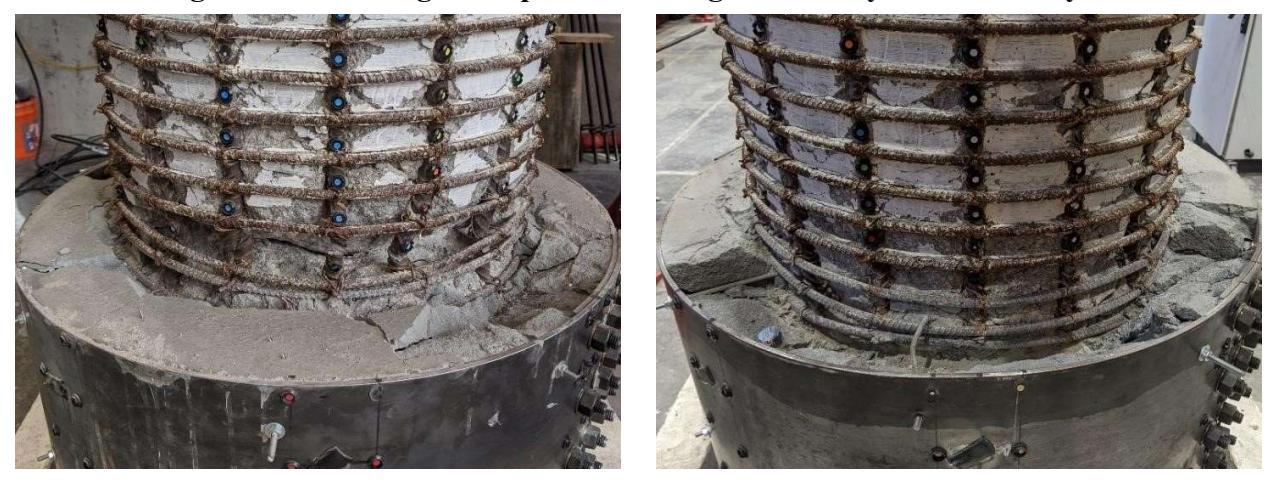
In summary, the south side performed similarly to what was seen in the previous test, but with slightly less damage. The three previously fractured bars (S3-S5) debonded, making the S2 and S6 the extreme bars that fractured in the repair test. The north side performance, however, was significantly different. For the first time ever, bars that had been fractured in the original tests (N3-N5) were fully anchored which led to them being refractured in the repair's relocated plastic hinge. It is worth emphasizing that not only did the North side have less damage to the repair, the relocated plastic hinge also formed completely above the top of the repair. For the previous two tests and the South side of this test, the relocated plastic hinge has appeared to be at or just below the top of the repair. It is believed that relocating the hinge above the repair is the ideal result for both capacity design and post-earthquake inspections.

Figure 4.34: Damage Comparison after the test with loose grout removed.

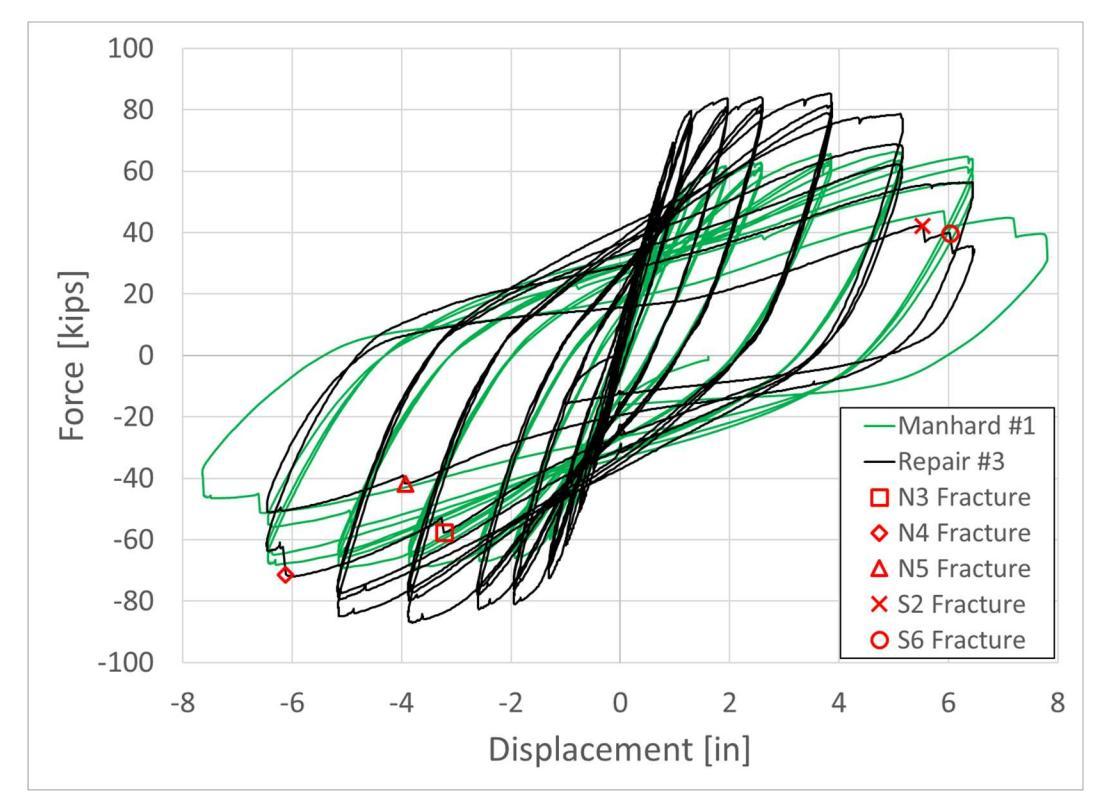
Figure 4.35 compares the Force vs. Displacement response of the repaired column with the original column, from which a few observations can be made. Firstly, we can see that the repaired column did not reach the same ductility cycle as the original. The repaired column test ended after 2 cycles at ductility 5 (6.44 inches), whereas the original test completed all 3 cycles at ductility 5 and then one cycle at ductility 6. This is attributed to the repaired column having a shorter effective height, which is further discussed later in this section.

Secondly, it is clear that the repaired column does not exhibit the pinching behavior discussed in Chapter 2 until very late in the test. This is consistent with the results of Repair #2 and is again credited to the pretensioned bolts preventing slip of the plates. Especially during the lower ductility cycles, the repaired response follows a similar unloading and reloading curve which is ideal for the repair and indicates high seismic resistance. The primary difference in the curves is that the repaired column is much stiffer, which leads to the next observation.

Figure 4.35: Force vs. Displacement Response of Repair #3.

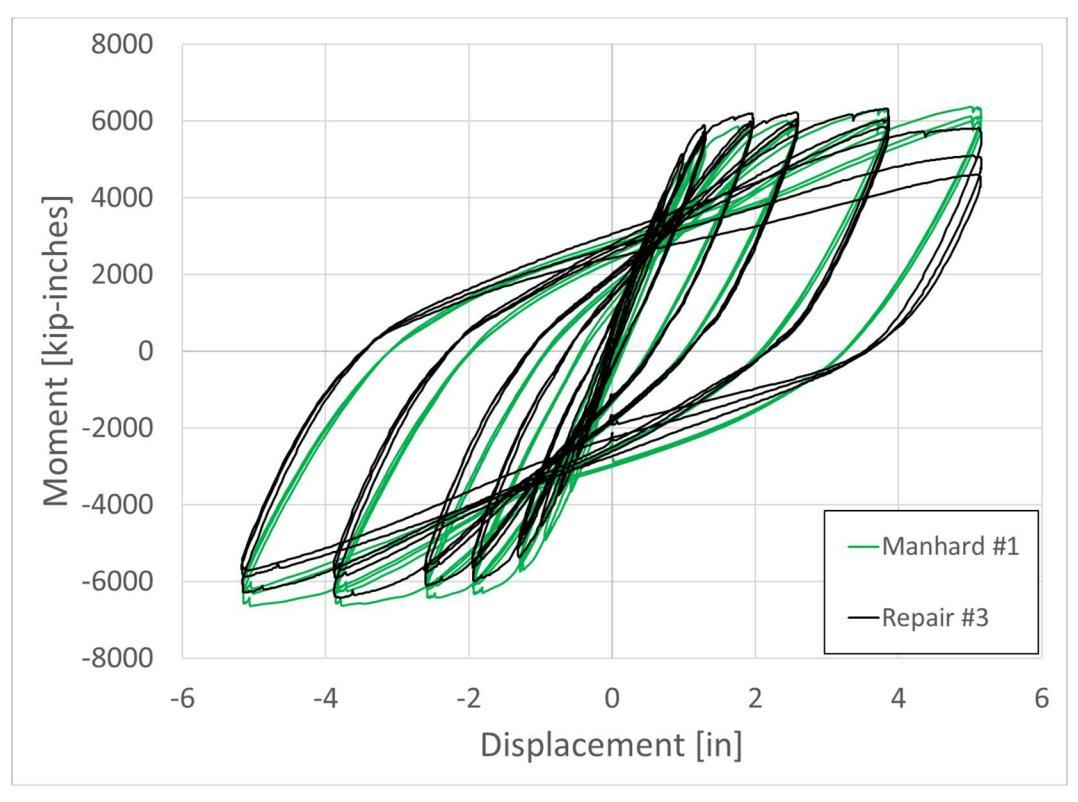
Figure 4.36 shows that the performance of the repaired column is very similar to that of the original column. Looking first at the positive displacement, we see that the response is almost identical until a displacement of 5.15 inches (ductility 4). This softening at 5.15 inches is attributed to the fractured bars having debonded and is further discussed in the following Section. In contrast, the negative displacement shows almost no softening, and the small amount is likely due to the socket-like anchorage of the repair being slightly weaker than a column-to-footing connection in the original test. Regardless, this curve still matches very well with the original column. It is worth noting that the original column test shows asymmetrical results with the negative displacement having higher strengths. A comparison of the positive moments of the original test and the negative moments of the repair test do not show the original column being stronger than the repaired column.

Figure 4.36: Moment in plastic hinge vs displacement for Repair #3.

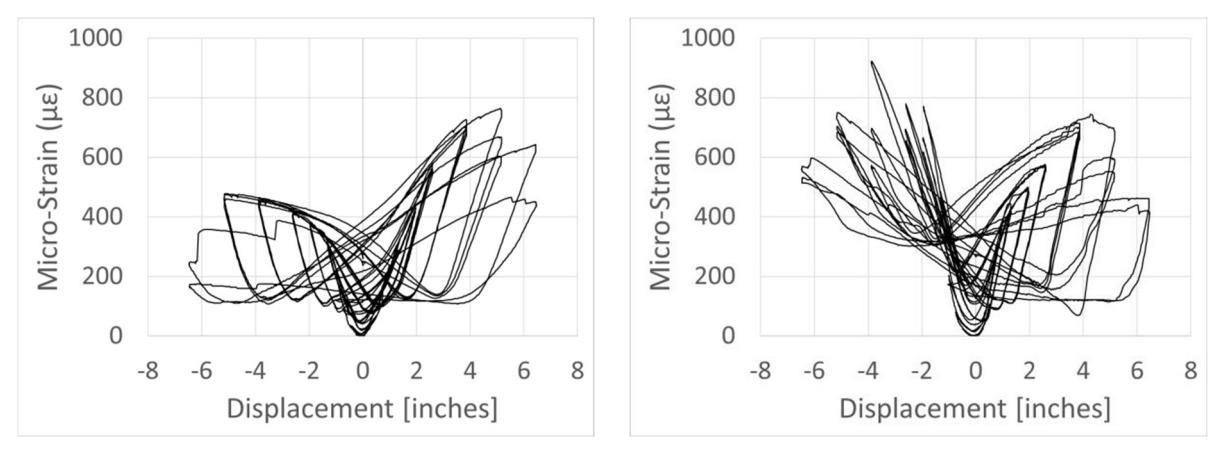
Since the objective of this repair was to prevent yielding of the sleeve, this data from the strain gauges on the sleeve are shown in Figure 4.37. These strain gauges were in the same location as the ones in Repair #2; 3.5 inches from the top of the sleeve and on the extreme North and South sides. As before, the yield strain of this steel is expected to be around 1500 $\mu\epsilon$, so yielding was successfully prevented.

Figure 4.37: Strains in steel sleeve on North (left) and South (right) sides of the column.

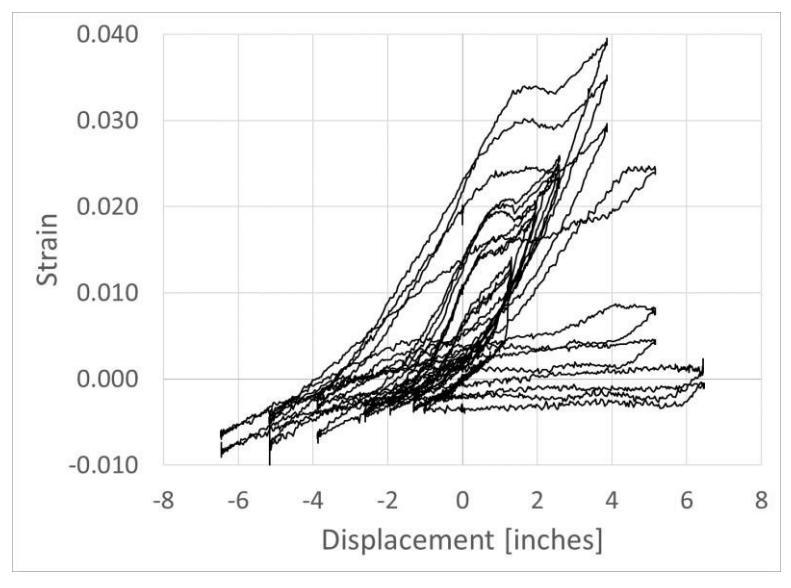
Knowing this, the analysis of the south side of the column will be presented first since the primary difference between this side and the previous repair is the thicker sleeve. Based off the observations made during the experimental test, this side of the column showed a similar behavior as Repair #2. Since the S2 and S6 bars were the bars that fractured in this test, the three bars between them bars must have debonded and the strain data shown in Figure 4.38 confirms this. Although the peak strain that the bar sustained increased from around 0.03 in Repair #2 to 0.04 in this repair, the bars ultimately debonded after the first cycle at ductility 3 (3.86 inches). Given this increase, it appears unlikely that further increase in passive confinement alone would be capable of fully anchoring these bars within the repair.

Figure 4.38: Strain History of S4 in Repair #3.

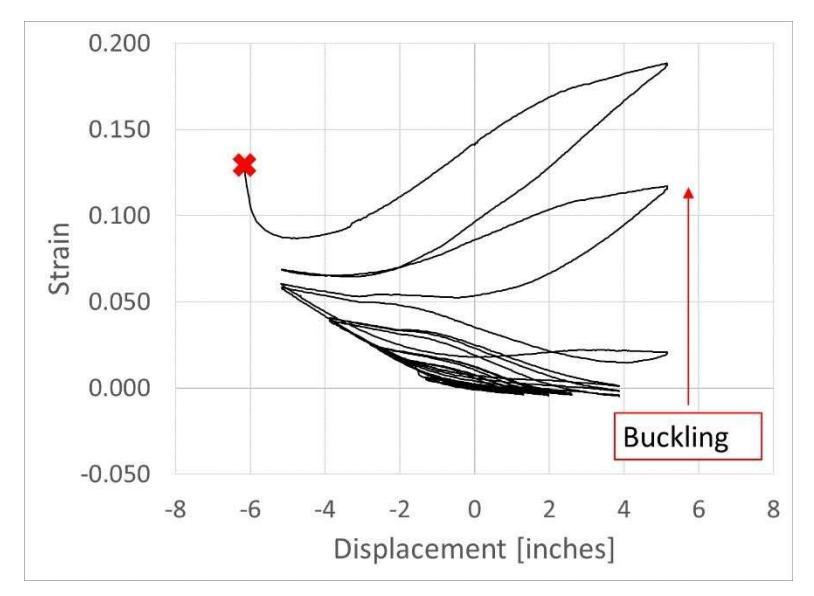
For the North side of the column, the combination of using the thicker steel sleeve and removing the concrete around the fractured bars was sufficient to fully anchor the bars within the repair. From Figure 4.39, the typical response of a well anchored longitudinal bar described earlier is seen, with increasing displacements corresponding to an increase in strains until buckling occurs when the bar is in compression. As the bar continues to buckle further, it eventually ruptures in tension, highlighted by the red x.

Figure 4.39: Strain History of N4 in Repair #3.

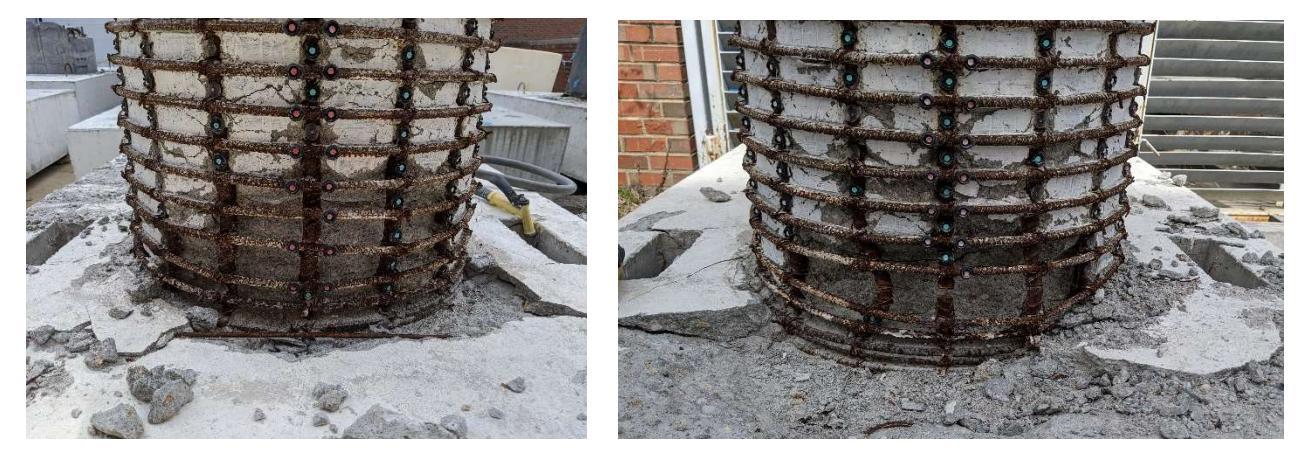
The initial damage condition of this column was 3 fractured bars on each side. The repaired column was subjected to the same axial load and displacement history as the original column. This repair maintained the use of the thicker steel sleeve from Repair #3, with the focus of evaluating the impact of chipping perimeter concrete around both fractured and unfractured bars. To accomplish this, the perimeter concrete was chipped around the fractured bars on the South side and concrete was chipped around all of the bars on the North side. Figure 4.40 shows the damage conditions prior to chipping perimeter concrete. The column after the concrete was chipped is shown in Figure 4.41. The properties for the original column and repair are summarized in Table 4.4.

Figure 4.40: Repair conditions for the North (left) and South (right) sides.

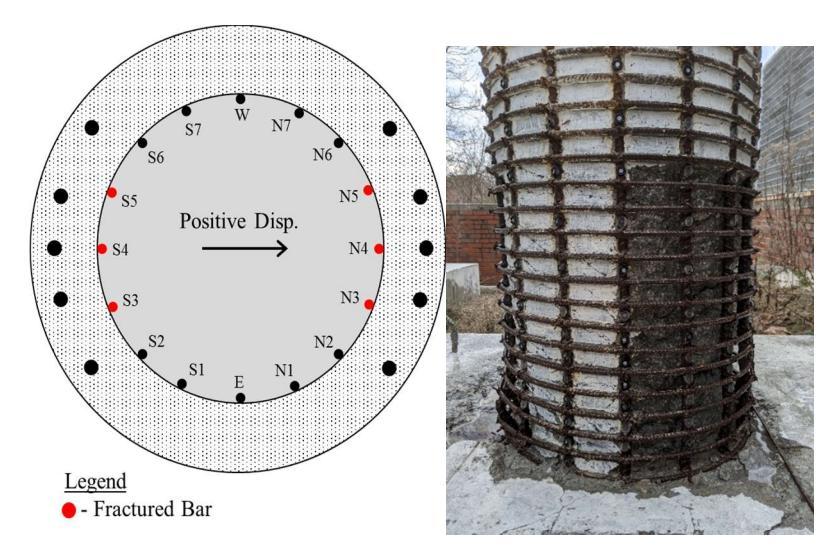
Figure 4.41: Repair cross section and conditions of chipped concrete for Repair #4.

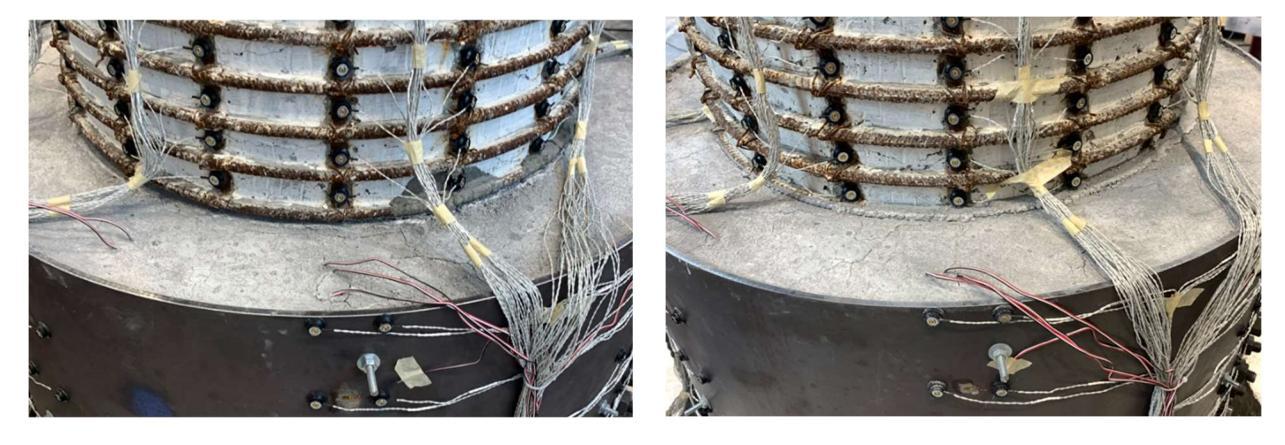
Figure 4.44: Damage Comparison after Ductility 1.5 of the North (left) and South (right) sides.

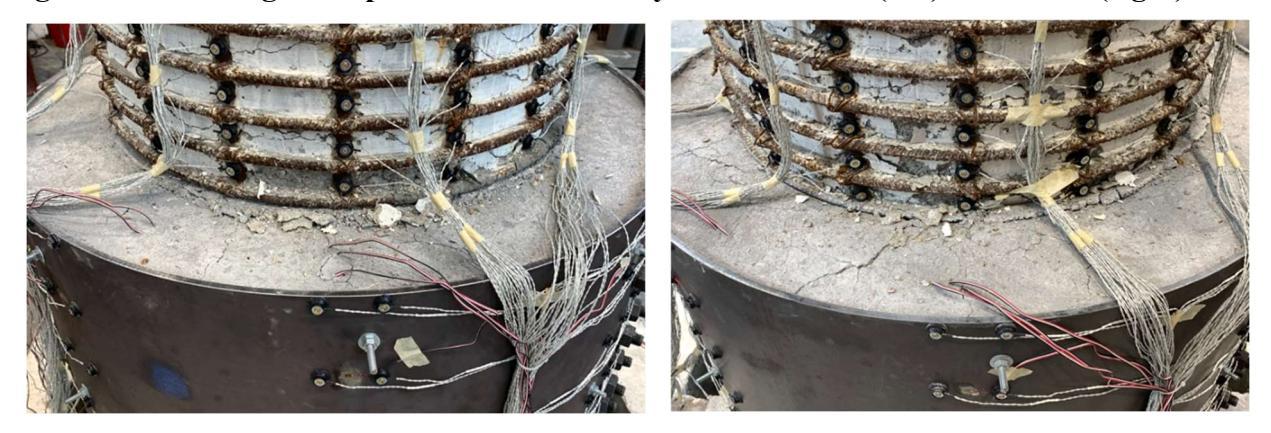
Figure 4.46: Damage Comparison after Ductility 3 of the North (left) and South (right) sides.

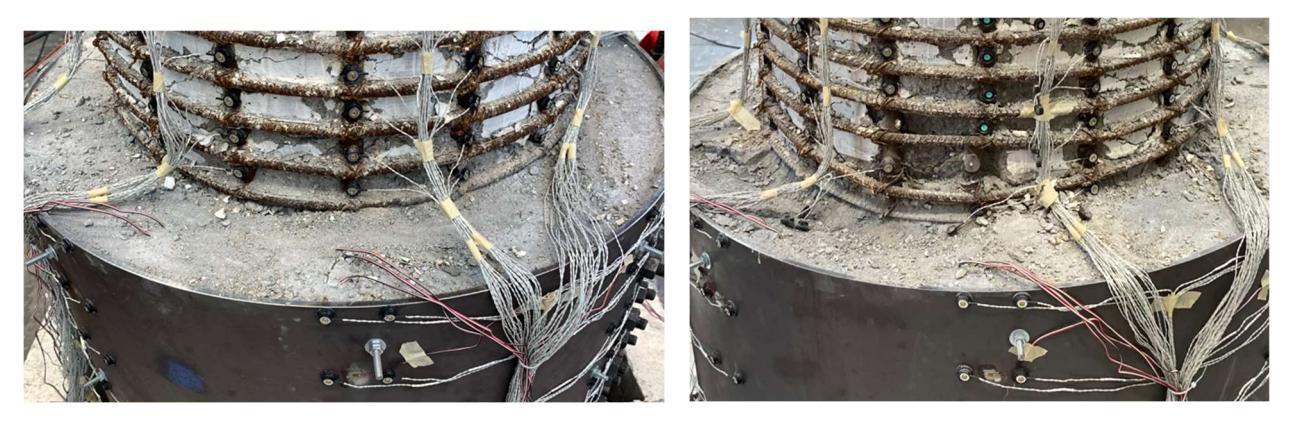
Buckling was observed during ductility 4 for the extreme bars on both sides of the column. On the South side, bars S4 and S5 buckled during the second cycle. On the North side, bars N4 and N5 buckled during the third cycle. The most extreme bars fractured on both sides of the column. S4 fractured on the South side during the third push of ductility 4, and N4 fractured on the first pull of ductility 5. Additionally, bars S3, S5, and S6 fractured in the cycles following the fracture of S4.

Figure 4.47: Damage Comparison after Ductility 4 of the North (left) and South (right) sides.

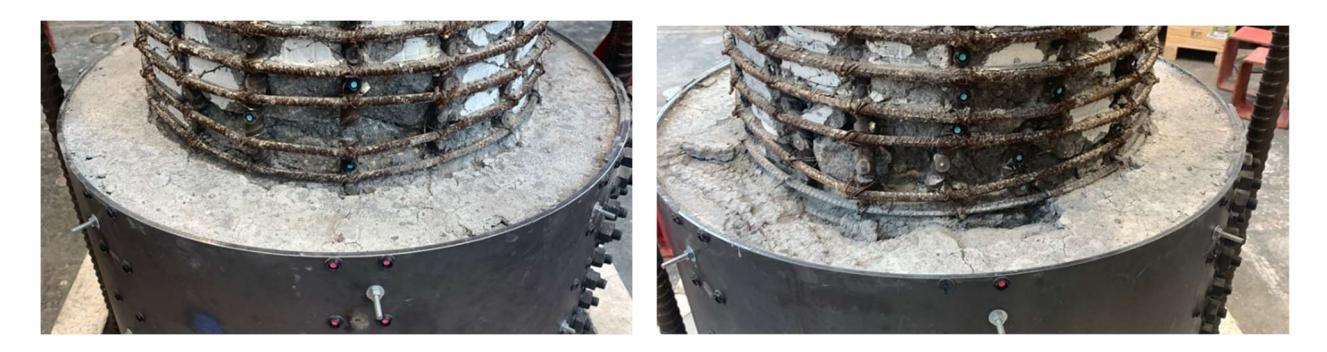
To assess the potential differences in damage for the two sides, pictures were taken of each side after each ductility. The damage progression is shown in Figures 4.42 to 4.48. The North face of the column is shown in the photos on the left, and the South face is shown on the right. Unless otherwise noted, the photos were taken at the completion of the ductility cycle, when the column was brought to zero displacement. Cracks in the repair grout closed in compression on the North and South side throughout the test. Starting in ductility 4, loose concrete and grout was removed. By the end of the test, about ¹/₄" of loose grout had been removed from the South side while the North side grout remained intact.

Figure 4.48: Damage Comparison after the test when all loose grout was removed of the North (left) and South (right) sides.

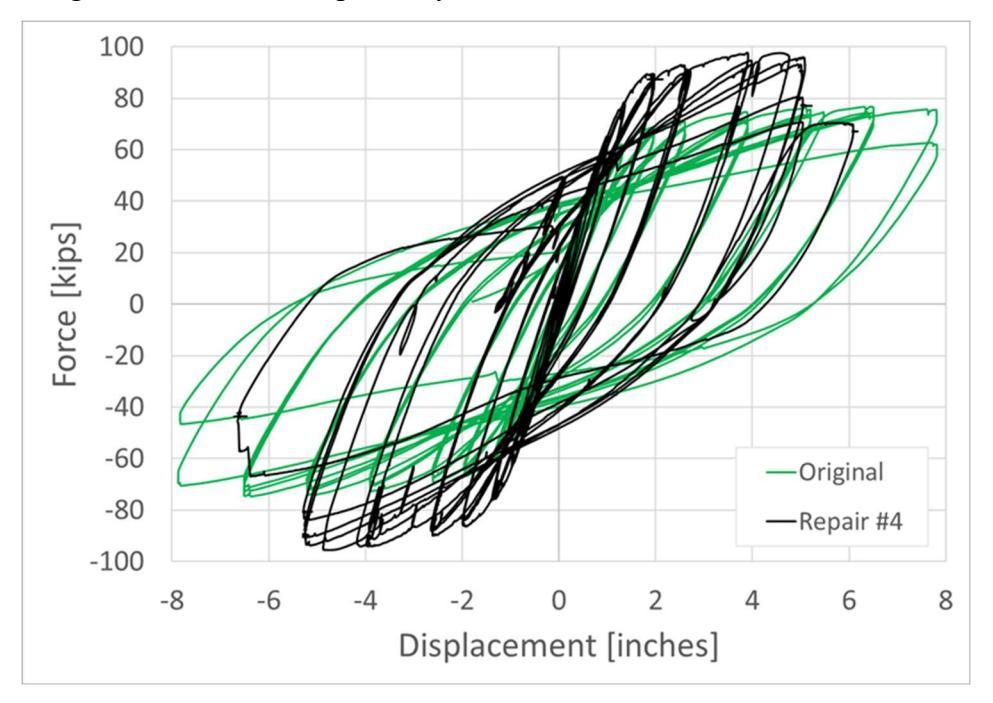
Figure 4.49 compares the Force vs. Displacement response of the repaired column with the original column. Similar to the third repair test, the repaired column did not reach the same ductility cycle as the original. The repaired column test ended after the first cycle of ductility 5. The original test completed 3 cycles at ductility 5 and went on to 2 cycles of ductility 6. The decreased ductility capacity is a consequence of the decreased effective height of the column imposed by the steel sleeve.

Figure 4.49: Force vs. Displacement Response of Repair #4.

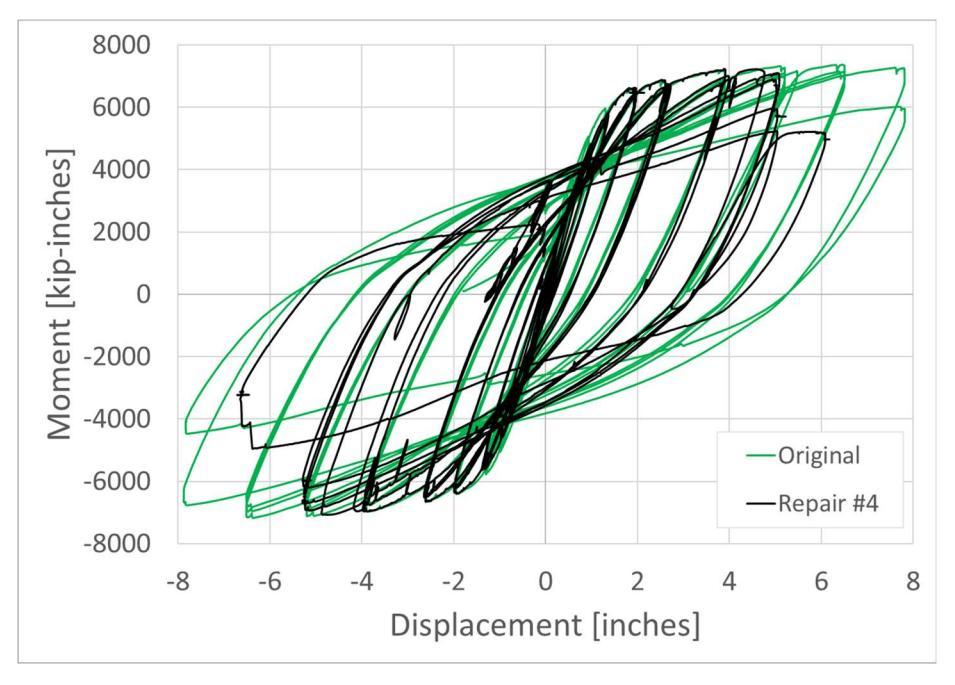
The moment vs. displacement response is shown in Figure 4.50, and was produced following the procedure discussed in Section 4.3.4. The effective heights for the original column and repaired column are 96 inches and 74 inches, respectively. The graph shows that the performance of the repaired column is very similar to that of the original column. The repaired column does not exhibit the pinching behavior seen in previous repairs; this is expected due to the pre-tensioning of the steel sleeve and improved bond conditions on both sides. The behavior of the repaired column is also fairly symmetric, indicating that the additional chipping of concrete away from bars that did not previously fracture did not provide additional benefits.

Figure 4.50: Moment vs. Displacement Response of Repair #4.
