Rapid Seismic Repair of Column to Footing Connections – Phase 2

Prepared By: Taylor J. Brodbeck, Ph.D. Student Zachary A. Shurow, MS Mervyn J. Kowalsky, Professor, Ph.D. Rudolf Seracino, Professor, Ph.D.

1. AGENCY USE ONLY (LEAVE BLANK)	2. REPORT DATE	3. REPORT TYPE AND DA	TES COVER	ED
	May 31, 2022	FINAL REPORT, Jan.	2019 thro	ugh May 2022
4. TITLE AND SUBTITLE Rapid Seismic Repair of Column to F	Footing Connections – Phase 2		5. FUNDING	NUMBERS

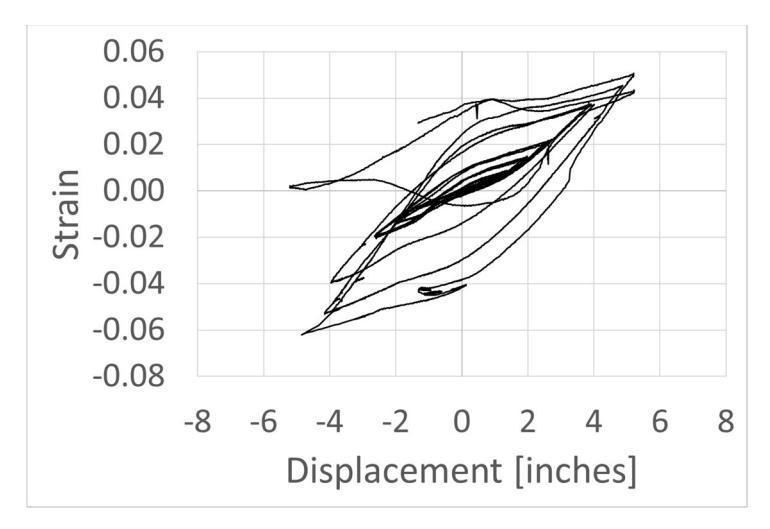
The most extreme bar on each side of the column (N4 and S4) fractured during the repair test. These bars had both fractured in the initial column test, and were anchored in the repair such that they were able to buckle and fracture above the repair. The strain history is shown for the S4 and N4 bars in Figure 4.51 and Figure 4.52, respectively. Both bars reached a maximum tensile strain of around 0.05 before buckling, which is larger than the peak strain prior to debonding for any of the previous repairs. This shows that the removal of perimeter concrete around fractured bars along with the sleeve thickness designed to remain elastic are necessary to anchor fractured bars.

Figure 4.51: Strain History of S4 in Repair #4.

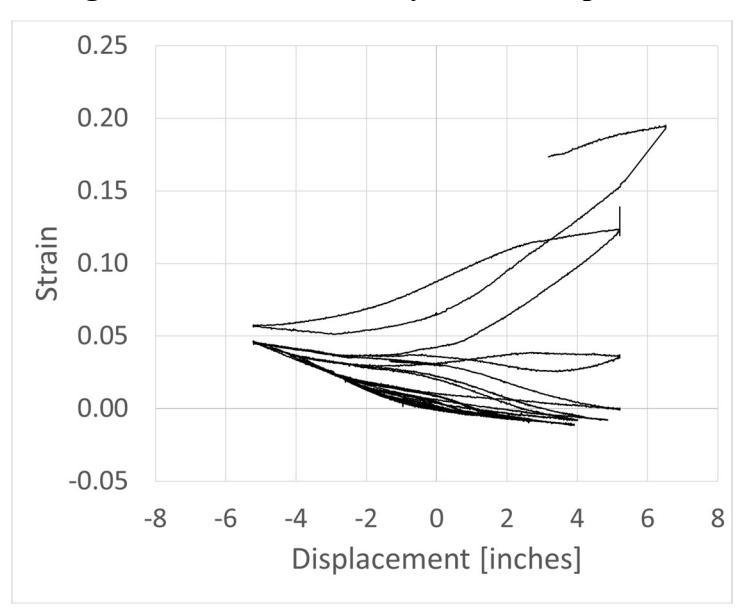
Figure 4.52: Strain History of N4 in Repair #4.

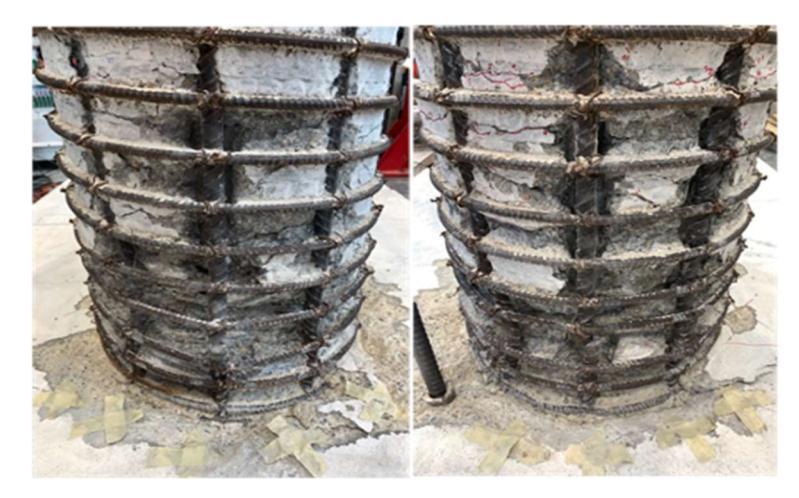
The initial damage condition of this column consisted of 1 fractured bar on the North side and 2 fractured bars on the South side. Based on the results of the previous tests, the concrete was chipped just around the fractured bars to improve bond conditions. Figure 4.53 shows the damage conditions for the North and South sides. For repairs using epoxy anchored bars in holes drilled in the footings, the number and size of bar is determined using the design outlined in Section 5.1 based on the number of bars that fracture in the original test. For this test with embedded couplers, the number and size of bar couplers that must be embedded is determined based on an assumed level of damage. The repair cross section was designed assuming no more than 3 longitudinal bars would fracture on each side of the column during the original test, resulting in 5 couplers placed in each side of the footing. Grade 80 threaded bars with a diameter of 0.75 inches were used with compatible couplers to construct the repair. Figure 4.54 shows the cross section and completed repair.

Figure 4.53: Repair conditions for the North (left) and South (right) sides.

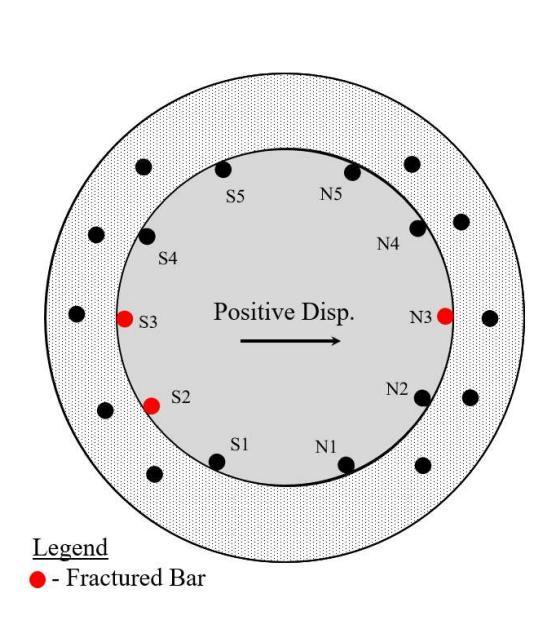
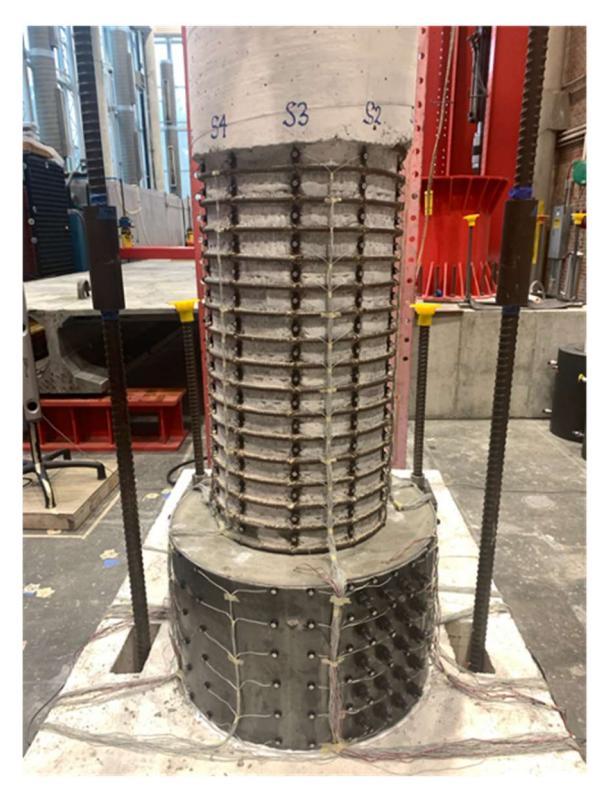
The properties for the original column and repair are summarized in Table 4.5. The aspect ratio (L/D) for the column in Repair #5 is 5.33, compared to an aspect ratio of 4 for the previous repairs in this report. The steel sleeve height maintained the same ratio of 0.9D, which reduced the height to 16.5 inches. The diameter of the steel sleeve was reduced to 26 inches, which provided a 4 inch annular ring for the backfill material. The bolted connection was adapted to the new repair height, following the design presented in Section 5.3.

Figure 4.54: Repair cross section and bolt configuration for Repair #5.

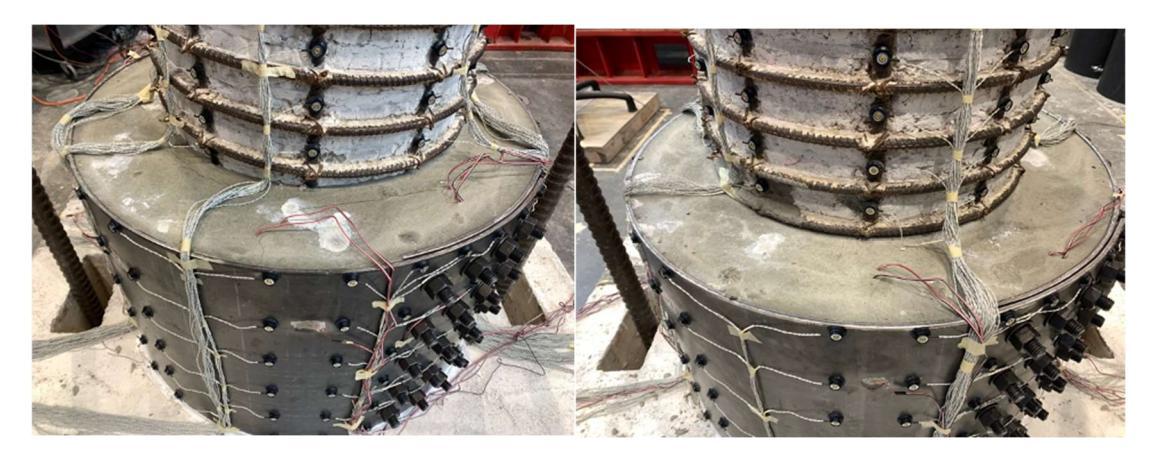
Figure 4.55: Damage after ductility 1 for the North (left) and South (right) sides.

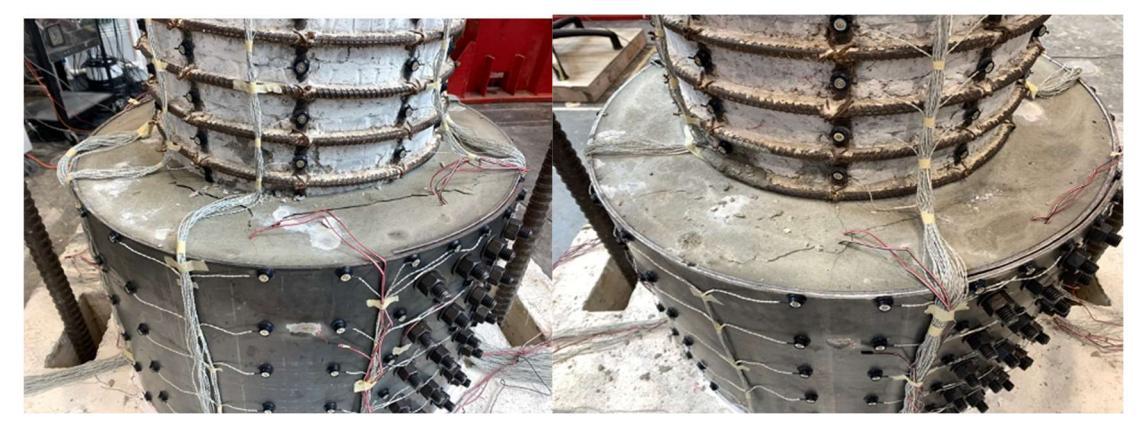
Figure 4.56: Damage after ductility 2 for the North (left) and South (right) sides.

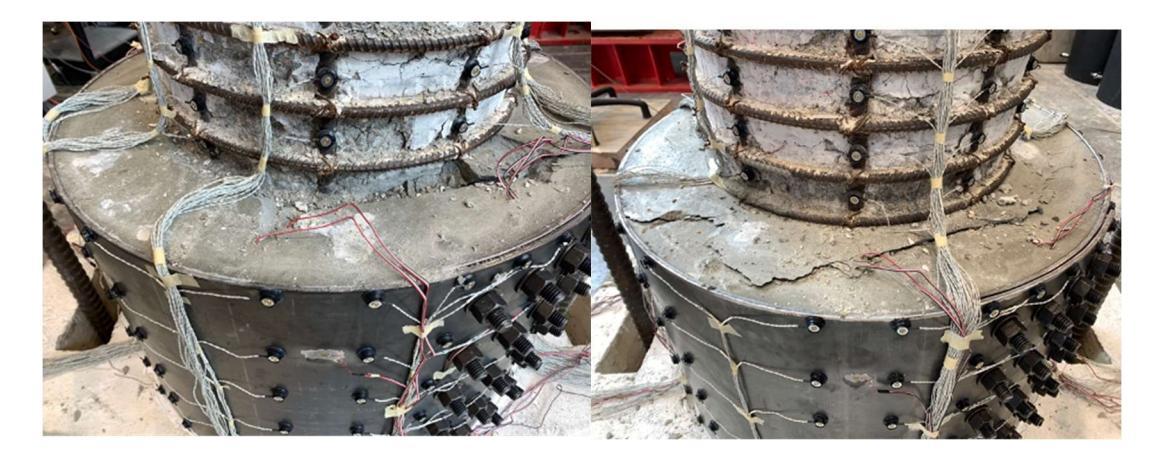
Figure 4.57: Damage after ductility 4 for the North (left) and South (right) sides.

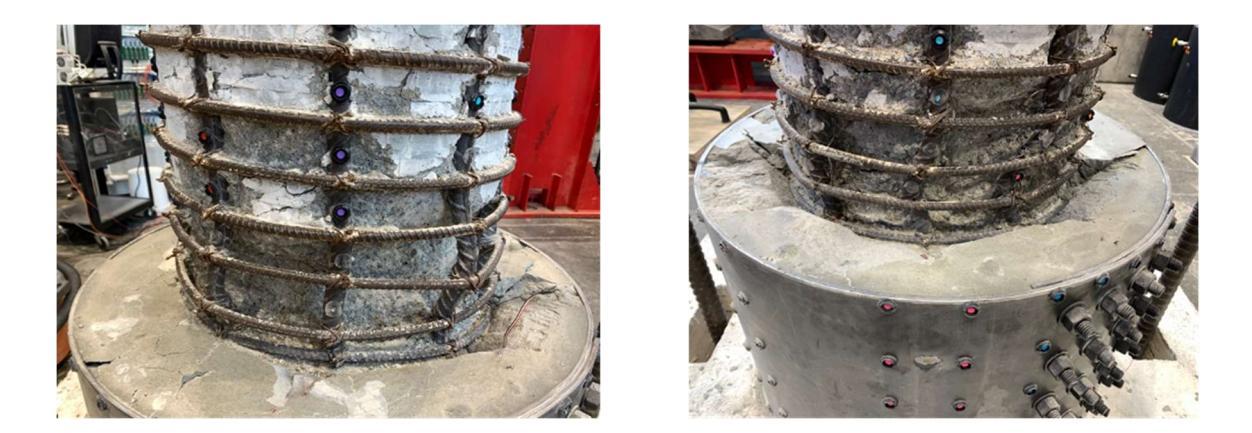
brought to zero displacement. Cracks in the repair grout closed in compression on the North and South side throughout the test. Starting in ductility 4, loose concrete and grout was removed. Buckling was observed during the second cycle of ductility 5 for the extreme bars on both sides of the column (bars S3 and N3). On the third cycle of ductility 5, N3 fractured. During the next push, S3 fractured before surpassing the ductility 5 displacement. The final damage condition consisted of bars N3 and S3 fractured in the relocated hinge, along with the buckling of N2.

Figure 4.58: Damage Comparison after the test when all loose grout was removed of the North (left) and South (right) sides.

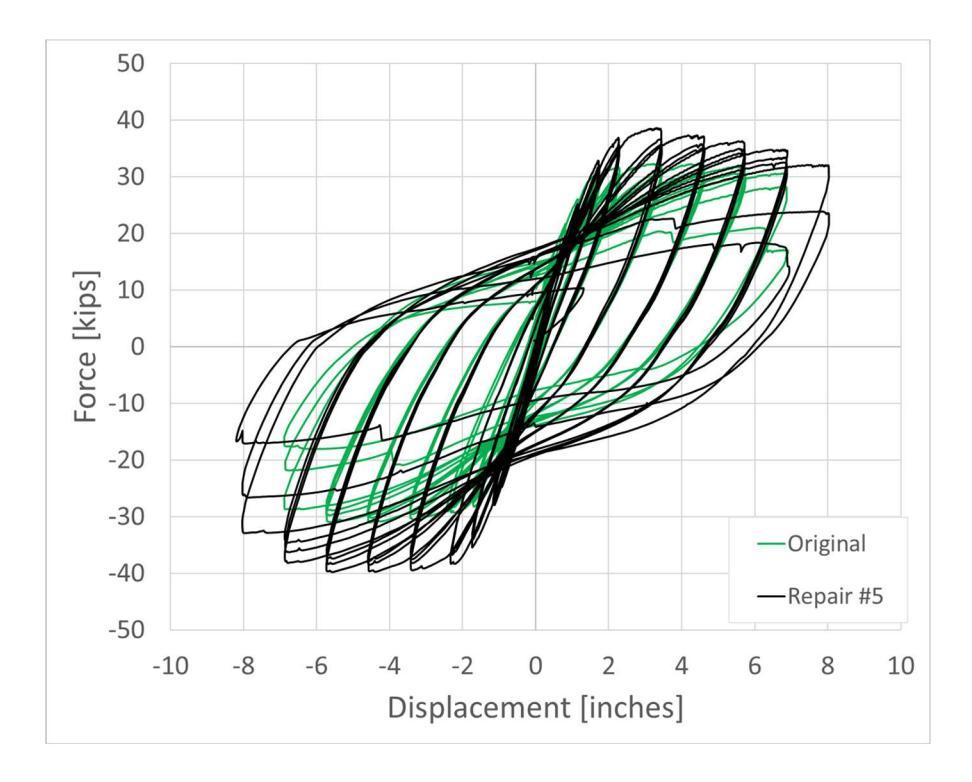
Figure 4.59 compares the force vs. displacement response of the repaired column with the original column. In this repair test, the repaired column did reach the same displacement as the original column. The original column completed 3 cycles at ductility 6. At the end of ductility 6 for the repair test, the forces had dropped approximately 20%, which is typically considered failure, but the test was continued through ductility 7 to determine if the previously fractured bars would remain anchored with the new repair height.

Figure 4.59: Force vs. Displacement of the Original and Repair Column Tests.

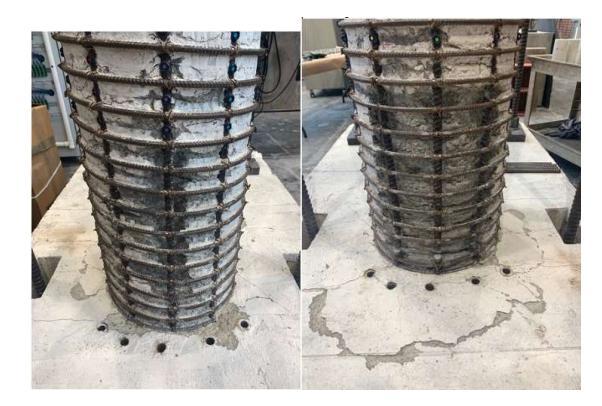
The initial damage condition of this column, shown in Figure 4.64, was one fractured bar on the North side and 3 fractured bars on the South side. The perimeter concrete was chipped around the fractured bars. The repair cross section is shown in Figure 4.65. In this design and the design of Repair #5, it was assumed that no more than 3 longitudinal bars would fracture on each side of the column, resulting in 5 couplers placed in each side of the footing during construction. For this repair, the actual damage of the original column was taken into account to decide how many bars would be placed in the couplers. On the South side, the assumed 3 bars fractured and therefore all 5 couplers were used. On the North side, only one bar fractured, so fewer repair bars could be used and still behave elastically according to the design, and two of the couplers were left empty.

Figure 4.64 Repair #6 damage state of the North and South sides.

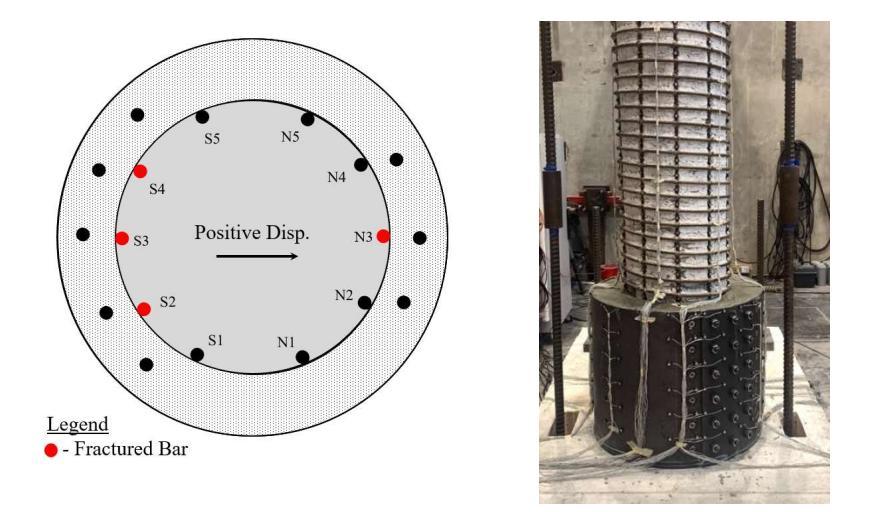
Figure 4.65: Repair #6 damage state of the (a) North and (b) South sides.

The properties for the original column and repair are summarized in Table 4.6. The height of the steel sleeve was increased to 22 inches for this repair. The increase from 0.9D was to account for the increase in the extent of plasticity associated with the taller column height. The height of the repair was chosen to ensure that the strains of the original column and the location of relocated plastic hinge remained below 0.02, following the recommendations of Krish (2018). Because the design of the couplers must be determined before the original column is constructed, the equation for plastic hinge length was used to determine the proper height. The strain data from the original test showed the actual maximum strain at the relocated hinge was 0.027.

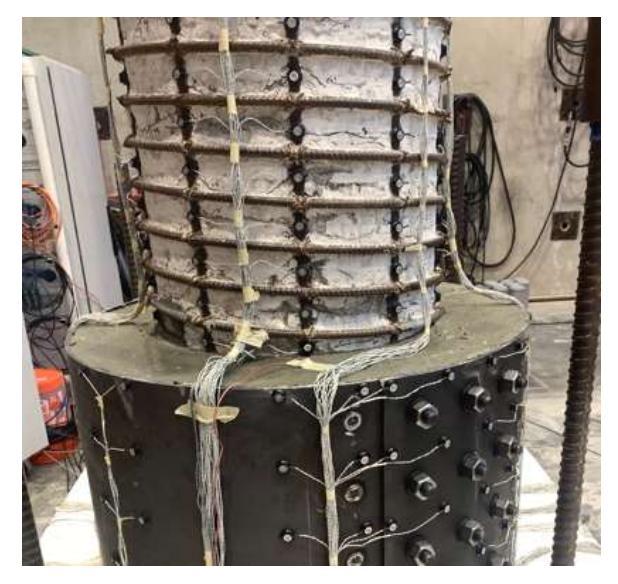
The first grout cracks appeared during the first yield cycle, and were diagonal through the top of the repair, radiating from the area where the core column chipping stopped. Circumferential grout cracks formed in the ductility 1 cycles. As you can see in Figure 4.66 the column exhibited large cracks in the new hinge region from the initial loading of the original test. These original column cracks also widened in the ductility 1 cycles. Beginning in ductility 1.5, new column cracks formed above the repair. Column concrete crushing happened during ductility 3.

Figure 4.66 Initial damage above repair.

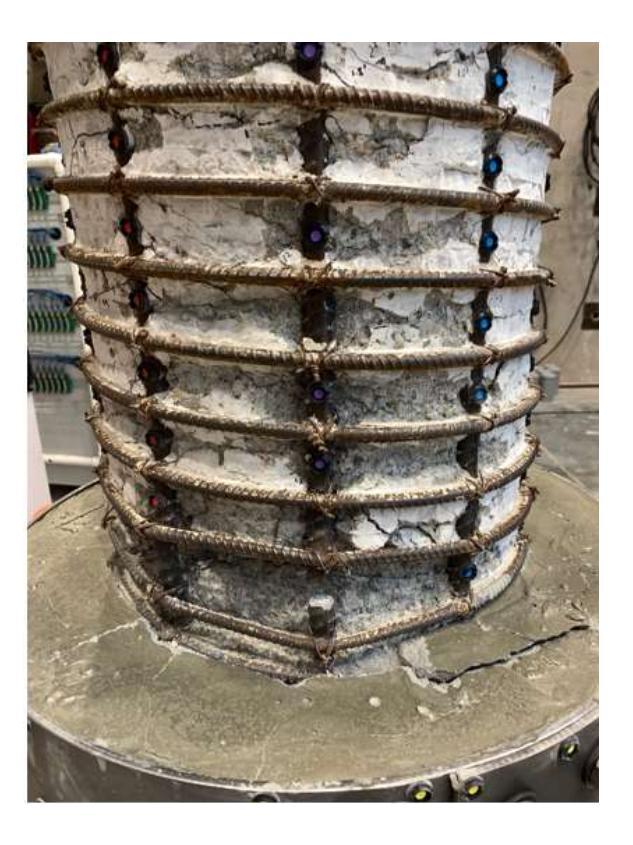
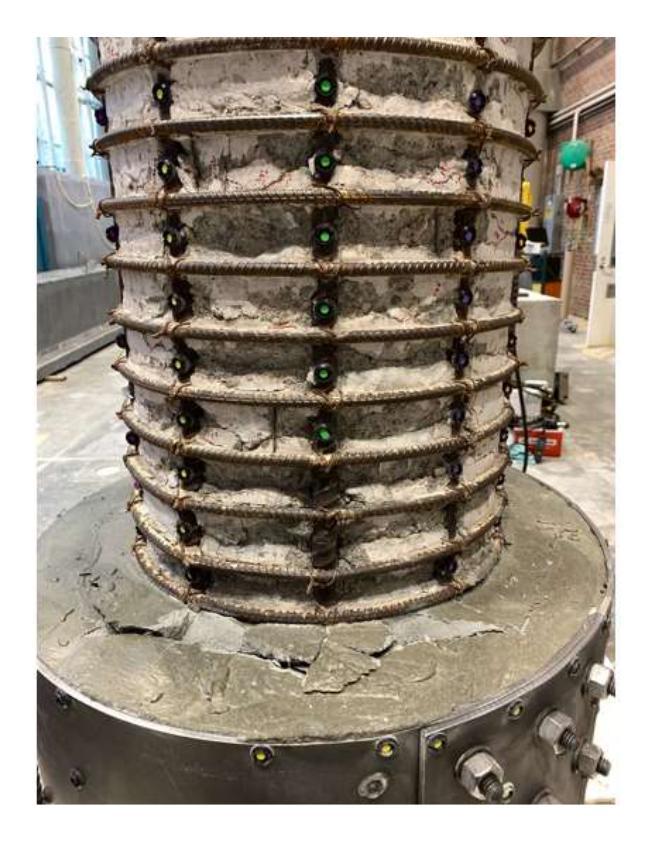
Buckling was observed during the second cycle of ductility 5 for the extreme bars on both sides of the column (bars S3 and N3). On the third cycle of ductility 5, N3 fractured. During the next push, S3 fractured before surpassing the ductility 5 displacement. In addition to N3 and S3 fracturing in the relocated hinge, N2 buckled.

Figure 4.73: Damage after the test when all loose grout was removed of the North (left) and South (right) sides.

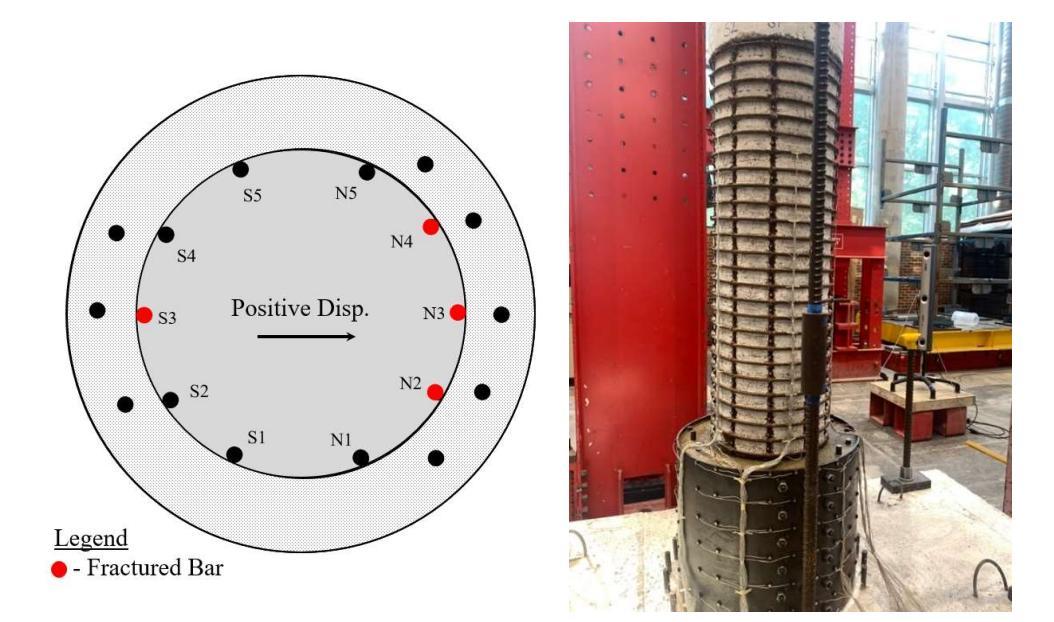
Figure 4.77: Repair Cross Section and Completed Repair.

The initial damage condition of this column consisted of 1 fractured bar on the South side and 3 fractured bars on the North side. The perimeter concrete was chipped around the fractured bars. 8 Grade 80 No.

6 bars were epoxy anchored into drilled holes in the footing. The strain from the previous test at the relocated hinge was less than the limit of 0.02 from Krish (2018). Epoxy grout was used as the backfill material and the completed repair is shown in Figure 4.77. The grout was poured to the same level as the top of the steel sleeve, but shrinkage resulted in a decreased height in addition to one large radial crack propagating through the entire height. Additional epoxy was poured into the crack, and after shrinkage the crack remained only at the surface. The properties for the original column and repair are summarized in Table 4.7.

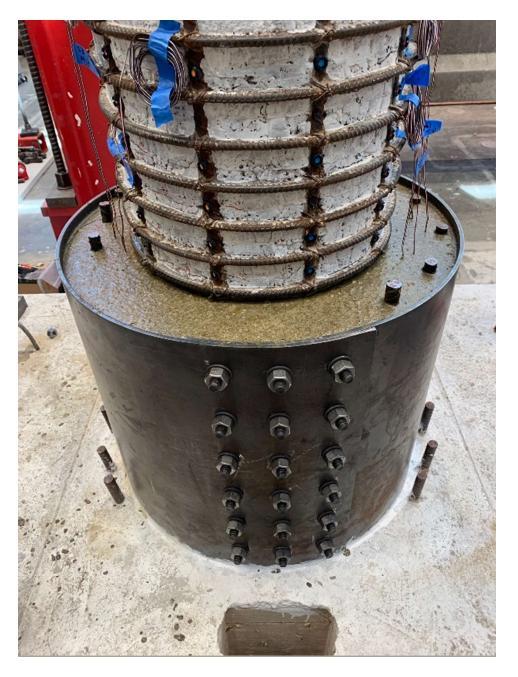
The original condition of the grout can be seen in Figure 4.78. The radial grout crack maintained the same size throughout the test, and no cracks formed in the grout for the majority of the test. One circumferential hairline crack formed on the South side during the first push of ductility 5. Cracks formed in the concrete at the interface between the column and repair during the first cycles of ductility 1; the original column cracks widened in these cycles. Beginning in ductility 1.5, new column cracks formed above the repair. Column concrete crushing happened during ductility 3. The damage progression is shown in Figures 4.80-4.85. Each picture was taken at the peak displacement for ductility cycle, with the shown side in tension.

Figure 4.78: Initial Conditions

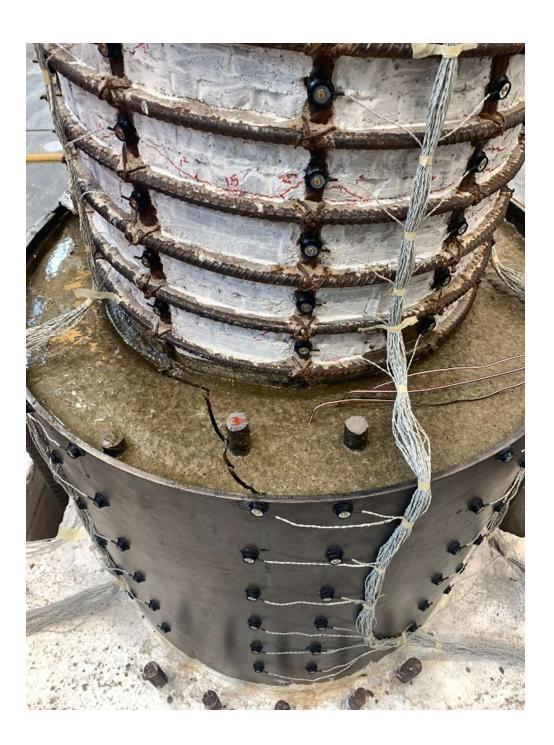
Figure 4.79: Initial Grout Crack

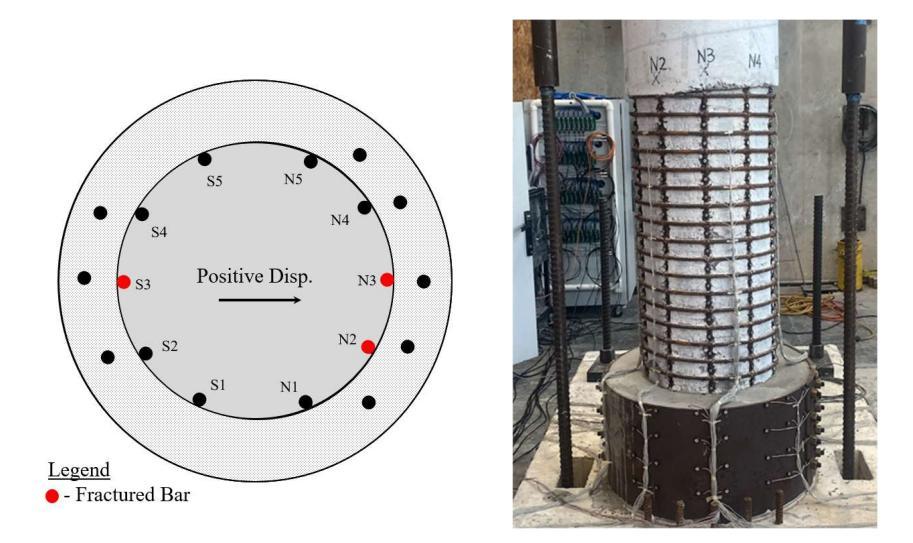
The initial damage condition of this column consisted of 2 fractured bars on the South side and 1 fractured bar on the North side. The perimeter concrete was chipped around fractured bars. The repair reinforcement consisted of 8 Grade 80 No. 5 bars which were anchored using epoxy in drilled holes. The cross section for the repair is shown in Figure 4.91. The properties for the original column and repair are summarized in Table 4.8.

Figure 4.91: Cross section for Repair #8 and Completed Repair Table 4.8: Column and Repair Properties for Repair #8.

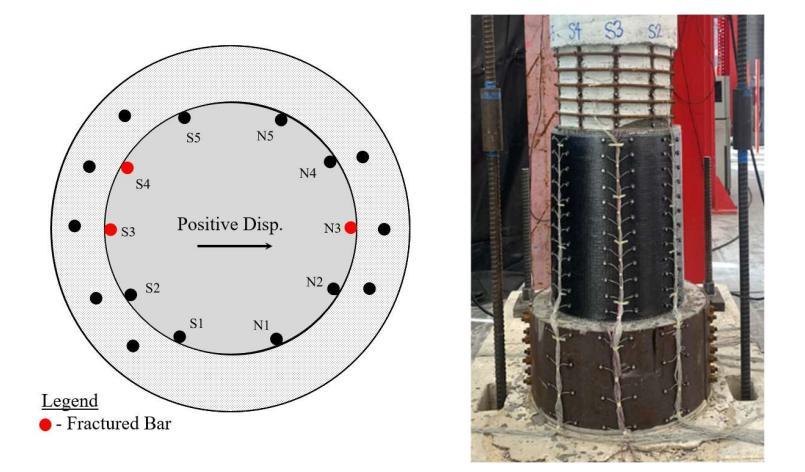
The initial damage condition of this repair was 1 fractured bar on the North side and 2 fractured bars on the South side. The perimeter concrete was chipped around the fractured bars. The cross section and completed repair is shown in Figure 4.102. To compare the influence of the CFRP wrap with Repair #8, the repair height was 13.5 inches. Although 13.5 inches was not sufficient to anchor all of the previously fractured bars in Repair #8, the CFRP wrap could improve the bond conditions, while minimizing the increase in moment demand at the footing. The properties for the original column and repair are summarized in Table 4.9.

Figure 4.102: Cross Section for Repair #9.

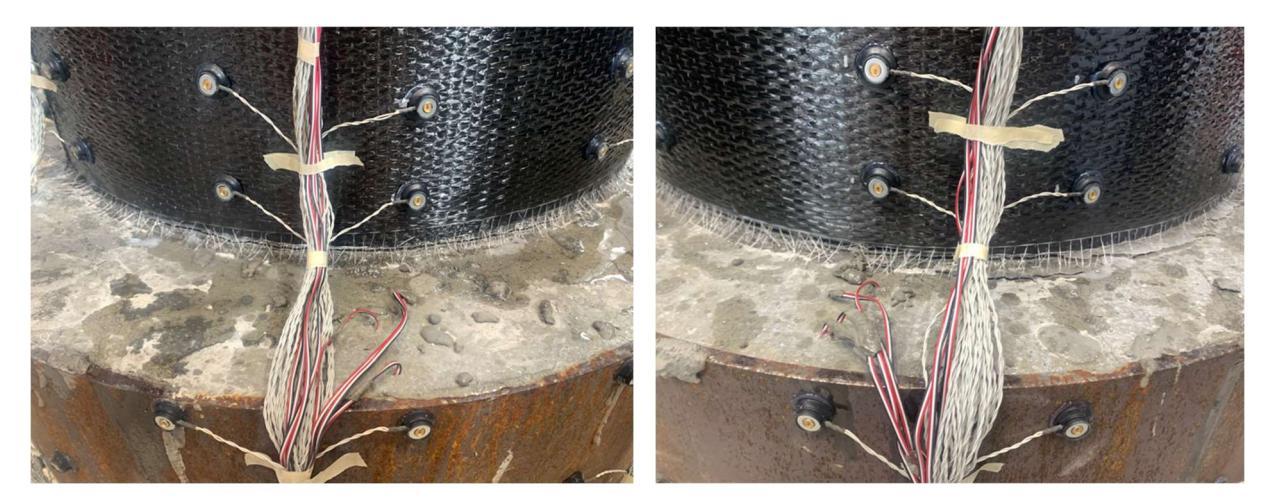
Figure 4.104: Damage During Ductility 2 of the North (left) and South (right) Sides.

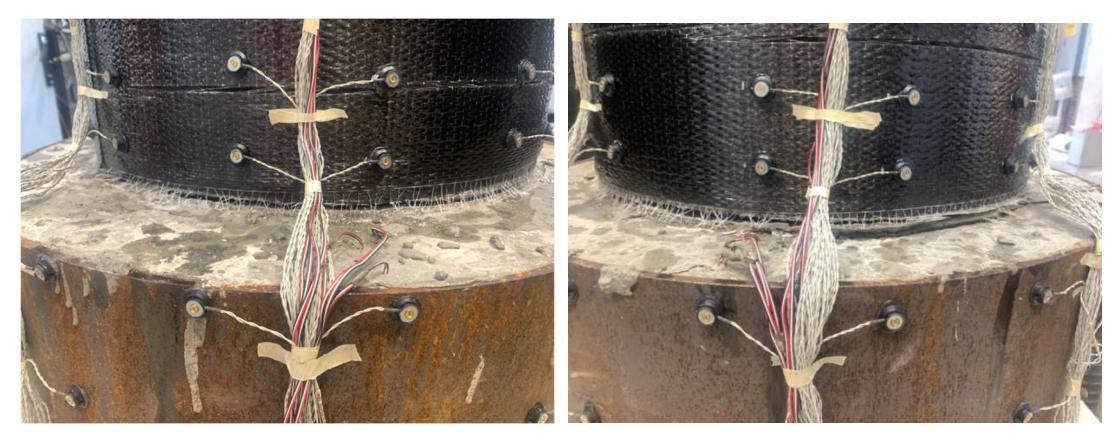
Figure 4.105: Damage During Ductility 4 of the North (left) and South (right) Sides.

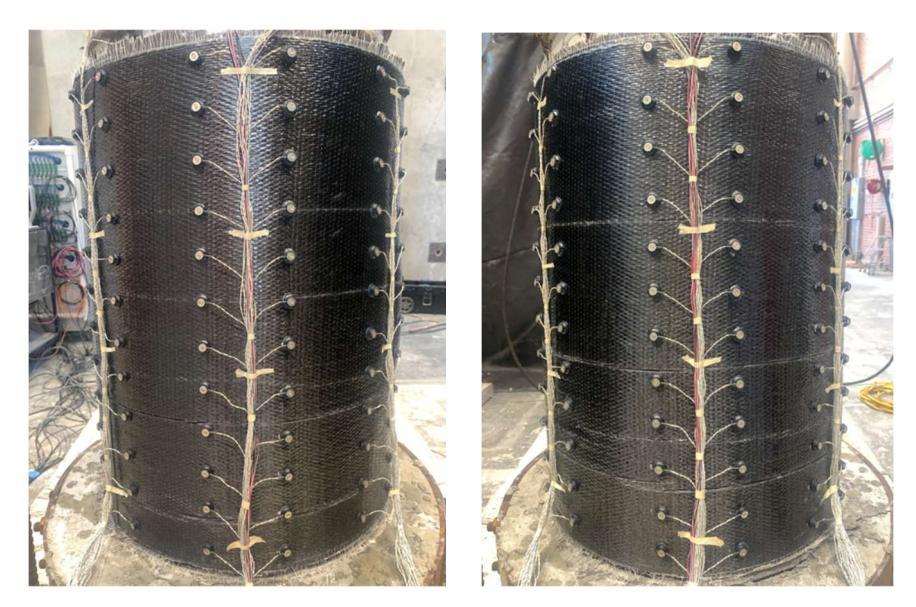
Figure 4.106: Damage During Ductility 6 of the North (left) and South (right) Sides.

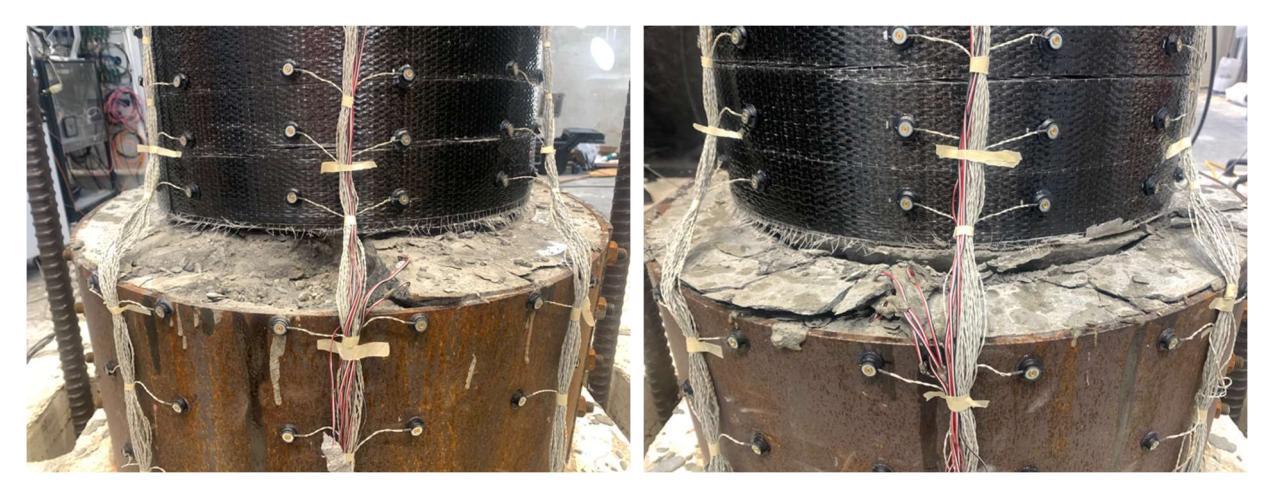
Figure 4.107: Final Damage of the North (left) and South (right) Sides.

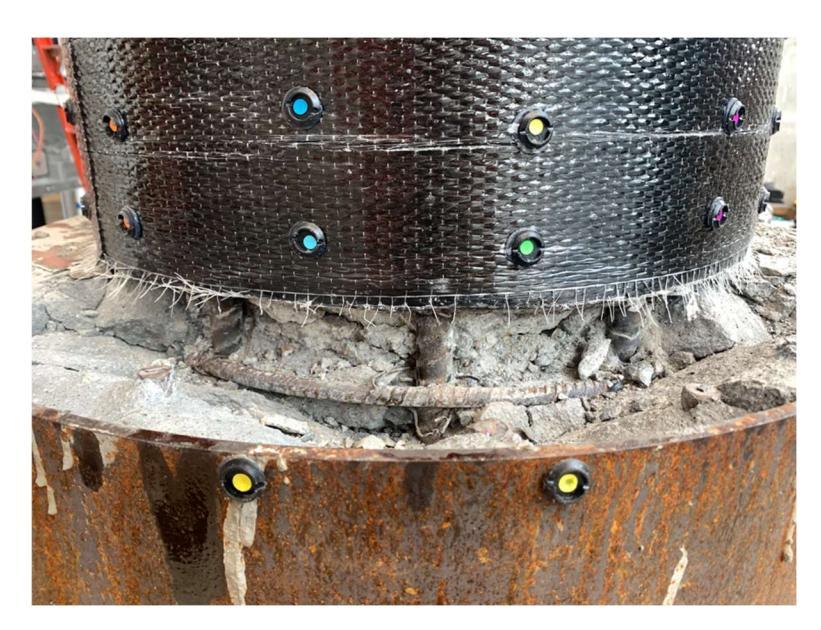
Because of the presence of the CFRP wrap, the longitudinal bars were not visible during the test, and they could not be instrumented with Optotrak LEDs to obtain direct strain measurements. The inferences about longitudinal bar behavior throughout the progression of the test were based on the changes in force applied by the actuator. During the first cycle of ductility 8, there was a loud noise and drop in force which indicated a bar fracture on the South side. In the following pull, 3 distinct noises and drops in force occurred. After the test concluded, the grout at the interface between the steel repair and CFRP was removed to determine the fracture locations. All 4 bar fractures that were heard in the test were found approximately one inch below the FRP, as shown in Figure 4.108. The bars did not show any sign of buckling.

Figure 4.108: Removal of Grout to Locate Fracture Points.

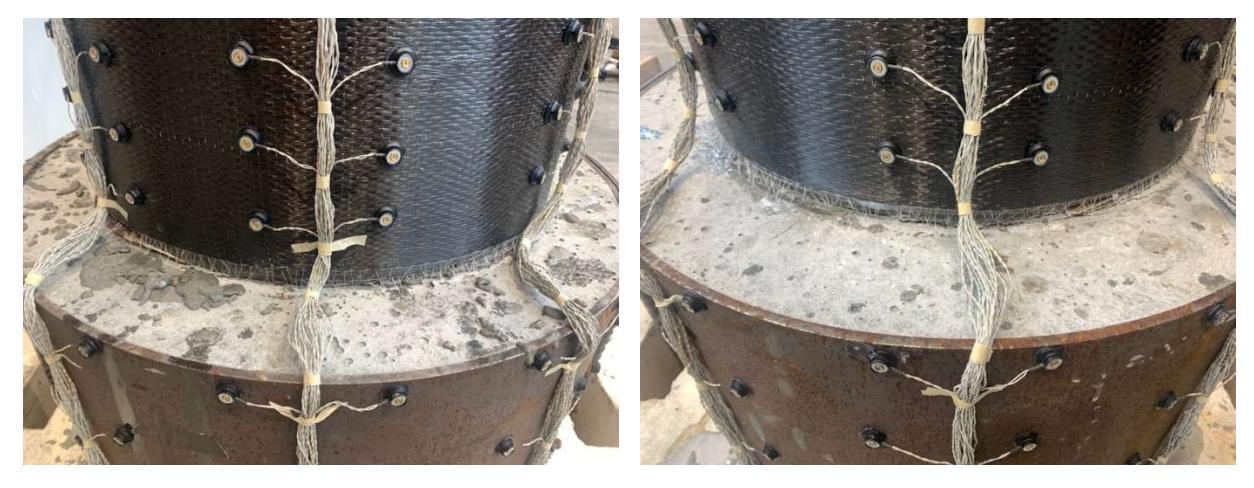
Photos of the test progression are shown in Figure 4.114 through Figure 4.121. Similar to the previous repair, the epoxy began to audibly crack around the first yield displacement, and a hairline circumferential grout crack formed at the base of the CFRP. However, this repair displayed more cracking in the grout, starting around ductility 2. Similar to Repair #9, transverse cracks formed in the FRP around ductility 1.5, and a concentrated crack at the base of the FRP formed during ductility 2. Cracks at the top of the grout also formed. The extreme bar on the South side (S3) fractured during

Figure 4.114: Damage During Ductility 1.5 of the North (left) and South (right) Sides.

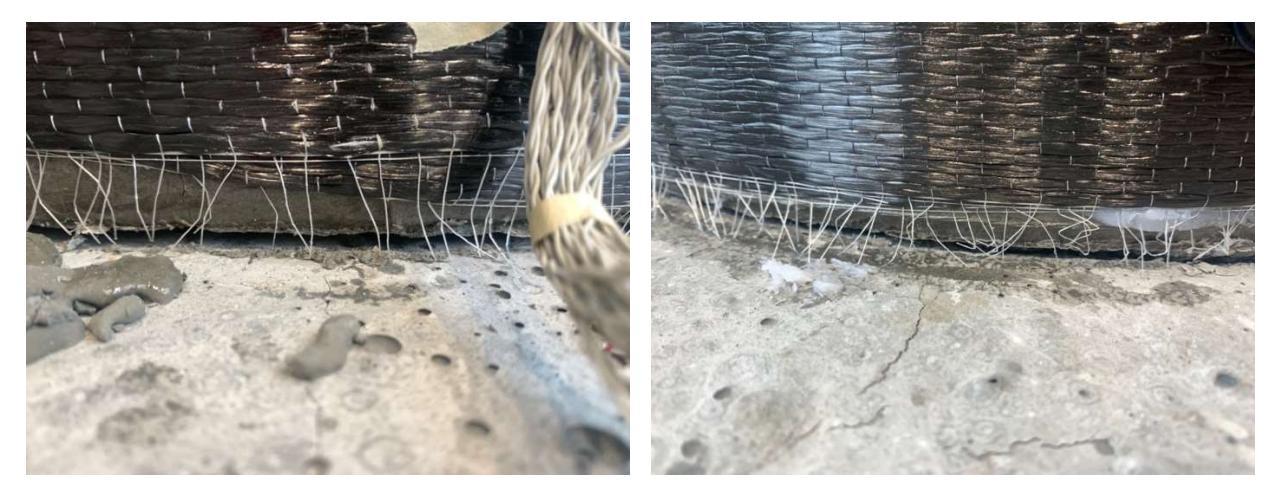
Figure 4.116: Damage Below CFRP During Ductility 2 of the North (left) and South (right) Sides.

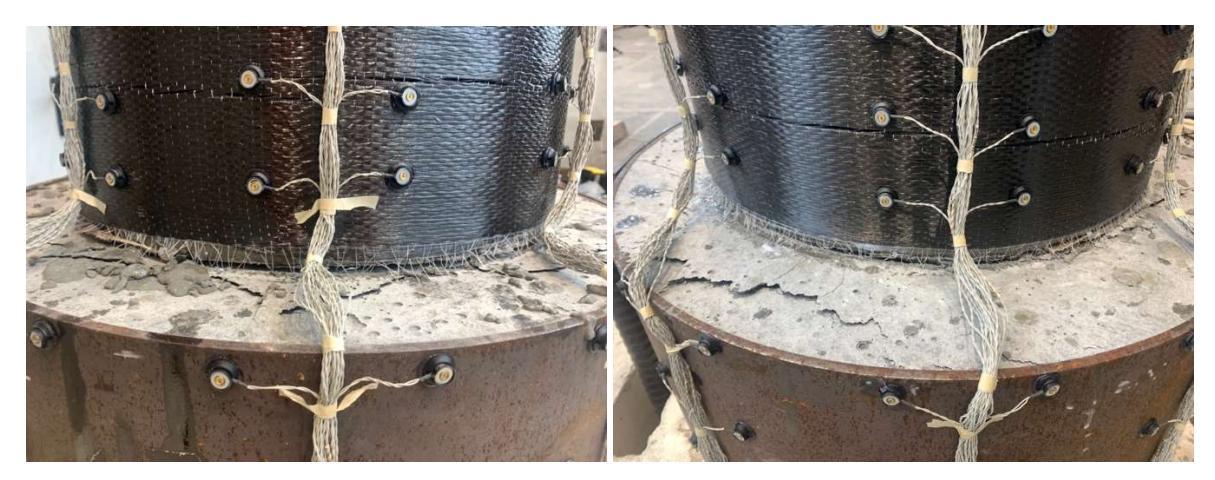
Figure 4.118: Damage Below CFRP During Ductility 3 of the North (left) and South (right) Sides.
