SUPPLEMENTAL GEOTECHNICAL REPORT

DALTON HIGHWAY 9 MILE HILL NORTH

FEDERAL PROJECT NO. NH-F-06502(3) / STATE PROJECT NO. 64899

MAY 2010

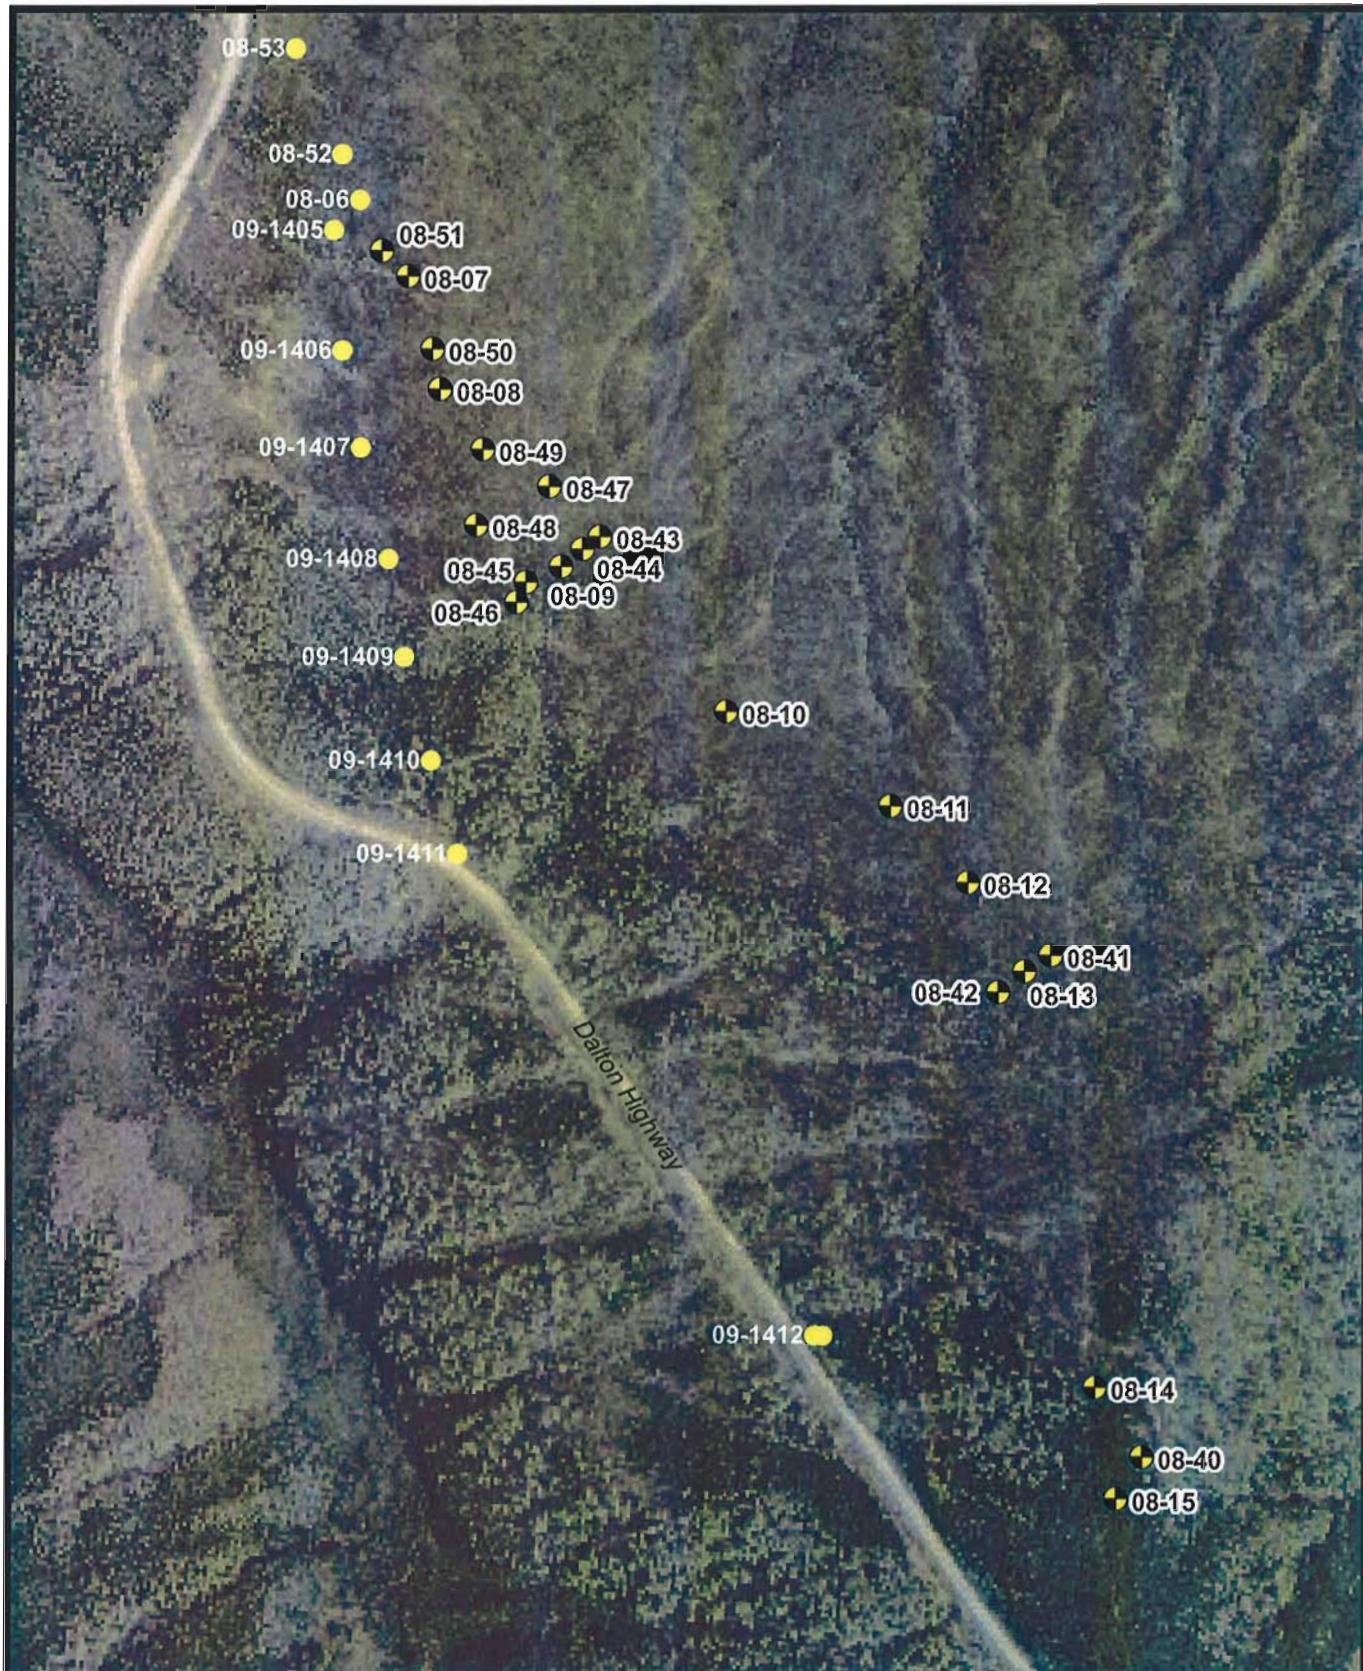
All other 2008 test holes (O line)
beyond current alignment

Dalton Hwy 9 Mile Hill North
Additional O line test holes (2008)
(not included elsewhere in report)

- J and O line test holes shown on Plan sheets
- O line test holes not included on Plan sheets

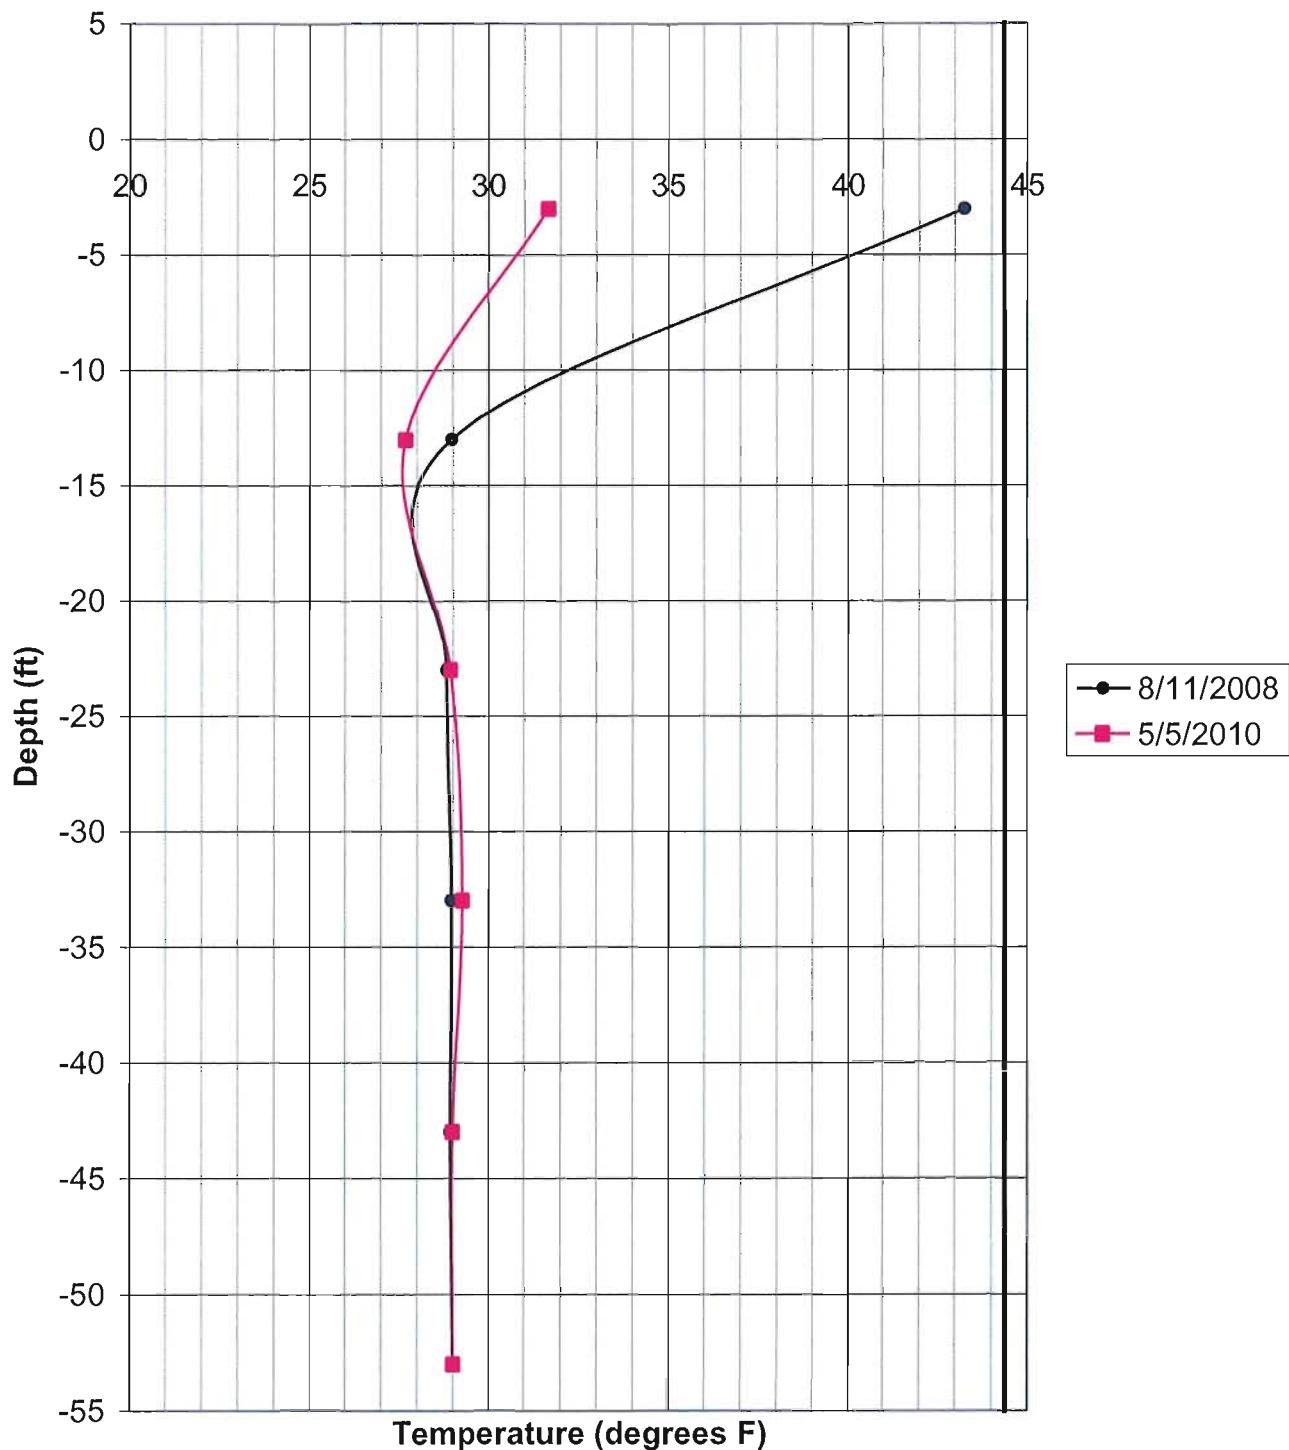
Dalton 9 Mile Hill
Ground temperatures - TH08-053

Permafrost temperatures measured in O line test holes ranged from 29.0 to 31.1 °F. Thermistor data is presented in Appendix E.
