STATE OF ALASKA  
Department of Transportation  
and Public Facilities

2015  
Alaska Marine Highway System  
**SHORE FACILITIES CONDITION  
SURVEY REPORT**

Prepared by  
Southeast Region  
Marine Engineering Section

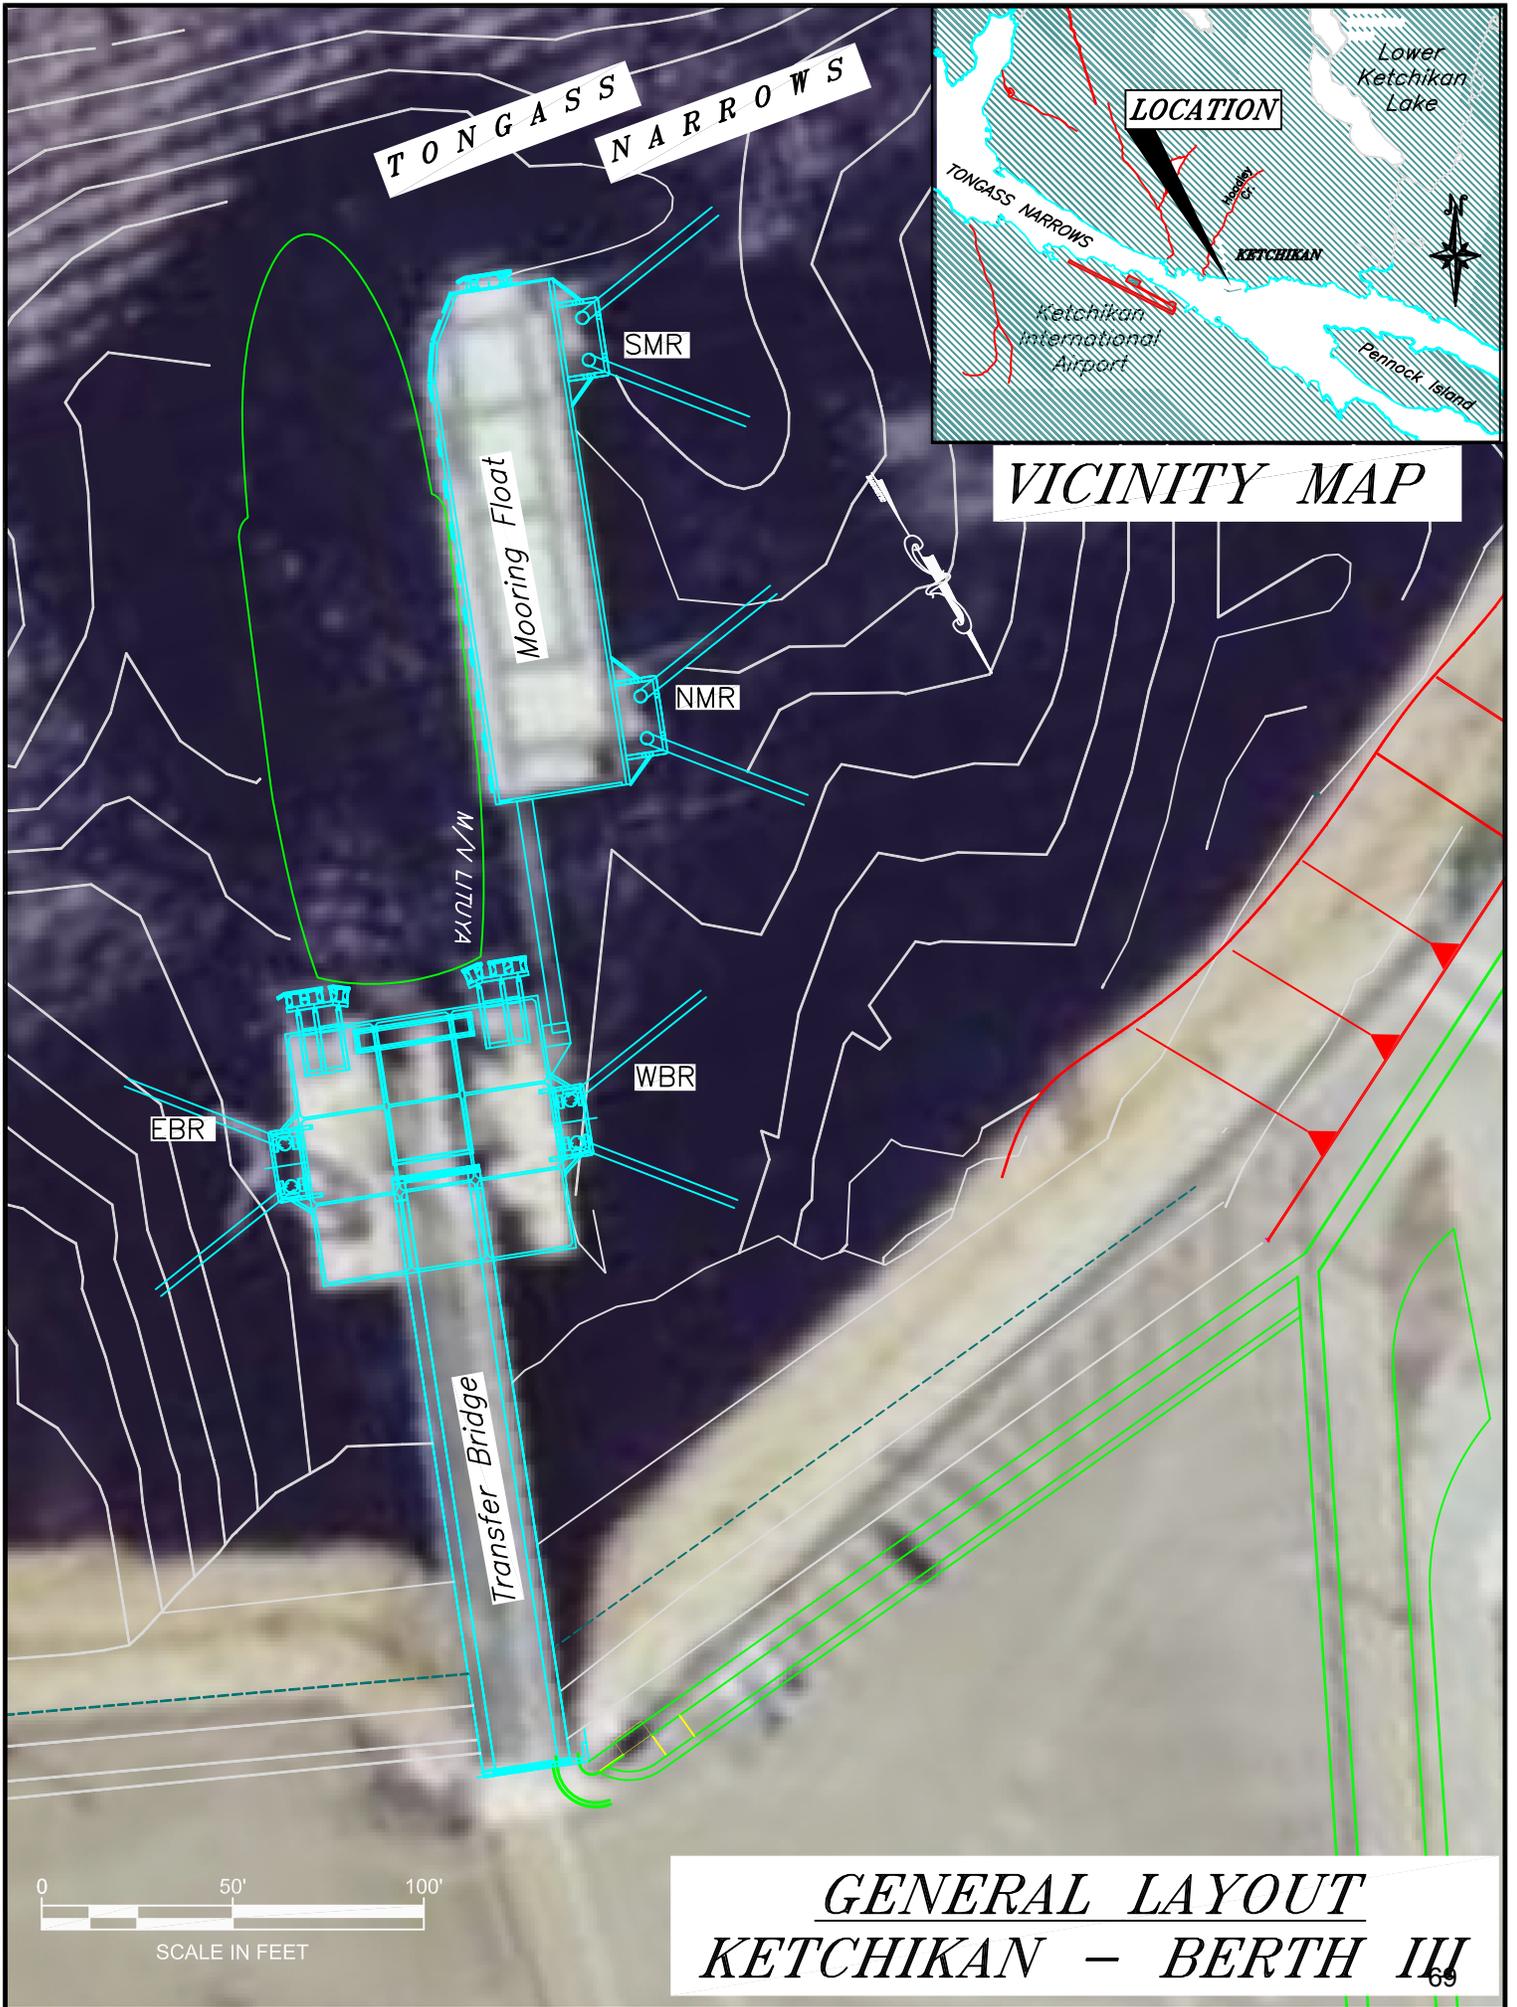
**GENERAL LAYOUT**  
**KETCHIKAN - BERTH III**

# Ketchikan Ferry Terminal, Berth III

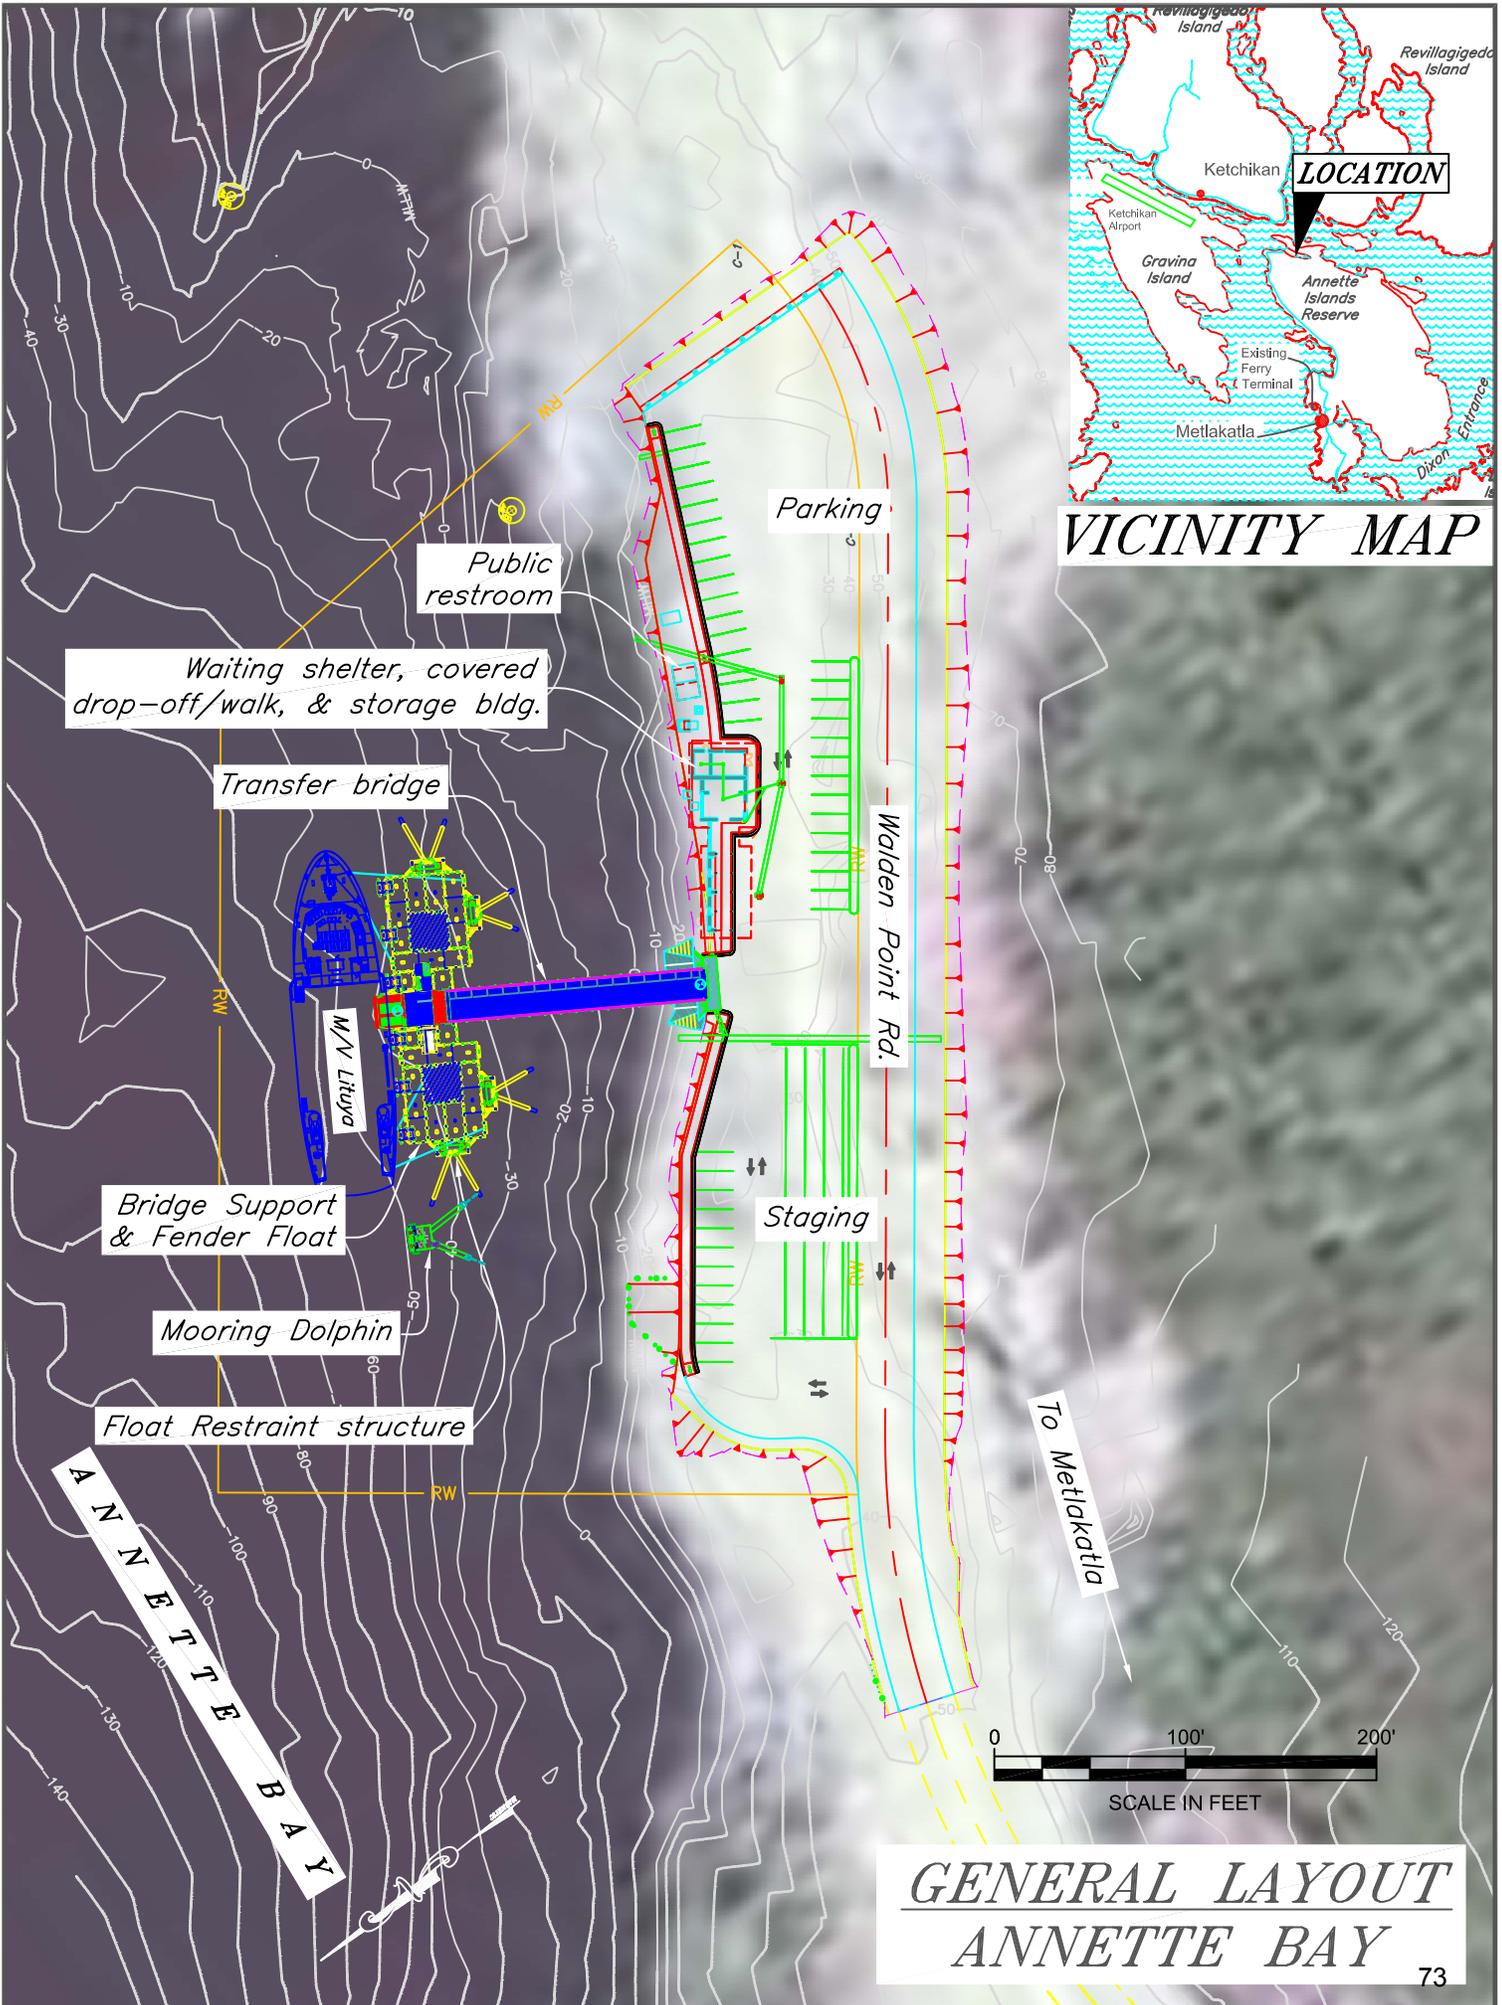
**GENERAL LAYOUT  
ANNETTE BAY**

**Terminal Description:** The Annette Bay Ferry Terminal, built in 2013, is the primary port of call for the M/V Lituya. Annette Bay is a side-berth loading facility. The vehicle transfer bridge and breasting fender panels are supported on a series of Flexifloats. Uplands are paved & striped for parking & staging areas with overhead lighting. There is an open-air waiting shelter, public pit toilets and generator building. There is no terminal building, nor terminal staff, so we didn't get any feedback from operations on the facility.

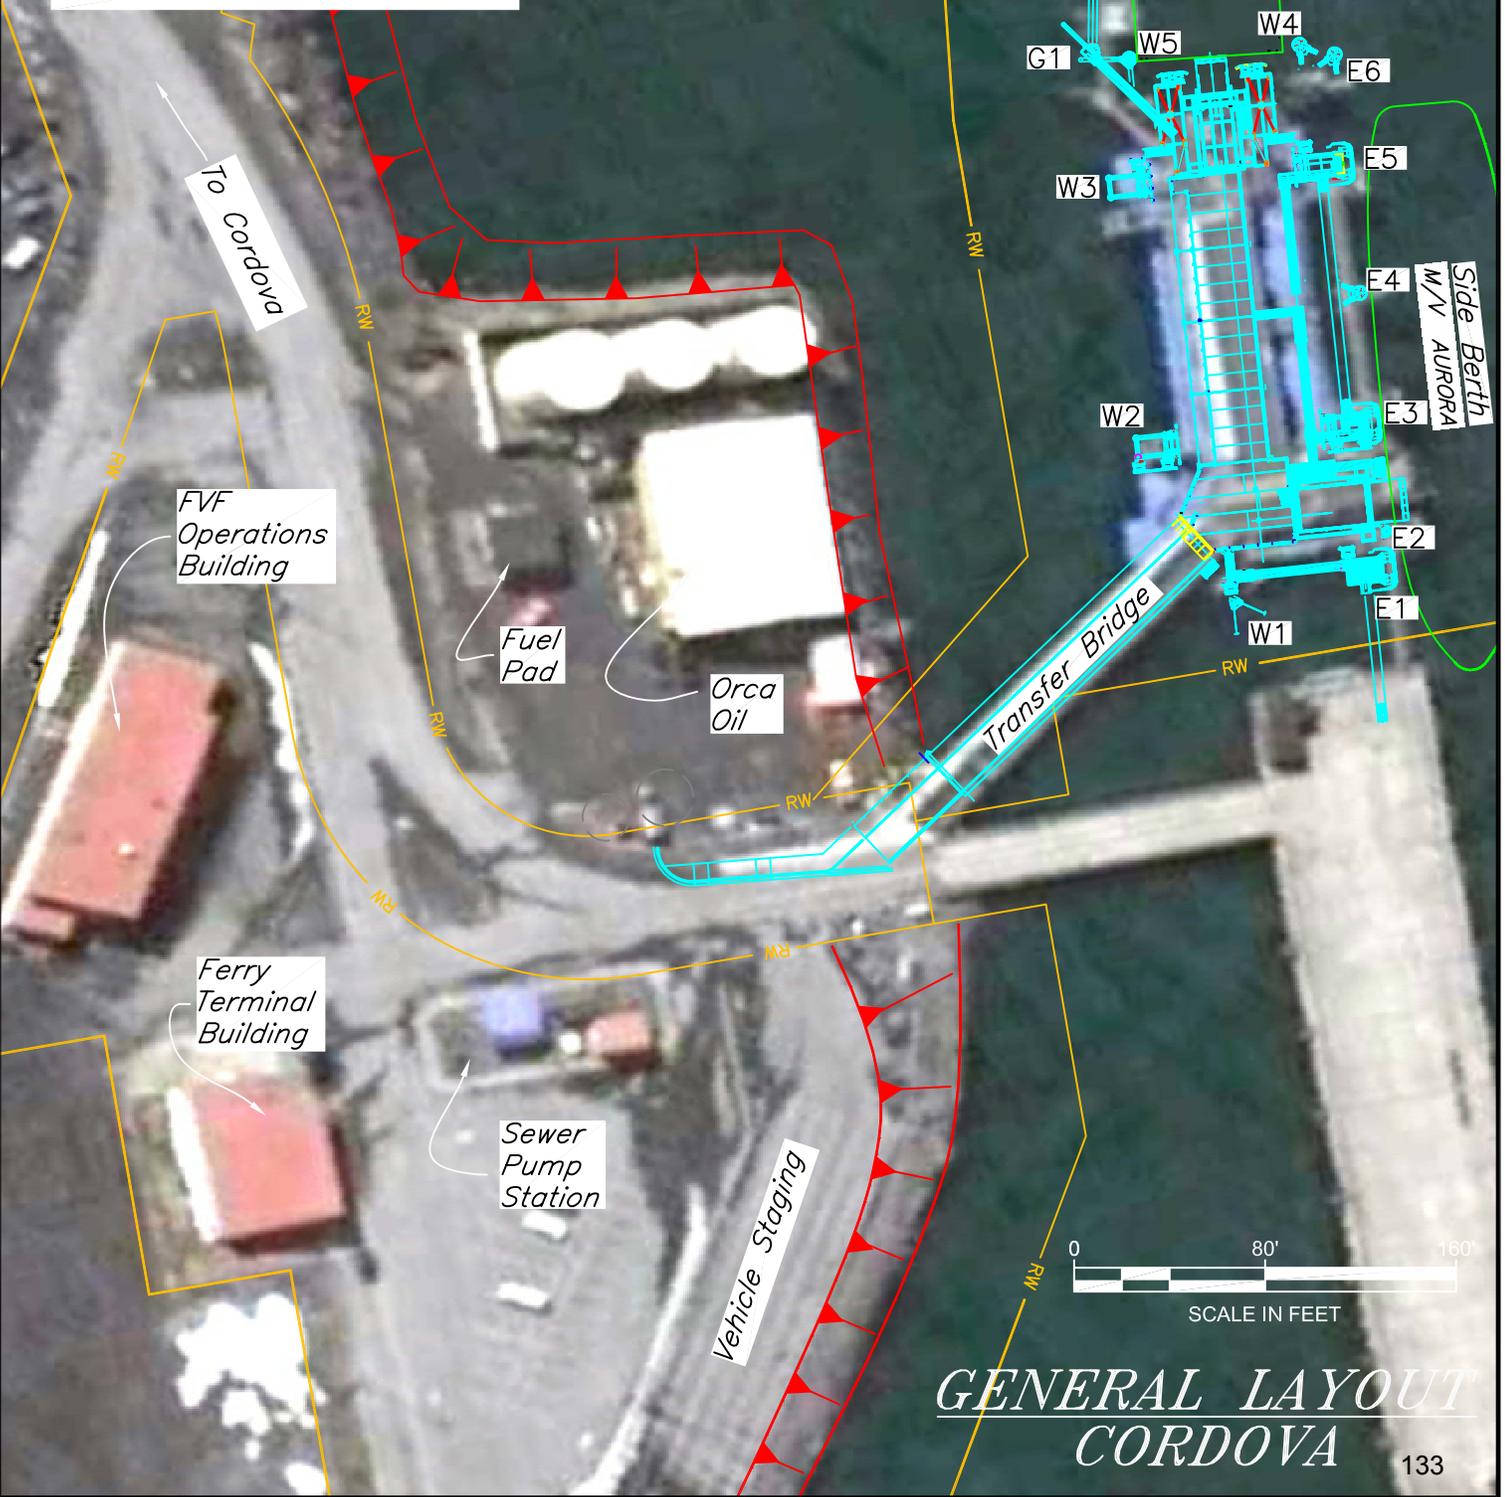
GENERAL LAYOUT  
CORDOVA

**Terminal Description:** Cordova has two berths, each connected to shore by a 40’ approach, 140’ transfer bridge and 60’ x 210’ flexifloat steel float system. The side-loading facility consists of an intermediate ramp & lift system, 6 steel pile dolphins and catwalks/gangways for line-handling access. The stern-loading facility consists of an intermediate ramp & lift system, 6 mooring dolphins and catwalks/gangways for line-handling access. The stern-berth is homeport of the Fast Vehicle Ferry (FVF) M/V Chenega. The past 10 years of total passenger and vehicle traffic at Cordova is shown below.

3. The stern load transfer facility off the southern end of the Cordova City Dock was removed and replaced in 2006 with a stern/side floating berth for all-tide mooring the MV CHENEGA while also providing moorage for the AURORA/KENNICOTT on the side-berth. The older bridge and lift system (installed in 1992) were salvaged and transported to Ketchikan. A 40 foot steel approach trestle and a 140 foot steel transfer bridge access a 60'x210' Flexifloat pontoon system with a raised steel platform and open grate deck. There is an intermediate ramp and apron on the southwest end of the float for a stern berth, and a ramp and apron on the northwest side for a side berth. Refer to the layout for identification of the various dolphin and restraint structures.

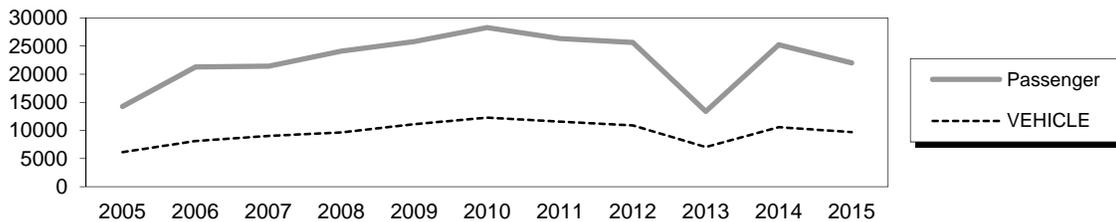
The past 10 years of total passenger and vehicle traffic at Homer is shown below. The M/V Tustumena was out of service most of 2013, causing a steep dropoff in traffic at the terminal.

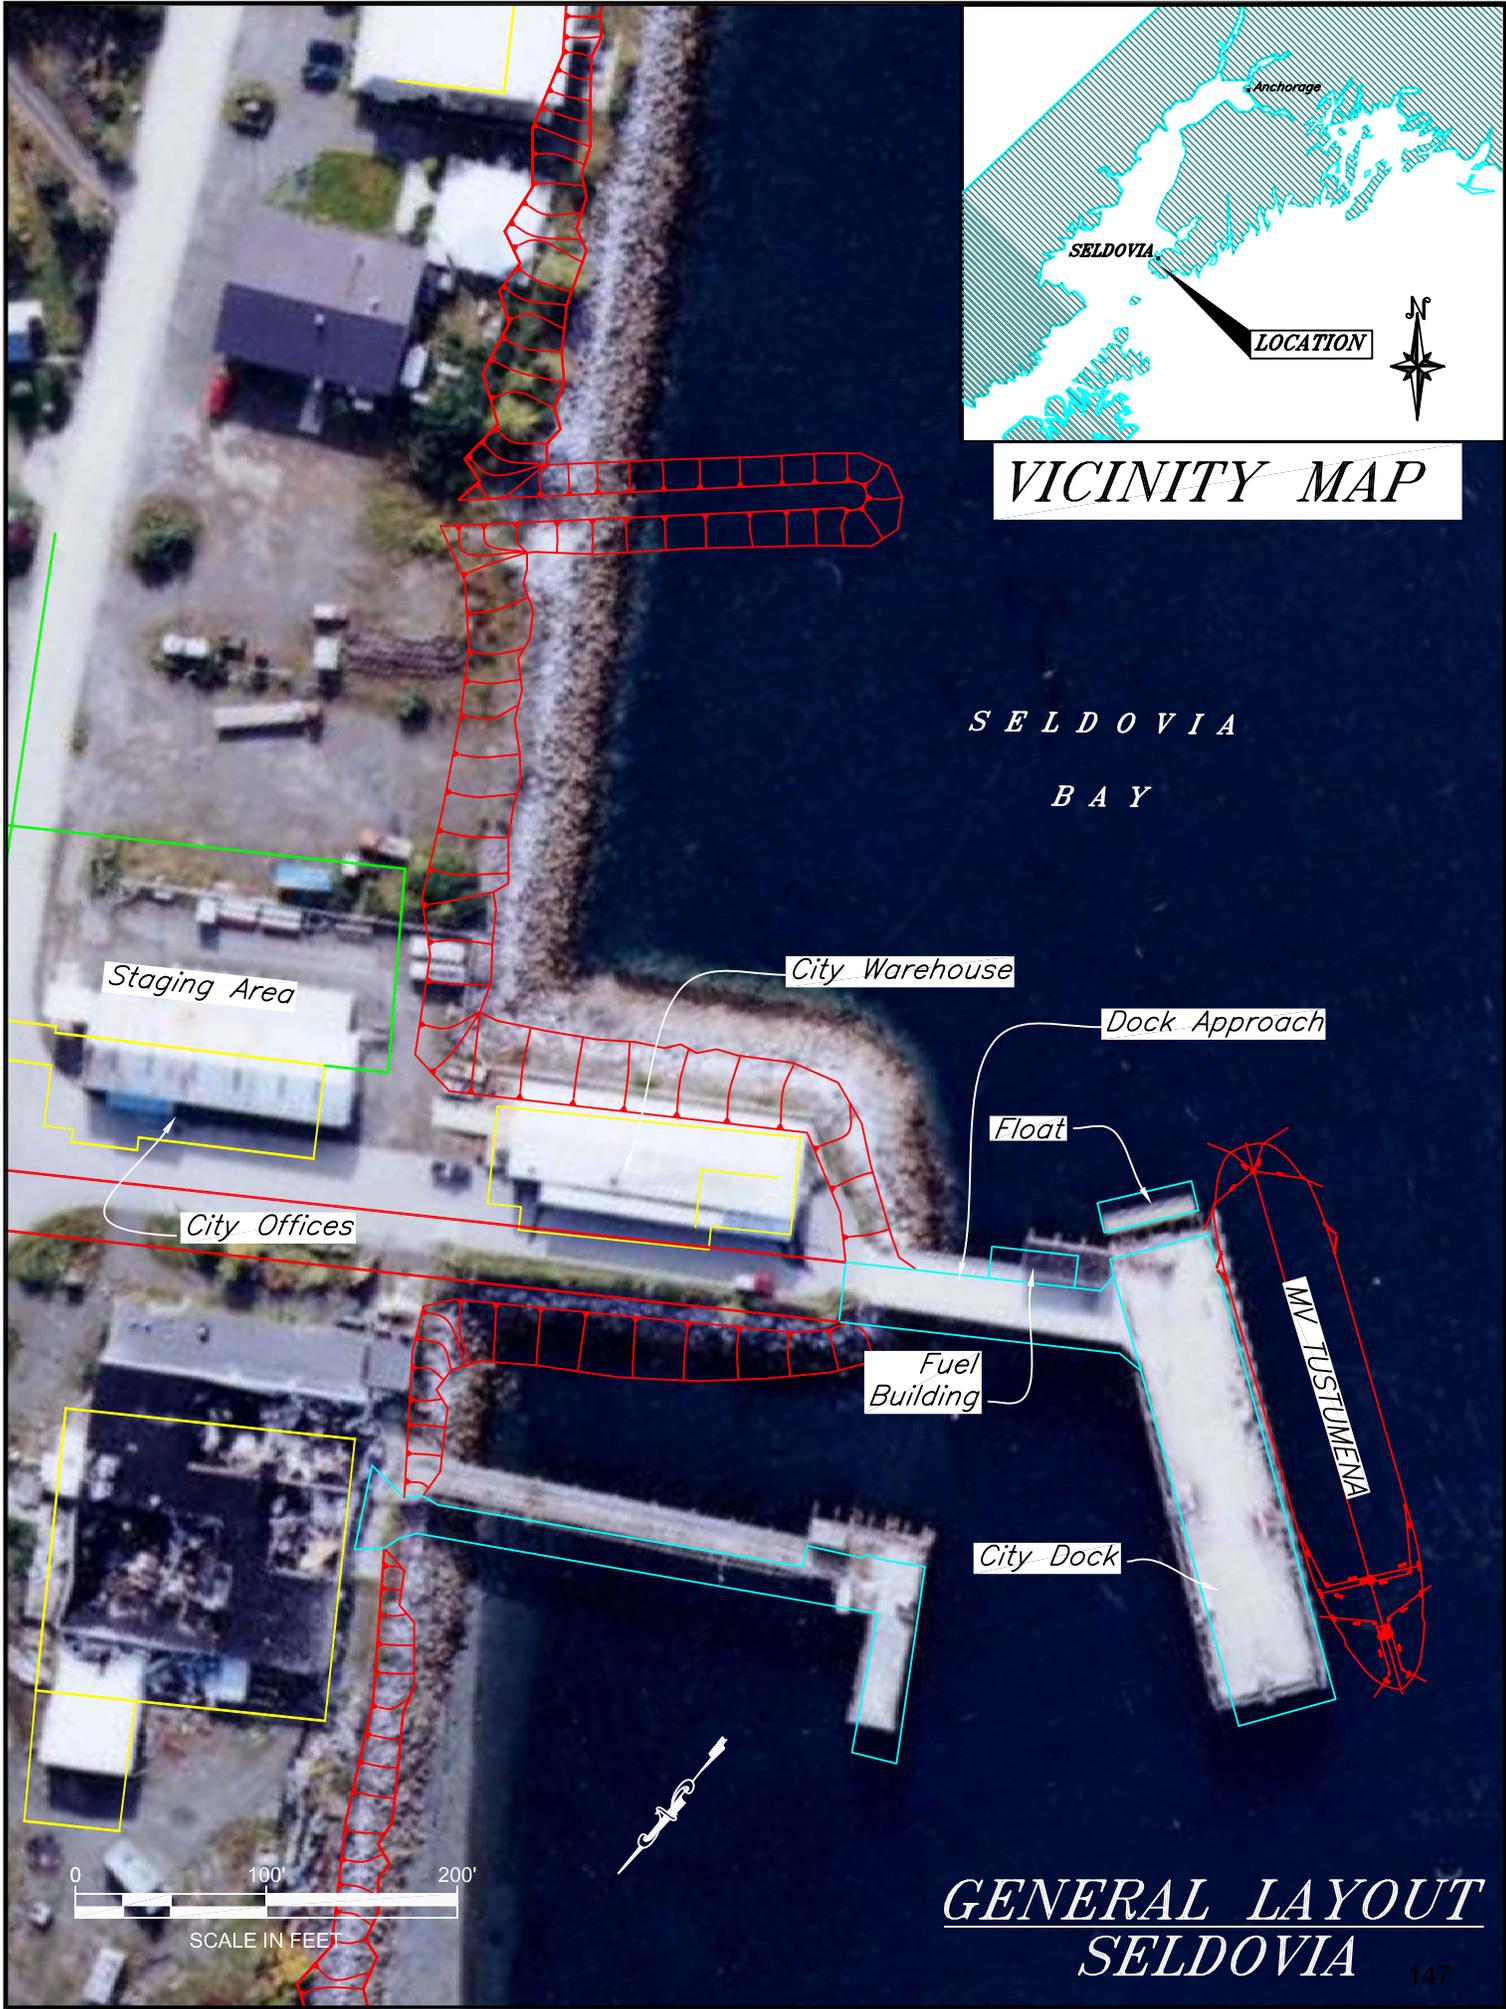
**GENERAL LAYOUT**  
**S E L D O V I A**

**Terminal Description:** Seldovia City Dock is a multi-purpose dock owned and operated by the City of Seldovia. The City & AMHS have an agreement for docking use. The dock is supported on steel pipe piling and has a steel and concrete superstructure with a steel wale, timber faced fender system. Vehicle access is via Dock Street and across a steel approach structure. There is a designated AMHS vehicle staging area (on City owned property), but no terminal building or other upland ferry terminal related facilities. This staging area does not appear to be utilized by ferry traffic. The dock and approach area has a fueling station, fuel storage facilities and serves as a freight wharf. The past 10 years of total passenger and vehicle traffic at Seldovia is shown below. The M/V Tustumena was out of service most of 2013, causing a steep dropoff in traffic at the terminal.

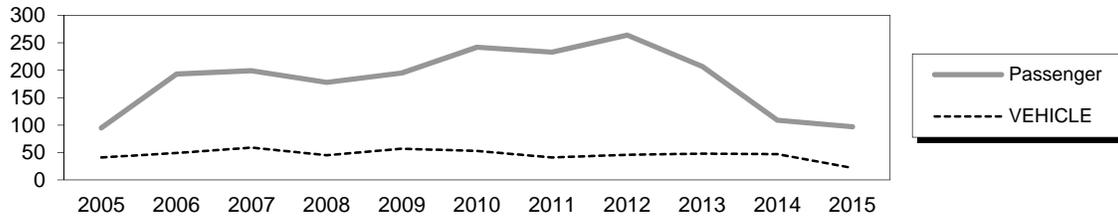
The past 10 years of total passenger and vehicle traffic at Tatitlek is shown below.

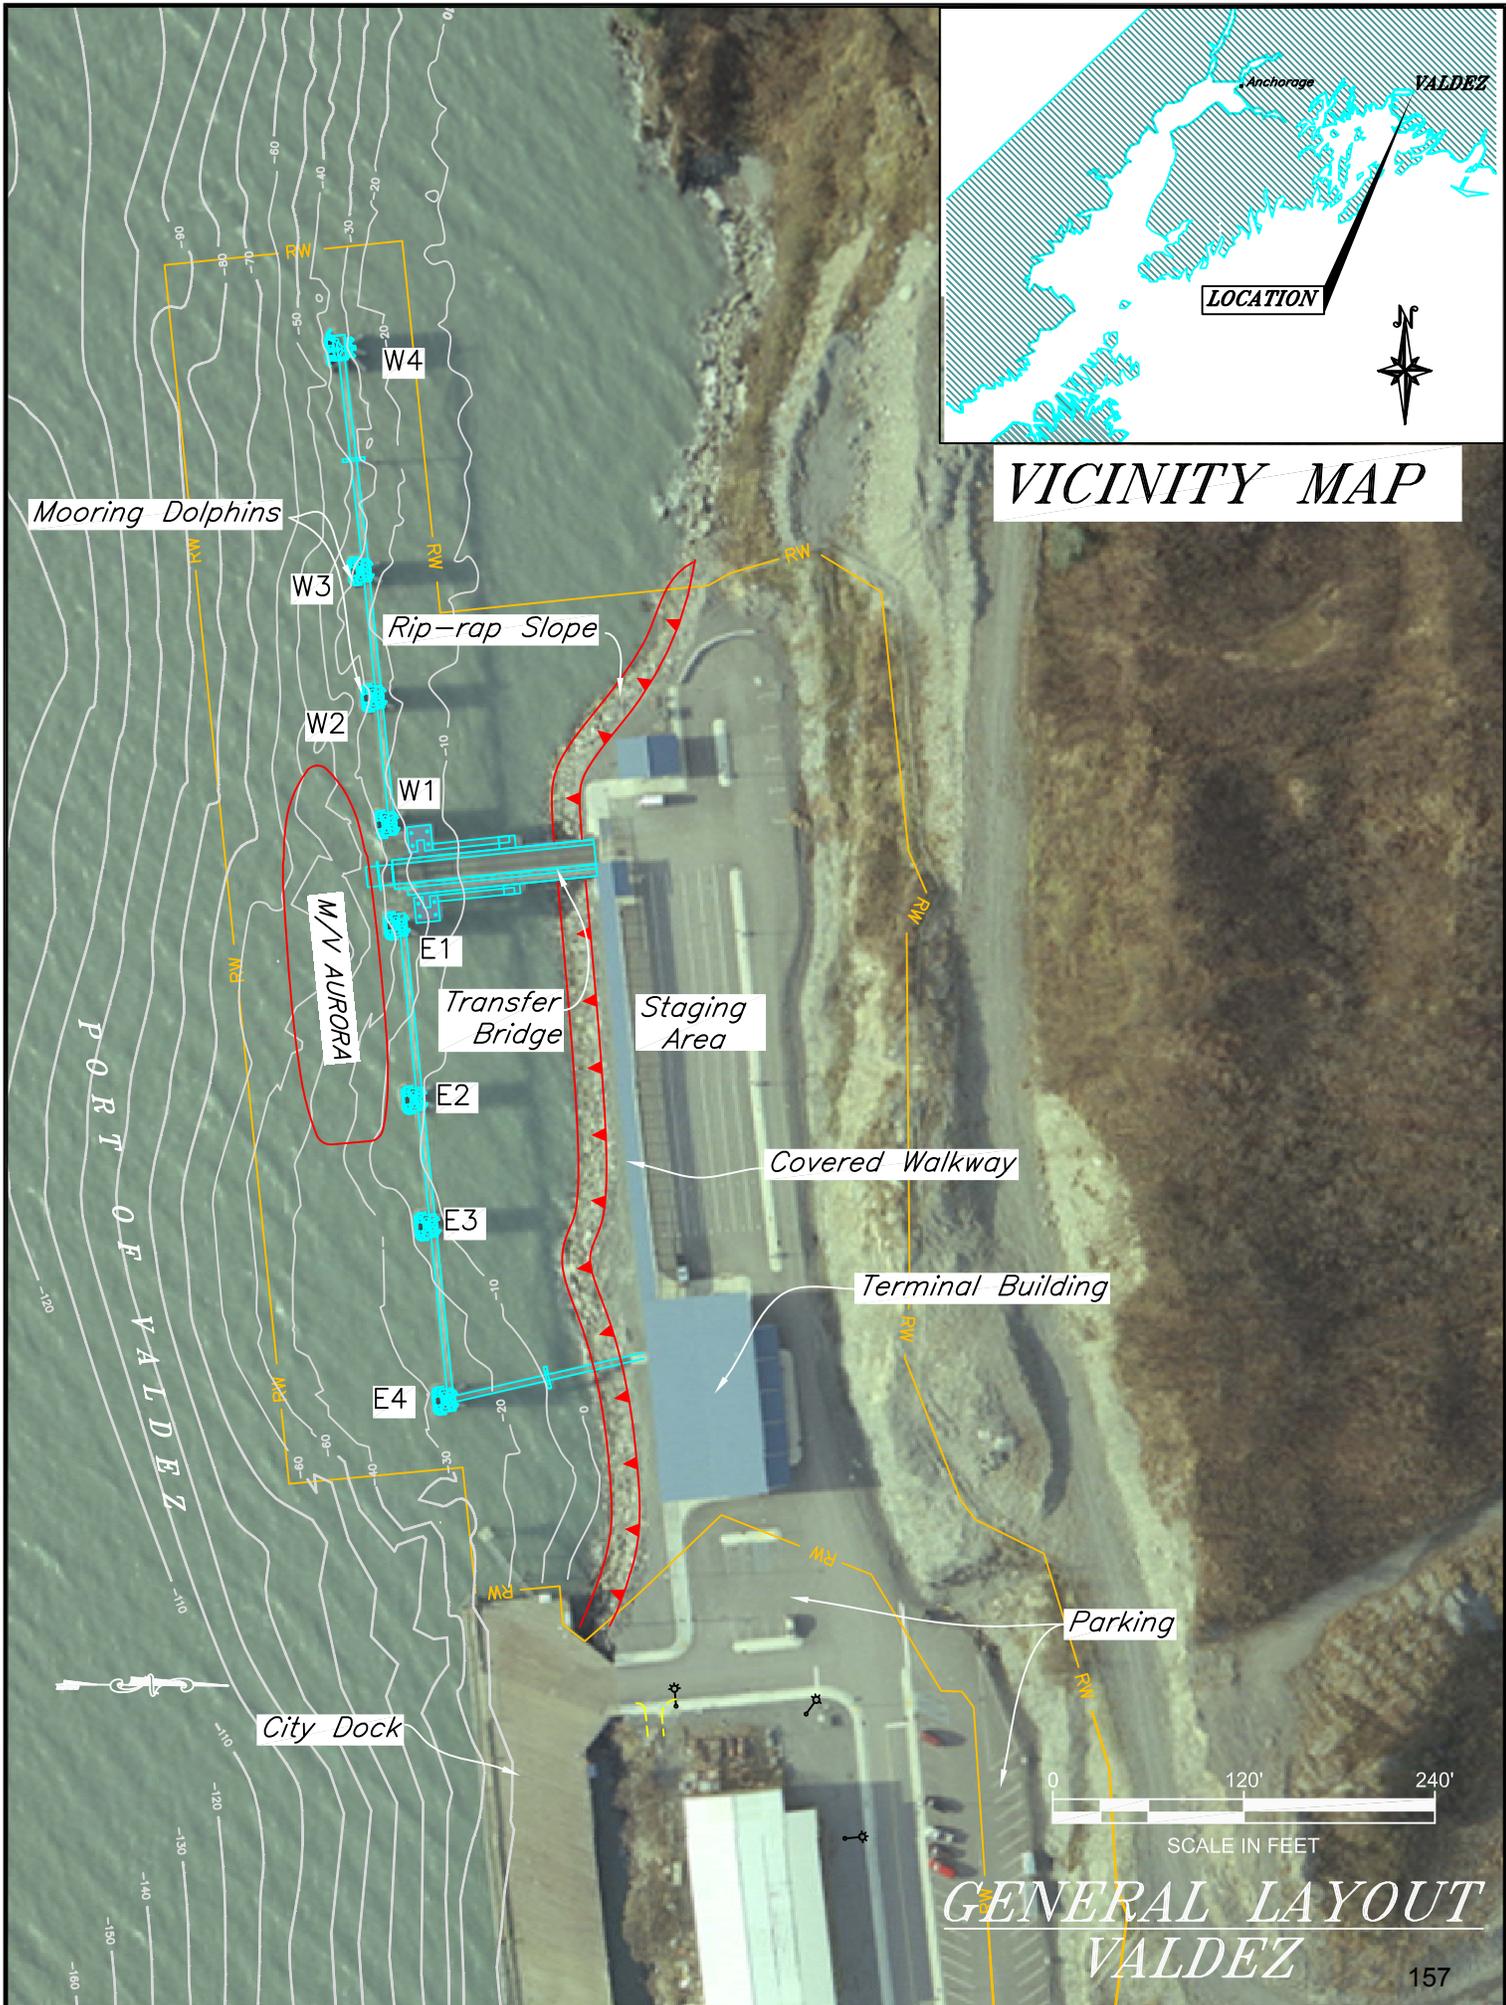
# GENERAL LAYOUT VALDEZ

**Terminal Description:** Valdez is a side-loading facility consisting of a dedicated staging and parking areas, terminal building, covered pedestrian walkways, steel transfer bridge with a cable supported bridge lift (Syncrolift) system, eight steel pile dolphins and catwalks/gangways for line-handling access. The past 10 years of total passenger and vehicle traffic at Valdez is shown below.

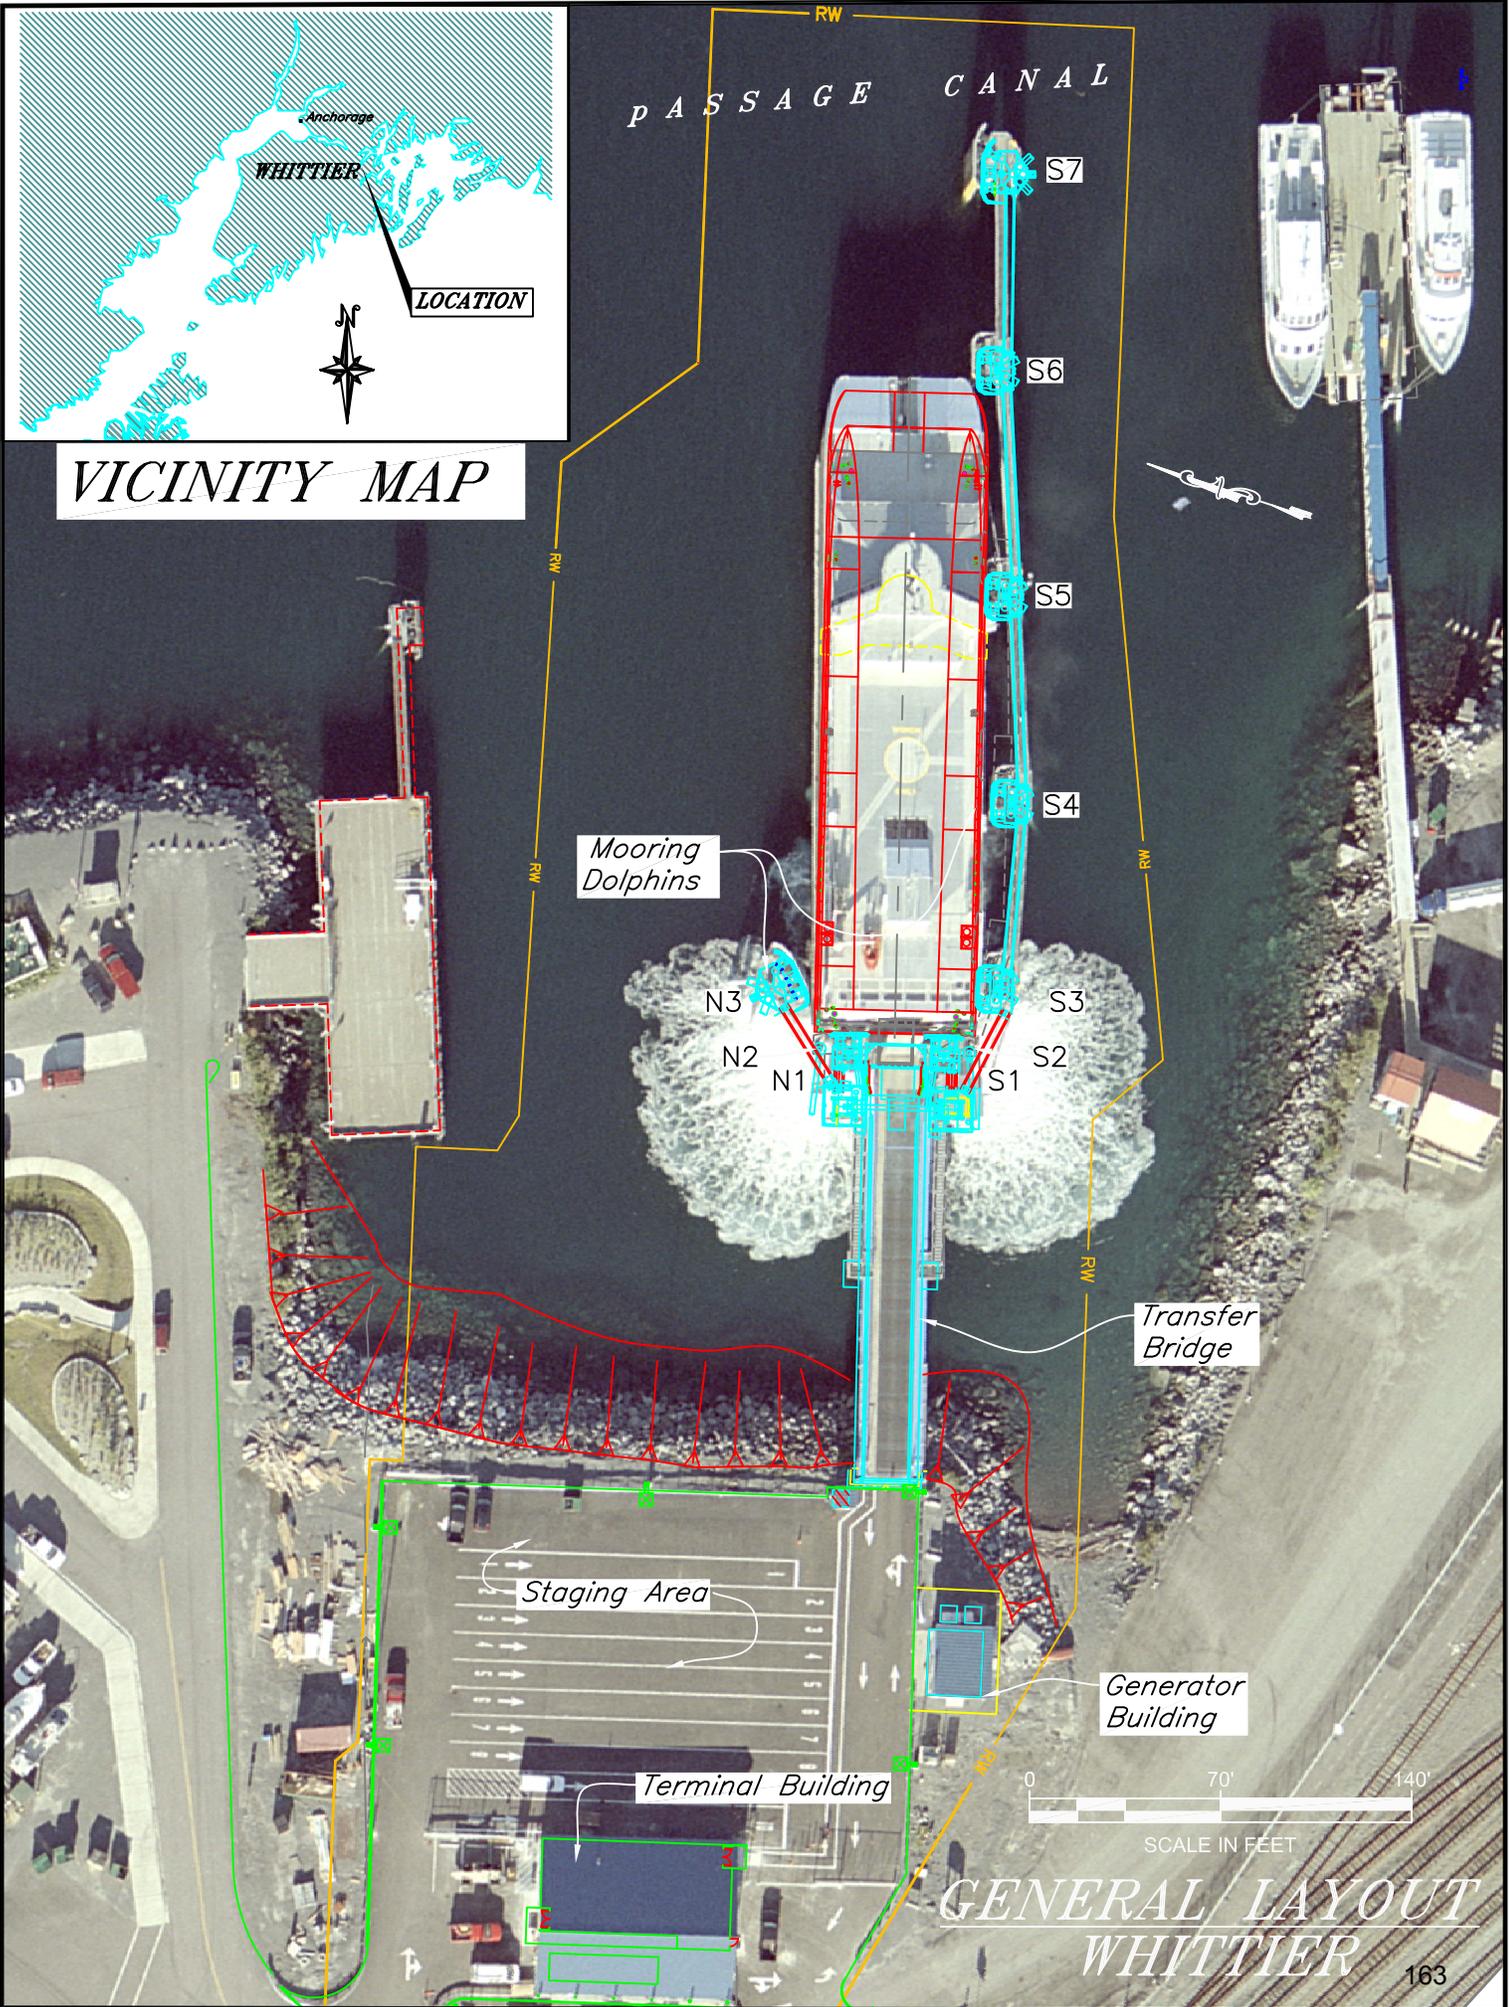
Mooring Dolphins

Transfer Bridge

**Terminal Description:** Whittier is a stern-loading facility consisting of a transfer bridge, twin lift tower syncrolift, 10 steel pile dolphins and associated catwalks/gangways for line-handling access. The facility was upgraded from a timber tidal ramp to a lift and transfer bridge with steel mooring structures in 1988. Modifications were made in 2005 to accommodate the M/V AURORA, M/V KENNICOTT and the Fast Vehicle Ferry, MV CHENEGA. A single-lane highway tunnel and the Alaska Railroad provide access to Whittier from Anchorage and Portage. Like Valdez, this is a key connection point between Cordova and Anchorage. Tourism accounts for much of the summer traffic volume through this port. The facility went to year round service starting in 2005 with the reopening of the new modification project. The past 10 years of total passenger and vehicle traffic at Whittier is shown below.

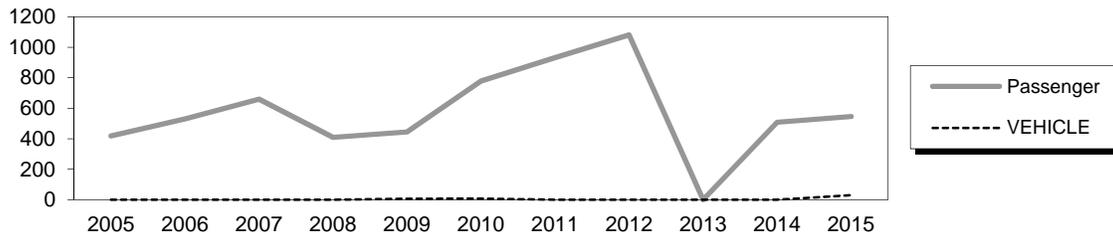
**Terminal Description:** The M/V TUSTUMENA docks in Akutan during its May through September Aleutian Chain trips. AMHS has previously discharged only passengers at this facility; however, sailings now include some vehicles. The Akutan City Dock is a platform dock constructed of concrete panels, steel pile caps and steel support piling. Abutting the back of the dock is an earth filled sheet pile bulkhead for the full length of the dock. There are two mooring dolphins with fender units on each side of the dock. In line with the western dolphins is a sheet pile wall that acts as a wave barrier for a small boat harbor, with a 50-foot extension installed in 2005. The past 10 years of total passenger and vehicle traffic at Akutan is shown below. Akutan had no ferry service in summer 2013 while the M/V Tustumena was in the shipyard for repairs.

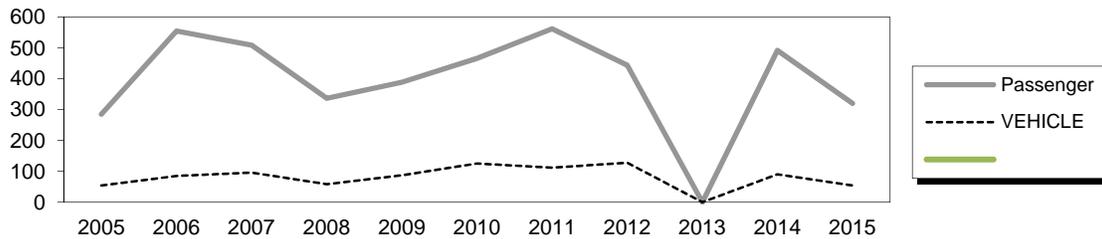
**Terminal Description:** The M/V TUSTUMENA docks at the old NorQuest seafood processor facility in Chignik during its May through September Aleutian Chain trips. The old NorQuest fish processing dock is an all timber structure built circa 1960. Trident Seafoods purchased this facility in 2006. The dock is U-shaped with the open side facing seaward. The west leg has a face 61' long and includes an icehouse, two pedestal cranes, and other ancillary equipment for commercial fish operations. The east leg has a 52' long face with a fuel shed and propane storage tank. The past 10 years of total passenger and vehicle traffic at Chignik is shown below. Chignik had no ferry service in summer 2013 while the M/V Tustumena was in the shipyard for repairs.
